A report on test pits dug at the church of **St James the Great,** East Hill, Colchester, Essex

March 2000

CAT REPORT 72

report by Howard Brooks

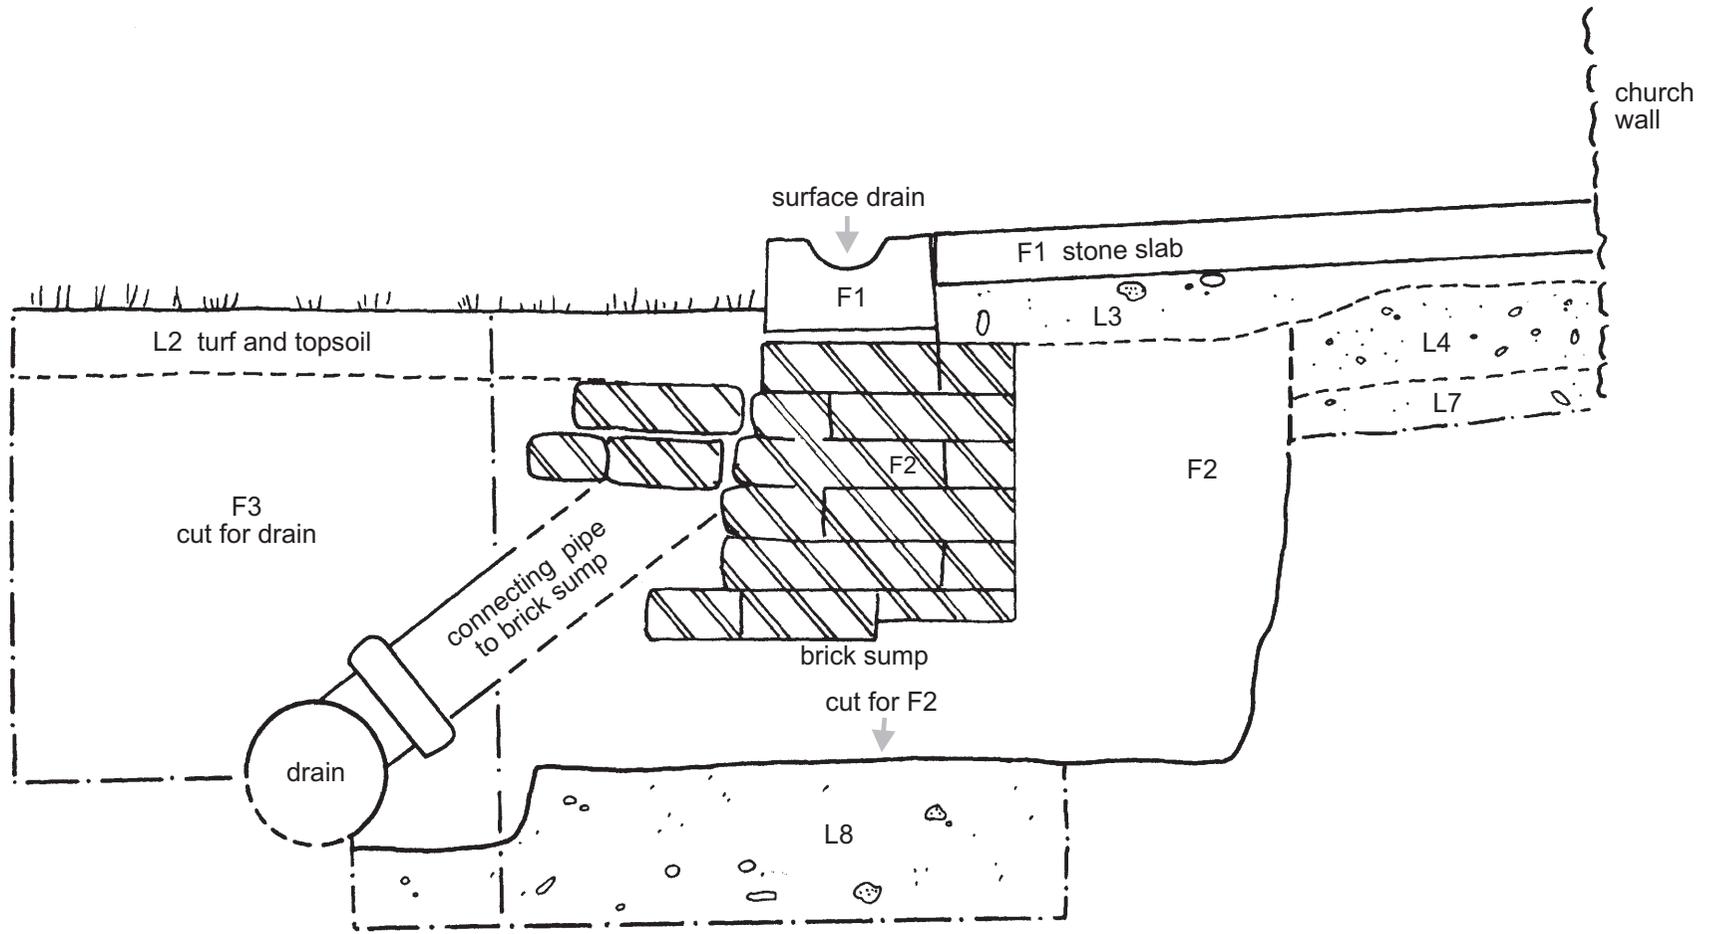
Fig 2 West face of Trench 1, and common conventions.

The drain consisted of a ceramic pipe laid in a trench (Feature 3 or F3) at a distance of 1.7m from the church wall. The pipe top was at 520mm below modern ground level and 470mm above the top of a brick sump (F2) which was revealed by the lifting of the stone surface drain blocks (F1). The sump was approximately 500 x 500mm in plan (not always a consistent dimension on the surface and in section) and 450mm deep (six courses of soft reds, loosely mortared). A short pipe running south and down connected the sump to the main drain line. The brick sump was full of soil, and breaking into the connecting pipe showed that this, too, was clogged with soil.

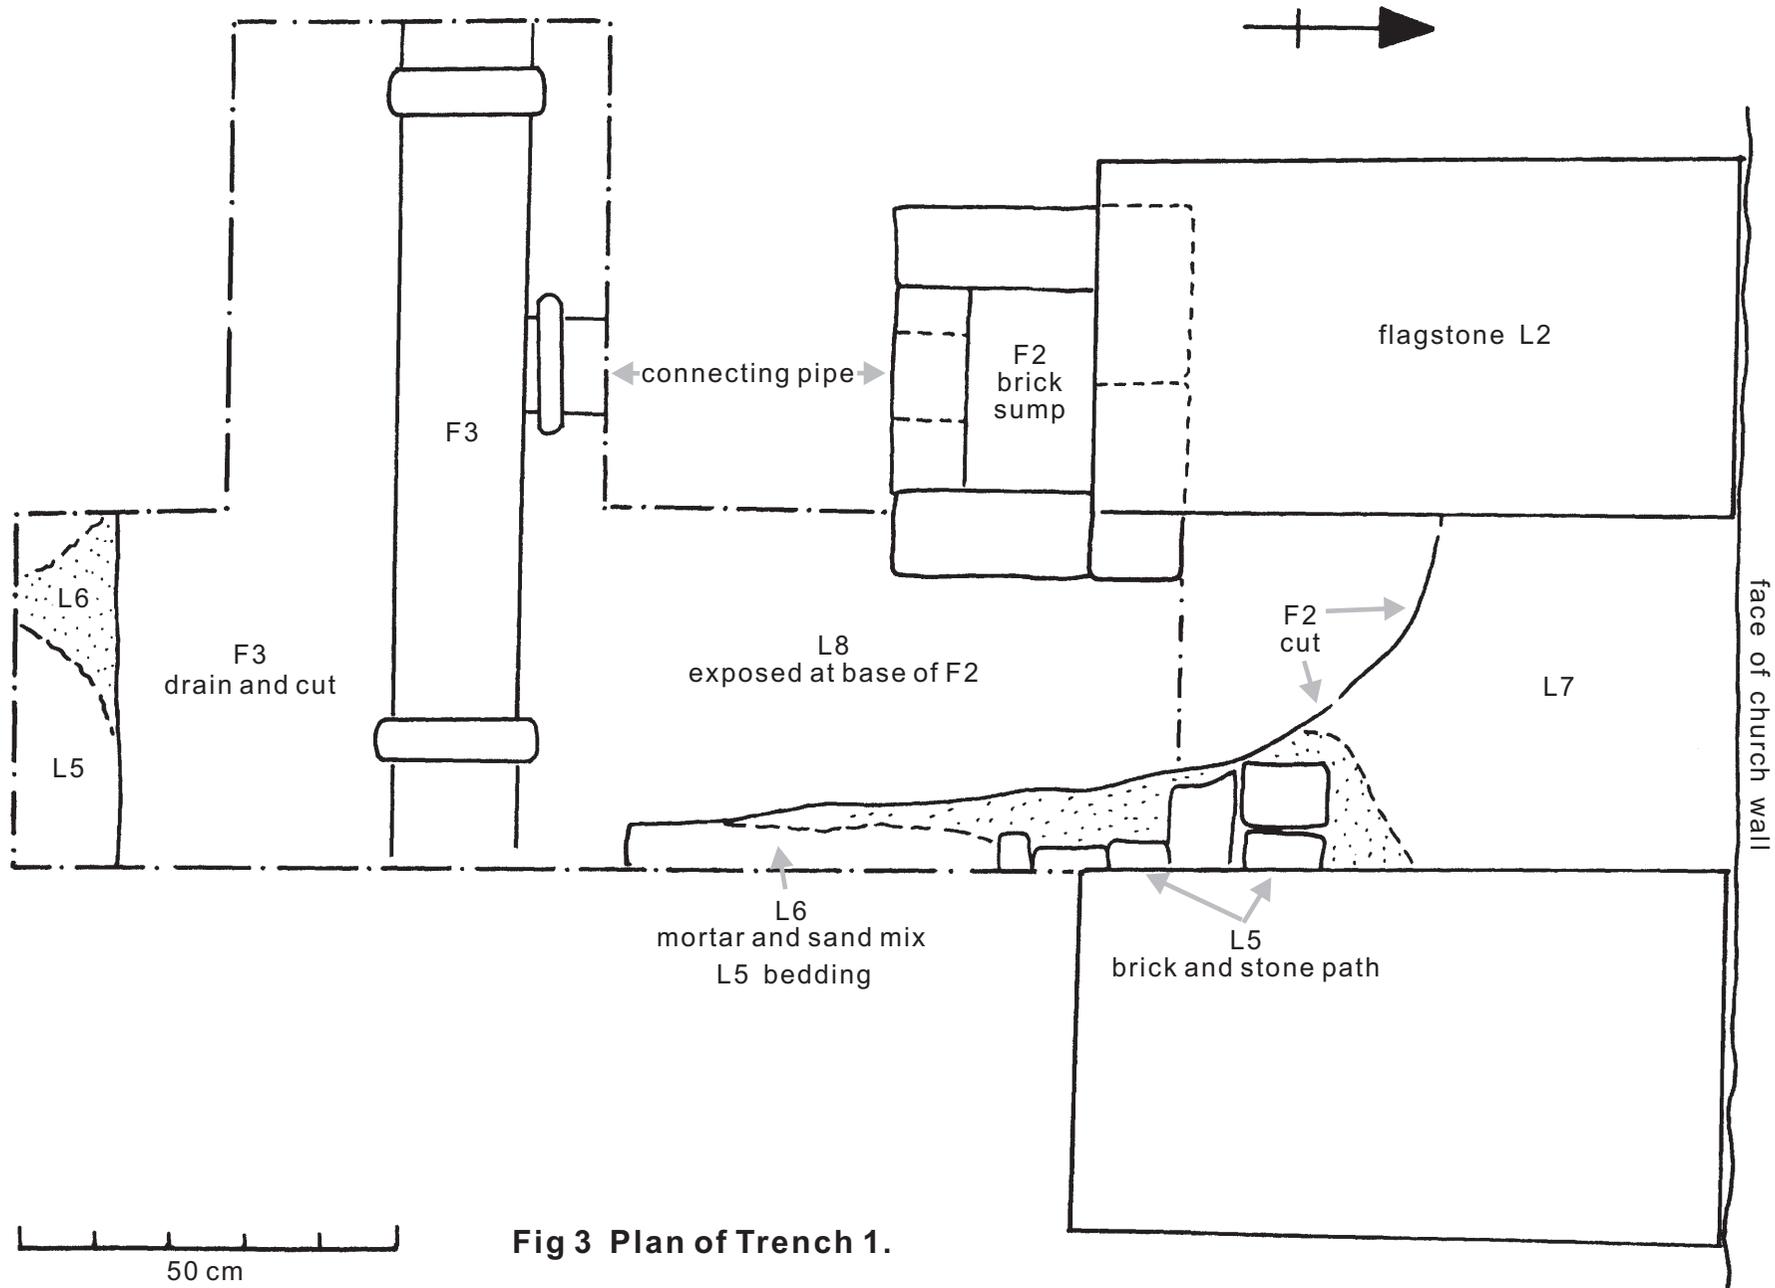
Fig 3 Plan of Trench 1.

The lowest horizon (L8) contained peg-tile, and is therefore most likely to be medieval or post-medieval. The next lowest, L7, which is sealed by L4 close to the church wall, also contained peg-tile, along with occasional Roman tile and amorphous mortar lumps. It is likely that all the Roman debris in L4, L7 and L8 is derived from demolished Roman buildings under or close to the church. L4 was cut by F2, the cut for the construction of the brick sump (also F2). This is contemporary with F3, the cut for the connecting pipe (and the pipe itself). The dating of F3 is given by a single piece of Fabric 40 ware of 16th- to 19th-century date (not very precise). Elsewhere this same trench (ie F7 in T2) is dated by finds to the post-medieval period. The drain cuts (F2, F3) are sealed by L3 and L2 topsoil respectively.

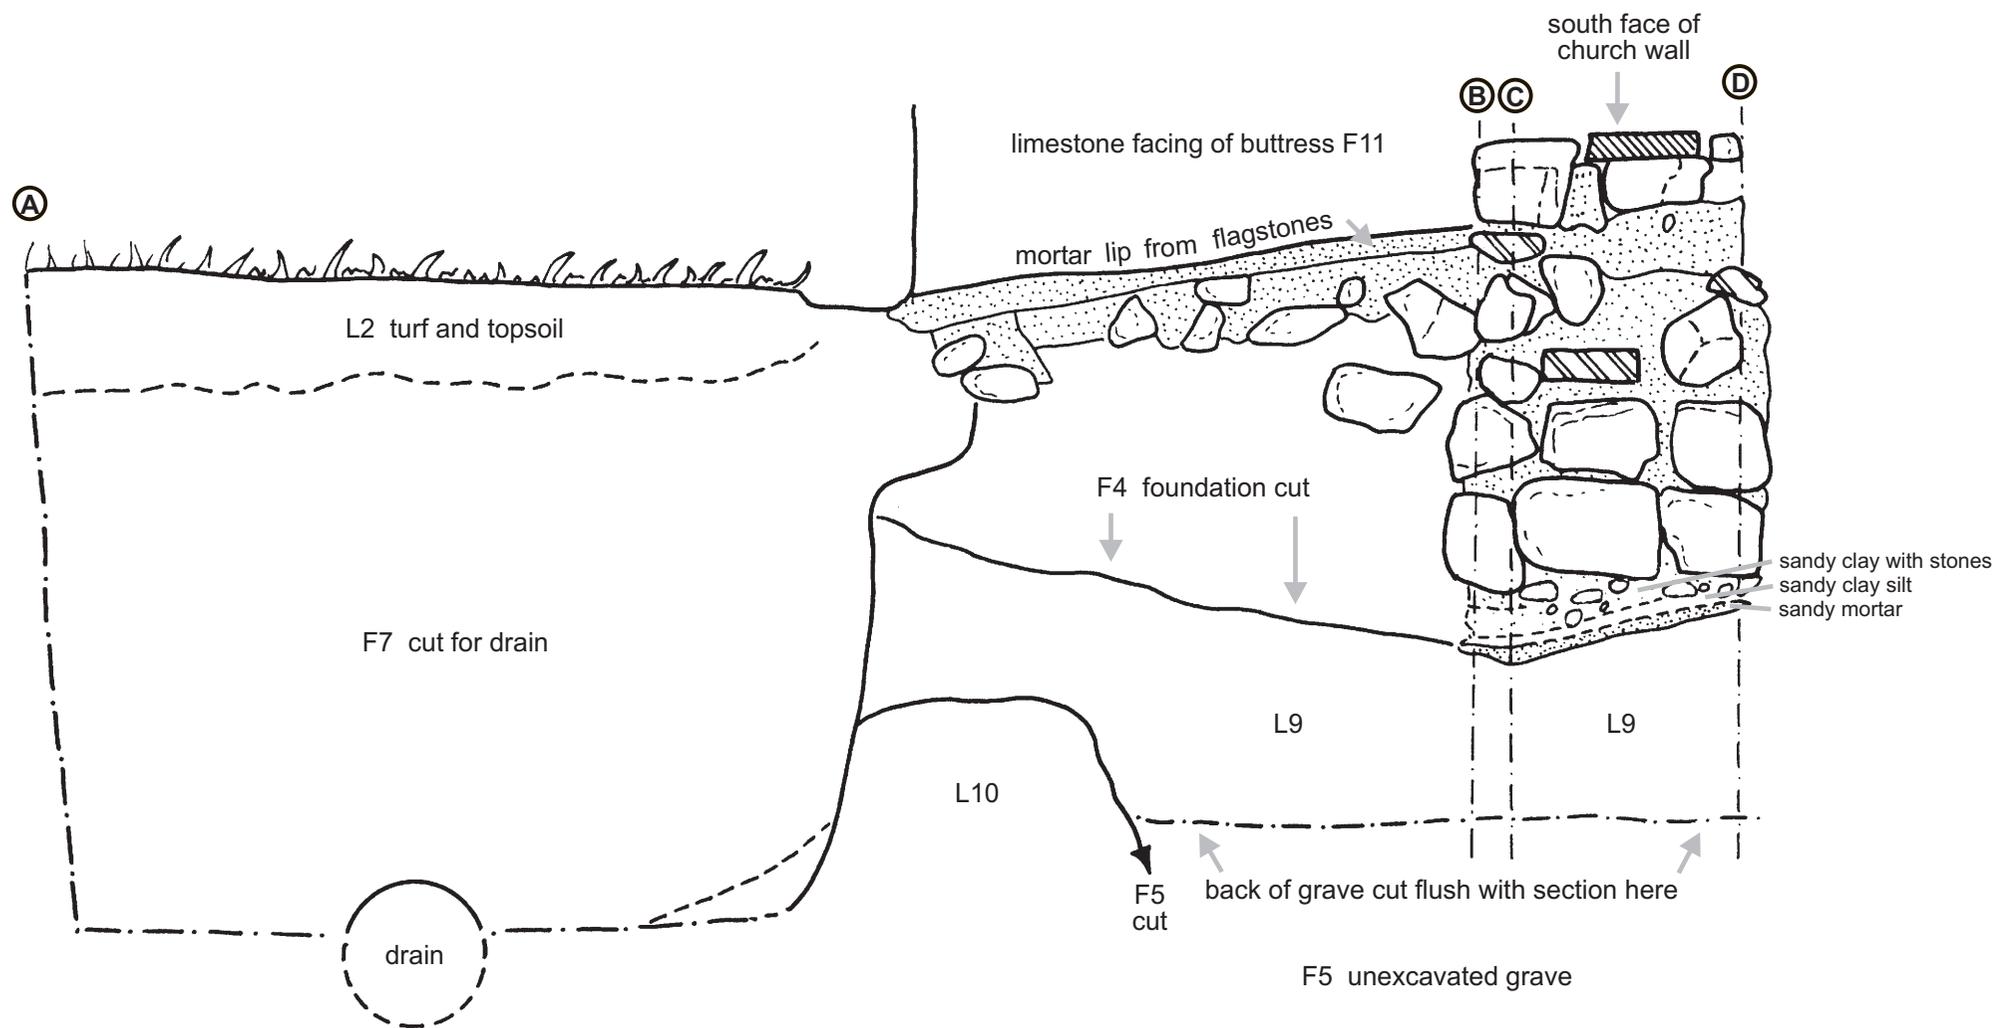
Fig 4 West face of Trench 2 and south wall of church.

Here, as in T1, the stone slab L1 was angled so that rainwater would drain off south into the surface channel, and thence into the drain via the brick sump. The ceramic drain was intercepted at a distance of 1.5m from the face of the church wall, and at a depth of 700mm below the top of the brick sump and 750mm below modern ground. The archaeological feature F7 was the trench cut to lay the pipe (this is the same trench as F3 in T1 and F10 in T3). On the eastern edge of the trench, the side of a brick sump (similar to that fully exposed in T1) was seen. It consisted, in section, of six courses of mortared brick, 430mm (18 inches) deep. Limited surface clearance at ground level on the east side of the trench exposed the top of the sump. It was seen to be full of soil, but it was not emptied.

This was the most interesting trench from an archaeological point of view. The top surface near the church was a stone slab (L1). South of the drain line it was the grass cover over topsoil (L2) in the graveyard. L1 was lifted, to reveal a grave (F5) which had been cut hard against the angle of the buttress and church wall. It was not the intention to excavate graves unnecessarily, so this was only emptied as far down as was reasonable to expose the architectural detail of the church wall (800mm deep). At this level, no coffin or bones were visible.

The exposed church wall was constructed as follows. The wall was not built on natural ground, but on L9 (a gravelly sand) which sealed L10 (a stony clay silt deposit). L9 and L10 extended below the bottom of the trench. At the base of the wall where it cut L9 were three thin bands of material, as follows (from top to bottom): beige sandy mortar (20mm thick); orangey brown sandy silt (20mm thick); and sandy clay with small stone fragments (40mm thick). Over those bands lay two courses of septaria stone in a brownish yellow mortar. The block sizes were typically 150mm wide by 100mm deep. Over that lay two loose courses of septaria and brick (not dated) in the same brownish yellow mortar. The total depth of the two regular plus the two irregular courses was 450mm (18 inches), and this was offset 100mm south of the church wall. Above that level, and set back 100mm north, was a band of mortar obscuring the wall face, and above that the main fabric of the church wall which was (where drawn here) septaria and Roman brick in brownish yellow mortar. The question of whether the adjacent

buttness was contemporary with the wall is difficult to answer. At the base of the ashlar blocks at the foot of the buttness was a band of modern mortar 20-50mm thick (associated with the flagstones). Below that was a layer of uncoursed septaria in brownish yellow mortar (60-150mm thick). Due to the position of septaria blocks at the point where the buttness met the wall, it was impossible to tell whether the buttness was applied to an existing wall. There was no detectable difference in the mortars between wall and buttness. Below the septaria-in-mortar layer, the buttness foundation was different to the church wall foundation. A trench F4 had been cut down to the level of the church foundation, and then filled with a rather loose gravelly sand with occasional septaria blocks. F4 had been cut (as had the wall foundation) into L9. This may imply that the buttness was applied to an existing wall, and that the builders dug down to find the bottom of the church wall, infilled the trench with gravelly sand, and built the buttness on top.

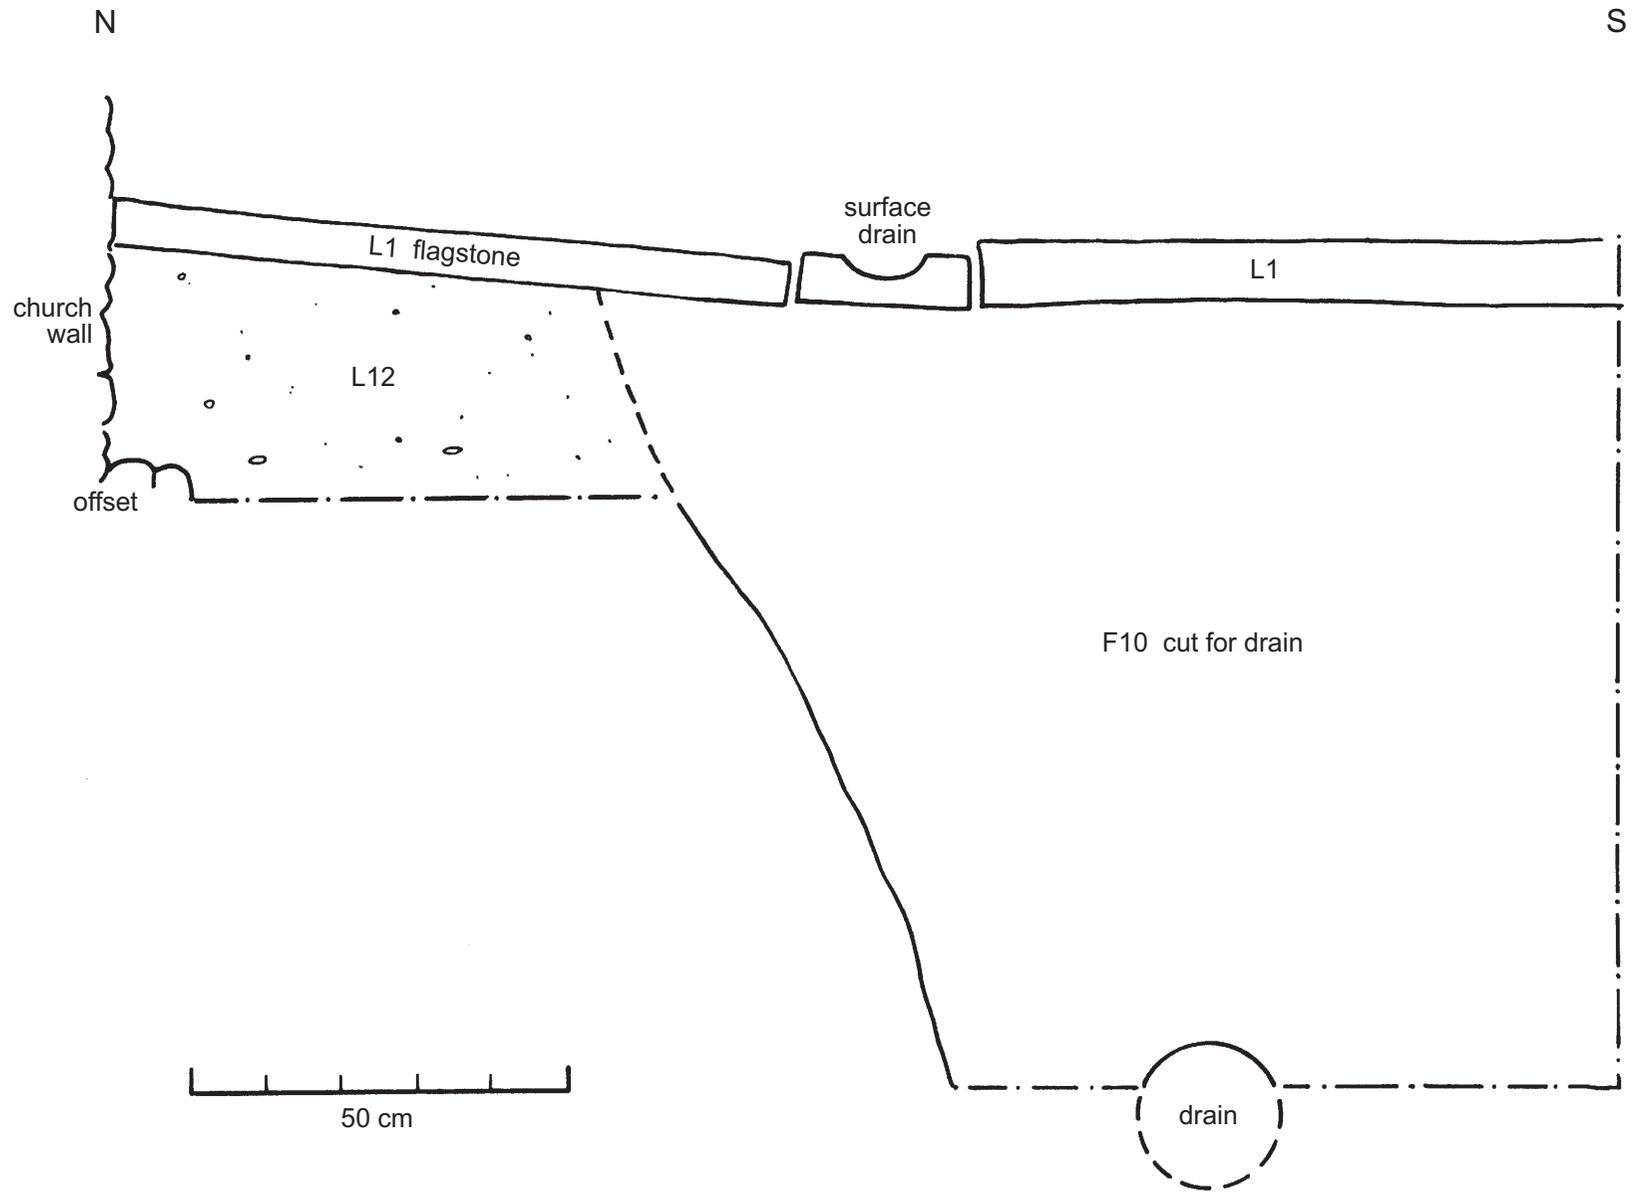
Fig 7 East face of Trench 3.

The ceramic drain was found at a depth of 900mm, and 1.5m south of the church wall. The archaeological feature F10 is the trench which was dug to lay the drain.

F9 was an offset of the south church wall, projecting 100mm south of the wall face. This was sealed by a thick deposit (L12) of dark yellowish brown sandy loam, which must be graveyard soil (mixed soil upcast by grave-digging). This was cut by a trench F10 in which the ceramic drain had been laid. This drain cut was sealed by the surface drainage channel, and by the stone slabs L11 (though not directly over this trench).
