**Archaeological Investigation
at Leaden Hall Farm,
Leaden Roding, Essex
April - November 2011**

CAT project ref: 11/04b
NGR: TL 5893 1340 (c)
ECC project code: LRLH 11
Saffron Walden Museum accession code: 2011.40

CAT Report 602
December 2011

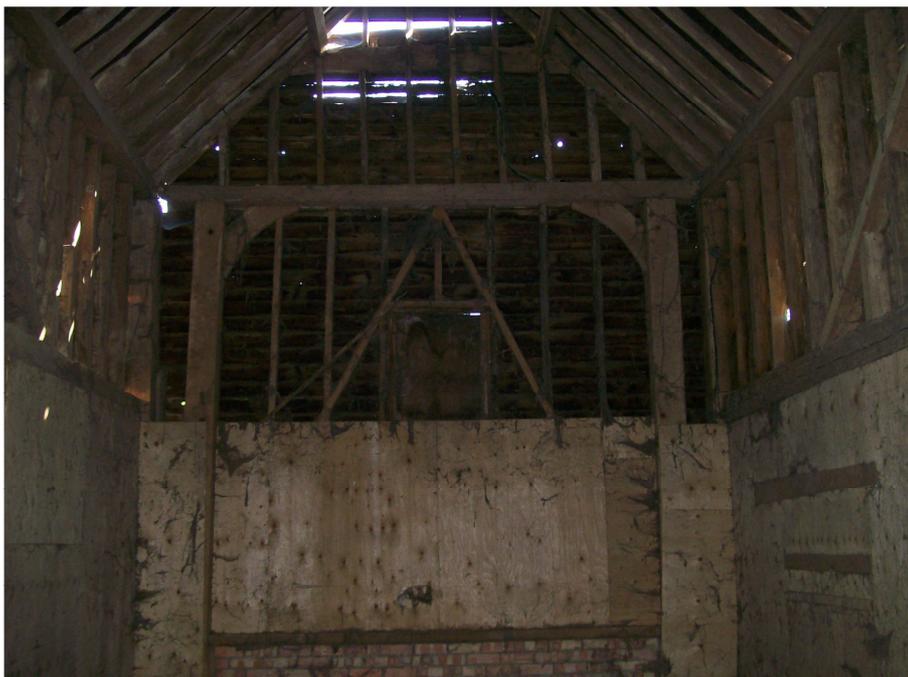
Plate 3 Building A, blocked doorway to south midstrey with original doorposts and hanging knee braces.

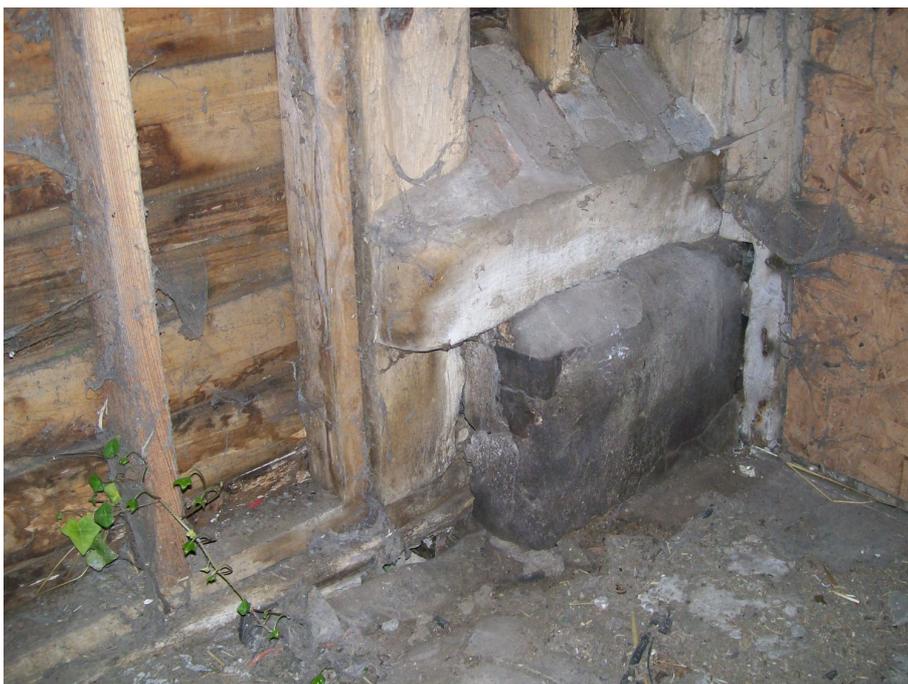
Plate 4 Building A, original doorpost clamped by sill beam, bay 3.

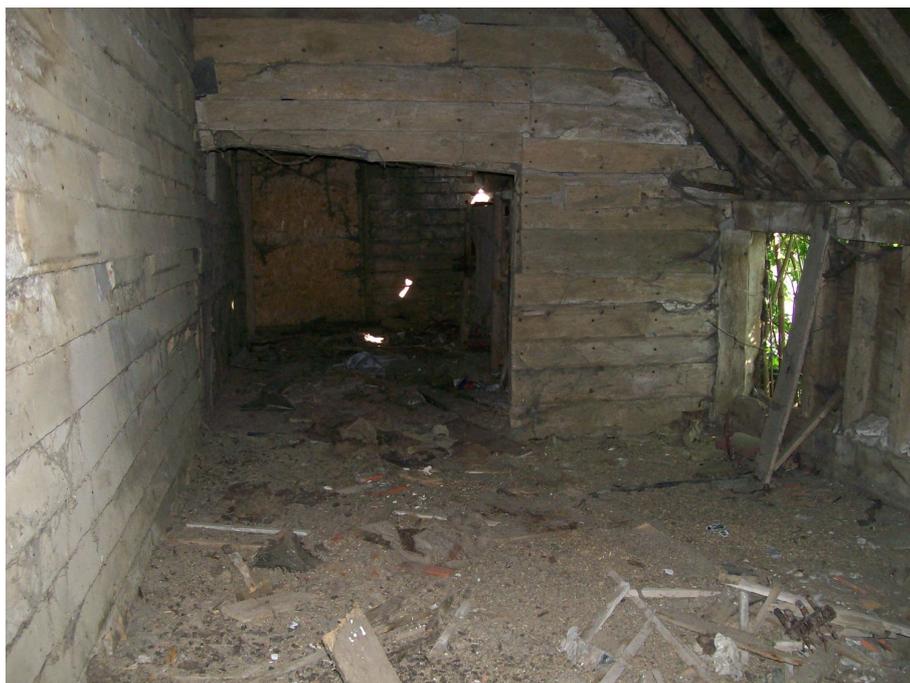
Plate 5 Building A, interior of shut-in showing ?original weatherboarding.

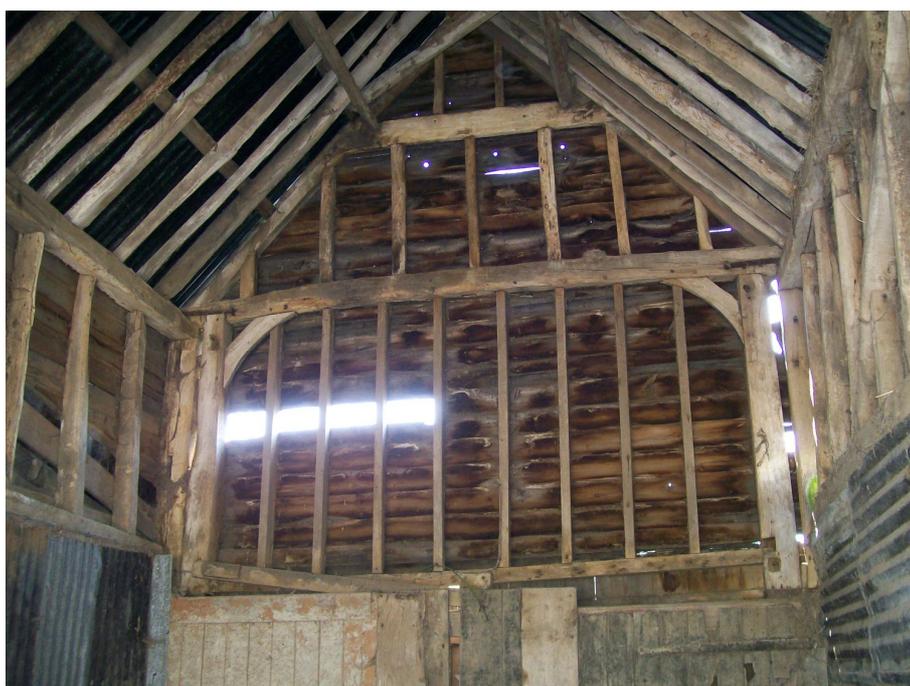
Plate 8 Building B, blocked doorway to midstrey with hanging knee braces and strengthening iron staples.

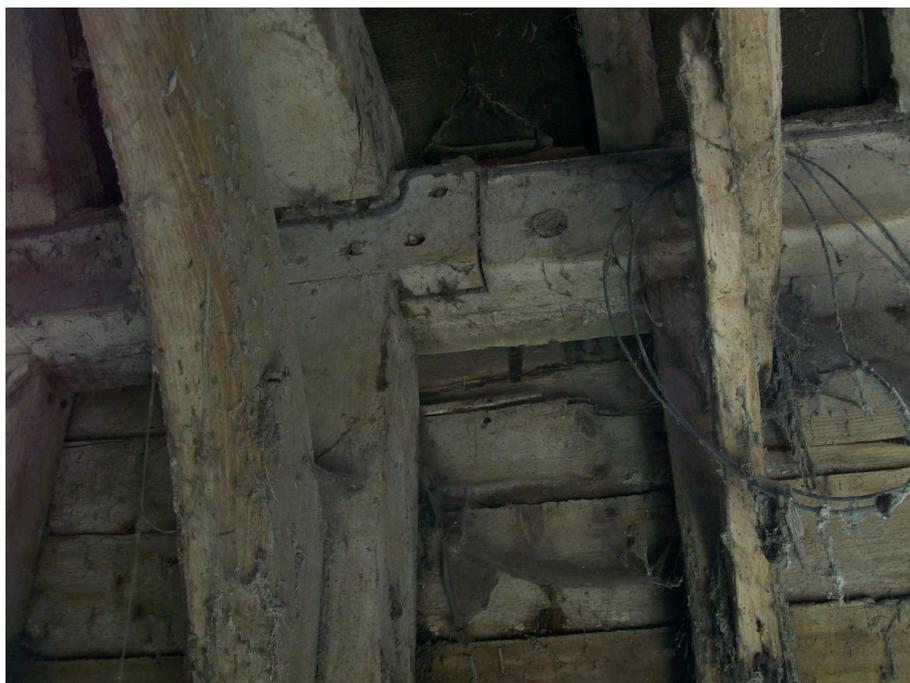
Plate 13 Building E, detail of wall plate scarf joint.

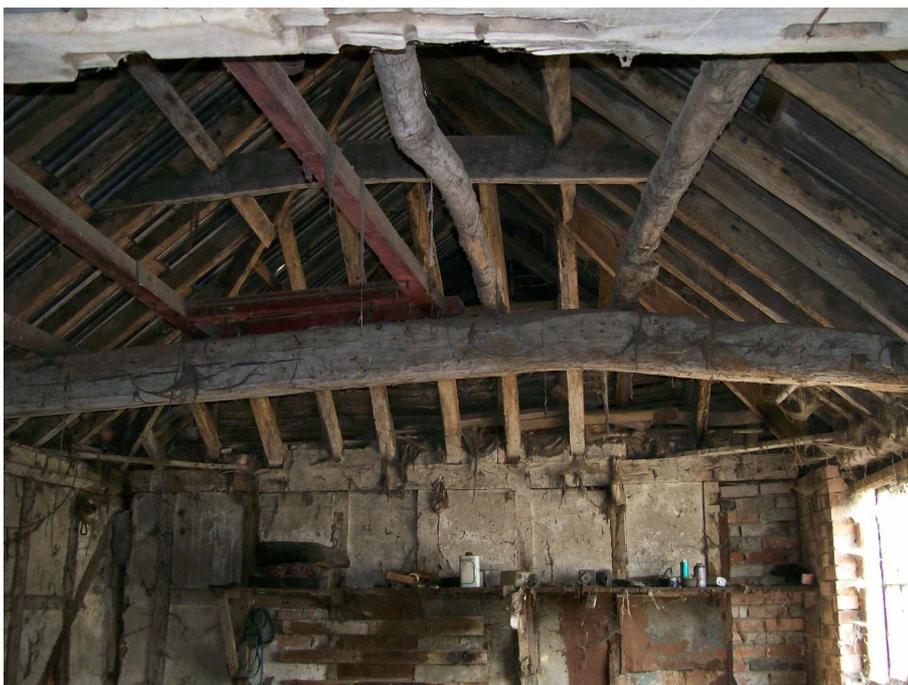
Plate 16 Building F south end, showing cambered tie beam, infilled timber-framing and original hipped roof timbers.

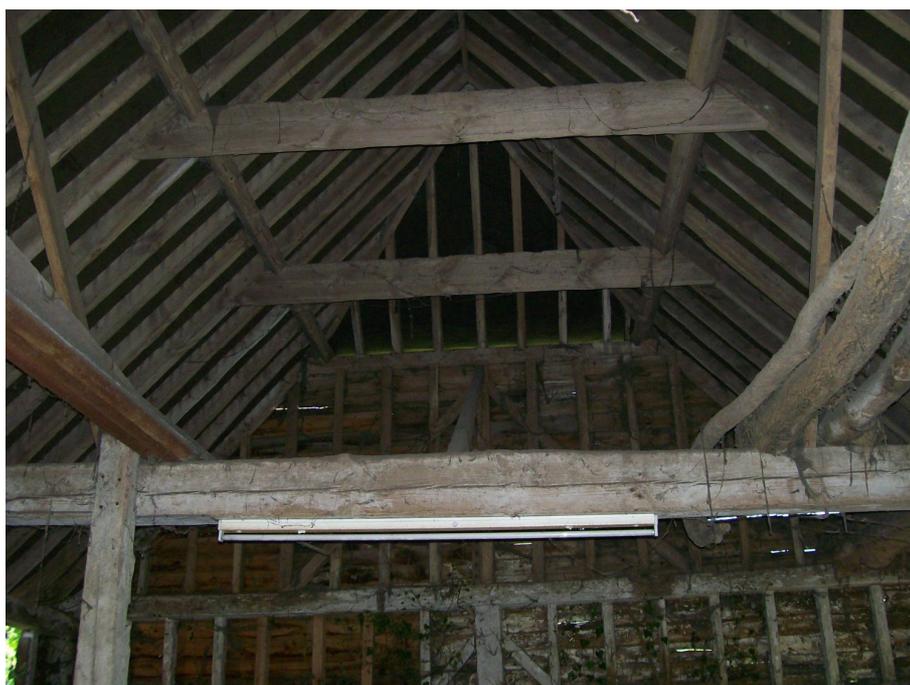
Plate 18 Building G, interior showing nailed tie beam support and collar-clasped purlins.
