**Historic building recording  
at Old Lodge Farm,  
White Hart Lane,  
Springfield, Essex  
May 2013**

**report prepared by  
Chris Lister**

**commissioned by  
Andrew Stevenson Associates  
on behalf of  
Jones Projects Ltd**

**CAT Report 705**  
May 2013

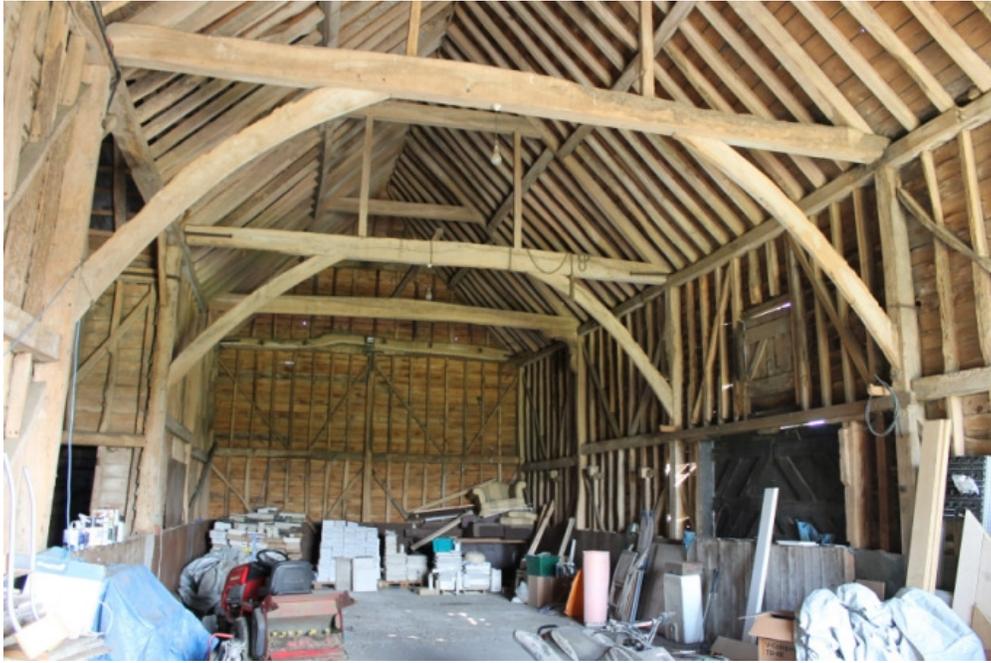
**Plate 3** Interior of barn 1a – view north-west

The interior of the barn was heavily cluttered at the time of the survey with the plinth and a portion of the lower register obscured by iron sheeting (Plate 3). The barn is divided into five bays, four of equal size with the central bay slightly wider, reflecting its function as the threshing floor. The floor throughout the barn is of modern concrete, although the central bay is higher than those to the sides which may indicate the presence of a brick threshing floor beneath.

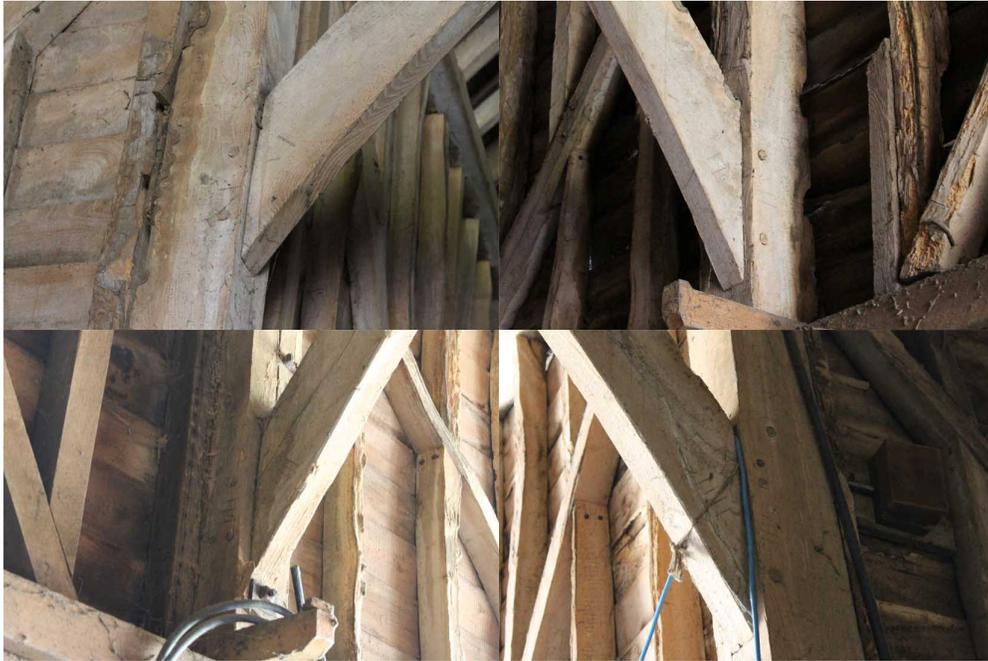
**Plate 5** Carpenters' marks on posts and braces of trusses B (top) and C (bottom)

Chiselled carpenters' marks appear on trusses B and C. Truss B has an 'I' at the joint with the post and brace on the midstrey side and an 'II' at the joint with the post and brace on the other side. Truss C has an 'IIII' at the joint with the post and brace on the midstrey side and an 'III' at the joint with the post and brace on the other side (Plate 5).

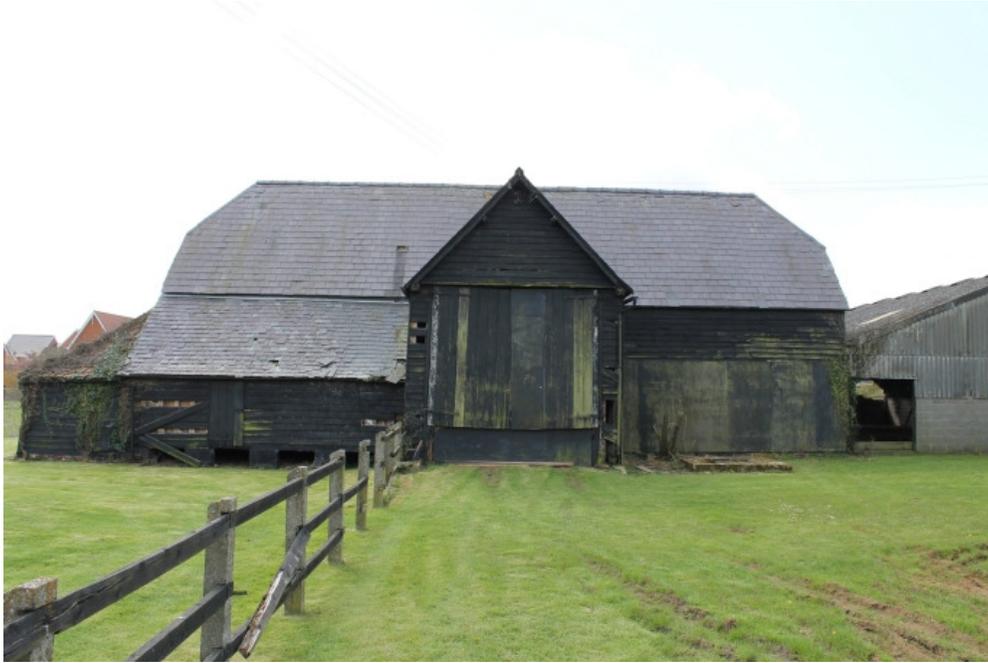
**Plate 11** North elevation of structure 2, showing the threshing barn 2a and outbuilding 2b and granary 2c/d to the left of the midstrey – view south

Barn 2a is a rectangular timber-framed structure, 6.6m wide x 18.7m long, aligned roughly east to west. It has a half-hipped slate roof and is clad in black-painted horizontal weatherboarding (Plate 11). There is a midstrey projecting from the north elevation with a gabled slate roof, full height barn doors on strap hinges and the slots for a threshold leap. A lean-to structure flanks the midstrey to the east. The barn sits on a brick plinth which is only just visible above ground level. Exceptions to this are the south walls of bays 1 and 2 where the foundation and lower wall frame have been replaced by concrete blocks, and the south wall of bays 4 and 5 where there is an elevated plinth constructed from red brick with dimensions of 220 x 107 x 61mm laid in Flemish bond. The south elevation has a centrally located doorway, complete with threshold leap and a pitching door above. Both ends of the barn have a small hatch with strap hinges centrally located beneath the eaves (Plate 17). There is a low, wide plank door in the west end and a plank door with strap hinges in the south wall of bay 5.

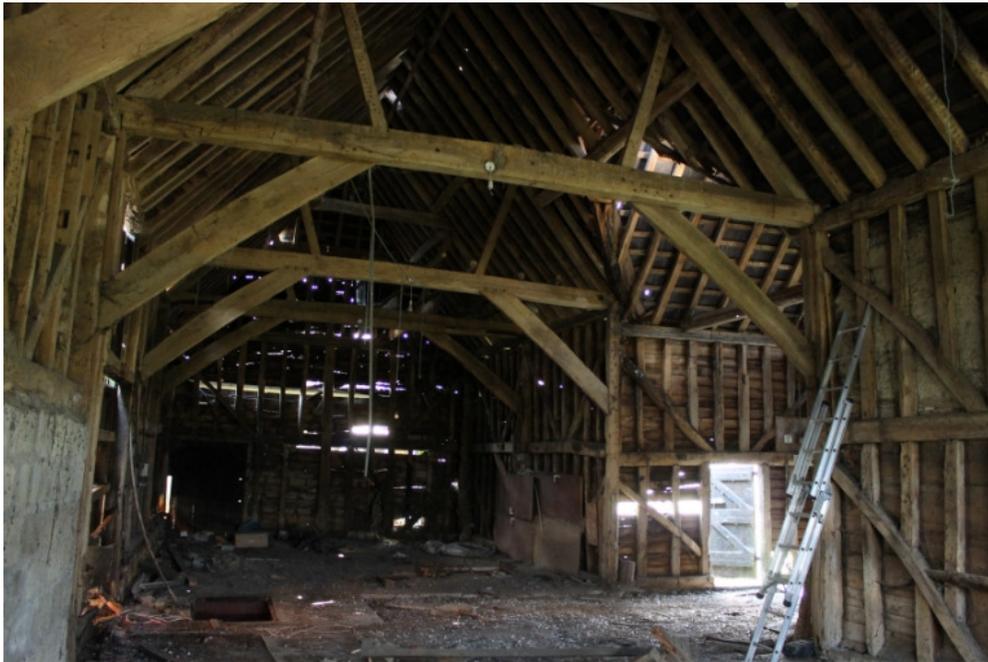
**Plate 12** Interior of barn 2a - view west

The interior of barn 2a was empty at the time of the survey and appears to have been unused for some time (Plate 12). The barn is divided into five bays, four of equal size with the central bay slightly wider, reflecting its function as the threshing floor. The 1990 list entry for the barn recorded that the threshing floor was of York stone, but this has since been replaced by concrete.

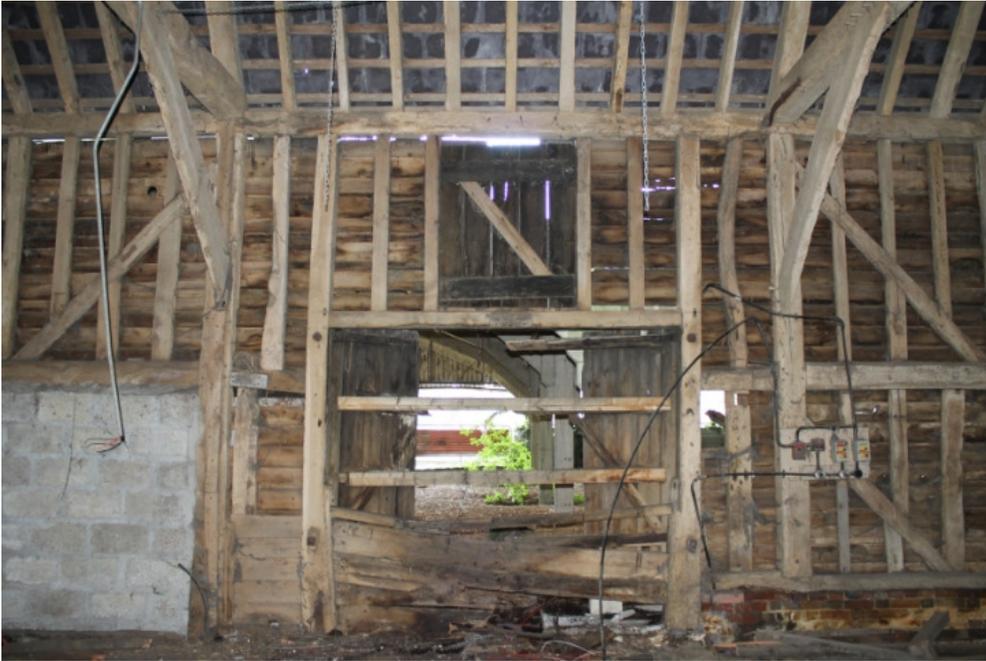
with edge-halved scarf joints in each bay. The upper registers of bays 1 and 2 have the original render. The barn doors in bay 3, opposite the midstrey doors, have flared bases to the door posts with slots holding a threshold leap. The original girding beam has been replaced and a pitching door has been inserted above it (Plate 13).

**Plate 13** Barn 2a, showing jowled bases to rear barn doors, threshold leap and inserted pitching door – view south

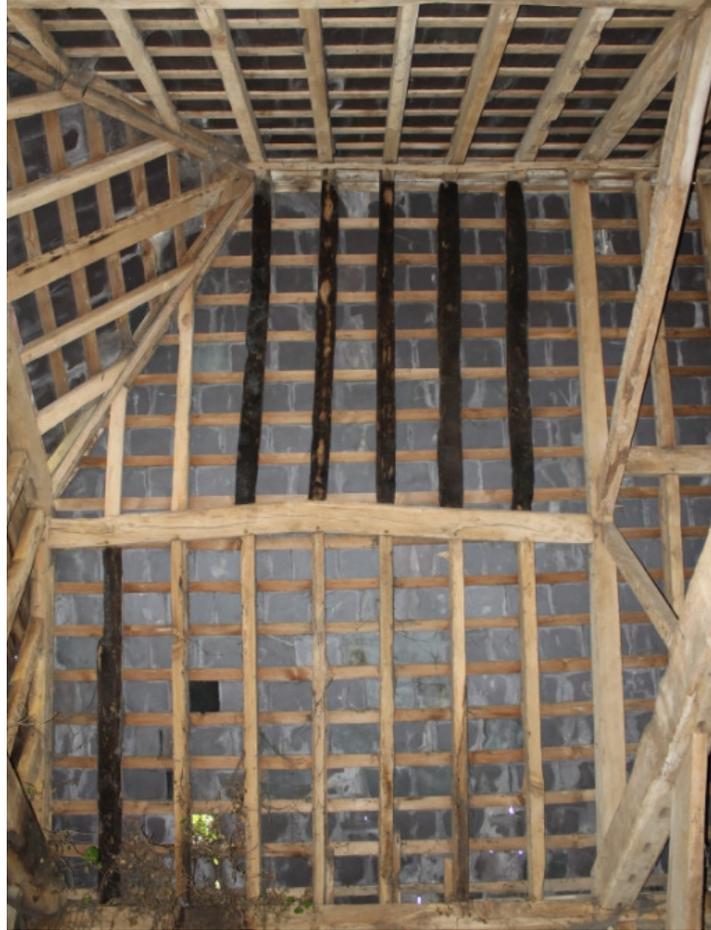
**Plate 15** Barn 2a, detail of fire-blackened and reused timbers in roof of bay 1

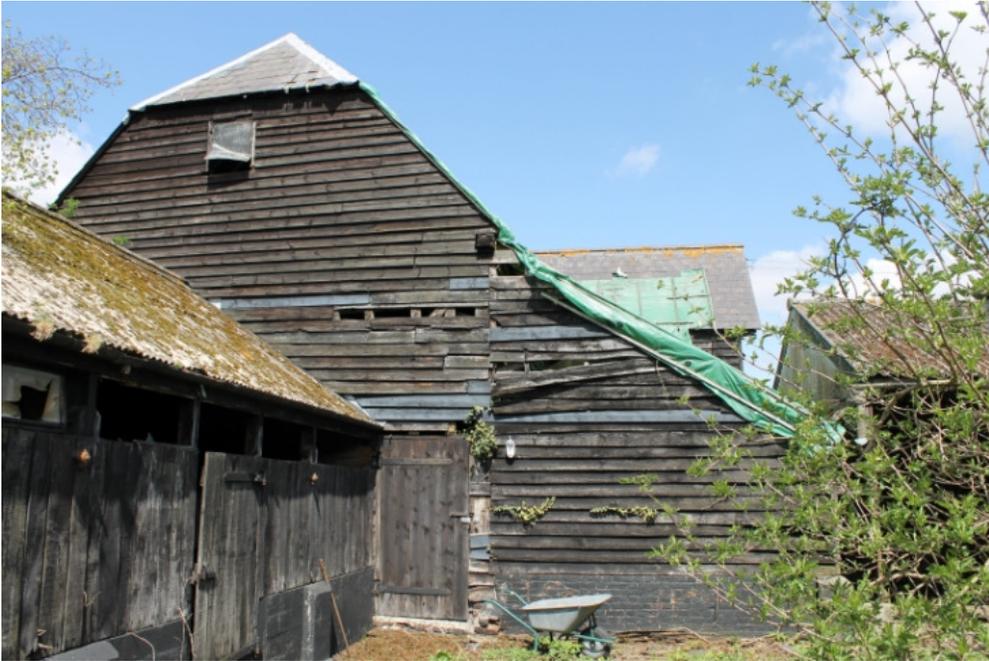
Shelter shed 3b is a single storey, open-fronted lean-to on the east side of barn 3a, measuring 7.2m long x 4.1m wide. The south wall is clad in black-painted horizontal weatherboarding and sits on a brick plinth (Plate 21). It has a mono-pitch roof covered in plastic sheeting, although presumably this has replaced slates. The open front is supported on iron I-beams with concrete buffers, rather than on timber posts.

**Plate 21** South elevation of barn 3a, with shelter shed 3b to the right and stable block 8 to the foreground – view north-west

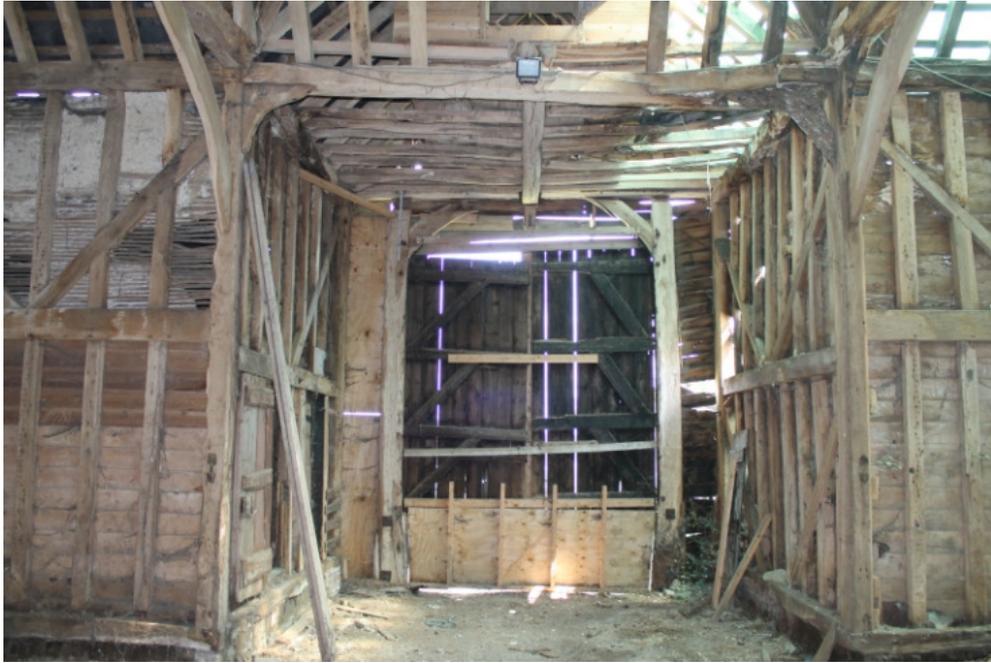
**Plate 27** Barn 3a, showing midstrey – view east

The midstrey has short curved braces supporting the wall plate above the doors which are single-pegged to the wall plate (Plate 27). The braces were originally single-pegged to the posts as well but these pegs have been replaced by iron bolts. The barn doors are later replacements but the posts, which are flared at the bases, have the original slots for the threshold leap. Two doorways have been inserted into the north midstrey wall, one providing access to granary 3c, the other opening onto the farmyard (Plate 23). A pigeon loft has been inserted into the gable, complete with nesting boxes (Plates 28, 29)

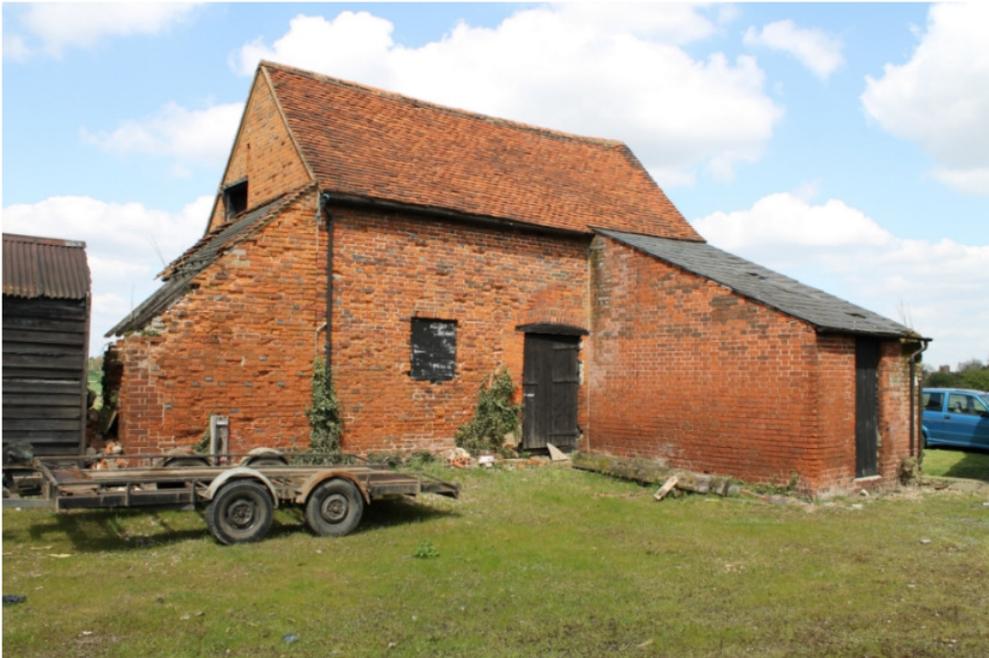
**Plate 34** Structure 4 – view north-east

Stable/granary 4a is a two storey rectangular brick building aligned north-east to south-west, measuring 8.6m long x 4.8m wide (Plate 34). At the time of the survey the building was structurally unsafe with substantial cracking clearly evident. The fabric has been repaired and patched multiple times (including the complete rebuilding of both gables) and buttresses have been added to the north-east corner. Despite these repairs it was possible to ascertain that the original fabric was of red brick with dimensions of 238 x 114 x 55mm, laid in Flemish bond. The gabled roof is of plain tiles. The south-east elevation has a centrally located doorway surmounted by a brick arch, which is a later insertion. This is flanked by lean-to 4c and a square wooden-framed window. The north-west elevation is plain brickwork apart from the presence of two small modern vents and the brick buttresses. The north-east elevation has a large window that has been converted from an earlier doorway and a smaller window in the gable (Plate 35). The south-west elevation has lean-to 4b attached to the stable and an elevated plank door providing access to the granary loft (Plate 36). The doorpost closest to the centre of the gable rises eight courses of brick higher than the lintel and has a pattern of rust-stained holes. This would have been the anchor point for a hoist used for raising sacks of grain to the loft.

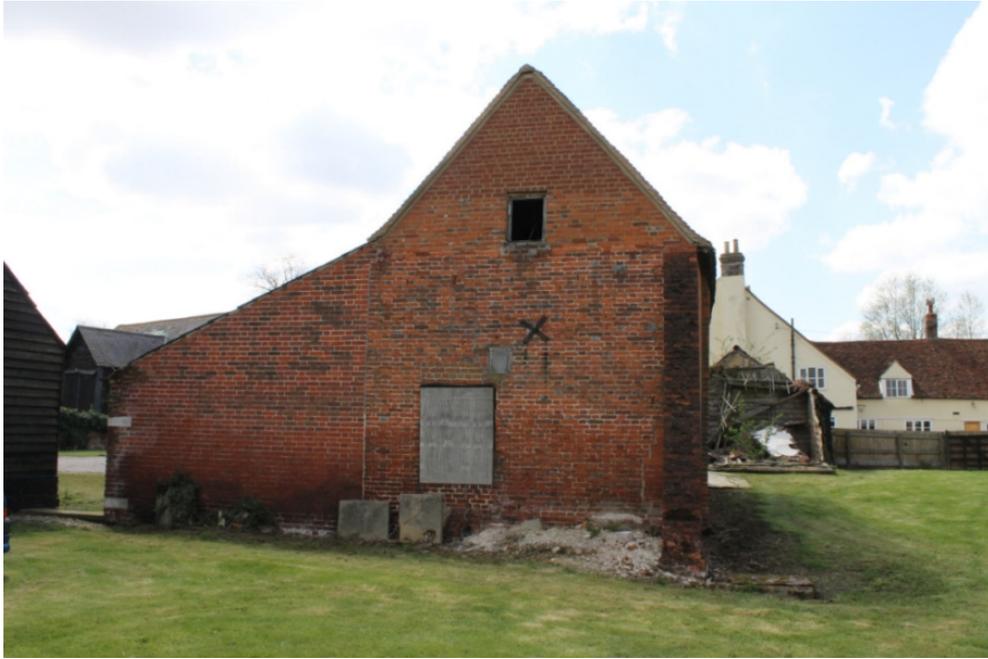
**Plate 35** Stable/granary 4a, showing converted doorway, rebuilt gable and later buttress – view south-west

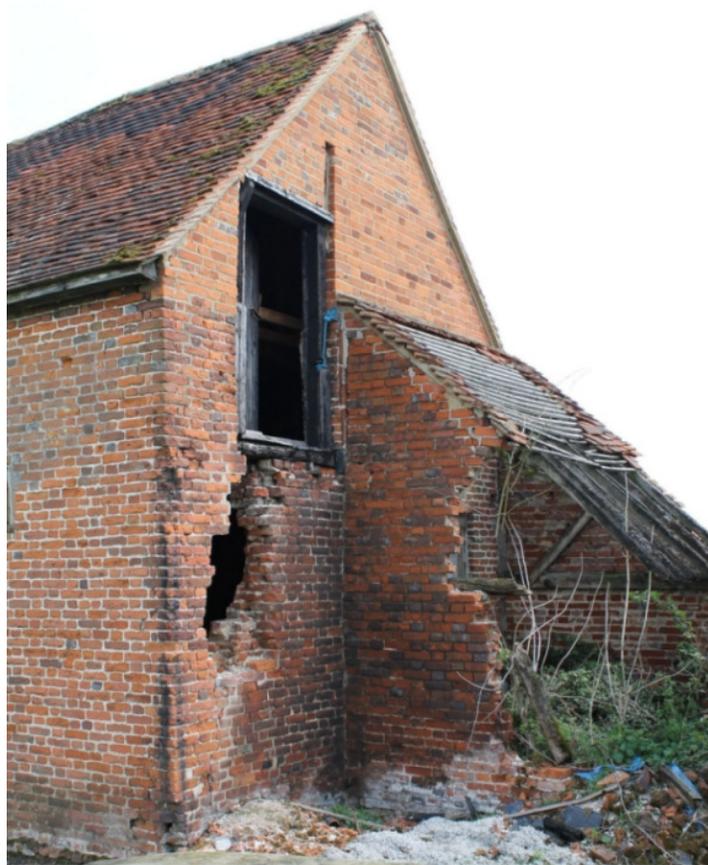
Lean-to 4b is a single storey structure on the south-west end of stable/granary 4a (Plate 34). It projects 2.5m out and is 3m wide. The lean-to is in a ruinous state, with many patches of repair to the brick work, but it is possible to see that the original construction was of red brick with dimensions of 230 x 109 x 60mm laid in Flemish bond. There are no indications of windows or doorways in any of the exterior walls, although most of the north-west corner has collapsed, which may be the result of structural weakening caused by such an opening (Plate 36). The roof is a steep mono-pitch of plain tiles carried on timber battens.

**Plate 36** Stable/granary 4a with lean-to 4b and elevated doorway to granary loft – view east
