Historic building recording and archaeological monitoring at Stamfords Farm, Braintree Green, Braintree, Essex

Planning Application no: 14/01339/FUL
CAT project ref: 15/04c
NGR: TL 73457 21963

CAT Report 1078
March 2017

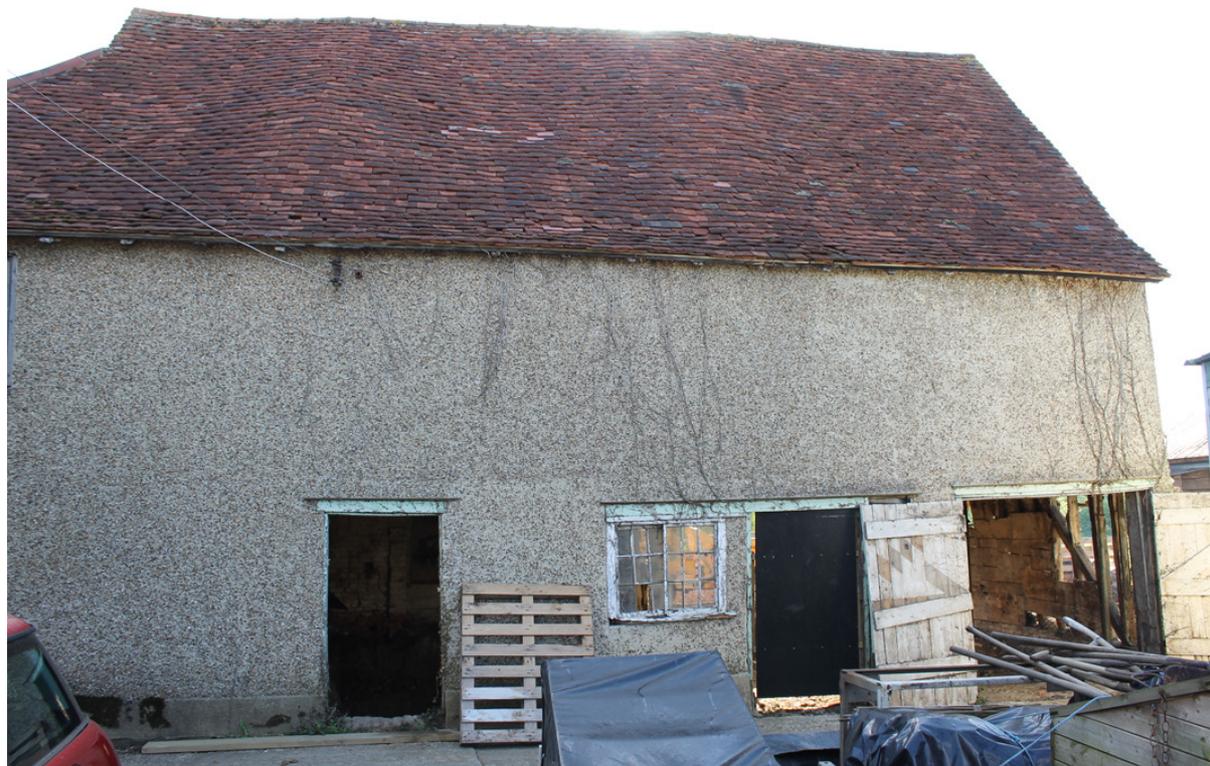
The west elevation (Fig 5) has three ground-floor entrances, two single doorways and one larger double door. It also has a ground-floor window in bay two and a pitching door on the first floor in bay one. These are all later insertions.

Photograph 1 Western exterior elevation of barn, showing inserted doors and windows. Photo taken facing east.

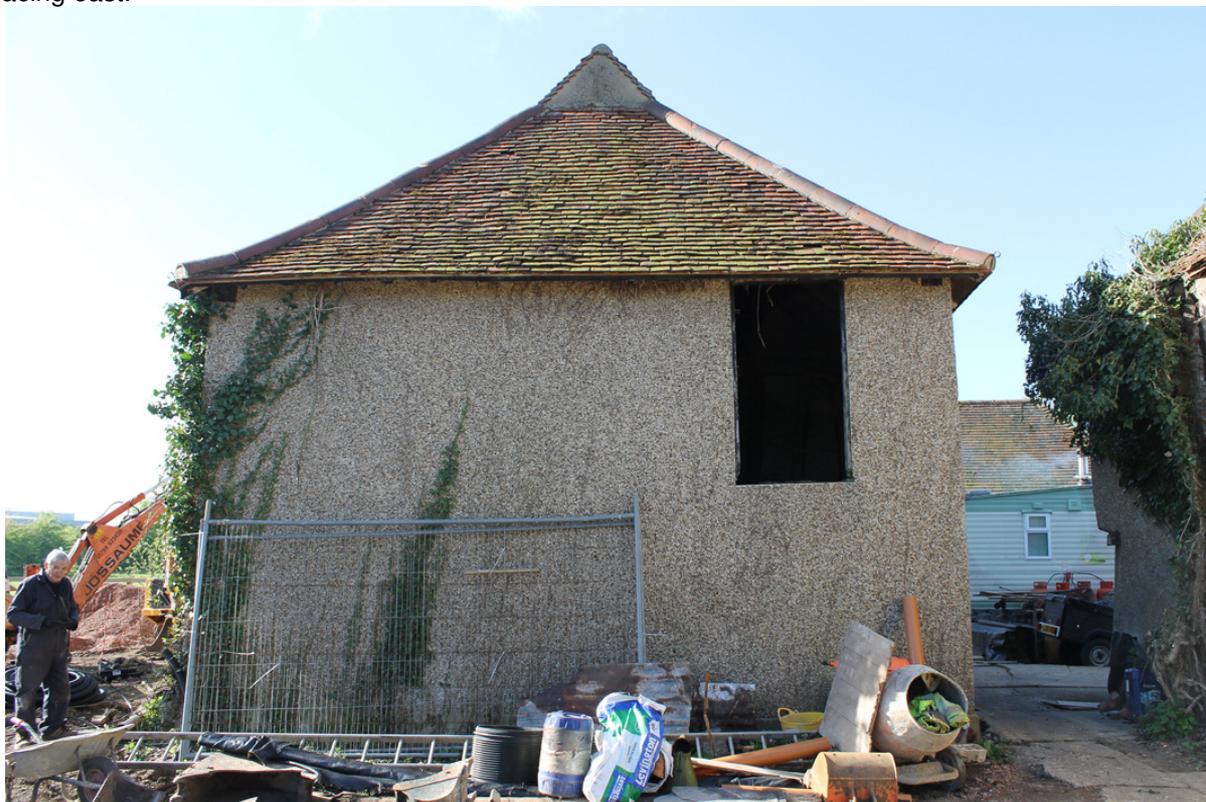
The barn has a gabled roof to the south, and a gablet roof to the north (Photograph 3). The north end was probably altered into a gablet after it was damaged or the gable collapsed (see discussion below). The entire roof is clad in plain clay tiles.

Photograph 2 Northern exterior elevation of barn, showing inserted pitching door and gablet roof. Photo taken facing south.

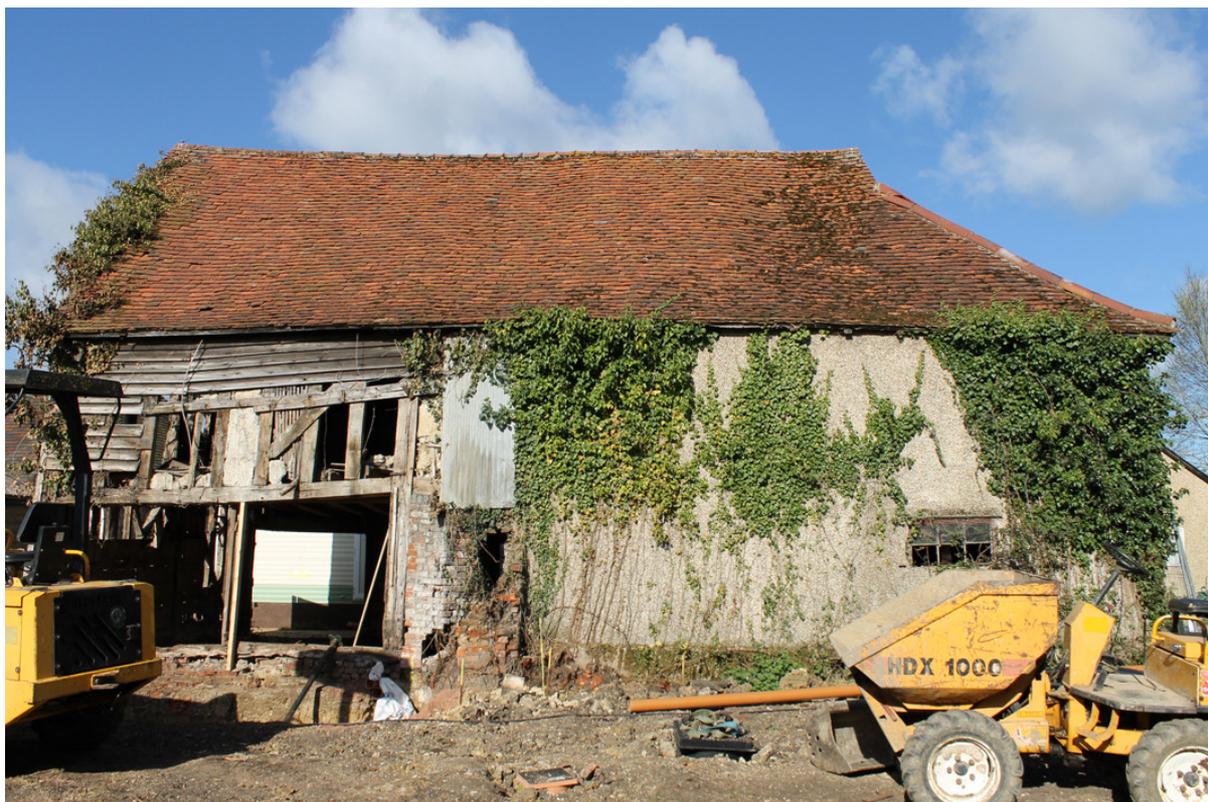
Photograph 3 Eastern exterior elevation of barn, showing brick repairs to bay two and removed timbers in bay three. Photo taken facing west.

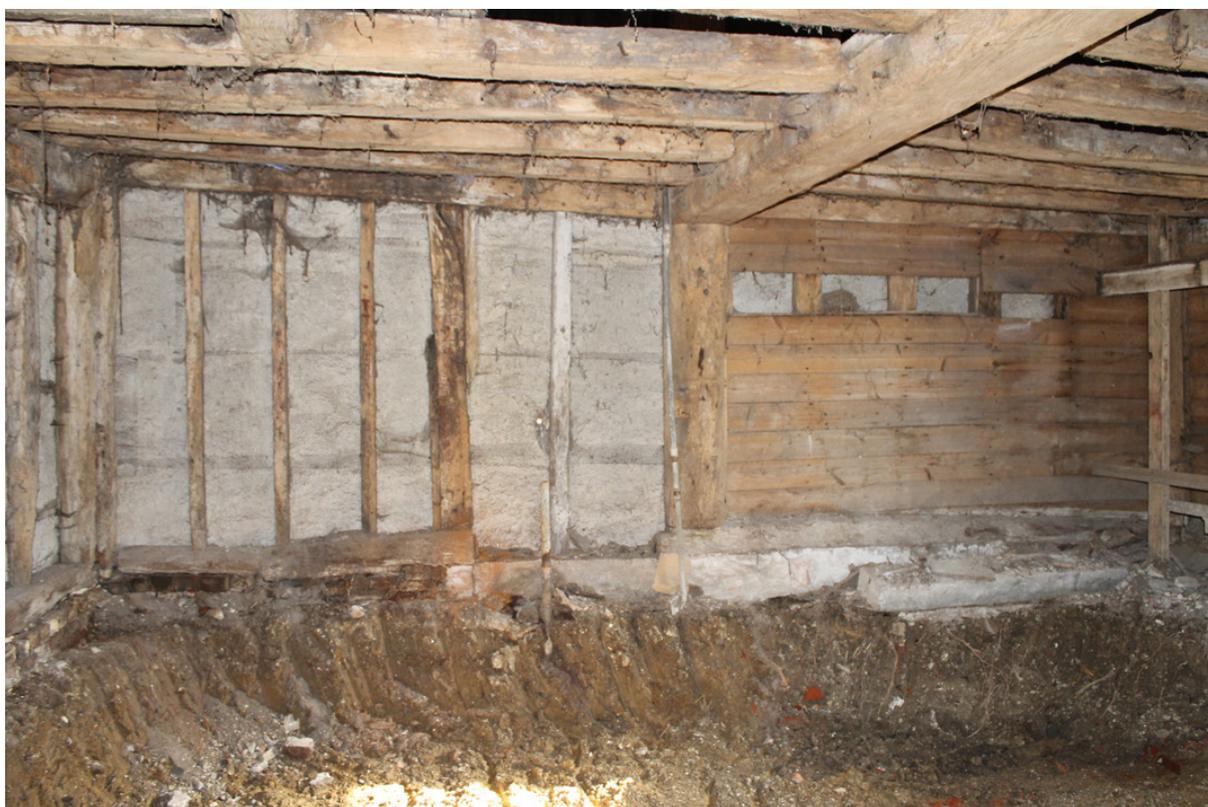
Photograph 4 North side of bay one, lower register. Blocked inserted doorway visible. Photo taken facing north.

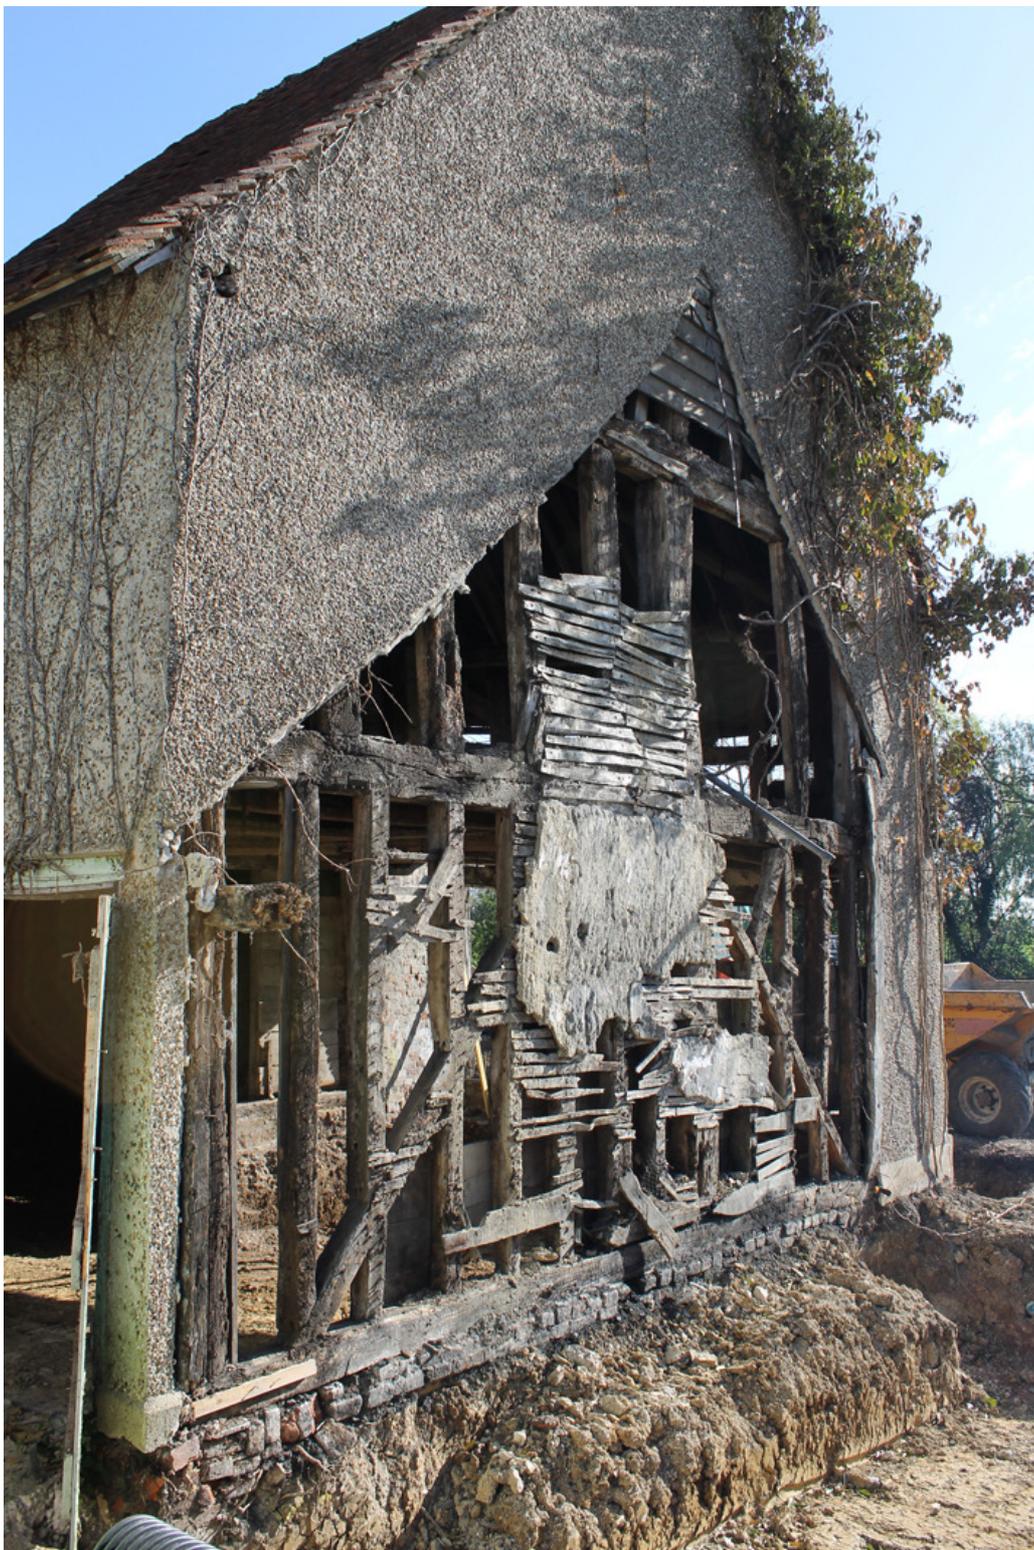
The south elevation has had large portions of the modern render and weatherboarding removed, corresponding to the location of the recently collapsed fore-building (Fig 6, Photograph 5). This has exposed the barn's timber-frame.

Photograph 5 Southern exterior elevation of barn. Scar in location of recently demolished outbuilding visible, exposing timber-frame. Photo taken facing north-east.

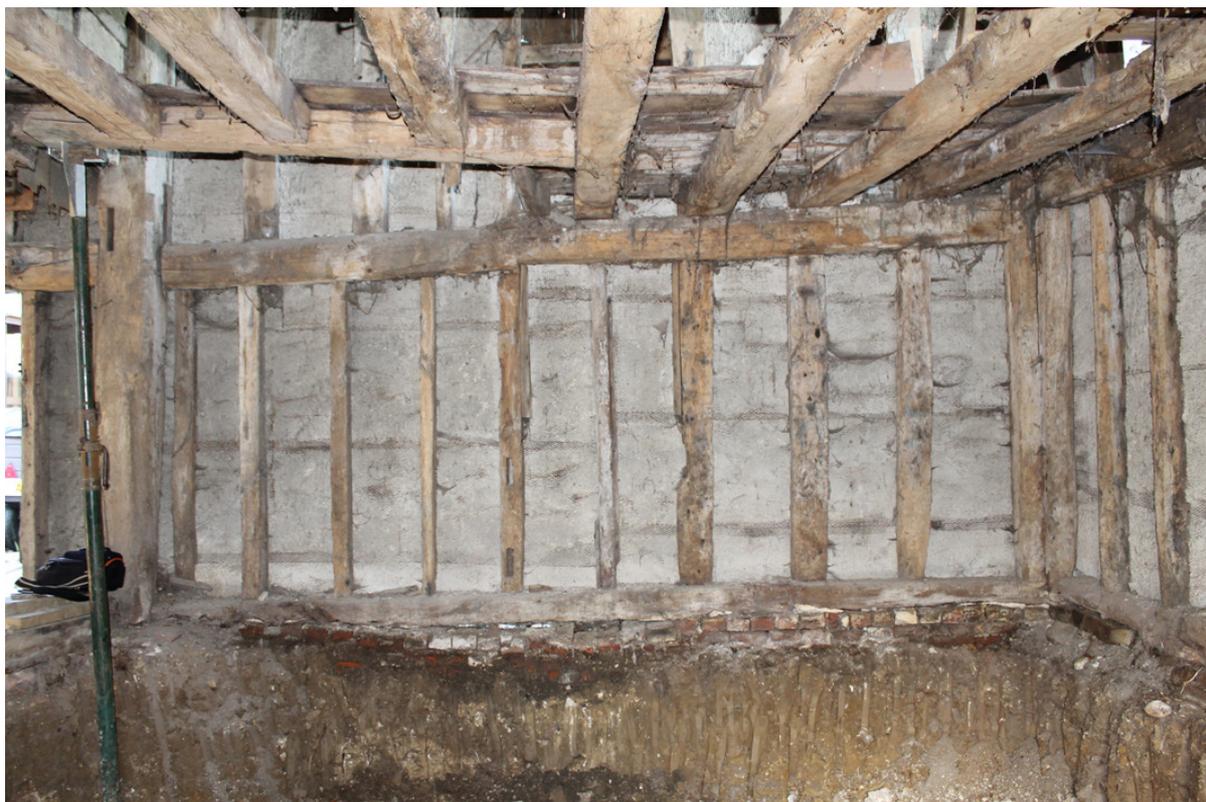
The west side of the bay (Fig 8) has a section of bracing on the upper register, which is single-pegged to the girding beam and corner post. A pitching door has been inserted through the first floor west wall. The girding beam and the wall-plate on the west elevation are re-used timbers, containing diamond shaped mullions and shutter grooves on their lower faces (Photographs 7 and 8). No corresponding mortices for the mullions or grooves are present on the opposing timbers. There is also a re-used timber being used as a stud on the lower register. The studs on the west side of the inserted pitching door and over half the remaining studs on the lower register are all hand-sawn, but not original to the building (Photograph 6).

Photograph 6 West side of bay one, lower register. Modern and reused timbers visible as studs. Natural curve on girding beam visible. Photo taken facing west.

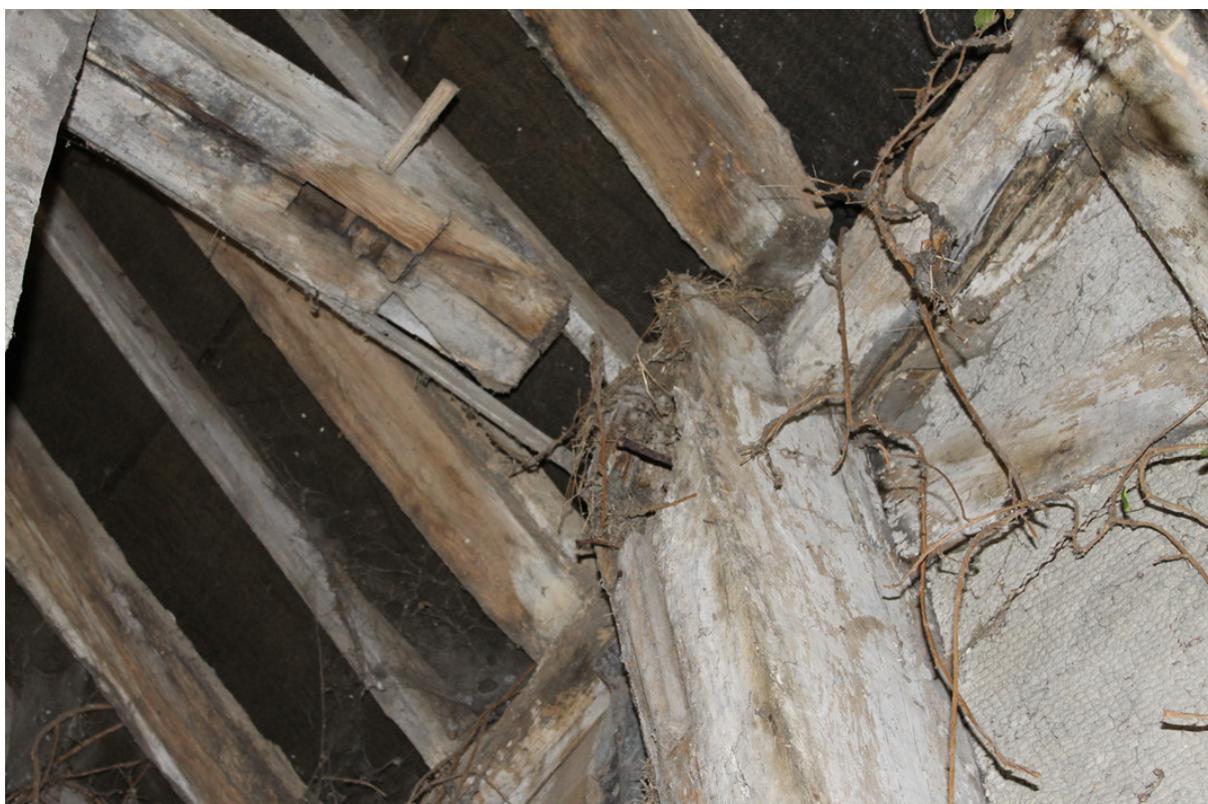
Photograph 11 Detail of damaged tying joint with lap dovetail between tie beam and storey post on eastern elevation. Photo taken facing north-east.

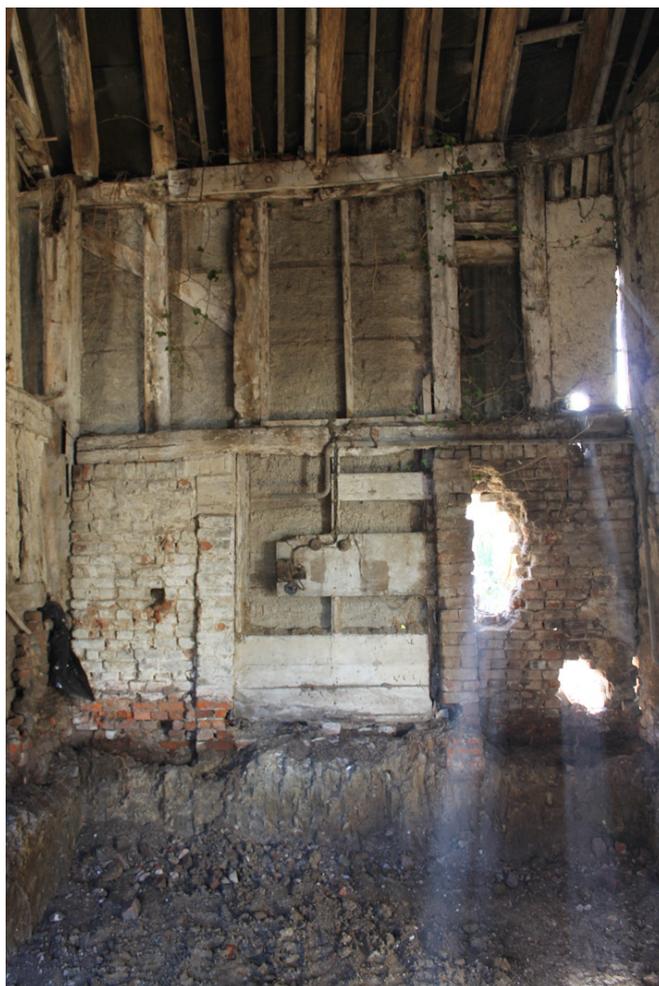
On the east side of the bay (Fig 9), the entire lower register has been removed and replaced with brickwork and modern machine-cut timbers (Photograph 12). The modern brickwork is laid in a mixed bond with dimensions of 190 x 110 x 70mm. The upper register on the east side of the bay has a section of bracing which is single-pegged to the storey post and a stud. Another modern machine-cut timber has replaced the centre stud in the upper register. The wall-plate has a snapped face halved scarf joint in the centre of the bay (Photograph 13).

Photograph 12 East side of bay two. Brick infill and modern repair visible. Photo taken facing east.

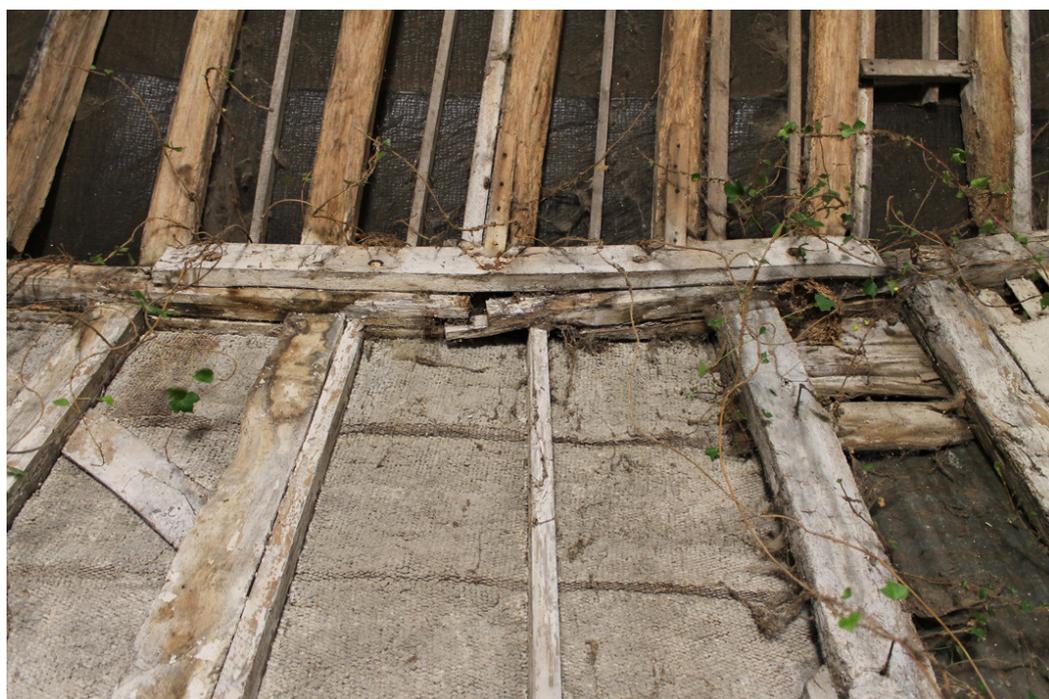
The damaged joint on the east wall-plate in bay two is a face-halved scarf joint with a long halving and a very unrefined bladed abutment. These style of joints came into use in the early 15th century (Hewett 1980, 269), and the unrefined nature of this particular joint suggests it is an early example of its type.

Photograph 13 Detail of snapped face-halved scarf joint on east side of bay two wall plate. Photo taken facing east.

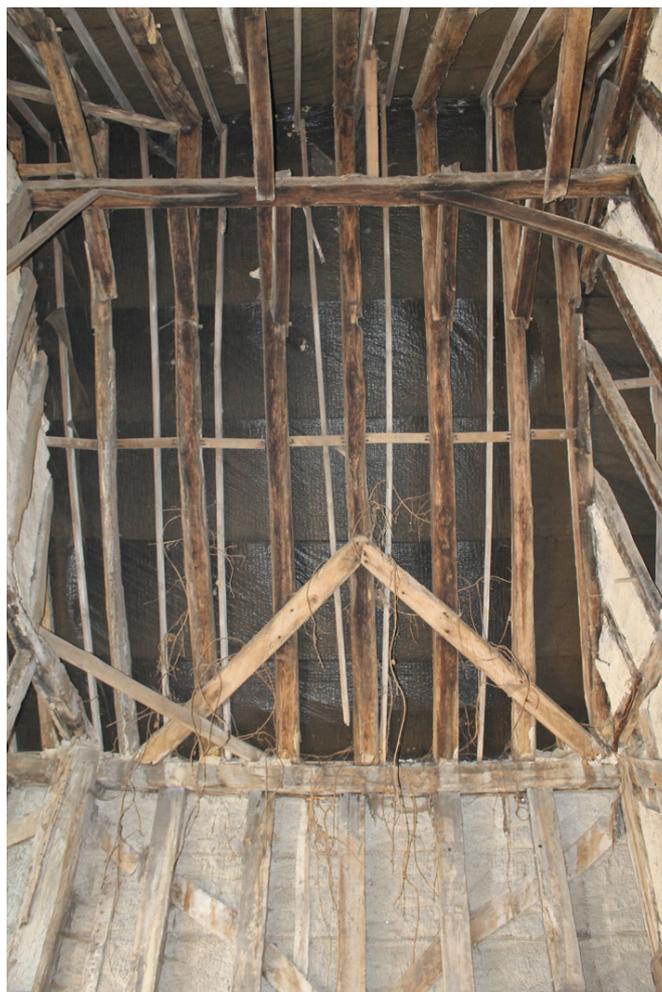
Photograph 15 West side of bay two, upper register and roof detail, showing modern reinforcing timbers. Photo taken facing south.

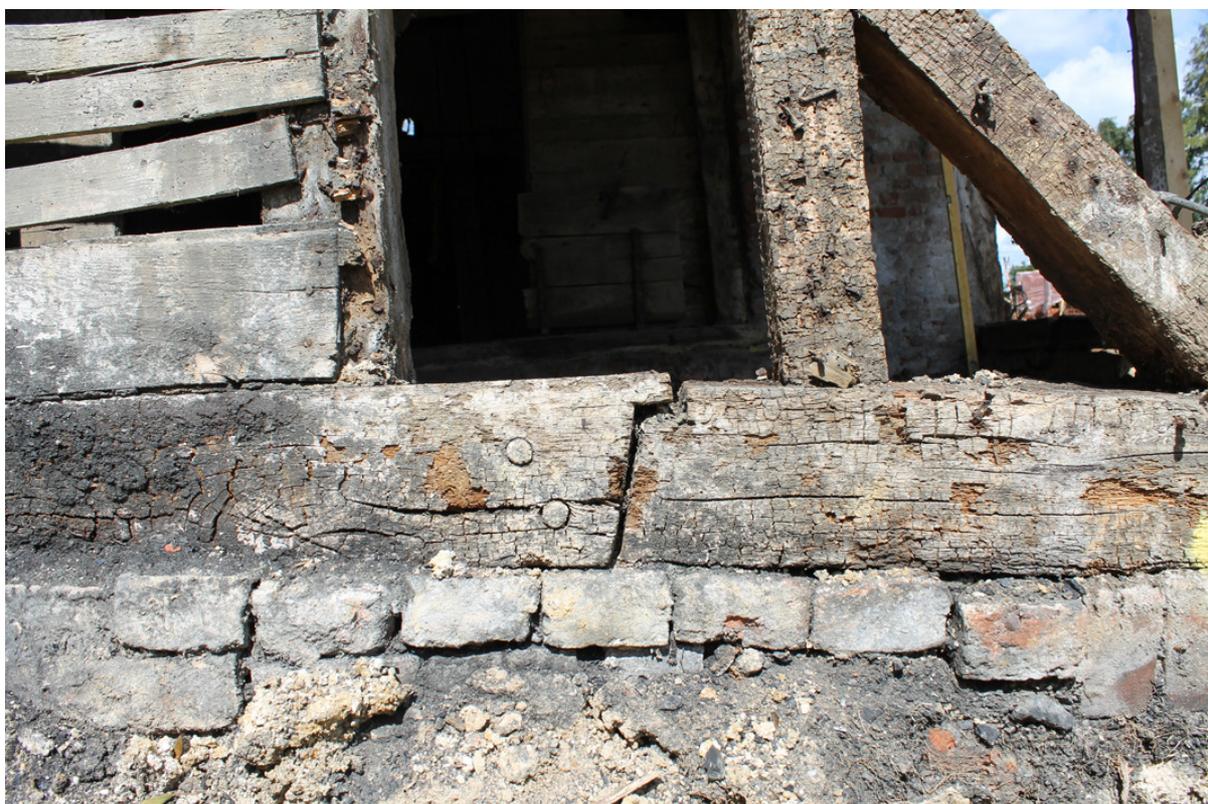
The south side of the bay (the south wall of the barn, Fig 10) has an entirely intact upper register, apart from one missing stud to the east of the storey post. In contrast the lower register is partially covered by boards and almost entirely made up of later replacement studs that fit poorly into the existing mortices on the girding and sill beams (Photograph 16). Only one original stud remains on the lower register. The sill beam has a straight bridling scarf joint with squinted abutments to the east of the storey post (Photograph 17).

Photograph 17 Straight bridling scarf joint with squinted abutments on south side of bay three sill beam. Photo taken facing north.

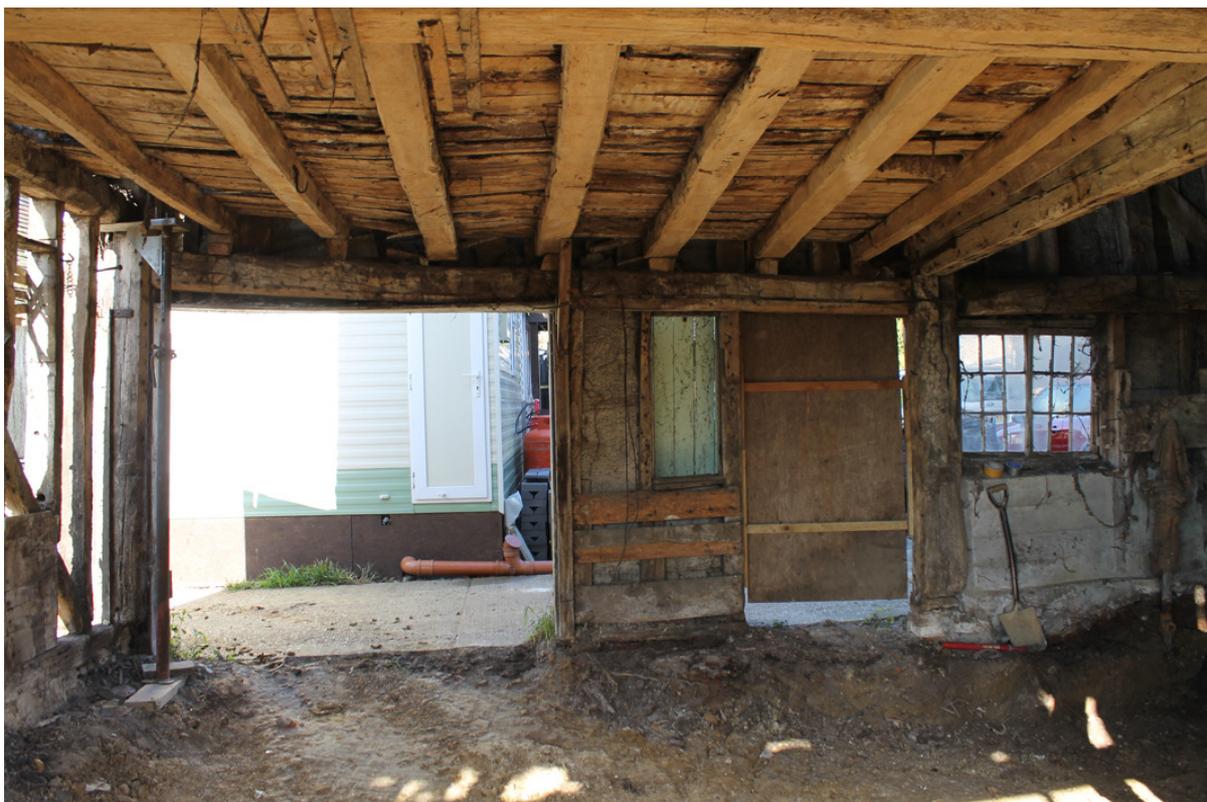
Photograph 18 West side of bay three, lower register. Modern doorways and windows into barn visible. Photo taken facing west.

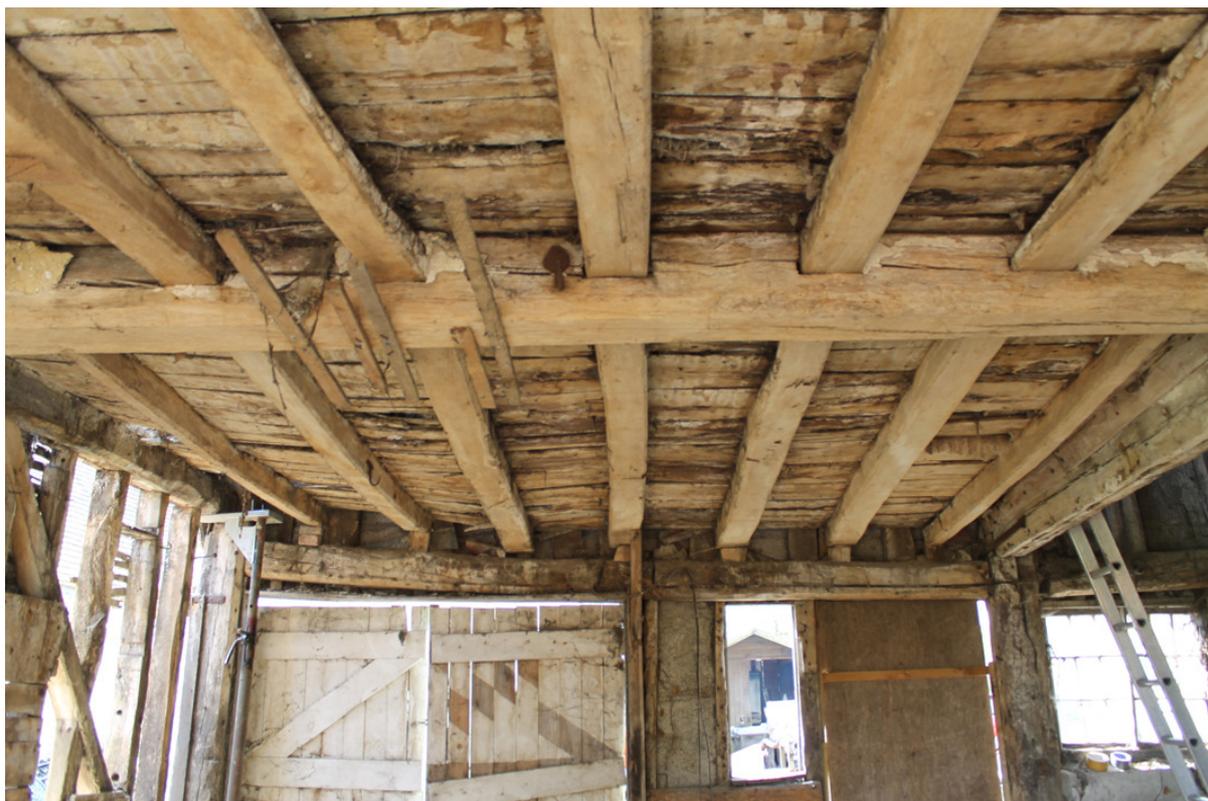
Photograph 21 Underneath of first floor in bay three, showing joists supported by offcut pieces of timber on west side. Photo taken facing west.

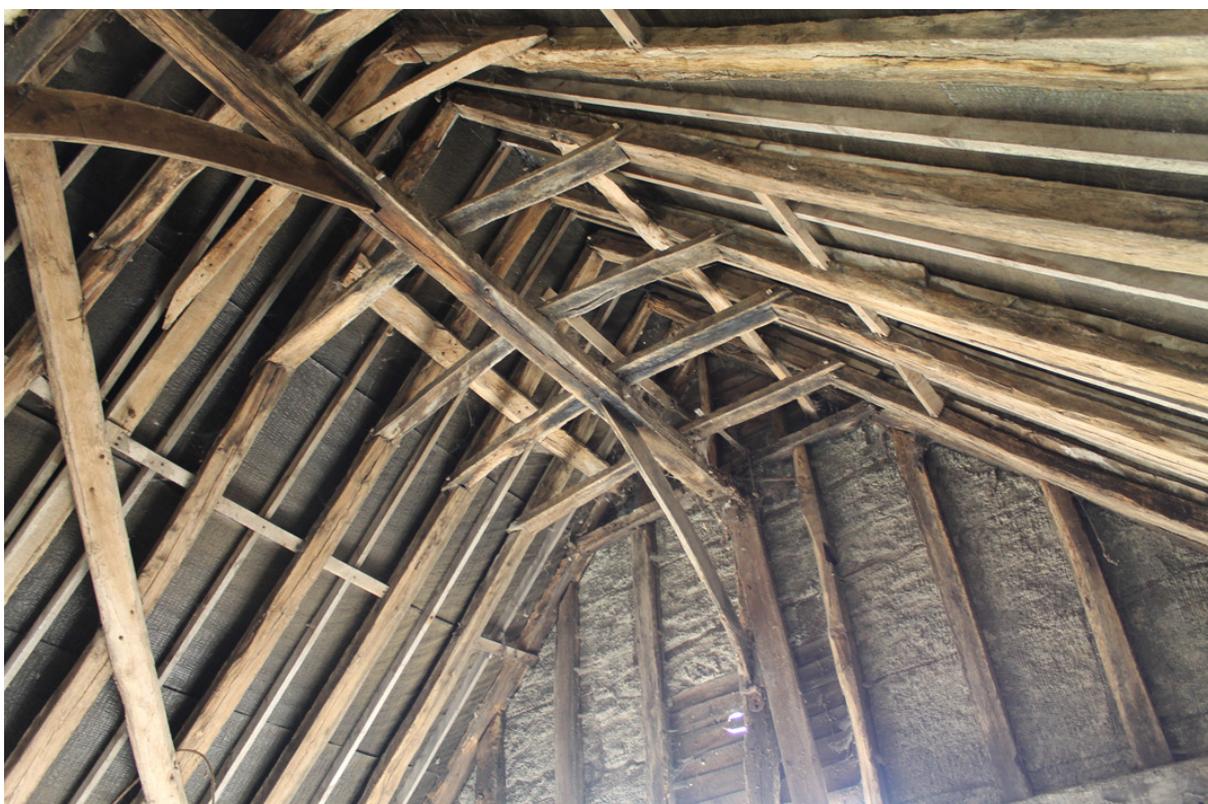
The southern end of the roof is a gable, but the crown post is broken and has been replaced (although the brace still runs to the broken timber).

Photograph 22 Detail of roof timbers at southern end of barn by gable. Photo taken facing south-east.

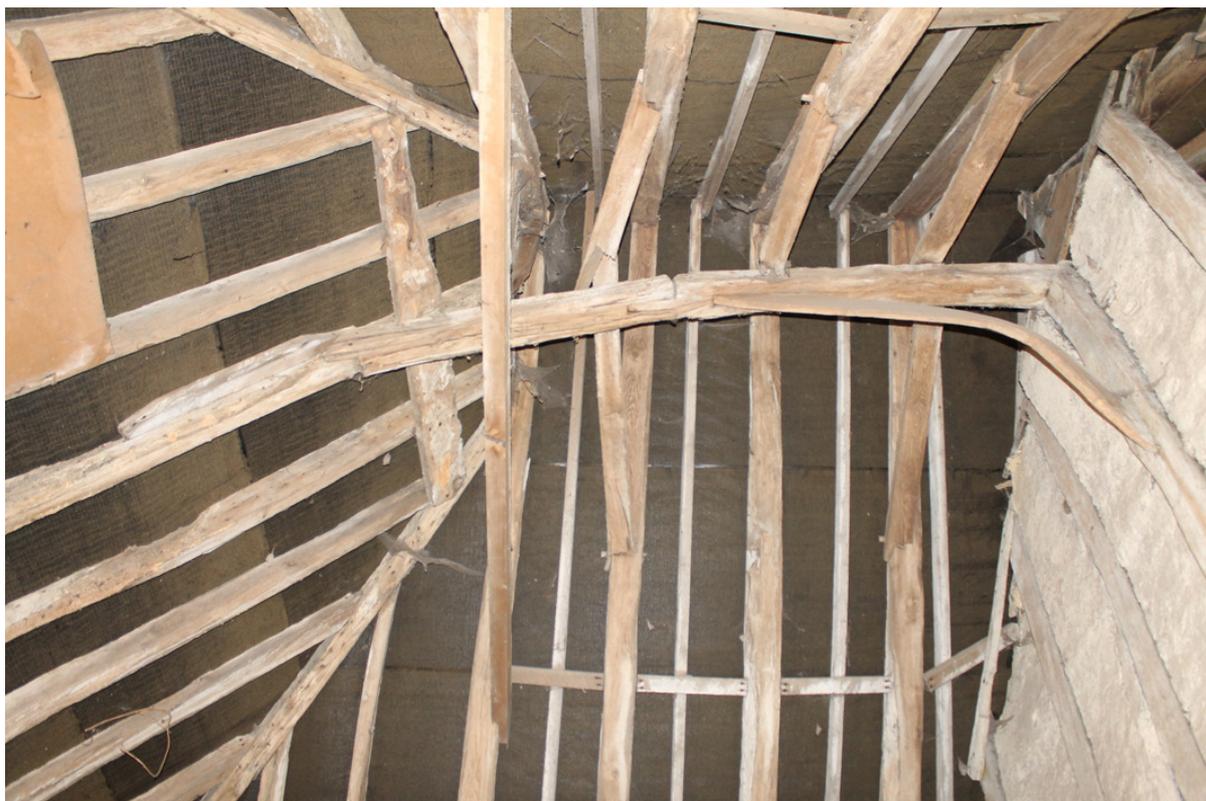
It appears that at some point the northern end of the roof was damaged and the gable collapsed, snapping the collar-purlin and probably some rafters. To reconstruct it using the same timbers would have necessitated the rebuilding of this end of the roof as a gablet. It seems likely that this rebuilding of the north end occurred at the same time the roof tiles were relaid.

Photograph 23 Detail of roof timbers at northern end of barn by rebuilt gable. Scarf joint in collar purlin visible. Photo taken facing east.

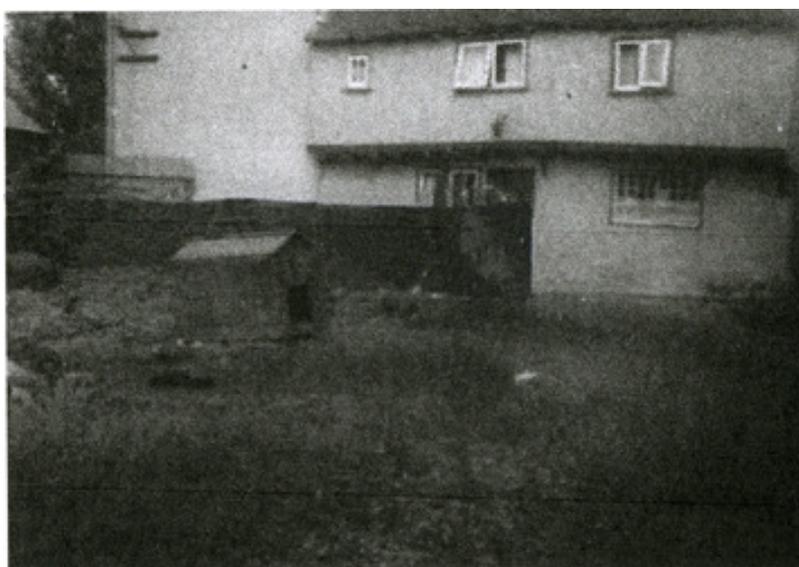
The only feature observed was a shallow modern foundation of frogged red brick in the service trench for the new water main (Fig 2), which corresponds to a garden wall visible in a black and white photograph provided by the client (Photograph 26).

Photograph 26 Photograph of site showing garden wall to the south of the farmhouse, the foundations of which were observed in the new water main trench. Photo taken facing north. Photo acquired from client.

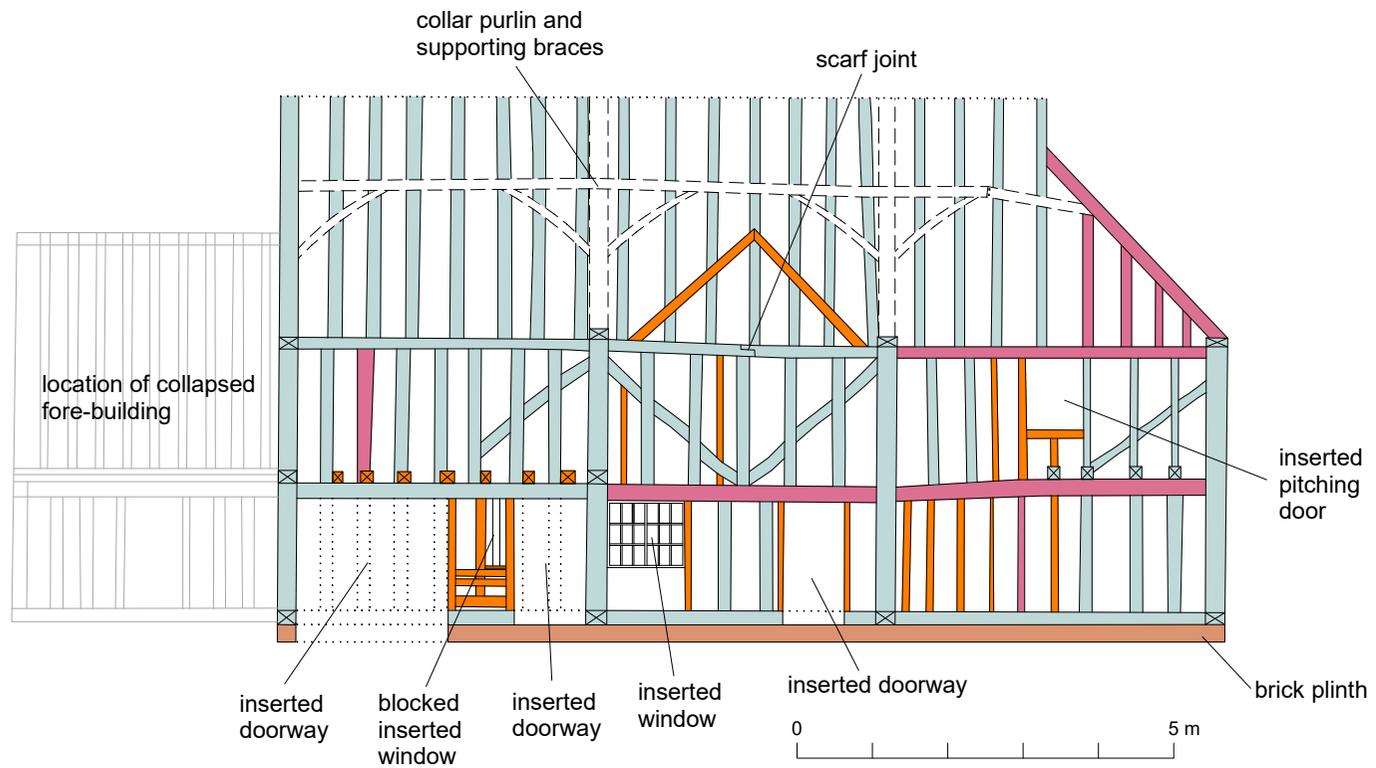
Fig 8 Frame drawing of the west wall of the barn, indicating the locations of original, re-used and replacement timbers.

Some structurally-significant timbers within the barn are clearly identifiable as being reused from an earlier building (Figs 8-11), most notably the sill beam and girding beam on the west side of bay one. Although not as obvious, it is quite likely that a high proportion of the rest of the barns frame also originated from an earlier building. Aside from the clearly modern machine cut timbers providing additional support to the roof, all timbers within the barn are hand-sawn, including the later replacement studs on the southern, western and northern walls. It is difficult to ascertain if the medieval carpentry techniques observed on the frame are original to the construction of the barn or they owe their heritage to an older building on the farm complex.
