**Historic building recording at  
Nagg's Farm, Old Road,  
Wickham St Paul, Braintree CO9 2PU**

**June 2017**

**CAT Report 1136**  
July 2017

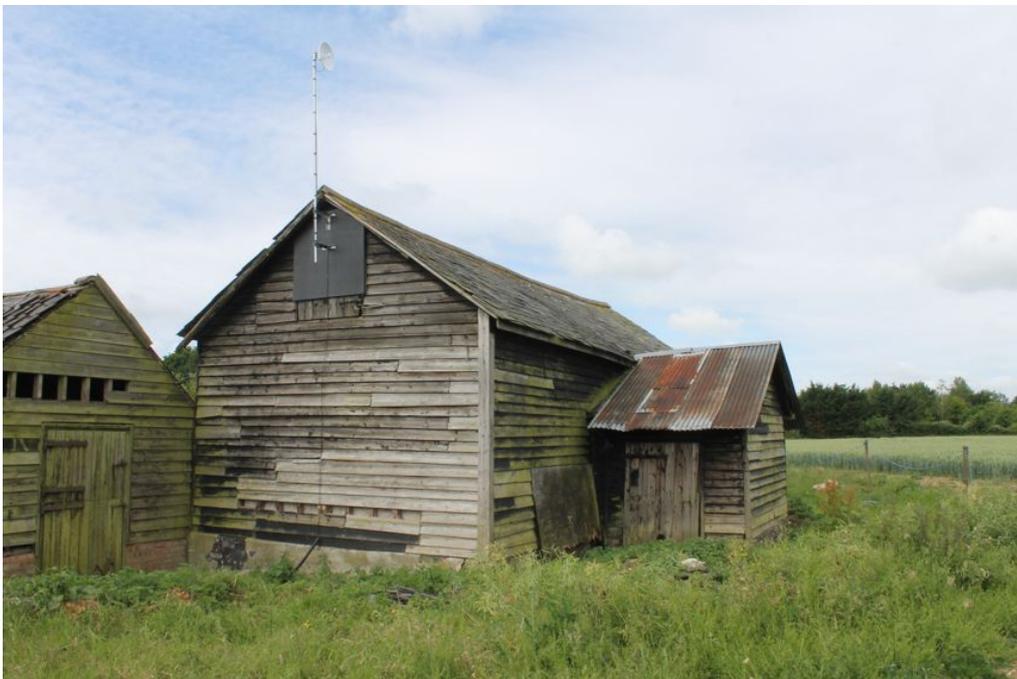
**Photograph 1** North-east and north-west elevation of barn. Photograph taken facing south.

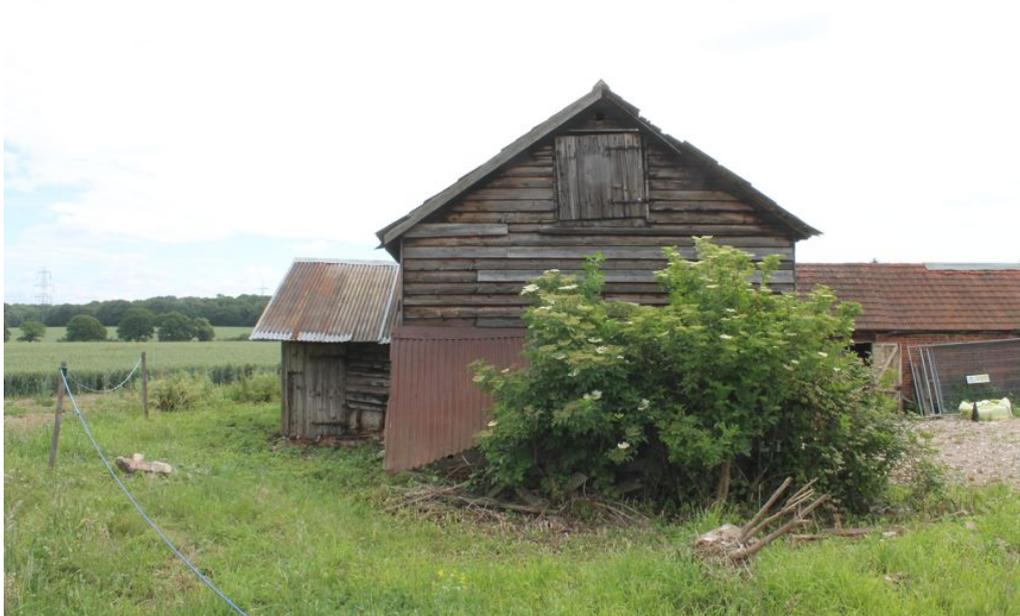
**Photograph 3** South-west elevation of barn, showing pitching door in gable. Collapsed lean-to in foreground. Photograph taken facing north-east.

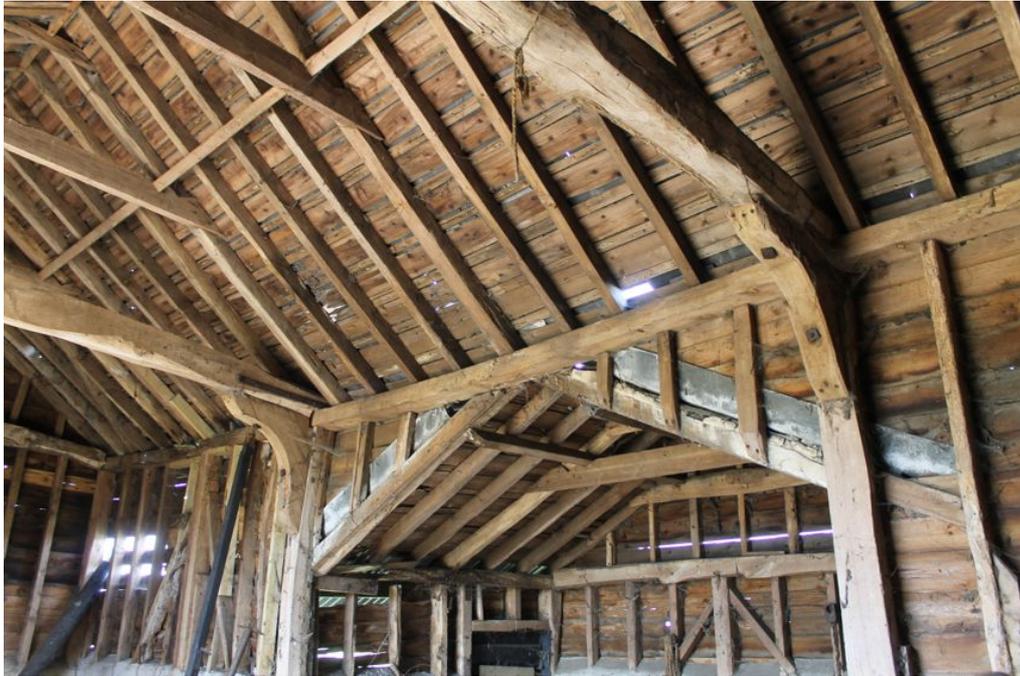
Although the midstrey is mostly constructed of hand-sawn timbers, its small size and the two machine-cut principal posts on the north-west elevation of the barn suggest it has been rebuilt at some point in its history. That the main range's roof has also been rebuilt supports this, as such a rebuilding would have been necessary after the removal/collapse of a full-height midstrey. The small midstrey is not a later addition, as by the lack of mortices on the underside of the north-west wall-plate of bay 2 prove (Photograph 5).

**Photograph 5** North-west side of bay 2, showing wall-plate and two machine-cut principal posts. Photograph taken facing west.

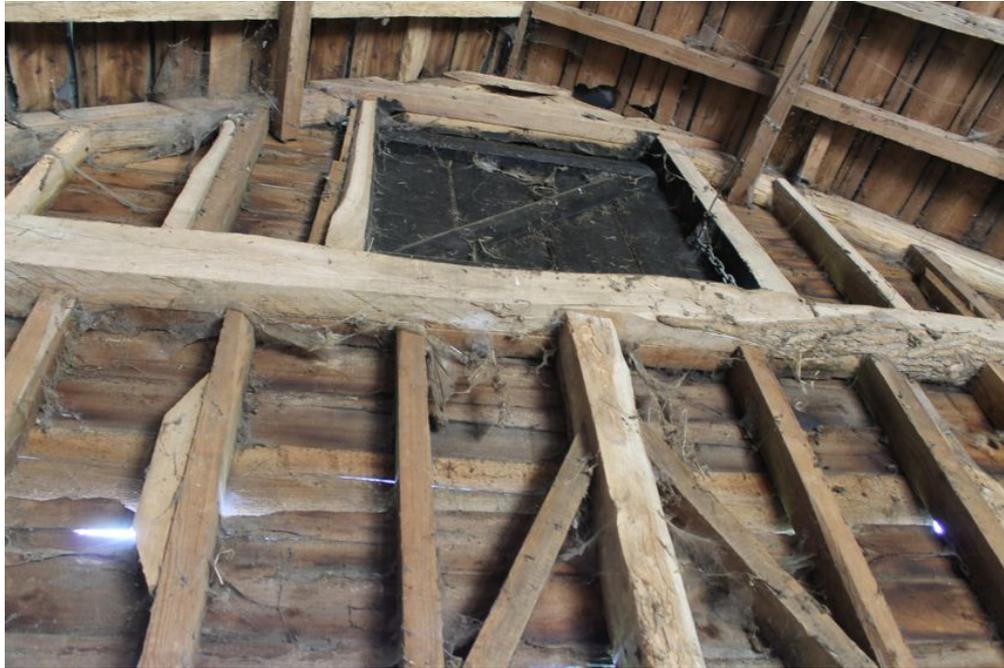
Most of the large, structural, timbers in the barn are hand-sawn, with the exception of the two principal posts on the north-west elevation, and the wall-plate on the south-eastern elevation of bay 3. The hand-sawn wall-plate on the north-eastern elevation has been repaired by a machine-cut timber behind it (Photograph 7).

**Photograph 7** Underside of wall plate on north-east elevation of barn, showing machine-cut timber used in repair. Photograph taken facing north-east.

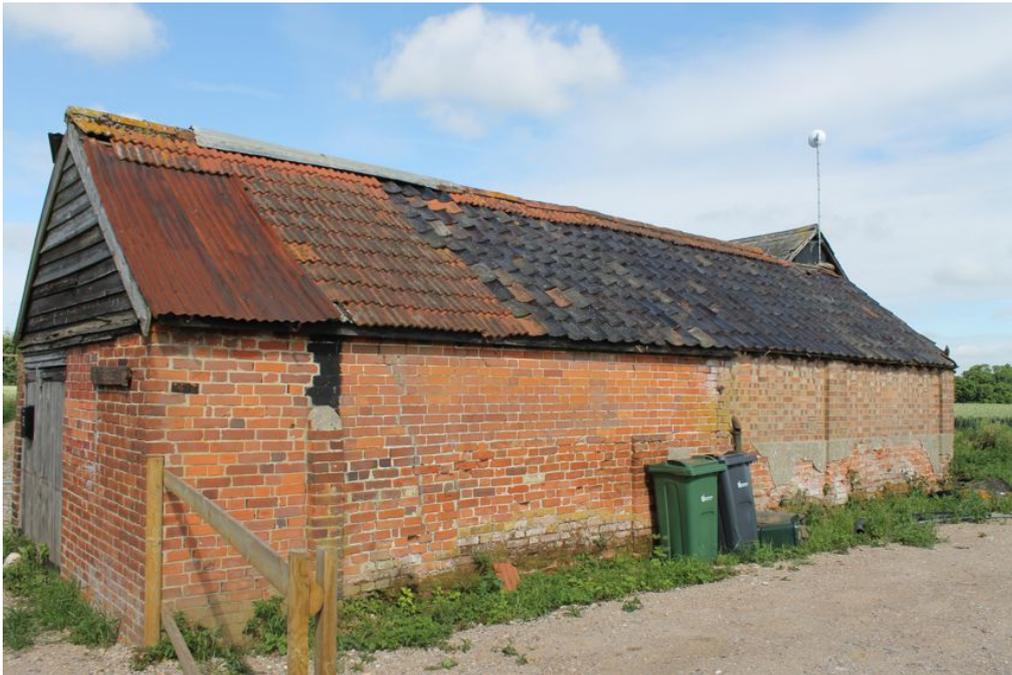
**Photograph 13** North-east elevation of brick outbuilding. Mismatched roof visible. Photograph taken facing west.

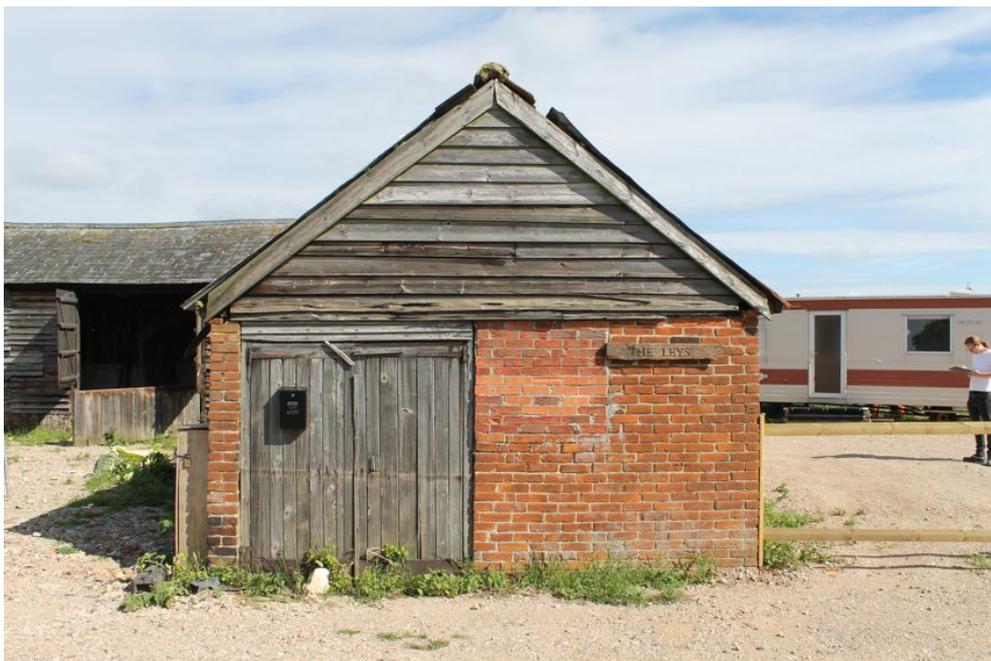
**Photograph 15** South-east elevation of brick outbuilding, showing double-door and blocked in opening. Photograph taken facing north-west.

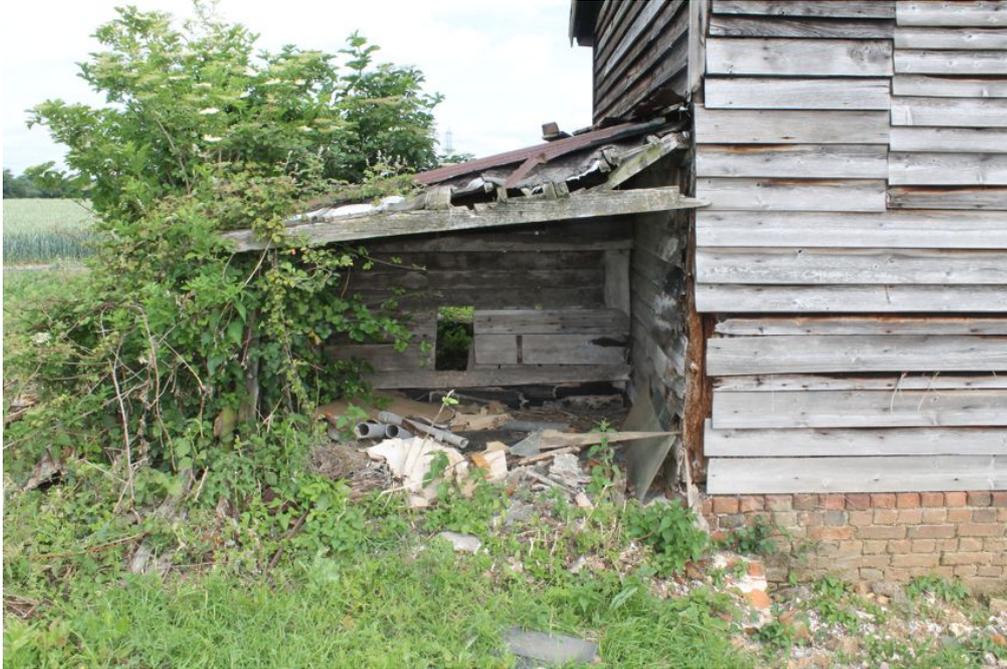
The lean-to against the south-west elevation of the barn is a rectangular timber-framed structure, 2.1m long x 4.8m wide (Photograph 19). It is constructed from machine-cut softwood timber, with a concrete floor. The building is roofed in corrugated iron sheeting. The timber-frame is nailed together. The north-western half of the structure has totally collapsed, and the south-eastern half is only partially standing.

**Photograph 19** Partially collapsed lean-to. Photograph taken facing north-west.

The building would only have been 2.1m high when intact, and there is no evidence that there was ever a doorway into the structure. It is clearly of modern construction and was probably used for storage, perhaps of firewood.
