Archaeological investigation at St Nicholas' Church, Copt Hall Lane, Little Wigborough, Essex

January 2019

*Tel:* 01206 501785 *E-mail:* <u>mb@catuk.org</u> CAT Report 1375 February 2019

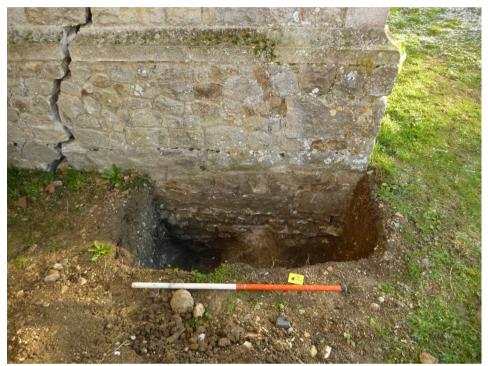
The exposed west nave and buttress wall foundation (F15) consisted of much the same material as observed in the 2005 (Fig 3). The foundations were a uniform vertical face of Kentish Ragstone bonded in lime mortar. Two small fragments of peg-tile were also observed within the foundations fabric. The full depth of the foundation was not reached in the test-pit, but it is known to be 1.35m deep based on previous investigation (CAT Report 350).

**Photograph 1** Test-pit showing foundation of nave and south-west buttress. Substantial crack in wall visible to left. Photograph taken facing east.

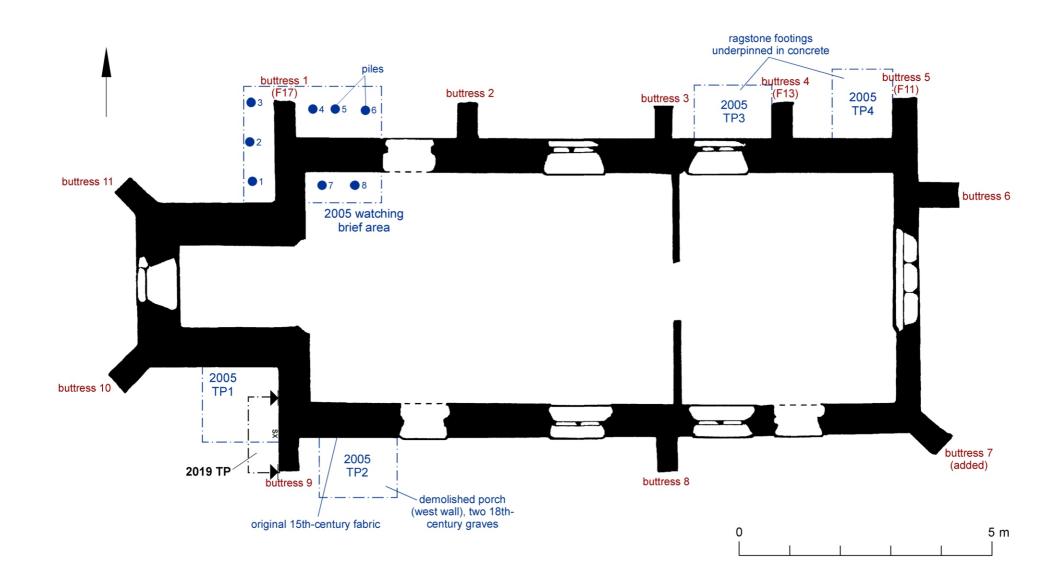
Fig 2 Plan of the church showing test-pit location and areas investigated in 2005 (in blue).

The single test-pit was located against the exterior western wall of the nave, adjacent to the west of south-west buttress (Fig 2). It measured  $1.5 \times 0.6$ m in size and was excavated to a maximum depth of 1.1 below the current ground level. It partially overlapped with the position of TP1 from CAT Report 350 (Fig 2).

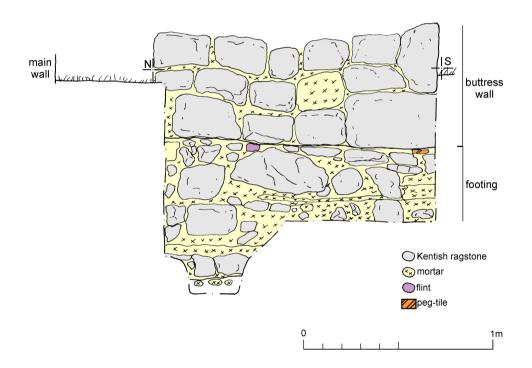
Fig 3 Representative section.

As postulated in 2005, these appear to be the original 15th-century footings of the church.
