**Historic building recording at B Mess,
formerly the Officers' Quarters,
Le Cateau Barracks, Colchester,
Essex,
November 2013 and December 2019**

**report prepared by
Chris Lister and Mark Baister**

**on behalf of
K2 Consultancy**

CAT Report 1512
February 2020

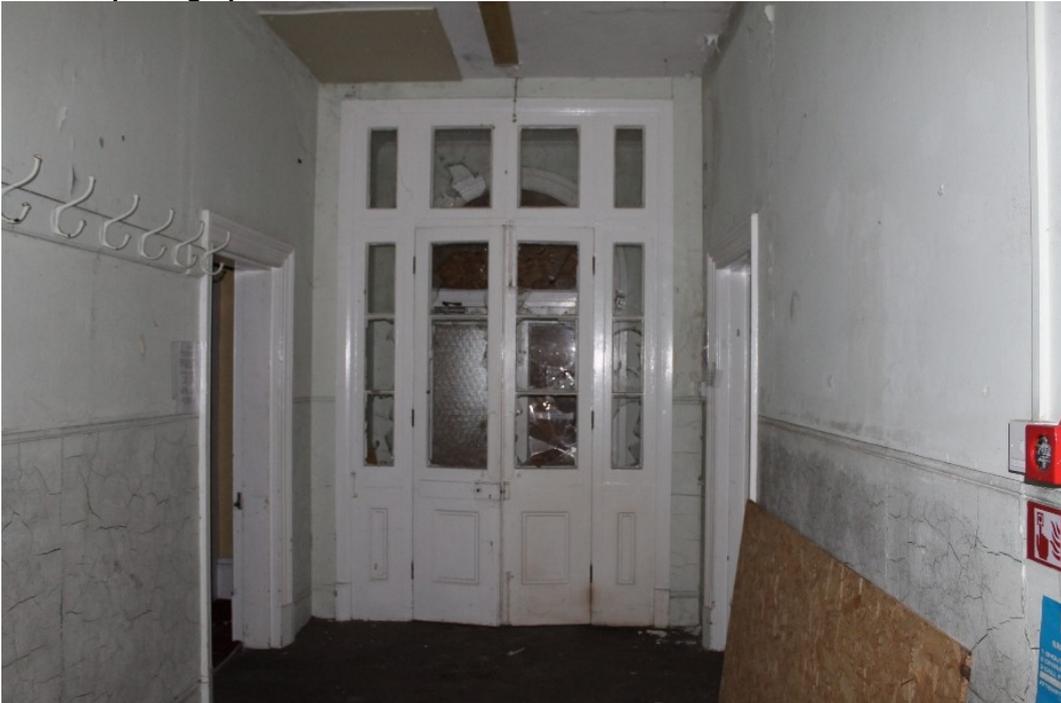
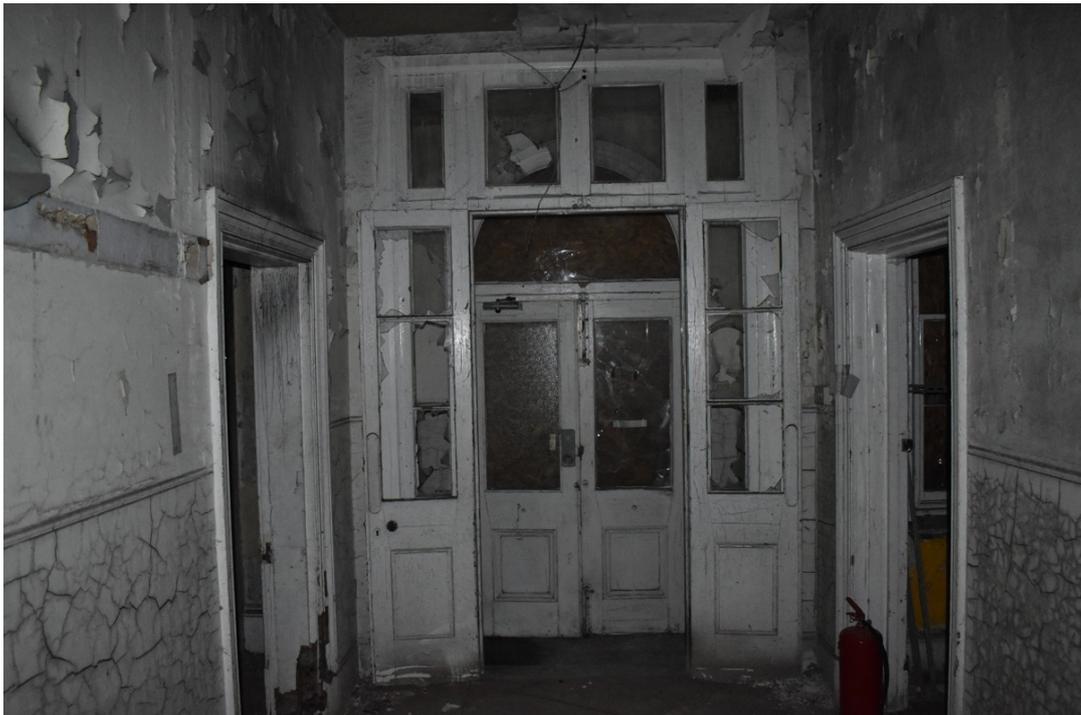
Plate 1 Entrance way ii, showing the original inner and outer doors of the porch and original coat hooks on the left wall - view south-east. Photo from November 2013 above, photo from December 2019 below.

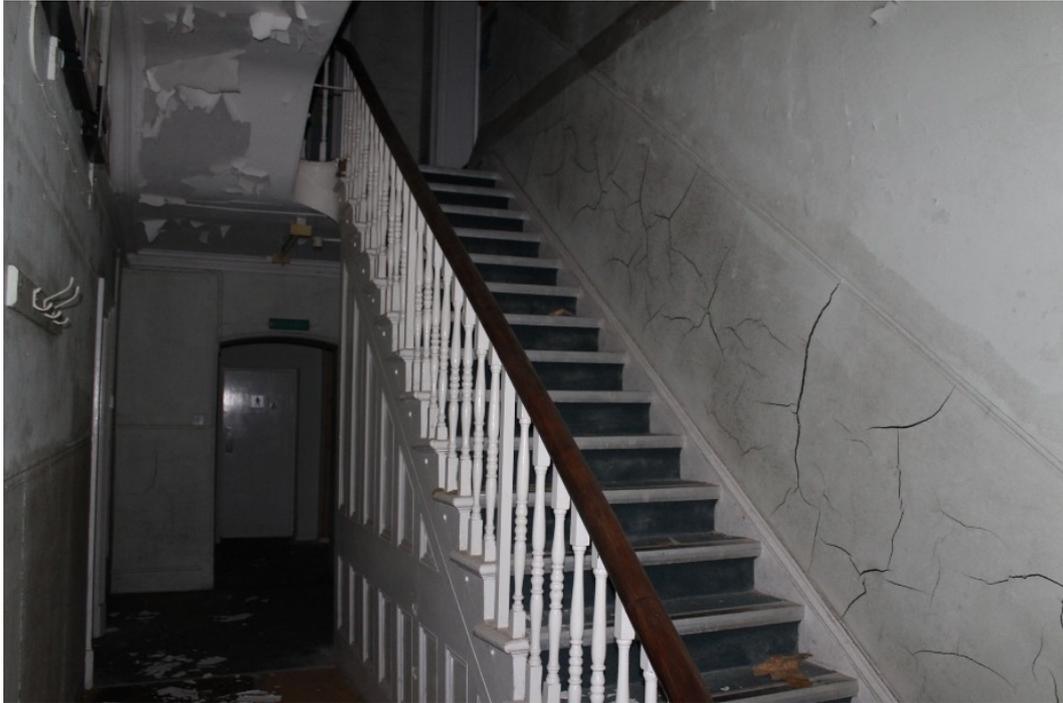
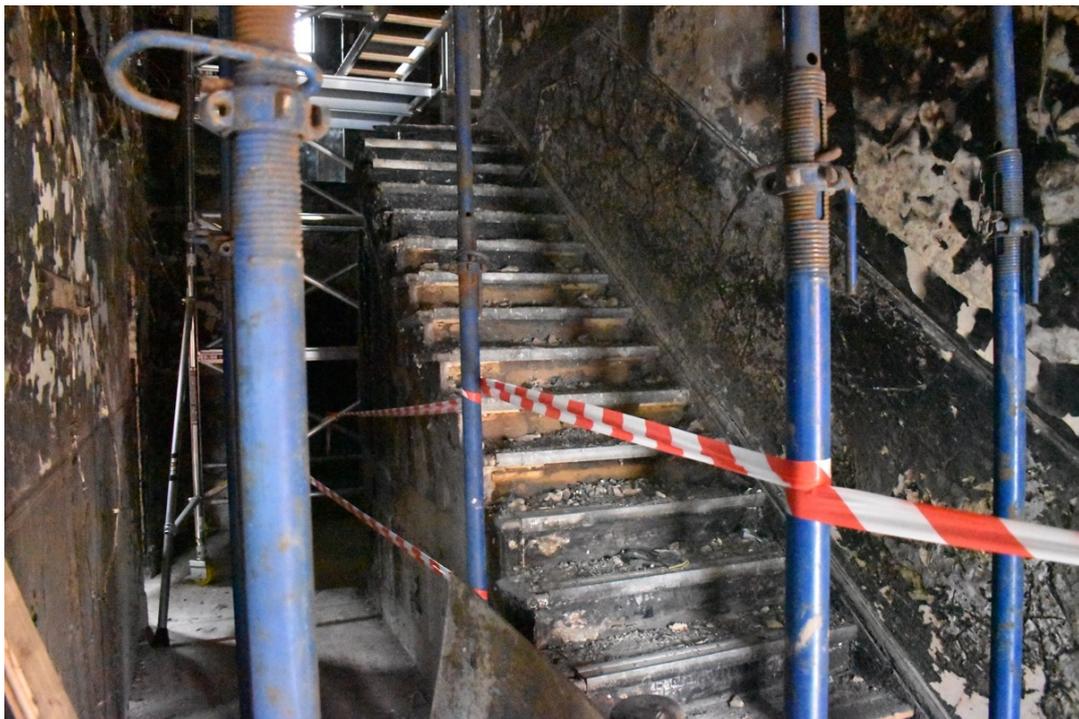
Plate 2 Stairwell iv, showing the original staircase, coat hooks and the entrance to the 1904 lavatory – view north-west. Photo from November 2013 above, photo from December 2019 below.

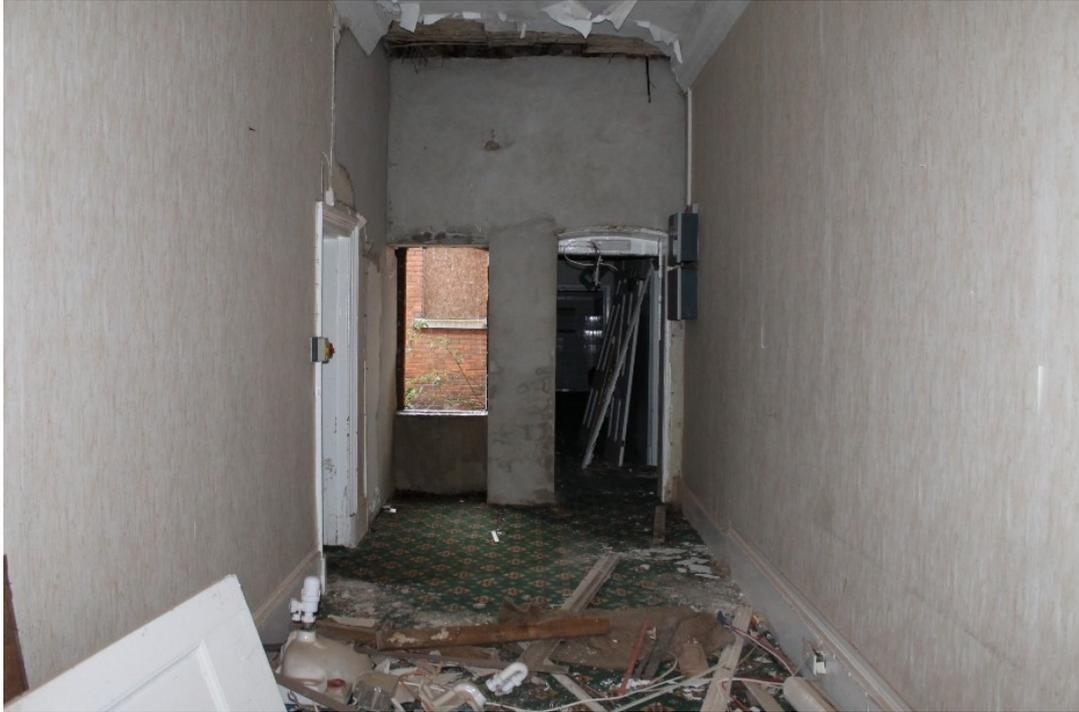
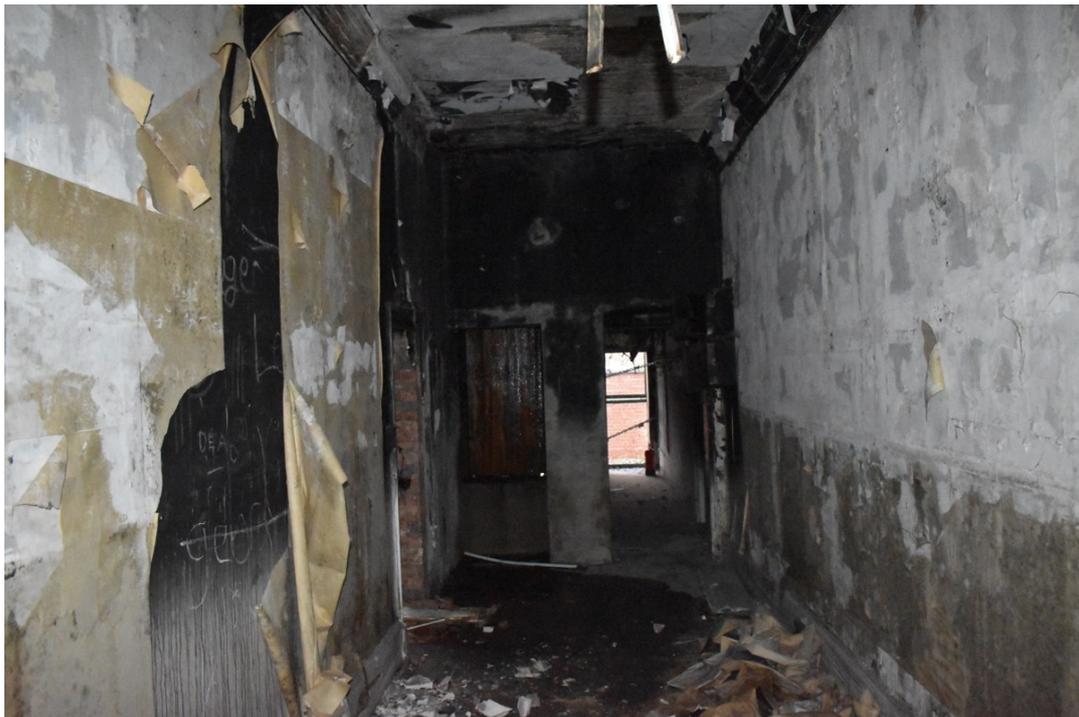
Plate 4 Entrance way *iii* with the removed staircase and the 1904 toilet block to the rear - view north-west. Photo from November 2013 above, photo from December 2019 below.

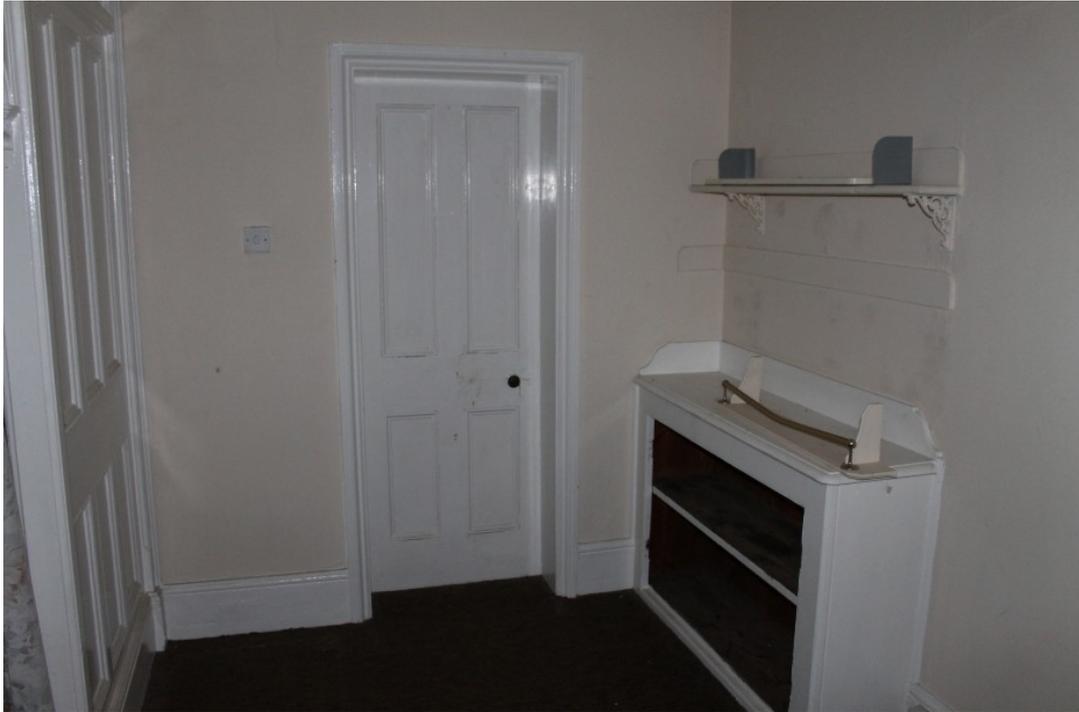
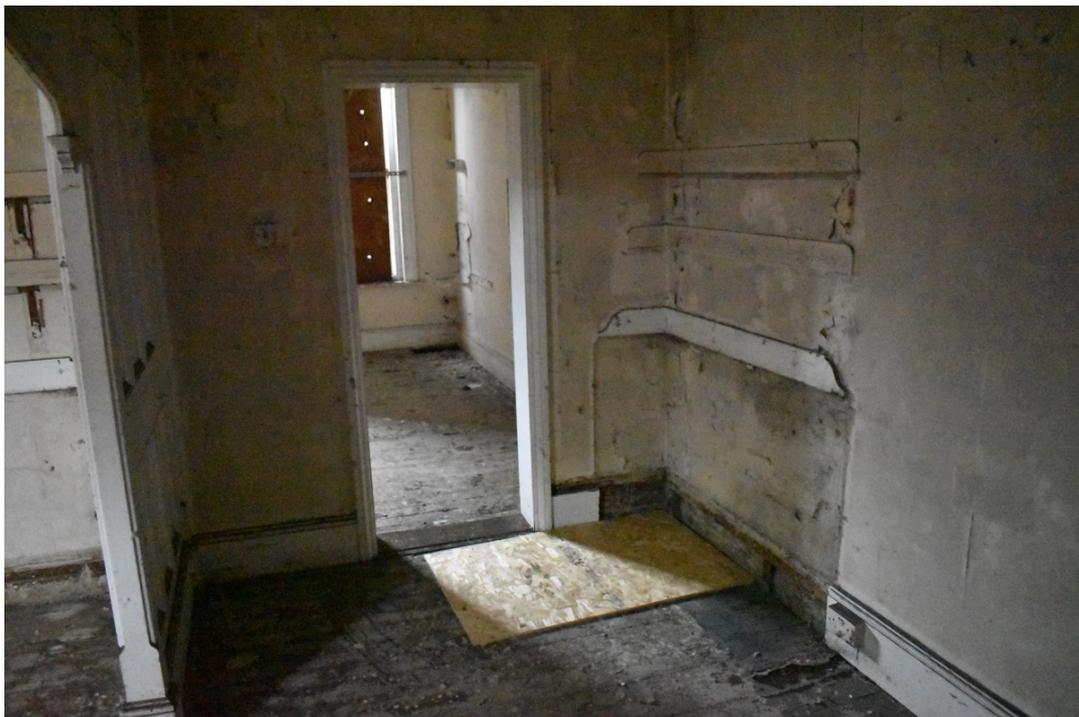
Plate 13 Room 11, showing the additional dresser and shelving in the sleeping area and the connecting doorway with the sleeping area of Room 12 – the panelled wooden partition separating the sleeping area from the sitting room can be seen on the left – view south-east. Photo from November 2013 above, photo from December 2019 below.

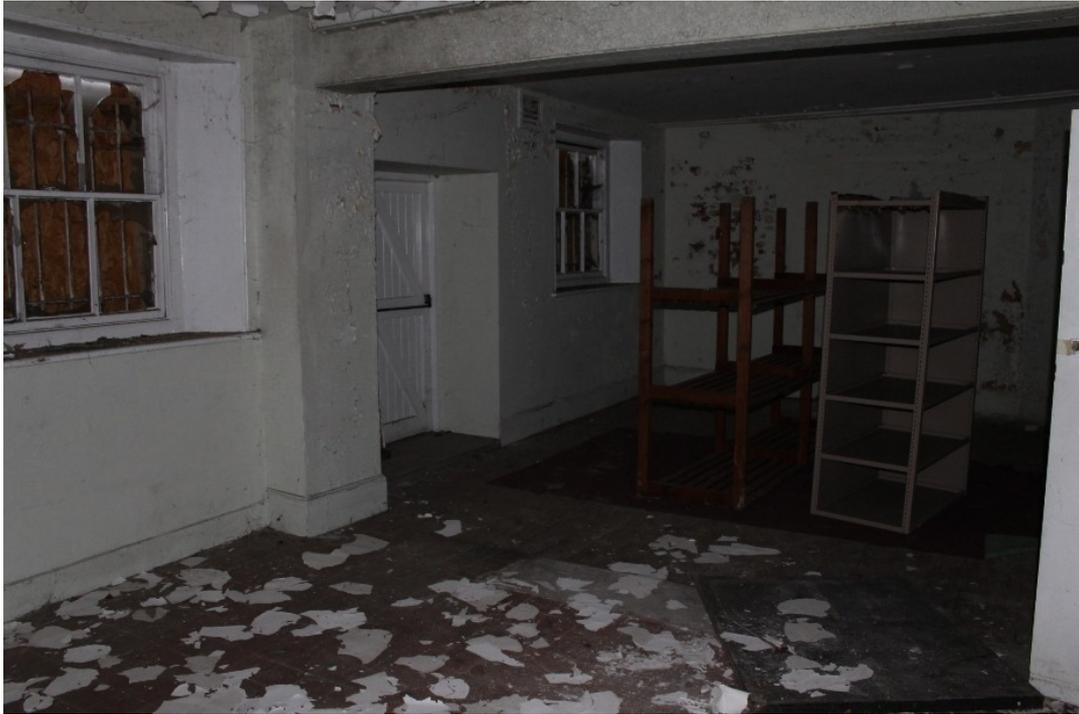
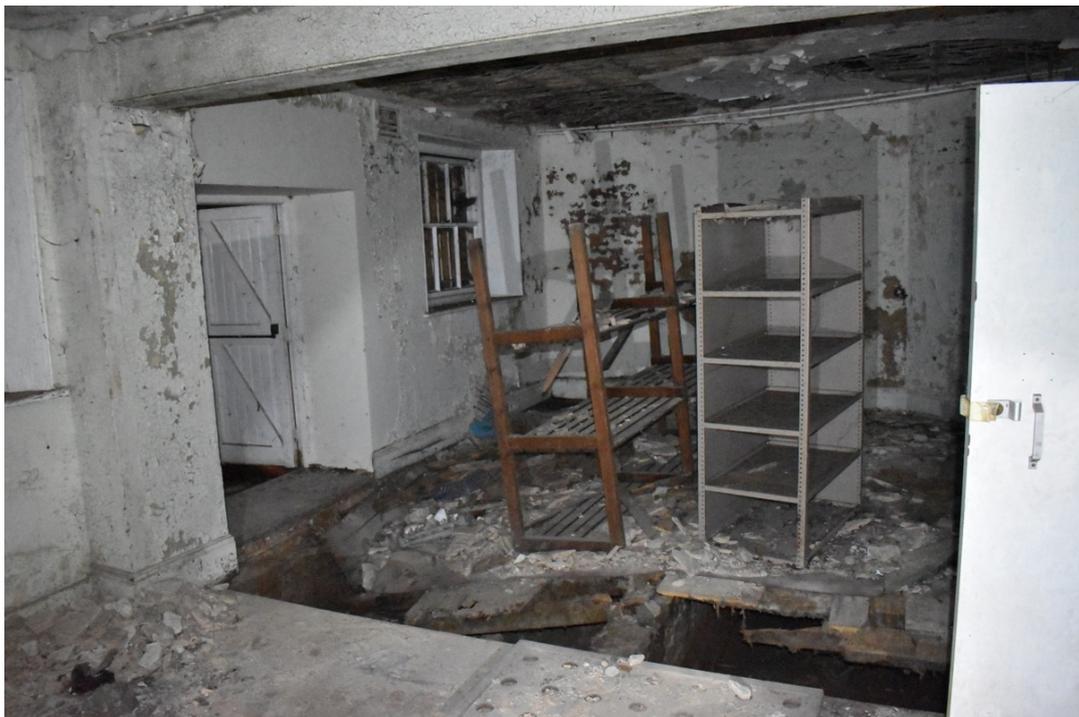
The basement was largely insulated from the effects of the fire, and so the only damage suffered is the floor of rooms 38 and 39.

Plate 22 Rooms 39 and 38, the former kitchen and mess manager's room, with the dividing wall removed and a doorway inserted through one of the windows of the mess manager's room – view south. Photo from November 2013 above, photo from December 2019 below.

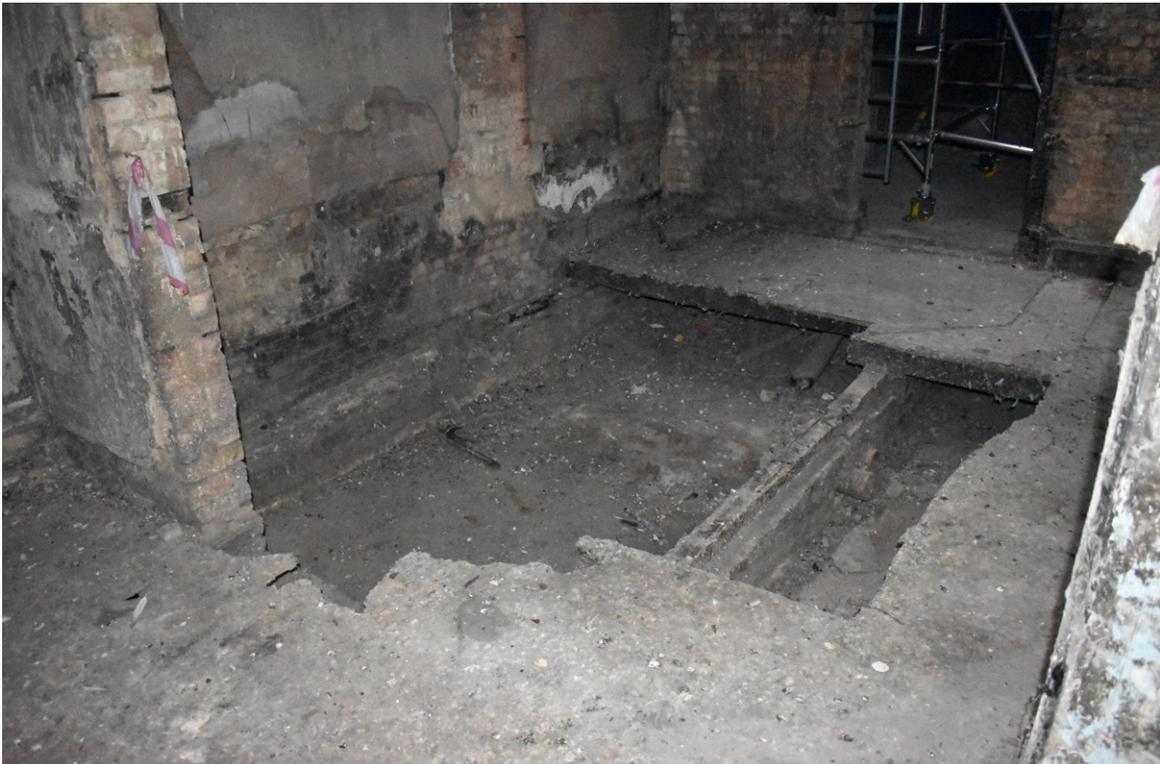
The fire the Officers' Quarters suffered in 2014 caused considerable damage to the building. It has completely destroyed rooms 24 and 25 on the first-floor, and the rooms below them on the ground-floor, leaving only the brick-built shell. Rooms immediately adjacent to the epicentre of the blaze, including the bar and entranceway iv, have also been heavily damaged. The fire is, however, not responsible for all of the damage the building has suffered in the last six years. A large number of the original features and fittings, including dressers, shelves and some doors, have been removed from the structure, most of them from the south-west end of the building in areas impacted very little by the fire. Ironically, the rooms left most inaccessible due to the blaze (rooms 26 and 27 on the first-floor) have all their features surviving (albeit in a damaged state).

Plate 24 Missing floor in ground-floor on building below room 24, with exposed brick plinths - view north.

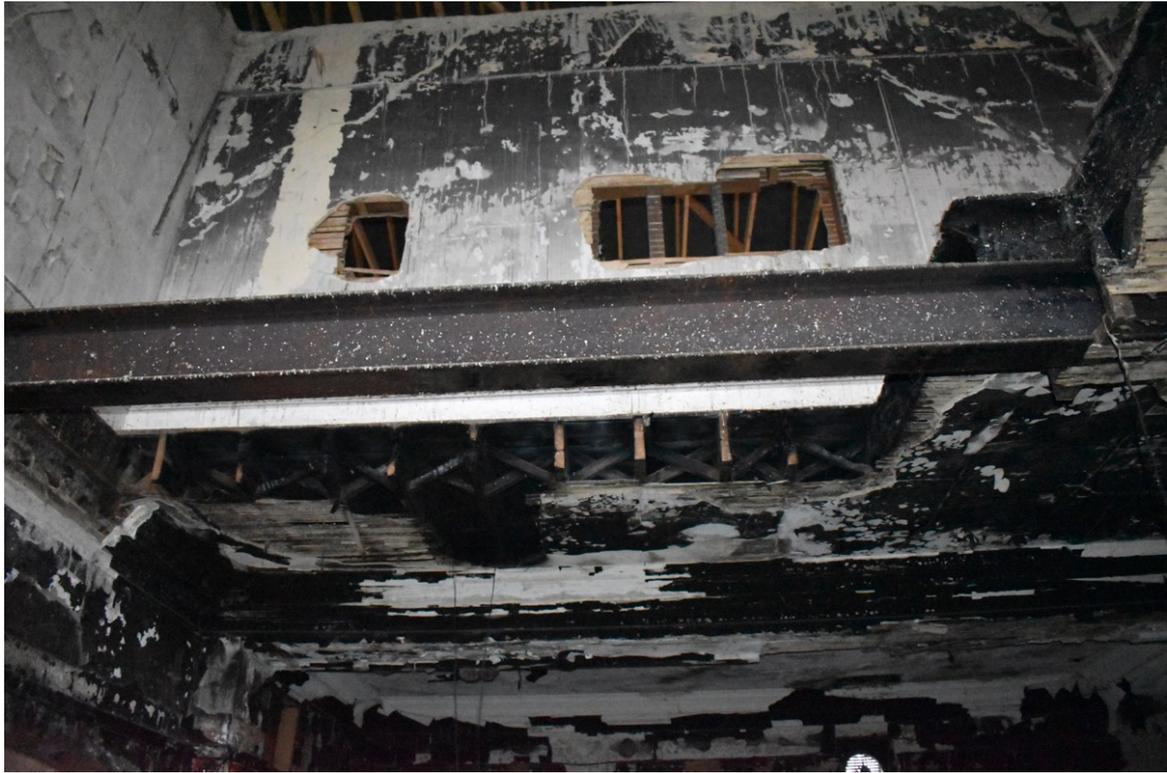
From the bar eastwards is the section of the Officers' Quarters most severely damaged by the 2014 fire, and many of the features described above no longer survive, or, if they do, are in a significantly dilapidated state. Most of the wallpaper has burnt away and the flooring is heavily damaged, with several holes exposing the brick plinths below (Plate 24). In addition, the first-floor above the eastern rooms only partially survives, with a large section of ceiling above the bar completely absent. This has exposed the bridging beams and shown them to be constructed of metal, rather than timber. Similarly, the beams supporting the inserted archways are also shown to be of metal construction (Plates 25 and 26).

Plate 25 Metal beam that would have supported the floor of room 22 prior to the fire. Herringbone strutting visible behind - view south-east.

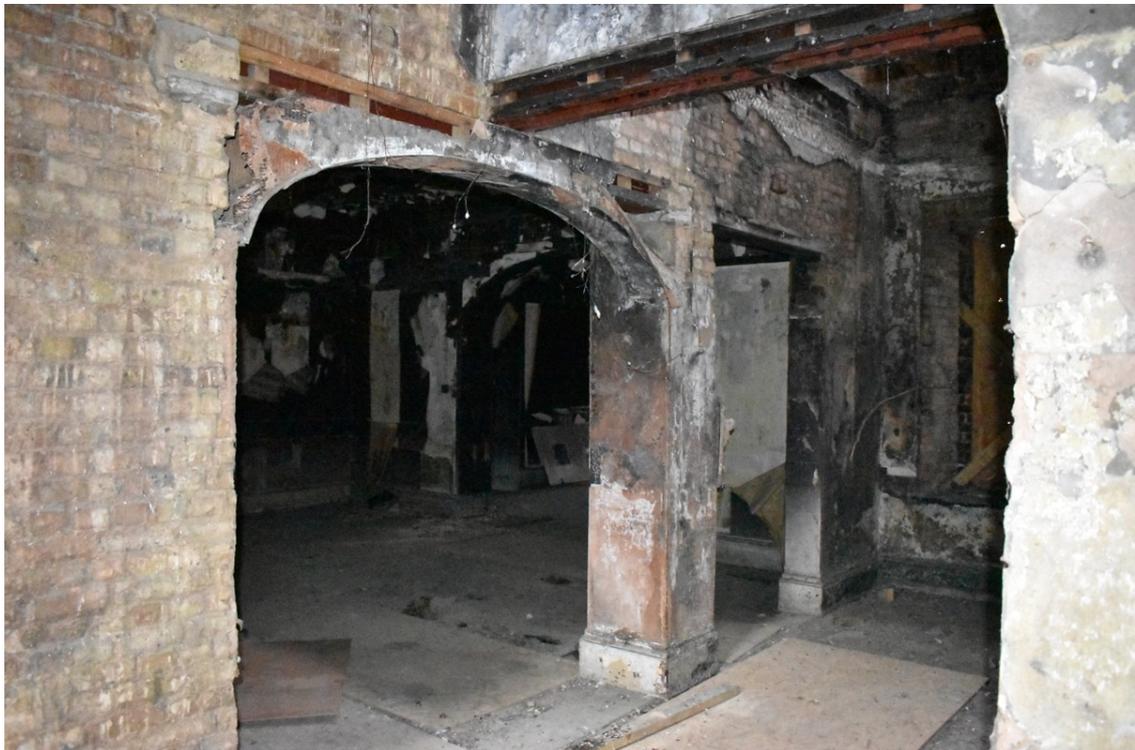
Plate 26 Inserted arch leading into bar with removed wall to right, both supported by metal beams - view west.

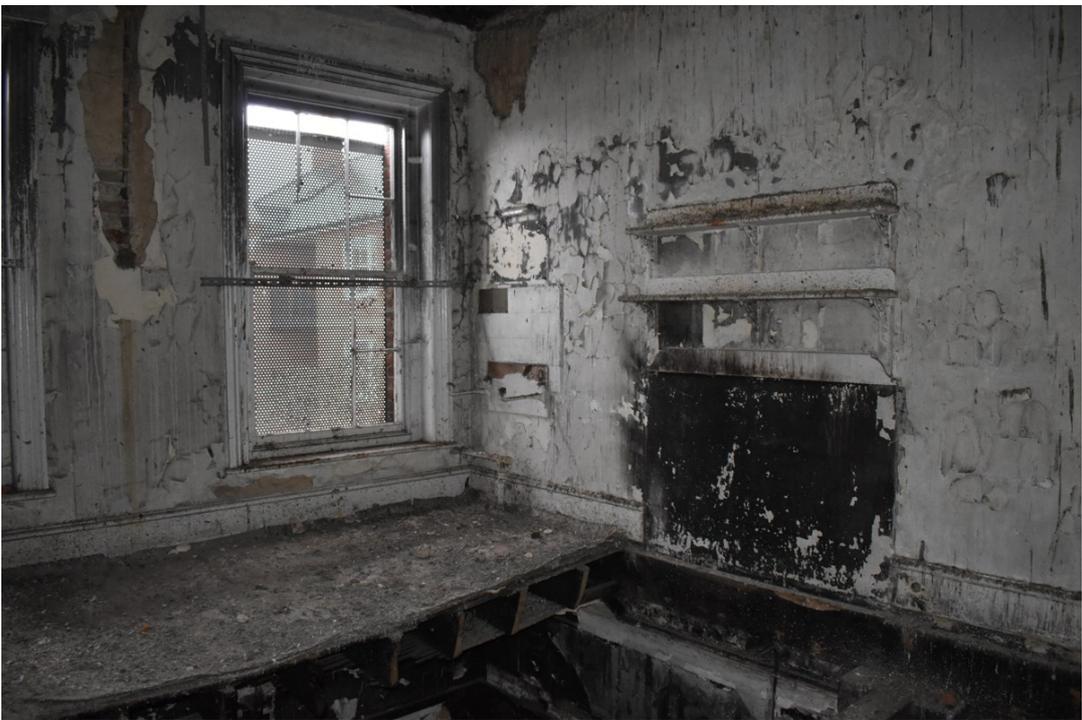
Plate 30 Room 22, showing the missing floor and dresser, but surviving shelves - view north.

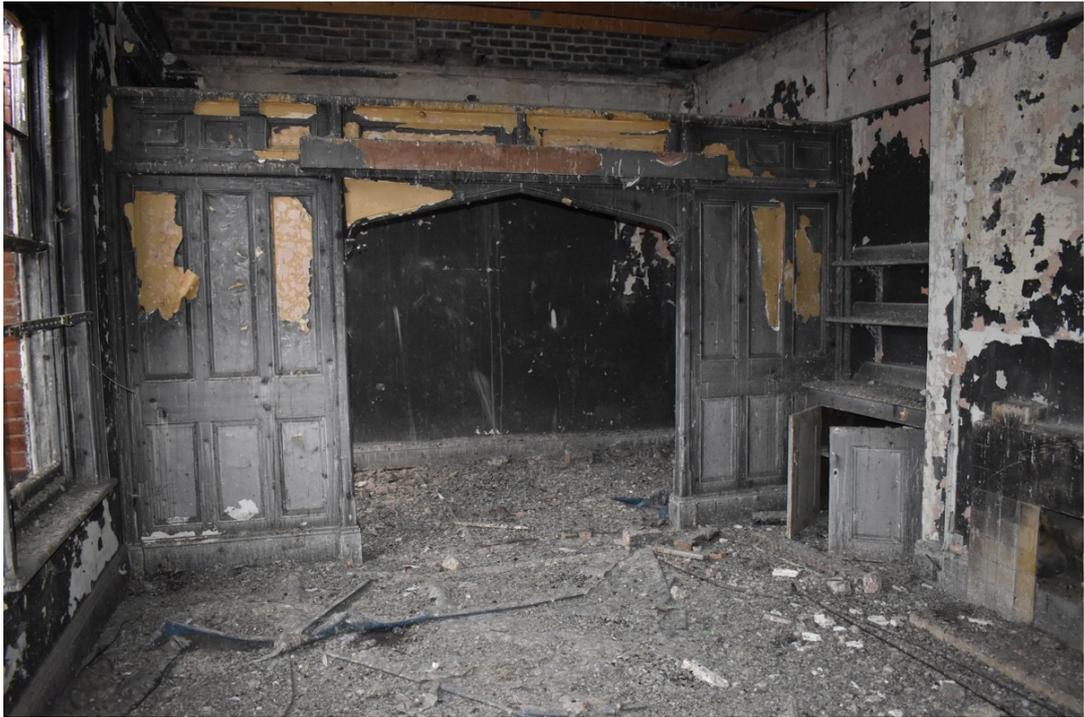
The landing above stairwell iv was destroyed by fire, but remarkably the dressers, shelving and wooden partitions in rooms 26 and 27 have all survived, albeit in a damaged state (Plates 31 and 32).

Plate 31 Interior of room 26 showing surviving, but damaged, features - view north-east.

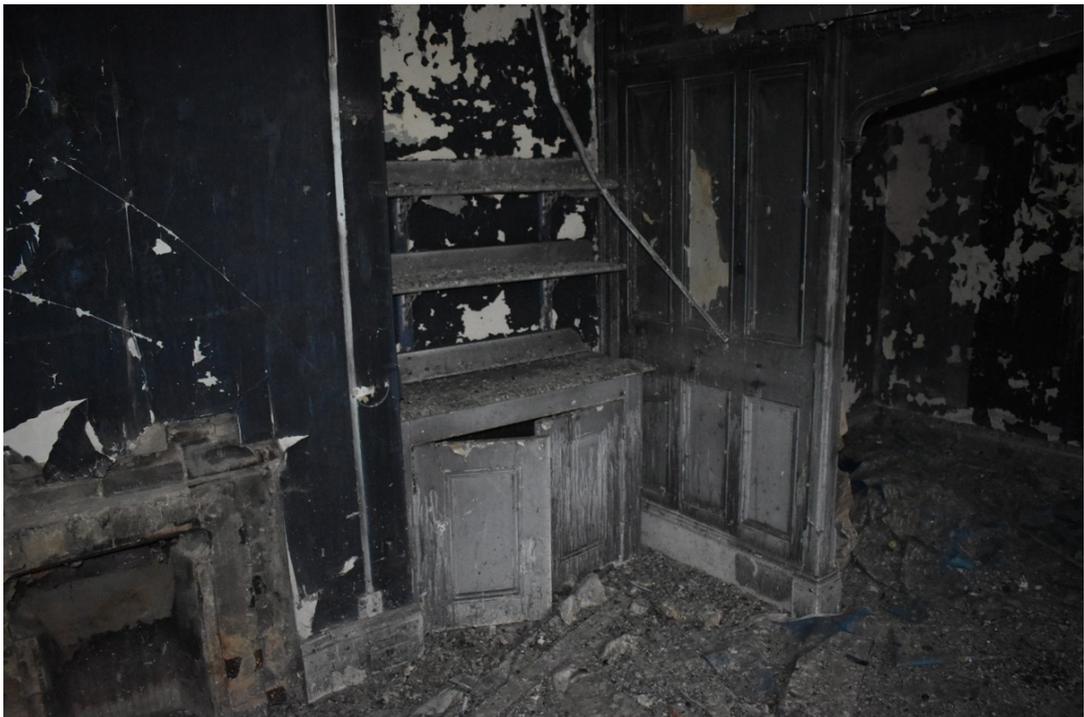
Plate 32 Surviving, but damaged, dresser and shelves in room 27 - view north.

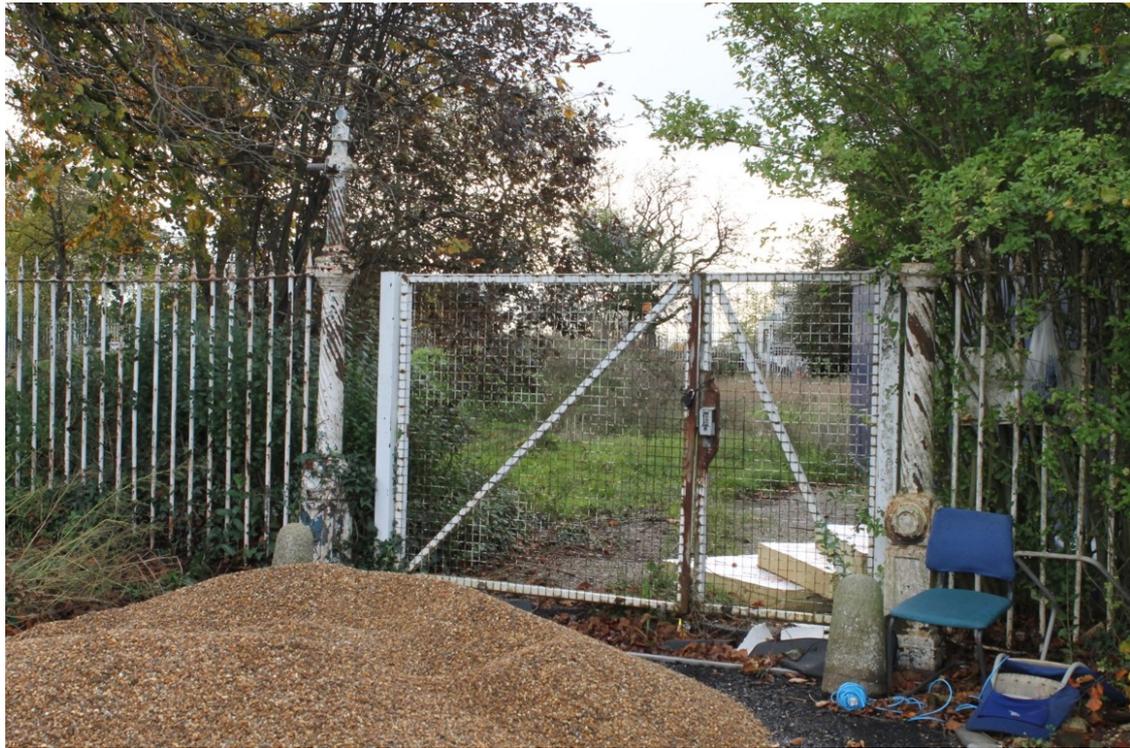
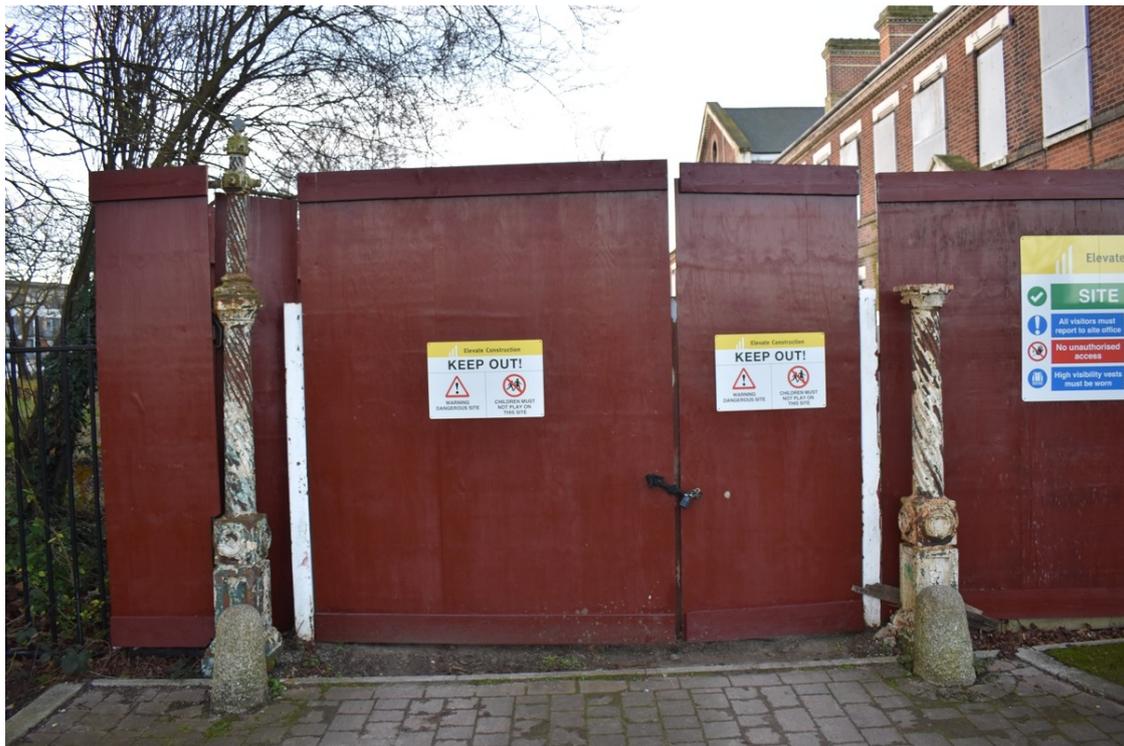
The perimeter fence of the Royal Artillery Barracks has long since been removed, with only the section surrounding the garden in front of the Officers' Quarters surviving. Probably at the same time as the 1904 alterations were carried out (or shortly after) the Officers' Quarters was enclosed in its own iron fence, joined to the earlier palisade and provided with gates formed by iron barley-twist posts incorporating gas lamps. Although the gates themselves have since been replaced, all four of the gate posts and short sections of the fence have survived. *Only three of the gate posts are now extant; the northern one on the western entrance is missing. The surviving posts, however, are in the same condition they were six years ago (Plates 33 and 34). The fence has since been entirely replaced.*

Plate 33 Surviving gate posts with gas lamps at eastern entrance to site. Note missing top of right post. Photo from November 2013 above, photo from December 2019 below.

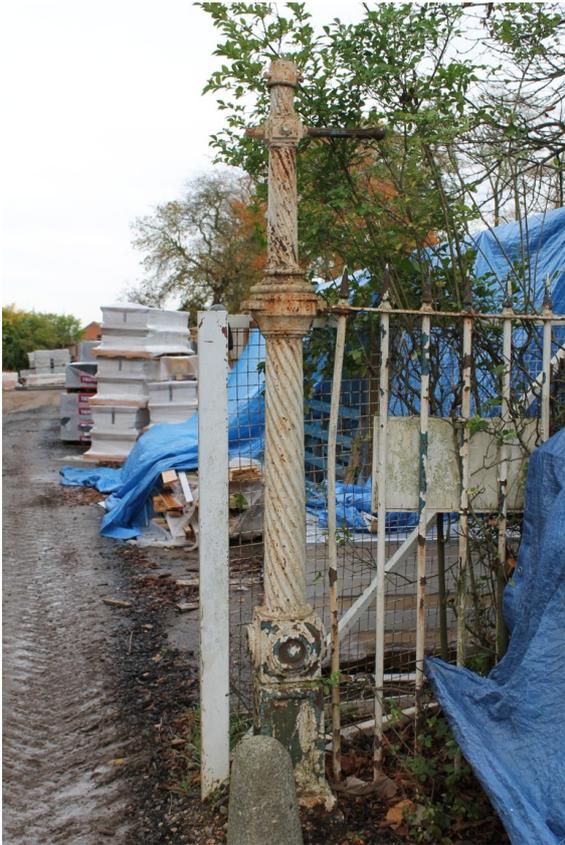
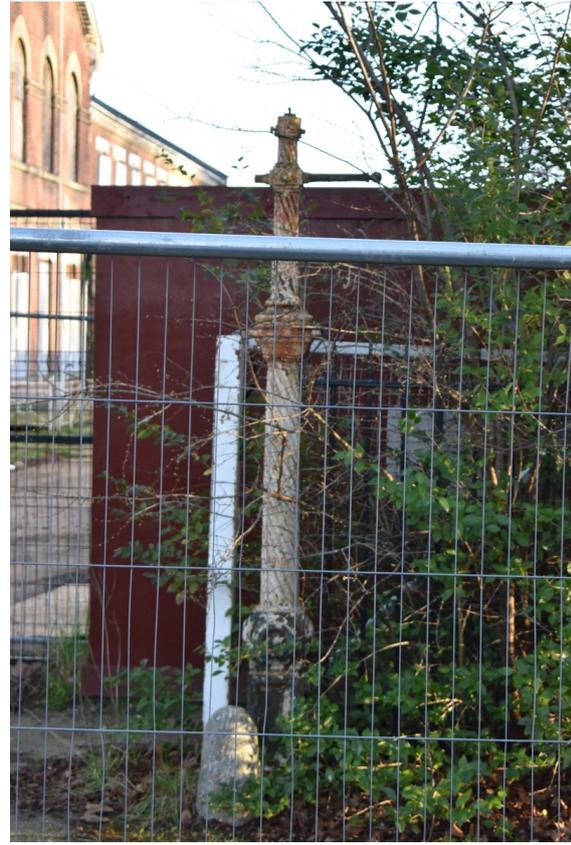
Plate 34 Surviving southern gate post and gas lamp at western entrance. Photo from November 2013 left, photo from December 2019 right.
