Historic building recording of Braintree College, Church Lane, Bocking, Essex, CM8 2BD

August 2020

CAT Report 1606
October 2020

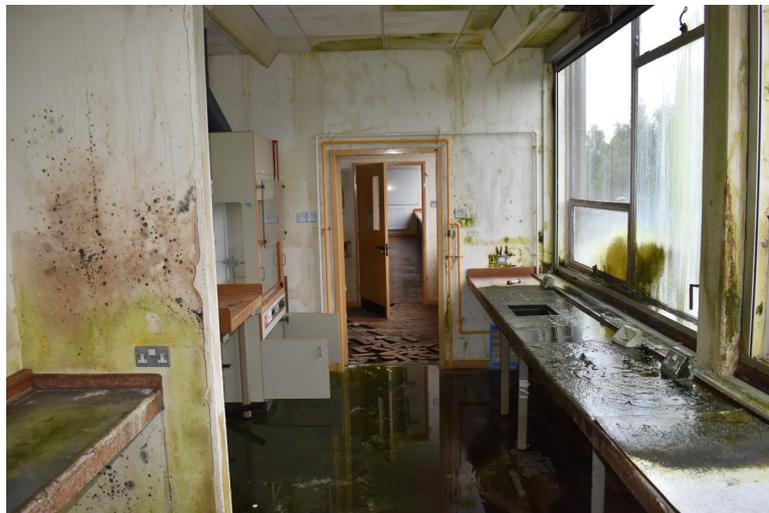
The college buildings have not been in use for over a year and, as a result, they have become quite derelict, with large sections of water-damage on the upper-floors and several instances of vandalism. As a result many features do not, or only partially, survive and where this is the case it is noted in the descriptive record below.

Photograph 22 Chemistry laboratory (room A115) on first-floor, with extensive water damage visible. Photograph taken facing north-west.
