Archaeological monitoring and historic building recording at Hedingham Castle, Castle Hedingham, Essex, CO9 3DG

March-April 2021

CAT Report 1664
May 2021

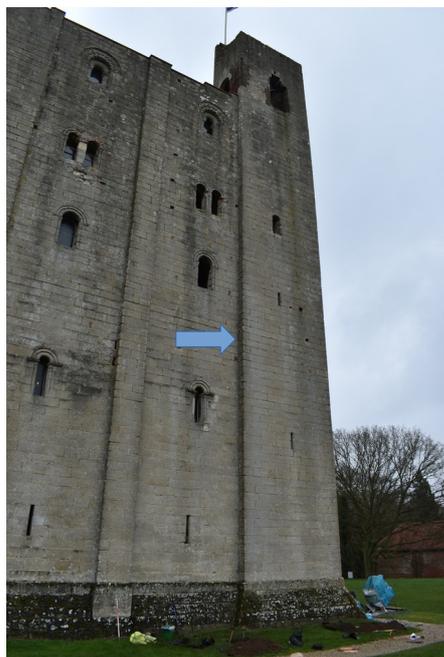
Photograph 1 Southern elevation of keep. Cable for lightning conductor located in corner labelled with arrow. Photograph taken facing north.

Two new cables for lightning conductors were installed on the eastern and southern sides of the keep's south-eastern tower. The cables were located as to be as unobtrusive as possible and were colour matched to the ashlar stone (Photograph 1).

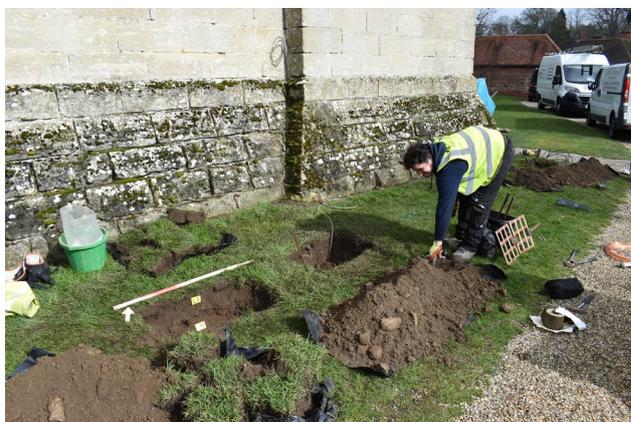
Photograph 2 Excavation of pads for lightning conductor in progress. Photograph taken facing north.

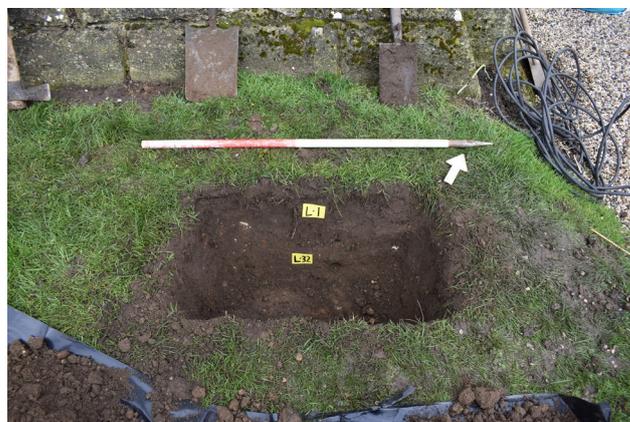
The pads impacted two layers (Photograph 3); a modern topsoil (L1, c 0.21m thick mid-brown/black sandy silt) which overlaid a makeup layer containing mortar and CBM fragments (L32, mid-brown/grey sandy silt). Fragments of modern glass and iron nails were recovered from L32, but were not retained.

Photograph 3 Easternmost pad for lightning conductor, showing layers. Photograph taken facing north-west.

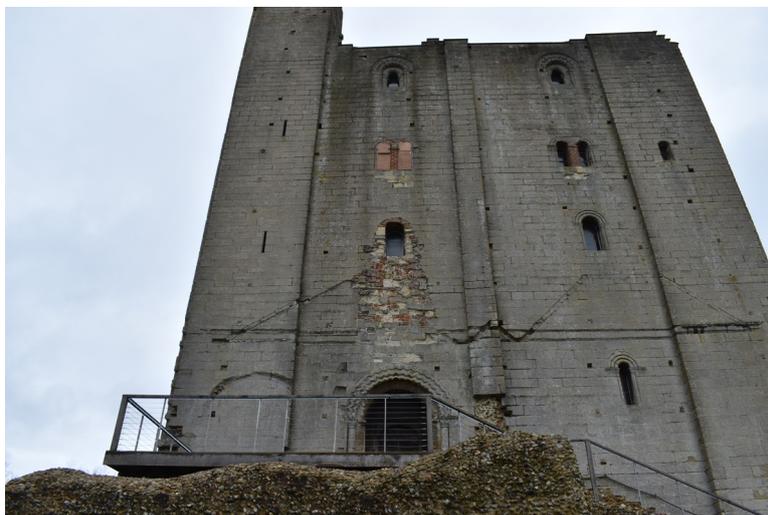
The section of wall in need of repair is located on the keep's western side, above the first-floor entrance and the remains of the fore-building (Photograph 4). The wall section measures 5.20m in height and between 1.21-2.43m in width, being narrower at the top and the base (Fig 3).

Photograph 4 The keep's western elevation. Section of recorded wall visible in centre of frame, with first-floor entrance below. Photograph taken facing north-east.

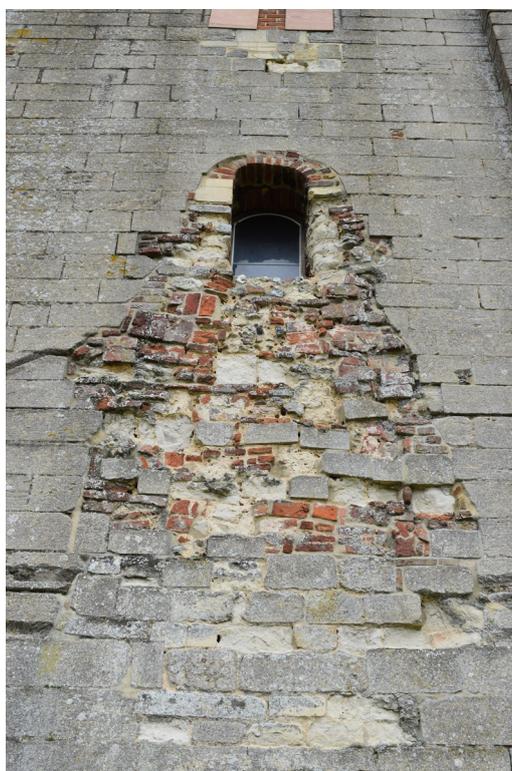
Photograph 5 Detail of wall section. Photograph taken facing north-east.

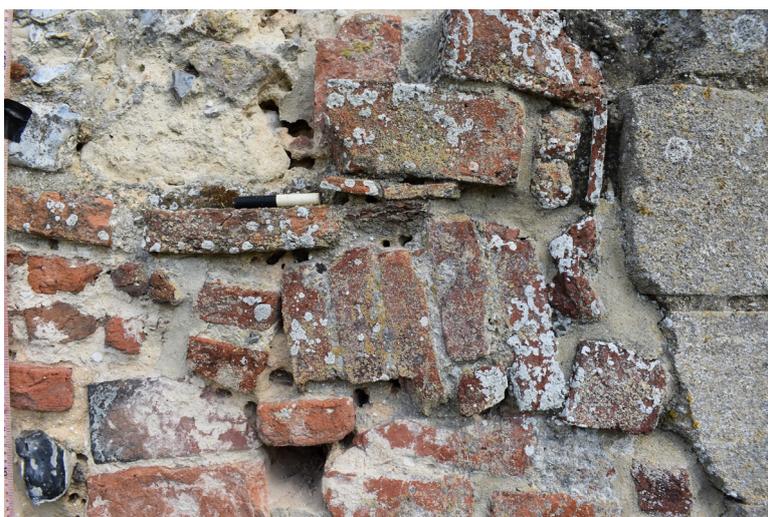
Photograph 6 Detail of reused Tudor brickwork in make-up of wall, bonded in cement. Photograph taken facing north-east.

materials present. Several of the bricks in the wall are on edge, and in places whole sections of brickwork have been taken from other structures (see discussion below), rotated 90 degrees (Photograph 6) and then added to the walls makeup.

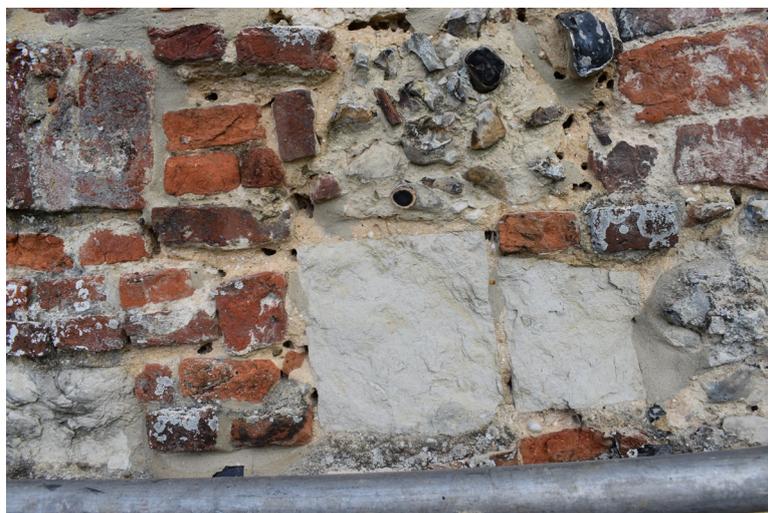
Photograph 7 Detail of wall showing numerous masonry bee burrows. Photograph taken facing north-east.

In addition to the exposed nature and poor construction of the section of wall causing structural issues, it was clear, once in close proximity to the wall's surface, that there is also substantial damage from masonry bees burrowing into the exposed lime mortar (Photograph 7).

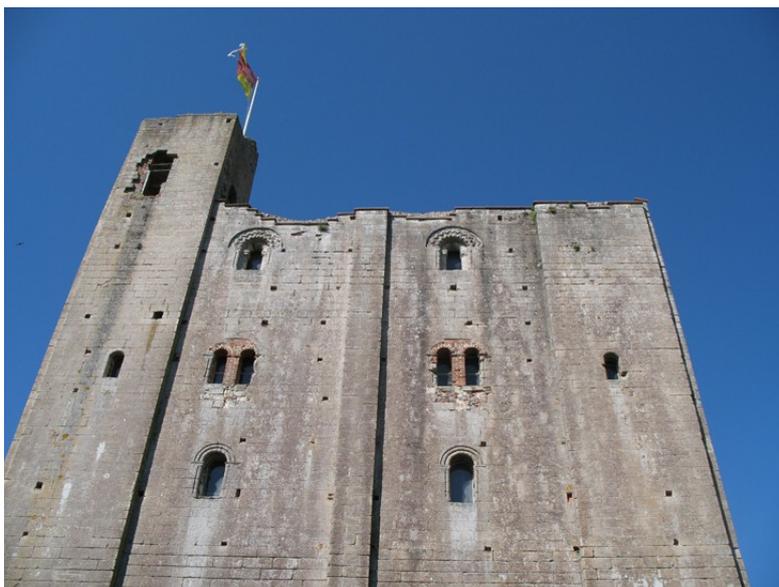
Photograph 8 Eastern elevation of the keep, showing repairs undertaken to other windows, including some with apparent collapse below. Photograph taken facing south-west.

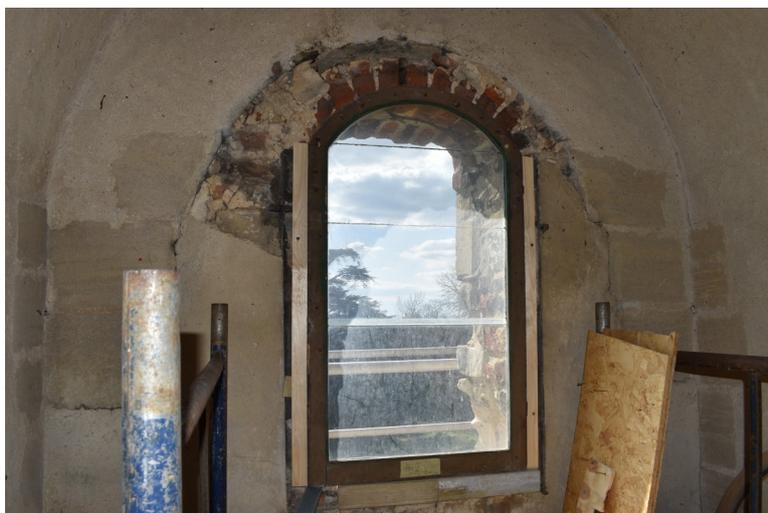
During the fieldwork for this report, some work within the keep necessitated the removal of a section of plaster, exposing the interior of the brick arch surrounding the current window. This clearly showed that the current arch is inserted, as would be expected, into an earlier, original archway made of lime mortar and flint (Photograph 9). This arch would have housed the carved ashlar surround of the original window opening (visible in the drawings above). Observation from the interior of the keep made it very clear that the current brick arch is bonded onto the mortar and flint in only a very rudimentary fashion, with several gaps present (Photograph 10).

Photograph 9 Interior of window in section of wall, showing exposed brick arch. Photograph taken facing west.

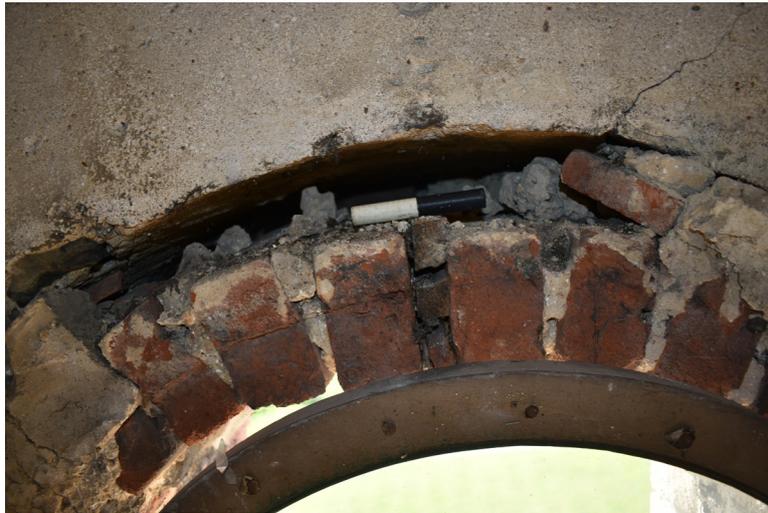
Photograph 10 Detail of interior of brick arch above window, showing gap between it and the mortar and flint above. Photograph taken facing south-west.

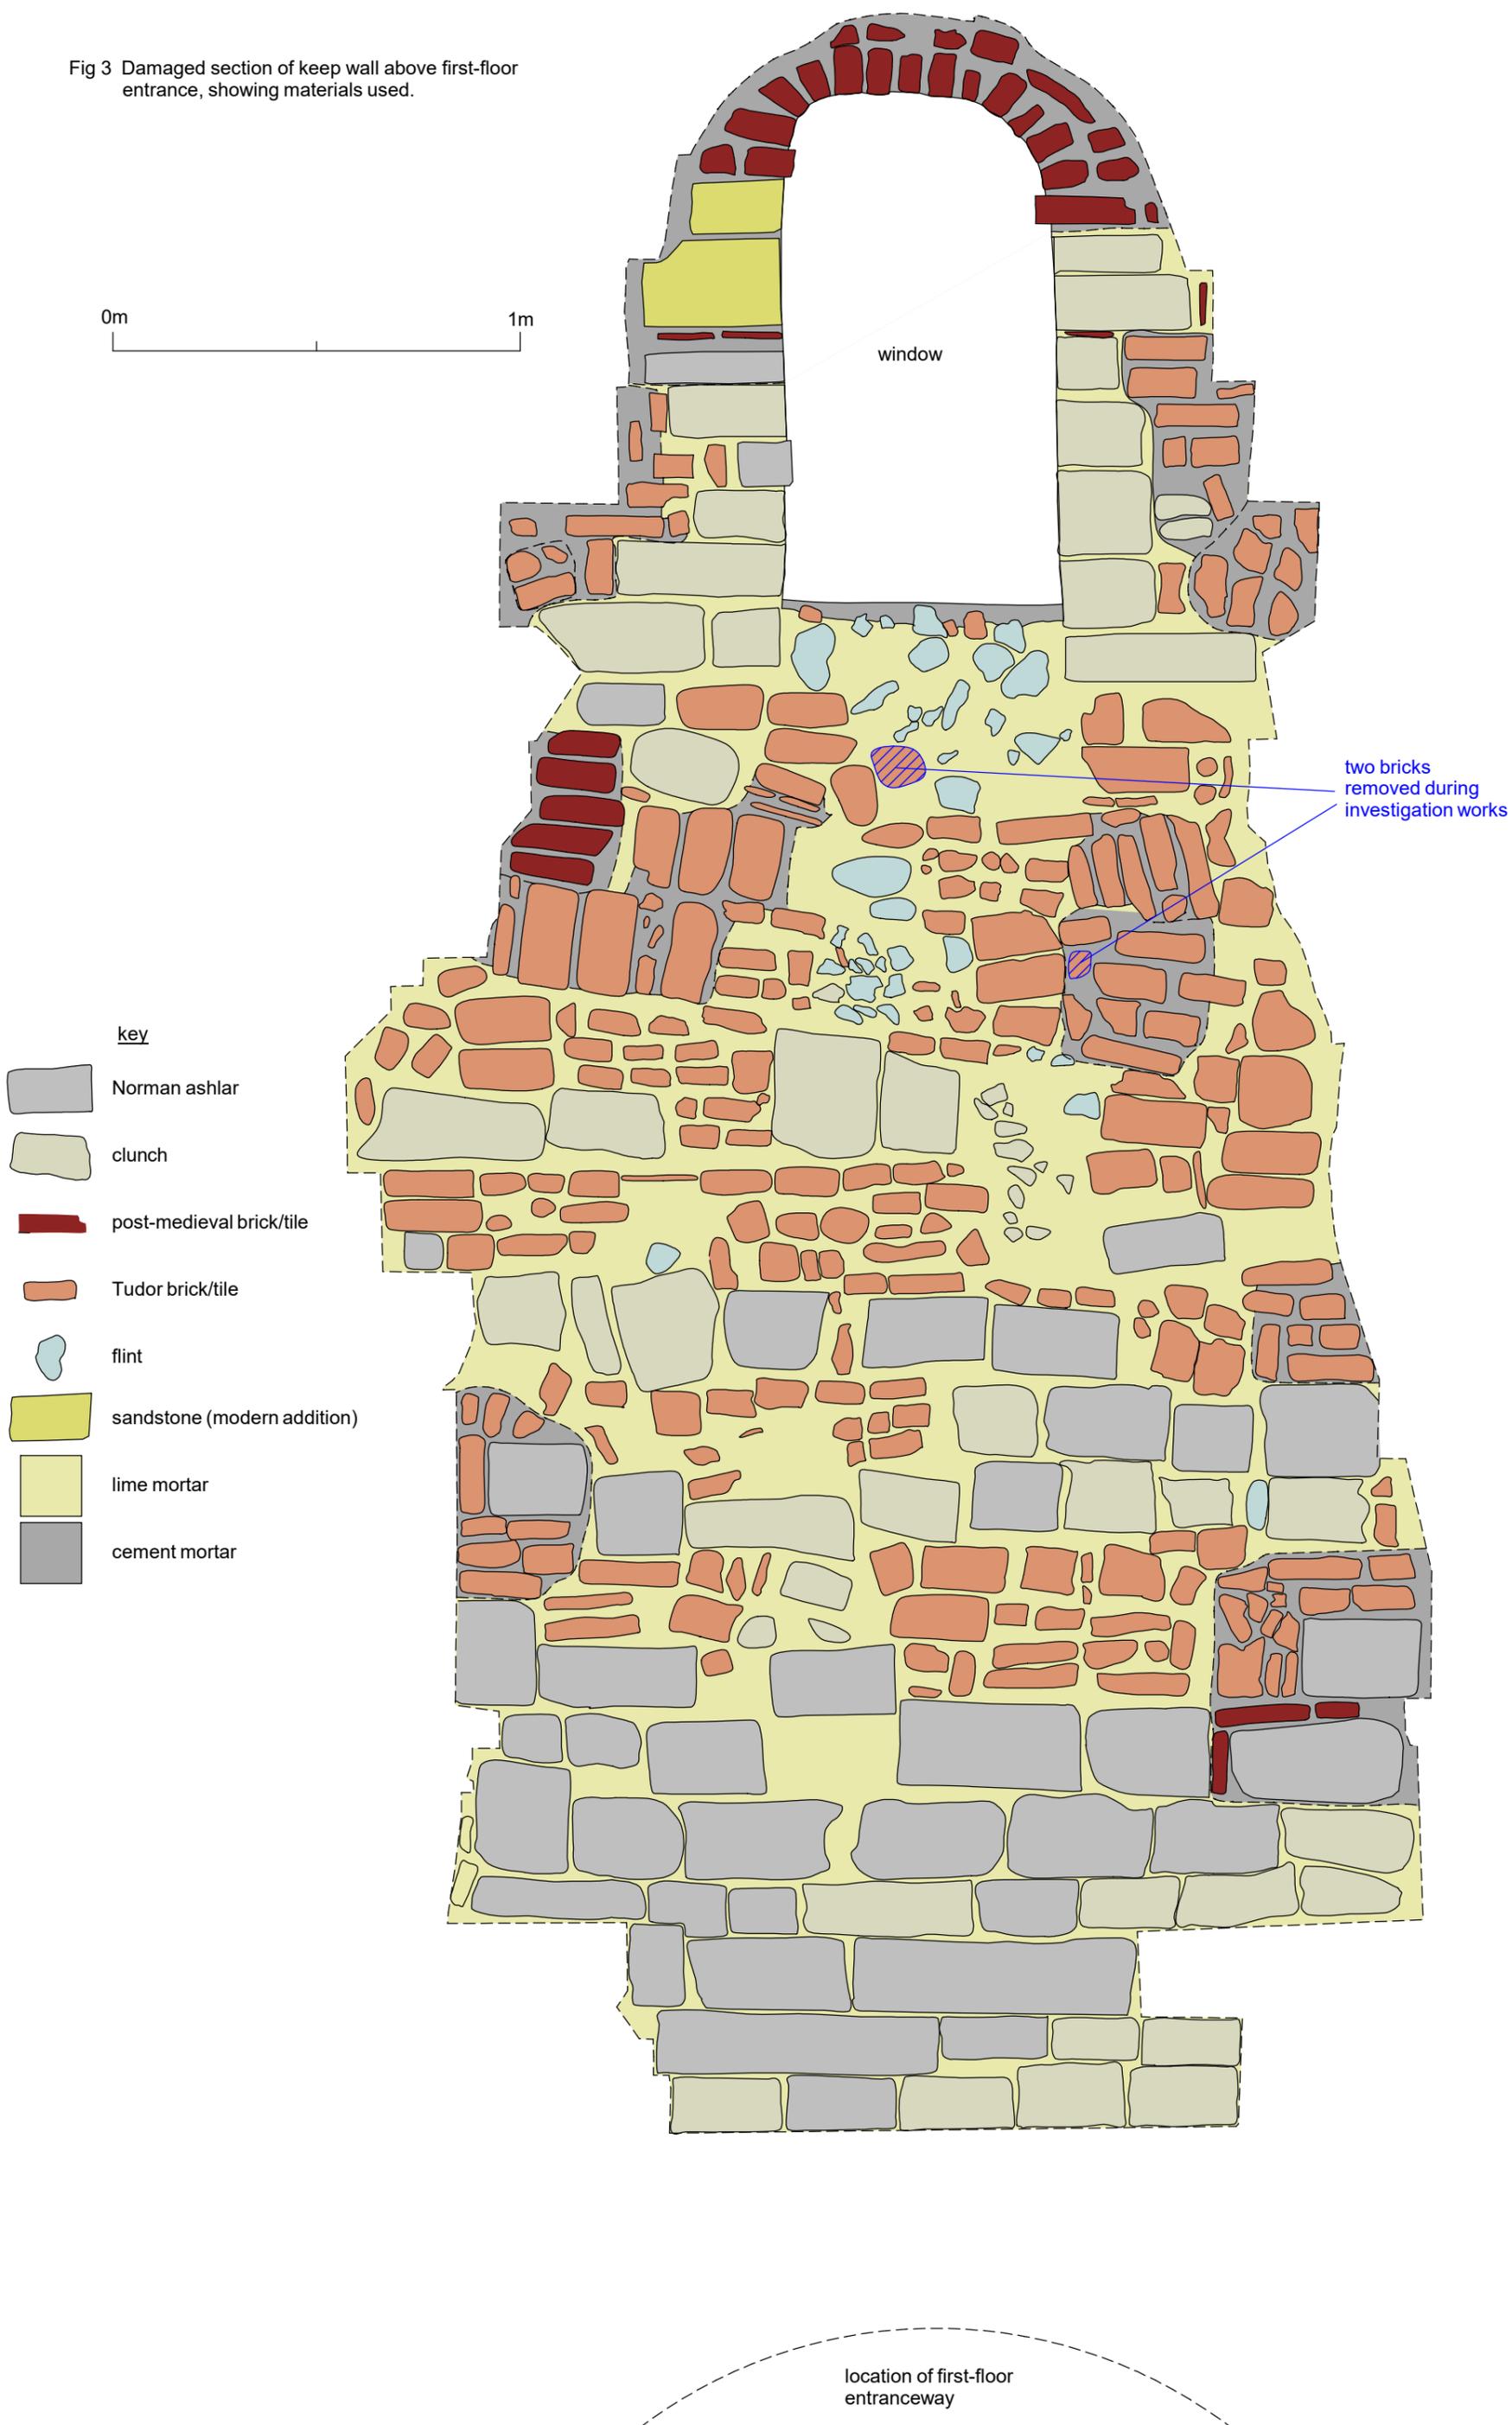
Fig 3 shows the section of wall in detail and describes its fabric. Of note, the majority of the identifiable brick and tile within the wall appears to be Tudor in origin, so where any CBM is too fragmentary to be confident in assigning a date, it has been assumed to be Tudor. None of the bricks in the wall appear to contain frogs.

During the recording for this report, two bricks were removed from the wall section in order to check for cavities and the general condition of the wall behind the face. The location of these two bricks have been noted on Fig 3.

Fig 3 Damaged section of keep wall above first-floor entrance, showing materials used.

Although this repair is beginning to fail, it is hoped that the new repair work being carried out shortly will serve to reinforce and solidify this section of wall in a much more permanent fashion, preserving it for many more years to come.
