**CAT Report 1888
issued March 2023**

**Historic building recording at Thrift Farm,
Moulsham Thrift, Chelmsford, Essex, CM2 8BP**

**CAT project ref.: 2022/08i
ECC code: CFTF22**

October 2022

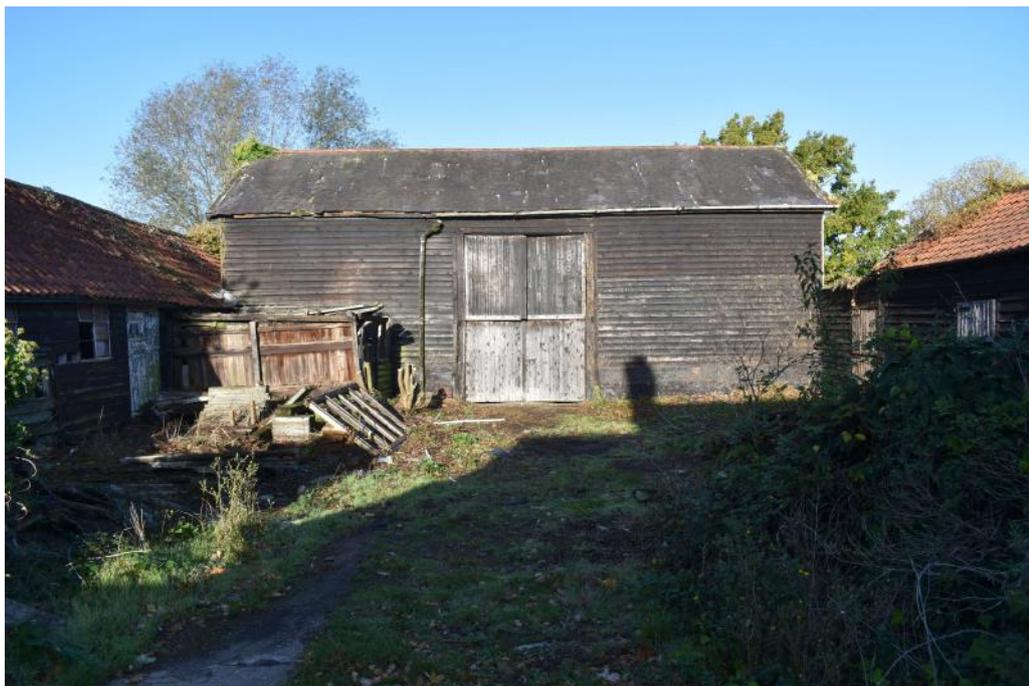
The eastern elevation (Fig 3) of the barn has a set of large central vertically-planked doors, which are replacements in the original opening. They mimic oversized stable doors and, unusually, open inwards. There are three pintles either side of the doors from the original barn doors. To the south of the doors, some possibly original weatherboarding survives behind store 6.

Photograph 1 Eastern elevation of barn. Photograph taken facing west north-west.

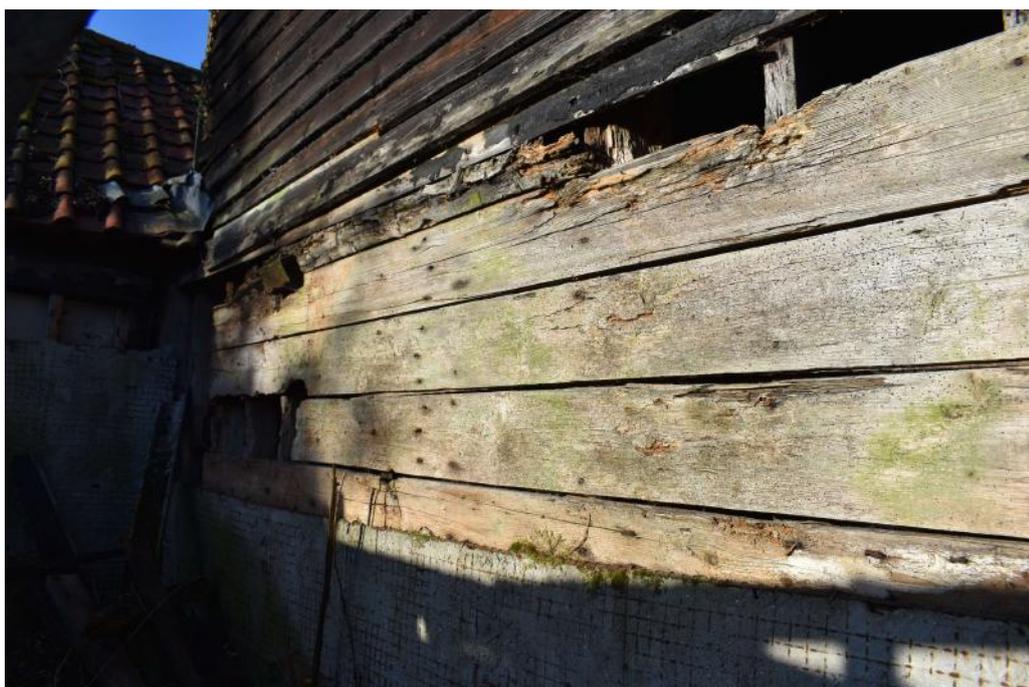
Photograph 2 Possible original weather-boarding on eastern elevation of barn (in store 6). Photograph taken facing south-west.

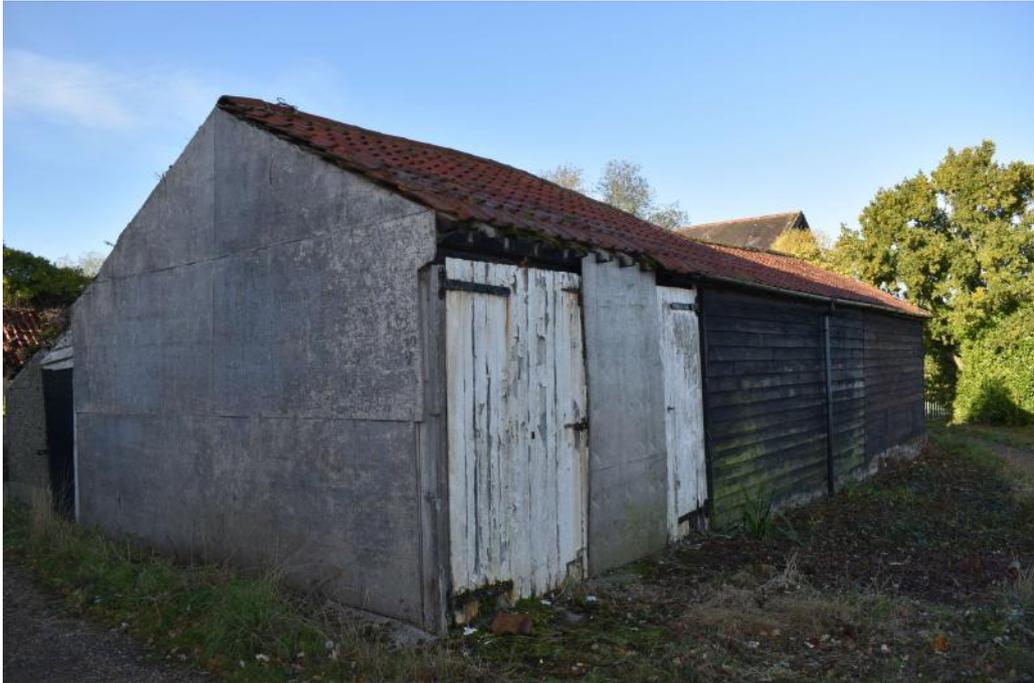
Photograph 3 Northern and eastern elevations of northern range (store 9 and 12). Photograph taken facing west.

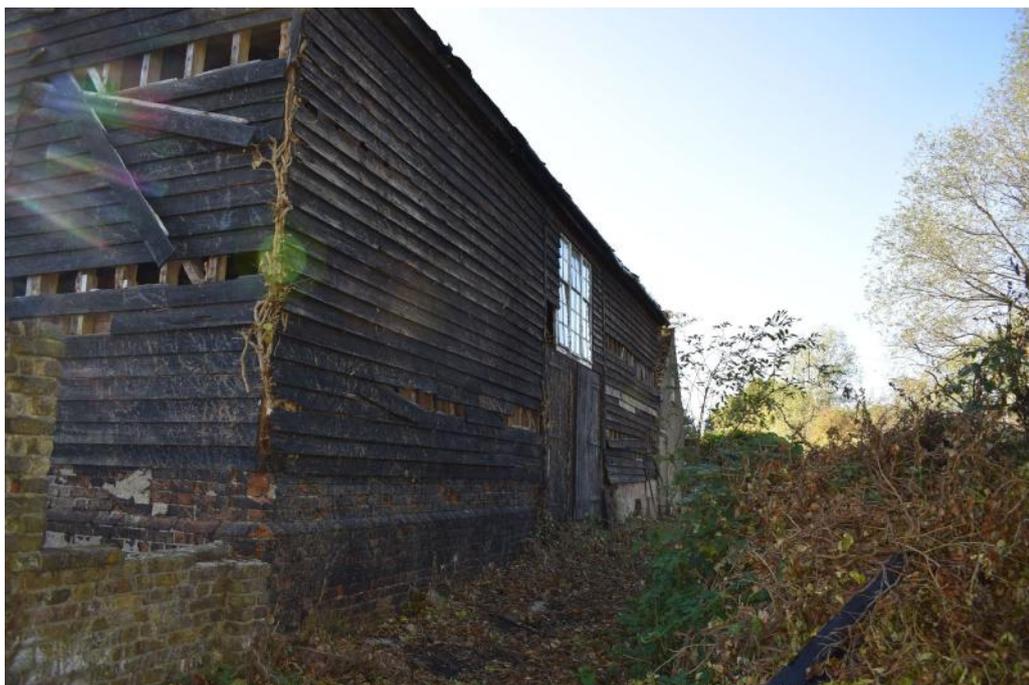
The western elevation (Fig 5) comprises black weatherboard, pebble-dash and brick. The barn is clad in weatherboard with a set of central replacement double doors. Above these are three re-used Crittall windows. They are four-over-six-light windows with the metal frame painted white. The outer two windows have the awning in the bottom six lights while the central window has it in the top four lights, all of which open on a central pivot. The double doors and Crittall windows are located in an original full-height opening. To the south of this, the brick plinth has been repaired with concrete render.

Photograph 4 Western elevation of barn. Photograph taken facing south

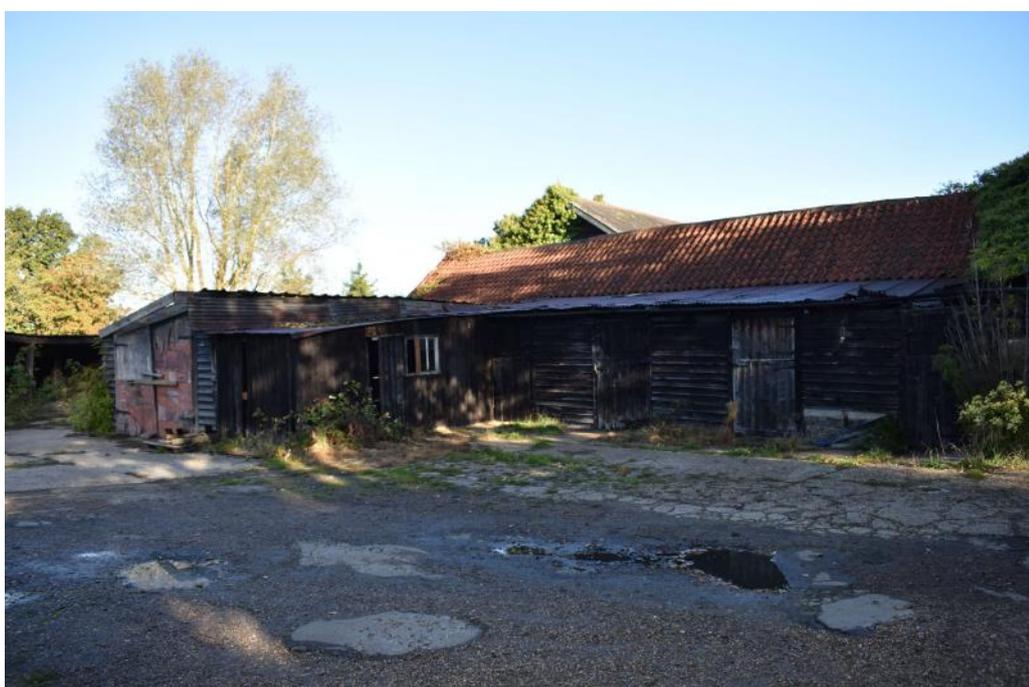
The southern elevation (Fig 6) is completely clad in black weatherboard. Store 1 has a set of double-doors while store 4 has four single stable doors. Store 2 is featureless on this elevation and much of the barn is obscured by the southern wing.

Photograph 5 Eastern and southern elevations of stores 1, 2 and 4. Photograph taken facing north.

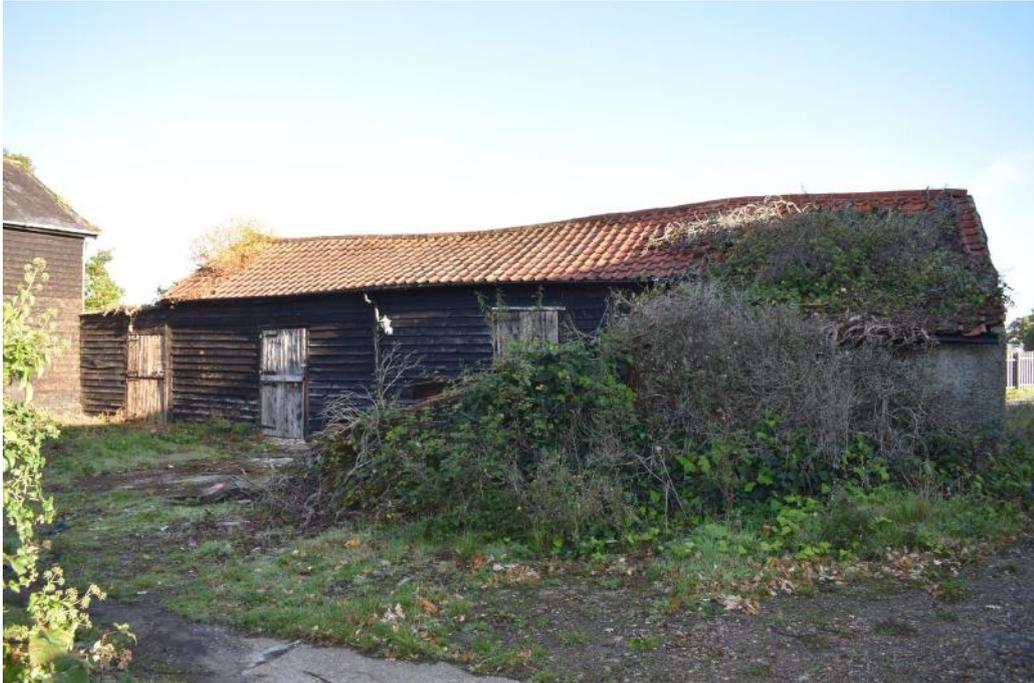
The southern elevation of the courtyard (Fig 7) is mainly clad in black weatherboard and has three stable doors: one on store 8 and two on store 9. Store 10 is constructed of red brick, with occasional yellow stock bricks, laid in a Flemish-bond. It is enclosed and around 1.15m tall. Store 11 is finished in pebble-dash render.

Photograph 6 Southern elevation of interior courtyard. Photograph taken facing north.

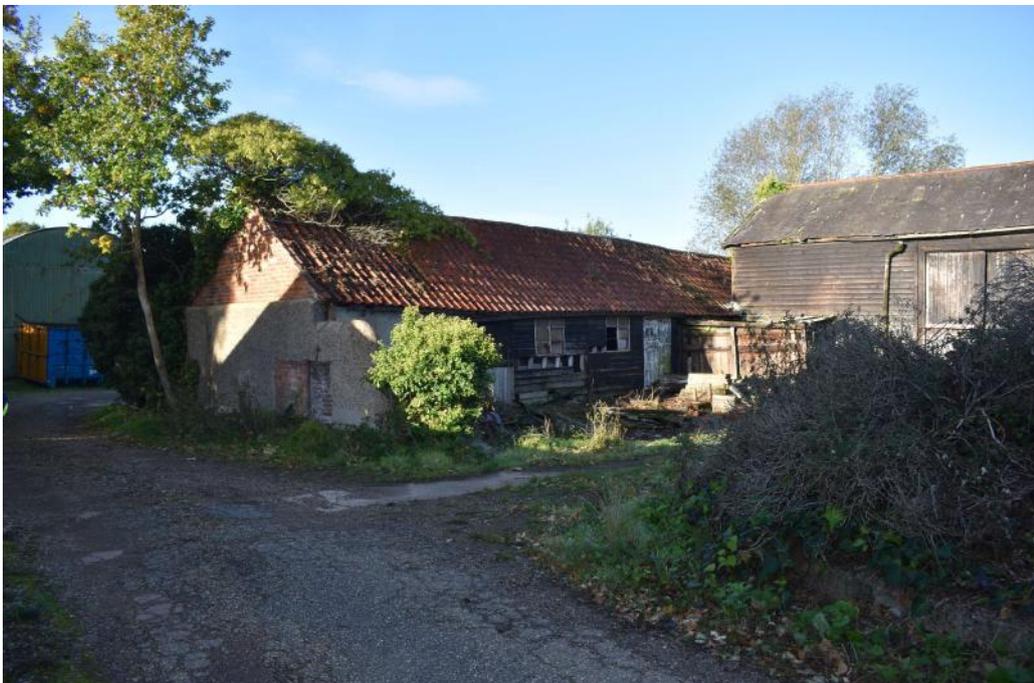
The northern elevation of the courtyard (Fig 8) is rendered in pebble-dash at the south-east end and the rest clad in black weatherboard. Three doors, two on store 5 and one on store 6, and three windows, all on store 5, are present on this elevation. The doors are all stable doors. The southern-most window is a nine-light fixed window with a timber frame while the remaining two are metal-framed six-light awning windows. Store 6 also has two unglazed window openings.

Photograph 7 Northern elevation of the interior courtyard. Photograph taken facing west.

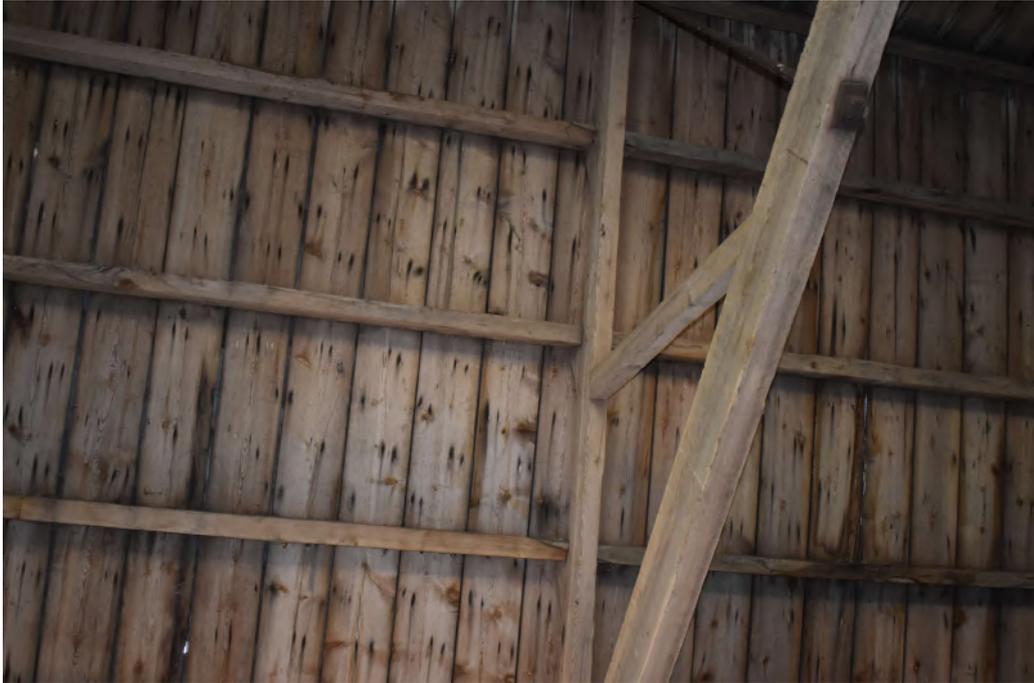
The roof of the barn is gabled and comprises pairs of principal rafters rising from the wall-plate and meeting at a ridge-board. The rafters support four through purlins on each roof pitch. Every purlin has a splayed scarf joint, either between bays 2 and 3 or bays 3 and 4, arranged in an off-set pattern. There are four tie-beams, from which inclined struts rise to meet the principal rafters, with a central iron king bolt. The tie-beams are supported by knee-braces held in place with four bolts. In bays 1 and 5, there is a wind-brace present on both roof pitches. All of the timbers are machine-cut.

Photograph 10 Detail of scarf-joints in purlin in eastern roof pitch between bays 2 and 3 of the barn. Photograph taken facing south-east.

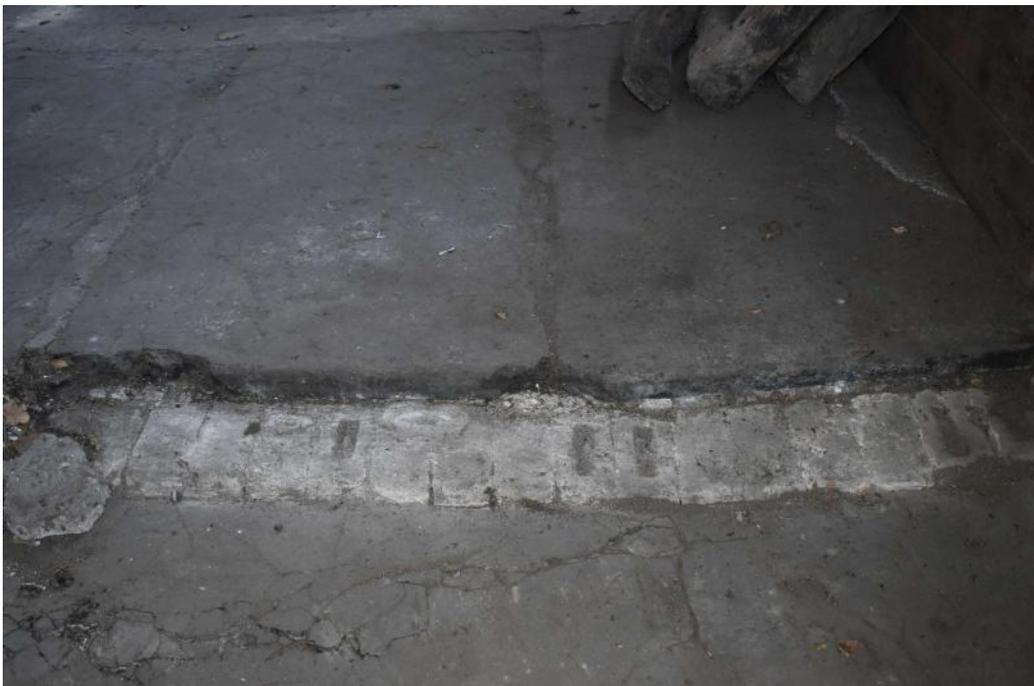
In bay 3 of the barn, the edge of the brick threshing floor is visible beneath the concrete. It appears to be constructed from red bricks with shallow frogs laid flat.

Photograph 11 Detail of shallow-frogged bricks in floor of bay 3 of barn. Photograph taken facing south.

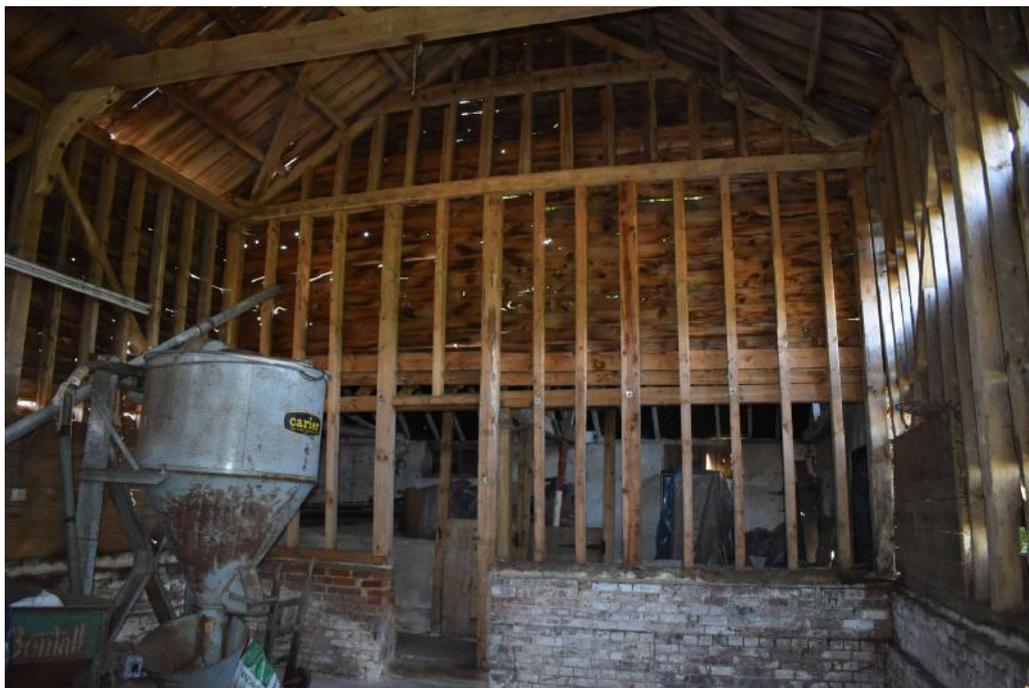
Bay 1 is the southern-most bay of the barn. The brick plinth and sill-beam have been cut through to insert a doorway in this wall, which leads to store 5. All of the studs between the gable-tie and the sill-beam and the sill-beam to the east of the door have been replaced. There is an iron strap on the southern sill-beam to secure it to the western sill beam. There is a side-halved scarf joint in the eastern sill-beam in bay 1.

Photograph 12 Southern wall of barn. Photograph taken facing south.

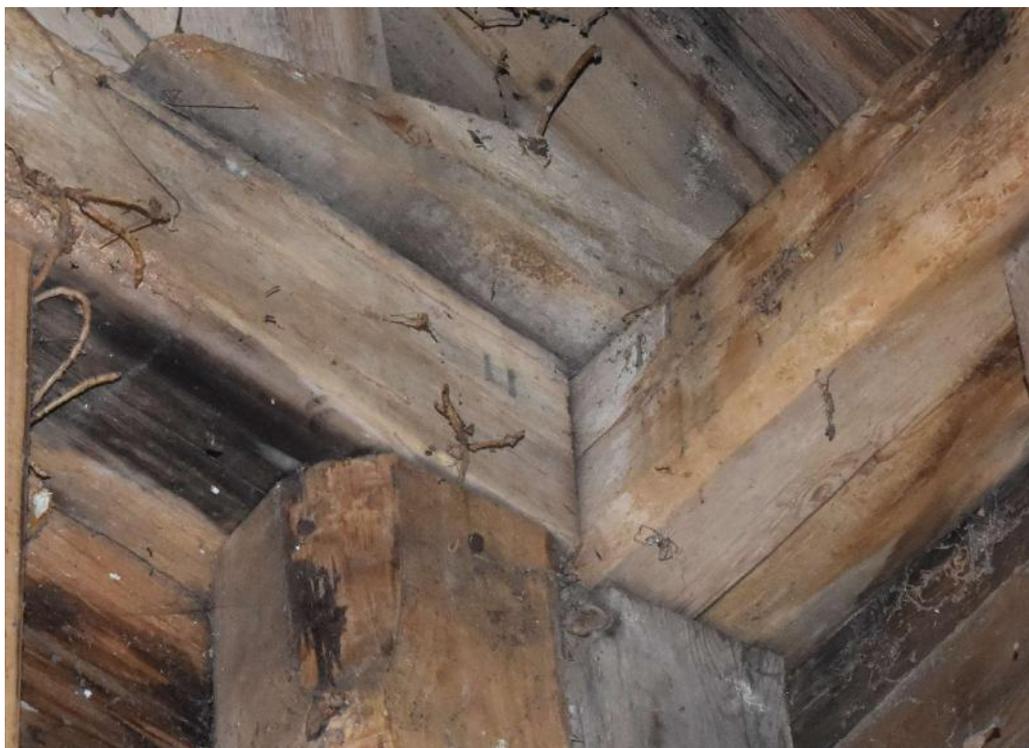
Chiselled carpenters' marks 'II' are located in the north-west corner of this bay, on the gable-tie and on the wall-plate.

Photograph 13 Detail of carpenters' mark 'II' on gable-tie and wall-plate in north-west corner of bay 1 in barn. Photograph taken facing north.

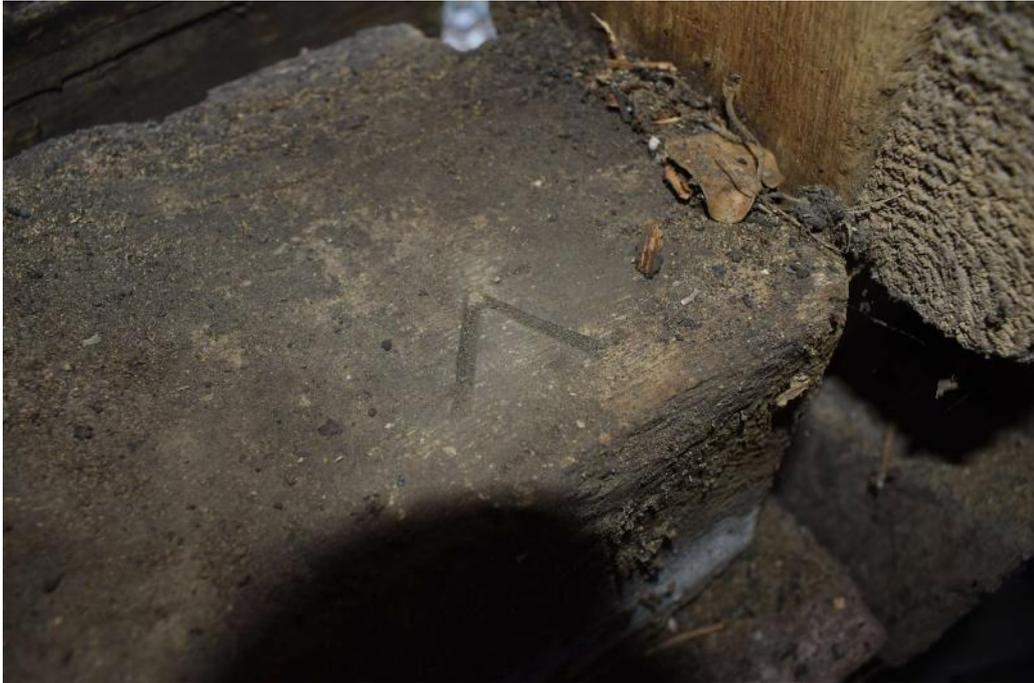
Photograph 14 Detail of carpenters' mark 'V' on sill-beam on western wall of bay 2 in barn. Photograph taken facing north.

Bay 2 has the carpenters' mark 'V' chiselled into the western sill-beam, next to the post between bays 2 and 3.

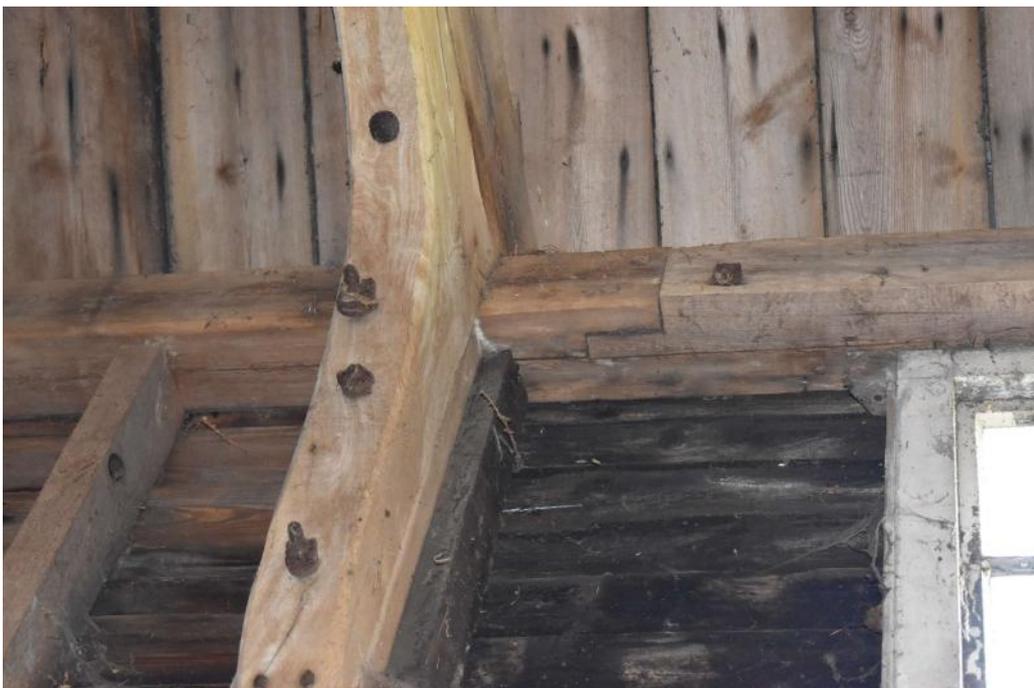
Photograph 15 Detail of scarf-joint in wall-plate of western wall of bay 3 of barn. Photograph taken facing south-west.

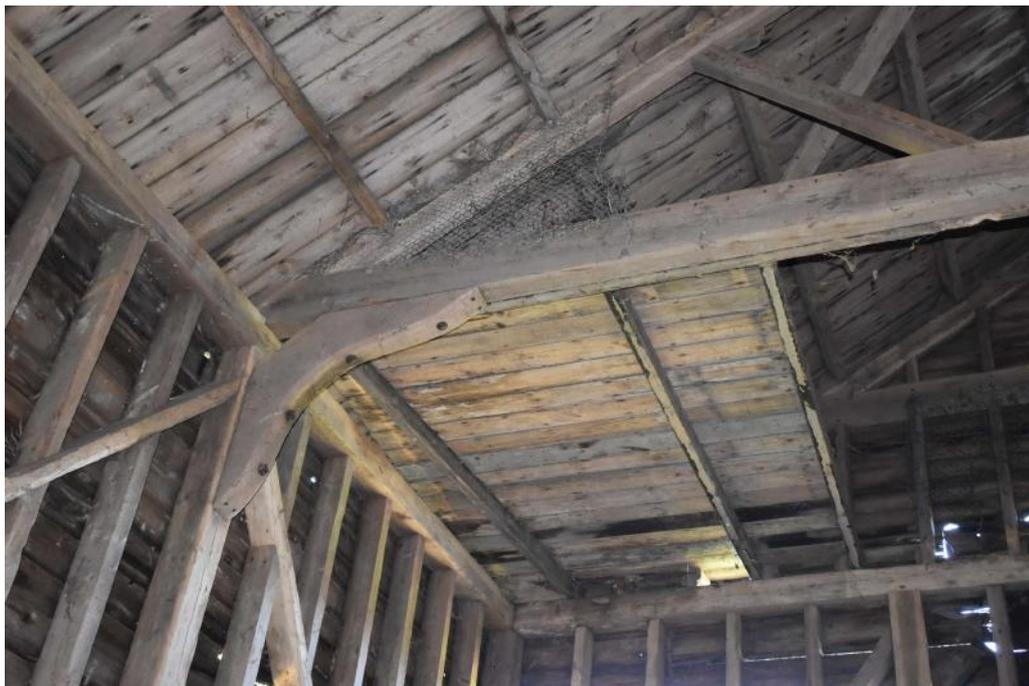
Bay 5 is the northern-most bay of the barn. There is an inserted loft level on the western side of bay and evidence this level once spanned the entire footprint of bay 5. In the northern wall there is evidence of an inserted, and now blocked, opening. Similarly to the sill-beam in bay 1, iron straps have been used to secure the sill-beam in the corners of bay 5. A side-halved scarf joint is located in the eastern sill-beam of bay 5. Also visible on the eastern wall is a Baltic timber mark on the post between bays 4 and 5.

Photograph 17 Detail of inserted loft level in bay 5 of barn. Photograph taken facing north.

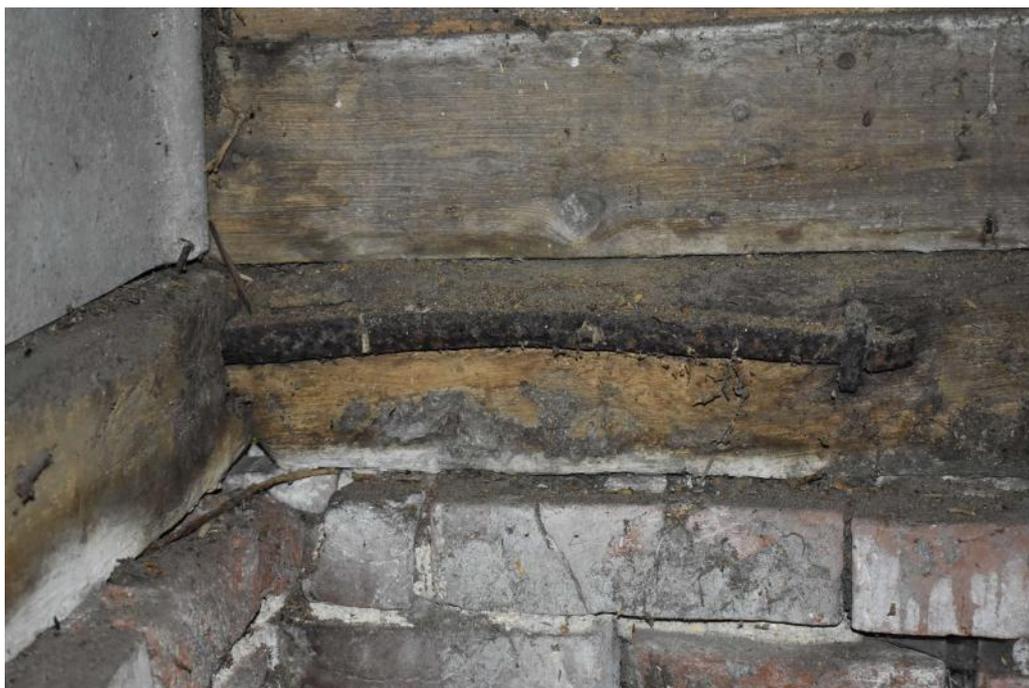
Photograph 18 Detail of iron strap on sill-beam of northern wall of bay 5 of barn. Photograph taken facing north.

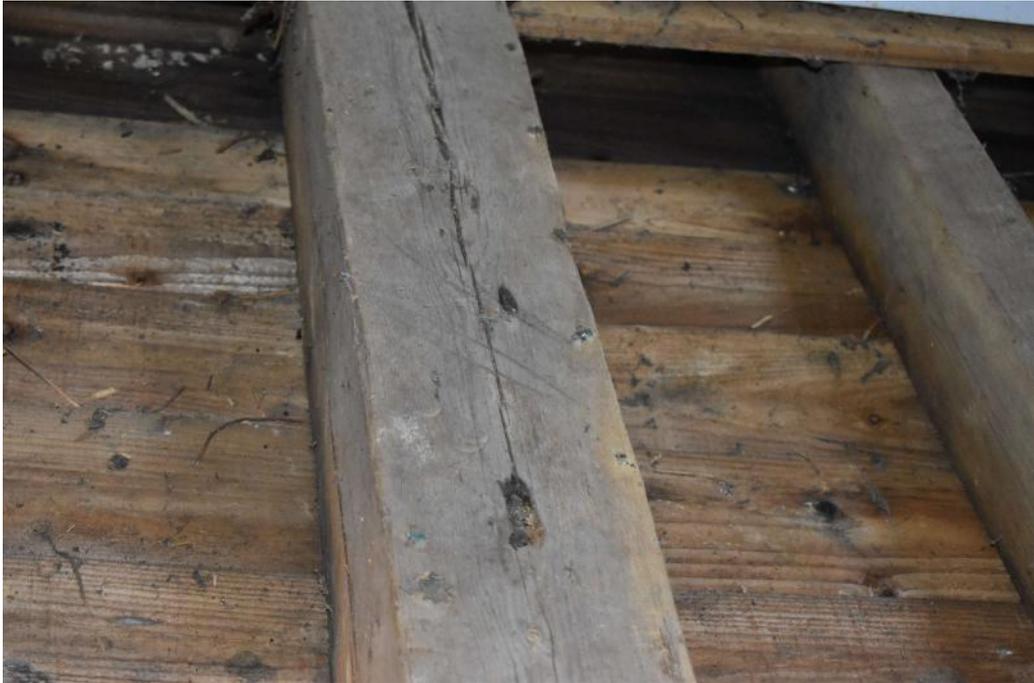
Photograph 19 Detail of Baltic timber mark on post of eastern wall between bays 4 and 5. Photograph taken facing south-east.

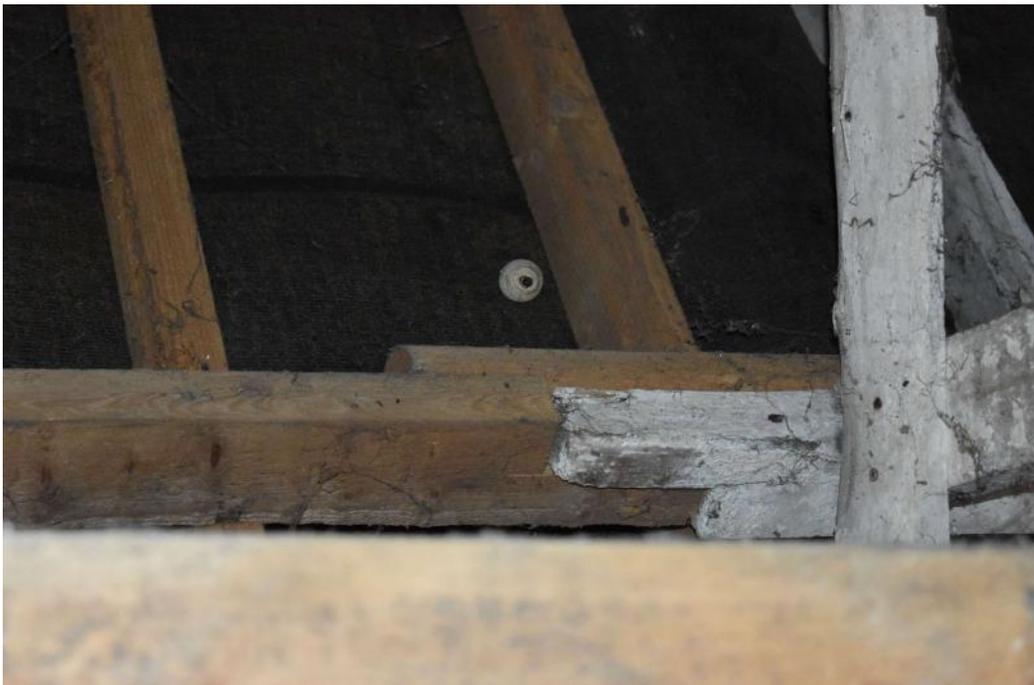
Several side-halved and side-halved and bridled scarf joints have been used to join the wall-plate and purlins of the original part of store 5 to the extension.

Photograph 21 Detail of scarf-joint in purlin on the northern pitch of the roof of the store 5. Photograph taken facing north.

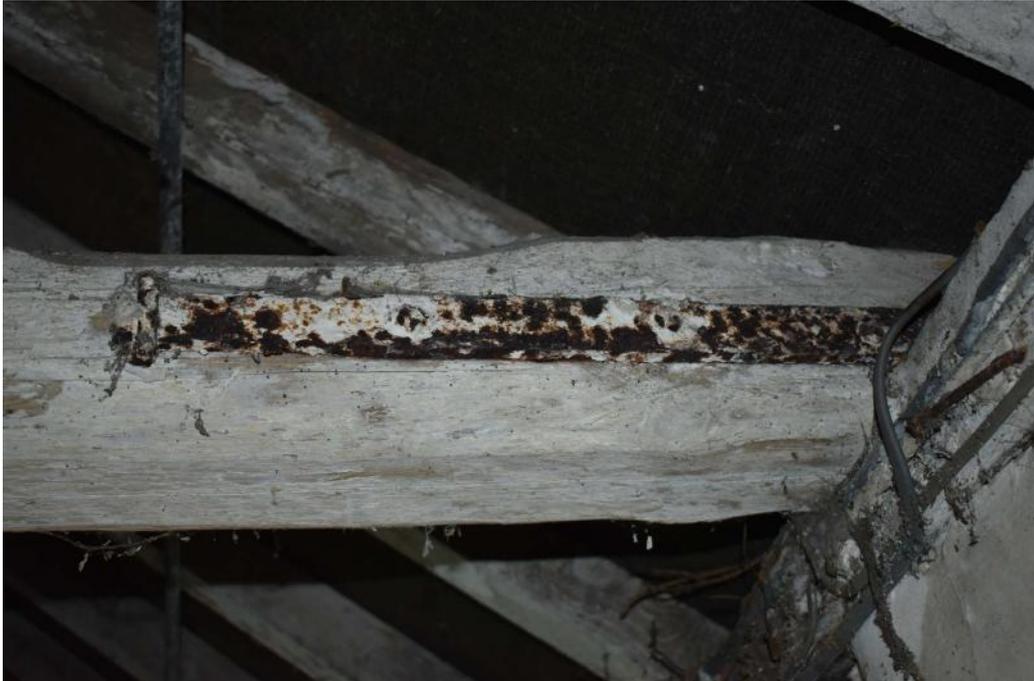
Photograph 22 Detail of iron-strap on tie-beam of store 5. Photograph taken facing north-west.

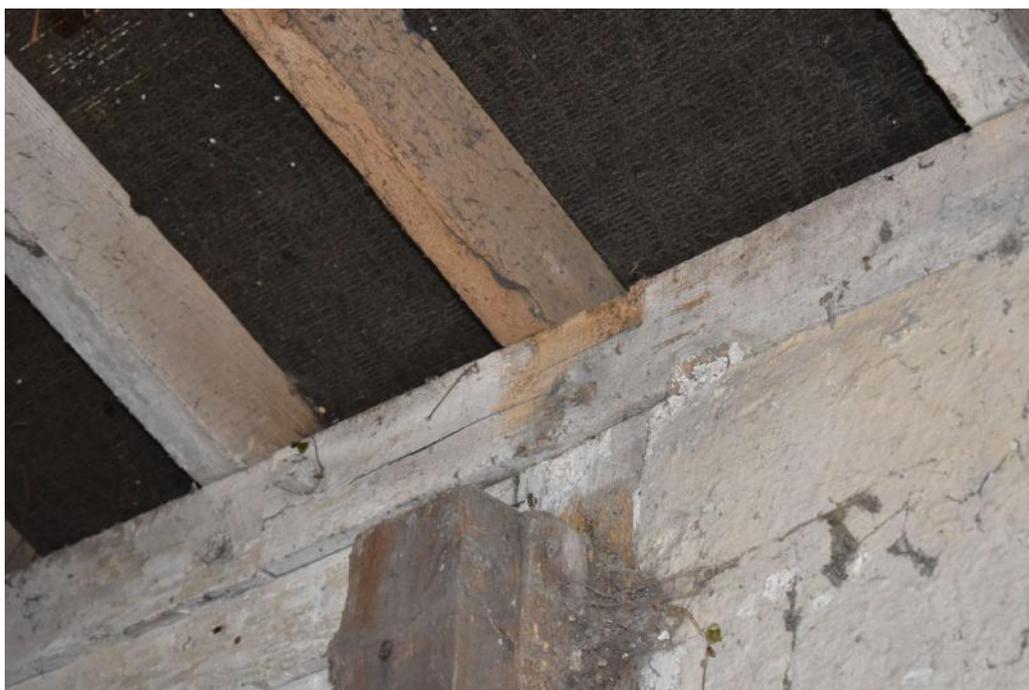
Photograph 24 Detail of removed tie-beam in store 9. Photograph taken facing north.
