**CAT Report 1905
issued April 2023**

**Historic building recording of Shell House, St
Osyth's Priory Park, St Osyth, Essex, CO16 8GW:
February 2023**

**Historic building recording of Shell House, St
Osyth's Priory Park, St Osyth, Essex, CO16 8GW**

**CAT project ref.: 2023/01g
CAT Report 1905**

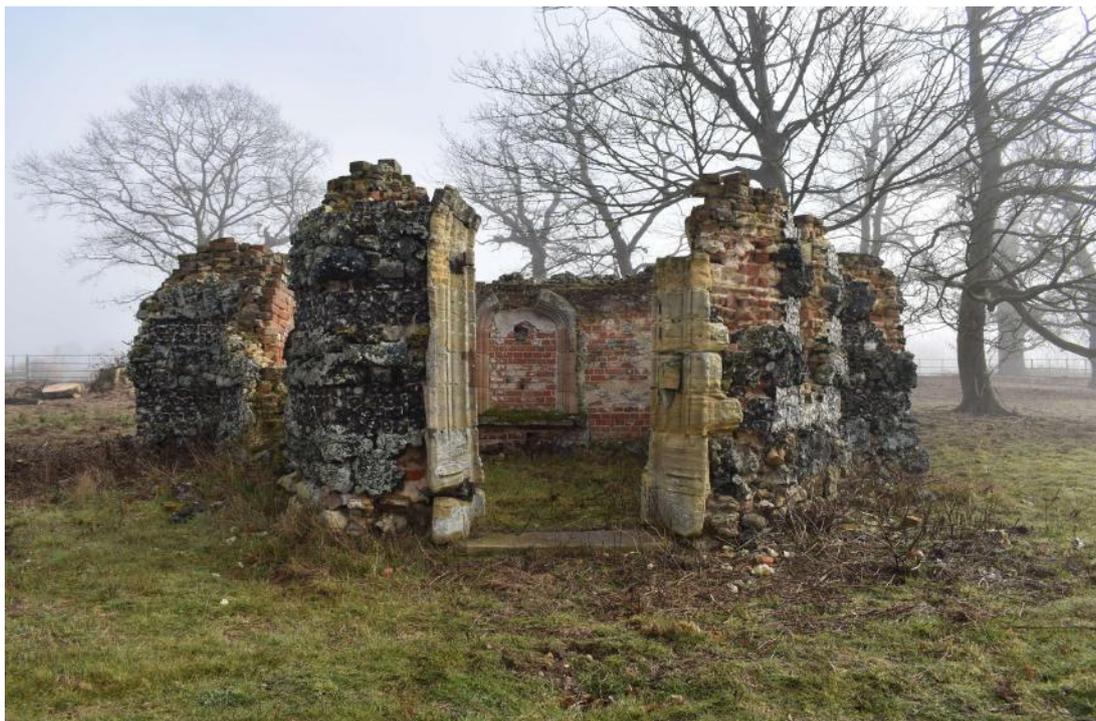
On the western elevation is a doorway with a carved stone surround (Photograph 11). There are two iron pintles on the northern side and a mortice carved into the stone on the southern side. There are remains of a window opening on both the northern and southern elevations: both are degraded but the northern more so. There is evidence of a brick window-sill on the southern opening. On the interior of the folly, the windows were surrounded with carved stone blocks and slag. Photographs 3 and 4 show the windows originally had a pointed arch shape, evidence of this shape can be seen on the window opening in the southern wall (Photograph 14).

Photograph 7 Western elevation. Photograph taken facing south-east.

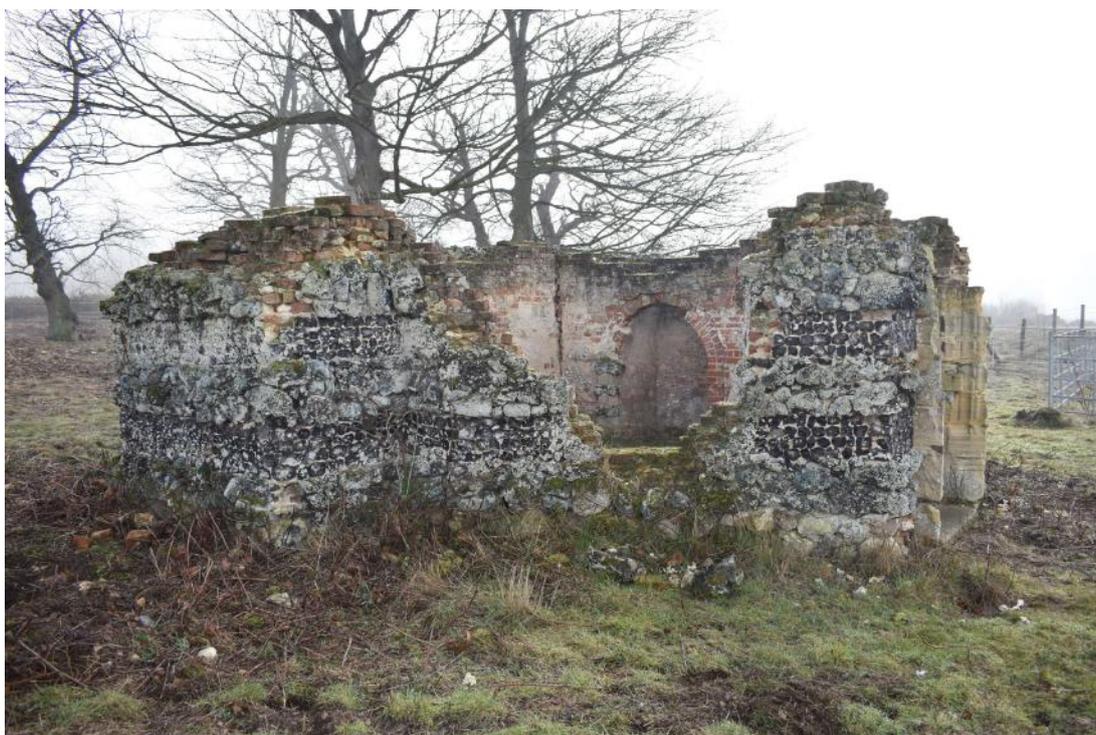
Photograph 8 Northern elevation. Photograph taken facing south-west.
