**CAT Report 1912
issued April 2023**

**Historic building recording of a bothy, glasshouse,
boilerhouse and other garden structures in the
walled kitchen garden at St Osyth's Priory,
St Osyth, Essex, CO16 8GW**

**CAT project ref.: 2023/01i
ECC code: STOWG23**

February 2023

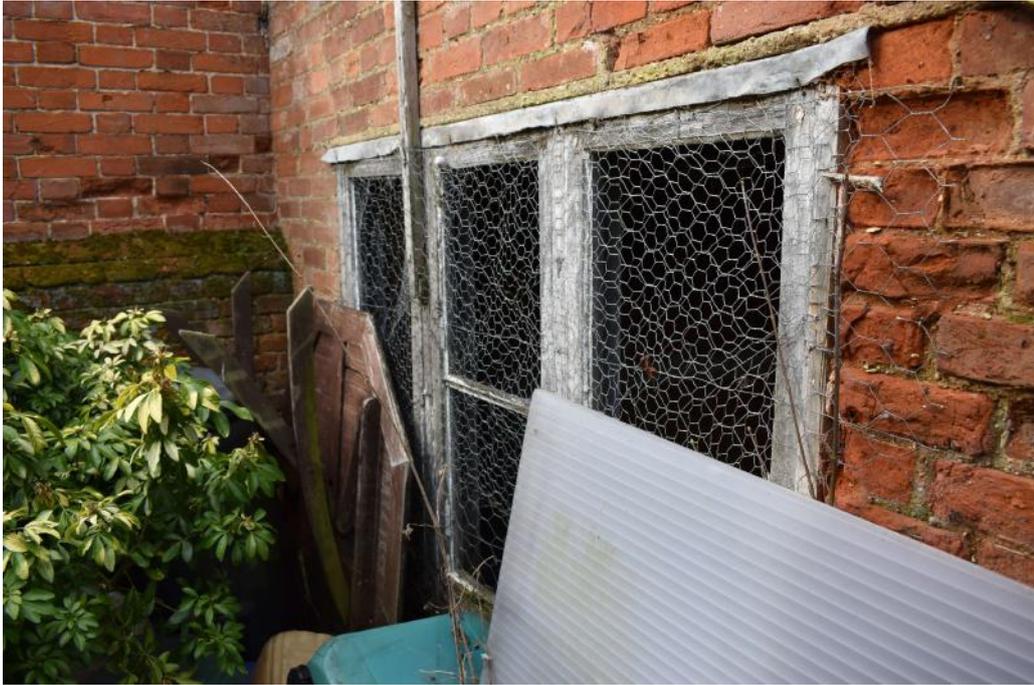
The roof of the boilerhouse is mono-pitched, sloping to the north-east, and clad in slate. Deterioration has caused slates to be lost from the lower portion of the roof. This area has been covered with chicken wire.

Photograph 19 Detail of window in south-east elevation of boilerhouse. Photograph taken facing west.
