**CAT Report 1934  
issued May 2023**

**Historic building recording of two WWII-era huts at  
Great Easton Manor, Dunmow Road, Great  
Easton, Essex, CM6 2DL**

**Planning ref.: UTT/22/3361/HHF**

**commissioned by Samuel Brampton  
(Pelham Structures)  
on behalf of the homeowner**

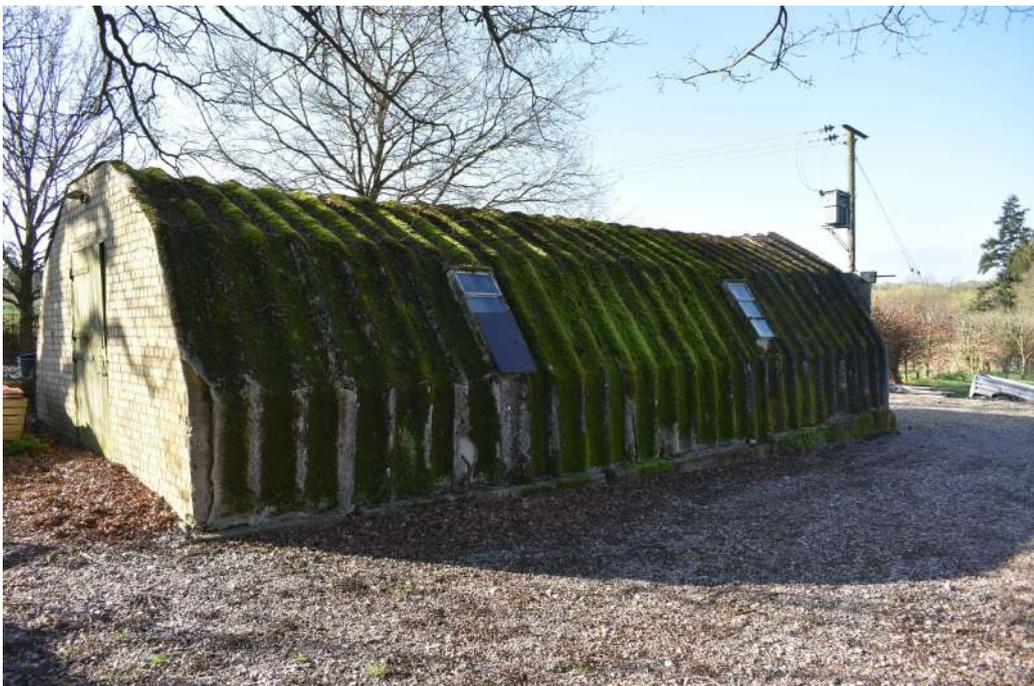
**Photograph 2** Northern elevation of the handcraft hut. Photograph taken facing south south-west.

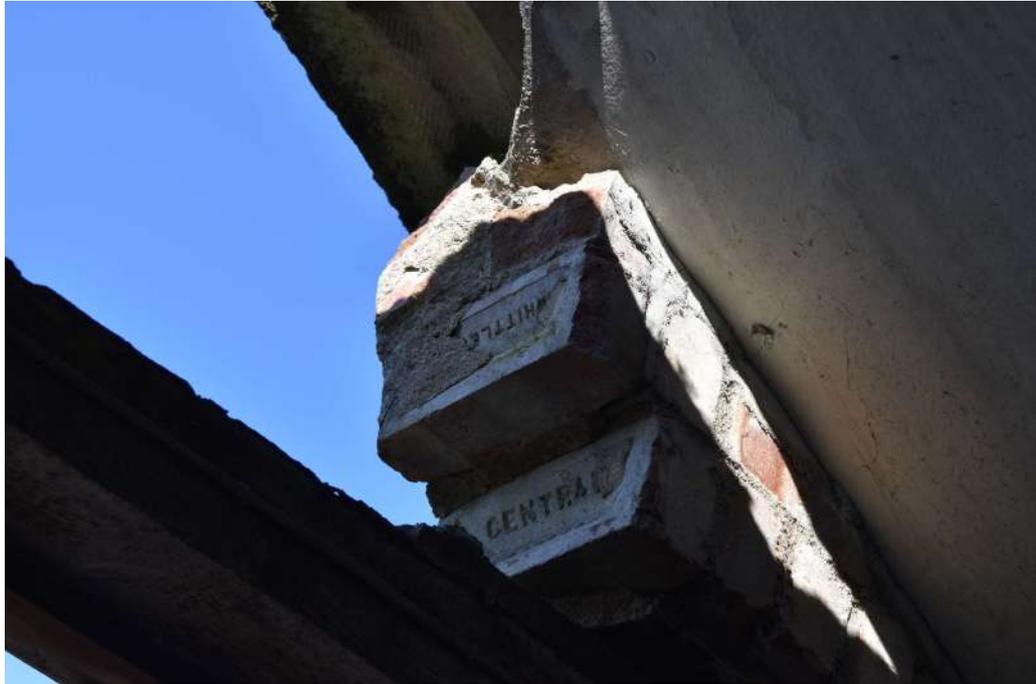
The western elevation is dominated by set of timber double doors, which are strengthened by diagonal wind-braces in the frame. The lintel of the doorway is two rows of brick, laid header bond. The eastern elevation has a single timber stable door with a slightly arched brick lintel. The top course of bricks on both elevations are stretchers laid on edge.

**Photograph 3** Detail of bricks above door of western wall of the handcraft hut. Photograph taken facing west.

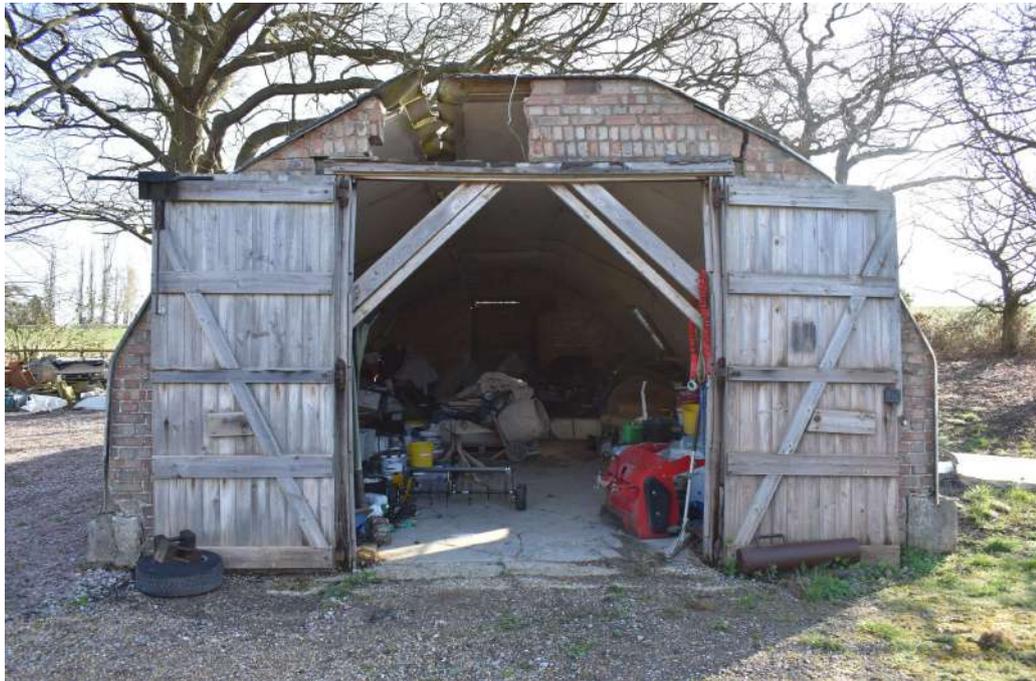
**Photograph 4** Western elevation of the handcraft hut. Photograph taken facing north-east.

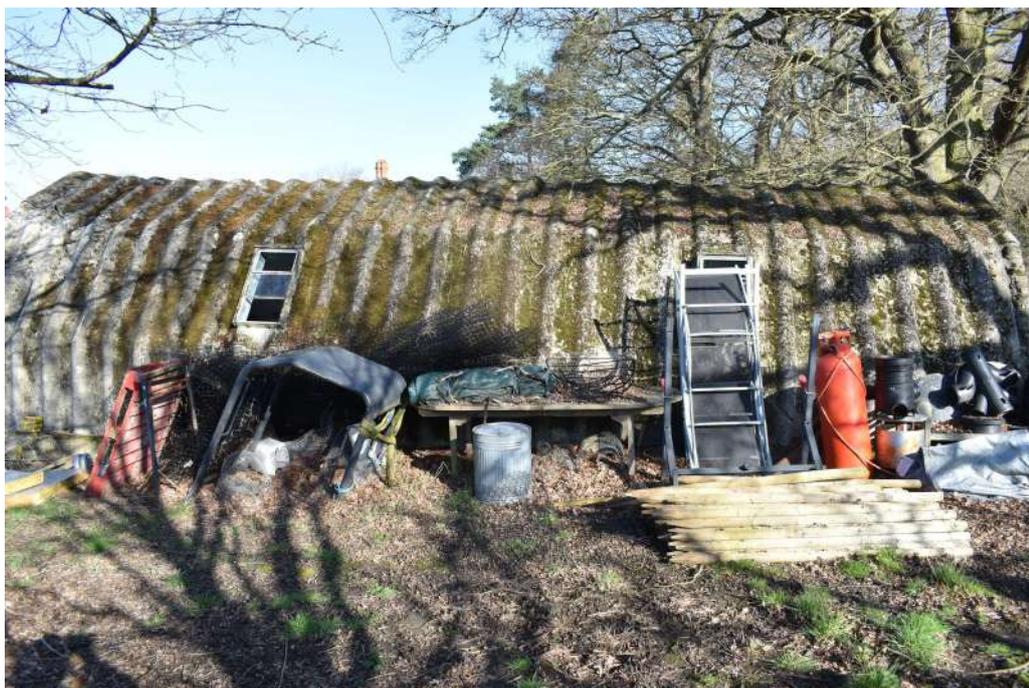
The northern and southern elevations both have two metal framed windows. They are all three-light with a top awning opening and appear to be original to the hut.

**Photograph 5** Southern elevation of the handcraft hut. Photograph taken facing north-west.

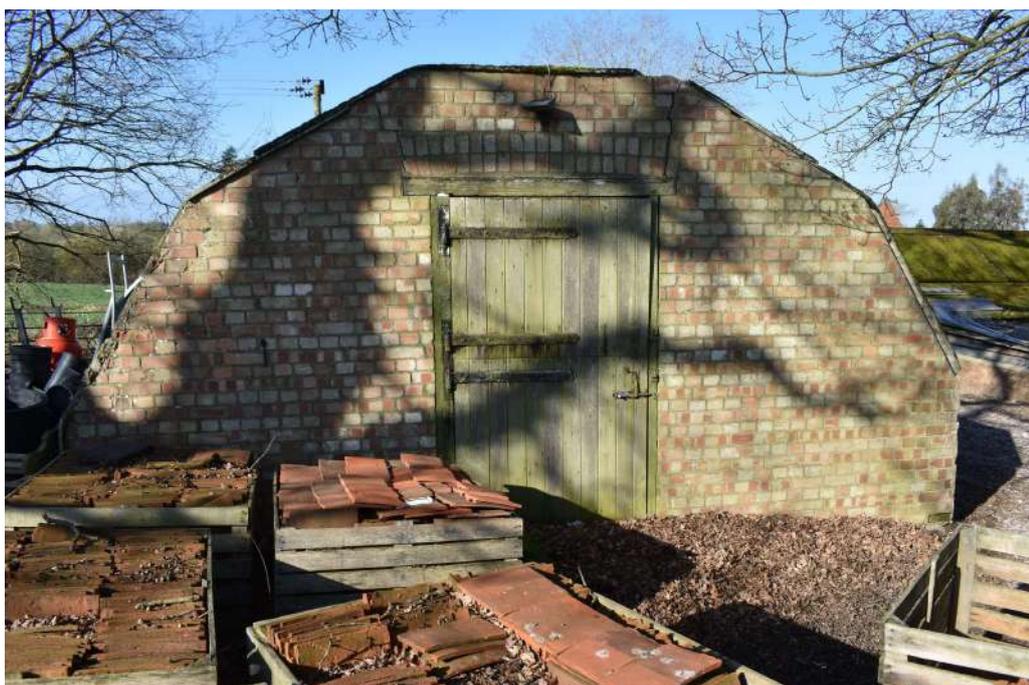
**Photograph 6** Eastern elevation of the handcraft hut. Photograph taken facing south-west.

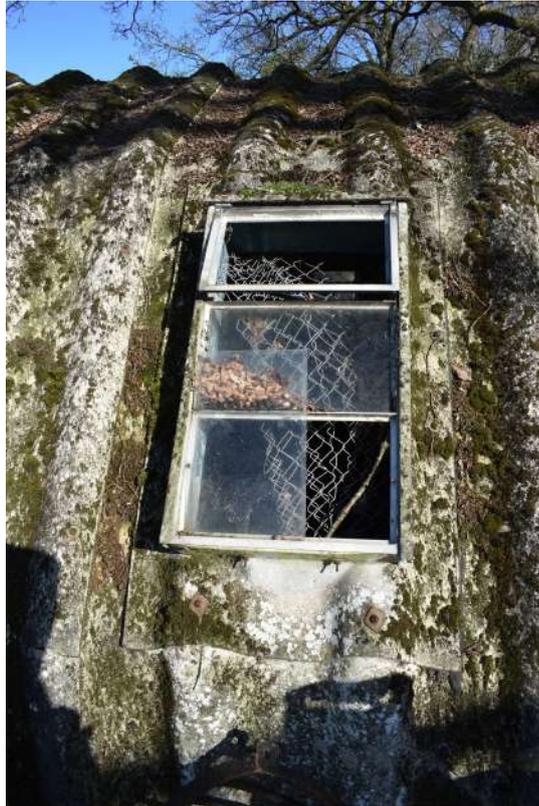
**Photograph 7** Detail of window on southern elevation of the handcraft hut. Photograph taken facing north-west.

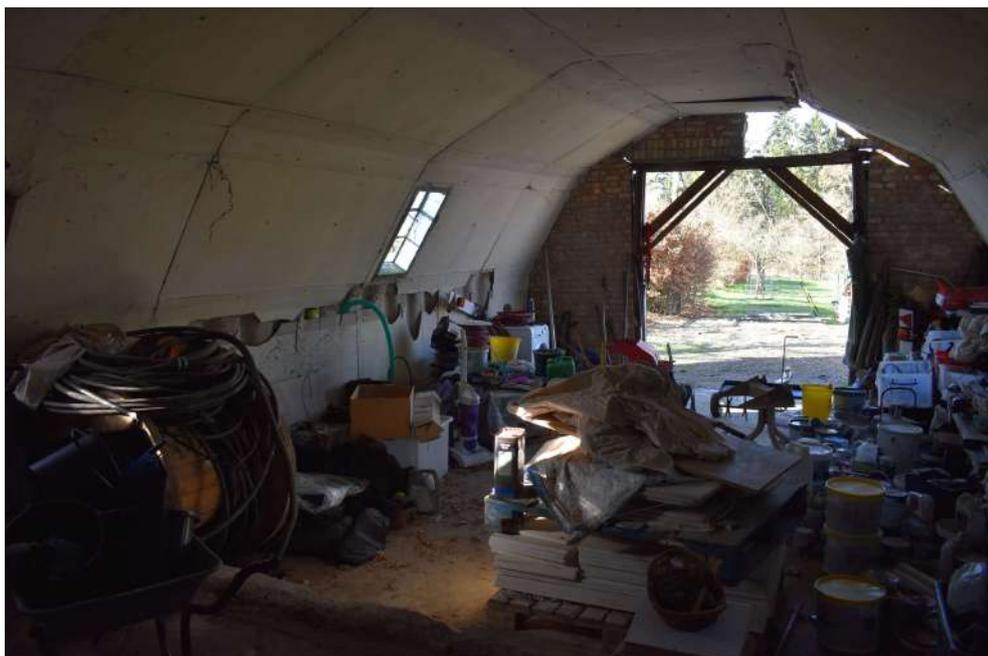
On the interior, the arch of the Handcraft Hut is lined with the original asbestos-cement sheeting, while the eastern and western walls are plain brick. The floor is poured concrete with a step at the eastern end. There are four windows – two in the northern wall and two in the southern wall. There is a door at the eastern and western ends of the hut.

**Photograph 8** Internal view of the handcraft hut. Photograph taken facing south.

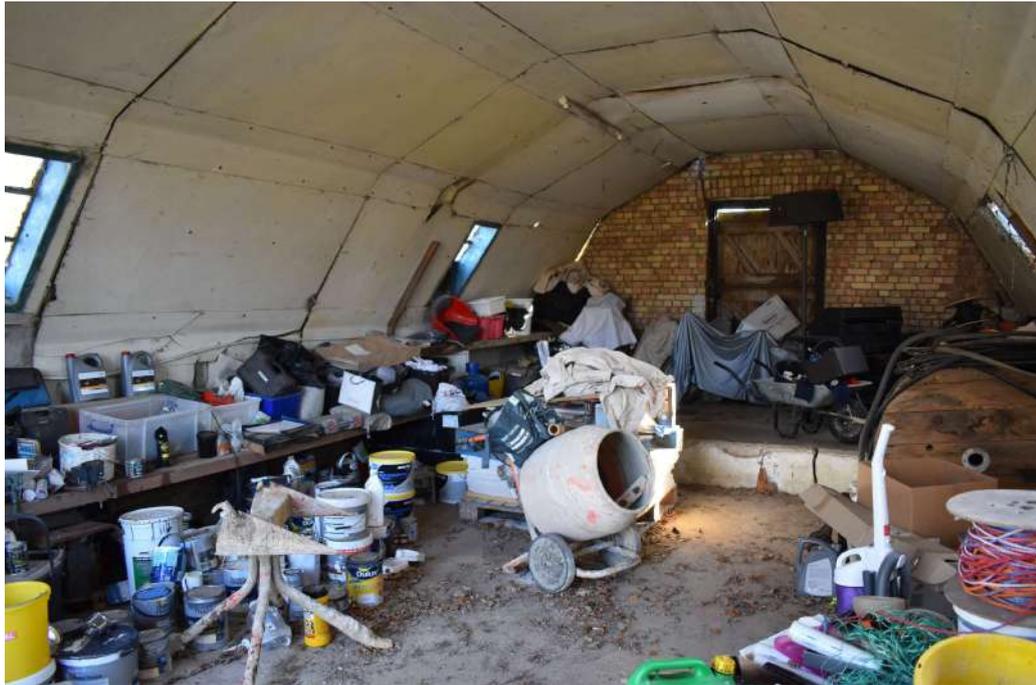
**Photograph 9** Internal view of the handcraft hut. Photograph taken facing north.

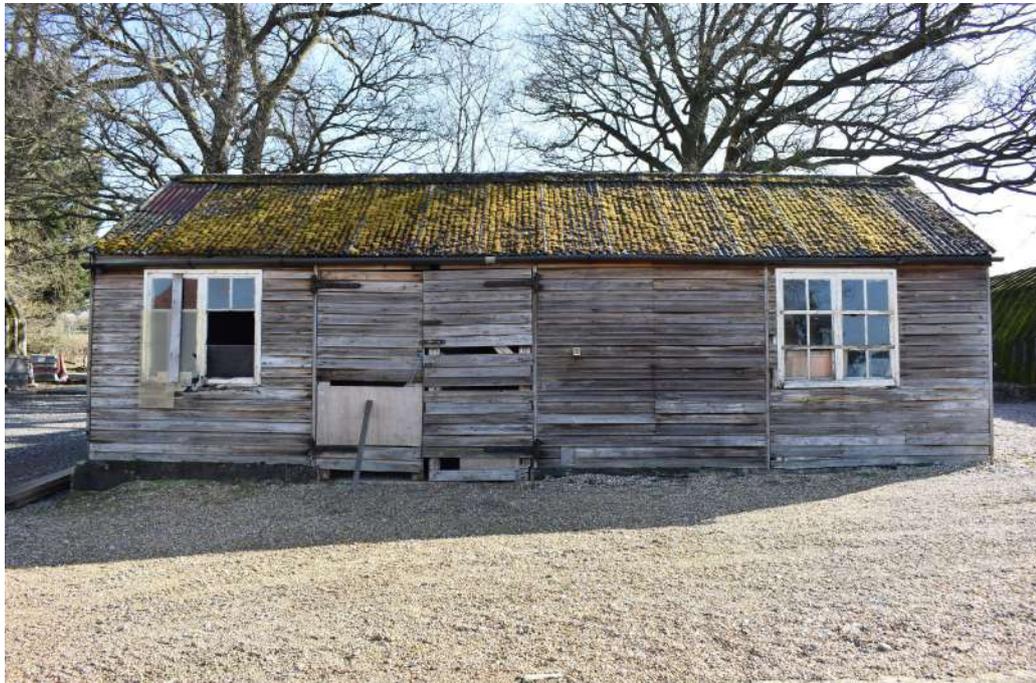
**Photograph 10** Western elevation of the sectional timber hut. Photograph taken facing north-east.

The western elevation is clad in weatherboard. There are two twelve-light casement windows, one at each end of the elevation, and a set of double timber doors which are offset from the centre. The doors and windows are all replacement.

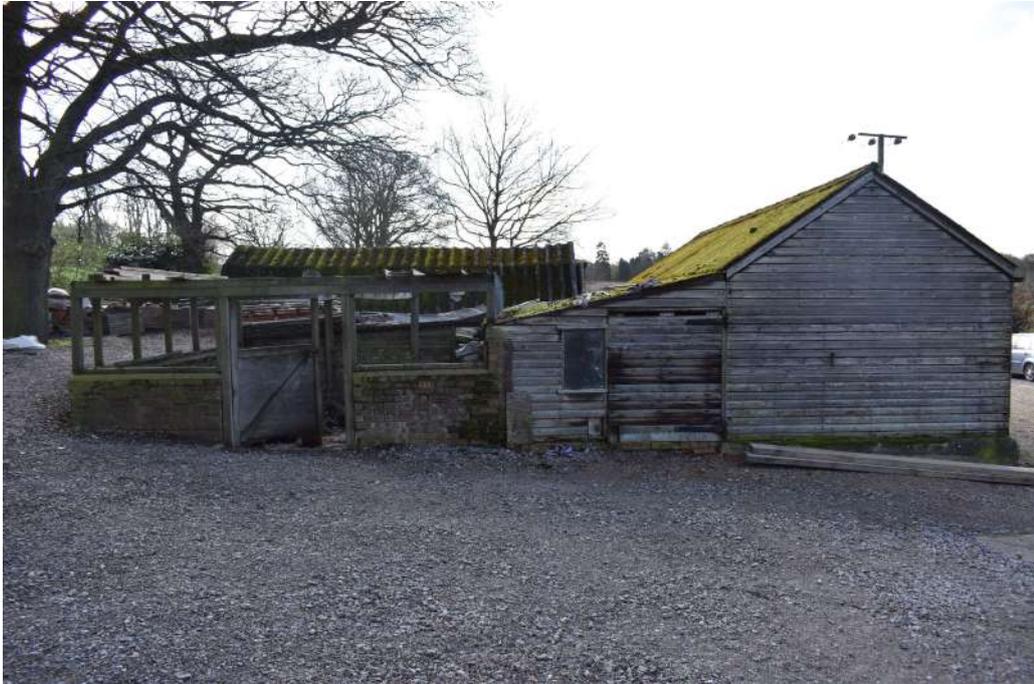
**Photograph 11** Northern elevation of sectional timber hut. Photograph taken facing south-east.

On the northern elevation, the sectional timber hut and extension 1 are clad in weatherboard. Extension 1 has a single timber door and a single-light fixed window. The lower half of extension 3 is red brick laid in Flemish bond (brick dimensions: 225 x 110 x 65mm) and the upper is a timber frame covered with chicken wire. There is a single door in the centre of extension 3.

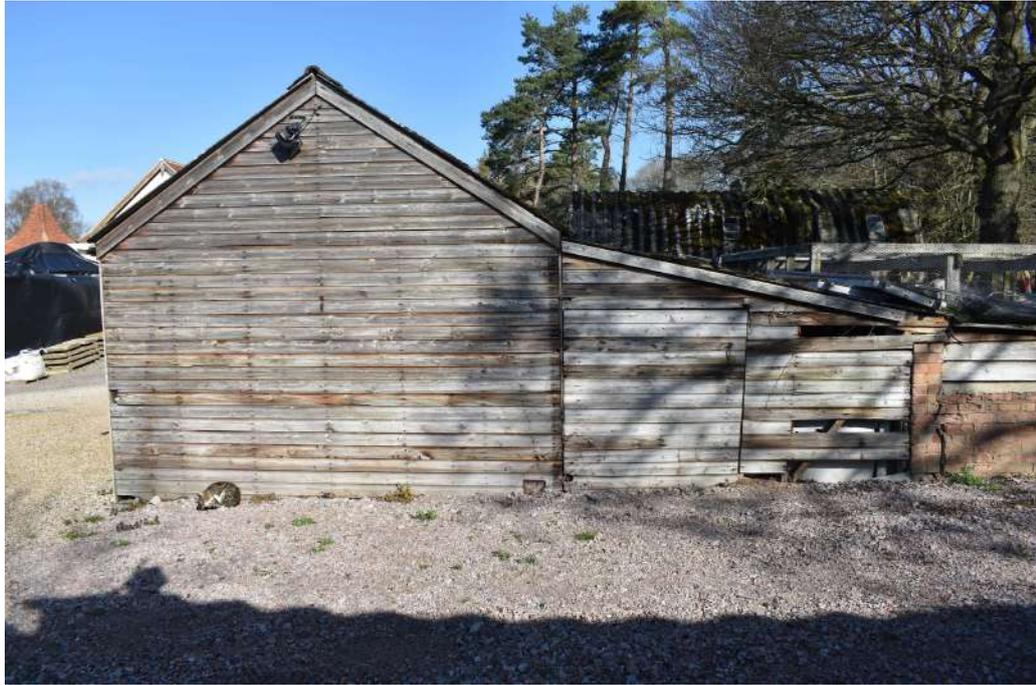
On the southern elevation, the sectional timber hut and extension 1 are clad in weatherboard. Extension 1 has a single timber door. Extension 2 is red brick laid in Flemish bond with weatherboard above.

**Photograph 12** Southern elevation of the sectional timber hut. Photograph taken facing north-west.

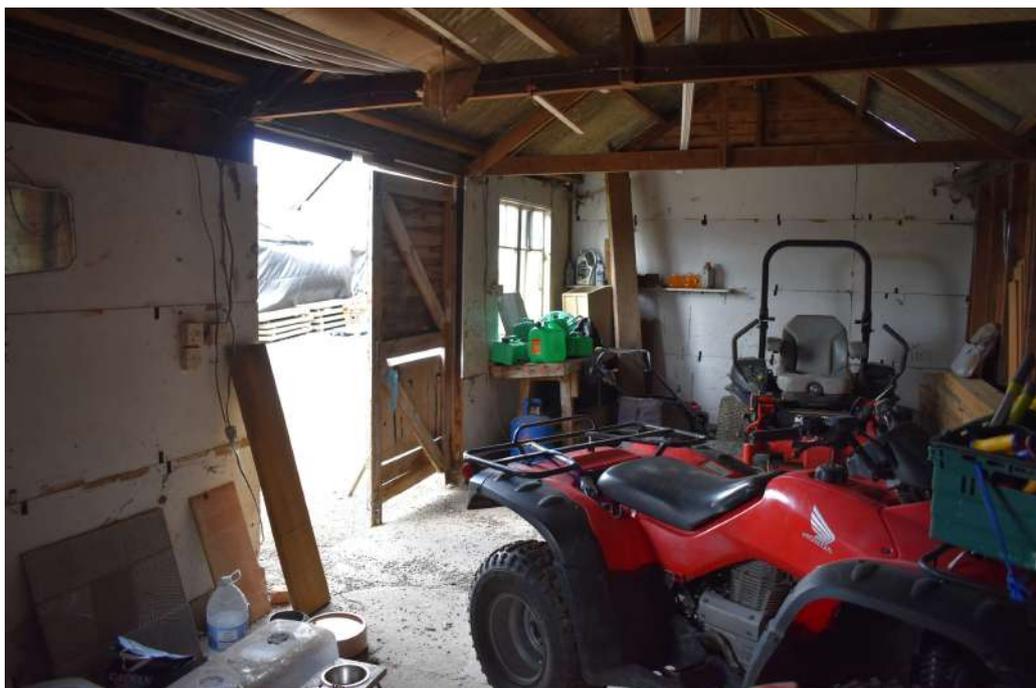
The roof of the sectional timber hut comprises pairs of double rafters, which straddle the tie-beams and rise to meet at the apex of the roof. There are three through-purlins on each roof pitch and king posts rising from the tie-beams. The tie-beams are supported on wall-plates on both walls. All of the timbers in the frame of the sectional timber hut are machine cut.

The northern, southern and western walls are clad in white fibreboard while the eastern wall is the bare timber-frame. There is a door and two windows in the western wall and an inserted door in the eastern wall. The floor is poured concrete.

**Photograph 13** Internal view of sectional timber hut. Photograph taken facing north-west.

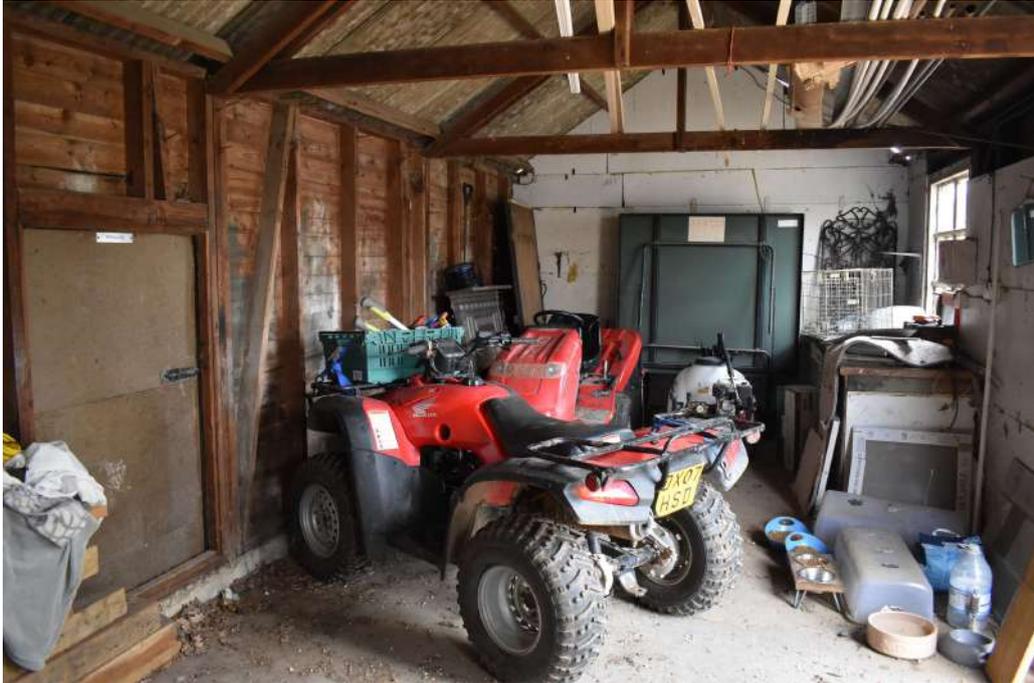
**Photograph 14** Internal view of sectional timber hut. Photograph taken facing east.

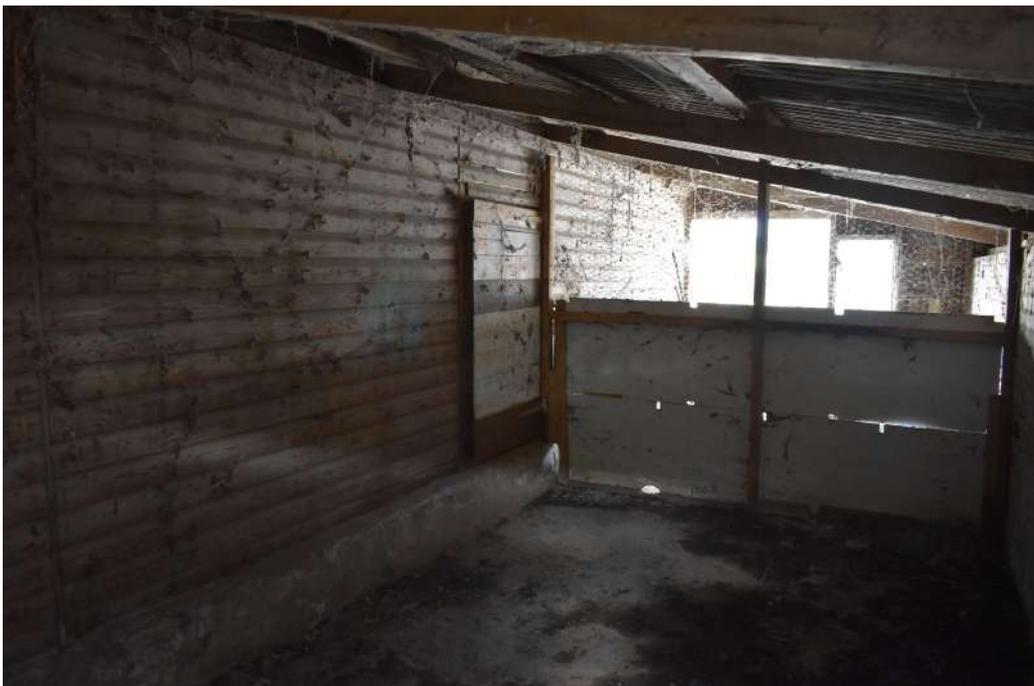
The western wall is the original eastern elevation of the sectional timber hut and is clad in weatherboard, while the eastern wall is red brick in a rough Flemish bond. There is an inserted door in the western wall. The northern and southern walls are both timber. The northern wall has a door and window and the southern wall a single blocked doorway. There is a crude dividing wall, constructed from timber, chicken wire and fibreboard, segregating roughly the north third of extension 1. The floor is poured concrete.

**Photograph 15** Internal view of extension 1. Photo taken facing north-west.
