CAT Report 1938
issued June 2023

**Historic building recording of outbuildings at 111
Newland Street, Witham, Essex, CM8 1BG**

CAT project ref.: 2023/04d
ECC code: WH28

**Planning ref.: 20/00808/FUL
(Appeal reference: APP/Z1510/W22/3293210)**

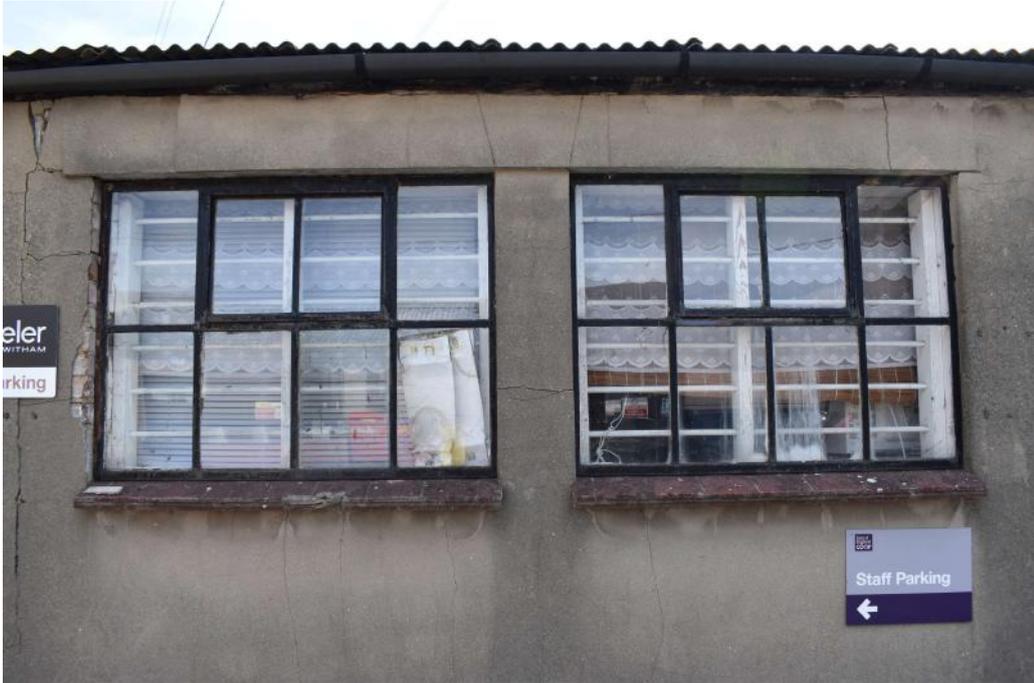
Photograph 3 South-west elevation of outbuilding 2. Photograph taken facing north-east.

Outbuilding 2 has a concrete render on all elevations. Areas of damage to the render has revealed the brickwork beneath (Photograph 6) – red brick (brick dimensions: 220 x 105 x 60mm) laid in Monk bond. The roof is mono-pitched, sloping to the south-west, and clad in corrugated asbestos. There are two Crittall eight-light awning-windows (Photograph 4) and two blocked openings on the south-west elevation (Photograph 3). They all have concrete lintels. The south-east elevation (Photograph 5) has a timber louvre vent while the north-east elevation (Photograph 7) is plain render with small areas of damage.

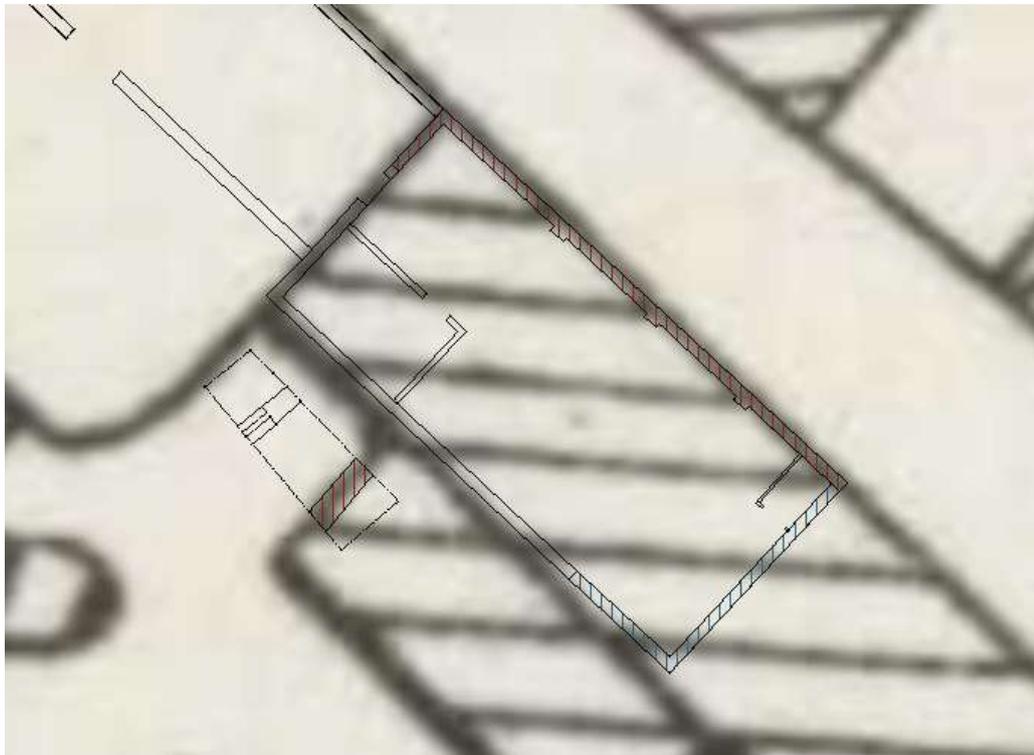
Subsequent evaluation trenching on the site revealed a further wall related to the historic outbuildings (CAT Report forthcoming). A north-east/south-west orientated wall aligns with the north-western wall of an extension to the outbuilding present on historic mapping (Map 9). Sometime after the demolition of this and later extensions, outbuilding 2 was open-fronted, as indicated by the iron posts supporting the roof which the breeze block infill has been built around.

Map 9 Extract of the 1897 25-inch OS Map overlain with outbuilding 2 and evaluation trench 1. Historic walls highlighted in red and potential historic walls highlighted blue.

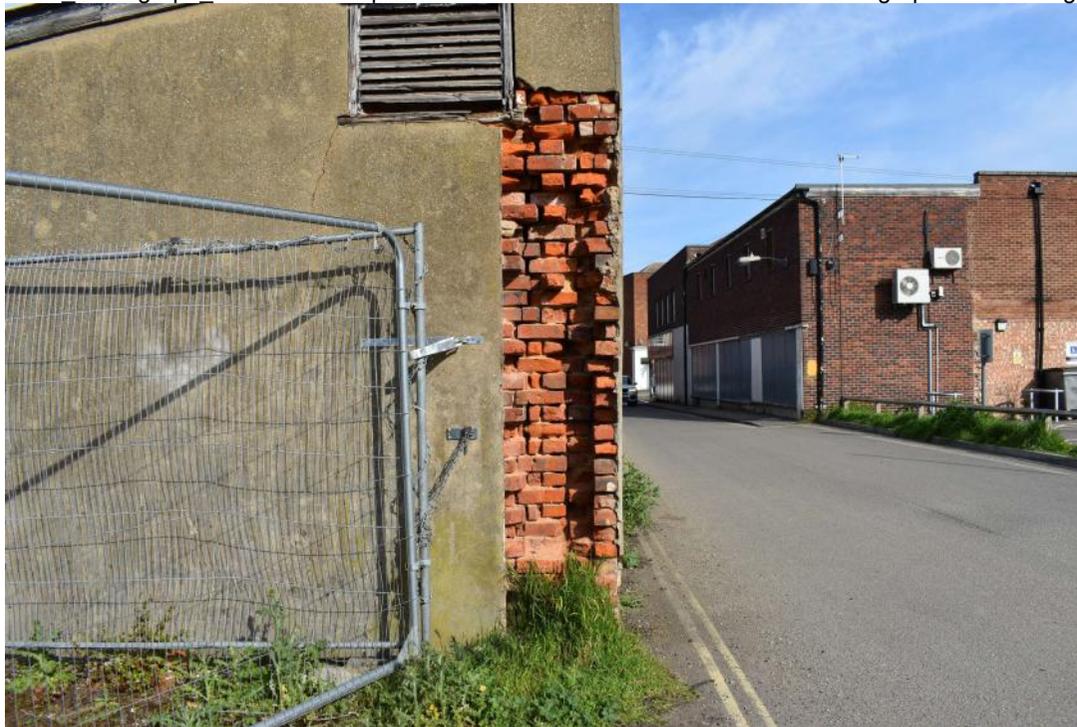
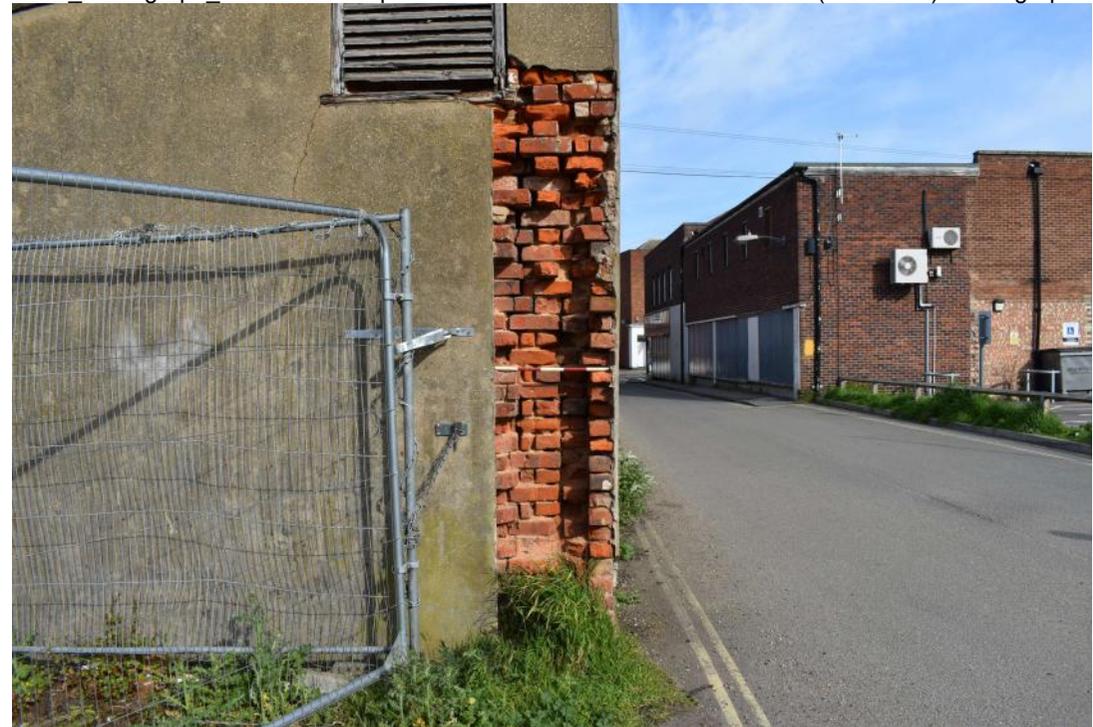
WH28_Photograph_011 Detail of exposed brickwork on south-east elevation. Photograph taken facing... WH28_Photograph_012 Detail of exposed brickwork on south-east elevation (with scale). Photograph ...

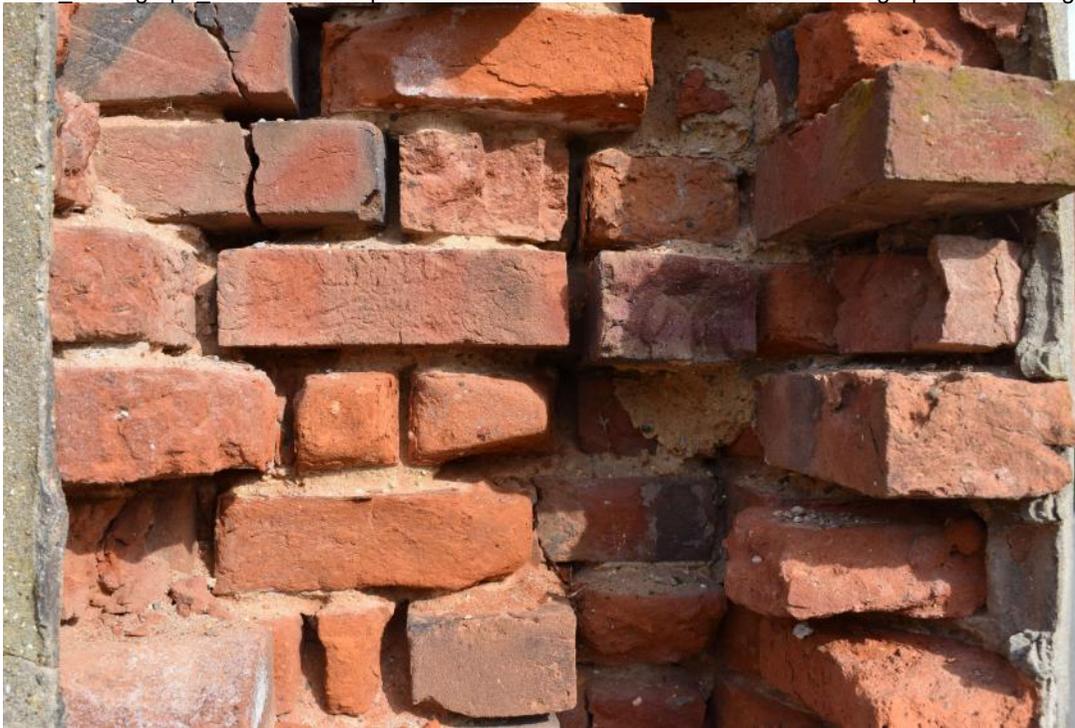
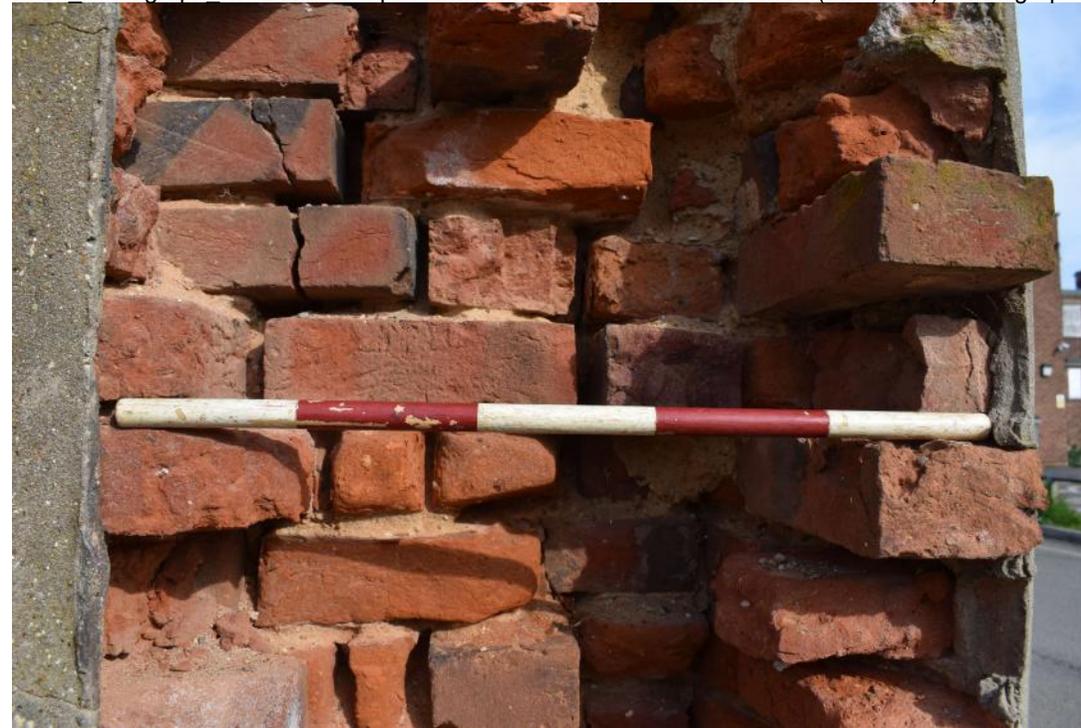
WH28_Photograph_013Detail of exposed brickwork on south-east elevation. Photograph taken facing... WH28_Photograph_014Detail of exposed brickwork on south-east elevation (with scale). Photograph ...

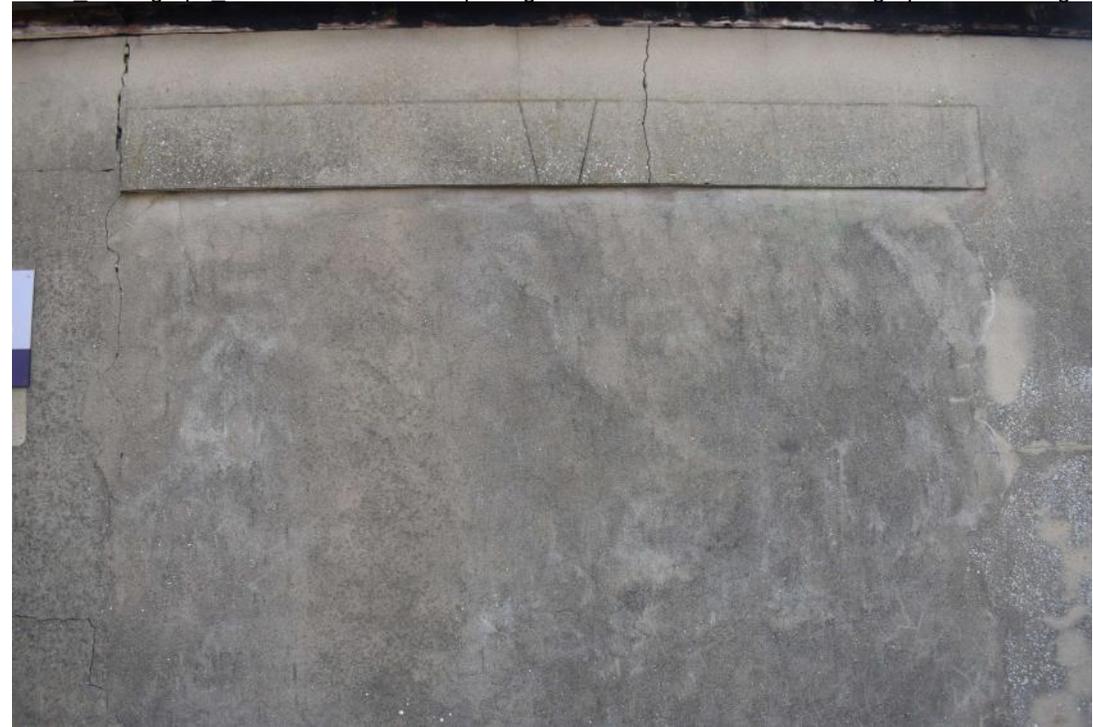
WH28_PhotoGraph_022Detail of blocked opening on south-west elevation. Photograph taken facing ...

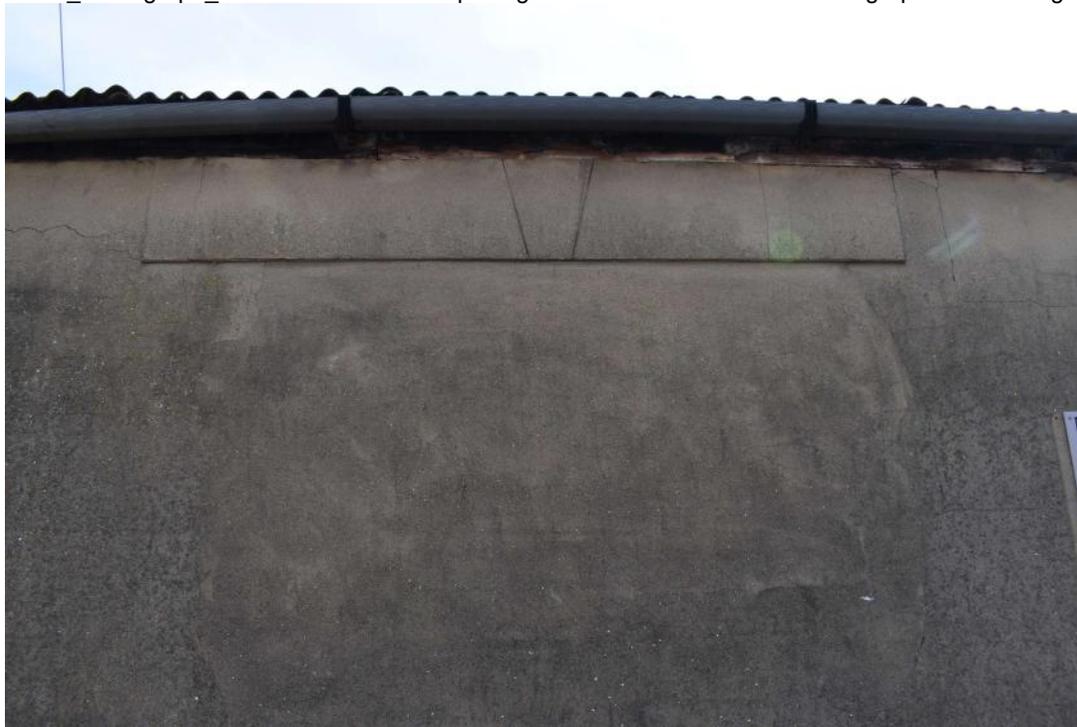
WH28_PhotoGraph_023Detail of blocked opening on south-west elevation. Photograph taken facing ...

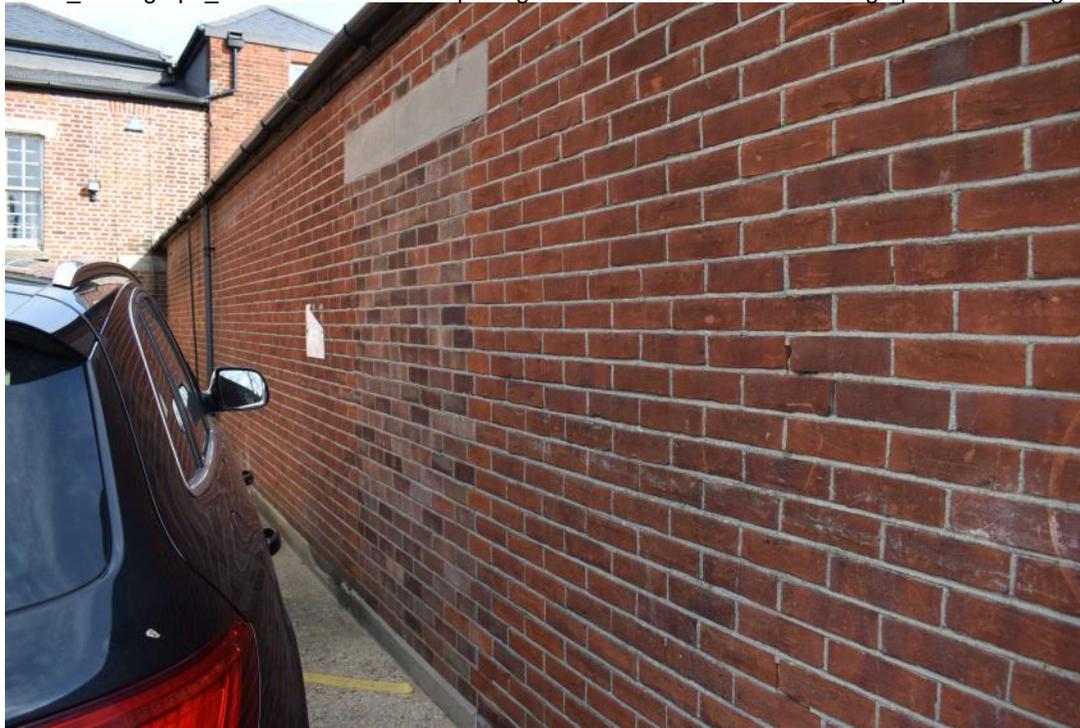
WH28_Photograph_033Detail of blocked opening on south-west elevation. Photograph taken facing ...

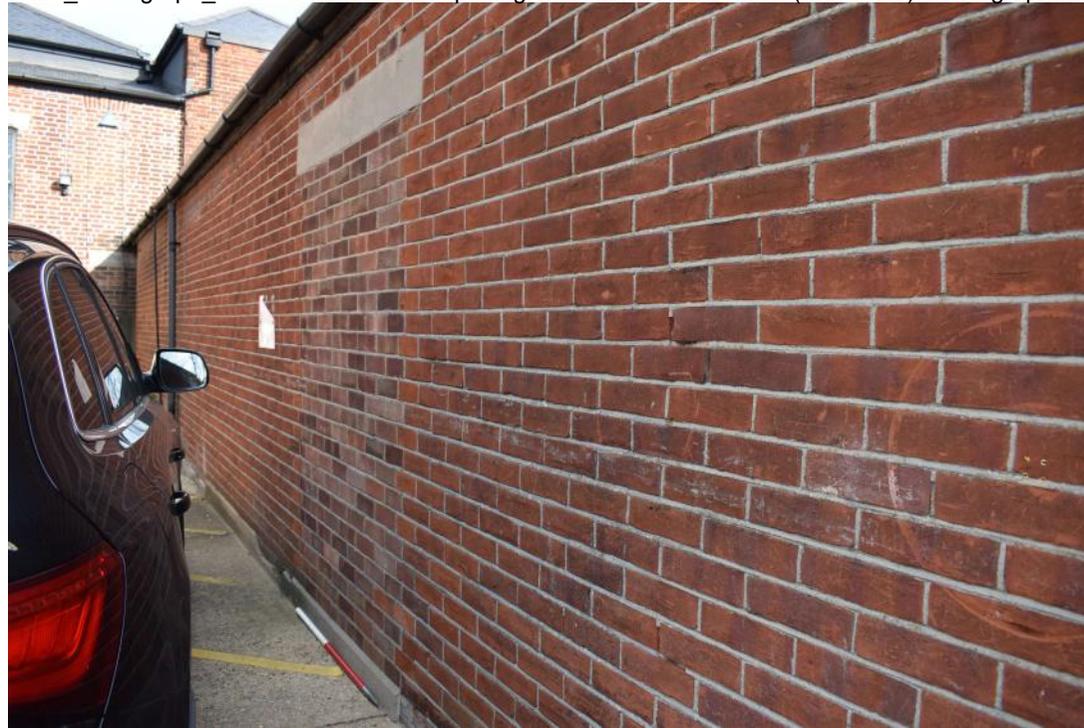
WH28_Photograph_034Detail of blocked opening on south-west elevation (with scale). Photograph ta...

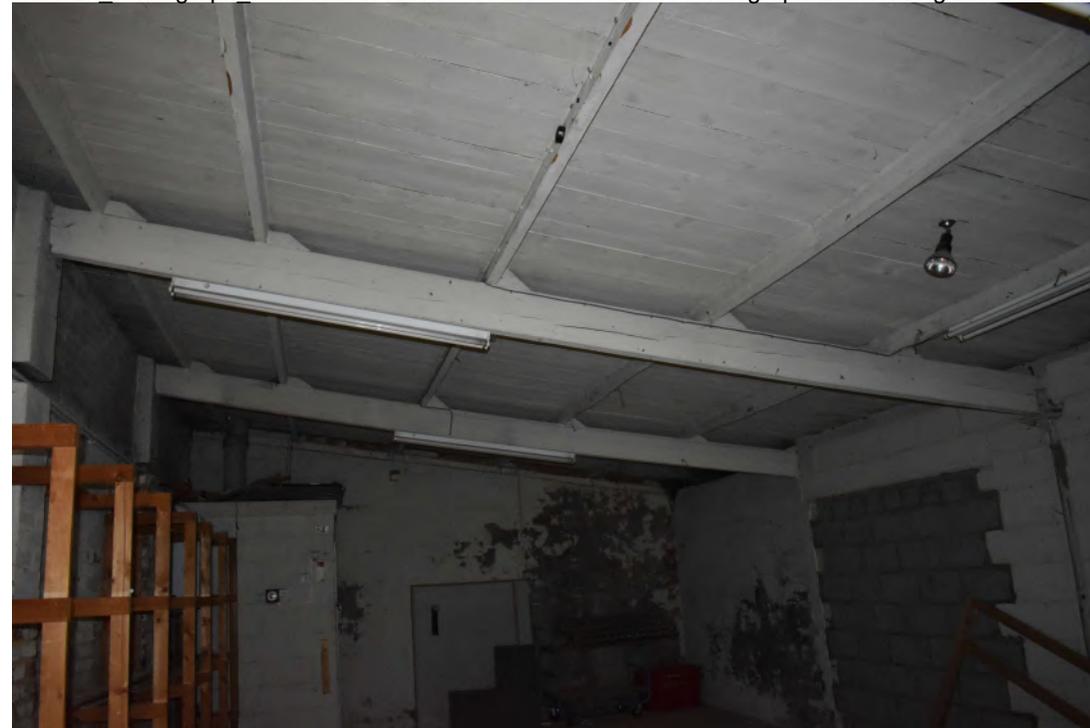
The roof of outbuilding 2 (Photograph 10) is constructed from single rafters that rise to meet a series of engaged-columns on the north-east wall. Two of the rafters are supported on iron posts on the south-west wall (Photograph 11), while the eastern rises from the wall. There are five purlins supported by the rafters. Each purlin has a splayed scarf joint and is supported on each rafter by a cleat.

WH28 Photograph_058Detail of roof construction in room 3. Photograph taken facing south-east.

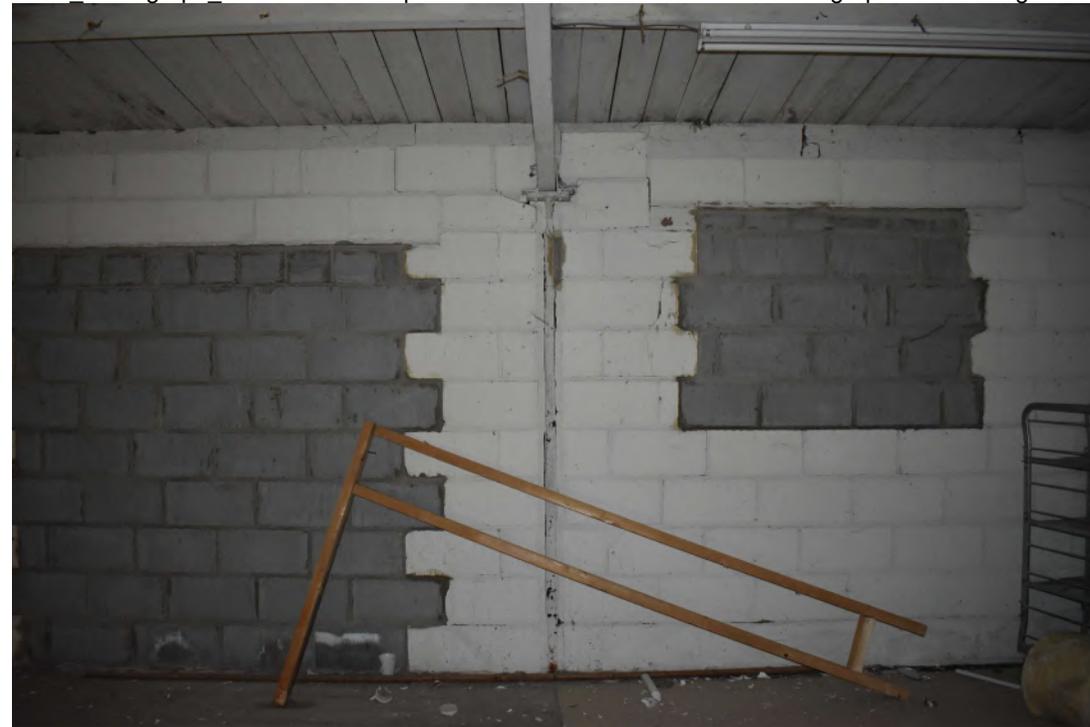
WH28 Photograph_060Detail of iron post in south-west wall of room 3. Photograph taken facing south-west.

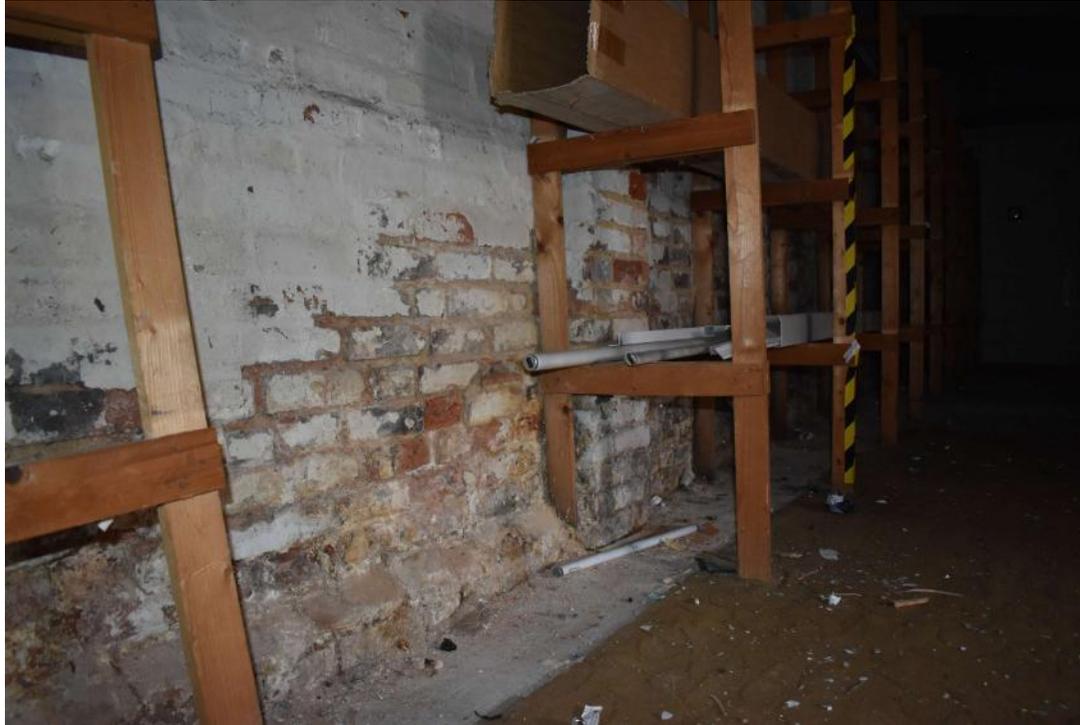
While outbuilding 2 also has modern components, it seems to have incorporated at least two outer walls of the historic outbuilding into its north-east and north-west walls. This can be evidenced by overlaying the floor-plan of outbuilding 1 onto historic mapping. It is also possible that the south-eastern wall represents an internal brick wall from the original outbuilding and the brick portion of the south-east wall is also part of an outer wall (Map 9). The brick walls are constructed from red brick, laid in Monk bond. Monk bond is similar in appearance to Flemish bond, except with the addition of an extra stretcher between each pair of headers, thus making it a cheaper way of building. The roof of outbuilding 2 is likely a later replacement – all the timbers are regular in size and machine cut, showing no evidence of carpenter's marks or Baltic timber marks.

WH28 Photograph 061 Detail of exposed brickwork on north-east wall of room 3. Photograph taken f...
