**CAT Report 1943  
issued June 2023**

**Historic building recording of a barn at  
Tylde Hall Farm, Heath Road, Ramsden Heath,  
Billericay CM11 1HP**

**CAT project ref.: 2023/04a  
CAT Report 1943**

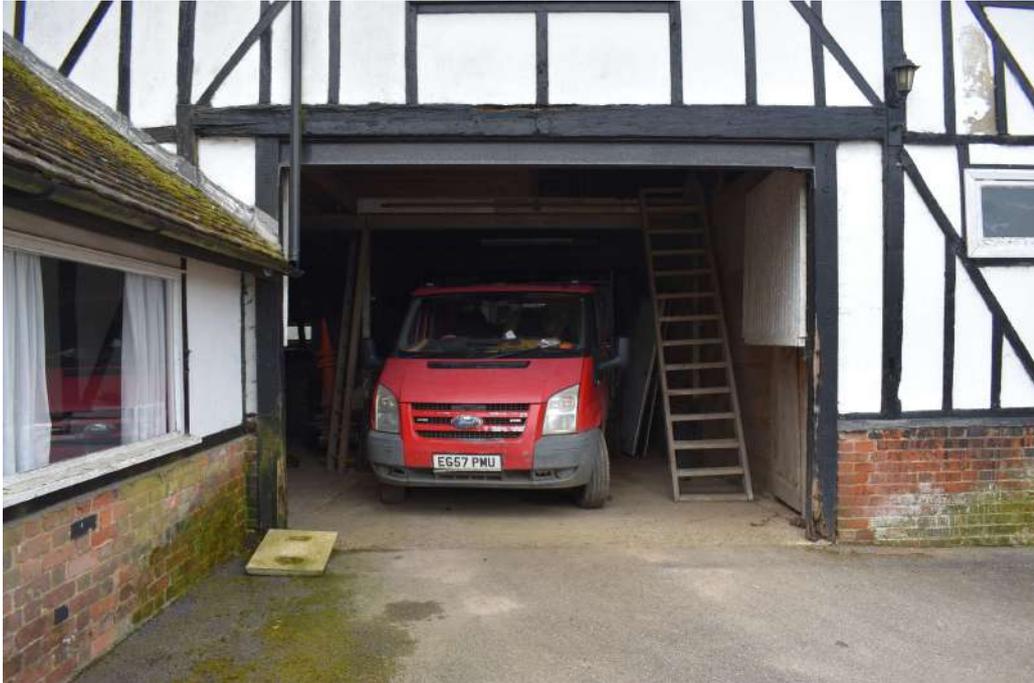
**Photograph 2** Detail of barn entrance (eastern elevation). Photograph taken facing south-west.

In the centre of the barn's eastern elevation is a set of replacement double doors (only the top half of which are surviving). A wall has been inserted above the doors, the original barn doors having been the full height of the elevation. This elevation has 16 windows, including three dormer windows inserted into the barn's roof and a further 10 two and three-light windows inserted into the barn's elevation.

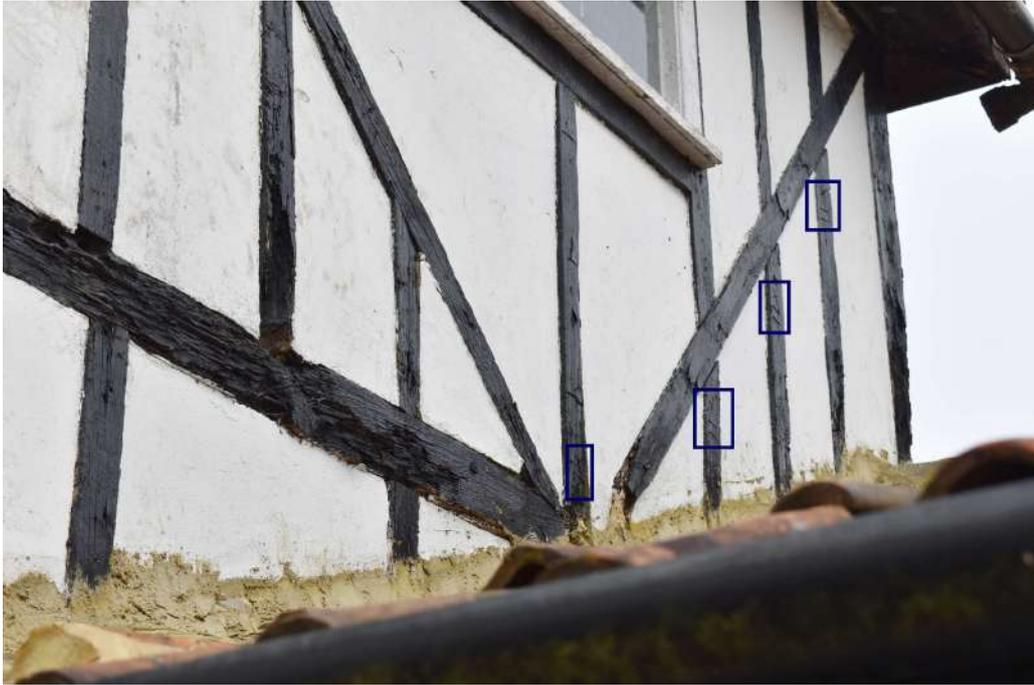
**Photograph 3** Detail of carpenters' marks on eastern elevation of barn (upper register). XX on the central stud and 'XII' on last three studs (outlined in blue). Photograph taken facing west.

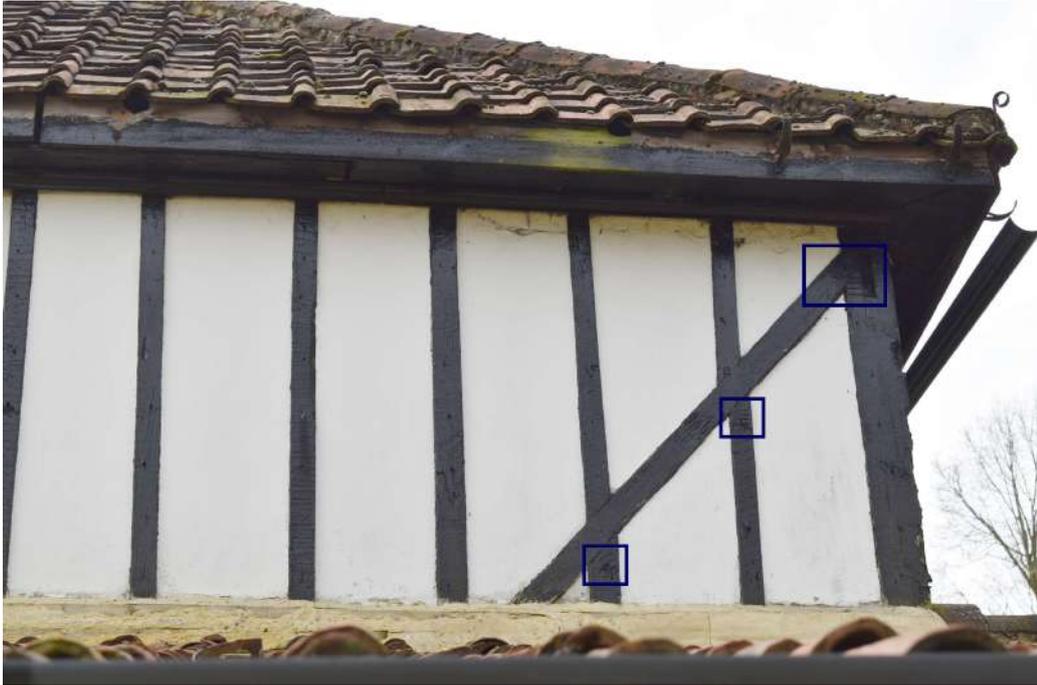
**Photograph 4** Detail of carpenters' marks (outlined in blue) on northern elevation of barn (upper register). 'IIII' on the principal post and the two studs to the left. Also, detail of reused timber for corner post. Photograph taken facing south.

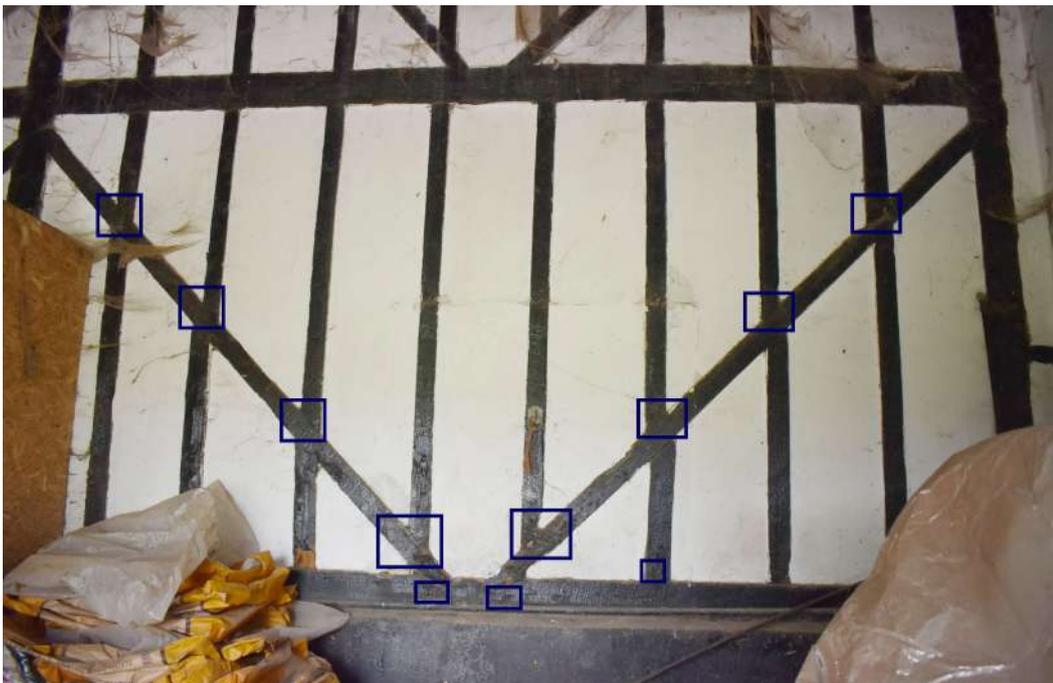
**Photograph 5** Detail of northern elevation of barn (lower register) visible in stable 4. carpenters' marks outlined in blue. Photograph taken facing south-east.

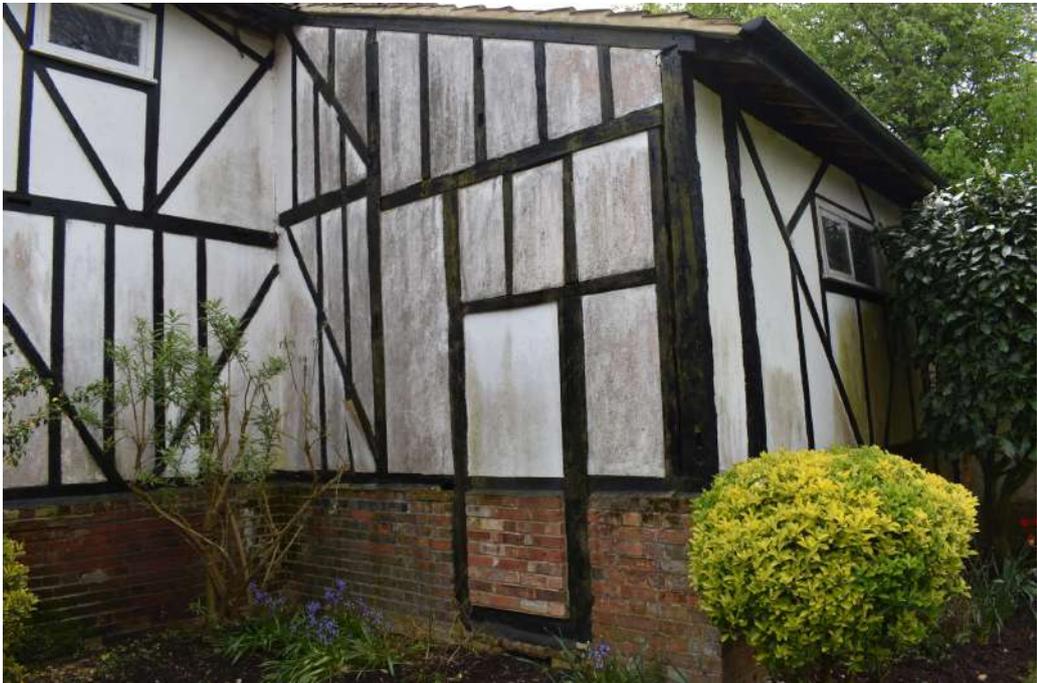
It seems likely that some of the timber-frame on this elevation of midstrey has been rebuilt as the frame does not align with the barn's timbers.

**Photograph 7** Northern elevation of midstrey. Photograph taken facing south-east.

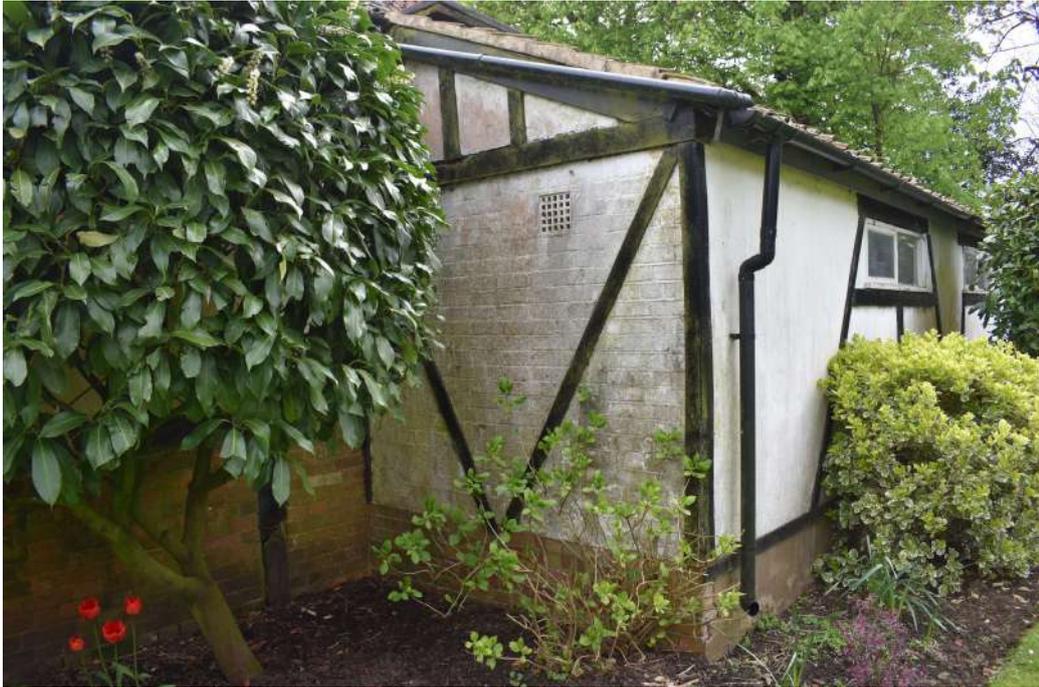
The northern elevation of the barn extension does not have mortar infill between the timber-frame, instead it is red-brick laid in English bond. Most of the brick has been painted white to match the barn's infill.

**Photograph 8** Northern elevation of barn extension. Photograph taken facing south-east.

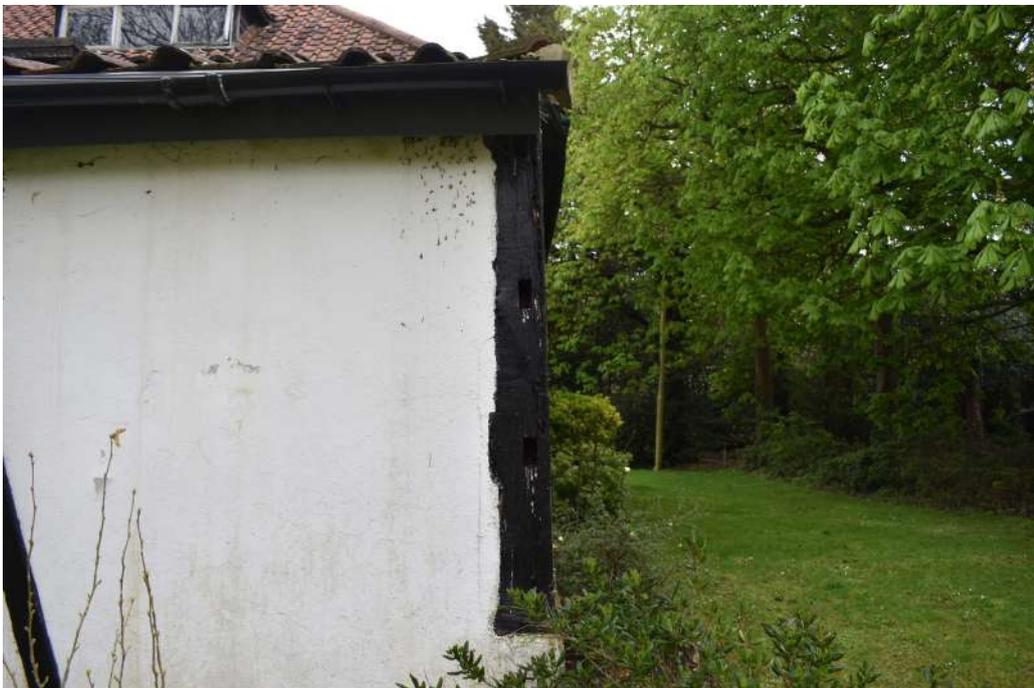
**Photograph 10** Detail of reused corner post on western elevation of barn extension. Photograph taken facing north-east.

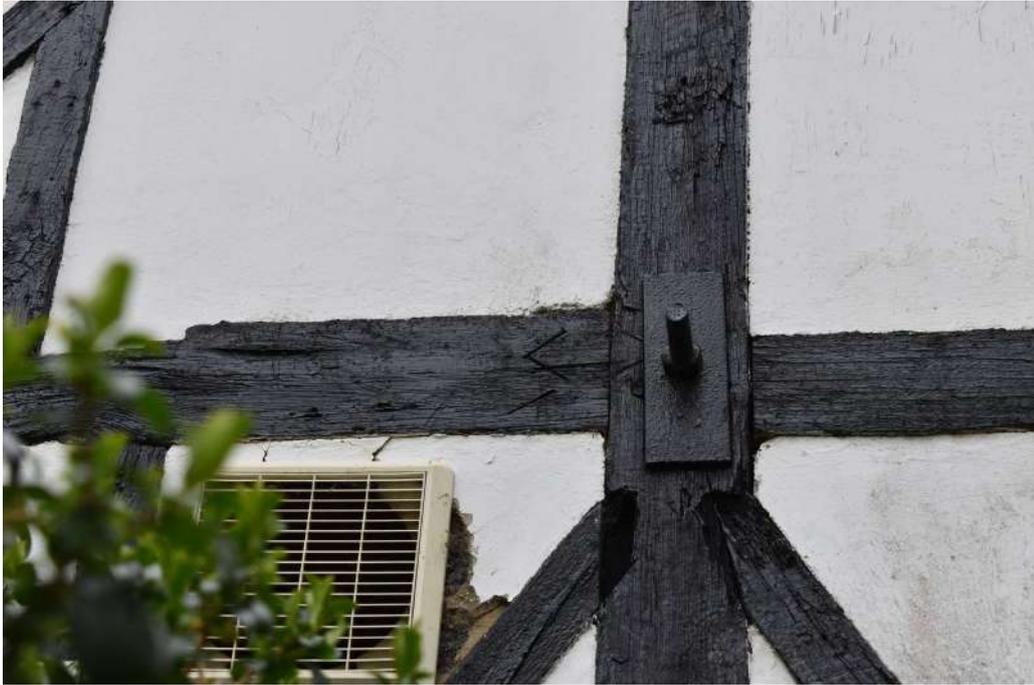
**Photograph 11** Detail of carpenters' marks 'VI' on girding-beam on western elevation of barn. Photograph taken facing east north-east.

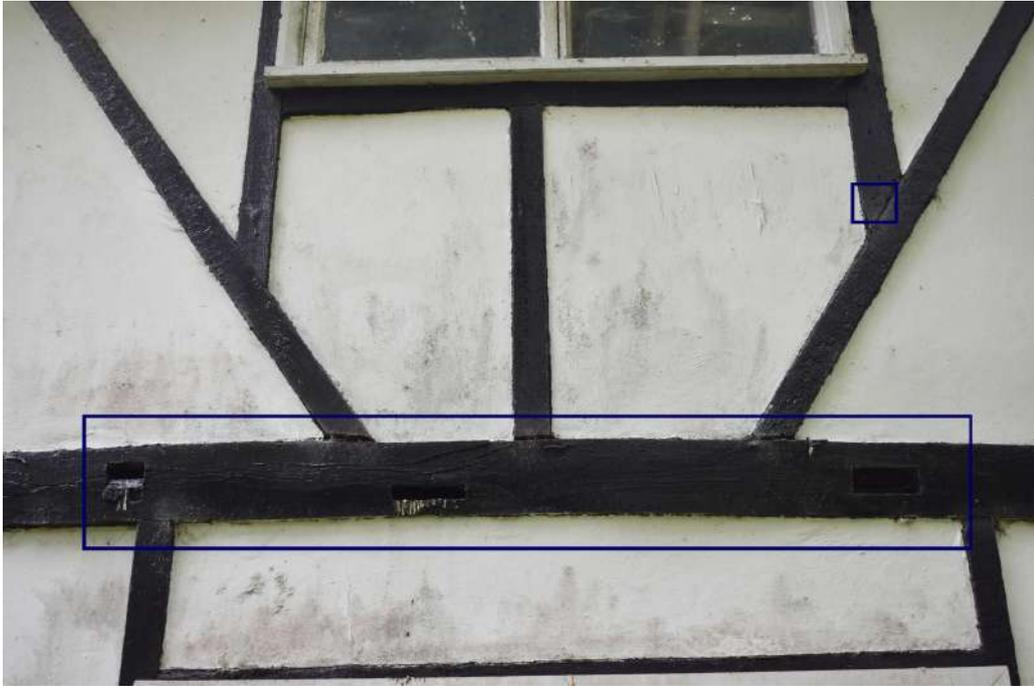
**Photograph 13** Detail of reused girding-beam in southern elevation of barn (upper register). carpenters' mark 'II' on right-hand stud. Both outlined in blue. Photograph taken facing north north-west.

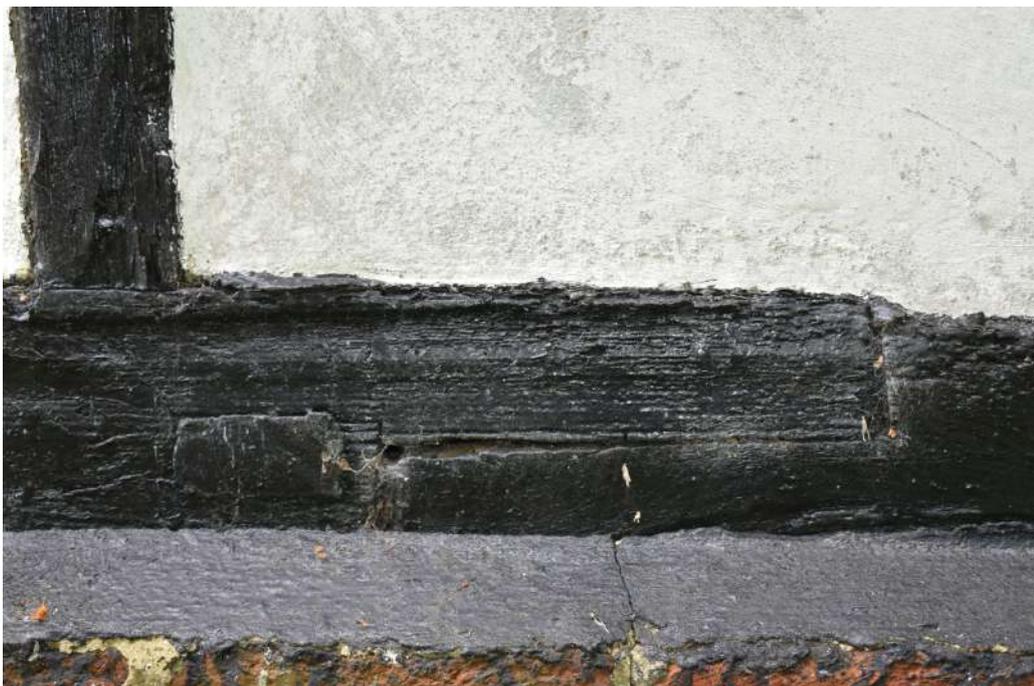
**Photograph 14** Detail of side-halved scarf joint in sill-beam on southern elevation of barn. Photograph taken facing north north-west.

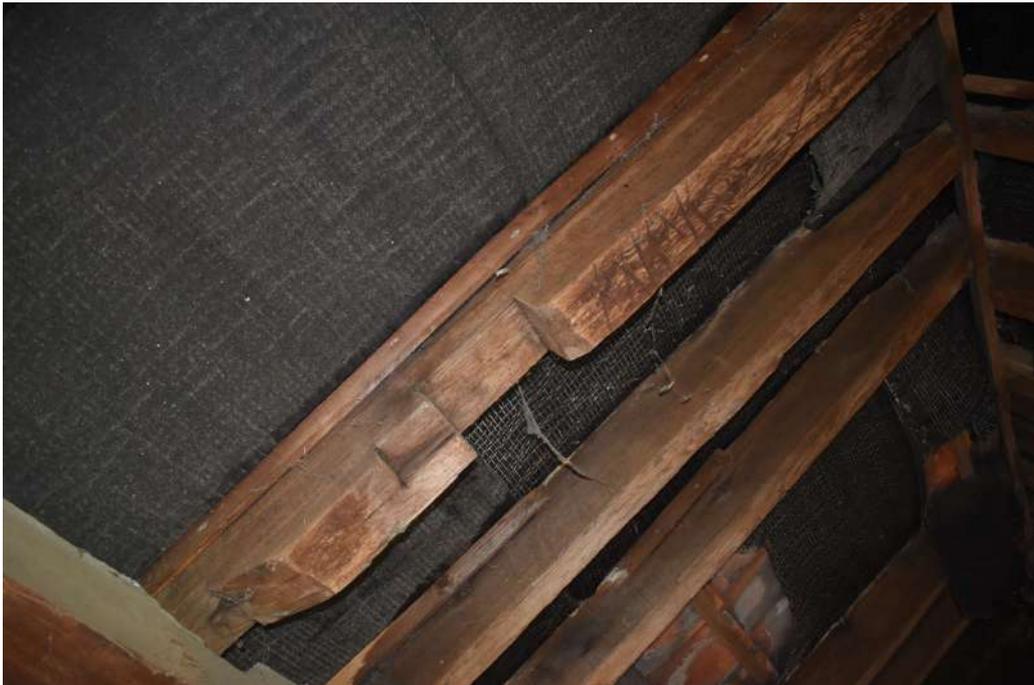
There are two clasped purlins on each roof pitch, the upper clasped by the collar and the lower by an inserted post, and evidence of a third having been removed. The upper purlin appears to be a replacement, as it is smaller than the notches present in the rafters. The lower purlin has several splayed scarf joints: between bays 3 and 4 on both walls, between bays 4 and 5 on both walls and between bays 6 and 7 on the eastern wall. Some of the purlins also have signs of reuse.

**Photograph 15** Example of notch in rafter from removed purlin and Baltic timber mark in western roof pitch of barn (between bays 5 and 6). Photograph taken facing north-west.

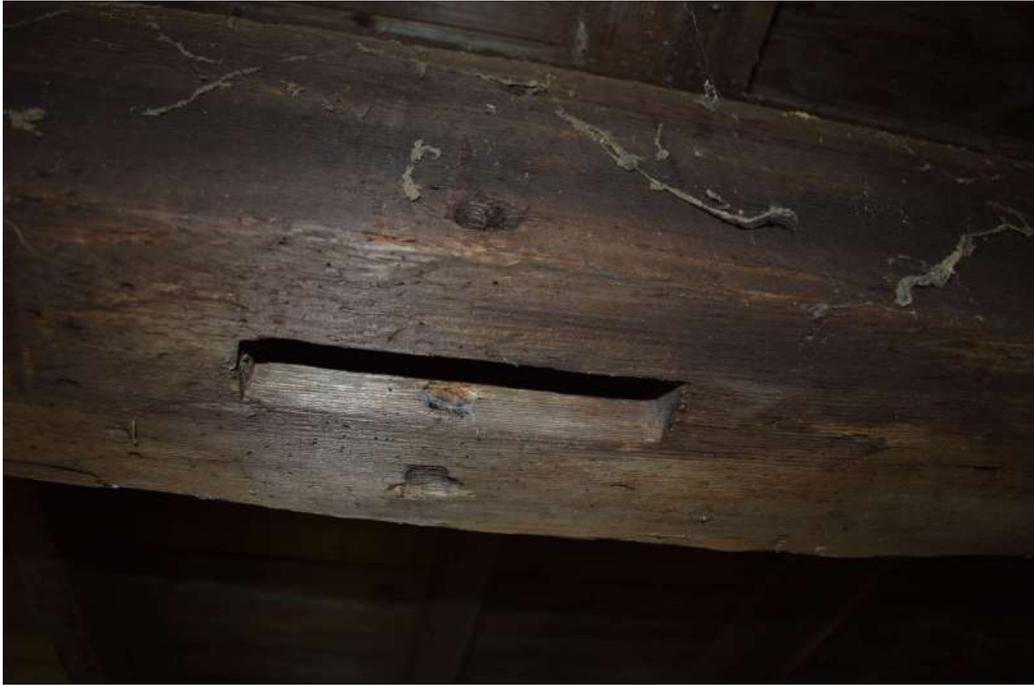
**Photograph 16** Example of empty mortice from removed brace in tie-beam (between bays 6 and 7) of barn. Photograph taken facing east south-east.

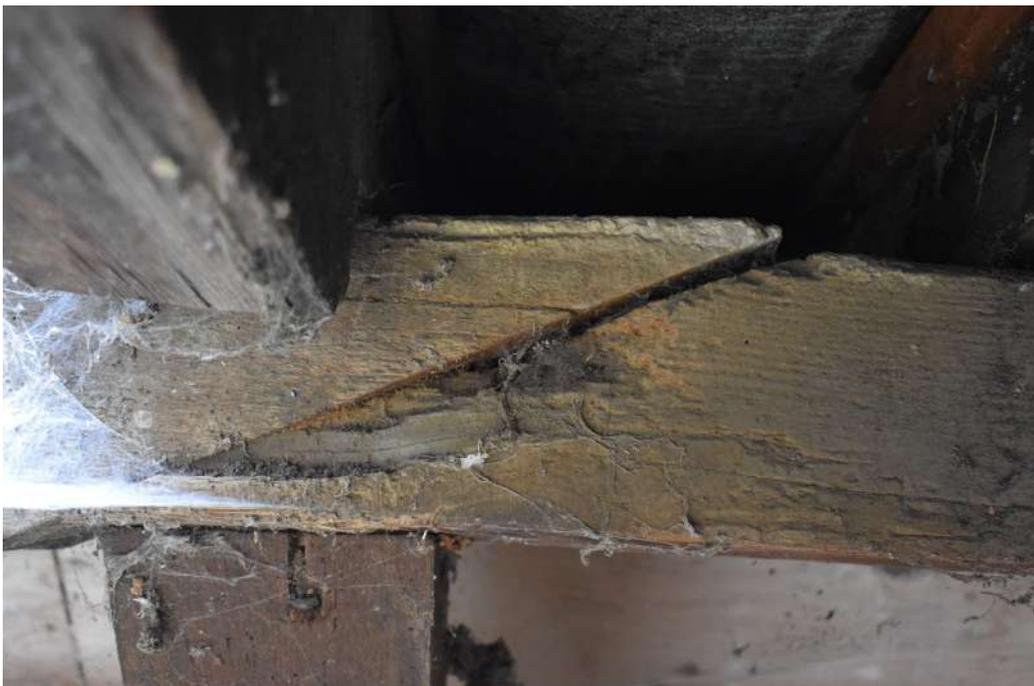
**Photograph 17** Detail of splayed scarf joint in purlin on eastern roof pitch of barn, between bays 6 and 7. Photograph taken facing north-east.

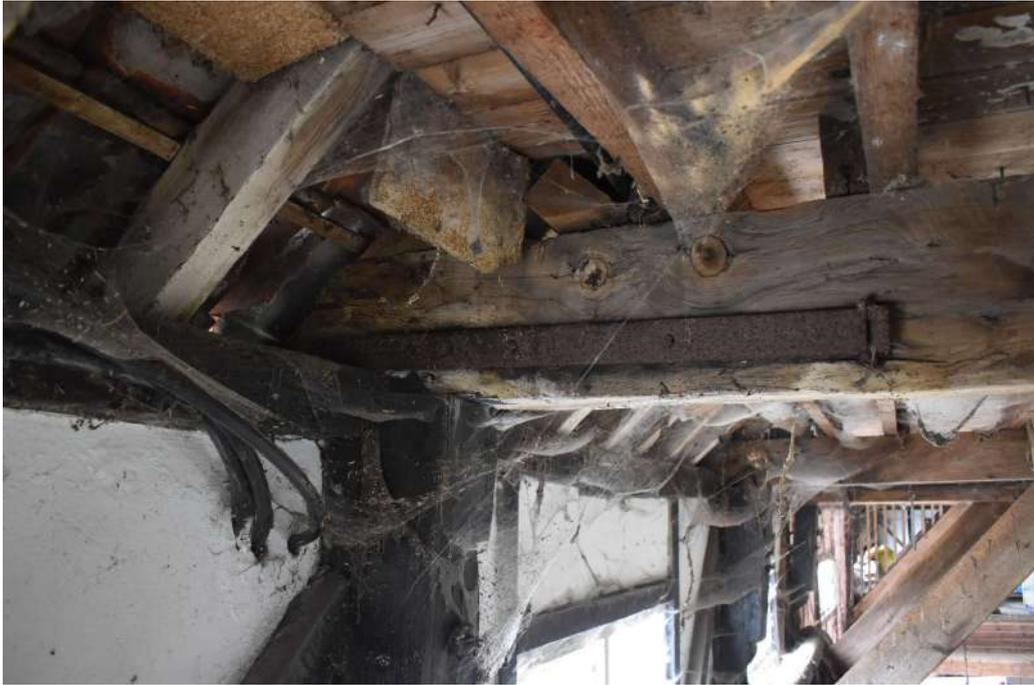
**Photograph 18** Example of tie-beam iron strap (eastern end of tie-beam between bays 1 and 2). Photograph taken facing east.

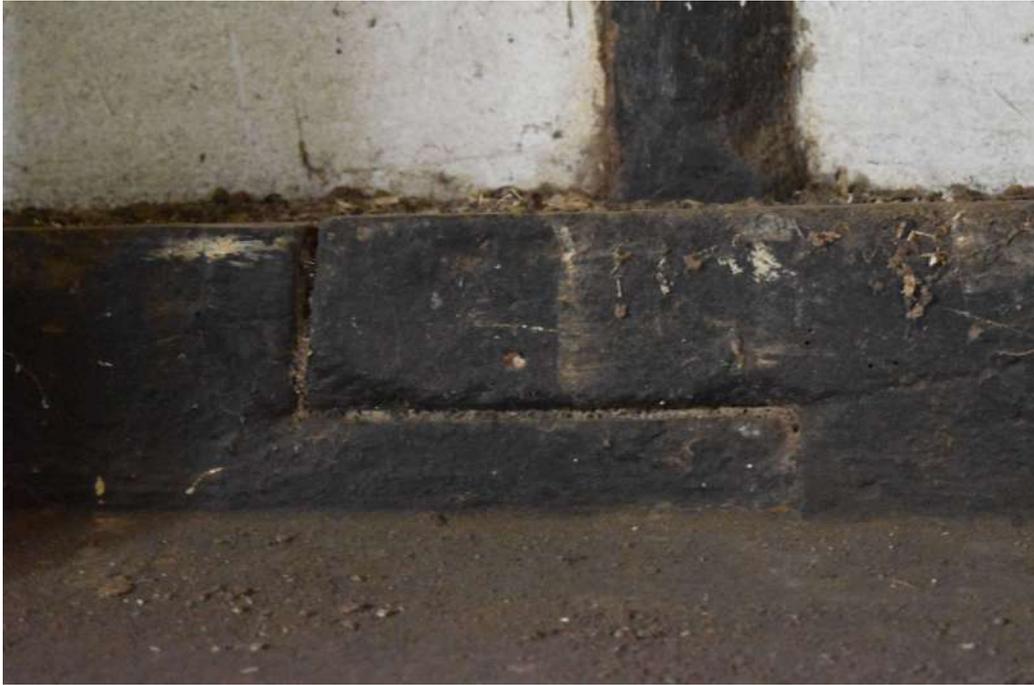
In the western wall of bay 1, the most northerly bay, a doorway has been inserted, and subsequently blocked. A side-halved scarf joint is present in the northern sill-beam and some of the timbers in the frame show signs of reuse. Two large modern, steel-framed livestock feeders have been hung on the northern wall.

**Photograph 21** Detail of side-halved scarf joint in northern sill-beam in bay 1 of barn.  
Photograph taken facing north-west.

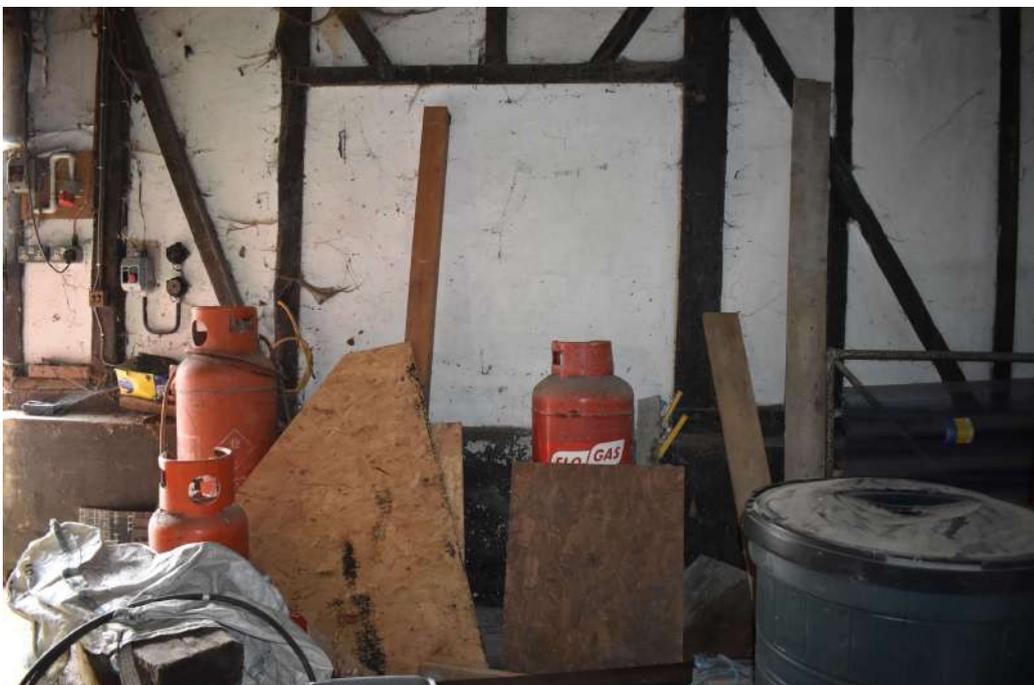
There is an inserted and blocked doorway in the eastern wall of bay 5. Bay 7 has three inserted windows, one in the eastern wall and two in the southern wall. The western wall of bays 5-7 has been removed and the intermediary posts replaced with telegraph poles. To the other side of these poles is the barn's extension. The southern and western walls of the extension are timber-framed and emulate the barn's structure while the northern wall is solid brick. Two windows are present in the western wall of the extension.

**Photograph 23** Detail of inserted and blocked opening in bay 5 of barn, ground floor. Photograph taken facing north-east.

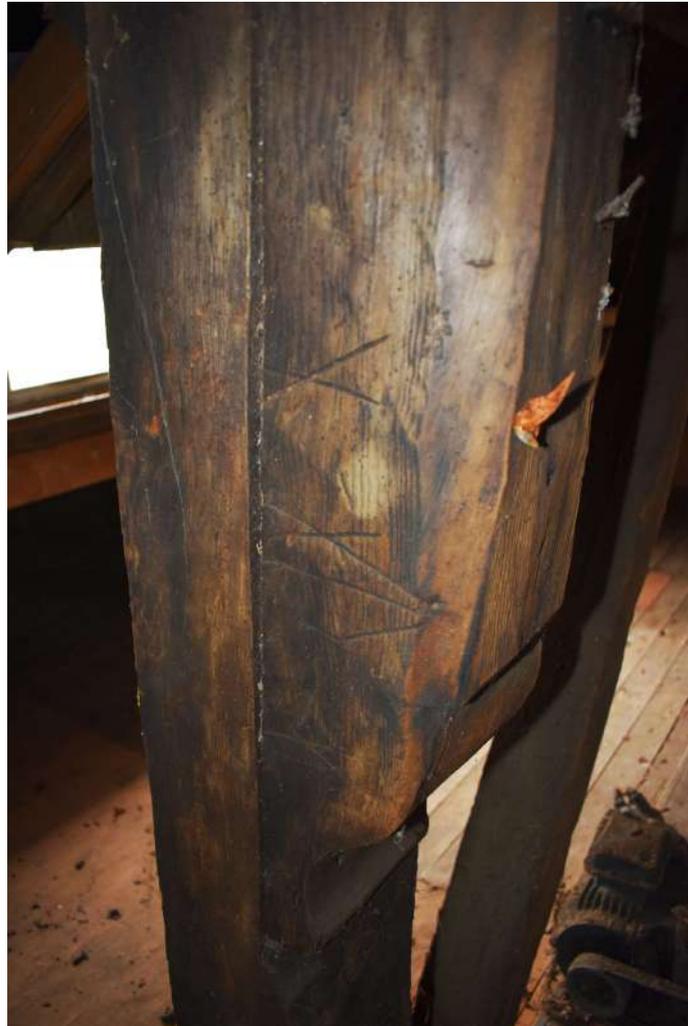
In bay 6, there is side-halved scarf joint in the eastern wall plate. Between bays 6 and 7, Baltic timber marks are present on the tie-beam, the eastern curved corbel and the western intermediate post (which also has signs of reuse). An inserted window is located in the eastern wall.

**Photograph 28** Detail of Baltic timber marks on post between bays 6 and 7 of barn.  
Photograph taken facing north-west.
