**CAT Report 1975  
issued October 2023**

**Historic building recording of the stables at Great  
Graces, Graces Lane, Little Baddow, Essex,  
CM3 4AY**

**September 2023**

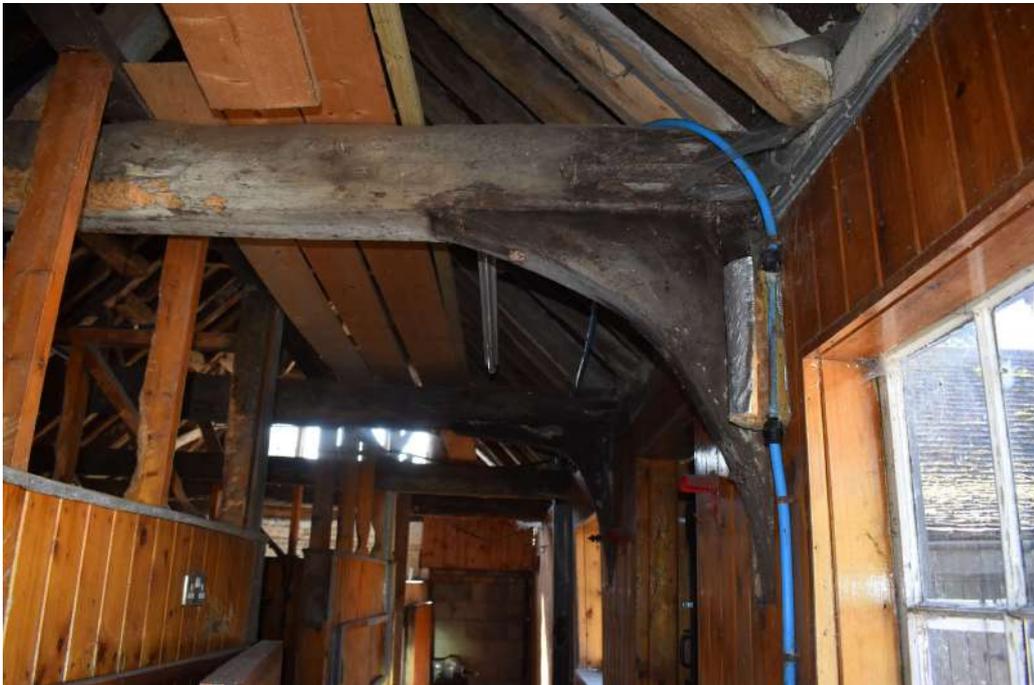
Between each truss, both roof pitches are supported on a series of butt-purlins, which are staggered between bays, and common rafters, which are interrupted by the butt-purlins. On the eastern side of the frame, between bays 3, 4 and 5, the tie-beams are supported on knee-braces. The braces are secured with two iron bolts and six nails.

**Photograph 13** Detail of knee-brace between bays 3 and 4 of stable 1. Photograph taken facing south.

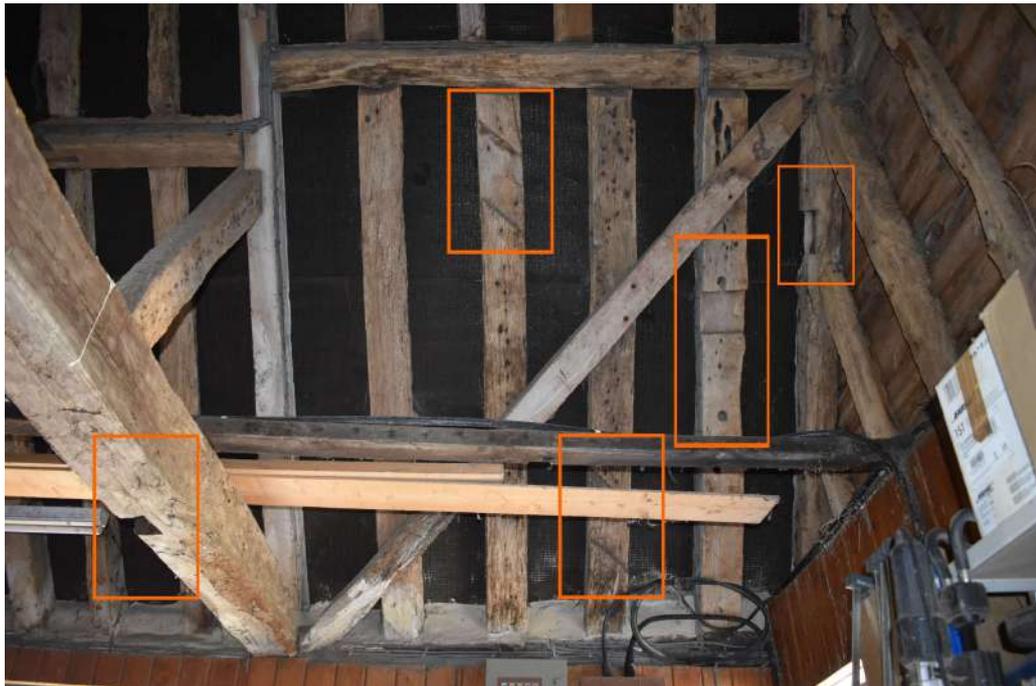
In bay 1, there is evidence of reuse on several common rafters, on both roof pitches, the tie-beam between bays 1 and 2 as well as on both principal rafters, studs and the purlin at the gable end. On the lower section of both roof pitches is a diagonal wind-brace. There is an inserted window in the northern wall. At the gable-end of bay 1, there is a stud which has been shortened and replaced with a modern timber. It is unclear if this is evidence of a blocked opening or simply an area of repair.

**Photograph 14** Detail of roof structure in western roof pitch of bay 1 of stable 1. Evidence of reuse highlighted in orange. Photograph taken facing west.

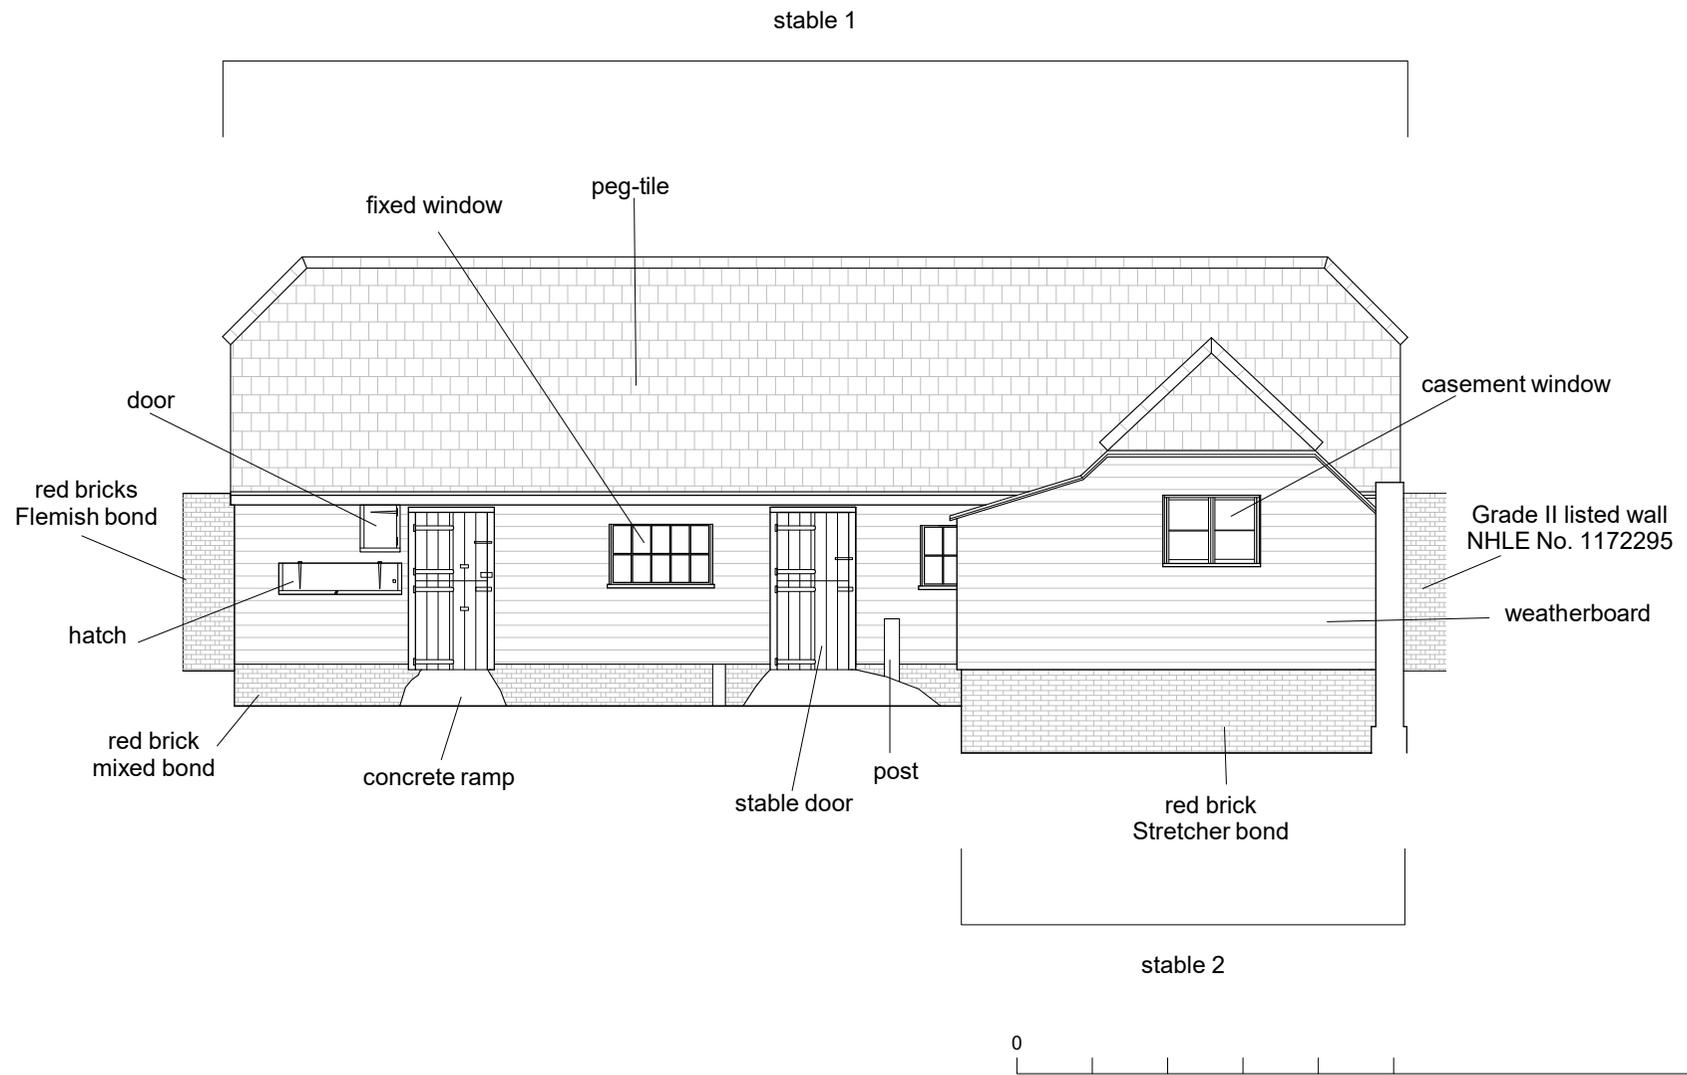
On the western elevation, there are two full-size doors along with a small door, at the top of the elevation, all of which are secured with iron strap hinges. Both full-size doors have a rudimentary concrete ramp leading up to them. A wide timber-hatch, also

secured with iron strap hinges, is present at the northern end of the elevation. Stable 1 has two ten-light fixed windows while stable 2 has a single four-light casement window. Two partial timber-posts are present on this elevation, either side of the southern-most door. A possible wall-plate scarf-joint is visible due to a gap between the weatherboard and plinth. The weatherboard on this elevation of stable 1 has been charred by a fire.

Fig 3 Western elevation.

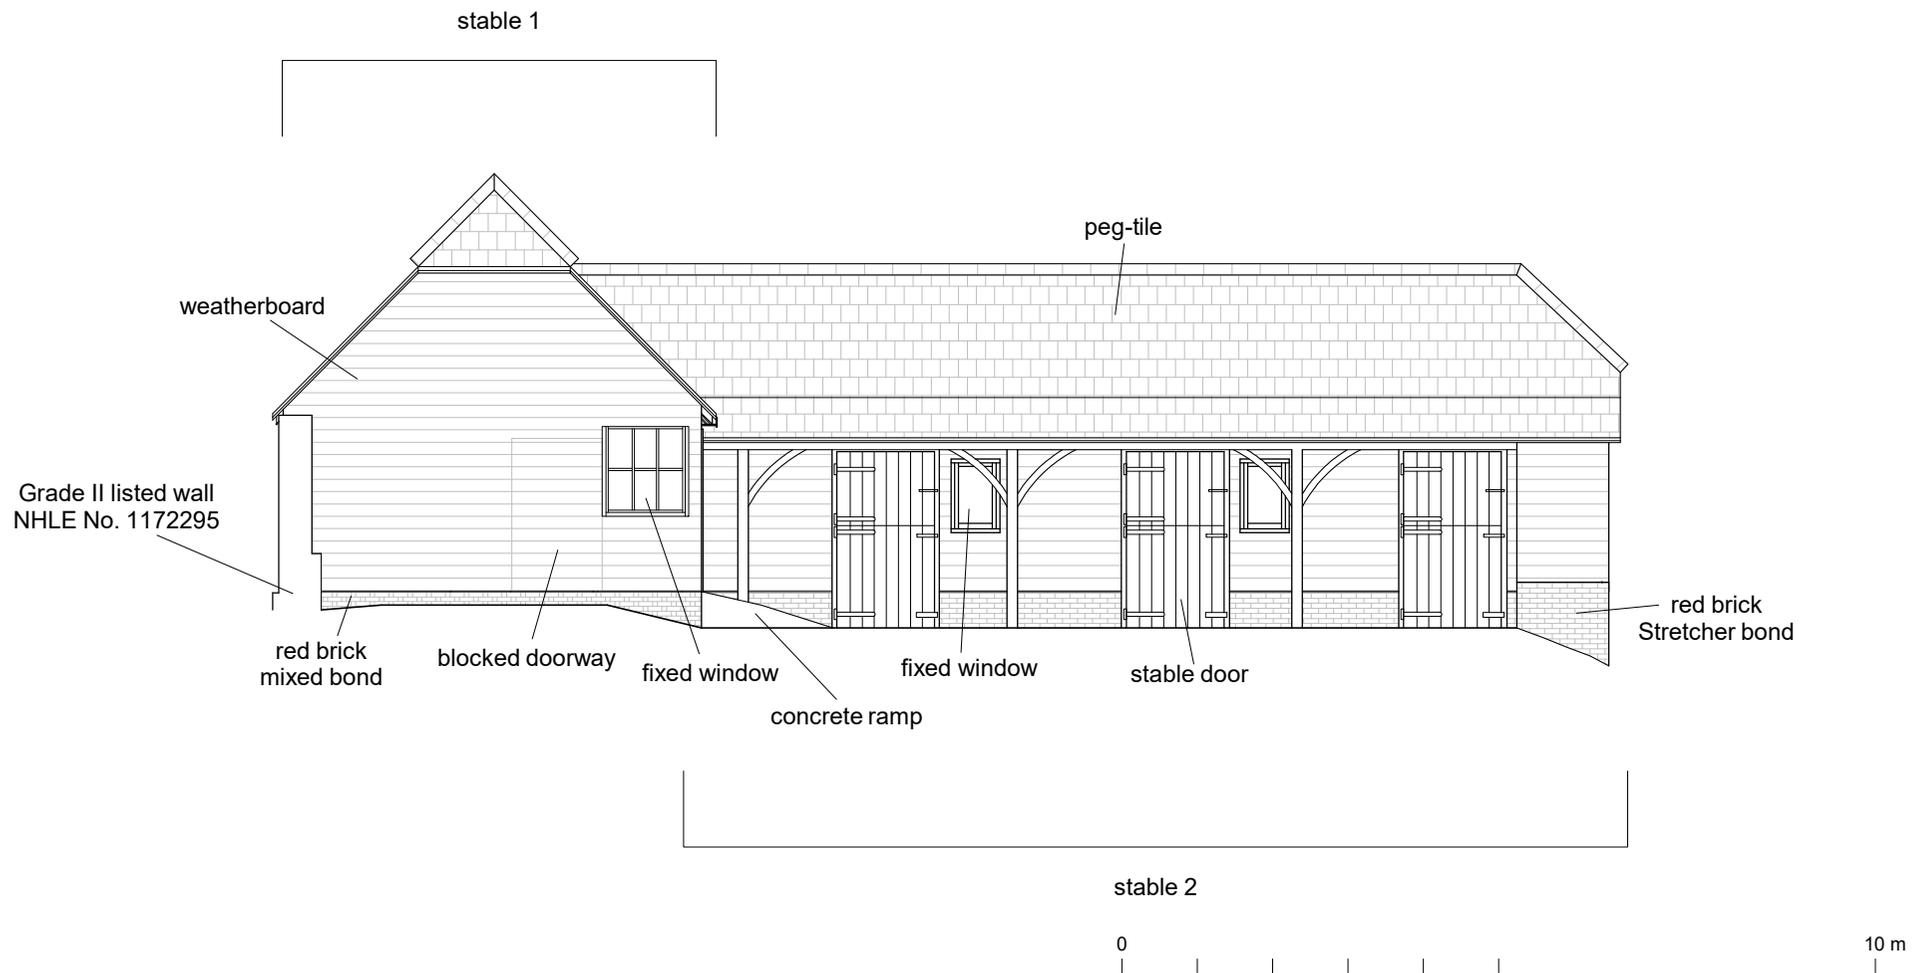
Stable 1 has a six-light fixed window, adjacent to a blocked doorway, on the northern elevation. Stable 2 has three doors and two single-light fixed windows. The porch area of stable two is supported on three timber-posts, each with curved bracing.

Fig 4 Northern elevation.

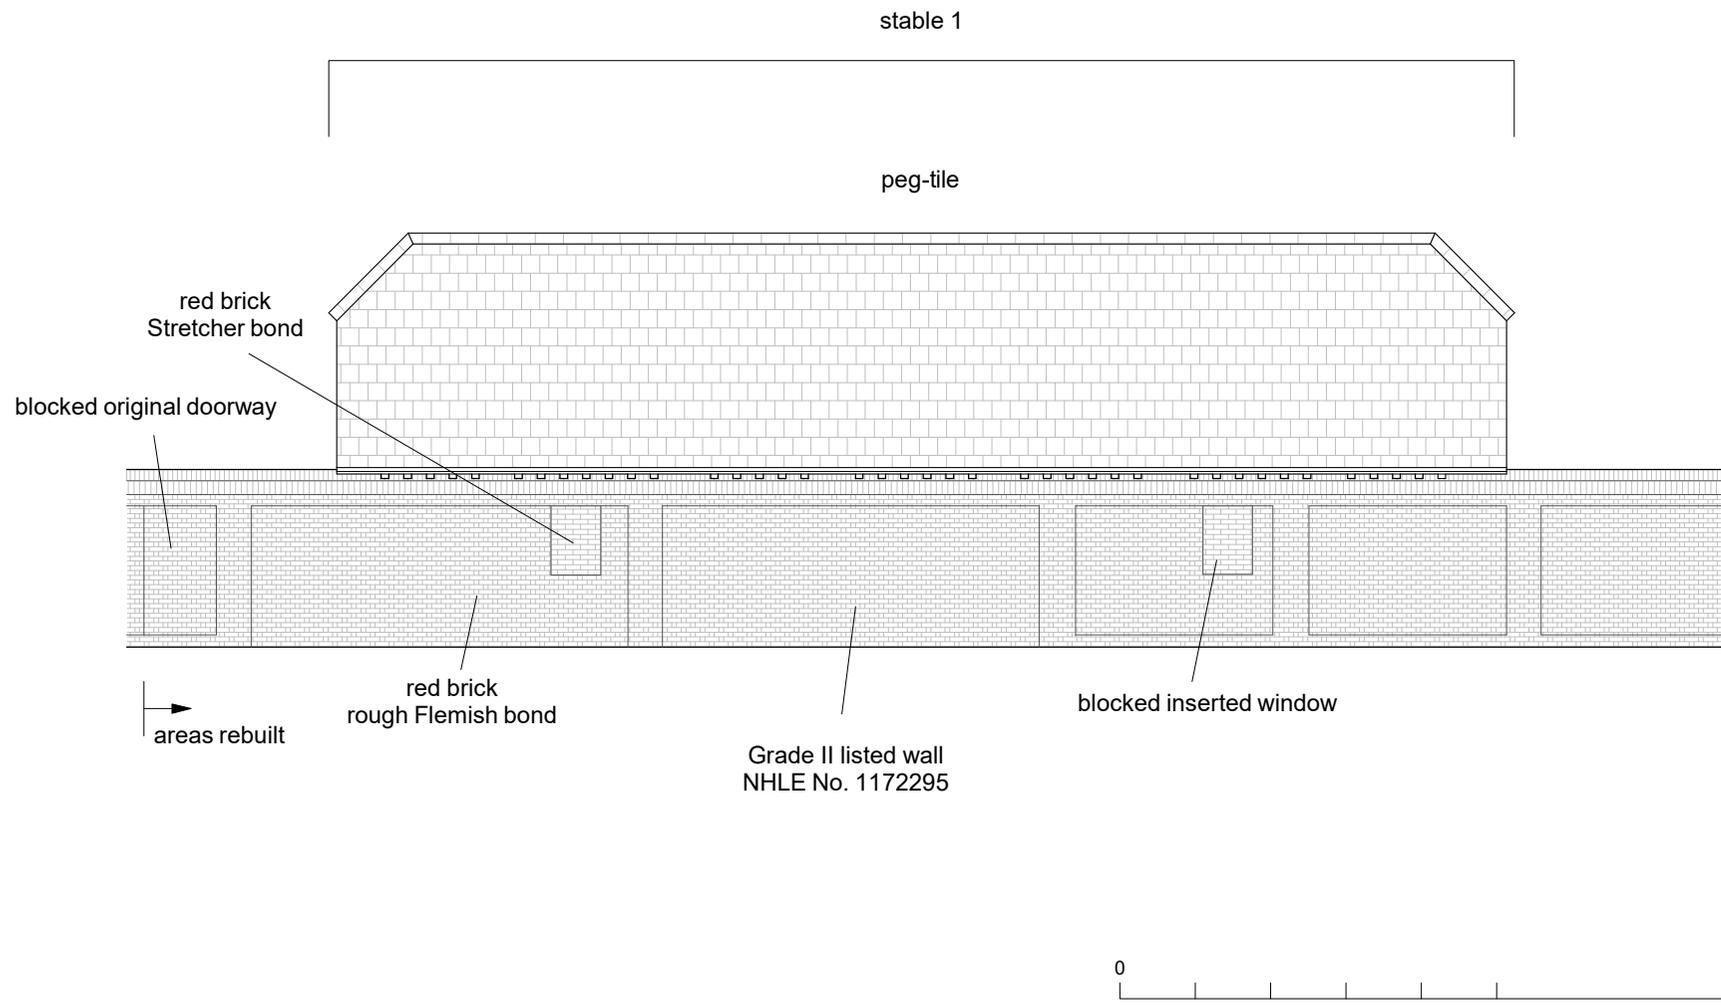
The eastern elevation is dominated by a Grade II listed wall (NHLE No. 1172295), onto which stable 1 has been built. The wall to the south of the stable block is laid in Flemish-bond using a mixture of red bricks (brick dimensions: 210 x ? 45mm), for the stretchers, and purple bricks (brick dimensions: ? 100 x 45mm), for the headers. The wall beneath the stable is constructed mainly of red brick (brick dimensions: 225 x 405 60mm) laid in a rough Flemish bond, indicating that much of this stretch of wall, except the pilasters, has been rebuilt.

Fig 5 Eastern elevation.

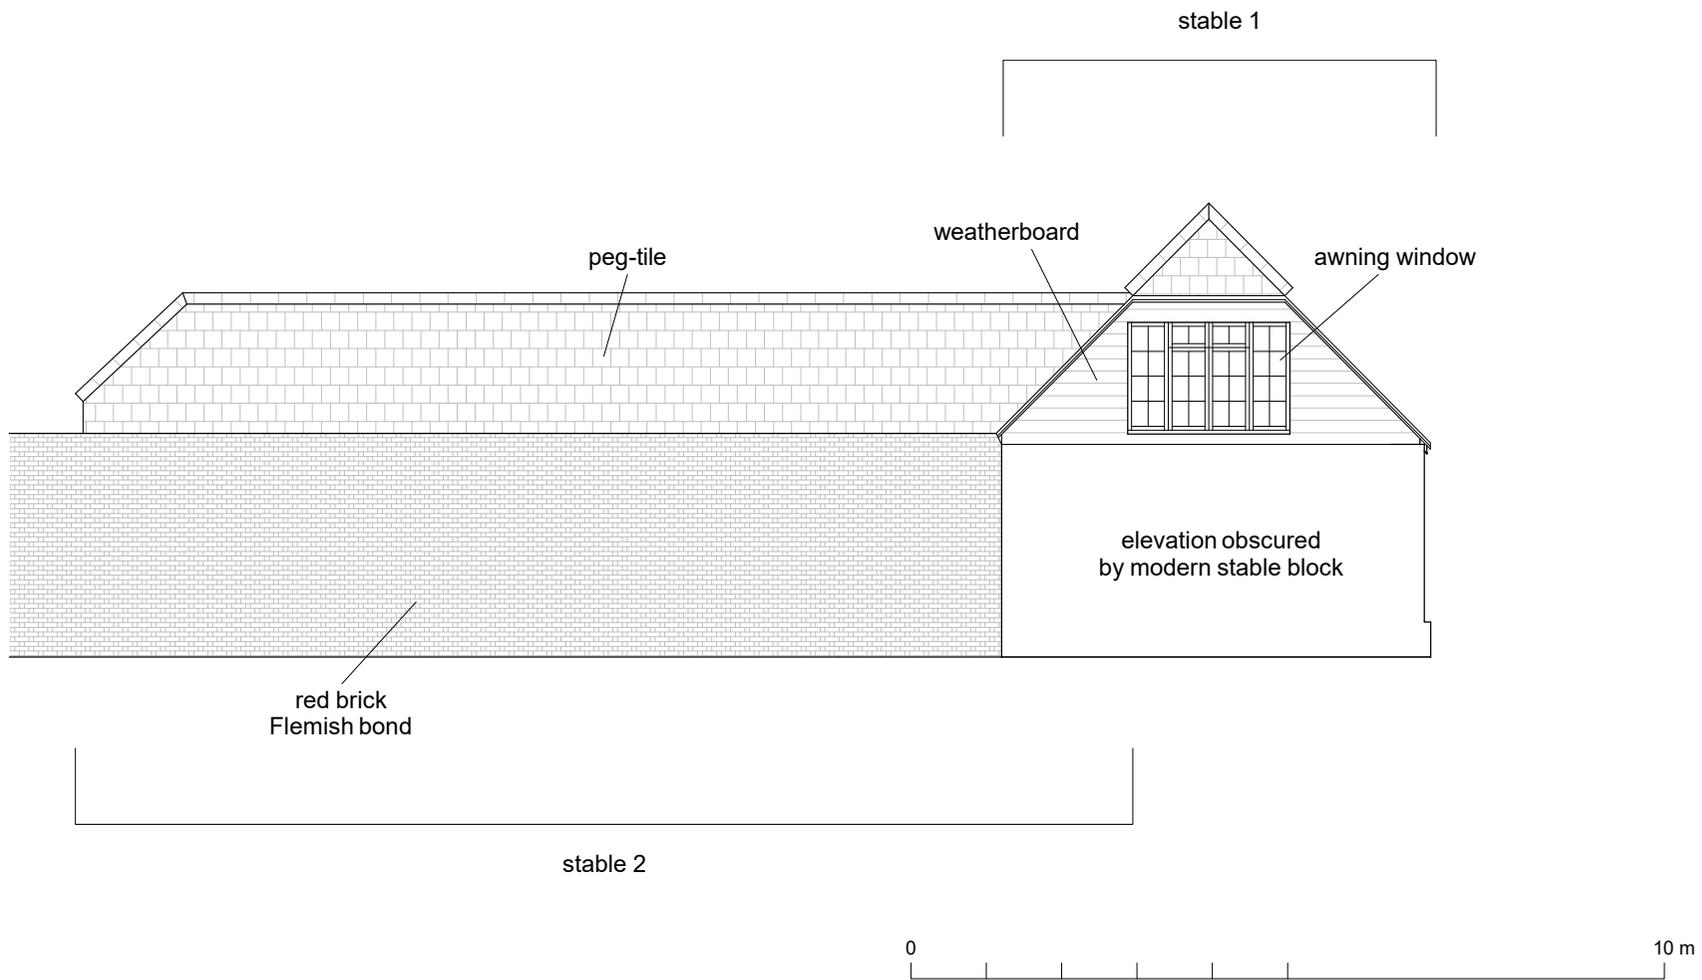
Stable 1 has a 32-light window with both casement and awning openings in the upper of the southern elevation. The lower half of the elevation is obscured by a modern stable building. The southern elevation of stable 2 is concealed by a wall comprising red bricks laid in Flemish bond (brick dimensions: 220 x 105 x 60mm).

Fig 6 Southern elevation.
