**CAT Report 2097
Issued December 2024**

**Historic building recording at
Slough Wood Cottage, Slough Road, Danbury,
Essex, CM3 4LX**

October 2024

**CAT project ref.: 2024/09j
ECC code: EEX60240**

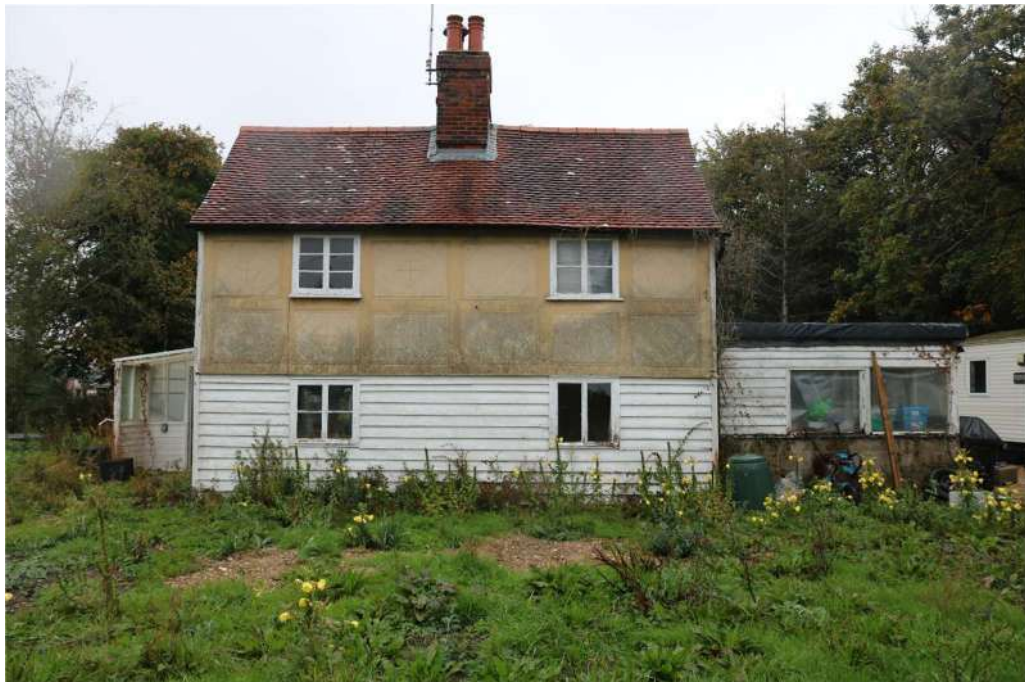
On the upper floor of the southern elevation, there are two replacement casement windows consisting of one six-light window and one four-light window. The lower floor consists of a further replacement four-light casement window and a two-light casement window. There is a single timber door to access extension 1, flanked by fixed windows. Extension two has two single-light fixed windows.

Photograph 1 Southern elevation. Photograph taken facing north.

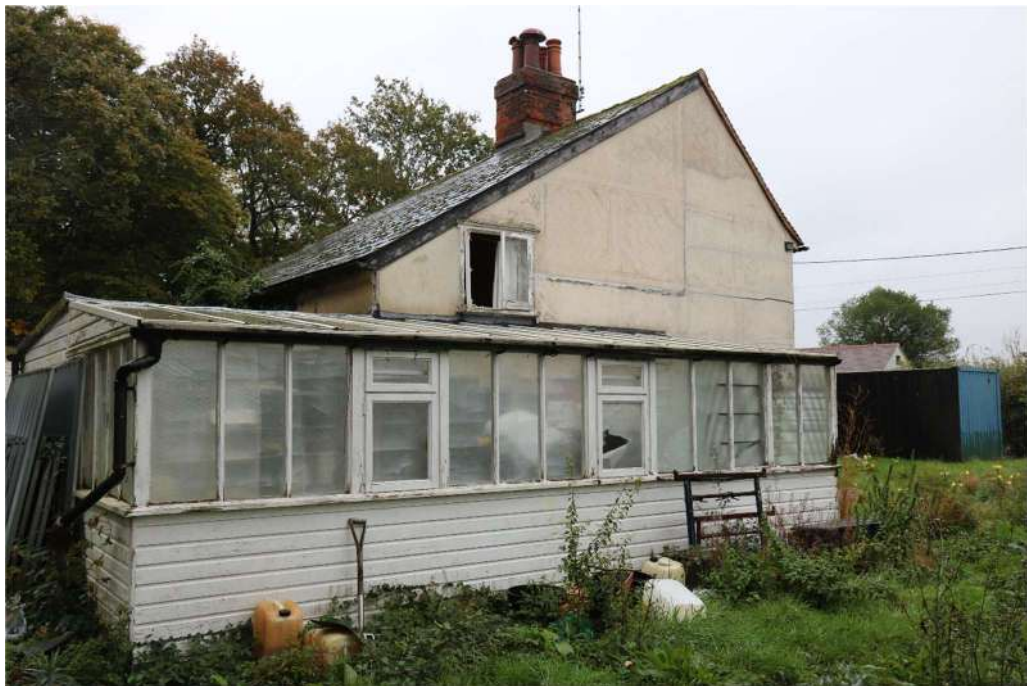
Photograph 3 Western elevation. Photograph taken facing south-east.

The imitation of pargeting on the western elevation is not as prominent as the other elevations with noticeable cracking and damage to the render. The upper floor has one replacement two-light timber-framed casement window, as does the lower floor. A change in the weatherboarding beneath the ground floor window suggests the window has been used to block a doorway. The western elevation captures the asymmetry of the roof with a longer pitch towards the northern elevation. Along extension 1, there are a number of windows comprising two two-light windows, with awning and casement openings, while the rest are single-light fixed windows.

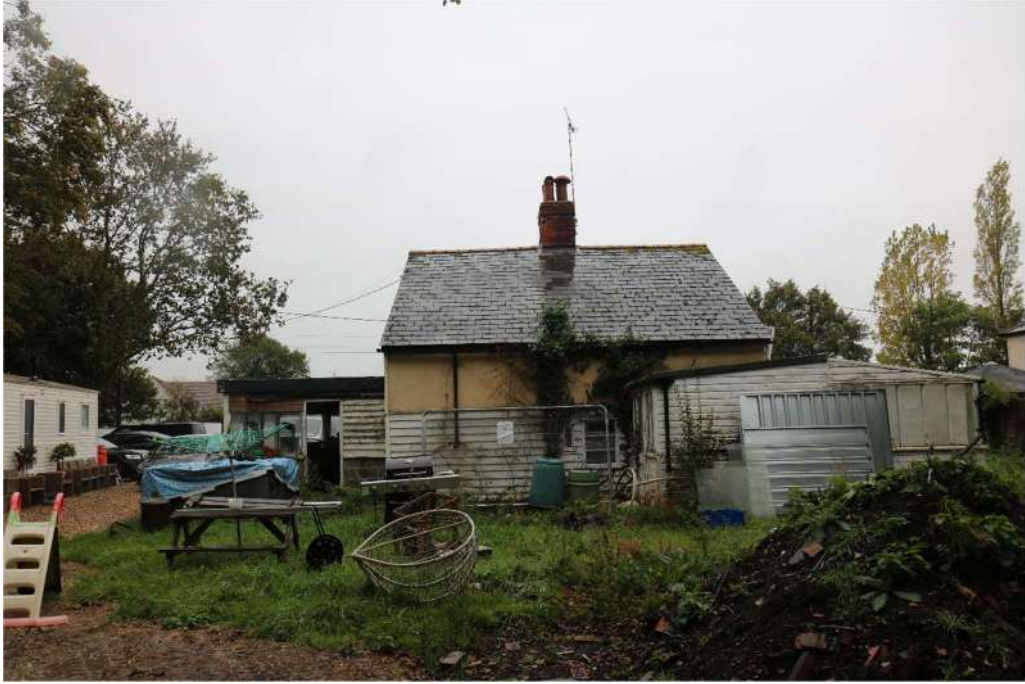
Photograph 4 Northern elevation. Photograph taken facing south.

There are two timber-framed windows on the northern elevation, a three-light casement window and a single-light awning window. On this elevation extension 2 has a single timber door for access inside and 4 single-light fixed timber-framed windows to the east of the door.

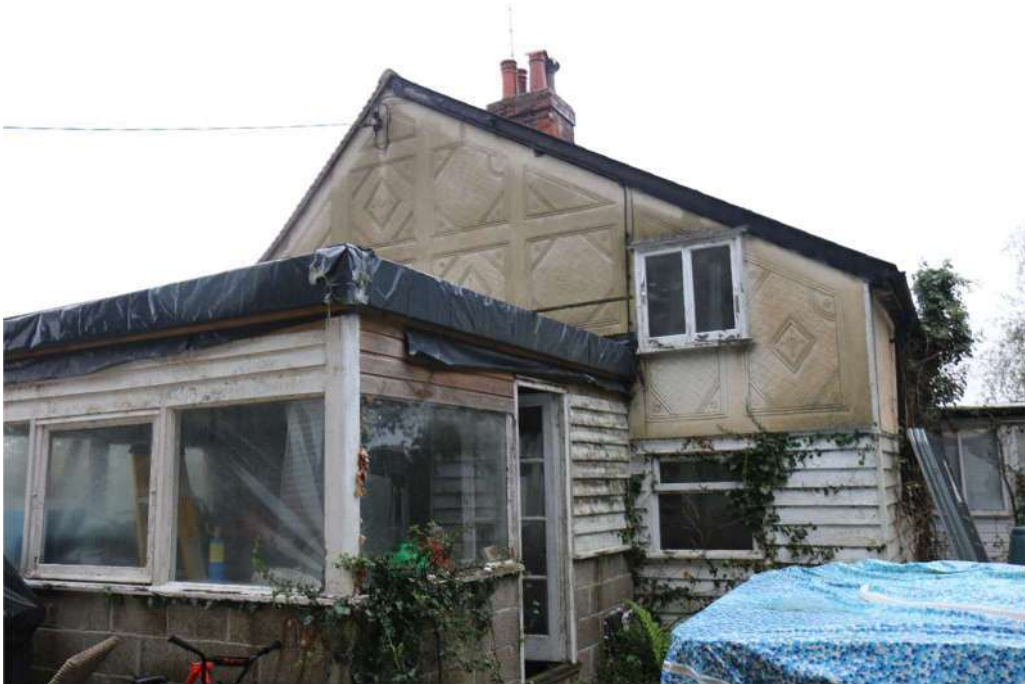
Photograph 5 Eastern elevation. Photograph taken facing south south-west.

The upper floor of the eastern elevation has a replacement two-light timber-framed casement window while there is a replacement two-light awning window on the lower floor. Extension 1 has two single-light fixed windows flanking a central timber door. Extension 2 has three timber-framed single-light windows on this elevation, two fixed and one with a horizontal pivot opening.

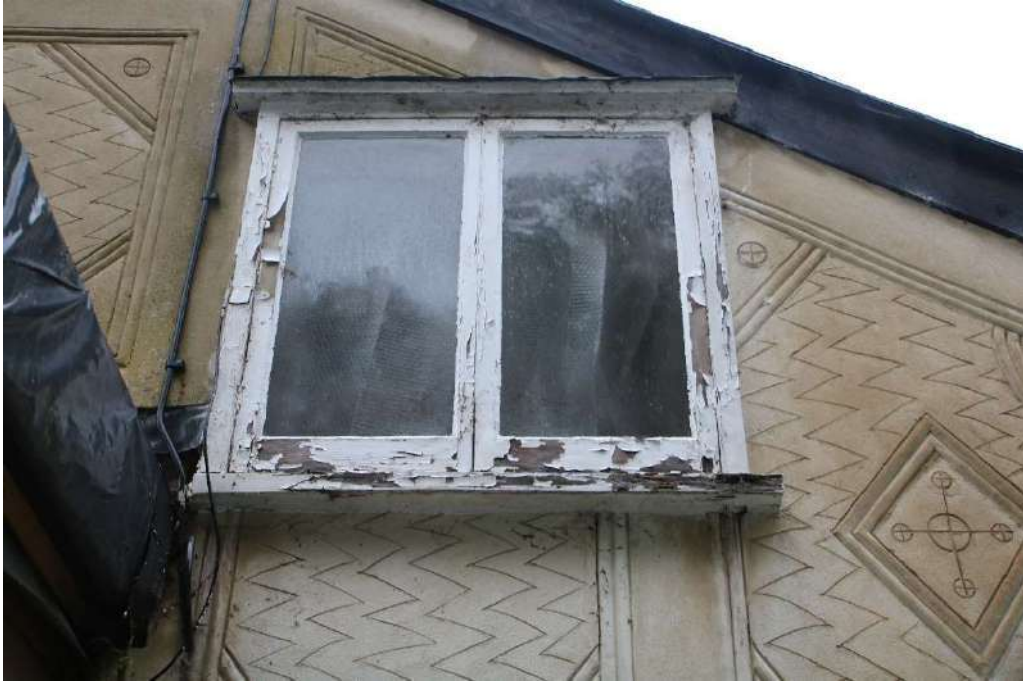
Photograph 6 Detail of first floor window on eastern elevation. Photograph taken facing west.

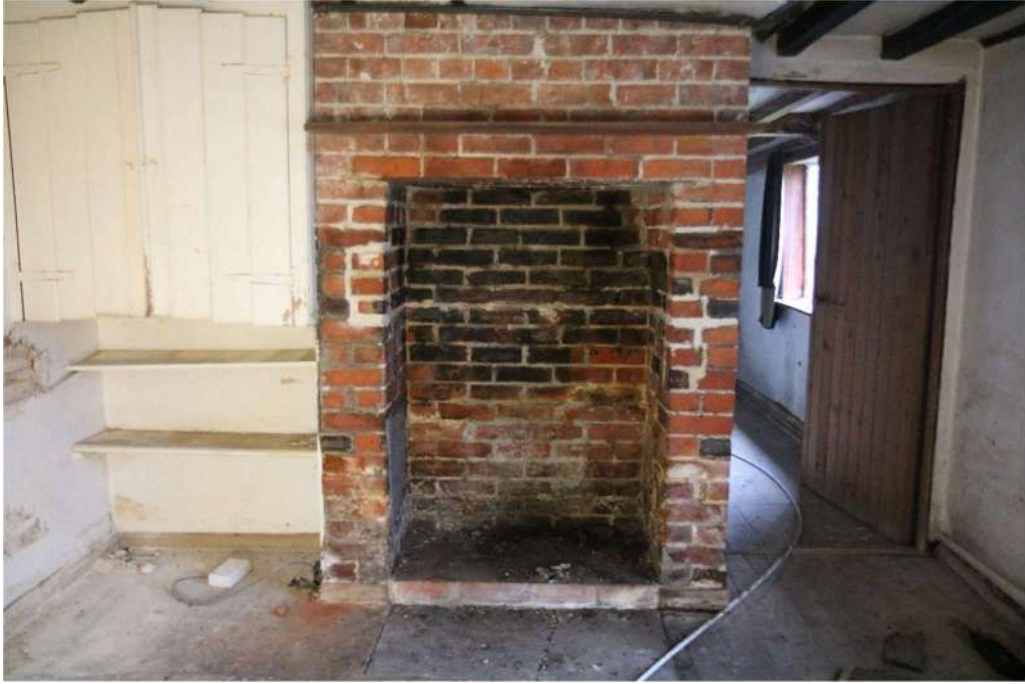
Rooms 1 and 2 are both positioned in the south of the ground floor, both of which have wooden floorboards and plaster walls with timber skirting boards. In room 1, there are replacement timber-framed windows in the southern and western walls. An original door is present in the northern wall with an inserted door in the eastern wall. A red brick fireplace is present on the northern wall, constructed in a rough Stretcher bond, showcasing stretchers with some headers. The opening of the fireplace is tall and rectangular in shape with a small timber mantle. Either side of the opening are two timber nogs set into the brickwork. There is evidence of burning on bricks in the back of the fireplace. To the north of the fireplace is a built-in wooden cupboard. The ceiling of room 1 is exposed joists with a central binding beam. The joists are mostly machine-cut while the binding beam is hand-sawn. The wall plaster has come away from certain parts on the northern wall revealing the laths beneath.

Photograph 7 Fireplace located in room 1. Photograph taken facing east.

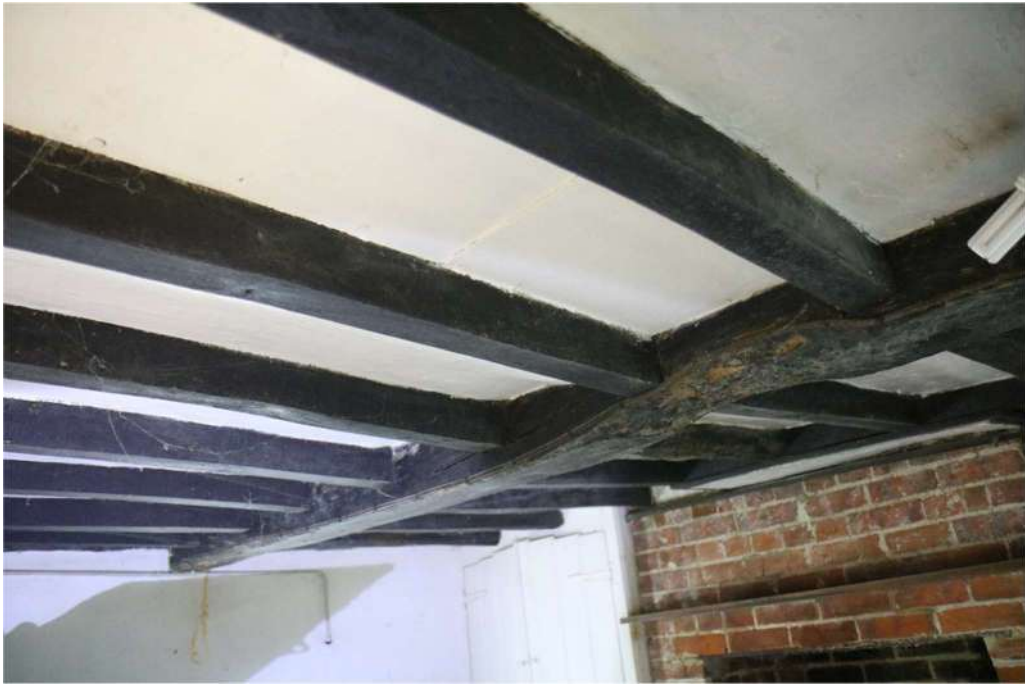
Photograph 8 Detail of joists and binding beam in ceiling of room 1. Photograph taken facing north north-east.

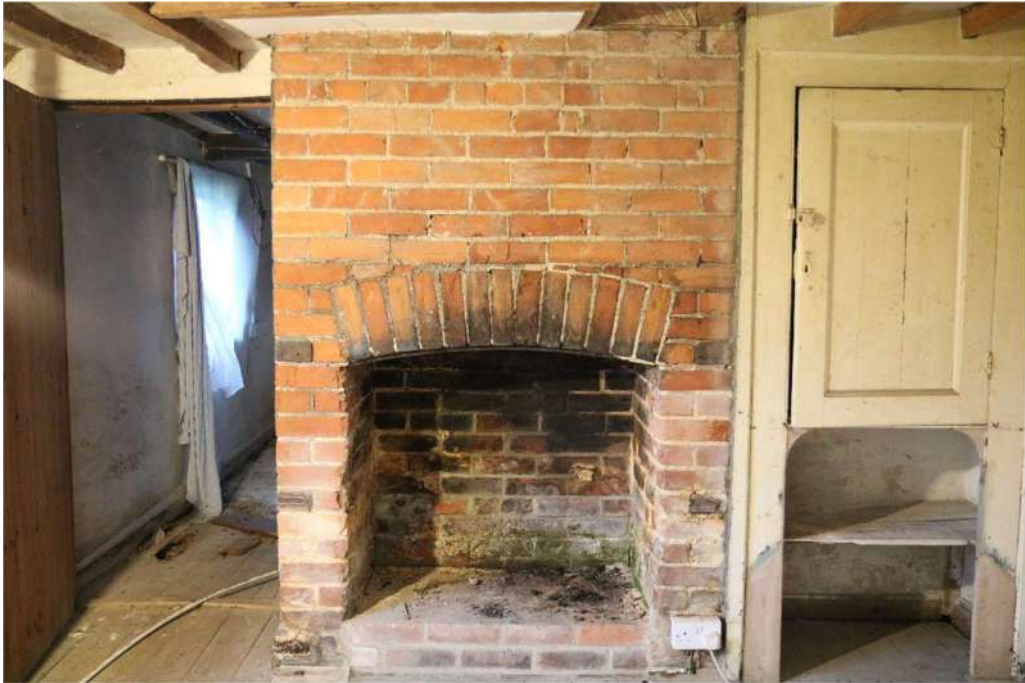
There is a replacement two-light timber-framed casement window on the southern wall of room 2. An inserted door is present in the western wall, with a an original (but blocked) door in the eastern wall and an original doorway in the northern wall. There is a fireplace on the western wall, which is also in a rough Stretcher bond, showcasing mostly stretchers with some headers. The opening of the fireplace has an arched brick lintel with no mantle. As with the fireplace in room 1, either side of the opening are two timber nogs set into the brickwork. Equivalent to room 1, room 2 has a similar white wooden cupboard on the western wall adjacent to the fireplace. The ceiling of room 2 is exposed joists with a central binding beam. The joists comprise a combination of hand-sawn and machine-cut timbers, some which have evidence of reuse. The binding

beam is machine-cut. Hand-sawn girding beams are exposed in the eastern and southern walls.

Photograph 9 Fireplace located inside room 2. Photograph taken facing west.

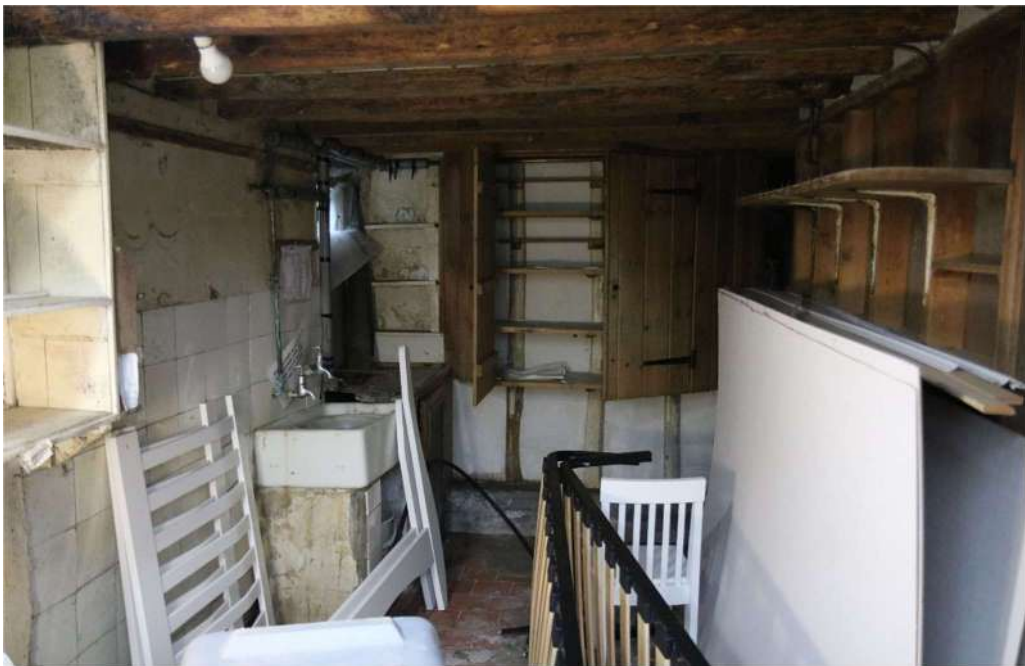
Photograph 12 Interior of room 4. Photograph taken facing east.

Room 4 appears to previously have been used as a kitchen. The walls are plastered, with the hand-sawn timber studs of the eastern wall exposed, and the floor is quarry tiles. A single timber-framed replacement window is in the northern wall with doorways in the southern and western walls, the western of which is inserted. Hand-sawn joists are exposed in the ceiling of room 4, some of which have evidence of reuse. A replacement staircase is present in the south of the room.

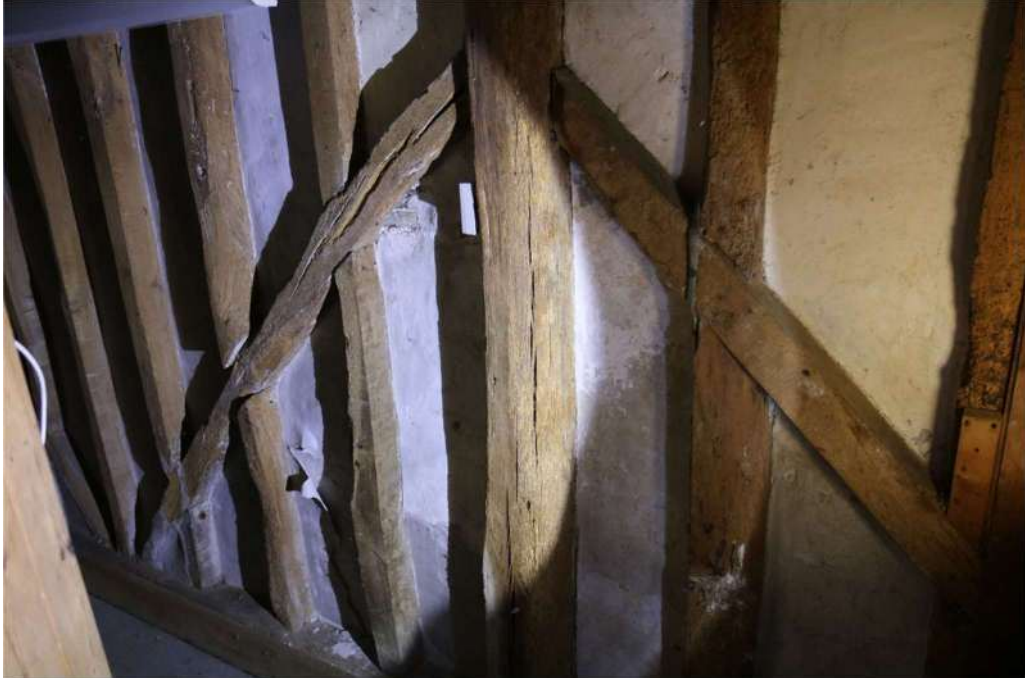
Room 5 is the hallway-like space, or under stair space, located in the middle of the ground floor. The floor of room 5 is a continuation of the quarry tiles from rooms 3 and 4. The ceiling comprises exposed joists, which are machine-cut. The timber-framing of the northern and eastern walls is exposed and comprises hand-sawn timbers, some of which have been crudely processed, with areas of repair using machine-cut timber. The frame displays diagonal through-bracing.

Photograph 13 Detail of exposed timber-framing in room 5. Photograph taken facing east.

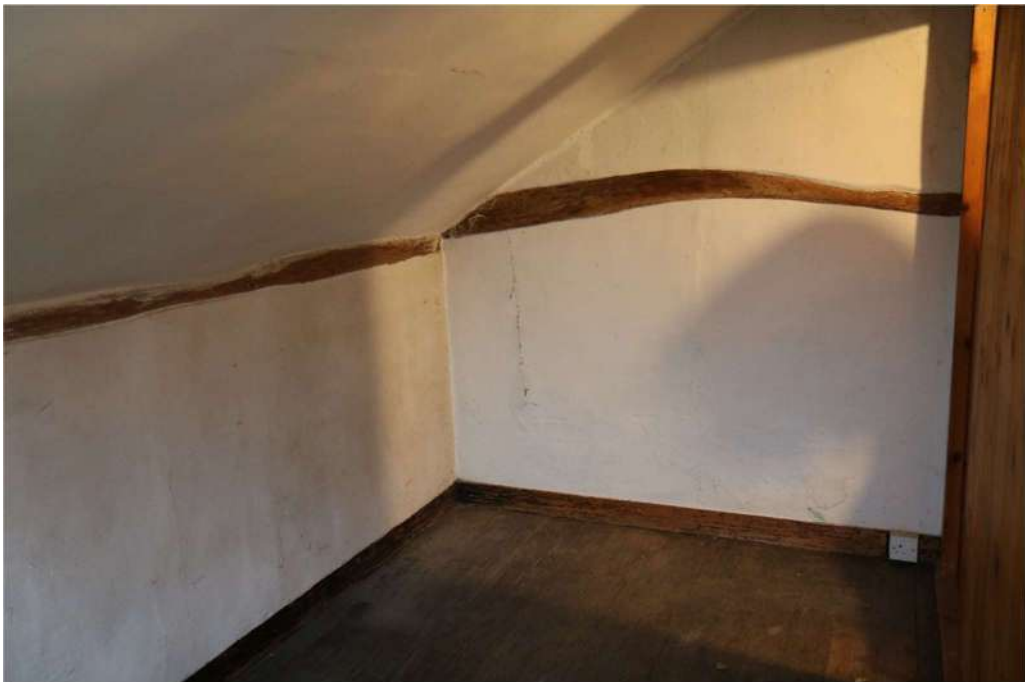
Photograph 14 Detail of exposed aisle tie-beam and wall-plate in room 8. Photograph taken facing north-east.

Room 8 has wooden floorboards with a wooden skirting board. There is a single replacement two-light timber-framed casement window in the western wall, beneath which is an exposed girding beam. The southern wall is clad with wooden panels and has a single replacement door. There is also a sliding glass window on the top part of this wall and a built-in cupboard that slides open. Across the eastern and northern wall, the hand-sawn aisle tie-beam and wall-plate are visible, both are sinuous in nature particularly the aisle tie-beam. There is a narrow part of the ceiling which is flat while the rest of the ceiling slopes downwards towards the northern wall.

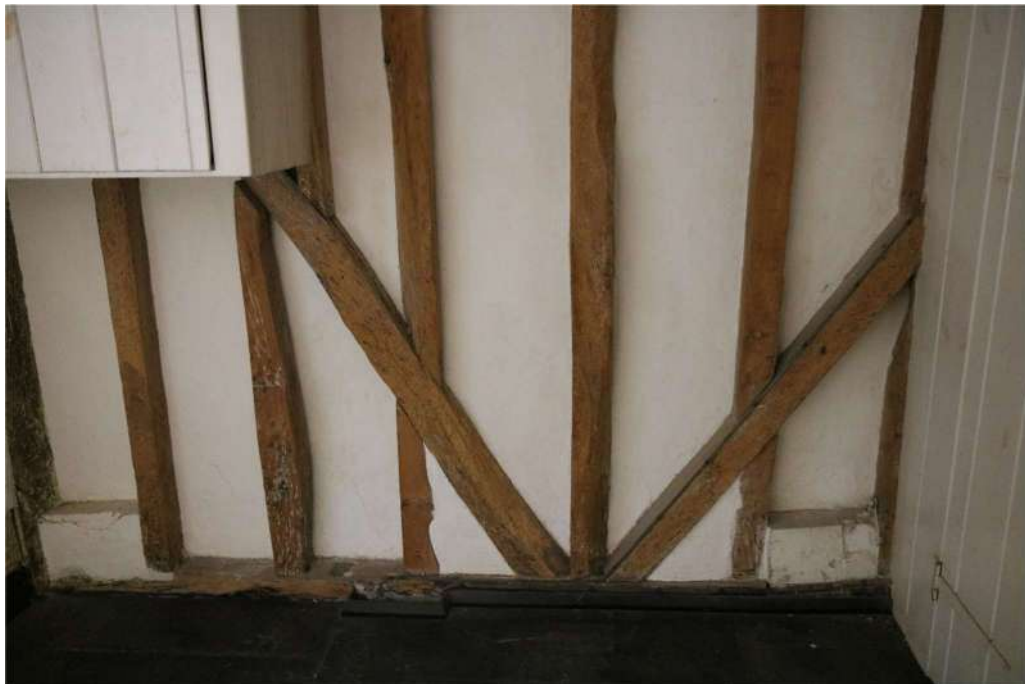
Room 9 has a single replacement two-light timber-framed casement window in the eastern wall, below which is an exposed girding beam. There is an original timber door in the southern wall adjacent to a built-in cupboard. There is a rectangular fanlight above the door to the cupboard. There is a slim part of the ceiling which is flat, while the rest of the ceiling slopes downwards towards the northern wall. The southern wall is exposed timber-framing, to which a cupboard is fixed.

Photograph 15 Detail of diagonal through-bracing on southern wall in room 9. Photograph taken facing south.

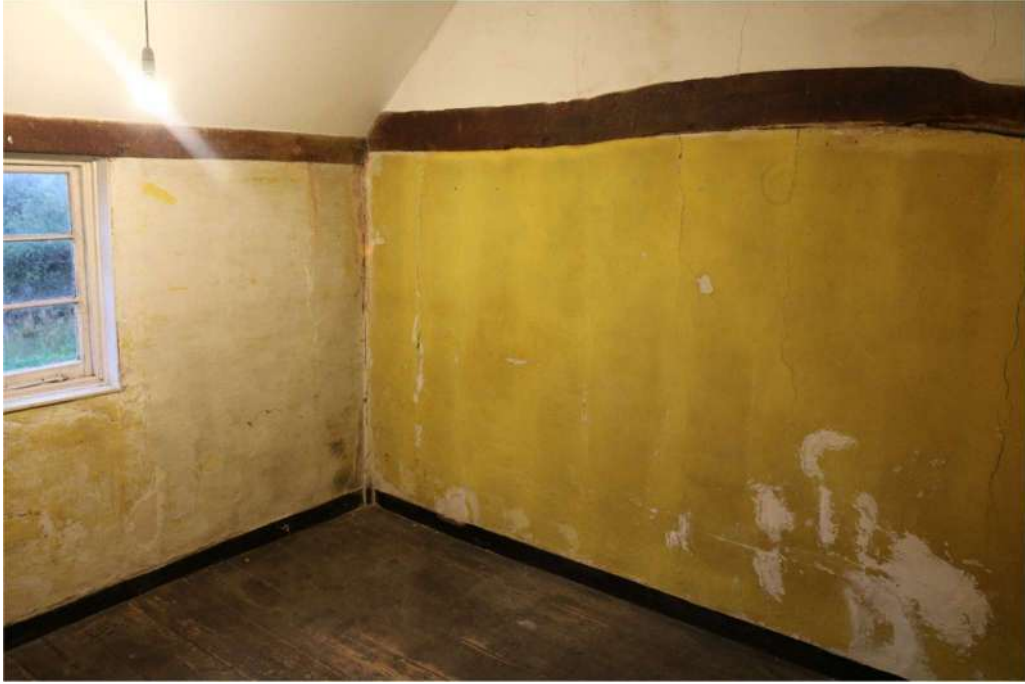
Photograph 16 Interior of room 10, evidence of hidden framing in yellow wall. Photograph taken facing south-west.

Rooms 10 and 11 are both square-shaped in plan. In room 10, there is a replacement six-light timber-framed casement window on the southern wall, along with a single original door on the northern wall. The room has wooden skirting boards. Two timber tie-beams are present at either ends of this room, both of which are sinuous. The wall-plates in the northern and southern walls are also exposed, both appear to be machine-cut replacements. There is a central brick fireplace projecting from the eastern wall. The fireplace has a cast-iron hob grate, with a brick hearth, both of which are off-centre. The red bricks surrounding the fireplace are painted white and appear to be laid in stretcher bond. The western wall has noticeable evidence of diagonal through bracing.

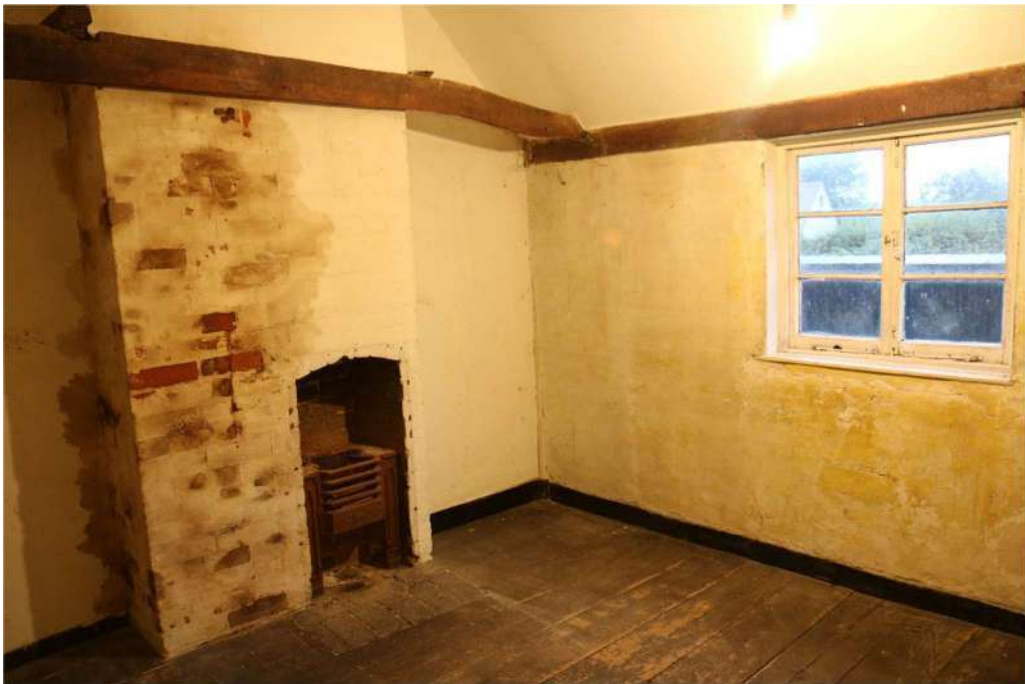
Photograph 17 Interior of room 10. Photograph taken facing south-east.

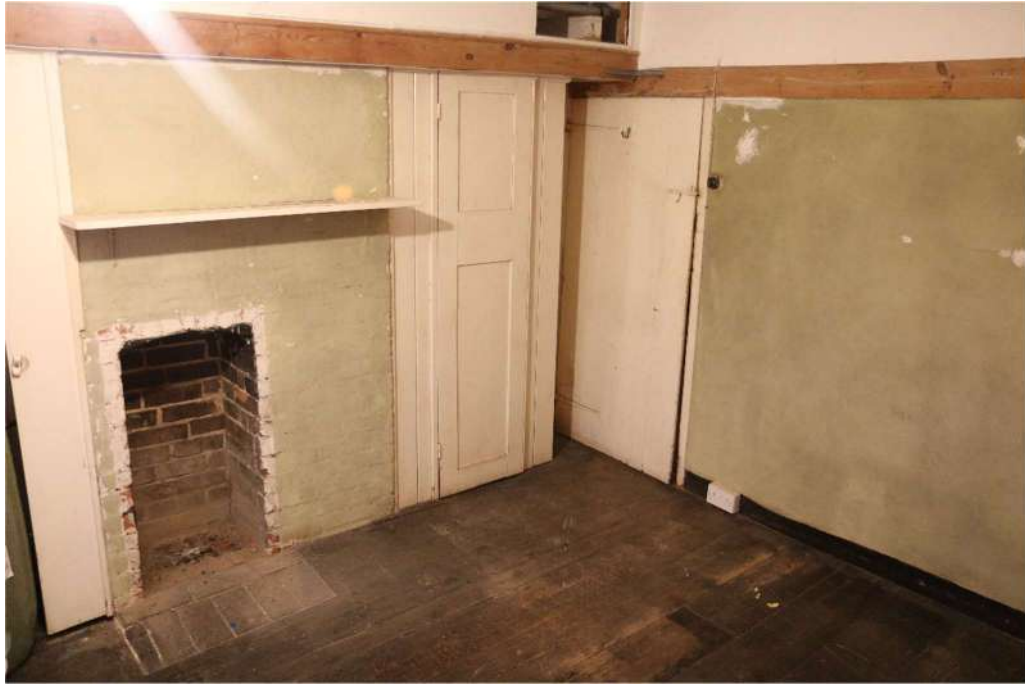
Photograph 18 Interior of room 11. Photograph taken facing north-west.

The southern wall in room 11 has a single replacement four-light timber-framed casement window and an original timber door is in the northern wall. The ceiling of the room slopes downwards towards the southern wall. The fireplace is central to the western wall, a fire grate is no longer present but the opening is still present. It is constructed from bricks, laid in Stretcher bond, some of which have been painted green. The fireplace is flanked by cupboards. On the eastern wall, the gable tie-beam is exposed, which is hand-sawn and fairly sinuous, and beneath which a trace of the timber-framing beneath the plaster is visible. A machine-cut replacement tie-beam is also visible in the western wall. The northern and southern walls have exposed wall-plates, both which appear to be a machine-cut replacement.
