**An archaeological
watching brief at
Gryme's Dyke,
Stanway Green,
Colchester, Essex**

January 2001

**on behalf of
24 Seven Utility Services Ltd**

CAT Report 94

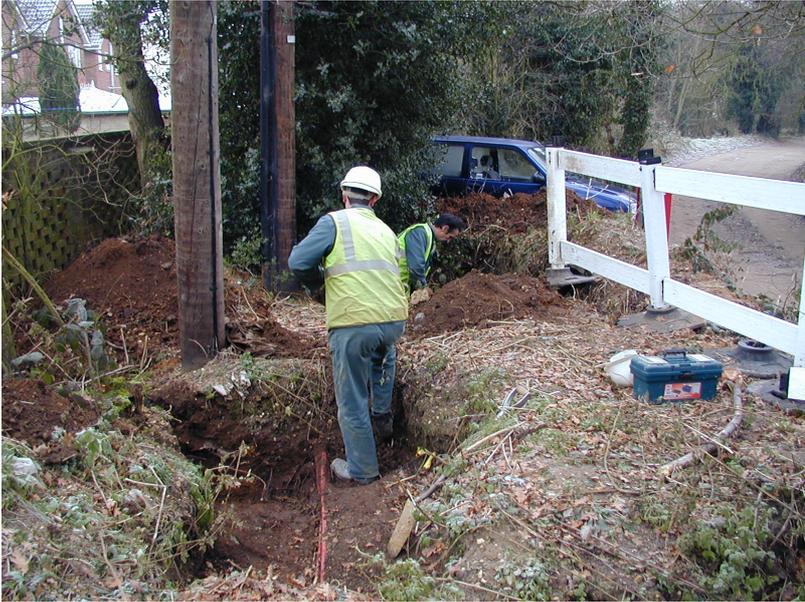
Plate 1 Photograph of the site looking south, with T1 in the foreground.

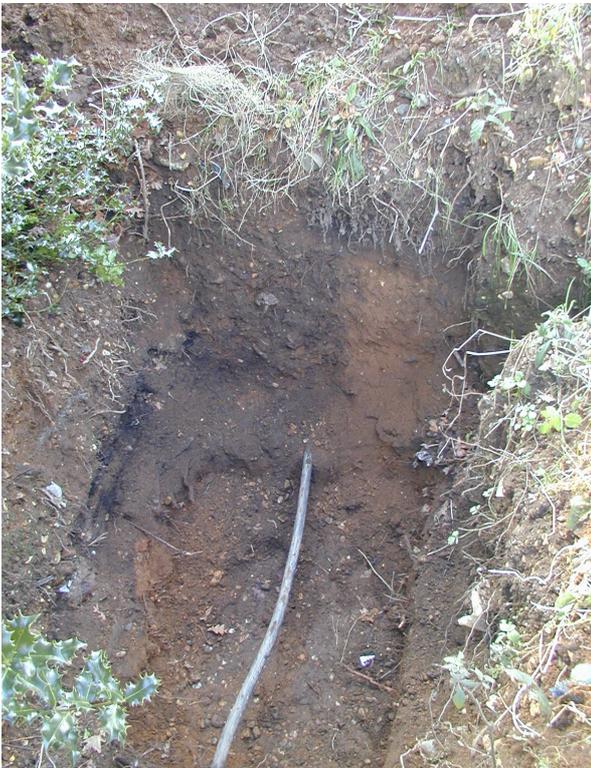
Plate 2 Photograph of T4 looking south, showing the cut of the cable trench.

- 6.2** This work was started again this year and was visited by the author on the 17th and 18th of January 2001. Existing trenches T1-T4 were still open and the reconnection of the new transformer involved the digging out of approximately 1m-deep baulks between trenches T1 and T2, T2 and T3, and T2 and T4, to connect the electricity cables. The material in these narrow trenches was the same disturbed dark brown sandy loam observed in February 2000. It contained modern pieces of plastic, brick and concrete.

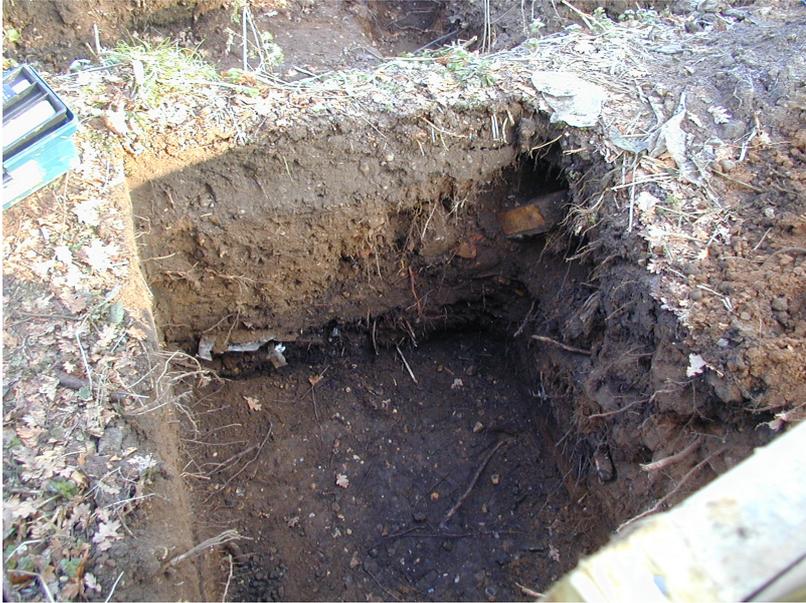
Plate 3 Photograph of T5 looking east, showing modern material in the bottom of the trench.

- 6.3** A new trench (T5) was dug for the new transformer to the west of T2, measuring 1.4m x 1.1m x 900mm deep. This area had not been dug for cables and so was potentially less disturbed. However, there was no indication of the rampart in this trench or of a previous land surface. All four sections contained a mid brown silty sand and gravel. In the easternmost section this material also contained modern plastic, china and glass down to 800mm, indicating a modern date for its deposition.

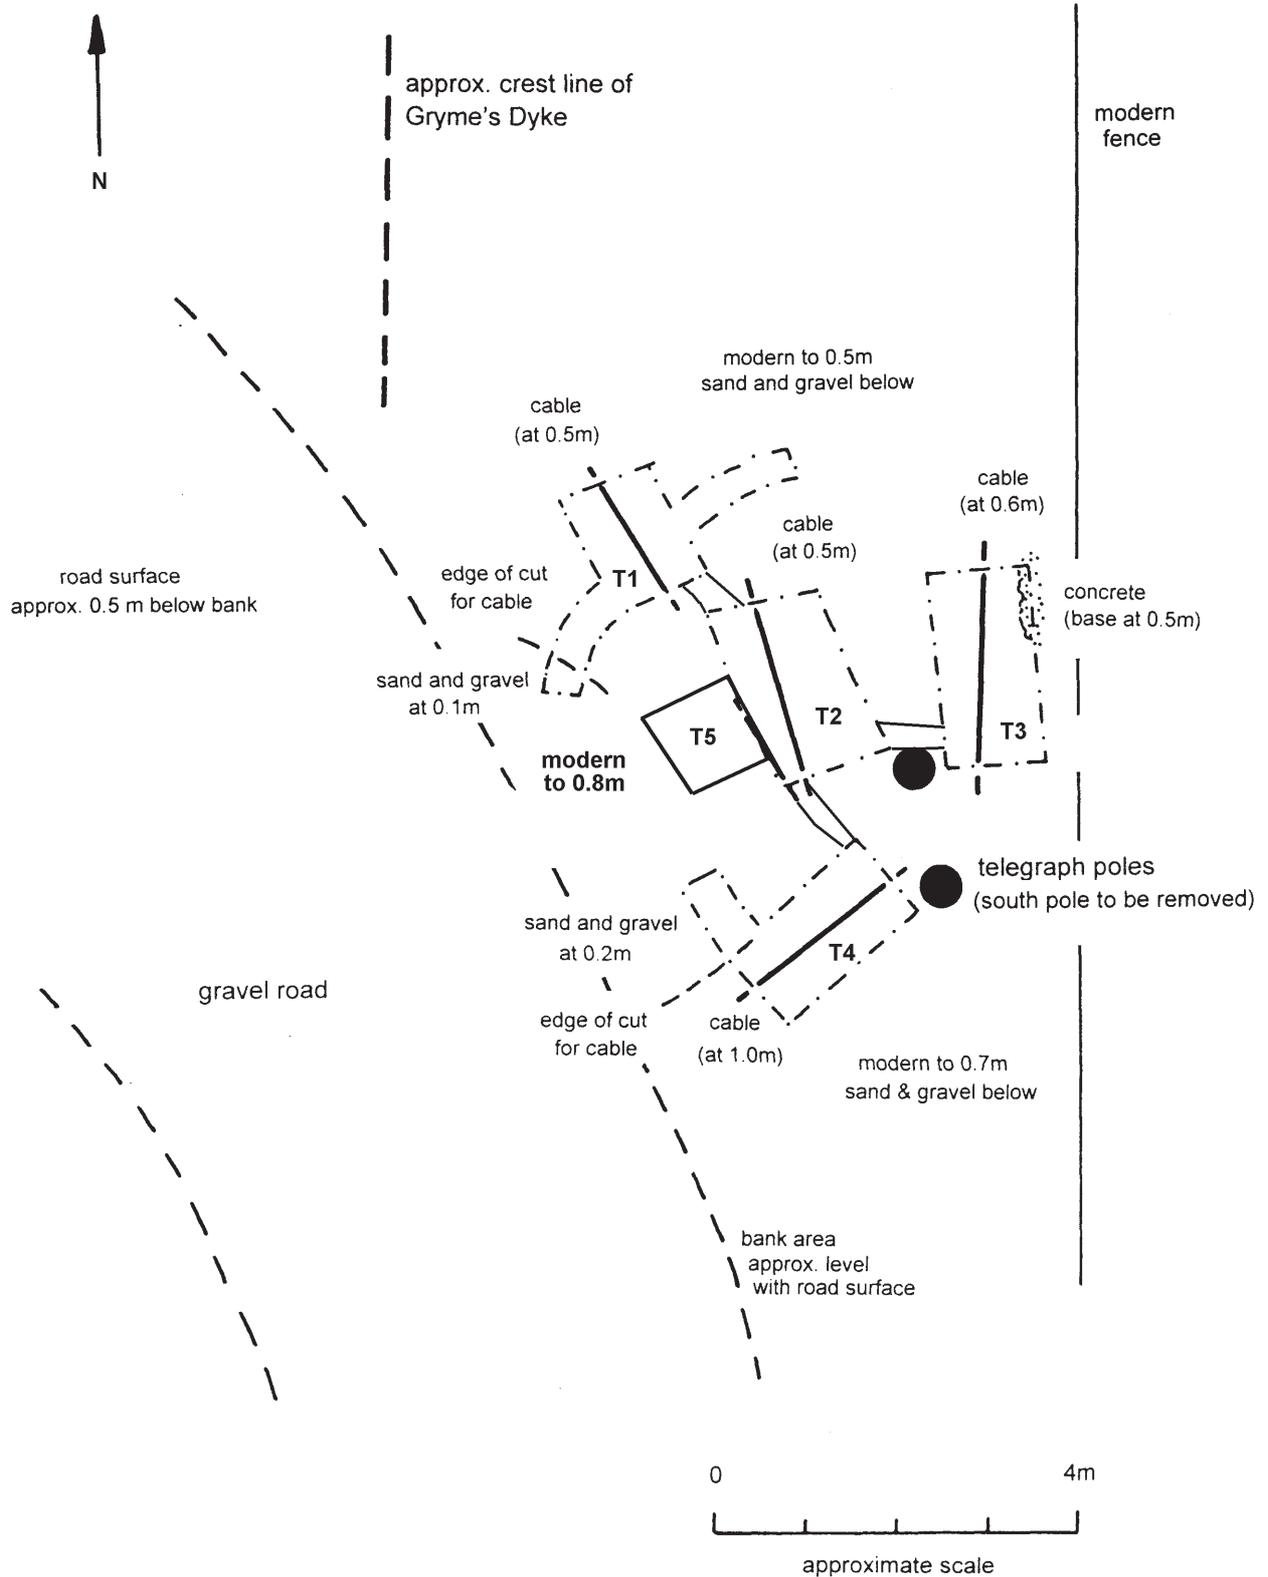
Fig 2 Location of contractor's trenches, 2000 and 2001.

A record of the position of the site excavations was made in 2000 which has been reproduced here with additional information in Figures 2 and 3. Soils types were noted and digital photographs taken in 2001 which have been reproduced here as Plates 1-3.

- 6.1** In February 2000, four small trenches had been dug next to two telegraph poles to expose electricity cables. These trenches T1-T4 measured between 1.5m and 2m in length, 1m and 1.25m in width, and 600mm to 1m in depth. Short lengths of narrow trench between 500mm and 1m deep had also been dug extending from T1 and T4 at this time. This work had been carried out in order to relocate and reconnect an electricity telegraph pole carrying a transformer. The work was monitored by CAT and a report has been written on this phase (CAT Report 63).

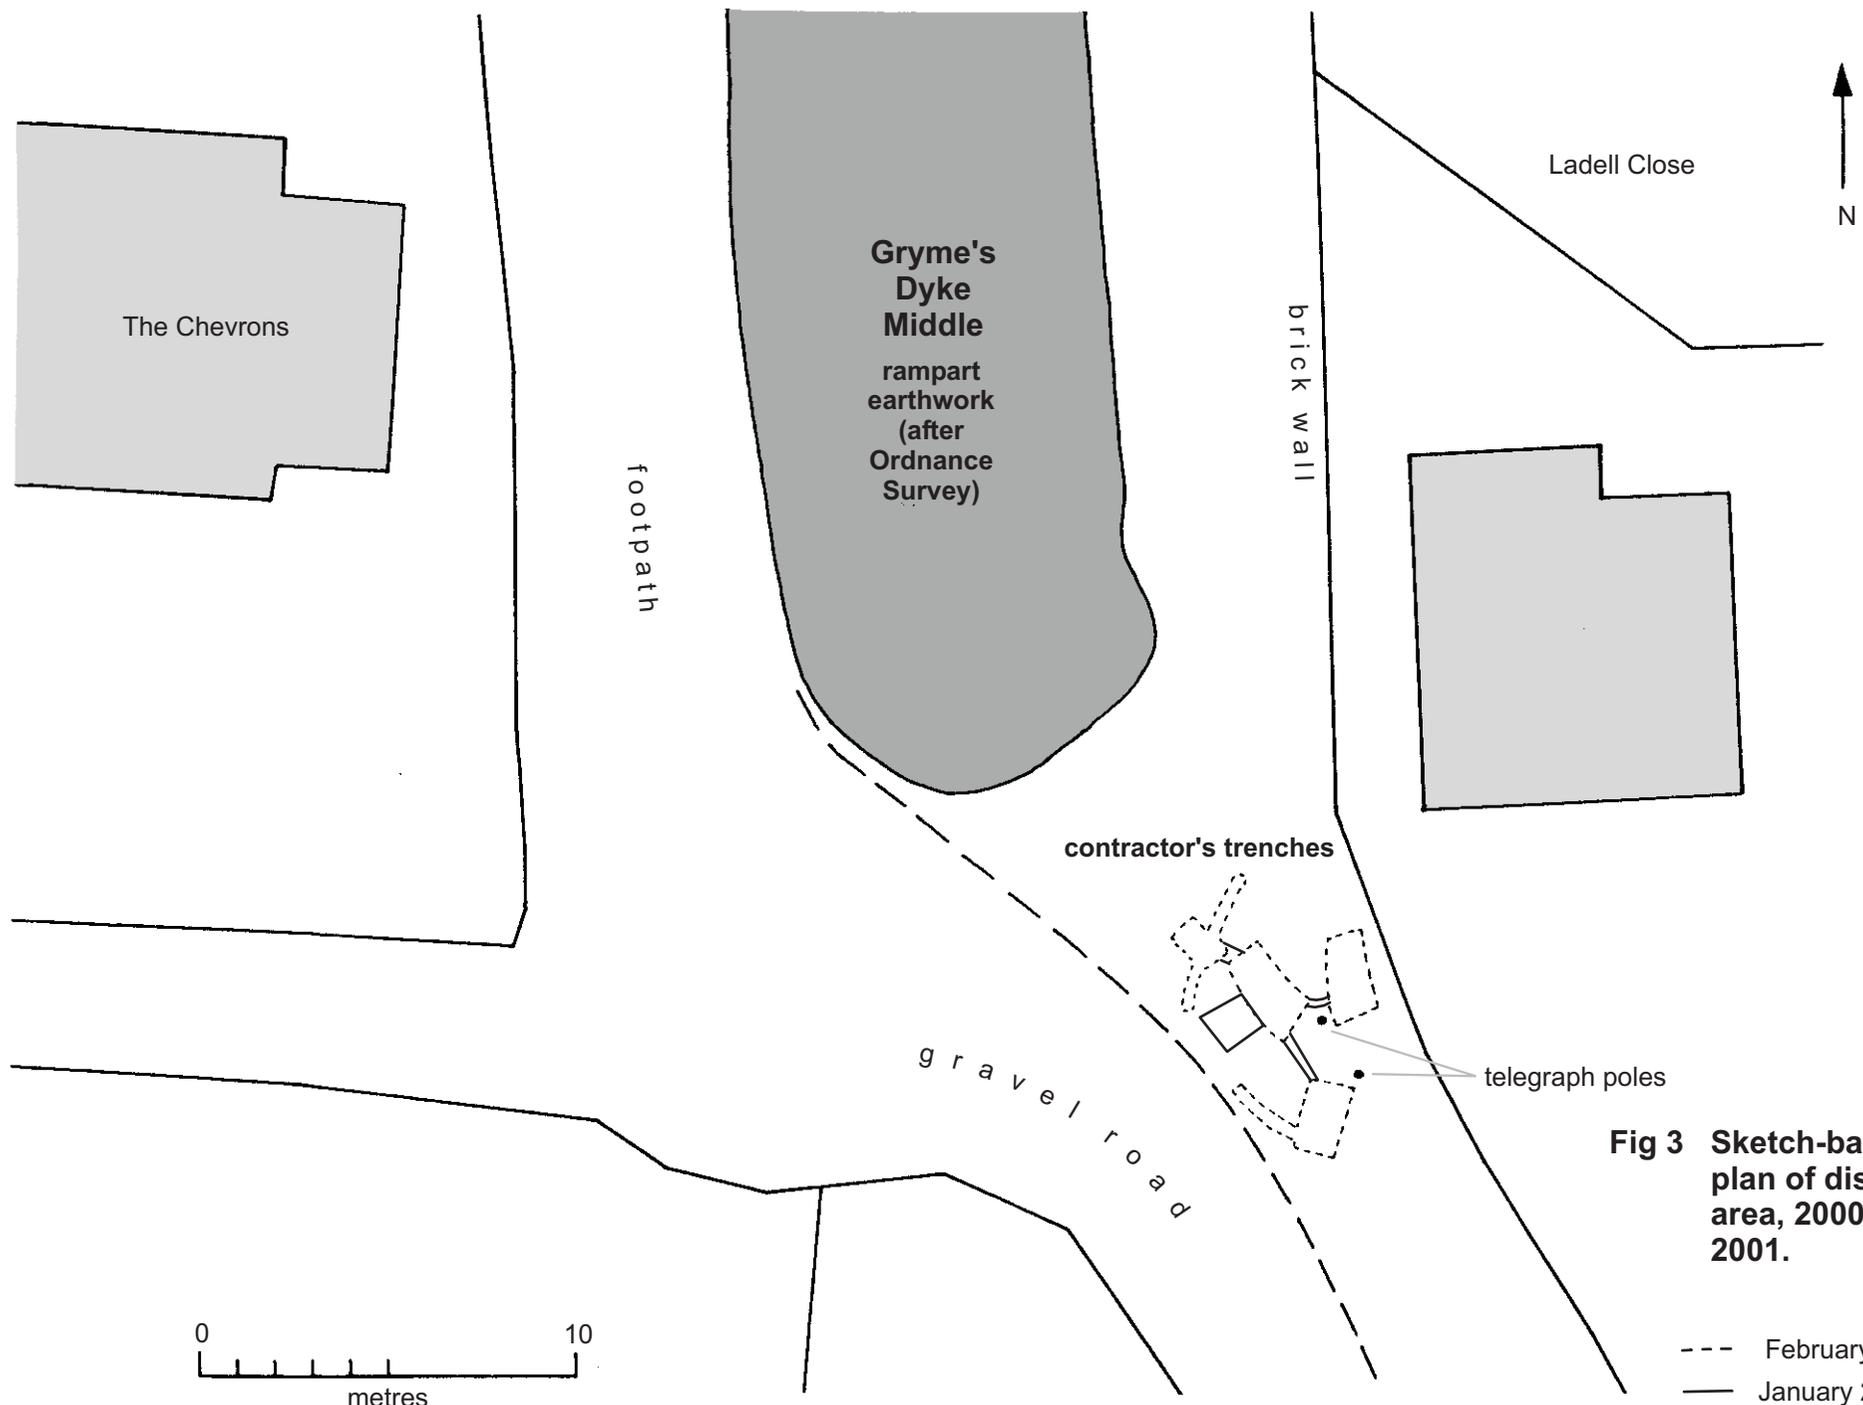
Fig 3 Sketch-based plan of disturbed area, 2000 and 2001.
