# Colchester town wall: miscellaneous sites from 1987 to 2000

on behalf of  
Colchester Borough Council

**CAT Report 144**

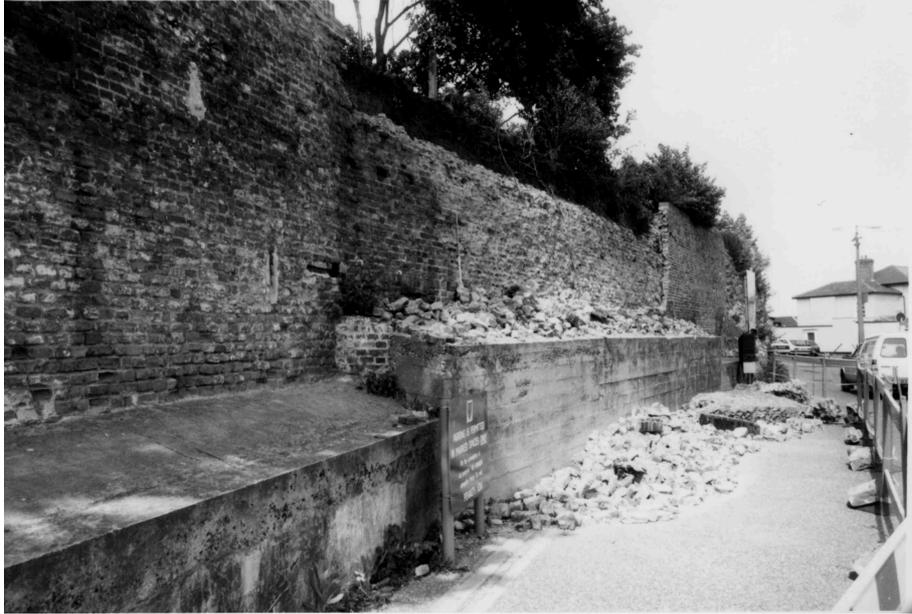
Fig 7 Priory Street car park (94/6b).

Part of a brick facing to the town wall collapsed onto the car park in Priory Street in 1994, revealing another brick wall behind it. The newly-exposed wall proved to be a continuation of the brick wall immediately west of the collapsed section, and the latter a localised refacing of it. The original wall and its refacing are similar in appearance

and are both likely to be 17th century in date. They presumably represent repairs to the town wall where it had been largely destroyed during the Siege of Colchester in 1648.

More of the damaged wall was pulled down (to a width of about 25 m) to make the area safe and to create a sound base for the new brick wall which was built to replace it.

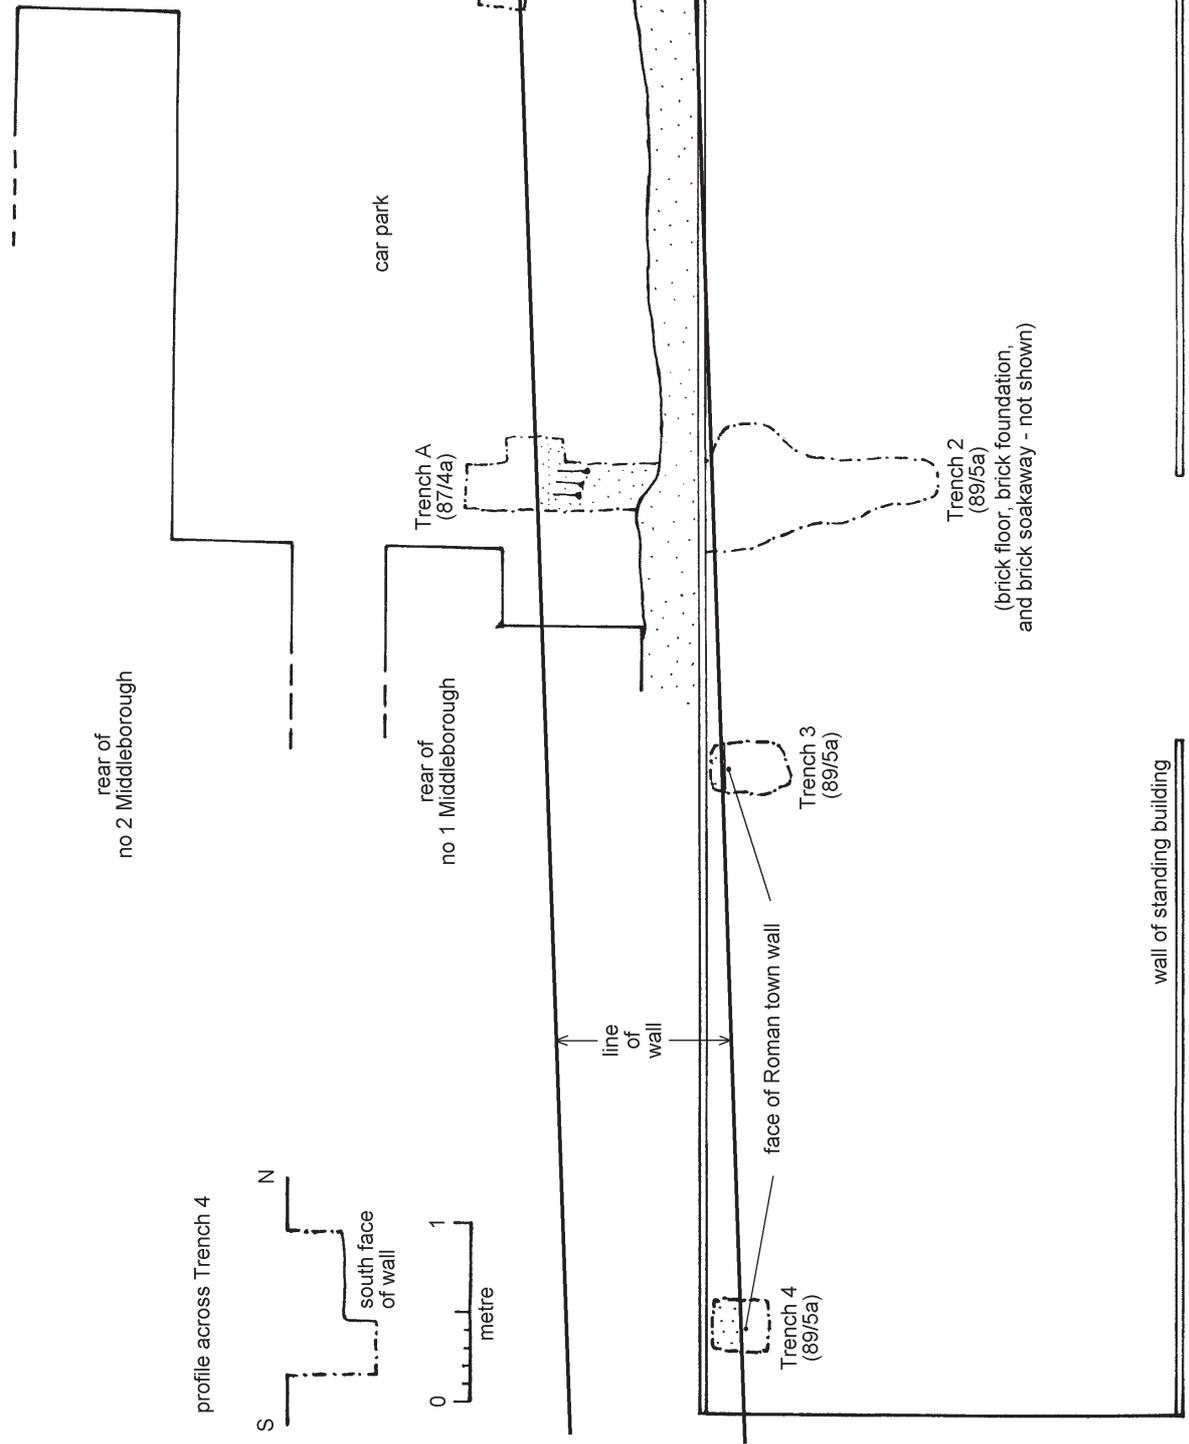
87/4a  
87/89  
2 Northgate Street  
and  
1 Middleborough

In 1987, three small trenches were dug at the request of the landowner Mr F Clater at the rear of no 1 Middleborough, to determine the position of the Roman town wall. Trench A revealed the core of the wall immediately below the tarmac surface at the base of the upstanding wall. The tarmac surface starts to fall away about 1 m from the core of the wall to a depth of 0.8 m where the wall face was encountered. This consisted of a course of four tiles, and below this two courses of dressed squared septaria were exposed (this being the limit of the excavation at 1.2 m). This face was unrobbed though weathered and set in pink *opus signinum* mortar. The face started 0.8 m below the modern surface. The trench started to show signs of stratigraphy at a depth of 0.9 m, with the dark silty clay loam being replaced by a silty clay, possibly indicating some activity other than simple build-up of dark earth. Trench B was dug to a depth of 0.5 m without encountering any wall, apart from large amounts of debris derived from the wall. Trench C revealed the top of the core. The north side of the wall dropped steeply away, suggesting robbing. The exact position of the face was not defined. The most northerly exposed masonry was north of the probable line of the north face of the wall (assuming it to be about 2.6 m wide), and therefore was presumably part of the foundation.

The warehouse occupies a 26.5 m frontage between no 2 Northgate Street and the rear of no 30 North Hill. The aim of the fieldwork was to establish the condition and exact location of the town wall underlying the north side of the building, as a preliminary to subsequent redevelopment. In the event, the inner face of the town wall was located at two points beneath the warehouse floor.

The existing concrete floor was broken open in four places by the contractor (Trenches 1-4). The wall lay immediately below the modern floor in Trenches 3 and 4. Part of the inner wall face was exposed by hand and its location was plotted in relation to the existing north wall of the warehouse. In Trench 2, manual excavation to a depth of approximately 1.4 m failed to locate the wall due to later ground disturbance. At the eastern end of the building, no evidence for the wall was found in Trench 1 which lay to the south of its projected course.

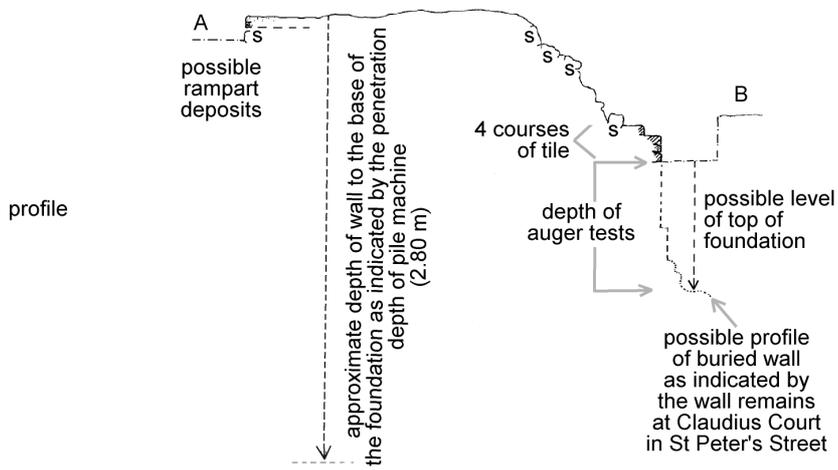
Fig 3

The south part of nos 22 and 22a Northgate Street is built on the buried remains of the Roman town wall. This caused subsidence and cracking in the house, and the Roman wall was uncovered during underpinning and other remedial works.

The wall proved to be well preserved to its full width, with no robbing of either face and with part of an interval tower on the south side. Like most of the other towers known so far, it lines up neatly with the centre-line of the north-south street to the south.

The wall was exposed in two rooms, and difficulty was experienced in getting the plans in both rooms to line up properly. As a result, there is a discrepancy in the width of the wall as shown in section (2.60 m) and on plan (2.66 m). On balance, the section seems more likely to be correct.

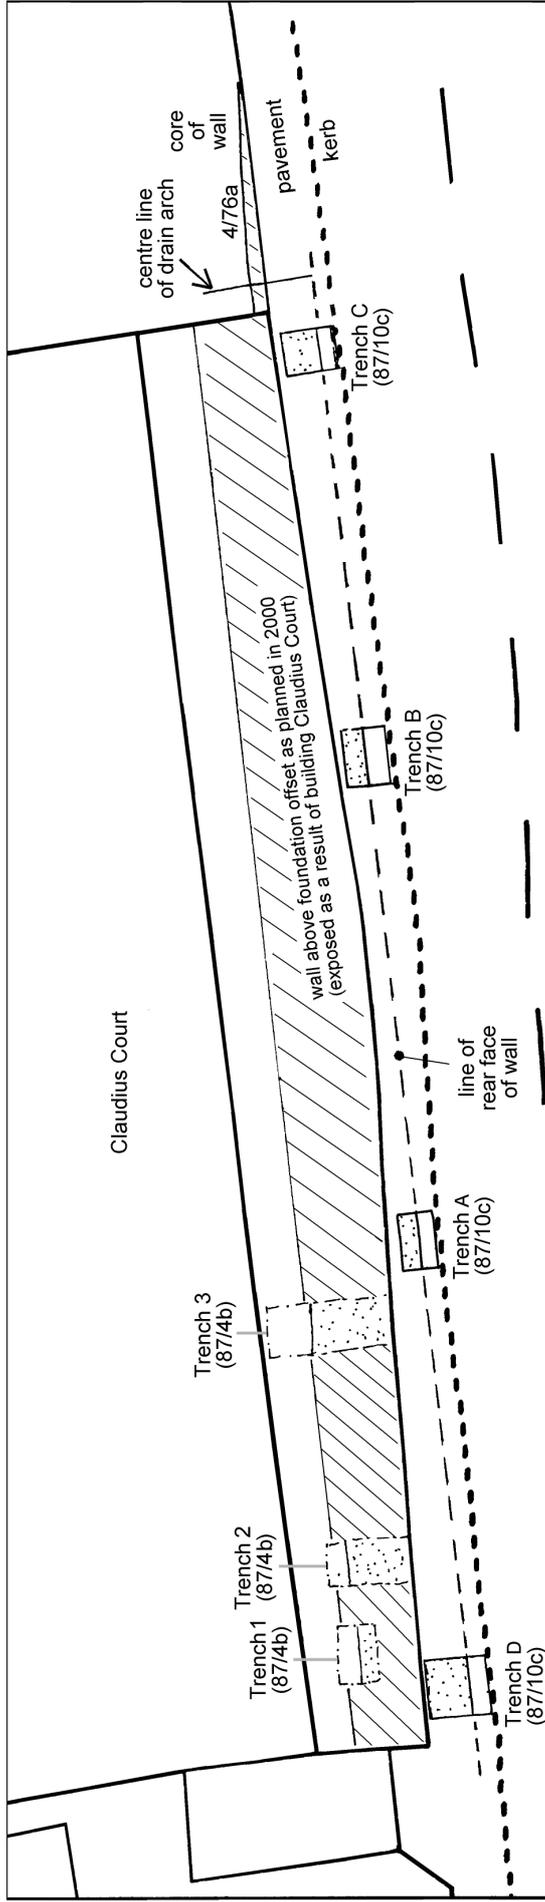
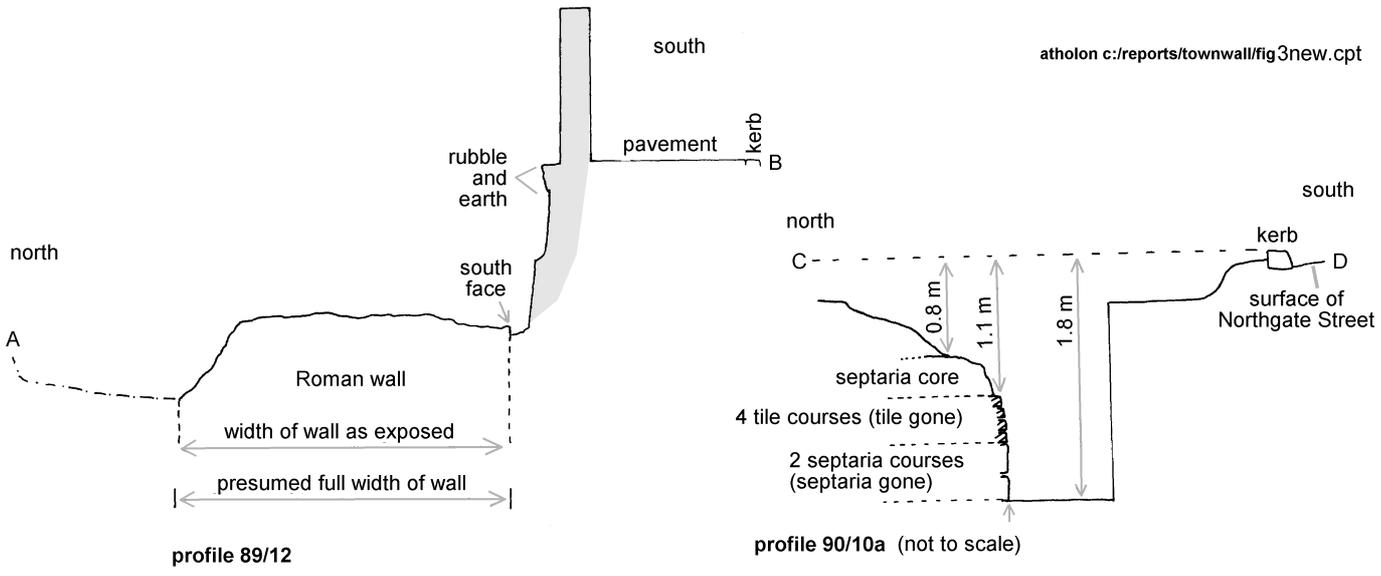
Fig 4

Three trenches (Trenches 1-3) were dug by machine against the south boundary of the site to determine the exact location of the town wall, which at that time was buried. The core of the wall was exposed in three places, with no clear trace being noted of the face. The new housing development was designed so that the wall would be exposed and not affected directly by the building works. Subsequently the exposed part of the wall was recorded (see 00/5h).

Four trenches were dug in the north pavement of Northgate Street to establish the position and depth of the south face of the town wall. The face was found in all the trenches and proved to be well preserved a short distance below the surface of the footpath. The depths of the highest surviving parts of the wall are as follows: Trench A: 0.29 m; Trench B: 0.89 m; Trench C: 0.80 m; and Trench D: 0.20 m.

In 2000, a plan (Fig 4) was made of the section of town wall which is permanently exposed between the north pavement of Northgate Street and the block of flats comprising Claudius Court. A north-south profile (Fig 4) across the highest part of the wall was drawn on the same occasion. The wall was surveyed so that reports could be prepared on the earlier exposures of the wall.

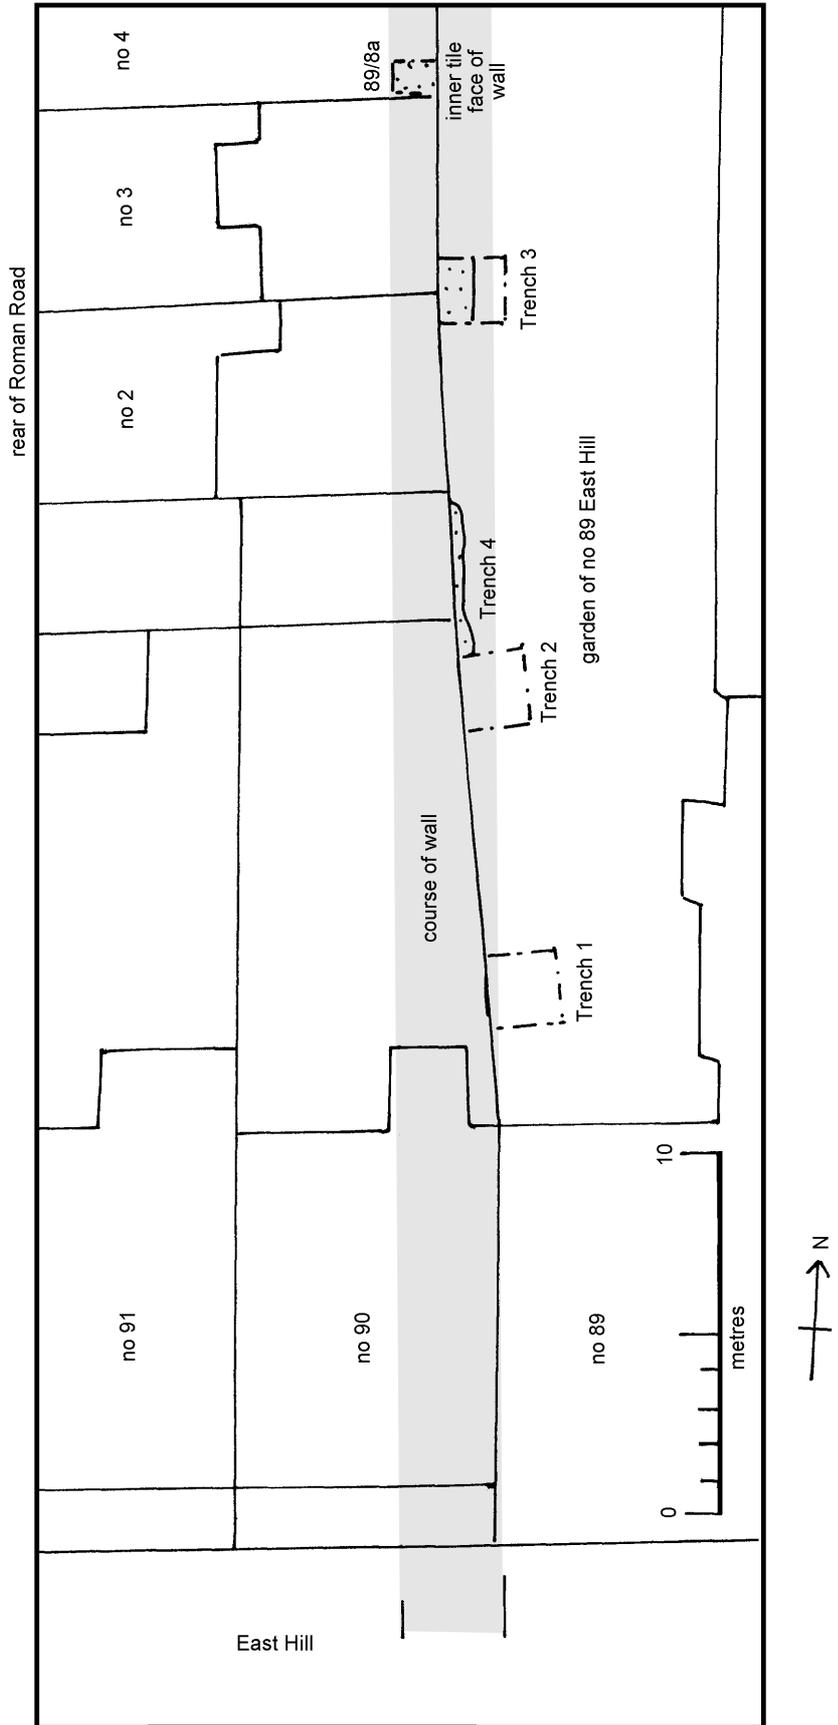
Fig Fig 6

When renovations were proposed for no 89 East Hill, the architects decided that there was a need to establish the course of the Roman town wall where it passed under the property, if possible. No trenches were possible in the house, so the investigation concentrated on the rear garden. Four trenches were dug, all located hard up against north brick boundary wall.

Little of the town wall proved to survive in the garden, and possibly none survives under the house itself. The highest part of the property is the centre and rear parts of the garden, where the base of the wall foundation still exists (Trenches 3 and 4). Elsewhere, near the house (Trenches 1 and 2), the ground-level has been lowered to a point where even the base of the wall foundation has been removed. This fits in with East Hill??, since it seems that the gradient of the street was reduced on at least one occasion in the 18th or 19th century.

The width of the wall shown on Figure 6 is based on measurements from elsewhere on the circuit. The east edge of the wall in Trenches 3 and 4 as shown in Figure 6 seems too far west if, as seems likely, this represents parts of the edge of the foundation. The explanation for the discrepancy may be related to the fact that there is a large difference in levels between the garden of no 89 and the gardens of the houses fronting onto Roman Road, and it is difficult to relate the areas accurately in plan.

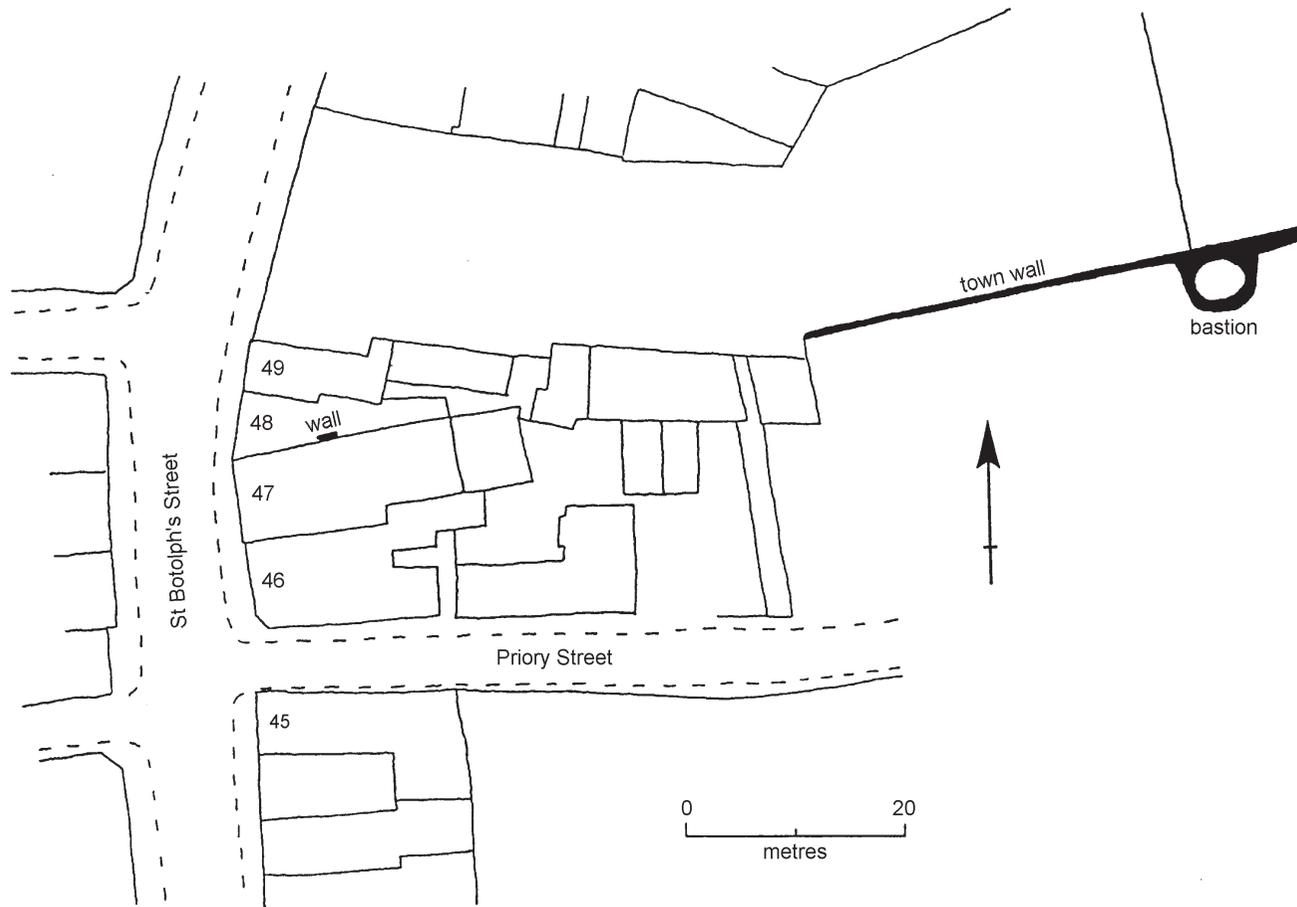
Fig 8 48 St Botolph's Street

The removal of a short length of modern brickwork against the south wall of no 48 St Botolph's Street, approximately 7 m back from the street frontage, revealed an earlier stretch of east-west wall which lay on the projected line of the inner face of the Roman town wall. The exposed section was 1.3 m long and 1.75 m high, and included a blocked archway which was 1 m high and just over 1 m wide (Fig 9). The insertion of modern brickwork to a height of 1.65 m had destroyed the eastern side of the archway together with most of the wall face further east. At the time of the recording, modern panelling masked the western and upper extent of the archway, while the base was obscured by a concrete floor.

The wall was mainly made of Roman building materials, including septaria, flint, tile and fragments of *opus signinum* set in a firm whitish mortar. However, traces of an earlier yellowish mortar adhered to some of the fragments, indicating reuse.

The material formed a well-preserved facing, rather than rubble core. There was no trace of the bands of septaria and tile courses characteristic of Roman work. A thin tile fragment, presumably peg-tile, suggested a post-Roman construction date, although the post-Roman brick was not conclusively primary. There was little evidence for pointing, garreting or indeed weathering, so that maybe the walling had been intended for internal use.

The four-centred arch was apparently an original feature, but it did not have a well-defined stone or brick lining. The rather slight nature of the archway may indicate that it formed a recess, rather than a doorway associated with a major rebuilding of the town wall such as that of c 1400.

A small group of bricks set into the wall face immediately west of the arch was probably a later repair. These bricks were similar to, and presumably contemporary with, those used to block the archway. The bricks included narrow examples (50 x 225 mm), possibly of 17th- or 18th-century date, as well as some larger ones (65 x 230 mm) of perhaps 18th- or 19th-century date, although their width and whether any were frogged remains unclear.

The archway was probably blocked in the 18th or 19th century, and it appears to represent a relatively late episode in the rebuilding of the Roman town wall, from which much of the building materials were presumably derived. The recently uncovered section of wall perhaps originated as part of the interior of a building of medieval or later date. Norden's map of Colchester in 1610 does not appear to show any structure against this part of the town wall, raising the possibility of a 17th-century date for the work, maybe even as part of a rebuilding after the Siege of Colchester.

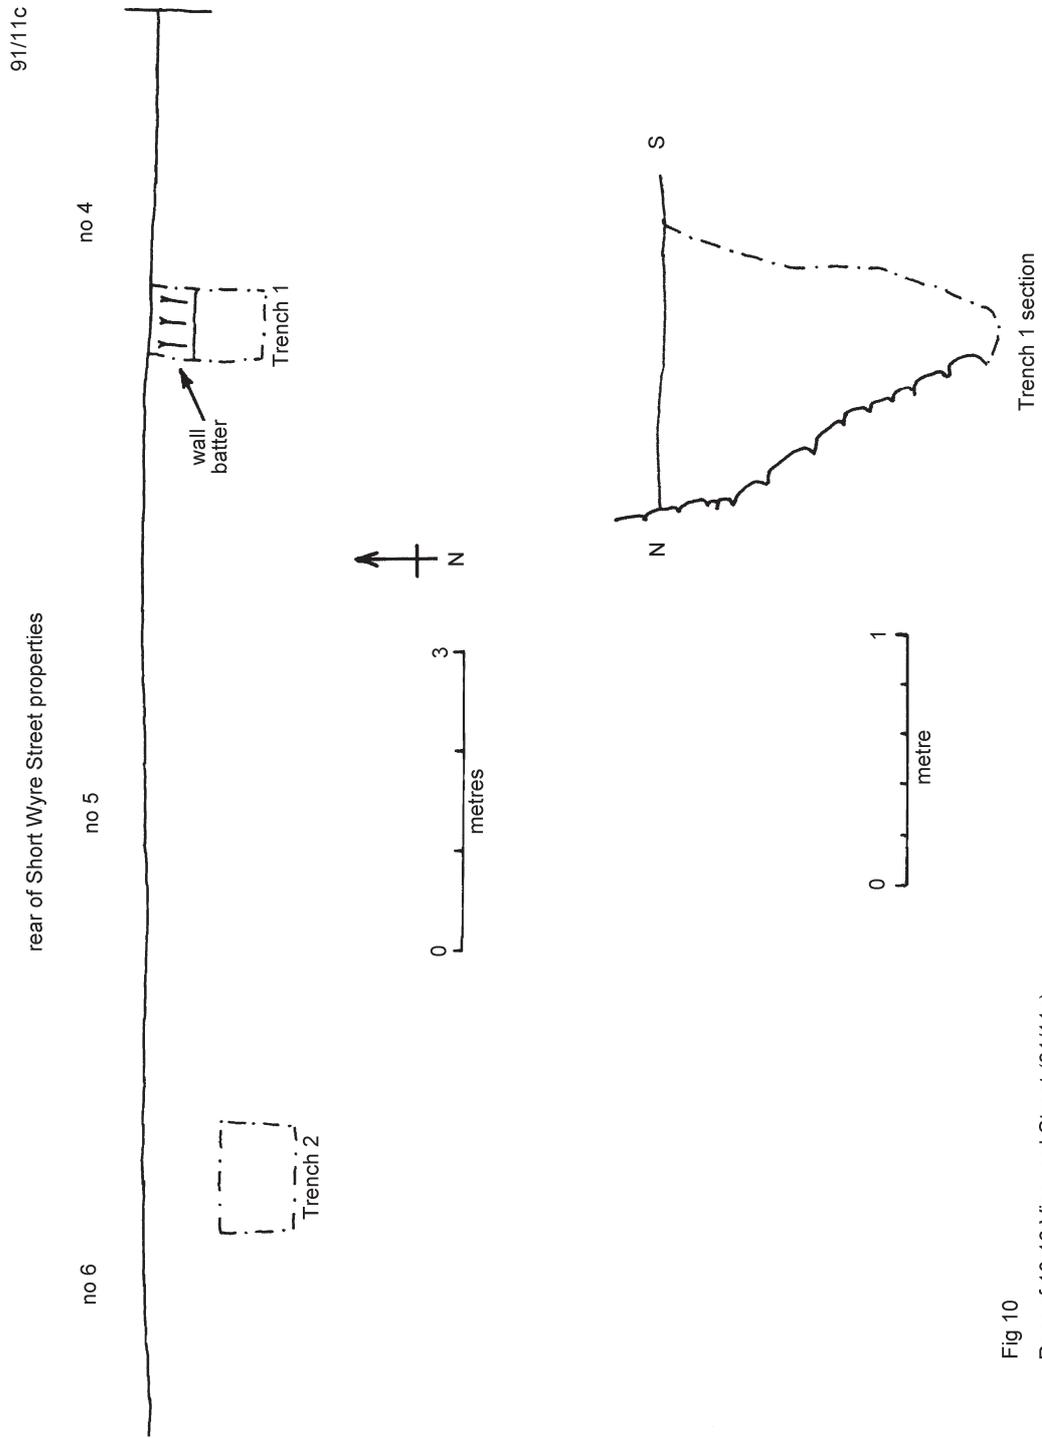
Fig 10  
Rear of 10-16 Vineyard Street (91/11c)

Two small exploratory trenches were dug to the rear of the property. The base of the town wall was uncovered in Trench 1. It was battered in the same way as the wall at Lion Walk, 150 m to the west, where it was shown to be part of a refacing to the town wall of c 1400 (*CAR 3*, 84-5).

No part of the town wall was found in Trench 2.

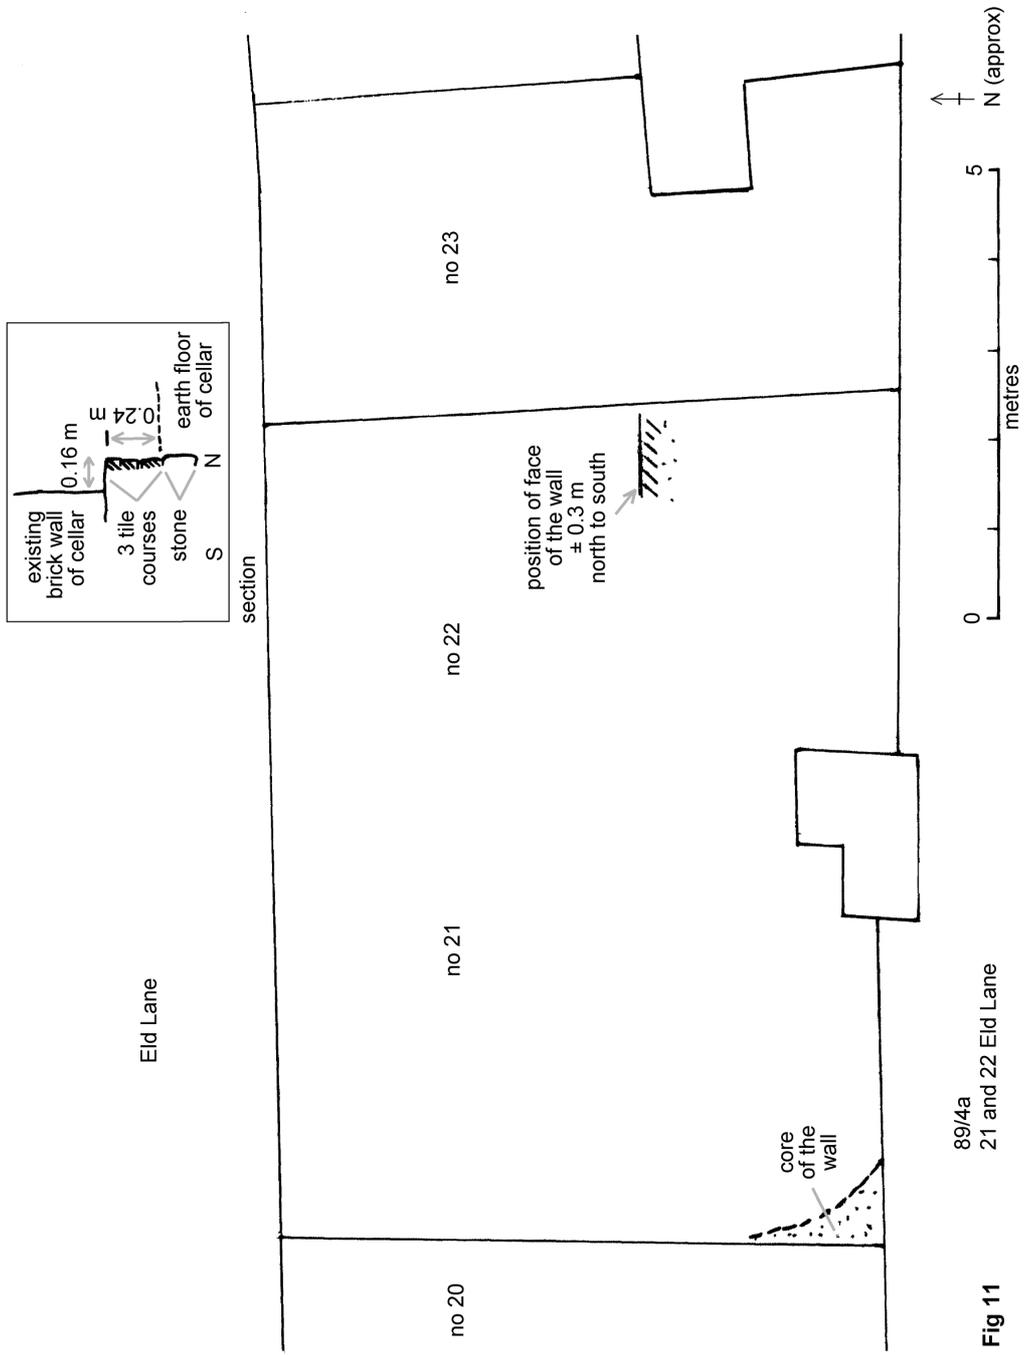
Fig 11

In 1989, the core of the town wall was exposed in the south-west corner of the cellar under no 21 Eld Lane when a hole was made in the cellar wall during refurbishment works. When the wall was being recorded, it was noticed that part of the north (ie the inner) face of the town wall was incorporated in one of the walls of the adjacent cellar under no 22. The position of the face could only be plotted to within  $\pm 0.8$  m north to south on the site plan, because the thickness of the cellar wall could not be determined.

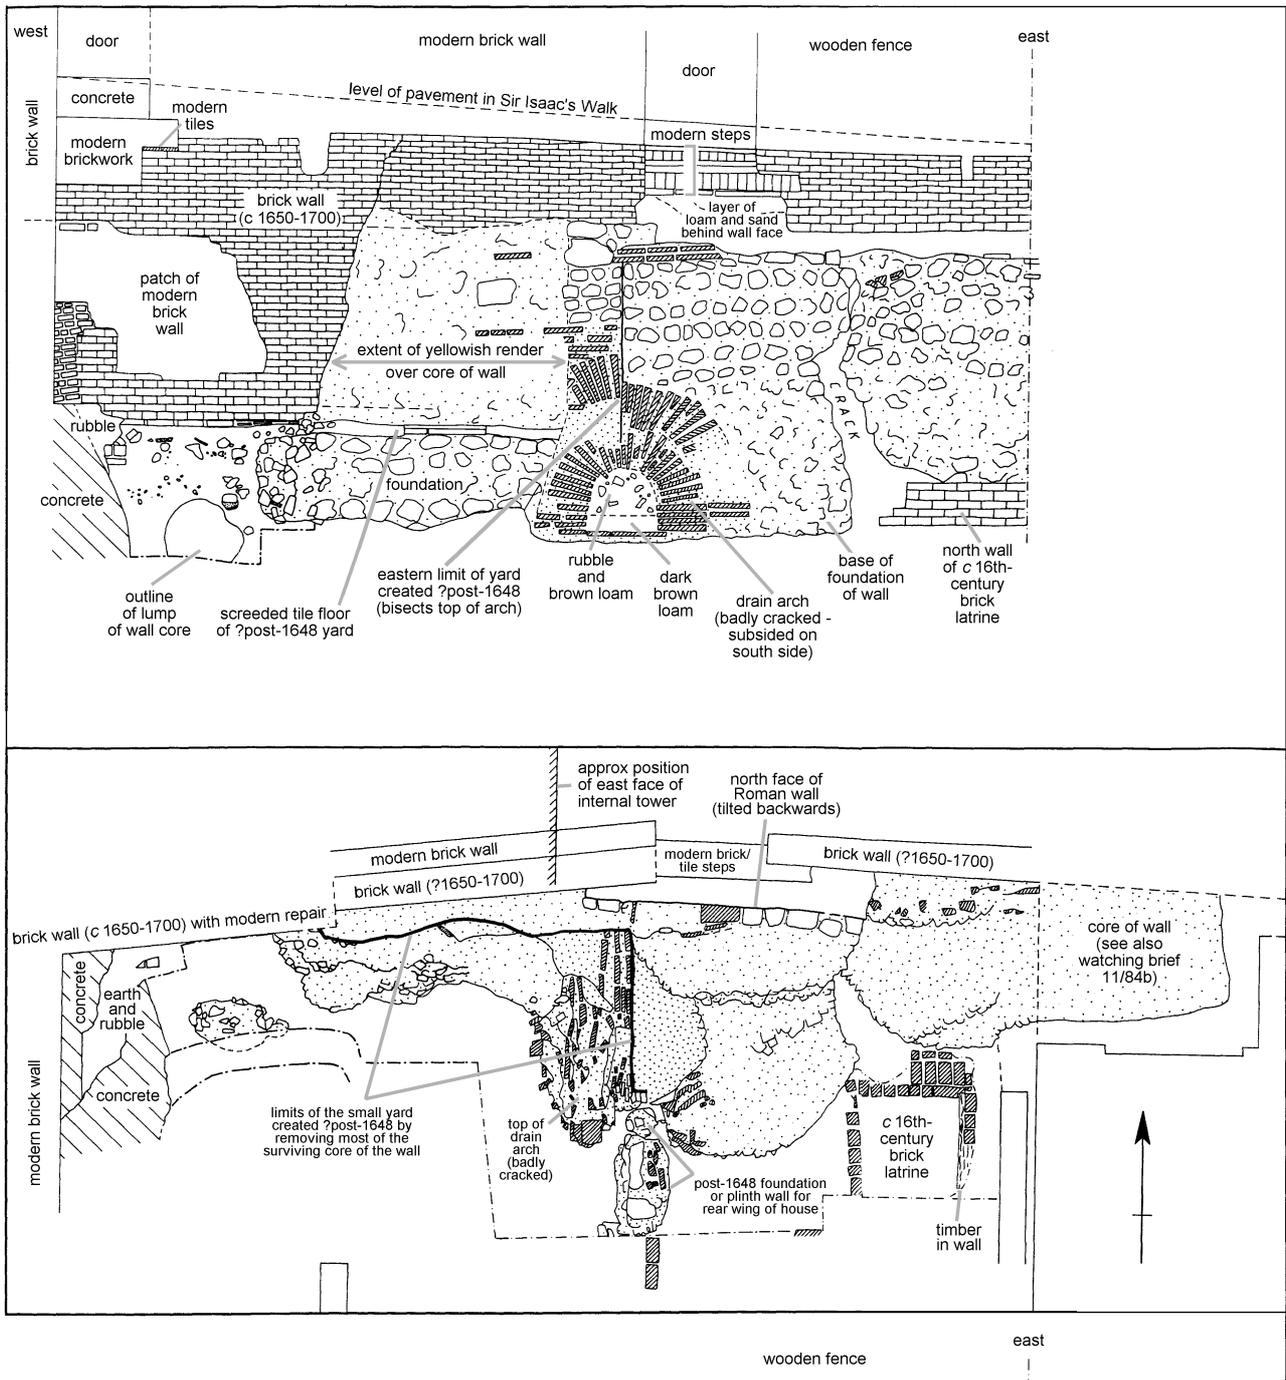
In 1988, part of the Roman town wall was exposed at the rear of no 43 St John's Street. The wall was of particular interest, because it incorporated part of a drain arch.

The full width of the Roman town wall could not be established because it had been too badly damaged. The position of the north face (which was unrobbed in places) closely corresponded to the line of the frontage along Sir Isaac's Walk. Nothing survived of the south face or the southern side of the foundation.

The upper part of the wall has been destroyed and its outer (ie southern) face has been completed?? leaving the core exposed. In places, the latter had been removed for almost the full width of the wall so as to expose the inner ends of some of the tiles forming the inner (ie northern) face of the wall. The drain, being completely built of tile, could not be so easily dismantled, with the result that it survived the robbing process better than the wall. The western half of the wall is the worst damaged, since most of it, including the western half of the drain arch, was removed to enlarge the north-west corner of the backyard. The remains of the wall are so thin in places that the wall has cracked into separate pieces, and part of the inner face has tipped forward in the same way as the wall about 20 m to the west which was recorded during the Culver Street excavations in 1985 (CAR 6, 63-4).

The pattern of tiles in the north face suggests the existence of a tower to the west, where there are no tiles and core material extends right up to the north boundary of the site. The approximate position of the east side of this postulated tower is shown on Figure ???. It appears that the wall has not moved where it incorporates the tower, despite extensive robbing; whereas, immediately east of the drain arch, the reduced state of the wall has led to cracking and the remains sliding forwards. However, given the way that different parts of the wall have moved, the tower could be illusory.

No direct dating evidence was found for any of the robbing of the wall, but it seems almost certain that the removal of the western part must post-date the Siege of Colchester when the wall was still functional.

A large section of detached masonry immediately south of the core incorporated a fragment of peg-tile and presumably represents the remains of the refacing of the wall of c 1400 noted at Lion Walk (CAR 3, 84) and elsewhere.

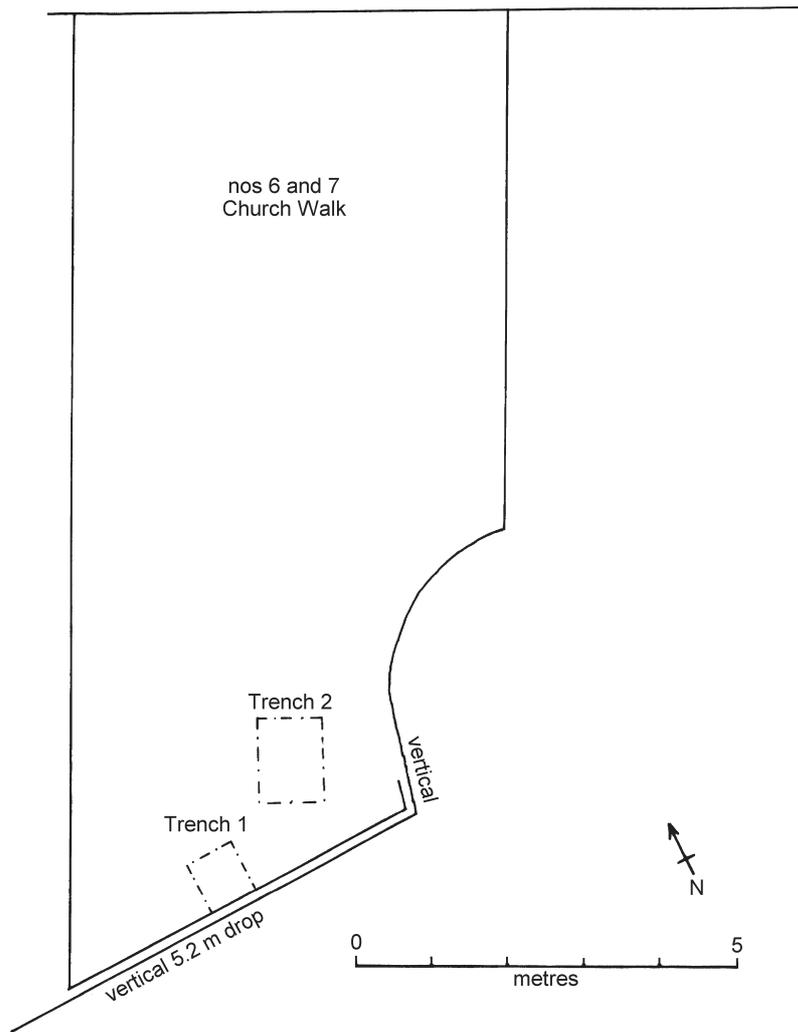
88/4b  
Fig 13 Nos 6 and 7 Church Walk

Two exploratory trenches were located on or close to the course of the town wall at the rear of nos 6 and 7 Church Walk. The work was done in advance of redevelopment. The trenches were excavated to a depth of 2 m, then probed by auger for a further 1 m, making 3 m in all. What appeared to have been part of the core of the town wall was noted in the south side of the southern trench. No masonry was seen elsewhere.
