**An archaeological watching brief
at the former Cooks shipyard and gasworks,
Wivenhoe, near Colchester, Essex
March 2006-November 2007**

**report prepared by
Kate Orr**

CAT Report 448
December 2007

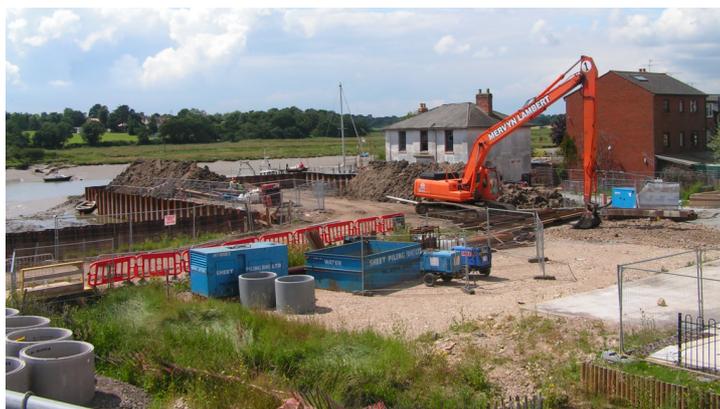
Plate 1: (front cover) Sheet piling work around the wet dock and to the west of it, July 2007; view south-west.

Groundworks resumed after a delay in the programme of several months. Sheet piling was being inserted around the wet dock and to the east and west of it during these visits. This involved contractors digging a continuous trench 1.7m wide and 600mm deep for the sheet-piling machine to sit in. The sheet piles were then pushed in by the machine by means of vibrations. On the 10th July, the area to the west of the wet dock was monitored. The sheet piling had already been inserted and the whole area had been reduced down to nearly 2m below ground-level. One metre-wide trenches had subsequently been dug down into this reduced level. These were dug to insert the steel tie beams which were to secure the sheet piling. The ground reduction had only stripped away modern material. The spoil heap was inspected and found to contain modern glass and ceramic bottles, plastic, unfrosted brick, oyster shells and wood. Two leather shoe soles were also retrieved (finds no 3). On the 17th July, sheet piling to the east of the wet dock was monitored. The open trench for the sheet-piling machine was monitored and seen to have been dug only through crushed concrete, laid down in 2006. On the 7th August, after the sheet piling to the east of the wet dock had been inserted, the author monitored some trenches which were opened up to their rear to insert tie beams. Again these were dug through made-up ground.

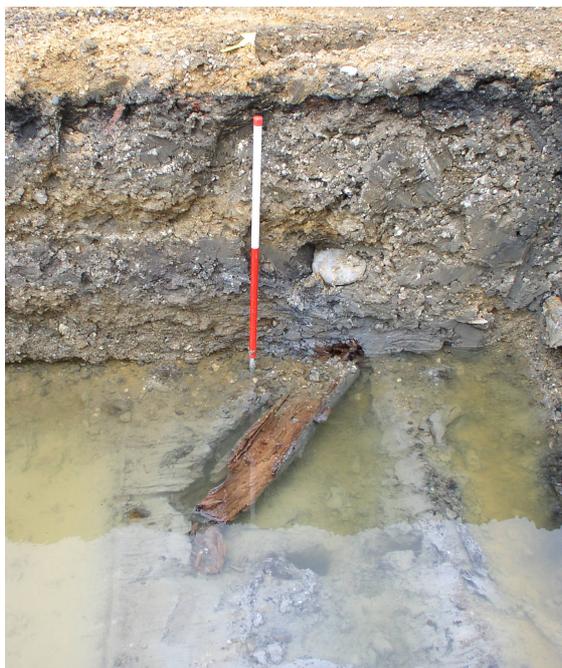
Plate 2: section of exploratory trench by the wet dock showing Timber 7, March 2006; view north-west.

An exploratory trench was dug alongside the wet dock, on its eastern side. This was 1.2-1.3m deep, 48.2m long and 2.2m wide. The sections of the trench were examined and the following profile recorded. The top 400mm consisted of loose asphalt mixed with stone and sand. Below this was a 300mm-thick layer of moist brown sand containing frequent stones. This sealed a layer of light greyish yellow sand. All these layers were modern and rather mixed. At the extreme southern end of the trench, at 800-900mm below ground-level, a layer of wood was observed in the east-facing section of the trench. This wood was partially water-logged and mainly consisted of small twigs but also included one larger timber lying on its side. This wood lay in a grey clay matrix. Below this and continuing to the base of the trench was a grey clay which was very sticky in consistency. This clay had the appearance of natural alluvium but the presence of an unfrosted brick (finds no 1) within it gives a post-medieval or early 19th-century date to this deposit. The trench filled up with water at high tide. Along the base of the trench, within the grey clay deposit, were seven partially water-logged timbers (Timber 1-Timber 7). Timber 1, at the southern end of the trench, was circular and lay horizontally on an east-west alignment. Timbers 2 and 3 were fragments of circular timbers lying horizontally within a clay-filled linear cut. The cut corresponded with the area of water-logged wood seen in the section and may be associated with it. Further north were the stumps of two upright square timbers (Timbers 4 and 5). A piece of clay pipe (finds no 2) was found in the clay next to Timber 4. Approximately half-way along the trench, in the east-facing section, was a second clay-filled cut containing another timber (Timber 6). This timber was horizontal but had been cut away and both the cut and the timber were seen in section only. Just to the north was another linear clay-filled cut on an east-west alignment. This contained a circular timber (Timber 7) which was lying horizontally (Plate 2). The northern half of the trench did not contain any timbers. Timbers 1-7 were only partially water-logged and did not appear to be of any great antiquity. The clay pipe and brick found in the clay matrix which contained the timbers makes it likely that they belong to the post-medieval period or the early 19th century. They may have been parts of a timber wharf to the shipyard.

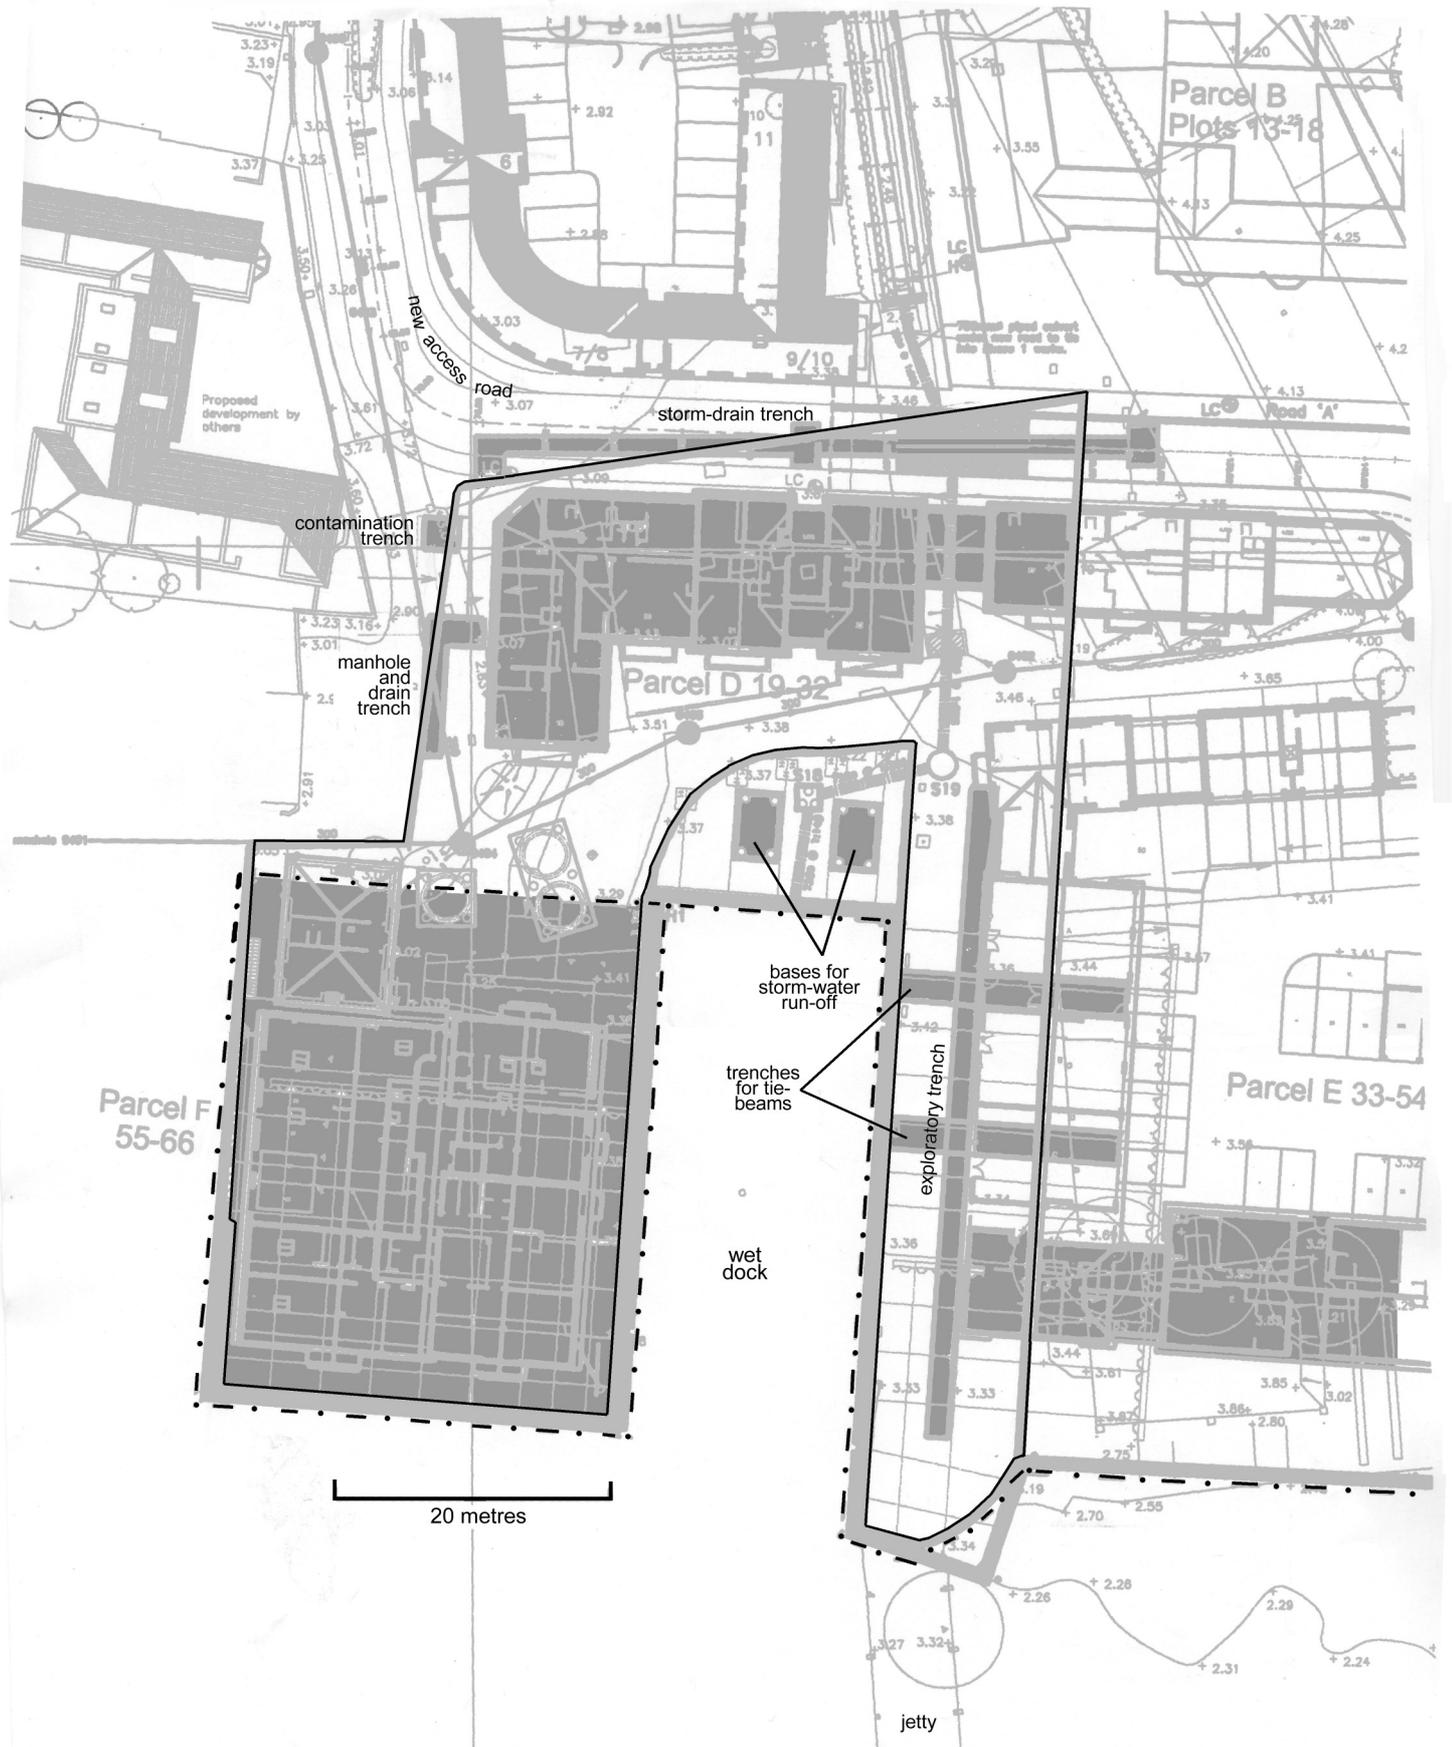
Fig 2 Plan of site, showing areas monitored.

- 5.1** An archaeologist from CAT made visits during the contractor's groundworks to carry out a watching brief. Groundworks included trenches dug for removal of contamination, an exploratory trench, piling, ground-beam trenches, drain trenches and manholes as well as trenches for sheet piling and tie beams. Twenty-four visits were made in total.

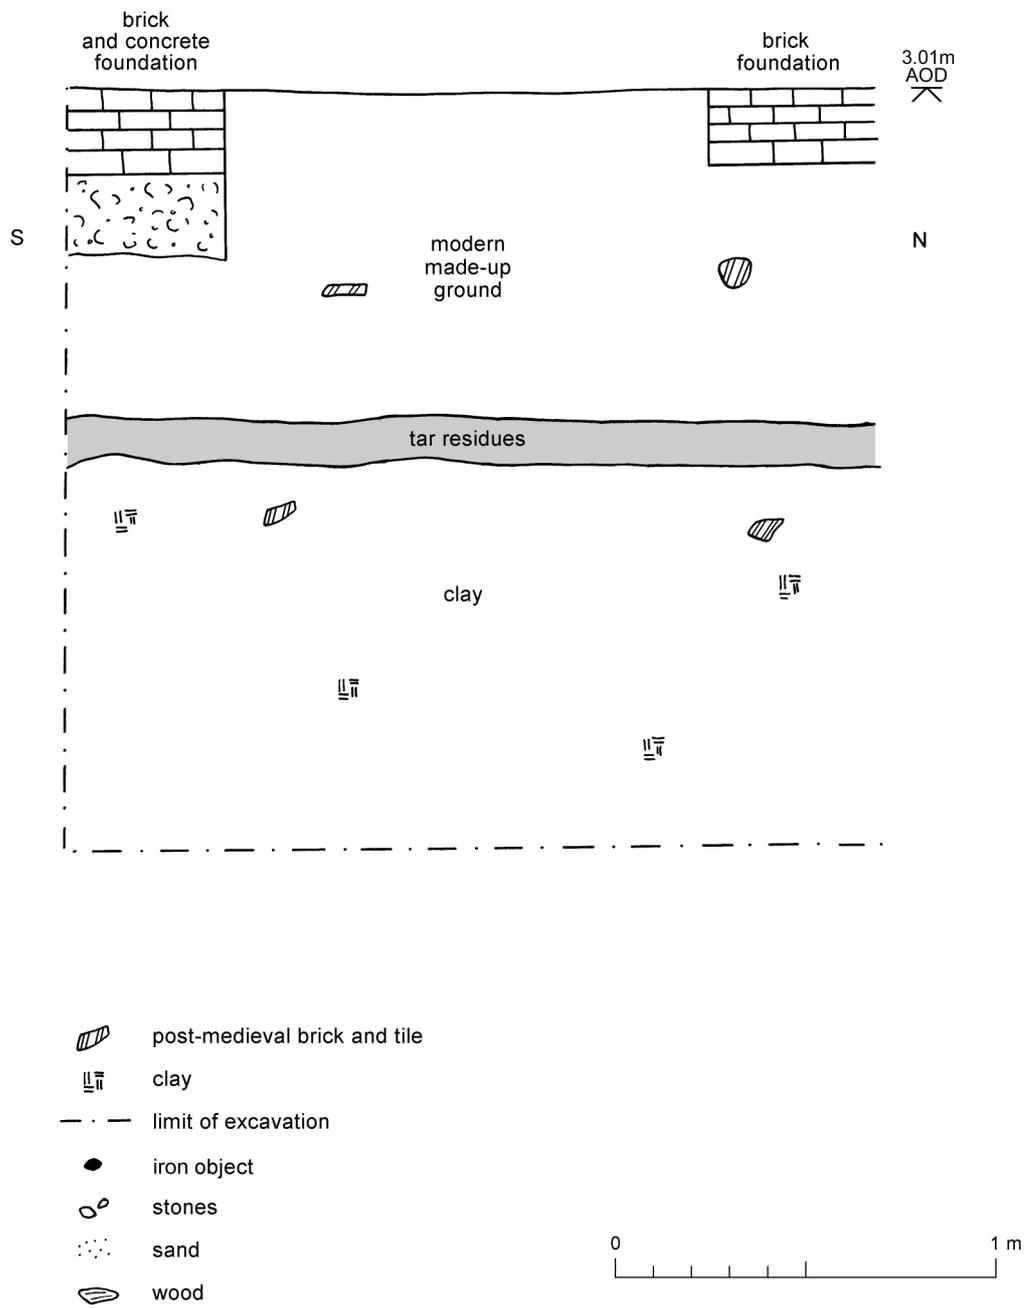
Fig 3 East-facing section of trench dug to remove contamination.

A trench was dug to a depth of 2m in order to remove contamination from the old gasworks site. The top 900mm of material consisted of modern made-up ground containing modern bricks and other material. Brick foundations for the former gasworks building were seen. At 900mm below ground-level, a seam of black oily contaminated ground was observed. This sealed grey brown clay which continued to the base of the trench. The clay layer contained some brick fragments higher up but lower down appeared to be natural alluvium. Tar residues from the layer above were seeping into the clay. It was not possible to enter the trench so the sides could not

be cleaned. However, no obvious archaeological features were present in the trench.
