**Building recording at Area K1,
the former Cavalry Barracks, Butt Road,
Colchester, Essex
May 2011**

CAT project ref.: 11/5g
Colchester and Ipswich Museums accession code: COLEM 2011.41
NGR: TL 9896 2422 (c)

CAT Report 606
August 2011

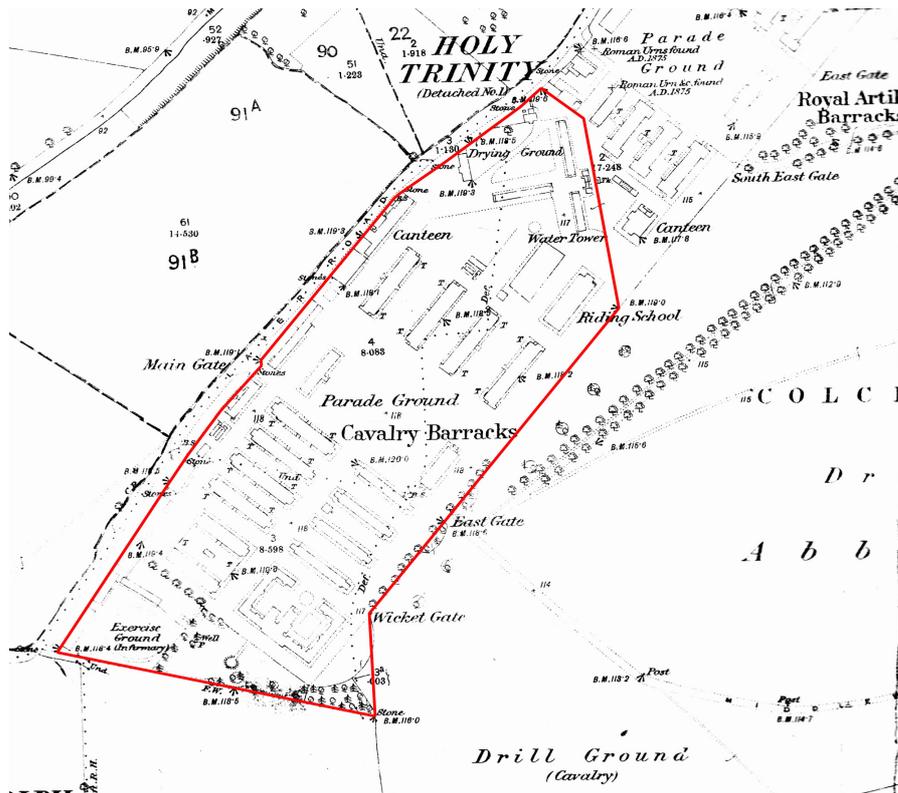
Illustration 1: O.S. 1st edition map of 1876 (scale 1:2,500), with the boundary of the Cavalry Barracks marked in red and the later Royal Artillery Barracks shown to the north-east.

The O.S. 1st edition map of 1876 shows the Cavalry Barracks a little over a decade after construction (Illustration 1, above). The buildings noted in section 3 (above) can be seen, with some, notably the Canteen, Water Tower and Riding School, being labelled. A sense of the new open-plan nature of the barracks recommended by the Royal Commission can also be gained from this map. This is clearly shown by contemporary postcards which give an impression of the barracks being airy, light and spacious, compared to those barracks described by the Commission as 'old, gloomy and bad' (Douet 1998). Illustration 2 (below) shows a view confirming the map evidence that there was a large area of open ground to the south of the Officers' Quarters and Illustration 3 (below) shows open space between the Soldiers' Quarters in this postcard. Building 5 of the survey, one of the Troop Stables, can be seen on the right of the three-storey Officers' Quarters.

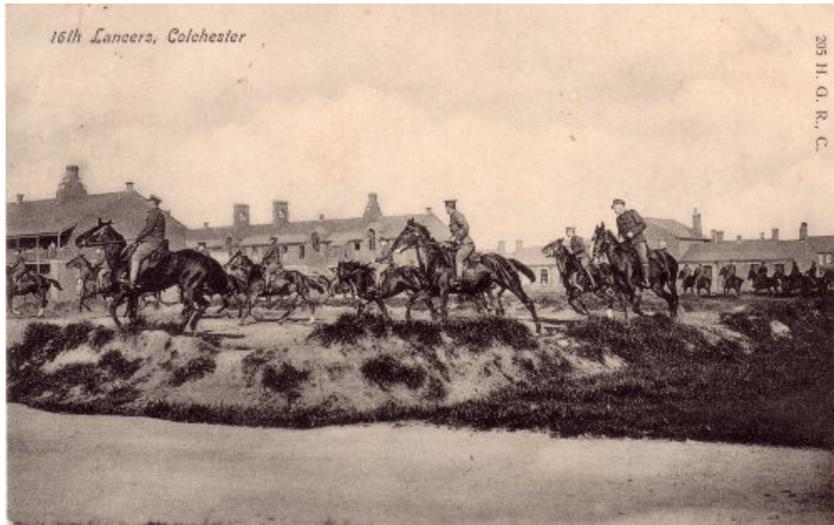
Illustration 4: men of the 16th Lancers exercising their horses c 1902 (postcard).

The *manège* to the north-west of the Riding School can also be seen on the extract from the O.S. map of 1876. This arena for exercising horses and riders is also depicted on an early 20th-century postcard (Illustration 4, below) which shows men from the 16th Lancers (stationed at Colchester in 1902) exercising their horses, with several of the Troop Stables with Soldiers' Quarters Above shown in the background.

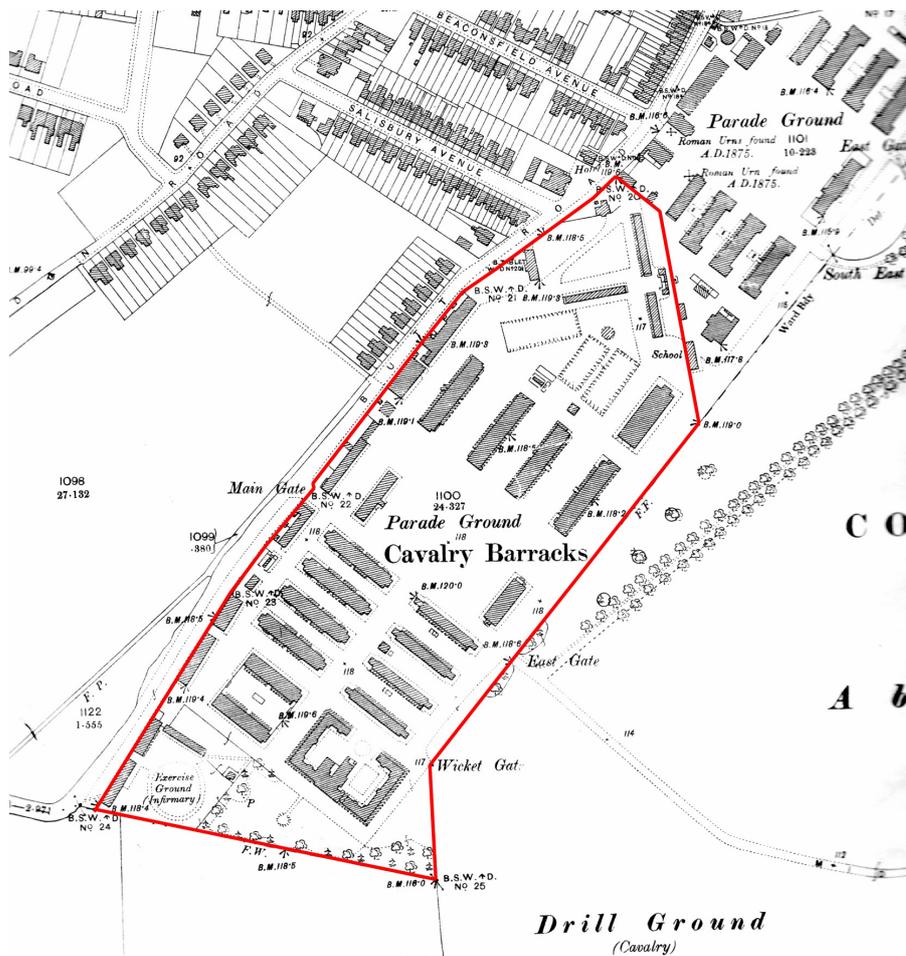
Illustration 5: O.S. 2nd edition map of 1897 (scale 1:2,500), with the boundary of the Cavalry Barracks marked in red.

All of the buildings appear as they do on the O.S. map of 1876, and the only apparent changes are two additional *manèges* located to the north-west of the original and an extension linking the Ablution House to the boundary wall. The *manèges* were probably added in response to the South African wars of the late 19th century. Outside the boundary wall, Colchester's suburbs can be seen to be encroaching southwards with the building of houses along Maldon Road and the recently renamed Butt Road and as well as the new developments of Beaconsfield Avenue and Salisbury Avenue. It may have been these new neighbours which prompted the 16th Lancers to post such formidable-looking sentries at the gate as are shown in a postcard from 1902 (Plate 1). This postcard shows the large central wooden gates tipped with iron spikes and one of the smaller outer gates. The brick piers with their York stone caps can also be seen.

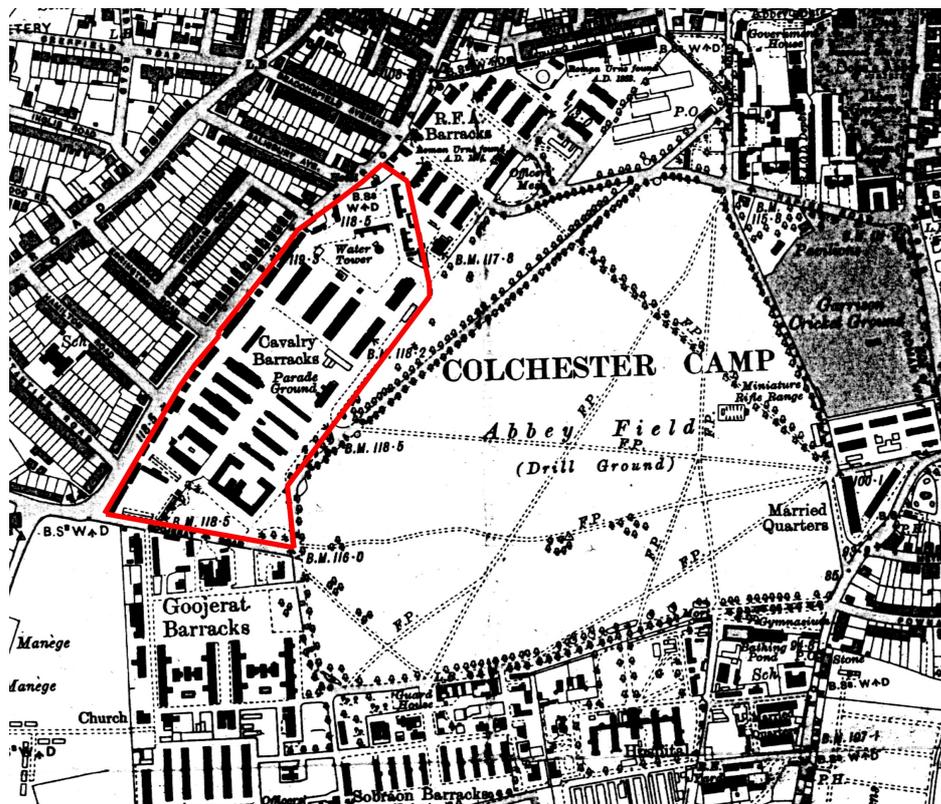
Illustration 6: O.S. map of 1921 (scale 1:10,560) with the boundary of the Cavalry Barracks marked in red.

The O.S. map of 1921 shows very little change to the Cavalry Barracks. A structure is outlined at the north-eastern corner of the parade ground but it is not blacked in like the other buildings on this map. This is probably indicative of a building which was planned but not built at the time of the 1921 survey. A similar outline can be seen to the north-east of the Officers' Mess in Le Cateau Barracks (shown on the map with its pre-1914 name, the 'R.F.A. Barracks' (Royal Field Artillery)). These planned buildings became the Dining Hall and Cook House for the Cavalry Barracks and, probably, the Regimental Institute for Le Cateau Barracks (this later became the Army Education Centre). Inscriptions on both buildings place the actual date of construction as 1937. The main point of interest to note from the O.S. map of 1921 is the expansion of the suburbs to the west of the Cavalry Barracks and the presence of the newer Goojerat Barracks

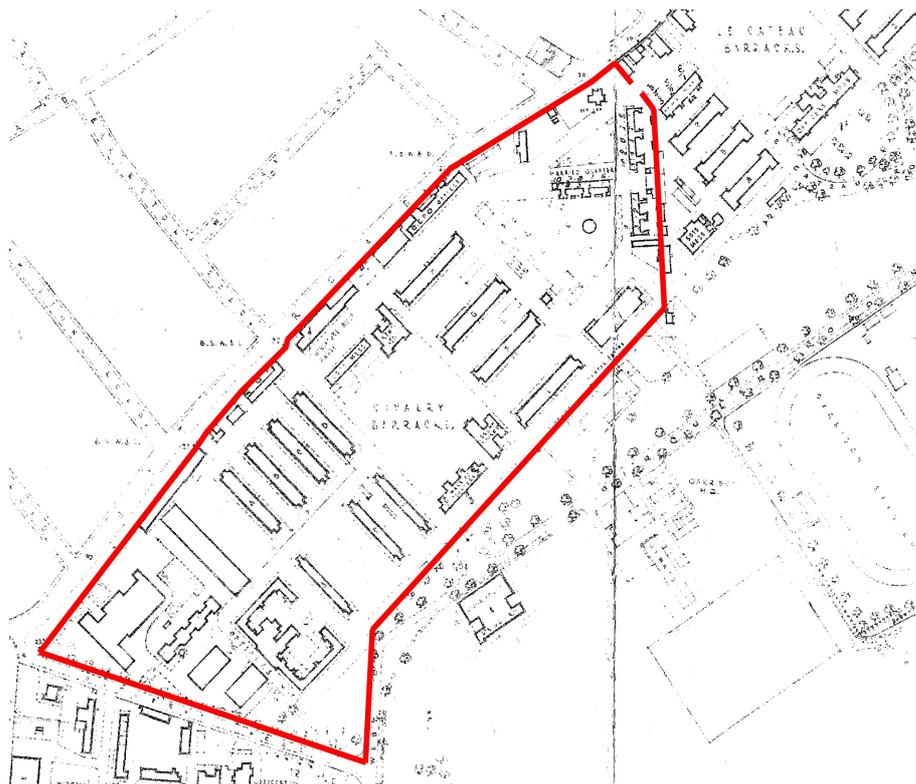
Illustration 7: Royal Engineers' map of 1949 with the boundary of the Cavalry Barracks marked in red.

A map of Colchester Garrison prepared by the Royal Engineers in 1949 (Illustration 7, below) shows the aforementioned Dining Hall and Cook House and also a Regimental Institute which was added to the Sergeants' Mess and Reading Room (also known as the Adult School) in 1935. However, this map notes four amendments (1953, 1955, 1956, 1962), but does not indicate what they were. Several original buildings, most notably the Officers' Stables (Building 4 of the survey), have been omitted when they were clearly still standing at the time and, as the purpose of this map is unknown, this casts doubt on the accuracy of this source. Significant changes include the complete removal of the Infirmary Stables and Exercise Ground, replaced by an office block, and the infilling of the open land to the south of the Officers' Quarters with what appear to be garages and outbuildings. The southernmost of the two Officers' Stables and the yard between them was replaced with a large warehouse, while the Wagon Shed and Commissariat Reserve Store was joined to the Commissariat Reserve Stores to create one long building. The Ablution House is shown to have an extension joining it to the boundary wall. The area of the *manèges* was replaced with a group of air-raid shelters, probably in 1939. The map also shows that the boundary wall separating the Cavalry Barracks from Le Cateau Barracks was breached.

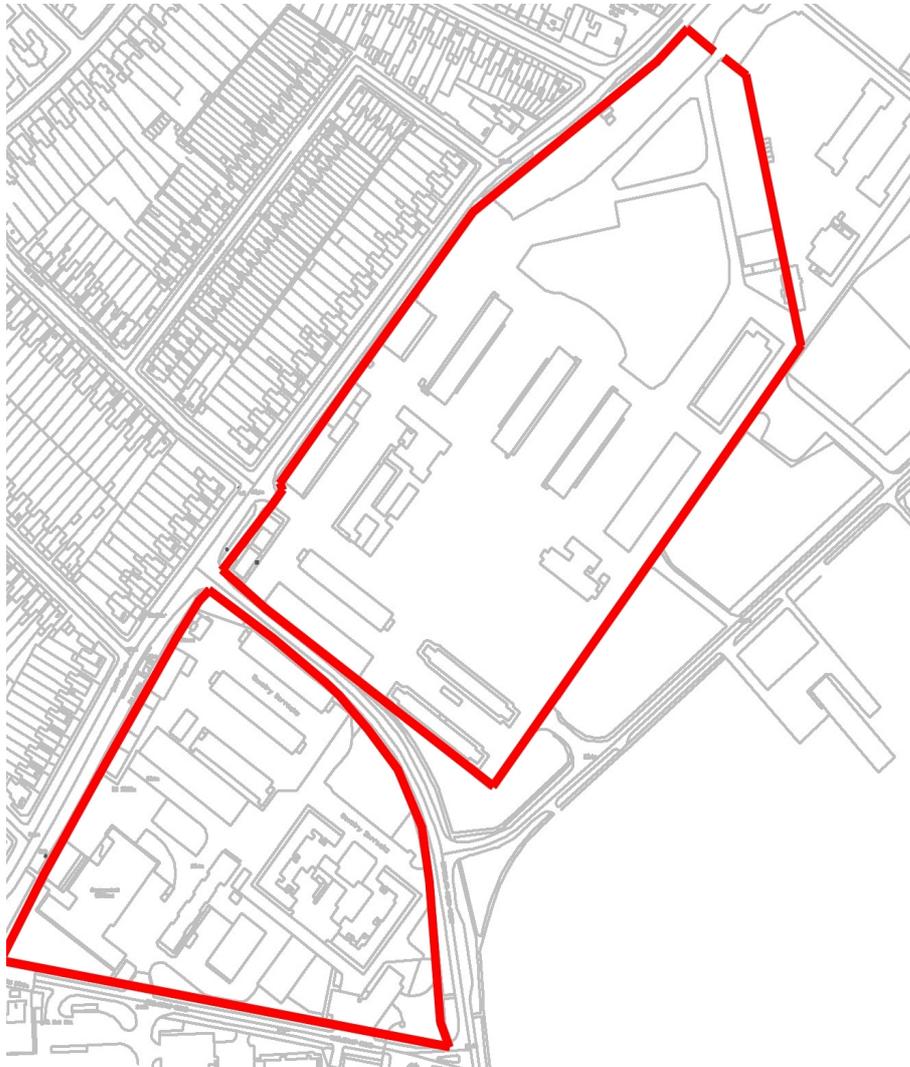
Illustration 8: modern O.S. map, with the boundary of the former Cavalry Barracks marked in red.

By far the greatest change to affect the Cavalry Barracks came in the late 1970s. The modern O.S. map (Illustration 8, below) clearly shows that the Cavalry Barracks ceased to function as an independent component of Colchester Garrison and was, instead, incorporated into the later barracks surrounding it.

The most visible sign of this is Circular Road West, the construction of which cut the Cavalry Barracks in two, linking the Abbey Field ring-road to the western suburbs. The insertion of this road destroyed two of the Soldiers' Quarters and one of the Troop Stables, as well as one of the Latrines and the Wicket Gate. It was probably at this time that the eastern boundary wall was removed and replaced with a chain-link fence closer to the buildings. The brick piers of the East Gate have been removed during the 21st-century redevelopment of the garrison, but they were, for a long time, visible standing among the trees alongside Circular Road North. Another significant change is the appearance of the Royal Military Police Station to the south-east of the Officers' Quarters. A small structure was constructed to the north-west of the remaining Officers' Stables. North of the new Circular Road West, the modern mapping shows the removal of many of the original buildings. The Staff Sergeants' Quarters to the east of the parade ground were removed, along with the Troop Stables with Soldier's Quarters Above to the north-east. Many of the buildings along the boundary wall have been demolished, leaving only the Shoeing Shed and Smithy and the Hay Store. The only original building to survive north of the remaining Troop Stables with Soldier's Quarters Above is the Riding School.

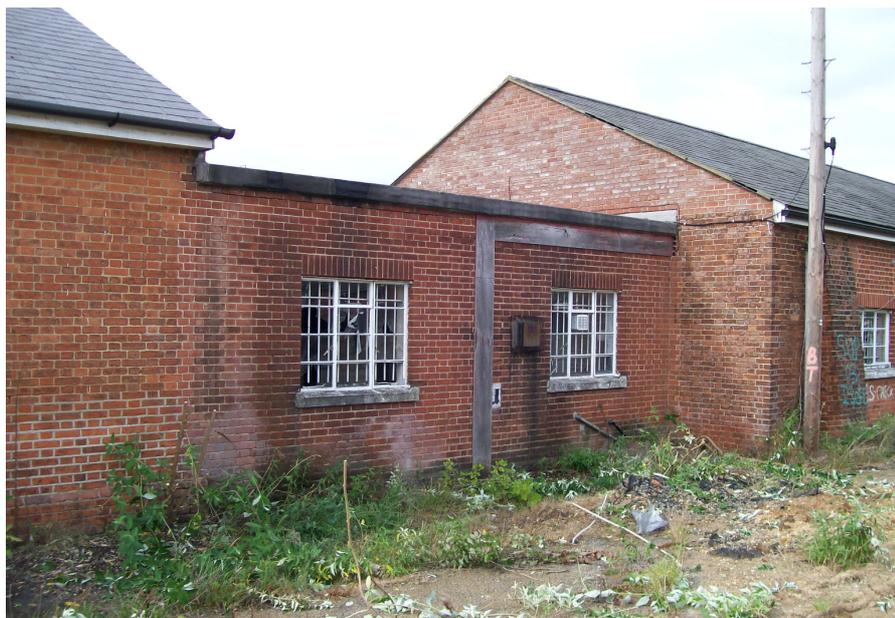
This small building joins Building 1, the Commissariat Reserve Stores, to Building 3, the Wagon Shed and Commissariat Reserve Store, being a much later addition to both of these original structures (Plate 2). It is a single-storey structure with a shallow, single-pitched roof of tarred felt. The south-east elevation is of red brick laid in Flemish bond with its other walls formed by the boundary wall to the rear and Buildings 1 and 3 to the south and north. Two Crittall windows with window heads of soldiers are symmetrically aligned in the south-east elevation. This is mirrored in the boundary wall although the windows in this elevation have been bricked in. The interior of this building is divided around a centrally-aligned corridor with one large room on the boundary wall side and two smaller rooms on the other side. The most southerly of the latter was used as a kitchen; it is not possible to say what purpose the other two rooms had.

Plate 2: Building 2 with the Wagon Shed to the right.

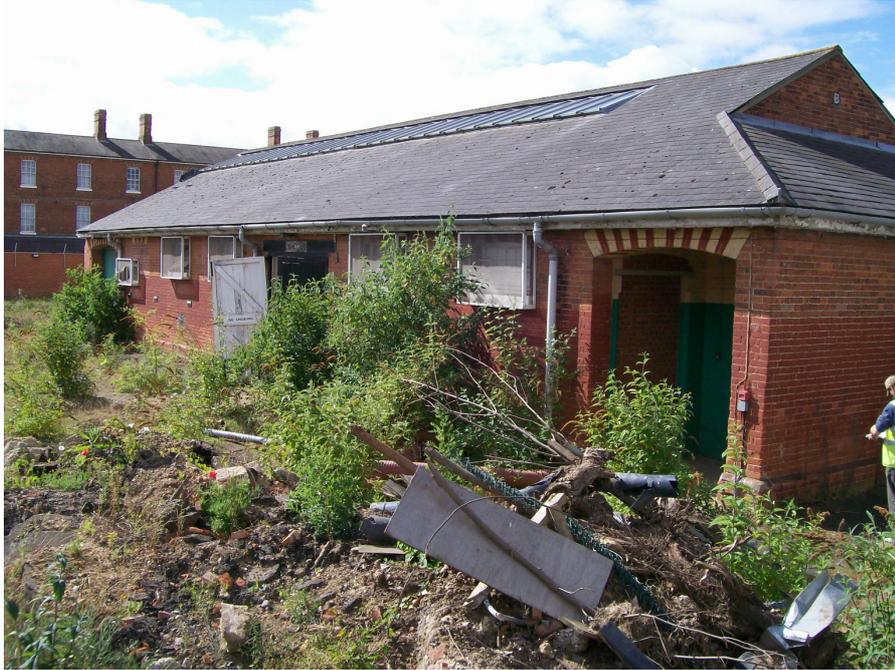
This is the surviving example of the two Officers' Stables which, with walls to the west and east, formed an enclosed stable yard with drinking troughs and a central dung-pit (Plate 3). It is a single-storey long rectangular structure of red brick laid in Flemish bond, with a small storage shed built onto the north-western end. The south-eastern end has been demolished, but map evidence suggests that a storage shed was attached to this end of the building also. The roof is pitched and covered with asbestos slates, and is fitted with a range of roof lights. Original features include a low red brick plinth, window and door heads of arched alternating red and yellow bricks, the use of York stone for sills and kerbs, and a drainage channel of Staffordshire blue bricks around the footprint of the building.

Plate 3: Building 4 (Officers' Stable) with Officers' Quarters in the background.

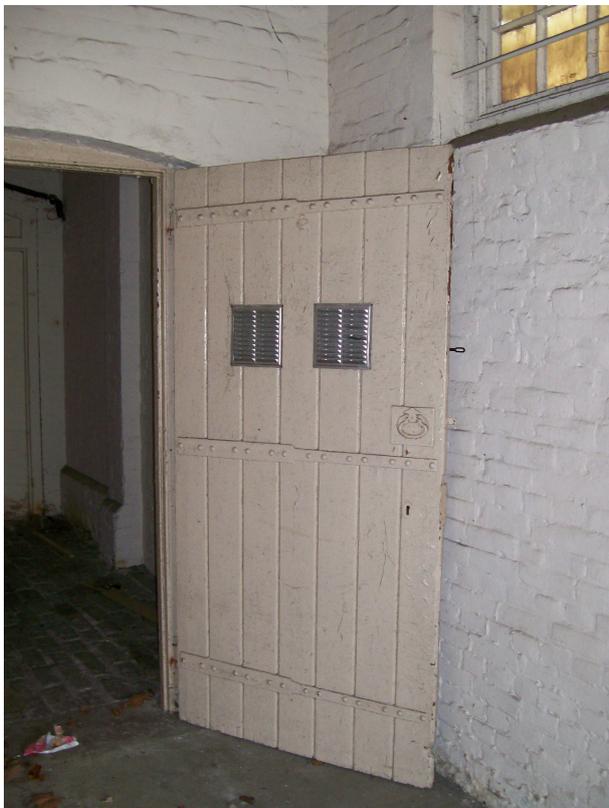
The surviving north-east elevation contains a brick porch at the north-western end leading to an enclosed space with an original door at either end (Plate 4). Beyond the far door is a brick porch projecting from the south-western façade of the main building. The entrance to this porch has been bricked in. To the left of the porch entrance, at the northern corner of the main range, is a bricked-in doorway. An identical doorway is located at the western corner. The north-western wall has a range of three windows, each of ten lights with glazing bars. These open inwards on side-mounted pivots and are operated by a means of a long metal chain (Plate 5). Four identical windows and one which has been bricked in can be found on the north-east elevation, which also contains two large entrances. Both have large double wooden plank doors, the ones furthest north opening outwards with a concrete lintel above. This is a later insertion to the façade and has completely removed a window. The entrance closer to what would have been the centre of the building has doors opening inwards with the characteristic brick arch above. This second entrance is original and opens into a corridor dividing the building. Doorways at each corner of this corridor (now bricked in) originally provided access to the interior of the stable in the same configuration as those at the north-western end of the building. In effect, the building comprises two separate stable blocks. The building has been demolished up to the wall forming this corridor, but map evidence suggests that this was the centre point for a line of symmetry and the main building has been reconstructed accordingly (Figs 4, 5). Map evidence suggests that the storage shed at the south-eastern end had a south-west projecting porch added sometime after 1921, and a photograph from the Ingram historic building assessment (Ingram 2000) shows the entrances at the corners of the building to have been reduced in height and width (Plate 6). The same photograph also shows that the area in front of these entrances was originally paved with granite setts.

Plate 4: Building 4; original door.

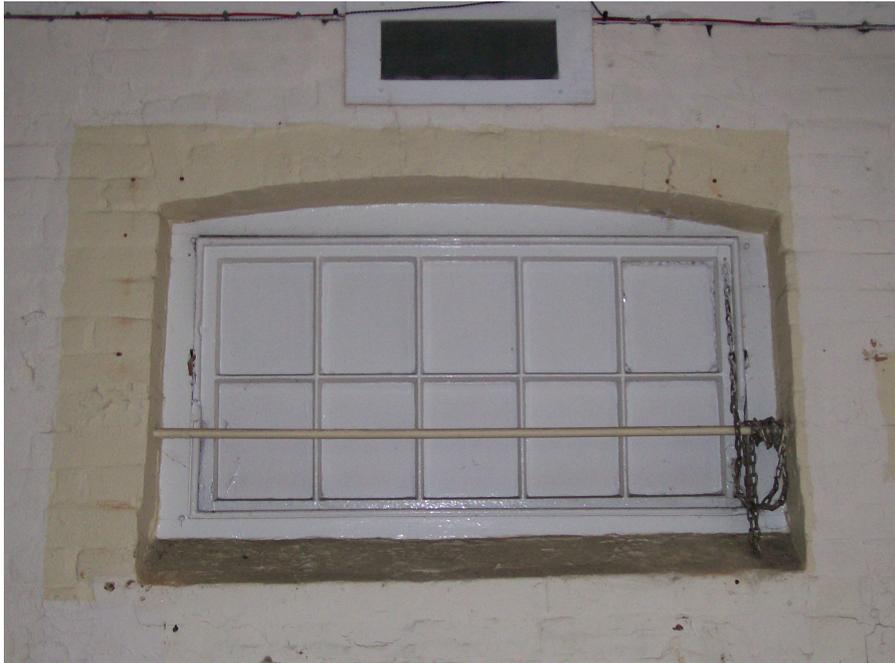
Plate 5: Building 4; stable window.

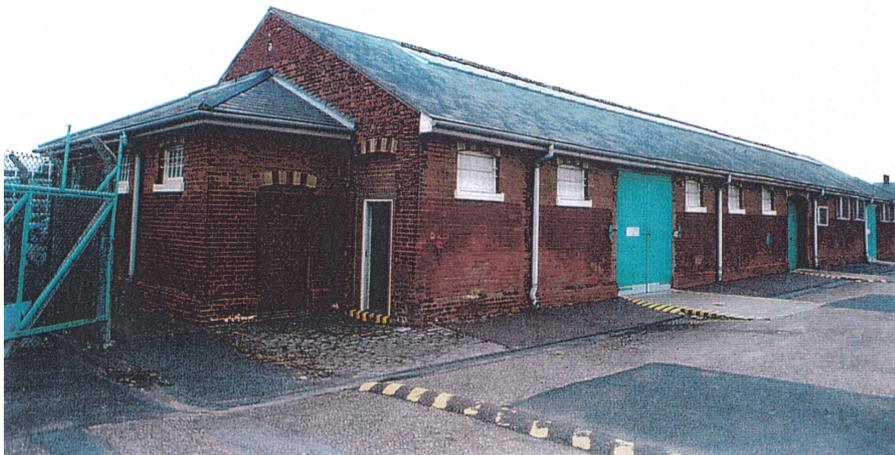
Plate 6: Building 4 prior to partial demolition. The granite setts can be seen in the foreground by the storage shed (Ingram 2000).

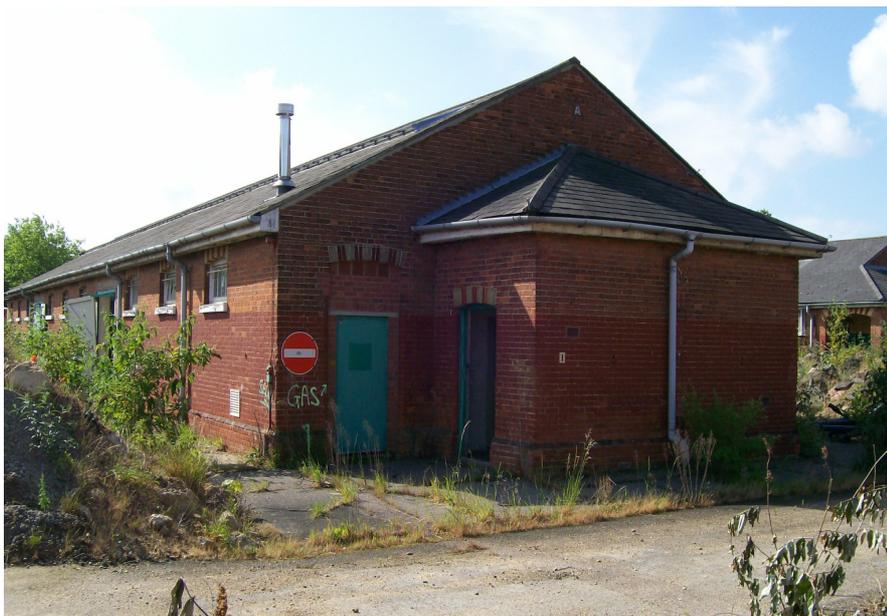
The storage shed on the north-western end is centrally located and does not extend the full width of the stable block. It is flanked by original entrances, both of which have been reduced in height and width. The storage shed has an entrance with the original wooden door in its north-eastern side and an original window high on the wall opposite. An entrance has been inserted from this shed into the main stable, but this is clearly later in origin. The north-east elevation of the main stable block has an alternating pattern of three windows followed by a large entrance of outward-opening double wooden doors with a concrete lintel above. This pattern is repeated and the length of the building, as shown on the O.S. map of 1875, suggests that the facade would have comprised three entrances and four sets of windows prior to the demolition of the south-eastern end. The concrete lintels indicate that these wide entrances are not original. Ranged along the wall beneath the most north-westerly of the windows are five unevenly spaced iron tethering rings (Plate 8).

Plate 7: Building 5, showing north-western storage shed and altered stable door.

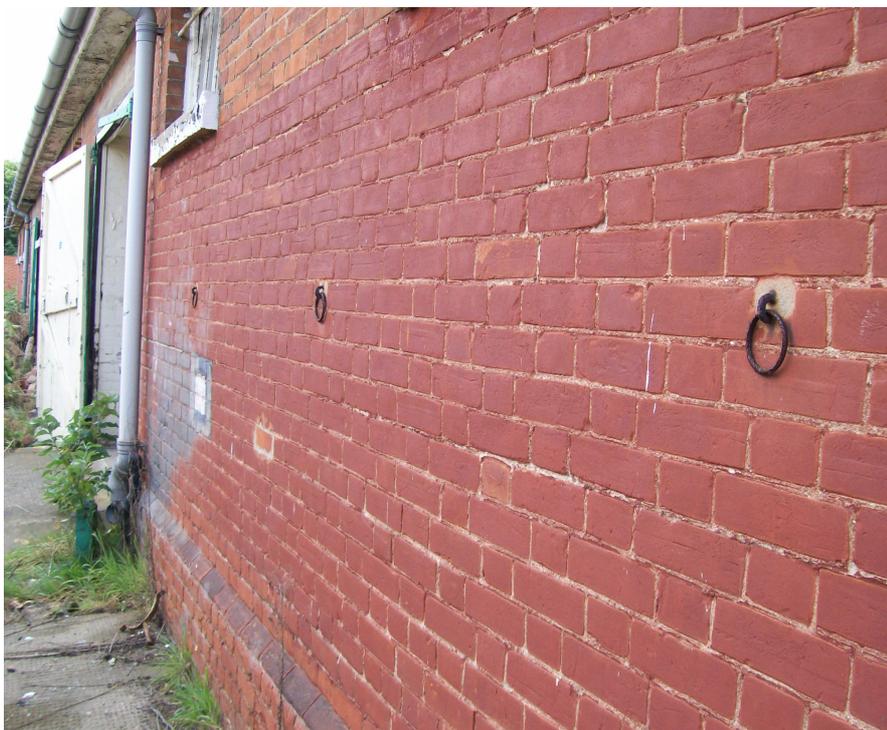
Plate 8: tethering rings on exterior of Building 5.

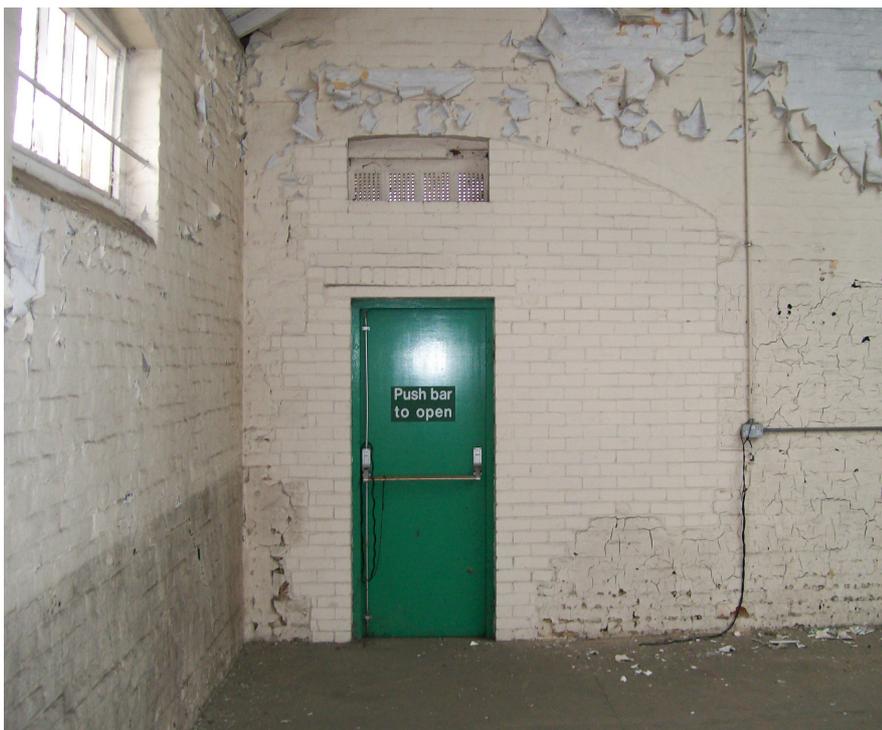
Plate 9: Building 5; the bricked-in archway of the original entrance with modern fire door where the opening would have been.

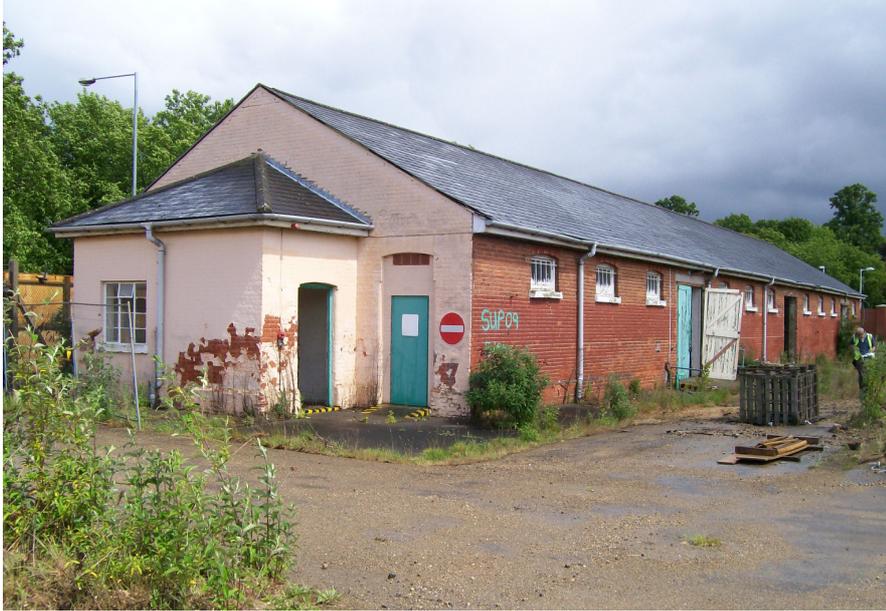
Plate 11: Building 6.

Building 6 was essentially identical to Building 5 at the time of construction. The only differences occur in the later alterations. Here the entrances on both of the long elevations have been widened to accommodate double wooden doors, with those on the north-eastern side subsequently bricked in, presumably when Circular Road West was constructed. The entrances to the main stable block on the north-west elevation have also been altered, again with one being subsequently bricked in. The storage shed on this elevation retains the original door and window but has had a later Crittall metal-framed window inserted into its long side (Plate 11). The north-west and north-east elevations have also been painted off-white. There are surviving tethering rings in the same locations as in Building 5, and a hay-bag tie can be observed on the south-west elevation near to the storage shed.

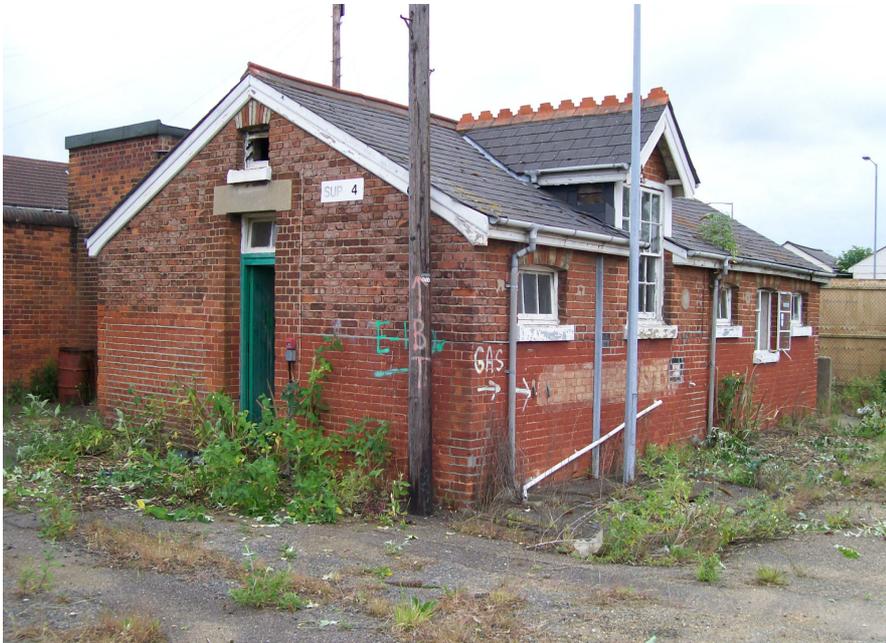
This building is a single-storey rectangular structure of red brick laid in Flemish bond and a pitched asbestos slate roof, with a flat, felted roofed extension to the rear joining it to the boundary wall (Plate 12). This extension is a later addition as is shown by the 1875 and 1897 O.S. maps which depict the structure as freestanding. The building originally functioned as the Ablution House in conjunction with the Soldiers' Latrine located to the north-east which was destroyed when Circular Road West was constructed in the late 1970s. The south-east elevation has a range of five windows, three of which are original, displaying the characteristic window heads of alternating red and yellow brick voussoirs. A later Crittall metal-framed window has been inserted into one of the original openings and is slightly wider than the arch of the window head. The remaining window of this elevation is a large dormer with an unhorned sash window of eight over eight lights. This has replaced the original entrance to the building. The ridgeline of this dormer has a crest of upright geometric tiles.

Plate 12: Building 7; the Ablution House with replacement dormer window and inserted entrance on short elevation. The later extension can be seen to the rear.

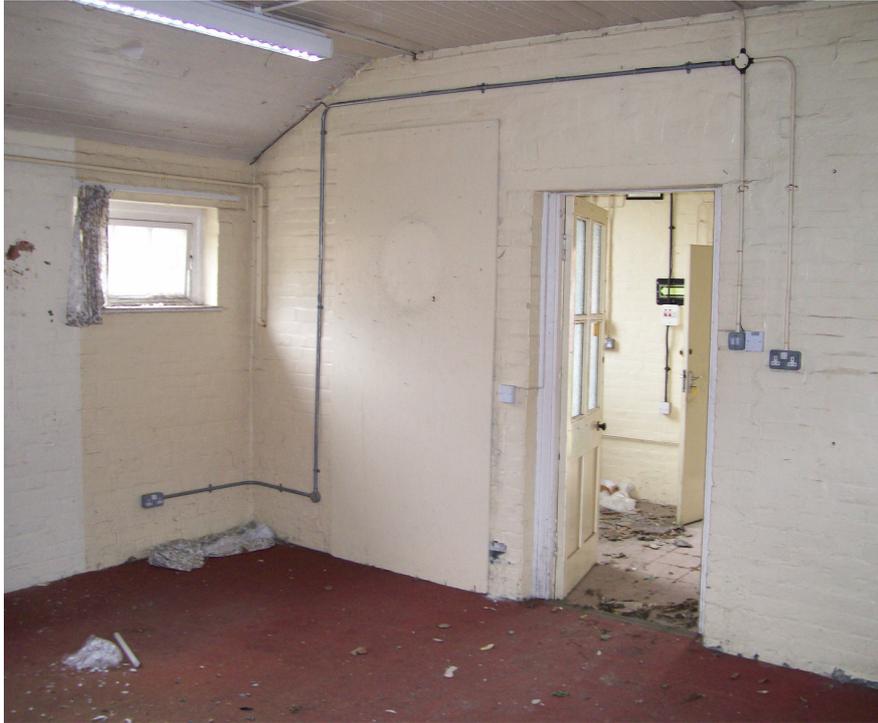
The interior of the former Ablution House has three distinct areas of increasing size. Off the south-western entrance are urinals and two WCs, on either side of a central passage. A door in a brick cross wall provides access to a larger room used as a kitchen, while a further door in a second cross wall provides access to a large square room, latterly used as an office. Both entrances in the cross walls show evidence of originally having been wider and of having a brick arch above. All three rooms have what appears to be the original boarded ceiling and have tiled floors, although the largest of the three rooms has carpeting concealing this (Plate 13). The rear wall of the central room is not original and has been moved further into the main block to accommodate the extension to the rear. The extension comprises a room with a WC and sink, closest to the main block, and a square room, which is empty except for shelving. As has been noted above, the height of the extension suggests the former presence of a water tank and these two rooms probably originally held the boiler room and equipment necessary to heat the water for the Ablution House. The tiled floor of the main block is original and reflects the function of the building. With the proximity of the Latrine to the north-east, it is unlikely that the smallest of the three rooms was ever originally designed as a lavatory. The presence of the louvred windows at either end of the building suggest that these rooms were designed to have a damp atmosphere and that the smallest of the rooms held sinks, whilst the largest was for baths, with the middle room doubling as both entrance and a place to heat water.

Plate 13: Building 7; the Ablution House, showing the original tiled floor and roof and the altered doorway.

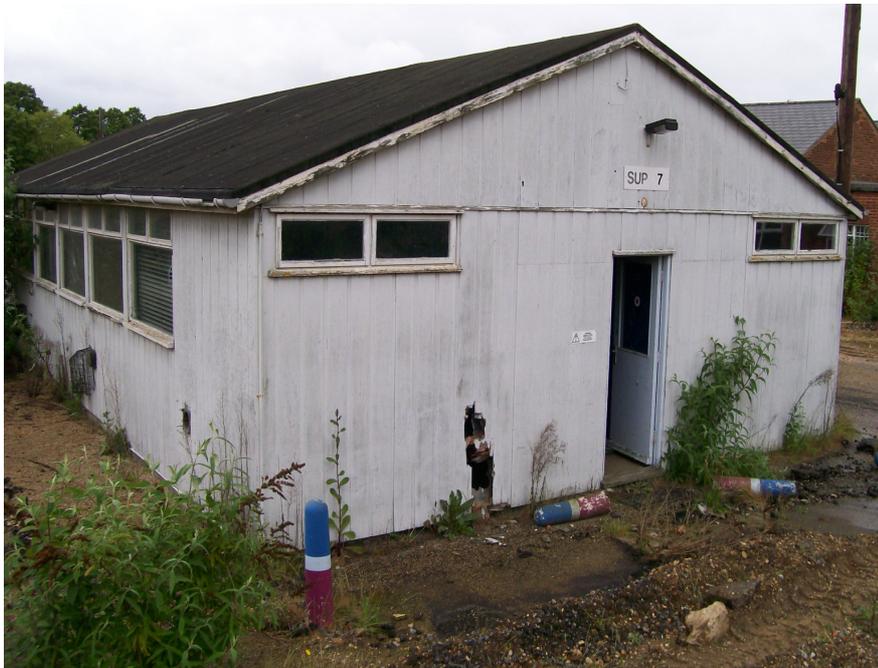
Plate 14: Building 8.

This building is a single-storey rectangular structure with a pitched felt roof and vertically-boarded cladding to the walls (Plate 14). Access is via off-centre doorways in either short end and there are six large windows on both of the long sides. The south-western end of this building is taken up with a WC and urinals on each side of the entrance and a large open-plan office. To the north-east of this are two square offices and a rectangular office on either side of a corridor leading from the entrance at this end of the building. This structure does not appear on the 1875, 1897 or 1921 O.S. maps and is only present on the modern O.S. map; as such it is likely to date to the latter half of the 20th century.

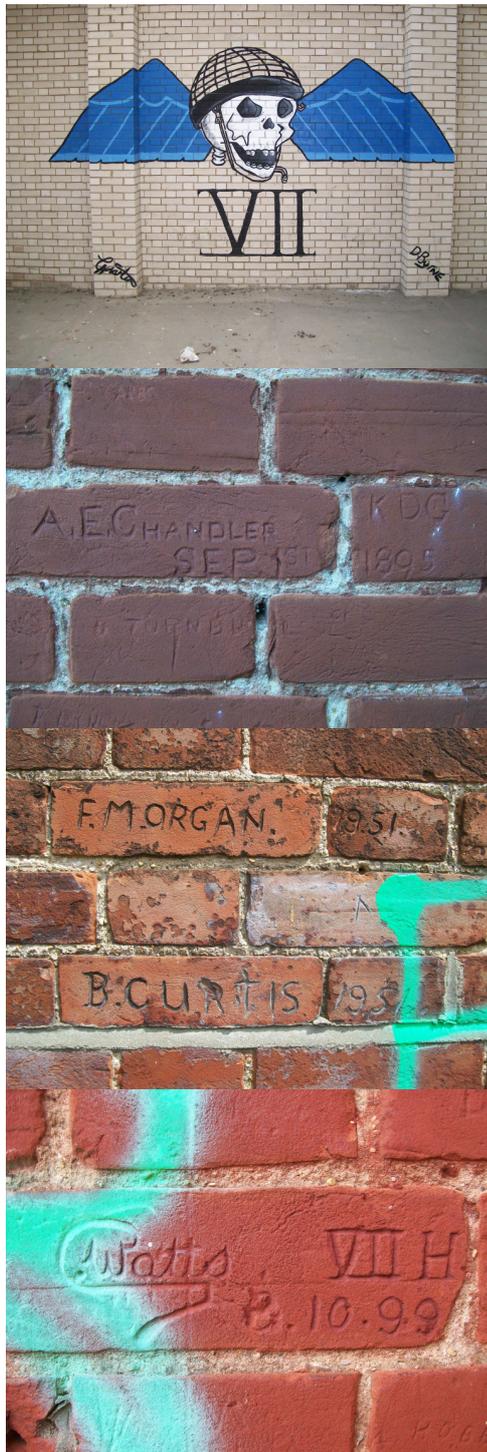
The buildings are also a tangible link with the men who served their country and were stationed at Colchester. Their graffiti provides a record, a snapshot in time of those individuals and, in some cases, perhaps a glimpse of their attitudes to their time in the Army and a desire to record their presence (Plate 15).

Plate 15: graffiti from two centuries.

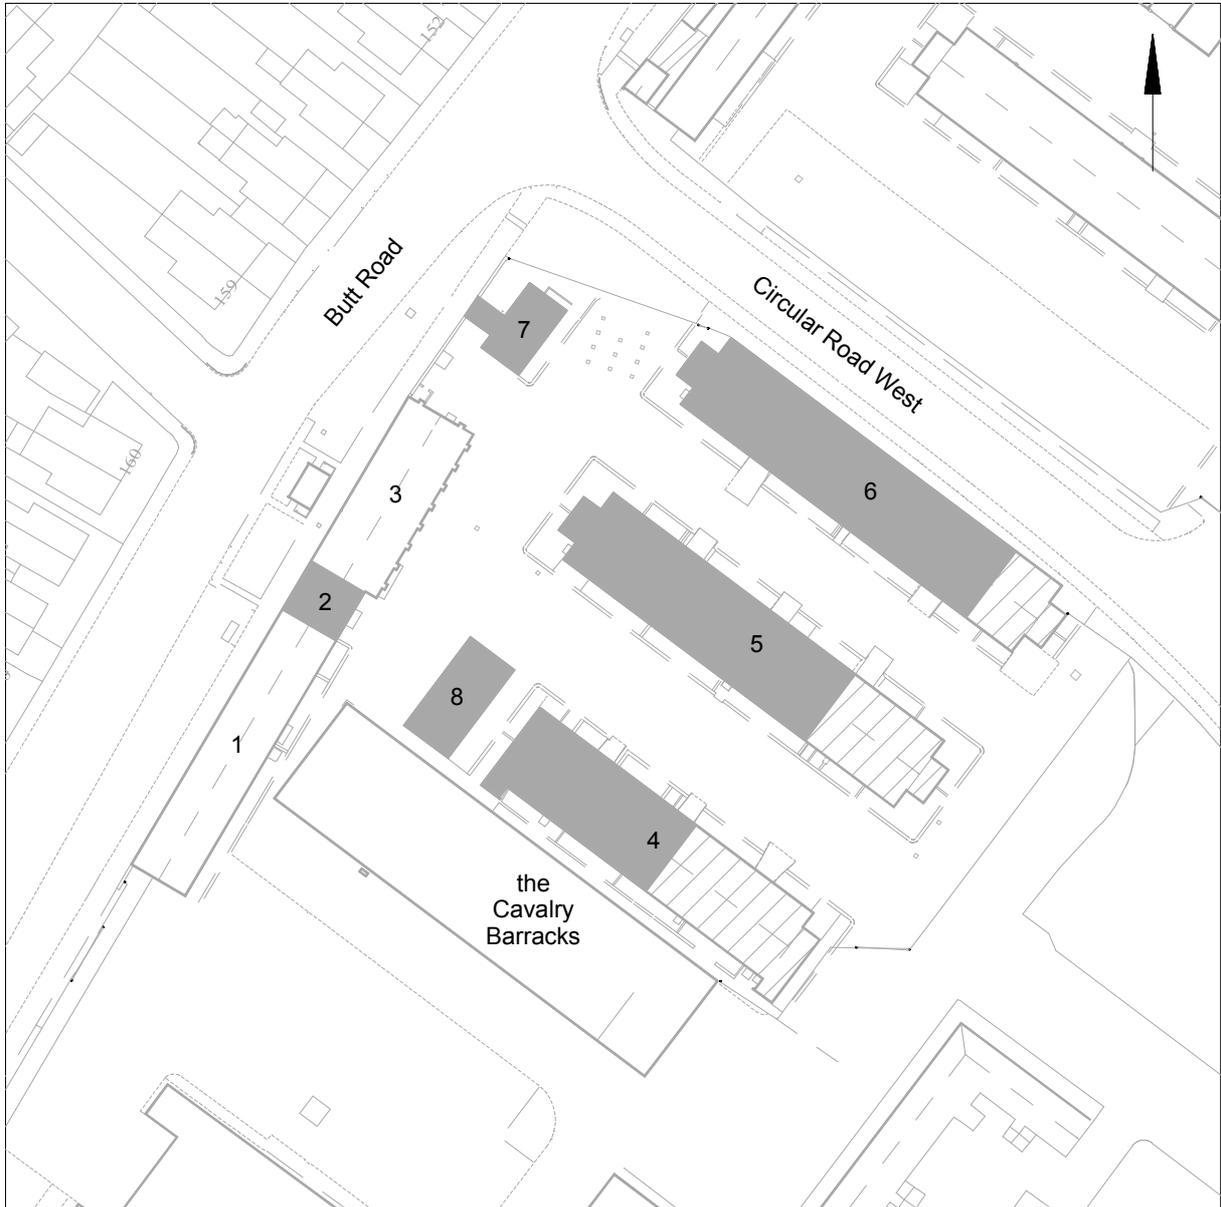
Fig 2 Block plan of Buildings 1-8.

The group of buildings has been numbered Buildings 1-8 (see Fig 2); Buildings 1 and 3 were not surveyed, but Buildings 2 and 4-8 were surveyed as they are scheduled for demolition. (The Garrison Riding School was built as part of the Cavalry Barracks in the early 1860s. It is a Grade II listed building and is not included in this survey, but it is shown on Figs 1 and 12. It was surveyed by CAT in February 2011 (CAT Report 585) ahead of conversion.)

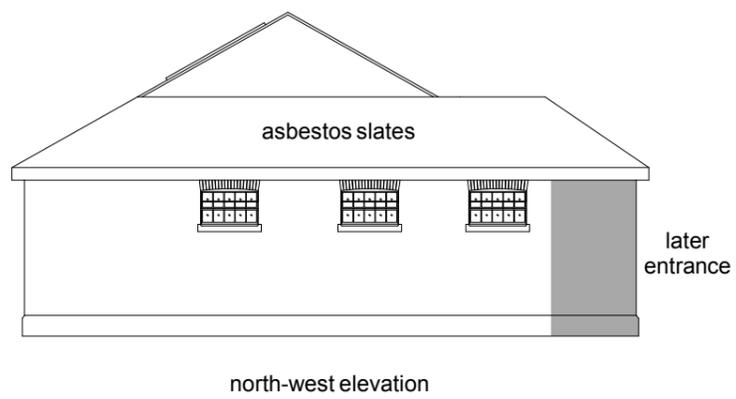
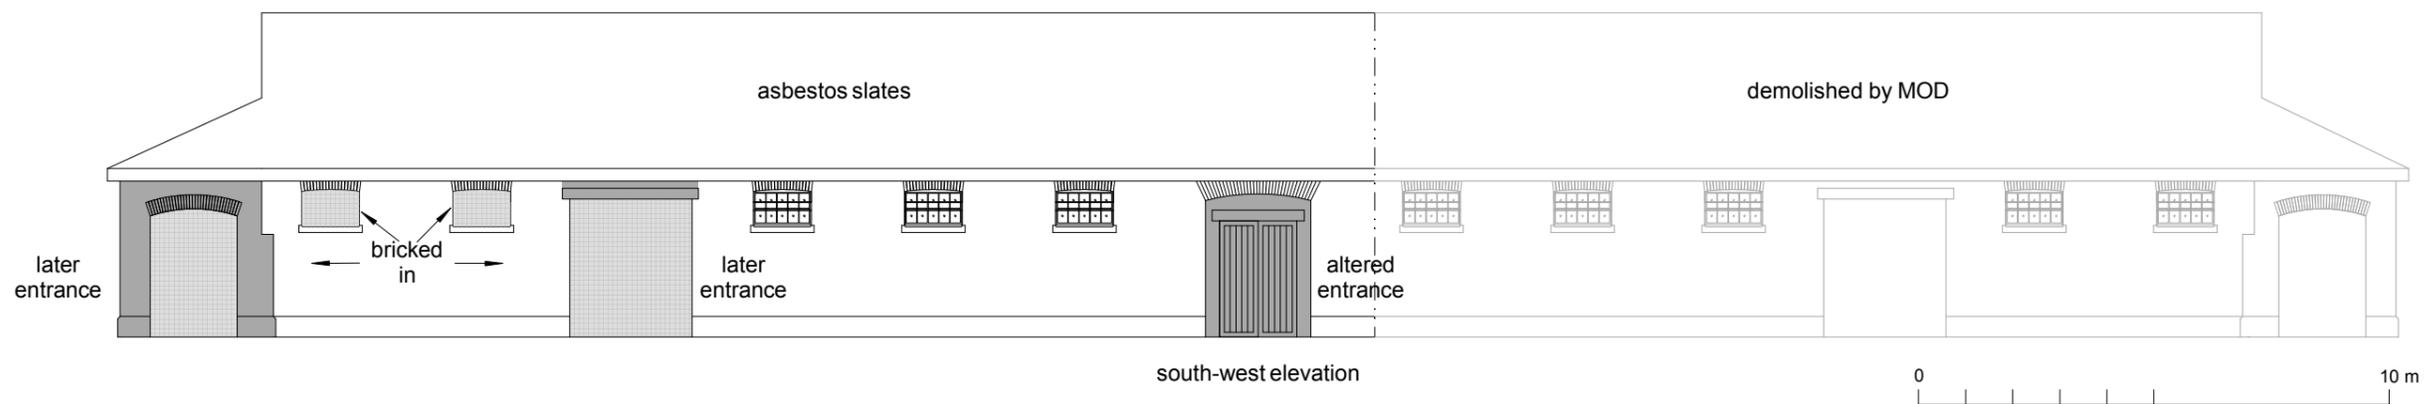
Fig 4 Building 4 (Officers' Stables): elevations.

The south-west elevation is identical to the north-east elevation in layout, but this has two bricked-in windows and the later entrance is also blocked. The central entrance on this elevation has been reduced in width and height.

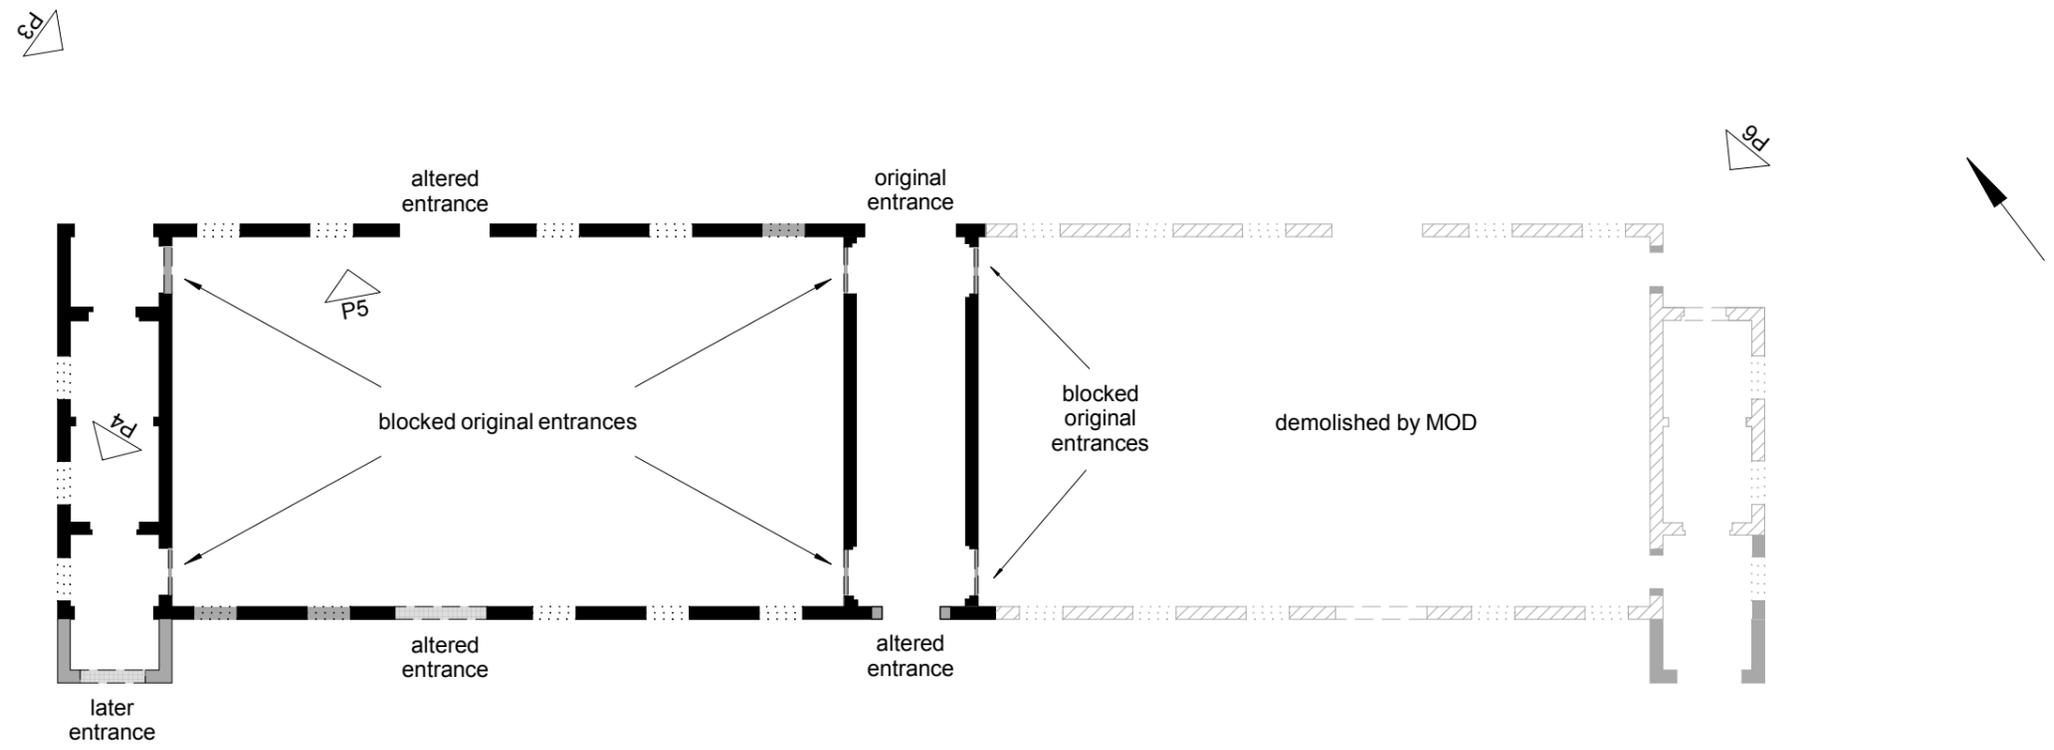
Fig 5 Building 4 (Officers' Stables): plan.

The interior of the Officers' Stable is a large empty space with a concrete and tile floor. Five wooden trusses held by iron bolts and banding support two large purlins on either side of the ridgeline. Originally the four doors at the ends of the block each had a sliding top section and a swing hung

lower section and would have provided access to a walkway paved with Staffordshire blue blocks around the perimeter of the stable (Fig 13). Off this walkway were individual horse stalls (eleven to a side) separated by metal bars hanging from chains fastened to a central masonry spine and iron posts. Although no trace remains of this, a litter shed was attached to the south-west elevation facing the enclosed stable yard.
