**Building recording at Area K1,
the former Cavalry Barracks, Butt Road,
Colchester, Essex
May 2011**

CAT project ref.: 11/5g
Colchester and Ipswich Museums accession code: COLEM 2011.41
NGR: TL 9896 2422 (c)

CAT Report 606
August 2011

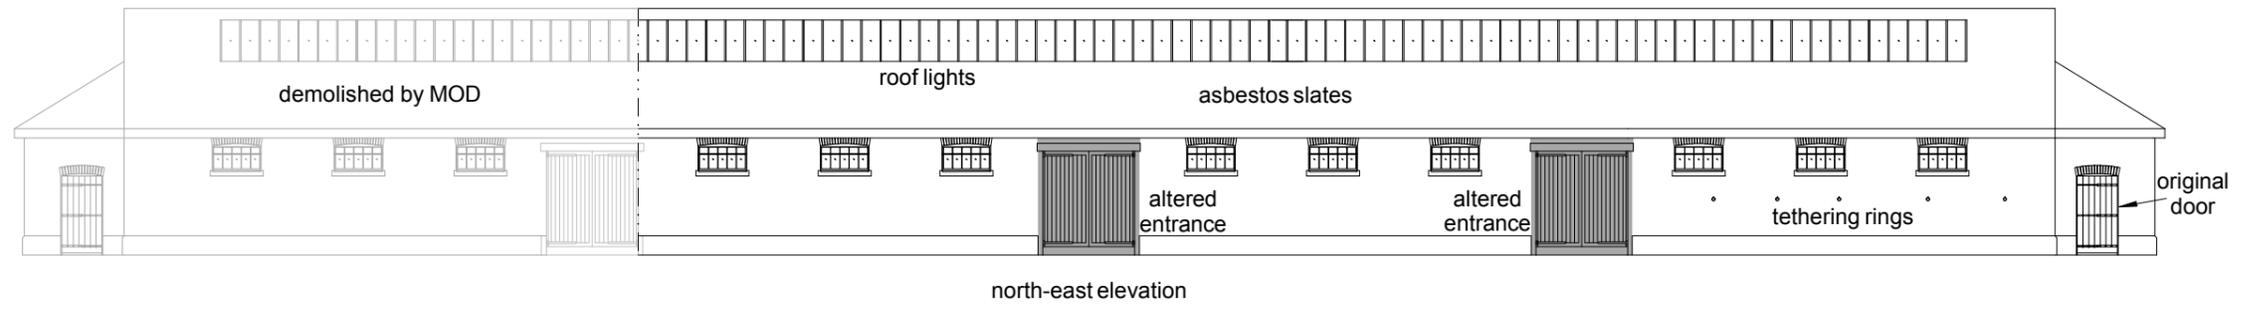
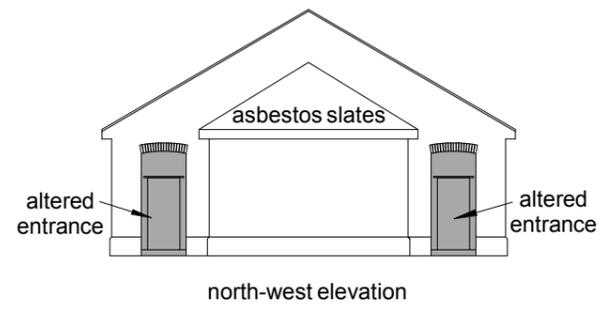
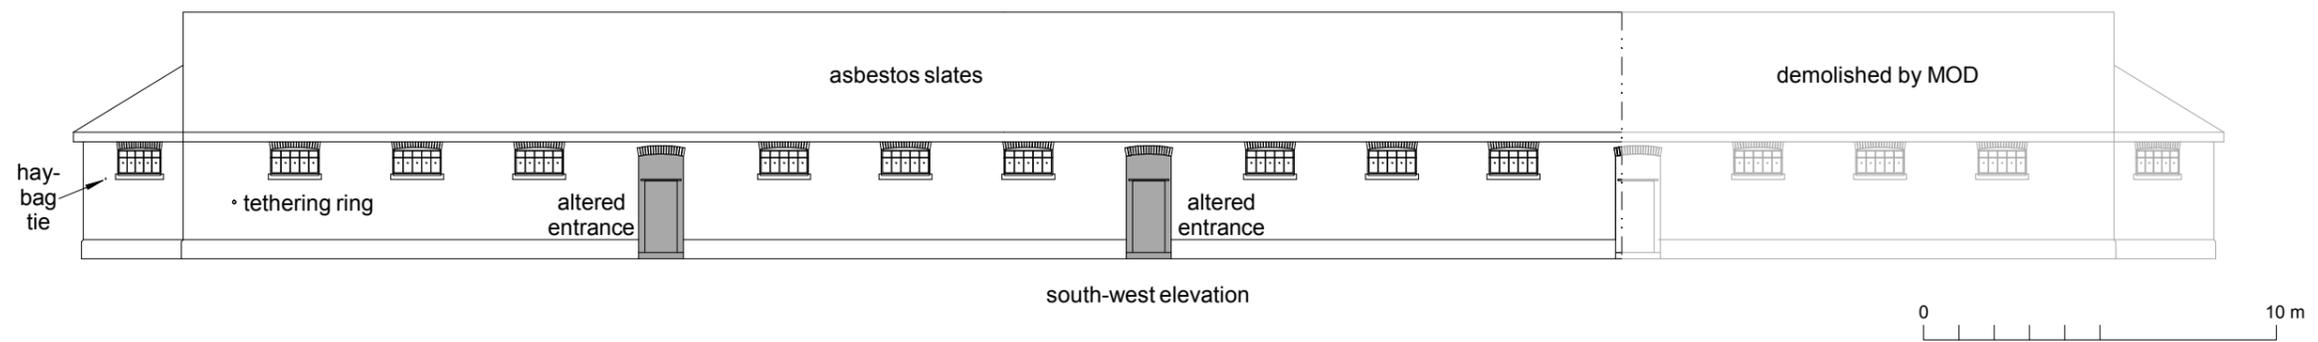
Fig 6 Building 5 (Troop Stables): elevations.

The storage shed on the north-western end is centrally located and does not extend the full width of the stable block. It is flanked by original entrances, both of which have been reduced in height and width. The storage shed has an entrance with the original wooden door in its north-eastern side and an original window high on the wall opposite. An entrance has been inserted from this shed into the main stable, but this is clearly later in origin. The north-east elevation of the main stable block has an alternating pattern of three windows followed by a large entrance of outward-opening double wooden doors with a concrete lintel above. This pattern is repeated and the length of the building, as shown on the O.S. map of 1875, suggests that the facade would have comprised three entrances and four sets of windows prior to the demolition of the south-eastern end. The concrete lintels indicate that these wide entrances are not original. Ranged along the wall beneath the most north-westerly of the windows are five unevenly spaced iron tethering rings (Plate 8).

The south-east elevation follows the same pattern of windows and entrances but here the entrances are narrower. Door heads of the characteristic alternating red and yellow voussoirs indicate that these entrances are original. They have, however, been reduced in width and height with the original stable doors being replaced with modern fire doors. It is logical to assume that this is what the north-east elevation would have resembled before the insertion of the larger entrances. Only one tethering ring is found on this elevation but there is an iron tie for a hay bag protruding from the storage shed. It is possible that more of these original fittings have been lost over time, but the surviving locations of fittings confirm what is shown most clearly on the O.S. map of 1897. The two large rectangles projecting from the long sides of the building are litter sheds flanking the central entrances, and the smaller rectangle probably represents a water trough. Taking this into account, it is possible that the rings surveyed (and the equivalent ones lost at the demolished end) represent the total number of tethering rings that were originally attached to the building.

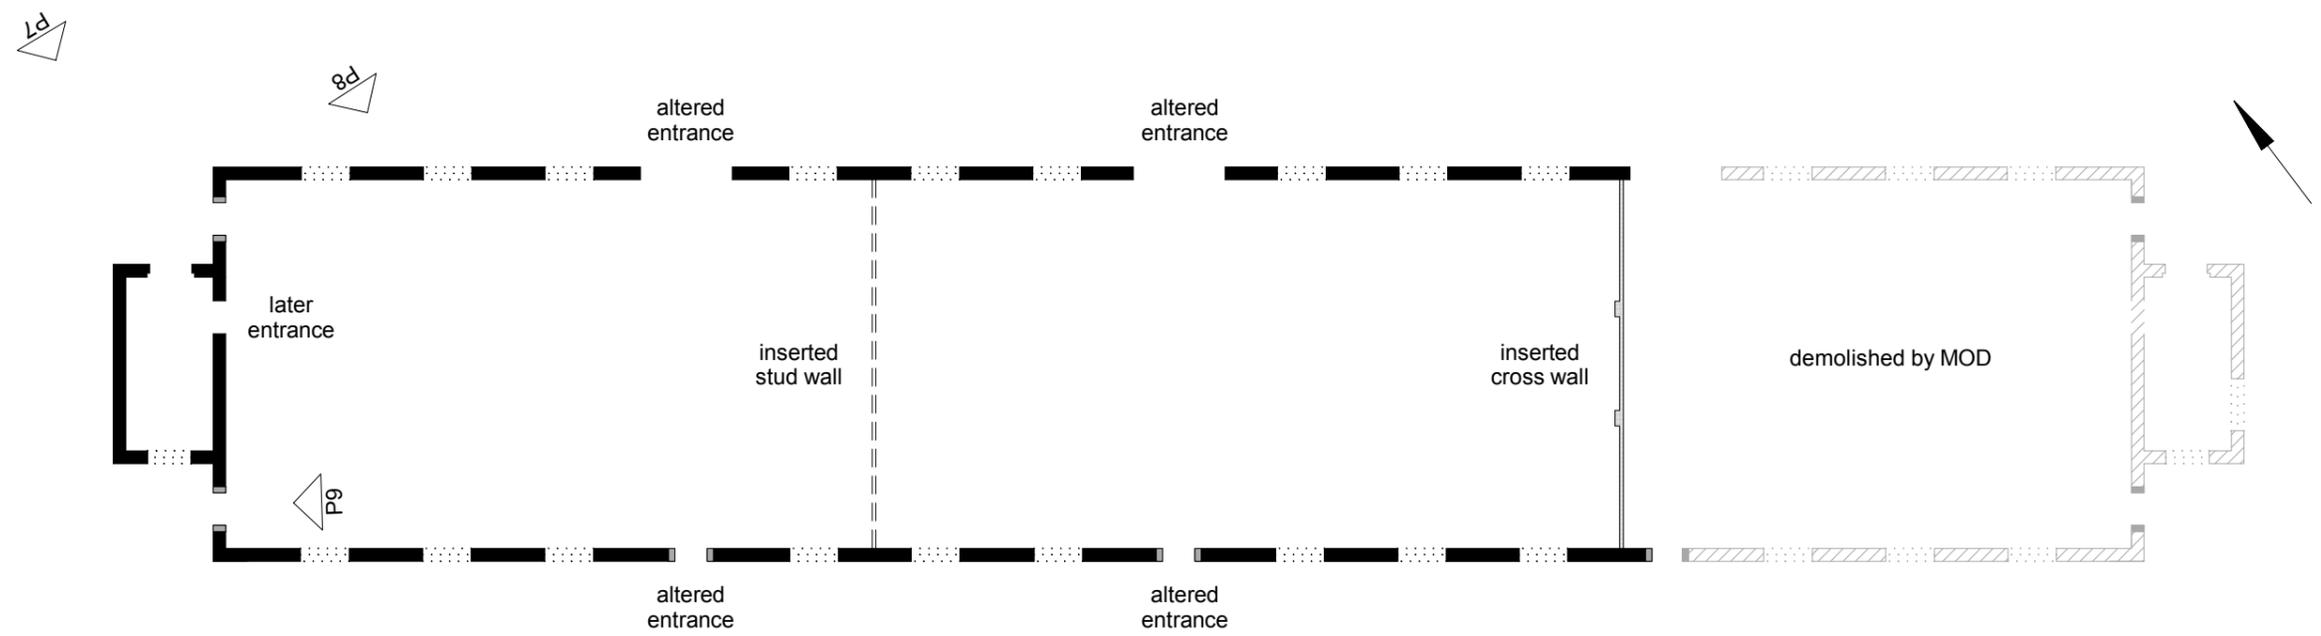
Fig 7 Building 5 (Troop Stables): plan.

This is one of the two examples of the Troop Stables recorded during the survey. It is a single-storey long rectangular structure of red brick laid in Flemish bond, with a small storage shed built onto the north-western end (Plate 7). The south-eastern end has been demolished, but map evidence suggests that a storage shed was also attached to this end of the building. The roof is pitched and covered with asbestos slates, and is fitted with a range of roof lights. Original features include a low red brick plinth, window and door heads of arched alternating red and yellow bricks, the use of York stone for sills and kerbs, and a drainage channel of Staffordshire blue bricks around the footprint of the building.

The interior of Building 5 is a large empty space subdivided roughly into thirds by a stud wall to the north-western end and a concrete block wall to the south-eastern end. Both of these are full height to the ridgeline and the building has been demolished to the line of the concrete block wall. The floor is of concrete. No evidence remains of original fixtures or fittings but it is possible to see the original brick archways which housed the sliding/swinging stable doors (Plates 9-10). The roof is of the same construction as Building 4, with wooden trusses held in place with iron bolts and strapping. The internal arrangement of Building 5 would have been the same as that of the Officers' Stables, only on a larger scale. This building

would have had 56 stalls, 28 on either side of a central spine with a walkway around the outer walls.

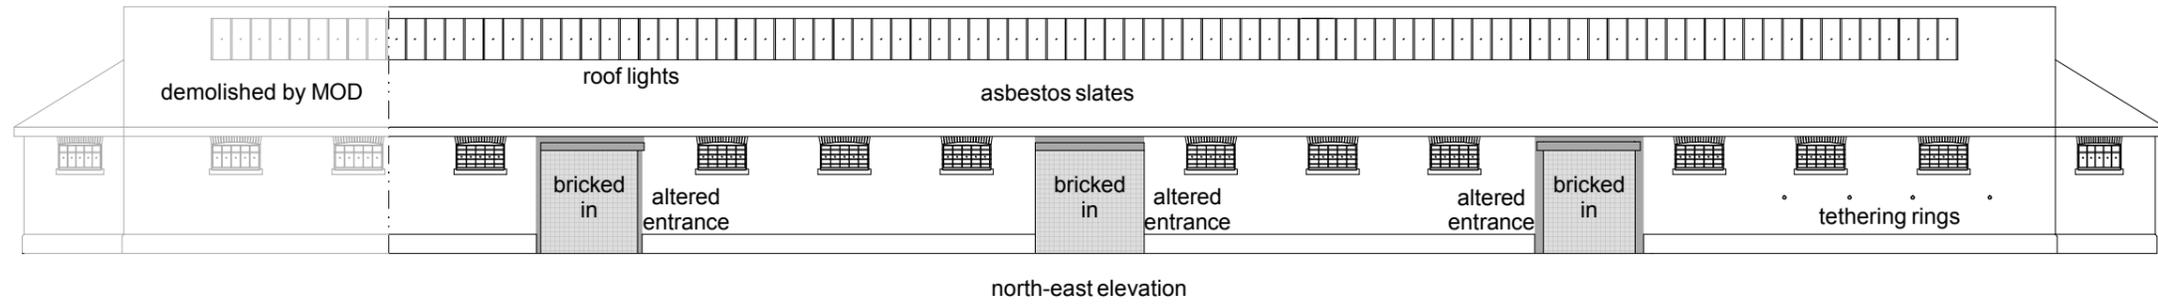
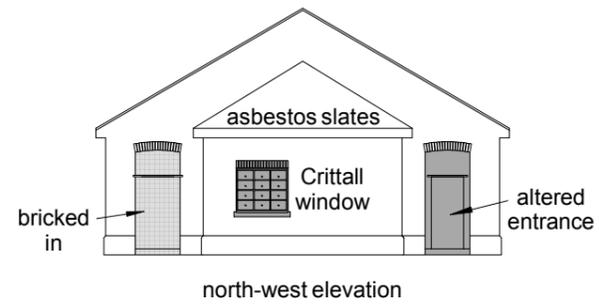
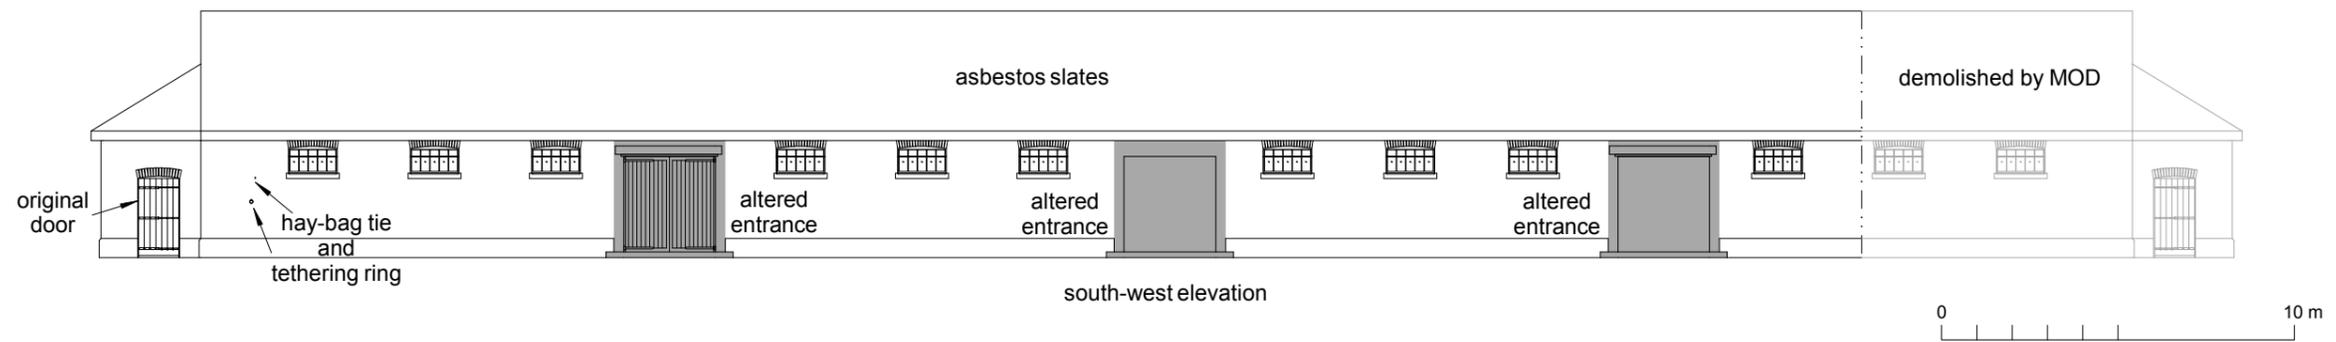
Fig 8 Building 6 (Troop Stables): elevations.

Building 6 was essentially identical to Building 5 at the time of construction. The only differences occur in the later alterations. Here the entrances on both of the long elevations have been widened to accommodate double wooden doors, with those on the north-eastern side subsequently bricked in, presumably when Circular Road West was constructed. The entrances to the main stable block on the north-west elevation have also been altered, again with one being subsequently bricked in. The storage shed on this elevation retains the original door and window but has had a later Crittall metal-framed window inserted into its long side (Plate 11). The north-west and north-east elevations have also been painted off-white. There are surviving tethering rings in the same locations as in Building 5, and a hay-bag tie can be observed on the south-west elevation near to the storage shed.

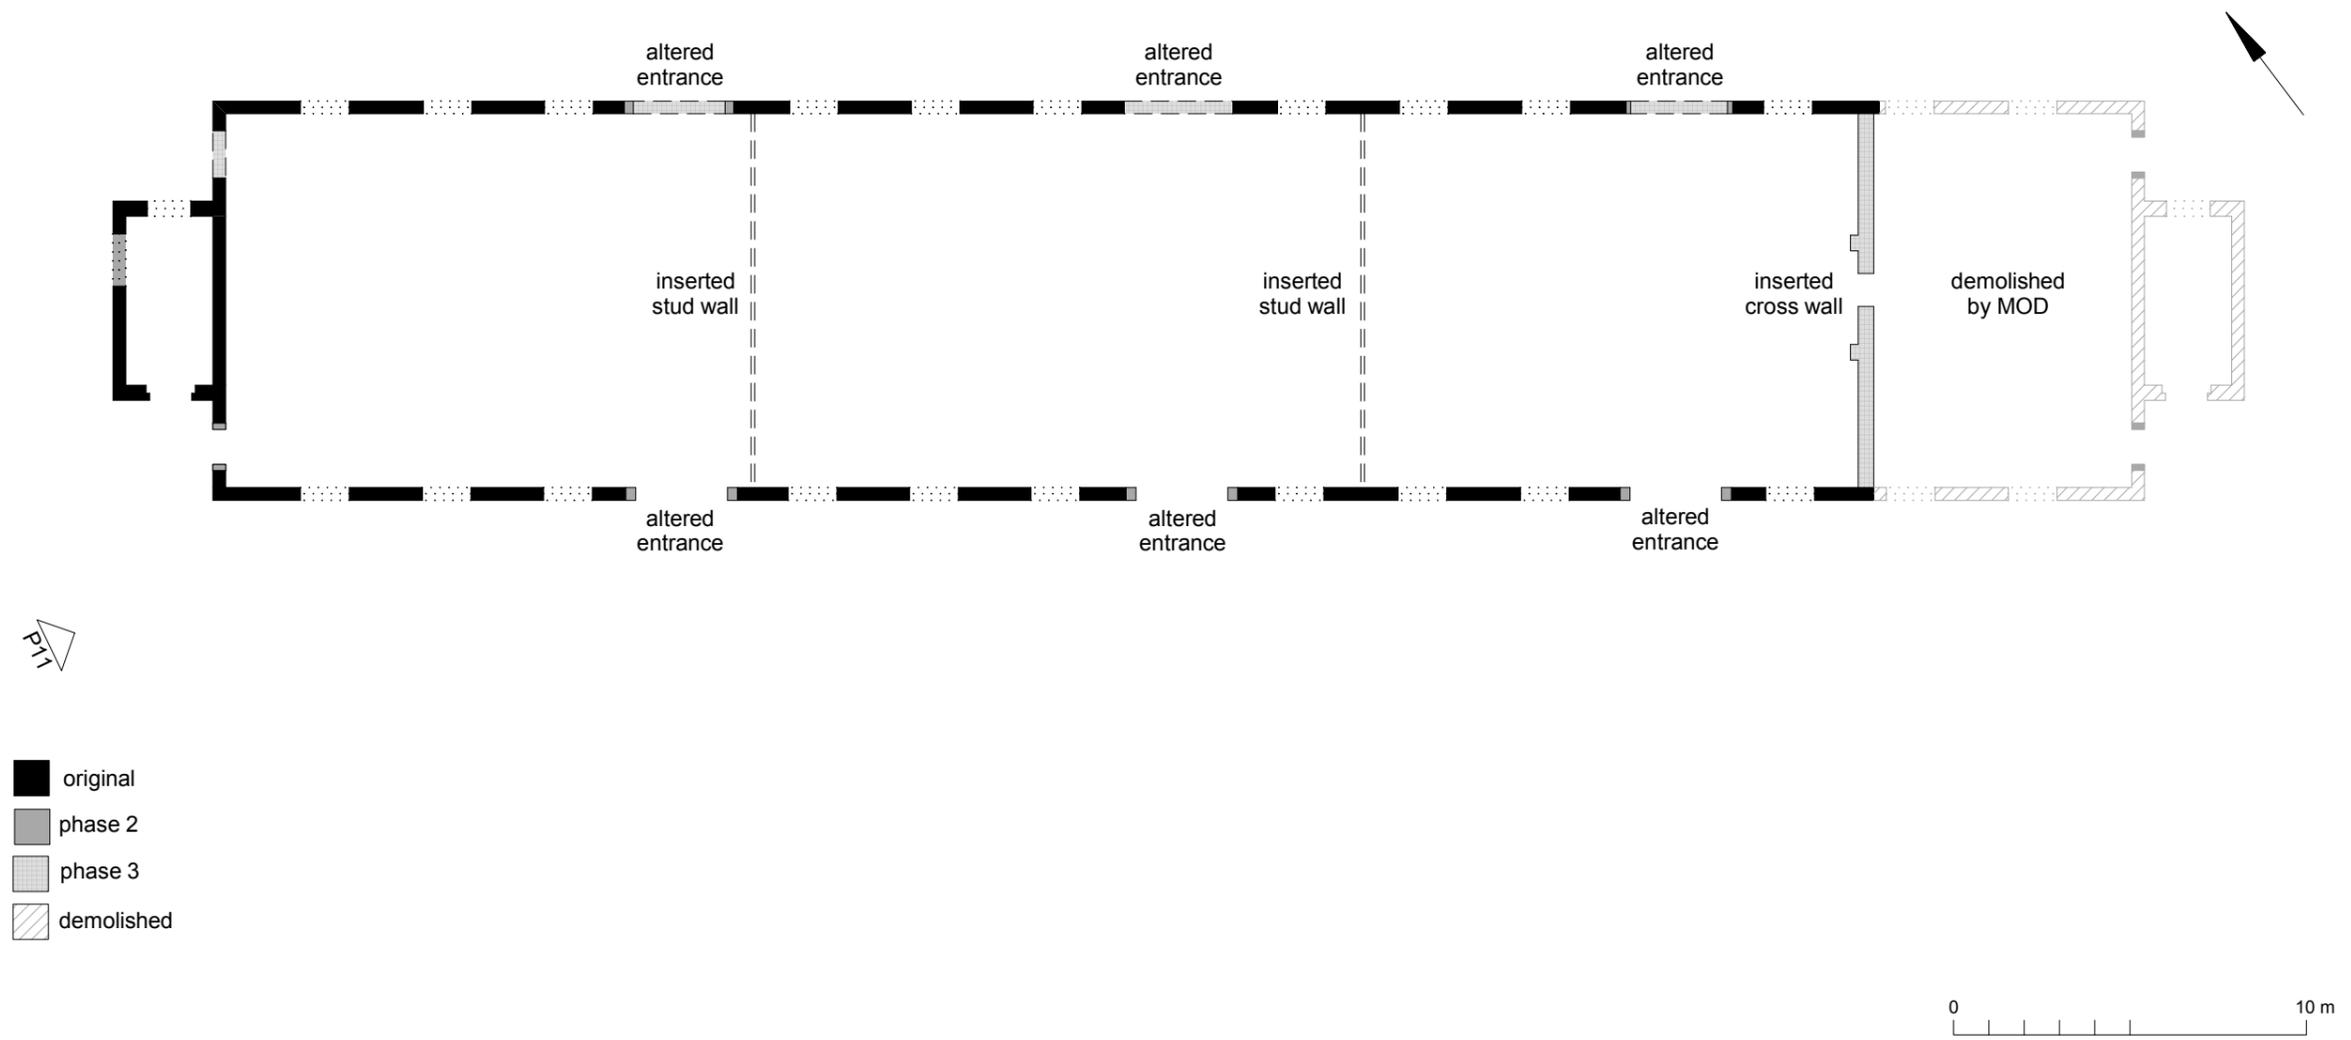
Fig 9 Building 6 (Troop Stables): plan.

The interior of Building 6 is a large empty space subdivided into three unequal parts. Two of these divisions are formed by wooden stud walls, the third by a concrete block wall with a door located off-centre. Building 6 has been demolished up to this wall. The floor is of concrete, and wooden trusses held in place with iron bolts and strapping support the roof. The original internal plan would have been the same as Building 5 and there would have been identical litter sheds and water troughs attached to the long sides.

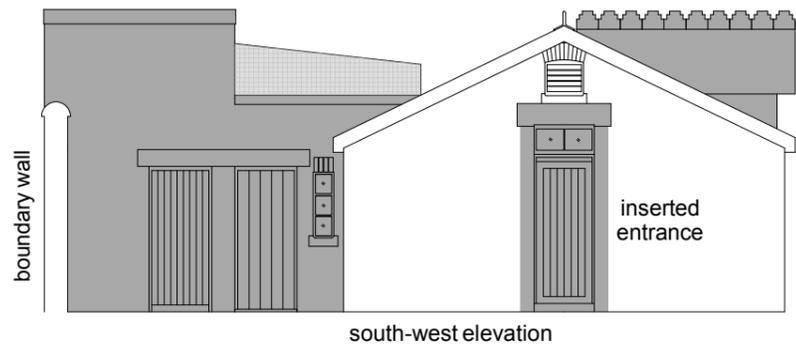
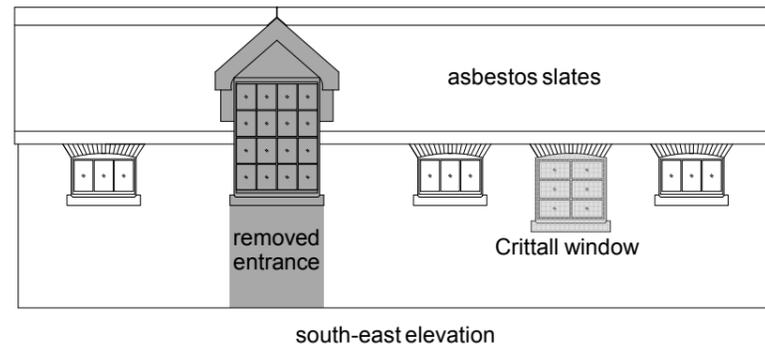
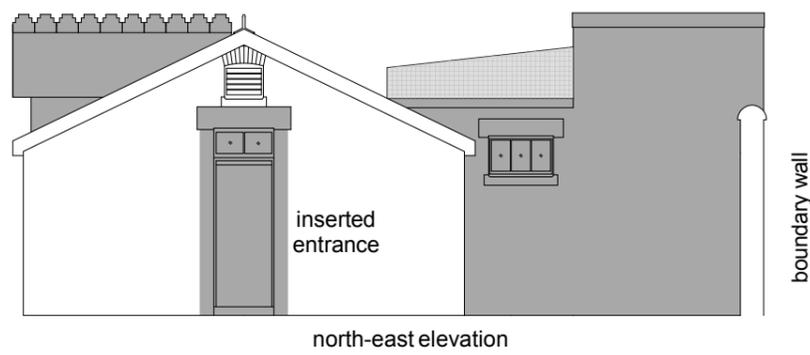
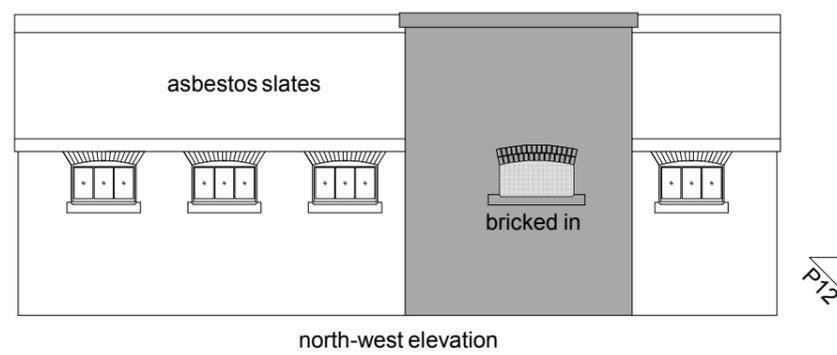
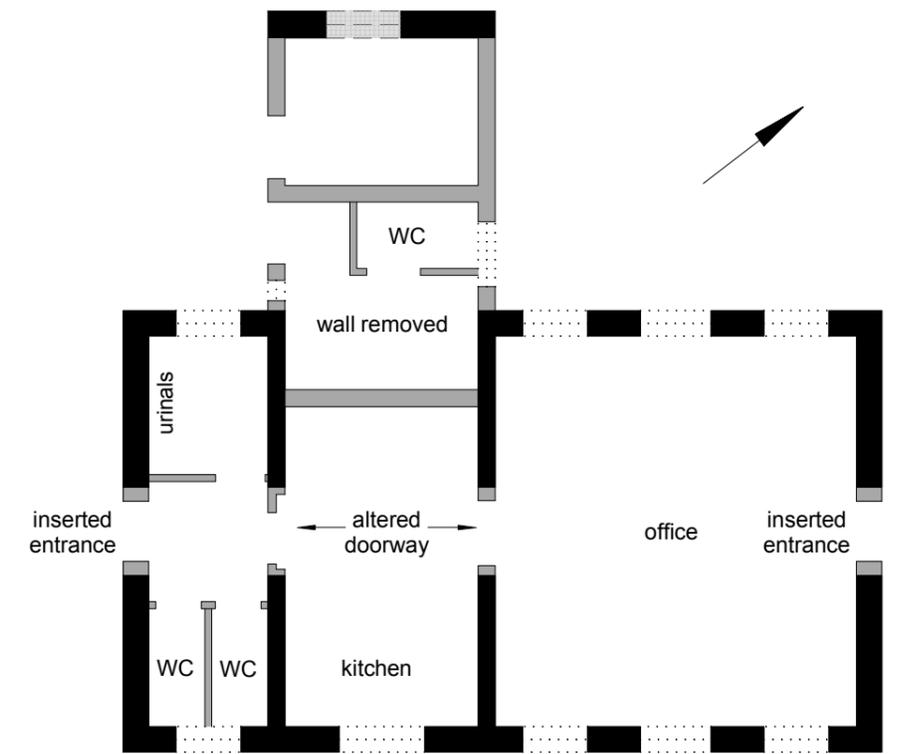
This building is a single-storey rectangular structure of red brick laid in Flemish bond and a pitched asbestos slate roof, with a flat, felted roofed extension to the rear joining it to the boundary wall (Plate 12). This extension is a later addition as is shown by the 1875 and 1897 O.S. maps which depict the structure as freestanding. The building originally functioned as the Ablution House in conjunction with the Soldiers' Latrine located to the north-east which was destroyed when Circular Road West was constructed in the late 1970s. The south-east elevation has a range of five windows, three of which are original, displaying the characteristic window heads of alternating red and yellow brick voussoirs. A later Crittall metal-framed window has been inserted into one of the original openings and is slightly wider than the arch of the window head. The remaining window of this elevation is a large dormer with an unhorned sash window of eight over eight lights. This has replaced the original entrance to the building. The ridgeline of this dormer has a crest of upright geometric tiles.

The north-west elevation, the rear of the building, has four original windows in line with those on the front elevation. A probable fifth window, in line with the original entrance, has been removed by the construction of the extension. However, a window looking out onto Butt Road does exist where this extension is tied into the boundary wall. This has been bricked in at a later date.

The south-west elevation shows a centrally-located entrance inserted into the short end of the original structure. This has two small lights above it and is surmounted by a deep cast concrete lintel. Directly above this lintel is an original small, square-shaped louvred window with a York stone sill and the characteristic window head. Immediately to the rear of the main structure is the later extension. The south-west elevation has a narrow Crittall window of three lights and two single door entrances surmounted by a wide concrete lintel, opening into two separate rooms. These flat-roofed rooms are of differing height, with the one tied into the boundary wall being built higher than the wall itself. It is probable that this increased height housed a water tank to provide pressure, although there is no direct

The north-west elevation displays the same inserted entrance and original louvred window as the opposite end on the main block, while the facade of the extension has a window near to the eaves of the lower-roofed room. This window is of the same dimensions as the original ones in the main block but has a sill and lintel of cast concrete.

The interior of the former Ablution House has three distinct areas of increasing size. Off the south-western entrance are urinals and two WCs, on either side of a central passage. A door in a brick cross wall provides access to a larger room used as a kitchen, while a further door in a second cross wall provides access to a large square room, latterly used as an office. Both entrances in the cross walls show evidence of originally having been wider and of having a brick arch above. All three rooms have what appears to be the original boarded ceiling and have tiled floors, although the largest of the three rooms has carpeting concealing this (Plate 13). The rear wall of the central room is not original and has been moved further into the main block to accommodate the extension to the rear. The extension comprises a room with a WC and sink, closest to the main block, and a square room, which is empty except for shelving. As has been noted above, the height of the extension suggests the former presence of a water tank and these two rooms probably originally held the boiler room and equipment necessary to heat the water for the Ablution House. The tiled floor of the main block is original and reflects the function of the building. With the proximity of the Latrine to the north-east, it is unlikely that the smallest of the three rooms was ever originally designed as a lavatory. The presence of the louvred windows at either end of the building suggest that these rooms were designed to have a damp atmosphere and that the smallest of the rooms held sinks, whilst the largest was for baths, with the middle room doubling as both entrance and a place to heat water.

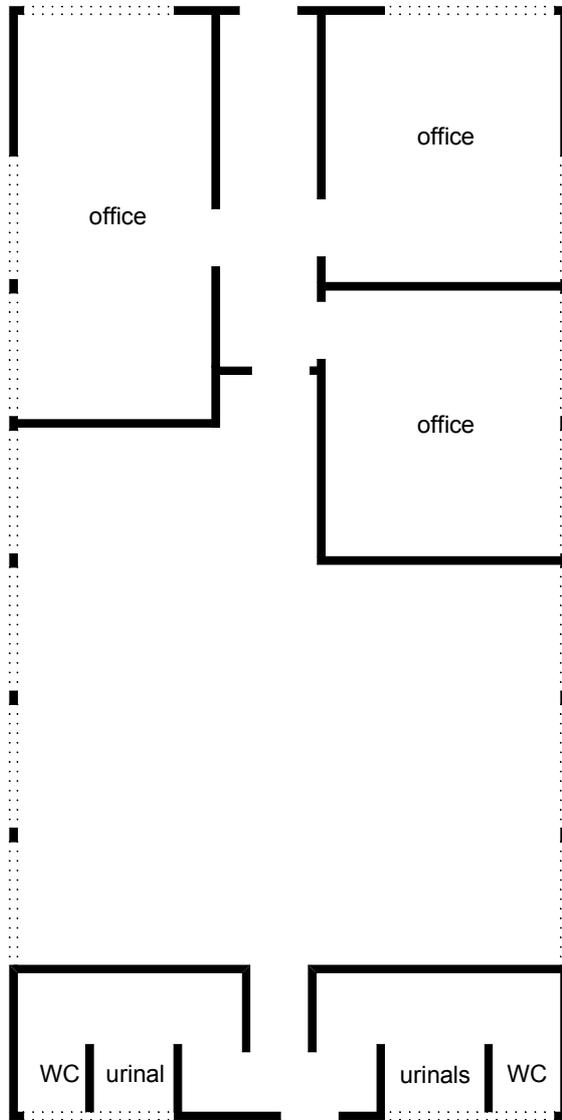
Fig 11 Building 8: plan.

This building is a single-storey rectangular structure with a pitched felt roof and vertically-boarded cladding to the walls (Plate 14). Access is via off-centre doorways in either short end and there are six large windows on both of the long sides. The south-western end of this building is taken up with a WC and urinals on each side of the entrance and a large open-plan office. To the north-east of this are two square offices and a rectangular office on either side of a corridor leading from the entrance at this end of the building. This structure does not appear on the 1875, 1897 or 1921 O.S. maps and is only present on the modern O.S. map; as such it is likely to date to the latter half of the 20th century.

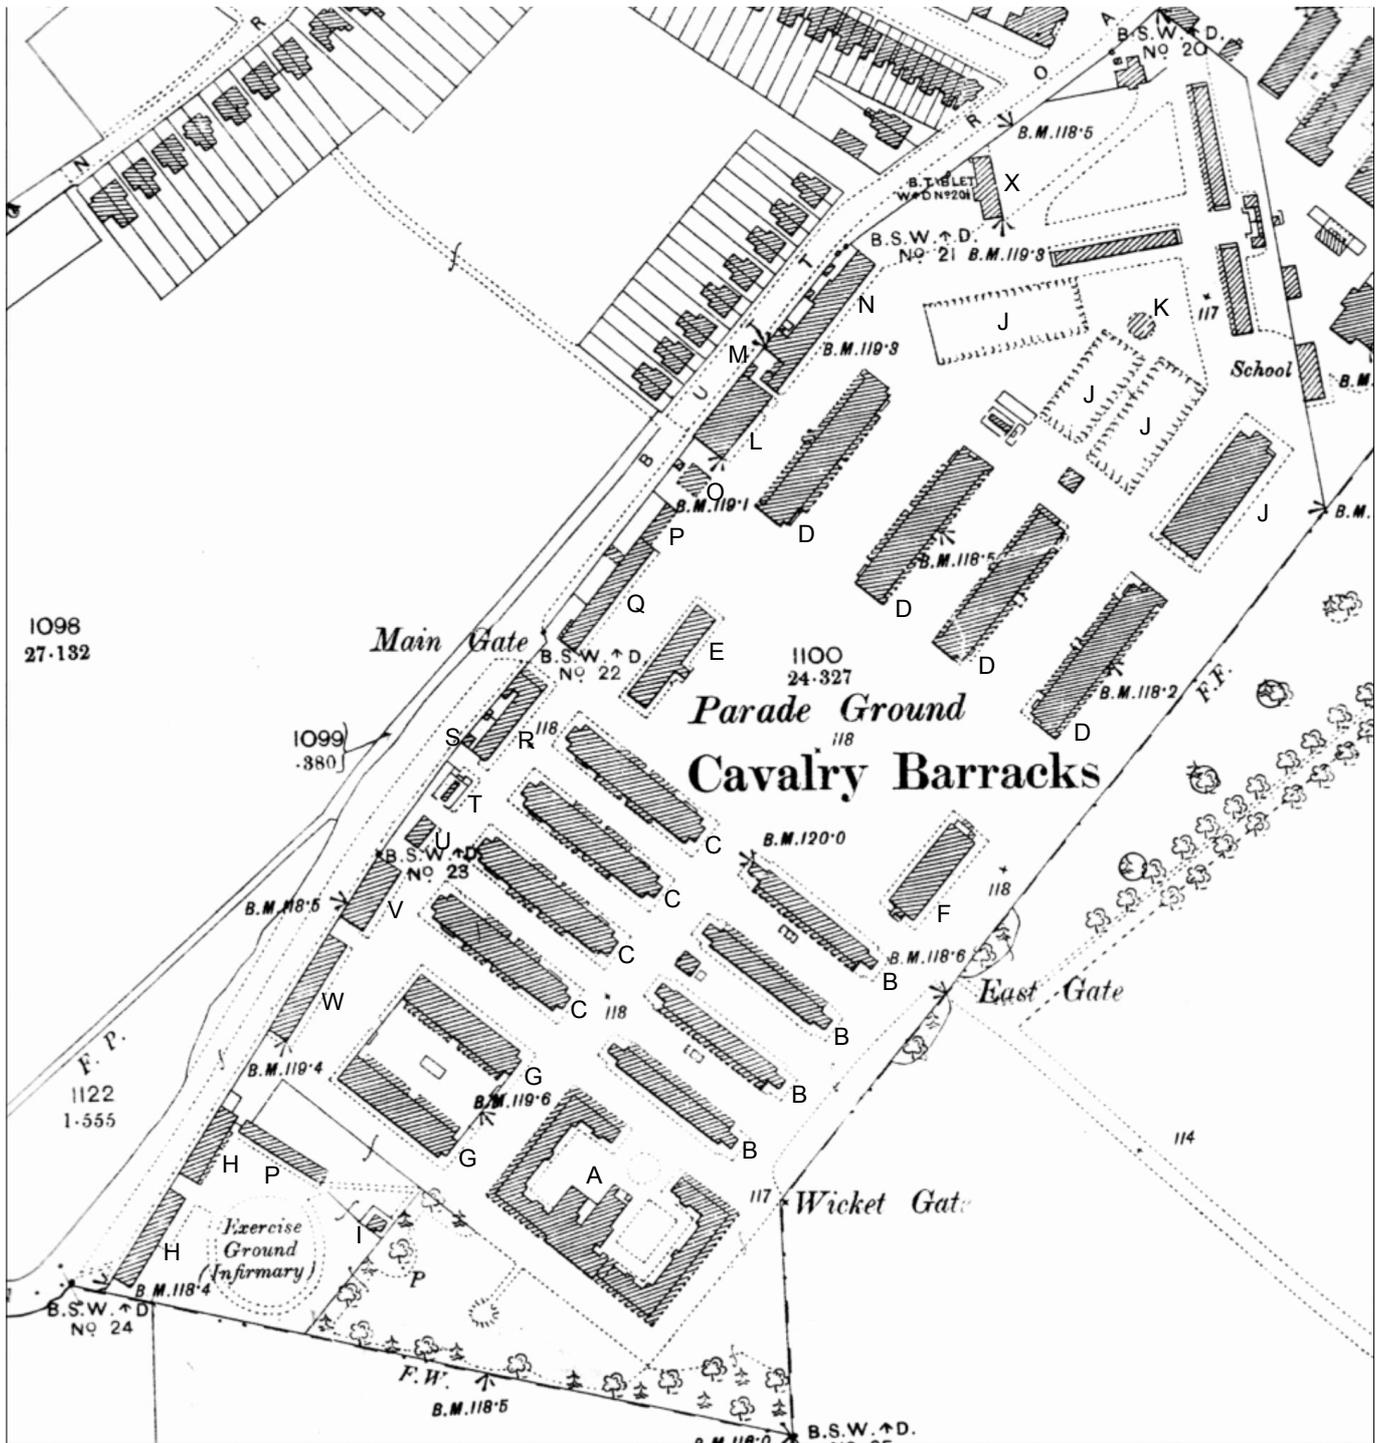
Fig 12 Plan of the Cavalry Barracks in 1897, illustrating function of buildings.

The barracks also had its own water supply, provided via a circular Water Tower on brick piers. Separating the barracks from Layer Road (now Butt Road) was a brick boundary wall approximately 10 feet high topped with semi-circular bricks, with a main gate of four brick piers forming a central wide opening flanked by two outer, narrower openings. The main opening was double gated while the outer openings each contained a single gate. The piers were capped with York stone. The remainder of the barracks' ancillary buildings were ranged along this boundary wall. They varied greatly in function and included offices for the Barrack Sergeant and Barrack Master, the Utensil Store, the Bedding Store, the Straw Store, the Coal House, the Ablution House, the Soldiers' Latrines, the Pay Master's Office, the Orderly Room, the Cells and Lock-up, the Guard House, the Shoemaker's, Saddler's and Tailor's Shops, the Quartermaster's Office and Store, the Armoury, the Forge and Shoeing Shed, a Granary on staddle stones, the Hay Store, the Bread and Meat Stores, the Tap Room, the Canteen, the Sergeants' Room and the NCOs' Room. The Magazine Store, located at a distance to the accommodation, was also along the boundary wall. (See locations of these buildings on the plan of 1897, Fig 12.)

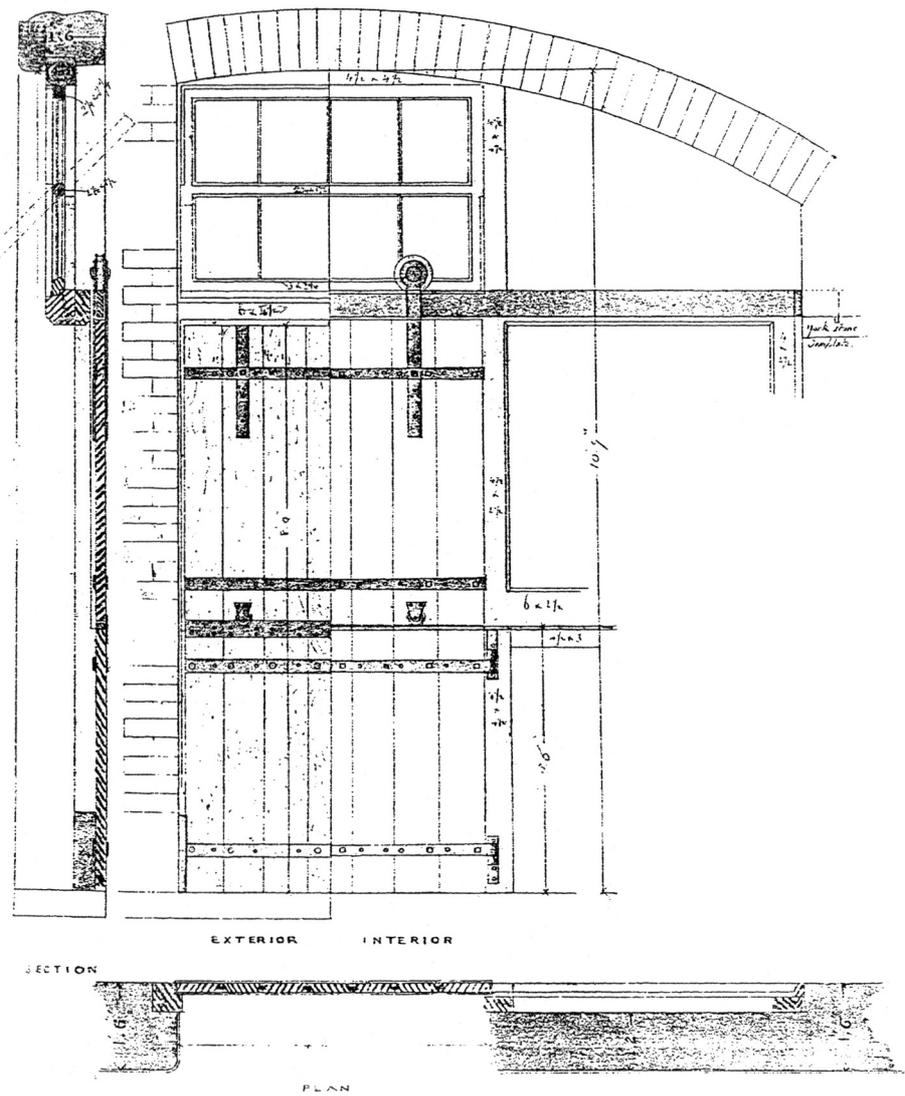
Fig 13 Original schematic for sliding/swing hung stable door.

lower section and would have provided access to a walkway paved with Staffordshire blue blocks around the perimeter of the stable (Fig 13). Off this walkway were individual horse stalls (eleven to a side) separated by metal bars hanging from chains fastened to a central masonry spine and iron posts. Although no trace remains of this, a litter shed was attached to the south-west elevation facing the enclosed stable yard.
