**An archaeological excavation  
at the Hope Inn,  
16 High Street, Tollesbury, Essex**

**October 2011**

**CAT Report 636**  
March 2012

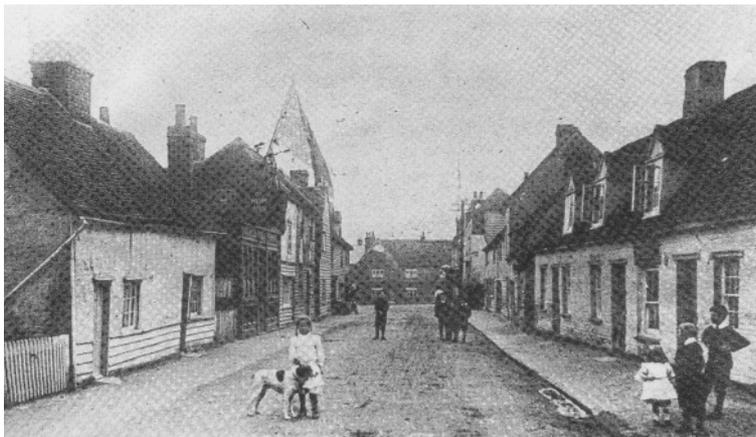
**Plate 1** Tollesbury High Street before 1910 (Lovell 1989b)

The Ordnance Survey maps of 1874-5 and 1897 also show there was an additional building located between the Hope Inn and the post-medieval structures identified in the excavation. Plate 1 shows the two-storey Hope Inn with a single-storey extension to its east and the additional building in the foreground on the left of the photograph. The additional building is shown to be a free-standing single-storey structure divided into two cottages and appears to be of timber-framed construction with a peg-tile roof. It is separated from the Hope Inn and the other buildings shown on the Ordnance Survey maps of 1874-5 and 1897 by narrow alleys on either side. These are closed off by a picket fence and gate. The gravel and peg-tile surface corresponds to the west alley exactly.

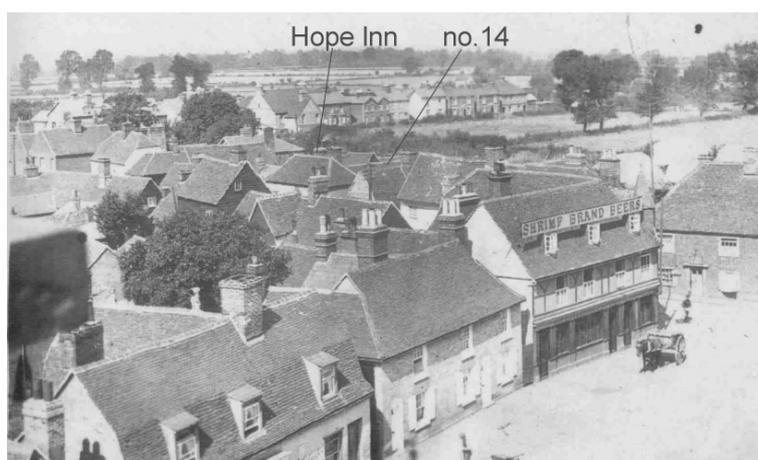
**Plate 2** Bird's eye view of Tollesbury High Street (Lovell 1989a)

Plate 2 is a bird's eye view of Tollesbury taken from the tower of St Mary's Church showing the rooftops along either side of the High Street. The easily identifiable gambrel roof of no. 14 High Street is in the centre of the photograph with the hipped roof of the earlier Hope Inn to its left. The extension to the Hope Inn is obscured by the buildings on the south side of the High Street, as is most of the freestanding single-storey building. To the left of this the rooftops of the post-medieval buildings found during excavation can be seen. As the map evidence suggests, the building to

the east is quite narrow but extends north from the street for a long way. The photograph clearly shows that the peg-tile roof is in two sections. The part of the building closest to the street has a hipped roof with a lower ridgeline than the rest of the building and a chimney stack, which would appear to be in the right position to be F13. The rest of the building (two thirds of the overall length) appears to be an earlier structure with a gable roof and a single chimney stack at the north end. The other building identified in the excavation is aligned to the street and has a half-hipped mansard roof covered in peg-tile, with an internal chimney stack. The extension to the north-south building appears to have been built up against the west structure. This would suggest the west building pre-dates the one to the east (or at least pre-dates the extension), a theory supported by the brick dates from the hearths.

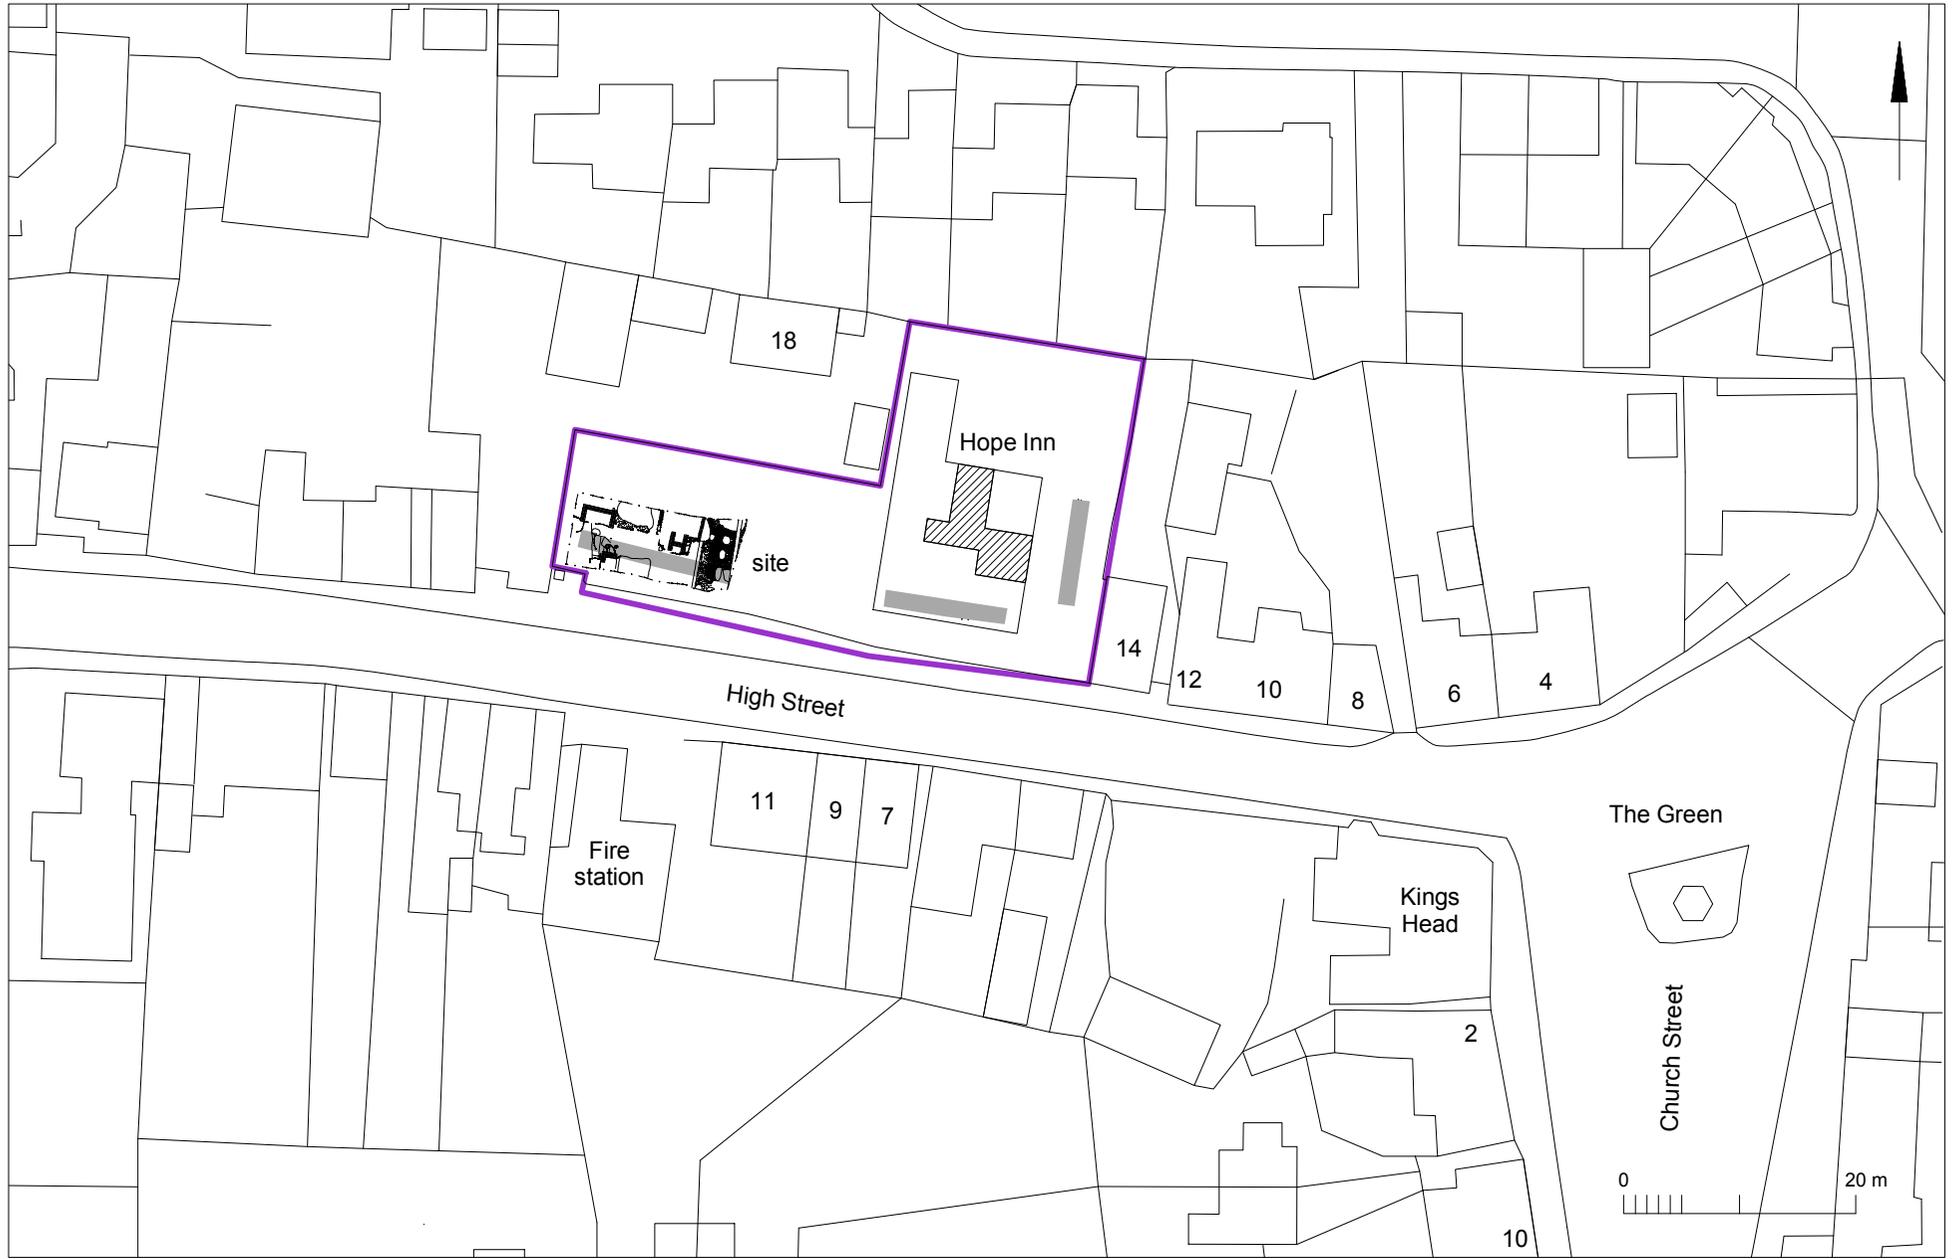
Fig 1 Site location in relation to evaluation trenches and demolished Hope Inn.

The excavation area was centred on the westernmost of the three evaluation trenches, T1, which remained open after the evaluation (Fig 1). This was an area of hard standing covered in tarmac that served the Hope Inn as a car park. When the decision was taken to expand the evaluation trench, the contractor removed the tarmac, hoggins and underlying crush (L1) with a mechanical excavator to the extents of the proposed building. This was not carried out under archaeological supervision, but a subsequent site visit (26th July 2011) confirmed that the archaeology observed during the evaluation phase had not been damaged, apart from the north-west corner of the site where a percolation test-pit was machined through the archaeology to the full depth of the foundation trench. The site remained open at the stripped level until October, when CAT returned to fulfil the terms of the second HEM team brief.

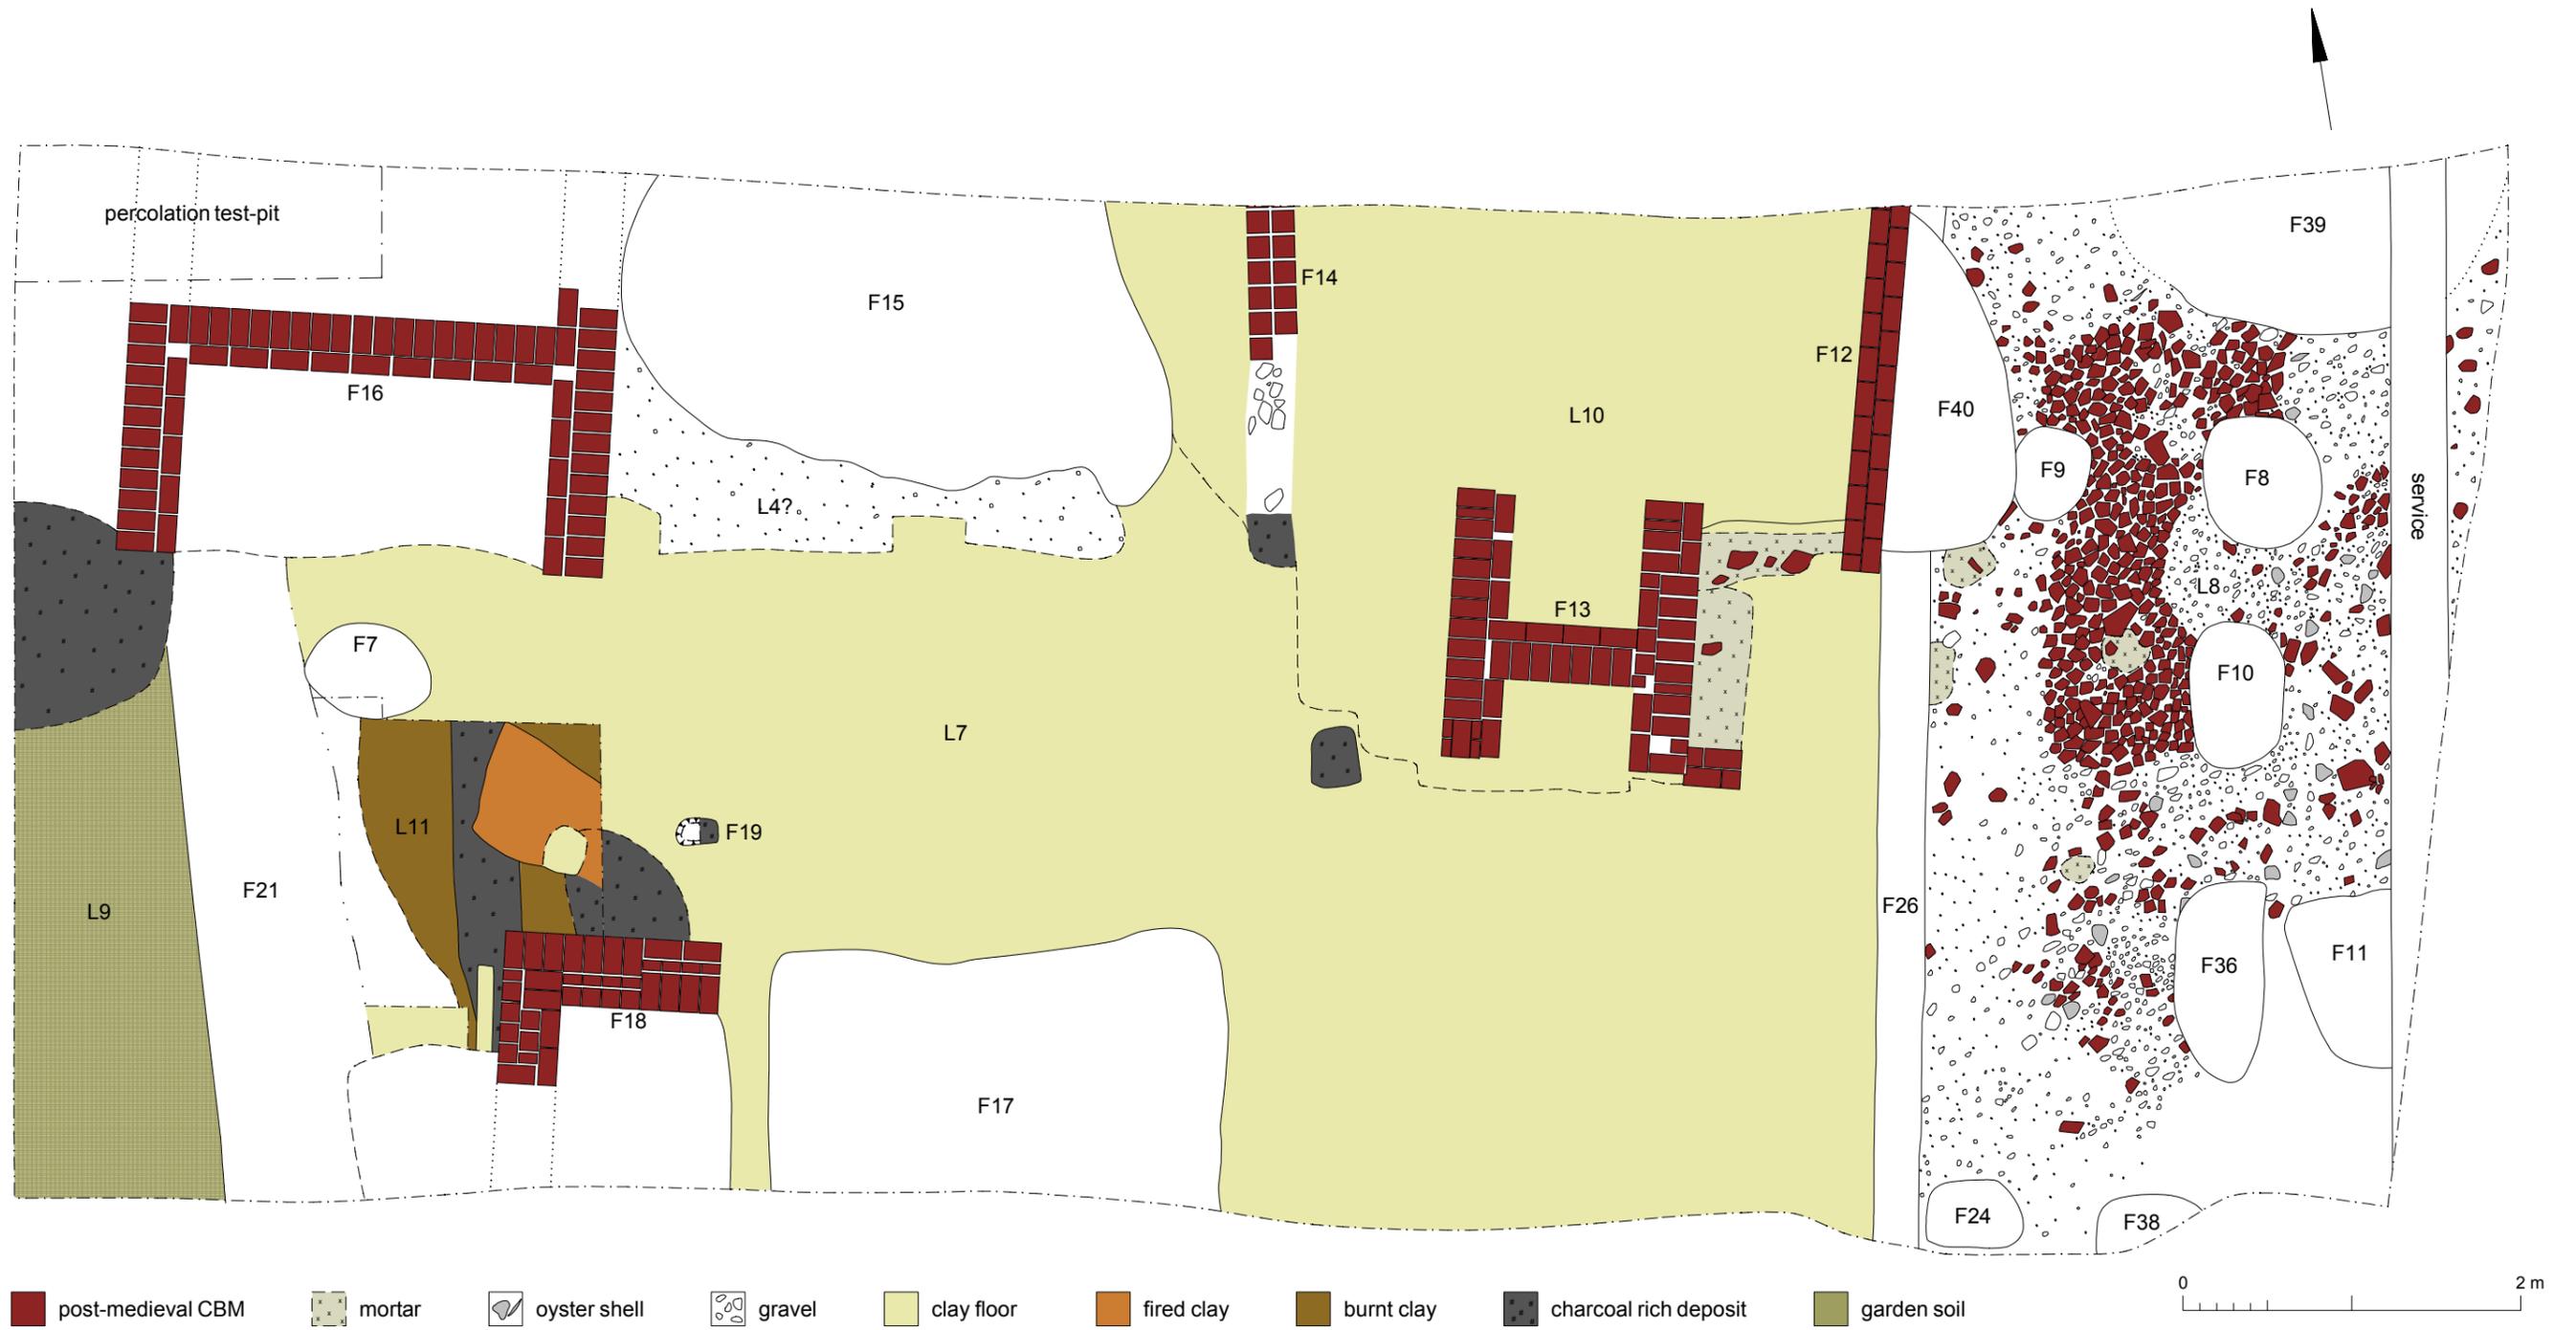
Fig 2 Hope Inn excavation: results from initial strip.

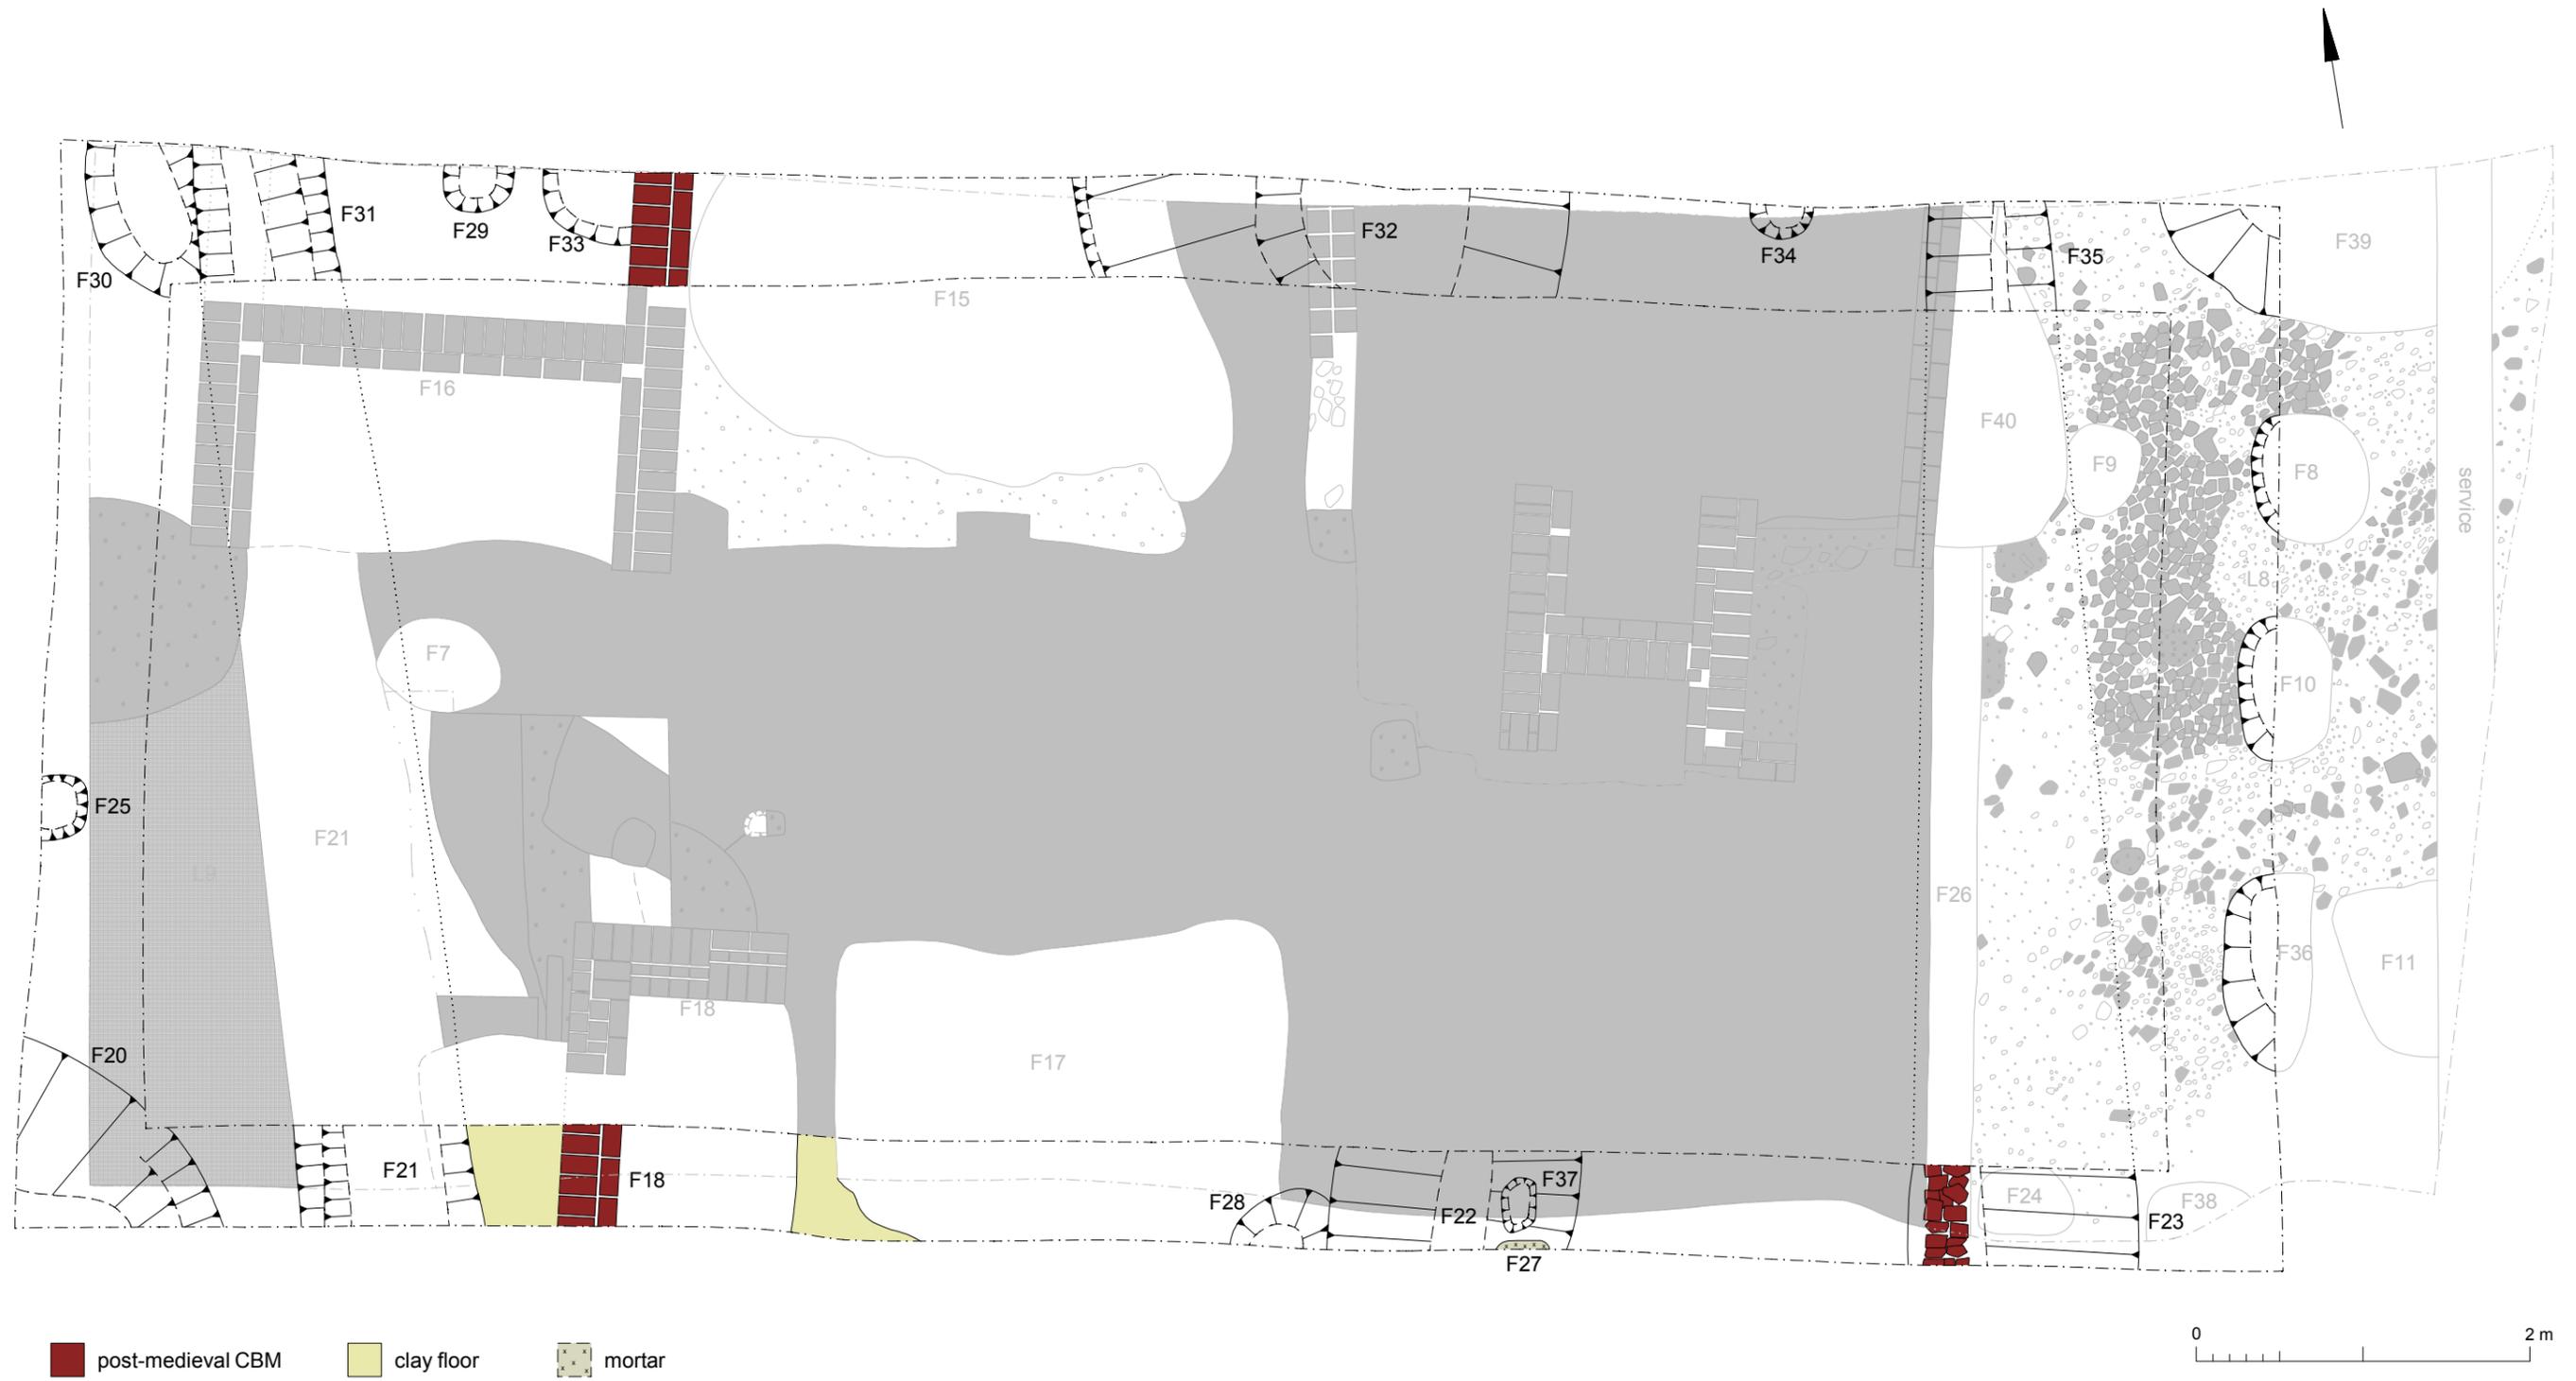
Fig 3 Hope Inn excavation: results from the foundation trench.

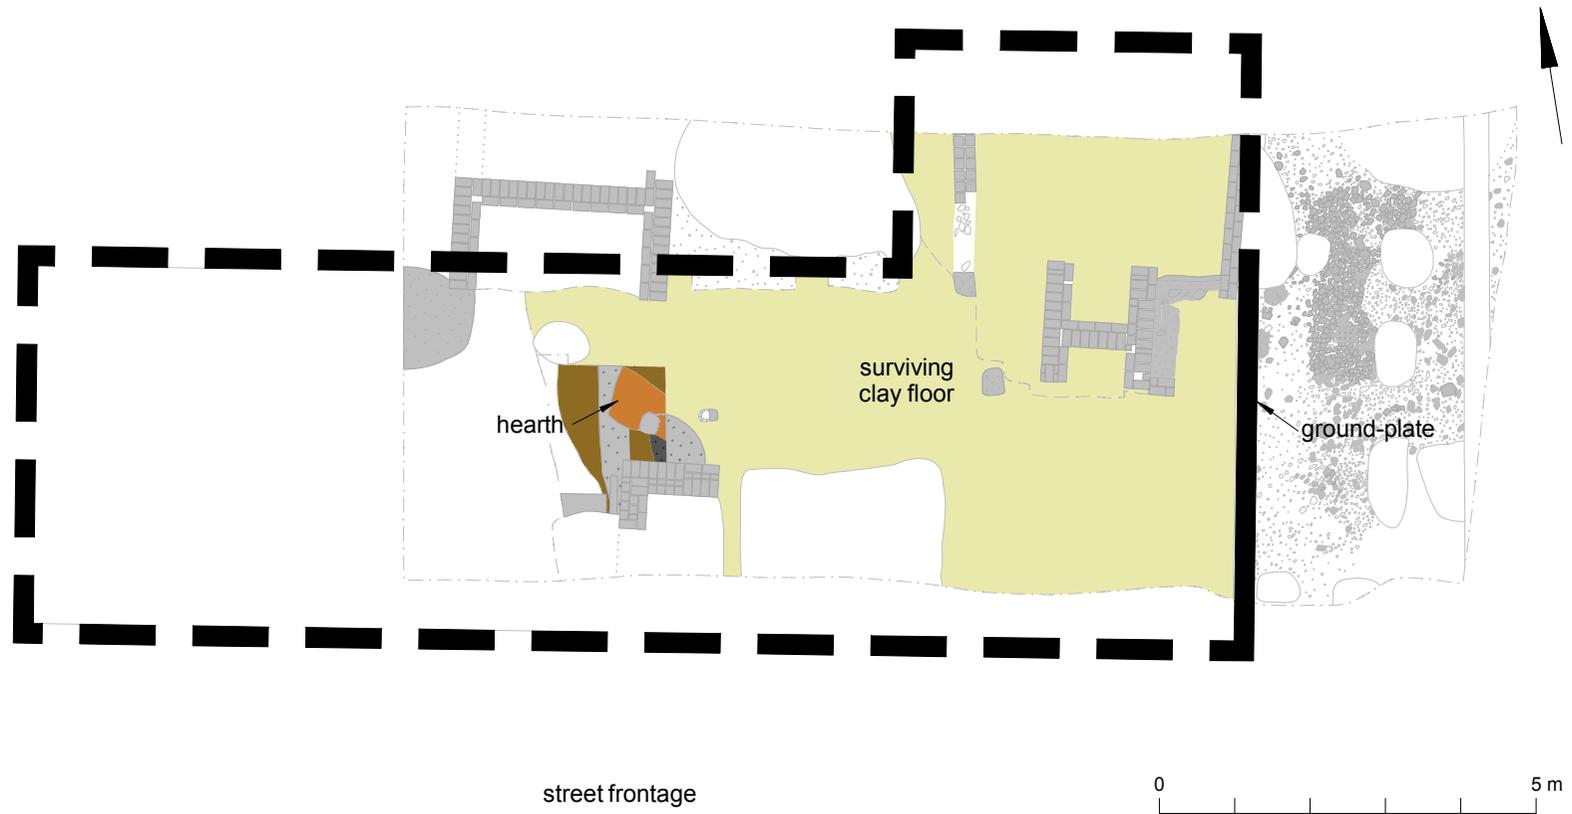
Fig 4 Speculative footprint of medieval building with cross-wing to the east.

The third phase of activity, Period 1c, was the actual occupation of the site. The clay floor L7 indicates there was a building on the site by the late 14th century. As no foundations were observed, it is logical to assume this would have been a timber-framed structure with the beams of the ground-plate sitting directly on the ground. There is possible evidence for this on the east side of the site, where F26 may be the remains of a ground-plate demarcating the eastern edge of the building. The flat peg-tiles seen in the foundation trench were probably an attempt at damp coursing. Due to the lack of structural elements, it is not clear what plan-form this building took. It may have been a medieval hall-house aligned parallel to the street, similar to Roebuck House and nos 4-6 High Street (Fig 6). If this is the case, then there is a good chance that the area of burning, L11, represents the hearth of this building and that the extent of the building was further west than the current property boundary. If

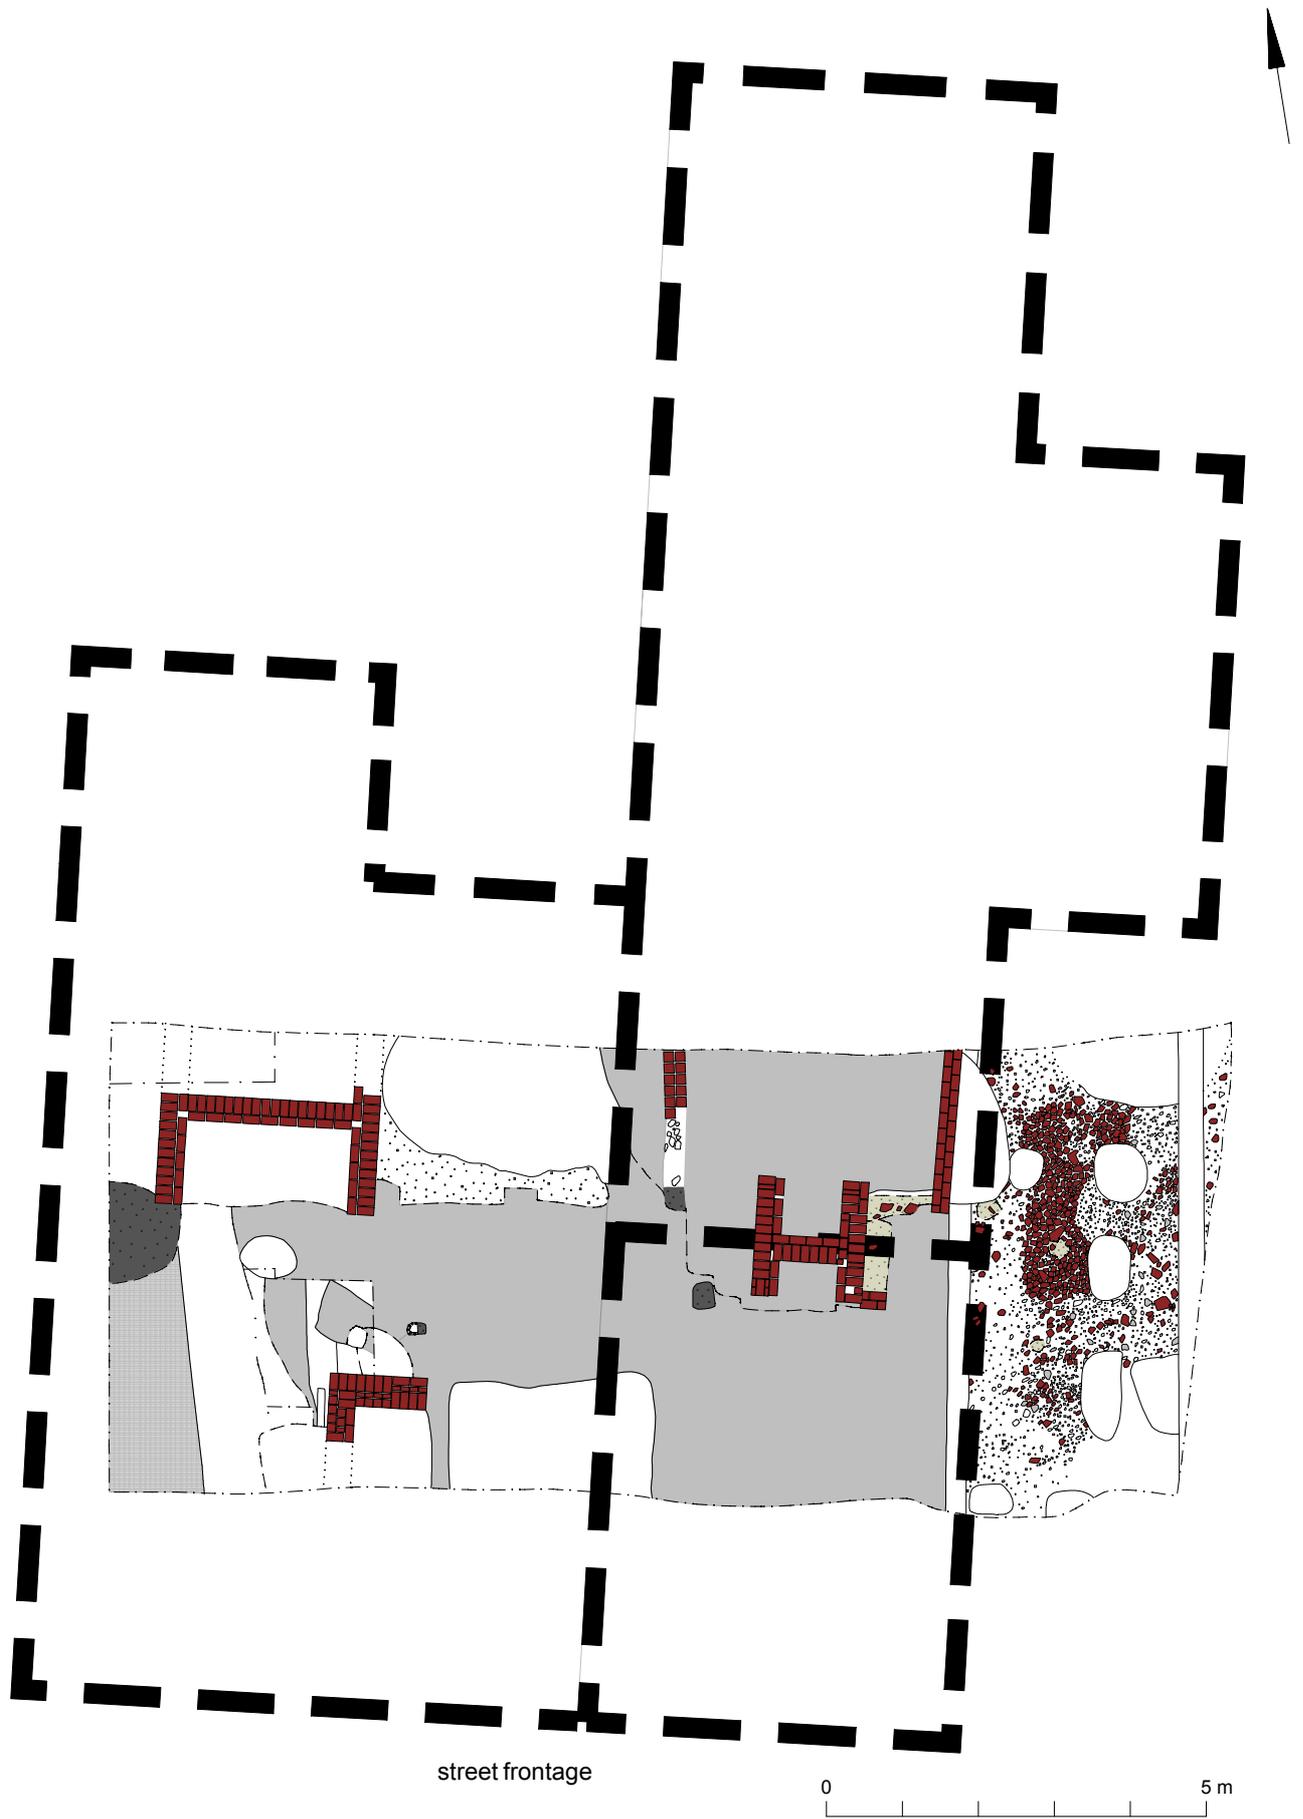
Fig 5 Speculative footprint of post-medieval buildings.

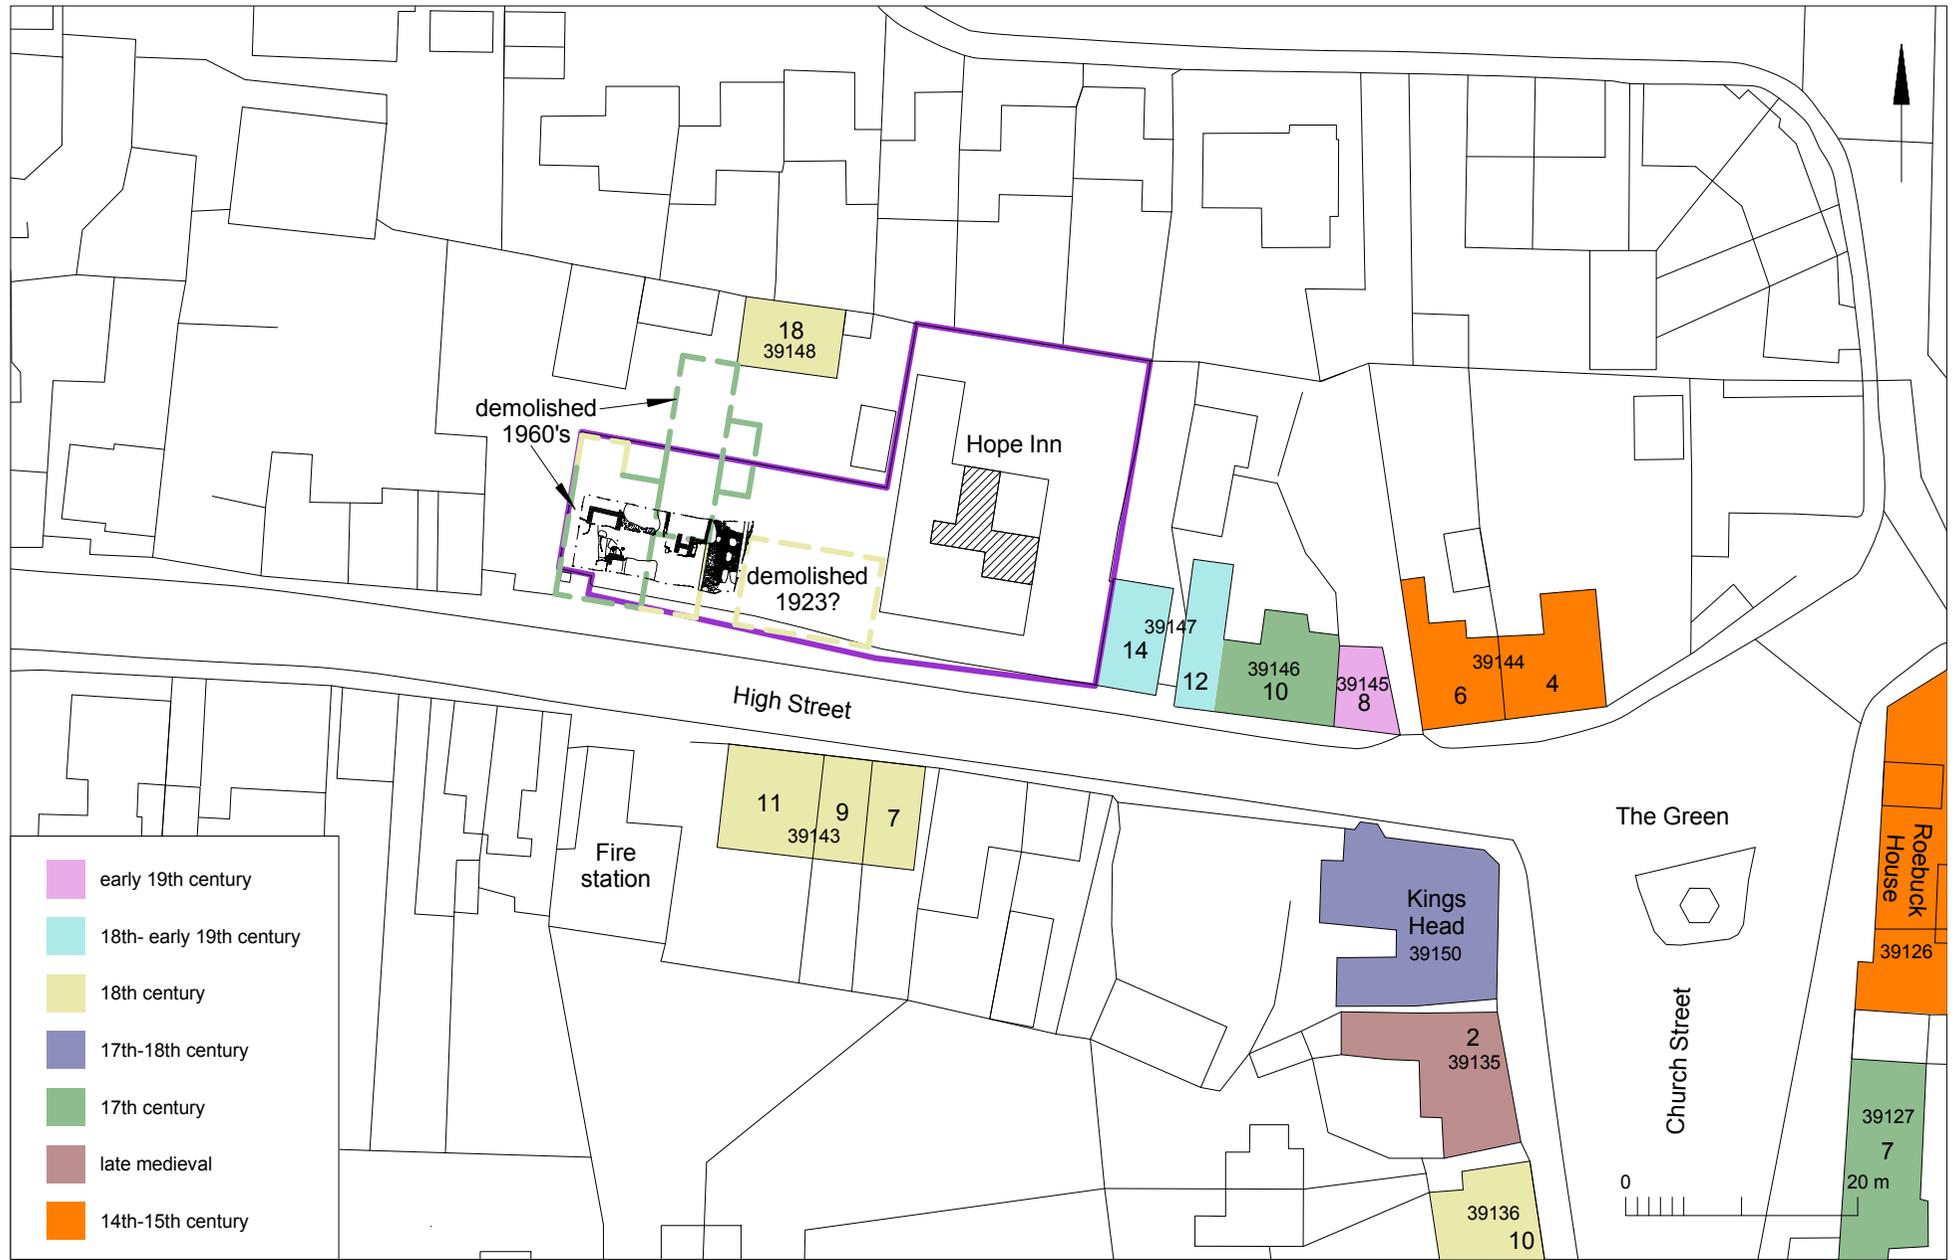
Fig 6 Grade II listed timber-framed buildings and footprints of demolished post-medieval buildings (EHER numbers included on plan).

The development of Tollesbury can be mapped using the surviving timber-framed buildings. As the distance increases from the focus of the settlement (immediately to the north-west of St Mary's Church and Tollesbury Hall), the age of the surviving timber-framed buildings generally decreases (Fig 6). This indicates that, in Tollesbury, timber-framed buildings replaced earlier timber-framed buildings right up until the early 19th century. Proximity to the church and manor-house probably reflected the wealth and status of the owner. Consequently these buildings were probably better constructed and maintained than those further out which, over time, needed to be replaced.

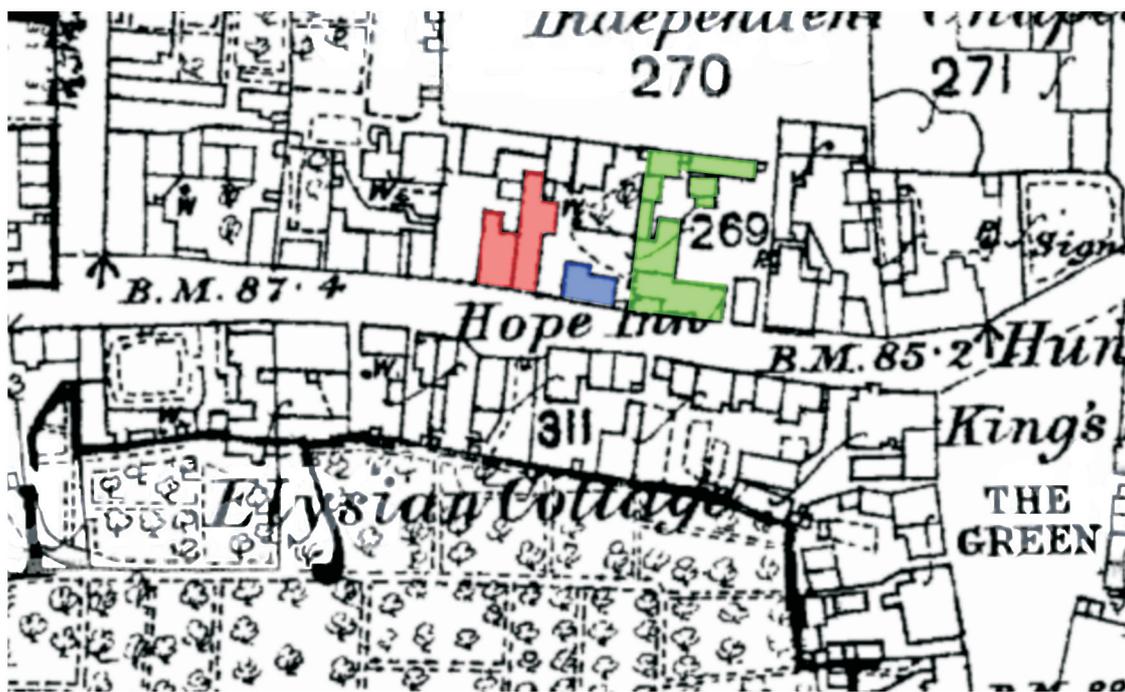
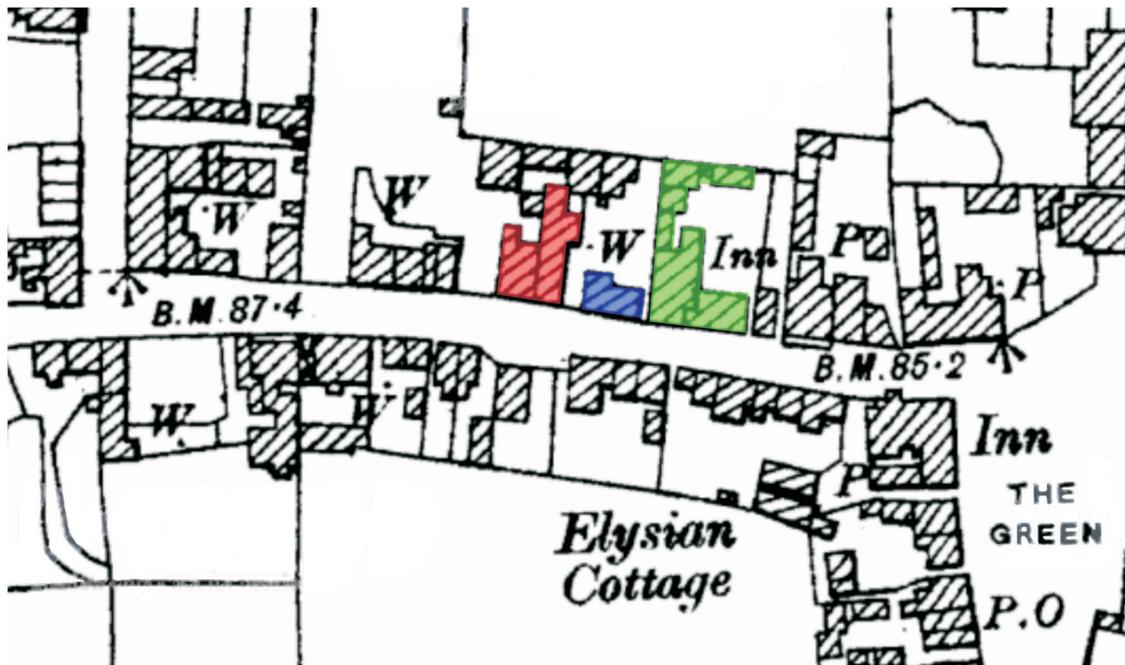
1874-5 1st edition Ordnance Survey map

Fig 7 Tollesbury High Street showing the post-medieval cottages encountered during the excavation (red), the pre-1923 Hope Inn (green) and the cottages (blue) demolished in 1923 for the re-building of the Hope Inn.

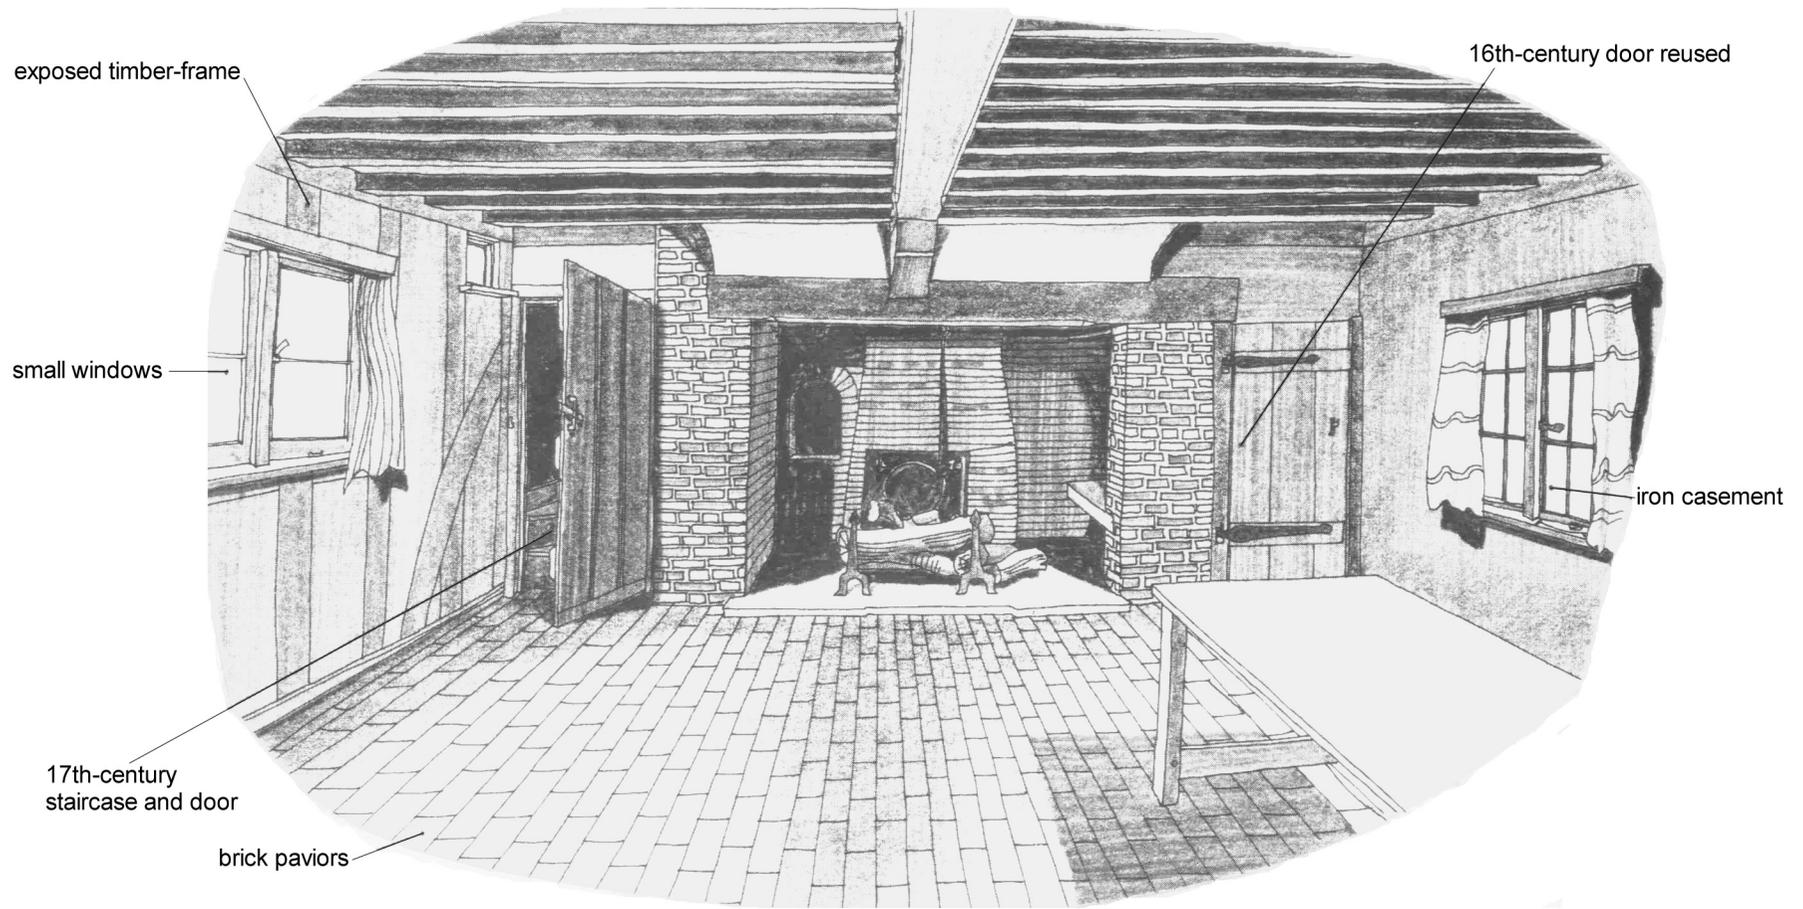
Fig 8 Interior of typical timber-framed house, taken from ECC publication *Conservation in Essex no. 4, Historic Buildings*.
