**An archaeological excavation  
at the Hope Inn,  
16 High Street, Tollesbury, Essex**

**October 2011**

**CAT Report 636**  
March 2012

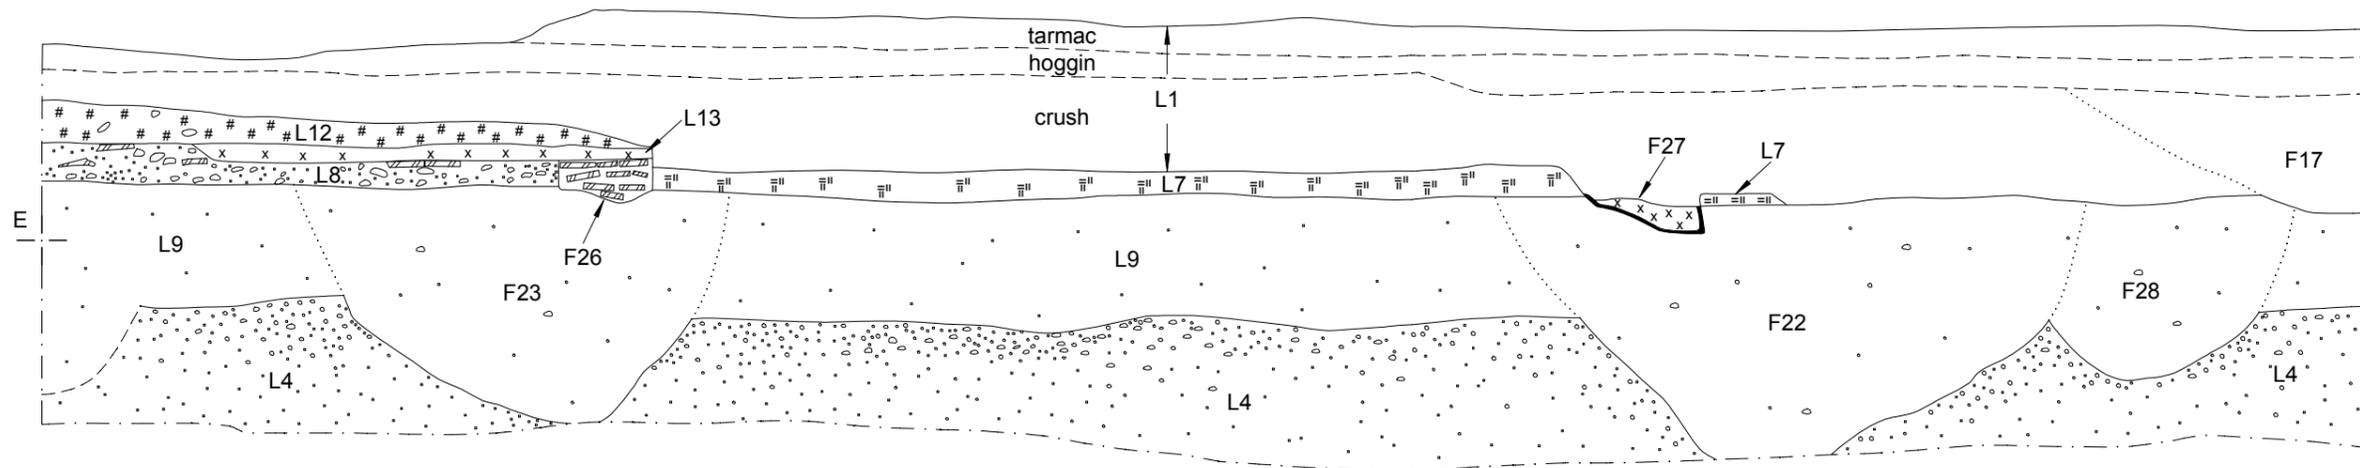
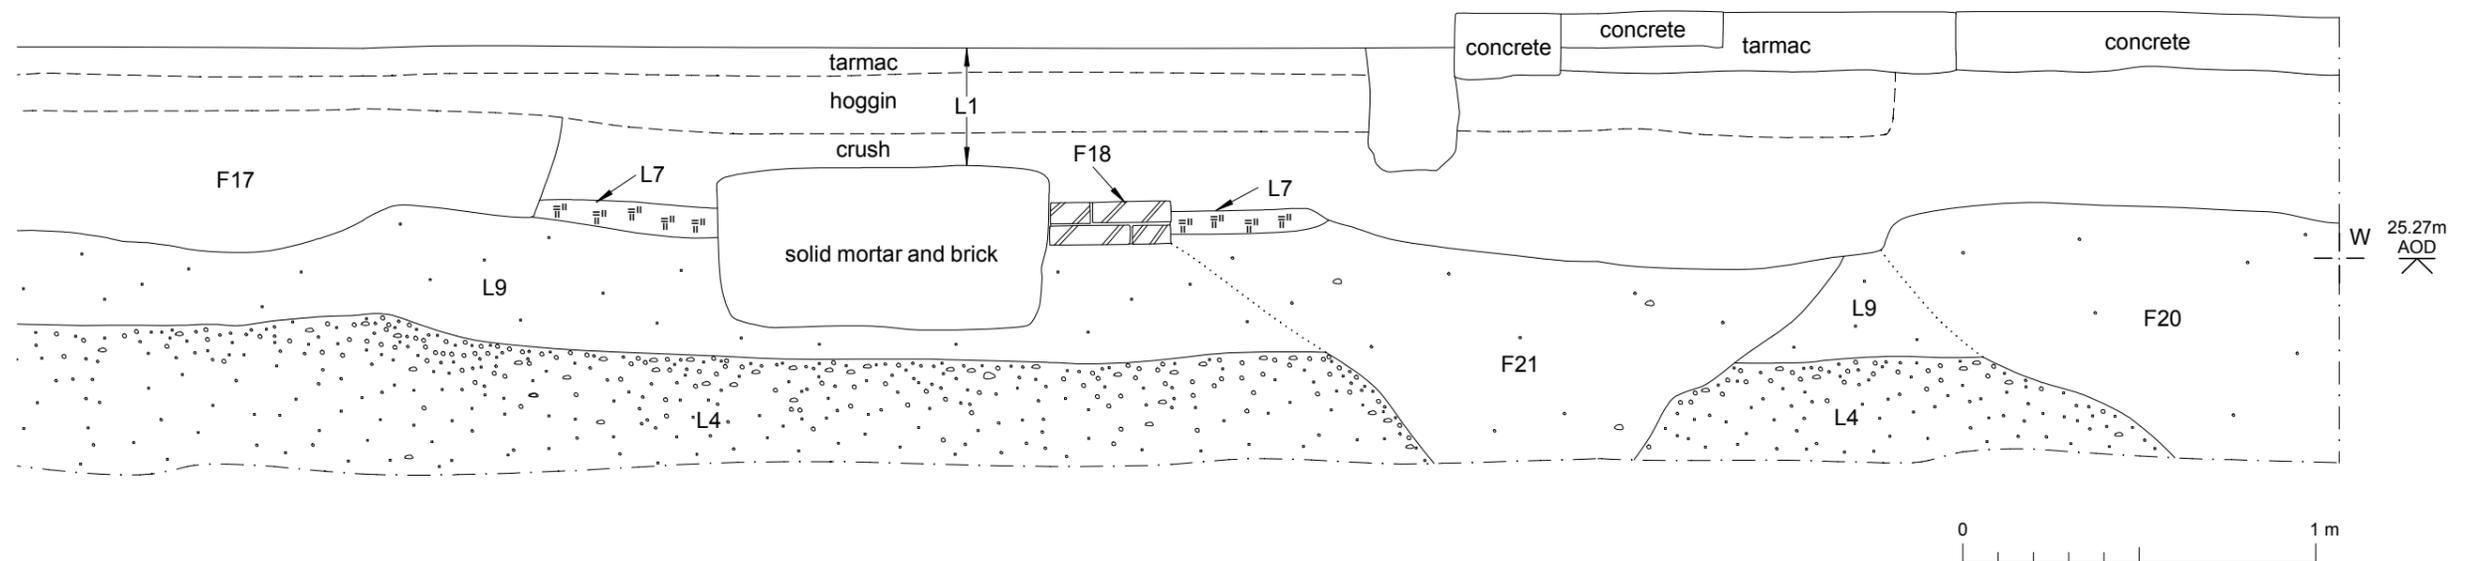
Fig 9 Running section of south foundation trench.

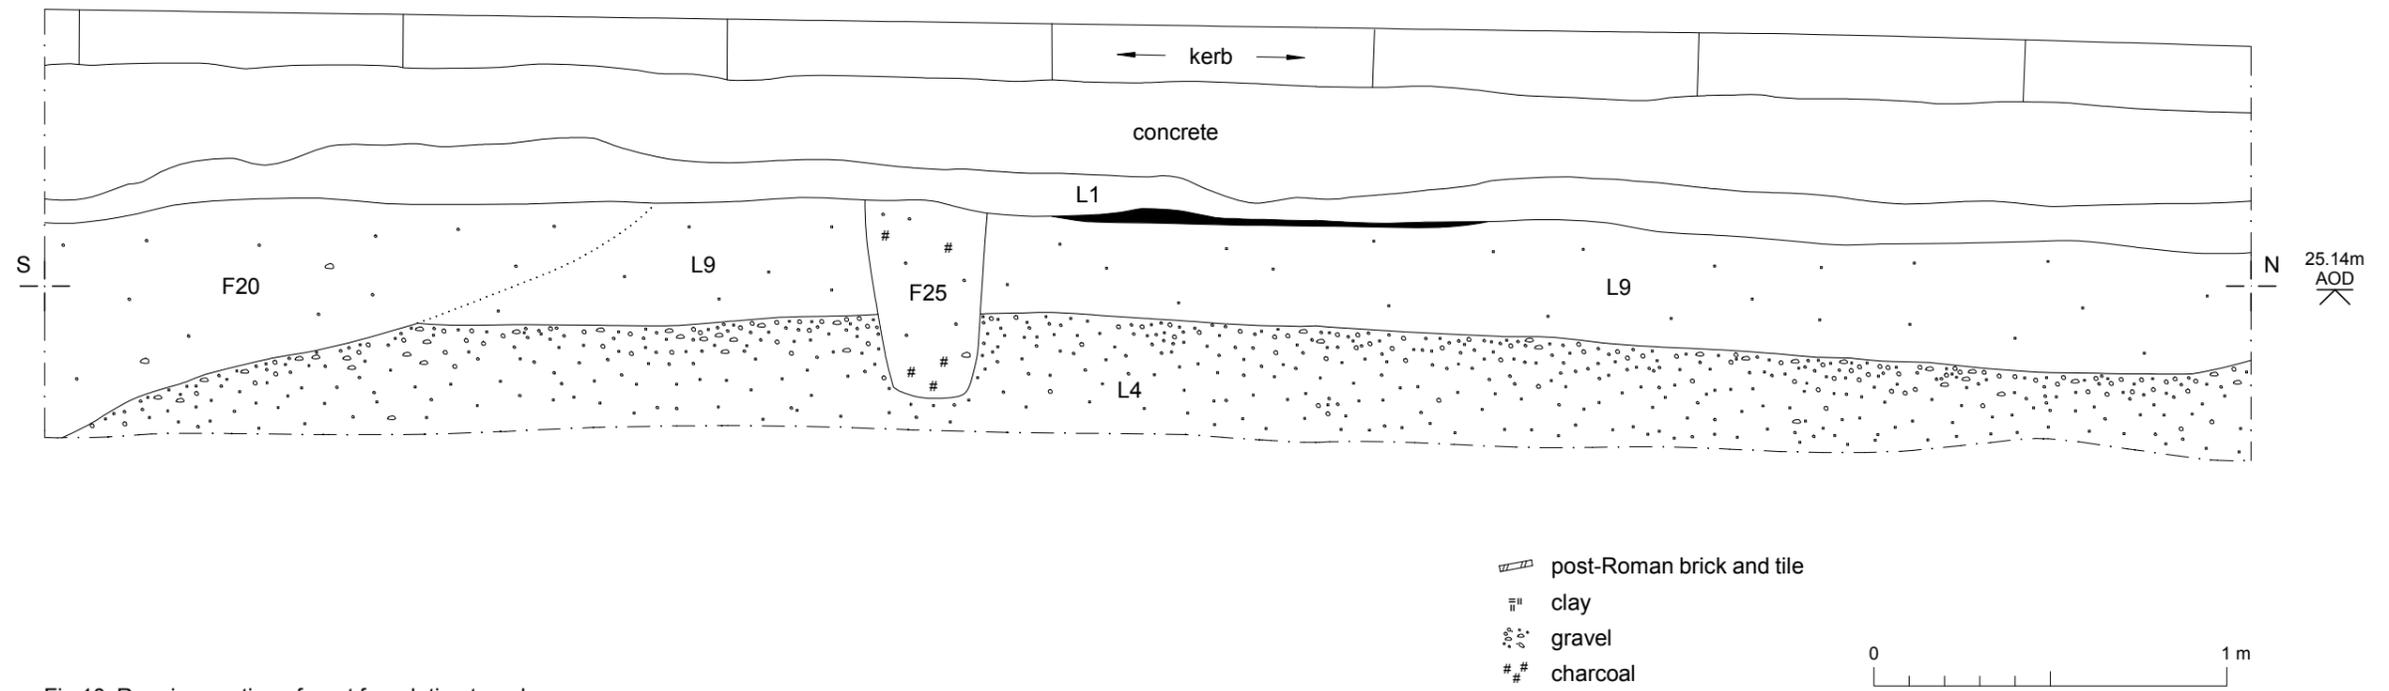
Fig 10 Running section of west foundation trench.

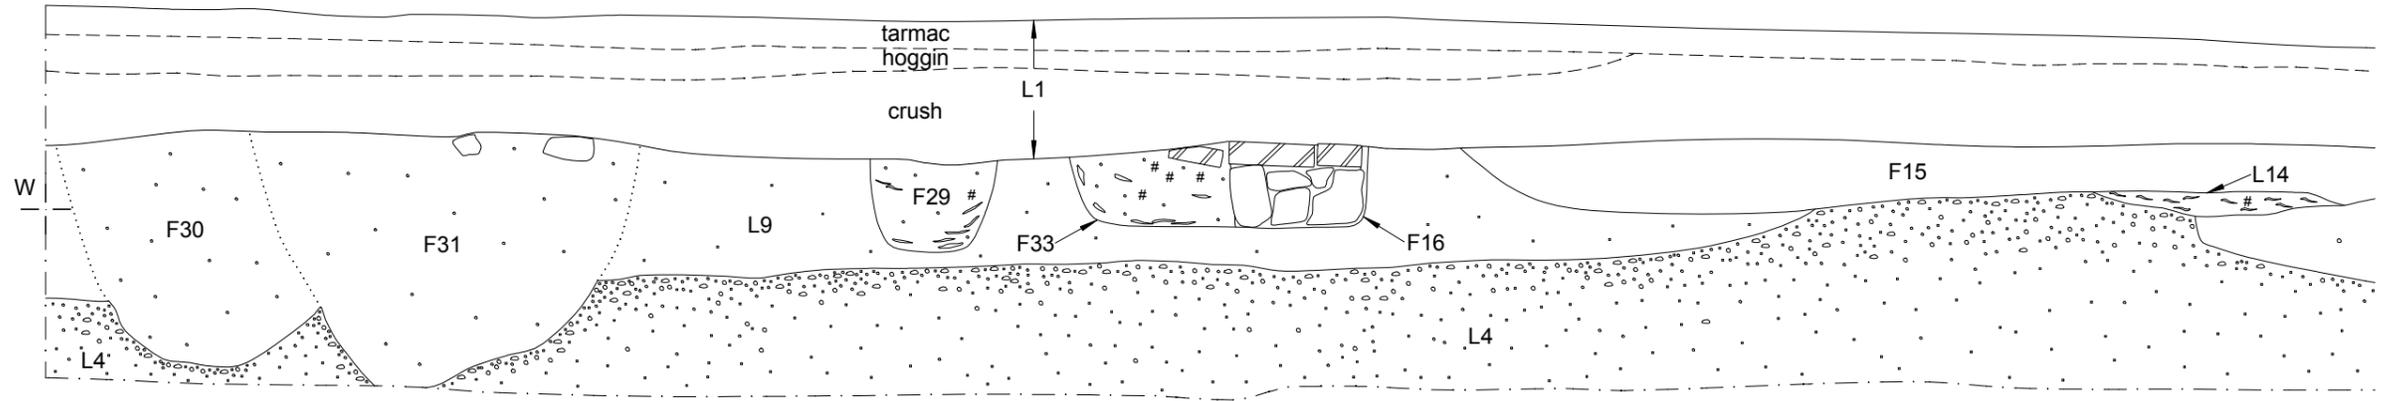
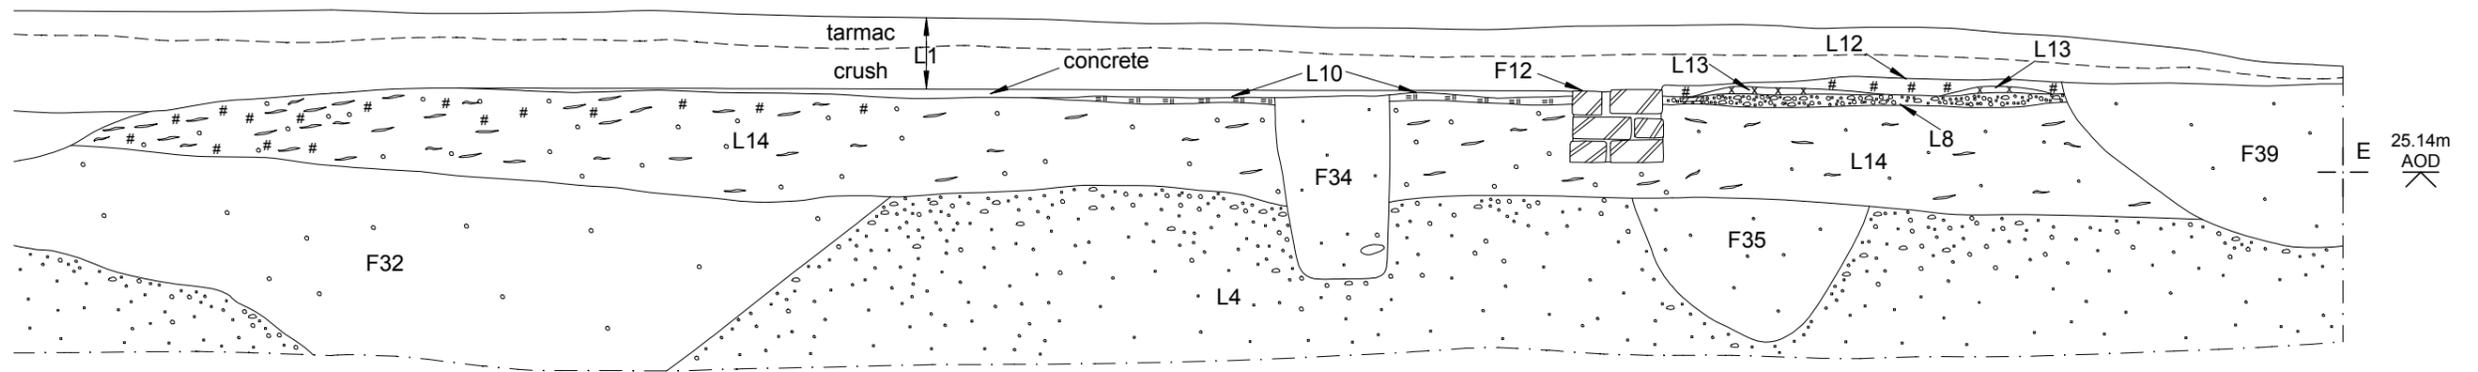
Fig 11 Running section of north foundation trench.

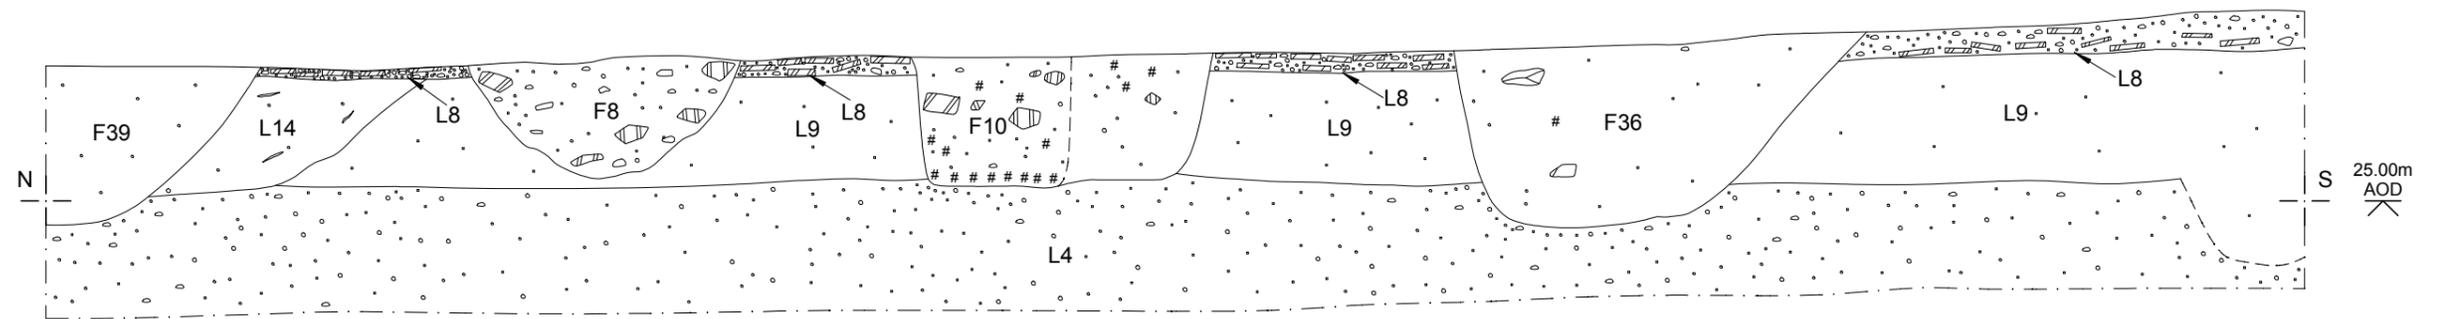
Fig 12 Running section of east foundation trench.

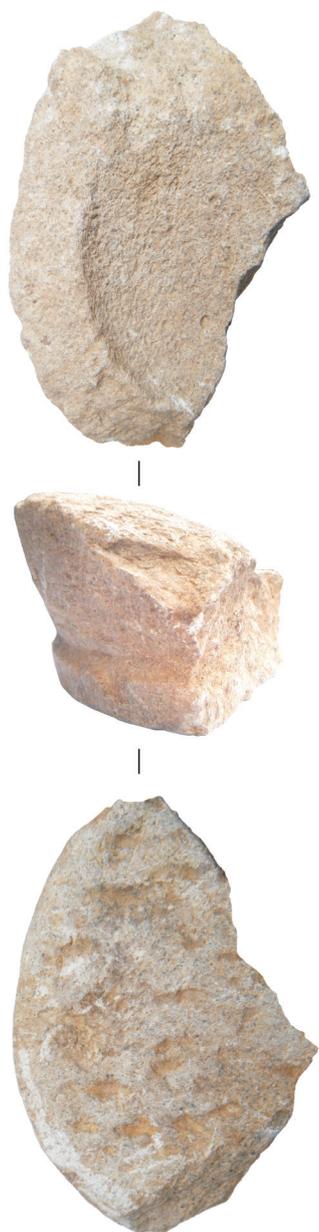
Fig 13 Medieval limestone mortar fragment.

Four pits (F7, F19, F29 & F33) were also recorded. F7 was a small, shallow pit filled with oyster shell. F19 was a small, shallow pit with an ashy fill. F29 contained complete oyster shells, peg-tile and clay pipe stems. F33 had straight sides and a flat bottom. The west part of this feature contained complete oyster shells, similar to F29, but the east part was cut by a continuation of hearth F16. This suggests that F16 was also a back-to-back hearth. The excavated section showed that the bricks of F16 were only one course deep. However, beneath the bricks there were large sub-rounded stones and septaria blocks. Included in this sub-foundation was a base fragment from a very large medieval mortar.
