# Historic Building Recording at Harlow Town Park, Essex

June 2014

**CAT Report 781**  
July 2014

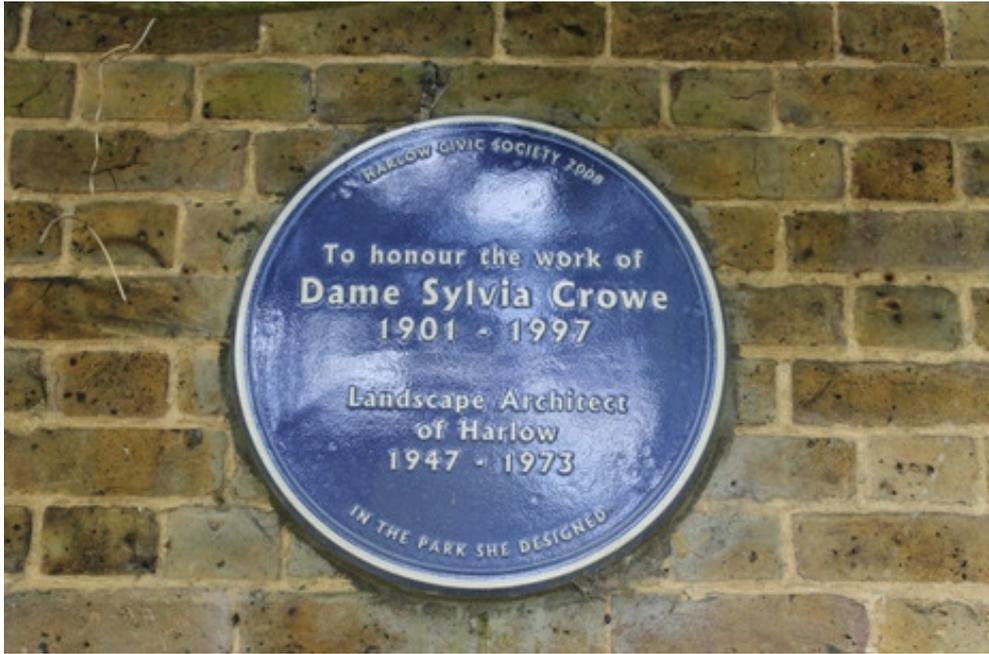
Spurrier's House is located at the north-west end of Spurrier's Core, a linear arrangement of buildings aligned north-west to south-east (Figs 1 & 2). Constructed in the early 1860s from yellow stock brick laid in Flemish bond, the building comprises a main two-storey rectangular range with a hipped slate roof and a smaller two-storey range to the south, also with a hipped slate roof. On the south side of this there is a single-storey service wing with a hipped slate roof. On the north elevation is a blue plaque (Plate 1) commemorating the work of Dame Sylvia Crowe, principal designer of Harlow Town Park.

**Plate 1 Commemorative blue plaque on north wall of Spurrier's House - view south-east**

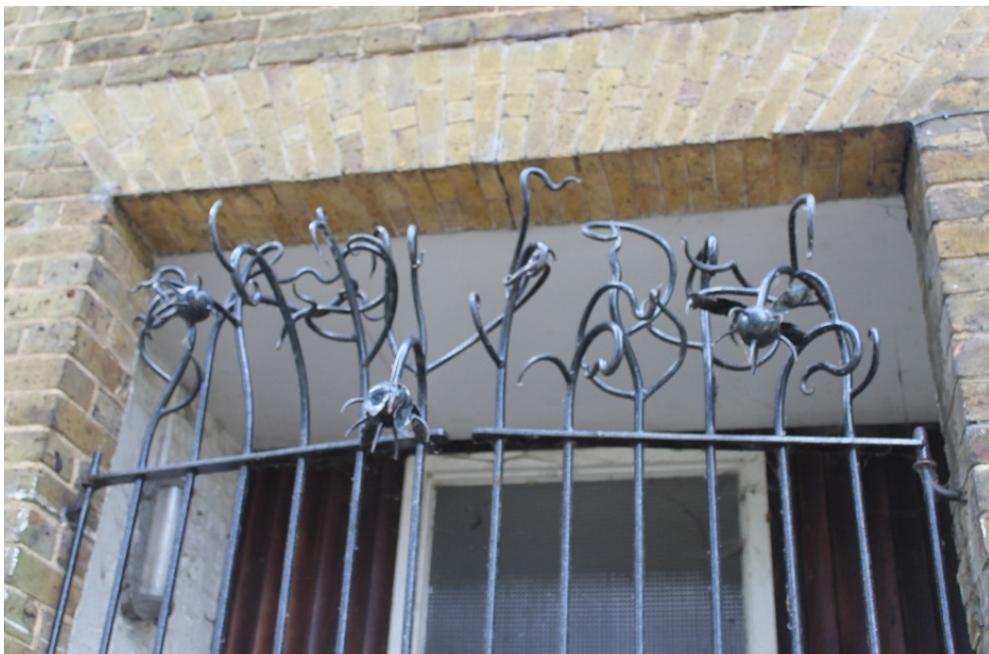
In keeping with the strong tradition of public art in Harlow, the security bars installed by Harlow District Council on the ground floor windows and doors have aesthetic qualities, wrought in the shape of plants with flowering seed pods (Plate 2).

**Plate 2 Detail of wrought iron security bars in the shape of seed pods - view south-east**

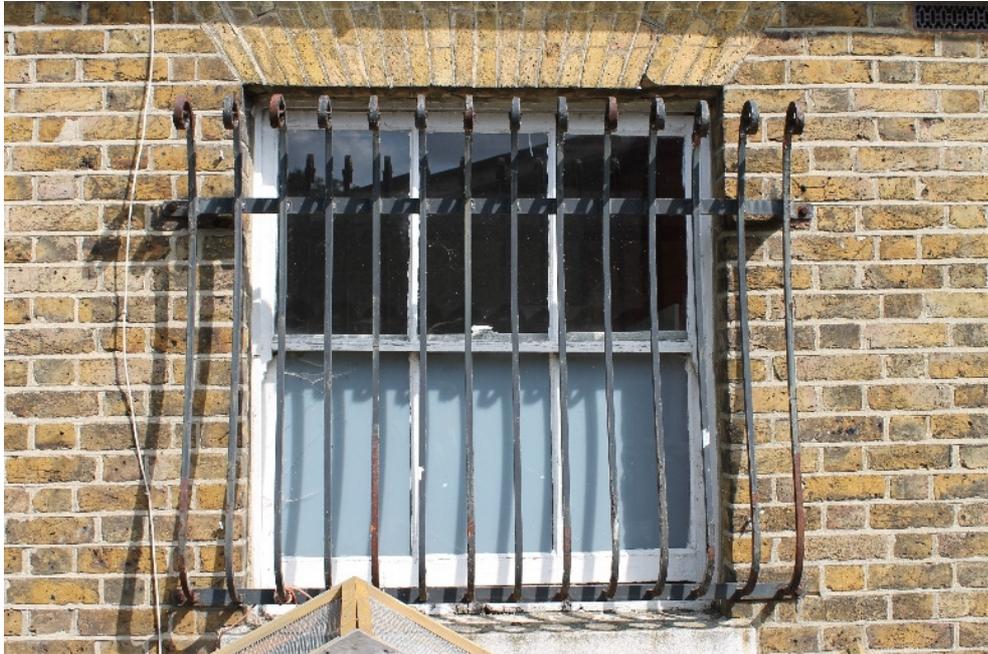
The security bars covering the windows on the service wing at the rear of the building are also more than merely functional, although not as ornate as those on the

public sides of the house (Plate 3). They are, however, more ornate than the gates over the rear entrances and it may be concluded that this represents a chronology for the security features of the building which became progressively plainer over time.

**Plate 3 Detail of wrought iron security bars on extension to Spurrier's House  
- view north-west**

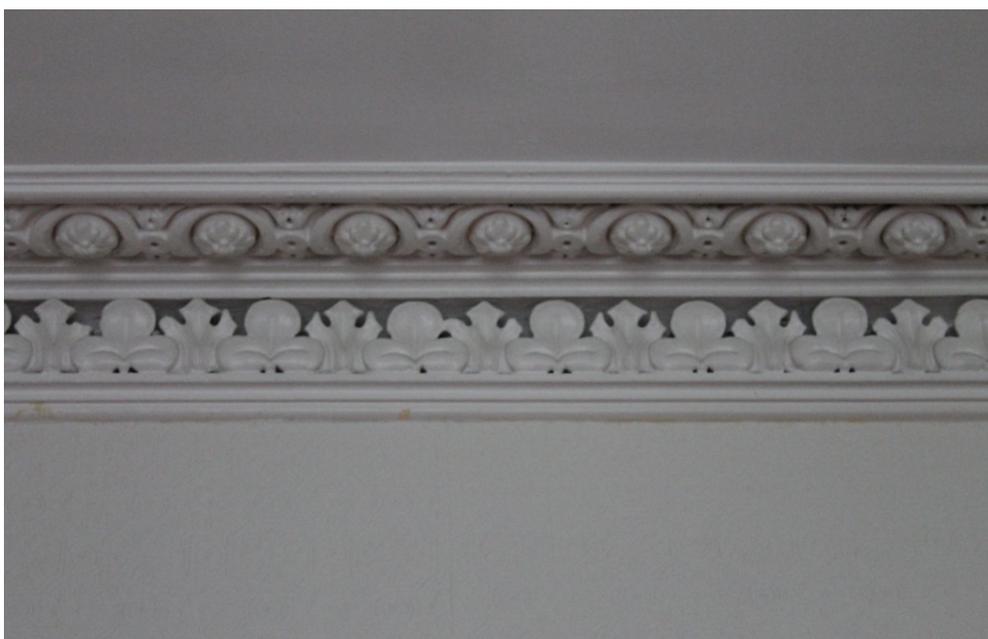
As part of the regeneration programme, the ground floor of Spurrier's House is to be renovated, retaining original features such as the plaster moulding and removing later alterations which detract from the historic integrity of the building (Plates 4 & 5). Included in these works will be the conversion of the basement.

**Plate 4 Detail of decorative plaster moulding in Spurrier's House**

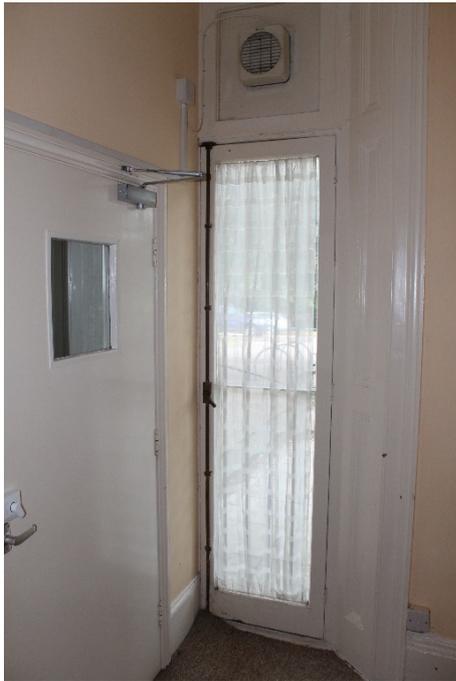
**Plate 5 Original French doors of Spurrier's House truncated by inserted stud wall - view north-west**

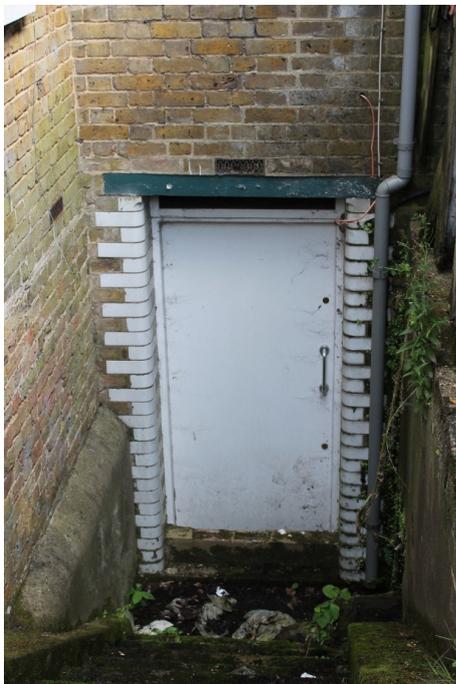
The basement of Spurrier's House has two entrances, one external (Plate 6) and one internal (Plate 7). The external entrance is down a flight of steps beside the single-storey service extension and has a door surround formed of white-glazed brick.

**Plate 6 Basement entrance to Spurrier's House - view south-east**

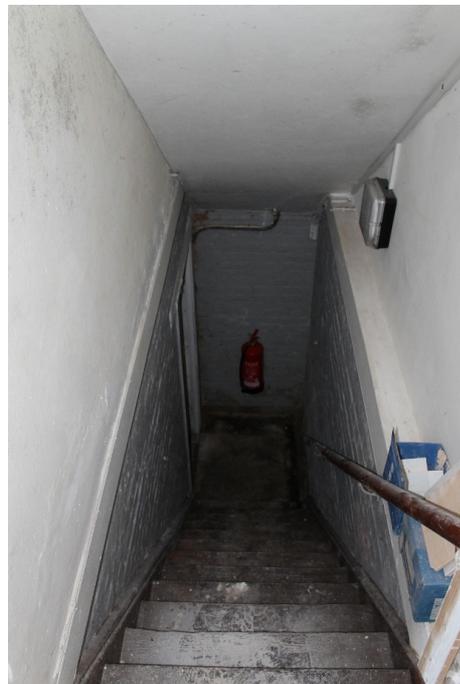
**Plate 7 Internal staircase to basement of Spurrier's House - view north-west**

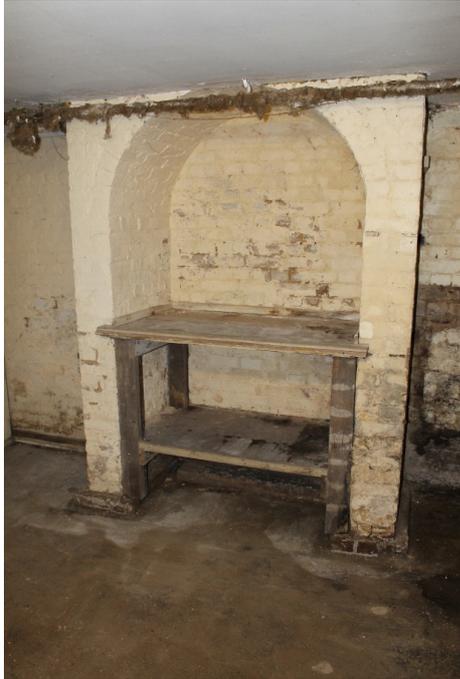
Although the basement has been used as a storage area since the building was acquired by HDC it retains several original features. These include a brick arch (the purpose of which is uncertain, but which may have been an area for keeping wine; Plate 8), a recess lined with white-glazed tiles/bricks and with an iron and glass light grill above it, probably fulfilling a scullery function (Plate 9) and the carcass of a wooden sideboard, probably original to Spurrier's House and relocated from the dining room upstairs (Plate 10).

**Plate 8 Original brick alcove in basement of Spurrier's House – view south-east**

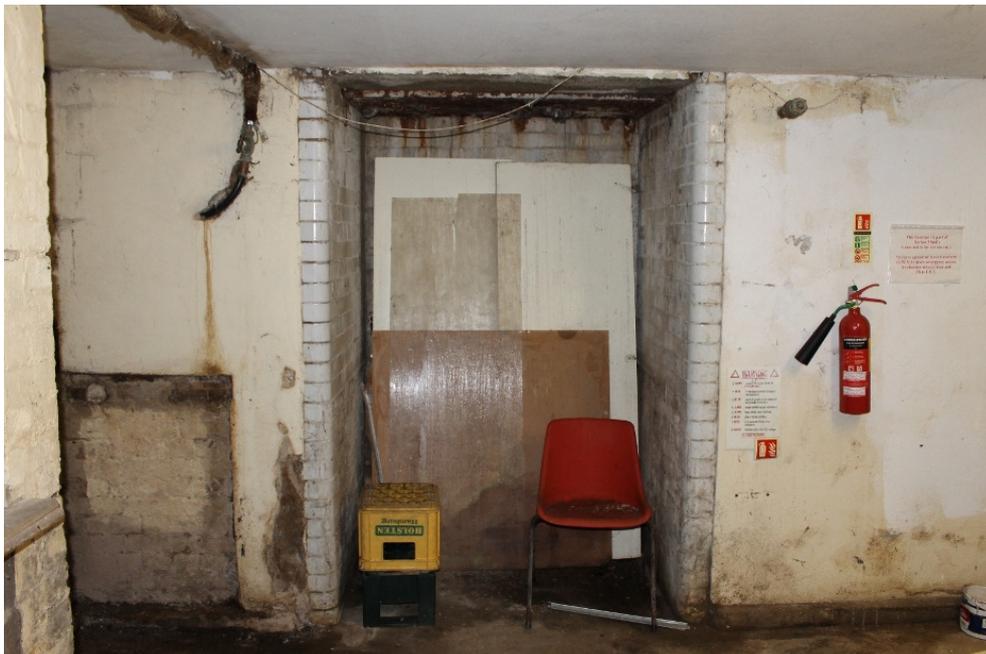
**Plate 9 Tiled recess in basement of Spurrier's House, possibly a scullery area - view south-west**

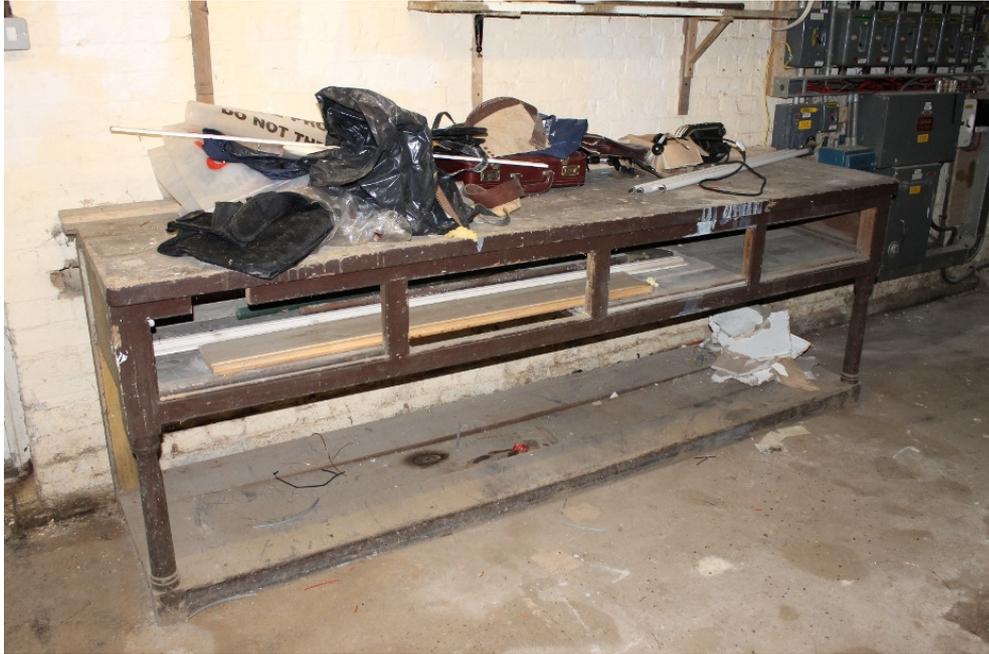
**Plate 10 ?Original sideboard, possibly from the dining room of Spurrier's House - view north**

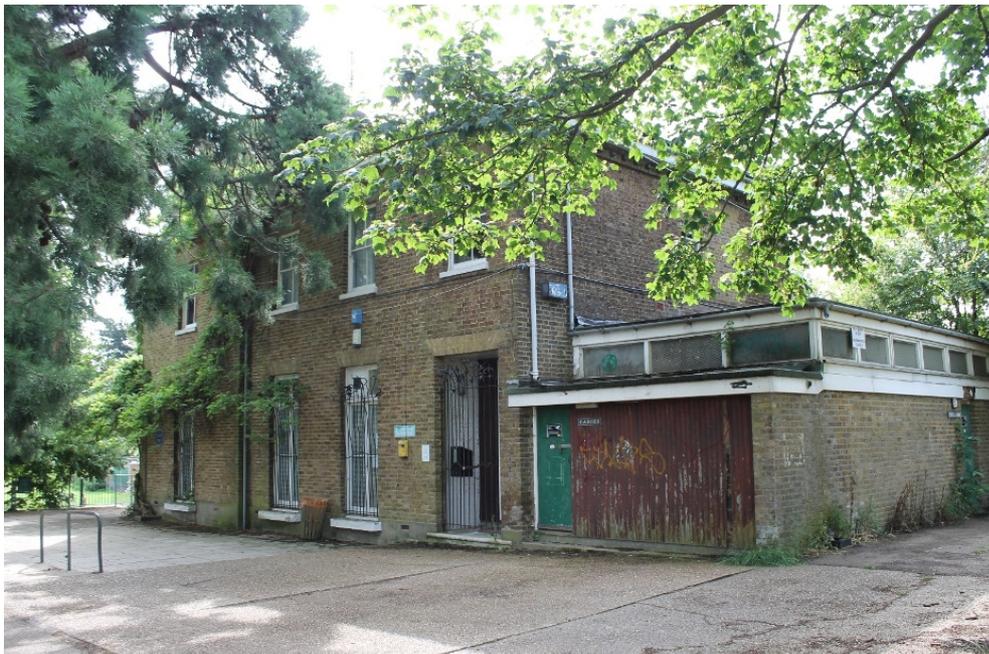
The original stables to Spurrier's House were incorporated into Pets Corner in 1966 and it is probable that this was when the toilet block was constructed against the west side of Spurrier's House. The toilet block is a single-storey, flat-roofed structure of yellow stock brick laid in stretcher bond (Plate 11), although the north elevation containing the entrance to the Ladies' toilets is formed from vertical plank cladding. The flat roof has a continuous range of narrow windows just below the eaves, providing additional illumination to the interior of the toilets.

**Plate 11 Spurrier's House with 1960s toilet block attached - view south-east**

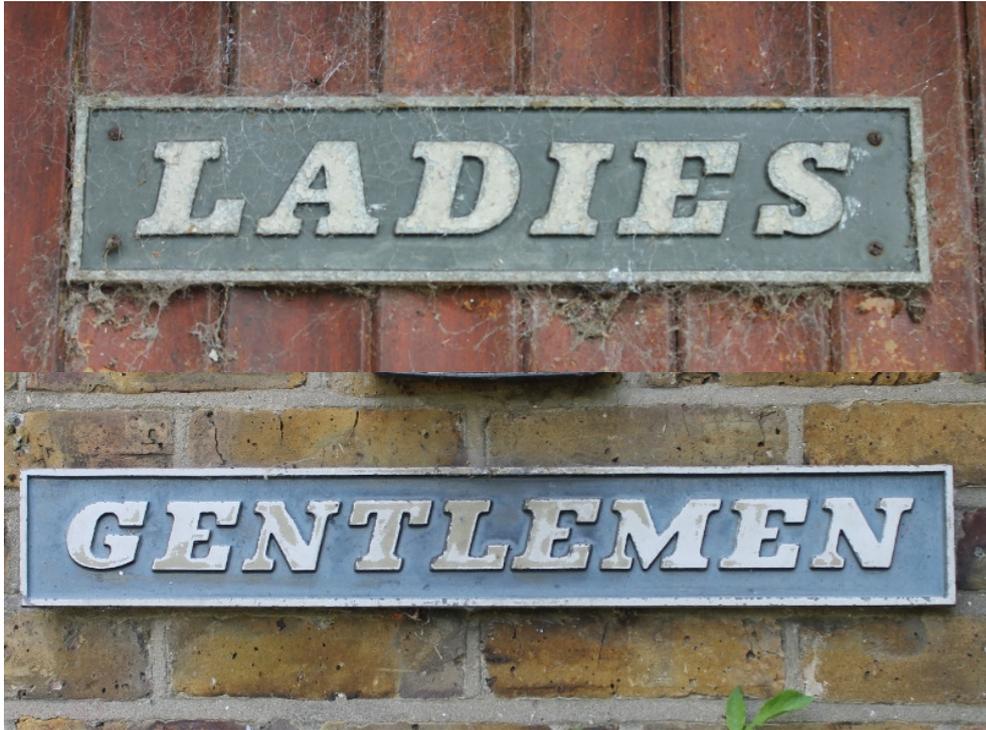
Both the Ladies' and Gentlemen's toilets have the original signage, executed in a typical 1960s font (Plate 12).

Plate 12 The original 1960s signage on the toilet block at Spurrier's House

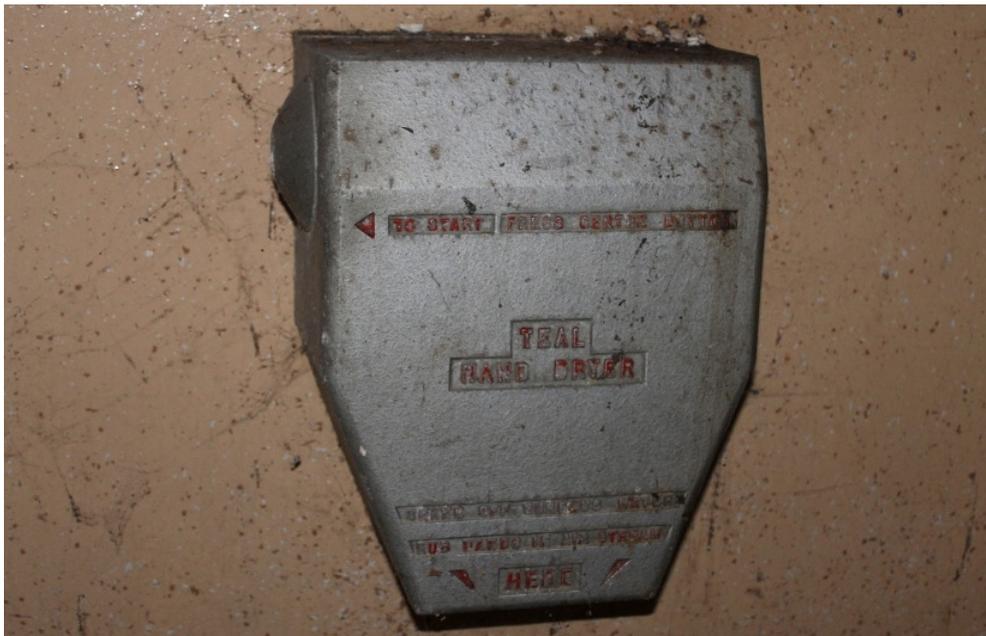
It was not possible to access the Ladies' toilets but examination of the Gentlemen's facilities showed the interior to be relatively basic in layout and design with plain, utilitarian WCs and urinals, a stark contrast to the ornate fixtures and fittings that would be encountered in a Victorian or Edwardian example. One interesting feature was the original 'Teal' electric hand-drier (Plate 13).

Plate 13 The original 1960s 'Teal' hand-drier in the toilet block at Spurrier's House

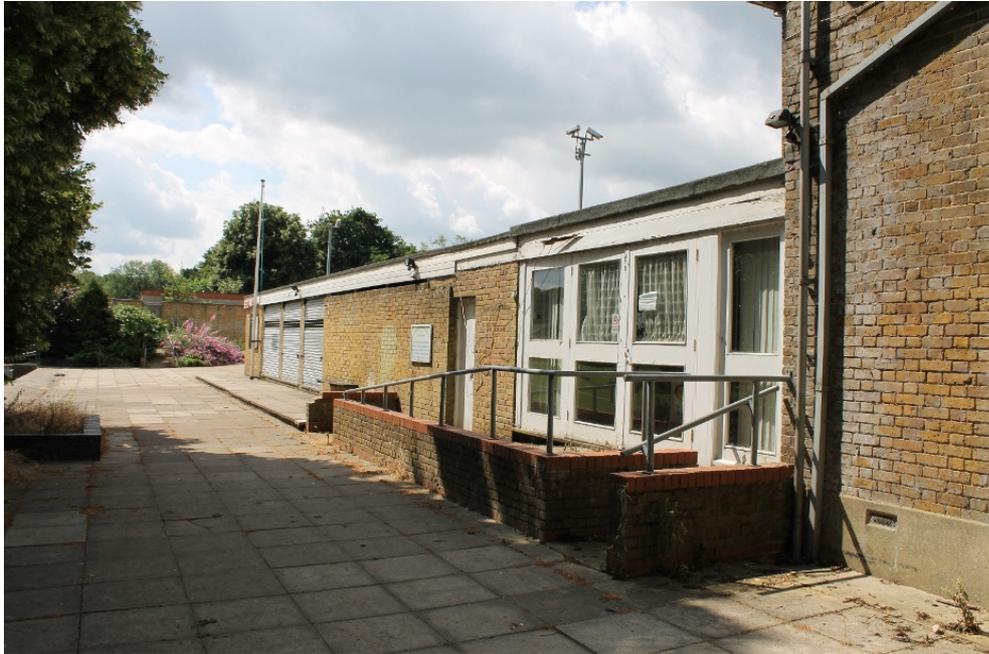
An additional extension was built in 1971 at the south-east corner of the main range to house the Town Museum and a drinks dispensary (Plate 14). This was a flat-roofed structure, constructed from yellow stock brick in an attempt to blend in with Spurrier's House.

**Plate 14 Spurrier's Core with Spurrier's House to the right and the cafe extensions - view south**

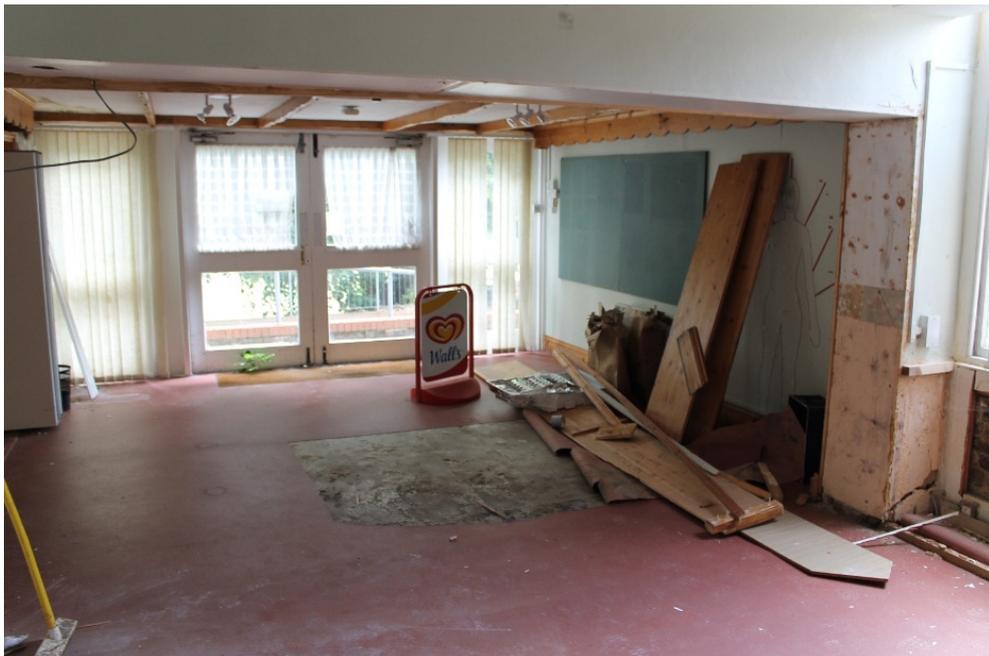
The construction of Spurrier's Core removed a large section of the ground floor wall of Spurrier's House (Plate 15). The drinks dispensary was fitted out with exposed roof beams in an unsuccessful attempt to make the building appear older than it is.

**Plate 15 The interior of the 1971 extension to Spurrier's House showing the width of the Victorian brickwork - view east**

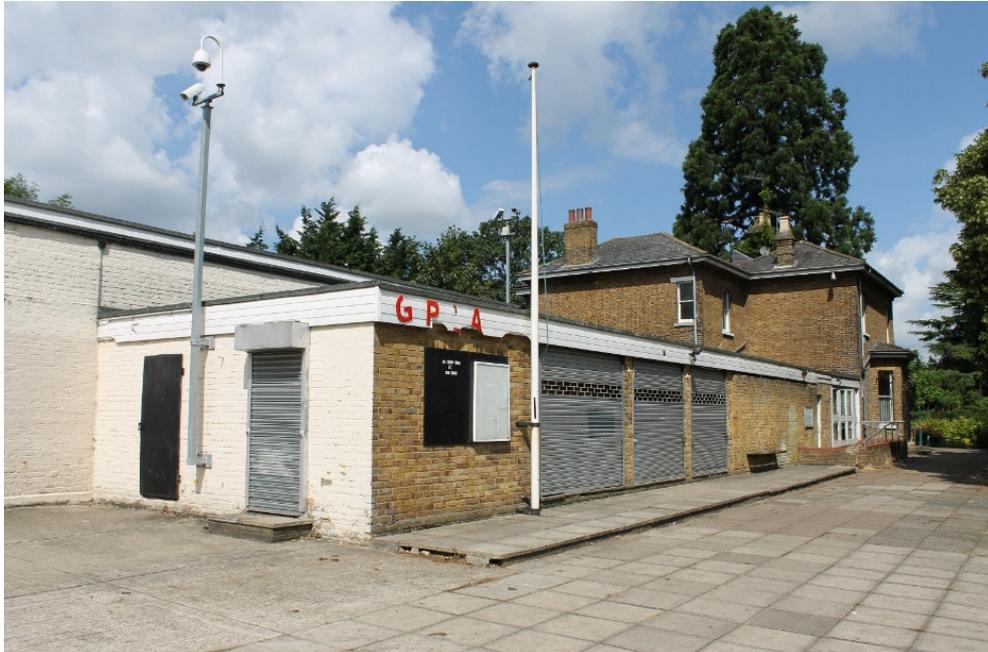
In 1973 the size of the drinks dispensary was deemed inadequate and a long, single-storey extension was built against the exterior of the east stable block to house a much larger café (Plate 16), whilst the Town Museum was moved to Passmore House. The whole of this new development became known as Spurrier's Core.

**Plate 16 Spurrier's Core with Spurrier's House to the right and the cafe extensions - view south**

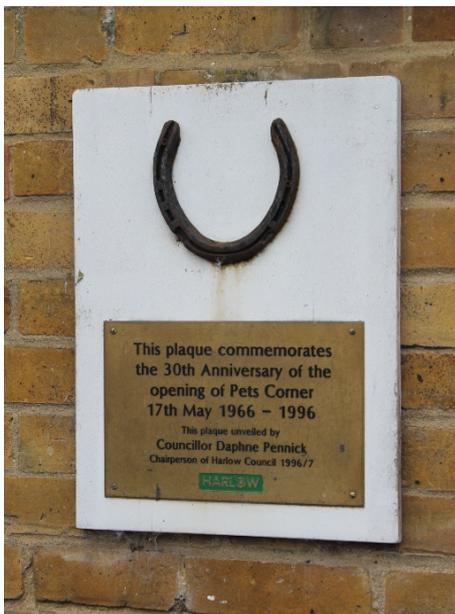
As mentioned above, Pets Corner was opened in 1966. This is commemorated in two anniversary plaques, a simple horseshoe attached to the Aquarium block, recording the 30th anniversary and a more ornate version consisting of representations of the animals in the zoo, commemorating the 40th anniversary, located above the main entrance (Plates 17 & 18).

**Plate 17 Plaque commemorating 30th Anniversary of the opening of Pets Corner**

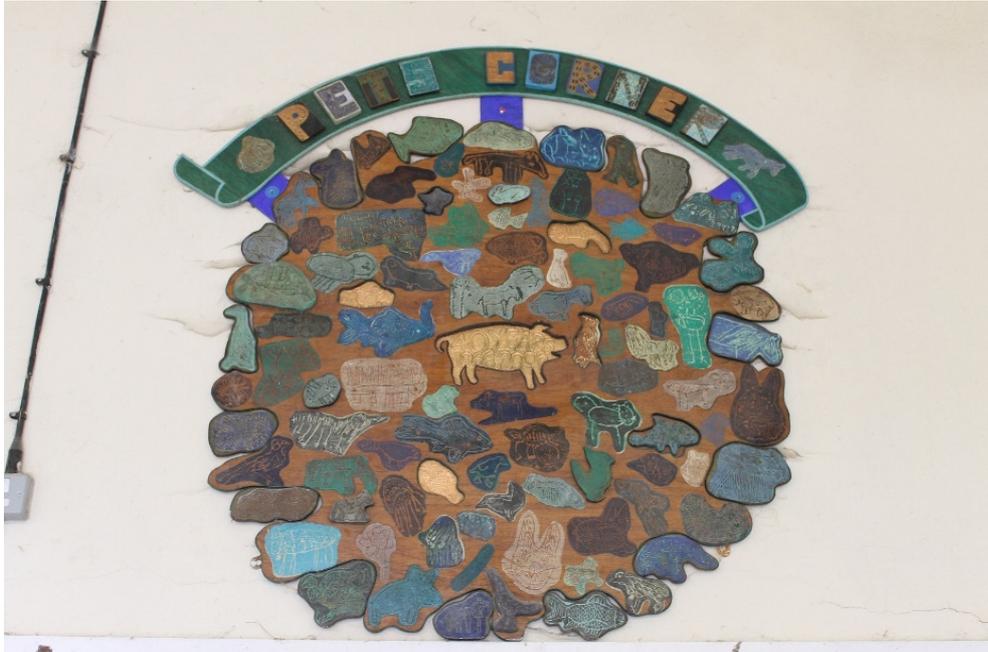
**Plate 18** Plaque commemorating 40 years of Pets Corner

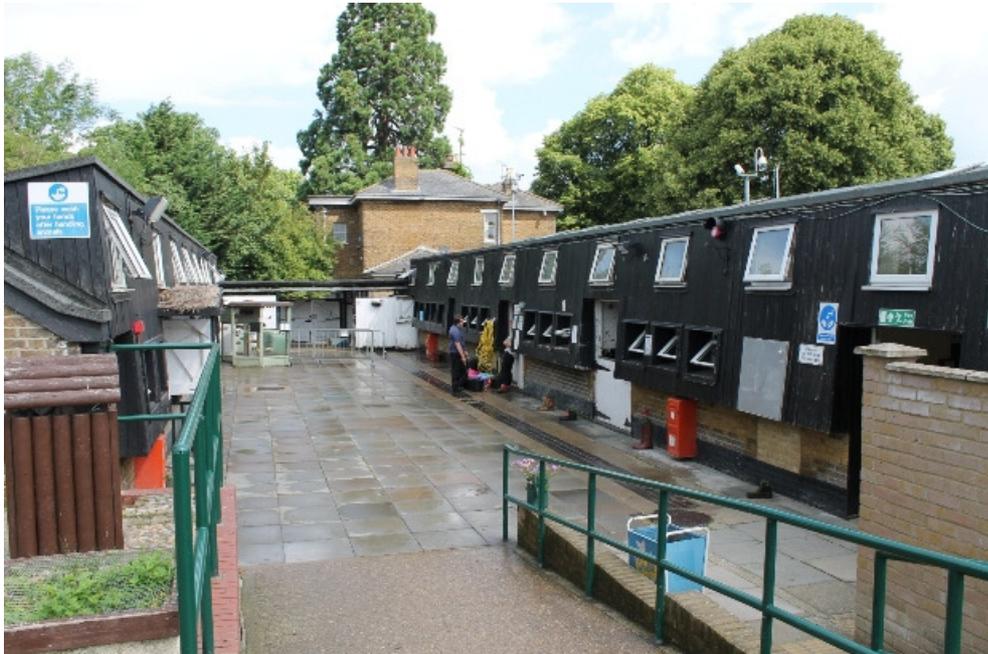
Pets Corner comprises two distinct areas, arranged in a linear pattern aligned north-west to south-east, along with a collection of paddocks to the west of the zoo. The northernmost of these areas comprises the original stable blocks for Spurrier's House (Plate 19) separated from the rear of Spurrier's House by the original Victorian stable yard gates (Plate 20).

**Plate 19** Pets Corner stable blocks with Spurrier's House in the background – view north

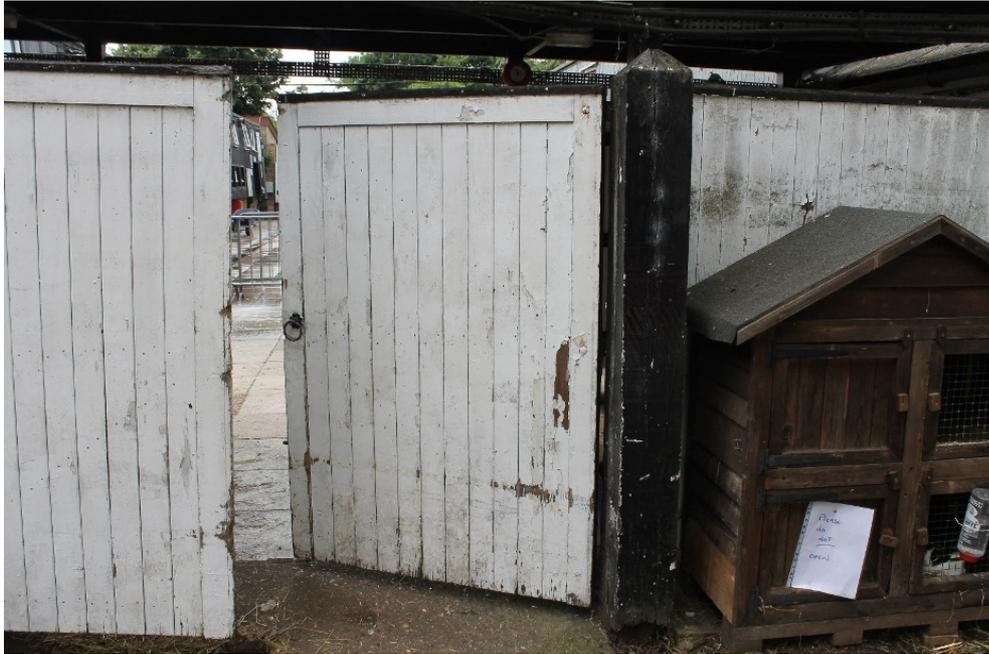
**Plate 20** Original stable yard gates of Spurrier's House, now the rear access to Pets Corner - view south-west

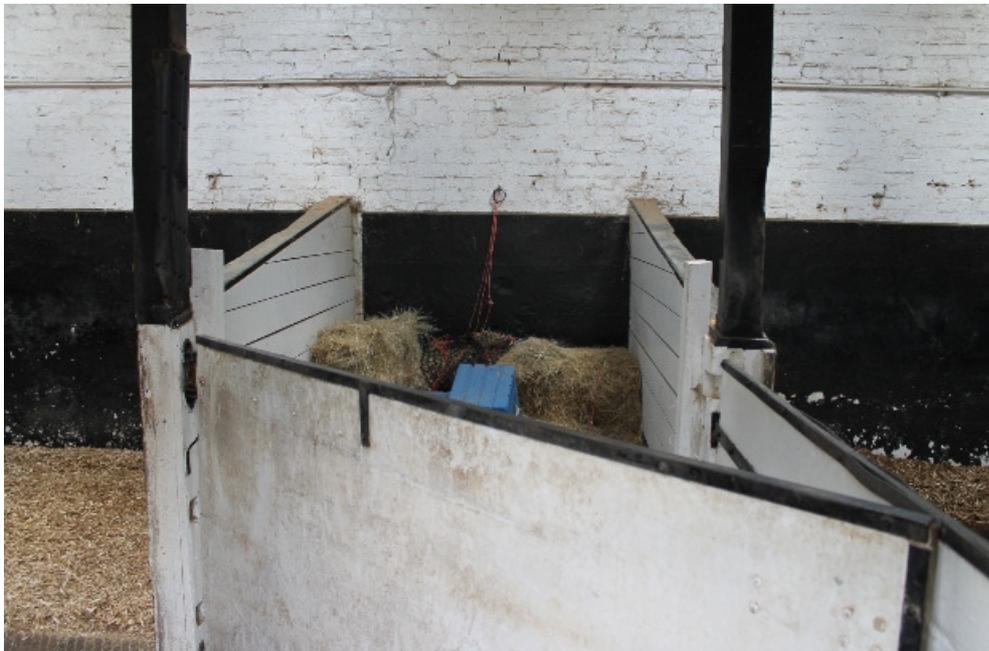
The stables have been extensively modernised, either in 1966 but probably more recently as the current stables have high roofs and double-glazed windows. Despite these alterations many original features have survived, including a drainage gully formed by Staffordshire blue bricks (probably original – but possibly later), tethering rings and stall divisions (Plate 21).

**Plate 21** Original stall dividers in the stable block - view north-east

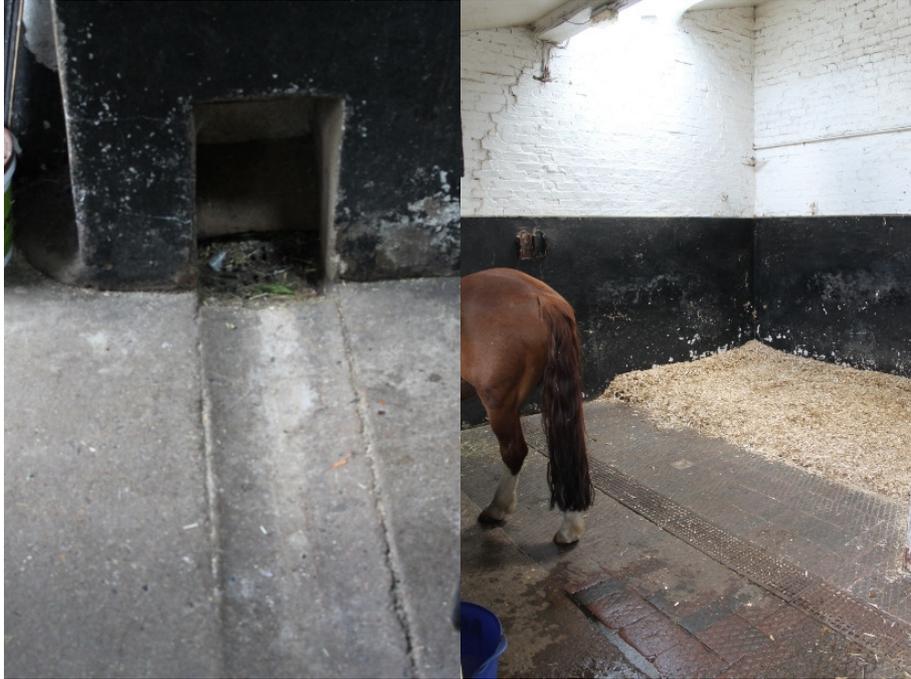
In addition to these features the internal drainage gullies and floor surfaces of the original stables have survived (Plate 22).

**Plate 22 Original drainage gullies and floor surface in the former Spurrier's House stable block**

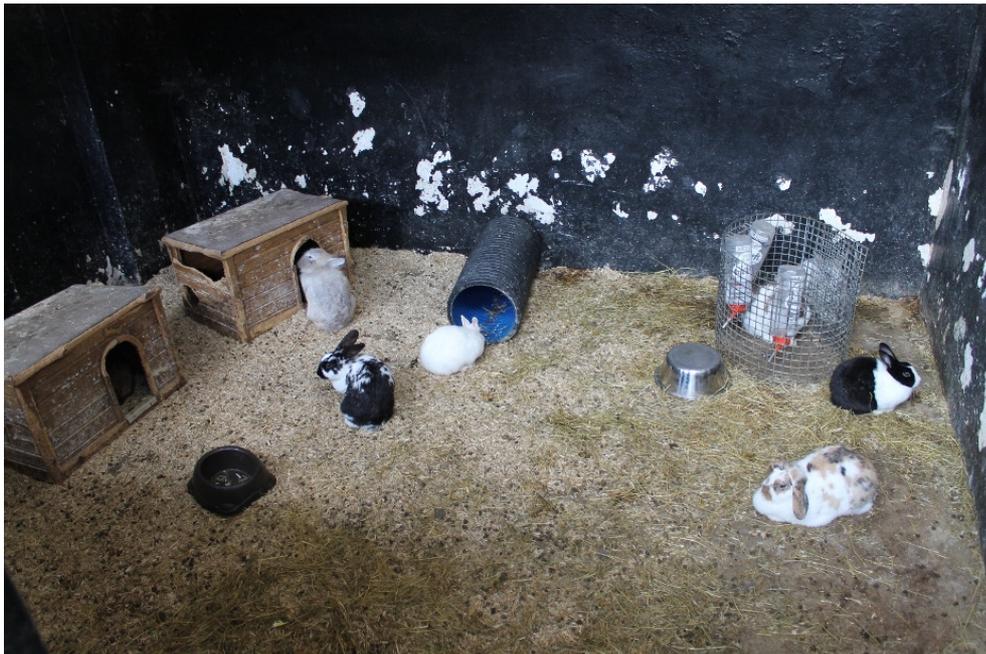
Although horses are still housed in the stables (as can be seen in Plate 22), some of the stalls have been given over to animals of a different temperament and much smaller size (Plate 23).

**Plate 23 Original stable block stall now home to a small colony of rabbits**

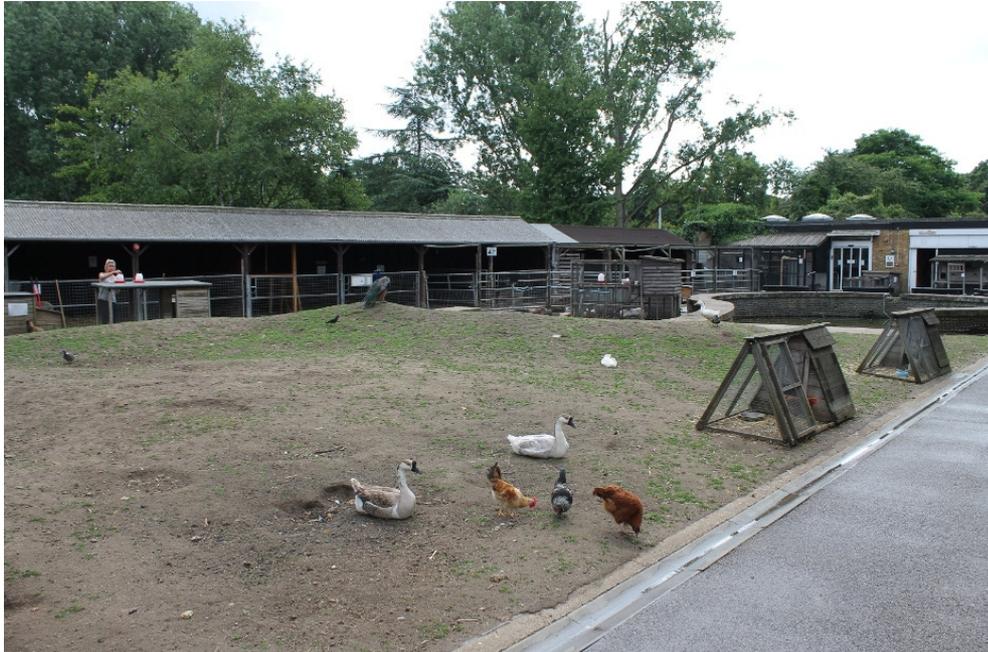
The southern part of Pets Corner dates to 1966 and consists of open-fronted shelter sheds/pens arranged around a green with a brick Aquarium at the south end (Plate 24).

**Plate 24 Pets Corner with the open stables and Aquarium block in the background - view south-east**

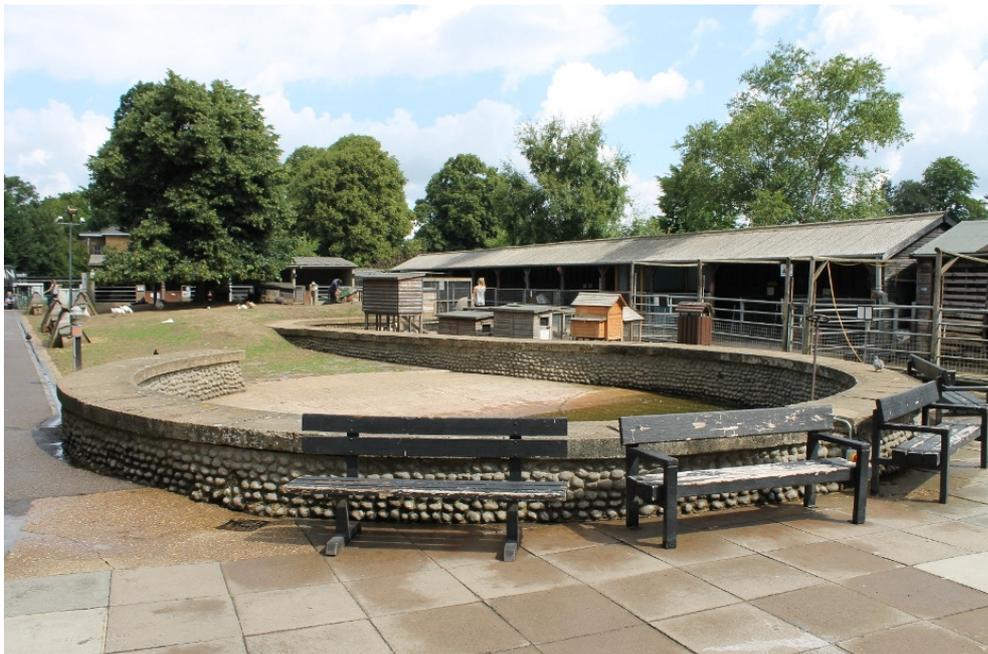
To the south of the green is a low S-shaped structure, built from river cobbles capped with concrete slabs. The south end of this forms a duck pond (Plate 25) whilst the north end is embedded into the green, forming a small plaza filled with bird cages.

**Plate 25 The interior of Pets Corner with the duck pond in the foreground and open-fronted shelter sheds to the right - view north**

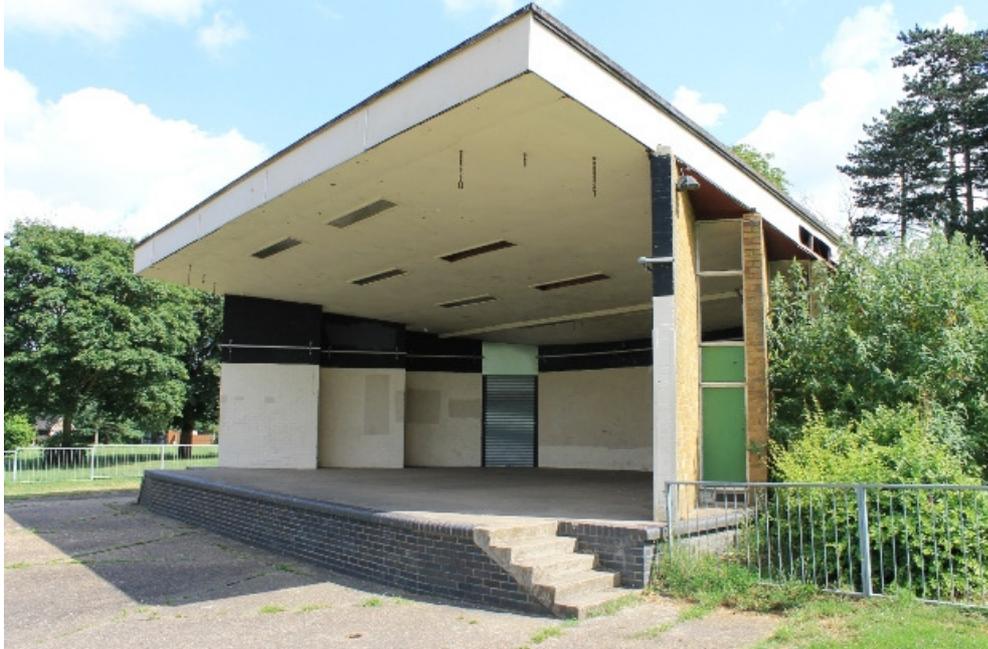
The Bandstand was built in 1973 and is a concrete and brick structure more akin to a theatre than a traditional bandstand. Like the other buildings of Spurrier's core it has been constructed of yellow stock brick in an attempt to blend in with the Victorian Spurrier's House. The Bandstand takes the form of a raised stage with funnelled sides and an overhead canopy (Plate 30).

**Plate 30 The Bandstand with its raised stage and angled walls – view north**

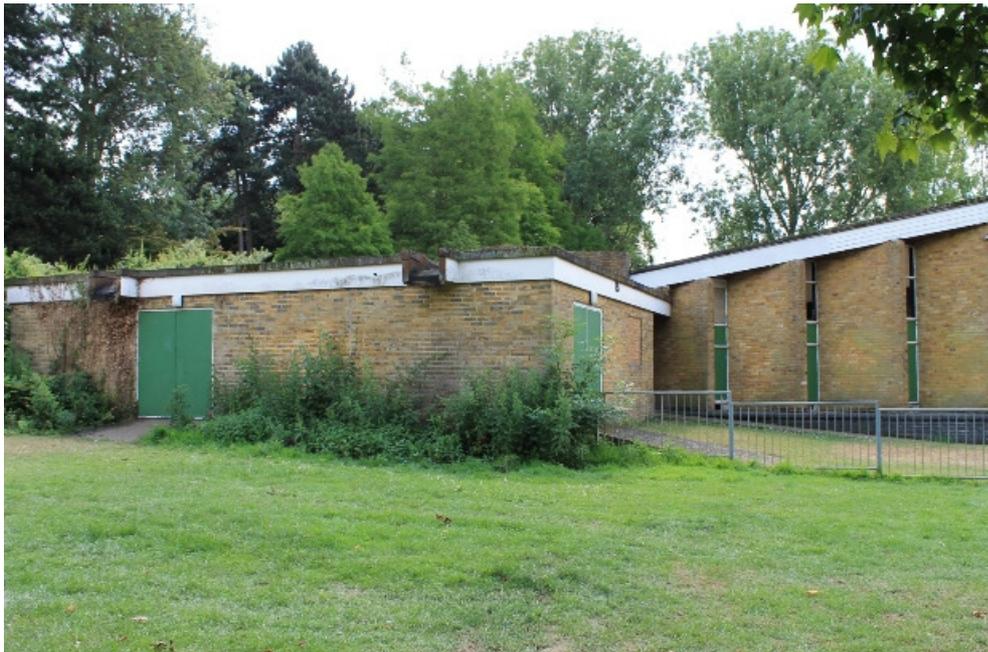
There is a single-storey, flat-roofed ancillary structure to the rear and the north, which housed the green room and dressing rooms (Plate 31).

**Plate 31 The ancillary structure at the side and rear of the Bandstand, housing the green room and dressing rooms – view south-east**

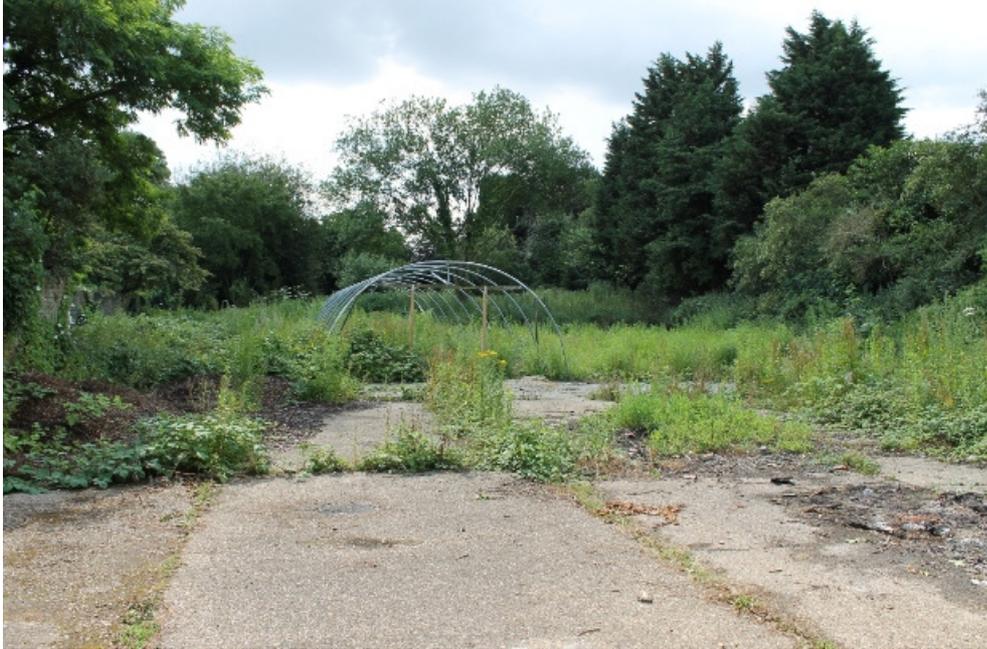
The nursery is located in the former walled garden of Spurrier's House and has been neglected for many years. The result is a wilderness (Plate 32) with some dilapidated structures that are all that remains of the gardener's office and potting sheds (Plate 33).

**Plate 32** The Nursery, formerly the walled garden of Spurrier's House - view south-east

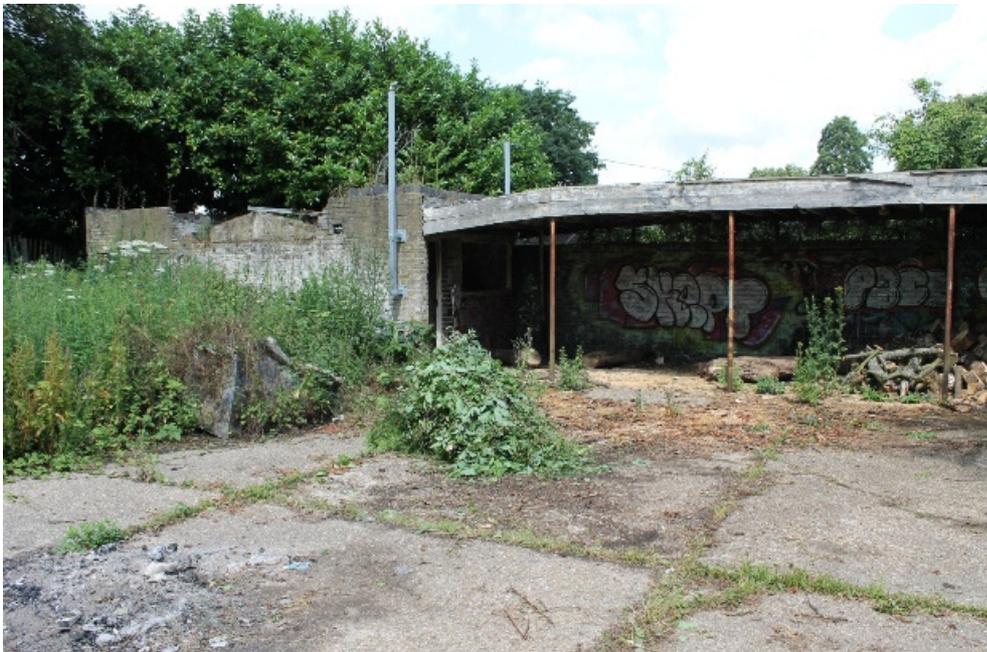
**Plate 33** Remains of the gardener's office and an open-fronted shed in the Nursery - view north-west

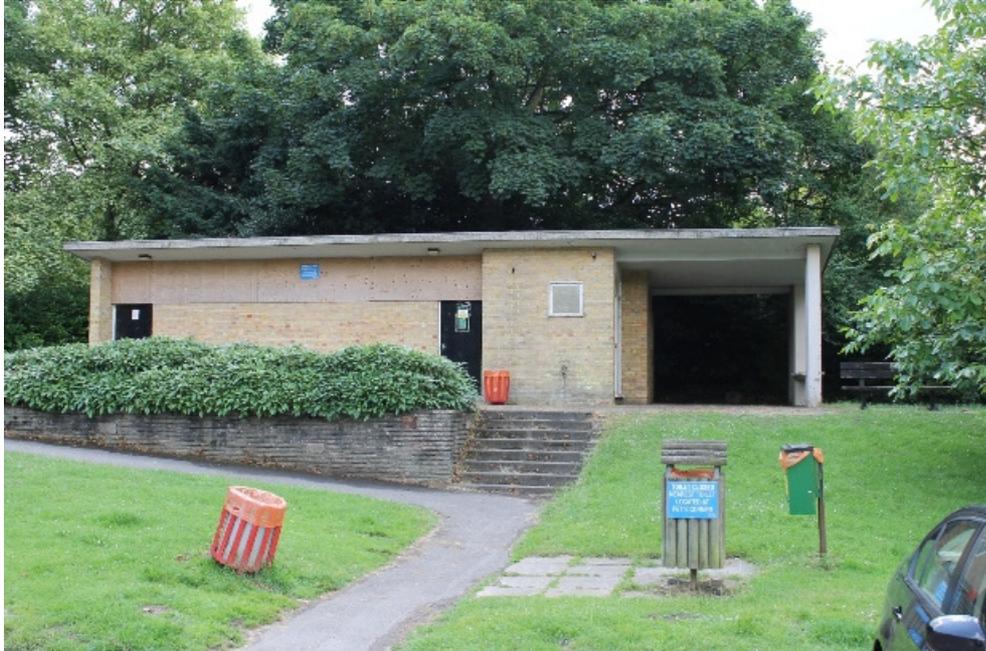
The proximity of the Greyhound toilets to the Bandstand suggests they were constructed to accommodate the increase in visitor numbers attending concerts in the park, either in 1973 at the same time as the Bandstand was built or shortly after. The toilets (named for the nearby public house which dates to at least 1810) occupy a low ridge on the south side of the car park (Plate 34).

**Plate 34 The Greyhound toilets - view south**

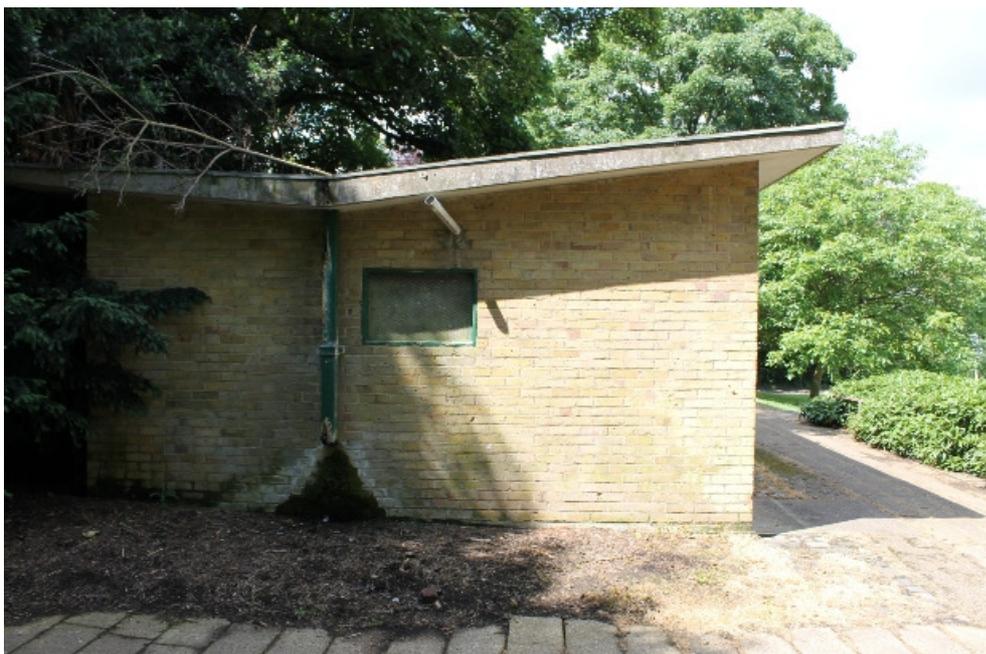
The toilets are constructed from brick and concrete and have an inverted roof designed to funnel rainwater to an integrated rainwater pipe at the east end of the building (Plate 35).

**Plate 35 The Greyhound toilets with the integrated roof drainage - view west**

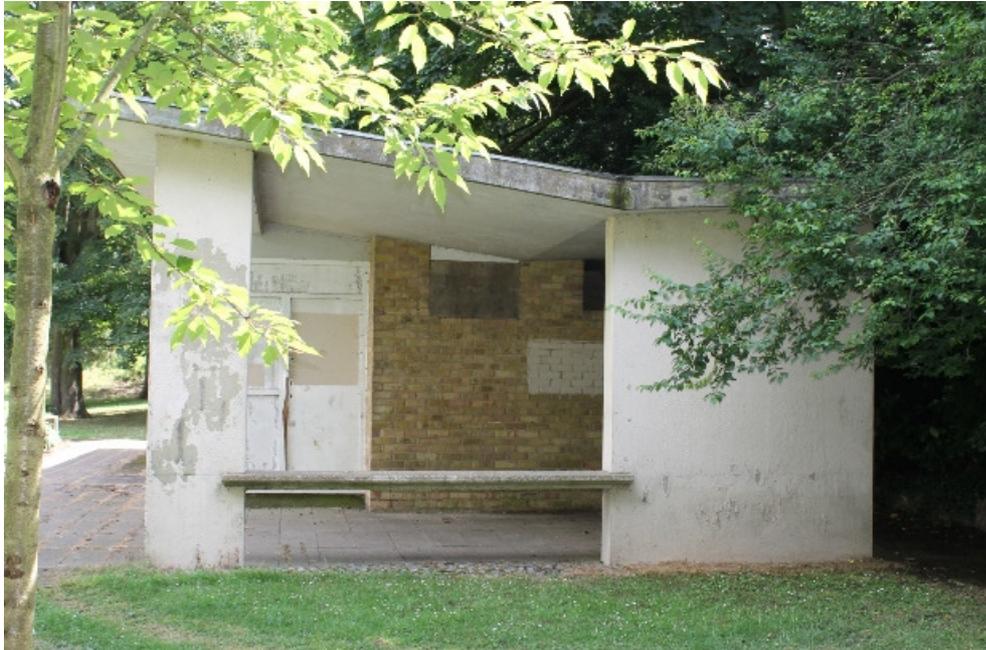
The west end of the structure has a projecting canopy supported on two different sized concrete piers, between which is a concrete bench (Plate 36).

**Plate 36** The west end of the Greyhound toilets with the canopy over the bench held by the roof piers - view east

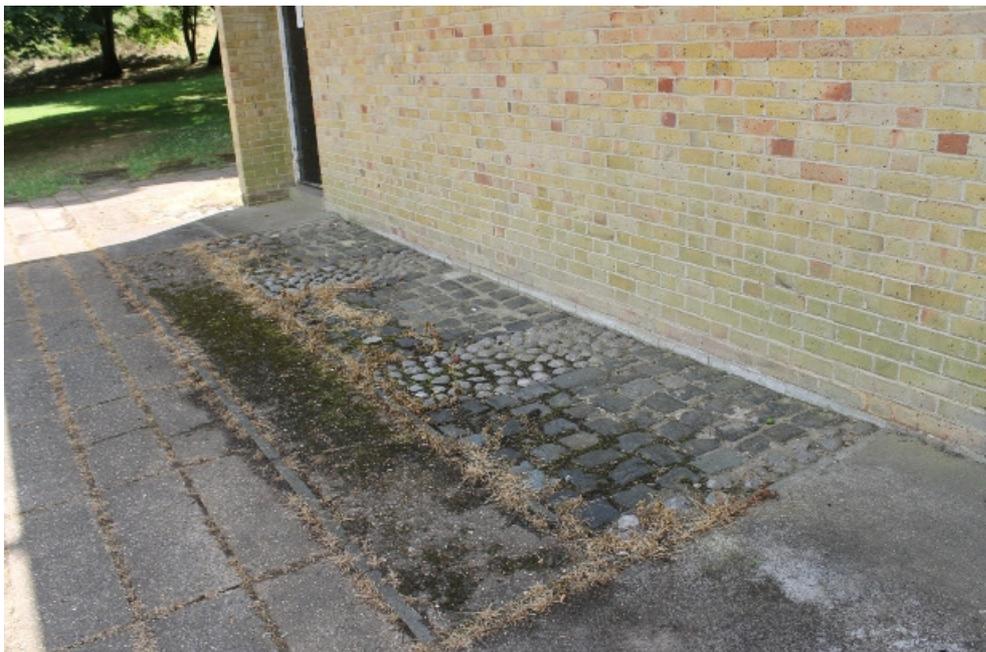
An area of hard-standing in front of the toilets has a tactile surface formed from granite setts and rounded cobbles, possibly an intentional reflection of the Pets Corner duck pond (Plate 37).

**Plate 37** Tactile surface outside the Greyhound toilets, possibly recalling the duck pond of Pets Corner - view east
