# Archaeological evaluation at the former Danbury Medical Centre, 7 Eves Corner, Danbury, Essex, CM3 4QA

November 2016

**CAT Report 1035**  
November 2016

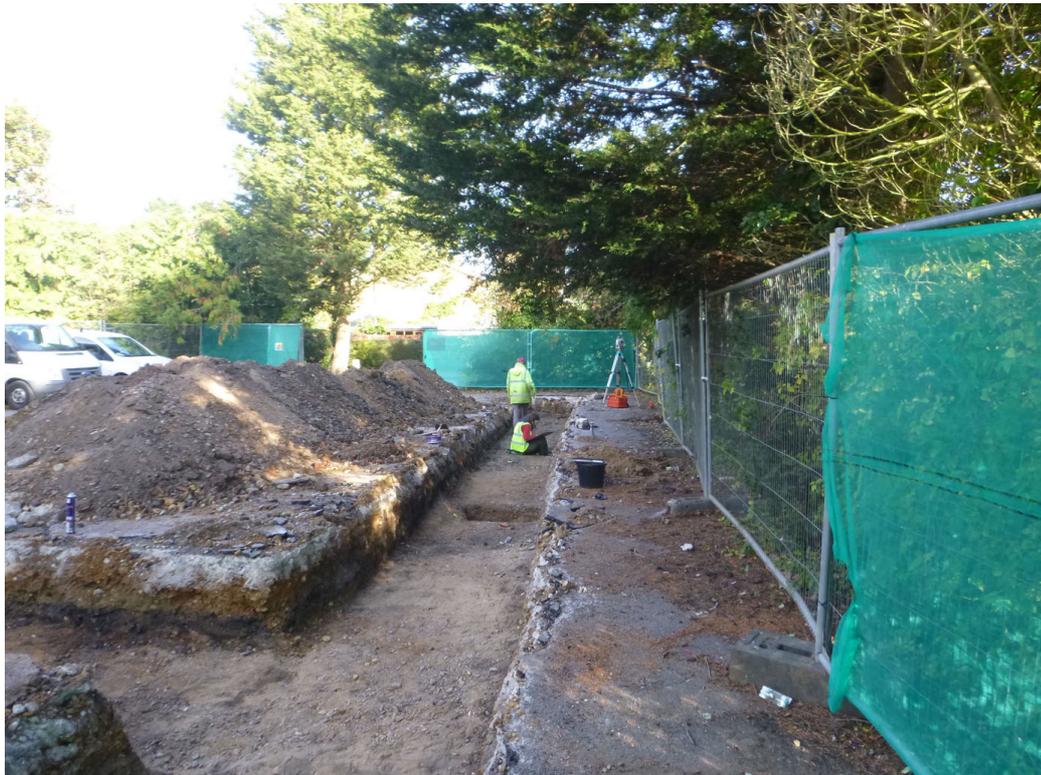
Photograph 1 Trial-trench, looking E

One trial-trench totalling 34m long by 1.8m wide was located within the footprint of the new dwellings. It was machine excavated under archaeological supervision.

Three layers were identified. Modern layers of tarmac, concrete and hoggin (L1, c 310-370mm thick) sealed a modern make-up spread of dark grey/brown sandy loam (L2, c 60-180mm thick). Beneath L2 were natural sands and silty-clays (L3).

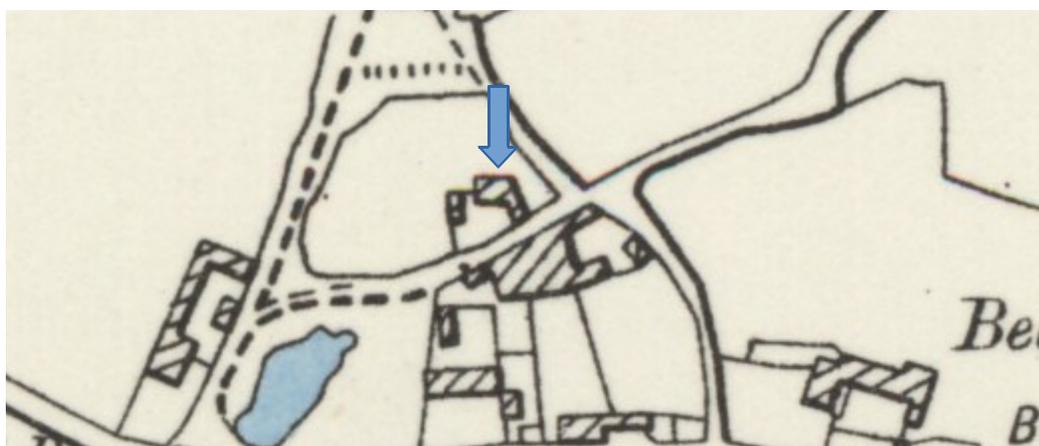
**Map 1** 1895 six-inch OS map (Essex LIII.SE) showing buildings on the development site (as indicated by the blue arrow)

Archaeological evaluation revealed two post-medieval/modern pits and two modern post-holes. The pits are probably associated with buildings that existed on the development site in the post-medieval/modern periods, as shown on early OS maps.

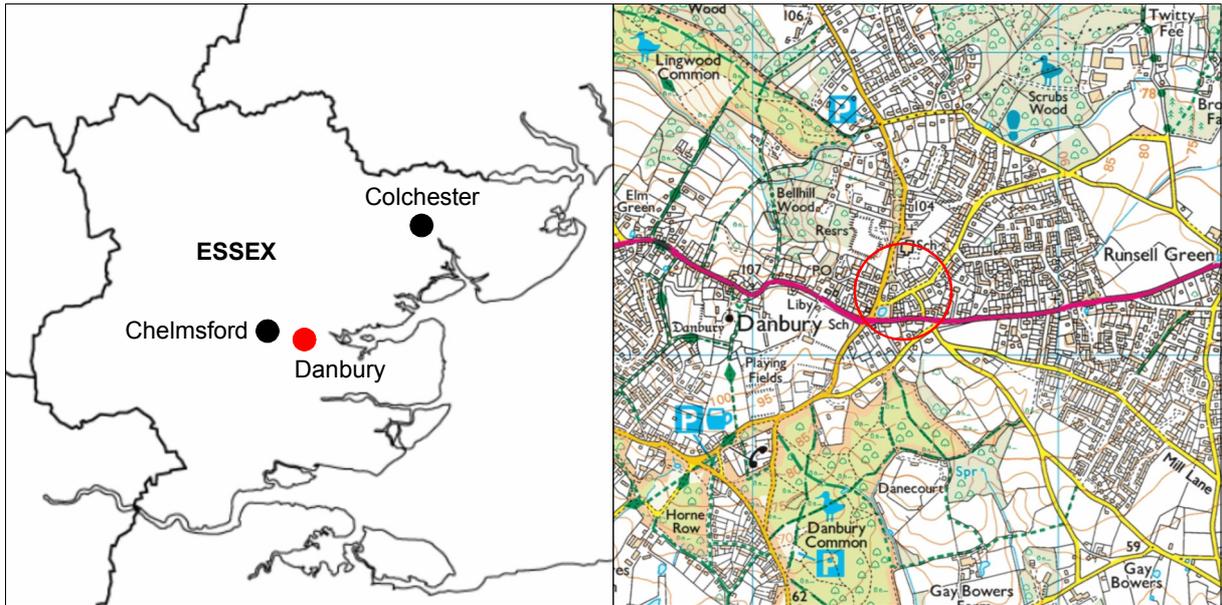
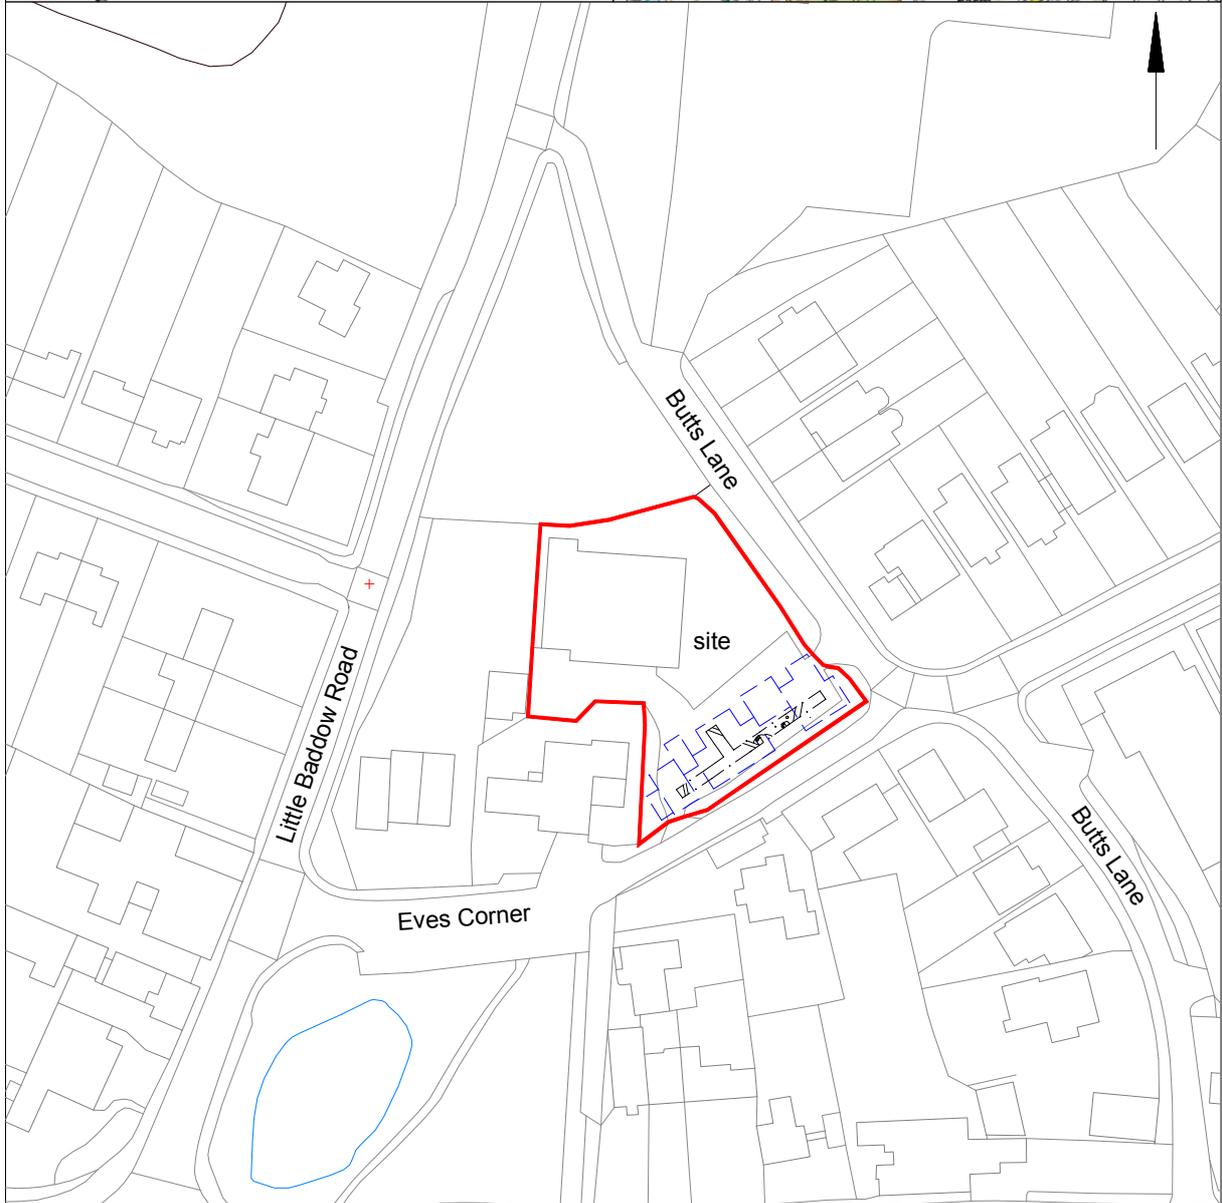
Fig 1 Site location and trench plan in relation to proposed development (dashed blue).

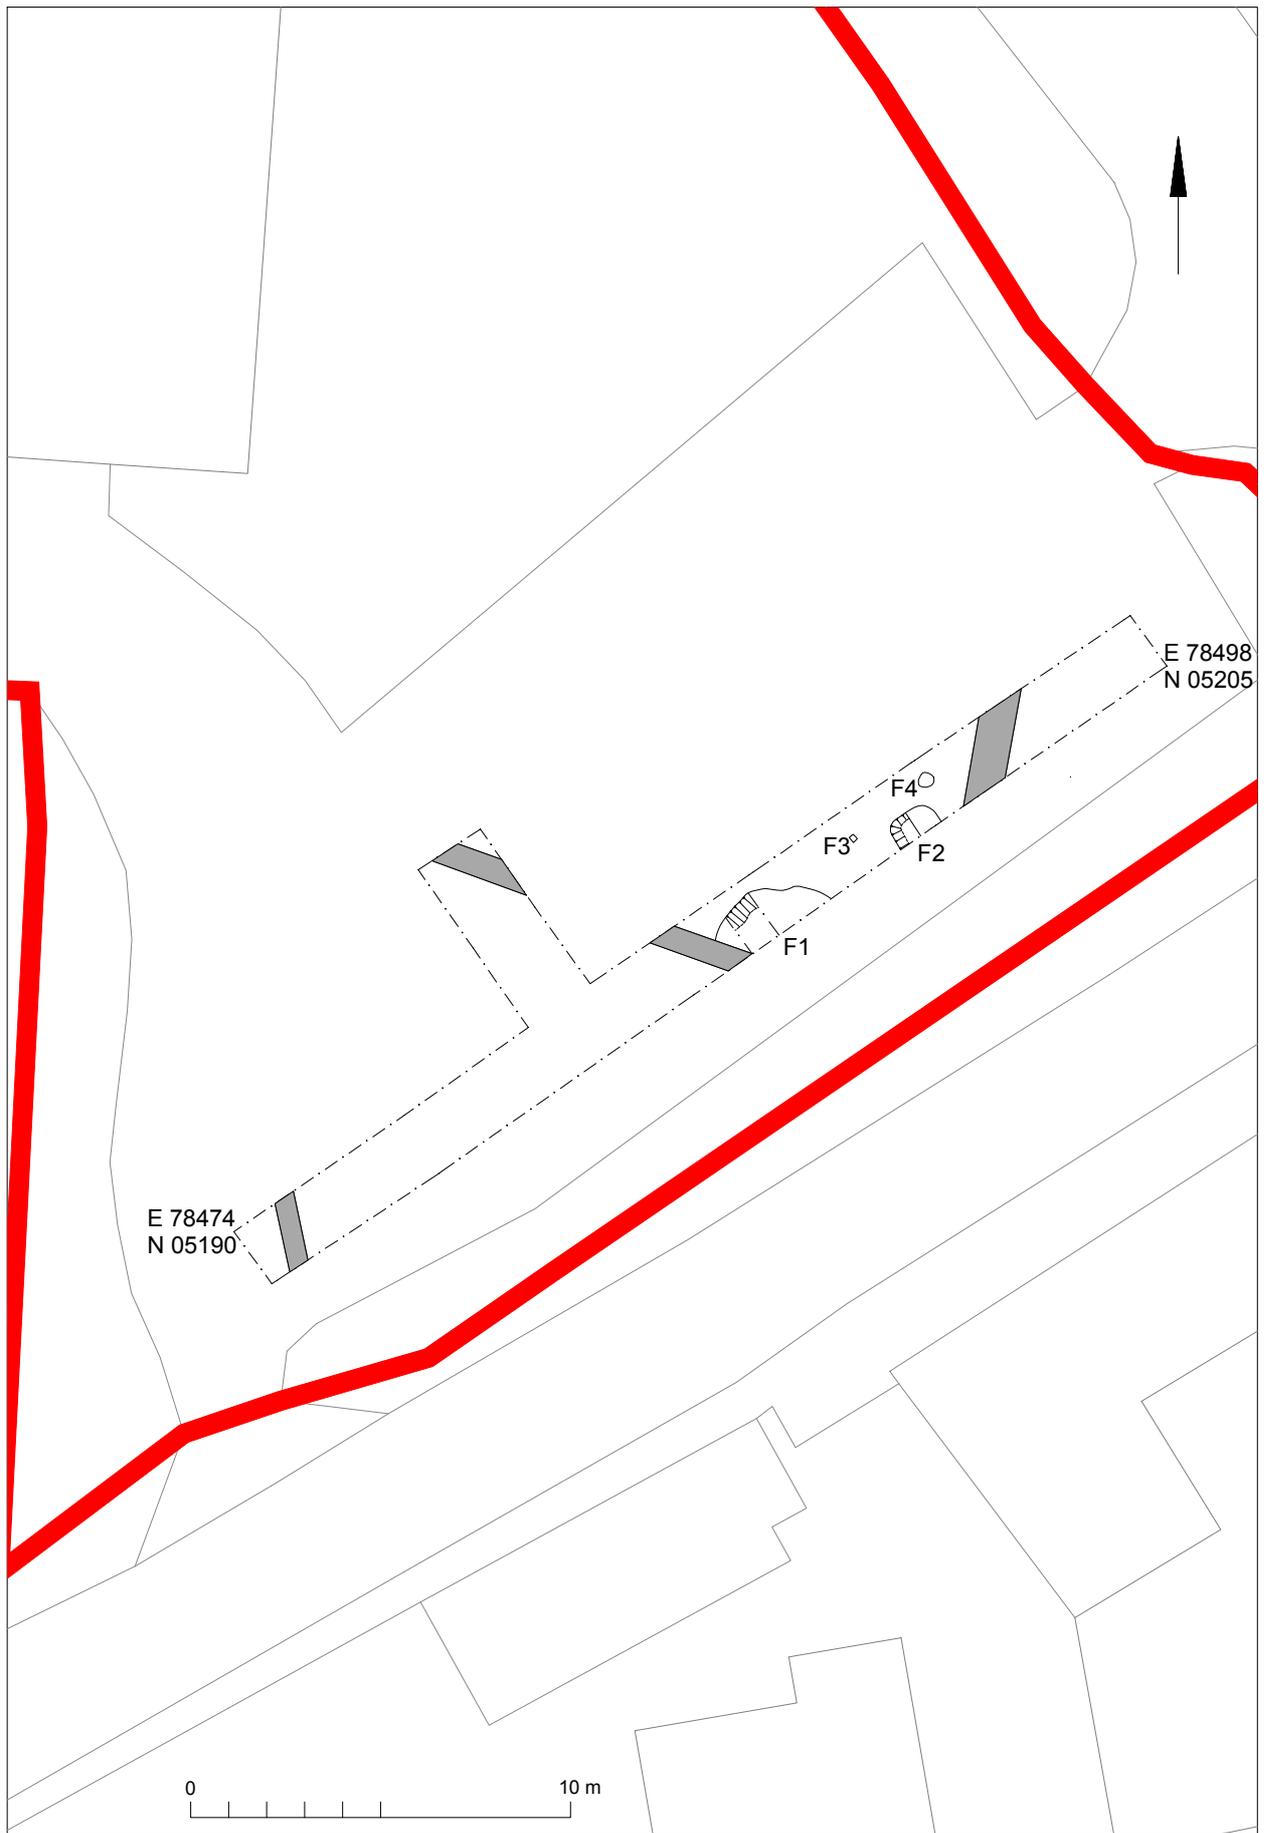
Fig 2 Trench plan

Two pits dating to the late 18th – early 20th century (F1) and the 19th century (F2), and two modern postholes were excavated. The postholes appeared to have been packed with a small quantity of peg-tile and still contained the rotting remains of the *insitu* modern timber posts (F3-F4). Three service trenches were also recorded.

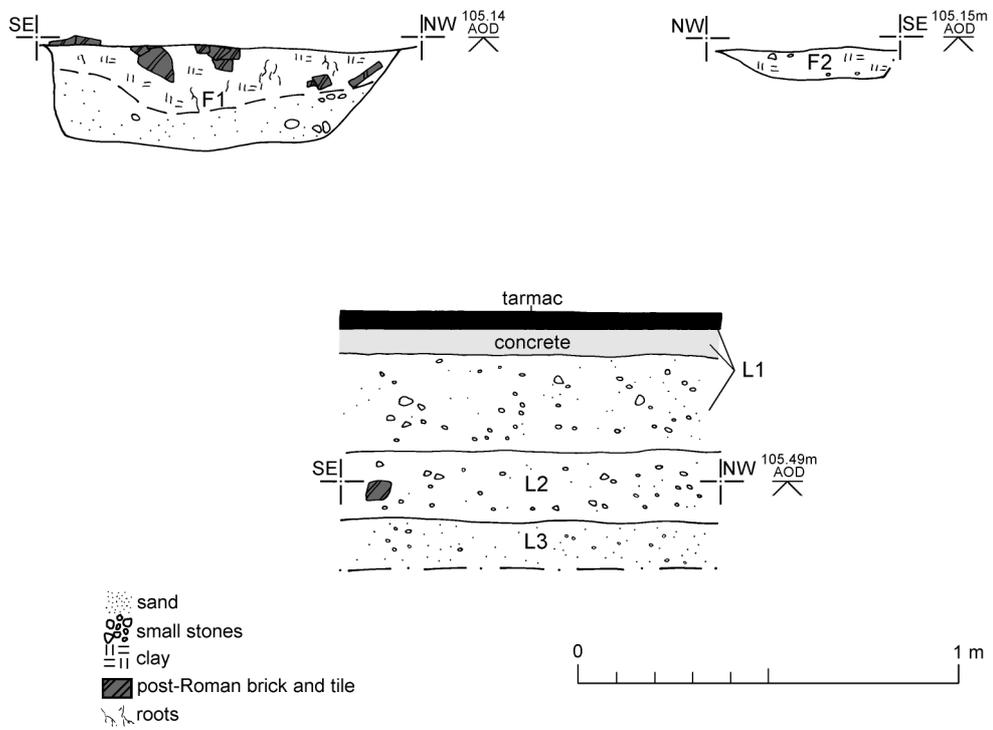
Fig 3 Feature and representative trench sections.
