**An archaeological watching brief
at East Hill House, 76 High Street,
Colchester, Essex, CO1 1UF
April 2014-March 2017**

**report prepared by
Donald Shimmin**

CAT Report 1202

January 2019

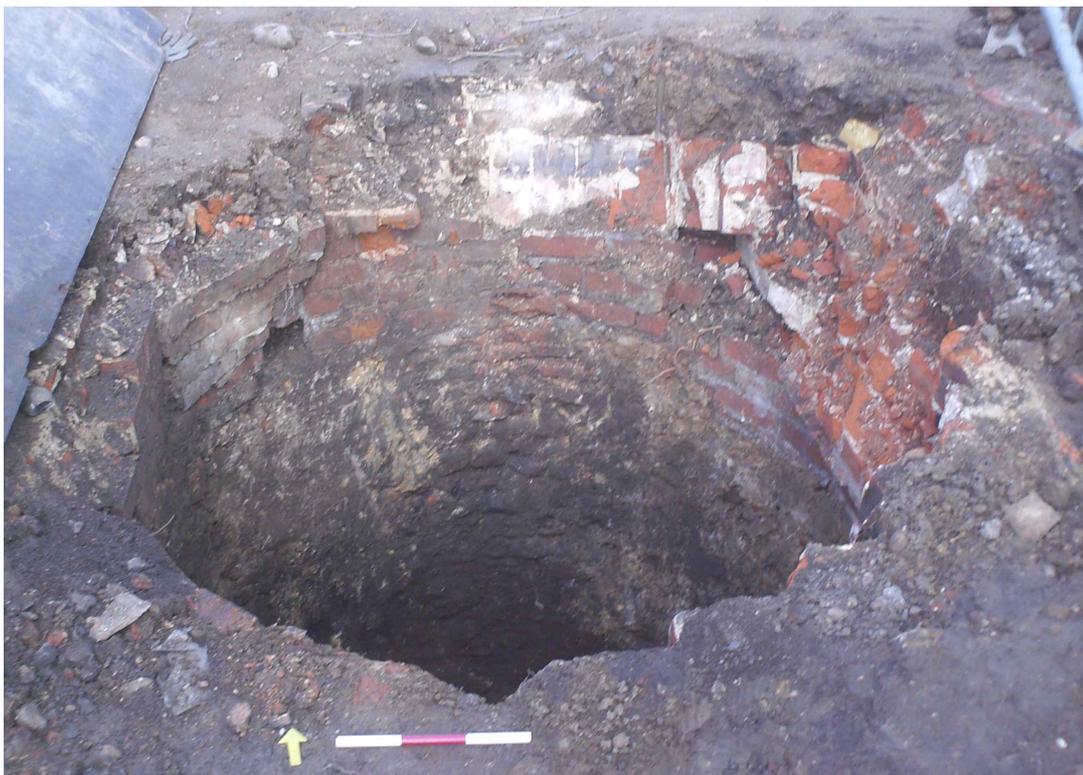
Photo 2 Well (F3), viewed from the south.

This shows the brick courses in the upper part of the well, together with what survived of the brickwork that overlay it. One of the small holes in the brick courses is visible in the north-western part of the well.

6.4.3 Above the rubble lining, in the circular part of the well, there were several courses of post-medieval/modern brick (Sx 1, Fig 5; Photos 2-3). The number of brick courses varied from 3 to 6, and measured approximately 200 to 400 mm in depth. The bricks were reddish, unfrogged, and roughly 230 x 110 x 63 mm in size. They looked later in date than those used in the construction of East Hill House and possibly dated to the early-mid 19th century.

6.4.4 A number of small holes or gaps in the brick courses were recorded (a-e in Fig 4; Photos 2-3). At least five of these holes were observed, several of which still had soil from the backfill in them. They varied slightly in size, from about 140 to 180 mm wide by 80 to 120 mm high. The holes all lay at about the same level in the well; just above the junction of the brick courses with the rubble lining below them. The holes possibly housed a timber structure, but

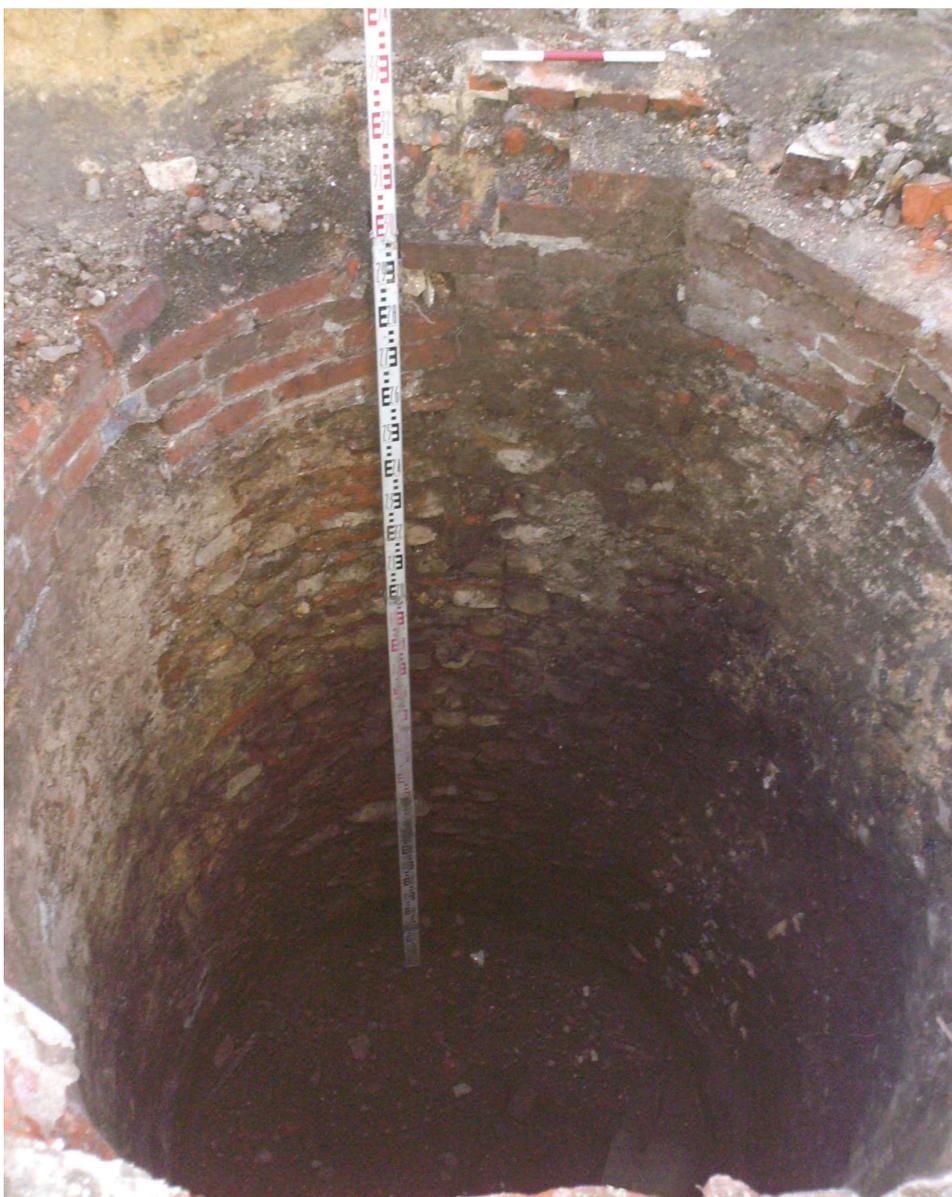
Photo 3 Well (F3), viewed from the east.

One of the small holes in the brick courses is visible in the north-western part of the well.

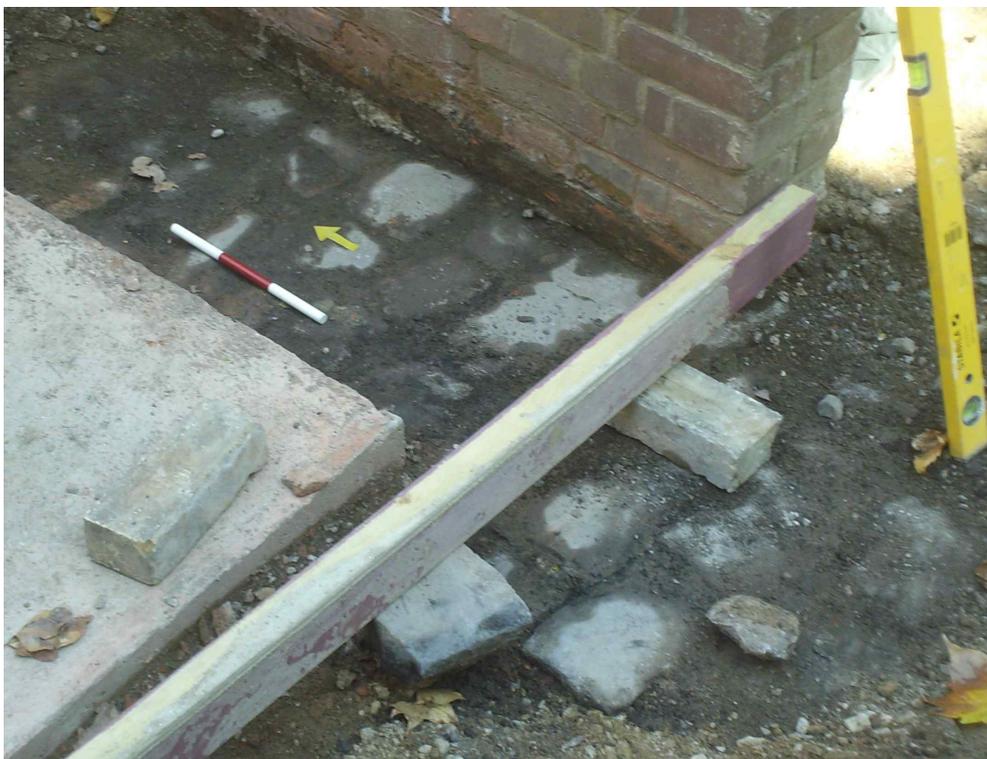
Photo 4 Large, squared cobbles (L4) at the northern end of the courtyard, viewed from the south-west.

6.6.3 More cobbling was uncovered during resurfacing work at the northern end of the courtyard, between two short lengths of north-south brick wall. These lay to the west of the front gate that gives access onto the High Street, immediately to the west of East Hill House (Fig 2). Between the more easterly brick wall and a concrete slab, an area of fairly large cobbles was exposed (Photo 4). This area measured approximately 1.8 m north-south by 0.8 m east-west. Each cobble had been roughly squared off and measured 100-150 mm across. The cobbles lay approximately 100 mm below the modern ground level.

6.6.4 The cobbling (L4) exposed during the watching brief presumably belonged to a former yard surface. It was revealed mainly over the north-western part of the courtyard to the east of the Coach House. How far it extended eastwards and southwards is unclear. In some places L4 appeared to be absent, although this was perhaps because in these areas it had been destroyed by later activity, such as the digging of pits and service trenches. The cobbled surface lay immediately below the modern tarmacked yard surface (L1). No firm dating evidence was recovered for L4, but possibly it was laid down around the time that the Coach House was built, probably in the mid-19th century. Its proximity to the existing yard surface perhaps indicates that it continued in use into the 20th century.

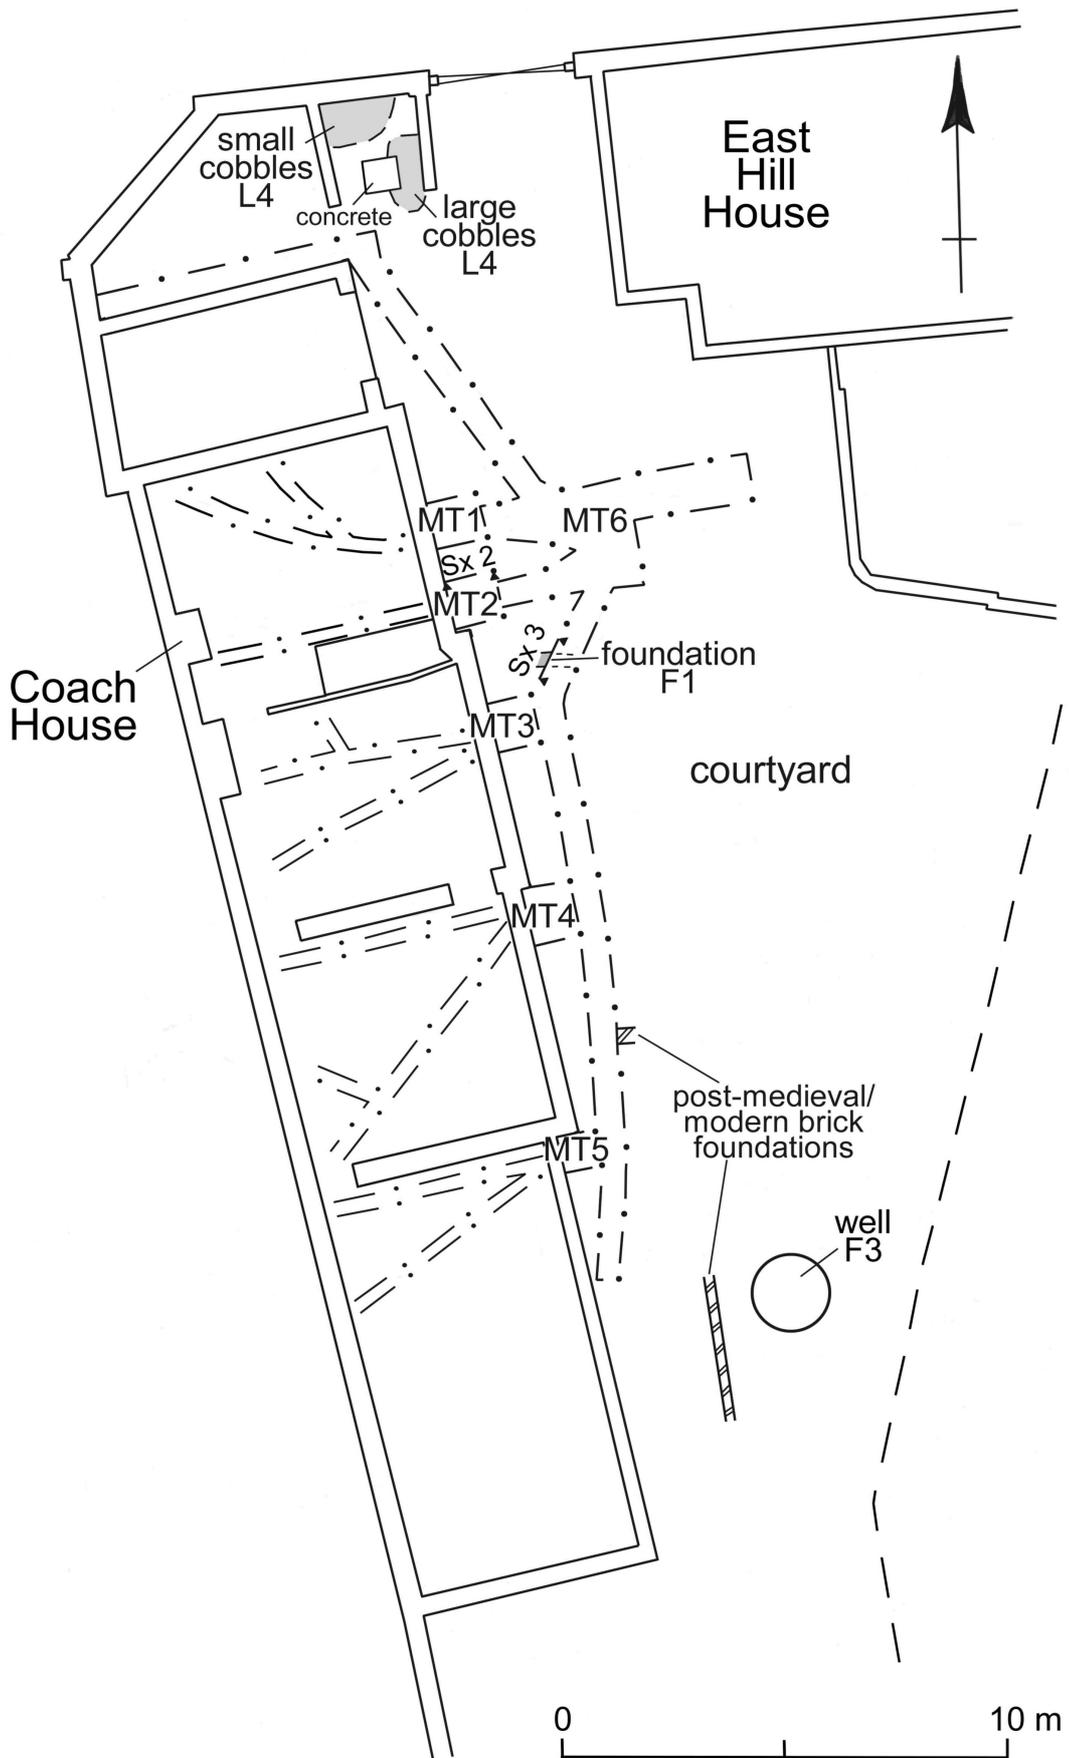
Fig 2 Plan of the Coach House and the adjacent courtyard.

- 5.3** In November 2014, a series of trenches for drains was dug inside the Coach House, after the floors had been taken up (Fig 2). The trenches extended from west to east and were approximately 300 mm wide. They varied in depth from approximately 500 mm to 250 mm.

- 5.4** Also in November 2014, work began laying drains in the courtyard to the east of the Coach House. Initially, five small trenches for manholes (MT1-MT5, Fig 2) were dug in the courtyard, up against the east wall of the Coach House. These trenches were roughly square-shaped. They varied in size from approximately 800 mm to 1.2 m square, and from 800 mm to 950 mm deep.

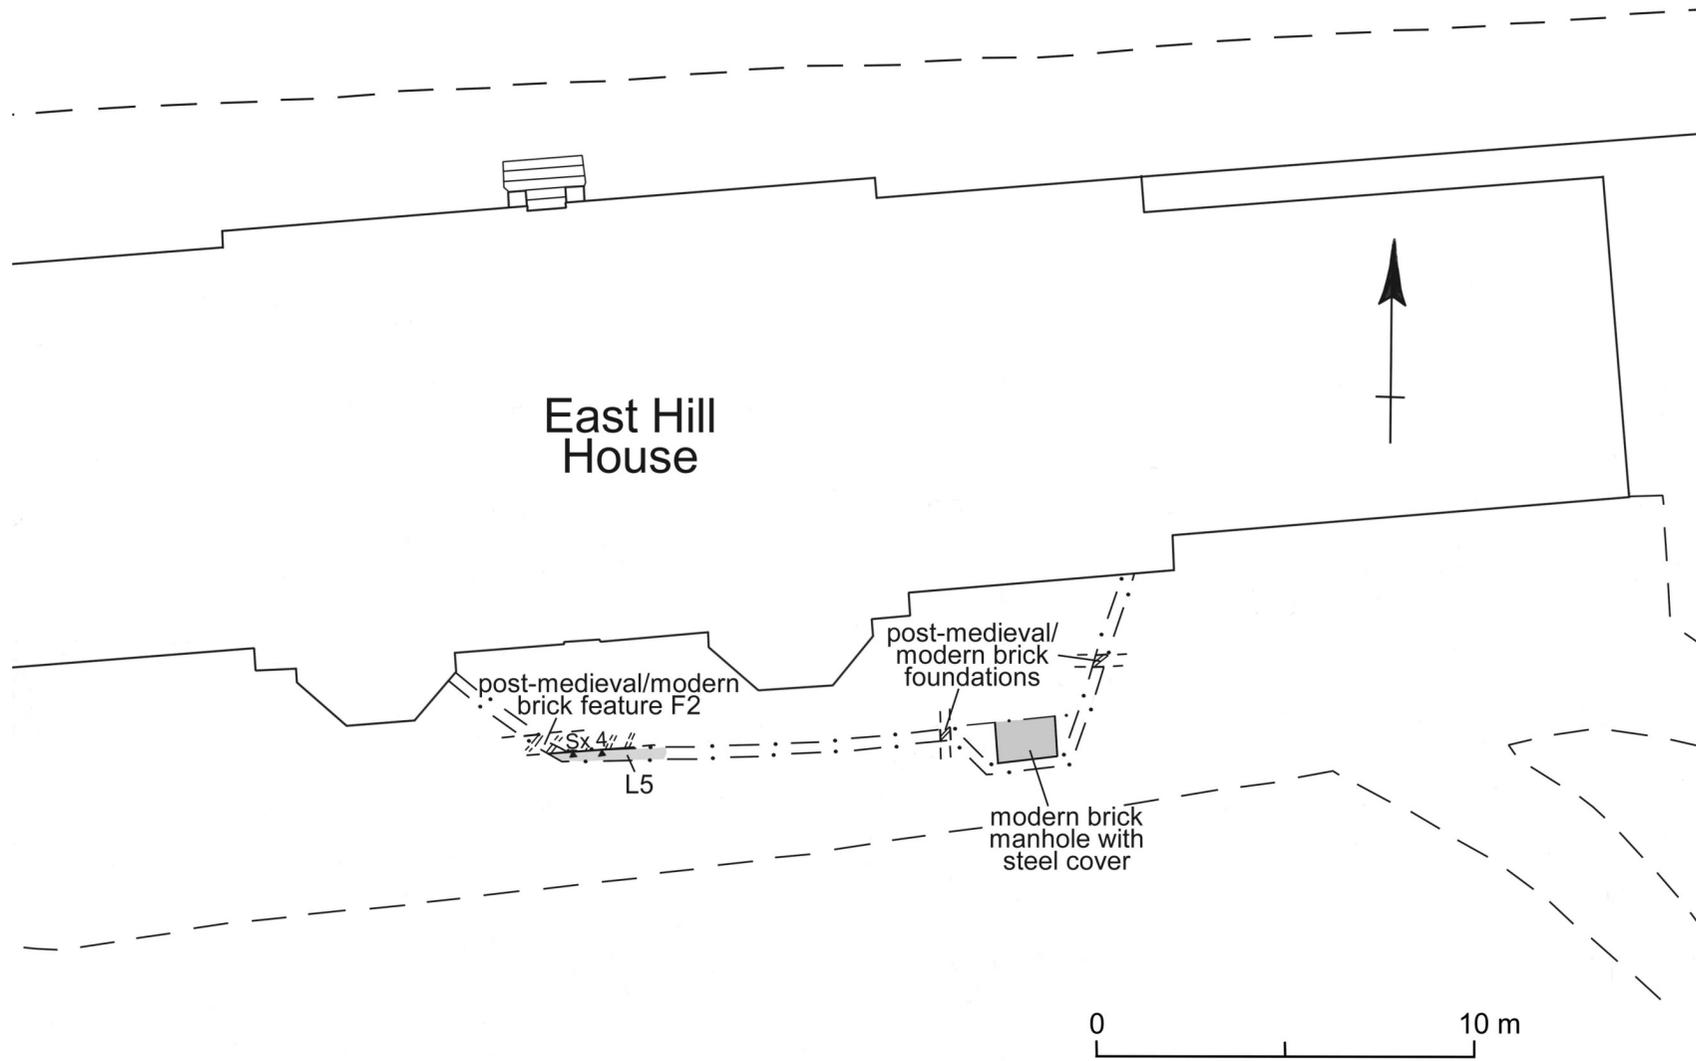
Fig 3 Plan of the pipe trench to the south of East Hill House.

- 5.6** In January 2016, a narrow trench for a gas pipe was dug in a tarmacked path immediately to the south of East Hill House (Fig 3). This trench, which lay within the SAM, was approximately 22.5 m long and 250-300 mm wide. It was dug approximately 700 mm deep, although the western end was shallower. It was necessary to divert the eastern part of the trench around a modern brick manhole that was encountered during the machine-trenching.

6.7.2 The shallow brick feature (F2) that sealed L5 was traced for just under 3 metres in the narrow pipe trench to the south of East Hill House (Fig 3). The brick feature was aligned roughly east-west and extended beyond the limits of the pipe trench in both directions. The southern face of F2 was visible in the north section of the east-west part of the trench for approximately 2 m. Where the pipe trench changed alignment from east-west to northwest-southeast, F2 was cut through. It was approximately 500 mm wide. It survived two brick courses, or approximately 220 mm, high (Sx 4, Fig 6). The bricks were set in pale greyish-brown mortar. The top of F2 lay 320-340 mm below the modern ground level. Pieces of ceramic pipe were visible where F2 was cut through, so the brick feature presumably housed a drainpipe.

6.7.3 Two post-medieval and/or modern brick foundations were cut through during the digging of the eastern part of the pipe trench to the south of East Hill House (Fig 3). One of these foundations extended east-west and was located about 2 m south of East Hill House, near the eastern end of the pipe trench. This foundation was approximately 350 mm wide and lay 200-240 mm below the modern ground level. Approximately 4 m to the south-west, another brick foundation was uncovered. This one extended north-south and lay about a metre to the west of a large brick manhole. It was approximately 300 mm wide and lay 450-600 mm below the modern ground level. Both foundations seemed to be constructed of unfrogged red brick and perhaps dated to the first half of the 19th century. Their significance is unclear, but they were perhaps associated with a terrace to the south of East Hill House.

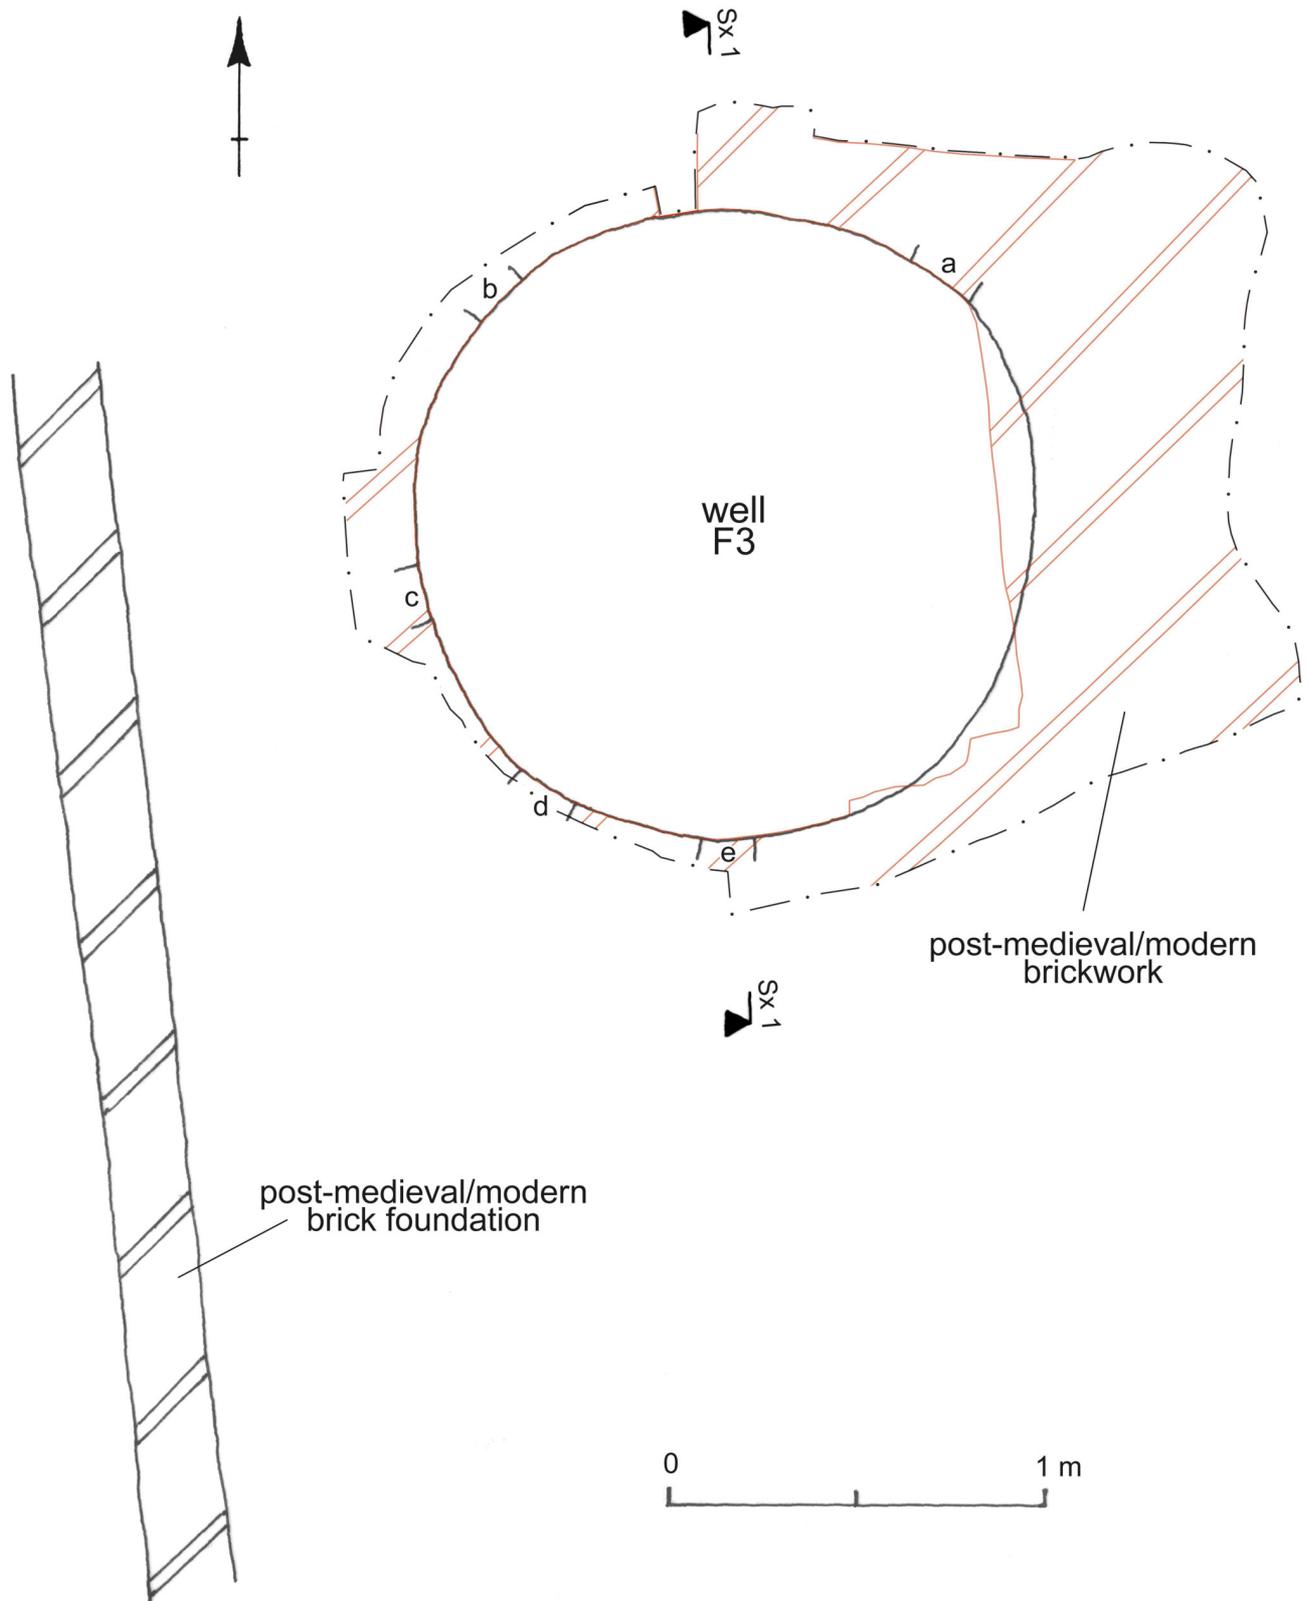
Fig 4 Well (F3): plan.

The brick courses in the top of the well and the remains of the brickwork that overlay it are shown in red.

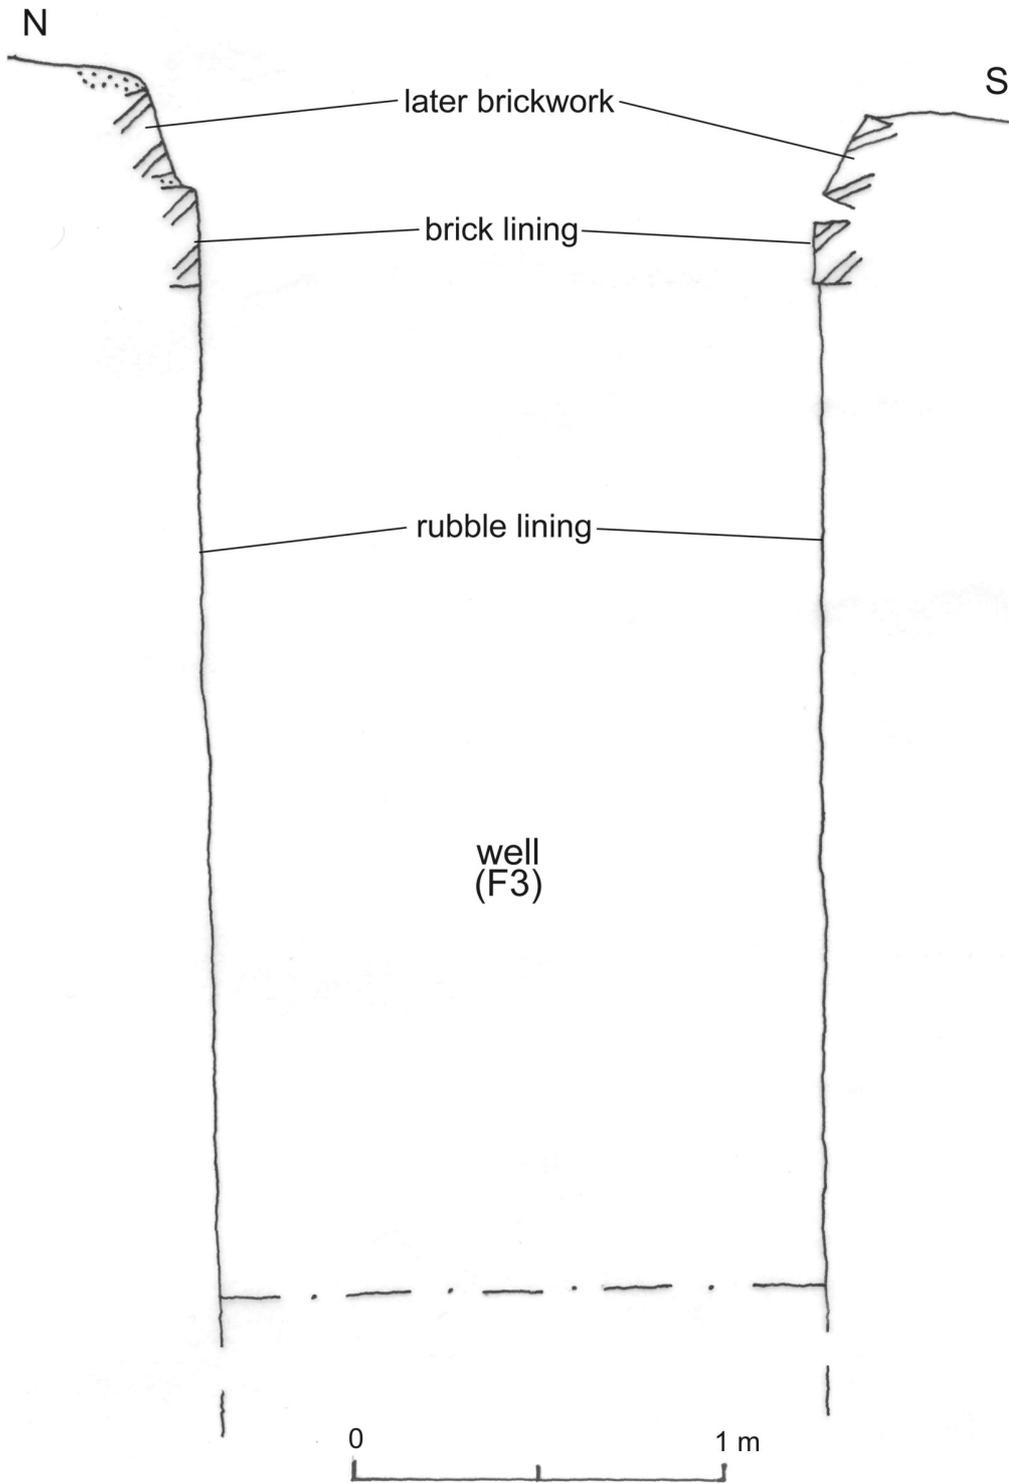
Fig 5 Well (F3): section 1.

— approximate level of courtyard surface
= approximate level of top of surviving brickwork overlying well

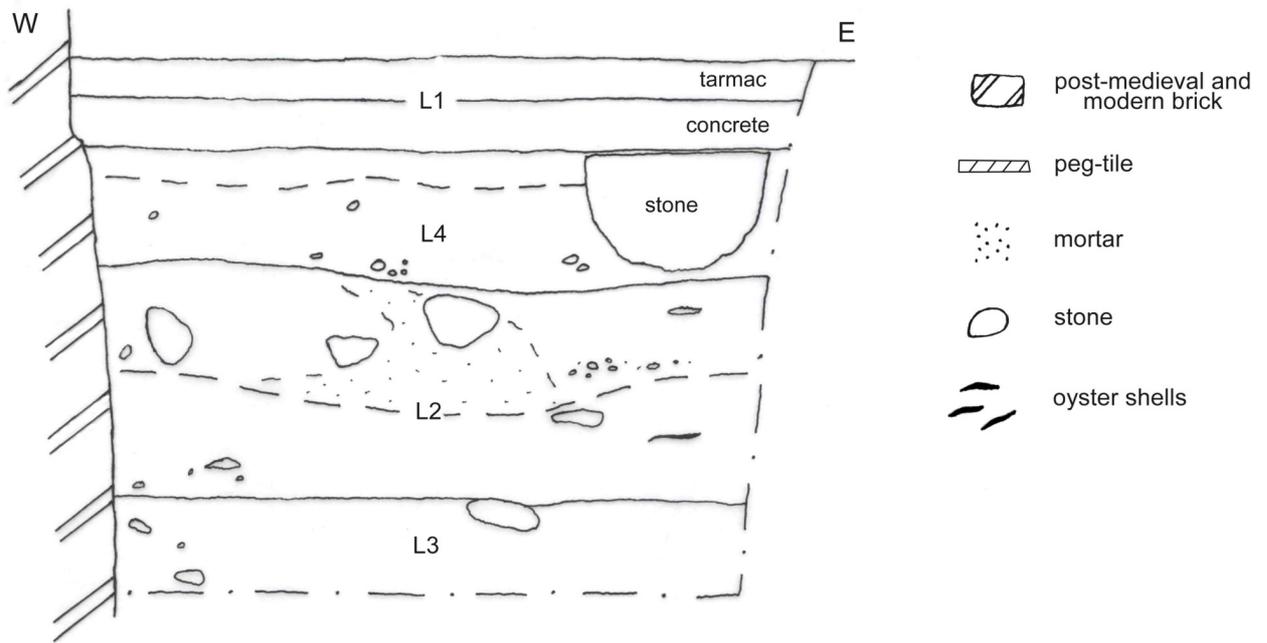
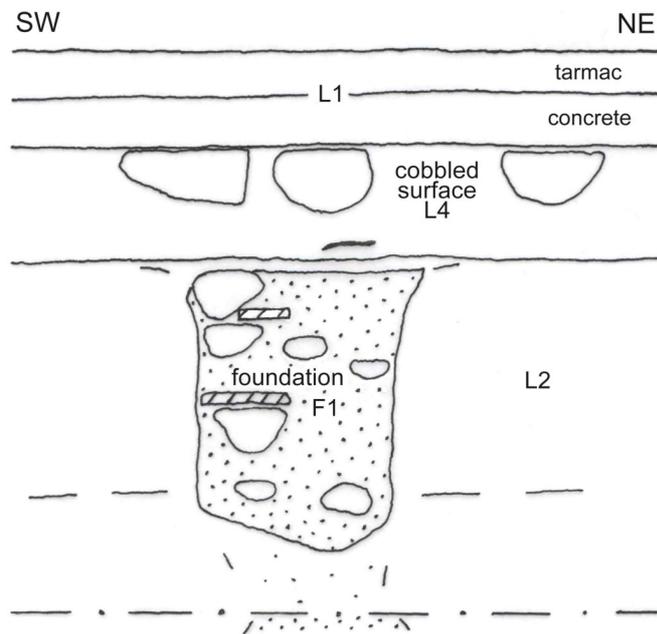
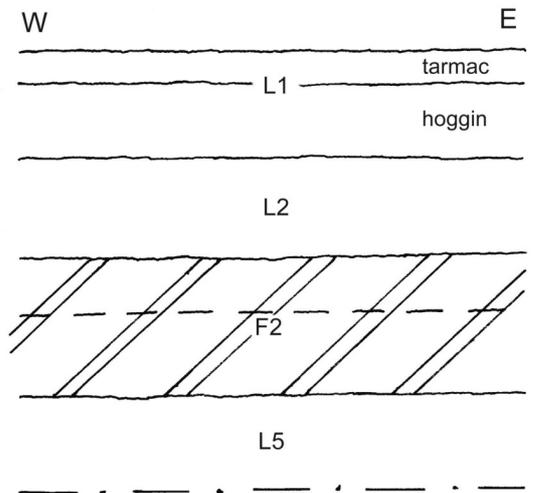
Fig 6 Sections 2-4.

6.5.2 The foundation F1 was constructed of fragments of stone and peg-tile set in a pale yellowish-brown mortar. It was approximately 300 mm wide, and survived at least 400 mm high in the side of the trench (Sx 3, Fig 6). However, there were also traces of pale brown mortar immediately below F1 in the bottom of the trench, at approximately 900 mm below the existing yard surface. It was unclear whether these traces of mortar were part of F1 or the remains of something earlier.

6.5.3 There was little evidence for the date of foundation F1, apart from the presence of peg-tile and the absence of brick. It was sealed by the cobbled yard surface L4 (Sx 3, Fig 6), which was probably of 19th-century date. Thus it seems likely that F1 was late medieval or post-medieval in date. Perhaps it belonged to one of the buildings that were cleared away in the 18th century to make way for East Hill House (*VCHE 9*, 151). Alternatively, it could have

6.6.2 Initially, the cobbled surface L4 was recorded in the manhole trenches MT1-MT3 (Fig 2 & Sx 2, Fig 6). Subsequently, it was observed in places in the pipe trenches to the east of MT1-MT3 and also between MT3 and MT4 further south. In these trenches, L4 seemed to consist mainly of large, squared stone blocks that measured roughly 150-300 mm across. They lay at a depth of 140-160 mm below the existing tarmacked yard surface (L1). The large stone blocks appeared to extend for approximately 4 m to the east of the Coach House, and then to give way to smaller cobbles. However, as only a small number of the latter were seen, it was not possible to confirm this. The foundation F1 that lay to the north-east of MT3 was sealed by L4 (Fig 2 & Sx 3, Fig 6). Elsewhere L4 usually sealed post-medieval and/or modern dump/make-up layers (L2).

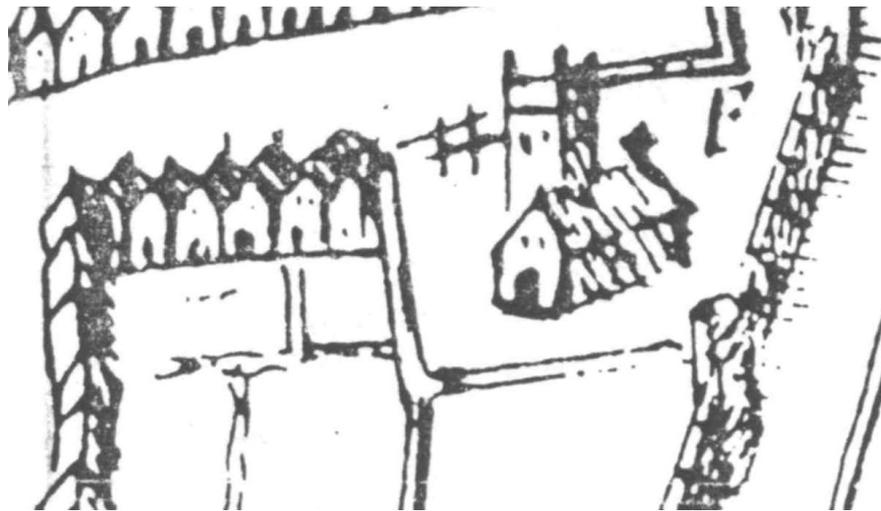
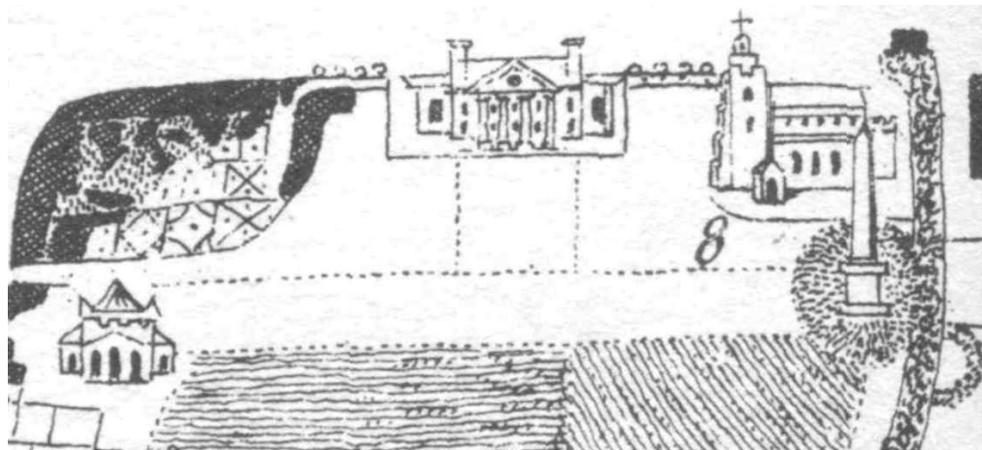
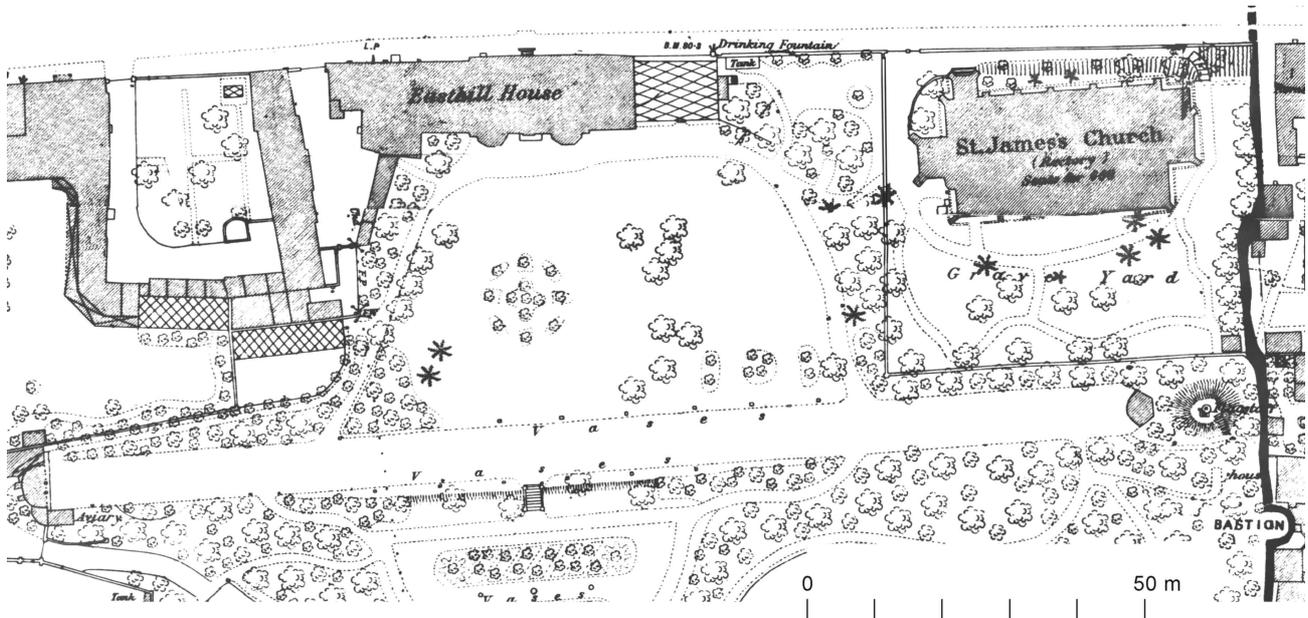
Fig 7 Top: detail of map published in Speed (1610).
 Centre: detail of map published in Morant (1748).
 Below: detail of OS map published in 1876.

This is reinforced by the cartographic evidence. An east-west wall is shown extending over the position of the well on an OS map published in 1876 (Fig 7 below), as well as on later OS editions. Monson's map of 1848, although less accurate than the OS maps, shows an east-west wall in a similar position. Therefore the well had clearly been built over by 1876, and had probably gone out of use before 1848. The brickwork that was found overlying the well in 2017 presumably formed part of the east-west wall, and/or its foundation, that is shown on these maps. A slight circular thickening of the line of the wall on the 1876 map (Fig 7 below) perhaps represents the brick capping over the well.
