Archaeological monitoring on barns at Beaumont Hall, Church Lane, Thorpe Le Soken, Essex, CO16 0AZ

November 2021

CAT Report 1751
January 2022

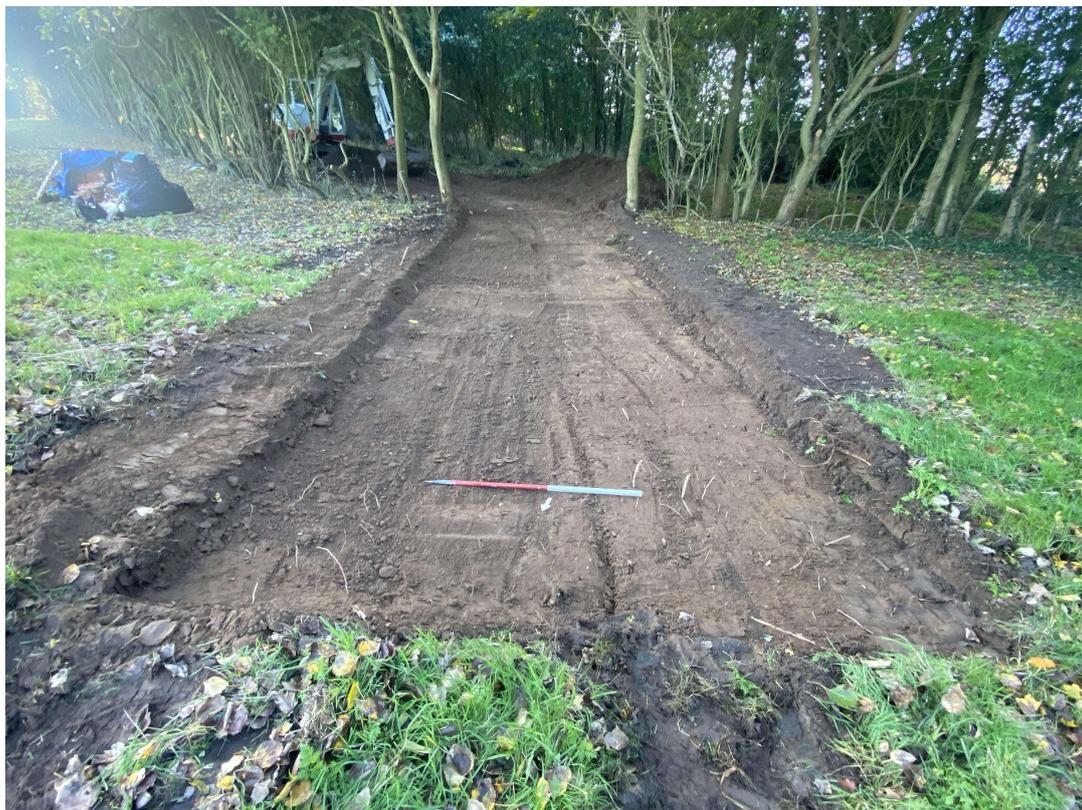
Photograph 1 Shallow excavation of Trench A from north-west end, looking south.

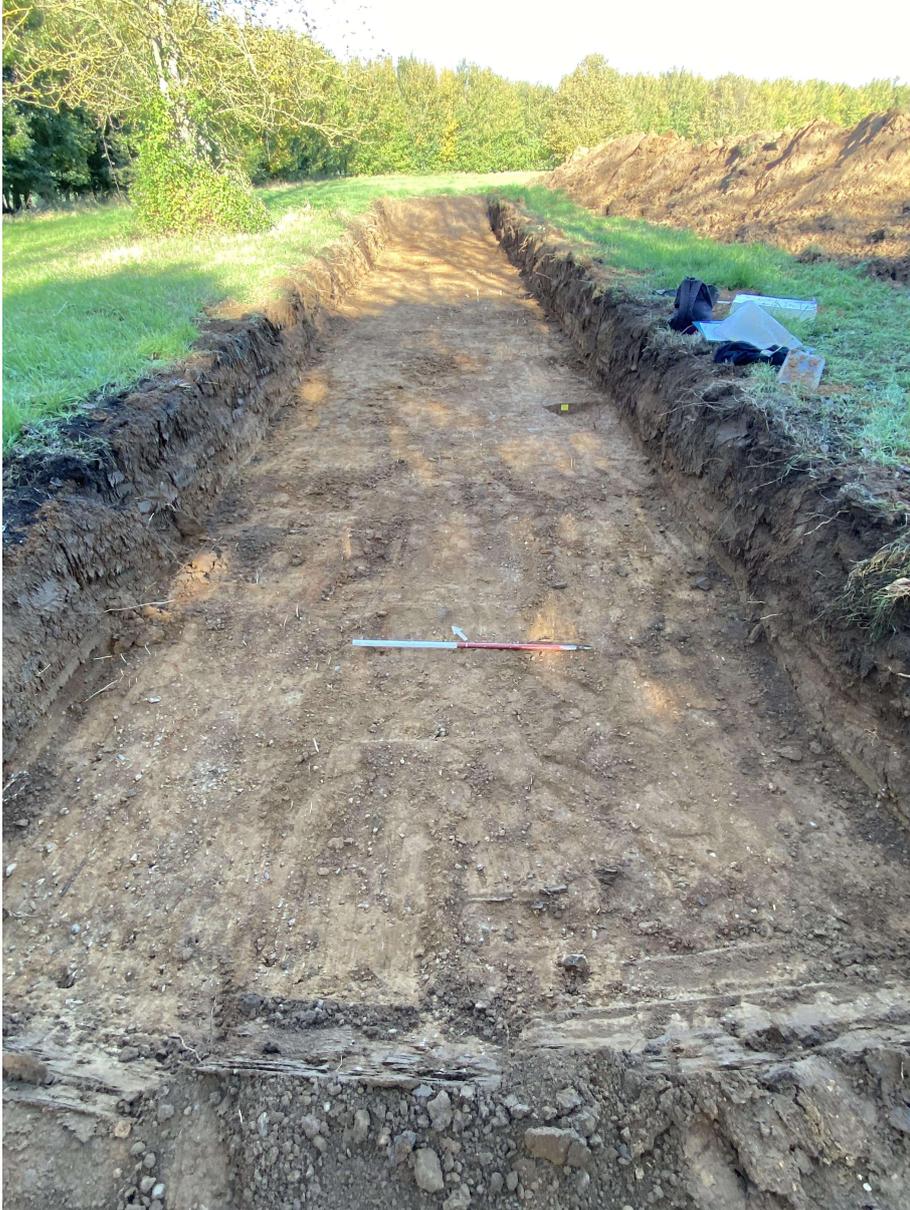
Trench A was approximately 122m long and c 3.3m wide. The majority of this trench was only excavated down by 0.2-0.3m (Photograph 1), but the last 22m to the north was dug down by 0.8m (Photograph 2). Three layers were recorded. Topsoil (L1, 0.3m thick) sealed subsoil (L5,

0.3-0.45m thick), which covered natural (L4, from c 0.6m below current ground level (bcgl)). Two tree-throws (F2 and F3) were found in the deeper section of this trench. F2 was oval in shape, 0.15m deep and 0.8m long. F3 was only visible in section, and was 0.3m deep and 0.7m wide.

Photograph 2 Deeper excavation of Trench A at north-west end, looking north-east.

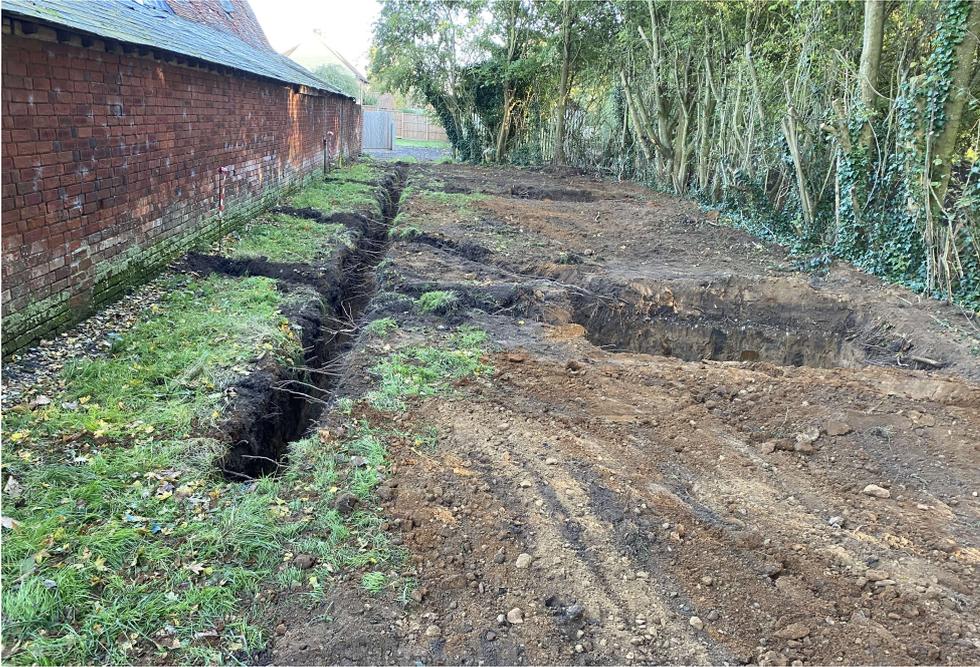
Trench B consisted of trenches totalling approximately 47m long by 0.5m wide and 0.8m deep, along with two holes for septic tanks. These were c 2.3m by c 2m and 2.3m deep. Topsoil (L1, 0.2m thick) sealed subsoil (L5, 0.4m thick) which covered natural (L4, from c 0.6m bcgl). No archaeological features were present.

Photograph 3 Trench B from north-west end, looking south-east.

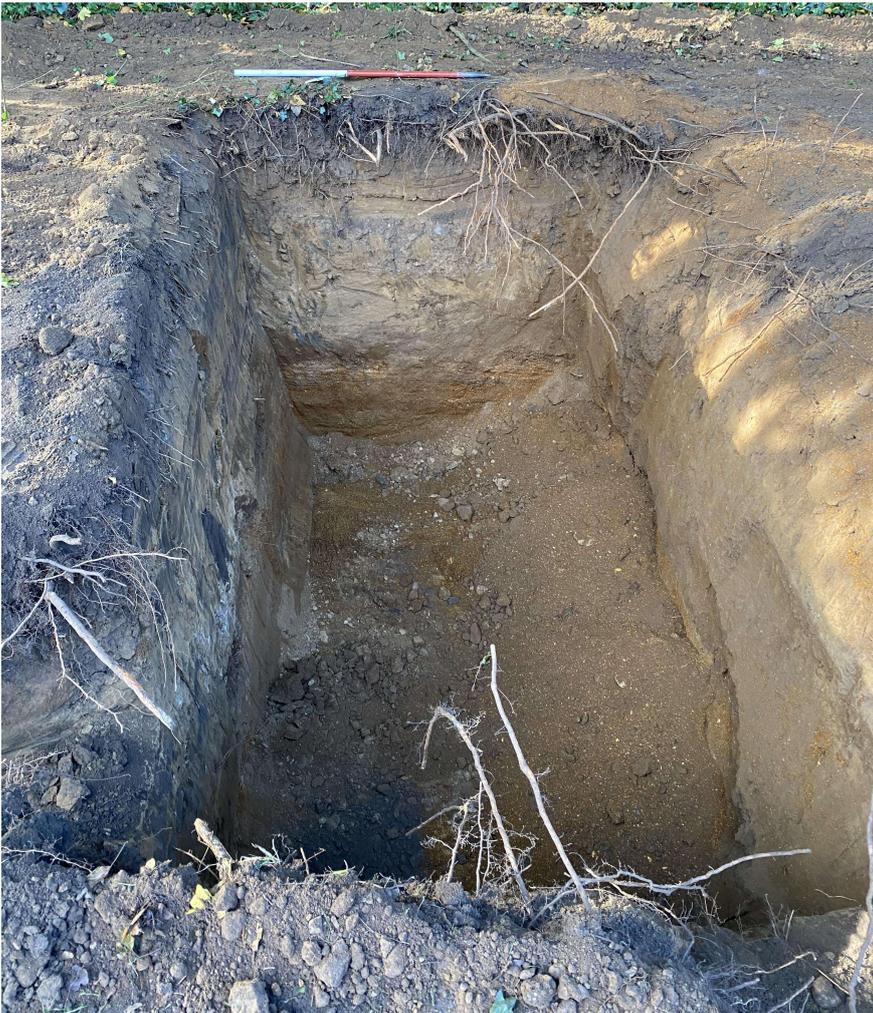
Photograph 4 Trench C representative section, looking roughly west.

Trenching within the courtyard totalled c 74m in length, were between 0.4-0.8m wide, and reached depths of at least 2m. The concrete courtyard sealed c 1m of modern made-ground with natural (L4) identified beneath. Natural (L4) was seen from c 1m deep. Full measurements could not be taken due to unsafe working conditions. No archaeological features were noted.

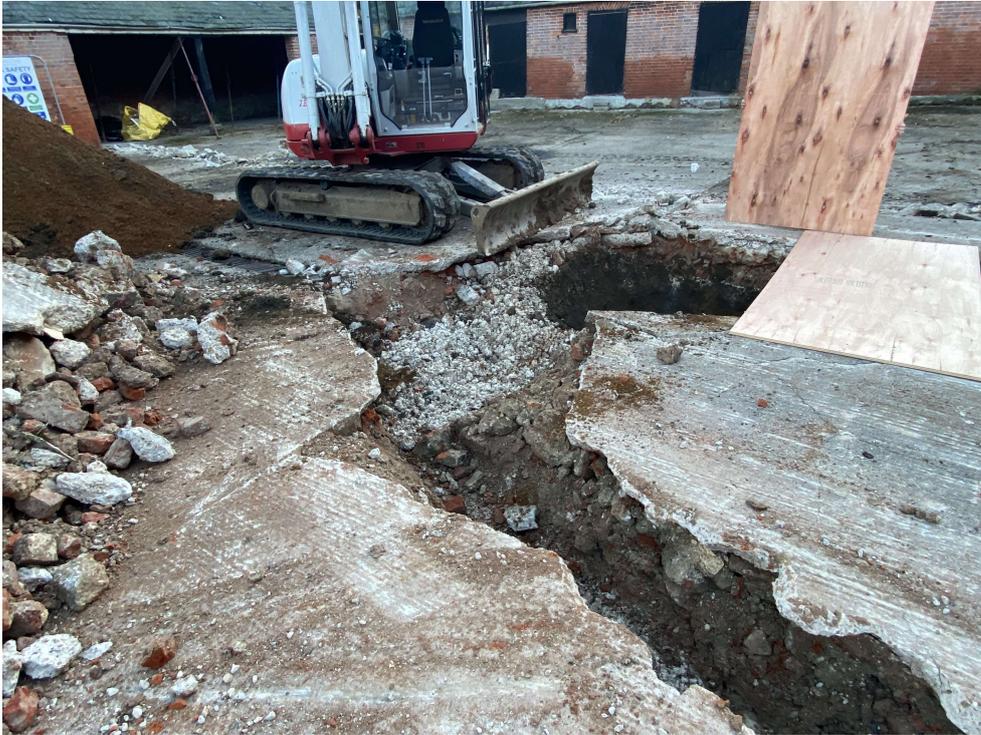
Photograph 5 Excavation in Trench C, looking roughly north.

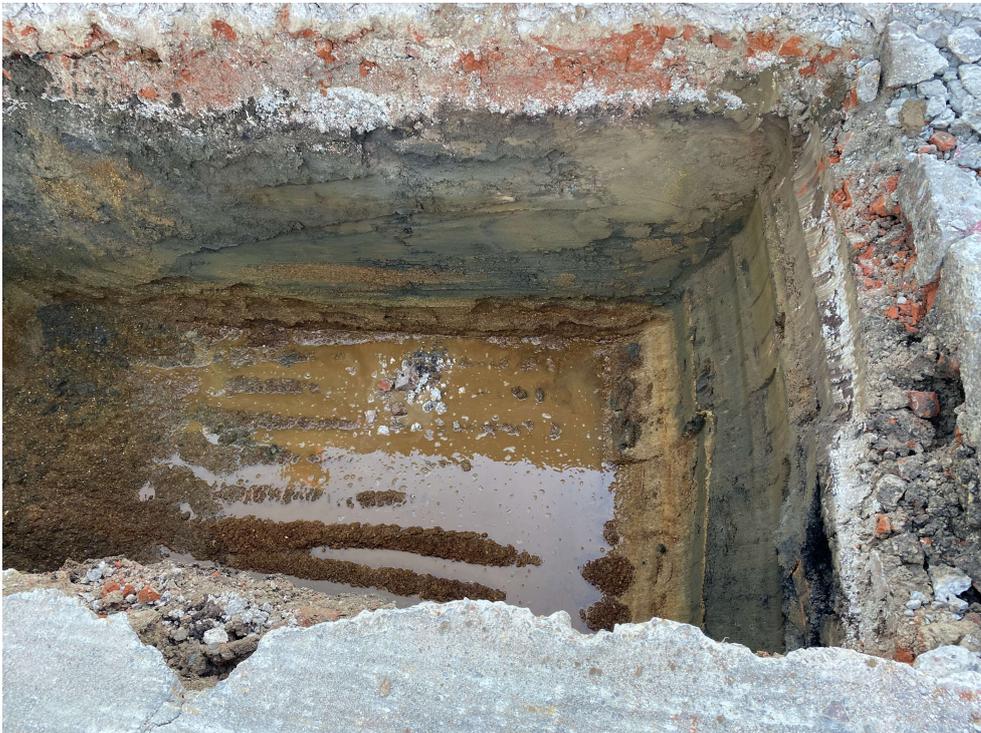
Photograph 6 Excavation in Trench C, looking roughly north-east.

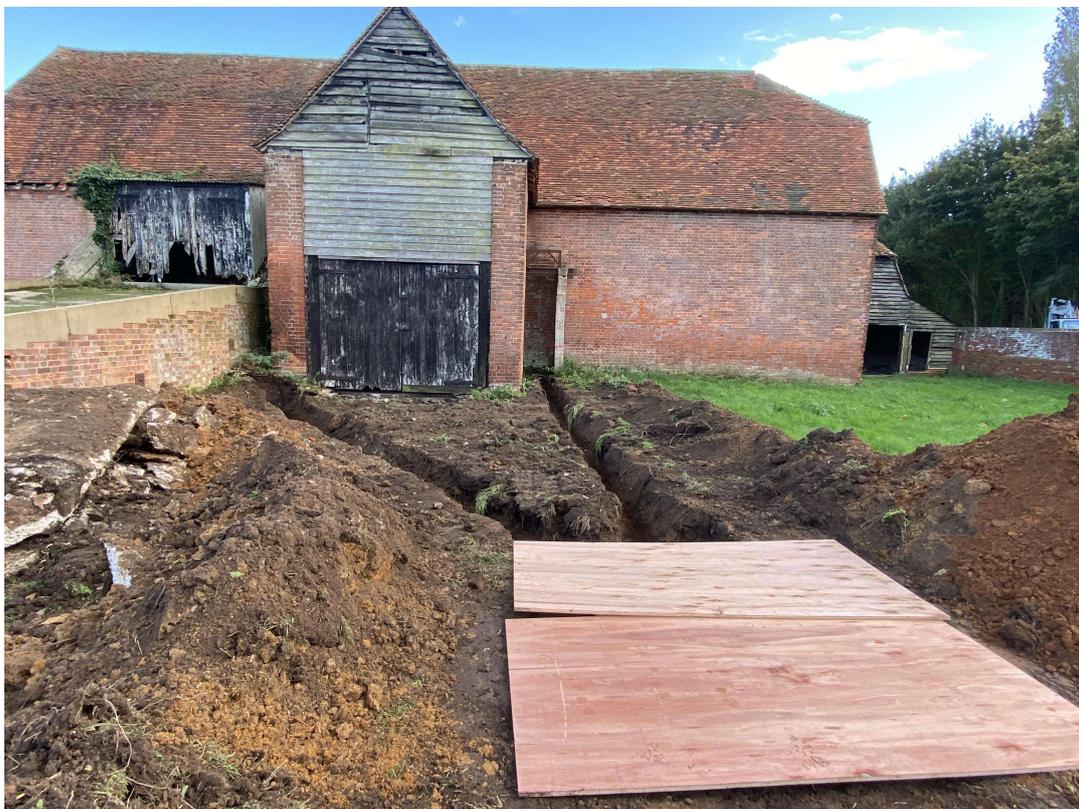
Trench D totalled c 19m in length, was 0.5m wide, and between 0.4 and 0.8m deep. The connecting soakaway was 1m by 1m and 2.7-3m deep. Topsoil (L1, 0.25m thick) covered a layer of make-up (L3, 0.3m thick) with natural sealed beneath (L4, from c 0.65m bcgl). No archaeological features were present.

Photograph 7 Trench D, looking south-east.

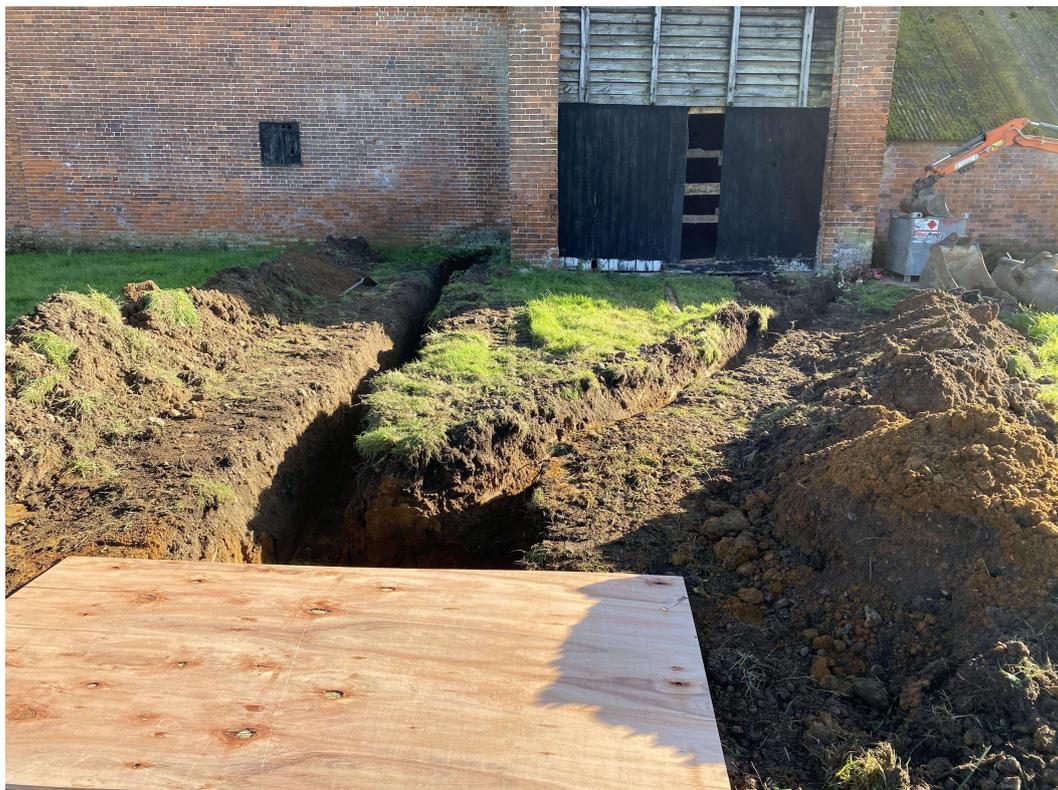
Trench E totalled c 18m in length, was 0.5m wide, and between 0.4 to 0.8m deep. The connecting soakaway was 1m by 1m, and 2.7-3m deep. Topsoil (L1, 0.25m thick) covered a stony band (L2, 0.15m thick) which sealed make-up layer L3 (0.3m thick). Natural (L4) was identified at c 0.65m bcgl. Pit/tree-throw F1 was recorded in section. It had an uneven base and steep edges, and was 0.6m wide and between 0.2-0.3m deep.

Photograph 8 Trench E, looking south-east.

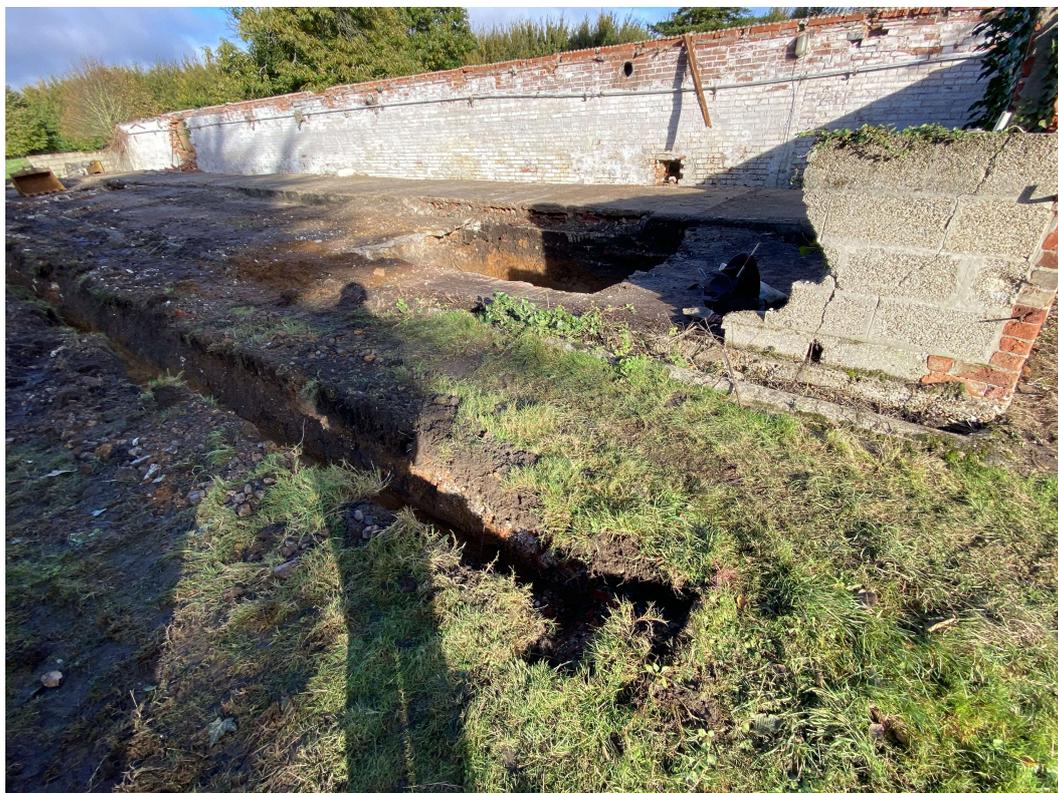
The last trench totalled c 35m in length, and was between 0.4-0.5m wide and c 0.6m deep. The two associated soakaways were c 2m by c 3.3m and 2.3m deep. Excavations cut through concrete and modern debris which sealed natural (L4, from c 0.8m deep). Remains of a partial brick foundation (F4) was found at the east end of the trench, likely in a northwest-southeast orientation. It is at least 1m wide and 0.3m thick.

Photograph 9 Excavation of Trench F from south-east end, looking north-west.

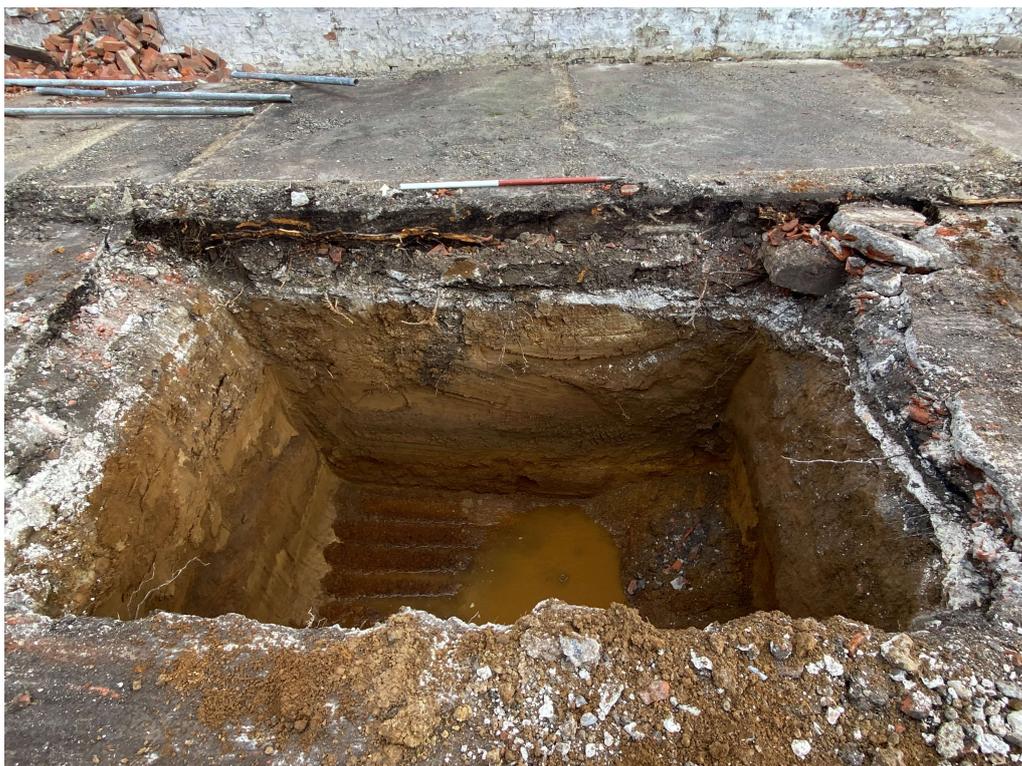
Photograph 10 North-west soakaway in Trench F, looking roughly north.

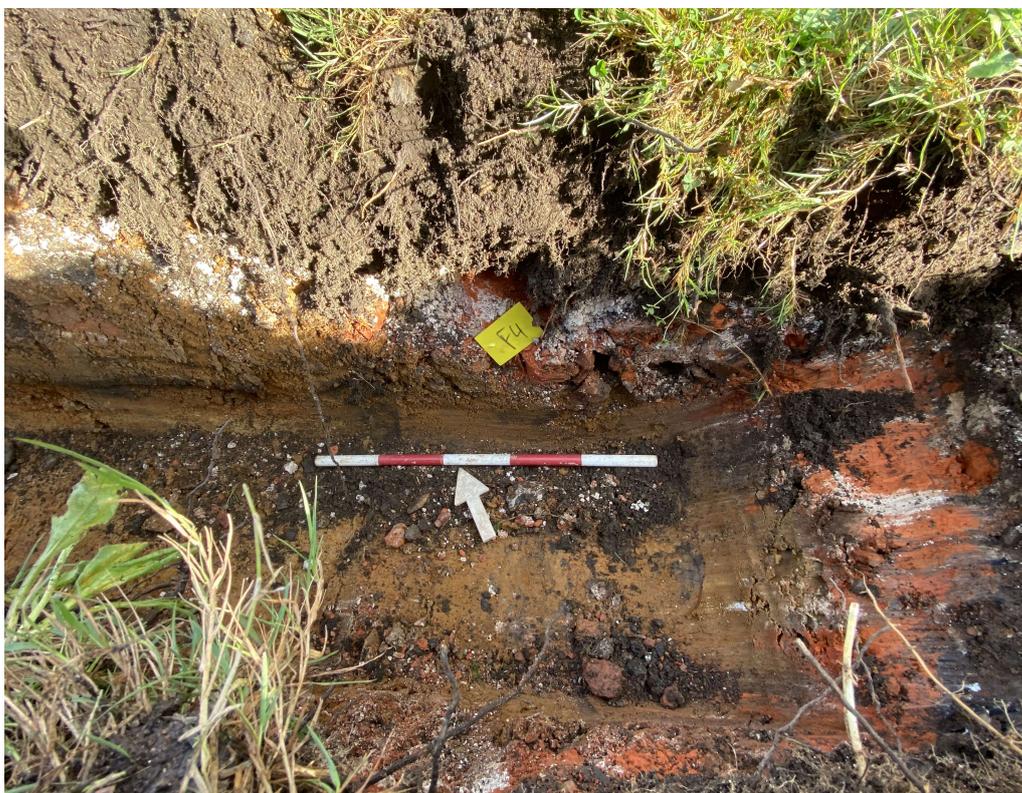
Photograph 11 F4 section, looking roughly north.

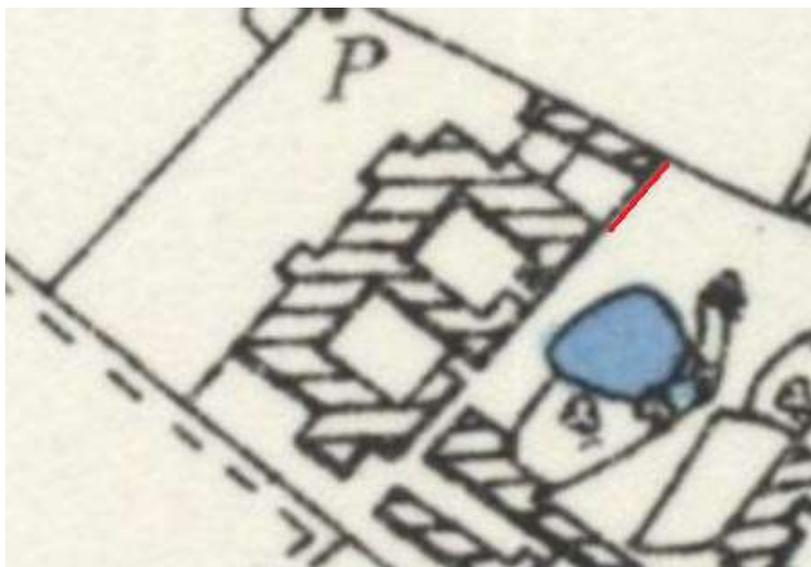
Archaeological monitoring at the barns at Beaumont Hall resulted in four features, two undated tree-throws and a modern pit/tree-throw and a modern wall foundation. The possible wall foundation (F4) appears to correspond to a wall as seen in Map 1 from 1888-1913 (Map 1), highlighted in red. The nib-tile from L6 indicates activity at the development site from the medieval period, as mentioned in the Archaeological Background. The mix of periods in layers are unsurprising and corresponds with agricultural activity and the active past of Beaumont Hall from the past 400 years.

Map 1 Map of Beaumont Hall from 1888-1913, showing a former wall (underlined in red) which seems to correspond with F4.

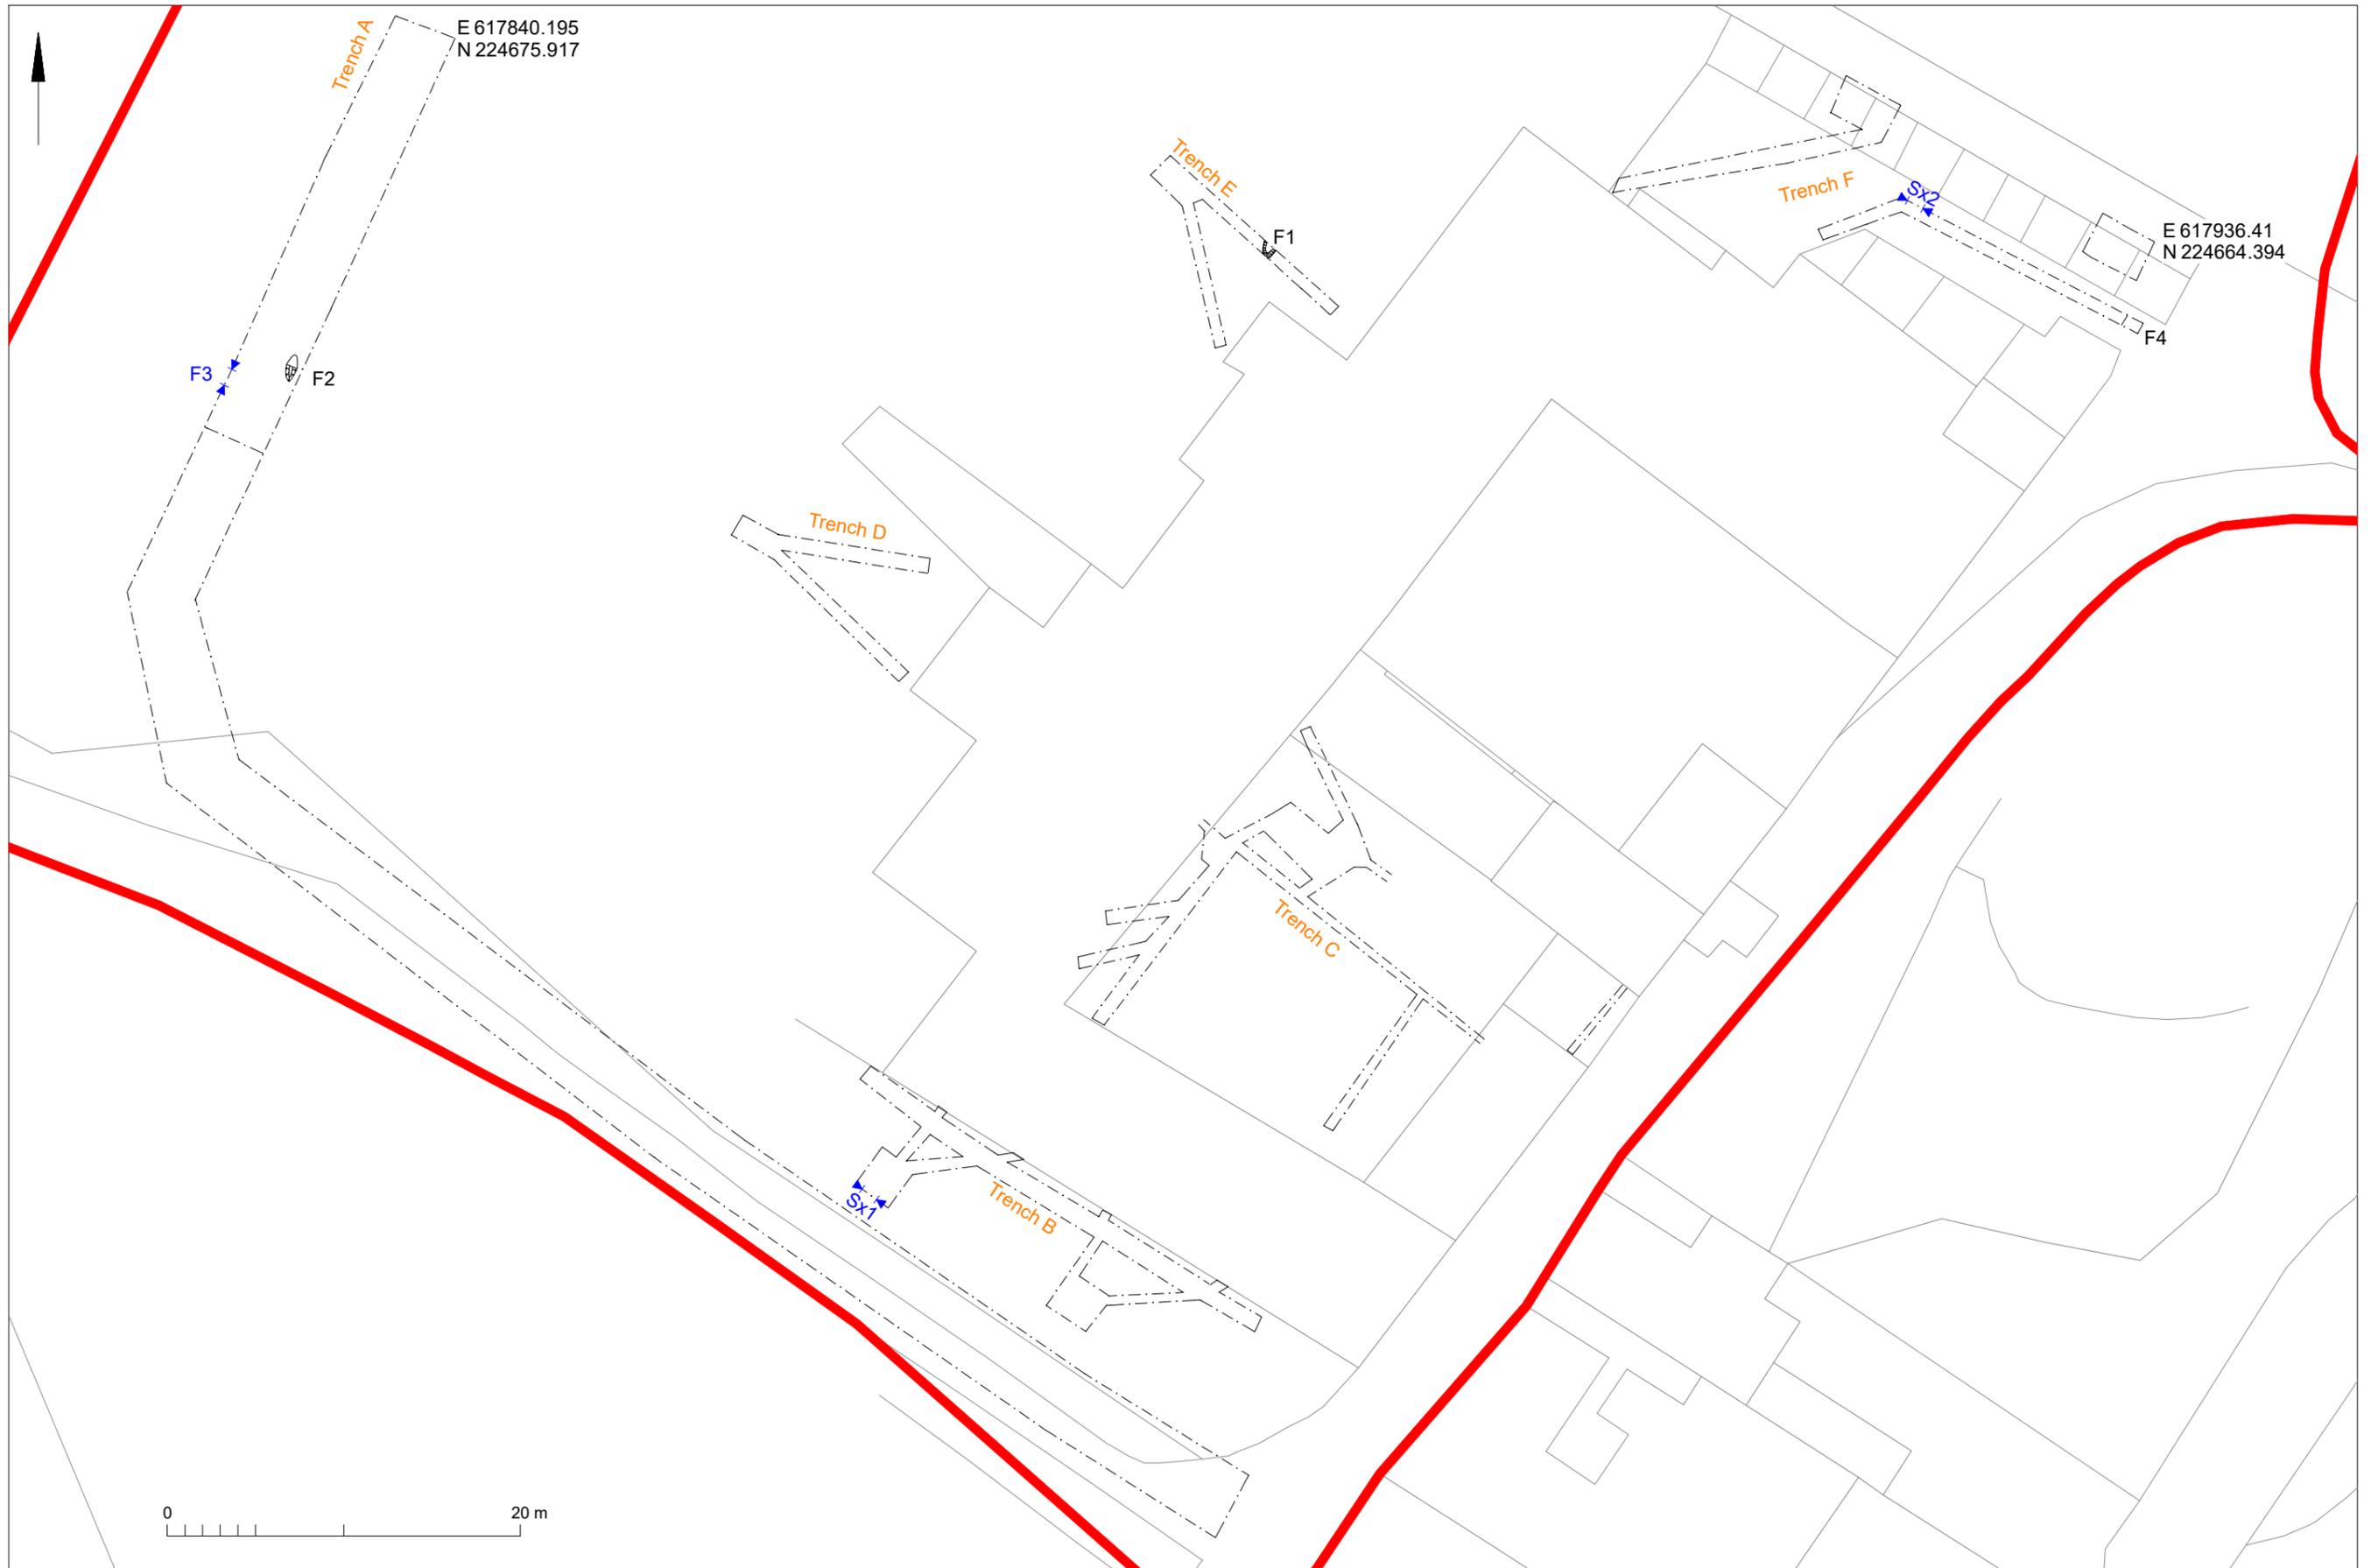
Fig 2 Results.

A total of 628m² of trenching was machine-excavated under the supervision of a CAT archaeologist. There were five areas monitored, and they are as follows: the road (Trench A), soakaways in the piggery (Trench F), soakaways to the northwest (Trenches D and E), septic tanks to the south (Trench B) and trenching within the courtyard (Trench C). They will henceforth be referred to by their trench letters.
