# Archaeological monitoring at Michaelstowe Farm, Ramsey Road, Ramsey, Essex, CO12 5EW

June 2021-February 2022

**CAT Report 1782**

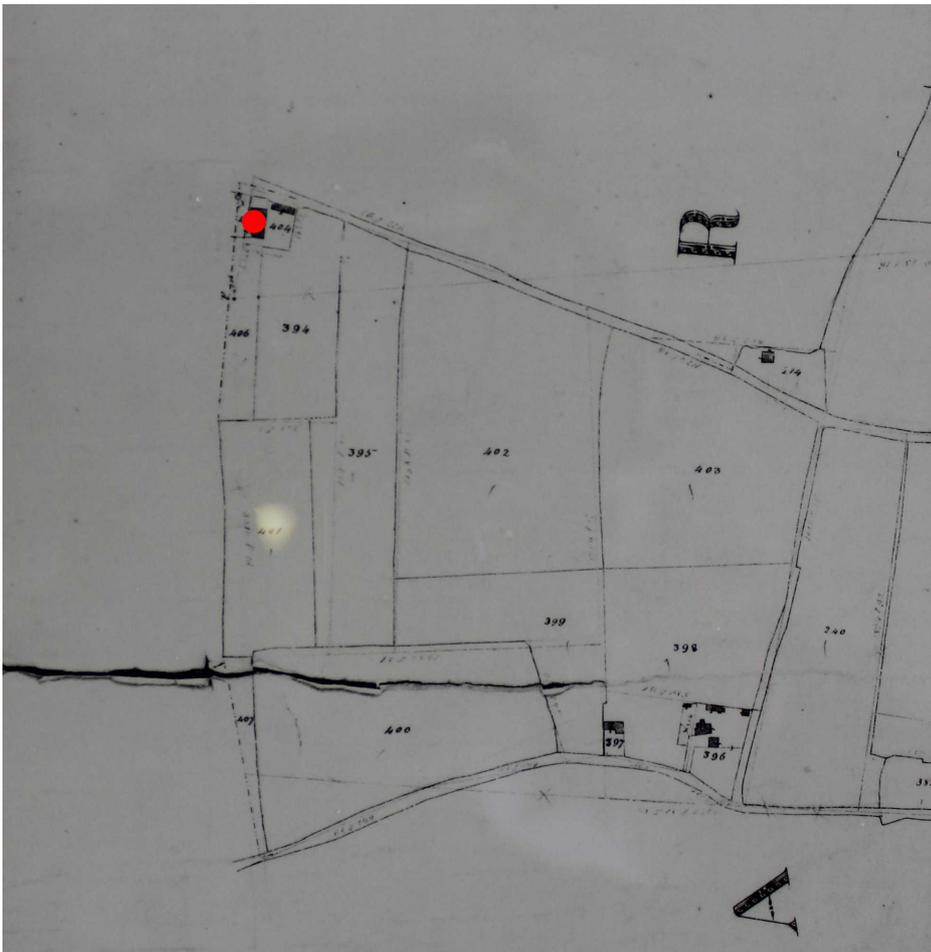
**Map 2** 1840 Dovercourt tithe map (ERO D/CT 117). Site location in red.

The now demolished farm buildings correlate with buildings visible on early OS mapping. However, wall foundation F6 did not match expected wall locations within the former threshing barn. There are two buildings visible on the Dovercourt 1840 tithe map within the site. The building on tithe map plot 405 is in the location of the threshing barn but is different in shape. Overlaying the results with the tithe map (see Fig 3) shows F6 is likely the only *in situ* remains of this earlier building. Wall foundation F8 recorded during the evaluation phase also aligns with a boundary between tithe plots marked on this map.

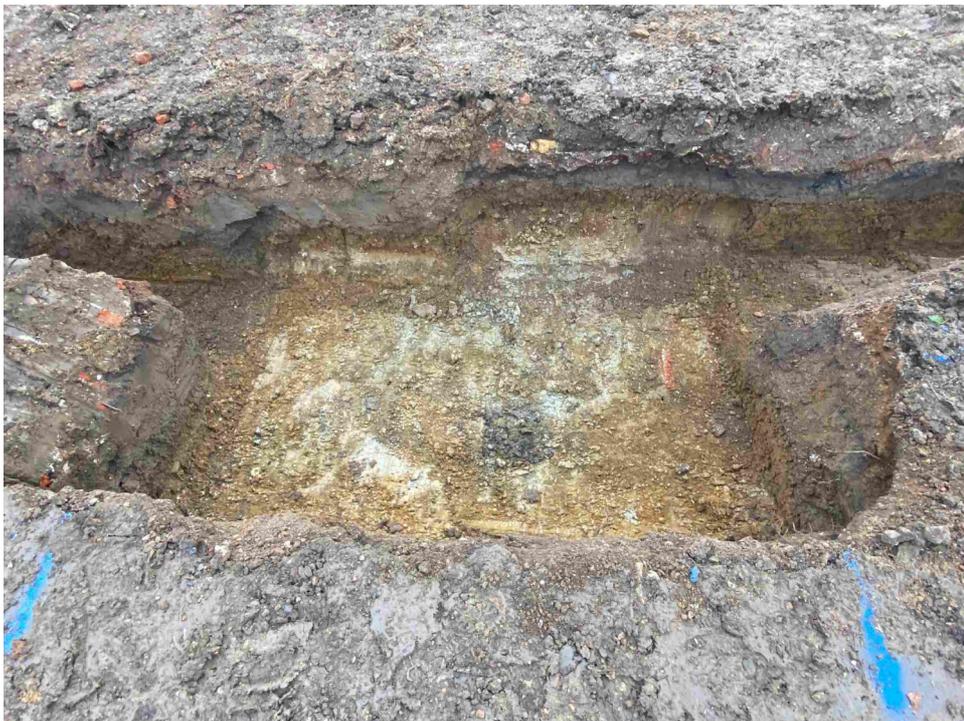
**Photograph 1** Plot 1 porch area showing post-hole F3, looking south-southeast.

Post-hole F3 was uncovered within the area of the porch. F3 was 0.32m wide and 0.9m deep. The fill contained modern brick.

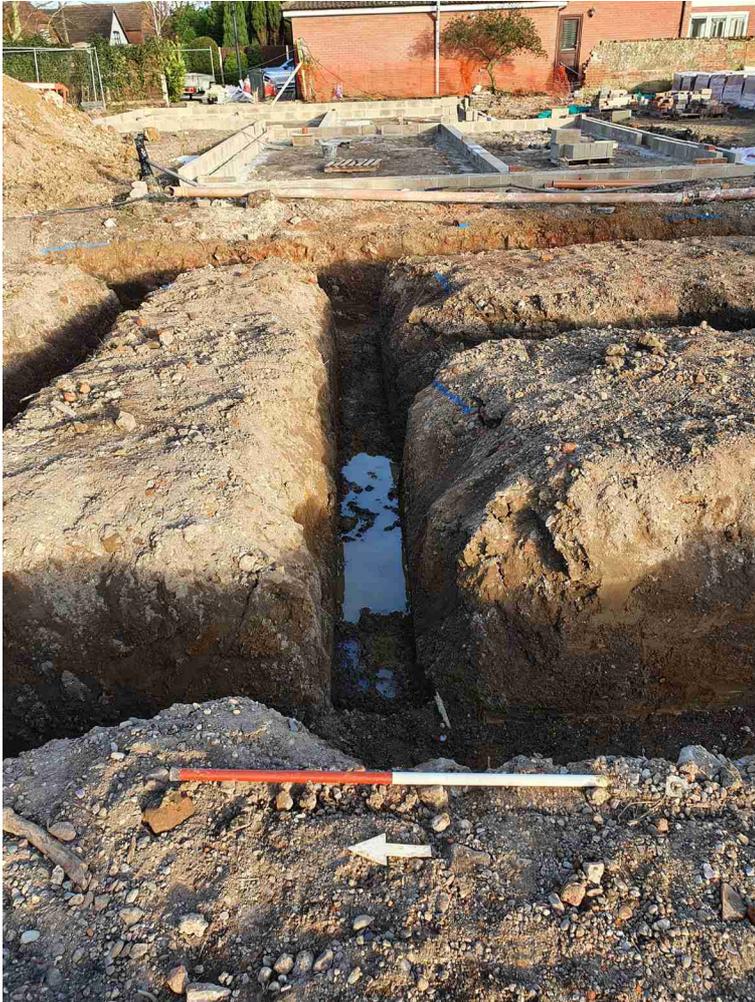
**Photograph 2** Plot 2 in the foreground with Plot 1 behind, looking northeast.

**Foundation trenching for Plot 2**, 10m long, 15.1m wide, 1m deep  
Plot 2 was cut through L2 (c 0.39-0.5m thick) and L4 (c 0.34-0.39m thick) into L5 (encountered at a depth of 0.69-0.89m bcgl).

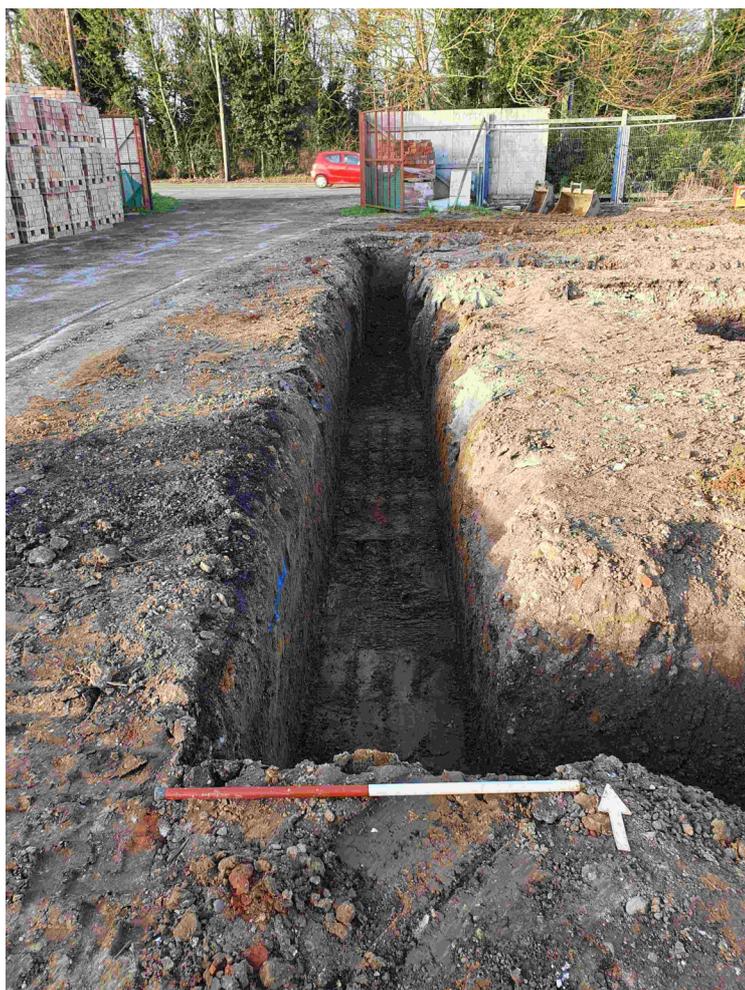
**Photograph 3** Plot 3, looking north. Completed access road on the left.

**Foundation trenching for Plot 3**, 10m long, 15.1m wide, 1m deep  
Plot 3 was excavated through a modern layer of crush (L2, c 0.09-0.14 thick), a yard surface L6 (0.28-0.32m thick) and an undatable make-up layer (L7, c 0.31-0.59m thick) into L5 (encountered at a depth of 0.74-0.8m bcgl). The yard surface was recorded in the evaluation phase as L4. The extent of the yard surface seen during the monitoring is marked on Fig 2.

Pit F4 was uncovered in the western part of Plot 3. It was 2.25m wide and 0.81m deep and contained a few fragments of post-medieval pottery. The large pit was sealed by yard surface L6.

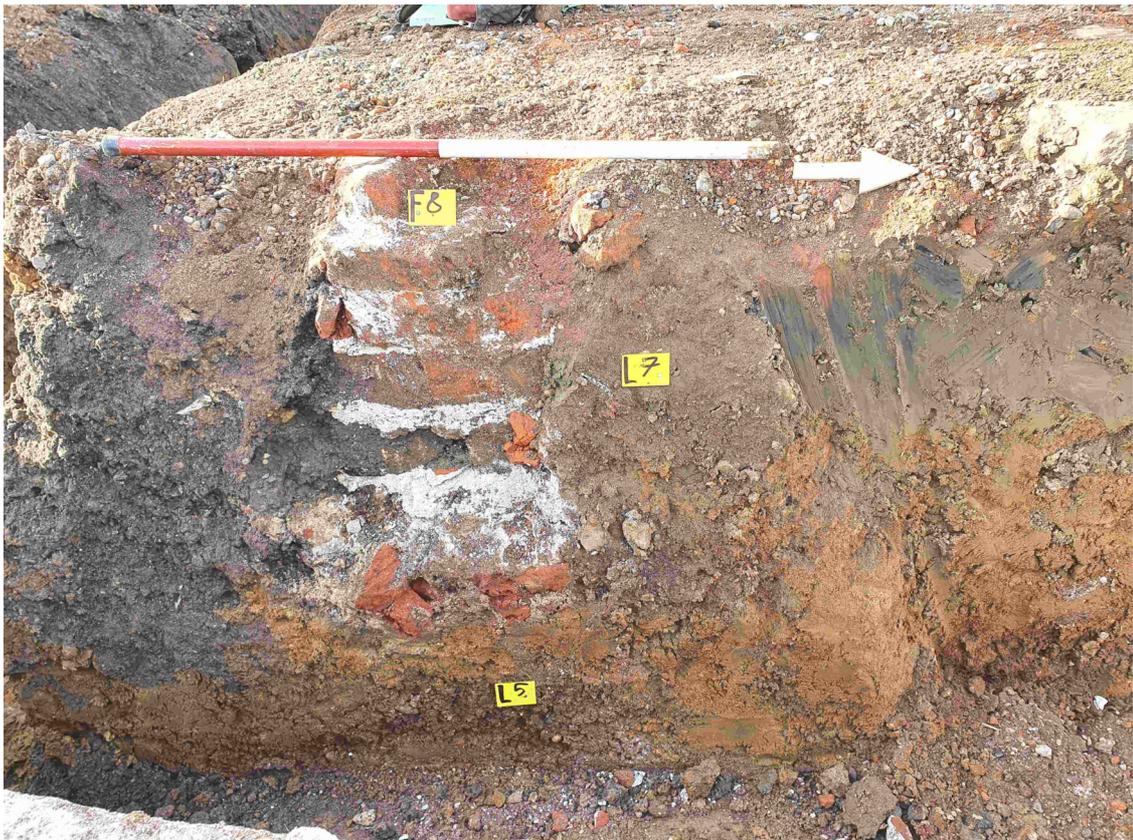
Photograph 5 F8 within Plot 2, looking west-southwest.

Wall foundations F5 and F7-F8 all measured c 0.6m wide at the base. They are all constructed of red unfrogged brick set in white mortar. These are all located within the former threshing barn and form part of barn external walls.

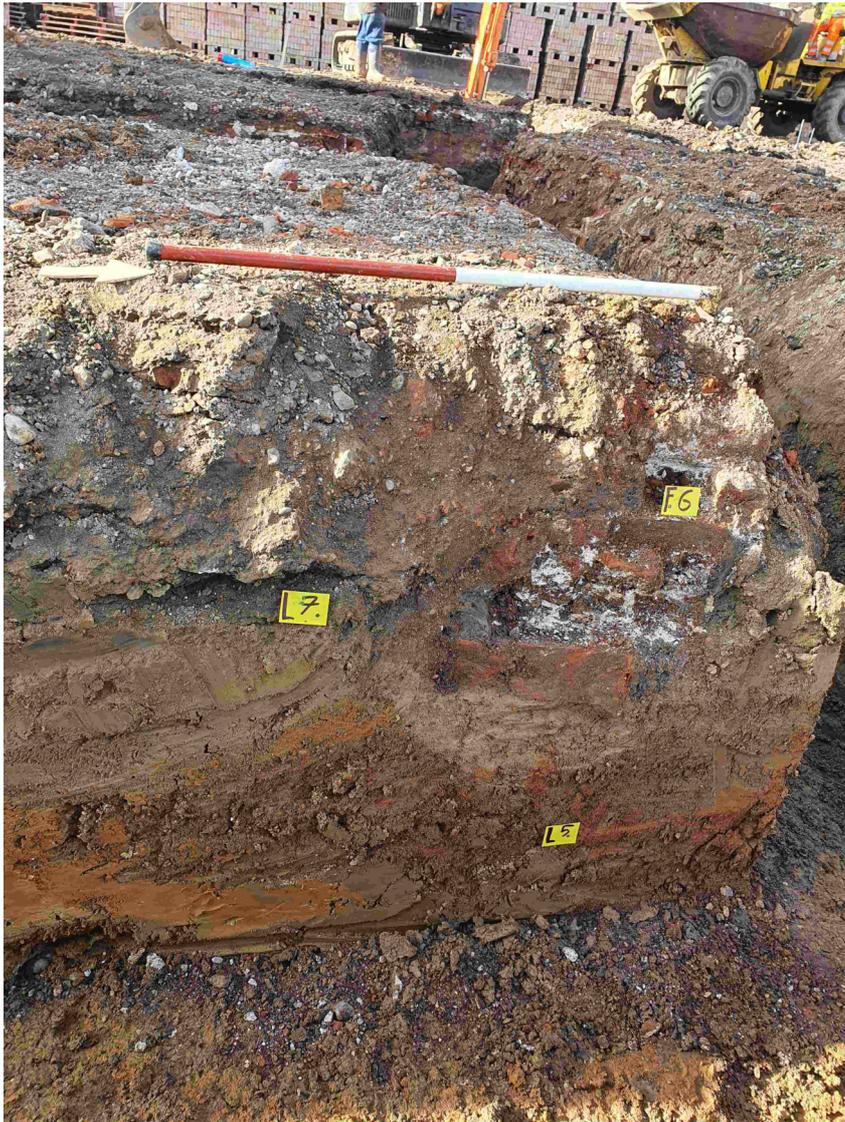
Photograph 6 F6 within Plot 2, looking west-southwest.

F6 is also located within the former threshing barn but does not correspond to expected wall locations recorded in the historic building recording. The wall is comprised of red unfrogged brick and white mortar and is c 0.4m wide.

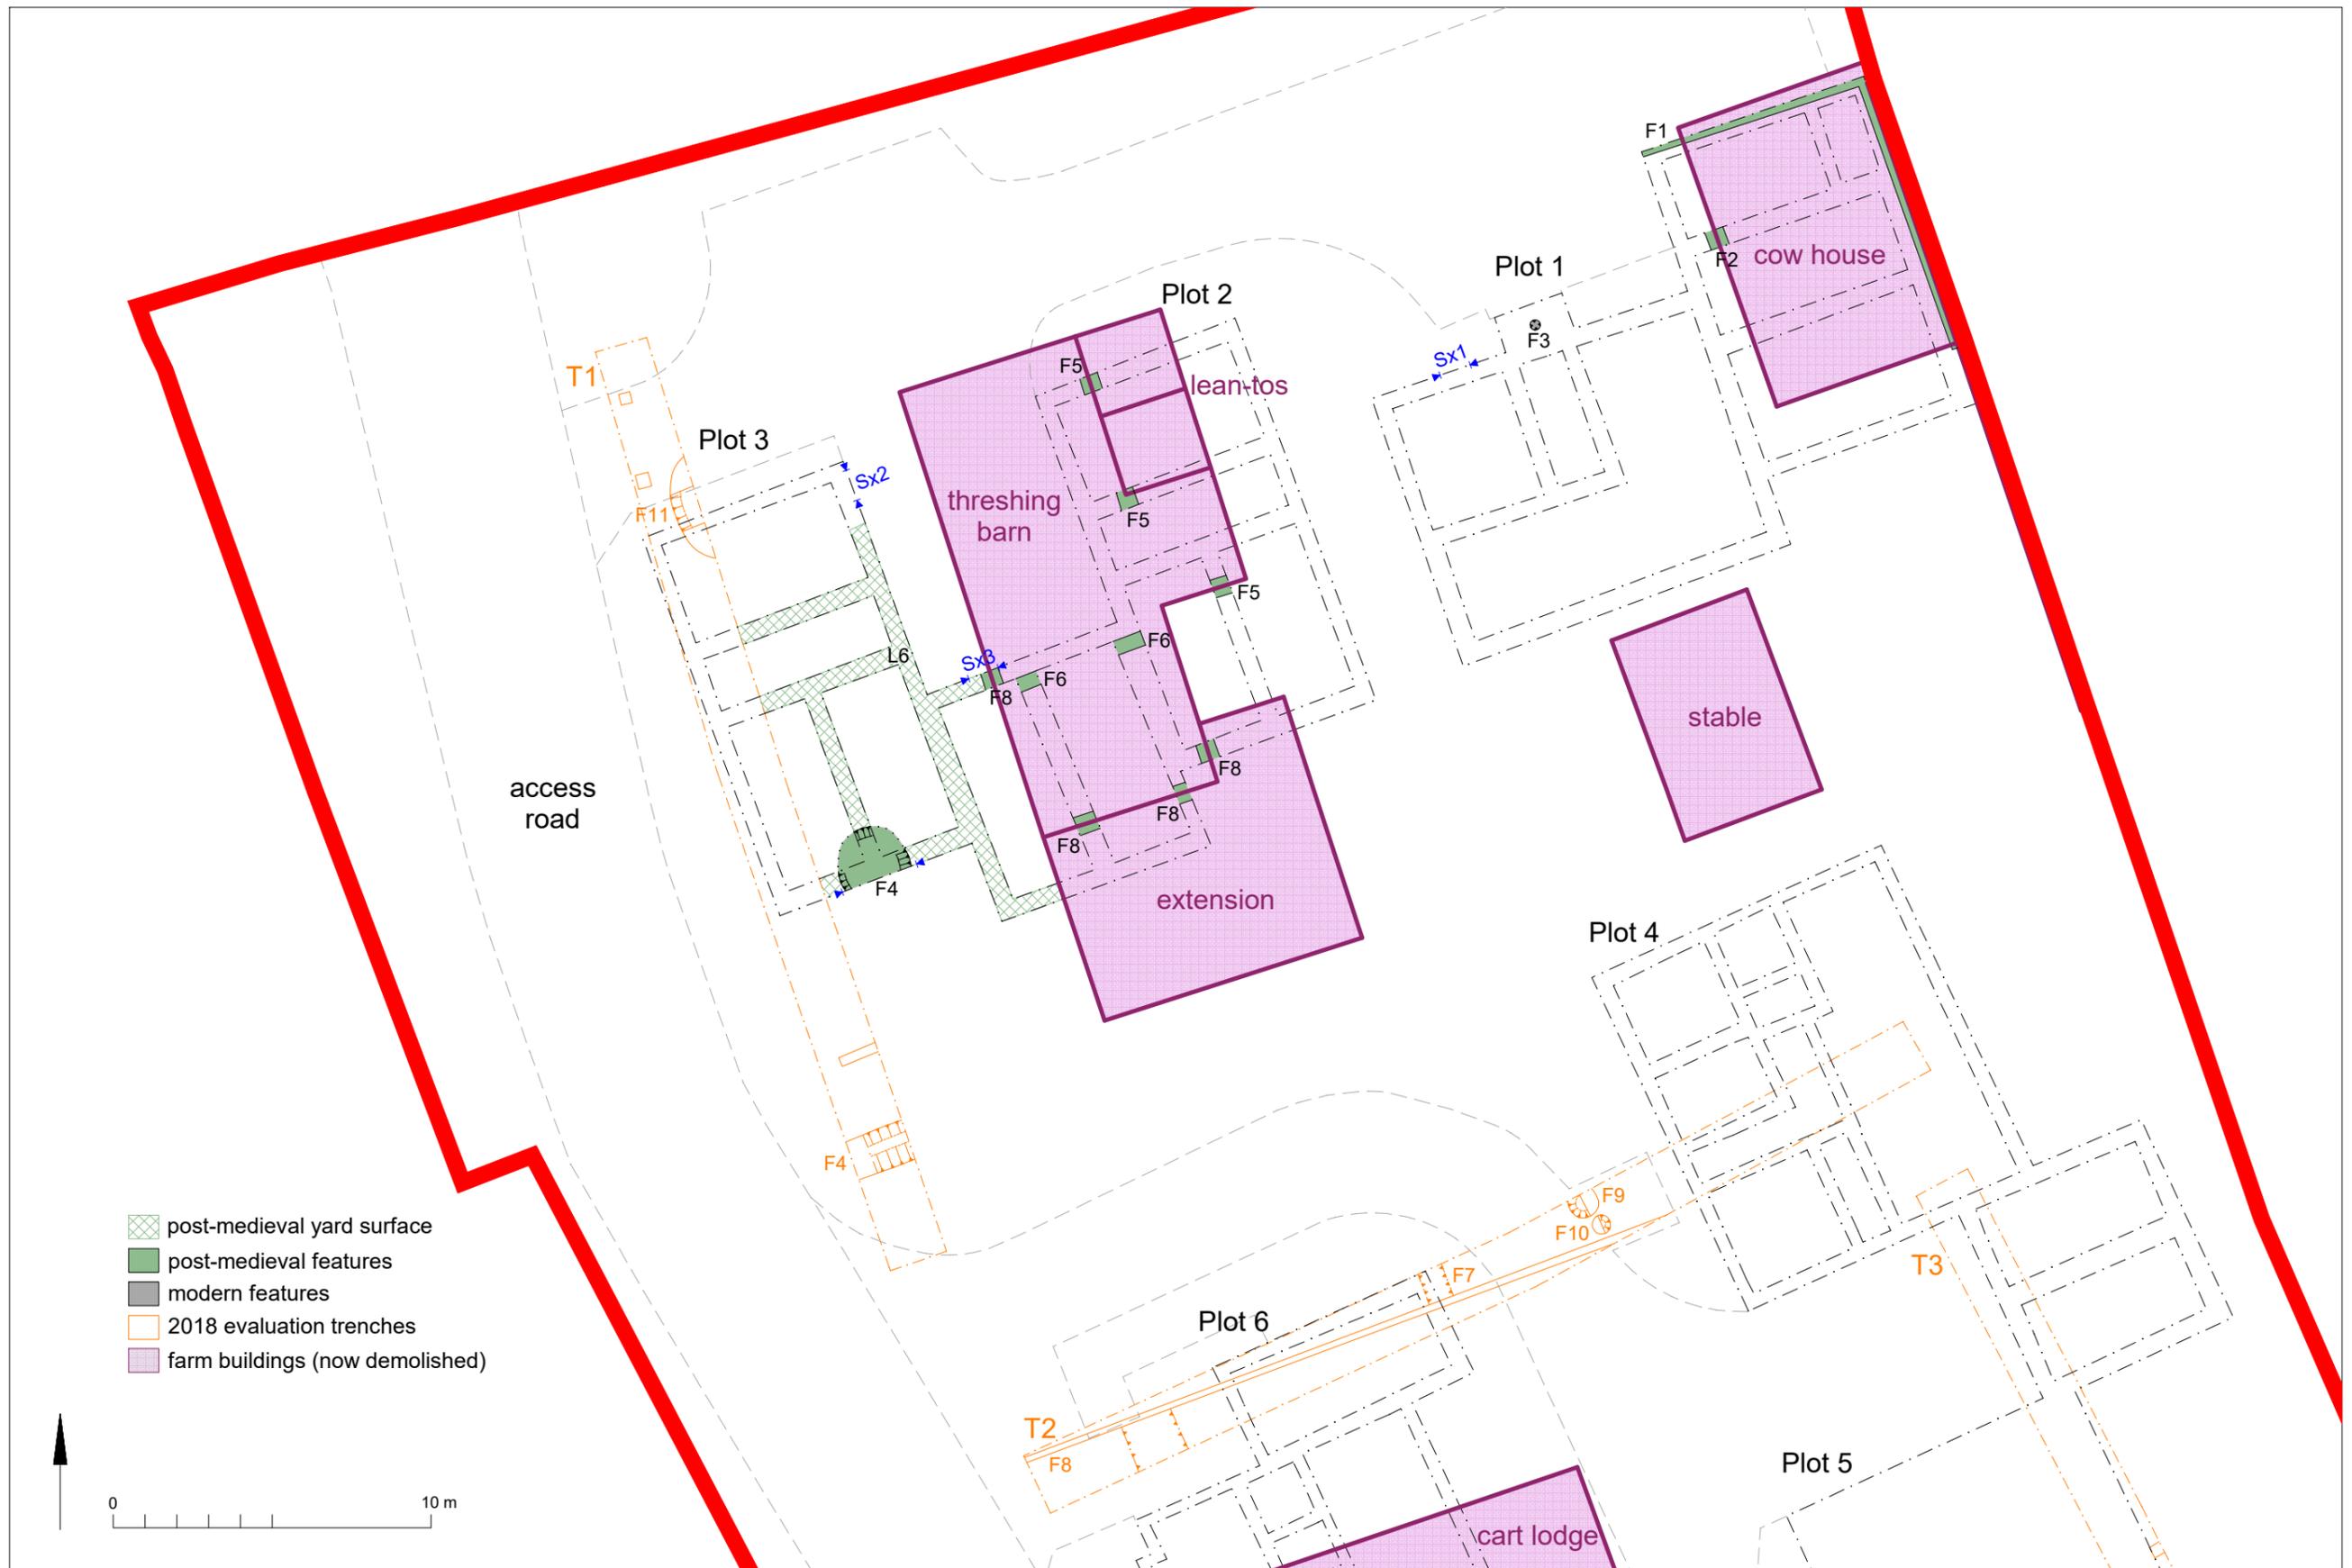
Most of the features recorded within the stripped areas were wall foundations, often with the lowest few courses of the wall surviving. F1 and F2 are approximately 0.6m wide at the base and survive up to seven courses high along the eastern edge of Plot 1. The walls were constructed of red unfrogged brick set in white mortar. These walls correspond to external walls of the former cow house noted in the historic building recording.

Fig 2 Monitoring results in relation to the former farm buildings (pink) and the evaluation trenches (in orange).

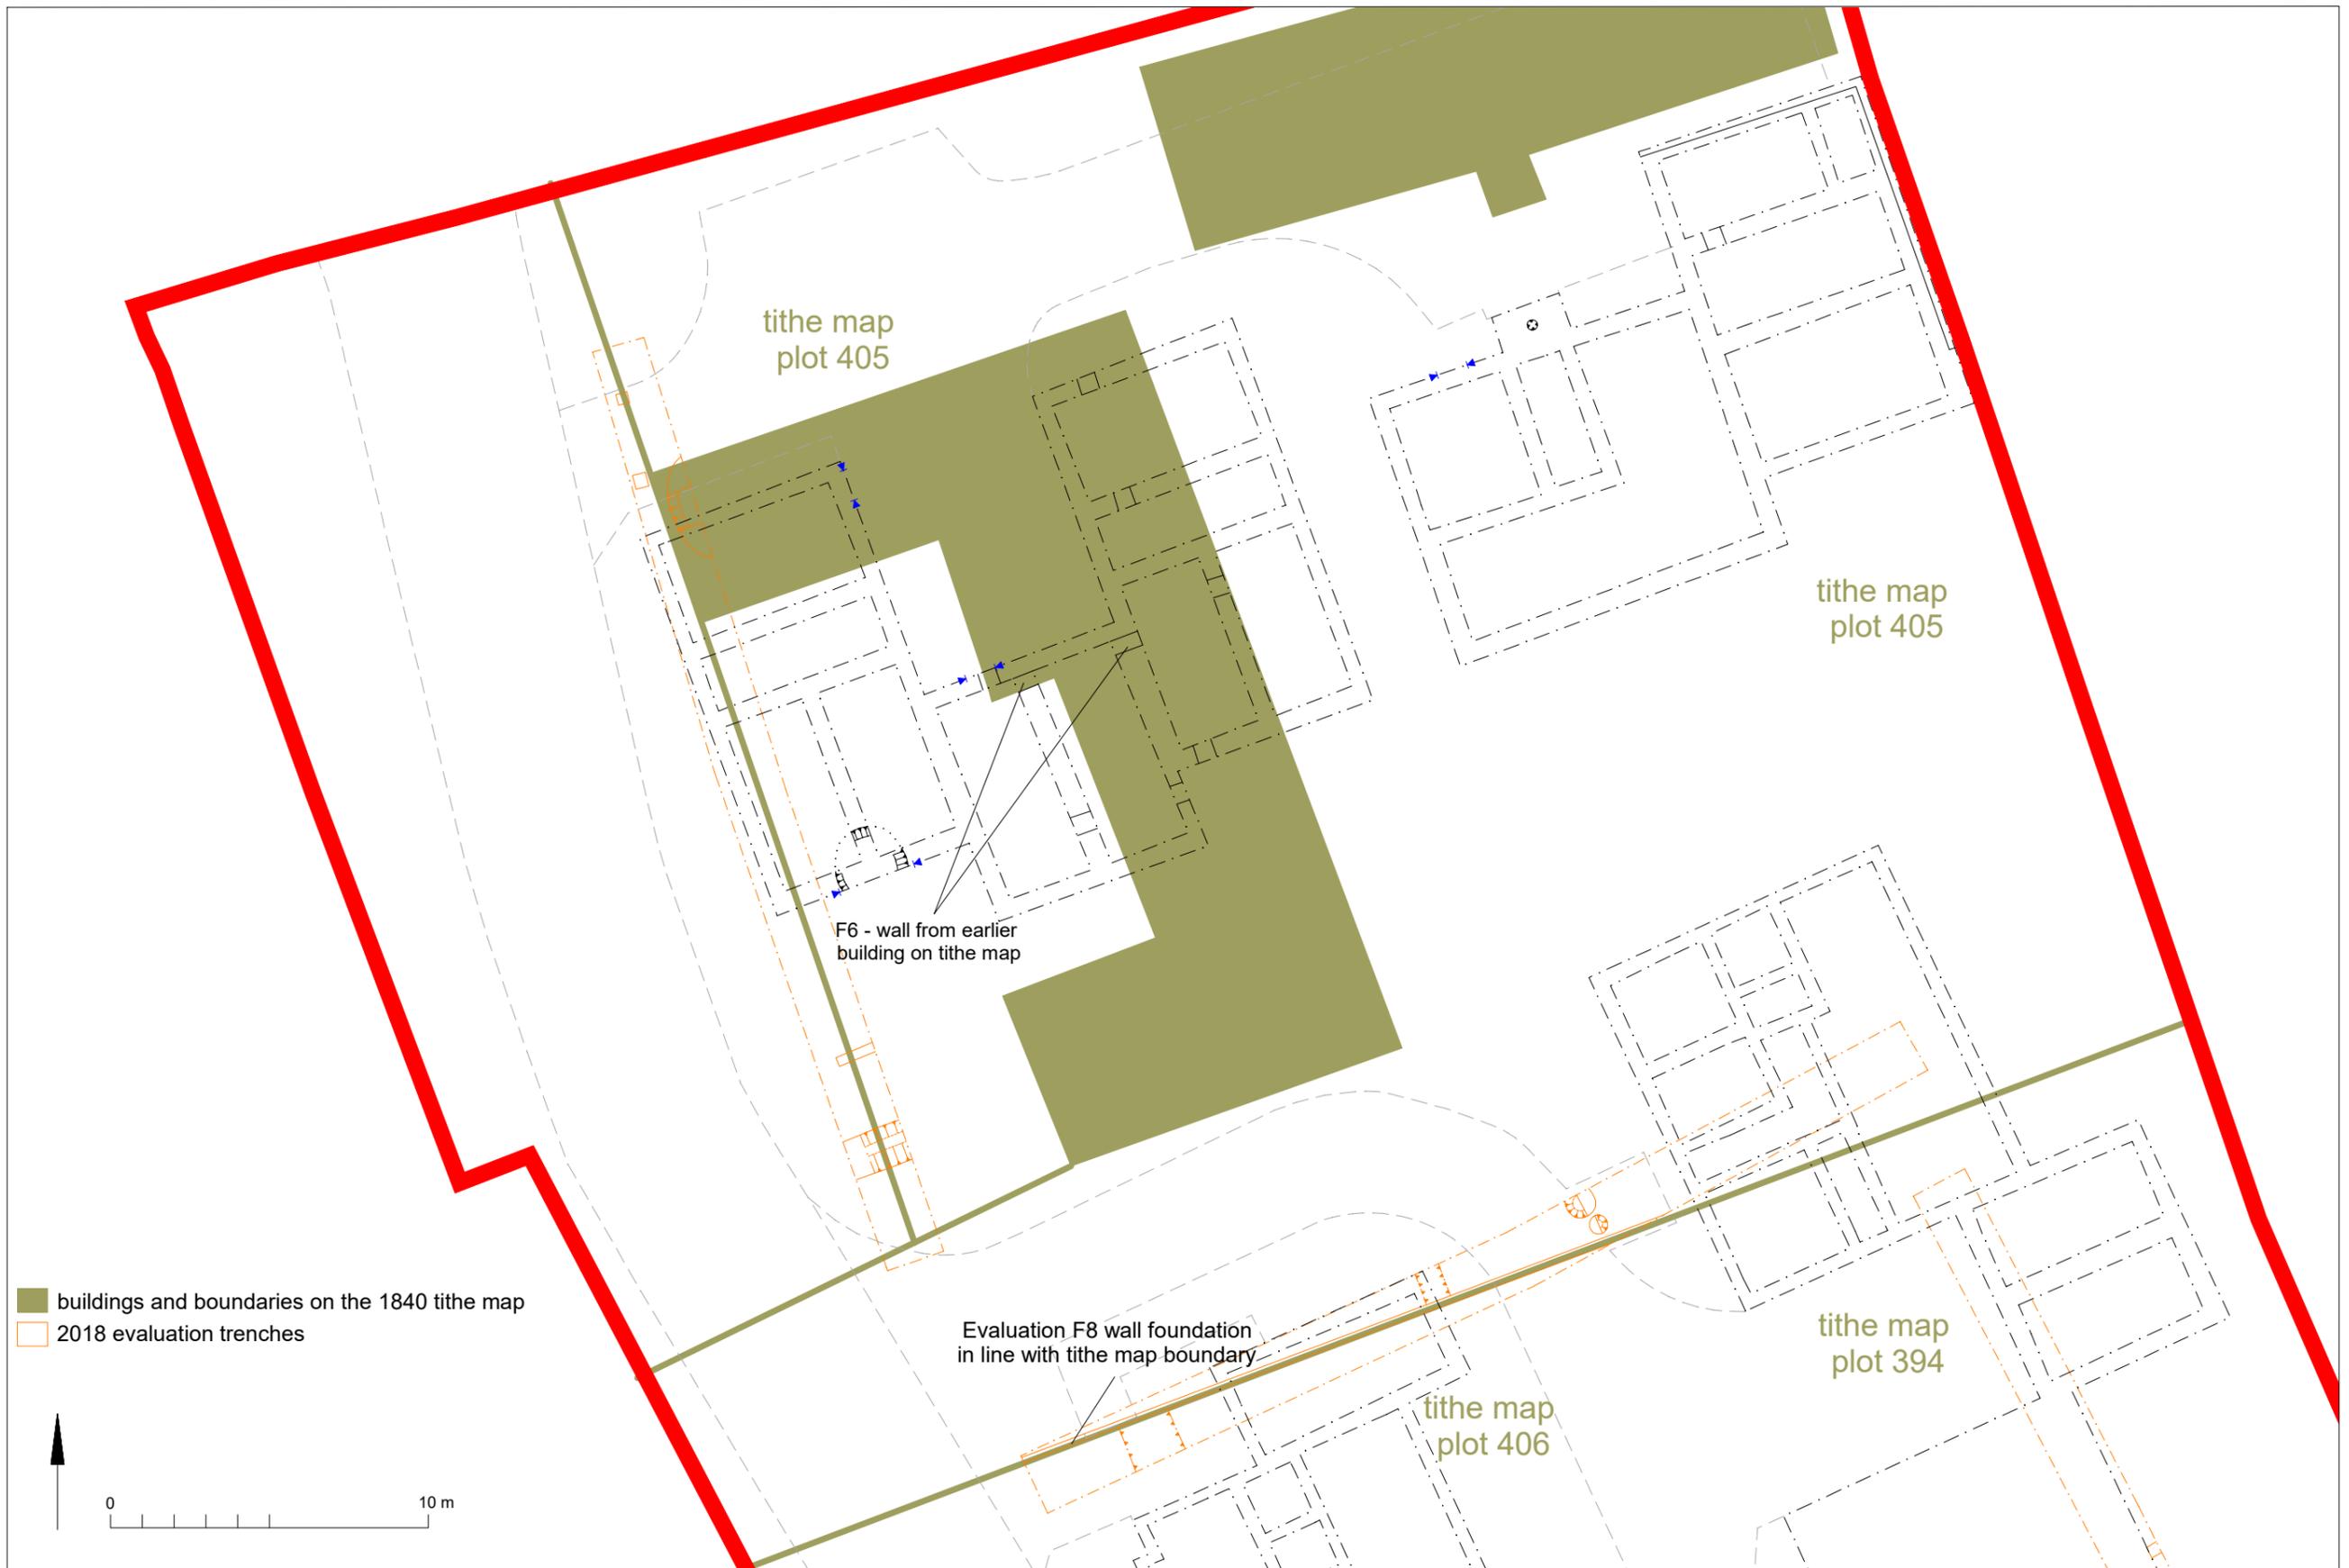
Fig 3 Monitoring results in relation to buildings visible on the 1840 Dovercourt tithe map (brown).

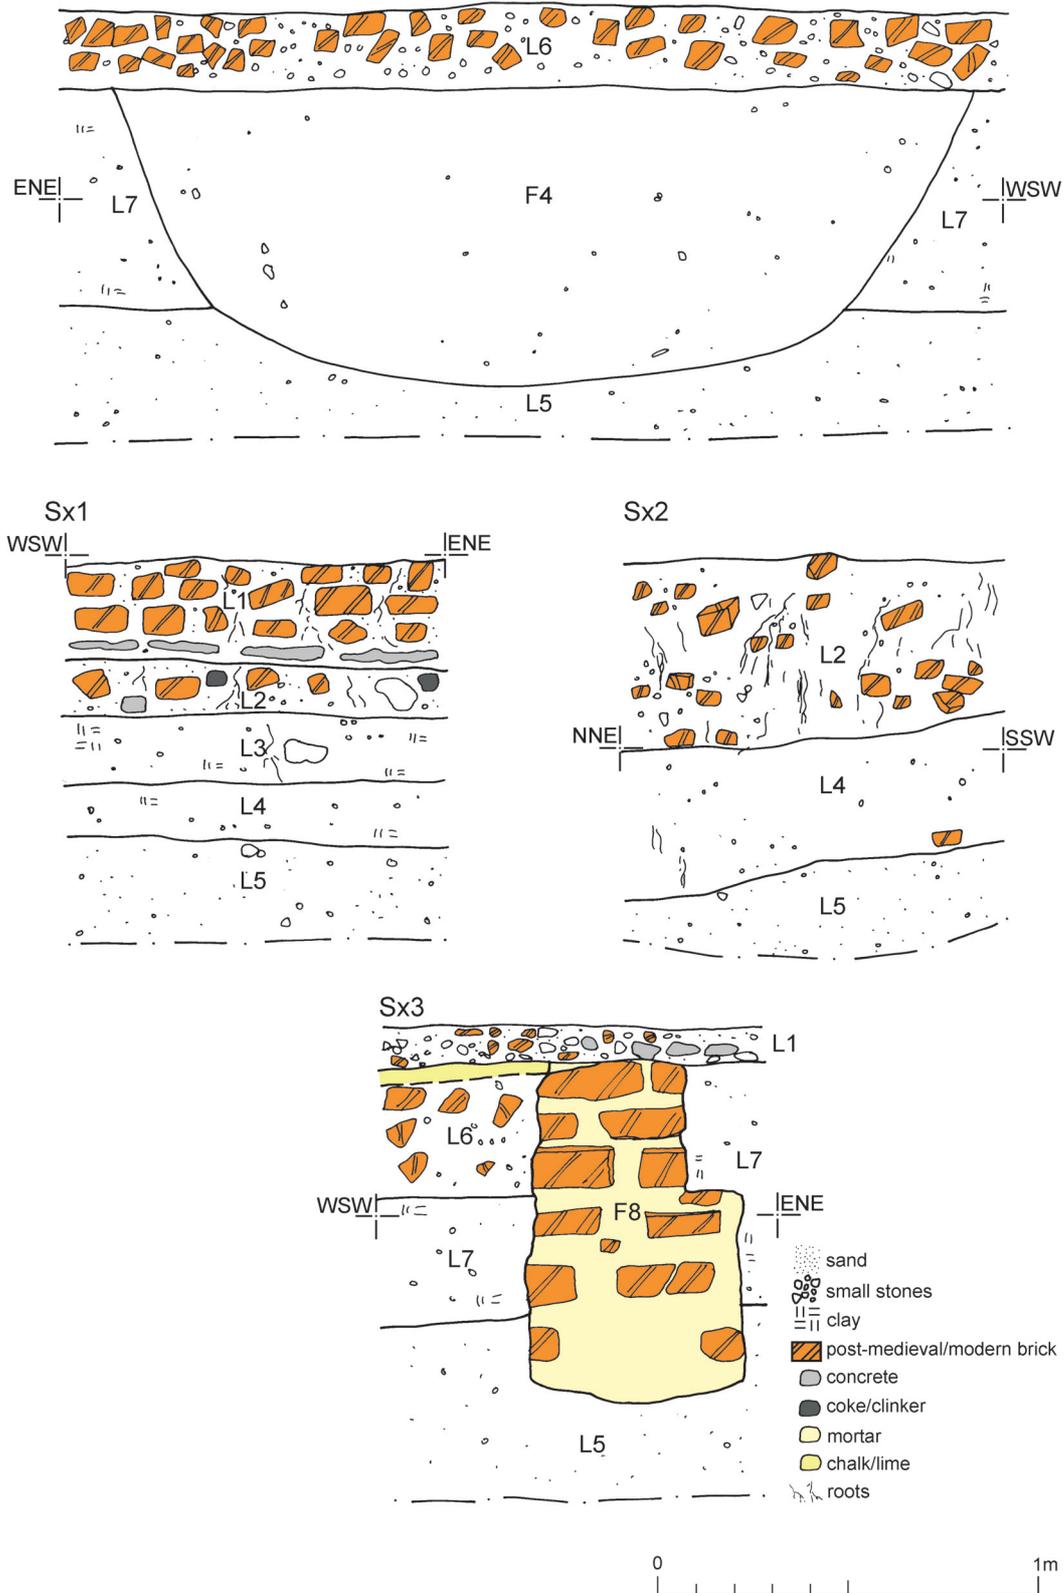
Seven layers were recorded. The northern section of the Plot 1 foundation trenching was cut through a modern brick rubble surface (L1, c 0.24-0.3m thick), a modern layer of crush (L2, c 0.12-0.15m thick), an undatable make-up layer (L3, c 0.17-0.18m thick) and a further undatable make-up layer (L4, c 0.13-0.18m thick) into natural (L5, encountered at a depth of 0.71-0.77m below current ground level [bcgl]).

Fig 4 Feature and representative sections.
