**CAT Report 1994  
issued December 2023**

**Archaeological monitoring at 3 Romans Place,  
Writtle, Chelmsford, CM1 3JD: October 2023**

**NGR: TL 67830 06174 (centre)**

**Planning ref.: 23/01177/FUL**

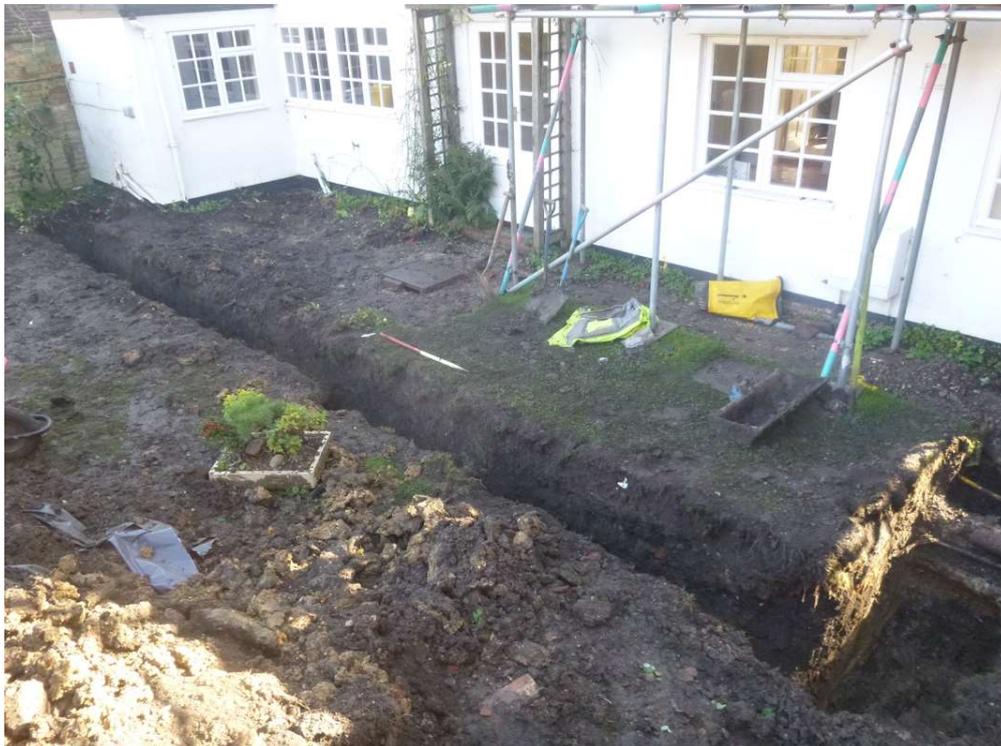
A trench for the footings of the extension was monitored, measuring approximately 9.8m<sup>2</sup>. It was between 0.6-0.7m wide and excavated to a depth of 1-1.2m.

Three horizons were noted. A garden topsoil (L1, c. 0.25m thick) covered the entire site. This covered a make-up layer (L2, c 0.5m thick), which sealed clayey natural (L3, from c. 0.8m below current ground level).

**Photograph 1** General shot of completed trench, view south-east.

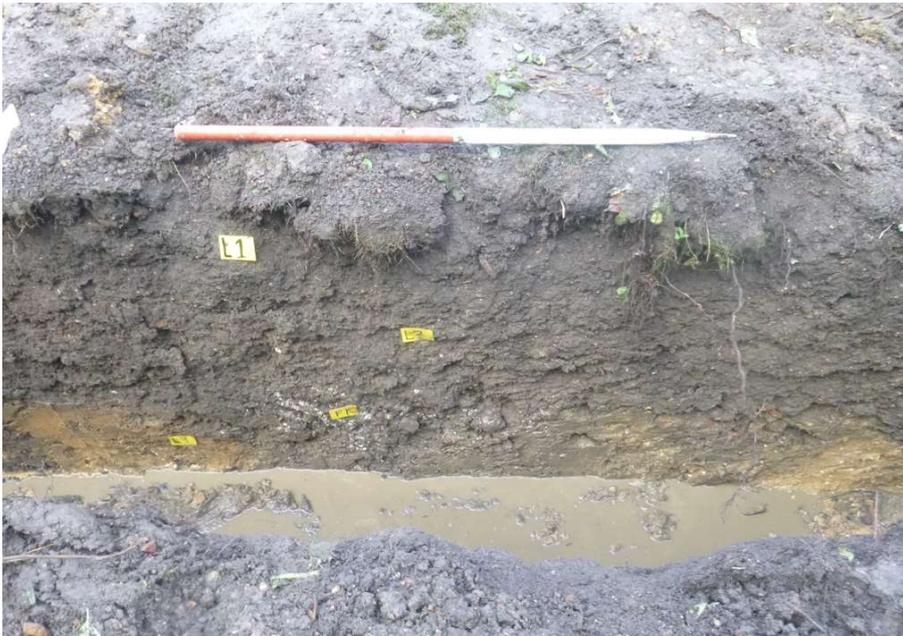
Three features were recorded during monitoring. The first (F1) was a large pit, measuring 1.7m long, at least 0.7m wide and at least 0.5m deep. The base of the feature was not reached at the required depth of the trench. Flecks of CBM were seen throughout, and a layer of oyster shell was noted in the lower half of F1. These were not retained for post-excavation analysis. The CBM flecks seen were not diagnostic in nature, but were noted on site to likely be medieval/

**Photograph 2** South-facing representative section including a section of F1, view north.

Archaeological monitoring undertaken at 3 Romans Place identified a pit of probable medieval/post-medieval date. The oyster shell in the pit possibly suggests a date prior to the post-medieval period, and the CBM flecks were thought to be medieval/post-medieval in date. Also uncovered were a post-medieval/modern soakaway and unidentified brick structure associated with the 18th-century property. Similar brick features were also found during archaeological monitoring at 1 Romans Place, dating to the 18th-19th century (CAT Report 1874). This included a well, which may provide a clue to the identification of the brick structure. Made ground was noted to be from 0.74m deep and natural from 0.93m bcgl at 1 Romans Place, akin to the current site. Their similarities are to be expected, as the properties are within close proximity, and contemporary to each other.

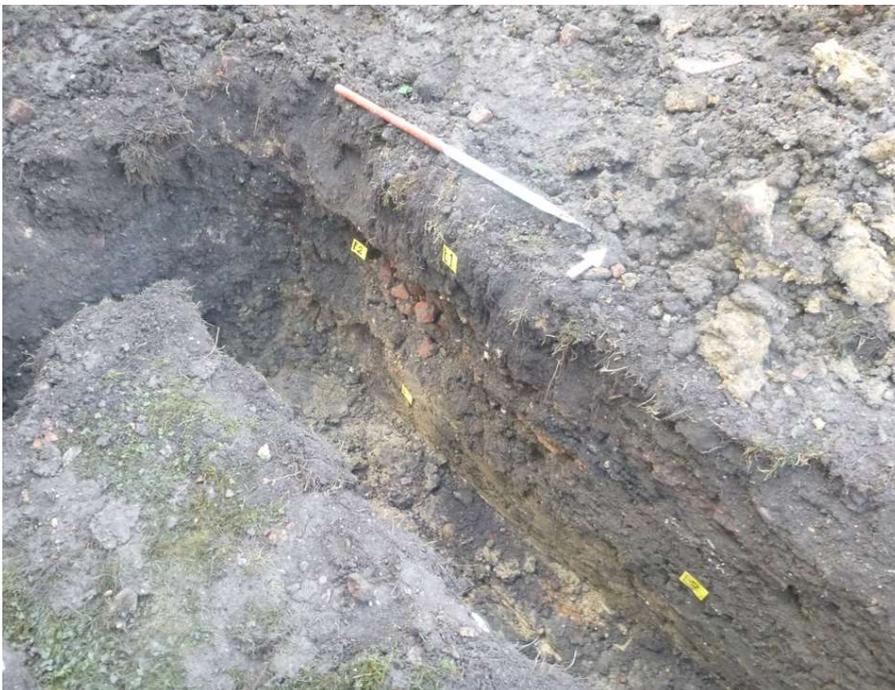
post-medieval in date. Feature F2 was a disused soakaway, backfilled with red brick and similar material. The full extent was not exposed, but measured at least 1.9m wide, 1.6m long, and 1m deep. The third feature was a brick structure of unknown function (F3). Only a small portion of the feature was seen, but was around 0.5m wide and at least two courses high. The structure may have been rounded in shape and appeared post-medieval/modern in date.

**Photograph 3** Northern section of F2, view north-west.

Soakaway F2 produced a fragment (414g) of medieval/post-medieval peg-tile, four sherds (221g) of modern Staffordshire-type white earthenwares (fabric F48D) from a bowl (EVE:0.13), and a piece (60g) of cattle/horse rib that had been sawn at one end. All of this material has been discarded.

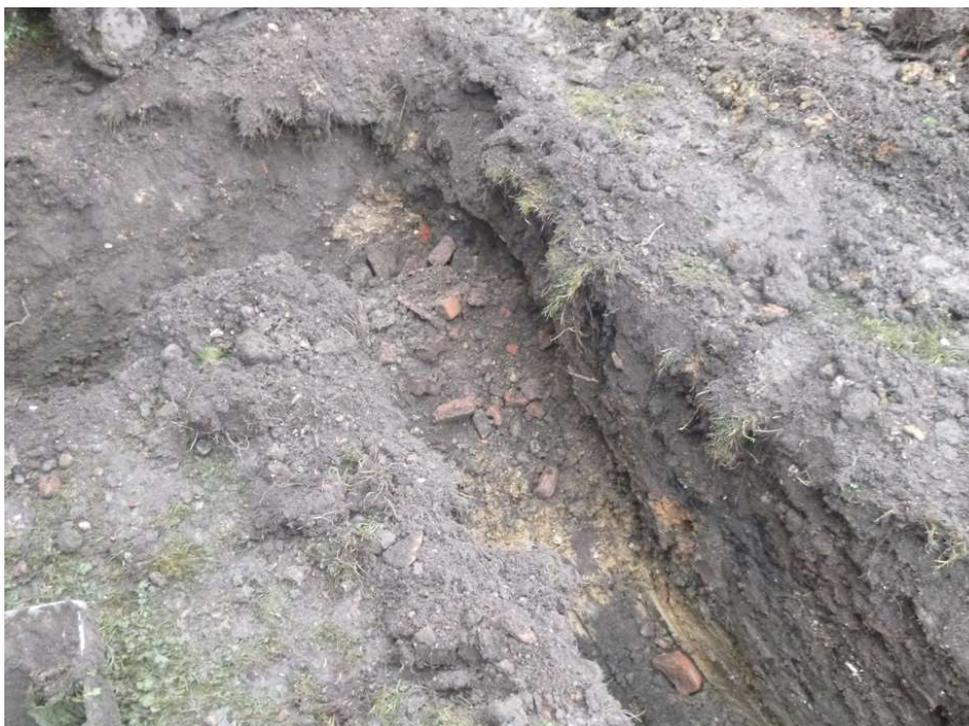
**Photograph 4** F2 during excavation, showing brick backfilled into feature, view north-west.

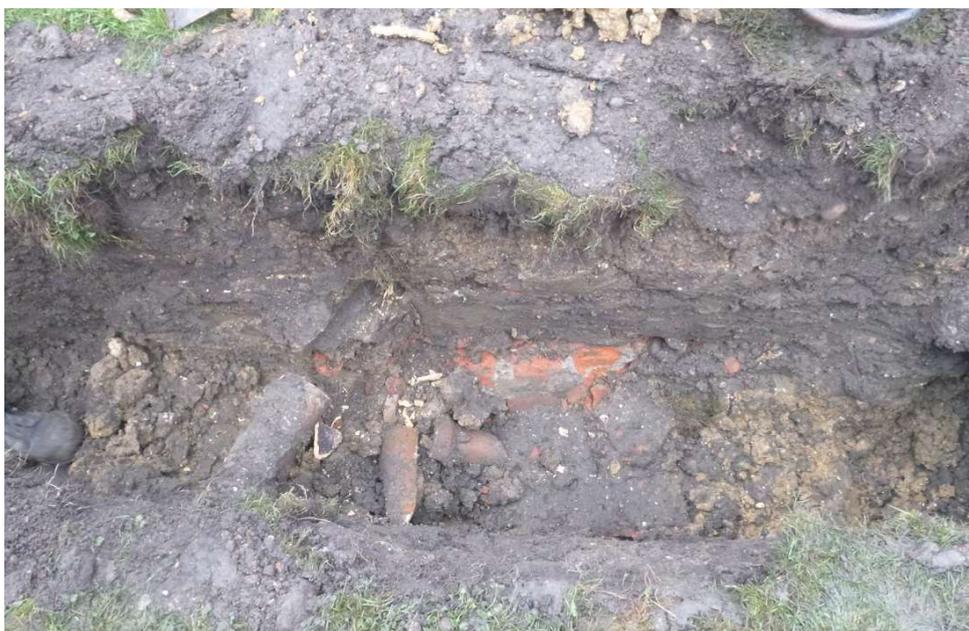
**Photograph 5** General shot of F3, view north.

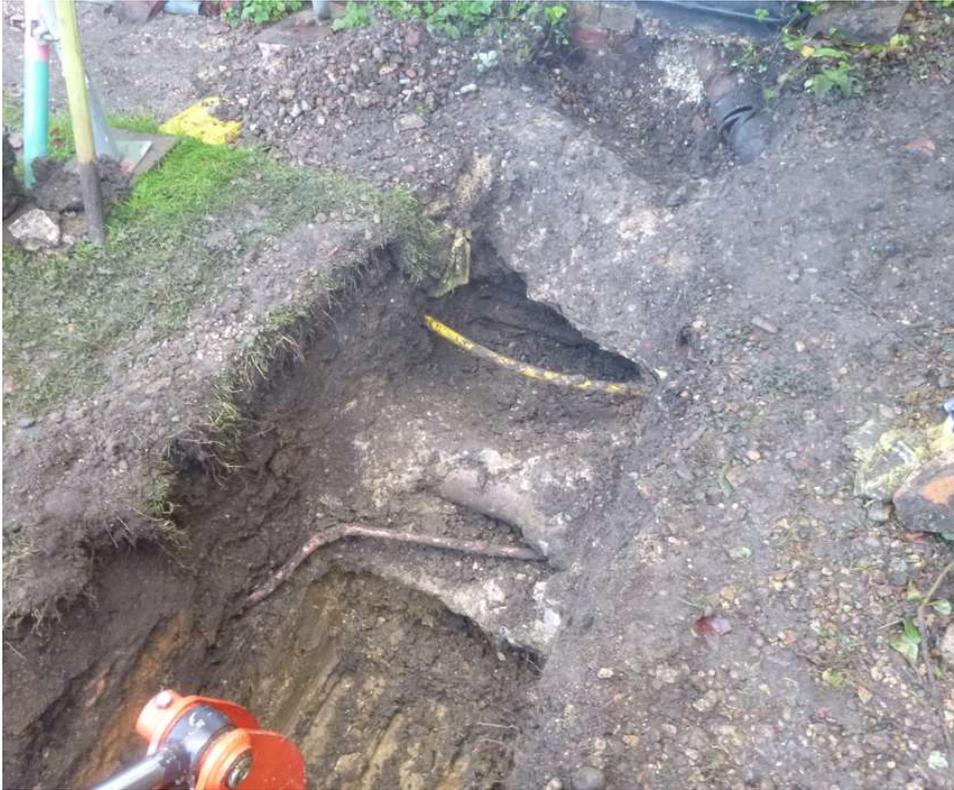
At least six service cables or pipes of varying types were noted during the excavation of the trench. These included gas pipes and disused ceramic drainage pipes.

**Photograph 6** Some of the service cables and pipes uncovered at south-west end, view south.

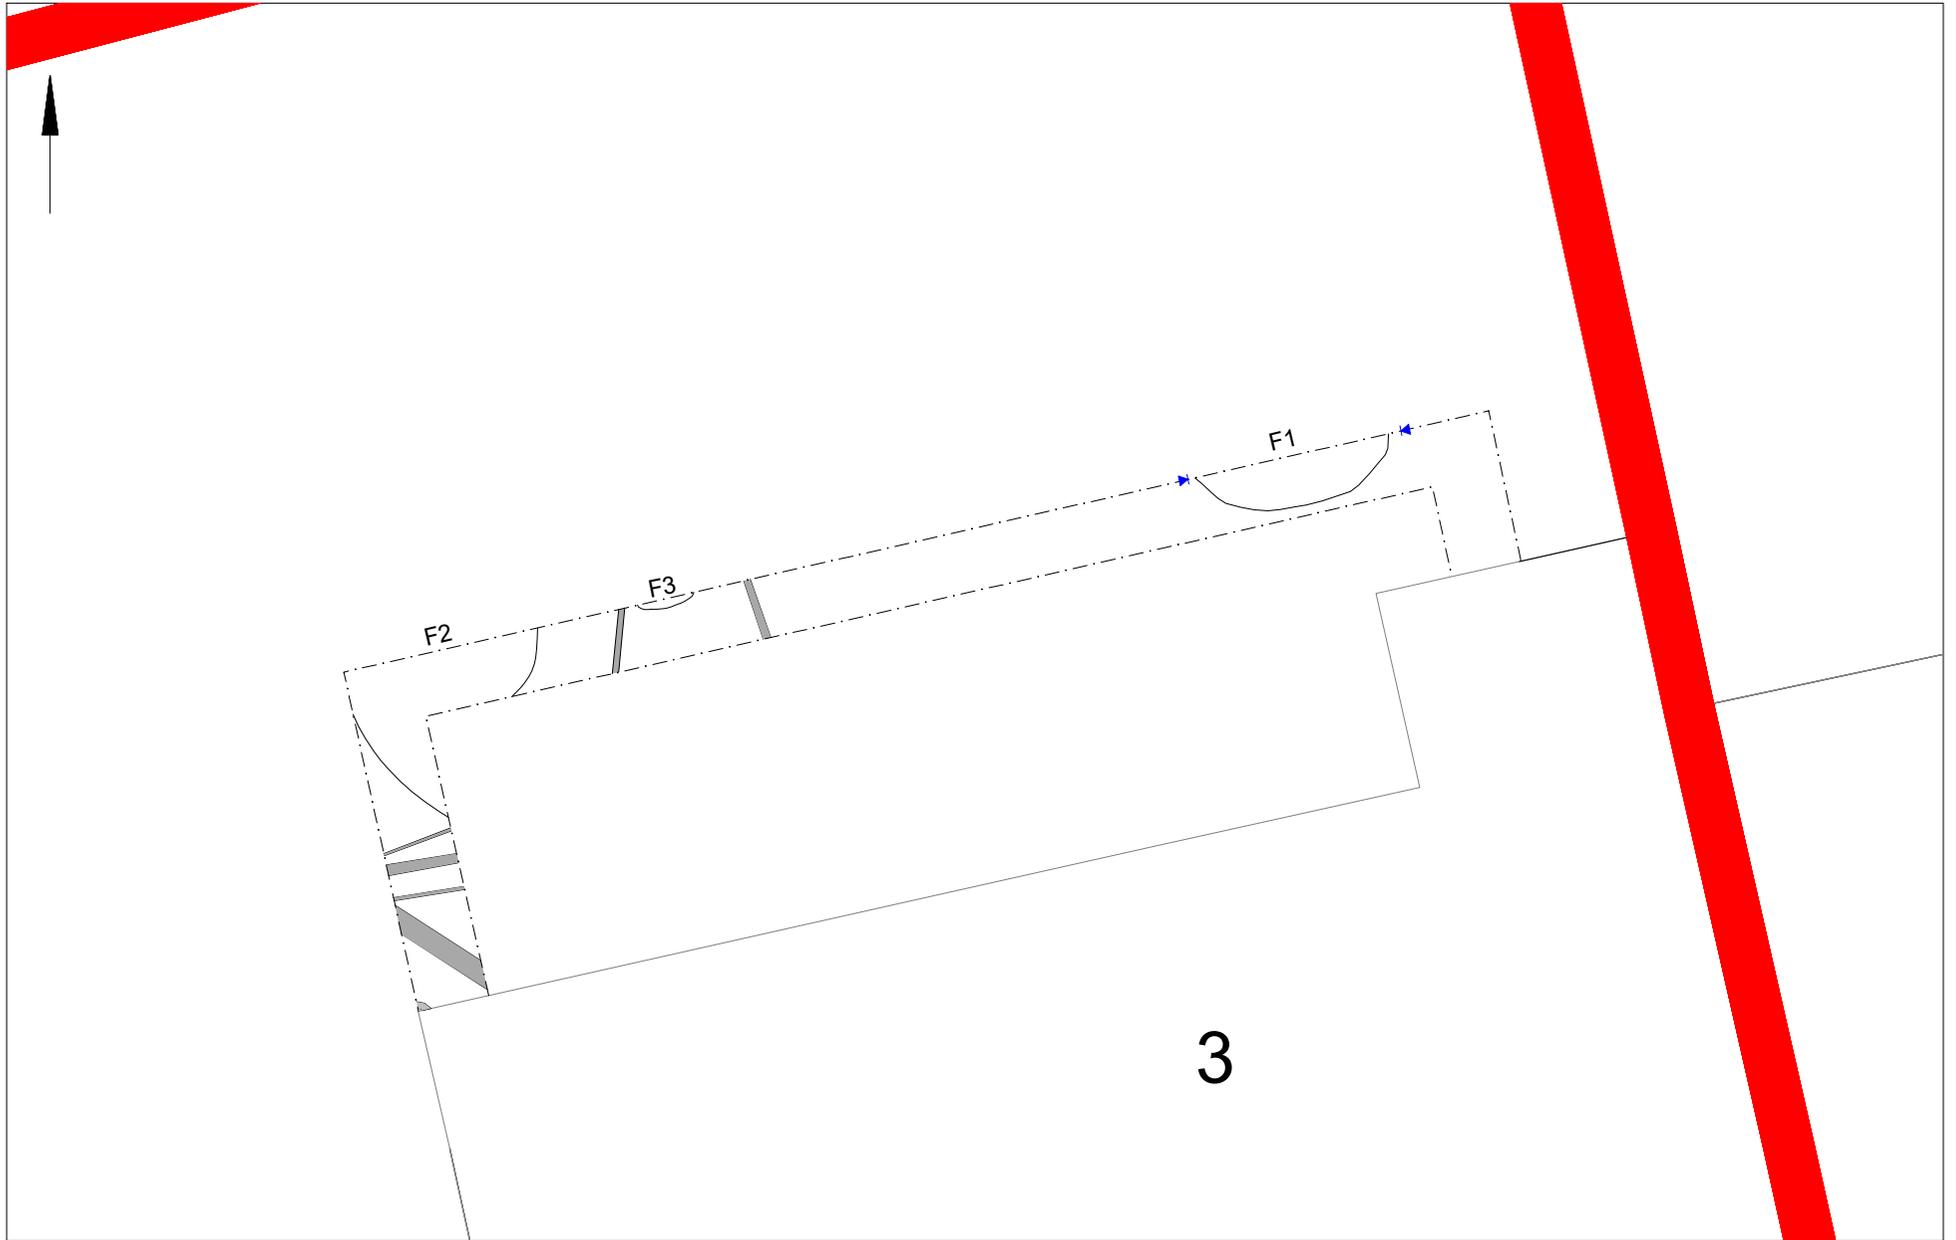
Fig 2 Results.  
Modern services are in grey.
