**CAT Report 2071
Issued August 2024**

**Historic building recording of two air-raid shelters
at Buckland Mill, Crabble Hill, Dover, Kent,
CT17 0SU**

July 2024

CAT project ref.: 2024/05c

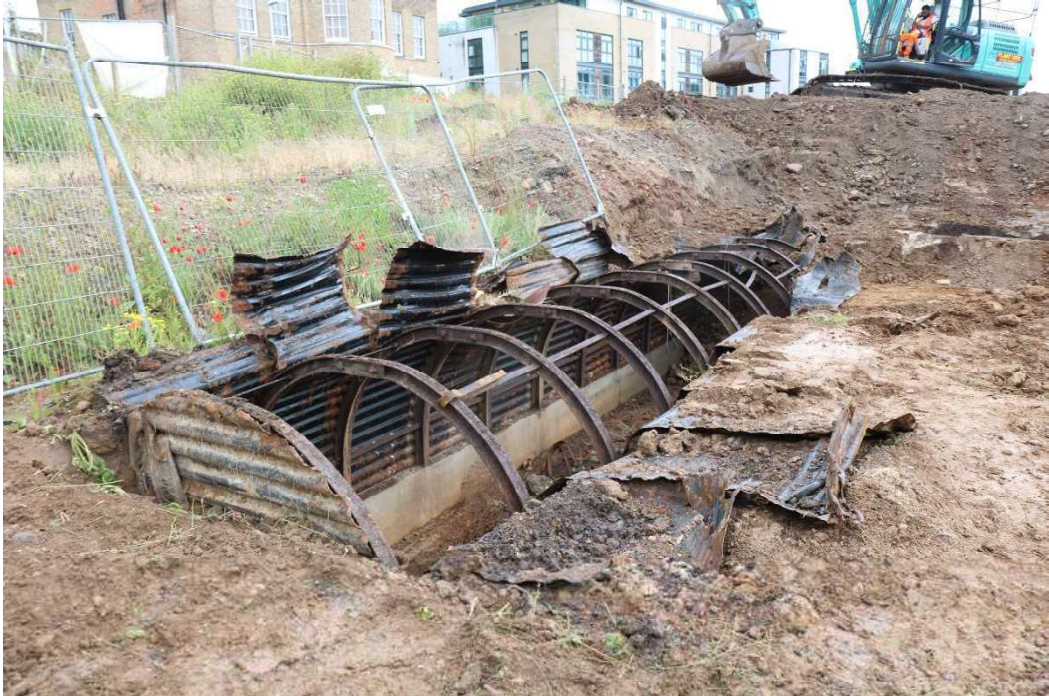
Photograph 1 Shelter one. Photograph taken facing east.

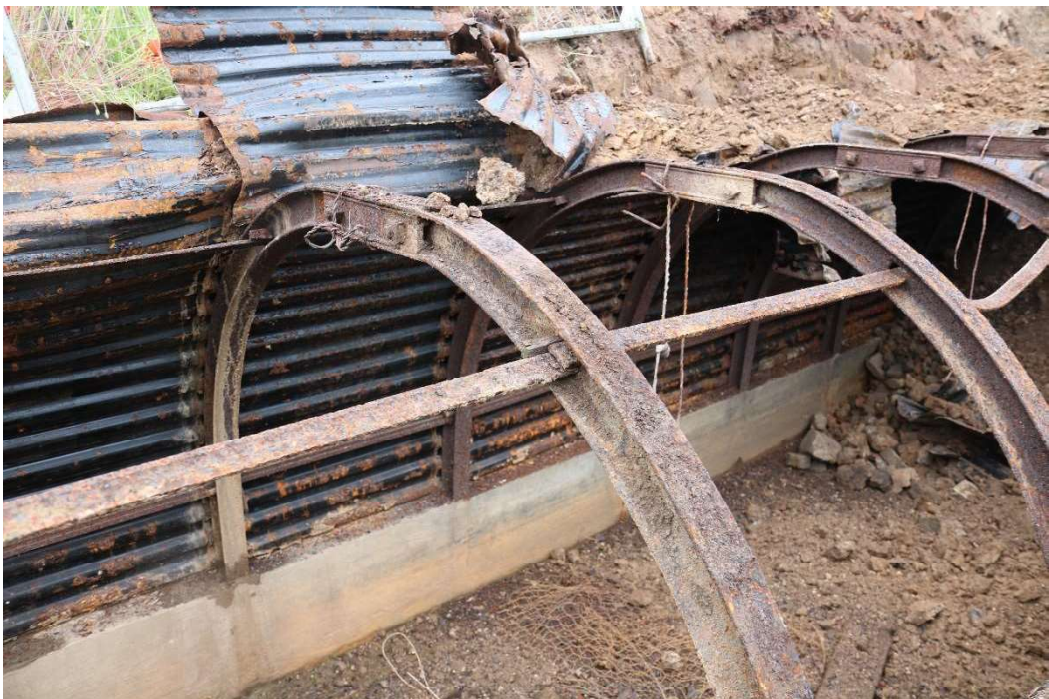
Photograph 2 Detail of arches of shelter one. Photograph taken facing north-east.

The air-raid shelters are both L-shaped in plan and have a footprint of roughly 28m². The frame of the shelters is composed of twelve arches (Photograph 2), each comprising two curved iron I-beams, set into a poured concrete plinth. The two I-beams are joined together with an iron fish-plate held with square-headed bolts (Photograph 3). Between each arch are four iron bars, seemingly operating as through-

The structures are built from a series of iron arches, known as Colliery Arches – a technique used in coal mining, also known as 'Collieries', the same construction technique used in some of the secret wartime tunnels under Dover Castle and The Deep Shelter at Fan Bay Battery. It's plausible to suggest that the use of Colliery Arches comes from advice from the Home Office Handbook and the resources may

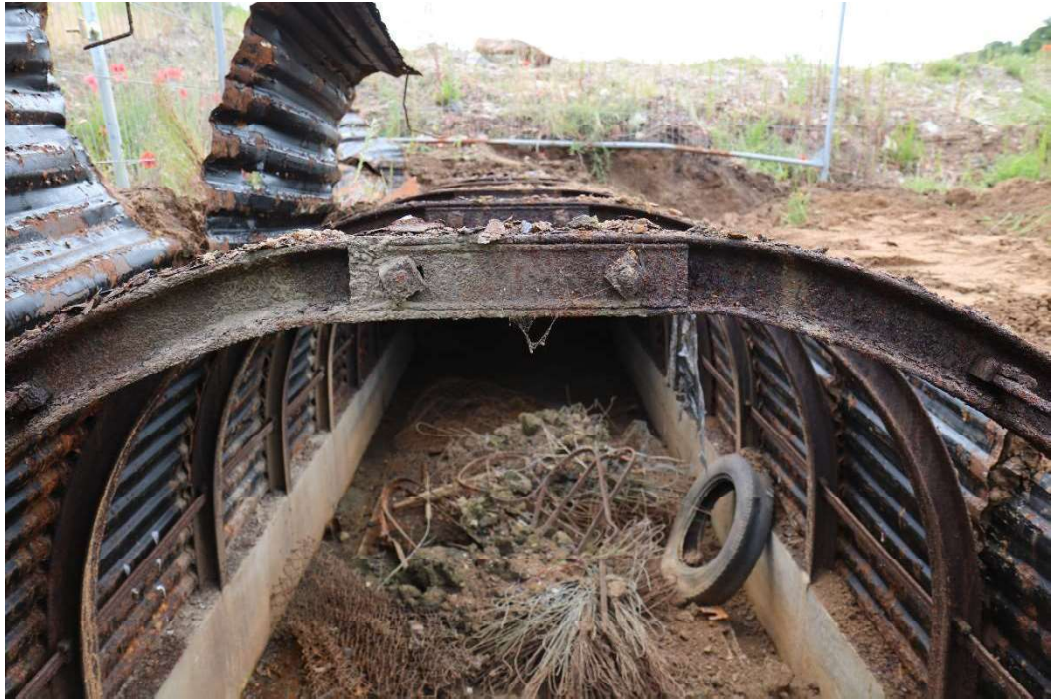
Photograph 3 Detail of fish-plate and square-headed bolts in frame of shelter one. Photograph taken facing south-east.

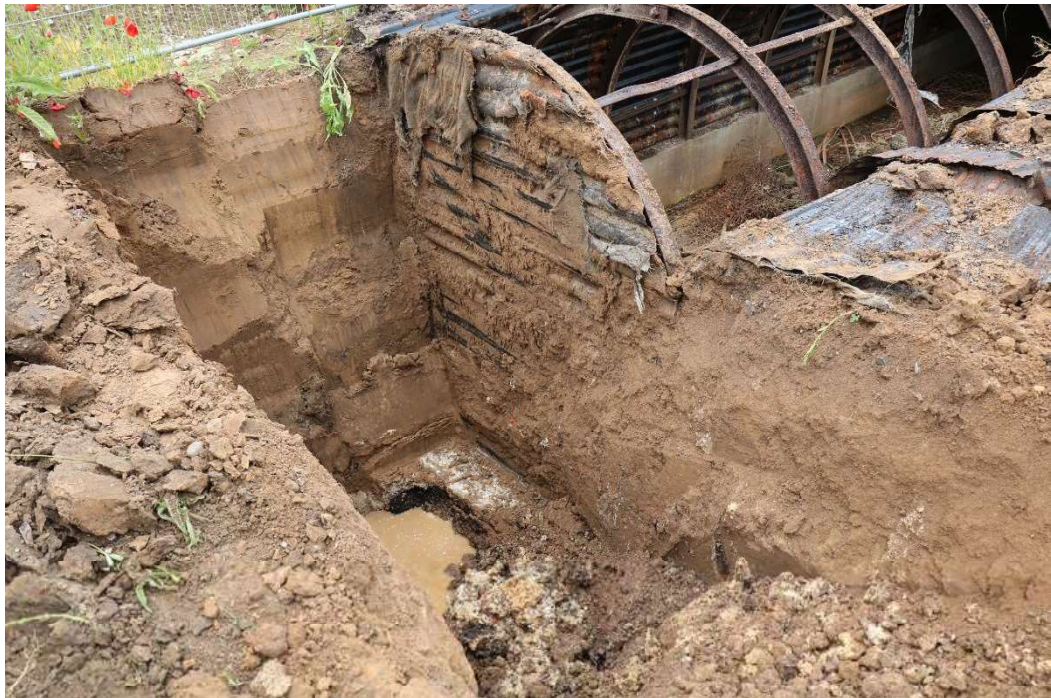
purlins, which are held in place by wooden chocks. The exterior of the arches are clad in corrugated iron sheets, painted black. The superstructure stands on a concrete pad (Photograph 4).

Photograph 4 North-western end of shelter one. Photograph taken facing east.

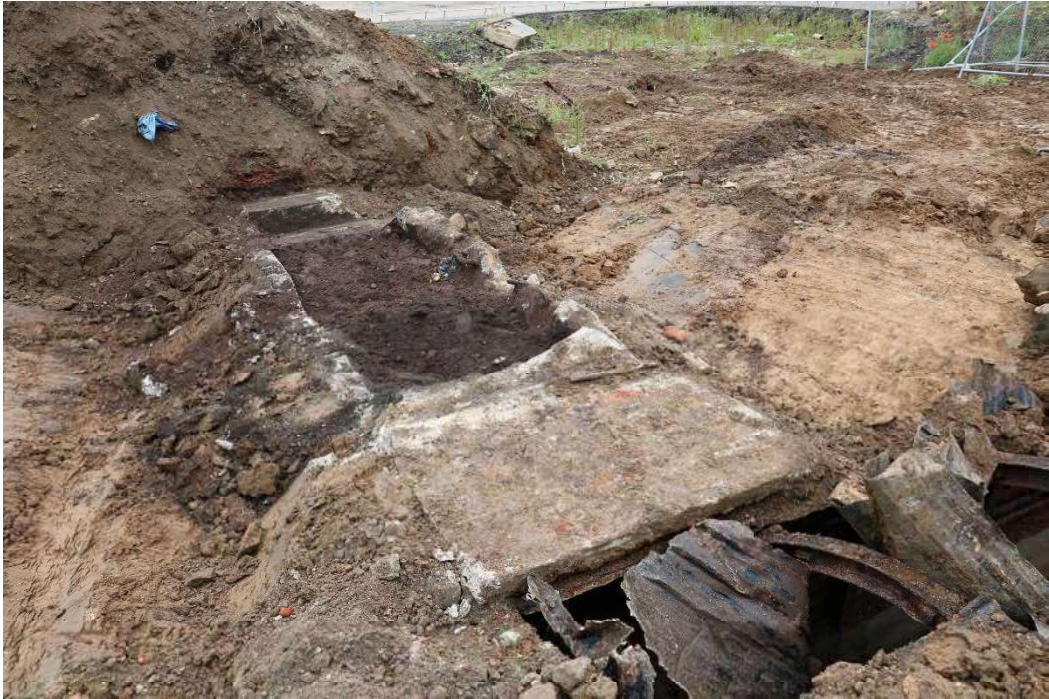
Each shelter has a set of entrance steps, projecting to the south-west (Photograph 5). The entrance has been formed from poured concrete, reinforced with rebar, with a concrete slab roof over the north-eastern end. An iron cross-bar is present between the two arches adjacent to the entrance.

Photograph 5 Concrete entrance to shelter one. Photograph taken facing south-west.

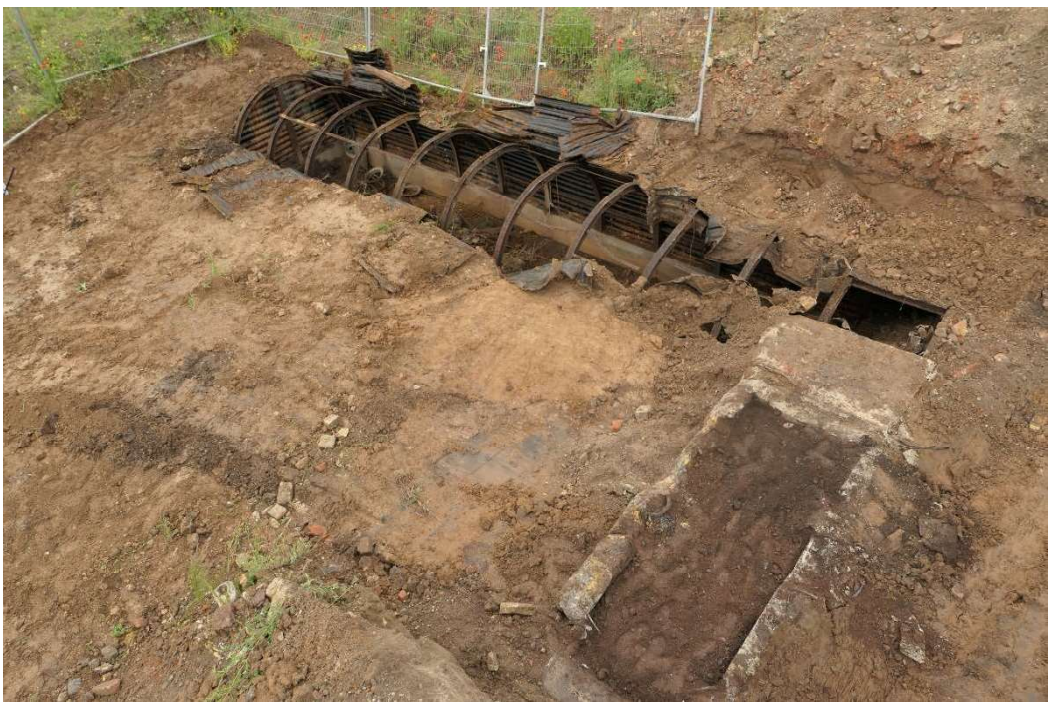
Due to accessibility issues and safety concerns, shelter one (Photograph 6) was not entered and was recorded from ground level. Internal photography was achieved via a pole-cam.

Photograph 6 Overview of shelter one. Photograph taken facing north.

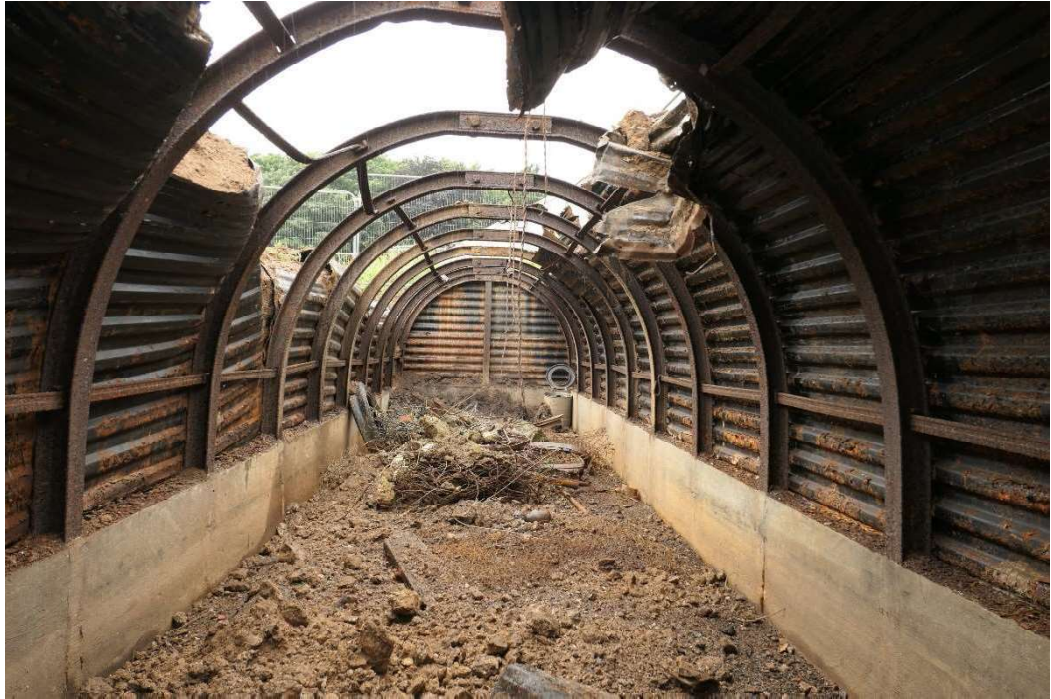
A layer of fabric was laid over the top of shelter one, seemingly some kind of burlap, probably as a crude form of insulation. The floor of the shelter is exposed concrete, with two parallel timbers set into it at each side, running the full length. These are possibly related to timber benches which would have been present on each long edge of the shelter.

Photograph 7 Interior of shelter one. Photograph taken facing north-west.

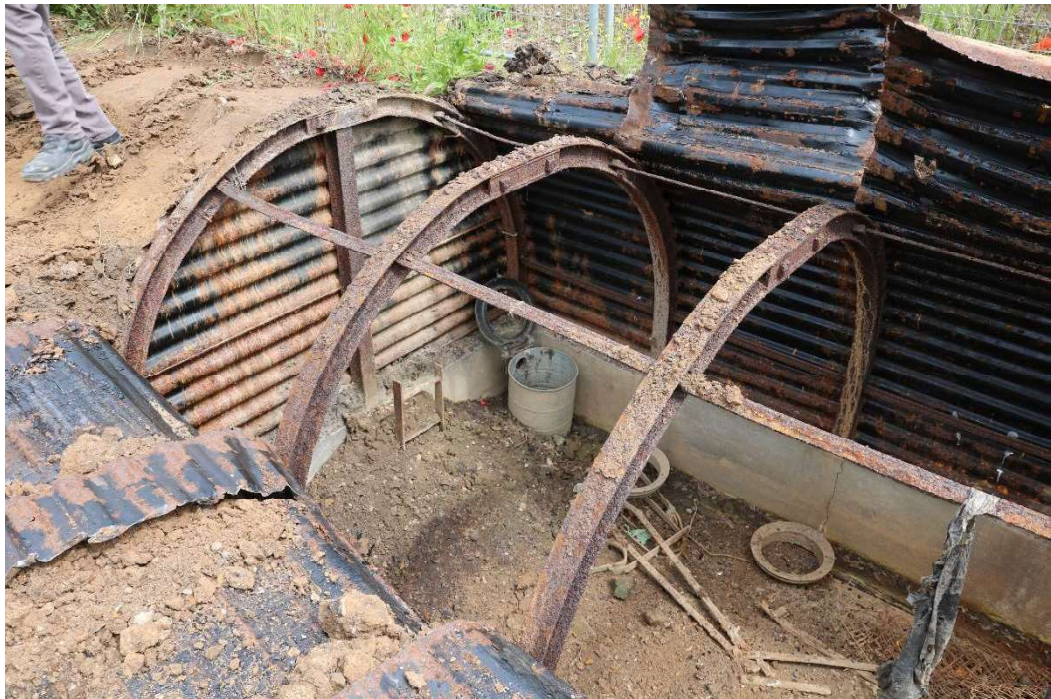
At the north-western end of shelter one are the remains of an escape ladder, roughly central to the floor (Photograph 8). This would have led to an escape hatch in the roof of the structure, in case the main entrance became blocked. Adjacent to the ladder is an Elsan-style chemical toilet (Photograph 8). Hanging from some of the arches are light fittings, with metal lamp holders and braided cables (Photograph 9).

Photograph 8 Interior of shelter one, the escape ladder and chemical toilet visible. Photograph taken facing north.

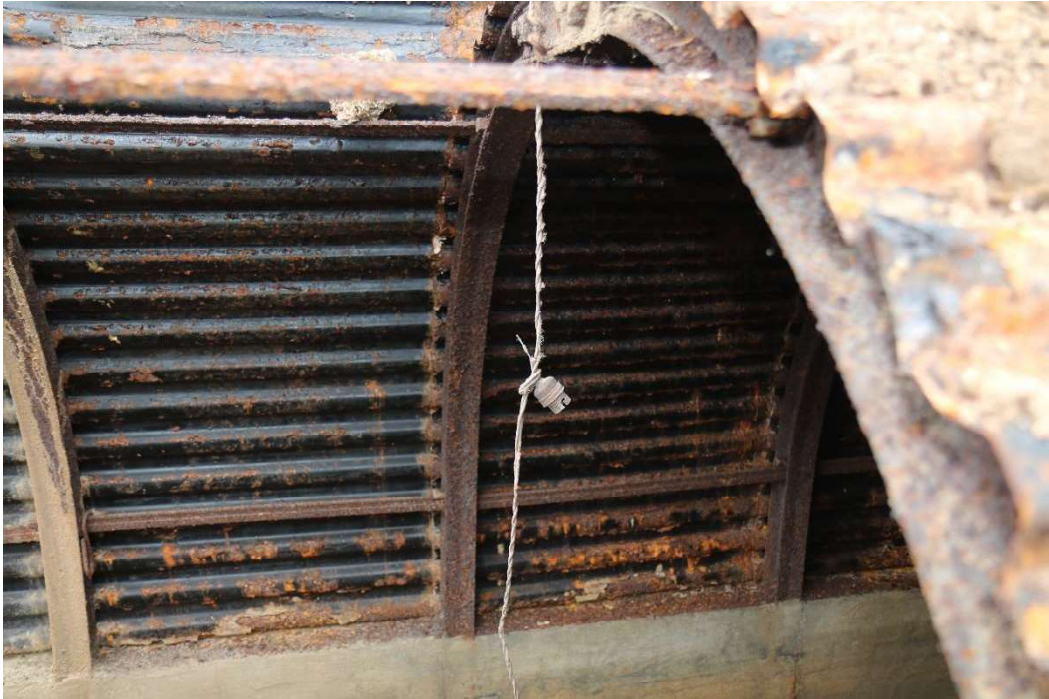
Photograph 9 Detail of light fitting in shelter one. Photograph taken facing north-east.

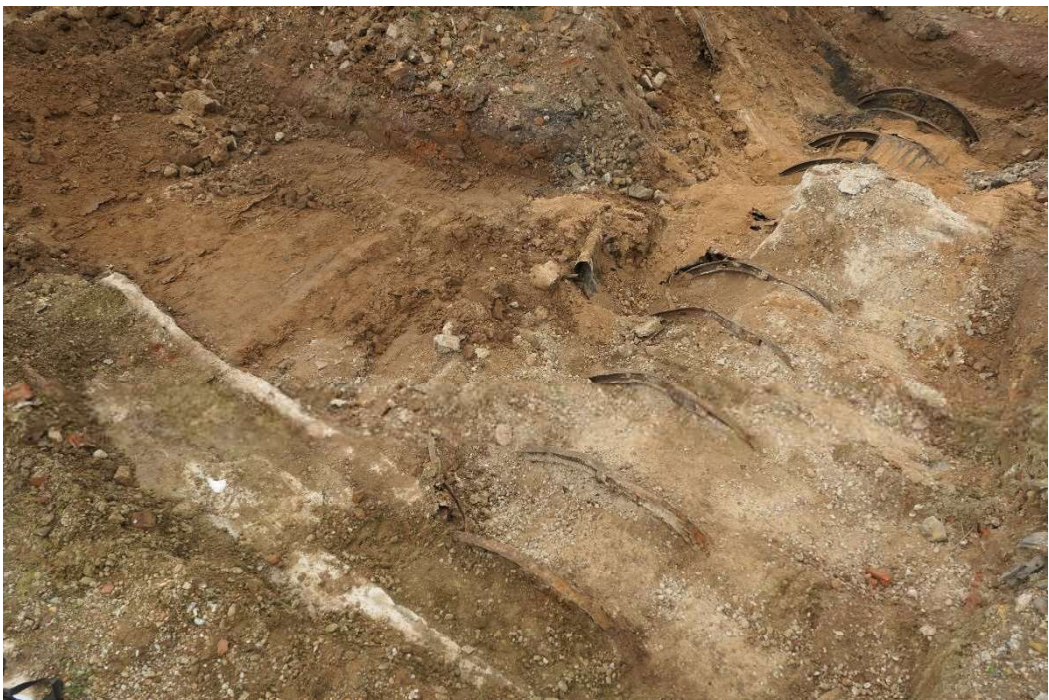
Shelter two (Photograph 10) has been backfilled, with a combination of concrete and burnt material (Photograph 11), so any meaningful recording was inhibited. From what was exposed, it can be presumed that it used the same materials and construction techniques as shelter one. The presence of the burnt material may indicate that shelter two was subject to fire damage at some point or it may represent waste material from the paper mill.

Photograph 10 Overview of shelter two. Photograph taken facing west.

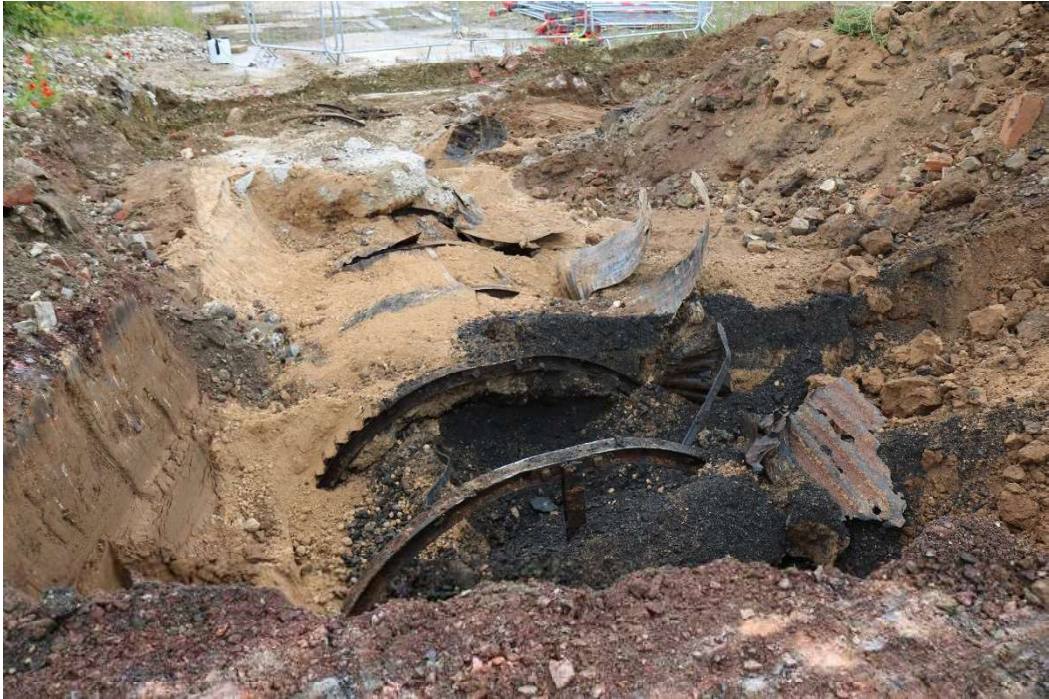
Photograph 11 North-western end of shelter two. Photograph taken facing south.

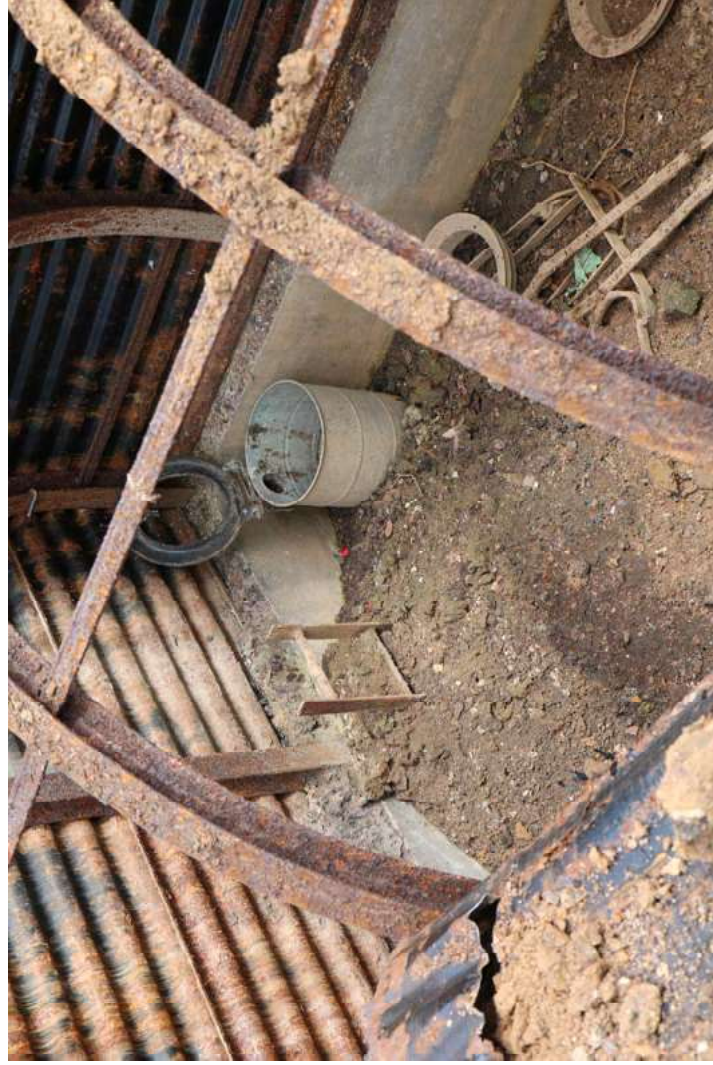
2024.05c_Photograph_003
Detail of toilet and ladder at north-western end of shelter one. Photograph taken facing north.

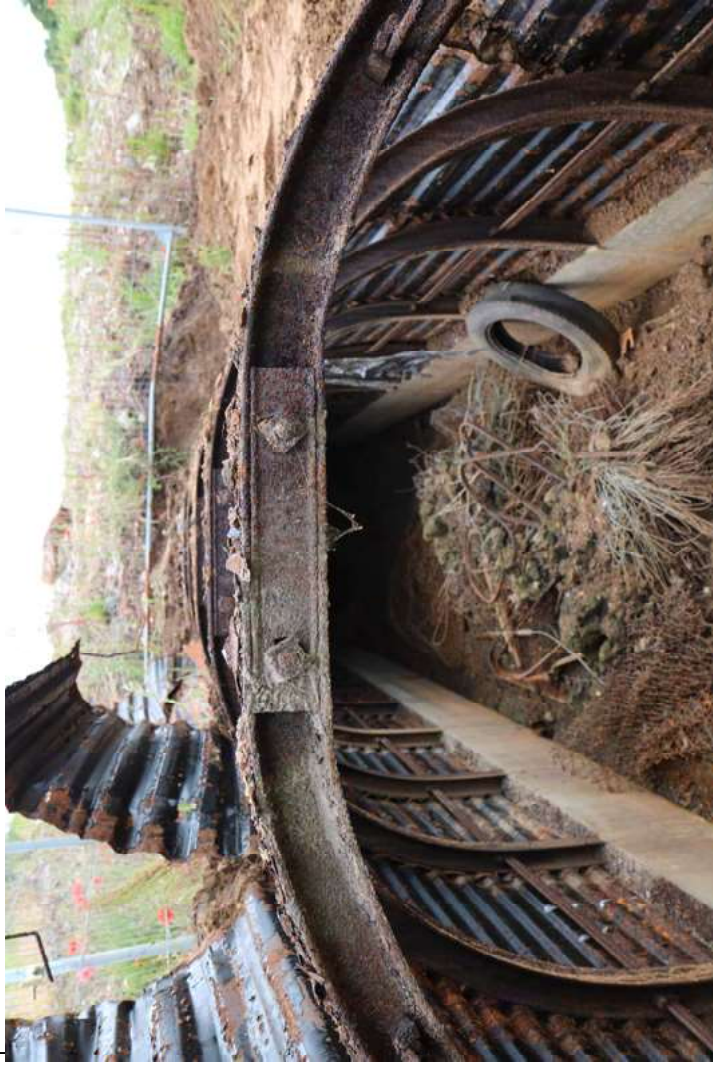
2024.05c_Photograph_006
Detail of fishplate and square-headed bolts in frame of shelter one. Photograph taken facing south-east.

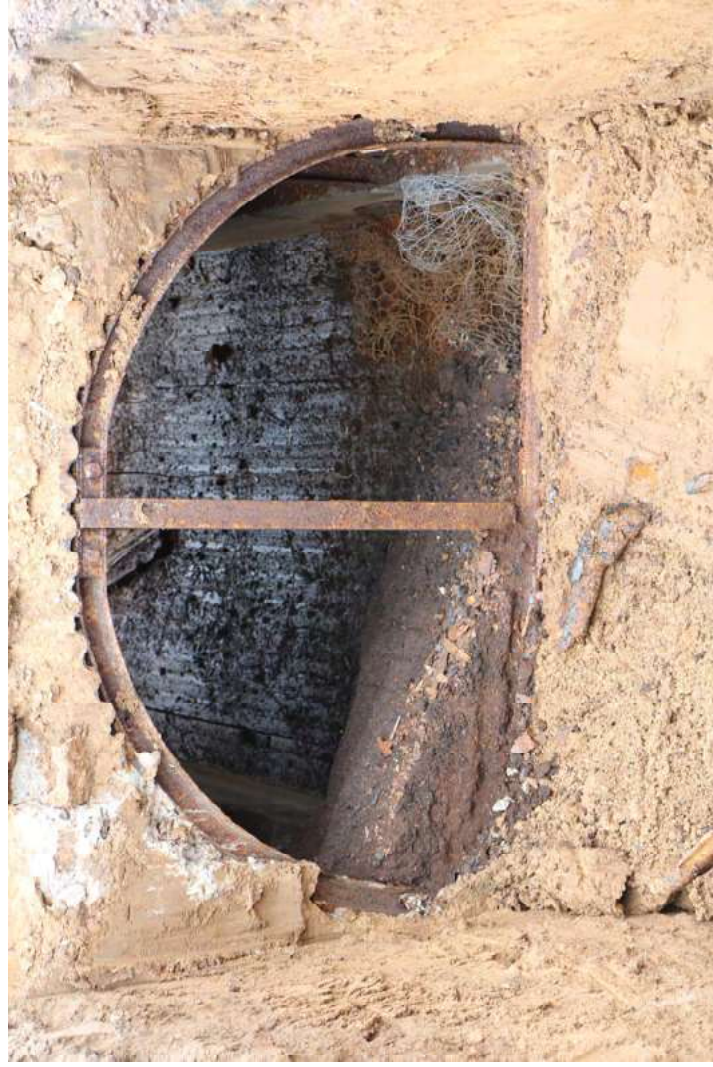
2024.05c_PhotoGraph_012
South-eastern of shelter one after removal of corrugated iron cladding. Photograph taken facing north-west.

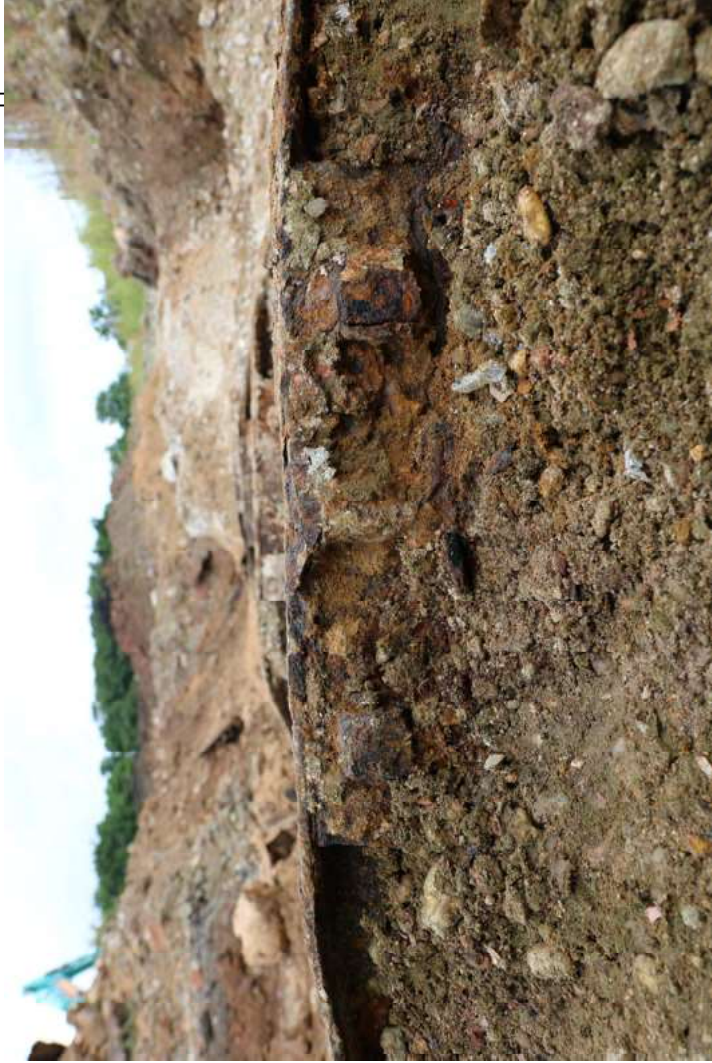
2024.05c_Photograph_037
Detail of removed cross-bar from shelter two south-eastern end. Photograph taken facing north-west.
