**Archaeological test-pit evaluation in the  
south wing of Darcy House, St Osyth Priory,  
St Osyth, Essex, CO16 8GW: January 2025**

**CAT project ref.: 2024/12b**  
**EHHER code: EEX60871**

**NGR: TM 12136 15722 (centre)**

**Scheduled Monument number: 1002193**

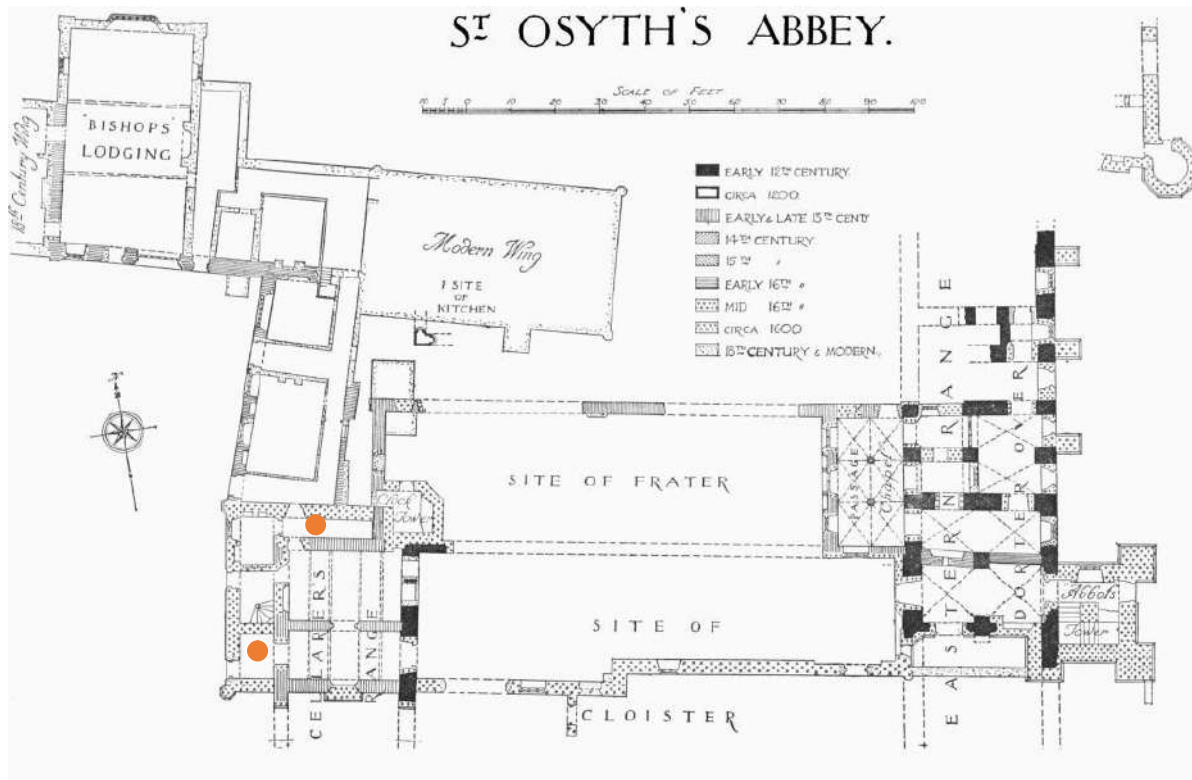
**Image 1** A plan of the historic phases of St Osyth's Priory with the location of the test-pits indicated by the orange circles. The plan shows that both test-pits are located outside of the 13th-century vaulted rooms and inside the rooms added in the mid-16th century. This plan was downloaded from British History Online.

Archaeological evaluation inside the south wing of Darcy House, St Osyth Priory, Essex, consisted of two test-pits (TPs) located within a part of wing that was built in the mid-16th century (see Image 1) but adjacent to 13th-century vaulted rooms. The excavation of both test-pits revealed modern and post-medieval contexts.

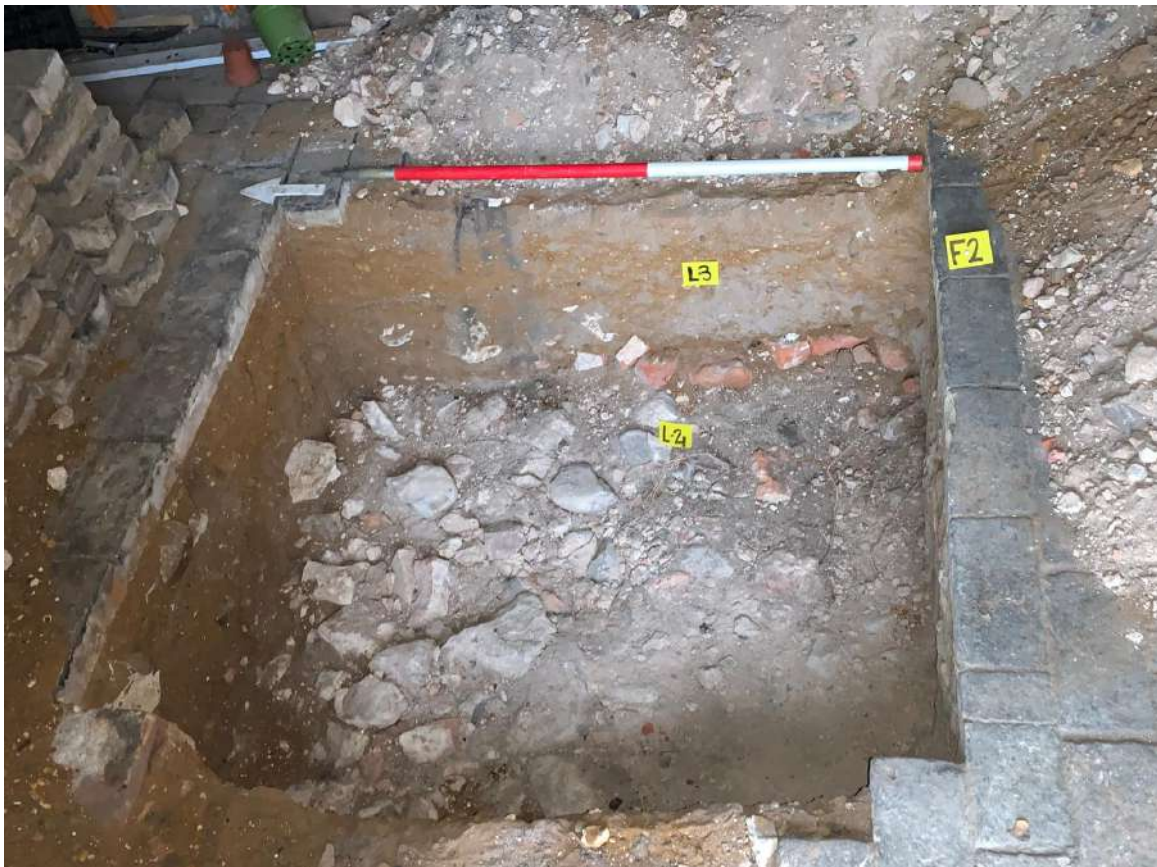
TP1 was excavated to an initial depth of 0.47-0.5m through brick floor F2 (0.07m thick) and sub-base L3 (0.24-0.36m thick) onto the top of demolition deposit L4. Subsequently, a 0.25m<sup>2</sup> slot was

excavated through L4 in the north-west corner of the test-pit. The base of this slot reached c 0.75m below current ground level (bcgl). Demolition deposit L4 (0.32-0.35m thick) sealed silty sand layer L5 (recorded at a depth of c 0.75m bcgl) which was identified at the base of the slot but not excavated. Visual inspection of the top of L5 revealed numerous coal fragments. Floor F2 comprised unfrogged 19th-century bricks laid, un-mortared, in a stretcher bond pattern. This floor probably dates to c 1900 when the building was refurbished. At some point the brick surface had been painted black.

**Photograph 1** Test-pit 1, showing F2, L3 and L4, looking east.

Brick floor F1 and sub-base L3 in TP1 are probably associated with the refurbishment of the building in c 1900 for Sir John Johnson (Smith 2011, 23). Demolition deposit L4 could be associated with the

dereliction of the building in the 19th century, as seen in contemporary images (Smith 2011, 22). Therefore, evidence from TP1 demonstrates that the proposed new flooring (requiring excavation of c 0.425m) will only impact 19th-century layers, which were recorded to a depth of 0.75m below current ground level.

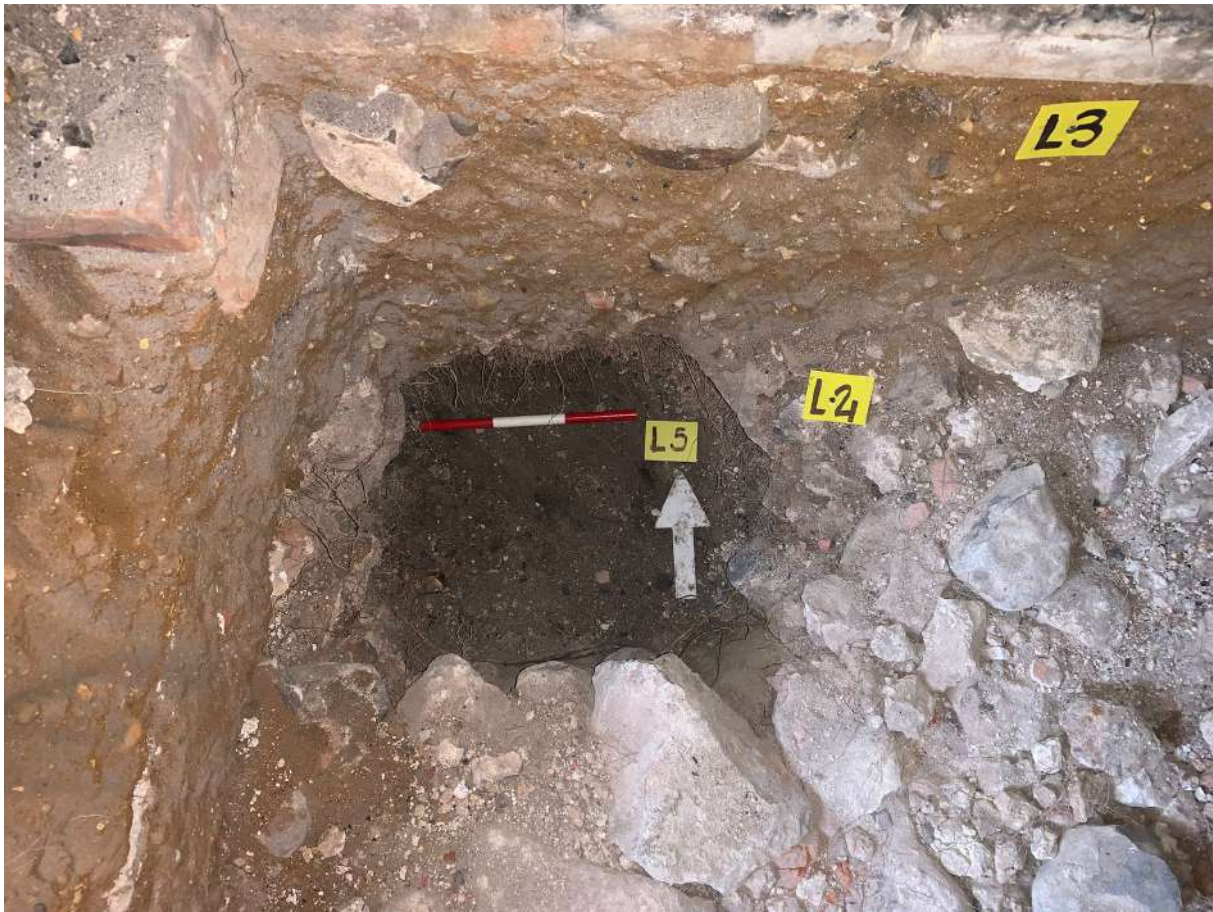
**Photograph 2** Test-pit 1, showing the slot through L4 and L5 beneath, looking north.

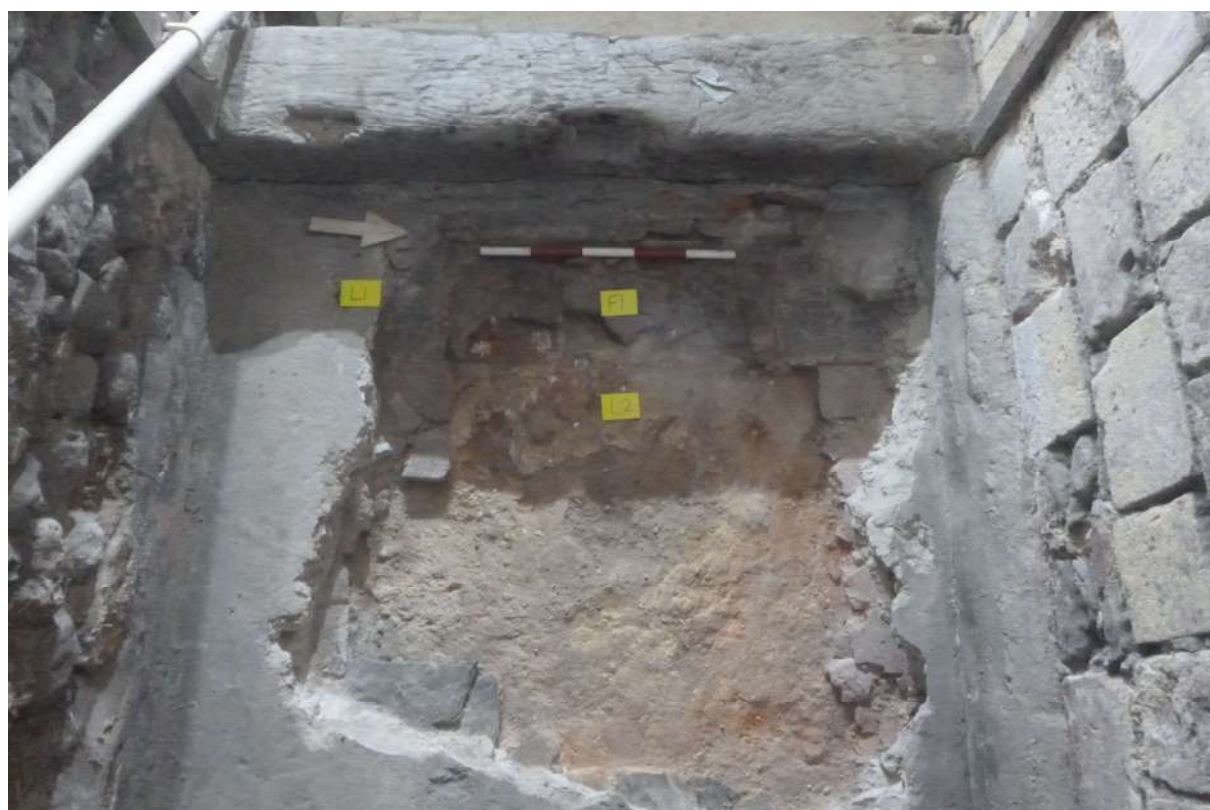
TP2, which was flanked on its west side by an oak doorstep, was initially excavated to a depth of c 0.25m cutting through concrete floor L1 (0.1-0.2m thick), tiled floor F1 (0.03m thick) and sub-base L2 beneath (c 0.12m thick). Excavation continued to a depth of c 0.7m bcgl in a 0.5m by 1m slot in the north half of the test-pit. Sub-base L2 sealed a layer of silty sand (L6, at least 0.55m thick as the base was not reached) which contained post-medieval CBM fragments and animal bone.

**Photograph 3** Test-pit 2, showing L1, F1 and L2, looking west.

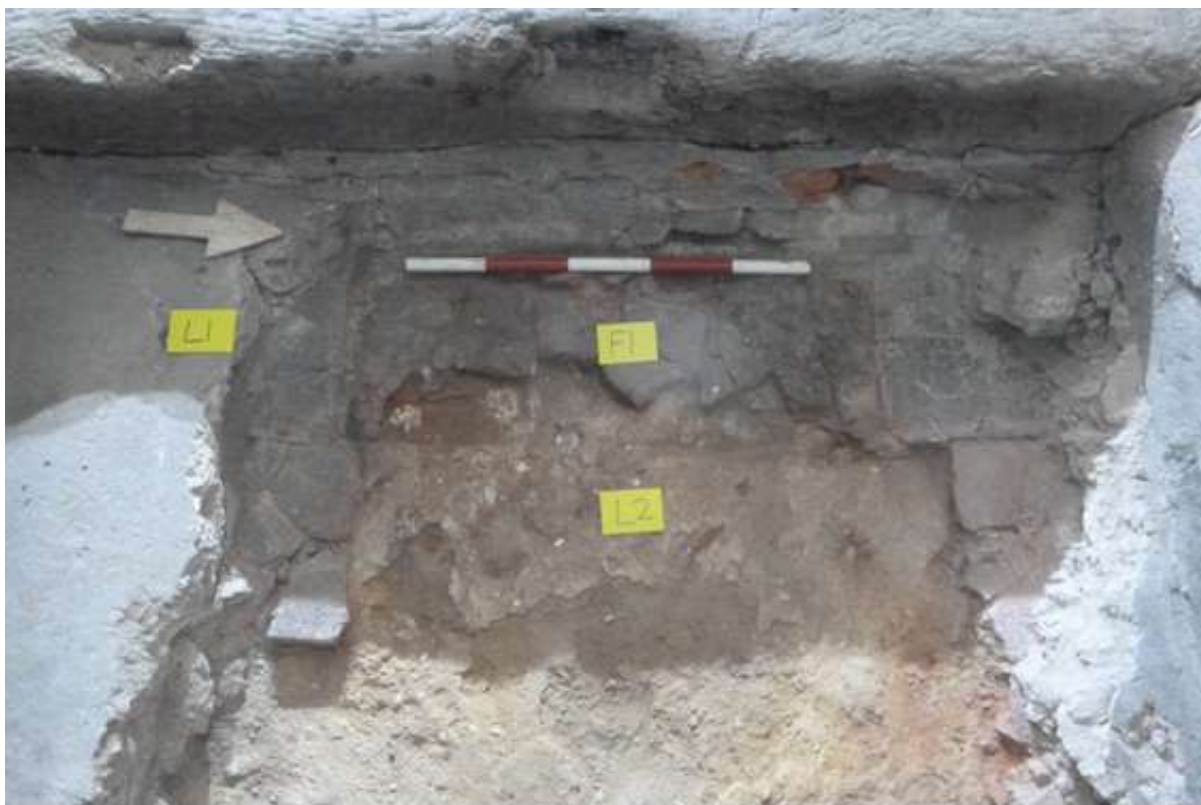
Tiled floor F1 was made of post-medieval floor tiles decorated with a dark green glaze, and probably also dates to c 1900 when the building was refurbished. Unfortunately, the floor was severely damaged when L1 was removed as part of this project. This is because the concrete had been laid directly on top of the tiles and as it was broken up the tiles fractured, meaning that none were recovered complete enough to allow dimensions to be recorded.

**Photograph 4** Test-pit 2, close-up of tiled floor F1, looking west.

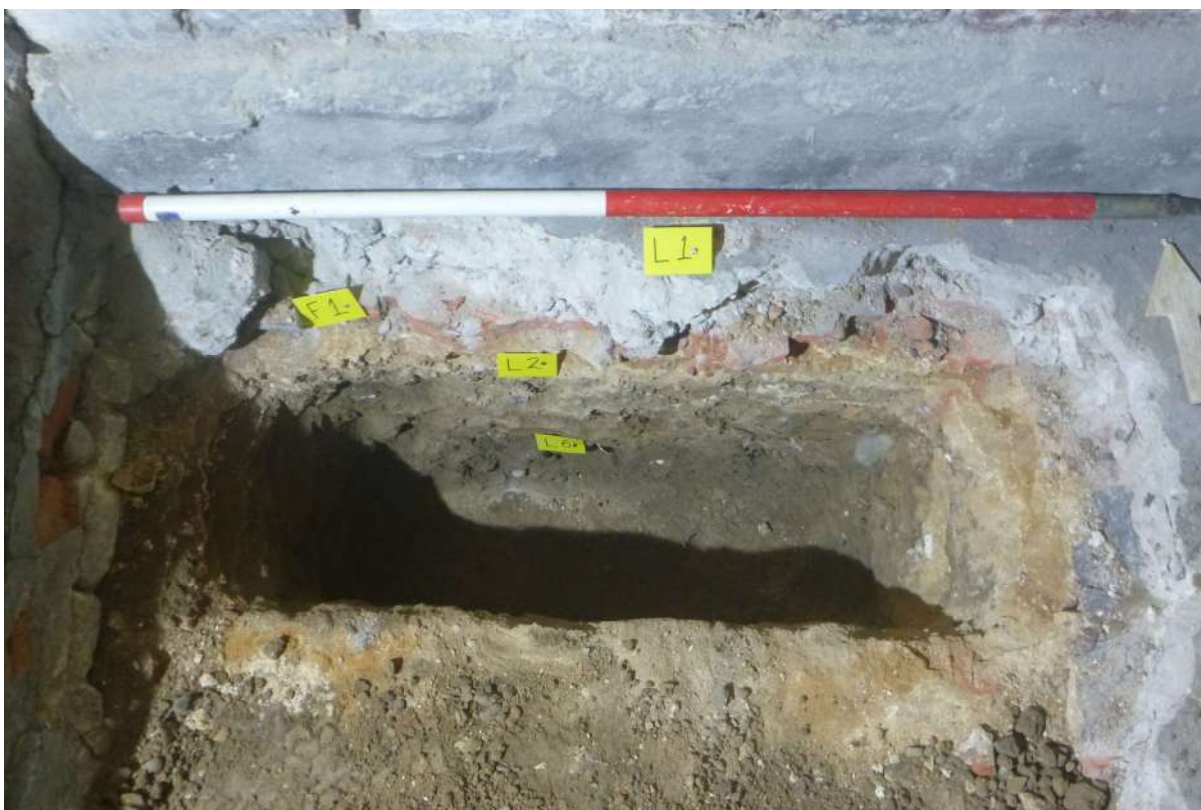
**Photograph 5** Test-pit 2 slot, showing accumulation deposit L6, looking north.

In TP2, post-medieval tiled floor F1 and sub-base L2 probably belong to the c 1900 refurbishment of Darcy House with L6 below producing bricks of a post-medieval date. Layer L6 could also be associated with the dereliction of the building in the 19th century (Smith 2011, 22) but produced less demolition material than L4 in TP1. Therefore, evidence from TP2, shows that the proposed new flooring (requiring excavation of c 0.395m) will remove the 19th-century tiled floor F1 and its base, and cut into the post-medieval accumulated soil beneath.
