A report on test pits dug at the church of **St James the Great,** East Hill, Colchester, Essex

March 2000

CAT REPORT 72

report by Howard Brooks

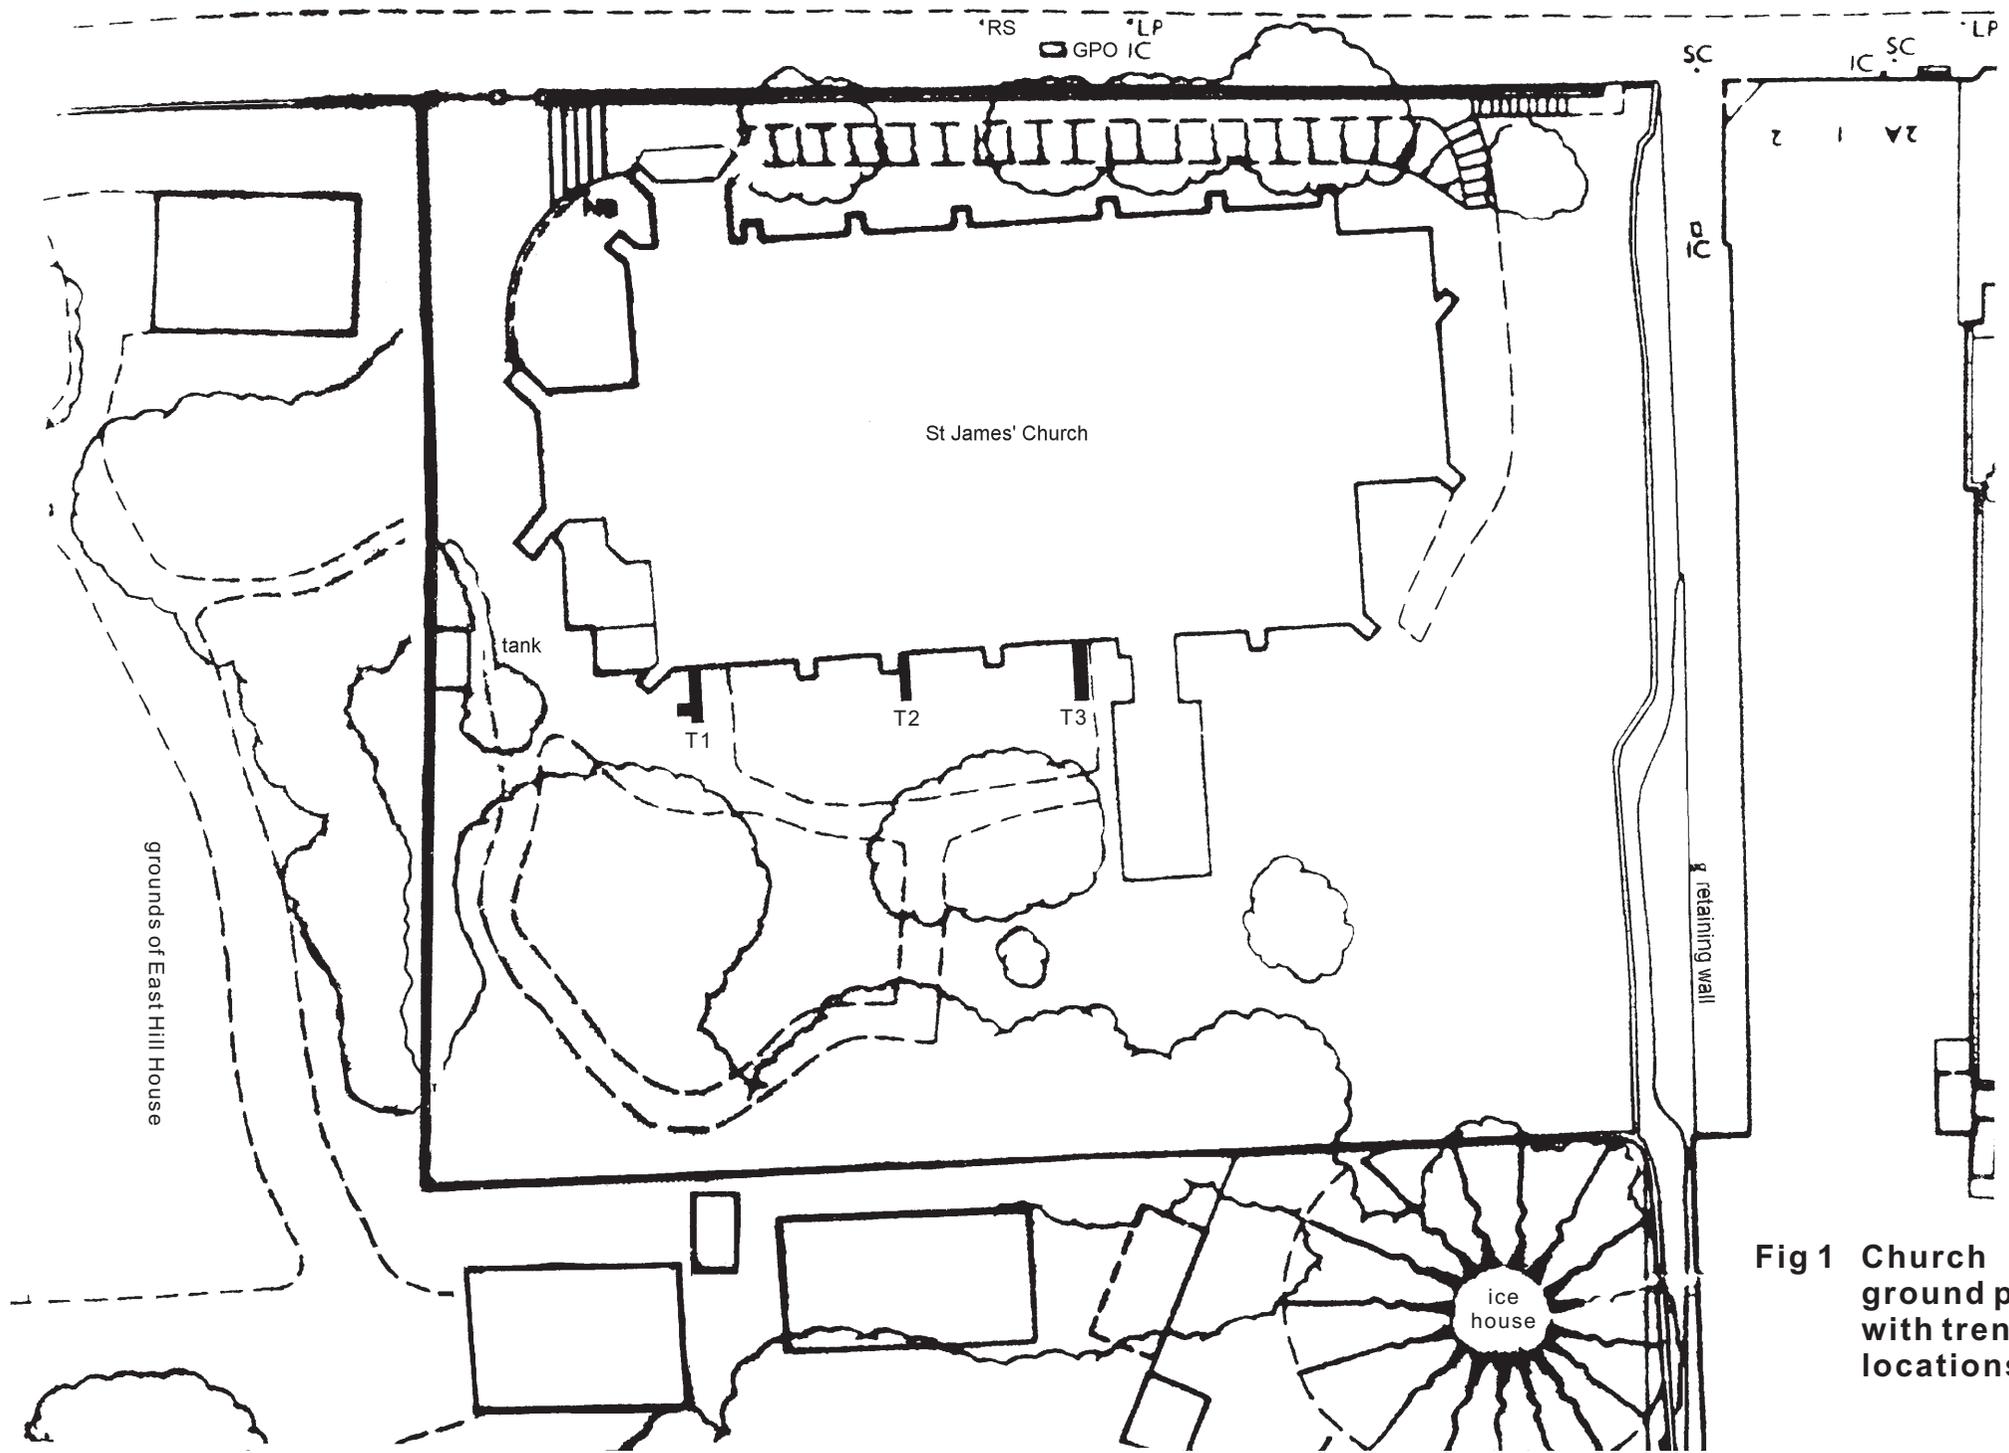
Fig 1 Church ground plan with trench locations.

This 2.3 x 0.46m trench (Trench 1 or T1) was hand-dug in the location shown on Figure 1, immediately west of the south door. The width was determined by the width of a stone slab (Layer 1 or L1) which was lifted to reveal a sealed topsoil layer, an older ground level (L2).

This trench was dug against the west edge of the pathway leading to the pebble-dashed church extension (Fig 1).
