Historic building recording and archaeological monitoring at Stamfords Farm, Braintree Green, Braintree, Essex

Planning Application no: 14/01339/FUL
CAT project ref: 15/04c
NGR: TL 73457 21963

CAT Report 1078
March 2017

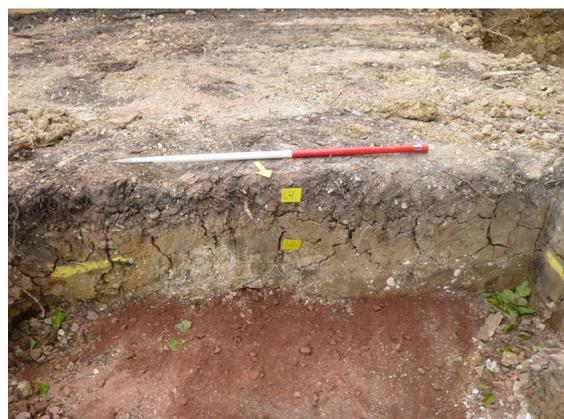
Photograph of foundation trench to east of barn after excavation. Shot taken facing south.

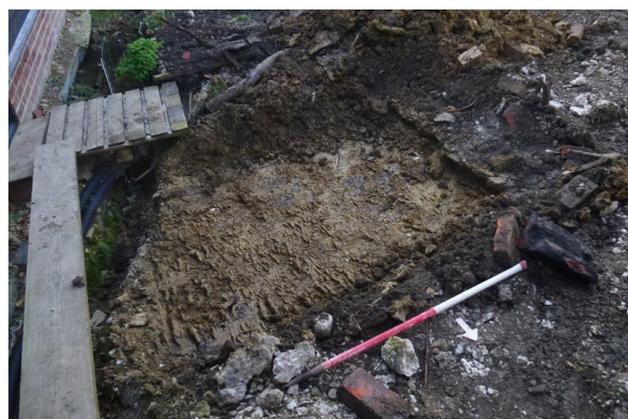
Photograph taken during ground reduction to west of barn, towards street. Shot taken facing south-west.

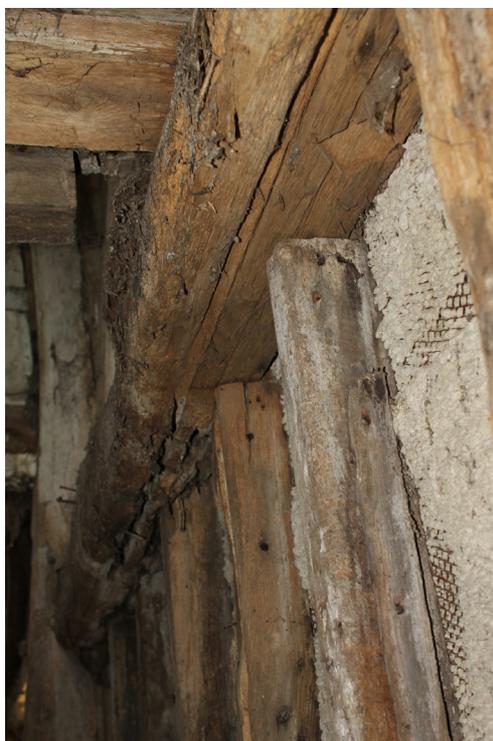
Photograph 7 Underside of girding beam on west side of bay one. Window mullions and shutter grooves visible. Photo taken facing south-west.

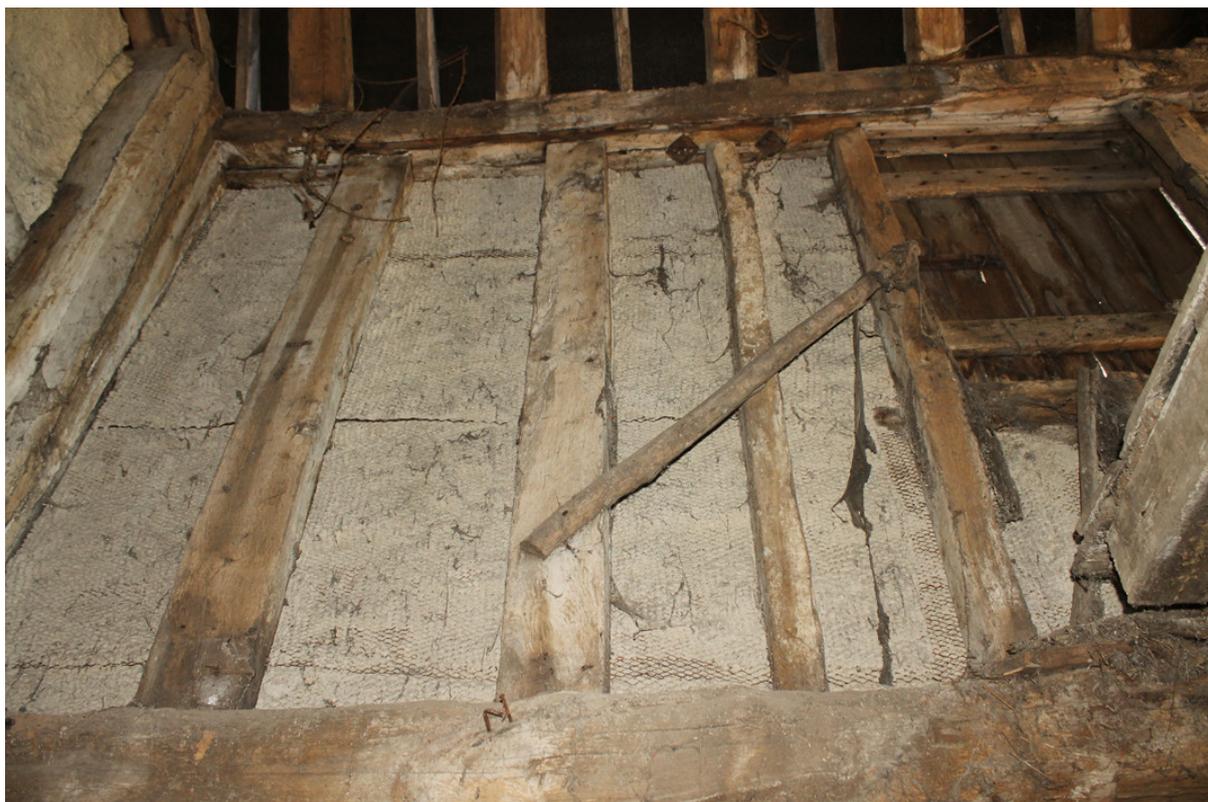
The west side of the bay (Fig 8) has a section of bracing on the upper register, which is single-pegged to the girding beam and corner post. A pitching door has been inserted through the first floor west wall. The girding beam and the wall-plate on the west elevation are re-used timbers, containing diamond shaped mullions and shutter grooves on their lower faces (Photographs 7 and 8). No corresponding mortices for the mullions or grooves are present on the opposing timbers. There is also a re-used timber being used as a stud on the lower register. The studs on the west side of the inserted pitching door and over half the remaining studs on the lower register are all hand-sawn, but not original to the building (Photograph 6).

Photograph 8 West side of bay one, upper register. Inserted pitching door to right of shot. Window mullions visible on wall plate. Photo taken facing west.

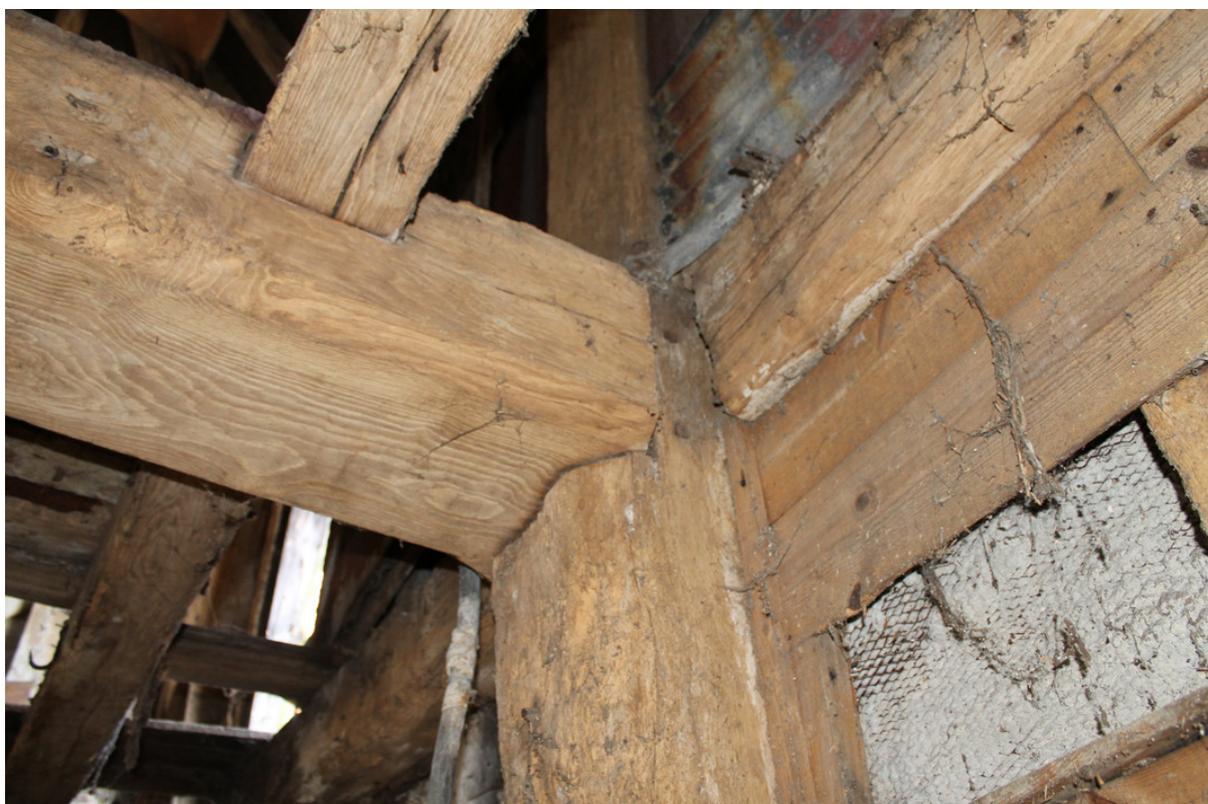
Photograph 9 North side of bay one, showing binding beam for first floor jointed to storey post. Photo taken facing north-west.

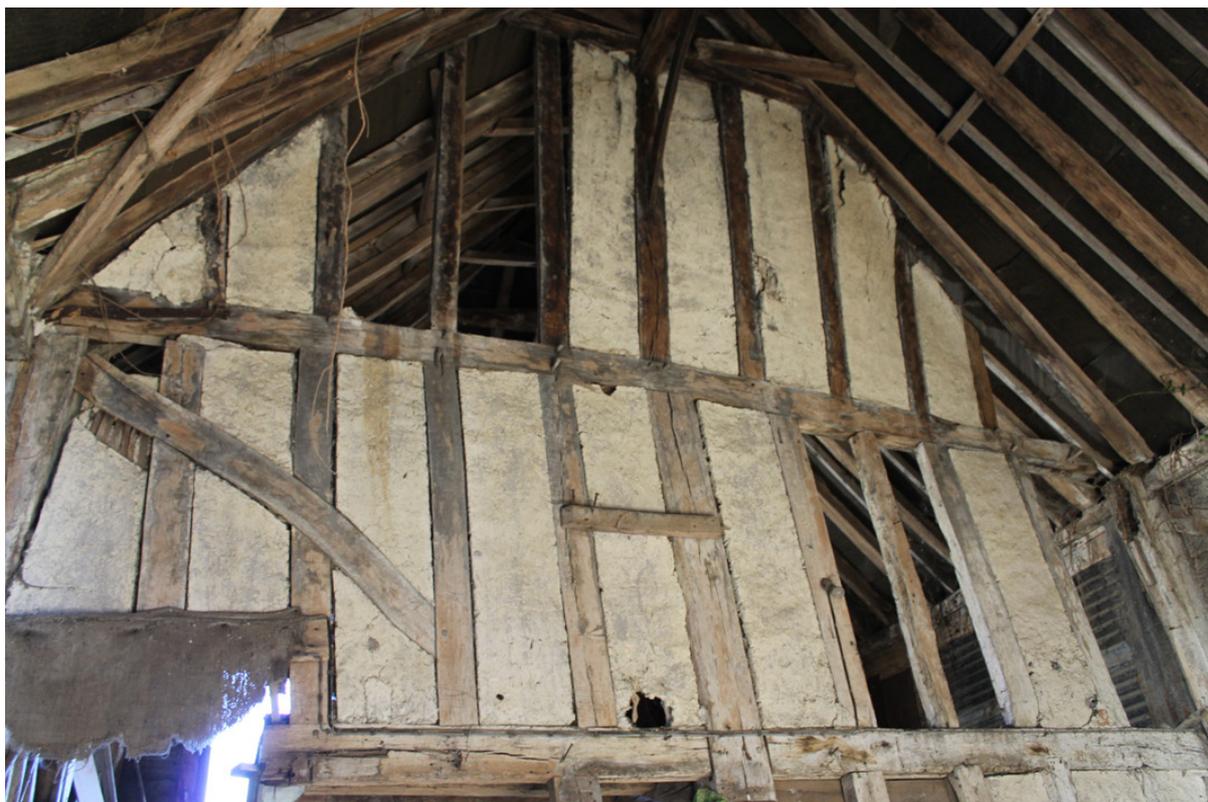
Photograph 10 North side of bay two, upper register. Showing wattle and daub infill between studs. Photo taken facing north.

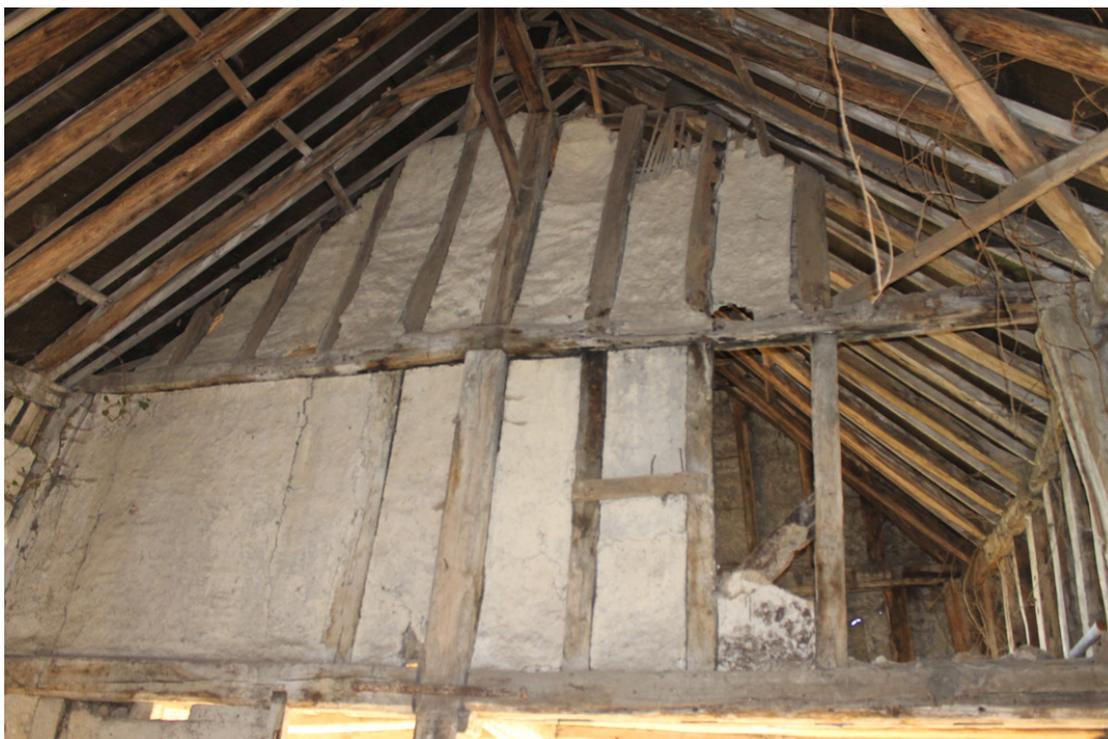
The south side of the bay (the south wall of the barn, Fig 10) has an entirely intact upper register, apart from one missing stud to the east of the storey post. In contrast the lower register is partially covered by boards and almost entirely made up of later replacement studs that fit poorly into the existing mortices on the girding and sill beams (Photograph 16). Only one original stud remains on the lower register. The sill beam has a straight bridling scarf joint with squinted abutments to the east of the storey post (Photograph 17).

Photograph 14 South side of bay two, upper register. Photo taken facing south.

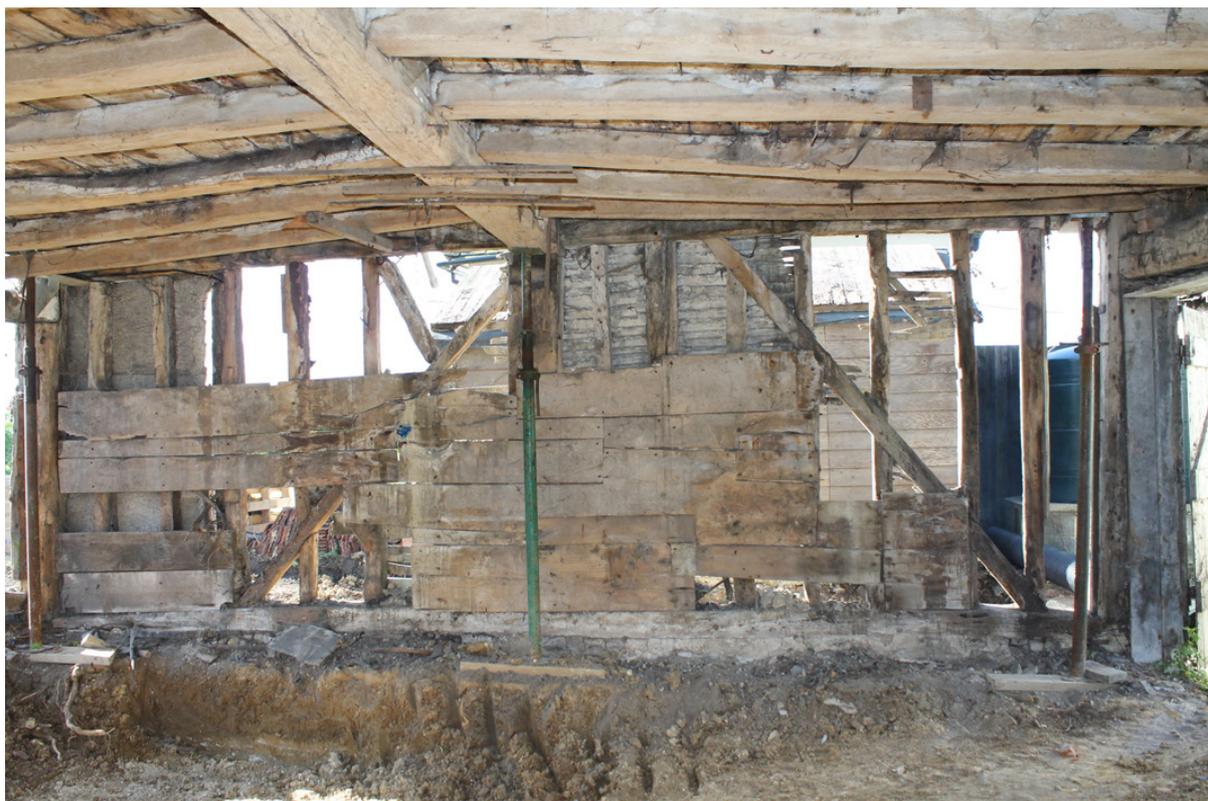
Photograph 16 South side of bay three, lower register. Photo taken facing south.

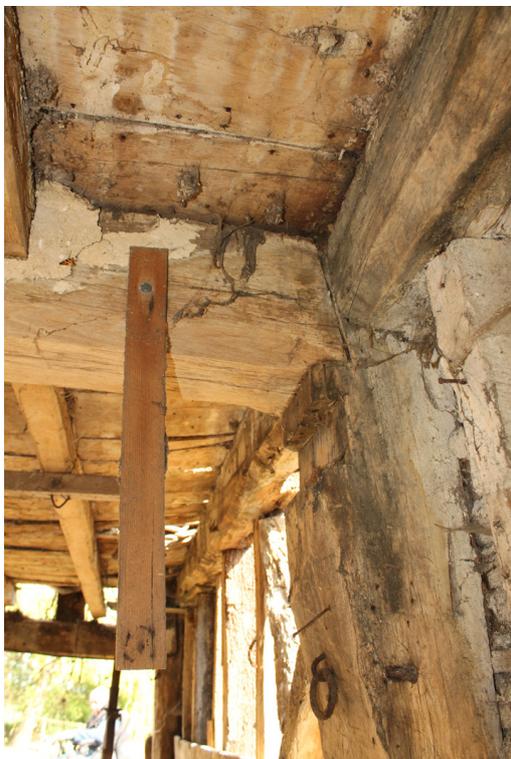
Photograph 19 South side of bay three, showing binding beam of first floor jointed to storey post. Photo taken facing east.

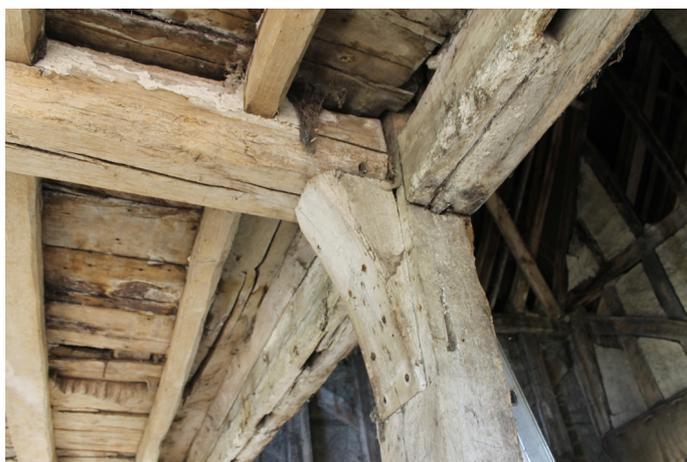
Photograph 20 North side of bay three, showing binding beam of first floor jointed to storey post and supported with a knee brace. Photo taken facing north-west.

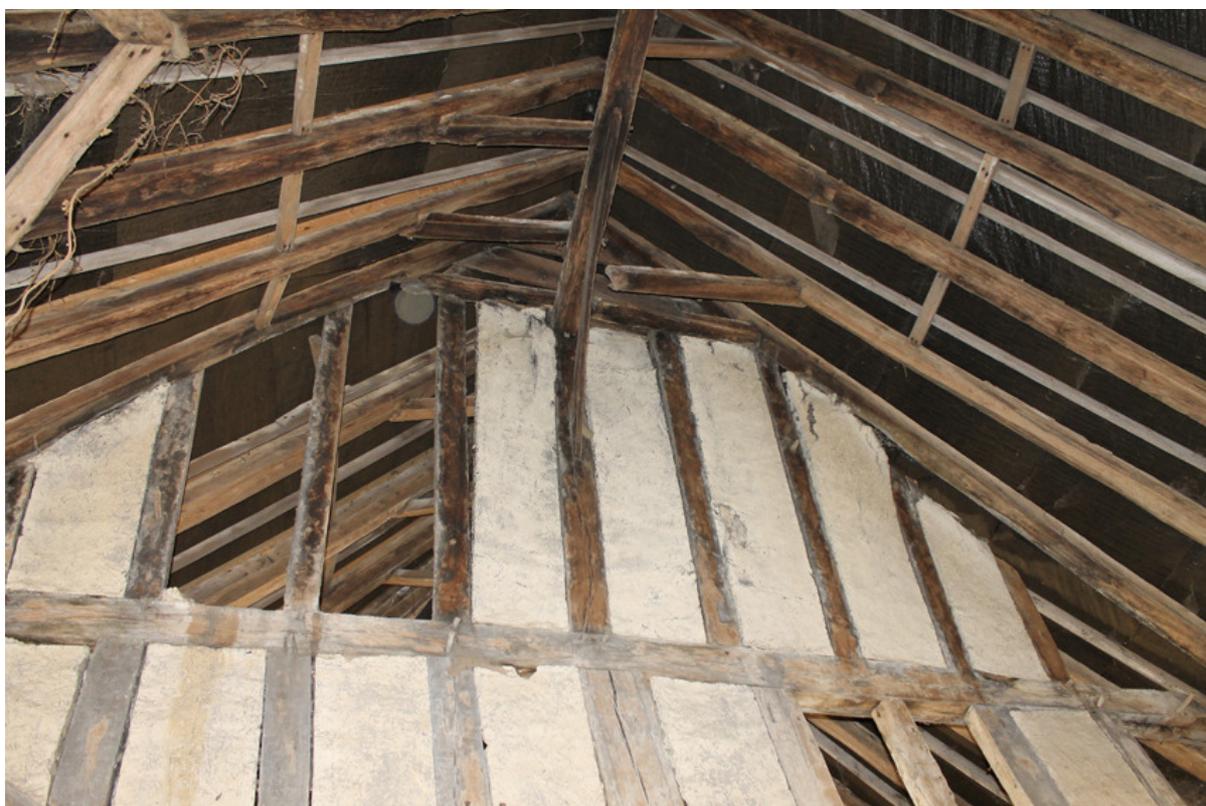
Photograph 24 Detail of crown-post roof truss and dividing wall with wattle-and-daub infill between bays one and two. Photo taken facing north.

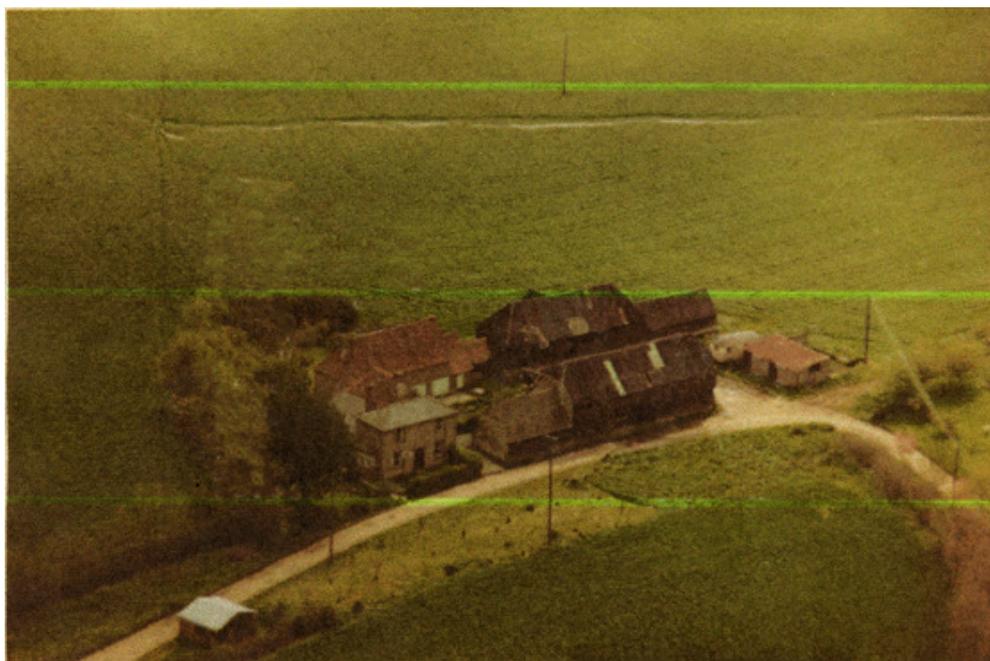
No foundations were observed that related to the demolished building on the street frontage (see historical background above). It is likely that the foundation for this building was only a plinth sitting on the natural clay (as is the case for the still standing barn) and it was totally removed when it was demolished.

Photograph 25 Aerial photograph of site showing buildings on street frontage that have since been demolished. Photo taken facing south-east. Photo acquired from client.

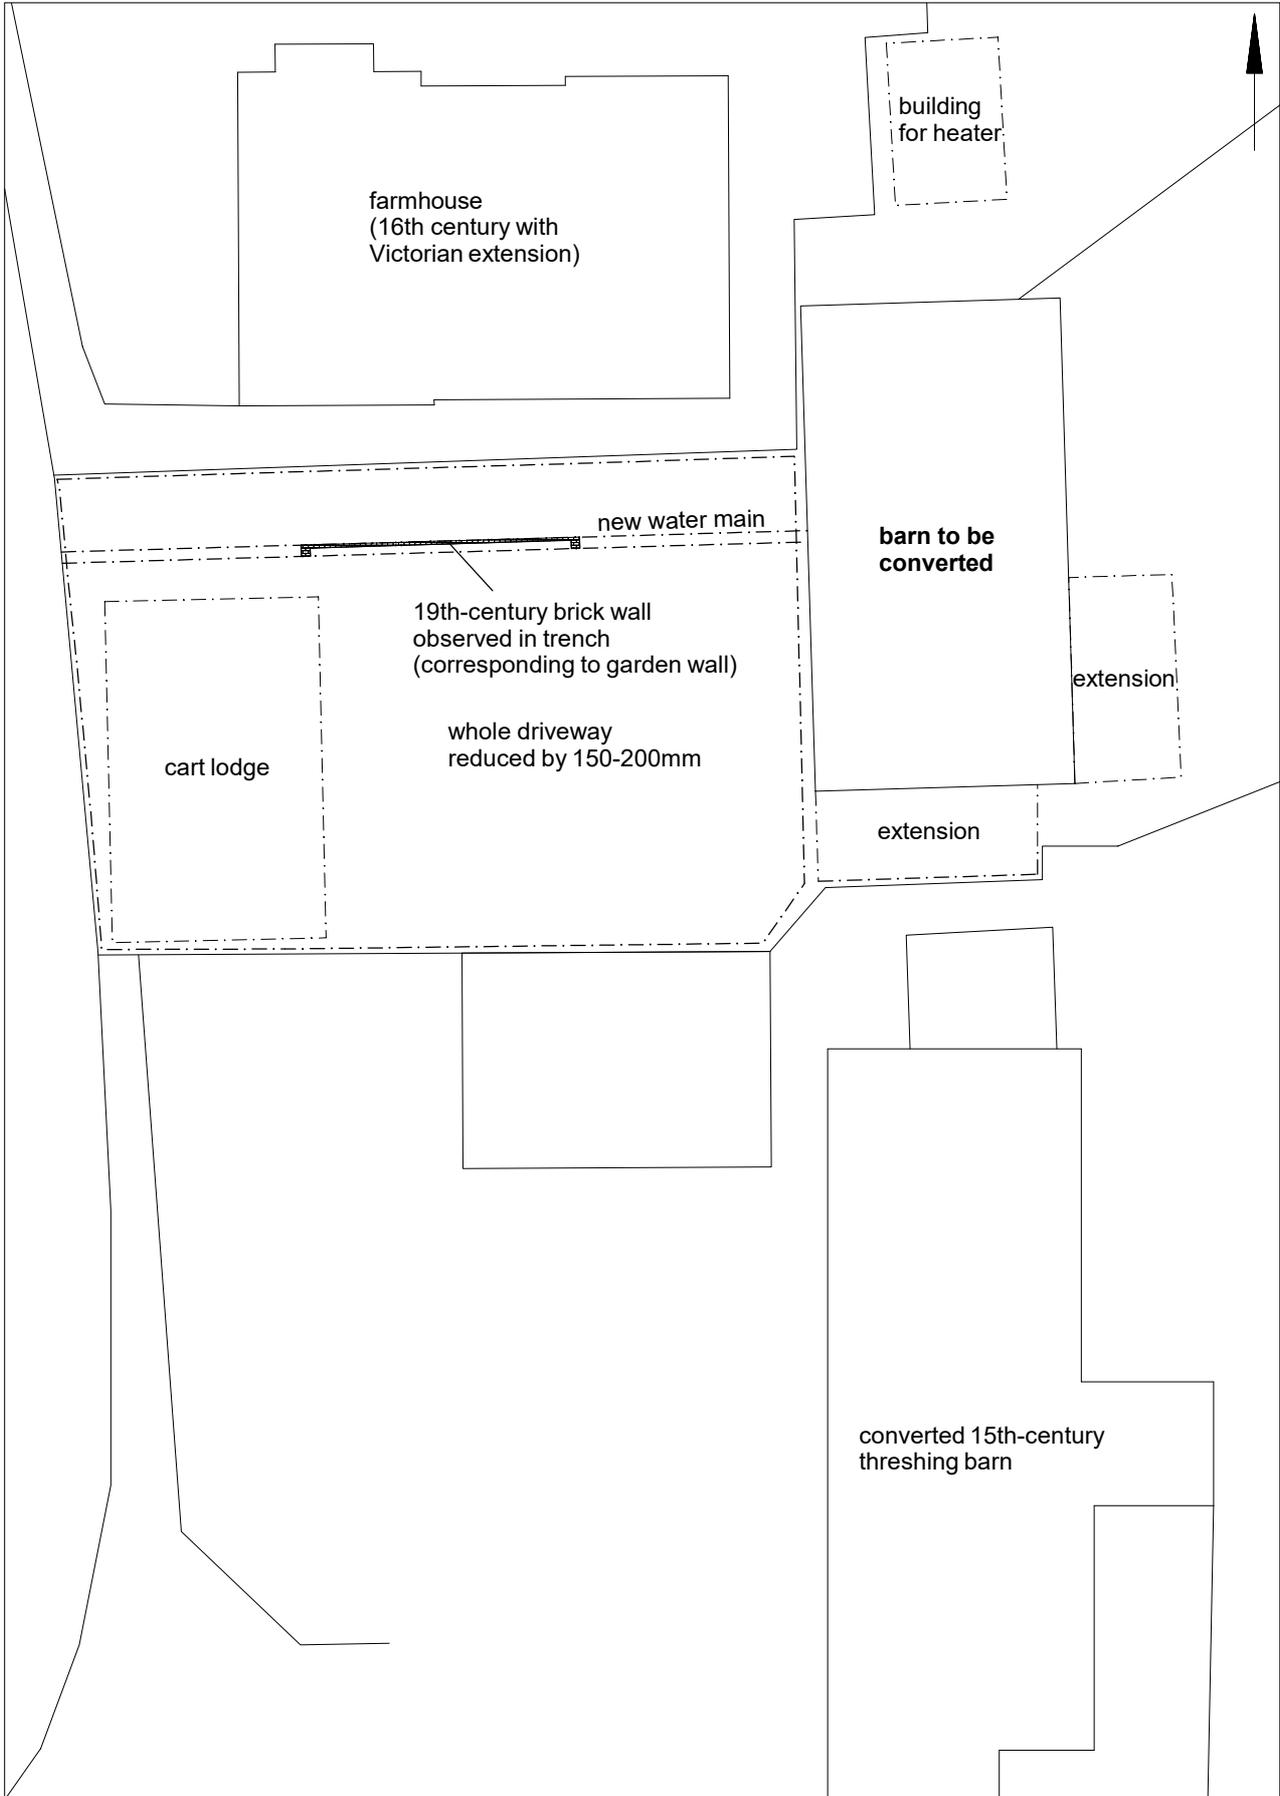
Fig 2 Monitoring results.

The only feature observed was a shallow modern foundation of frogged red brick in the service trench for the new water main (Fig 2), which corresponds to a garden wall visible in a black and white photograph provided by the client (Photograph 26).

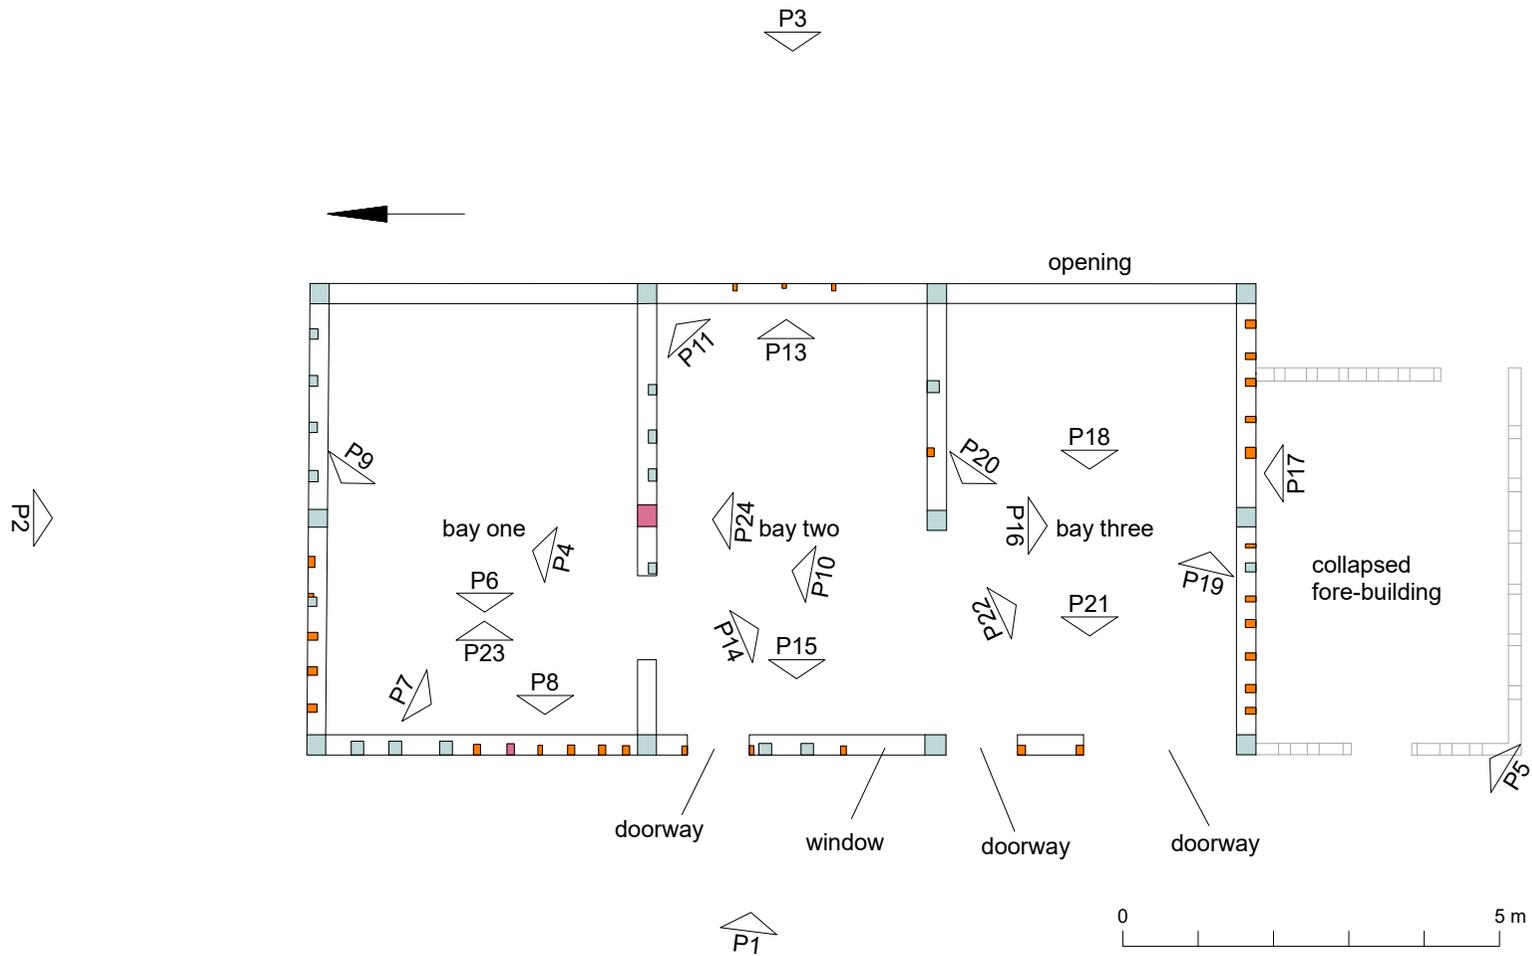
Fig 3 Plan of Stamford's Barn, showing phases and alterations. The location and orientation of photographs included in this report are indicated by the numbered arrows.

Stamford Barn is a rectangular timber-framed building, 12.5m long x 6.2m wide, aligned north to south. The barn sits upon a heavily repaired plinth, with red brick, modern frogged brick and concrete all being part of its make-up (Figs 3-6). Where sections of the original plinth are visible, it is made of of

The barn is constructed from large-section hand-sawn oak timbers and is divided into 3 bays (Fig 3) which have been labelled sequentially from north to south for the purposes of description. The bays all vary slightly in size, with the centre bay (bay two), being the smallest. The sill beams are all original to the building, while the girding beams, wall-plates and storey posts are a mixture of original and re-used timbers. Several of the storey posts and girding beams have natural bends, particularly the girding beam on the west wall of bay one (Photograph 6).

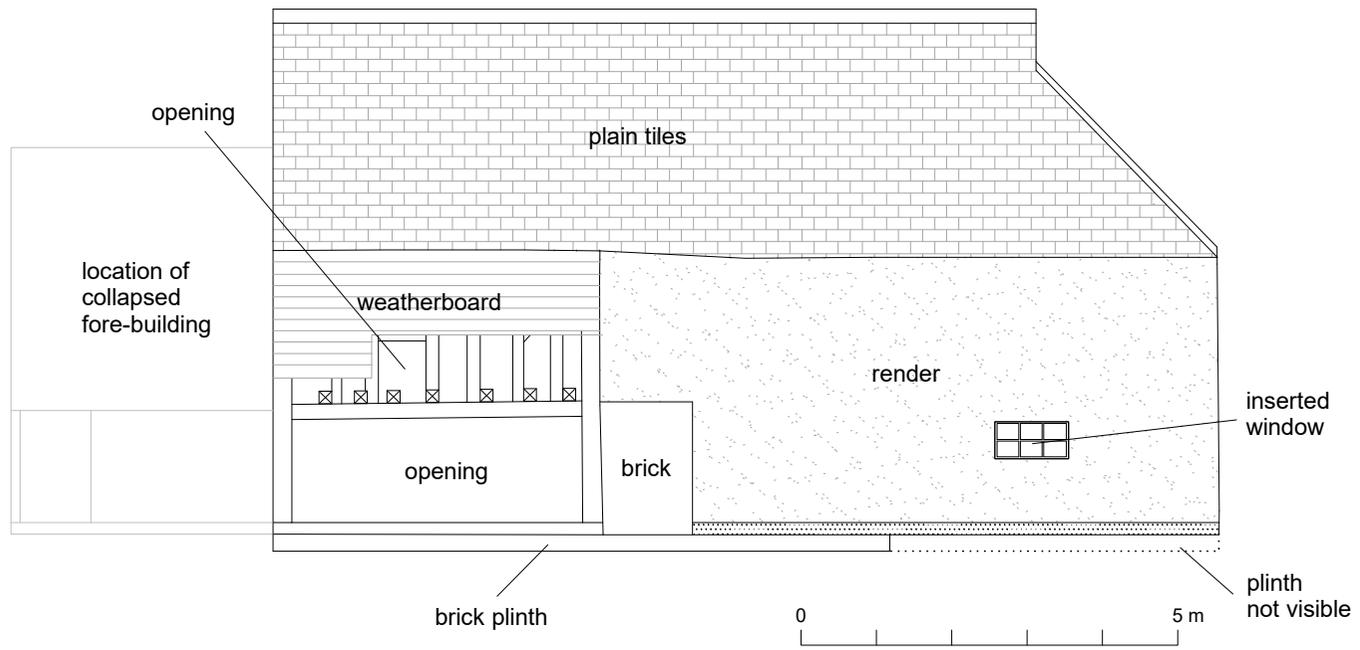
Fig 4 East elevation of the barn.

The north elevation is unremarkable apart from a large inserted pitching door on the first floor (Fig 6). The east elevation is overgrown with ivy but the exterior is rendered as the others. Visible on this elevation is an inserted window on the ground floor of bay one and a large amount of repair to bay two, mostly in brick (Fig 4). Also on this elevation there is a large opening on the ground floor of bay three, the studs between the sill beam and the girding beam having been recently removed to facilitate the access of a small mechanical excavator.

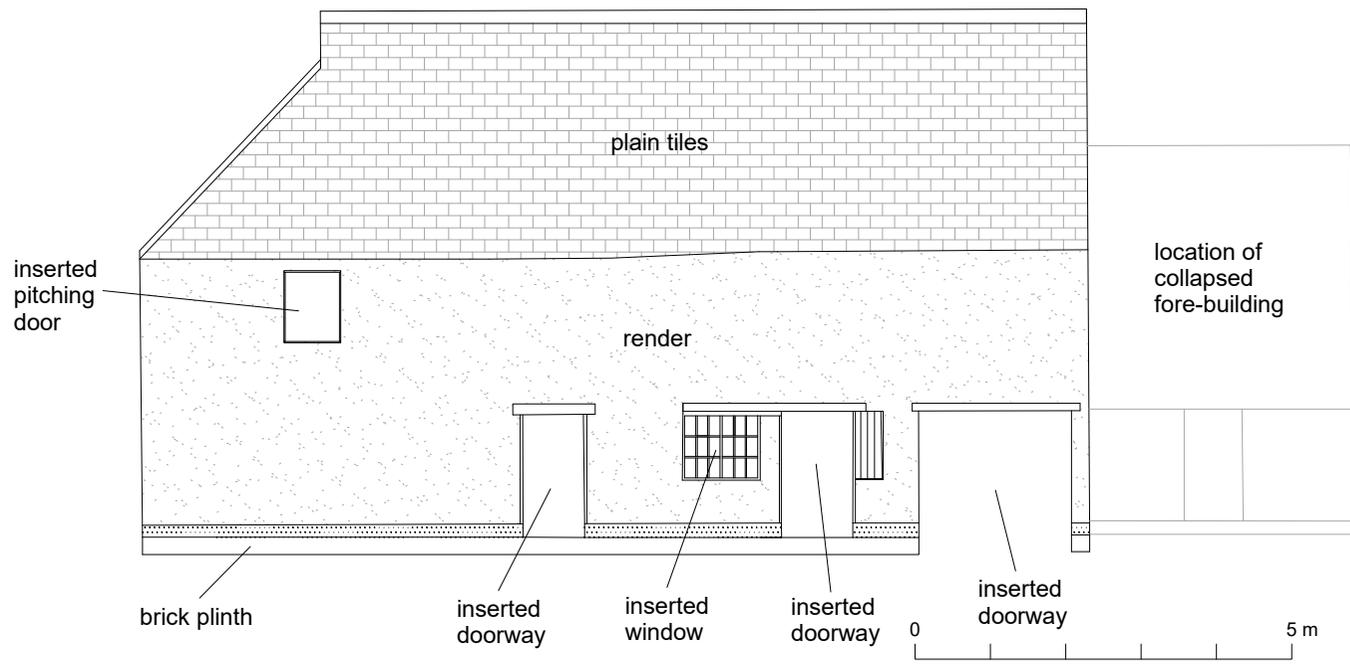
Fig 5 West elevation of the barn.

The west elevation (Fig 5) has three ground-floor entrances, two single doorways and one larger double door. It also has a ground-floor window in bay two and a pitching door on the first floor in bay one. These are all later insertions.

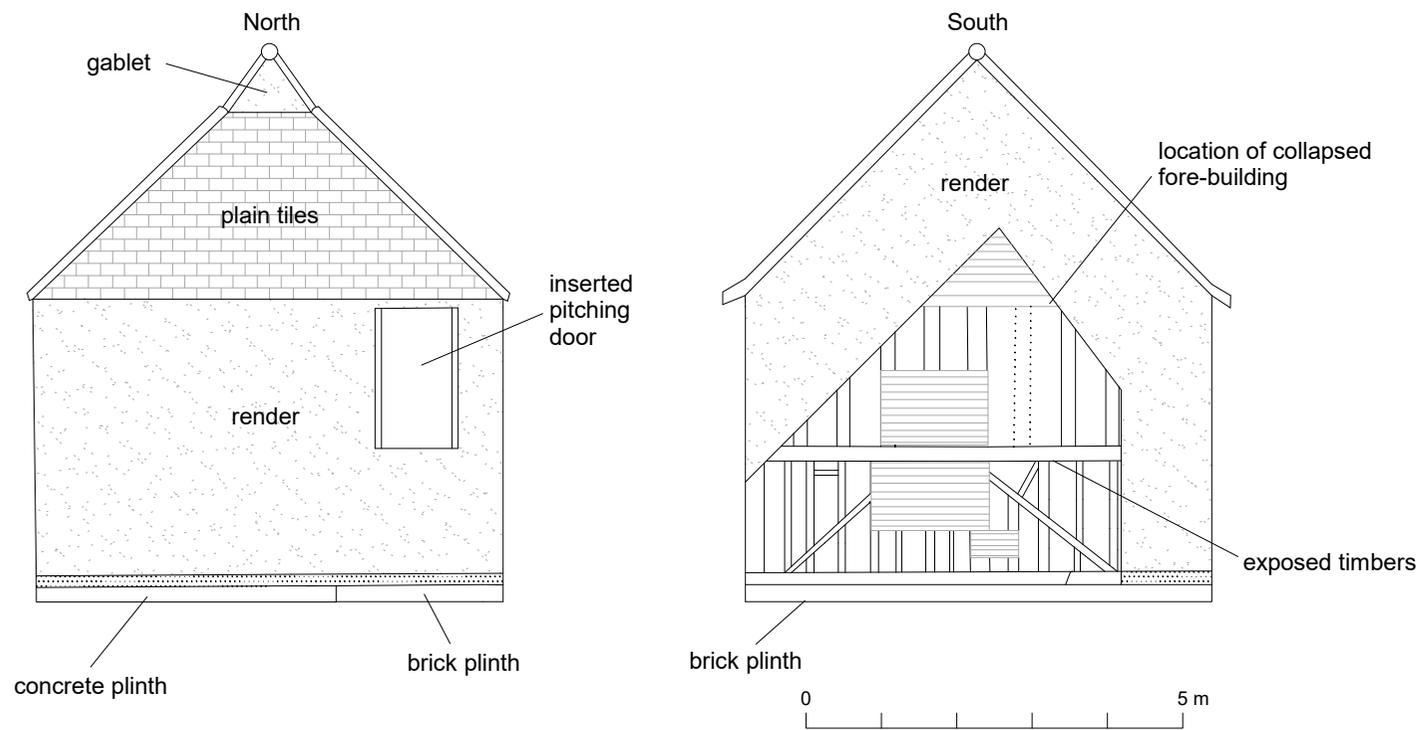
Fig 6 North and south elevations of the barn.

The south elevation has had large portions of the modern render and weatherboarding removed, corresponding to the location of the recently collapsed fore-building (Fig 6, Photograph 5). This has exposed the barn's timber-frame.

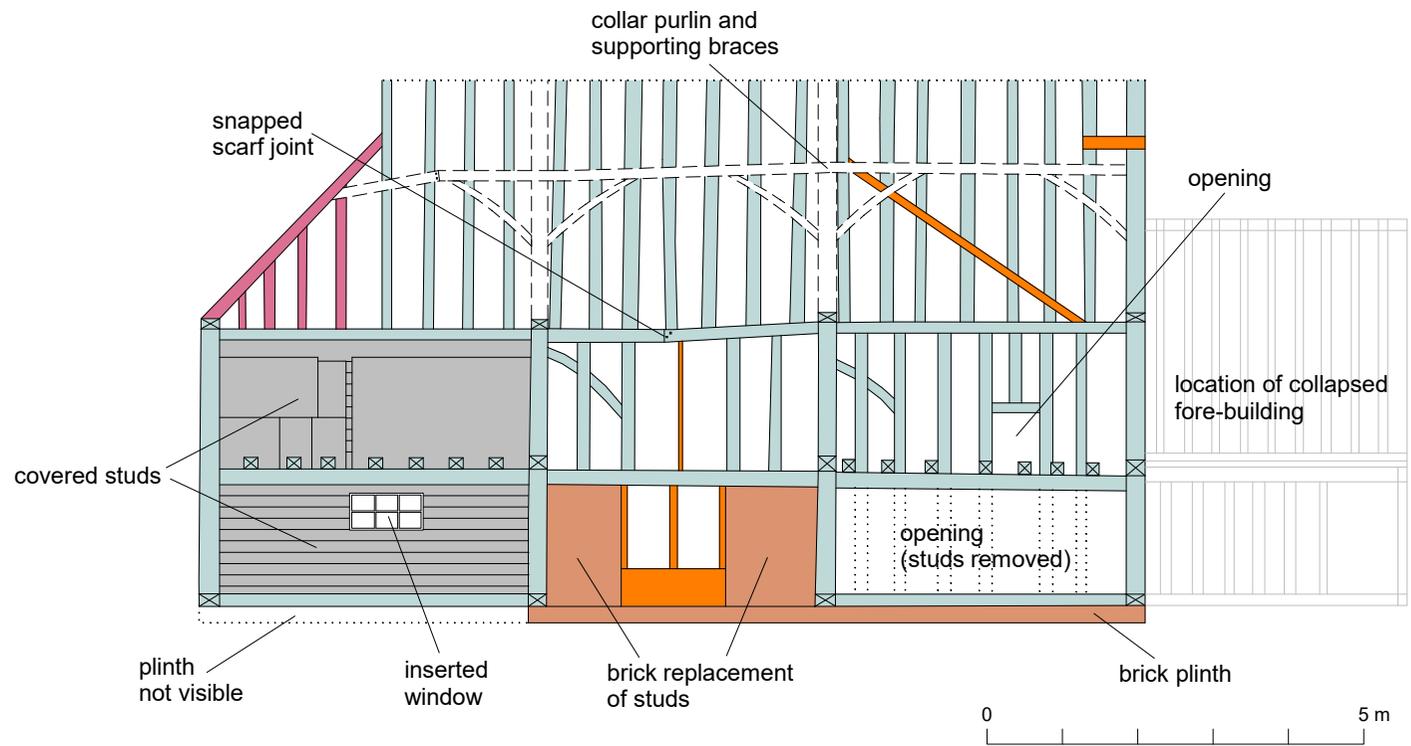
Fig 9 Frame drawing of the east wall of the barn, indicating the locations of original, re-used and replacement timbers.

On the east side of the bay (Fig 9), the entire lower register has been removed and replaced with brickwork and modern machine-cut timbers (Photograph 12). The modern brickwork is laid in a mixed bond with dimensions of 190 x 110 x 70mm. The upper register on the east side of the bay has a section of bracing which is single-pegged to the storey post and a stud. Another modern machine-cut timber has replaced the centre stud in the upper register. The wall-plate has a snapped face halved scarf joint in the centre of the bay (Photograph 13).

The roof is a variation on a crown-post roof with a collar purlin running its entire length (Figs 8 and 9). Instead of each pair of inclined common rafters being directly joined by a collar, most of the rafters are instead connected to the collar purlin by a short strut which is single pegged in place (Photograph 22). The roof is damaged and many of these short struts are missing or in a poor state of repair.

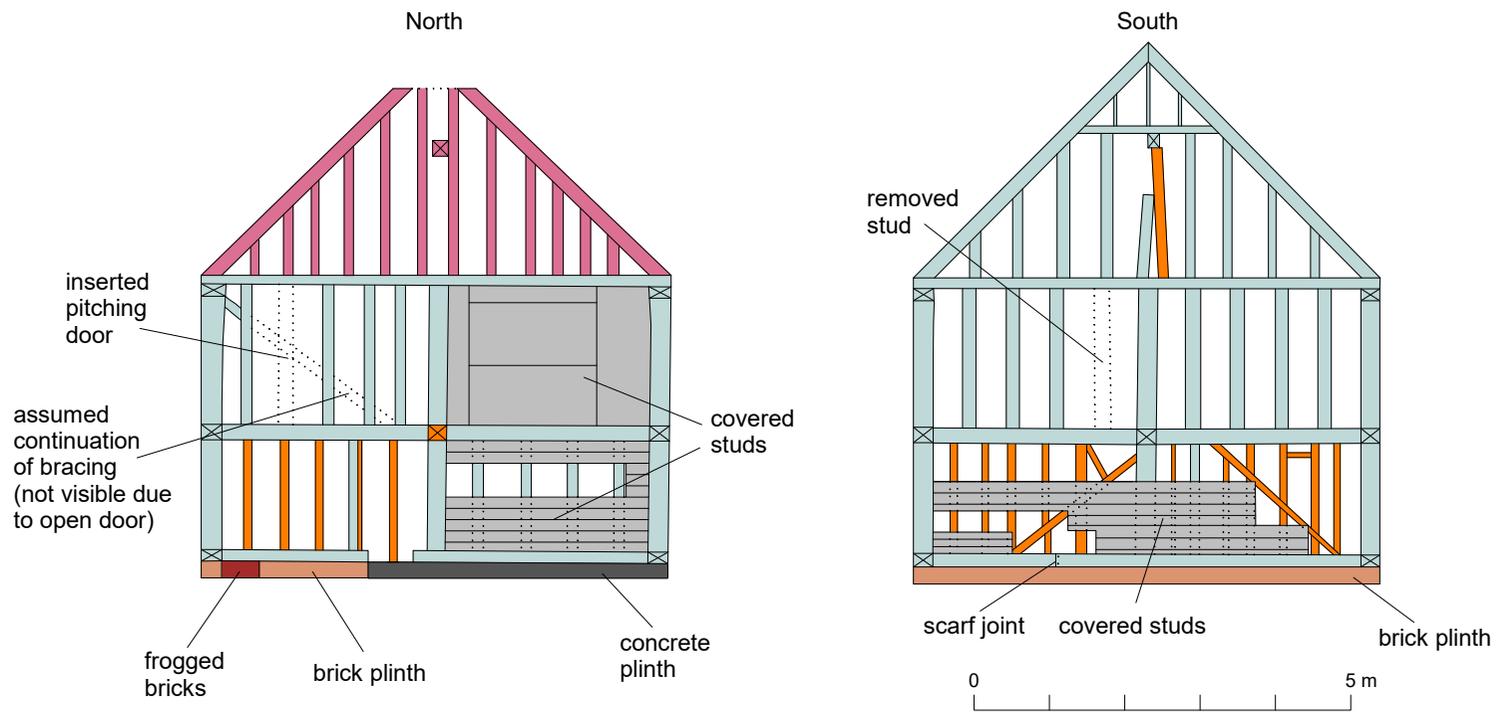
Fig 10 Frame drawing of the north and south walls of the barn, indicating the locations of original, re-used and replacement timbers.

The north side of the bay (the north wall of the barn, Fig 10) has an inserted pitching door on the first floor, removing part of a primary brace which is single pegged to the girding beam and corner post. The studs to the west of the centre post on the lower register are almost entirely later timbers, with only one original stud remaining. The sill beam has been cut (presumably for a doorway that has since been blocked up), but there appears to be one half of a scarf joint to the west of the storey post (Photograph 4). The frame to the east of the centre post is covered by boards and not visible (as is the whole east side of the bay – see below).
