**Historic building recording at  
Nagg's Farm, Old Road,  
Wickham St Paul, Braintree CO9 2PU**

**June 2017**

**CAT Report 1136**  
July 2017

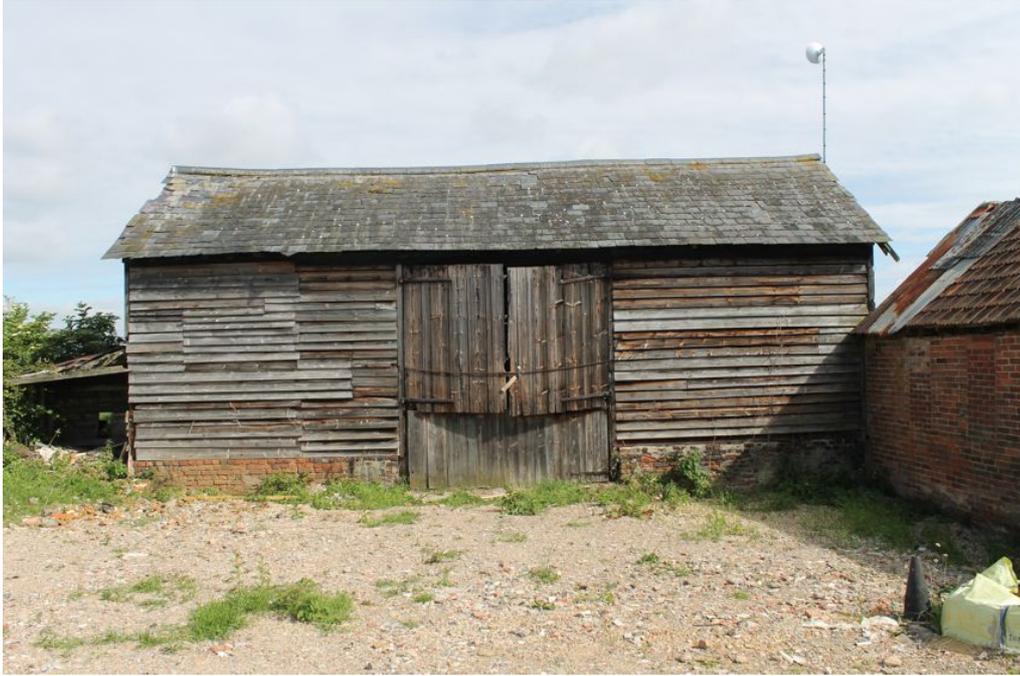
The south-eastern elevation of the building has a central vertical-planked threshold door, with a tall 'upper' door, and a shorter 'lower' door, both attached with metal hinges (Photograph 2). The north-east elevation of the midstrey has a vertical-planked door with a hole at its base to allow farm cats access (Photograph 1). The south-west elevation of the midstrey also has a vertical-planked door. The midstrey is considerably smaller than the main range of the barn, being only 3.3m high, compared to the barn at 5.1m. The gable-ends of the barn both have a vertical planked pitching door (Photograph 3).

**Photograph 2** South-east elevation of barn, showing threshold door. Photograph taken facing north-west.

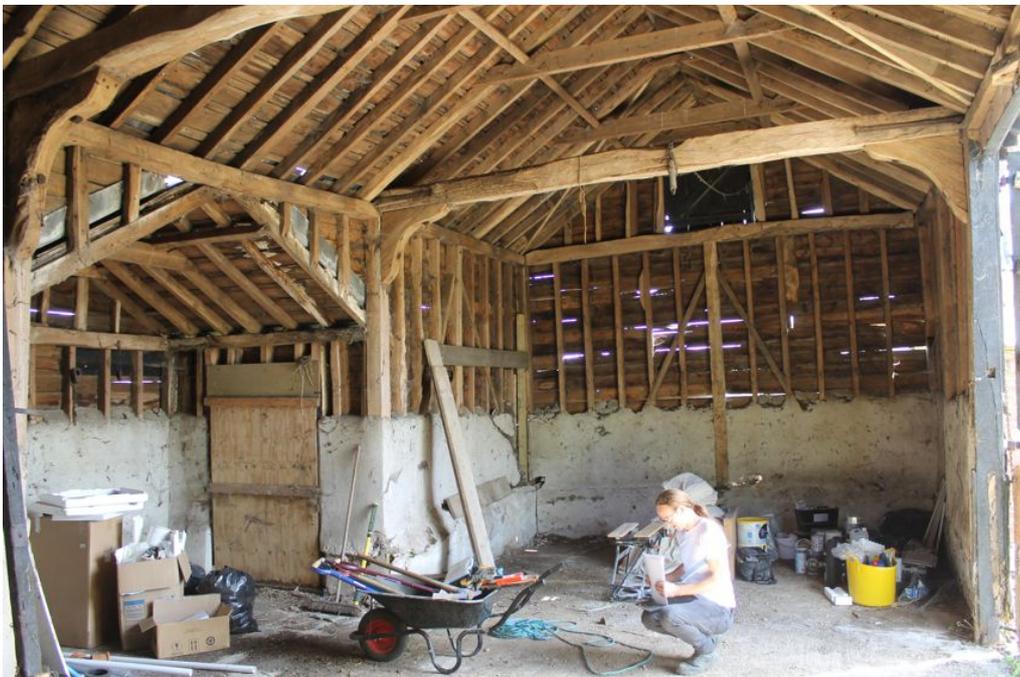
The timber-frame of the barn contains a mixture of machine-cut and hand-sawn timbers, and is supported by primary diagonal-bracing (Photograph 4). The roof is supported by wind-bracing above the threshold door and on the north-western pitch of bay 3. None of the hand-sawn timbers in the building have any evidence, such as unused mortices, of being re-used from an earlier structure. The entire lower quarter of the frame is covered with plaster, and as a result was not able to be examined during this investigation. The slate tiles on the roof are nailed directly to sarking boards, which in turn are nailed to the rafters (Photograph 5).

**Photograph 4** Interior of barn, showing timber-frame. Photograph taken facing north.

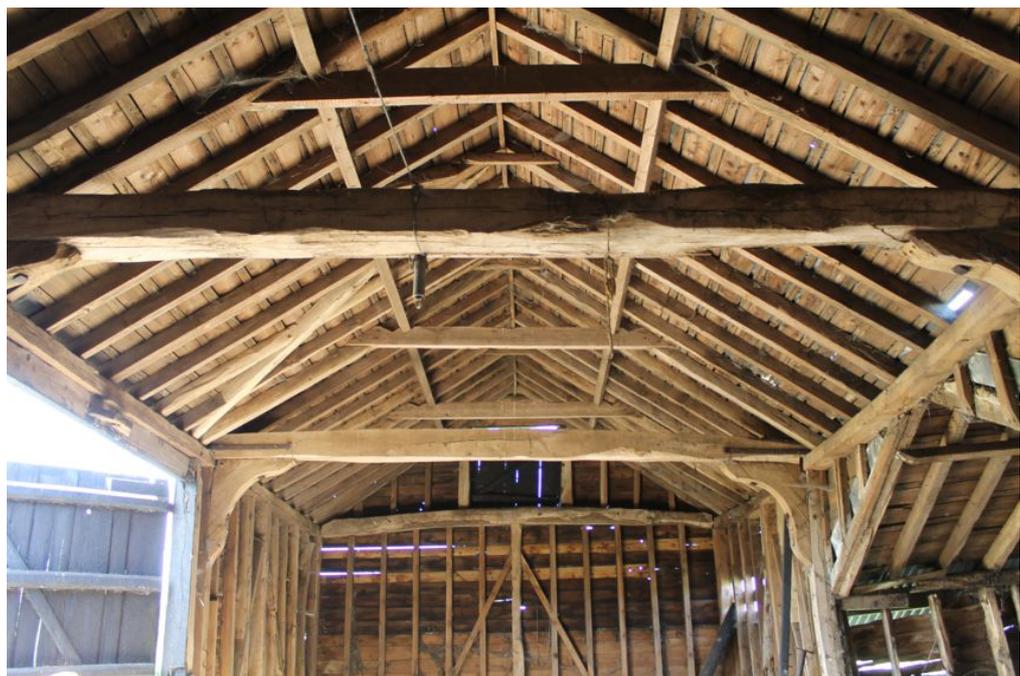
The machine-cut timbers in the barn include the two principal posts on the north-west elevation (Photograph 5), a substantial number of the studs and bracing, particularly on the gable ends of the barn, and most of the roof, including the purlins and collars (Photograph 6). The machine-cut timbers in the frame appear to be original to the building, with the exception of the roof, which has clearly been rebuilt. It is almost entirely made of machine-cut timbers, but also contains some larger hand-sawn timbers, which presumably originated from the original roof.

**Photograph 6** Roof of the barn, showing tie-beams and collars. Photograph taken facing south-west.

The truss in the barn consists of tie-beams jointed to the wall-plates, with a collar above them supporting a single, clasped, purlin on each roof pitch (Photograph 6). The tie-beams are supported by hand-sawn knee-braces rising from the principal posts, which are attached with nails and iron bolts.

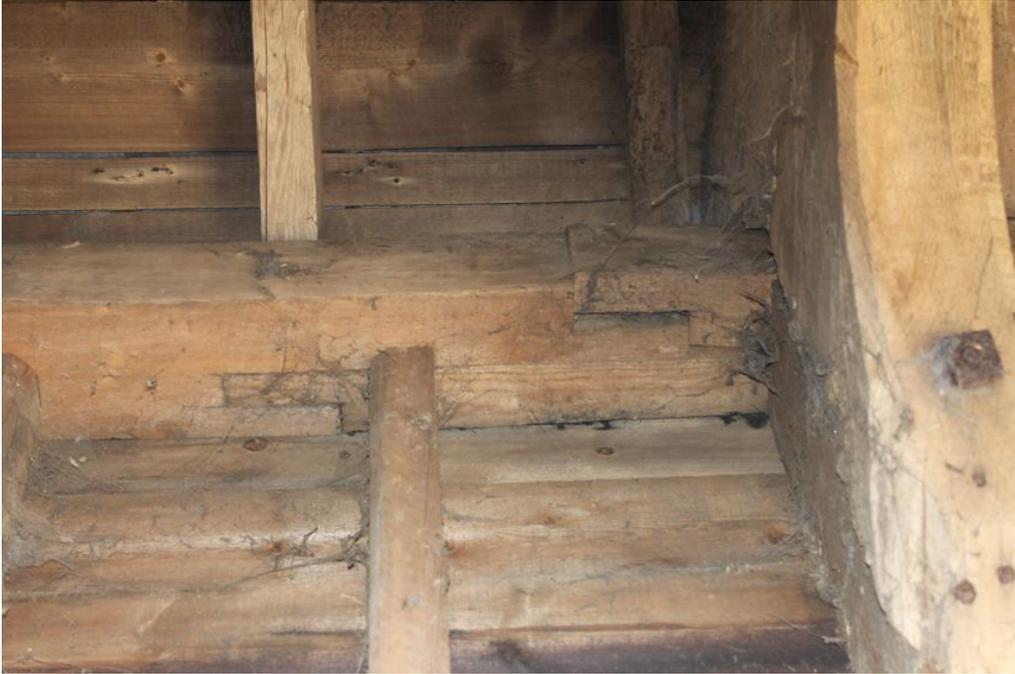
The wall-plates of the barn are jointed together with two face-halved and bladed scarf joints with four nails (Photograph 8). This style of scarf joint begins to be used in the 16th century and continues right through to the present day (Hewett 1980, 269). One joint is on the wall-plate behind the south-east end of the tie-beam between bays 2 and 3, and one is behind the north-west end of the tie-beam between bays 1 and 2 (Fig 2). As the sill-beams were covered by plaster they could not be examined for scarf joints. The modern machine-cut purlins had splayed scarf joints, secured with nails.

**Photograph 8** Detail of wall-plate on southern end of bay 3, showing scarf joint. Photograph taken facing south-east.

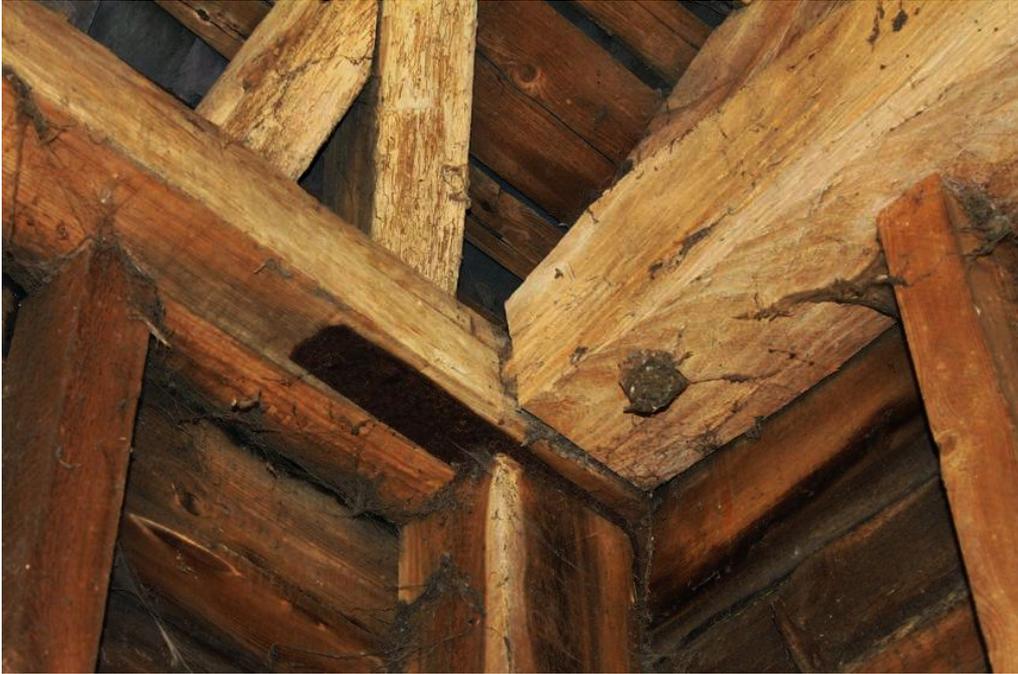
Each truss has a carpenter's mark on its north-western end. This starts at the north-eastern gable end at 'I' and progresses through to 'IIII' at the south-western gable end (Photographs 9 and 10, Fig 2).

**Photograph 9** Detail of carpenter's mark 'I' in north corner of barn. Photograph taken facing north. Contrast increased for better visibility.

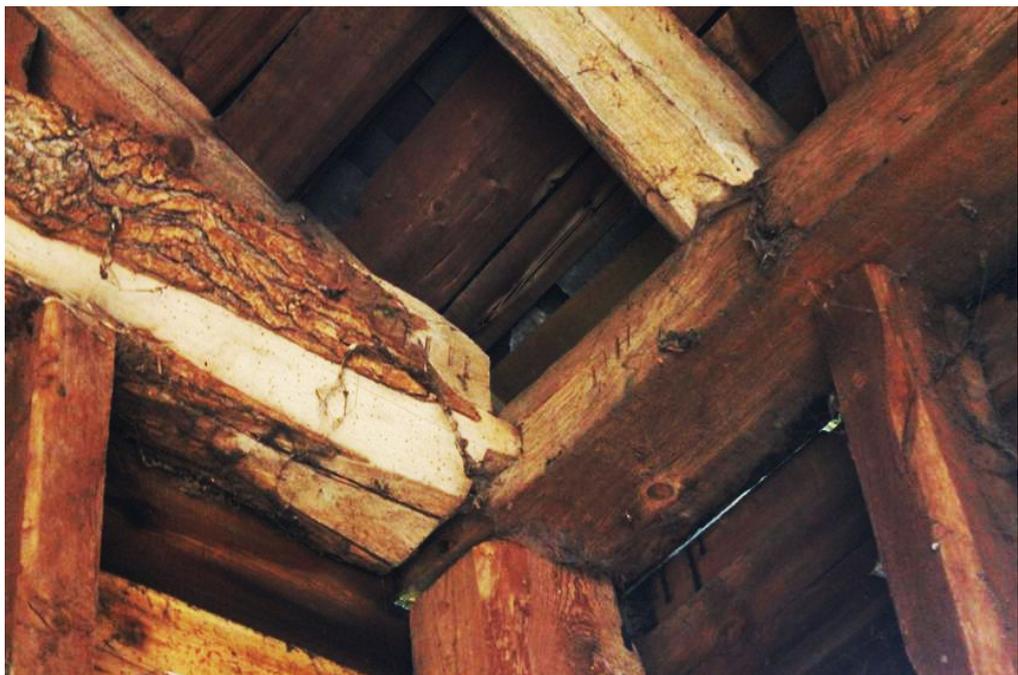
**Photograph 10** Detail of carpenter's mark 'IIII' in east corner of barn. Photograph taken facing east. Contrast increased for better visibility.

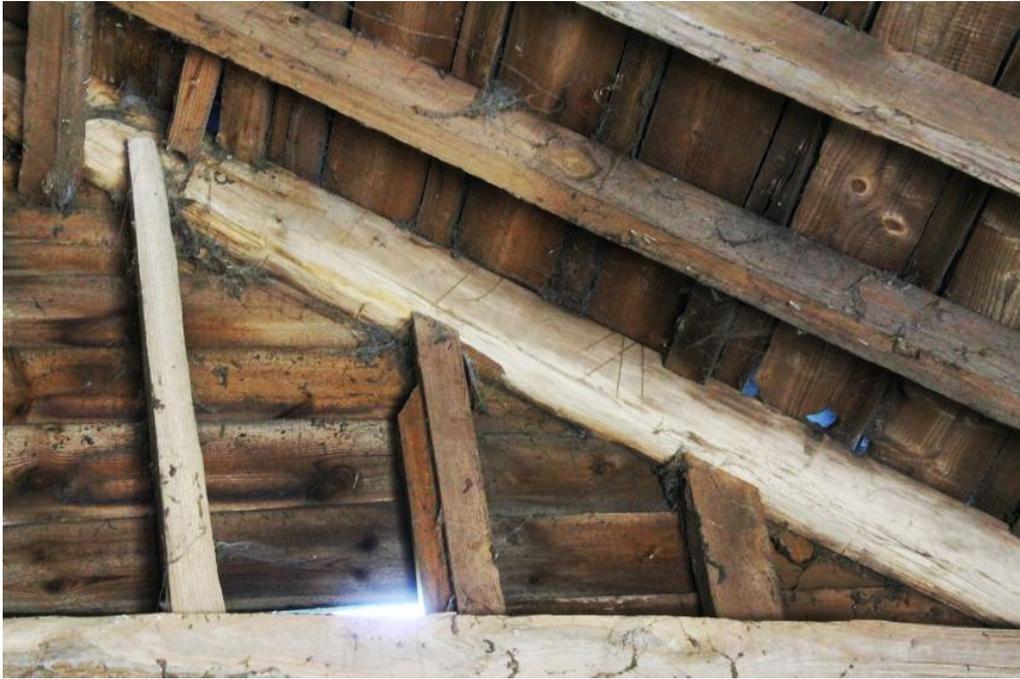
Numerous Baltic shipping marks were observed on the hand-sawn timbers in the barn, most clearly on some principal rafters and wall-plates (Photographs 11 and 12).

**Photograph 11** Detail of Baltic shipping marks on north-eastern gable end. Photograph taken facing north-east. Contrast increased for better visibility.

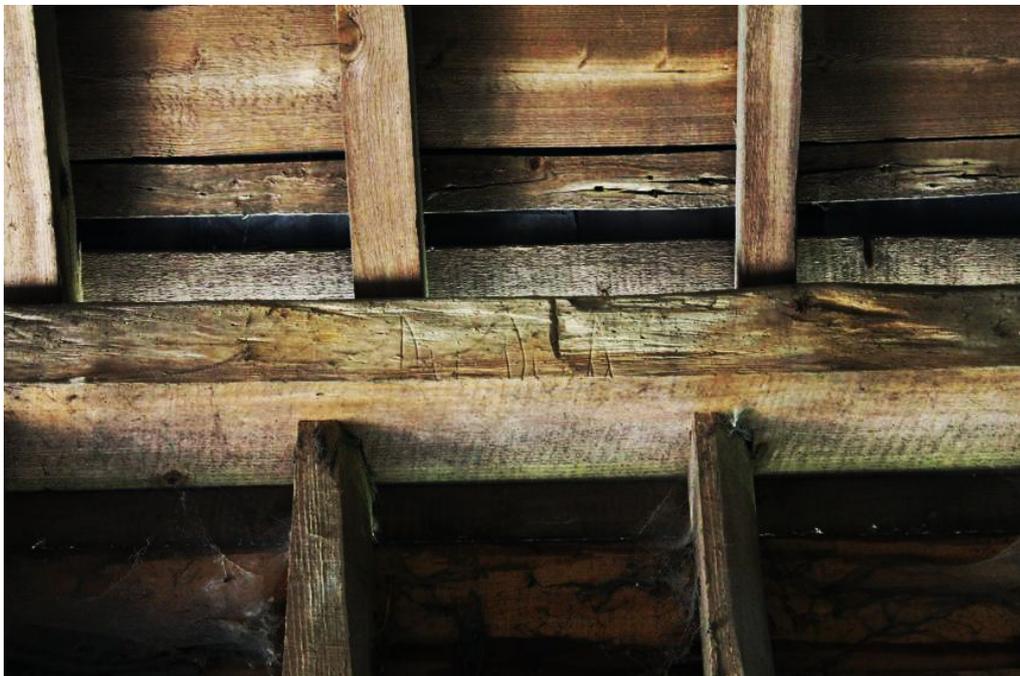
**Photograph 12** Detail of Baltic shipping marks on wall-plate on north-west side of bay 3. Photograph taken facing north-west. Contrast increased for better visibility.

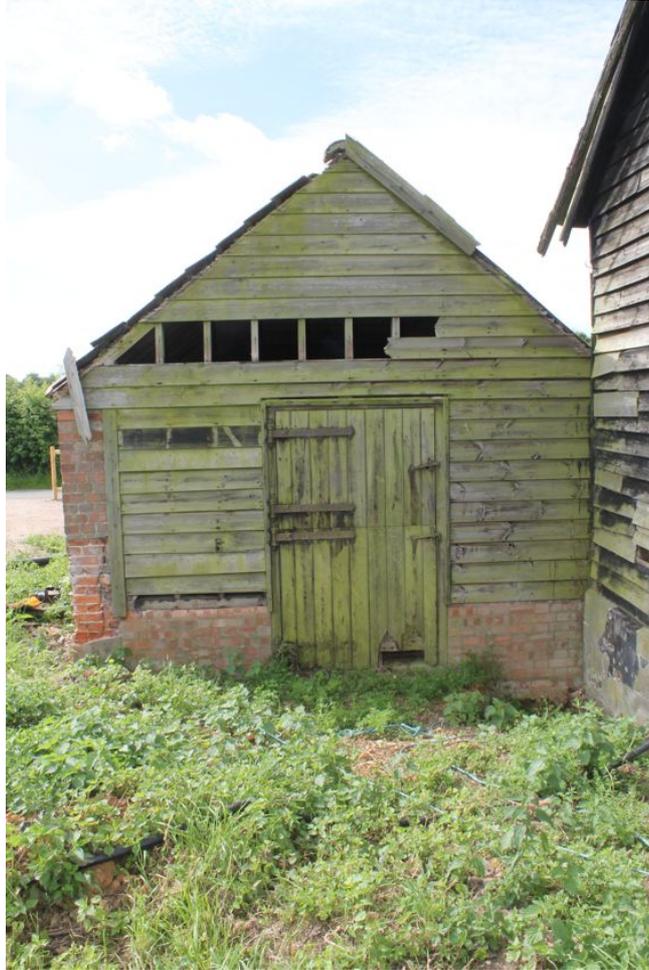
The north-west elevation of the building has a vertical-planked stable-door built into the timber-frame (Photograph 14). On the north-east elevation is a mismatch of brickwork, with the lower Flemish-bond brickwork being the remnants of the garden wall of the farmhouse, incorporated into the outbuilding (see Historical Background above). On the south-eastern elevation is a vertical-planked double door, next to a bricked over opening (Photograph 15). The south-west elevation has another vertical-planked double door, as well as three bricked over openings. The entire south-east and north-west elevation are constructed in spacer-bond.

**Photograph 14** North-west elevation of brick outbuilding, showing timber-frame. Photograph taken facing south-east.

Sometime between 1955 and 1970, the OS benchmark on the outbuilding was removed. As there are no vestiges of it today (Photograph 14), this probably was the result of the brickwork being redone, most likely on the south-east and south-west elevations, as they have identical spacer-bond construction. This was also likely to be the point when the building was re-roofed, although it has clearly received *ad hoc* repairs since then.

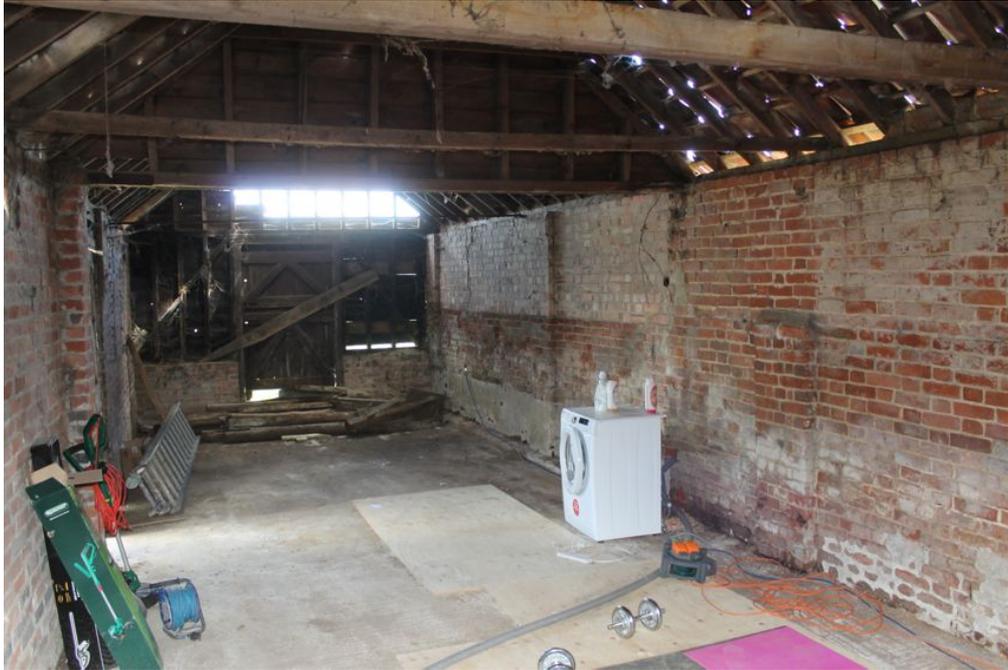
The building has a concrete floor and modern machine-cut timber roof (Photograph 16). There are wall-plates on top of the brick walls to support the roof. One scarf-joint was observed in the wall-plate of the original building: an edge-halved scarf with square abutments.

**Photograph 16** Interior shot of brick outbuilding. Photograph taken facing north.

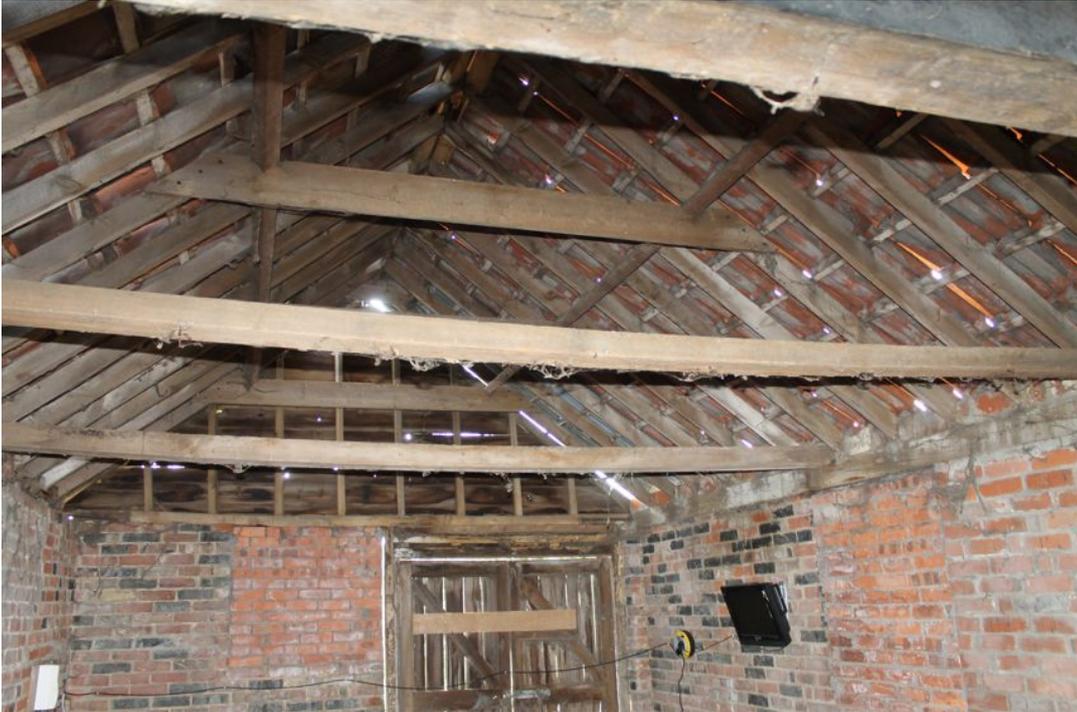
The original half of the structure has three tie-beams, which are supported on the wall-plates (Photograph 17). No braces support, or rise from, these tie-beams. The later extension has a metal tie-rod in the centre of the structure, bolted to each wall-plate.

**Photograph 17** Roof of original half of brick outbuilding. Photograph taken facing south.

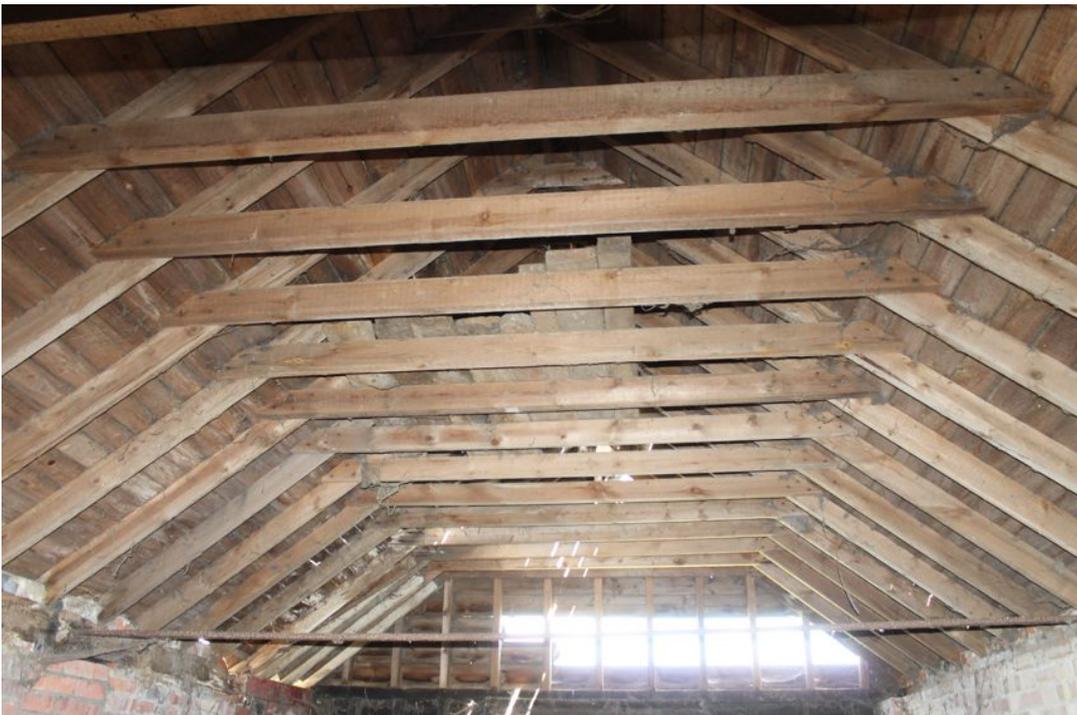
The roof is further supported by collars, which are occasional in the original roof, but in the extension there is a collar between each pair of rafters (Photograph 18).

**Photograph 18** Roof of extension to brick outbuilding. Photograph taken facing north-west.
