**Historic building recording at B Mess,
formerly the Officers' Quarters,
Le Cateau Barracks, Colchester,
Essex,
November 2013 and December 2019**

**report prepared by
Chris Lister and Mark Baister**

**on behalf of
K2 Consultancy**

CAT Report 1512
February 2020

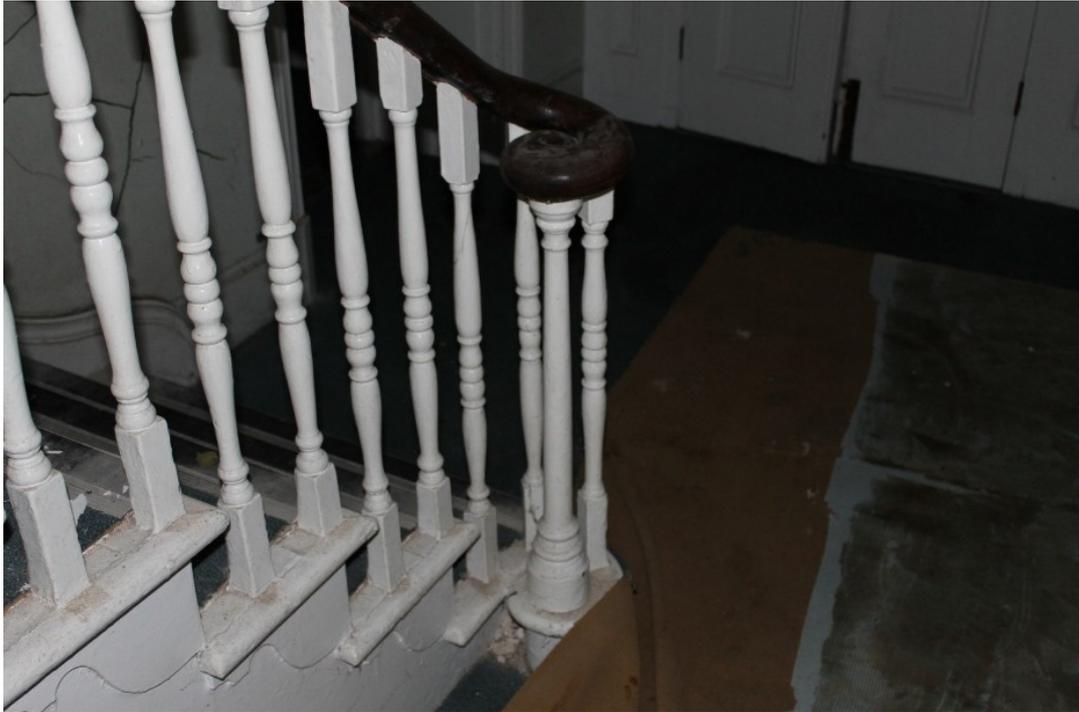
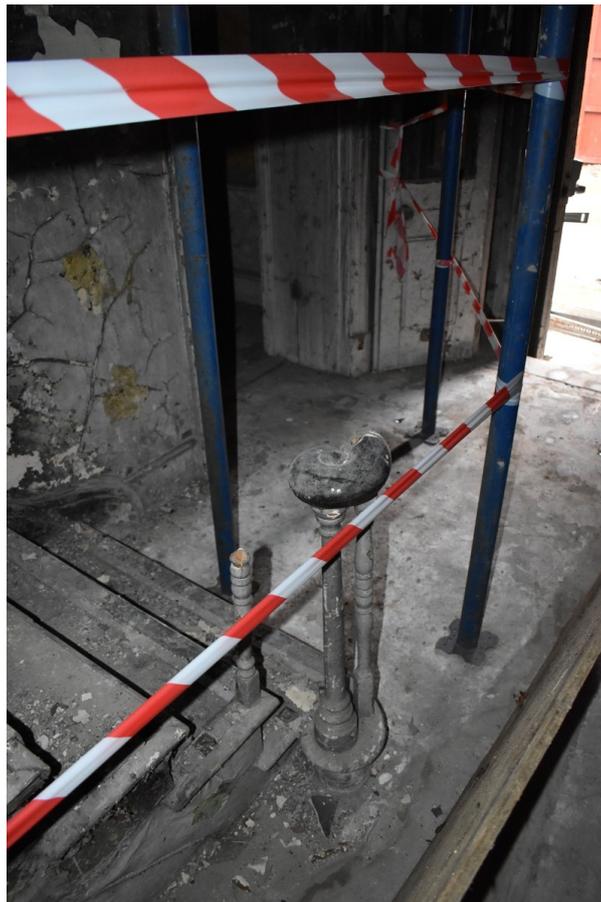
Plate 3 Stairwell iv, detail of the mahogany banister with spiral end and the turned balusters of the open string staircase. Photo from November 2013 above, photo from December 2019 below.

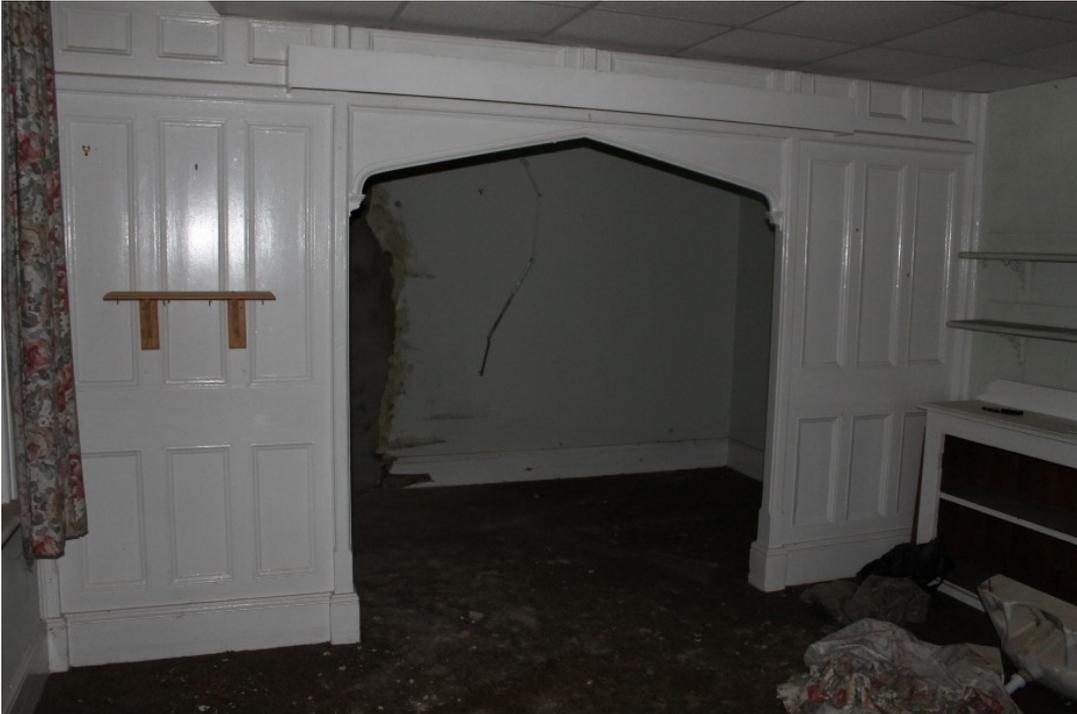
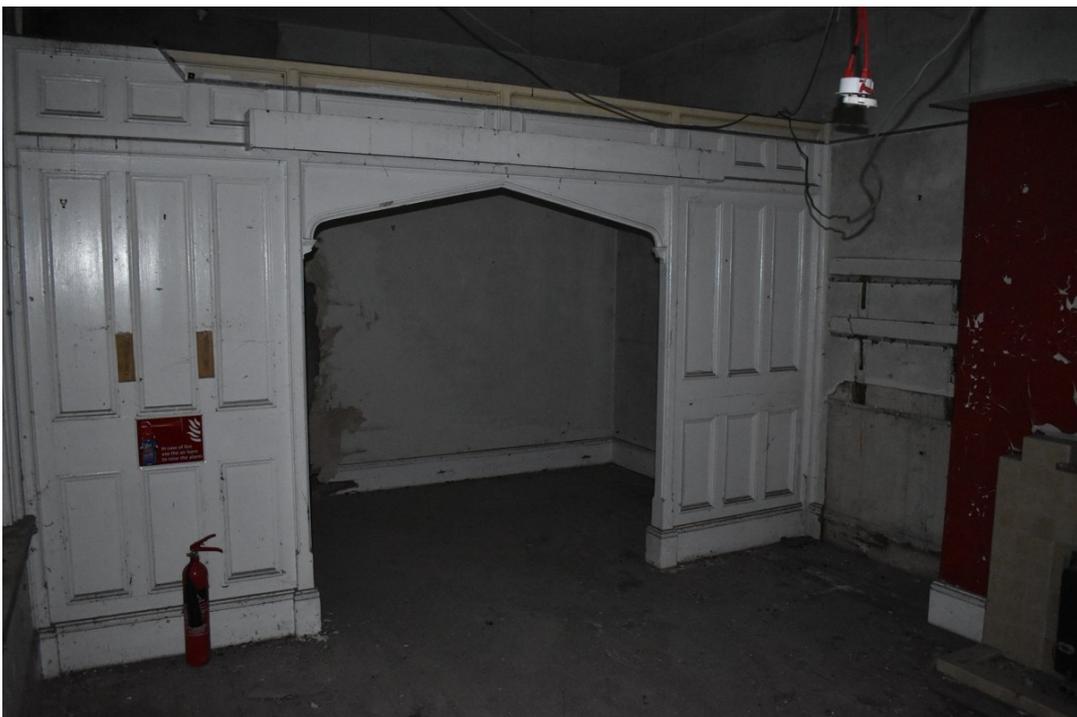
Plate 5 Original wooden partition in room 2 separating the sleeping area from the sitting room – view south-west. Photo from November 2013 above, photo from December 2019 below.

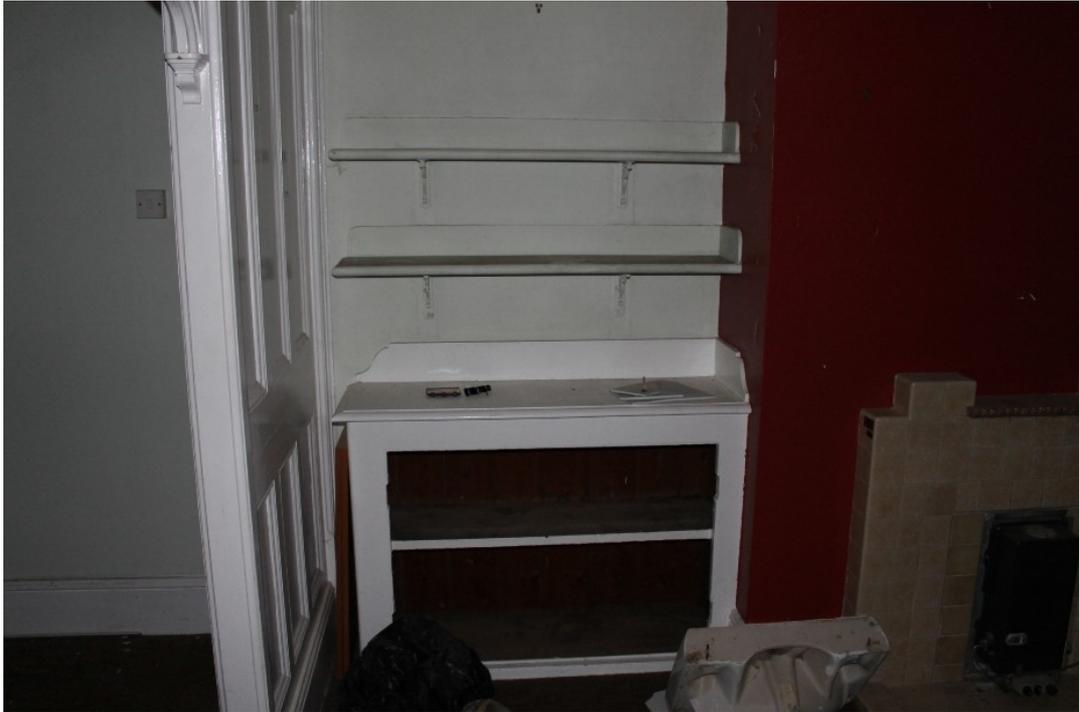
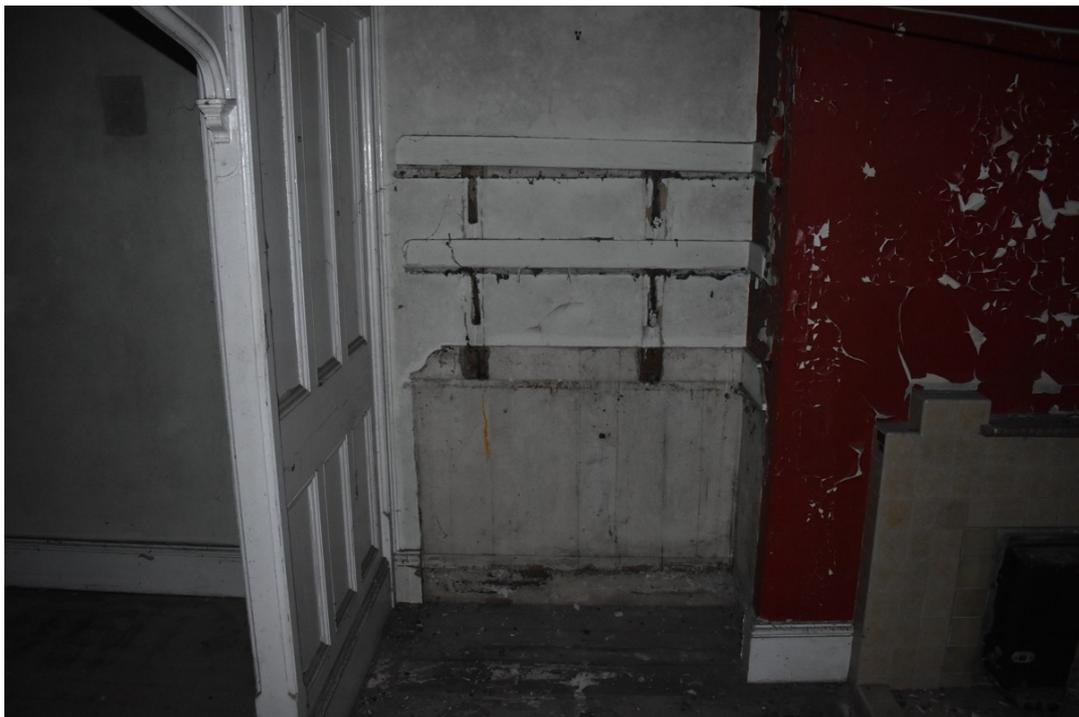
Plate 6 Dresser and shelving in room 2, either relocated from the 1876 rooms or faithfully reproduced – view north-west. Photo from November 2013 above, photo from December 2019 below.

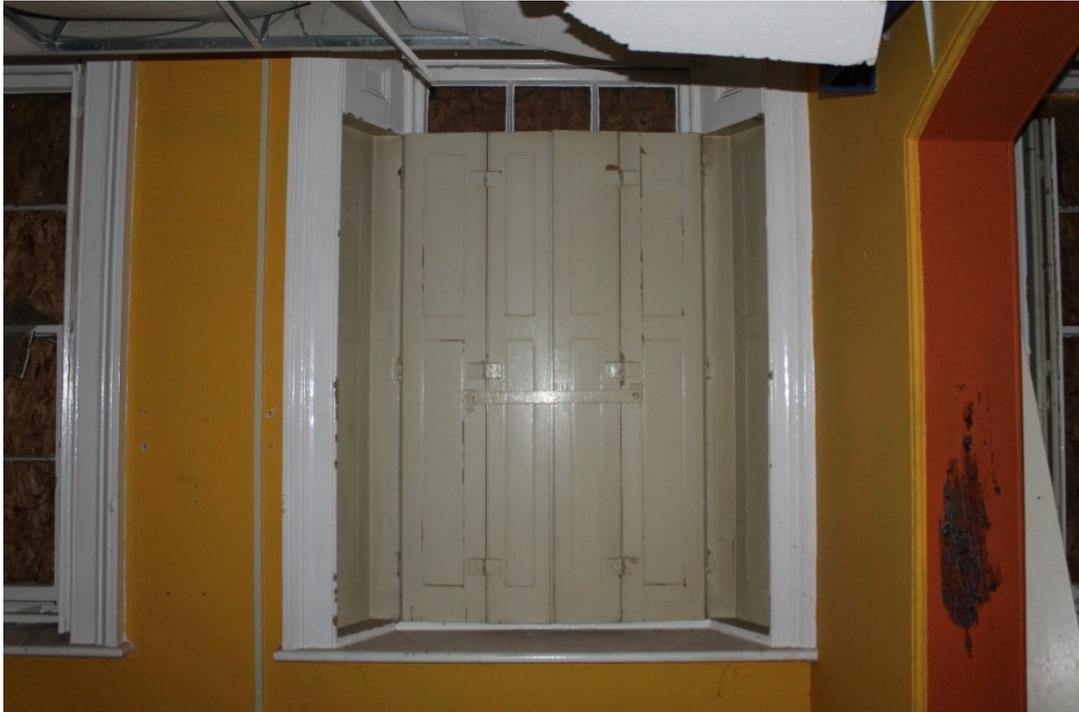
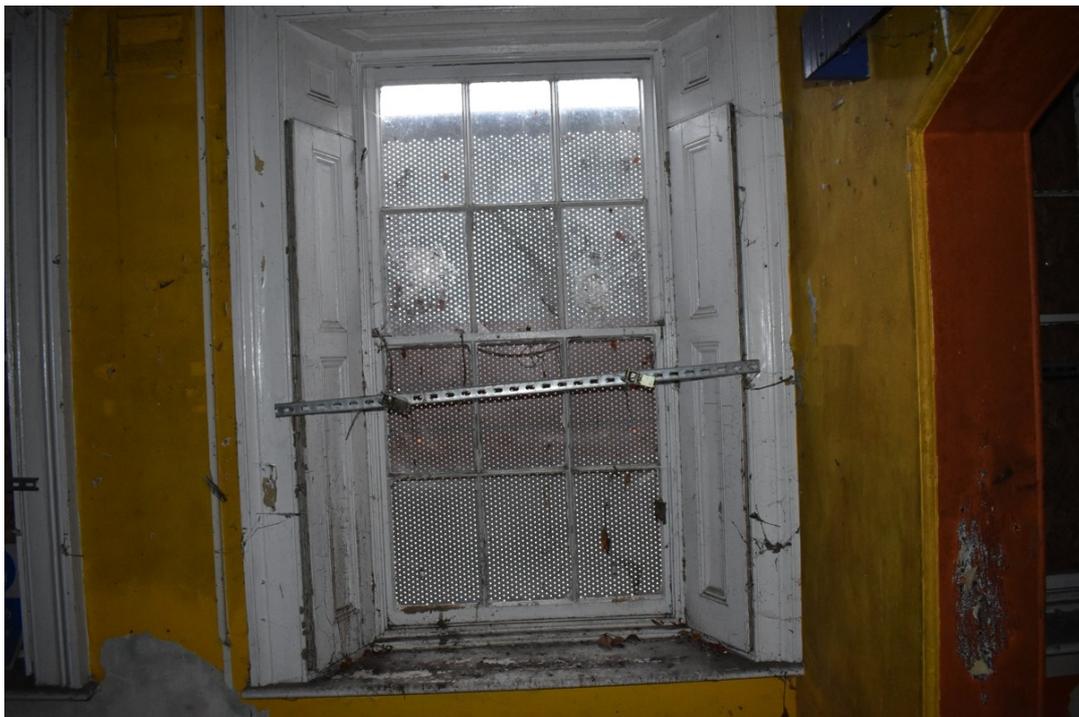
Plate 7 Example of the sash windows with recessed wooden shutters in the ground floor rooms of the 1874-5 building - view south-east. Photo from November 2013 above, photo from December 2019 below.

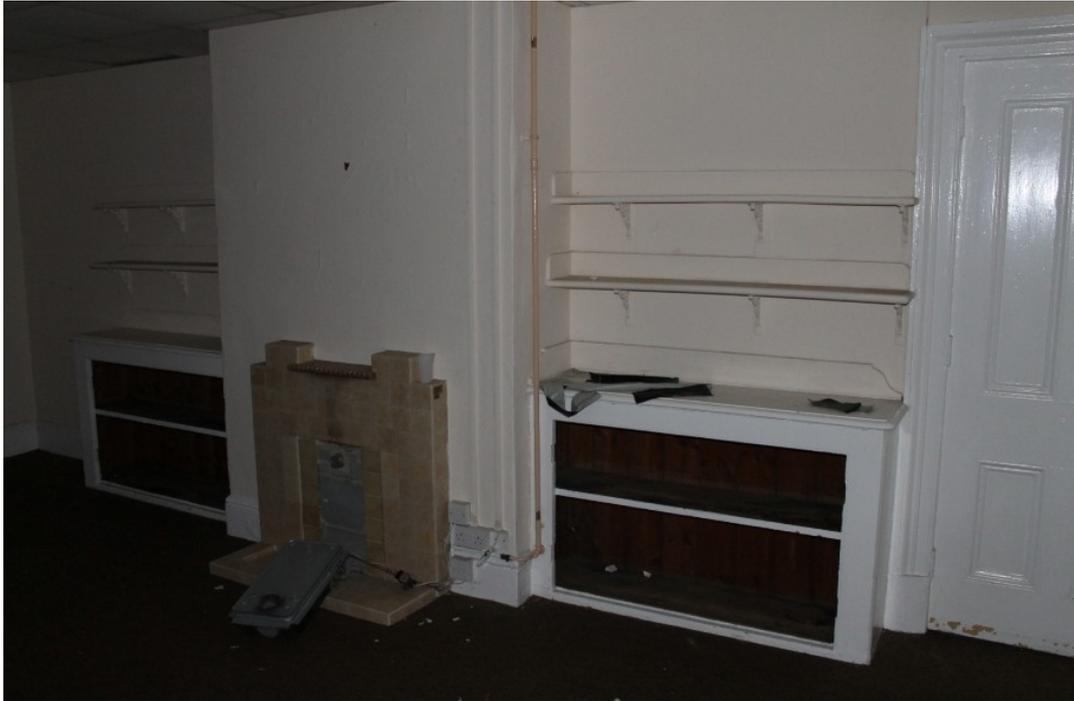
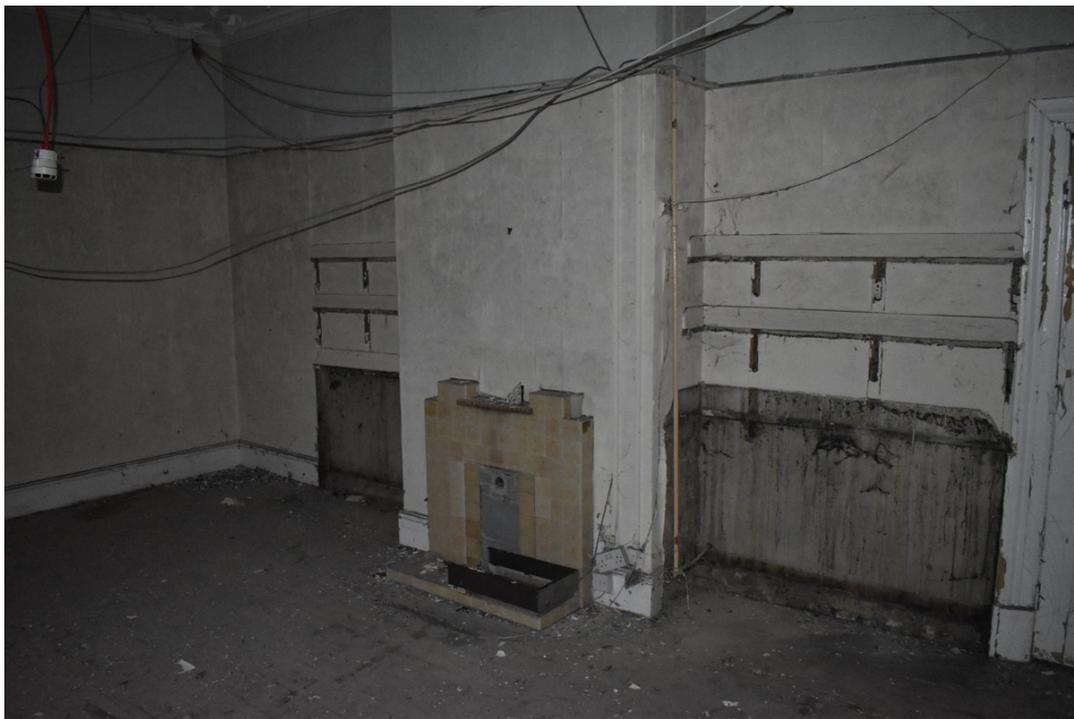
Plate 8 Room 4, formerly the sitting room of the second Field Officer, with the original four-panel door leading to the bedroom of said officer – view west. Photo from November 2013 above, photo from December 2019 below.

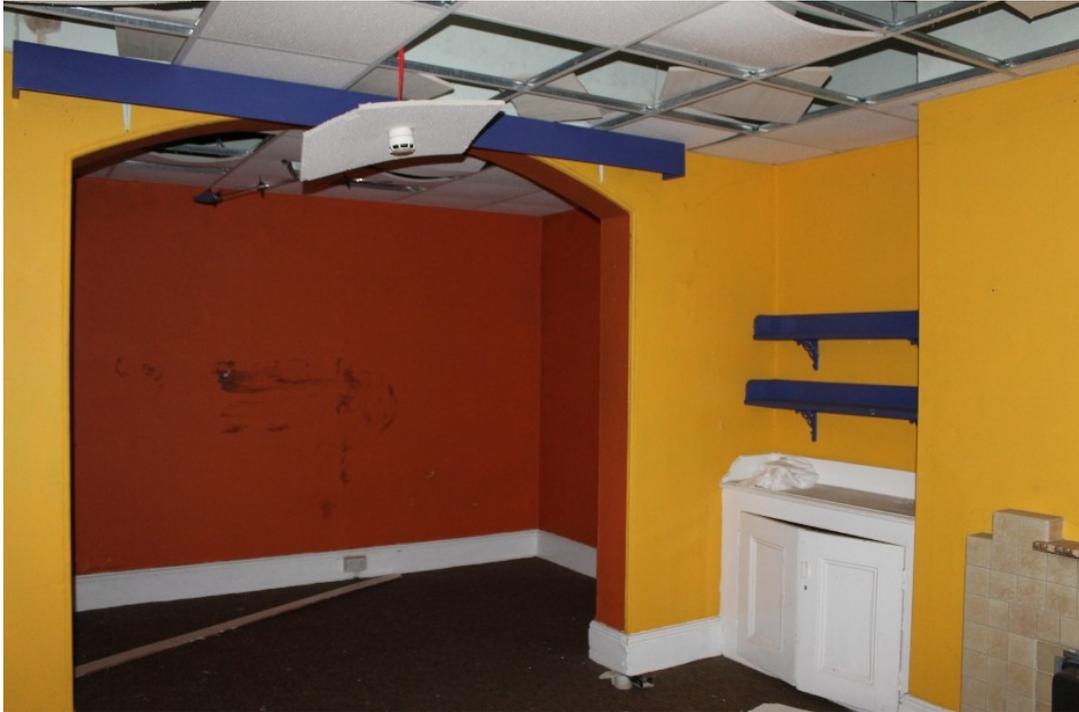
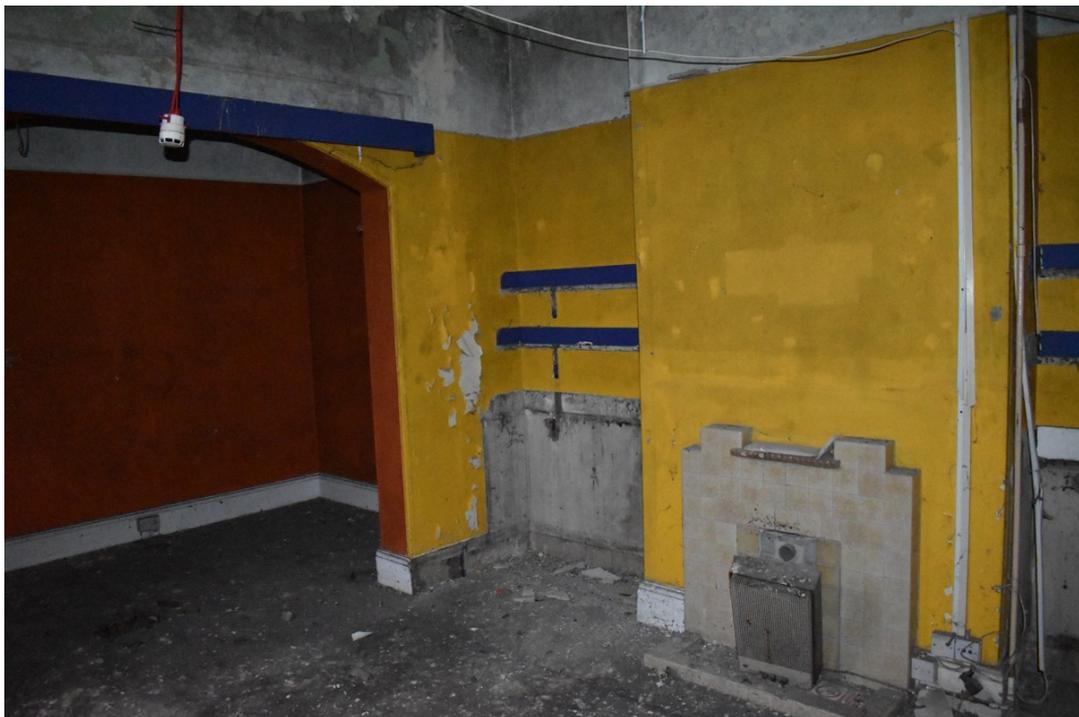
Plate 9 Room 7, formerly the quarters for Officer No.1, showing the brick arch separating the sleeping area from the sitting room, with the original dresser and shelving to the left of the chimney breast – view south. Photo from November 2013 above, photo from December 2019 below.

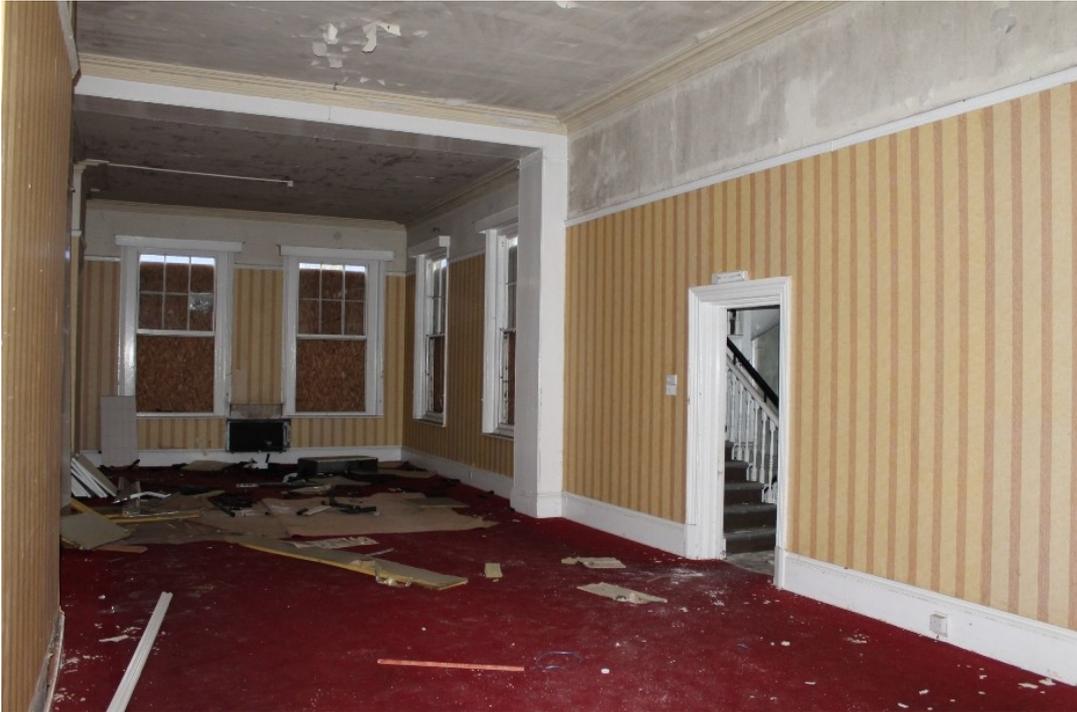
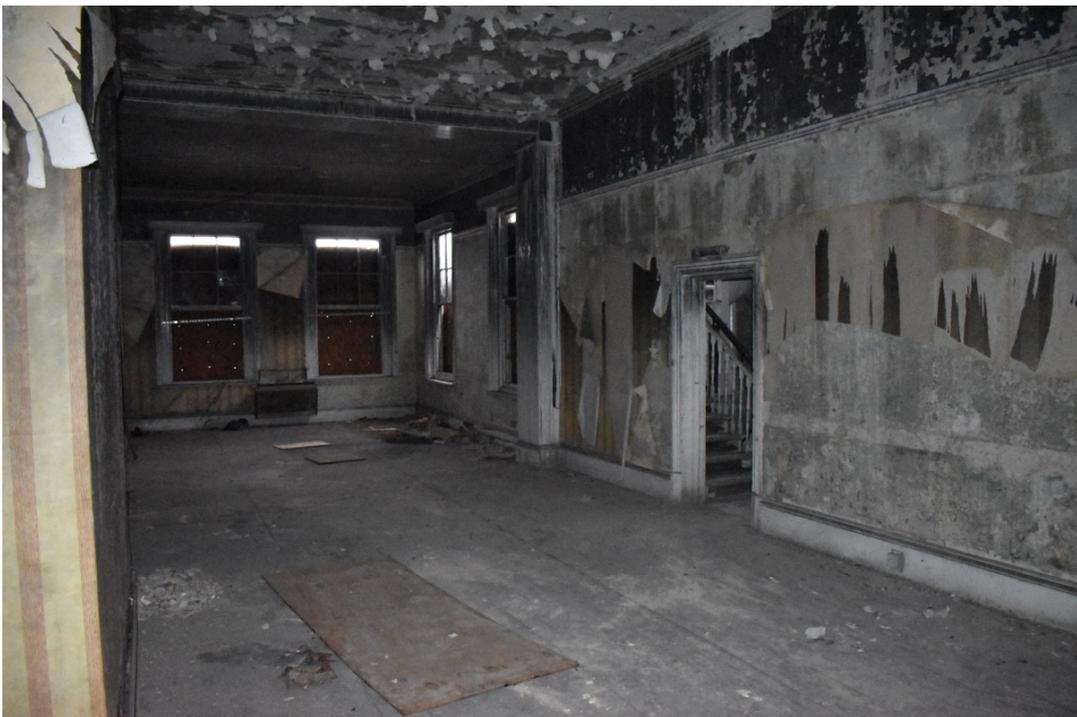
Plate 10 The mess room with the 1922-62 extension to the rear and the original doorway to the servant's stairs in the right-hand wall – view north. Photo from November 2013 above, photo from December 2019 below.

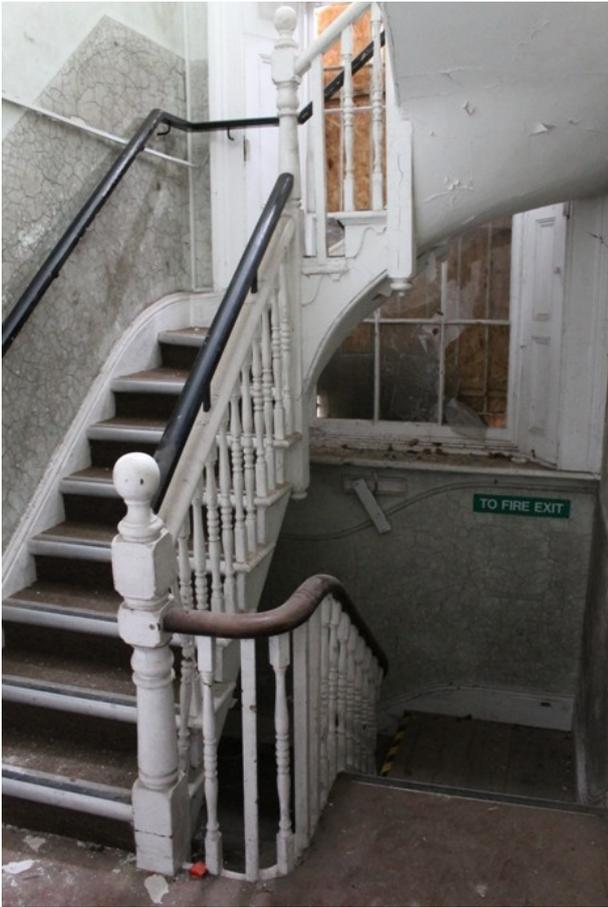
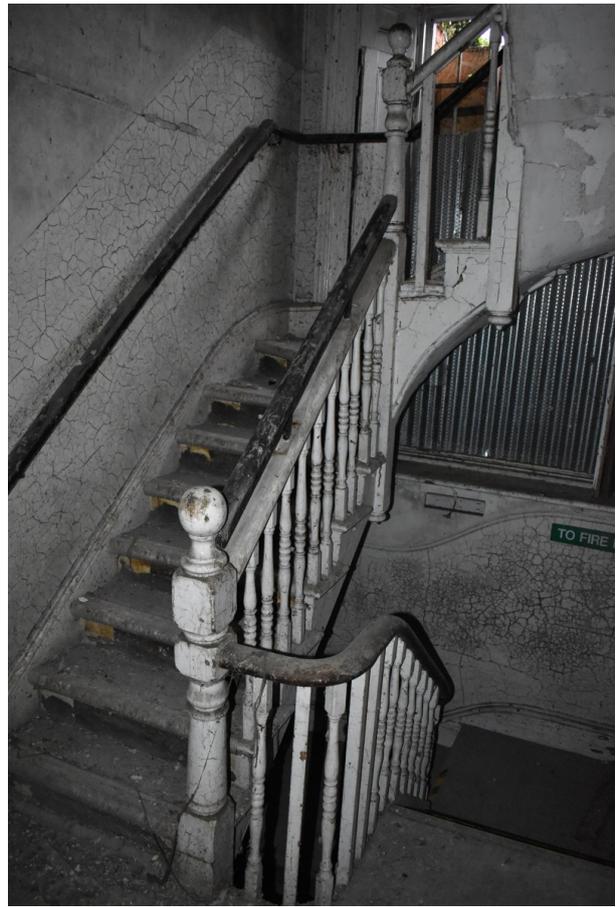
Plate 11 Servants' stairwell v, with the original access to the basement and the inserted staircase to the first floor - view west. Photo from November 2013 left, photo from December 2019 right.

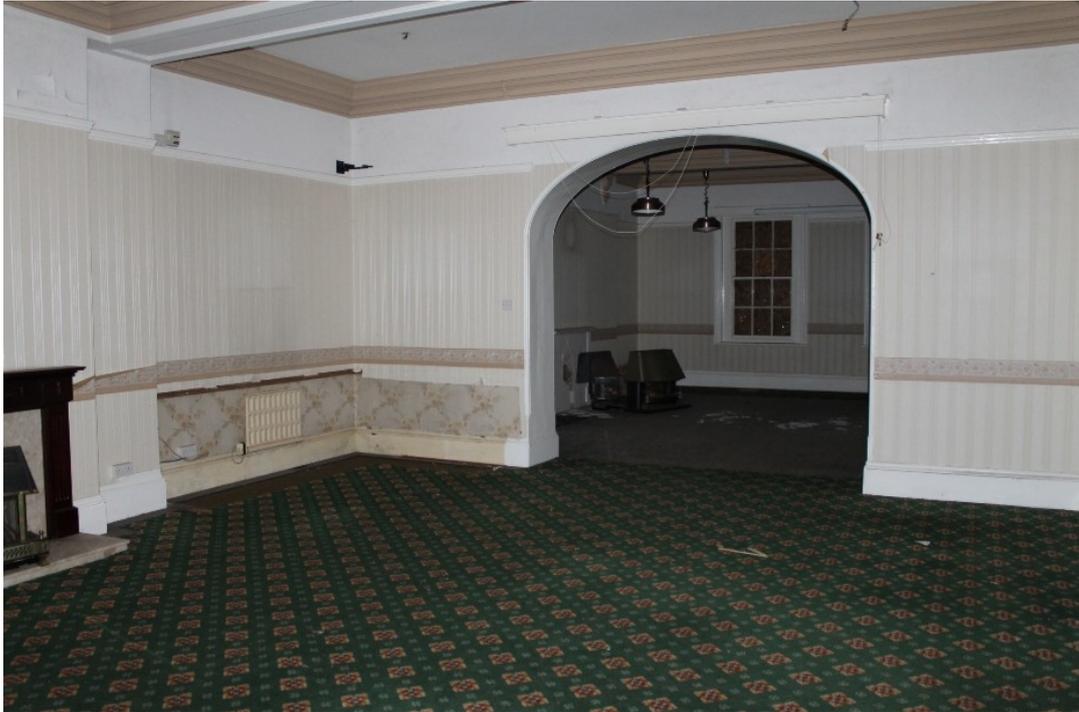
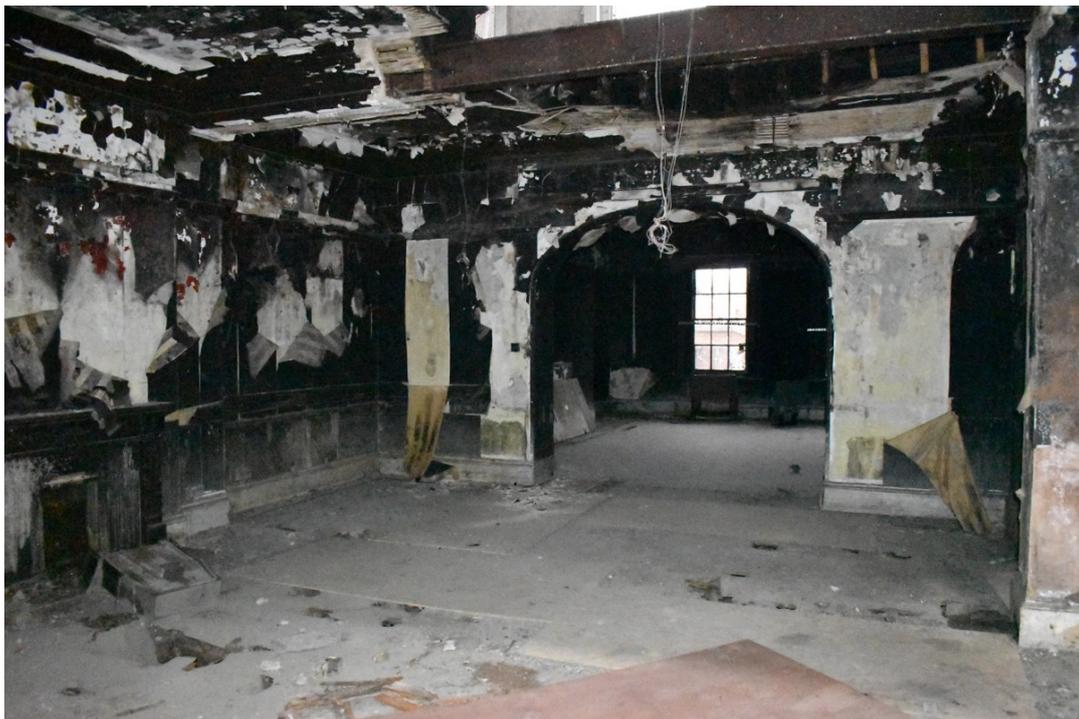
Plate 12 The 1904 bar converted from the quarters for Officers Nos.2 and 3, with the extension through the archway and the inserted fireplaces on the left-hand walls – view west. Photo from November 2013 above, photo from December 2019 below.

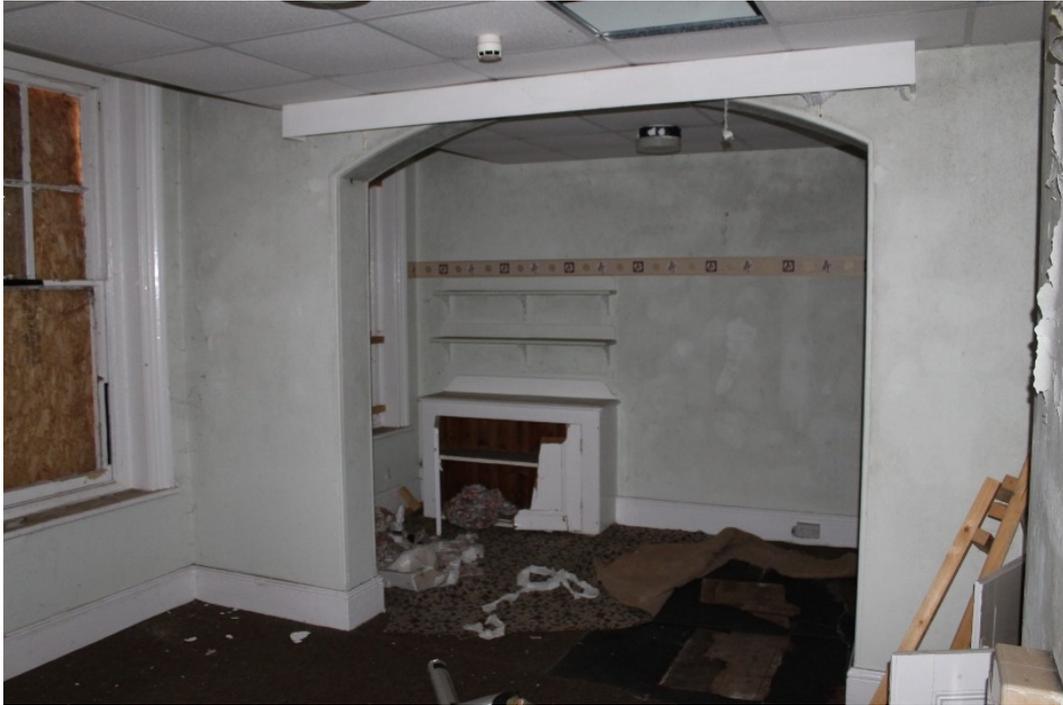
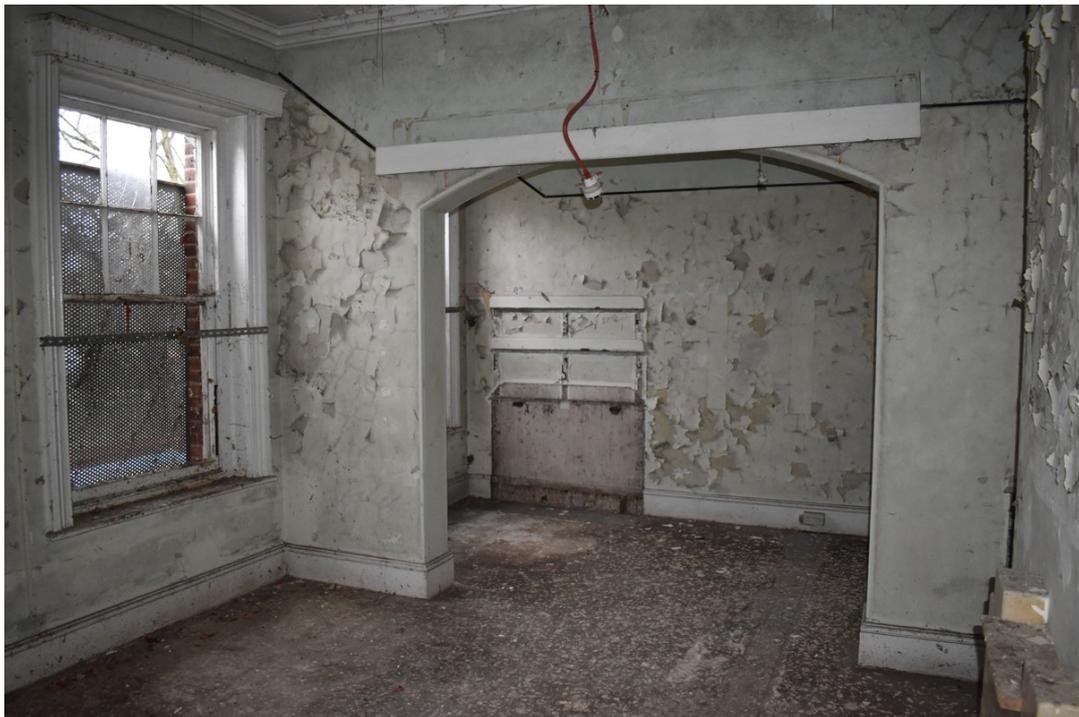
Plate 14 Room 17, the former quarters for Field Officer No.6, showing the repositioned dresser in the sleeping area and the windows without the recessed wooden shutters – view south. Photo from November 2013 above, photo from December 2019 below.

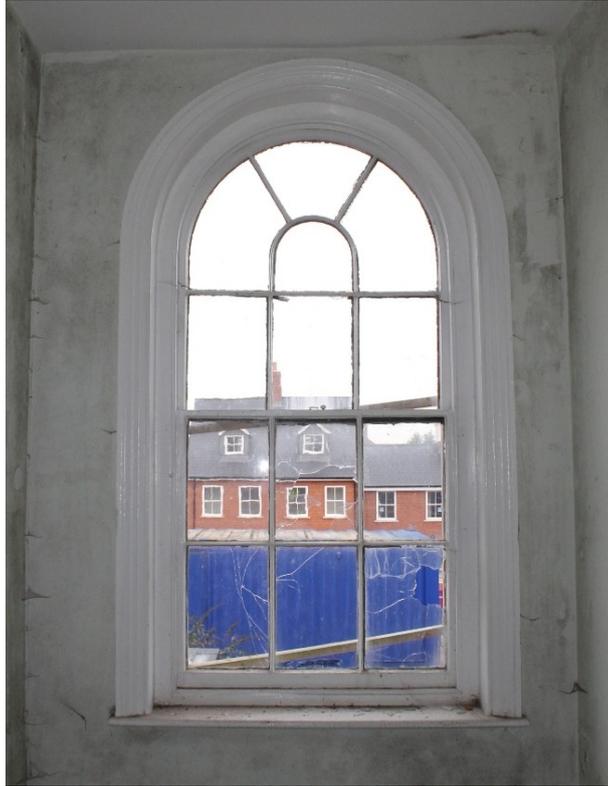
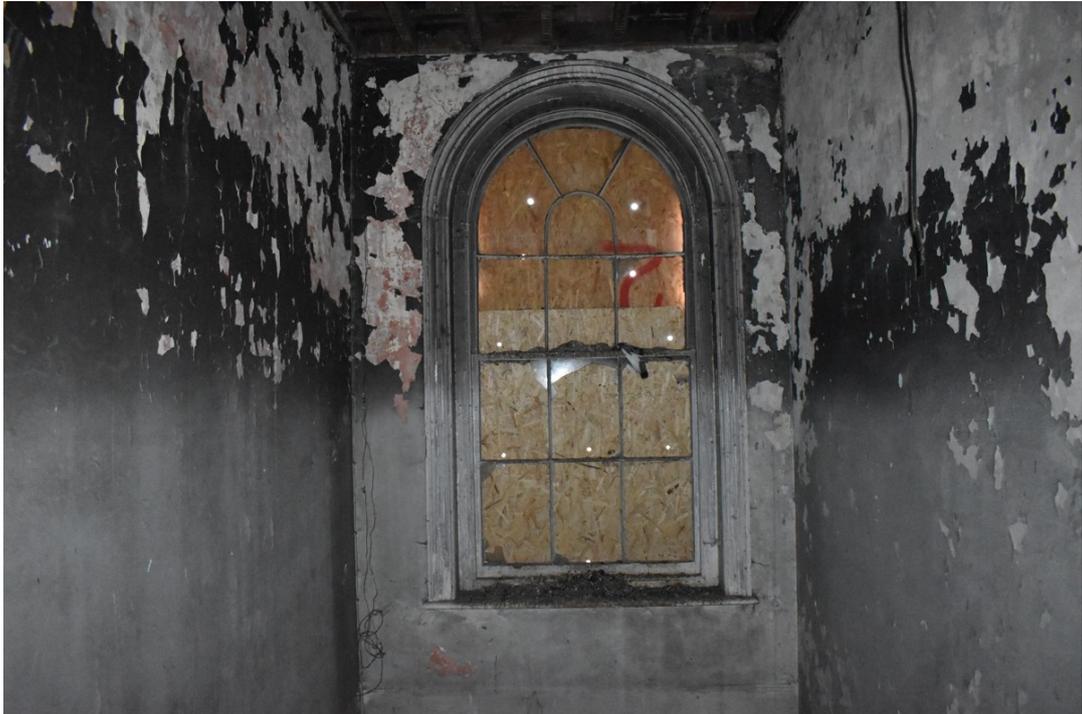
Plate 15 Example of the Italianate sash windows found in rooms 18-21. Photo from November 2013 above, photo from December 2019 below.

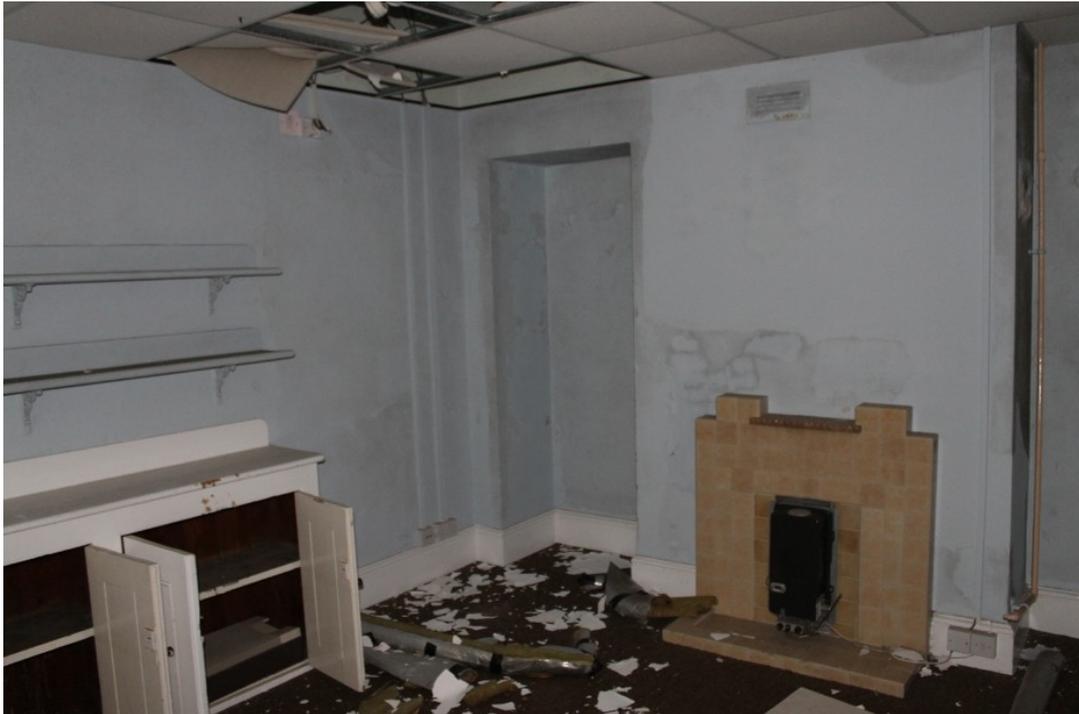
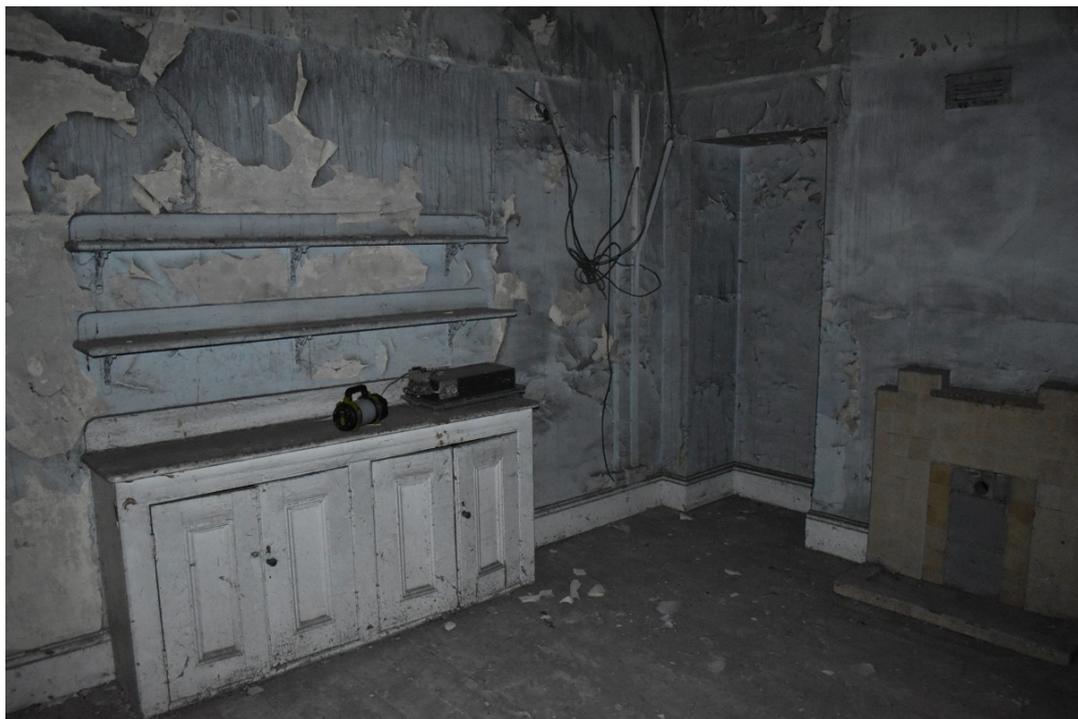
Plate 16 Room 18, formerly quarters for the servants of Officers Nos.1, 6 and 7, showing the bricked-in original doorway to the left of the chimney breast and the double-width dresser on the dividing wall – view south. Photo from November 2013 above, photo from December 2019 below.

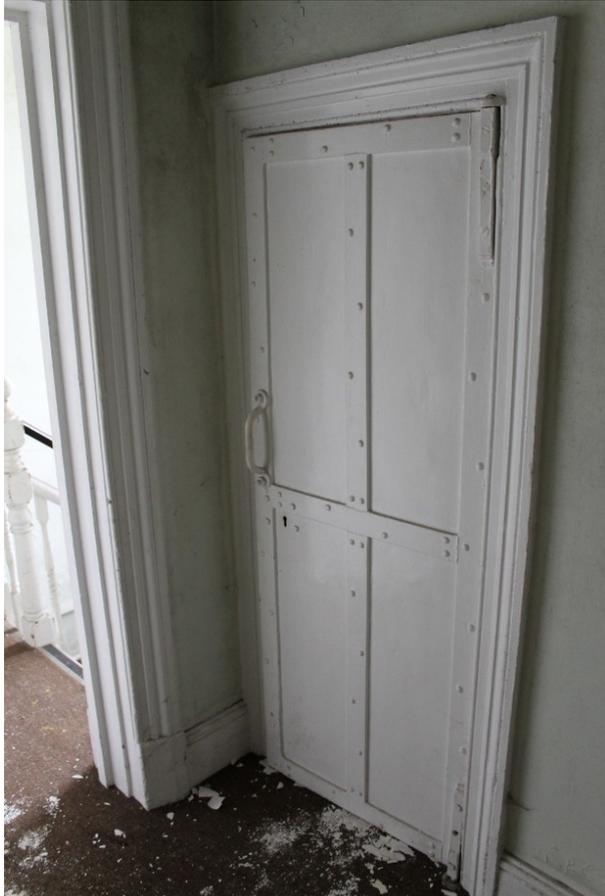
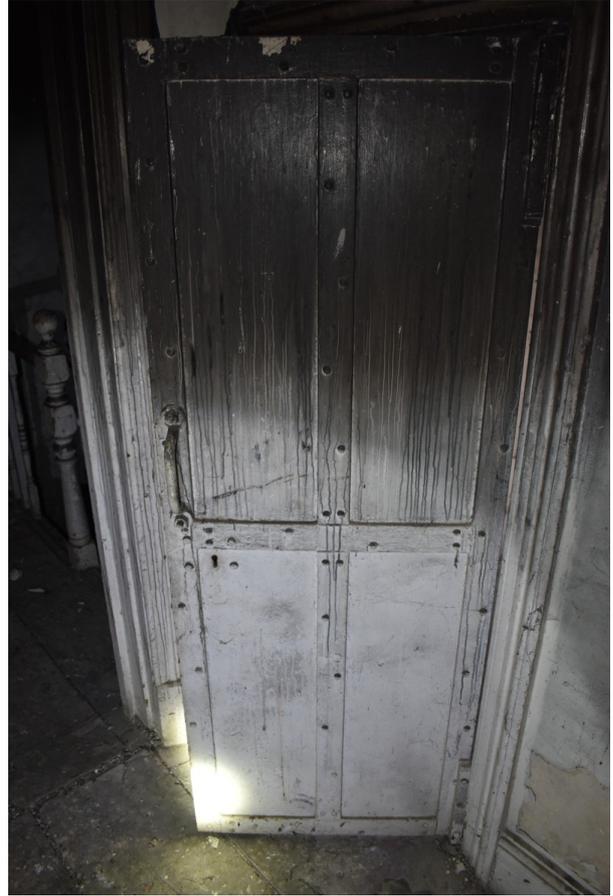
Plate 17 Iron door to strongroom 20, converted from the former servants' quarters for Officers Nos.2 and 3 - view west. Photo from November 2013 left, photo from December 2019 right.

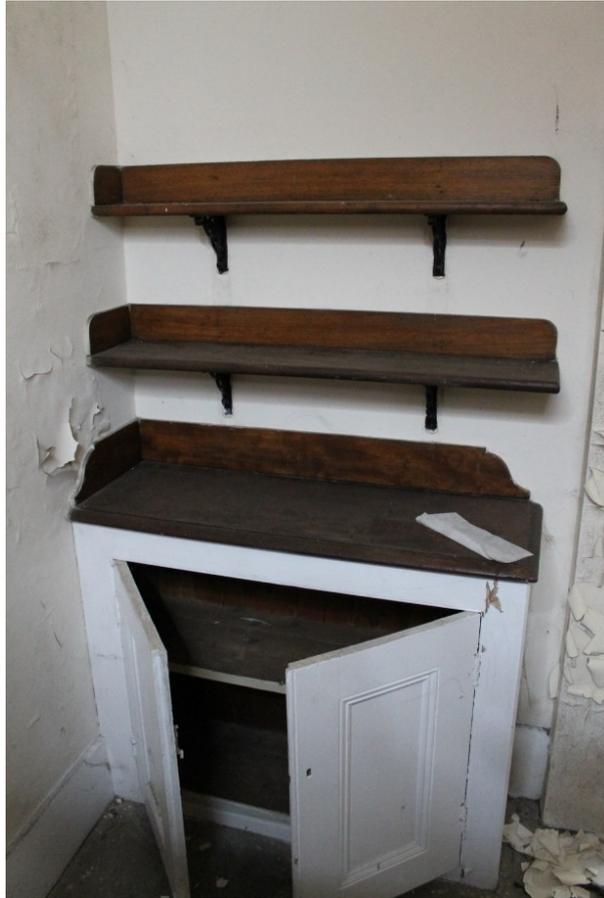
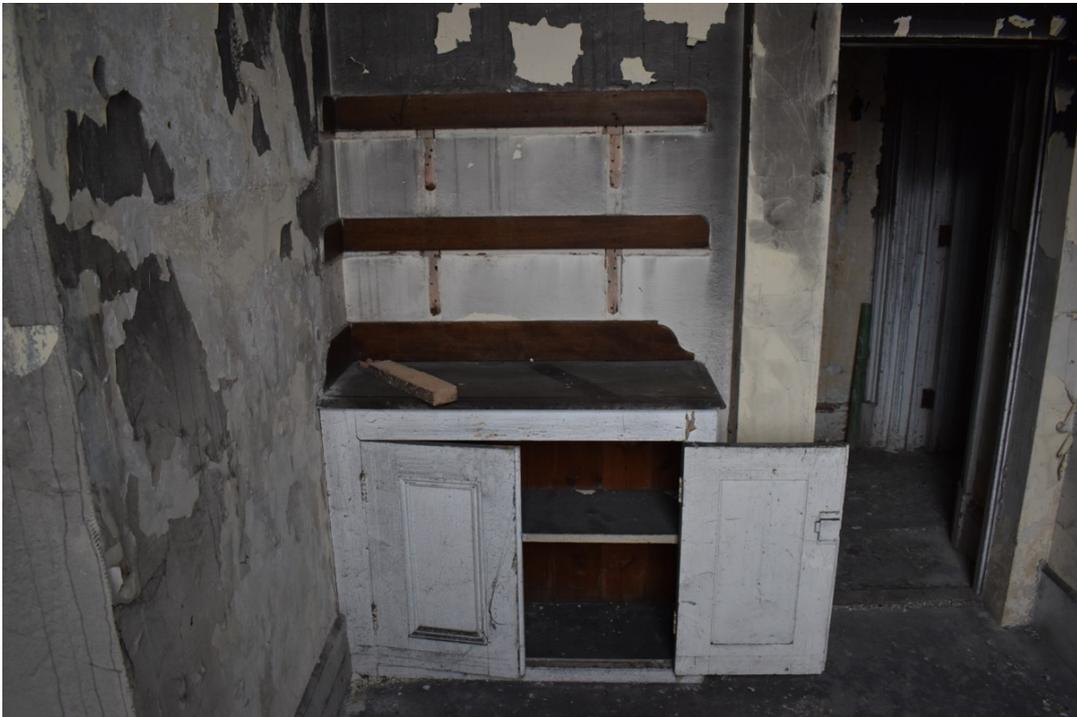
Plate 18 Detail of relocated dresser in room 20, showing the unpainted finish – view north-east. Photo from November 2013 above, photo from December 2019 below.

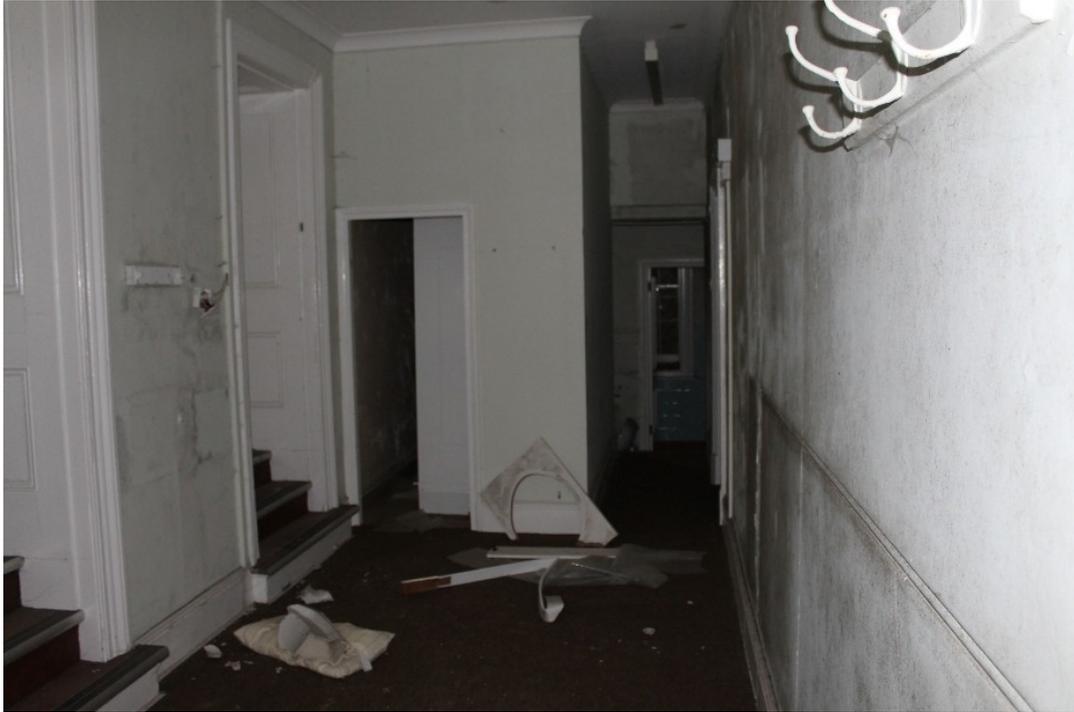
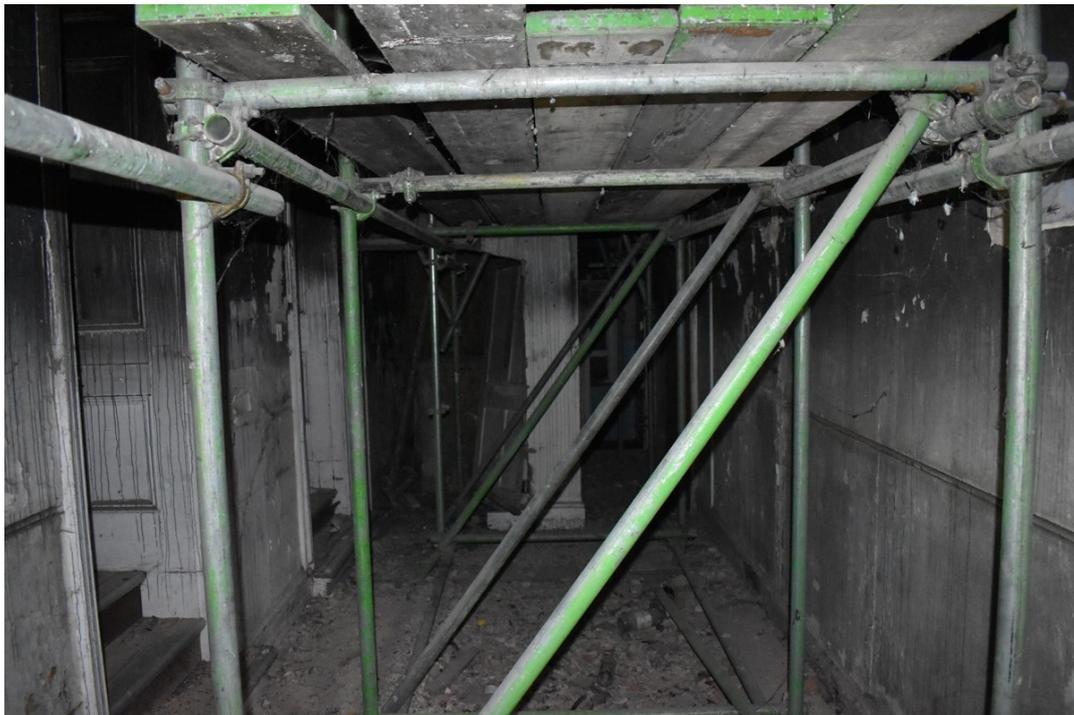
Plate 19 The converted landing of the former stairwell *iii*, with the inserted shower room, the 1904 ablution block to the rear and the original doorways to the servants' quarters in the left-hand wall – view north-west. Photo from November 2013 above, photo from December 2019 below.
