**Historic building recording at B Mess,
formerly the Officers' Quarters,
Le Cateau Barracks, Colchester,
Essex,
November 2013 and December 2019**

**report prepared by
Chris Lister and Mark Baister**

**on behalf of
K2 Consultancy**

CAT Report 1512
February 2020

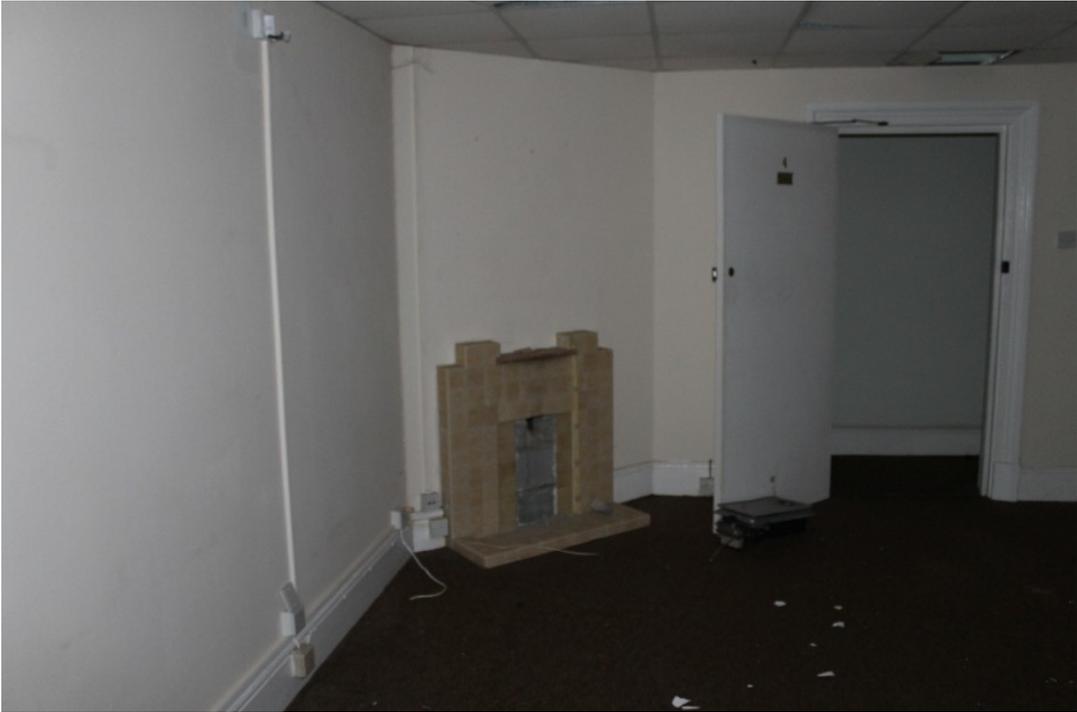
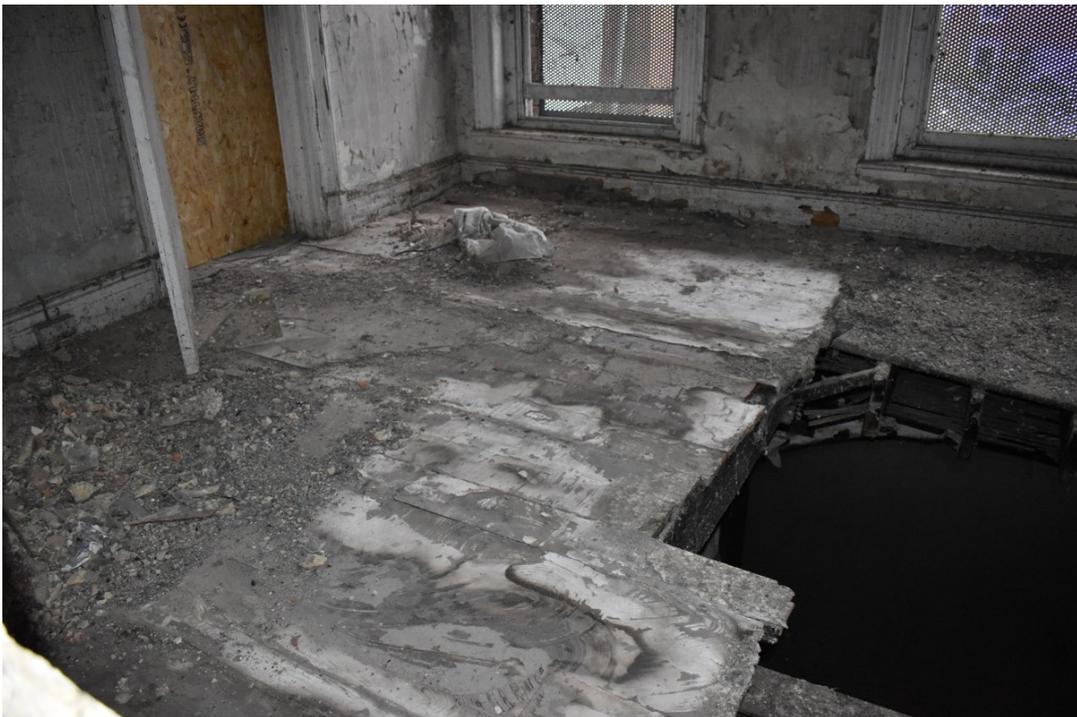
Plate 20 Room 22, formerly the quarters for Officer No.9, showing the relocated doorway and fireplace – view south-west. Photo from November 2013 above, photo from December 2019 below.

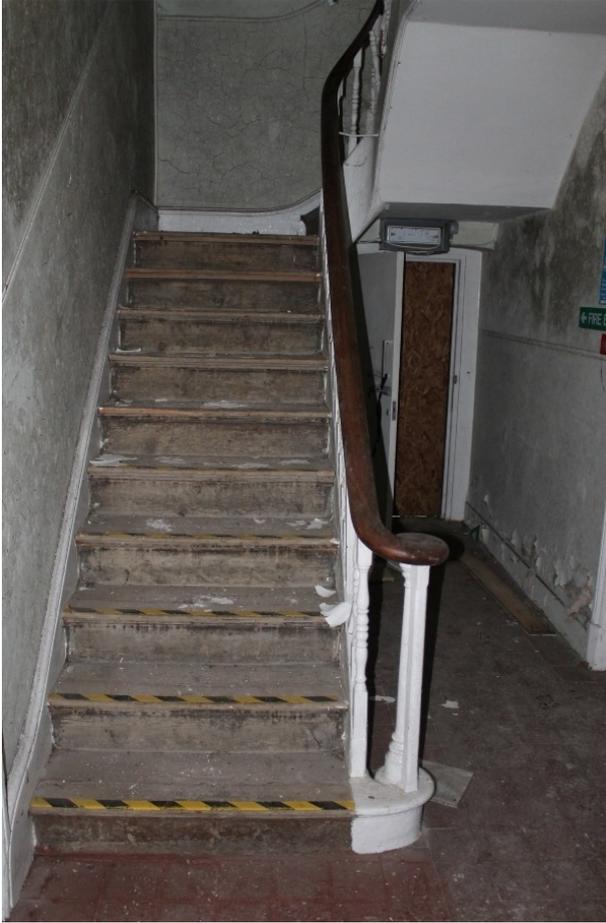
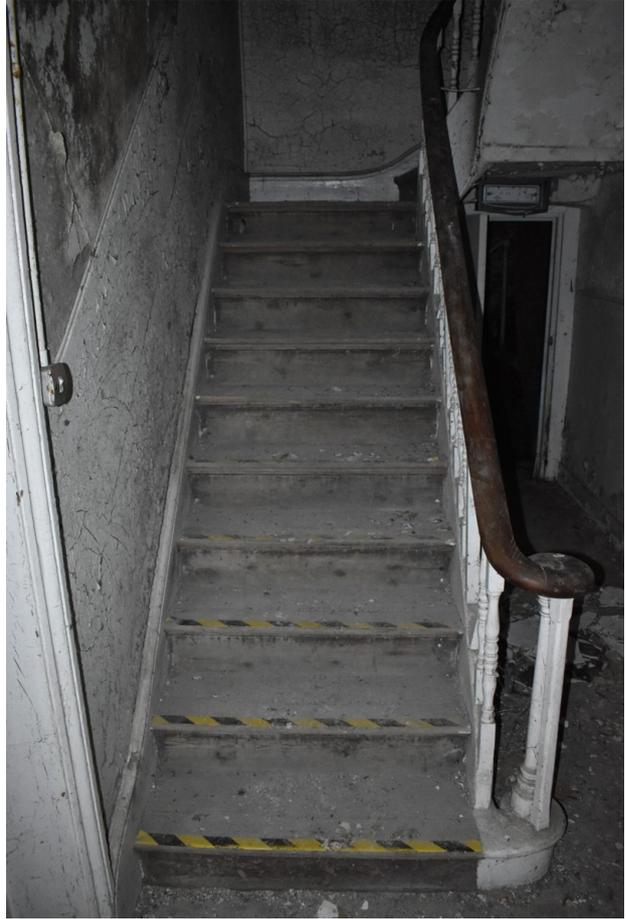
Plate 21 Stairwell v, the basement stairs with the same mahogany banister with spiral end and turned balusters as the staircases of the entrance ways – view north-west. Photo from November 2013 left, photo from December 2019 right.

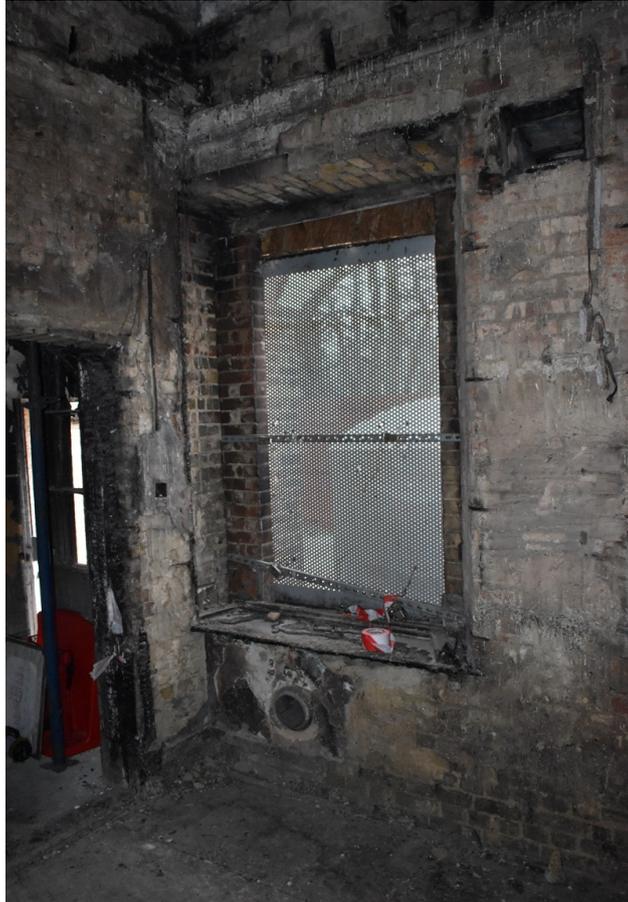
Plate 23 Detail of window opening on ground-floor of building below room 25, showing complete destruction of window-frame by fire – view east.

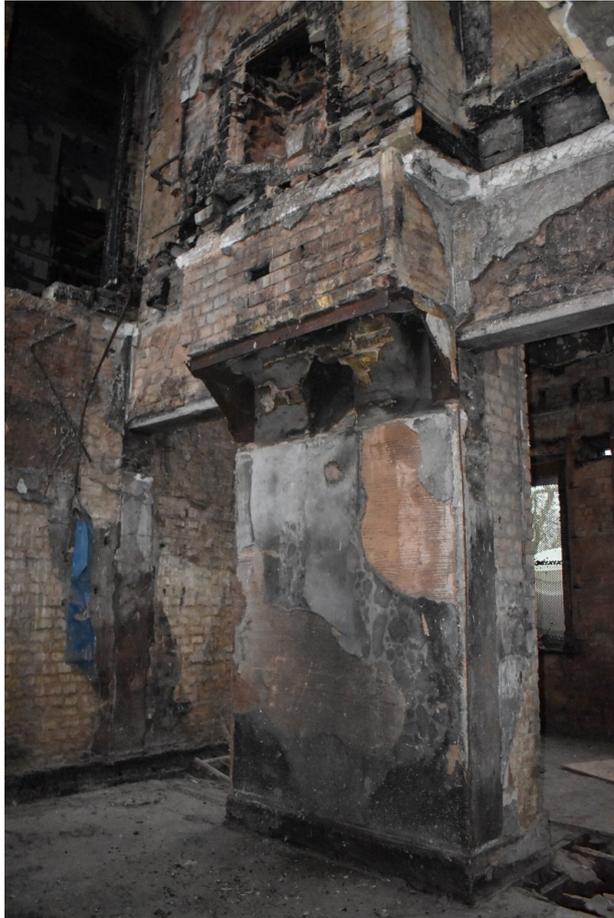
Plate 27 Chimney with removed fireplace below room 24 - view east.

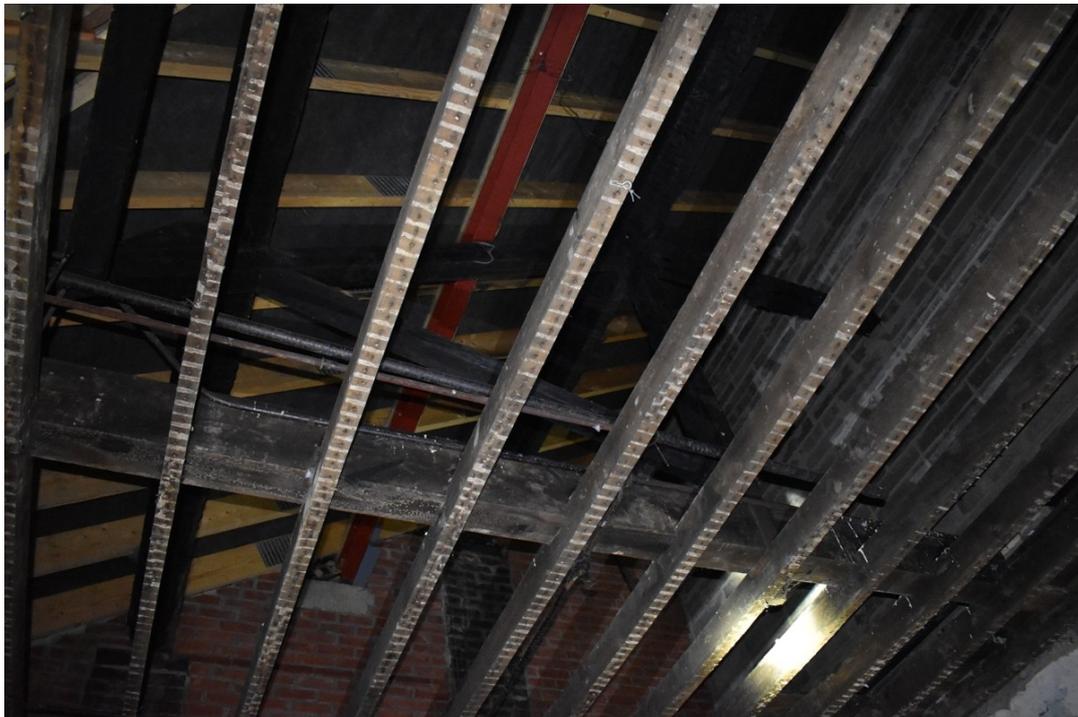
Plate 28 Detail of queen-post truss above room 19 on first-floor - view south-east.

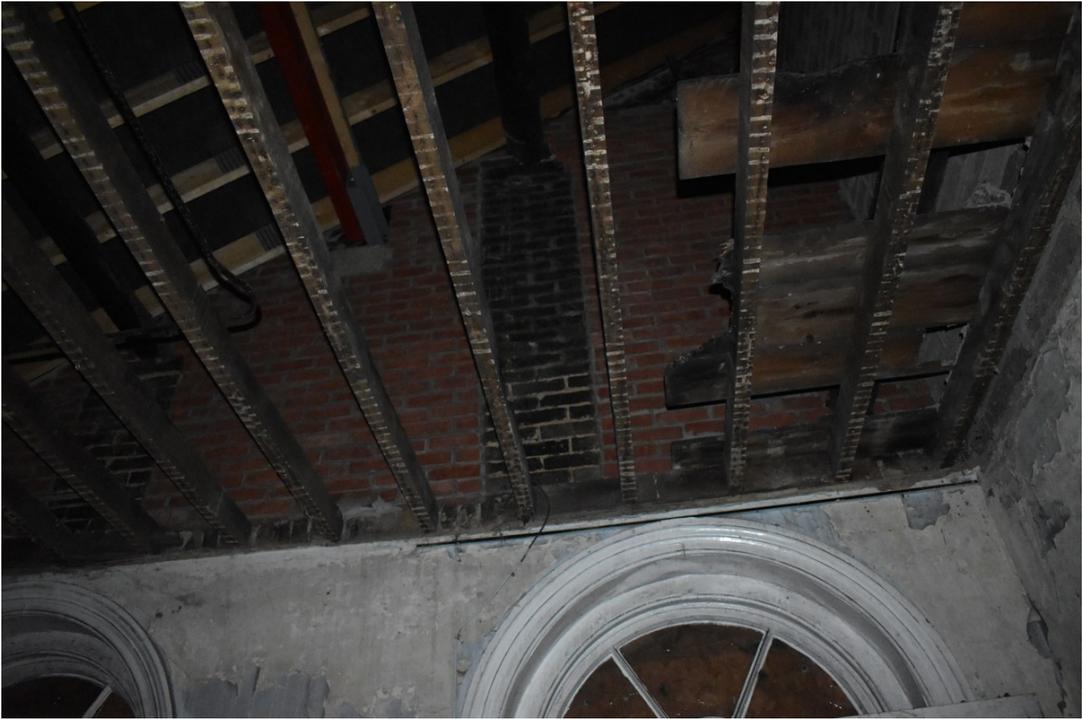
Plate 29 Engineering brick columns supporting purlins socketed into gable brickwork above room 19 - view south-east.
