Archaeological monitoring and historic building recording at Hedingham Castle, Castle Hedingham, Essex, CO9 3DG

March-April 2021

CAT Report 1664
May 2021

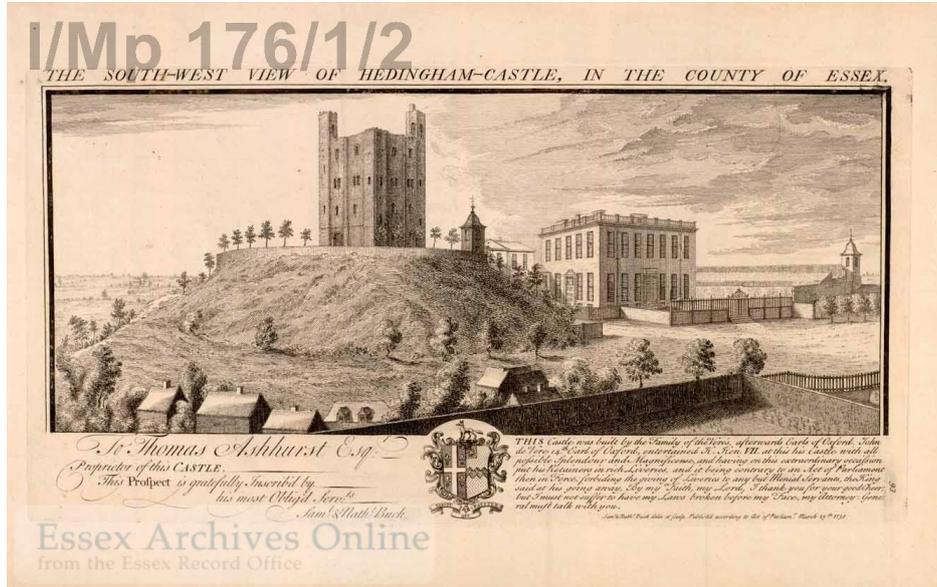
Drawing 1 1738 north-facing drawing showing the keep. The first-floor entrance and scar delineating the presumed top of the fore-building are both present, but no infilling or repair is visible. Image courtesy of Essex Record Office (ERO) I/Mp 176/1/2.

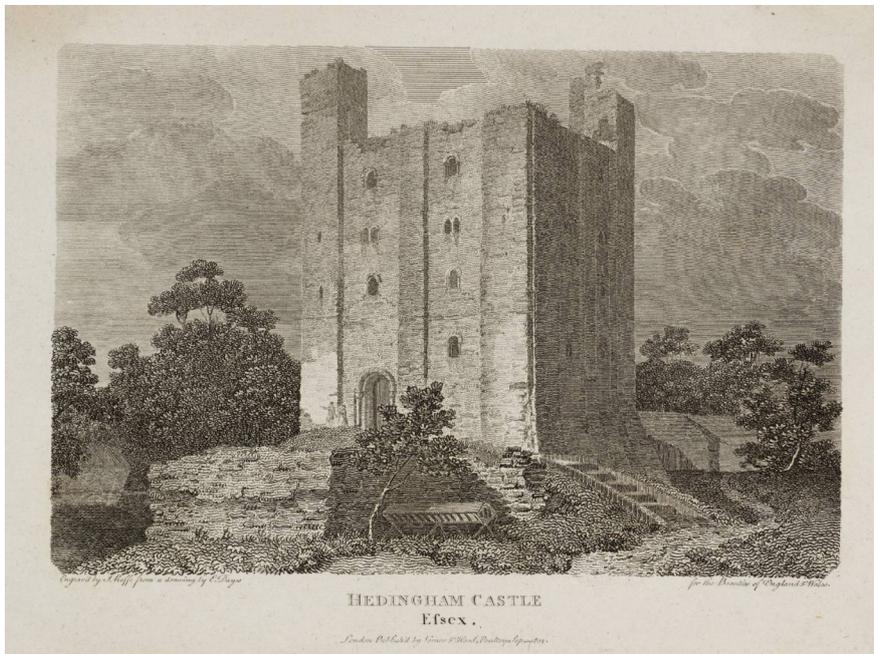
Drawing 2 1802 north-east facing drawing showing the keep. The ruined fore-building is visible, but there is no trace of any repair or infilling. Image courtesy of ERO I/Mb 176/1/5.

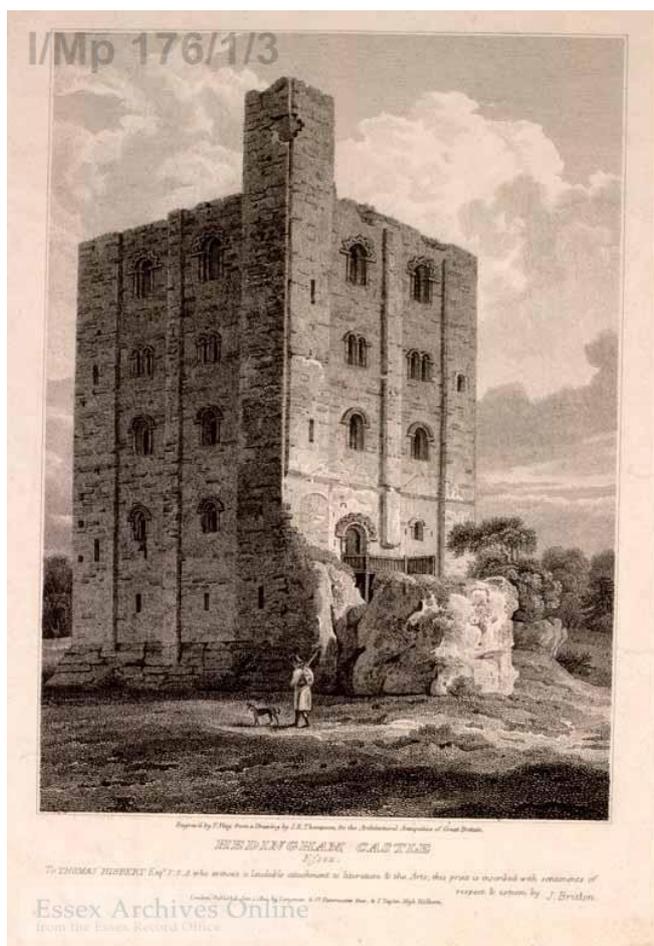
Drawing 3 1810 south-east facing drawing of the keep. No infilling or repair visible, and the window opening above the first-floor entrance clearly has a carved surround. Image courtesy of ERO I/Mp 176/1/3.

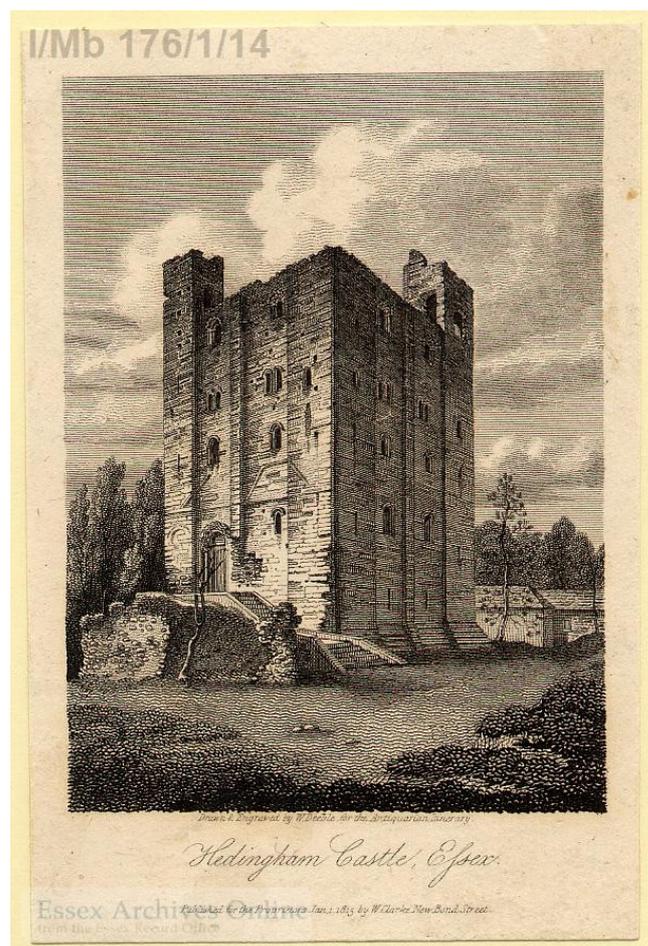
Drawing 4 1815 north-east facing drawing of keep. No infilling or repair visible. Image courtesy of ERO I/Mb 176/1/14.

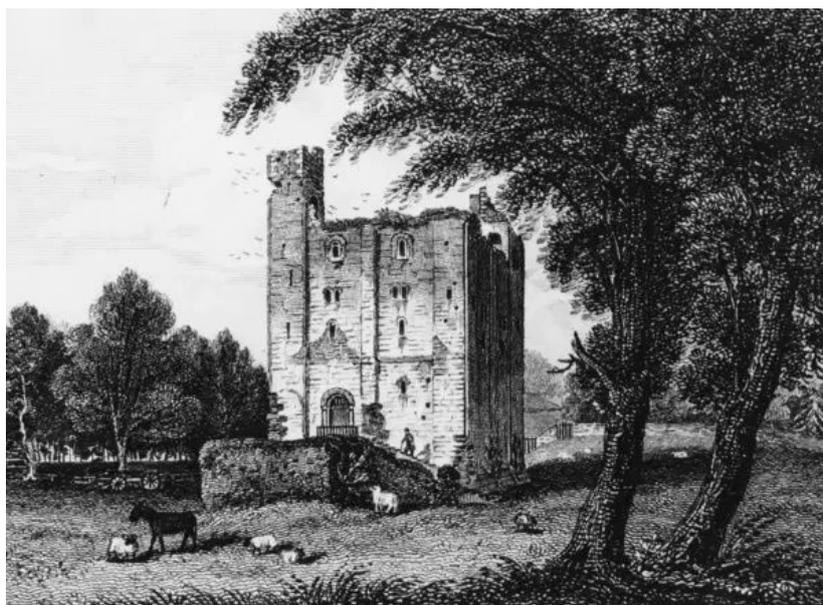
Drawing 5 1818 north-east facing drawing. Infilling/repair possibly visible above entrance way, but drawing quality is inconclusive. Image courtesy of ERO I/Mp 176/1/23.

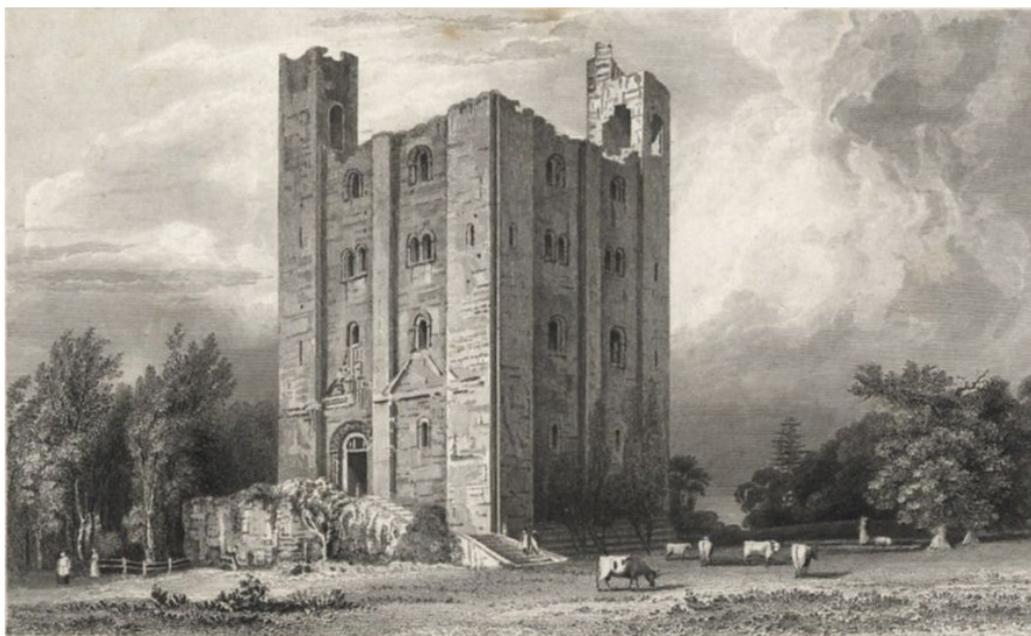
Drawing 6 1831 north-east facing drawing, showing the infilling/repair clearly for the first time. Also note the window above the first-floor entrance is now shown as smaller than in previous drawings, without a carved surround. Drawing courtesy of ERO I/Mp 176/1/24.

Judging from these drawings it would seem that the infilling does not appear on the side of the keep until 1831, well after the fore-building's demolition. All the previous drawings (apart from perhaps the 1818 example) show no indication of this section of wall being any different than the rest of the keep's ashlar facing.
