**CAT Report 1888
issued March 2023**

**Historic building recording at Thrift Farm,
Moulsham Thrift, Chelmsford, Essex, CM2 8BP**

**CAT project ref.: 2022/08i
ECC code: CFTF22**

October 2022

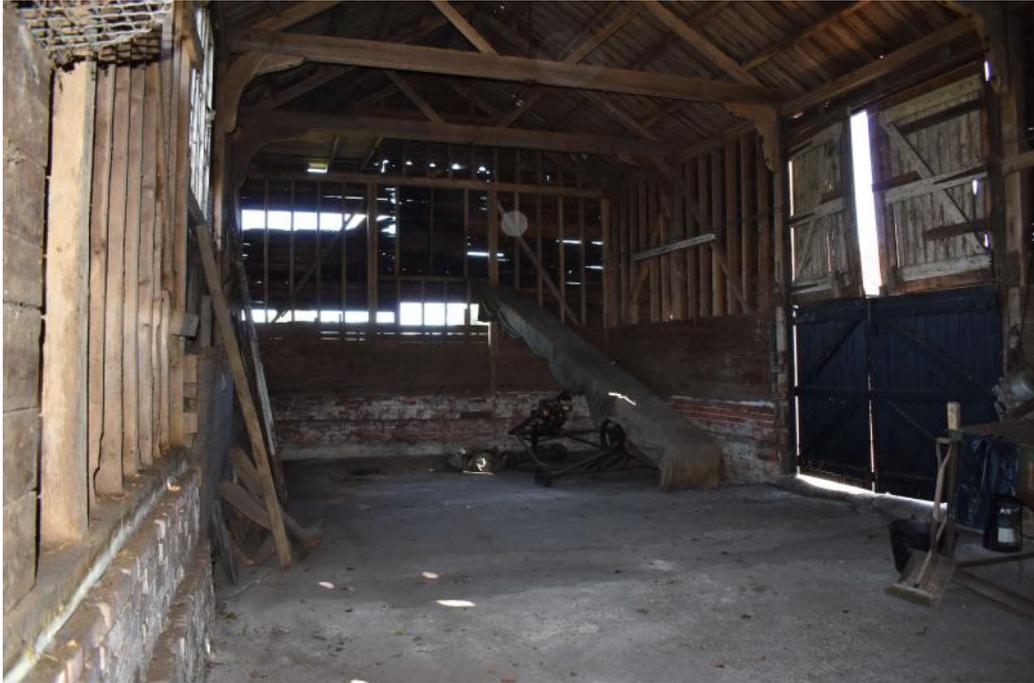
Photograph 8 Interior of barn. Photograph taken facing north-east.

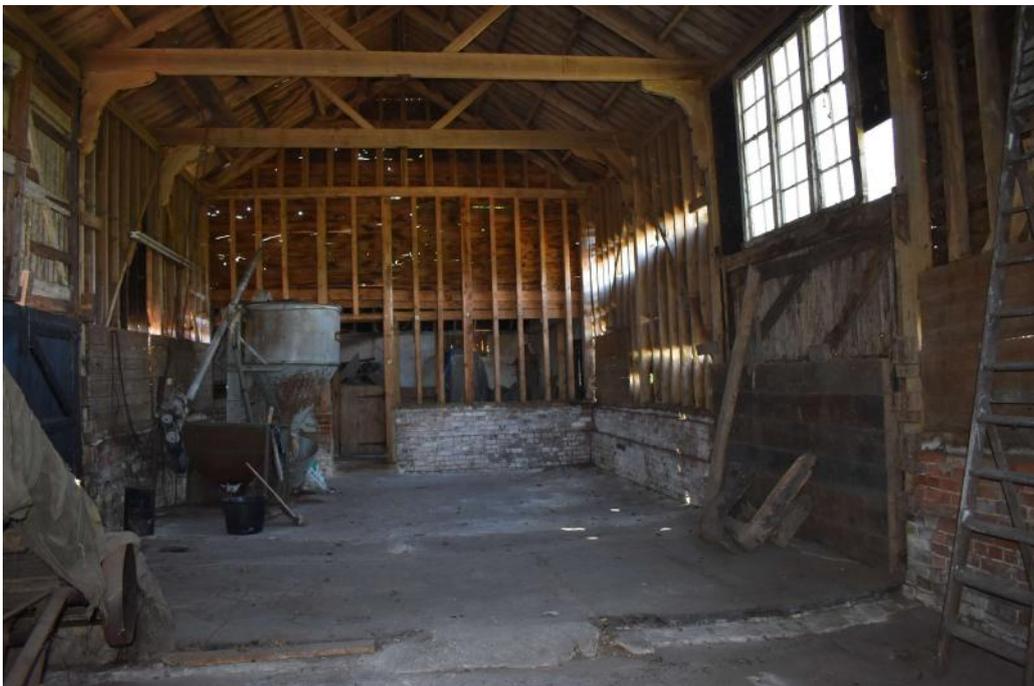
Photograph 9 Interior of barn. Photograph taken facing south-west.

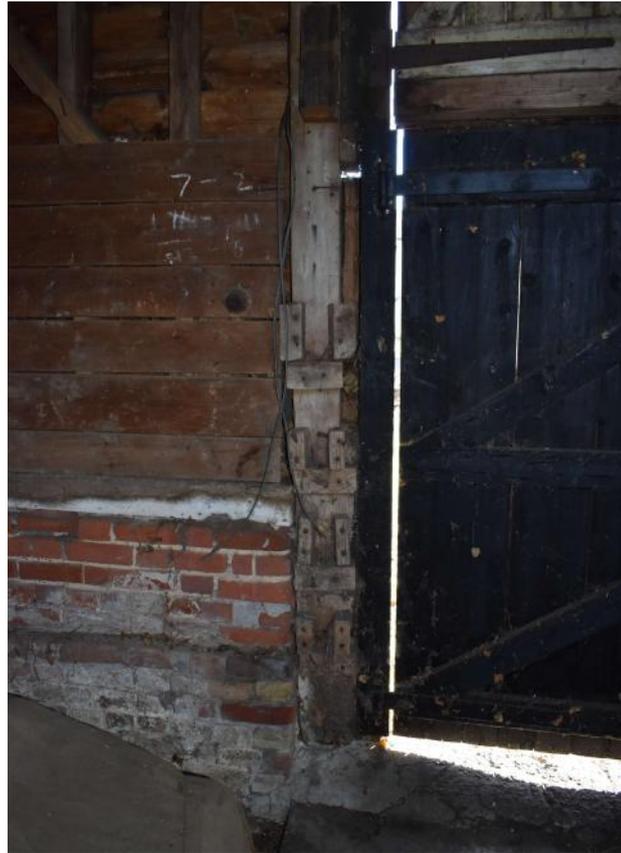
Photograph 16 Detail of wooden blocks adjacent to barn door on eastern wall. Photograph taken facing north-east.

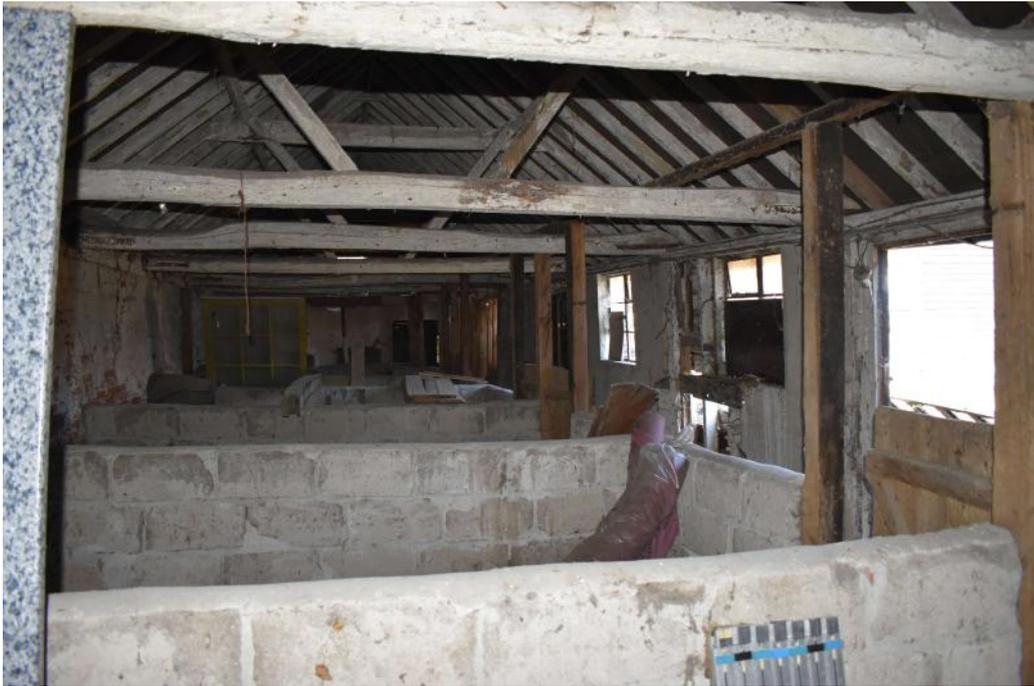
Photograph 20 Interior of store 5. Photograph taken facing north-west.

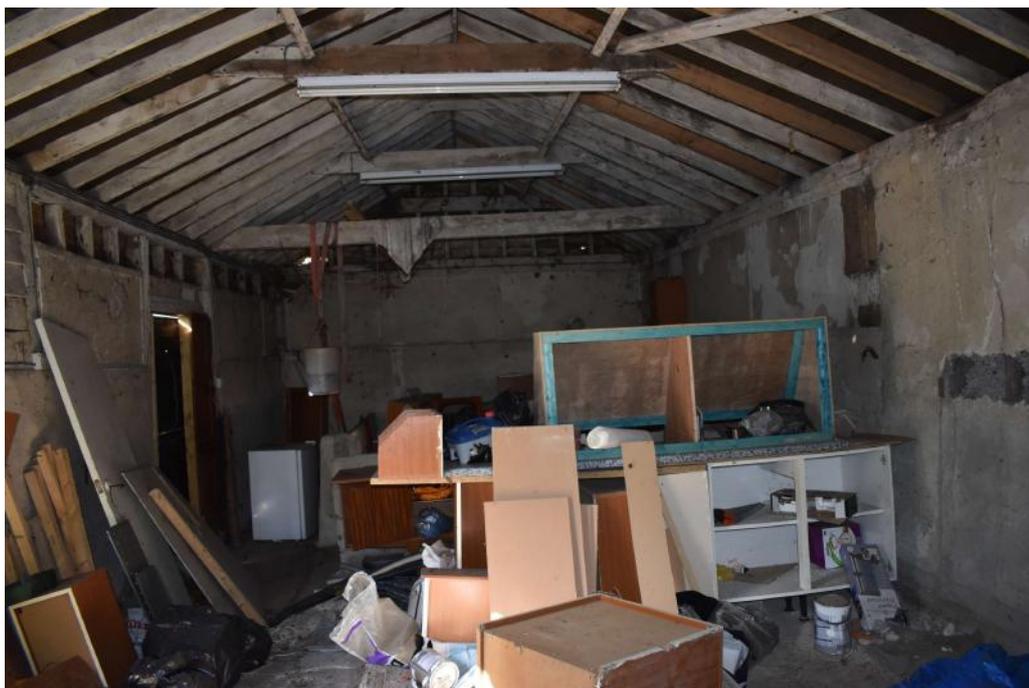
The walls of store 9 are mostly rendered with areas of wooden cladding. It appears that the southern wall was original closed and that the two windows (now boarded over) and two doors are all inserted. This indicates that the northern wall was probably originally open, and stores 9 and 12 were the original open-fronted cart-lodge.

Photograph 23 Interior of store 9. Photograph taken facing north-west.

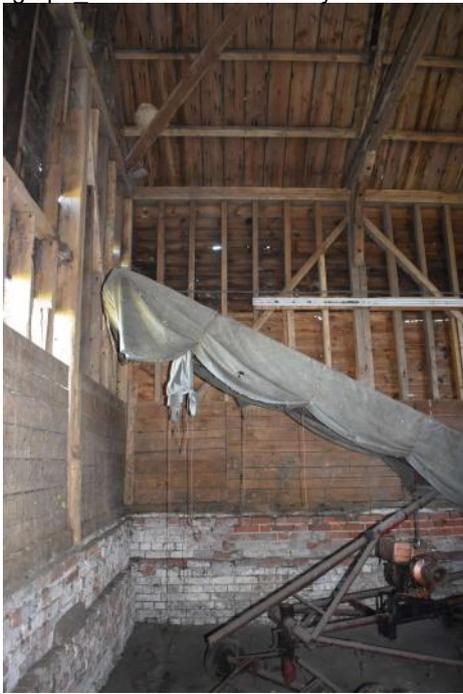
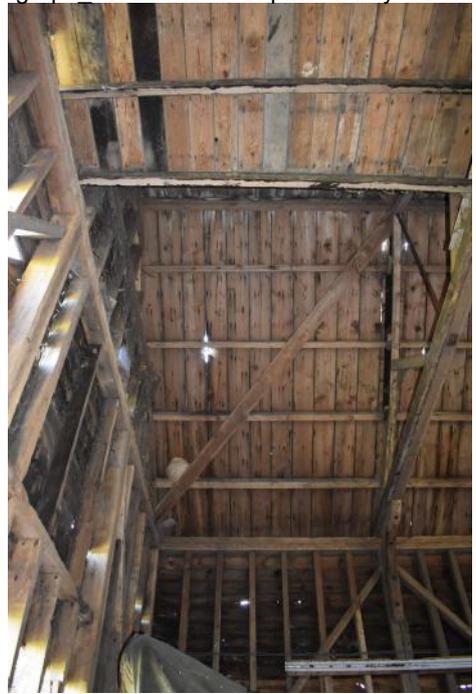
CFTF22_PhotoGraph_109Eastern wall of bay 5 of barn. Photograph ta... CFTF22_PhotoGraph_110Eastern roof-pitch of bay 5 of barn. Photogra...

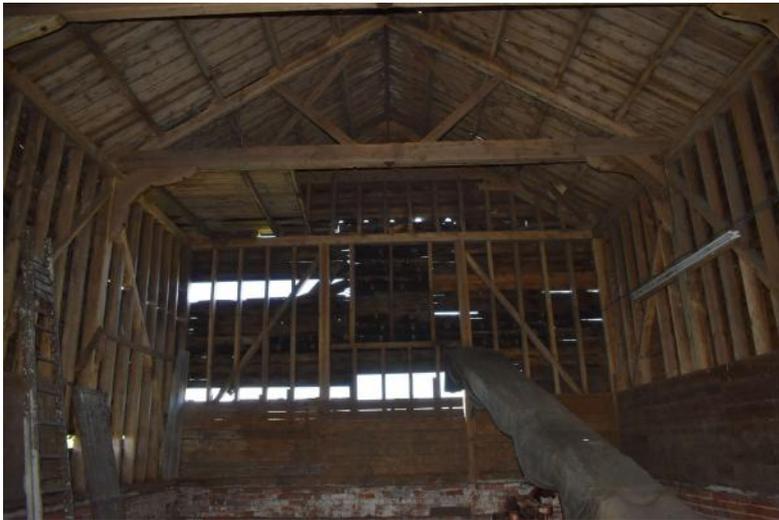
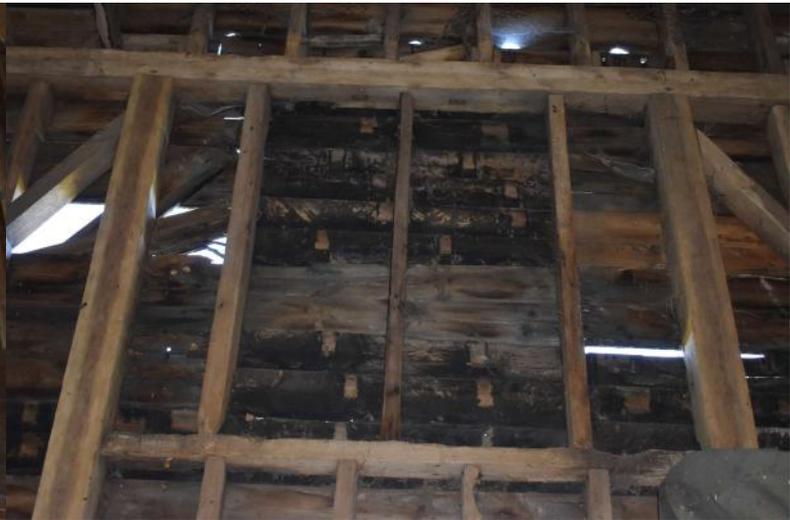
CFTF22_PhotoGraph_111Northern wall of bay 5 of barn. Photograph ta... CFTF22_PhotoGraph_112Detail of boarded-up inserted pitching door i...

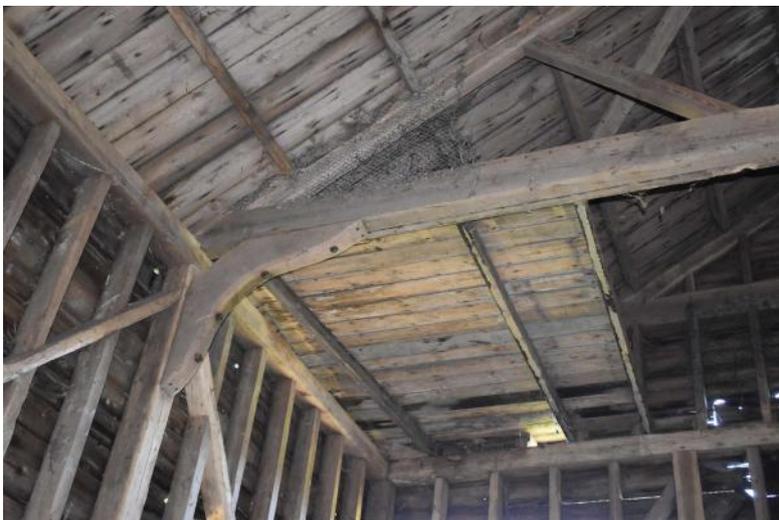
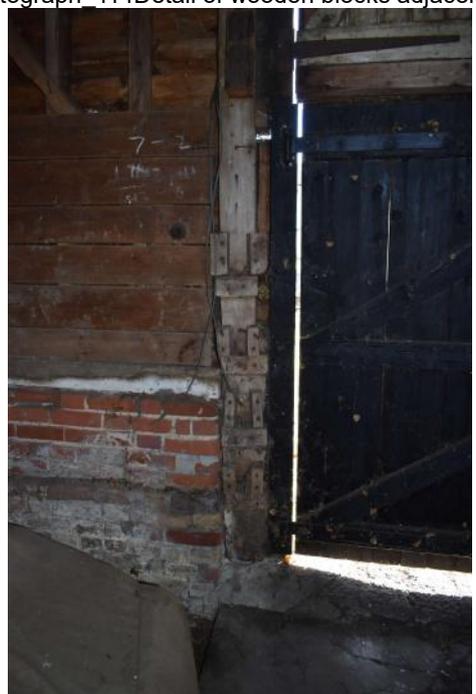
CFTF22_PhotoGraph_113Detail of inserted loft level in bay 5 of barn. P... CFTF22_PhotoGraph_114Detail of wooden blocks adjacent to barn do...

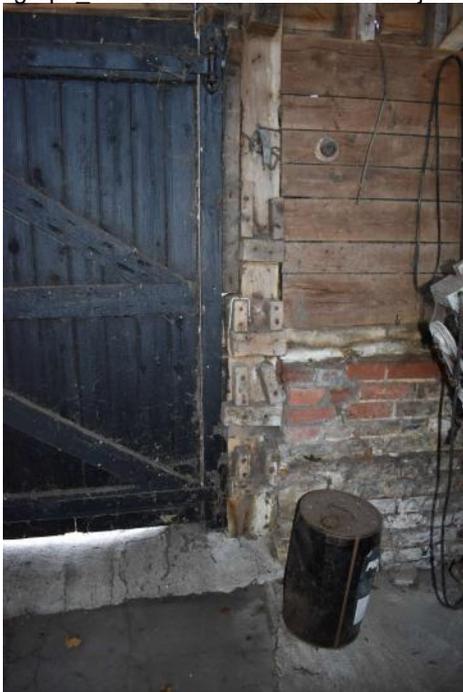
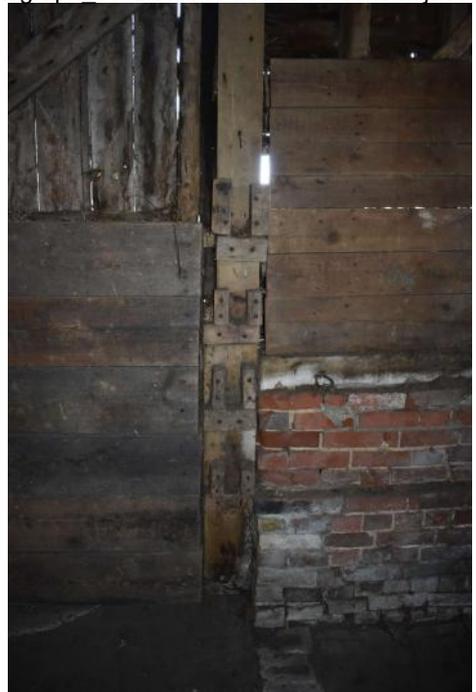
CFTF22_PhotoGraph_115Detail of wooden blocks adjacent to barn do... CFTF22_PhotoGraph_116Detail of wooden blocks adjacent to barn do...

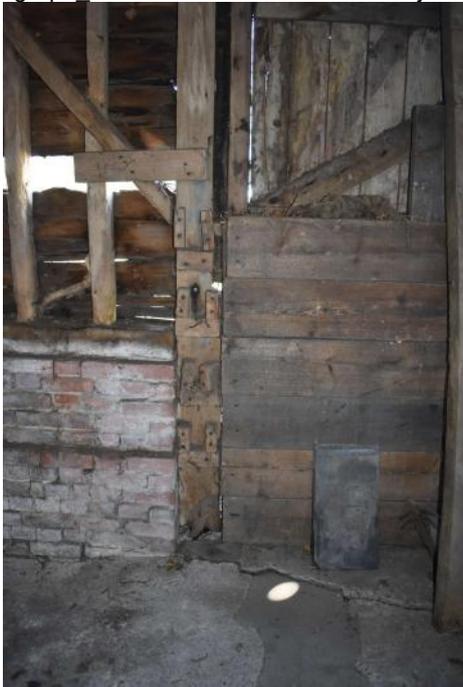
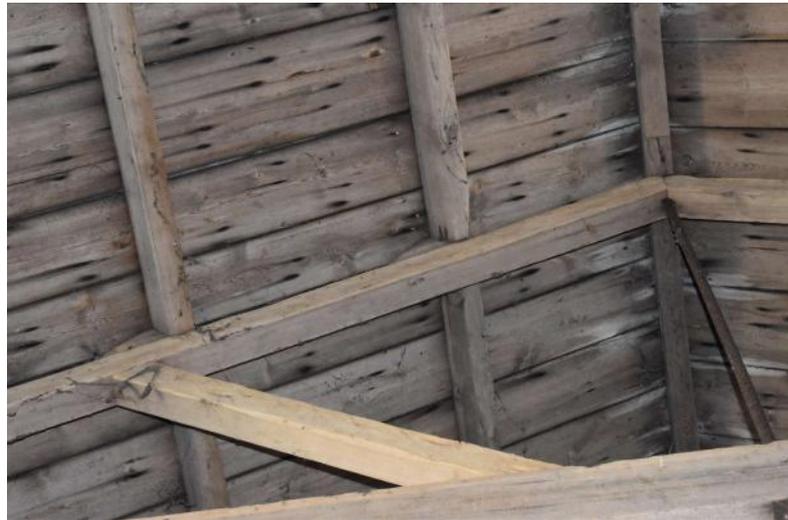
CFTF22_PhotoGraph_117Detail of wooden blocks adjacent to barn do... CFTF22_PhotoGraph_118Detail of upper scarf-joint in purlin in western...

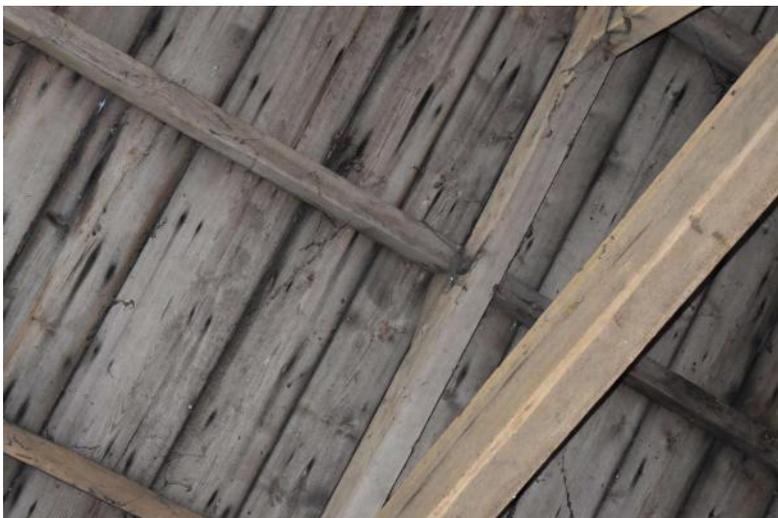
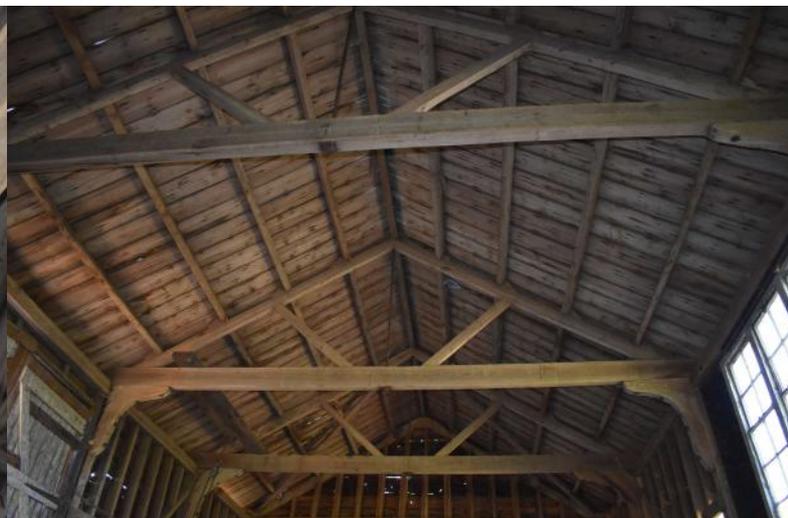
CFTF22_PhotoGraph_119Detail of lower scarf-joint in purlin in western ... CFTF22_PhotoGraph_120Detail of barn roof truss. Photograph taken f...

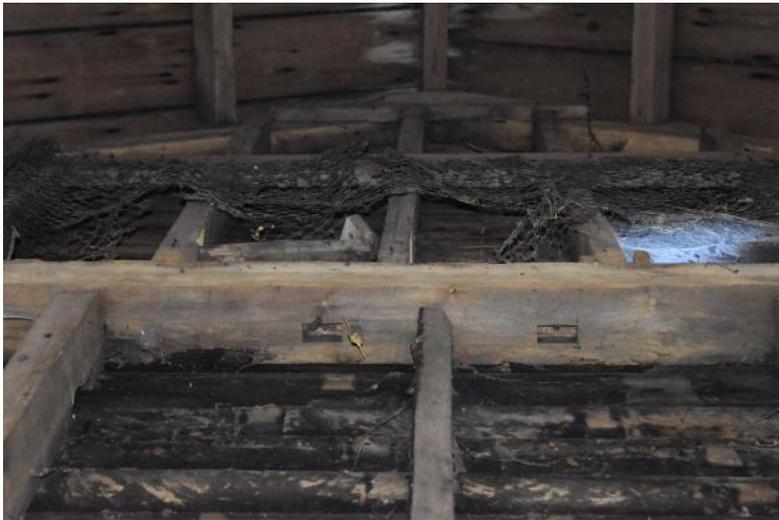
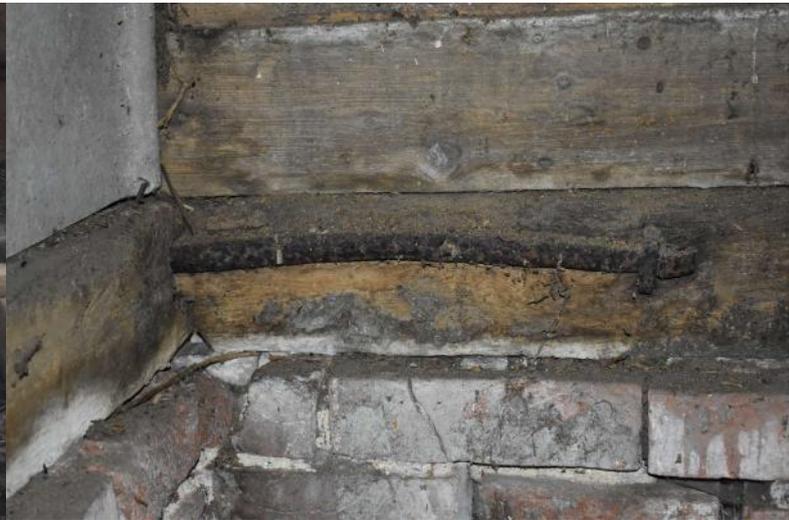
CFTF22_PhotoGraph_123Detail of empty mortices in gable-tie in bay 5... CFTF22_PhotoGraph_124Detail of iron strap on sill-beam of northern ...

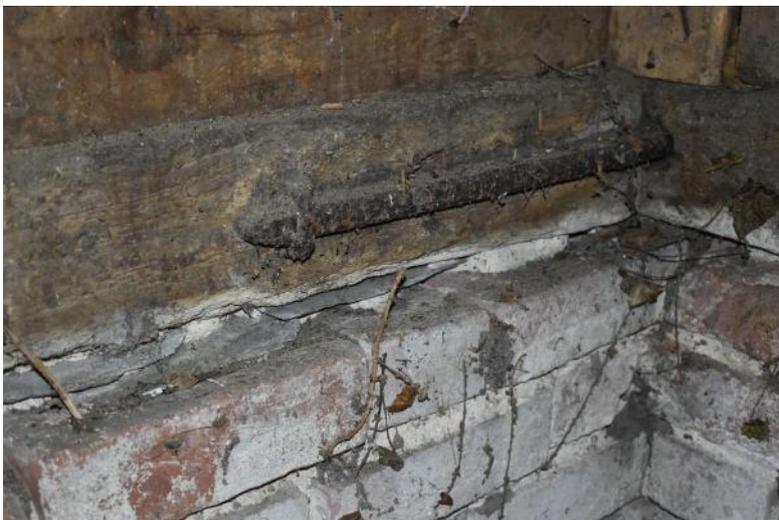
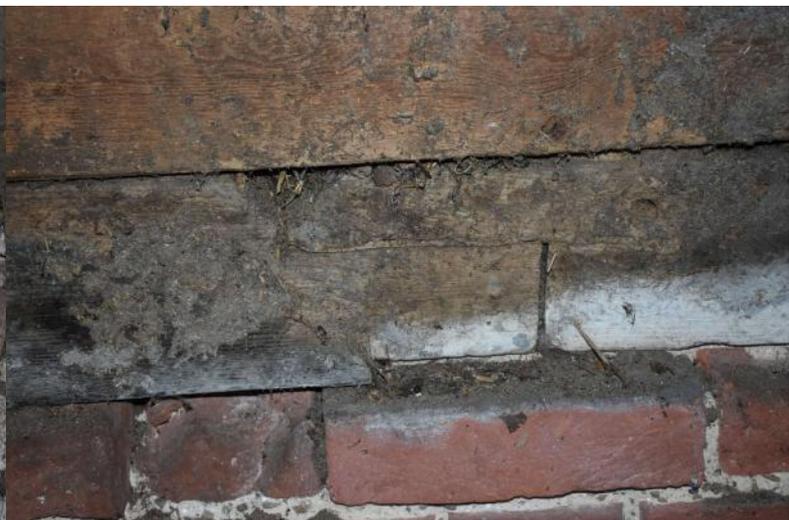
CFTF22_PhotoGraph_125Detail of iron strap on sill-beam of northern ... CFTF22_PhotoGraph_126Detail of scarf joint on sill-beam in eastern w...

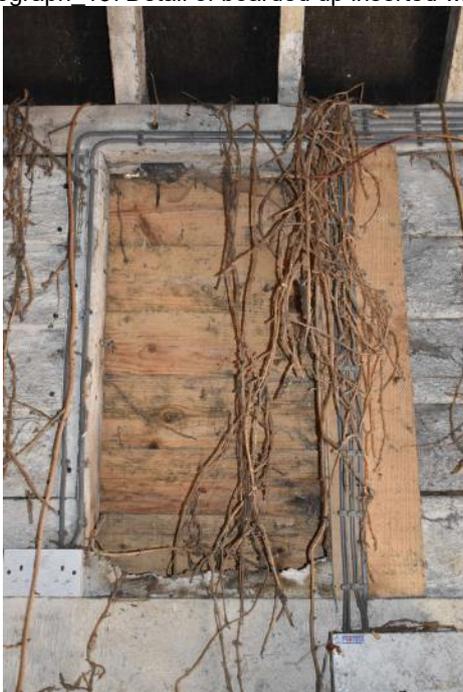
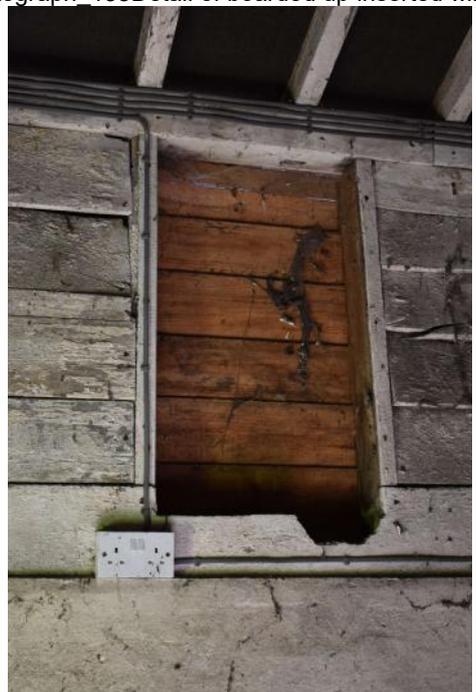
CFTF22_PhotoGraph_137Detail of boarded up inserted window on sou... CFTF22_PhotoGraph_138Detail of boarded up inserted window on sou...

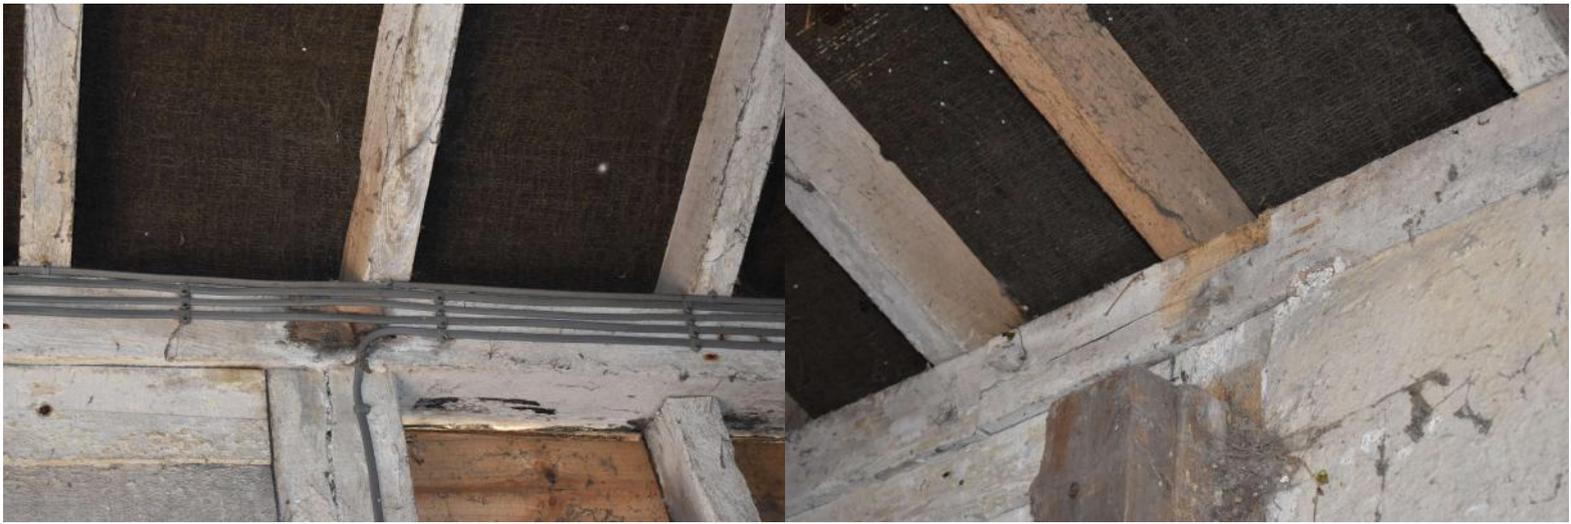
CFTF22_PhotoGraph_139Detail of removed tie-beam in store 9. Photo... CFTF22_PhotoGraph_140Detail of removed tie-beam in store 9. Photo...

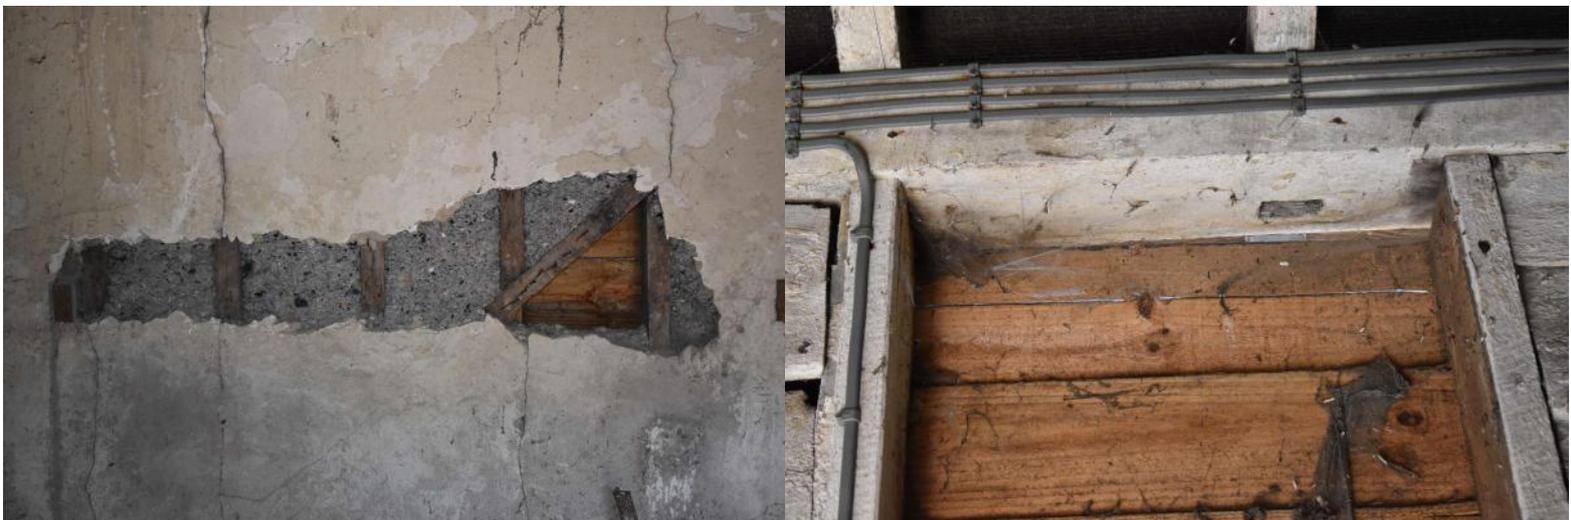
CFTF22_PhotoGraph_143Detail of timber-frame beneath damaged pla... CFTF22_PhotoGraph_144Detail of empty mortice in wall-plate of south...

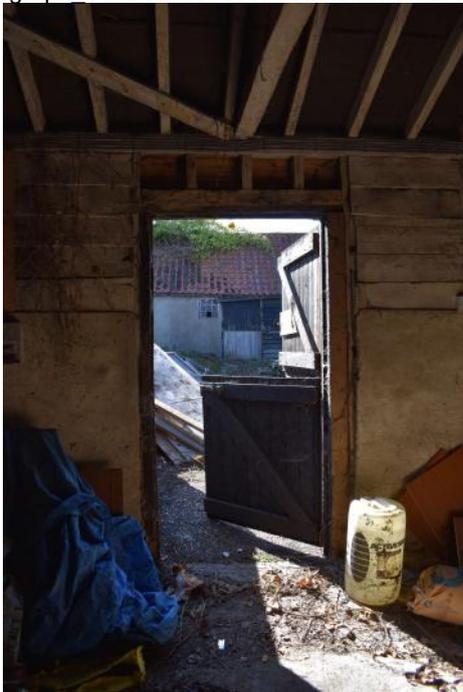
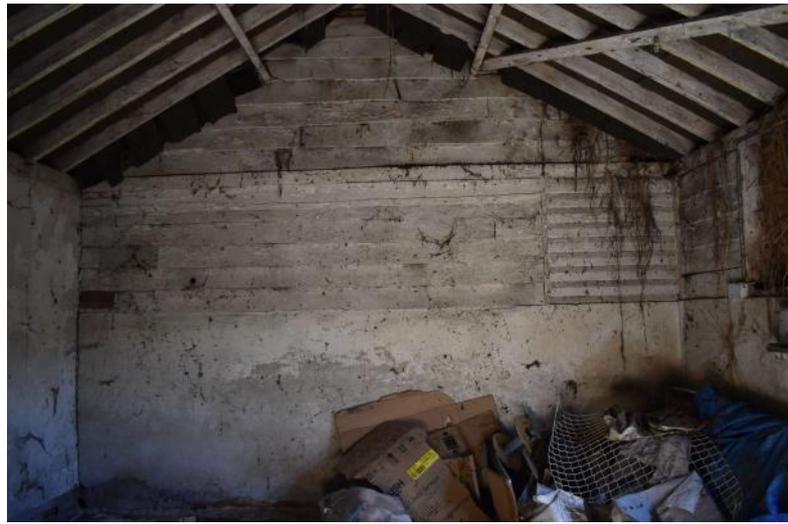
CFTF22_PhotoGraph_145Detail of door southern wall of store 9. Photo... CFTF22_PhotoGraph_146Inserted eastern wall of store 9. Photograph ...
