**CAT Report 1912
issued April 2023**

**Historic building recording of a bothy, glasshouse,
boilerhouse and other garden structures in the
walled kitchen garden at St Osyth's Priory,
St Osyth, Essex, CO16 8GW**

**CAT project ref.: 2023/01i
ECC code: STOWG23**

February 2023

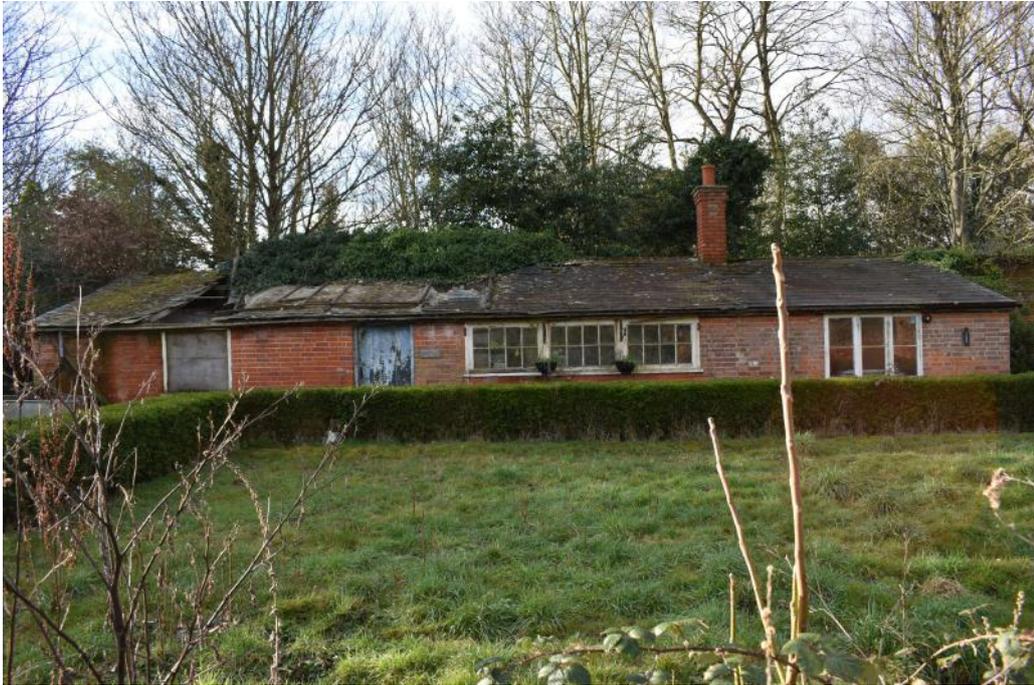
Photograph 1 Northern elevation of bothy. Photograph taken facing south-west.

The northern elevation (Photograph 1) has three windows and one door. The door is vertically planked and located in the eastern half of the elevation. The eastern most window has been boarded up. The middle window comprises three abutting eight-light windows, the central one of which has a horizontal-awning opening while the flanking two are fixed (Photograph 2). The western most window is six-light with two vertical-awning openings.

At the eastern end of the elevation, a curved brick corbel is present in the eaves. It is only a single brick wide. On the iron gutter at the western end is a decorative lion's head (Photograph 3).

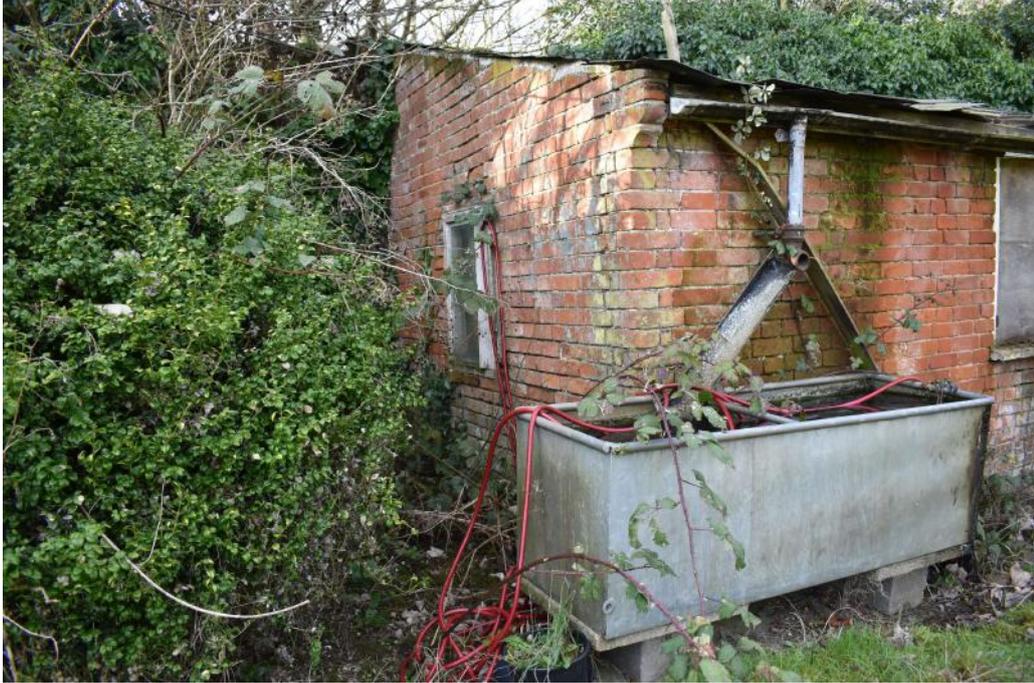
Photograph 4 Eastern elevation of bothy. Photograph taken facing south-west.

The eastern elevation (Photograph 4) has a single-light fixed window. There is a curved brick corbel present in the eaves on the northern edge of this elevation.

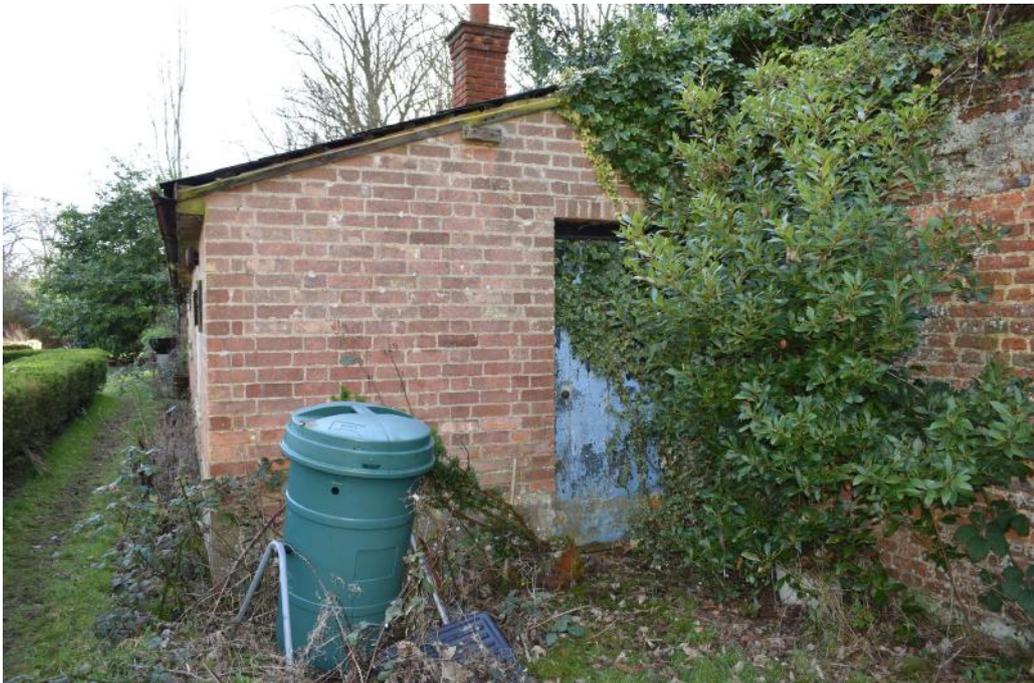
There is a single door in the southern (Photograph 6) and western elevations (Photograph 5). The southern door is a reused door, which appears to be in an existing doorway, and has a stone doorstep.

Photograph 5 Western elevation of bothy. Photograph taken facing south-east.

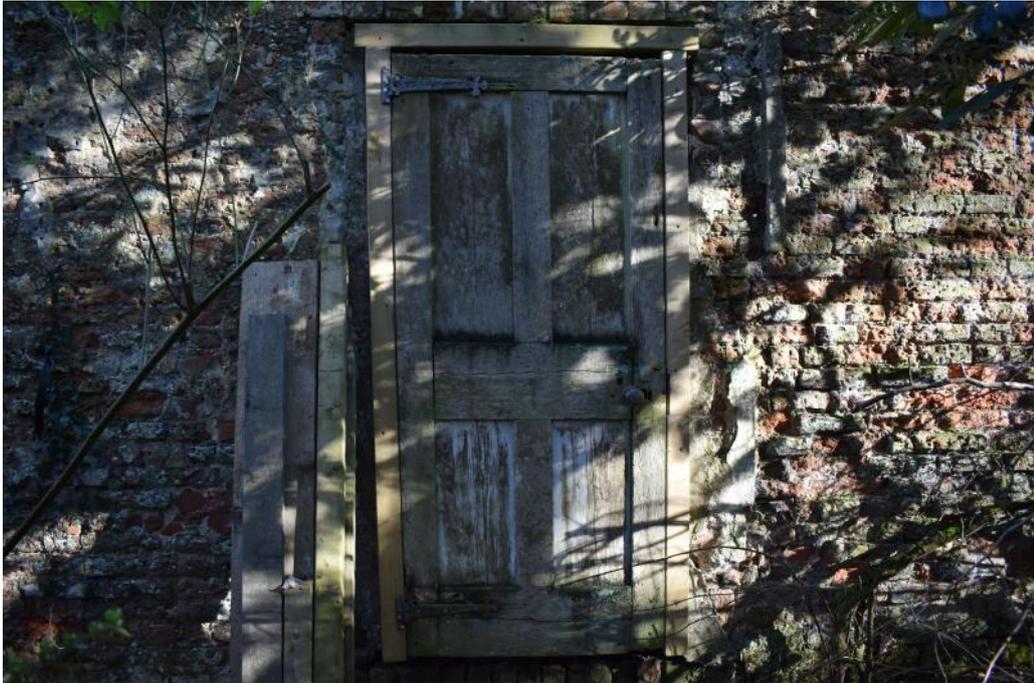
Photograph 6 Detail of door in southern elevation of bothy. Photograph taken facing north north-east.

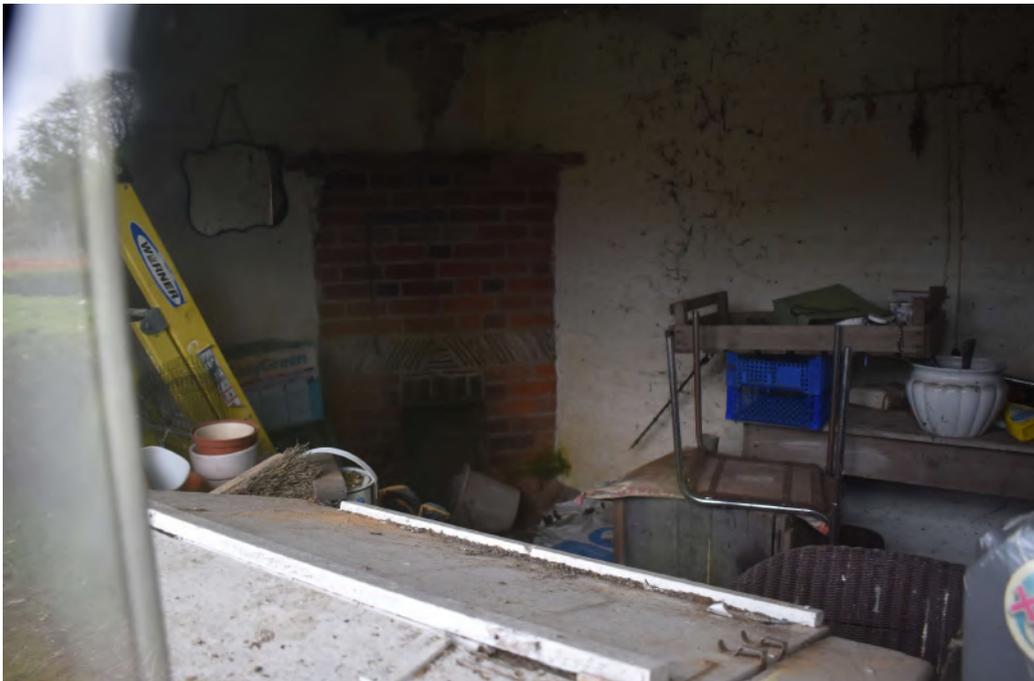
Photograph 9 Interior of bothy (locked room, through window). Photograph taken facing south-east.

Through the window of the small room, it could be observed that there is a brick fireplace with a decorative tile course (Photograph 9). Two small tie-beams and a timber wall-plate were also observed.

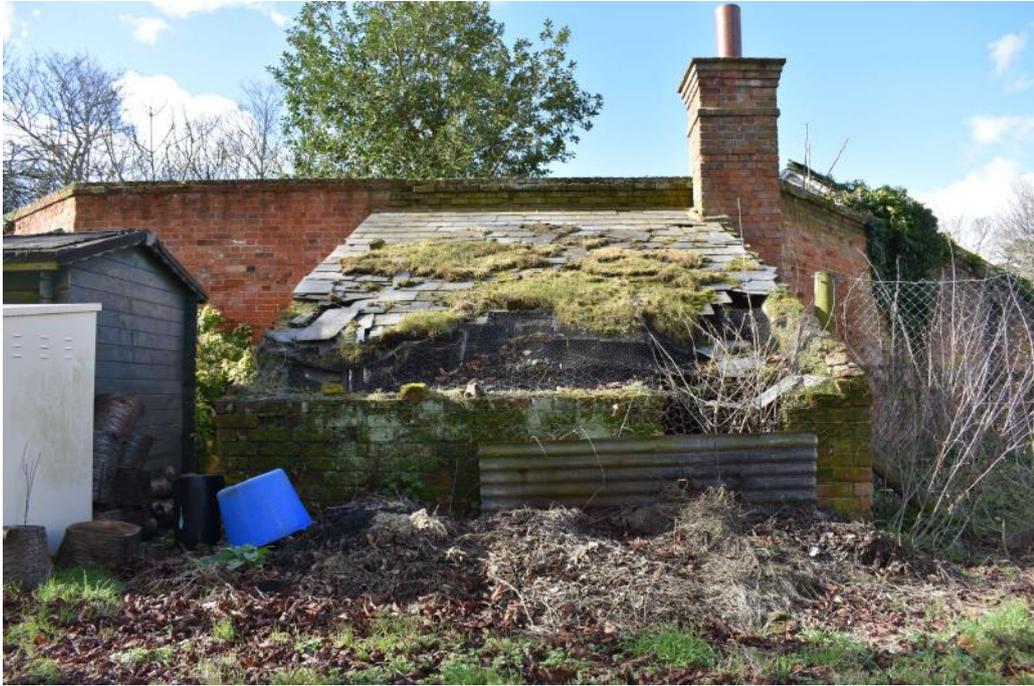
Photograph 17 North-east elevation of boilerhouse. Photograph taken facing south-west.

An opening is present in north-east elevation (Photograph 17). There is no evidence there was ever a door on the opening. There is a single window on the south-east elevation (Photograph 19). Although no glass remains, it would have been a fixed six-light window. The north-west elevation is plain brick with a chimney breast (Photograph 18).

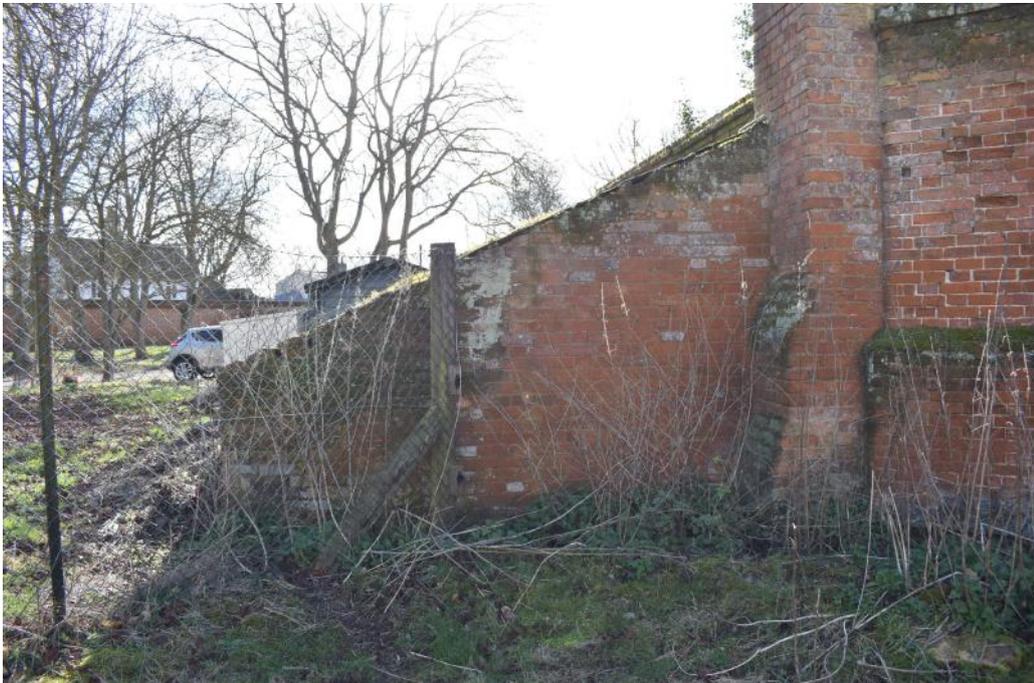
Photograph 18 North-west elevation of boilerhouse. Photograph taken facing south-east.

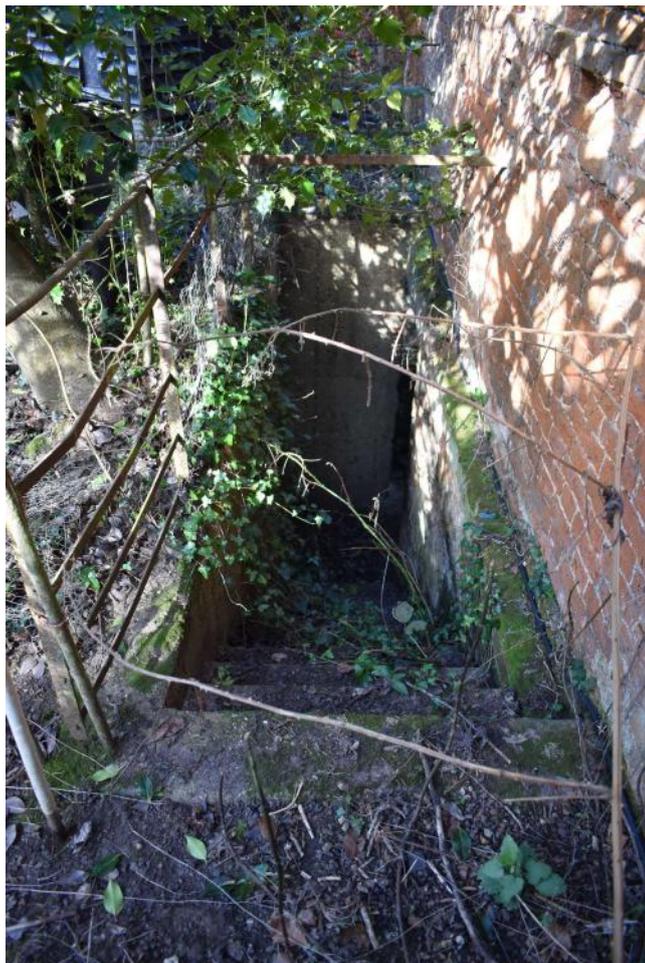
Photograph 20 Detail of stairs to boilerhouse. Photograph taken facing north-west.

The south-west elevation is dominated by the 19th-century garden wall. There is a wrought iron railing surrounding concrete steps which lead underground (Photograph 20).

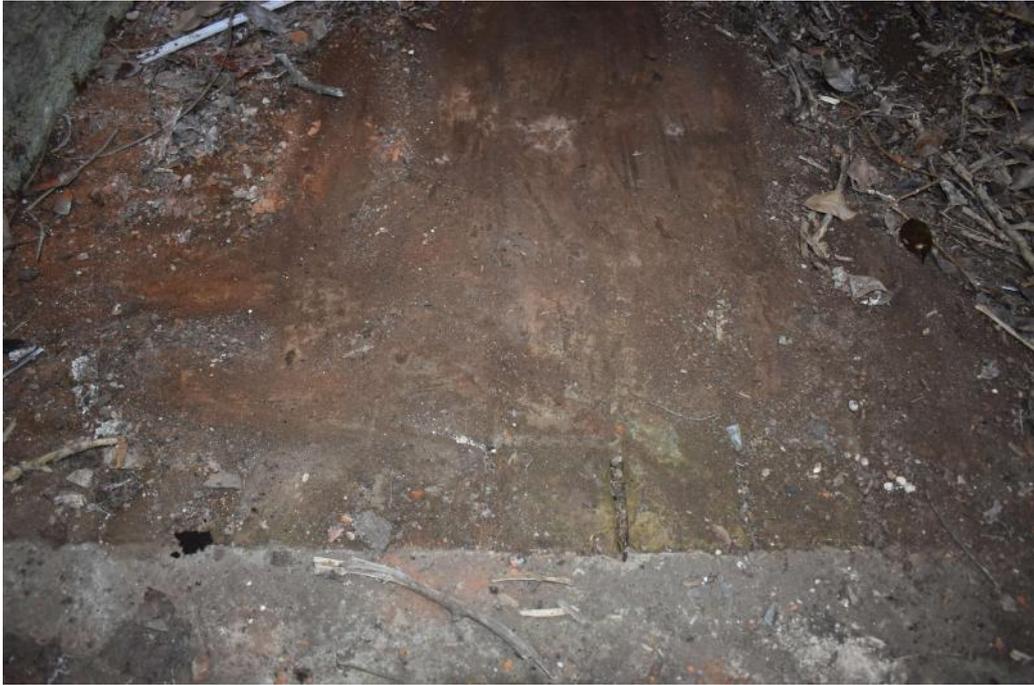
The floor of the boilerhouse is mainly poured concrete except one area where a brick floor is present. The bricks are laid flat and appear to be yellow in colour (Photograph 22).

Photograph 22 Detail of brick floor in boilerhouse. Photograph taken facing north-west.

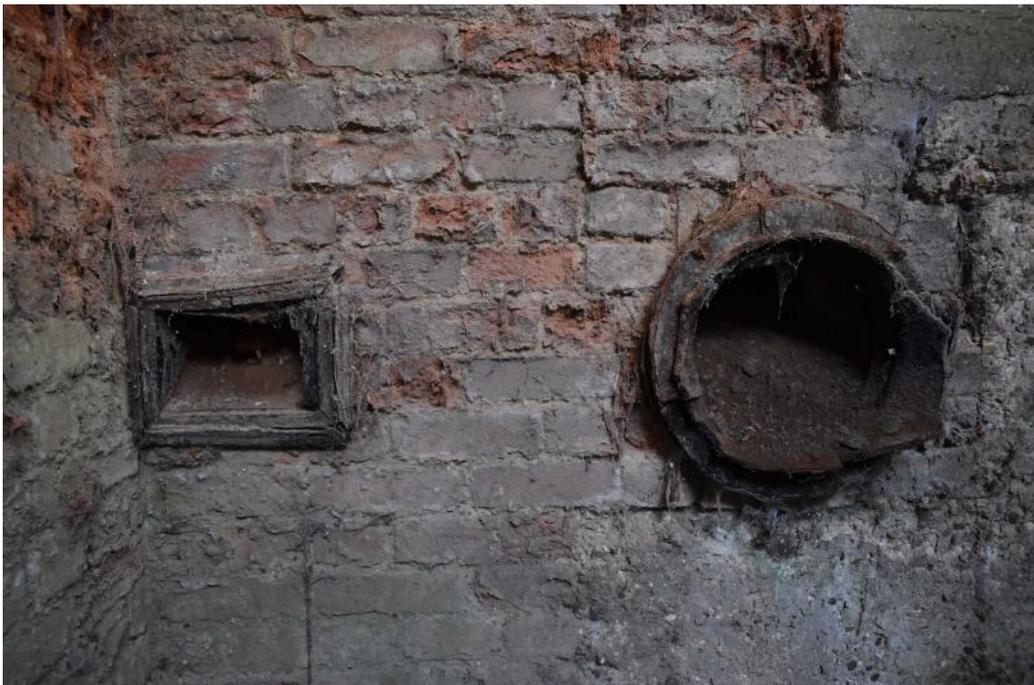
There is a doorway in the south-west wall (below ground) and an opening in the north-east wall (ground level). There is a window in the south-east wall. In the south-west and north-west walls are the remains of six iron pipes, five round and one rectangular (Photograph 23). Layers of flat iron sheeting has been incorporated in the brick work in the south-west wall, above the pipes, likely to protect the pipes from the weight of the brickwork. There is also an iron post next to the dividing wall.

Photograph 23 Detail of pipework in north-west wall of boilerhouse. Photograph taken facing north-west.

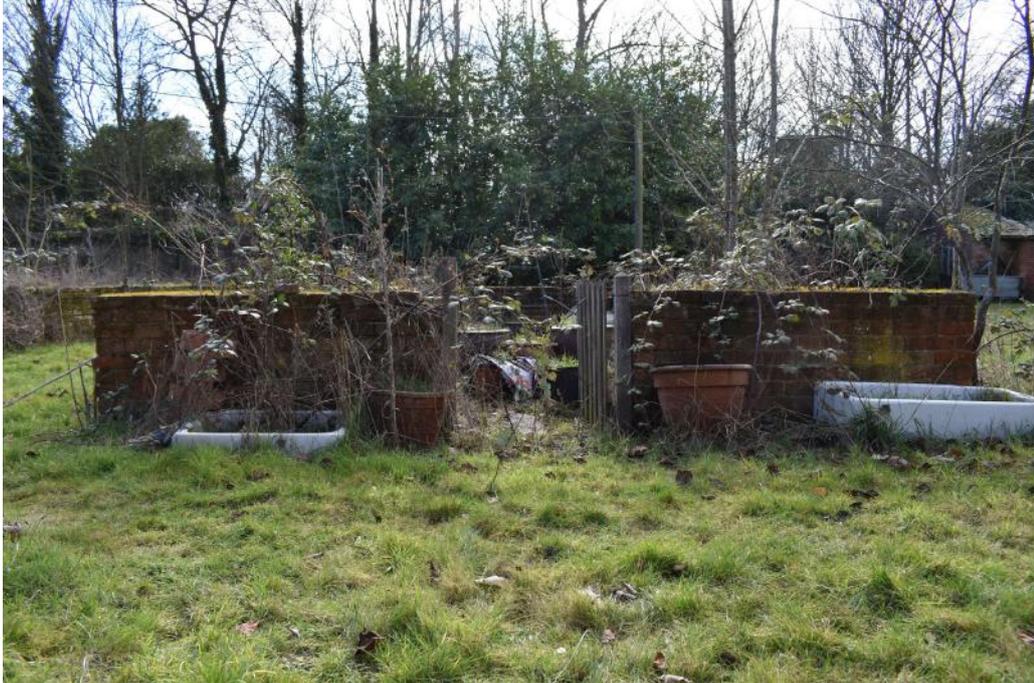
Photograph 24 Northern elevation of glasshouse base A. Photograph taken facing south south-west.

Glasshouse base A has an entrance on the northern elevation with a modern wooden gate (Photograph 24). On the southern elevation is area an area of brickwork laid in Flemish bond, either an area of repair or an entrance that has been blocked. There is rectangular concrete pond in the centre of structure.

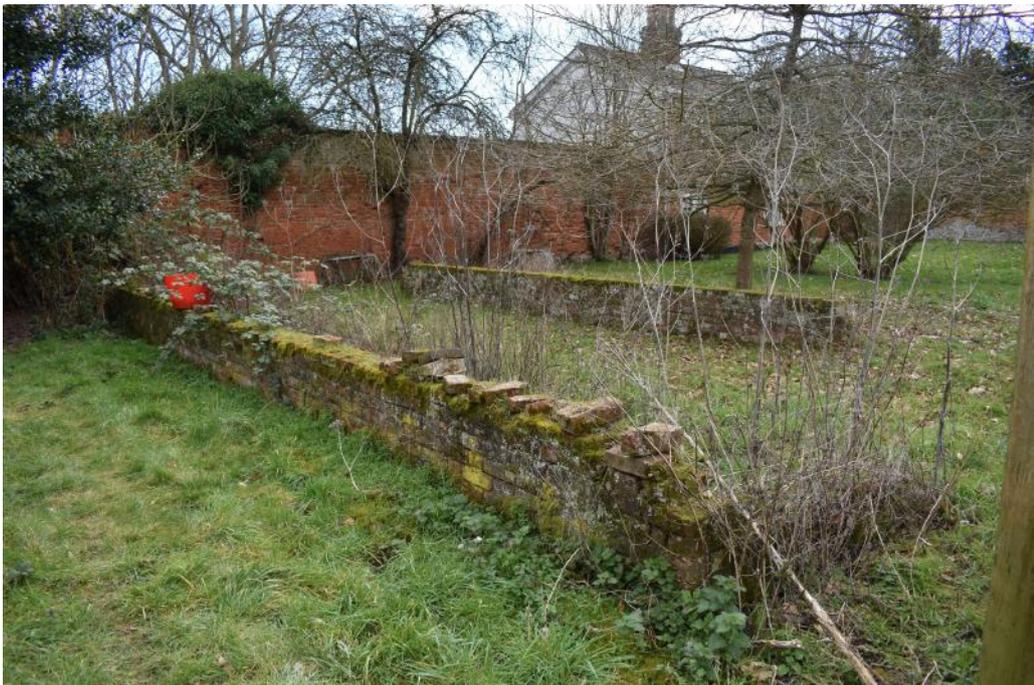
There are the remains of two brick raised beds parallel to one another (Photograph 27). Mapping indicates there were originally three beds, but none of the third remains.

Photograph 27 Northern elevation of raised beds. Photograph taken facing south-east.
