**CAT Report 1943  
issued June 2023**

**Historic building recording of a barn at  
Tylde Hall Farm, Heath Road, Ramsden Heath,  
Billericay CM11 1HP**

**CAT project ref.: 2023/04a  
CAT Report 1943**

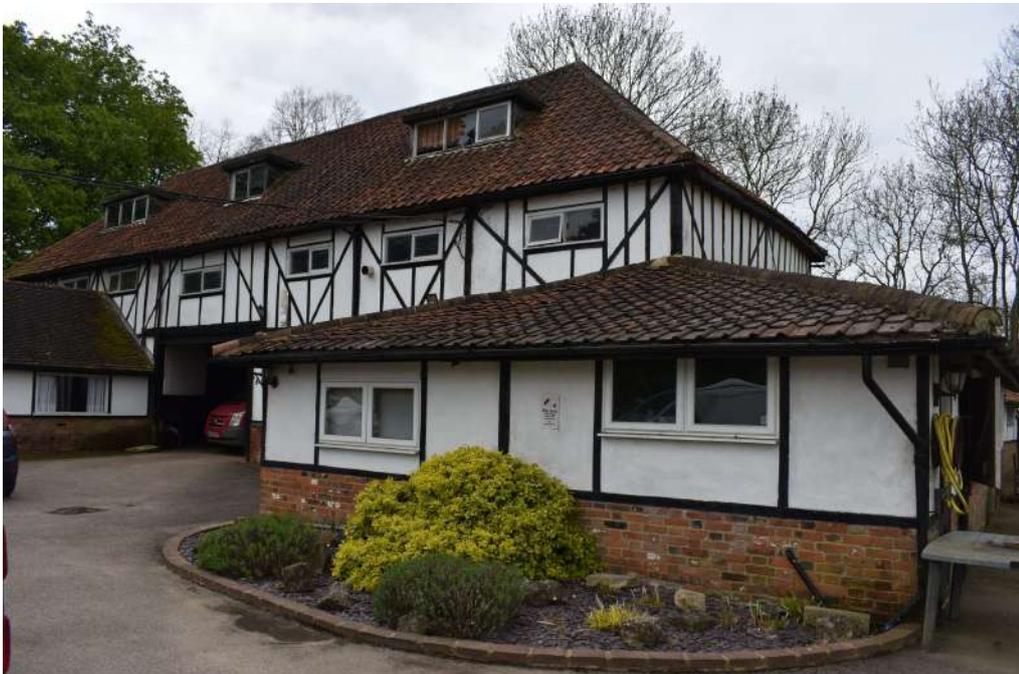
**Photograph 1** Eastern elevation. Photograph taken facing south-west.

On all elevations the timber-frame is exposed and painted black with a mortar infill, painted white. In many areas, the timber-frame of the barn has been altered or rebuilt – particularly where the windows have been inserted. All windows are timber-framed except those on the kitchen. All dormer windows have a flat roof covered with roofing felt.

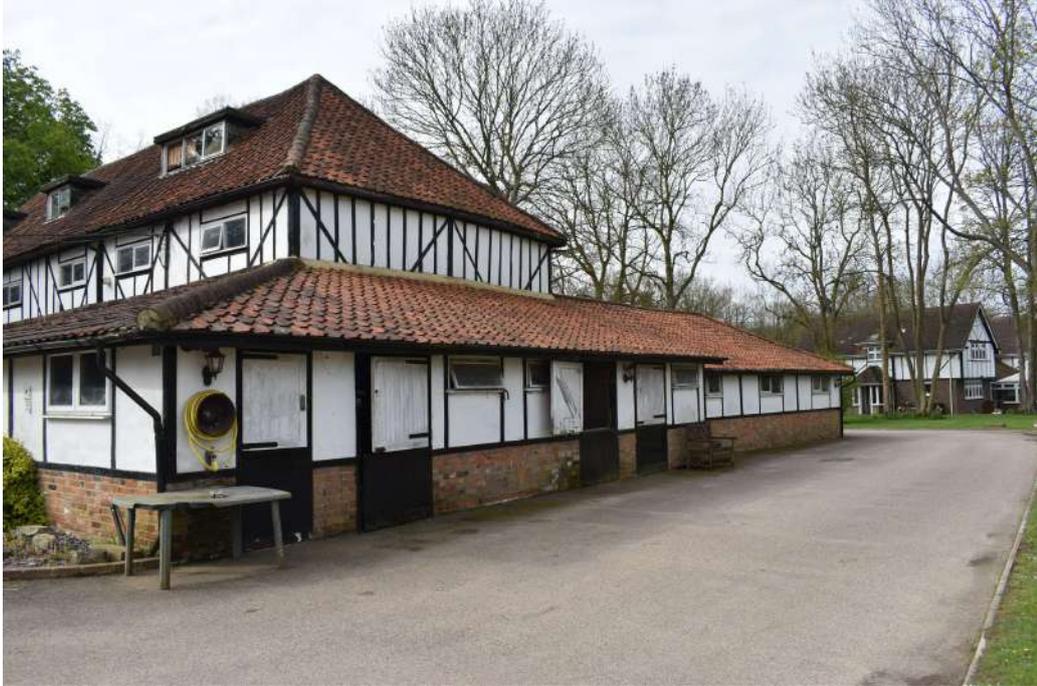
**Photograph 6** Northern elevation. Photograph taken facing south south-west.

It seems likely that some of the timber-frame on this elevation of midstrey has been rebuilt as the frame does not align with the barn's timbers.

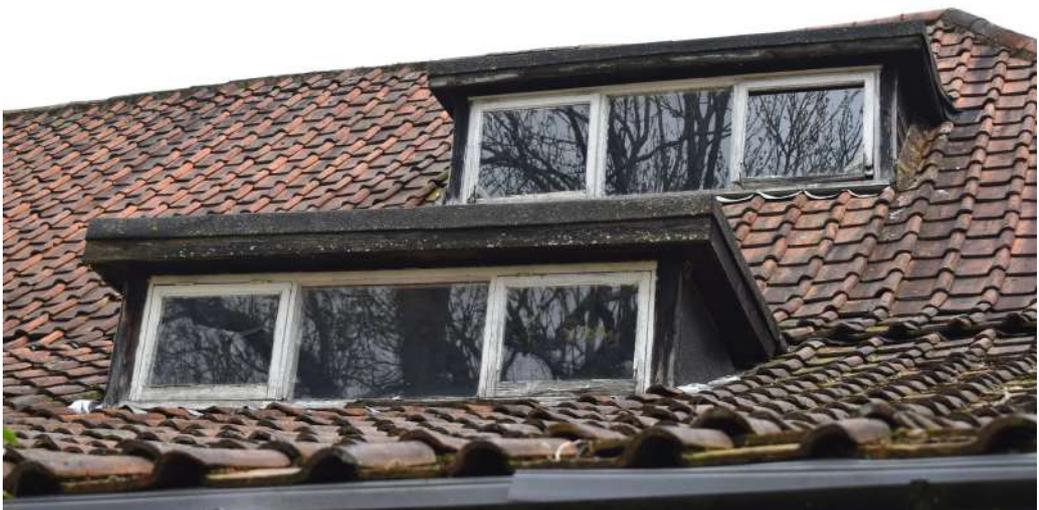
**Photograph 9** Detail of dormer windows on western elevation of barn and barn extension. Photograph taken facing north-east.

The western elevation of the barn has four inserted awning windows in the walls and two inserted dormer windows in the roof. The midstrey and the barn extension have four awning windows, including a dormer window on the roof of the extension. There is an inserted section of wall in midstrey, which has replaced the original barn doors. It seems likely the midstrey has also reduced in height; the original midstrey doors would have been the same height at the original barn doors on the eastern elevation. This is evidenced by the change in bond in the brick plinth between the two posts (possibly the original door frame) and the change in style of the timber-framing.

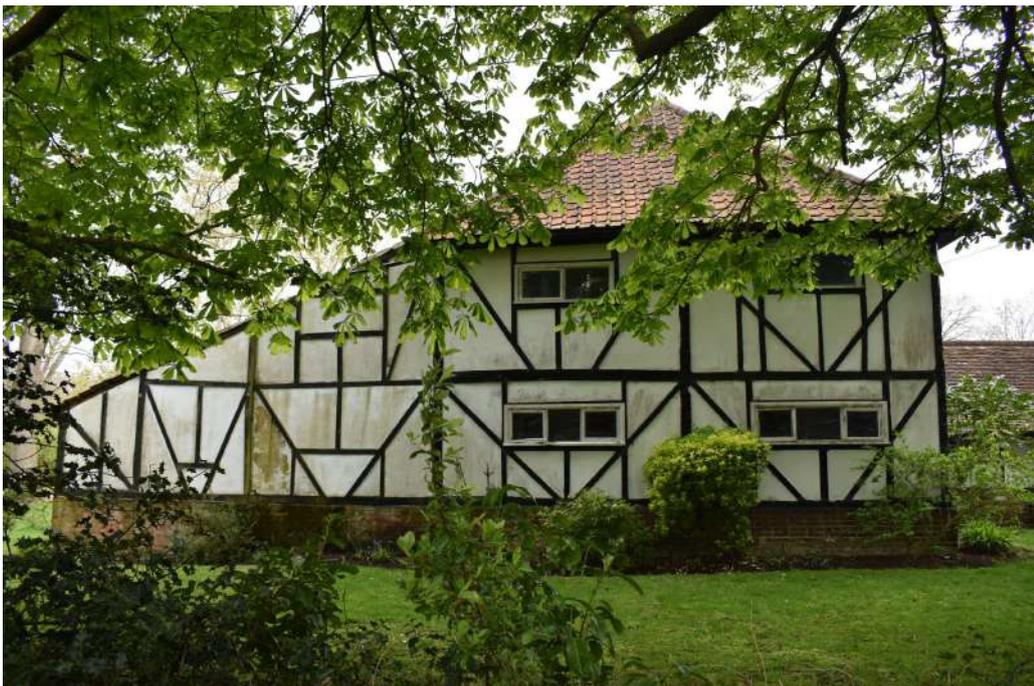
**Photograph 12** Southern elevation of barn and extension. Photograph taken facing north north-west.

On the southern elevation, the barn has four inserted awning windows while the office has three. A number of carpenters' marks, reused timbers and scarf joints are present on this elevation:

- VII on second stud from the west (upper register)
- VIII (above wind-brace) and I (bottom) on second stud from the east (upper register)
- Barn corner post replaced with a telegraph pole
- Reused western corner-post in barn extension

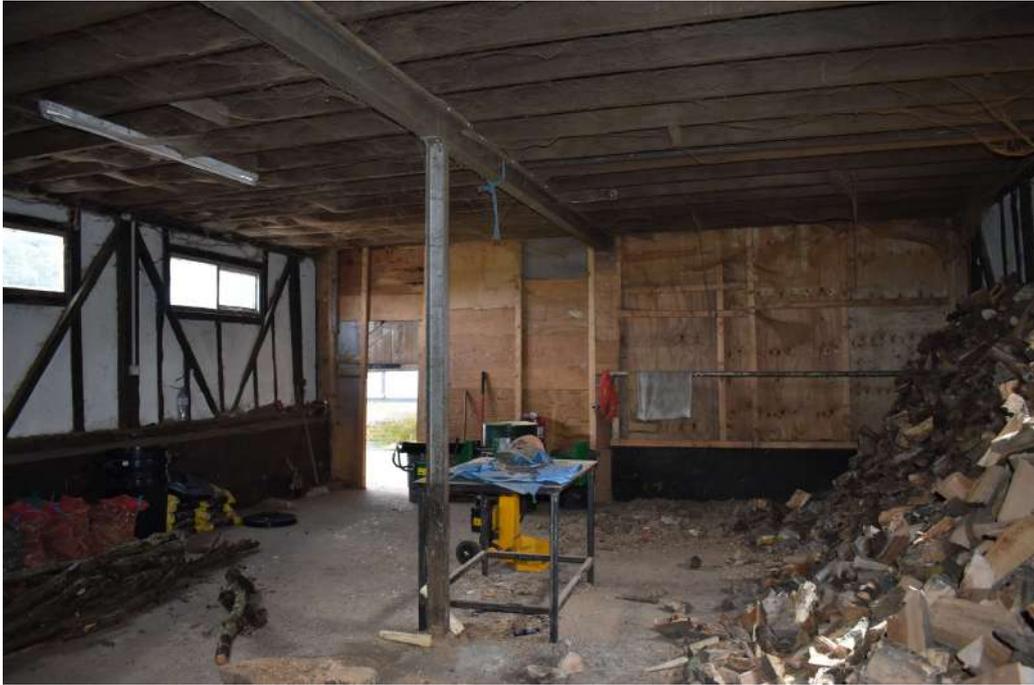
**Photograph 19** Interior of barn, bays 1-3, ground floor. Photograph taken facing east.

The ground floor of the barn has been divided by an inserted plywood-wall, creating a wood-store in bays 1-3.

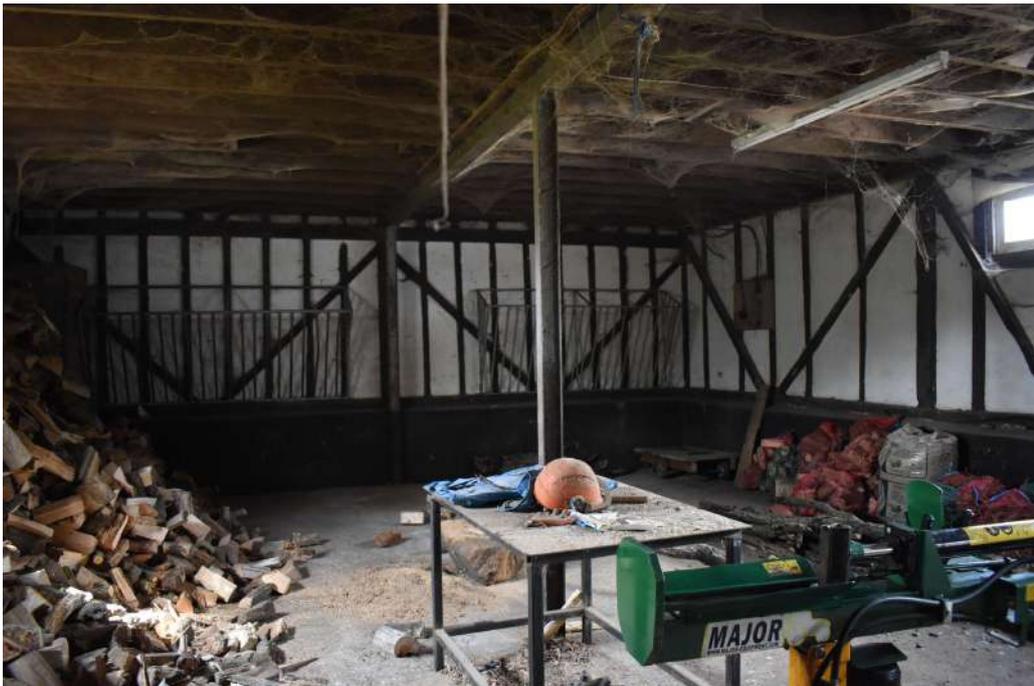
**Photograph 20** Interior of barn, bays 1-3, ground floor. Photograph taken facing north.

In the western wall of bay 1, the most northerly bay, a doorway has been inserted, and subsequently blocked. A side-halved scarf joint is present in the northern sill-beam and some of the timbers in the frame show signs of reuse. Two large modern, steel-framed livestock feeders have been hung on the northern wall.

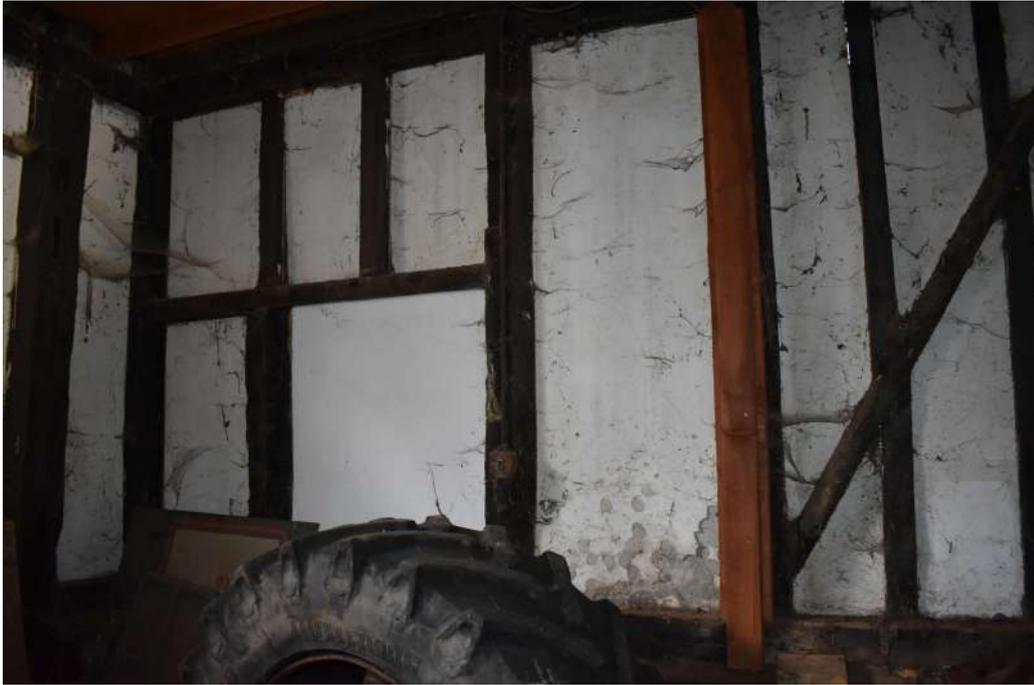
**Photograph 22** Detail of northern midstrey wall. Photograph taken facing north-west.

Bay 4 is the central and widest bay of the barn. The eastern wall is dominated by a set of timber barn doors. The ladder up to the first floor is present in this bay. The midstrey is adjacent to bay 4. There is a blocked doorway in the northern wall of the midstrey. Much of the western wall of the midstrey has been rebuilt, to replace an original barn doorway. Several reused timbers are present in the frame of the midstrey. A short, inserted wall divides most of bay 4 and the midstrey from bay 5 and the barn extension. There is evidence this was once an enclosed animal pen, the eastern wall of which has since been removed.

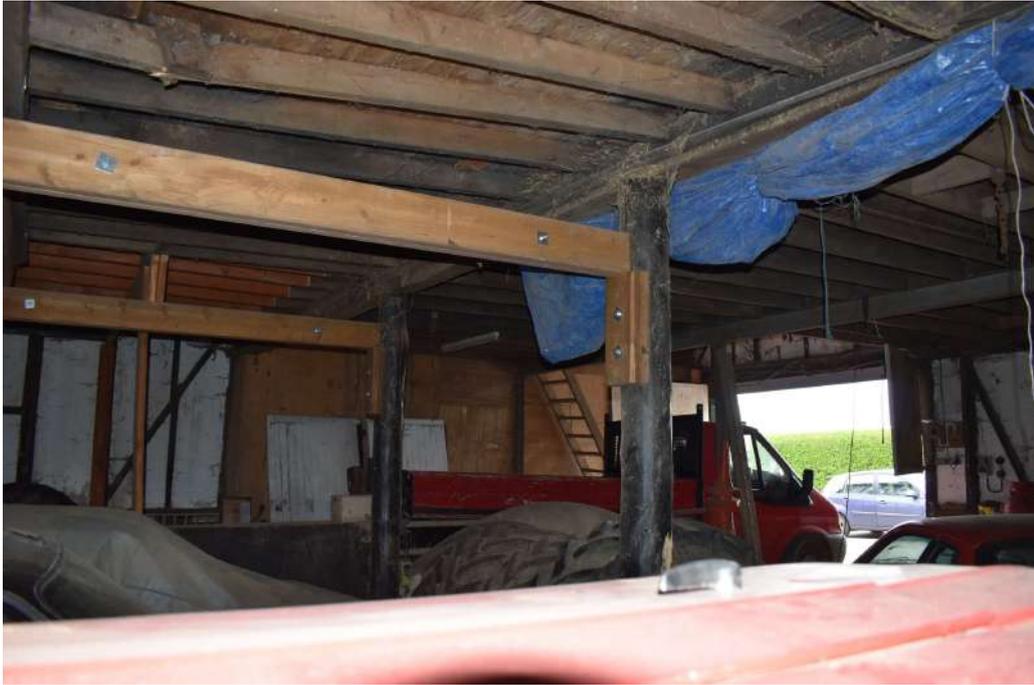
**Photograph 24** Interior of barn, bays 4-7, ground floor. Photograph taken facing north.

There is an inserted and blocked doorway in the eastern wall of bay 5. Bay 7 has three inserted windows, one in the eastern wall and two in the southern wall. The western wall of bays 5-7 has been removed and the intermediary posts replaced with telegraph poles. To the other side of these poles is the barn's extension. The southern and western walls of the extension are timber-framed and emulate the barn's structure while the northern wall is solid brick. Two windows are present in the western wall of the extension.

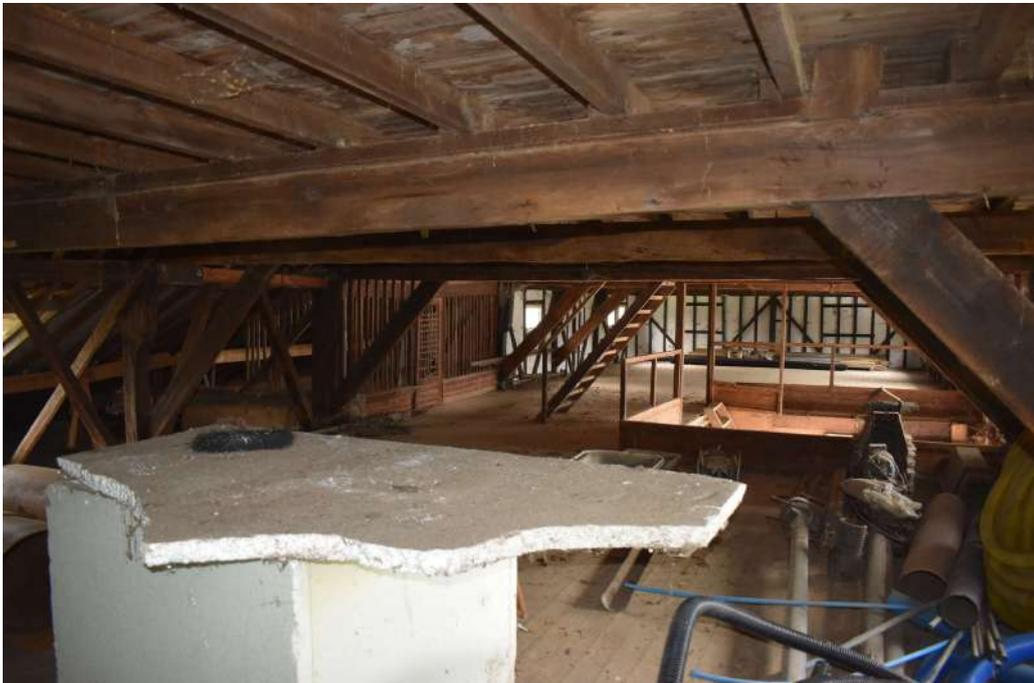
**Photograph 25** Interior of barn, first floor. Photograph taken facing north-west.

The first floor is where the division of the barn's bays is most obvious, as the tie-beams are visible from this floor. Bay 1 has an inserted window in both the eastern and western walls. There is evidence some of the timbers in northern wall have been reused as well as a Baltic timber mark on one wind-brace.

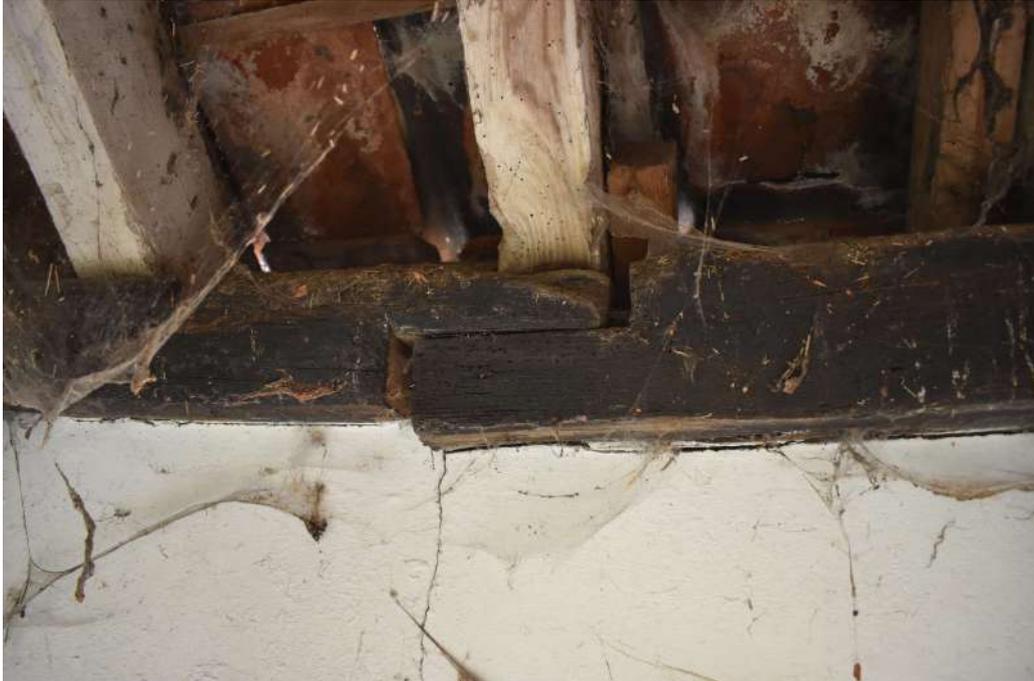
Bay 3 has a side-halved scarf joint in both the eastern and western wall-plates and an inserted window in both walls. A possible Baltic timber mark is present on the side of the eastern curved corbel between bays 3 and 4.

**Photograph 26** Detail of side-halved scarf joint in western wall-plate of bay 3 of barn. Photograph taken facing north-east.

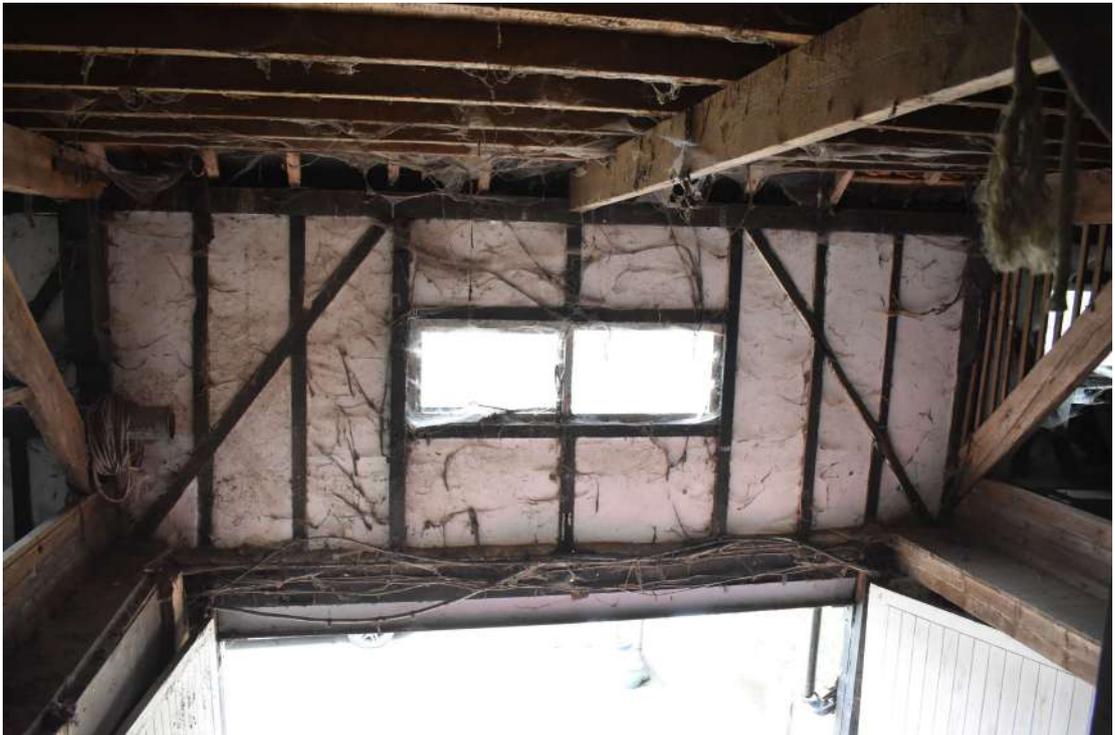
**Photograph 27** Eastern wall of bay 4 of barn, first floor. Photograph taken facing north-east.

The ladder up to the second floor is located within bay 4. The eastern wall of this bay is inserted and contains a window. The western wall is an inserted slatted wall, which has separated the area the first floor in the midstrey. Between bays 4 and 5, the area between the straight-braces and tie-beams has been infilled with wooden slats.

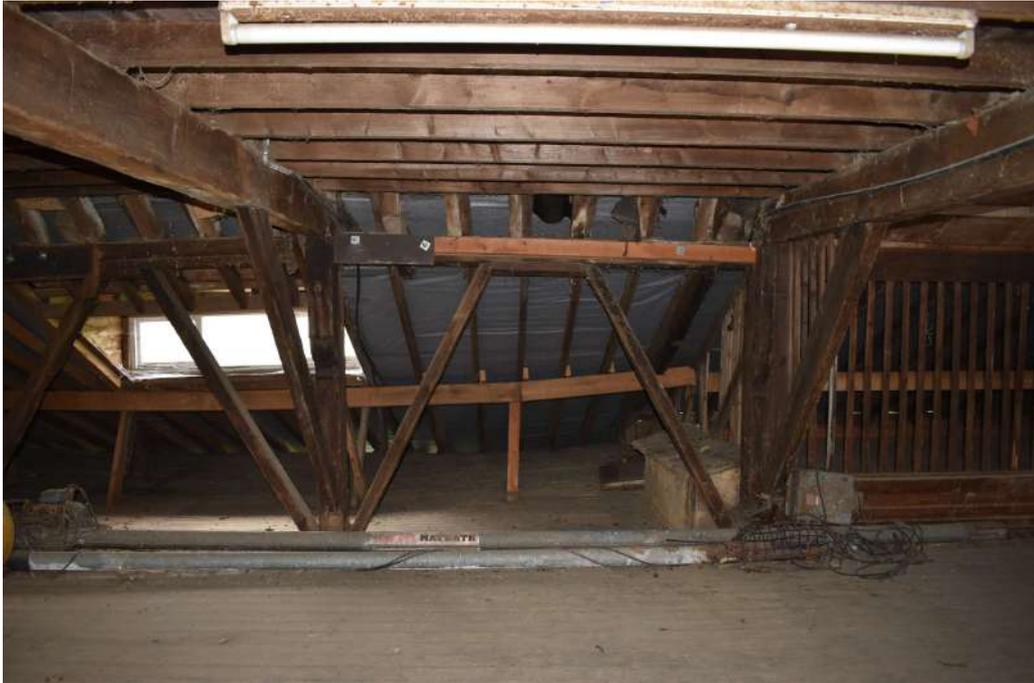
**Photograph 29** Western wall of bay 5 of barn, first floor. Photograph taken facing south-west.

The western walls of bays 5-7 have been removed to create accessible space in the roof of the barn's extension.

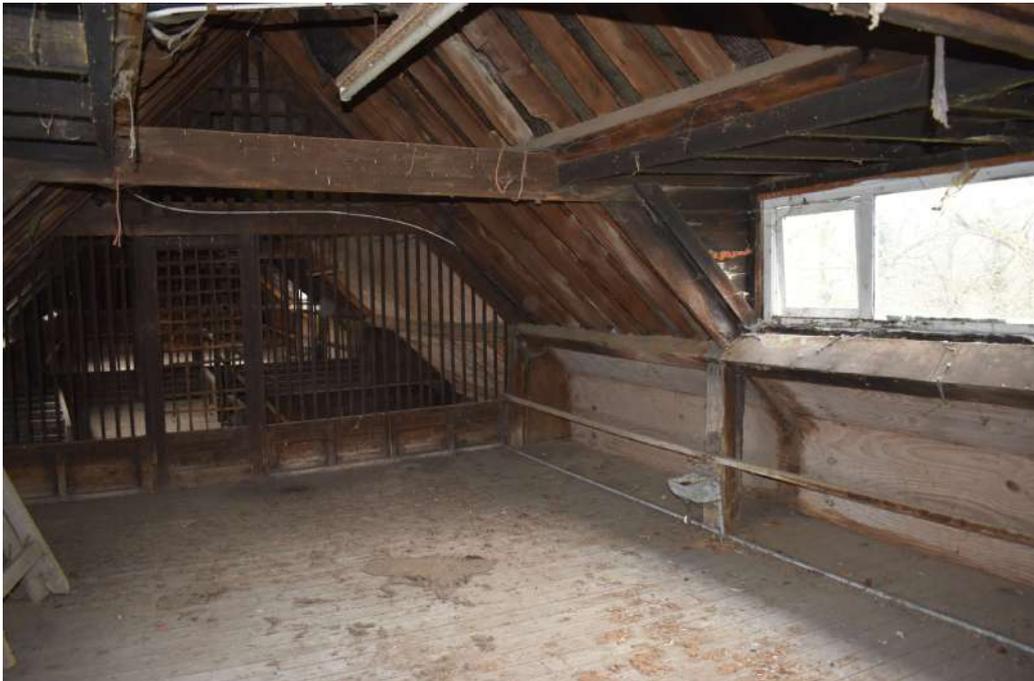
Two inserted walls on the second floor have segregated bays 1-3 and bays 5-7 to create chicken coops. The walls are slatted with a single door. Within these bays, the area below the lowest purling has been clad with plywood to create short walls.

Dormer windows have been inserted into the eastern and western roof pitches of bays 2 and 6 and the eastern roof pitch of bay 4. The rafters in bay 4 have been covered with ply-board. There is a trapdoor in the floor of bay 4.

**Photograph 30** Interior of barn, bays 1-3 (chicken coop), second floor. Photograph taken facing south-west.

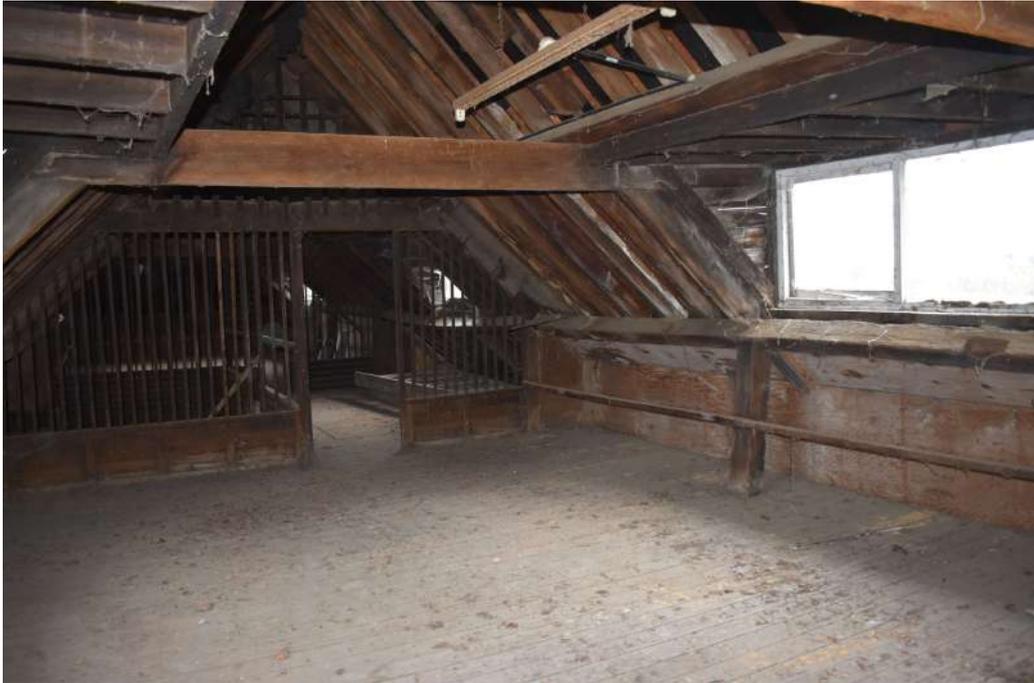
**Photograph 31** Interior of barn, bays 5-7 (chicken coop), third floor. Photograph taken facing north north-east.

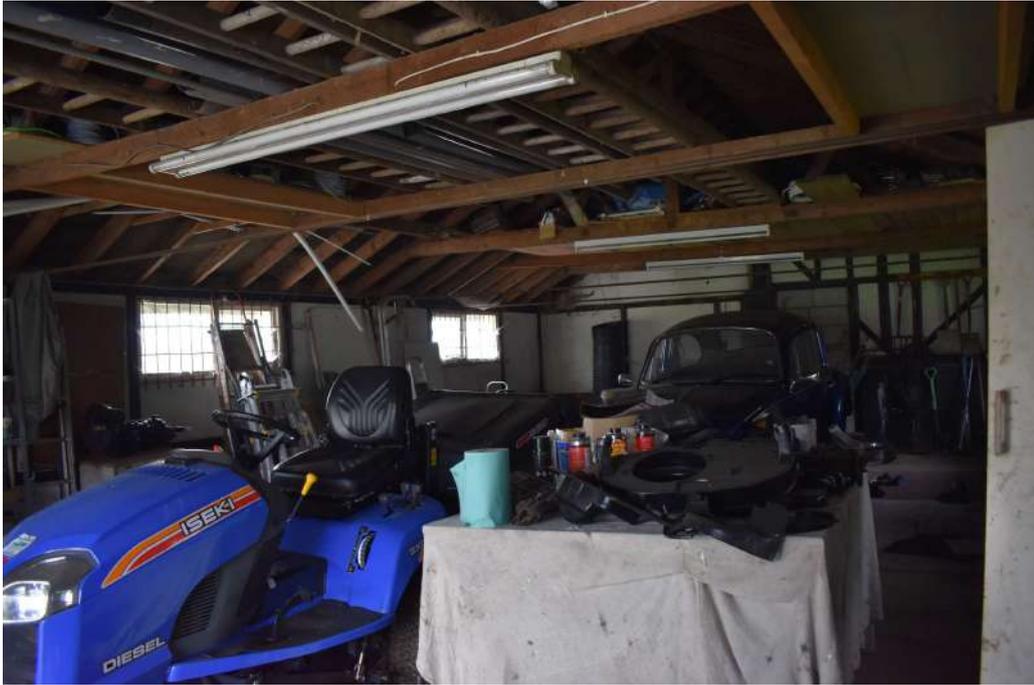
**Photograph 32** Interior of garage. Photograph taken facing north north-east.

The roof of the garage comprises pairs of rafters which meet at a ridge-board. The rafters are supported by collars, the central of which has a king-post and two inclined struts. There is a through-purlin on each roof pitch. All timbers in the garage roof are machine-cut. The floor of the garage is poured concrete.

The garage comprises a single room with windows in the northern and southern walls and a set of double garage doors in the western wall. In the eastern wall is a blocked doorway which has been inserted in the western corner of the barn.

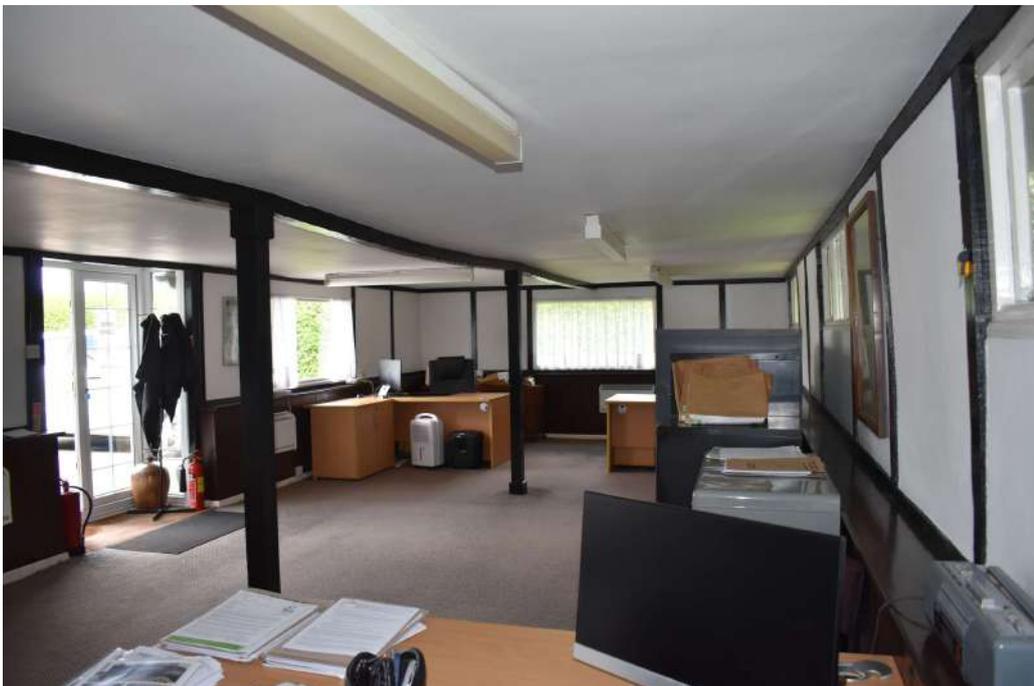
**Photograph 33** Interior of office. Photograph taken facing south-west.

The roof structure of the office was not visible at the time of recording. The walls of the office are plastered and painted white and the floor is carpeted. There are two posts in the centre of the room, supporting the roof structure.
