Historic building recording at Red House, High Street, Great Oakley, CO12 5AQ

February 2022

CAT Report 1797
April 2022

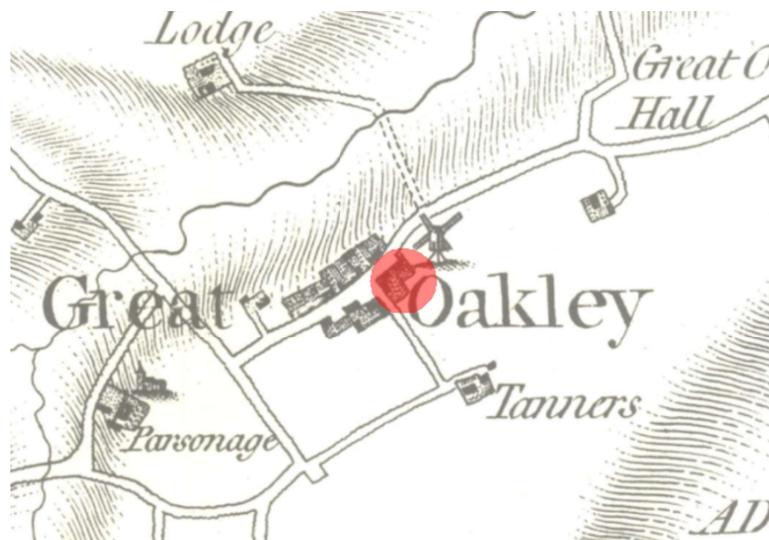
Map 1 Chapman and André 1777. The site of Red House highlighted in red.

The 1777 Chapman and André map (Map 1) depicts Great Oakley as a small settlement with a windmill to the east. The proposed development site (PDS) is visible as a series of buildings on the corner of High Street and Farm Road. It shows that the gap between Red House and The Maybush Inn which exists now was not originally there.

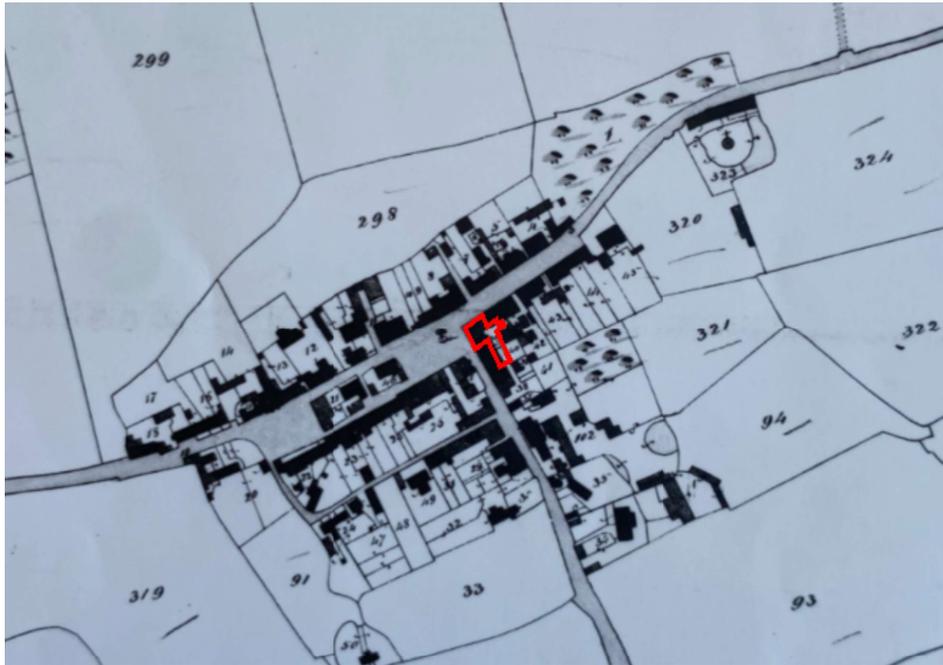
Map 2 Extract of the Tithe map of Great Oakley from 1841. The PDS is outlined in red.

On the 1841 Tithe map (Map 2) the Red House is identified as two separate properties: with the Tithe Award recording these as a house with bake office and a house with shop. The Tithe Map also shows the development of the village along the High Street and Farm Road. There does not seem to have been significant development of the historic centre of Great Oakley between 1841 and the publication of the OS Map in 1880.

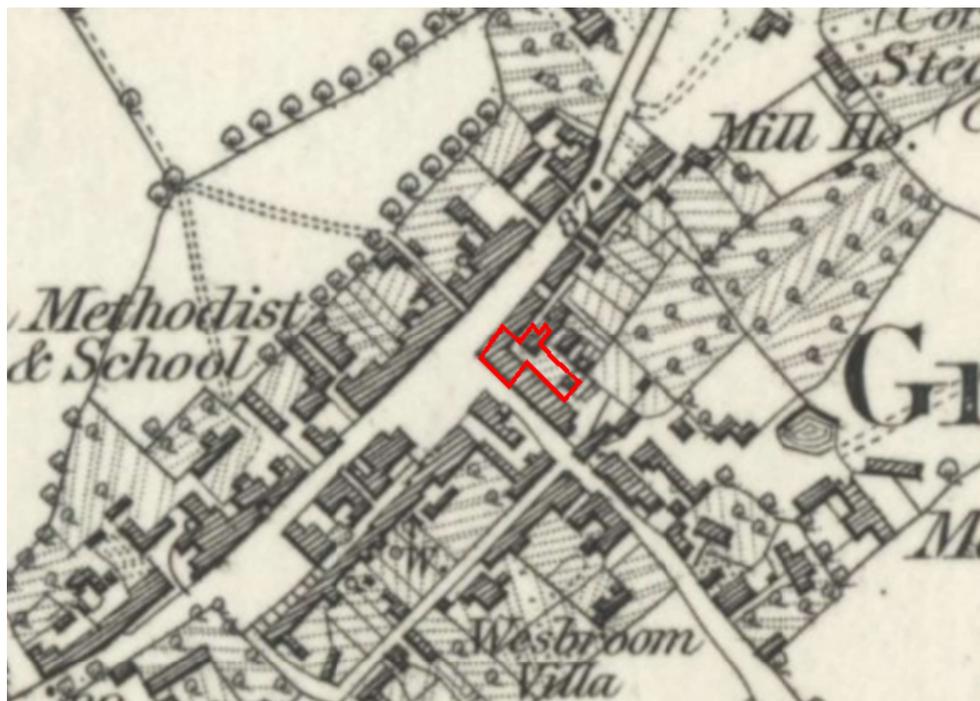
Map 3 Extract of the 1880 OS map with the PDS outlined in red.

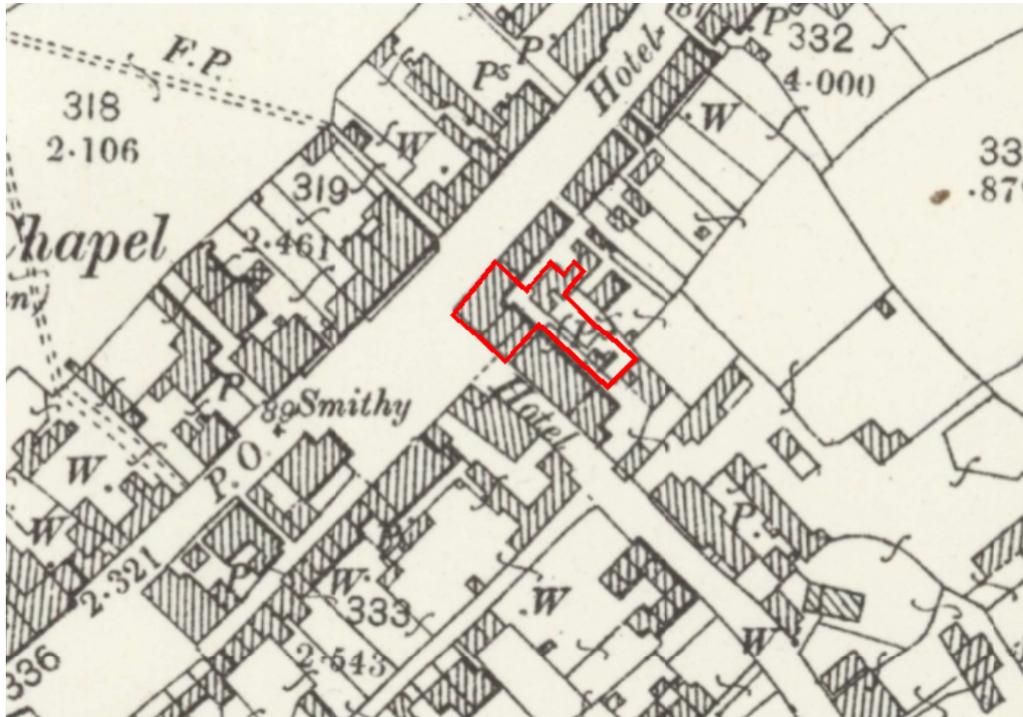
Map 4 1897 OS map showing PDS in red.

The 1897 OS map (Map 3) shows the PDS in some detail, with the two terraced houses situated between Red House and The Maybush clearly visible. There are two buildings visible on this map that are within the PDS boundary and which no longer exist.

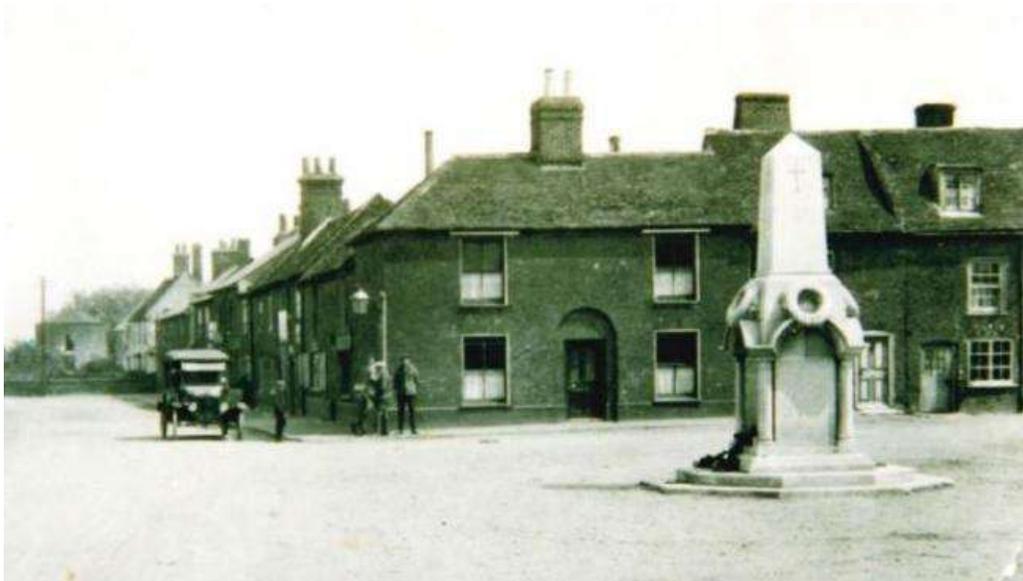
Photo 1 South-west facade of Red House in the late 1930's, showing the War Memorial, and houses in the gap between Red House and The Maybush.

The south-west elevation has four windows, two on each storey, flanking a single door. All four windows have concrete sills. The door is a modern wooden replacement with two single light windows. It sits in an arched recess, perhaps an indication there was once a fan light above the door (although the photo from the 1930s does not show this). There is a replacement doorstep made of Yorkstone.

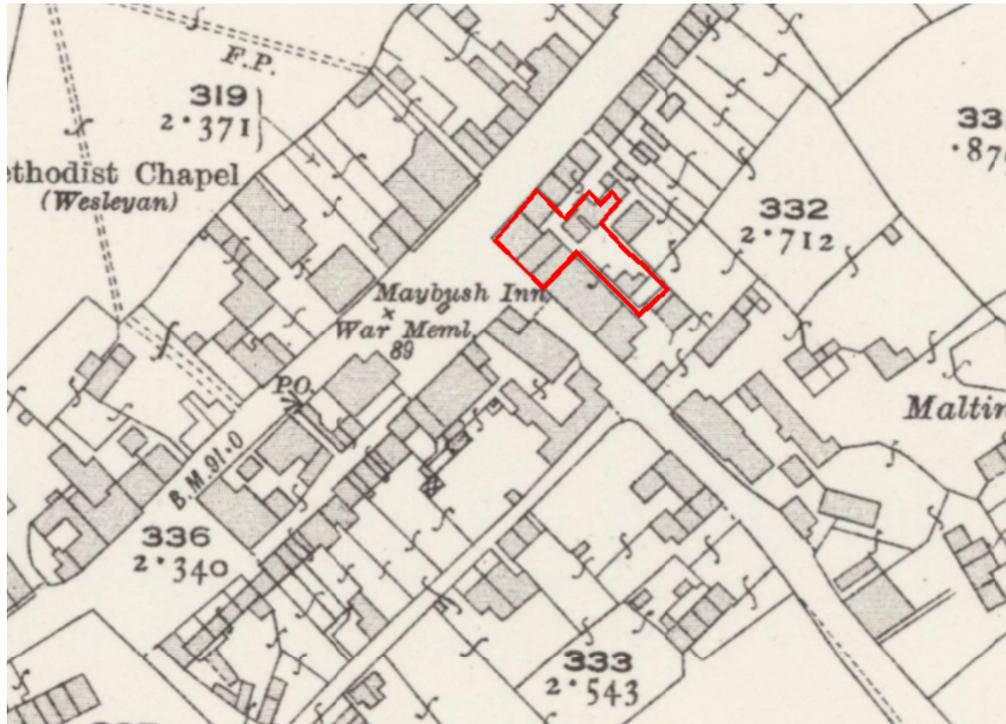
Map 5 Extract of the 1923 OS map showing the PDS in red

The 1923 OS map shows the division between the two properties that joined to become the Red House as it exists today.

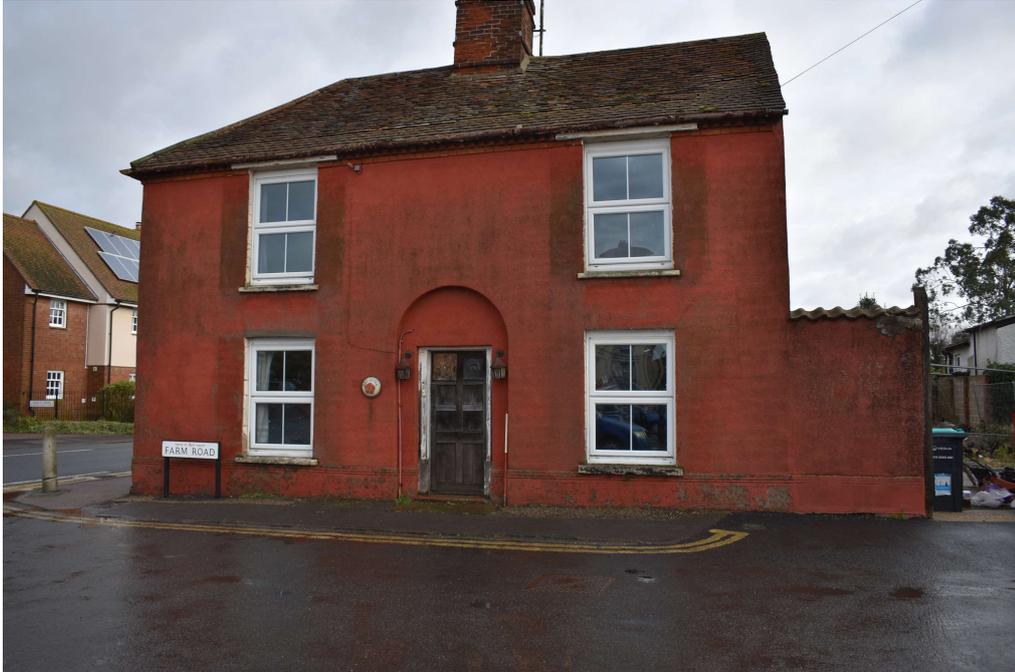
Photograph 2 South-west elevation. Photograph taken facing north north-west.

At the top of the elevation are two courses of exposed brickwork, one course laid in a houndstooth pattern and one in a Flemish-bond. At the bottom on the elevation is a lightly decorative limestone veneer, which may be original to the building. There is a modern boundary wall adjacent to this elevation that has an imitation veneer formed from concrete.

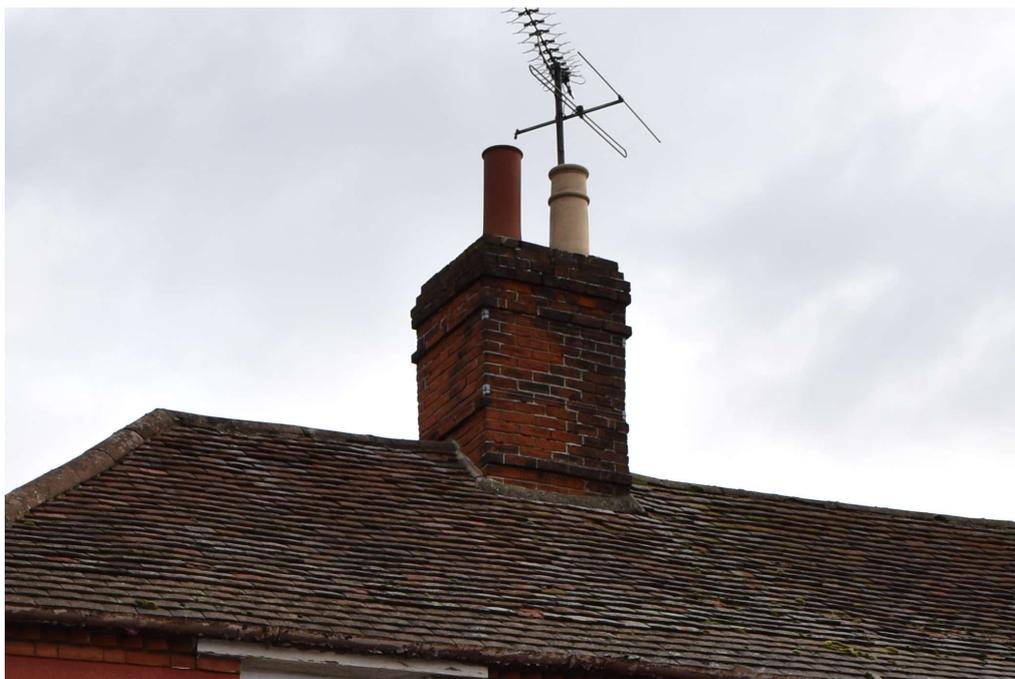
Photograph 3 Detail of original chimney. Photograph taken facing south-west.

The building has two chimneys, one on the ridge of the E/W range and one on the south-west roof pitch of extension 1. The chimney on the E/W range is original to the building and is constructed 23 courses of red brick rising from the roof tiles. The second chimney is a later addition, likely contemporary with the extension.

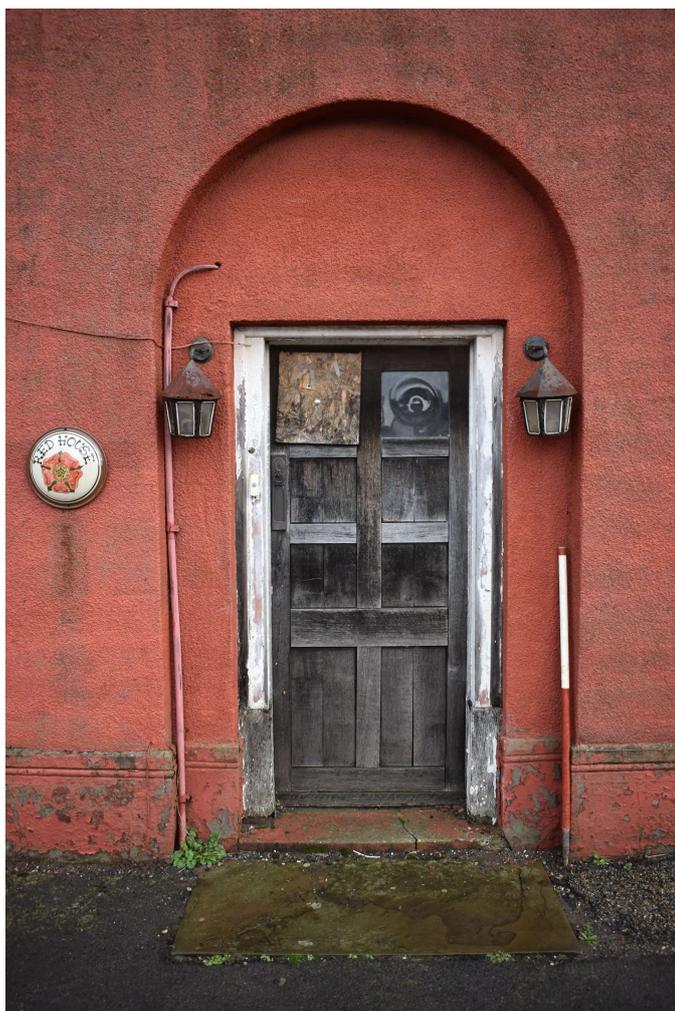
Photograph 4 Detail of front entrance. Photograph taken facing north-east.

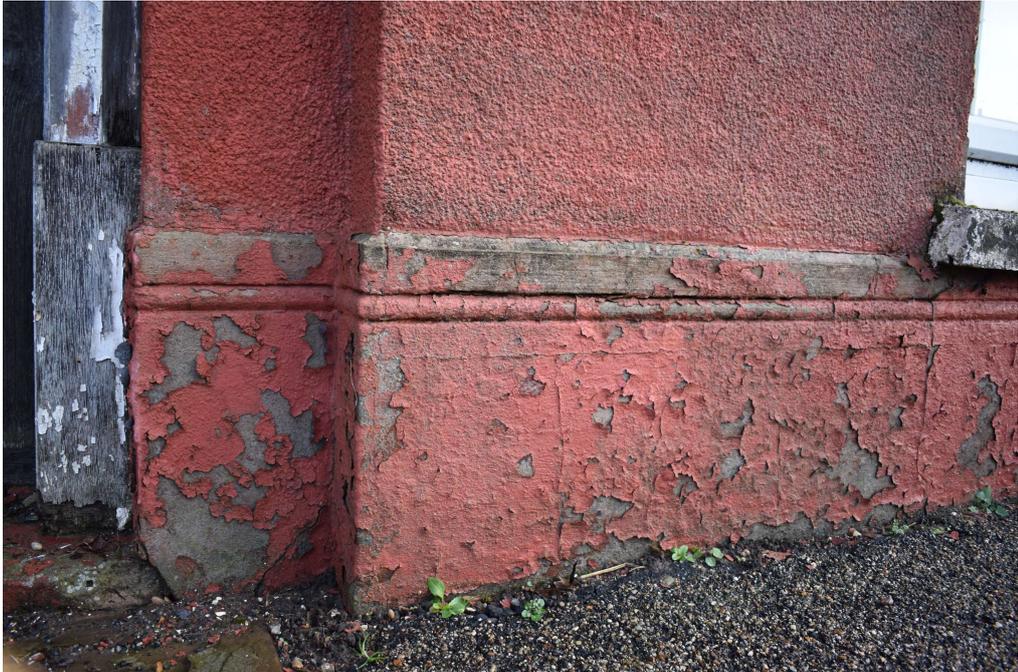
Photograph 5 Detail of limestone veneer. Photograph taken facing north-east.

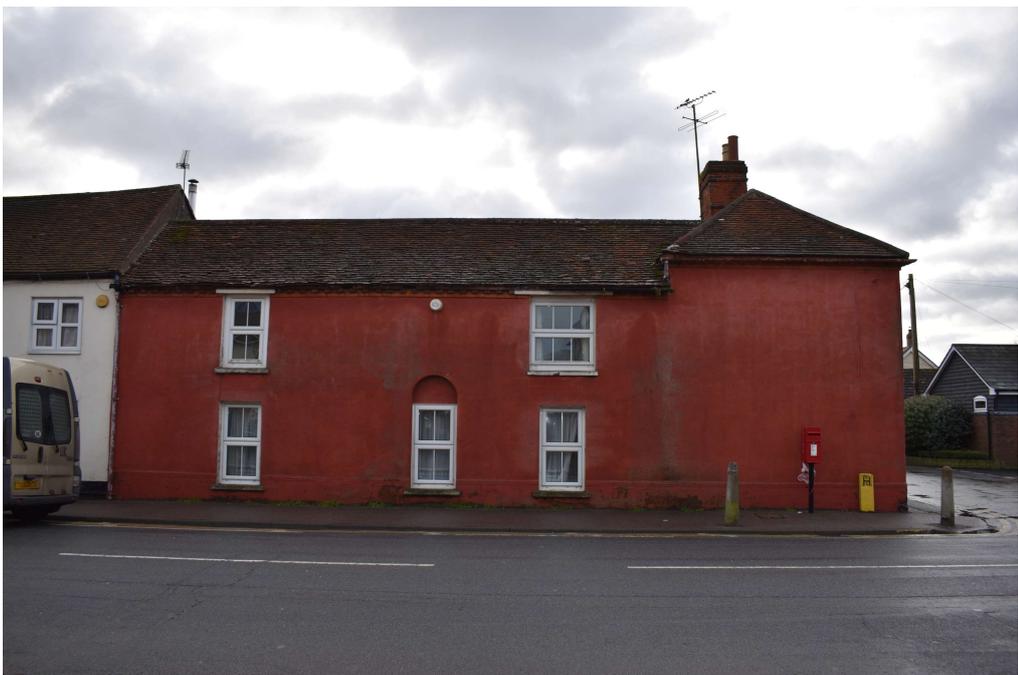
Photograph 6 North-west elevation. Photograph taken facing south-east.

The north-west elevation has five windows, three on the ground floor and two on the first floor, all with concrete sills. The middle window on the ground floor is in the location of an original doorway. It has an arched recess similar to the front door on the south-west elevation. The southern-most window on the second floor is wider than the other windows on this elevation. All of the windows are confined to the N/S range.

Three courses of exposed brick are present at the top of the elevation. The lowest course is laid in Flemish-bond, the middle course header-bond with alternating bricks protruding, and the uppermost course laid in stretcher-bond. The limestone veneer is also present on the bottom of this elevation.

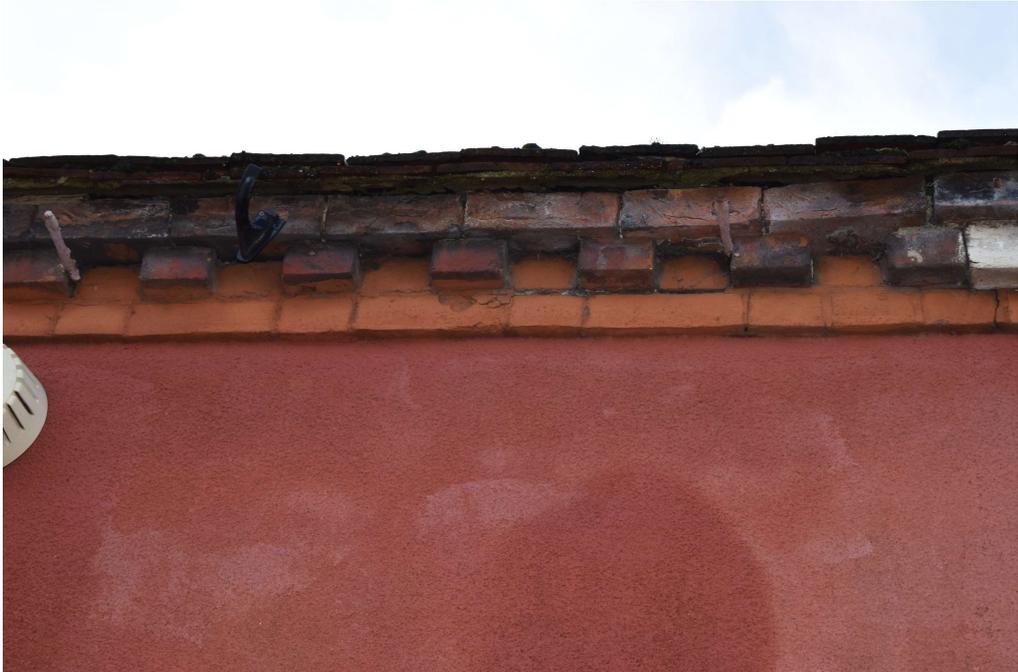
Photograph 7 Detail of brickwork on north-west elevation. Photograph taken facing south-east.

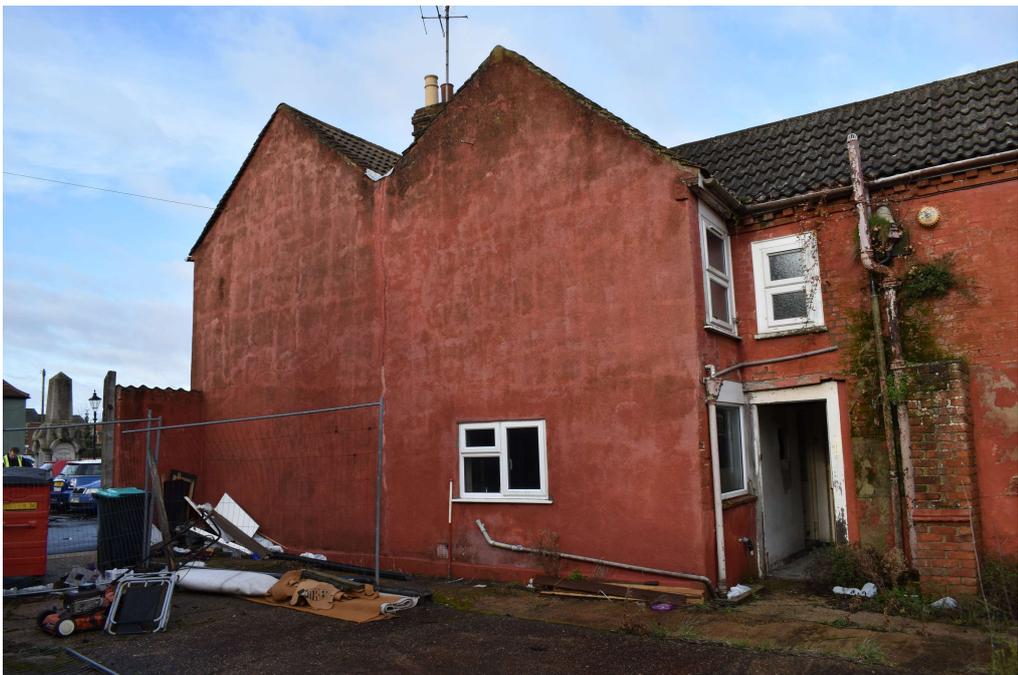
Photograph 8 South-east elevation. Photograph taken facing west.

There are five windows present on the south-east elevation, two on the ground floor and three on the first floor. All of the windows are located on the extension. All windows on this elevation have a plastic sill, except one ground floor window which has a tile sill. There is also a modern stable door. The southern half of this elevation has a concrete plinth.

At the top of the extension elevation there are three courses of exposed brickwork, laid in the same fashion as the north-west elevation. Also present on the extension are three modern buttresses constructed of red brick. These are a later addition added to support the wall of the extension. The area around the buttresses is rendered. Also present on this elevation is a cast-iron hopper which has been reused and incorporated into the drainage pipe exiting the building.

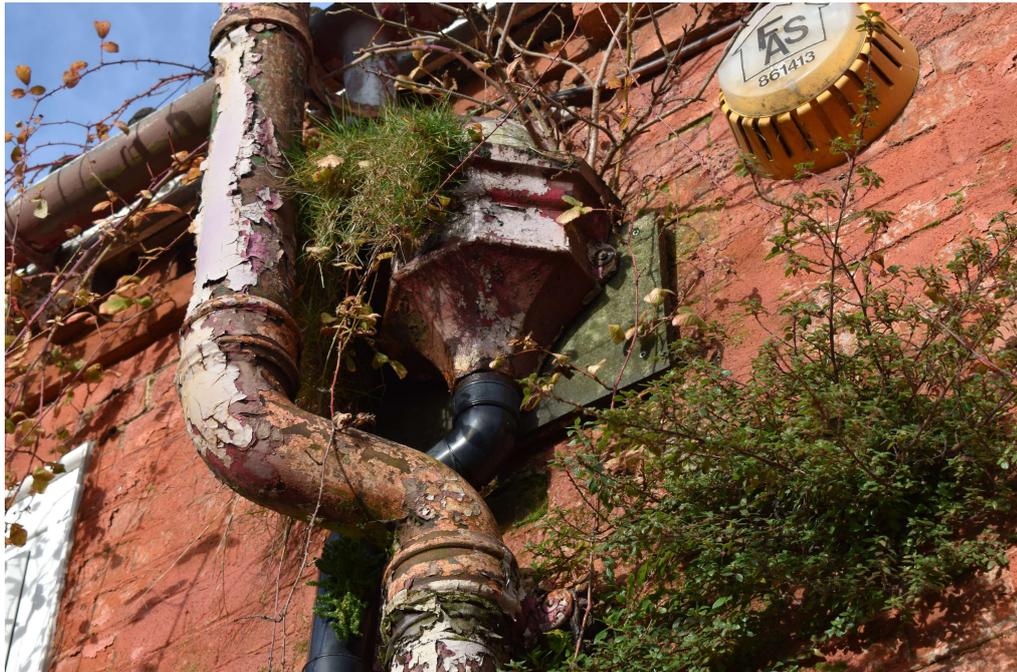
Photograph 9 Detail of re-used hopper on south-east elevation. Photograph taken facing north-west.

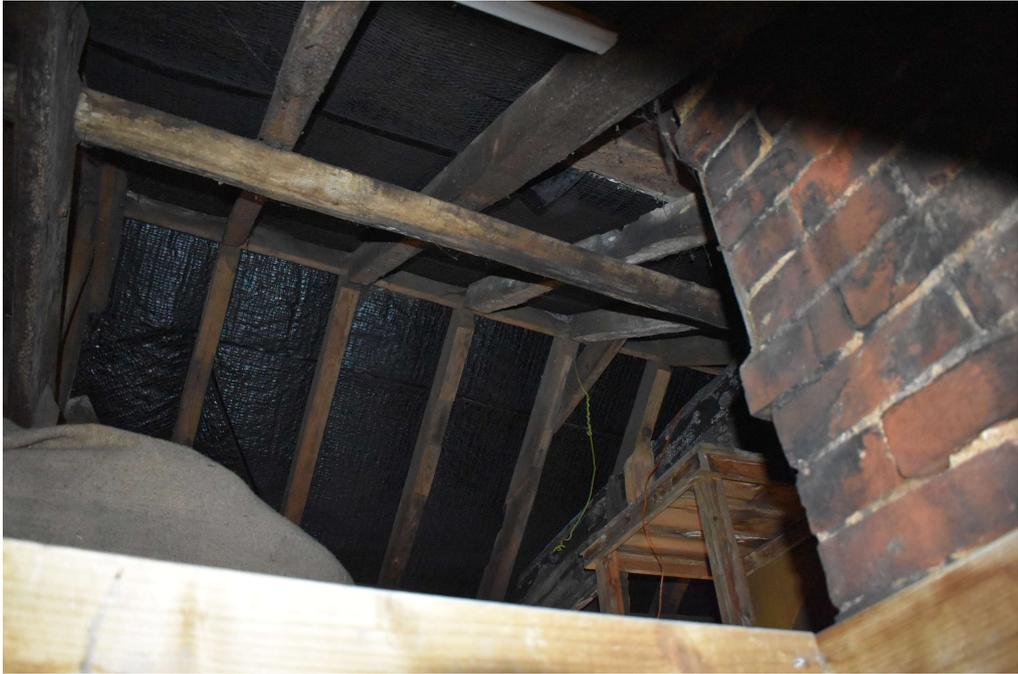
Photograph 10 Detail of roof structure above Landing. Photograph taken facing north-east.

Most of the modern plasterboard ceilings on the upper floors have been removed to expose the roof timbers. The roof is constructed of pairs of rafters meeting at a ridge-board at the apex of the roof. There is a purlin on each roof pitch with trenched collars and occasional upper collars. The timber used in the roof structure is a mixture of original and modern machine-cut timbers. Baltic timber marks were identified on some of the roof timbers.

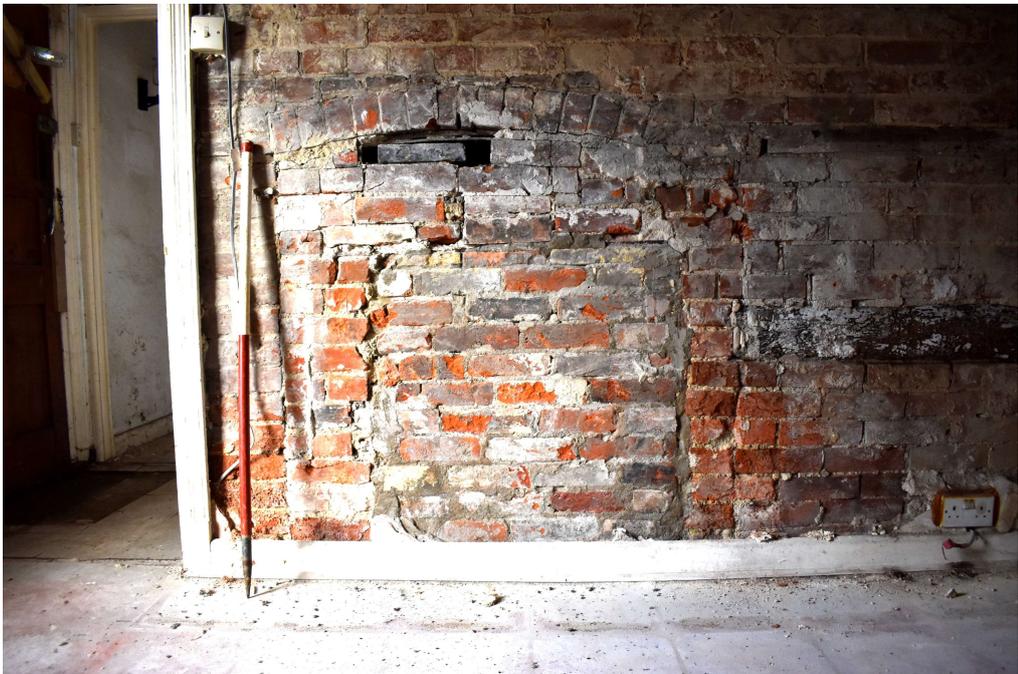
Photograph 11 Detail of in-filled fireplace in Study. Photograph taken facing north-west.

The study is located in the south-east corner of the E/W range on the ground floor. Much of the wall plaster in this room has been removed, revealing the brick-work beneath and exposing an in-filled fireplace in the north-west wall. The fireplace has a slightly arched top and has been blocked with red-brick laid in stretcher bond.

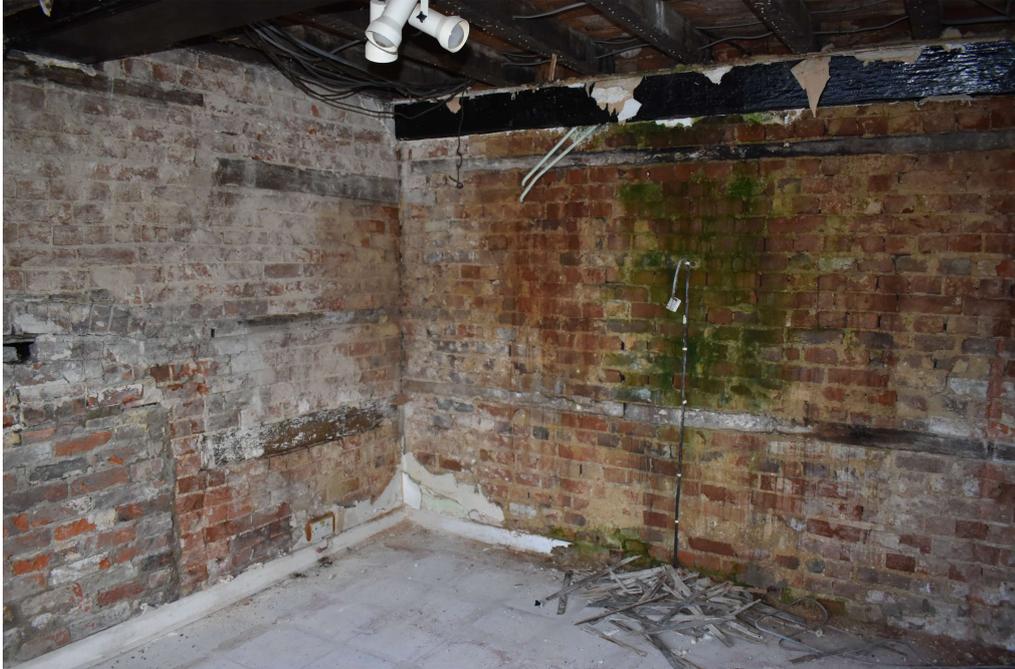
Photograph 12 Interior shot of Study showing bond timbers. Photograph taken facing north.

Visible in the north-west, north-east and south-east walls are bond timbers. There are two in the north-east and south-east walls and four in the north-west wall. These would have been incorporated during the construction of the walls to provide extra strength. A replacement bridging-beam is also present, it is sheathed in timber painted black and aligned north-west/south-east. The floor-boards above are 22cm wide and supported on machine cut floor-joists.

Bond timbers are lengths of timber worked in to a brick wall, usually to strengthen the wall or if the foundations were seen as 'suspicious' (Hurst, 2006). They are found in buildings world wide from many periods but were a feature of virtually all brick buildings in England throughout the 18th century until around the mid 19th century. The presence of bond timbers in the walls of Red House is a good indication it was constructed in 18th century when the use of bond timbers was at its peak in England.

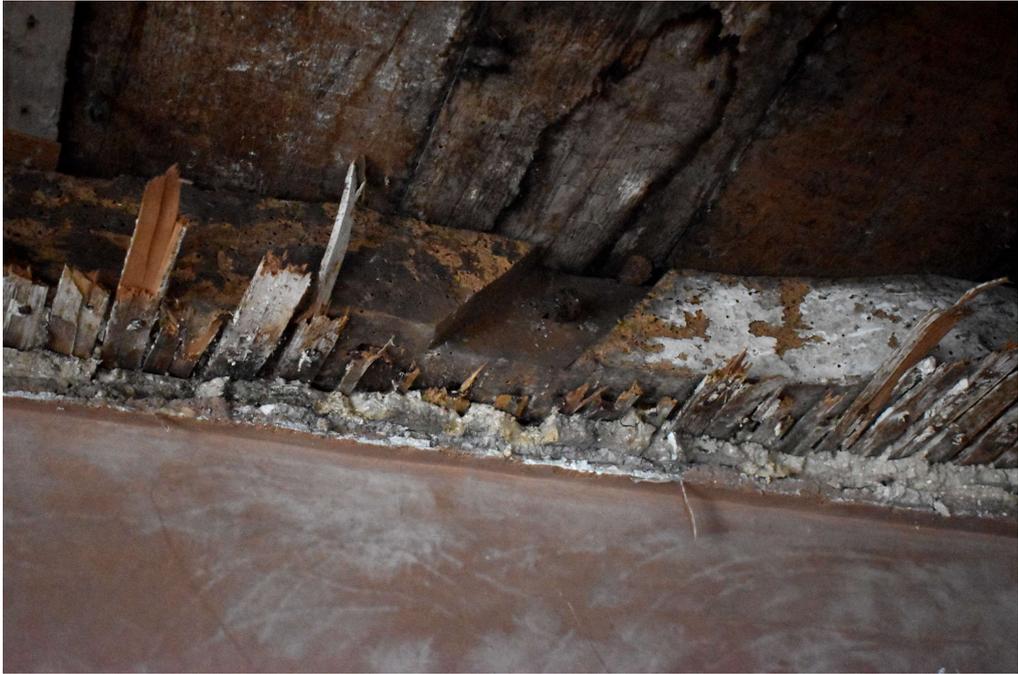
Photograph 13 Detail of reused timber wall plate in Sitting Room. Photograph taken facing north-west.

The original wall plate is visible on the north-west wall, it is a reused and unprocessed timber. There is also a sheathed north-west/south-east bridging beam, as in the study. The floor boards above are 23cm wide and supported on hand-sawn floor-joists.

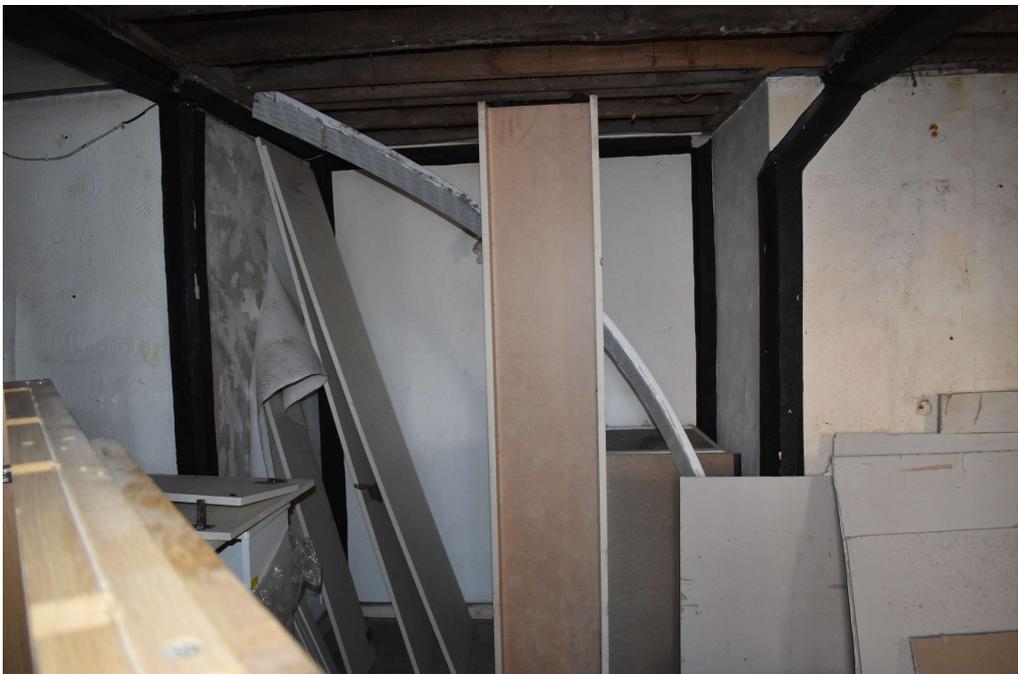
Photograph 14 Detail of alcove in Living Room. Photograph taken facing south-east.

The living room dominates the ground floor of the N/S range. The walls are plastered and painted white. On the south-east wall is an alcove, which was probably the original location of an oven for the bake office. From historic photographs a chimney can be seen in roughly the same location (see Photograph 24).

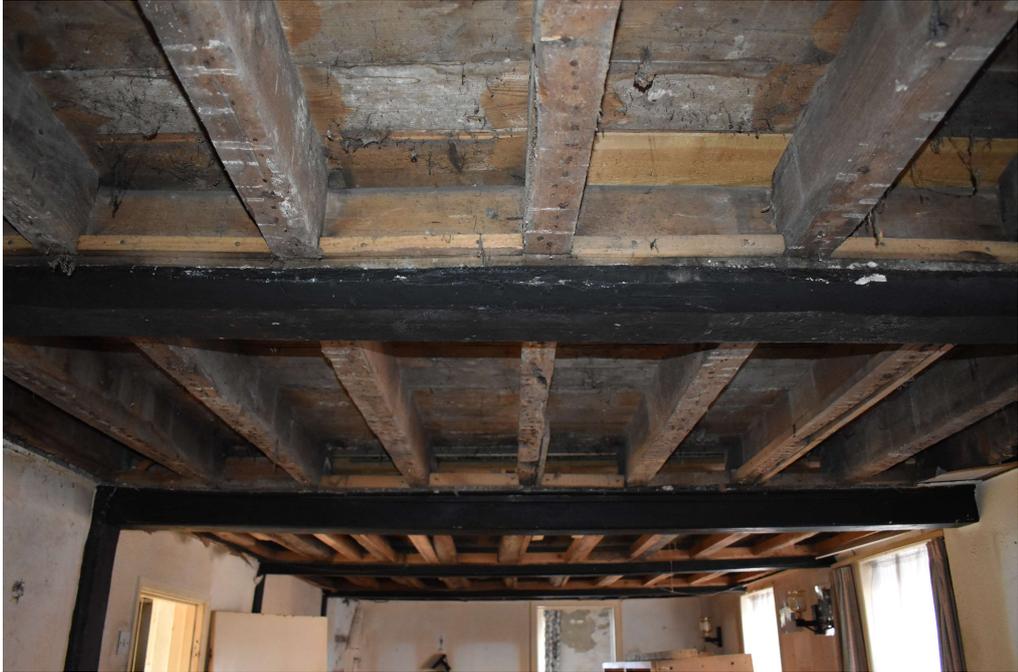
Photograph 15 Detail of Living Room ceiling. Photograph taken facing south-west.

The southern three bridging-beams are modern timber while the northern two are original, one of which has Baltic timber marks. The modern timber was likely inserted when the original stairs were removed. The floorboards above range from 15.3cm to 21cm in width. They are supported on hand-sawn joists, (an indication they may be original or reused).

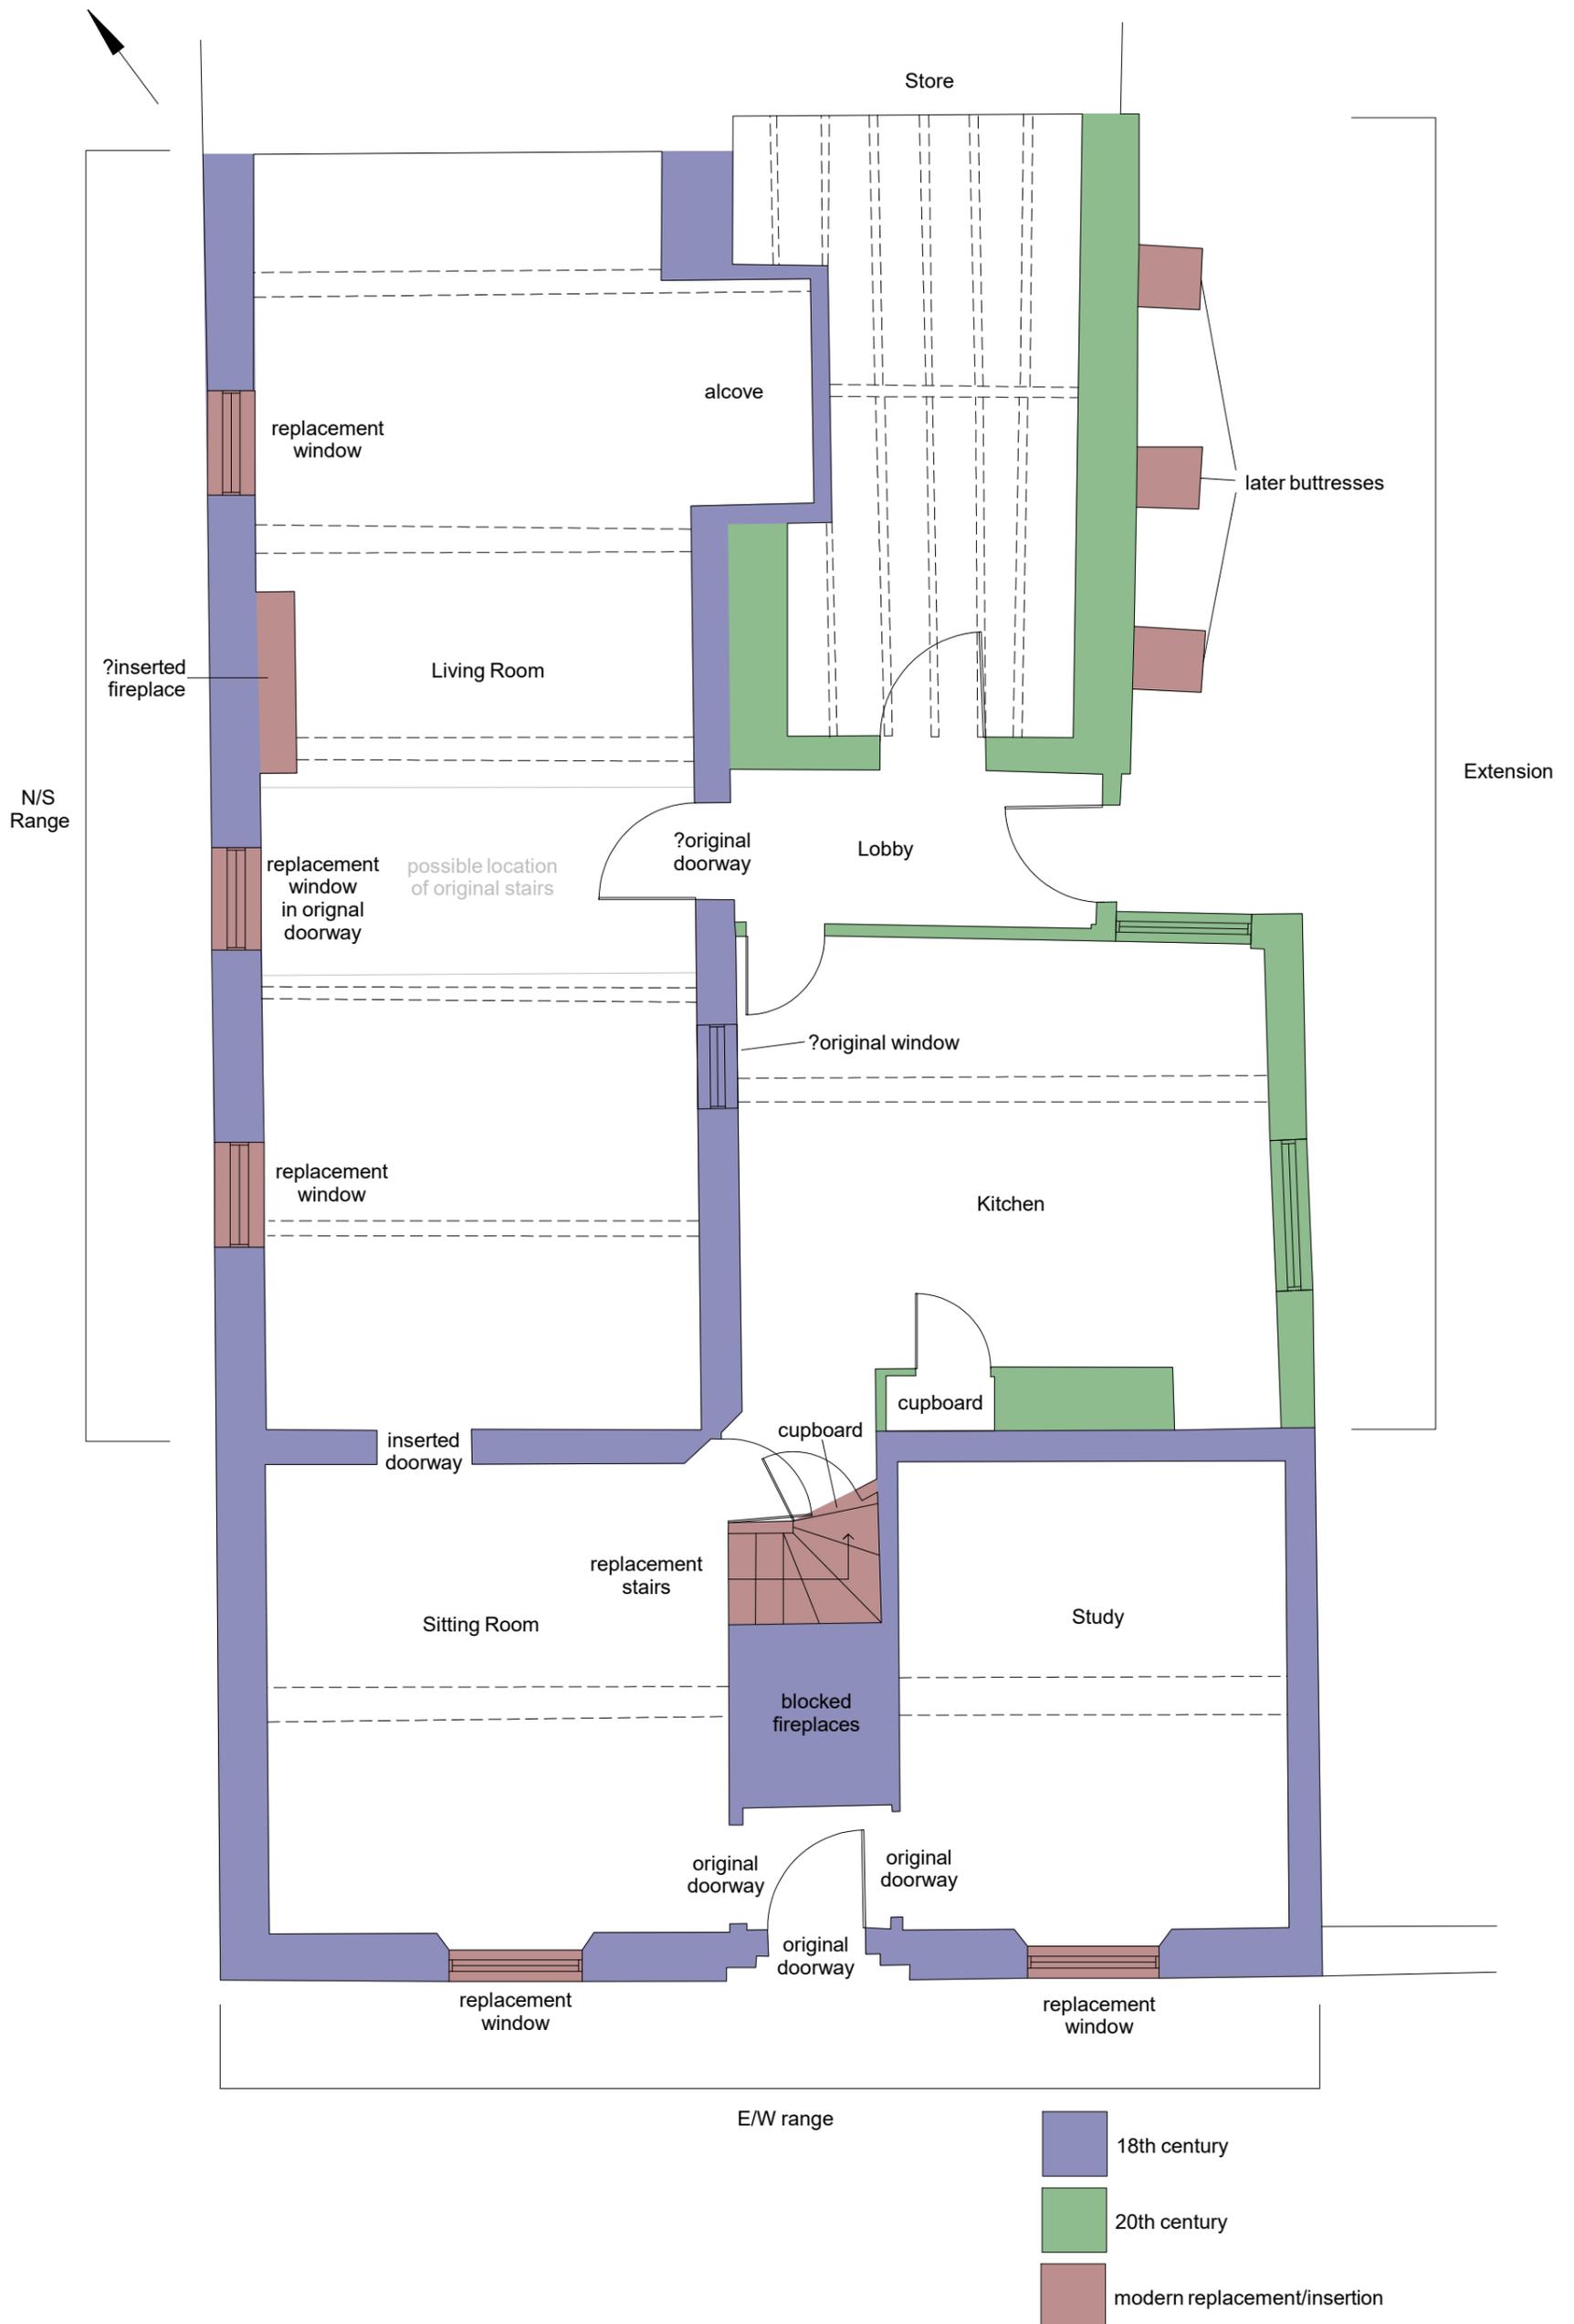
Fig 1 Ground floor plan.

The building consists of 14 rooms which have been labelled according to their function (see Fig 2 and 3).

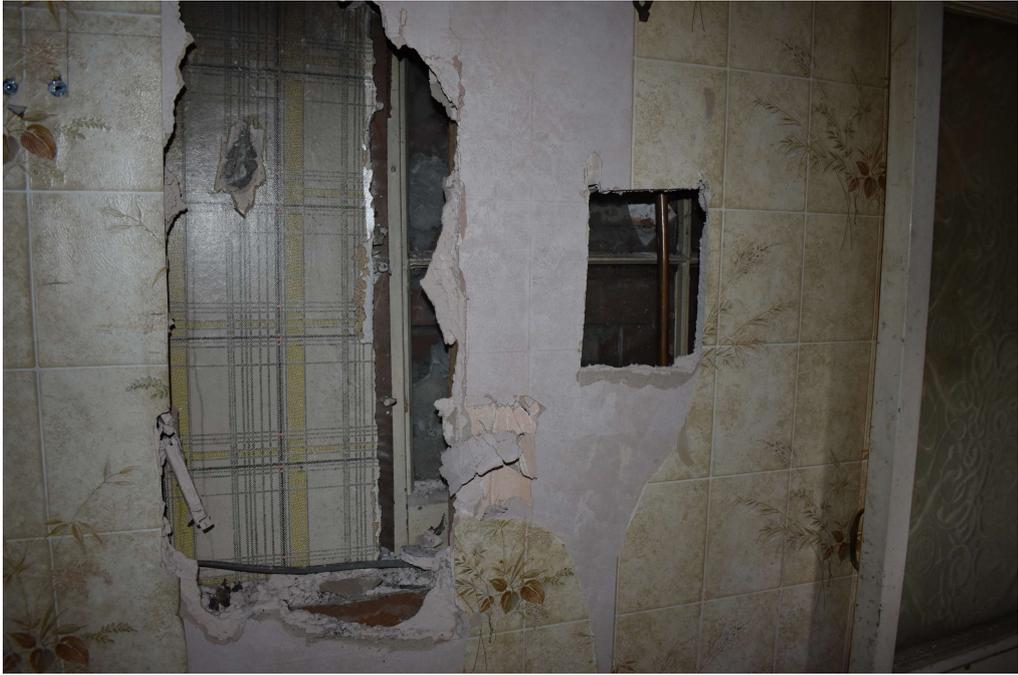
Photograph 16 Detail of window boarded up in kitchen. Photograph taken facing north-west.

The kitchen occupies the south-west half of the ground floor of the extension. The walls are variously covered with wallpaper, tiles and bare plaster. Damage to the plaster board of the south-west wall has revealed a 6-light fixed window associated with the N/S range. Some red and black floor tiles survive on the concrete floor.

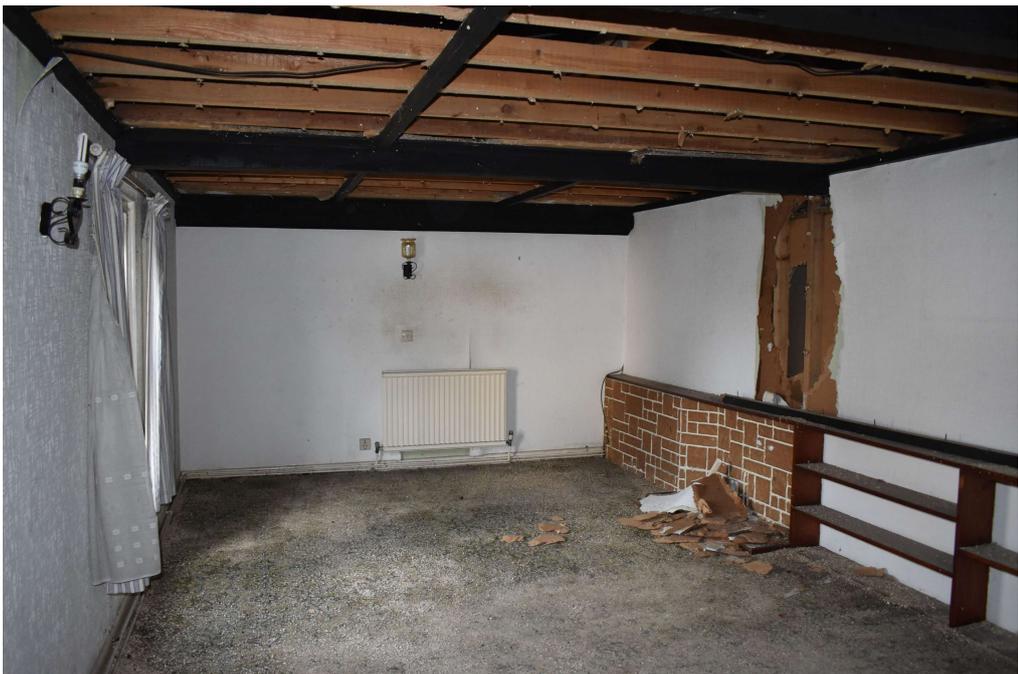
Photograph 17 Interior shot of Bedroom 1. Photograph taken facing north-east.

Bedroom 1 is located on the first floor in the north-east of the N/S range. The floor is raised slightly in the northern part of the room. It is possible that the removal of the original staircase caused this difference in height. There is a replacement window on the north-west wall and an inserted glass-sliding door on the south-east wall. The south-west wall is an inserted stud wall.

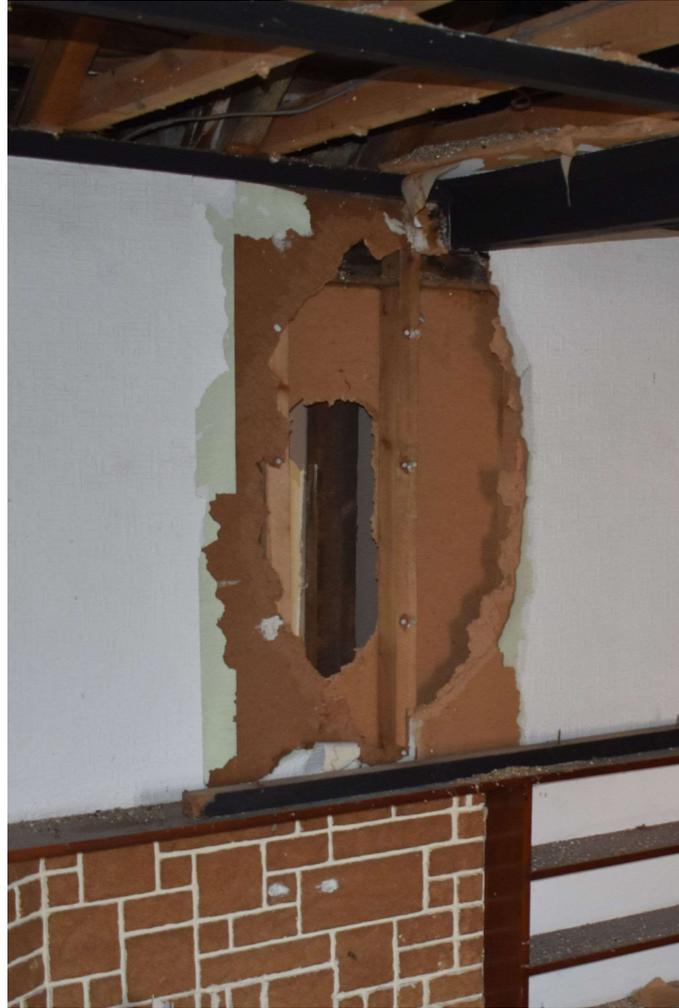
Photograph 18 Detail of exposed stud wall in Bedroom 1. Photograph taken facing south-east.

Damage to the plaster board of the south-east wall has exposed an area of stud-work inserted in to the original brick wall. This was probably inserted after the removal of the alcove, which is still present in the Living Room below, which would have left a gap in the brick wall.

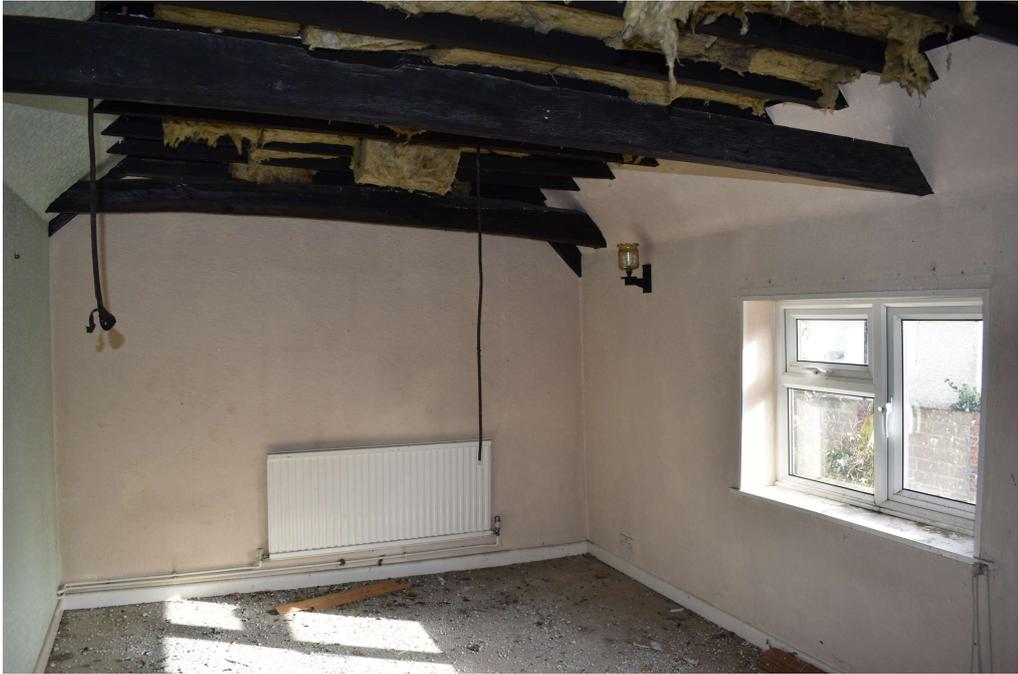
Photograph 19 Interior shot of Bedroom 2. Photograph taken facing east.

Bedroom 2 occupies the north-east corner of the first floor of the extension. There is a window on the south-east wall and a door and inbuilt cupboard on the south-west wall. Two hand-sawn beams are present in this bedroom.
