Historic building recording at Red House, High Street, Great Oakley, CO12 5AQ

February 2022

CAT Report 1797
April 2022

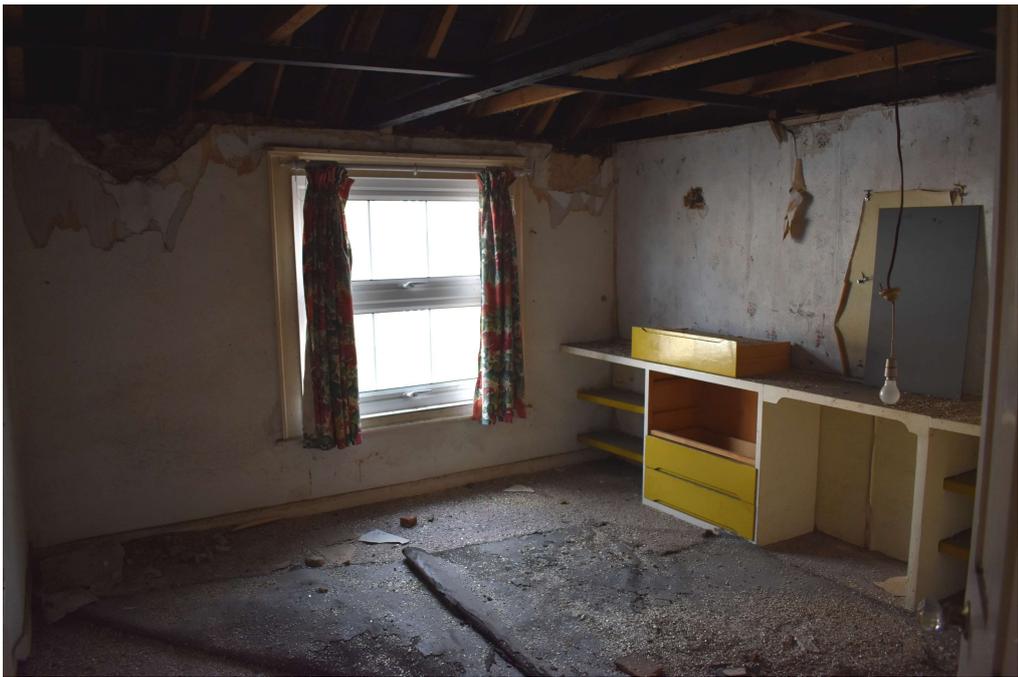
Photograph 20 Interior shot of Bedroom 3. Photograph taken facing north.

Bedroom 3 occupies the south-east side of the N/S range on the first floor. There is a replacement window on the north-west wall and an inserted doorway on the south-east wall. The north-east wall is an inserted stud wall, above which the original tie-beam is visible.

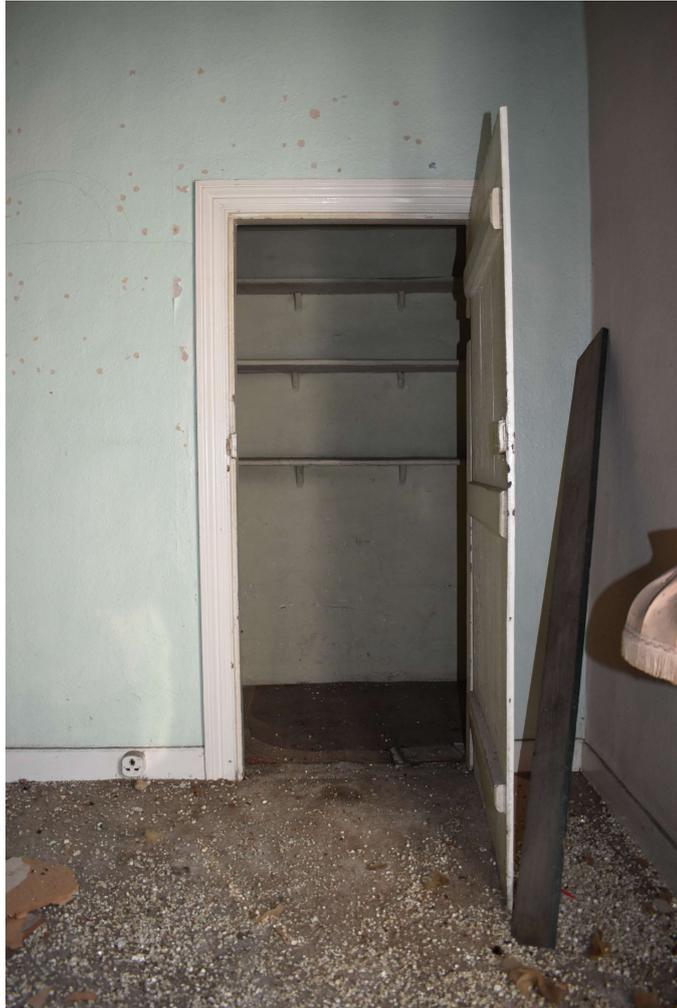
Photograph 21 Detail of ?original cupboard in Bedroom 4. Photograph taken facing south-east.

Bedroom 4 is located in the north-west corner of the E/W range on the first floor. On the south-east wall is an inbuilt cupboard original to the building. It has a vertical-planked door with strap hinges and four wooden shelves. There is a replacement window on the south-west wall and a replacement door on the south-east wall.

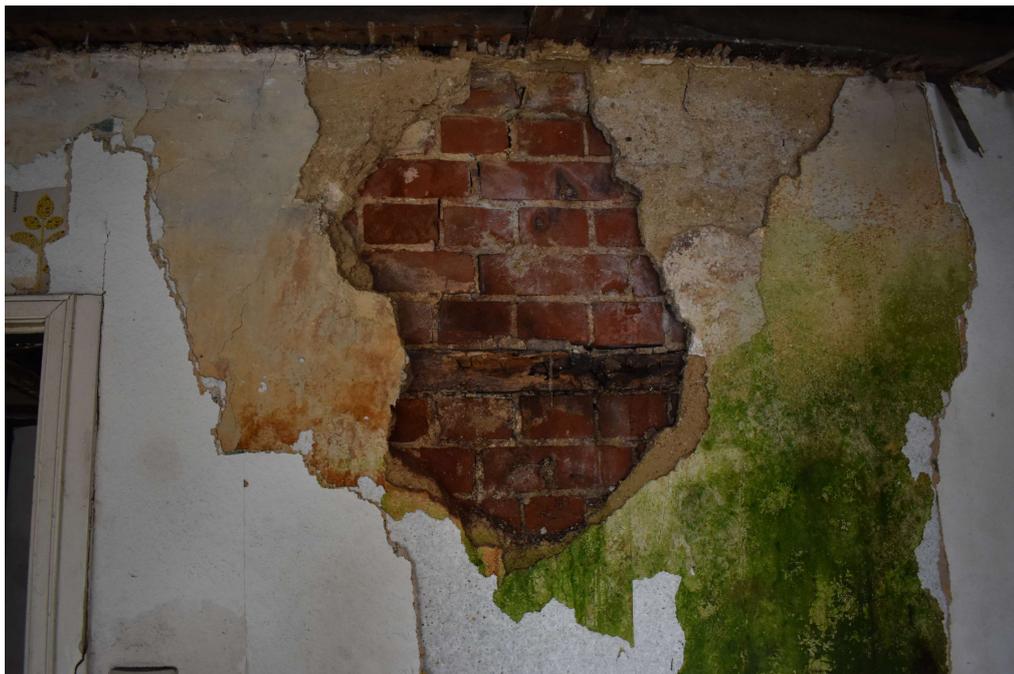
Photograph 22 Detail of exposed brickwork, horsehair plaster and bond timber in Bedroom 5. Photograph taken facing north-east.

Bedroom 5 is located in the south-east corner of the E/W range on the first floor. An area of damage to the plaster on the north-east wall has revealed a layer of horse-hair plaster below the modern plasterboard as well as a bond timber. There is a replacement window on the south-west wall and an inserted doorway in the north-east wall.

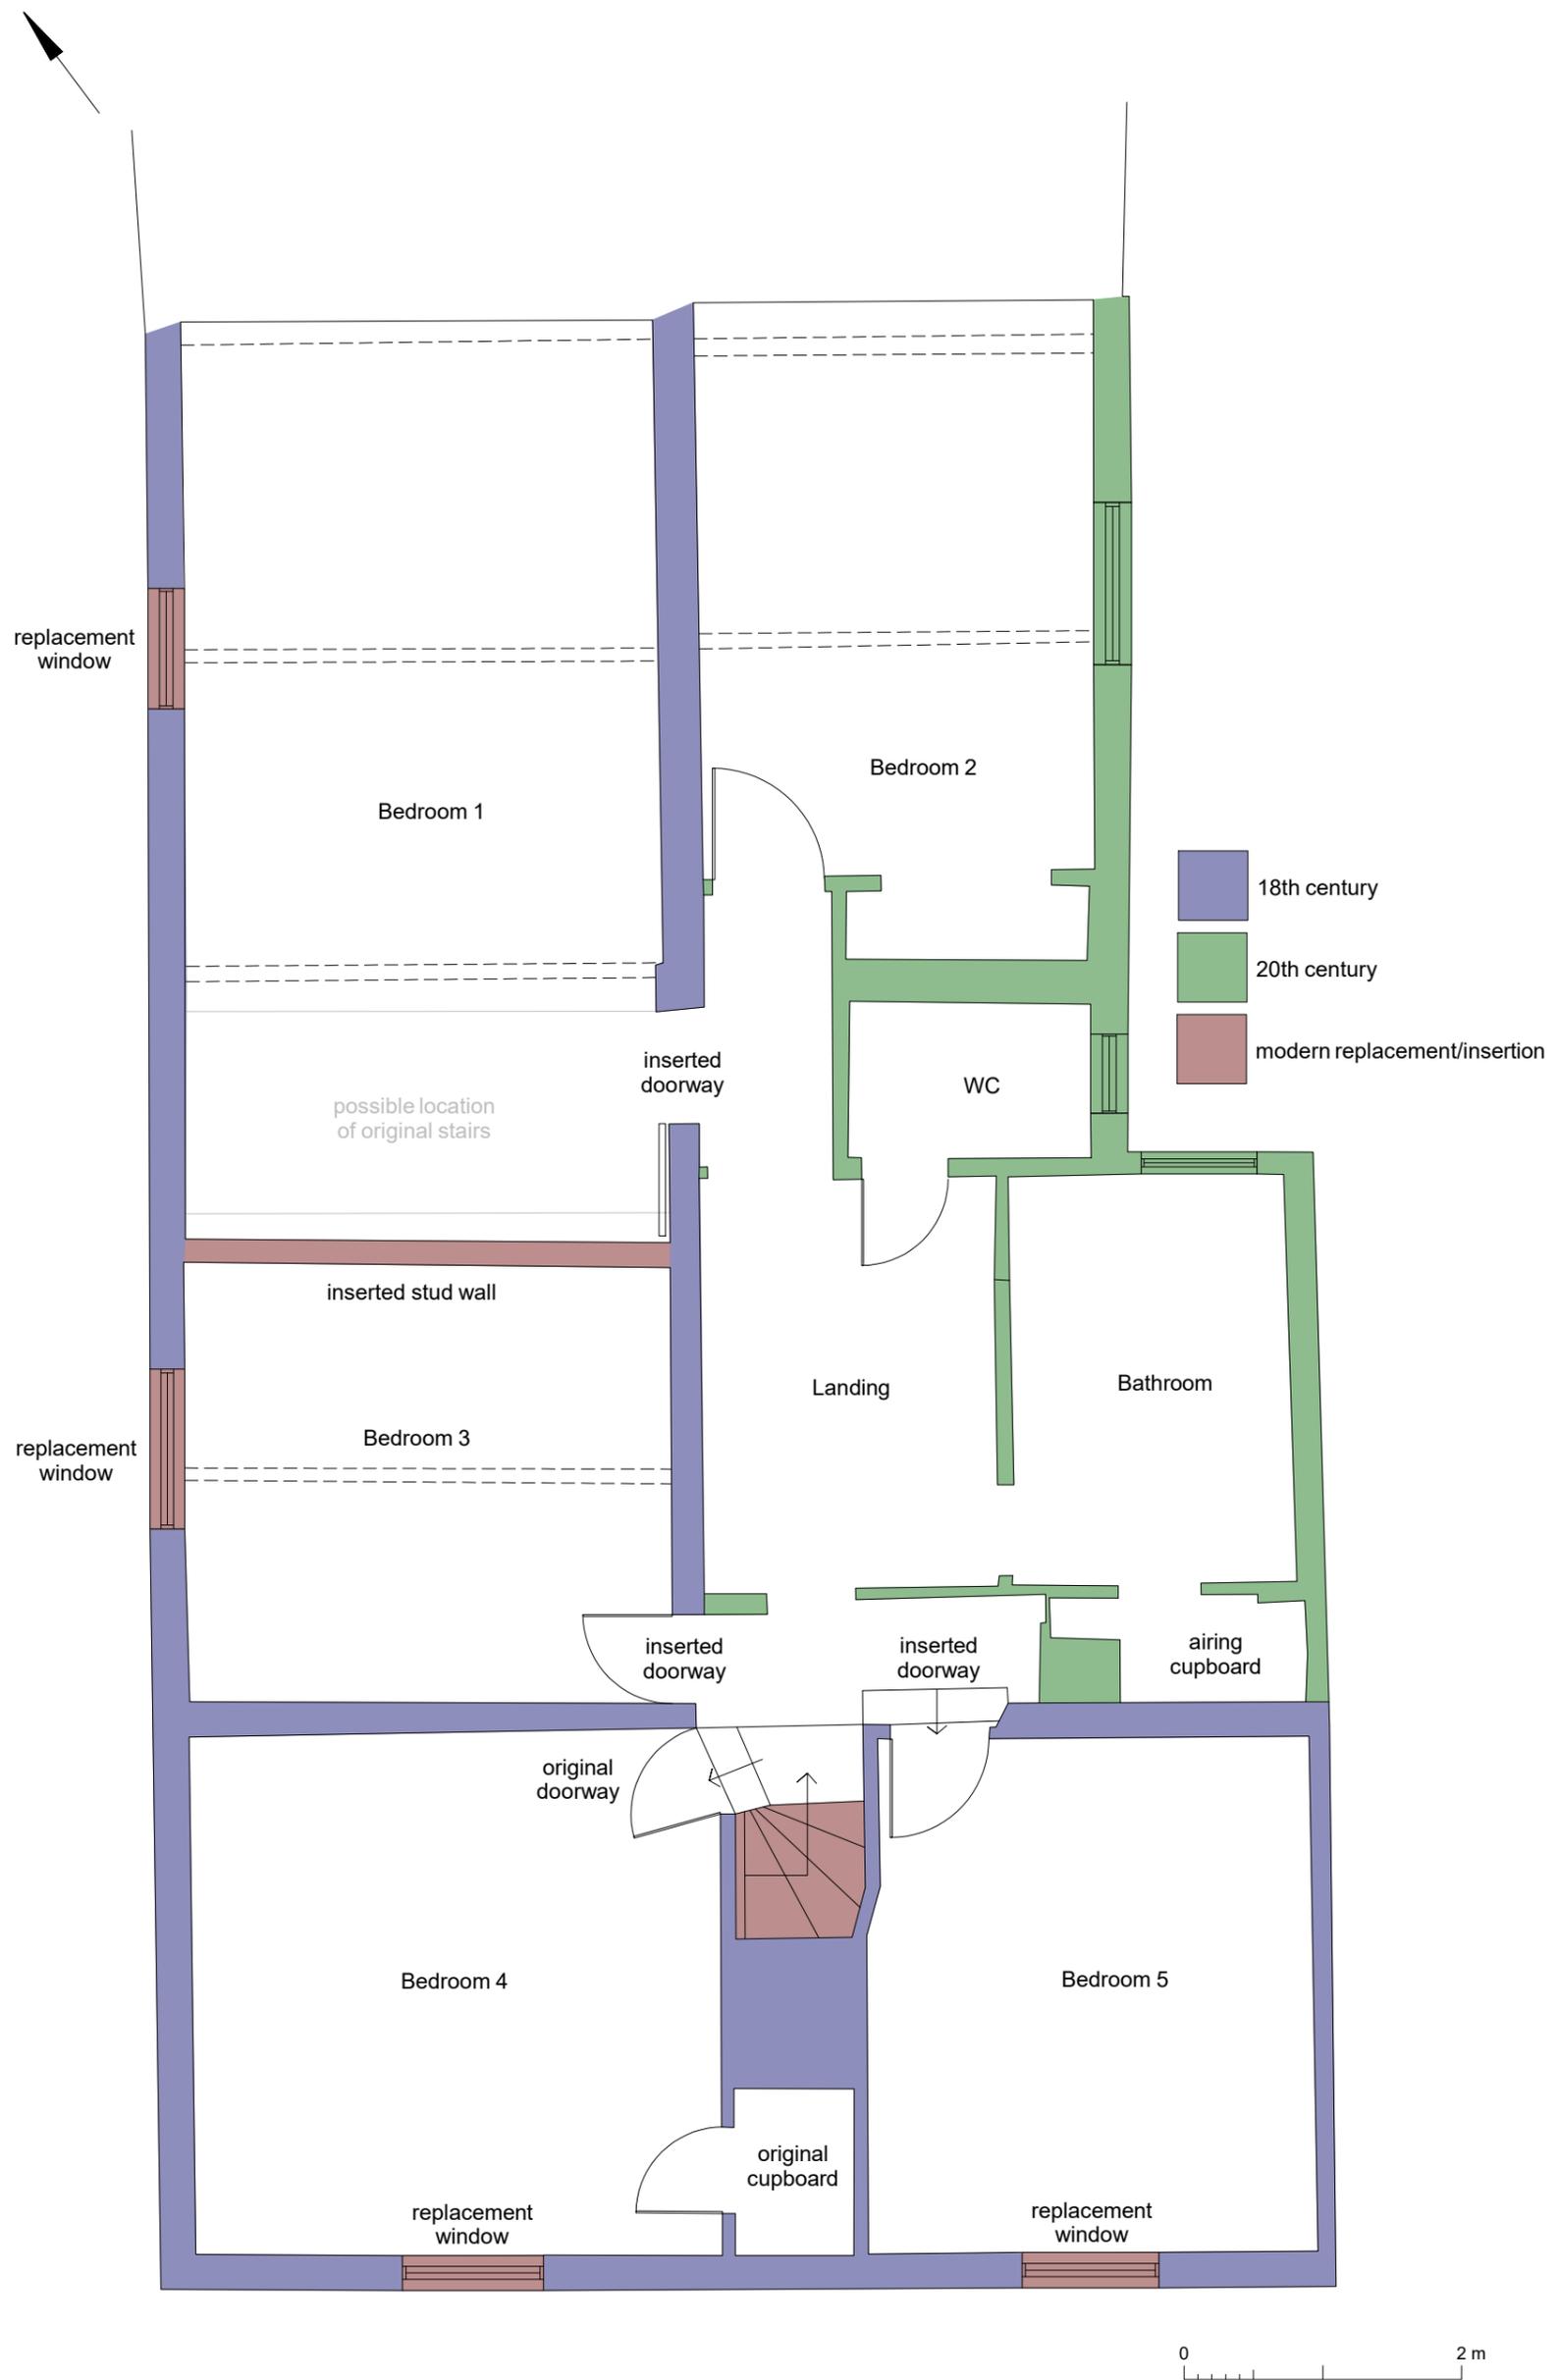
Photograph 23 Detail of ?original shelves above stairs. Photograph taken facing south-west.

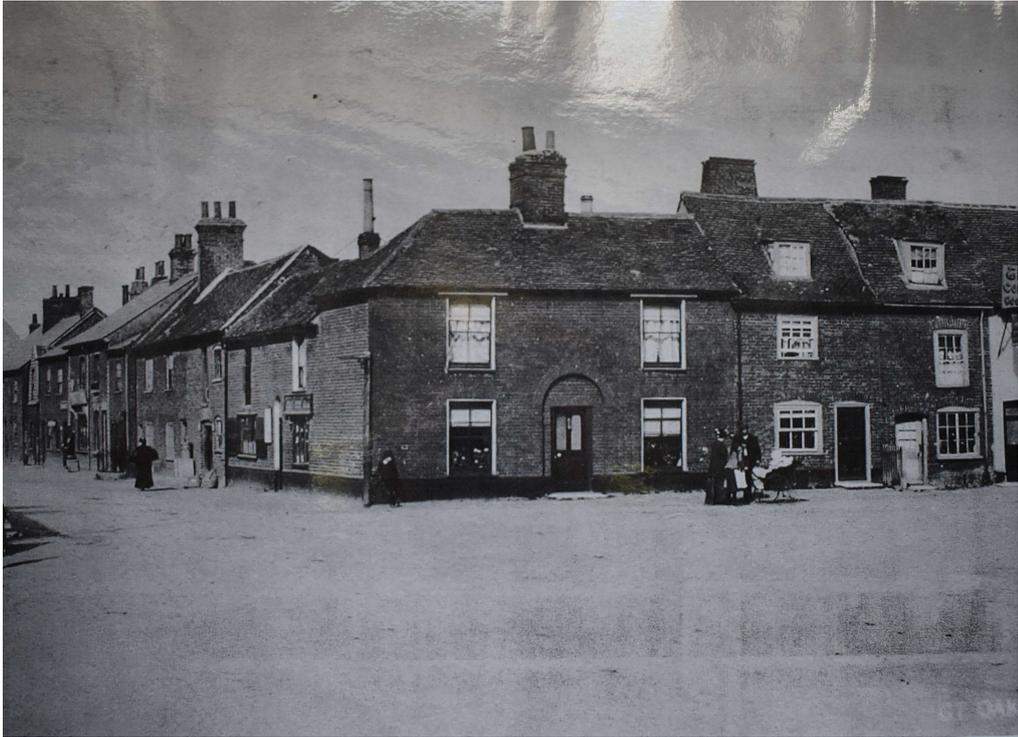
Photograph 24 Historic photograph of Red house (exact date unknown, pre-1920's). The probable bake office chimney can be seen on the N/S range.

The living room dominates the ground floor of the N/S range. The walls are plastered and painted white. On the south-east wall is an alcove, which was probably the original location of an oven for the bake office. From historic photographs a chimney can be seen in roughly the same location (see Photograph 24).

On the 1841 Tithe map (Map 2), the plot that is now Red House is identified as a house and bake office, and a house and shop. It seems that the N/S range was likely to be the bake office, there is an alcove present in the Living Room that was probably the location of an oven. Historic photographs show there was once a chimney in roughly the same location as the alcove.

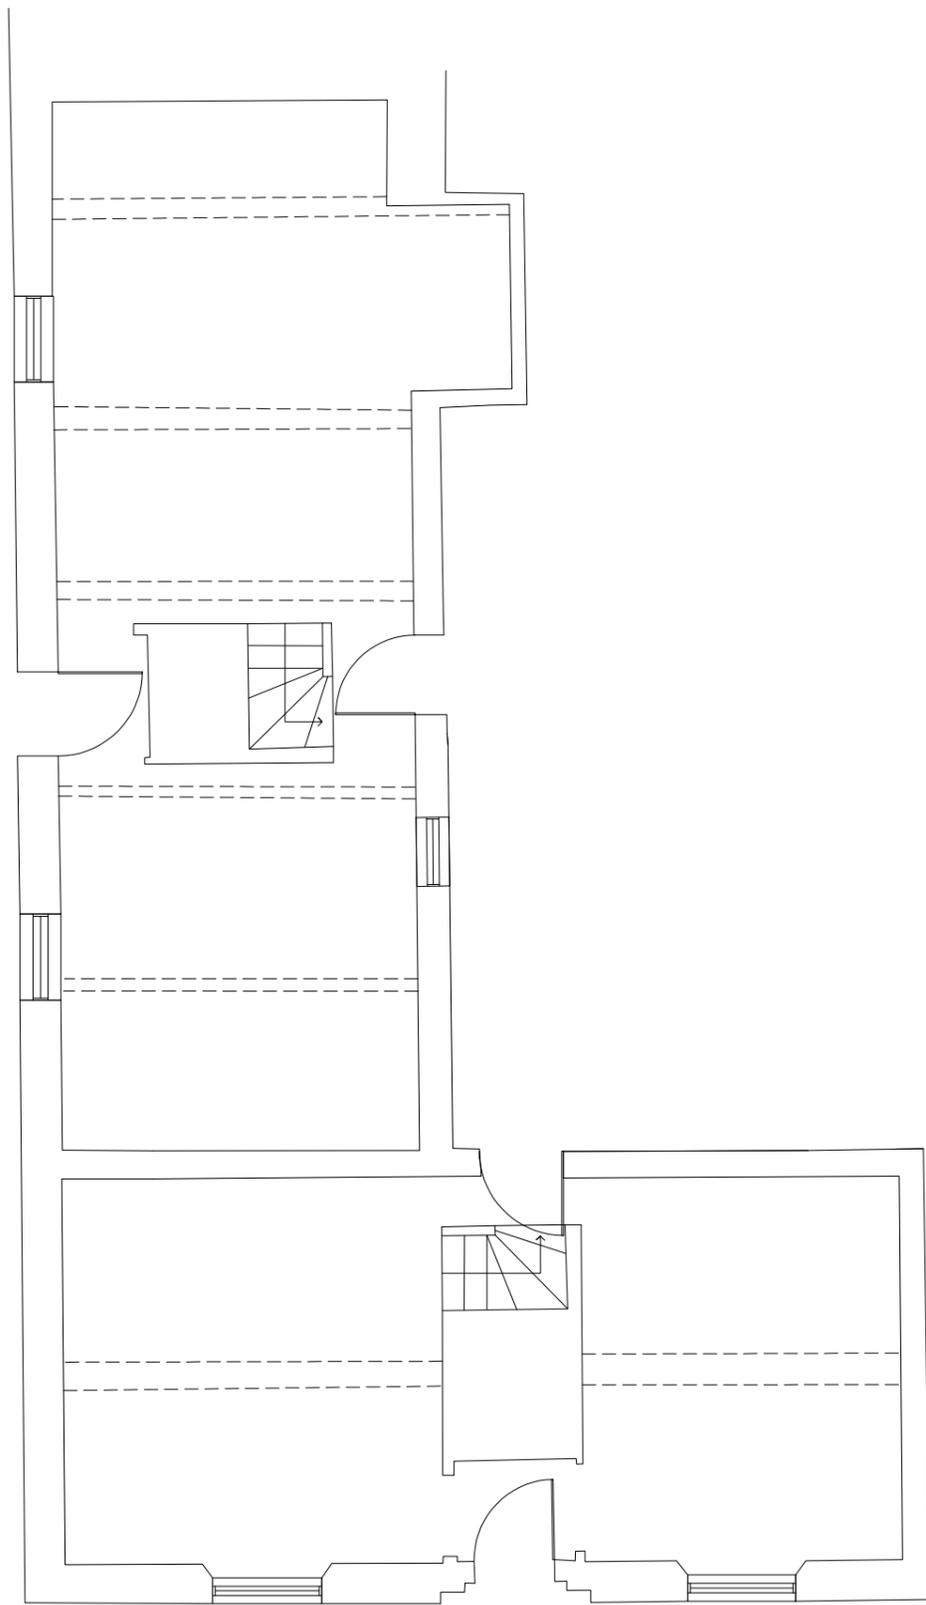
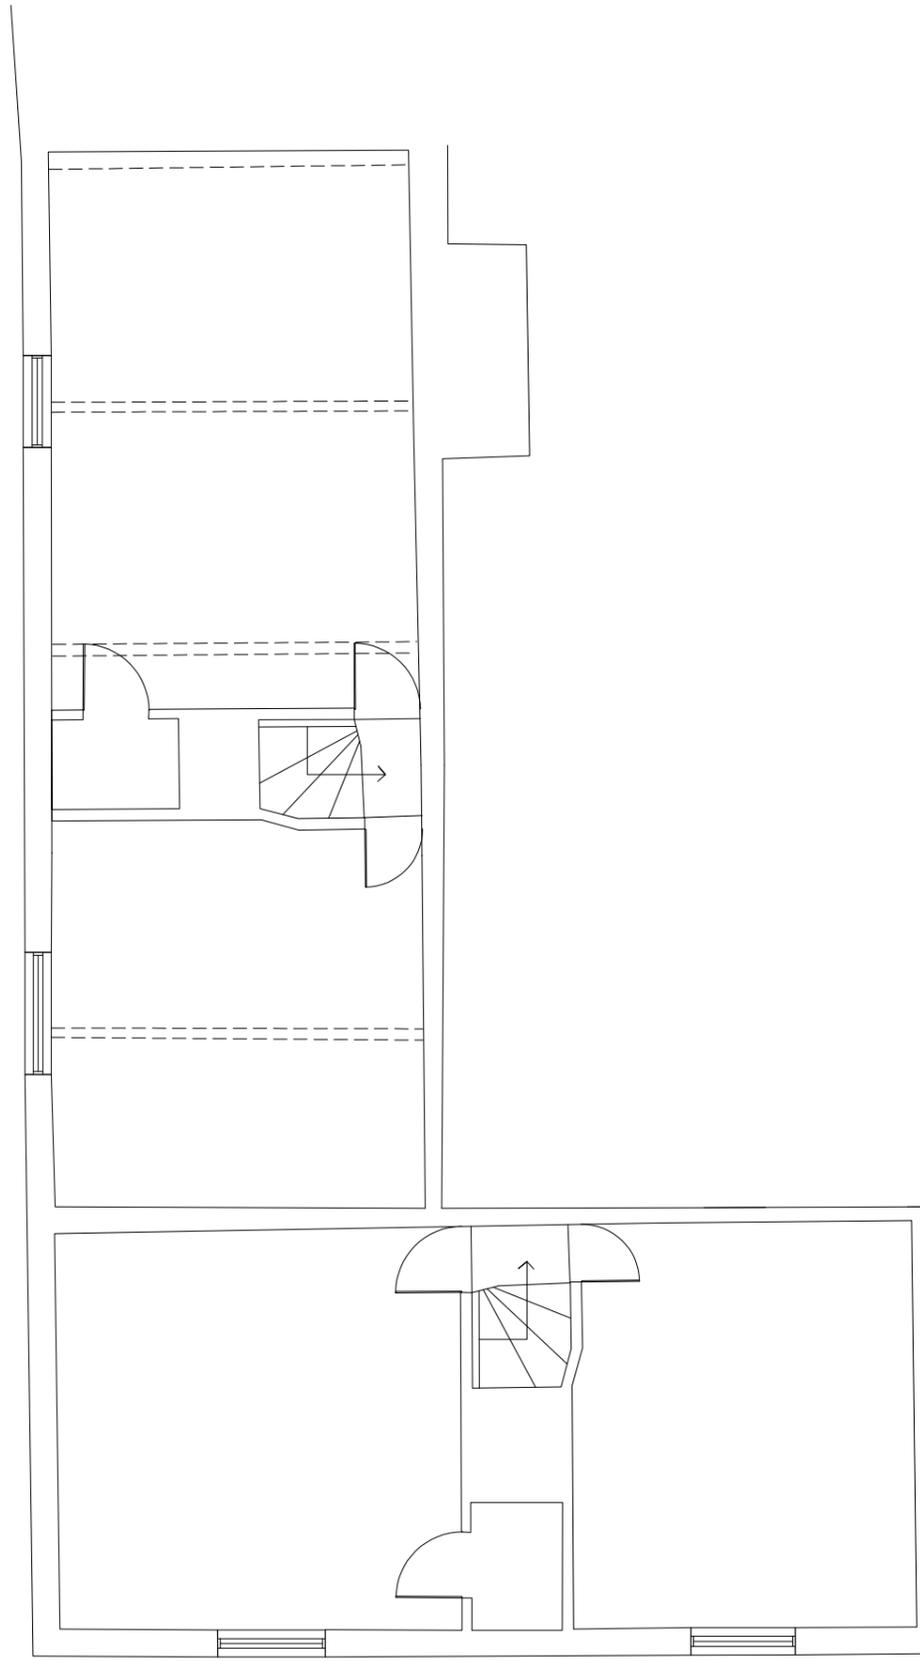
Fig 3 Possible original layout of Red House.

Ground floor

First floor

The building consists of 14 rooms which have been labelled according to their function (see Fig 2 and 3).

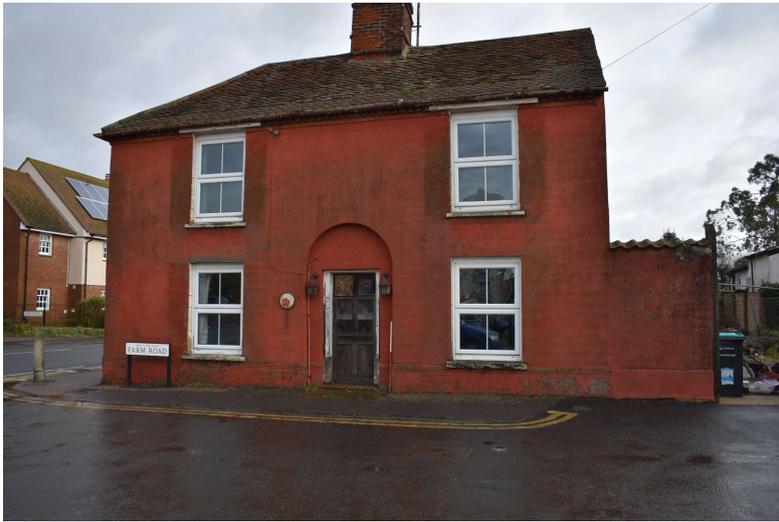
GOARH22_Photograph_001
South-west elevation. Photograph taken facing north north-west.

The south-west elevation has four windows, two on each storey, flanking a single door. All four windows have concrete sills. The door is a modern wooden replacement with two single light windows. It sits in an arched recess, perhaps an indication there was once a fan light above the door (although the photo from the 1930s does not show this). There is a replacement doorstep made of Yorkstone.

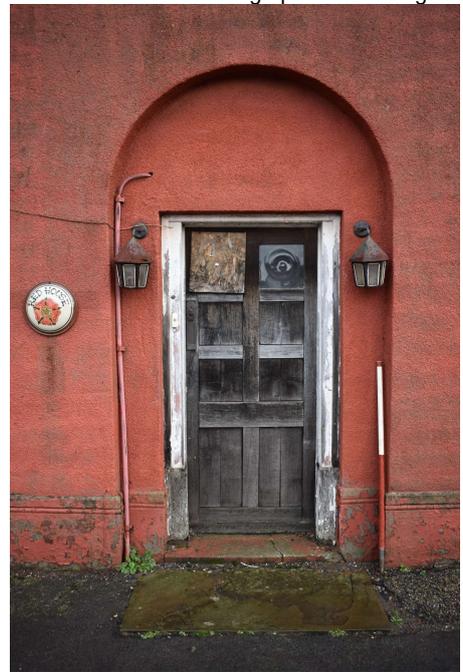
GOARH22_Photograph_004
Detail of front entrance. Photograph taken facing north-east.

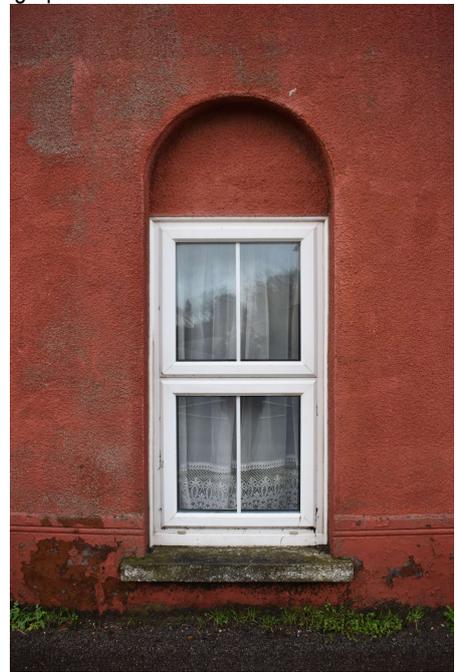
GOARH22_Photograph_008
Detail of original doorway with replacement window. Photograph taken facing so...

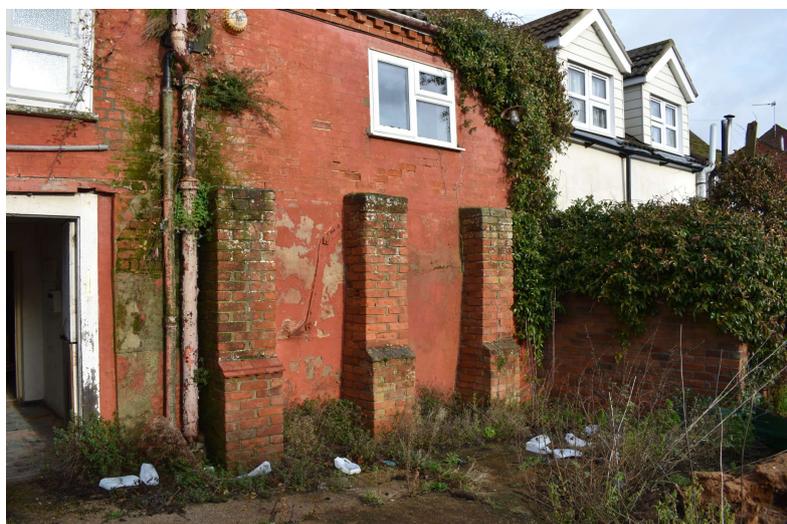
GOARH22_Photograph_012
Detail of butresses on south-east elevation. Photograph taken facing north-west.
Page 2/18

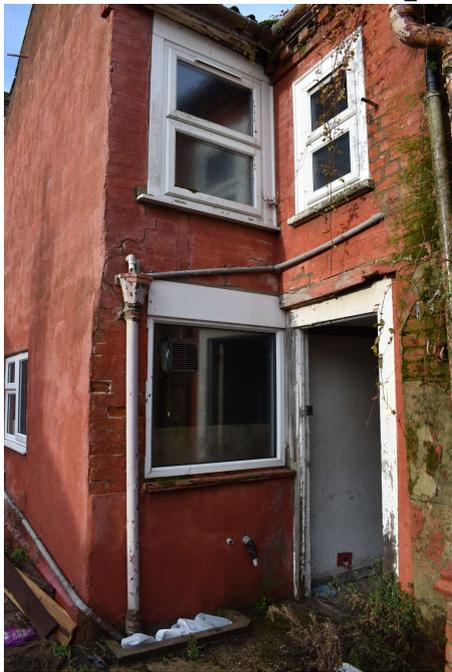
GOARH22_Photograph_013

Detail of inserted windows on south-east elevation. Photograph taken facing so...

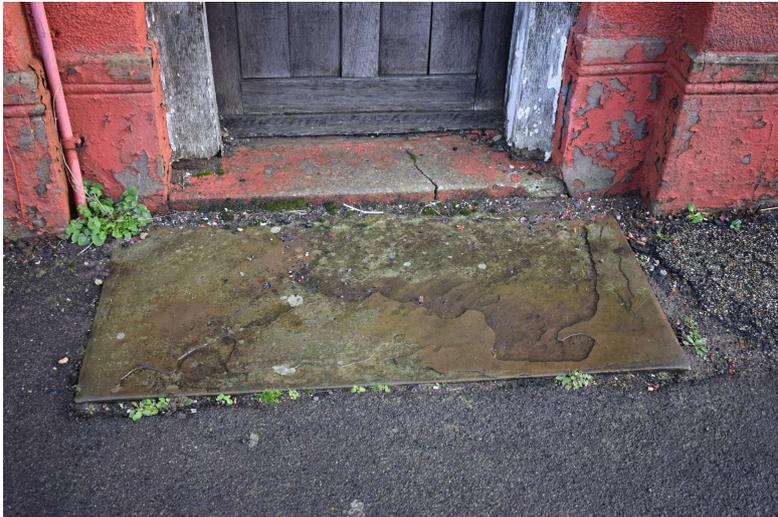
GOARH22_Photograph_015

Detail of yorkstone door step. Photograph taken facing north-east.

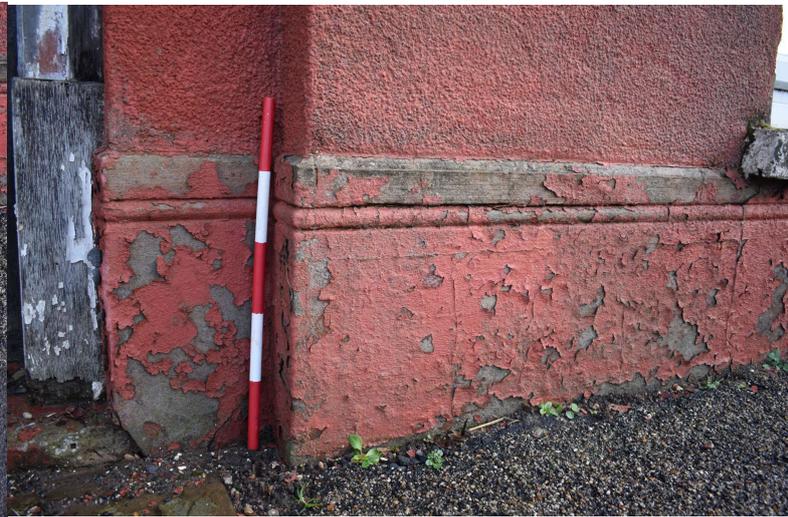
GOARH22_Photograph_016

Detail of limestone veneer. Photograph taken facing north-east.

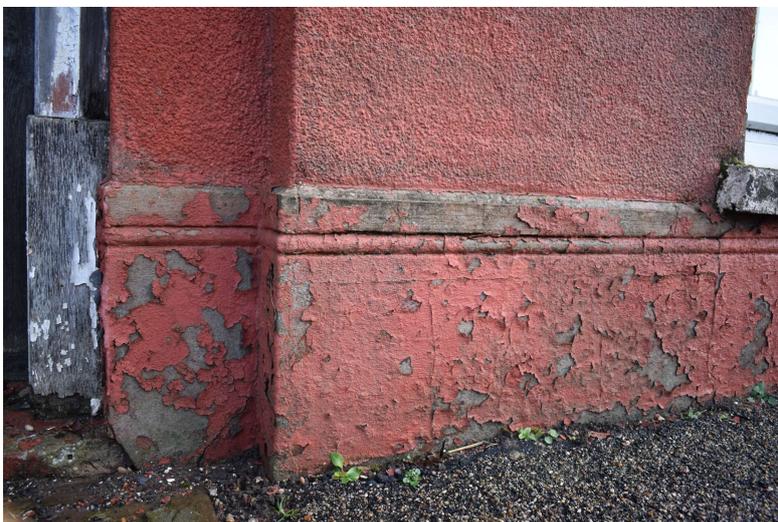
GOARH22_Photograph_017

Detail of limestone veneer. Photograph taken facing north-east.

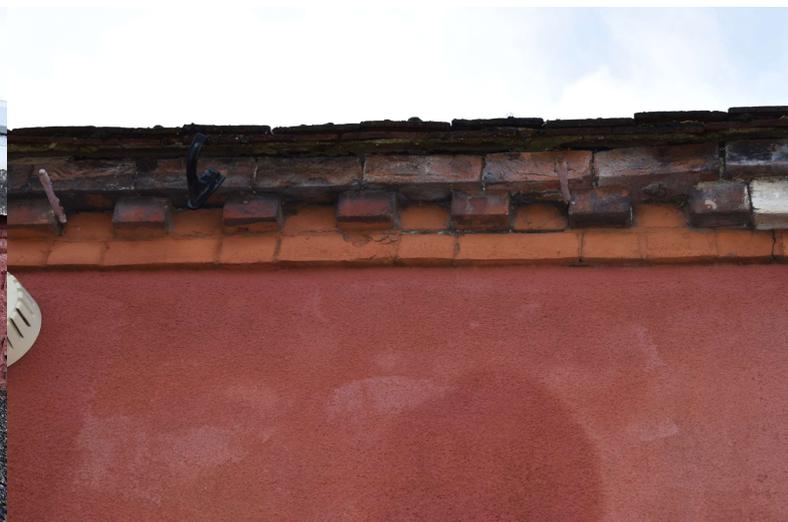
GOARH22_Photograph_018

Detail of brickwork on north-west elevation. Photograph taken facing south-east.

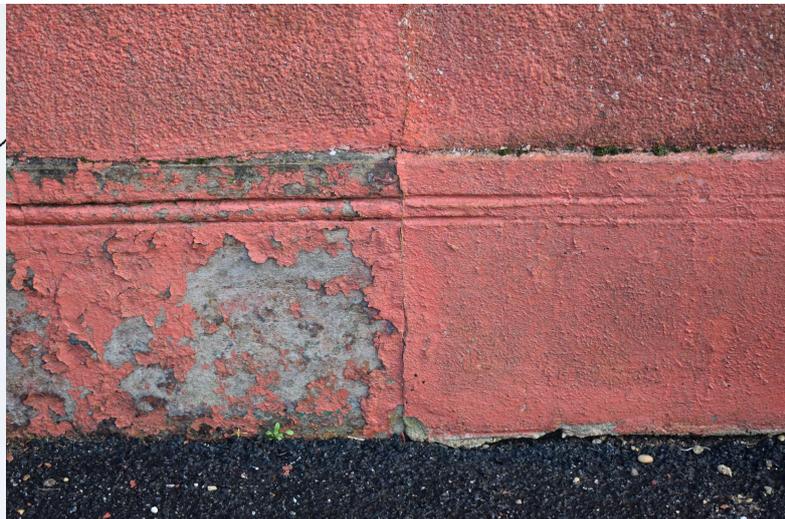
GOARH22_Photograph_022
Detail of original limestone veneer against modern concrete imitation. Photograph taken facing north-east.

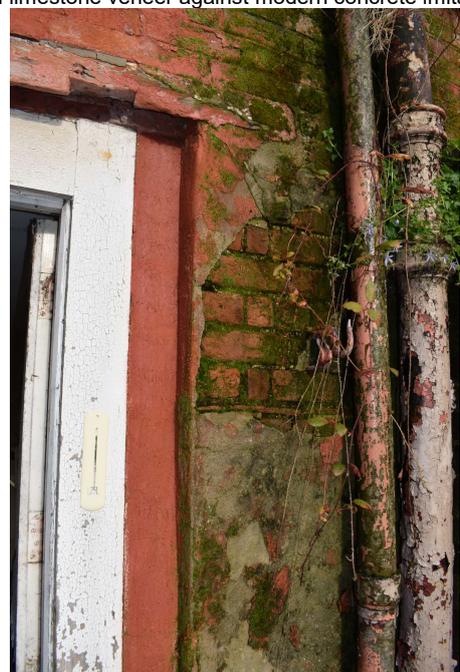
GOARH22_Photograph_024
Detail of queen closers on south-east elevation. Photograph taken facing north-east.

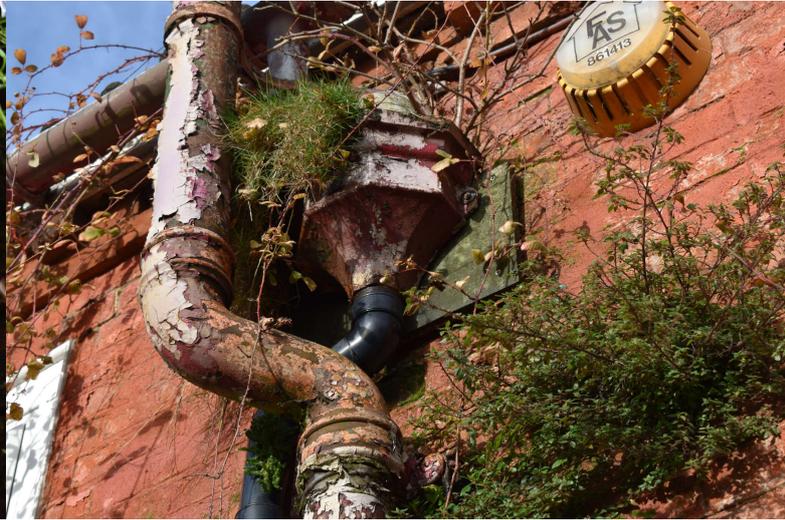
GOARH22 Photograph_026
Detail of re-used hopper on south-east elevation. Photograph taken facing north...

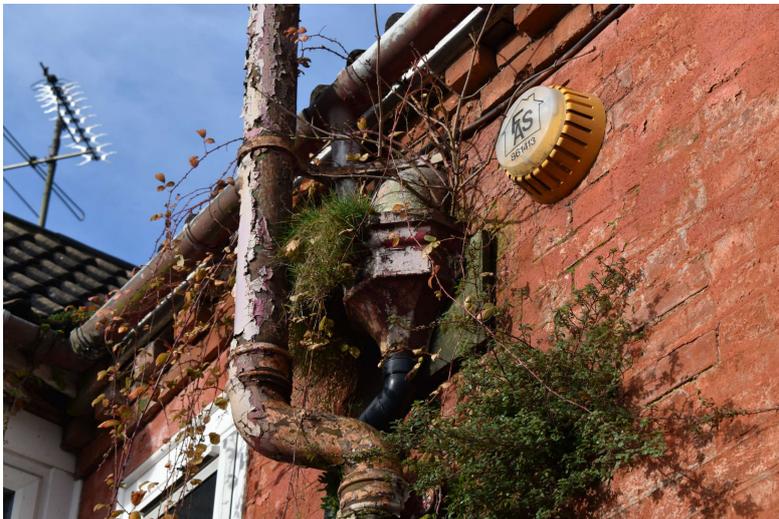
GOARH22 Photograph_027
Detail of re-used hopper on south-east elevation. Photograph taken facing north...

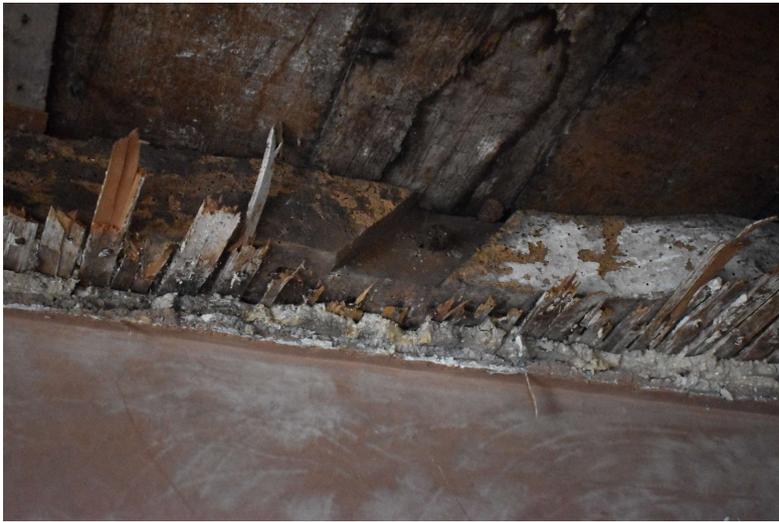
GOARH22 Photograph_031

Detail of reused timber wall plate in Sitting Room. Photograph taken facing north...

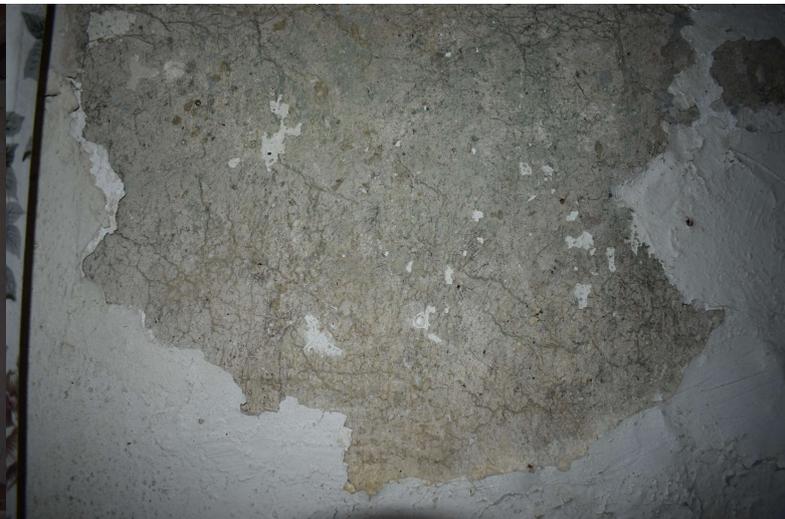
GOARH22 Photograph_034

Detail of horse-hair plaster in Sitting Room. Photograph taken facing south-west.

The sitting room is located in the south-west corner of the E/W range on the ground floor. The north-west wall is bare orange plaster while the others have been painted white. On the south-west wall an area of damage has revealed horse-hair plaster beneath the modern plaster skim. There is an original doorway present on the south-east wall and an inserted door on the north-west wall and in the eastern corner. A replacement window is also present on the south-west wall. Stairs to the first floor are located on the south-east wall and, while in the original location, the stairs themselves are a replacement.

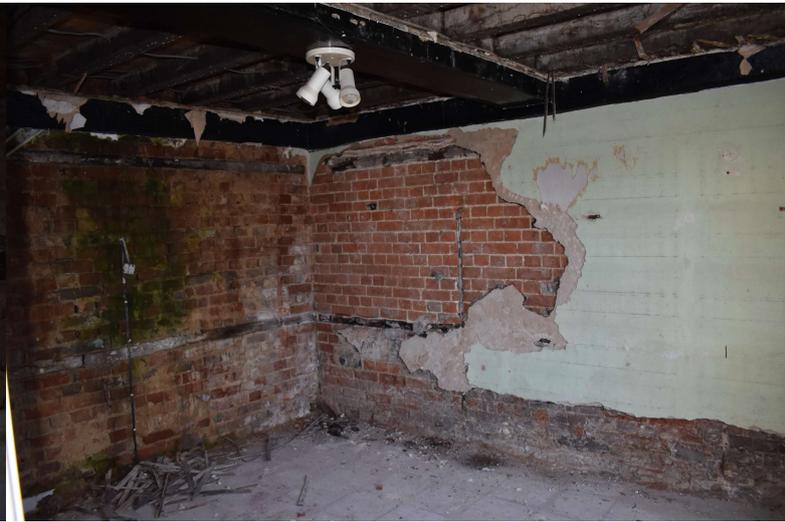
GOARH22 Photograph_037
Detail of infilled fireplace in Study. Photograph taken facing north-west.

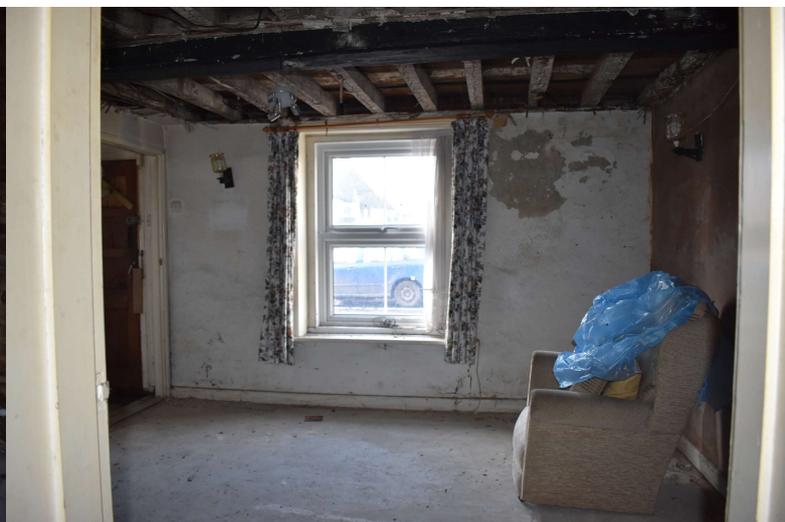
GOARH22 Photograph_041
Detail of Study wall with infilled fireplace and timbers. Photograph taken facing ...

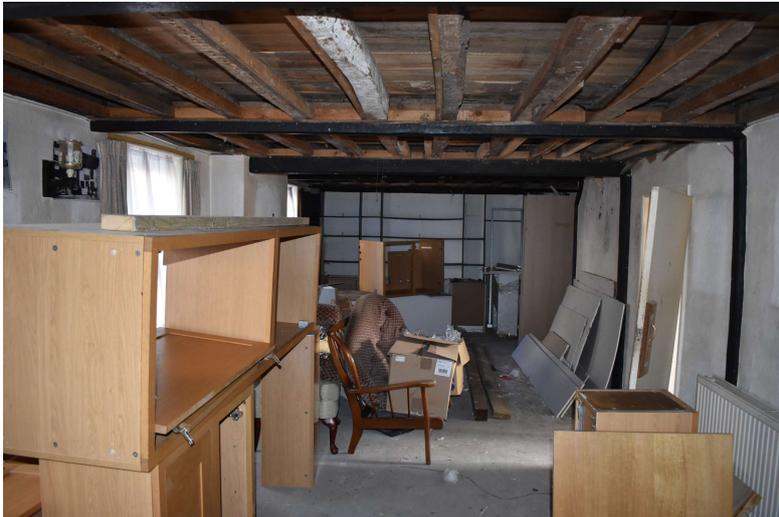
GOARH22_Photograph_044
Detail of alcove in Living Room. Photograph taken facing south-east.

Damage to the plaster board of the south-east wall has exposed an area of stud-work inserted in to the original brick wall. This was probably inserted after the removal of the alcove, which is still present in the Living Room below, which would have left a gap in the brick wall.

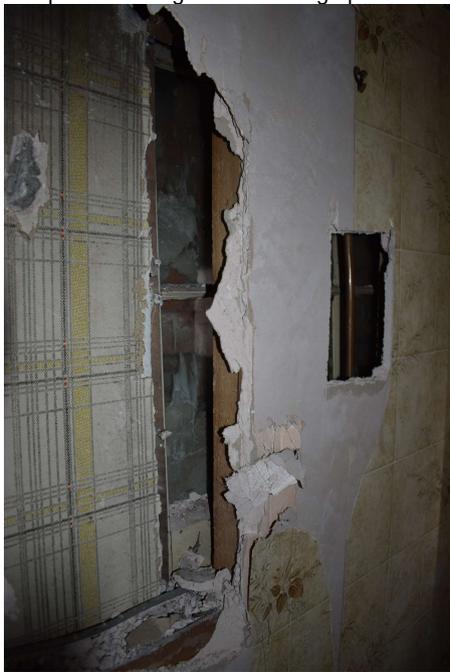
GOARH22 Photograph_050
Detail of window boarded up in kitchen. Photograph taken facing north-west.

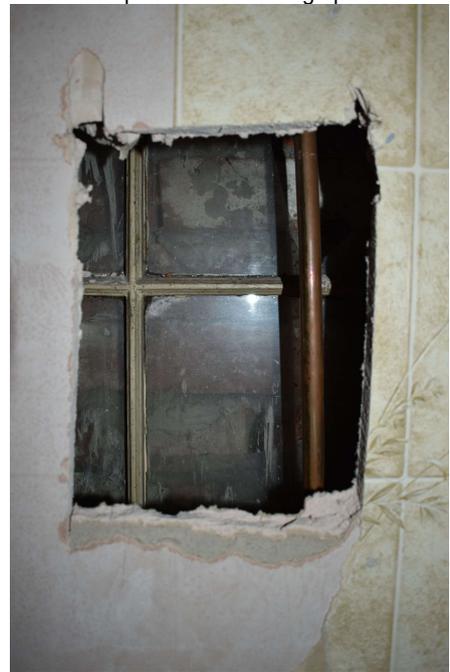
GOARH22 Photograph_051
Detail of window boarded up in kitchen. Photograph taken facing north.

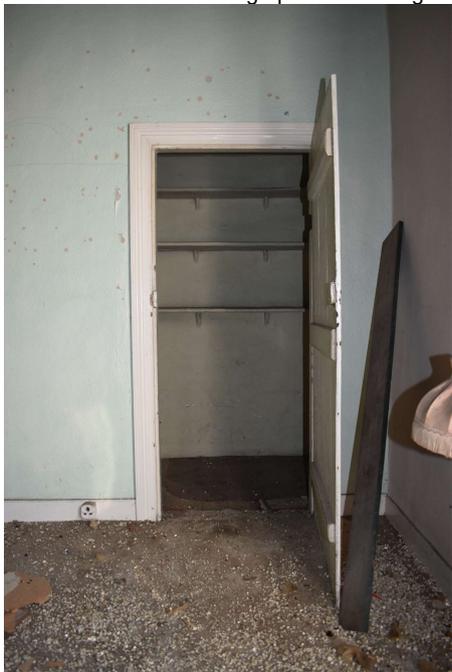
GOARH22 Photograph 062
Detail staircase entrance in Sitting Room. Photograph taken facing south-east.

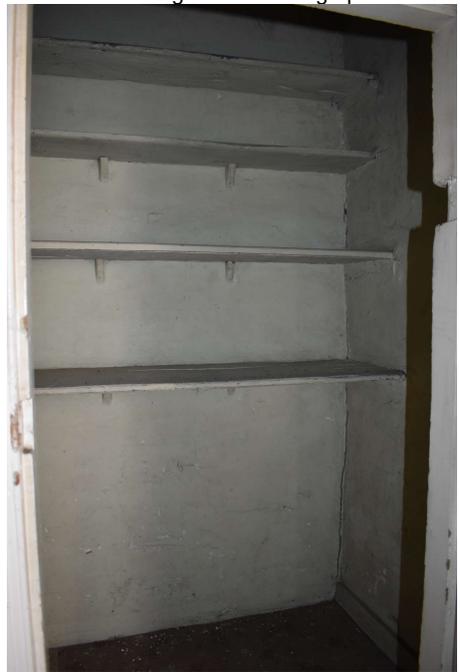
GOARH22_Photograph_063
Detail of ?original cupboard in Bedroom 4. Photograph taken facing south-east.

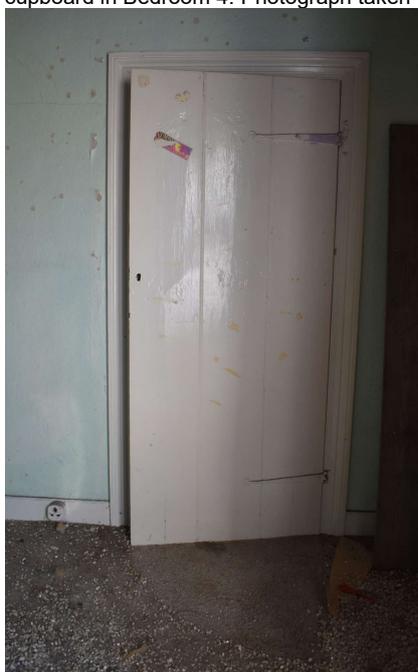
GOARH22_Photograph_064
Detail of ?original cupboard in Bedroom 4. Photograph taken facing south-east.

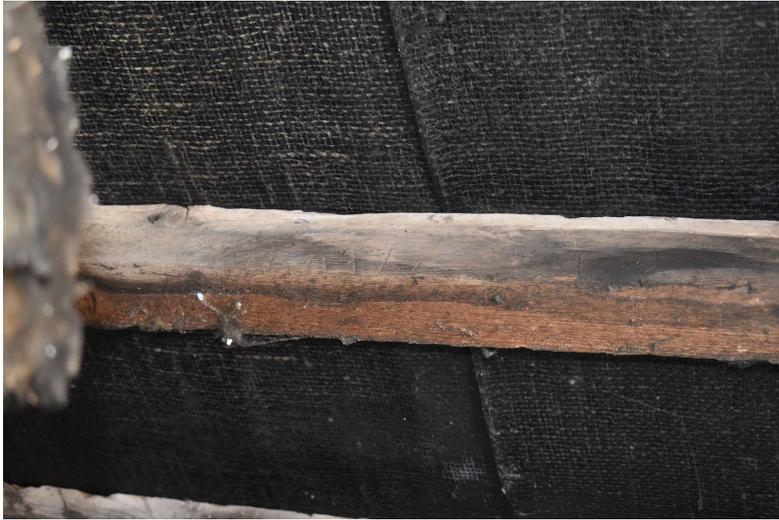
GOARH22_Photograph_066
Detail of roof construction in Bedroom 4. Photograph taken south-east.

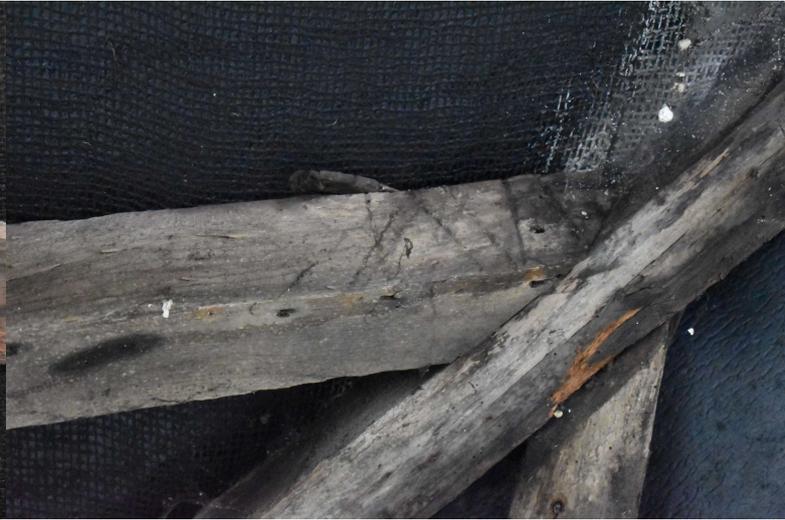
GOARH22_Photograph_067
Detail of Baltic timber marks on rafter in Bedroom 4.

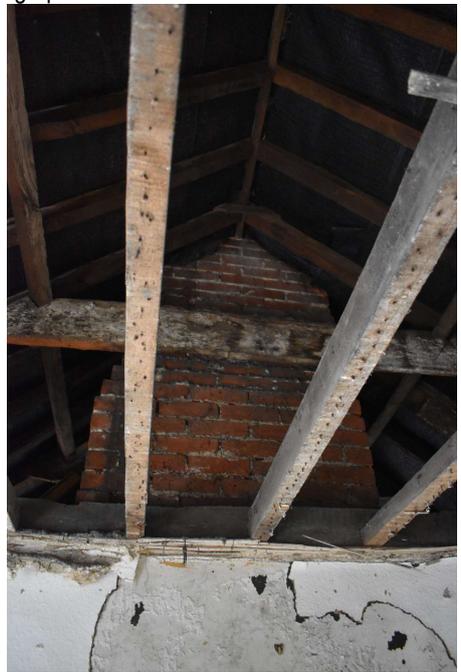
GOARH22_Photograph_073

Detail of painted brickwork in attic above Bedroom 5. Photograph taken facing s...

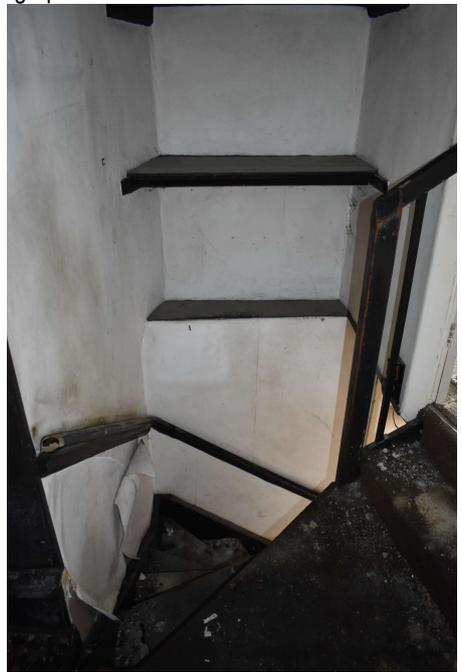
GOARH22_Photograph_079

Detail of ?original shelves above stairs. Photograph taken facing south-west.

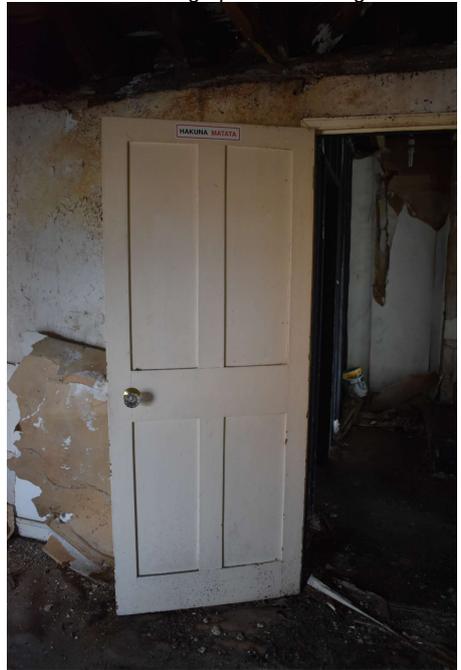
GOARH22_Photograph_081

Detail of ?original doorway into Bedroom 4. Photograph taken facing north-west.

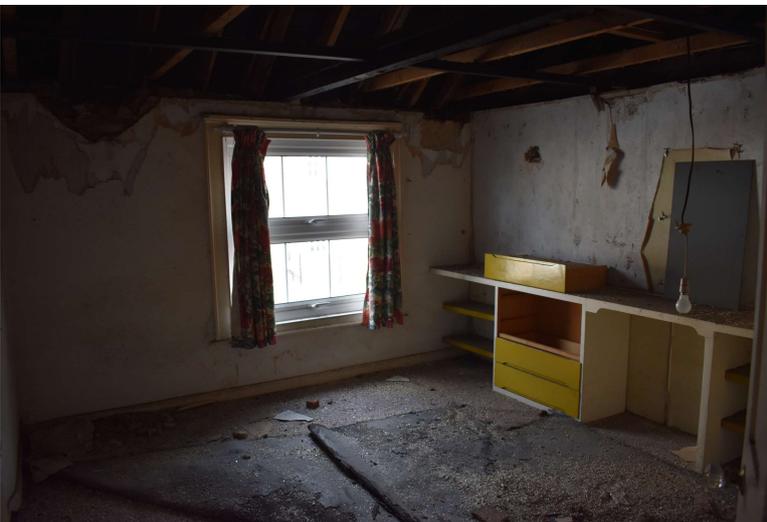
GOARH22_Photograph_082

Detail of door of Bedroom 3. Photograph taken facing east.

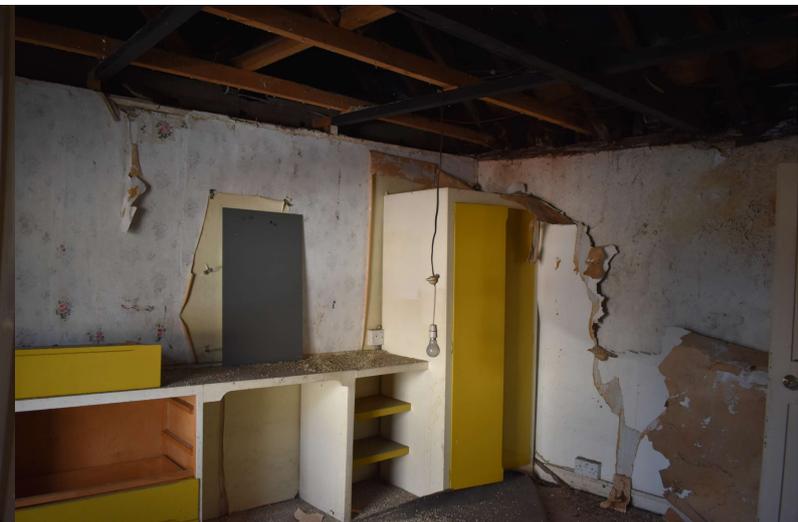
GOARH22_Photograph_083

Interior shot of Bedroom 3. Photograph taken facing north.

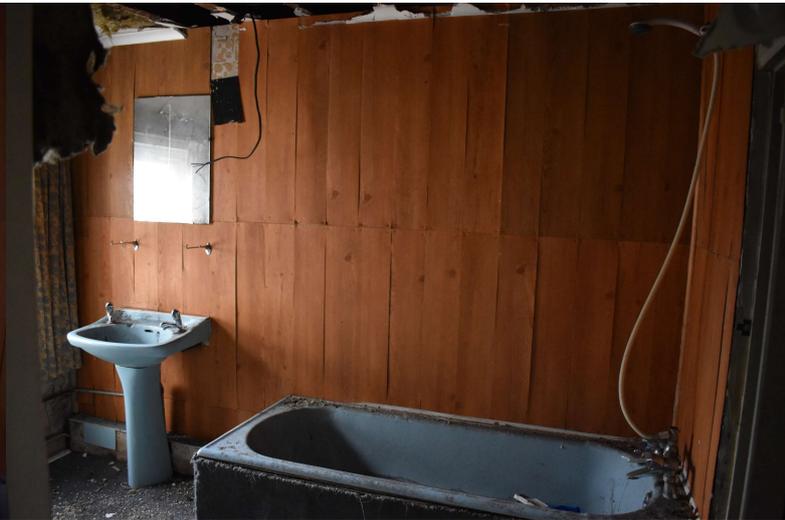
GOARH22_Photograph_085
Interior shot of Bathroom. Photograph taken facing north-east.

The bathroom is located on the first floor of the extension, adjacent to the landing. The bathroom contains a modern bathroom suite. The south-east and south-west walls are clad in timber and the north-east is plastered and wallpapered. Damage to the plasterboard on the north-west wall has revealed the laths of the wall beneath.
