Historic building recording at Red House, High Street, Great Oakley, CO12 5AQ

February 2022

CAT Report 1797
April 2022

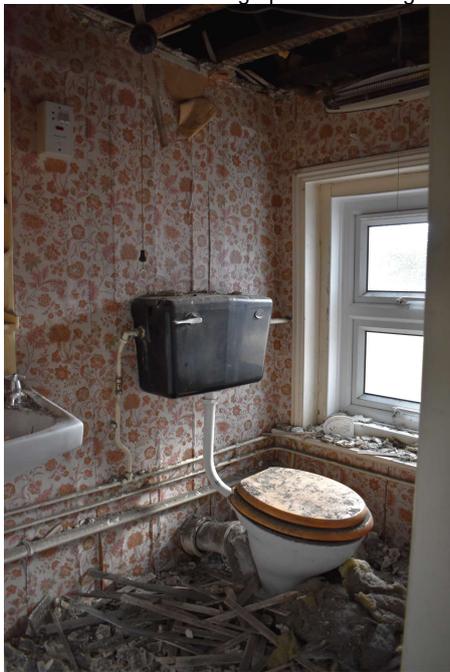
GOARH22_Photograph_086
Interior shot of Bathroom. Photograph taken facing south-east.

The bathroom is located on the first floor of the extension, adjacent to the landing. The bathroom contains a modern bathroom suite. The south-east and south-west walls are clad in timber and the north-east is plastered and wallpapered. Damage to the plasterboard on the north-west wall has revealed the laths of the wall beneath.

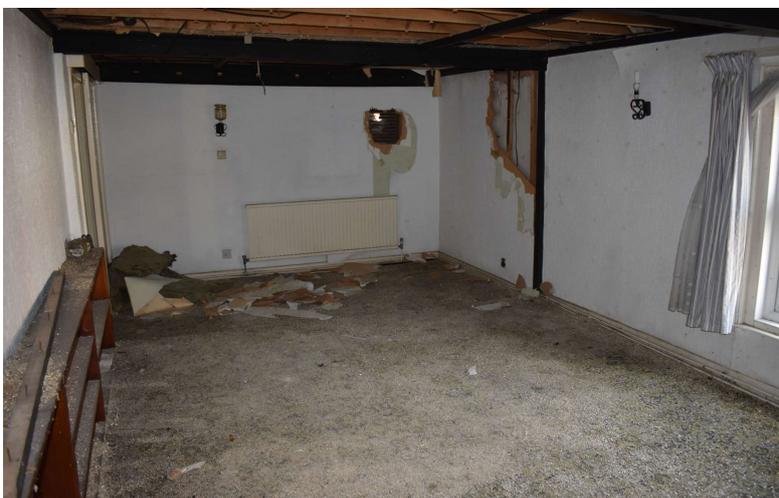
GOARH22_Photograph_088
Detail of roof above Bedroom 1. Photograph taken facing south-west.

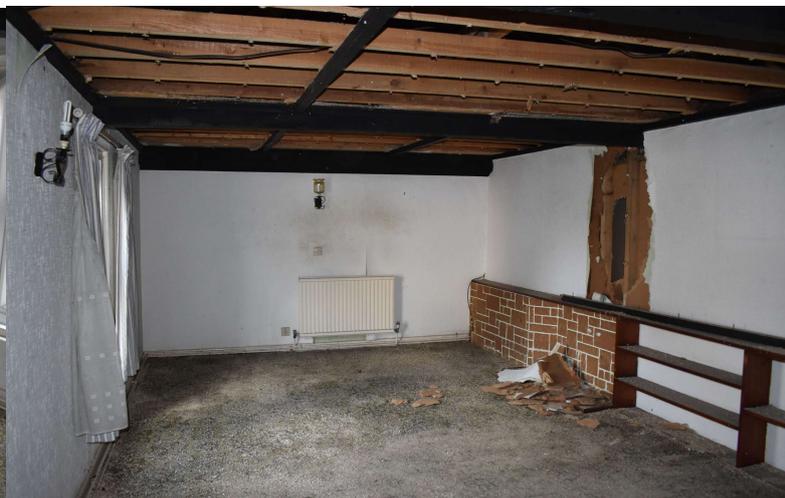
GOARH22_Photograph_089
Interior shot of Bedroom 1. Photograph taken facing south-west.

Bedroom 1 is located on the first floor in the north-east of the N/S range. The floor is raised slightly in the northern part of the room. It is possible that the removal of the original staircase caused this difference in height. There is a replacement window on the north-west wall and an inserted glass-sliding door on the south-east wall. The south-west wall is an inserted stud wall.

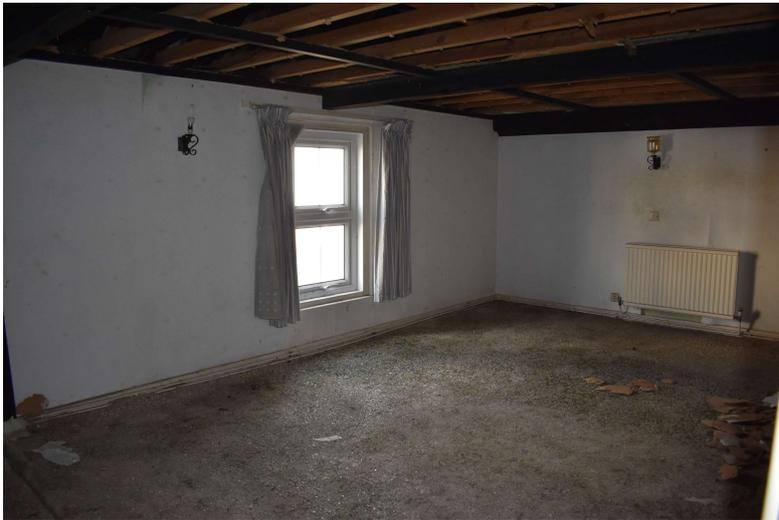
GOARH22_Photograph_090
Interior shot of Bedroom 1. Photograph taken facing north-east.

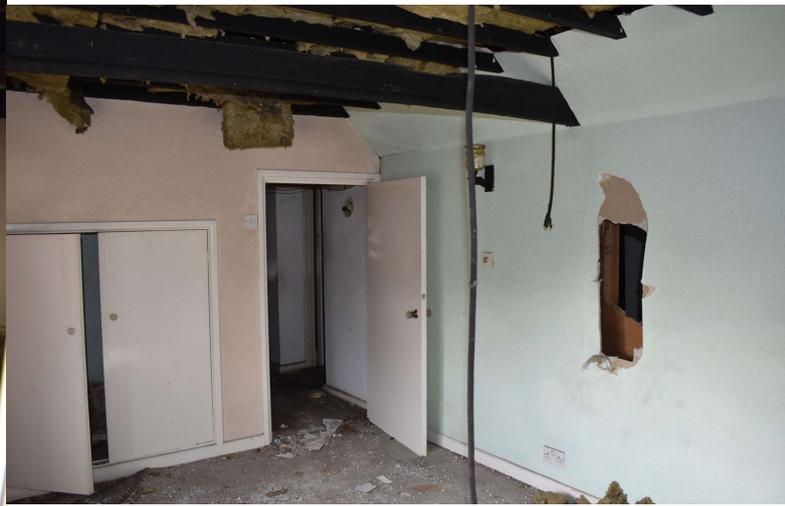
GOARH22_Photograph_091
Interior shot of Bedroom 1. Photograph taken facing north.

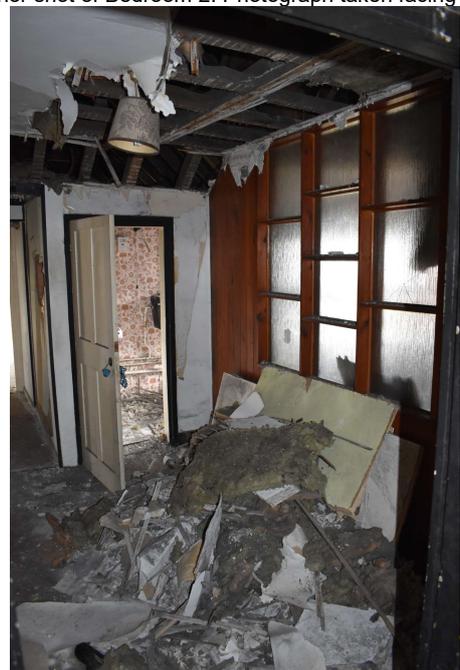
GOARH22_Photograph_095
Detail of inserted wall of Bathroom. Photograph taken facing north-east.

The north-west wall is timber with a large frosted ten-light fixed internal window. An external window was present on the north-east wall. Behind the south-west wall an airing cupboard is located.

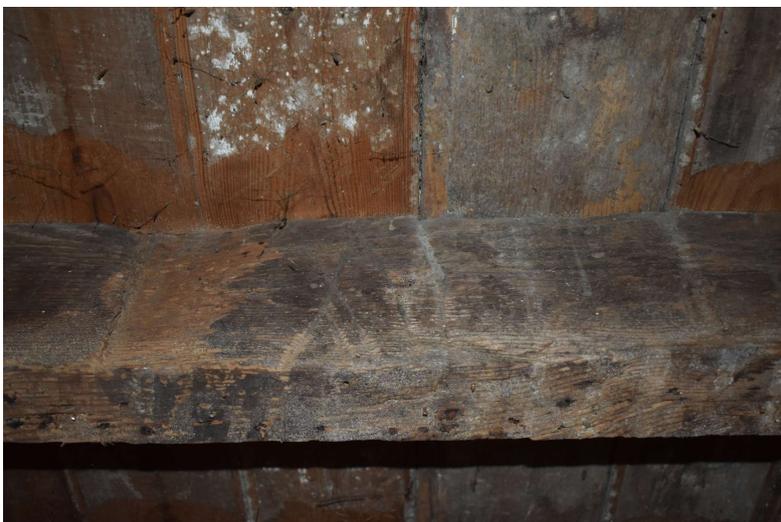
GOARH22_Photograph_100
Baltic timber marks in living room ceiling.

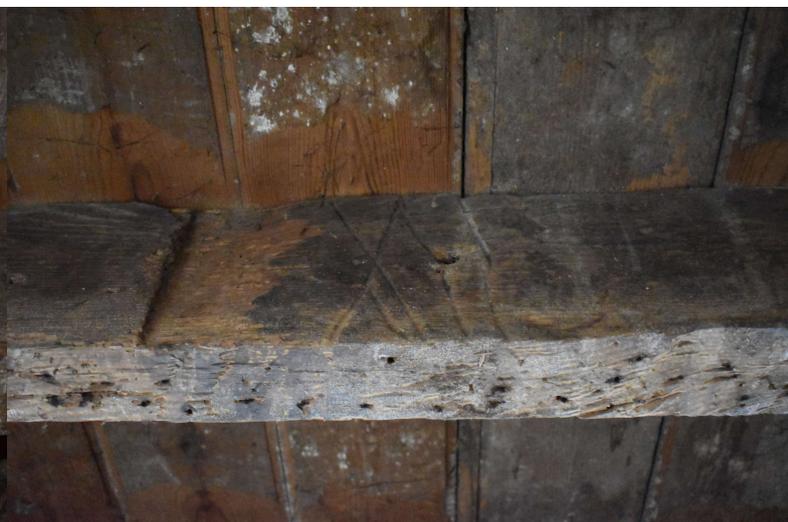
GOARH22_Photograph_101
Baltic timber marks in living room ceiling.

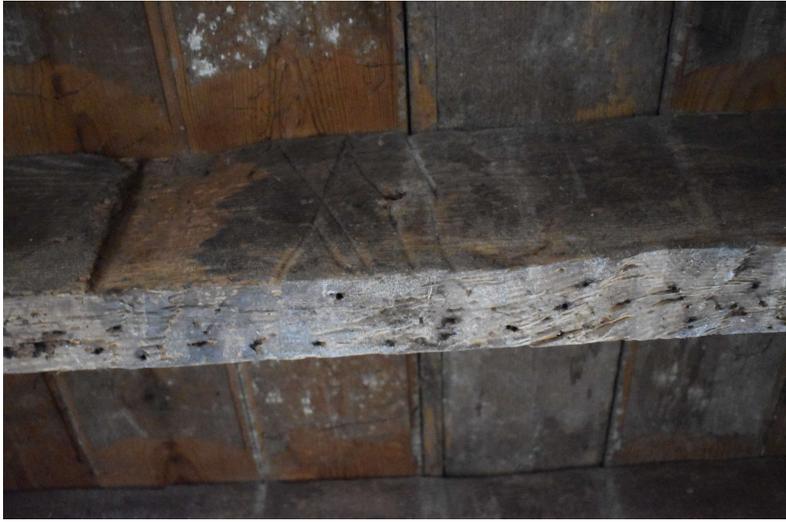
GOARH22_Photograph_102
Baltic timber marks in living room ceiling.

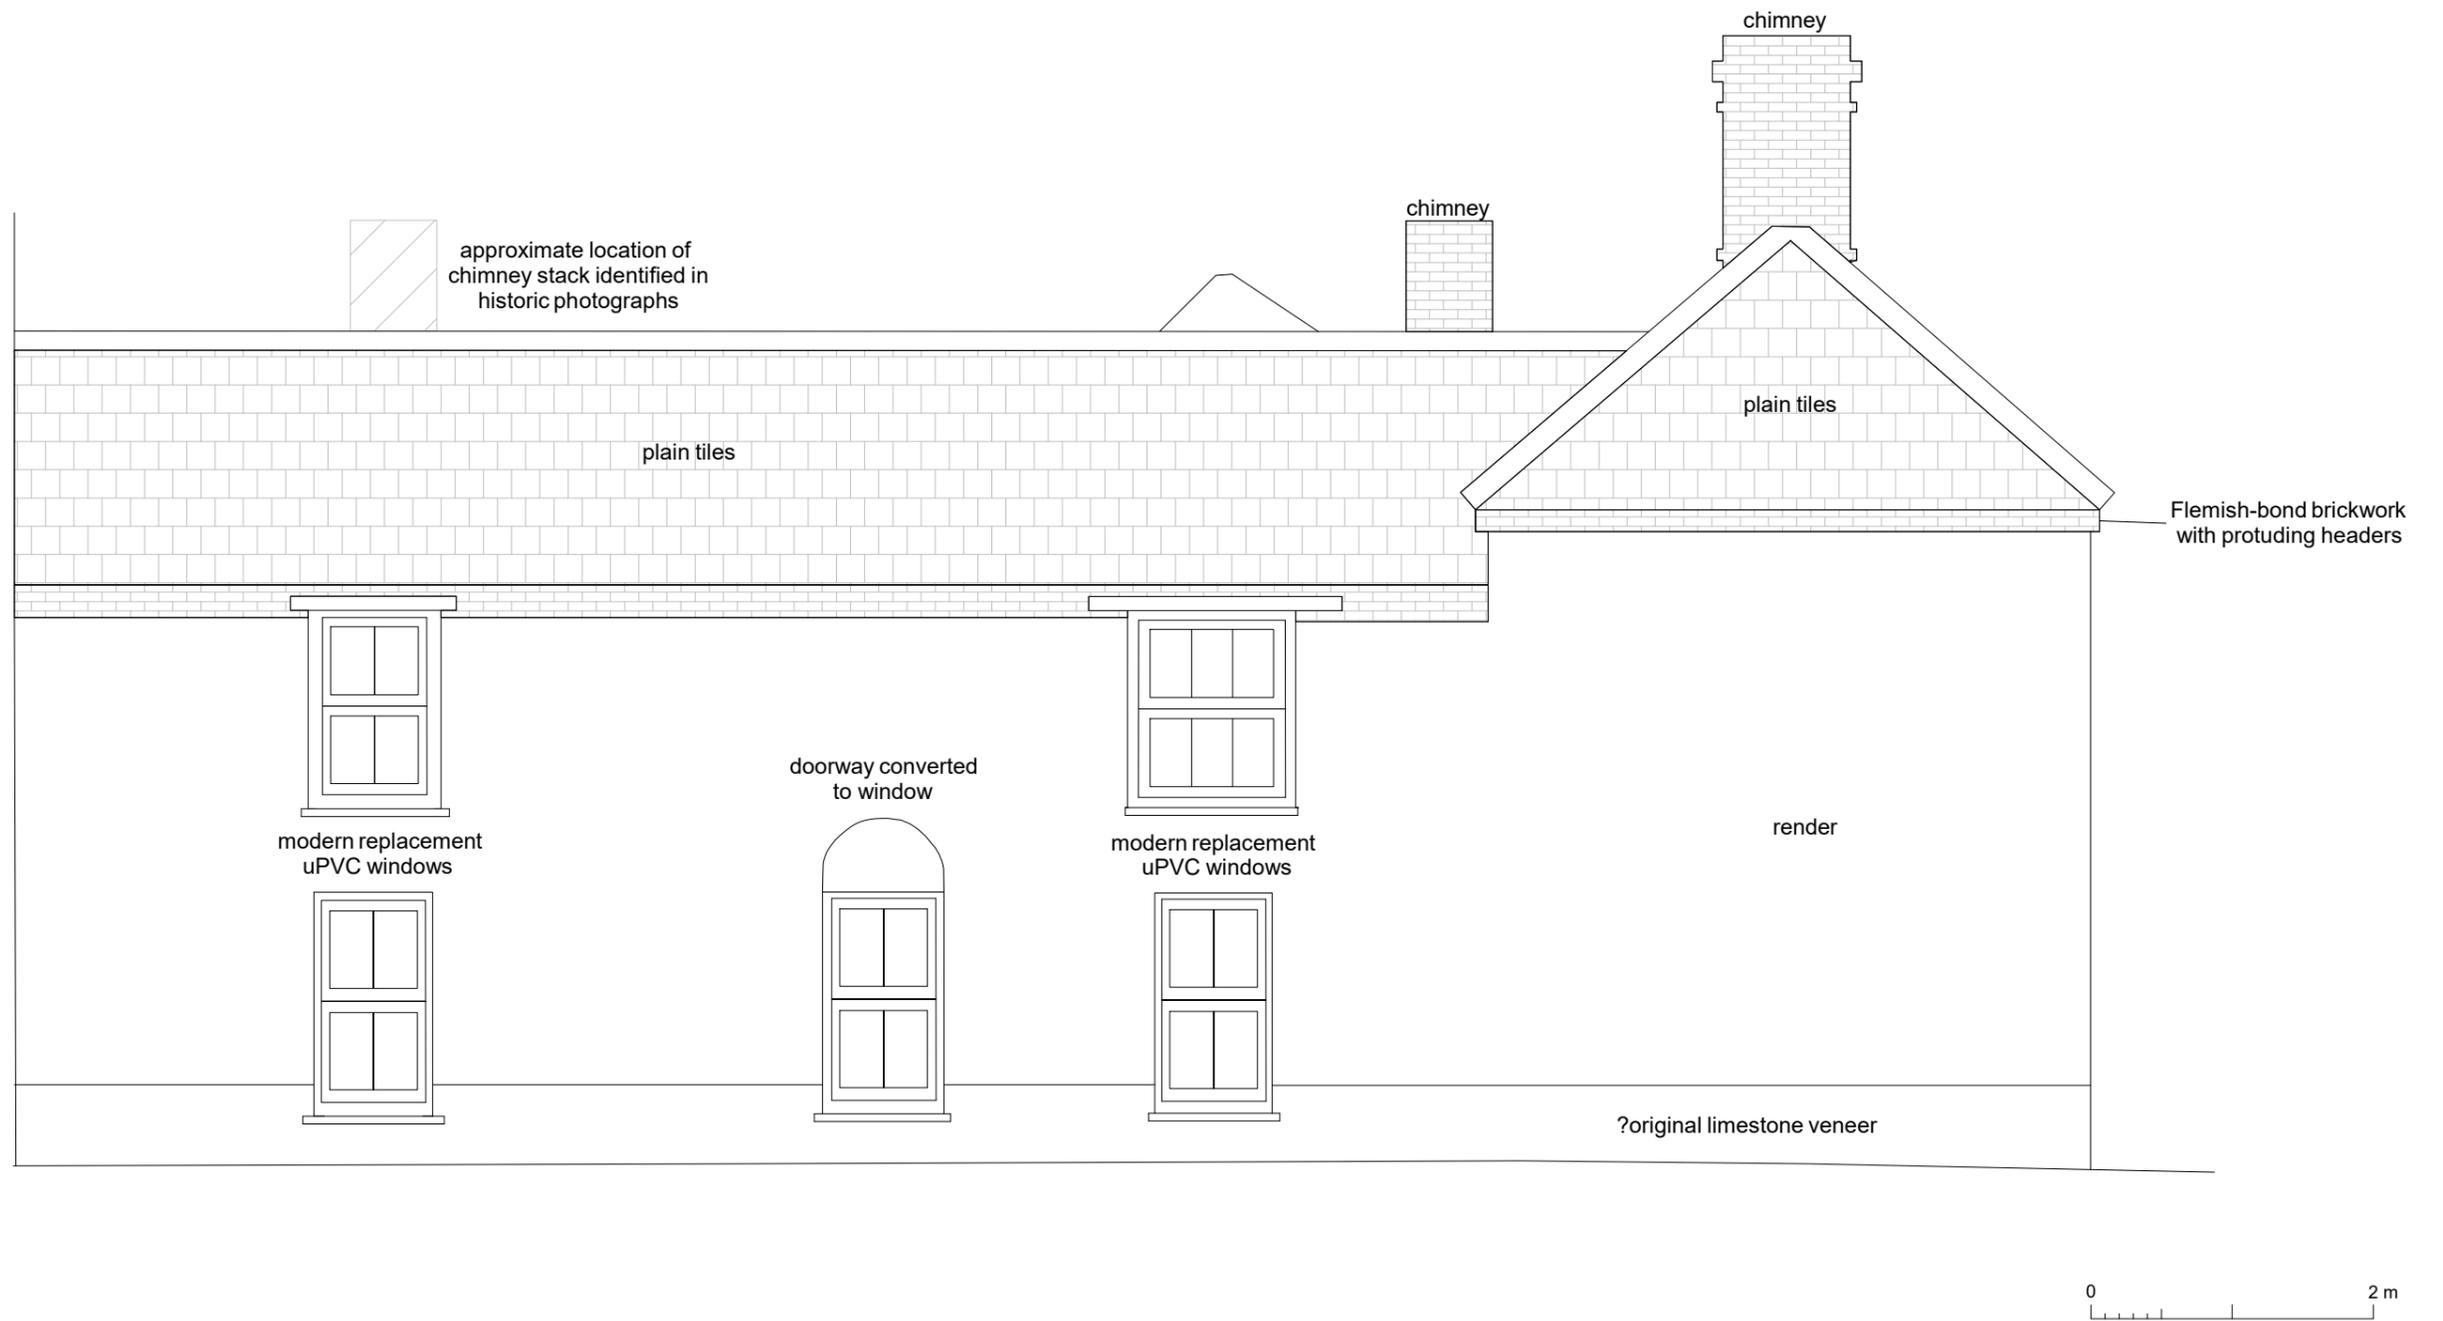
Fig 7 South-west elevation.

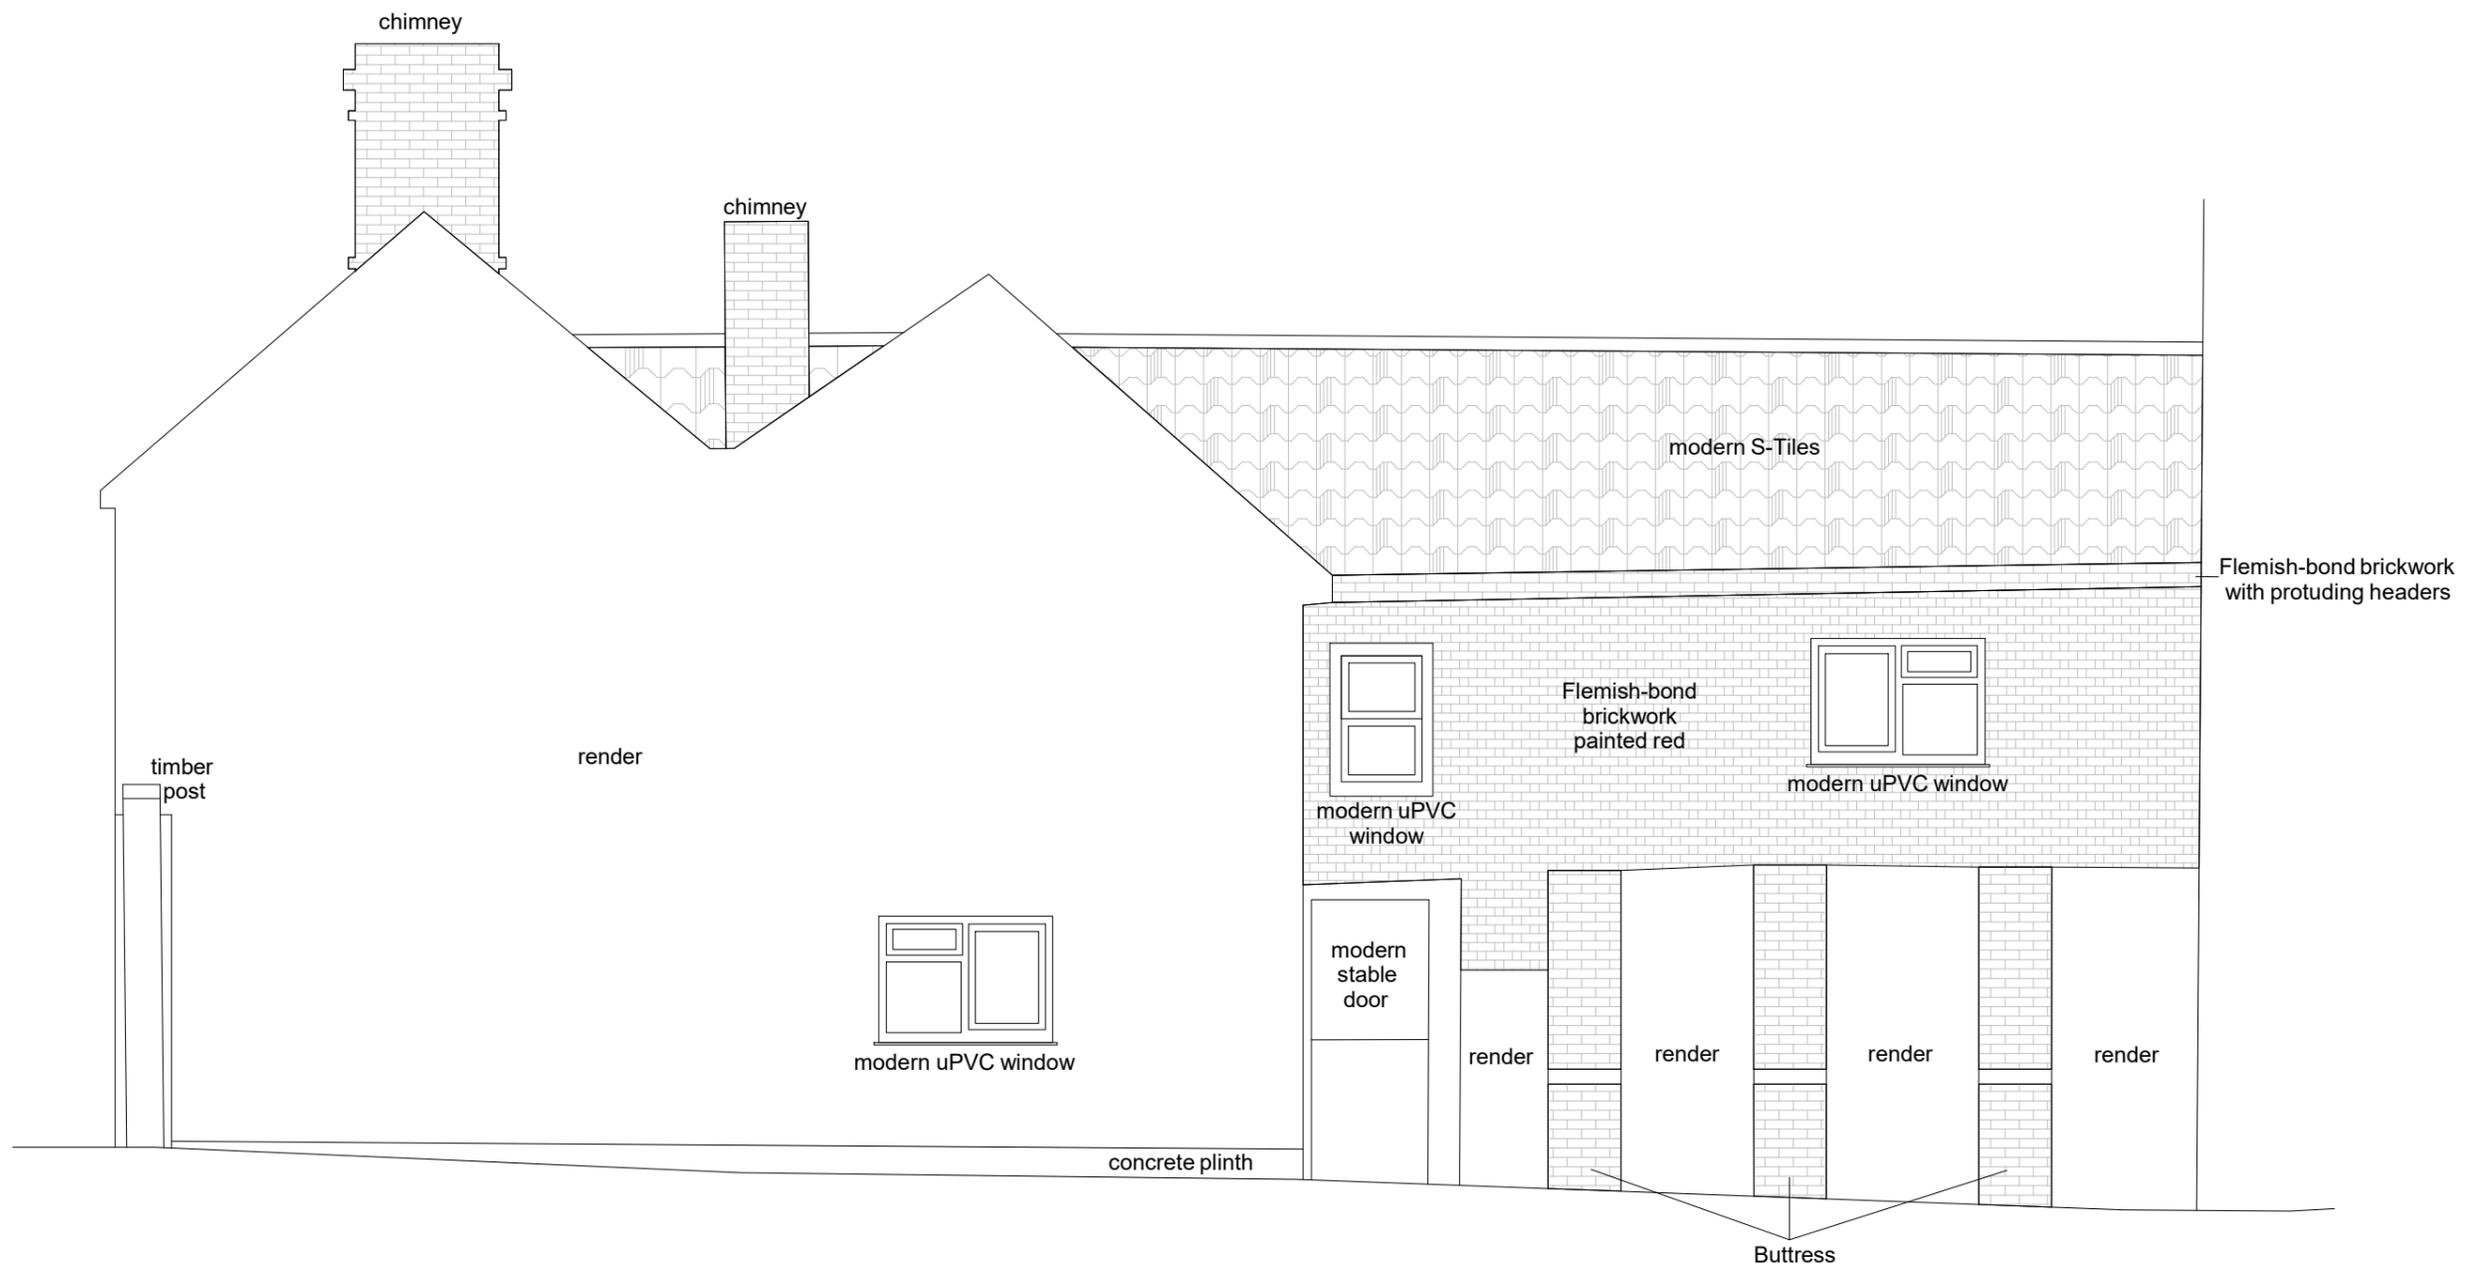
Fig 8 North-west elevation.
