# Historic building recording of 61-63 New London Road, Chelmsford, Essex, CM2 0ND

**CAT Report 1799**

*A programme of historic building recording was carried out by Colchester Archaeological Trust at 61 and 63 New London Road, Chelmsford CM1 0ND in March 2022.*

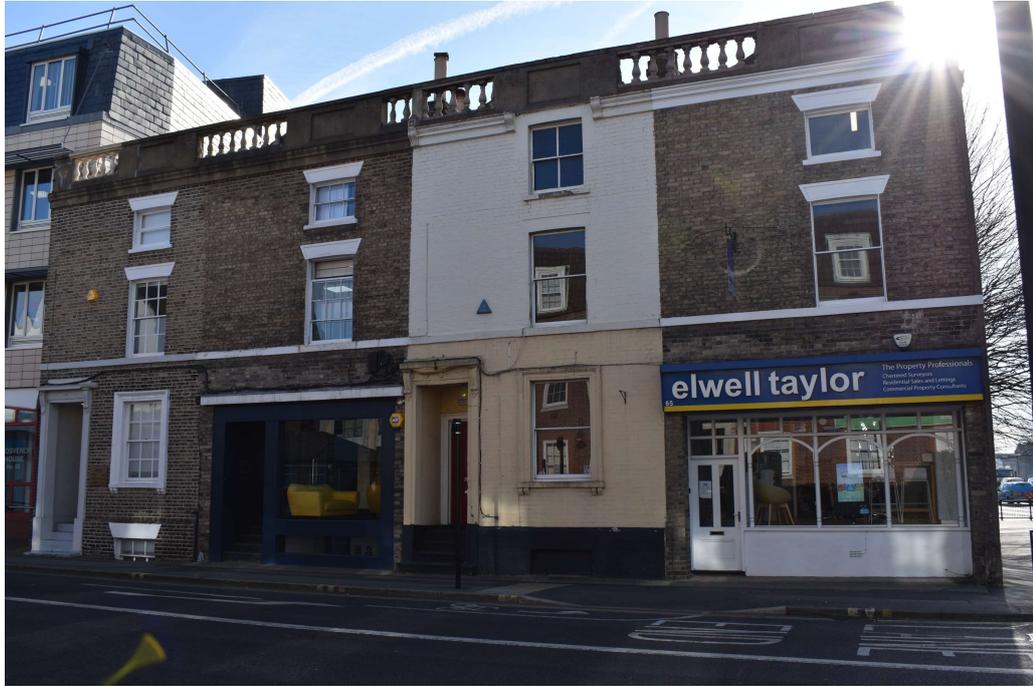
**Photograph 1** North-west elevations of no 61 and 63. Photograph taken facing east.

On this elevation the top two floors of no 63 have been painted white, the ground floor beige and the basement level black. There is an off-centre window on all three-storeys and a boarded up opening at basement level. The lower two windows are two-light while the upper is four-light. The first floor window and basement opening have flat-

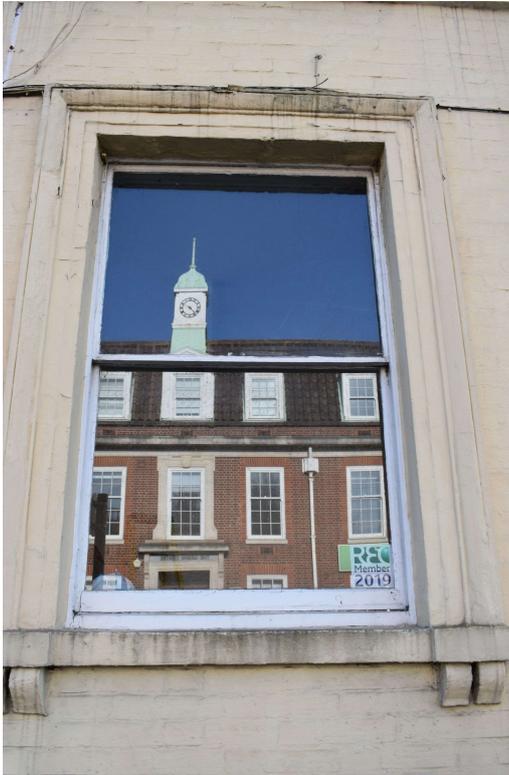
**Photograph 2** Detail of window on north-west elevation of no 63 (ground floor). Photograph taken facing north-west.

arched lintels, while the ground floor window has a stucco architrave surround. The second floor window is a larger replacement window, with an imitation flat-arched lintel, that interrupts the corncicing.

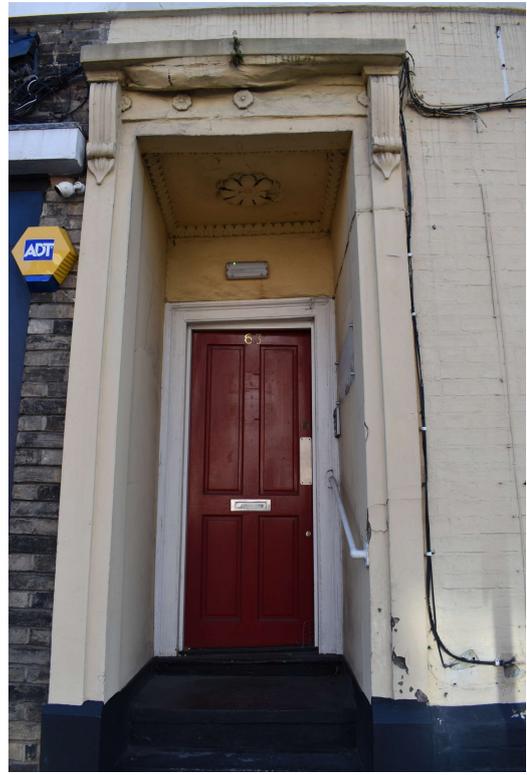
**Photograph 3** Detail of entrance to no 63. Photograph taken facing south-east.

There is an original doorway on the ground floor of no 63, with a recessed porch and a small staircase. It has an original decorative stone surround and a decorative plaster ceiling. The door is a replacement and the plastered area above the door may have once contained rectangular fanlight.

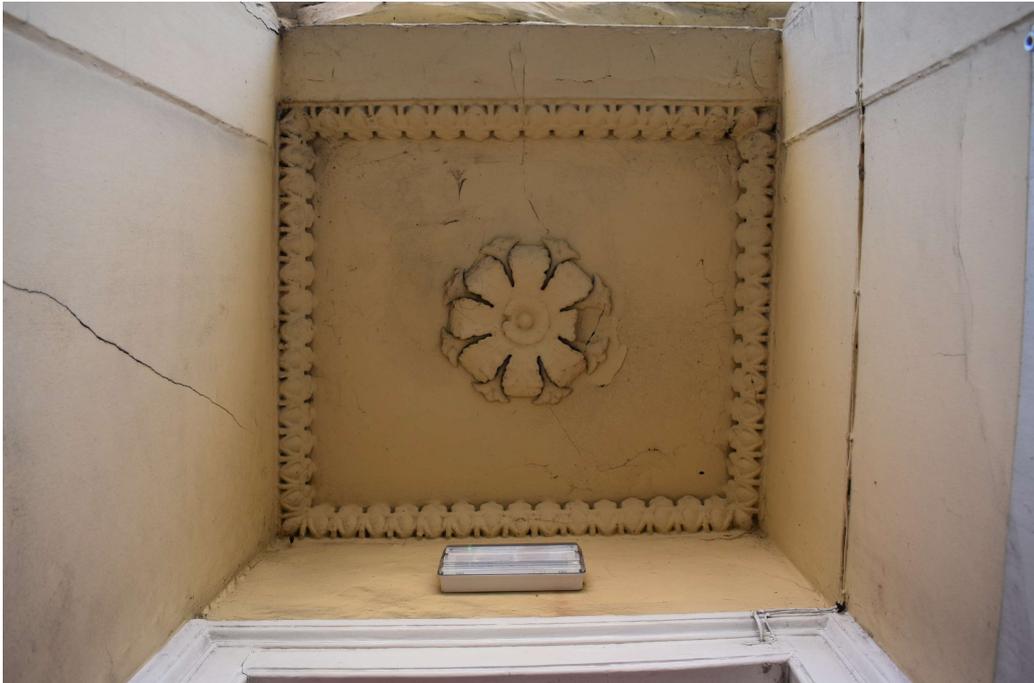
**Photograph 4** Detail of original plaster decorative ceiling in entrance way of no 63.

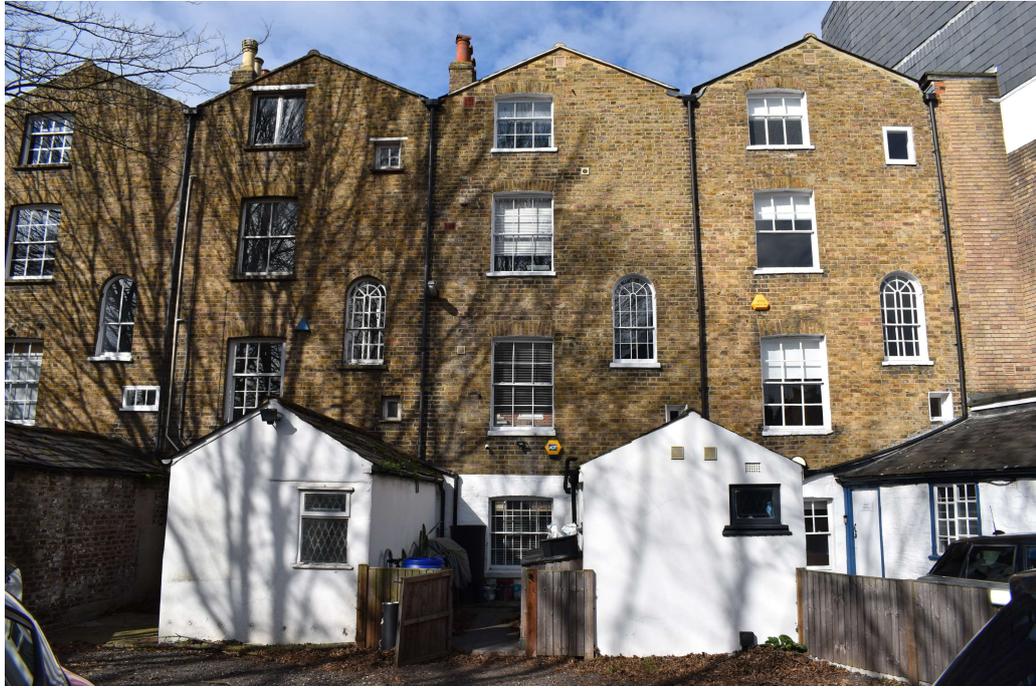
**Photograph 5** South-east elevation of nos 61 and 63. Photograph taken facing north-west.

On the south-east elevation, the main range of no 61 has six windows. Four are aligned to the south-west, one on each storey and one on the basement. These have a segmented brick arch. The window on the basement level is 16-light, the ground and first-floor windows twelve-light and the second floor nine-light.

On this elevation, the main range of no 63 has seven windows, mirroring the locations on 61 with an extra window on the second floor. The two upper-most windows are awning windows with a timber lintel. The top window is a larger replacement two-light window, which sits slightly higher than the original opening. The other second floor window is inserted, four-light and has a red tile sill.

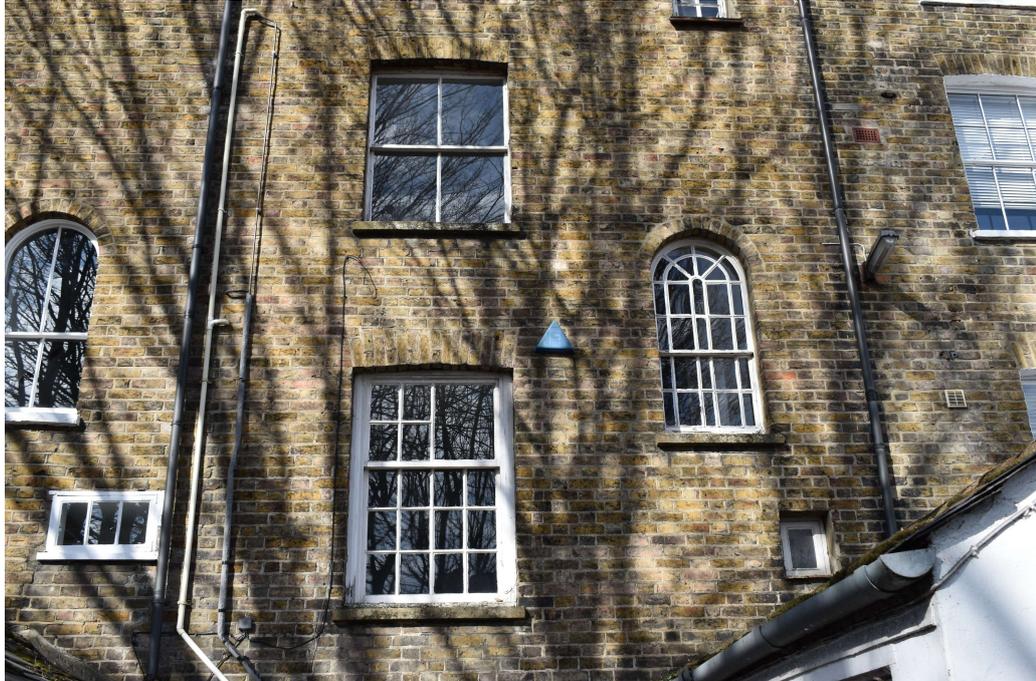
**Photograph 6** Detail of windows on south-east elevation (ground and first floor of no 63). Photograph taken facing north-west.

The ground floor and first floor windows have segmented brick arches and are 17-light and four-light, respectively. The window located between the ground and first floor is a round-headed 28-light sash-window with a brick arch. The small window at the bottom of the ground floor is a single-light awning window with no lintel and a red tile sill. At the basement level, the wall has been rendered and painted white. The window is a two-light awning replacement window.

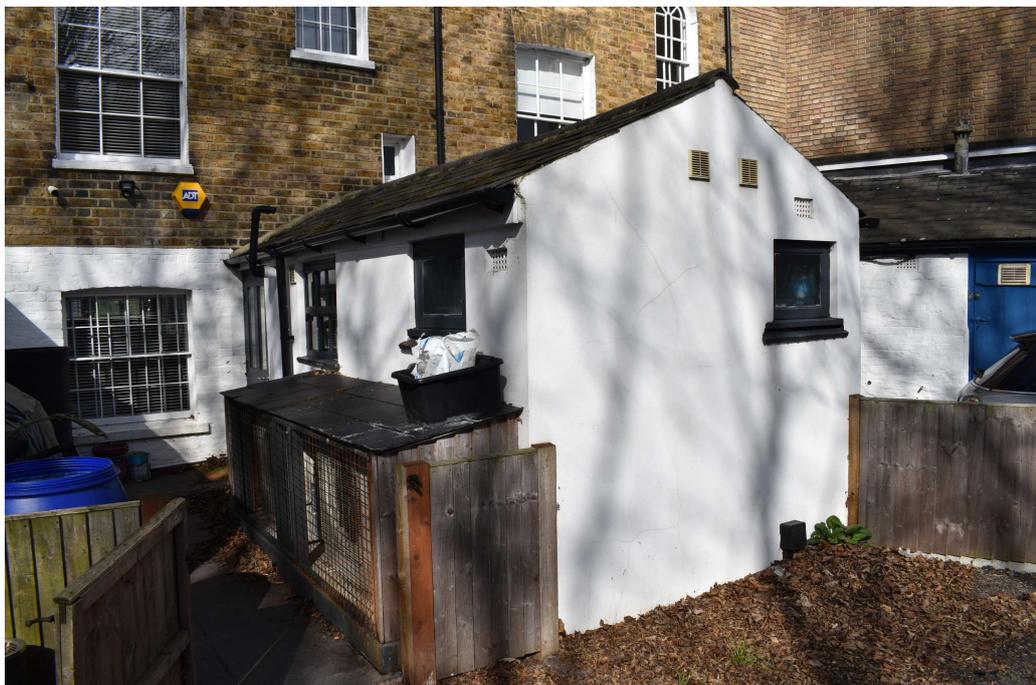
**Photograph 7** South-east and south-west elevations of no 61. Photograph taken facing north.

The windows on the rear wing of 61 are all awning windows with a wooden sill, two of which are single-light and the third six-light.

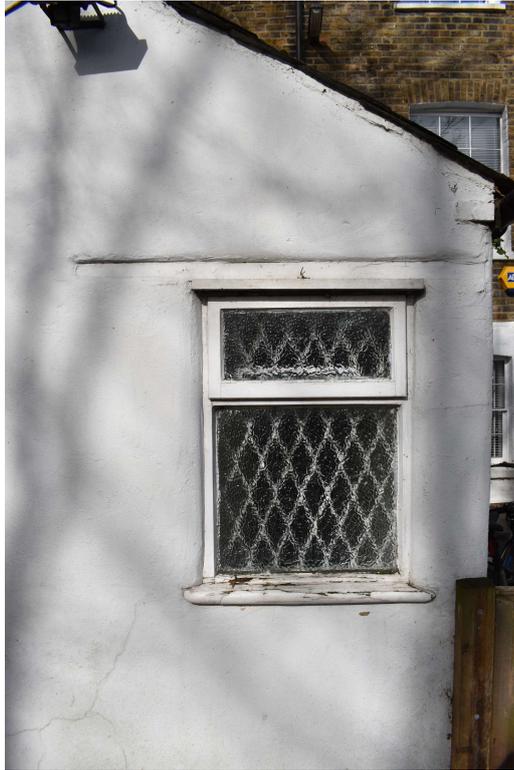
**Photograph 8** Detail of window on south-east elevation (ground floor of no 63). Photograph taken facing north-west.

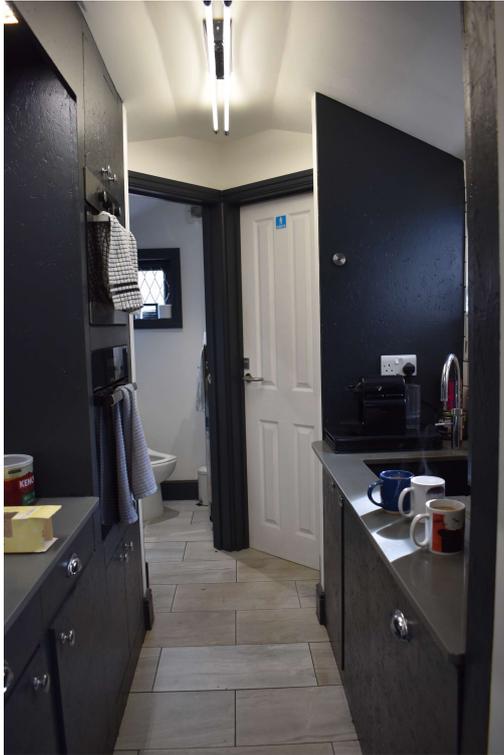
**Photograph 9** Interior of room 1 (basement of no 61). Photograph taken facing south-east.

At basement level, no 61 has three rooms (rooms 1-3) while no 63 has four (rooms 4-7). Rooms 1 and 4 are located in the rear wing. Both contain a modern kitchen and two modern toilets. Room 4 also has an inserted wall that divides off a small lobby area that contains a cupboard. Room 1 has three windows, one on the south-east wall and two on the south-west wall, while room 4 has four, one of the south-east wall and three on the south-west wall. There is also a door on the south-west and north-west walls of both rooms. Both have a lower floor level in the lobby area with a step up to the kitchen and hallway.

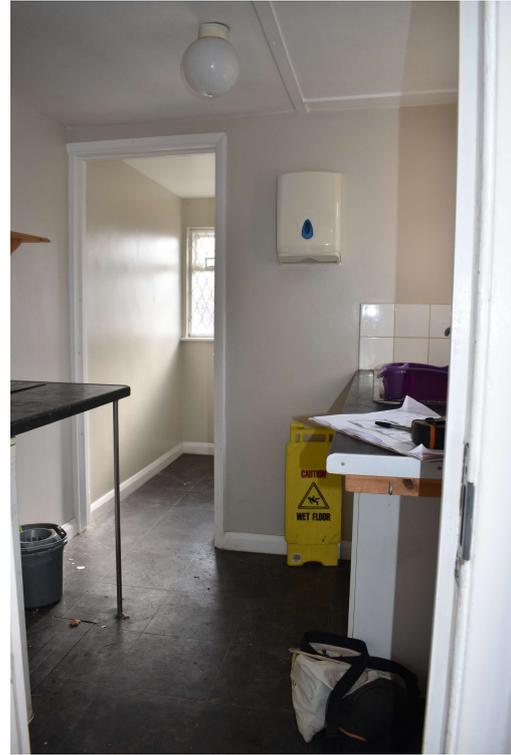
**Photograph 10** Interior shot room 4 (basement of no 63). Photograph taken facing south-east.

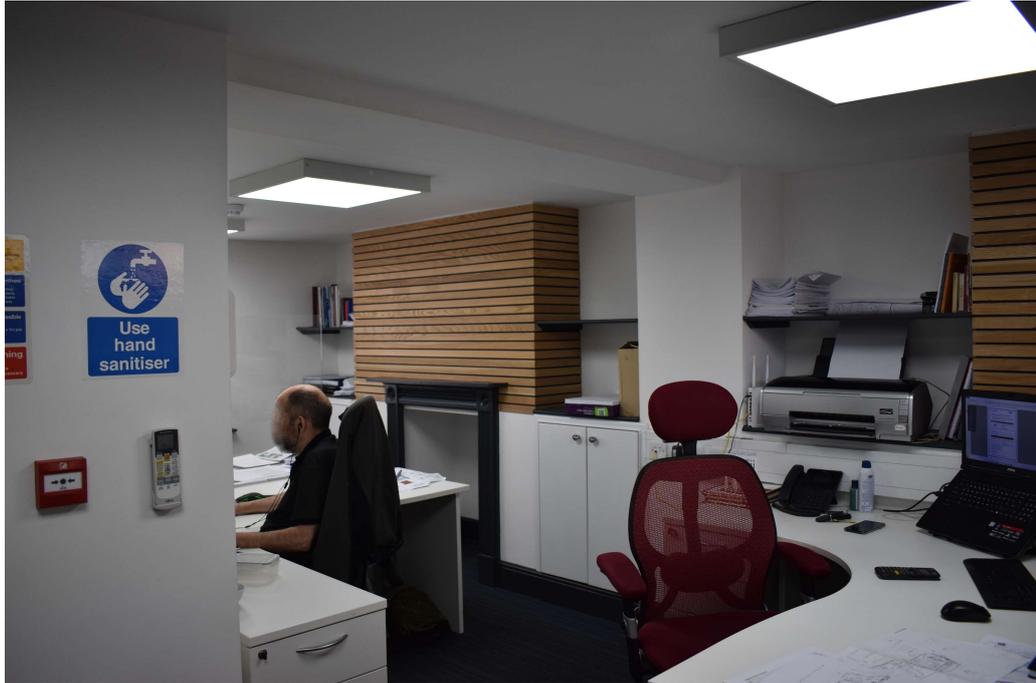
**Photograph 11** Interior shot of room 2 (basement of no 61). Photograph taken facing south.

Two rooms, 5 and 7, make up the rest of the basement level of no 63, whereas in no 61 these rooms have been combined to form one large room (room 2). Both buildings have a window on the south-east and north-west wall and a cupboard built into the northern corner.

Of the two former fireplaces in no 61, one is open (but not working) with a modern wooden surround and the other sealed. The fireplaces in no 63 have both been covered over.

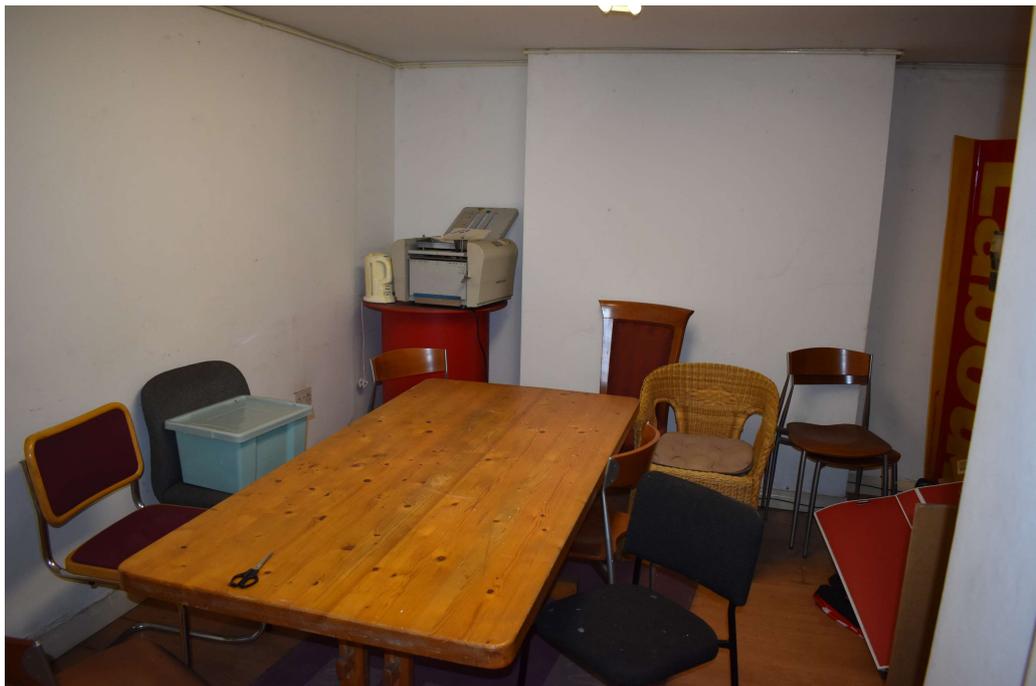
**Photograph 12** Interior shot of room 7 (basement of no 63). Photograph taken facing south-west.

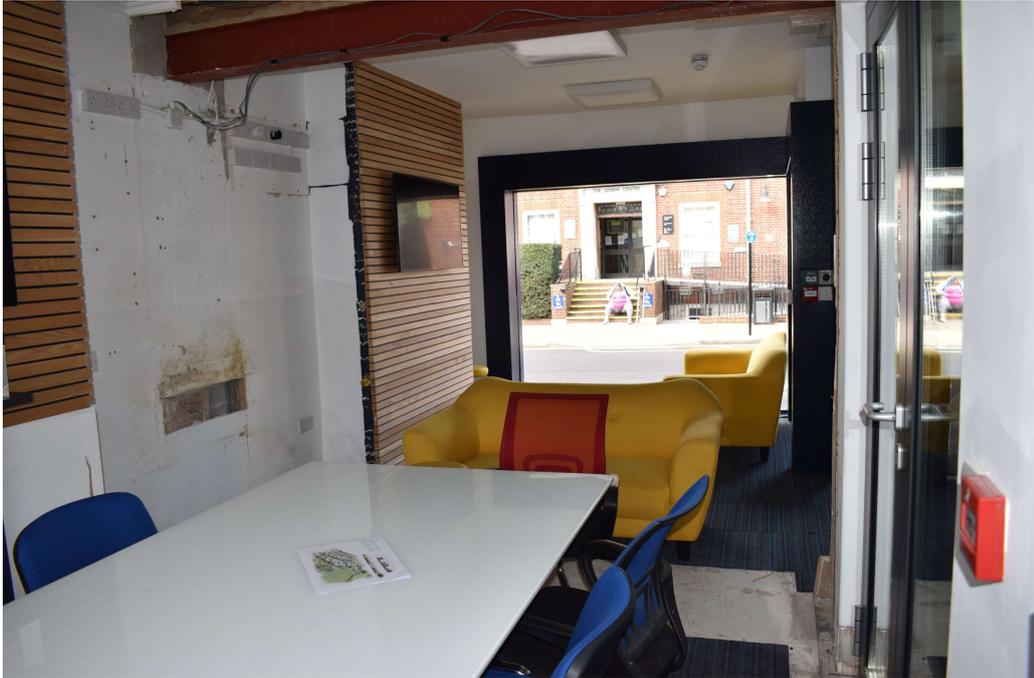
**Photograph 13** Interior of room 8 (ground floor of no 61). Photograph taken facing north-west.

Similar to the basement level of no 61, one fireplace is open (but not working) with a modern wooden surround and the other sealed. In no 61, the fireplace in room 10 has

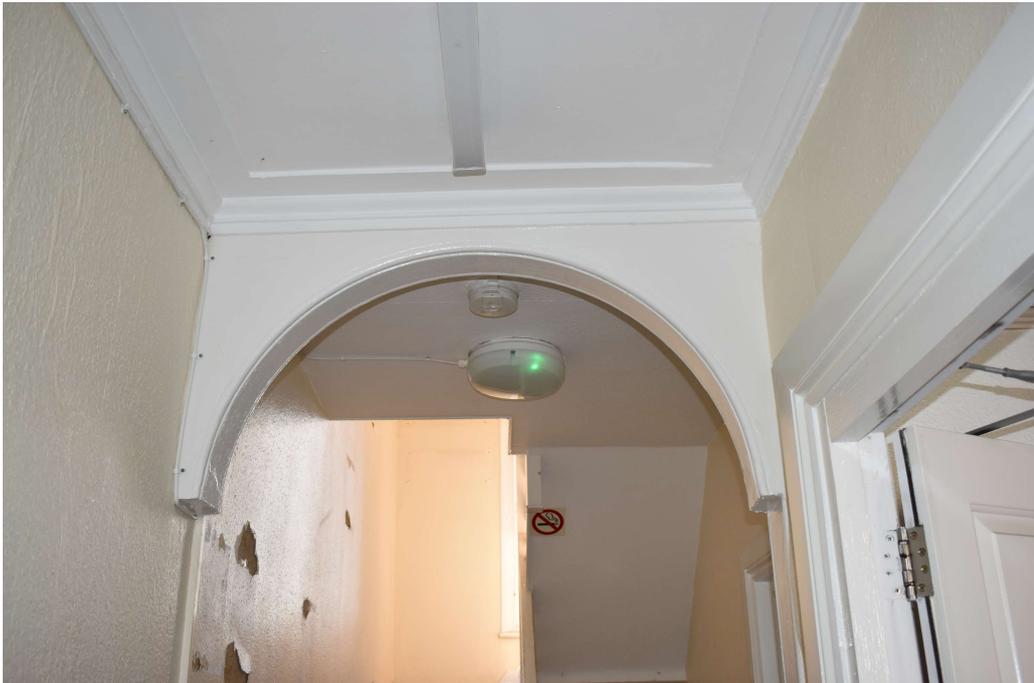
**Photograph 14** Detail of original timber arch in room 11 (ground floor of no 63). Photograph taken facing south-east.

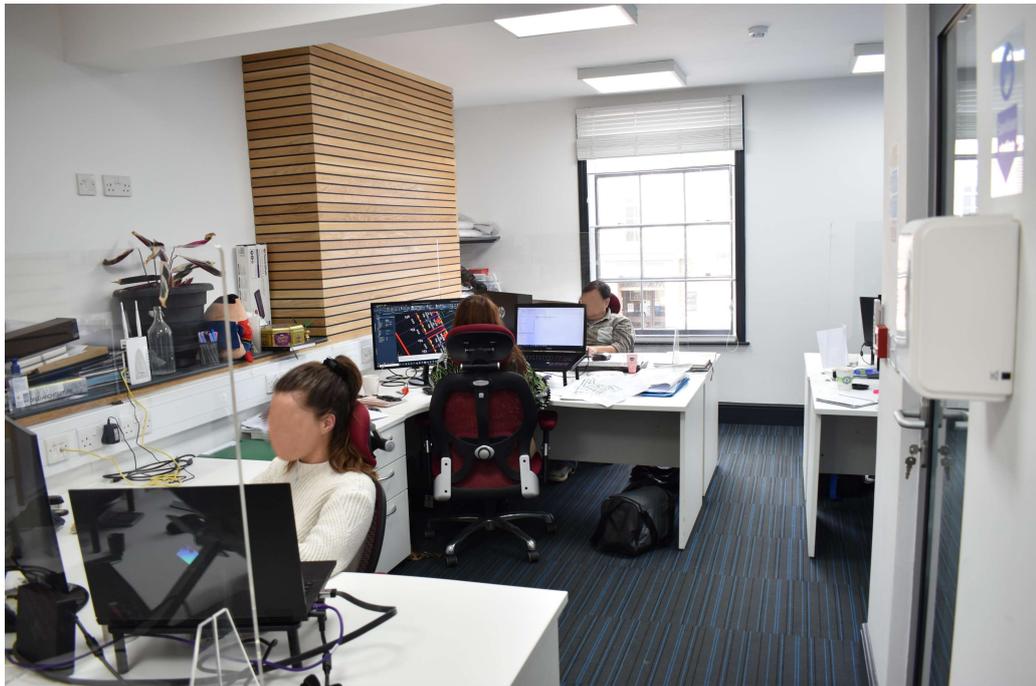
**Photograph 15** Interior of room 14 (first floor of no 61). Photograph taken facing north-west.

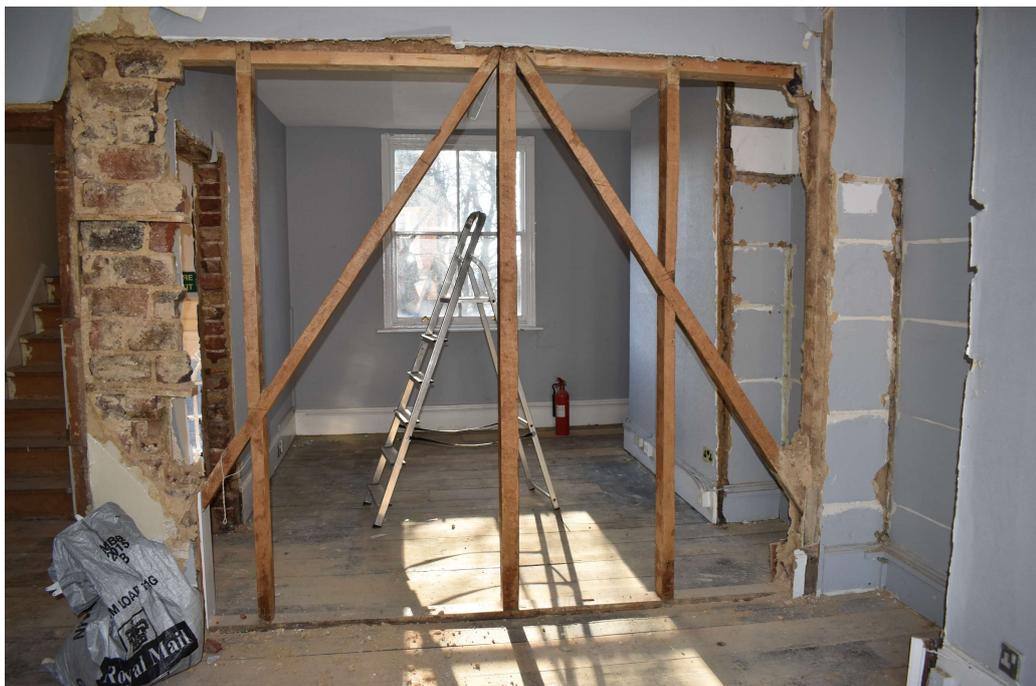
**Photograph 16** Detail of stud wall between room 16 and 17 (1st floor of no 63). Photograph taken facing south-east.

Removal of the plaster board on the wall between rooms 16 and 17 in no 63 has revealed a timber frame beneath. The wall has a middle post with a stud and diagonal through-brace either side. Carpenters marks are present in the form of 'I' and 'II' on the braces and stud. Baltic timber marks were also observed on both studs. Further removal of plaster, this time around the frame of the doorway between rooms 15 and 17, has exposed the wooden pegs used to peg the timber door frame together. The timber used in the stud wall and the door frame is machine-cut.

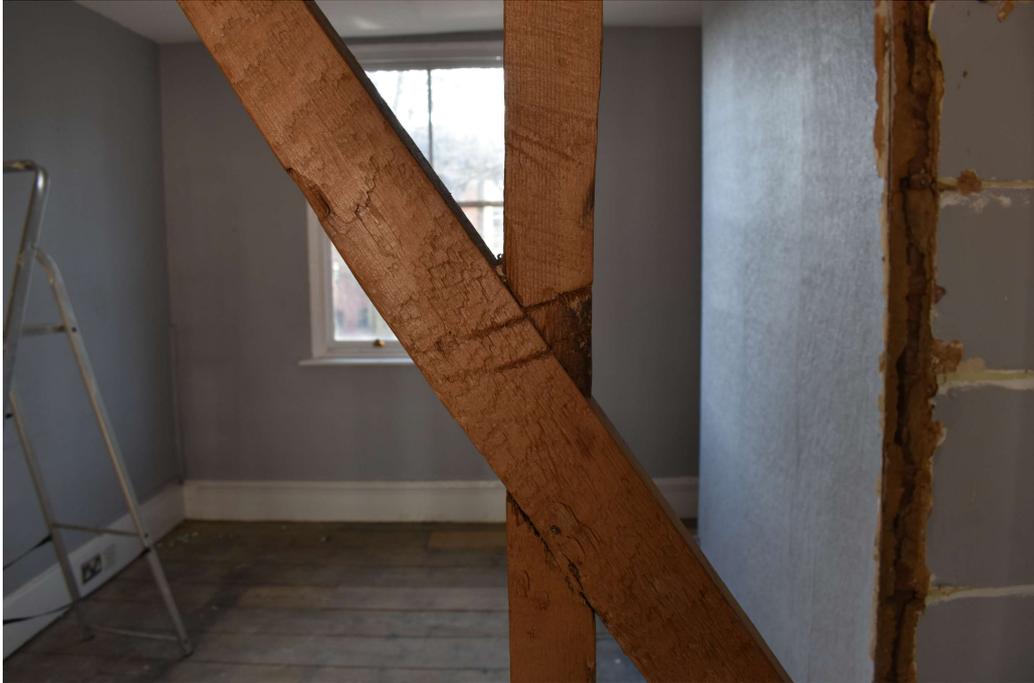
**Photograph 17** Detail of carpenters marks 'II' on stud and brace of stud wall of room 16 and 17 (1st floor of no 63). Photograph taken facing south-east.

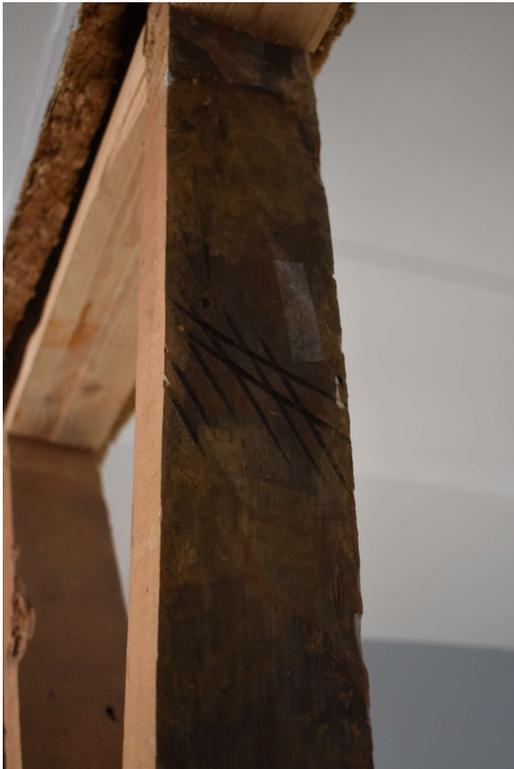
**Photograph 18** Detail of Baltic Timber marks in stud wall of room 16 and 17 (1st floor of no 63). Photograph taken facing east.

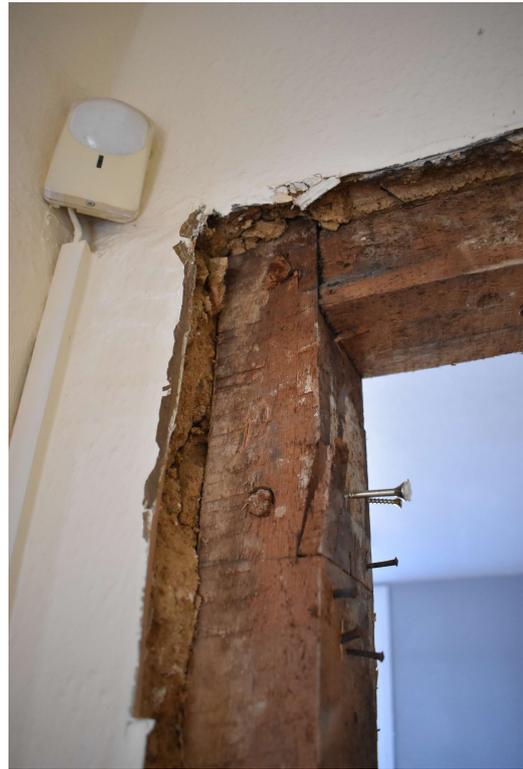
**Photograph 19** Detail of timber pegs in doorway in room 17 (1st floor of no 63). Photograph taken facing south-east.

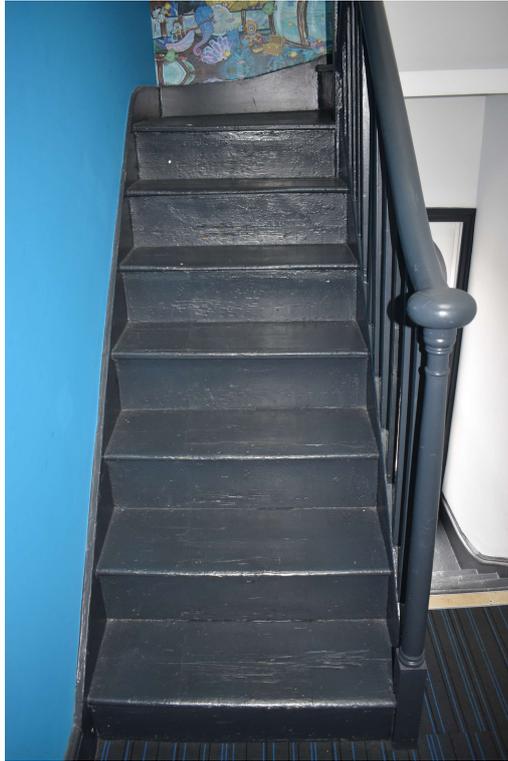
**Photograph 20** Detail of stairs in room 13 (first floor of no 61). Photograph taken facing south-east.

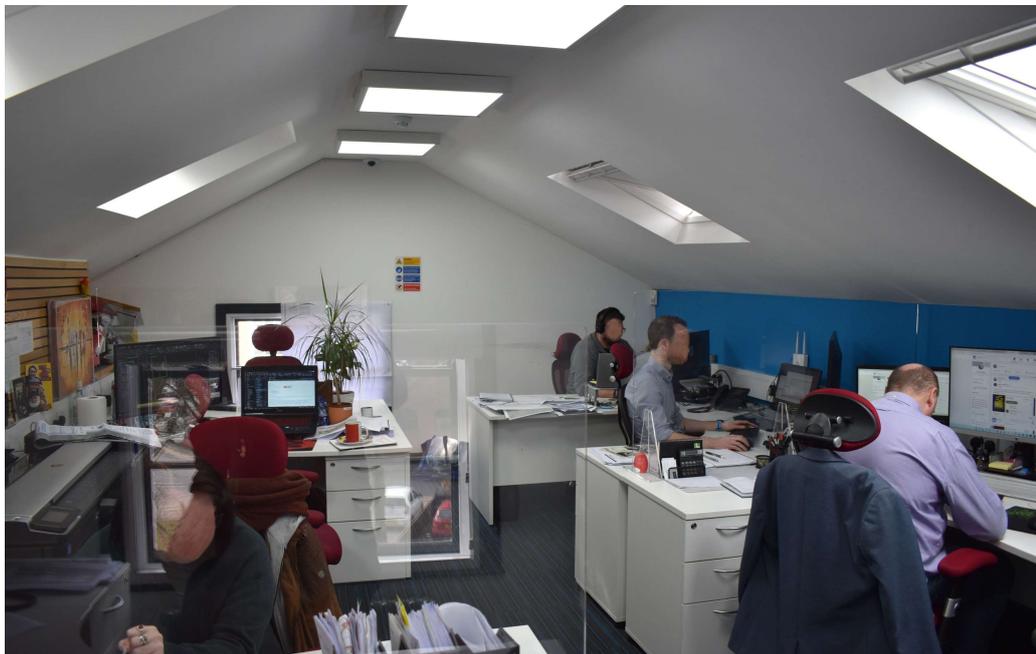
**Photograph 21** Interior of room 18 (second floor of no 61). Photograph taken facing south.

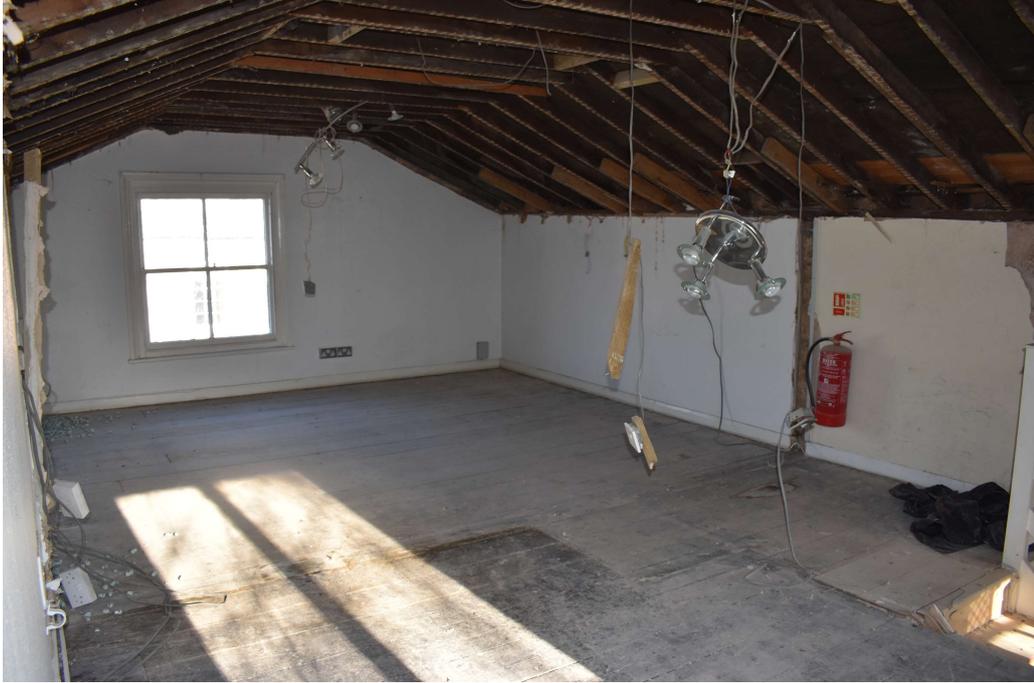
**Photograph 22** Interior shot of room 19 (2nd floor of no 63). Photograph taken facing north.

evidence in no 63 that the attic was originally split into three rooms with the same layout as the floors below. The attic would have been the same in no 61.

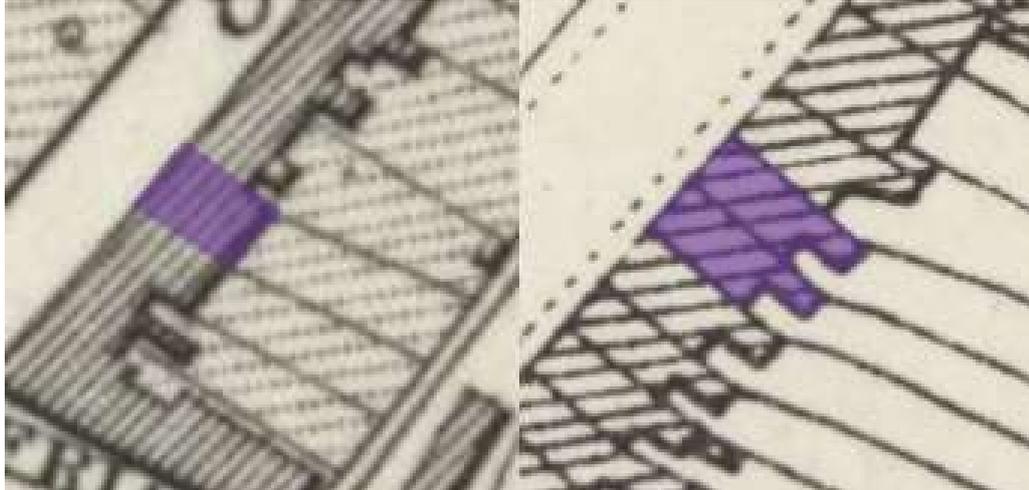
**Maps 7 and 8** Extracts of the 1881 (left) and 1897 (right) OS Maps, demonstrating the size of the extension in comparison to the surrounding terrace.

Although it is not immediately obvious from looking at the available cartographic information, it is evident that the rear wing was constructed prior to 1881, likely at the same time as the main range. On the first addition 6-inch OS map (Map 7), the part of the terrace containing nos 61 and 63 is depicted as rectangular with no defined rear wing. It can be noted, however, that when compared to the surrounding terrace buildings, with a more defined shape, the block projects to the same point\*. When compared with the later 1897 map (Map 8), which defines all the rear extensions on the terrace, this shows them to also protrude to the same point. The lack of definition on the 1st edition OS map is not unsurprising as the early 6-inch OS maps tend to lack the detail we have come to appreciate of modern maps.

It is also notable that the other buildings in the terrace have the same size and shape wing at the rear, an indication that they were probably constructed at the same time as each other when the main range of the terrace was built.

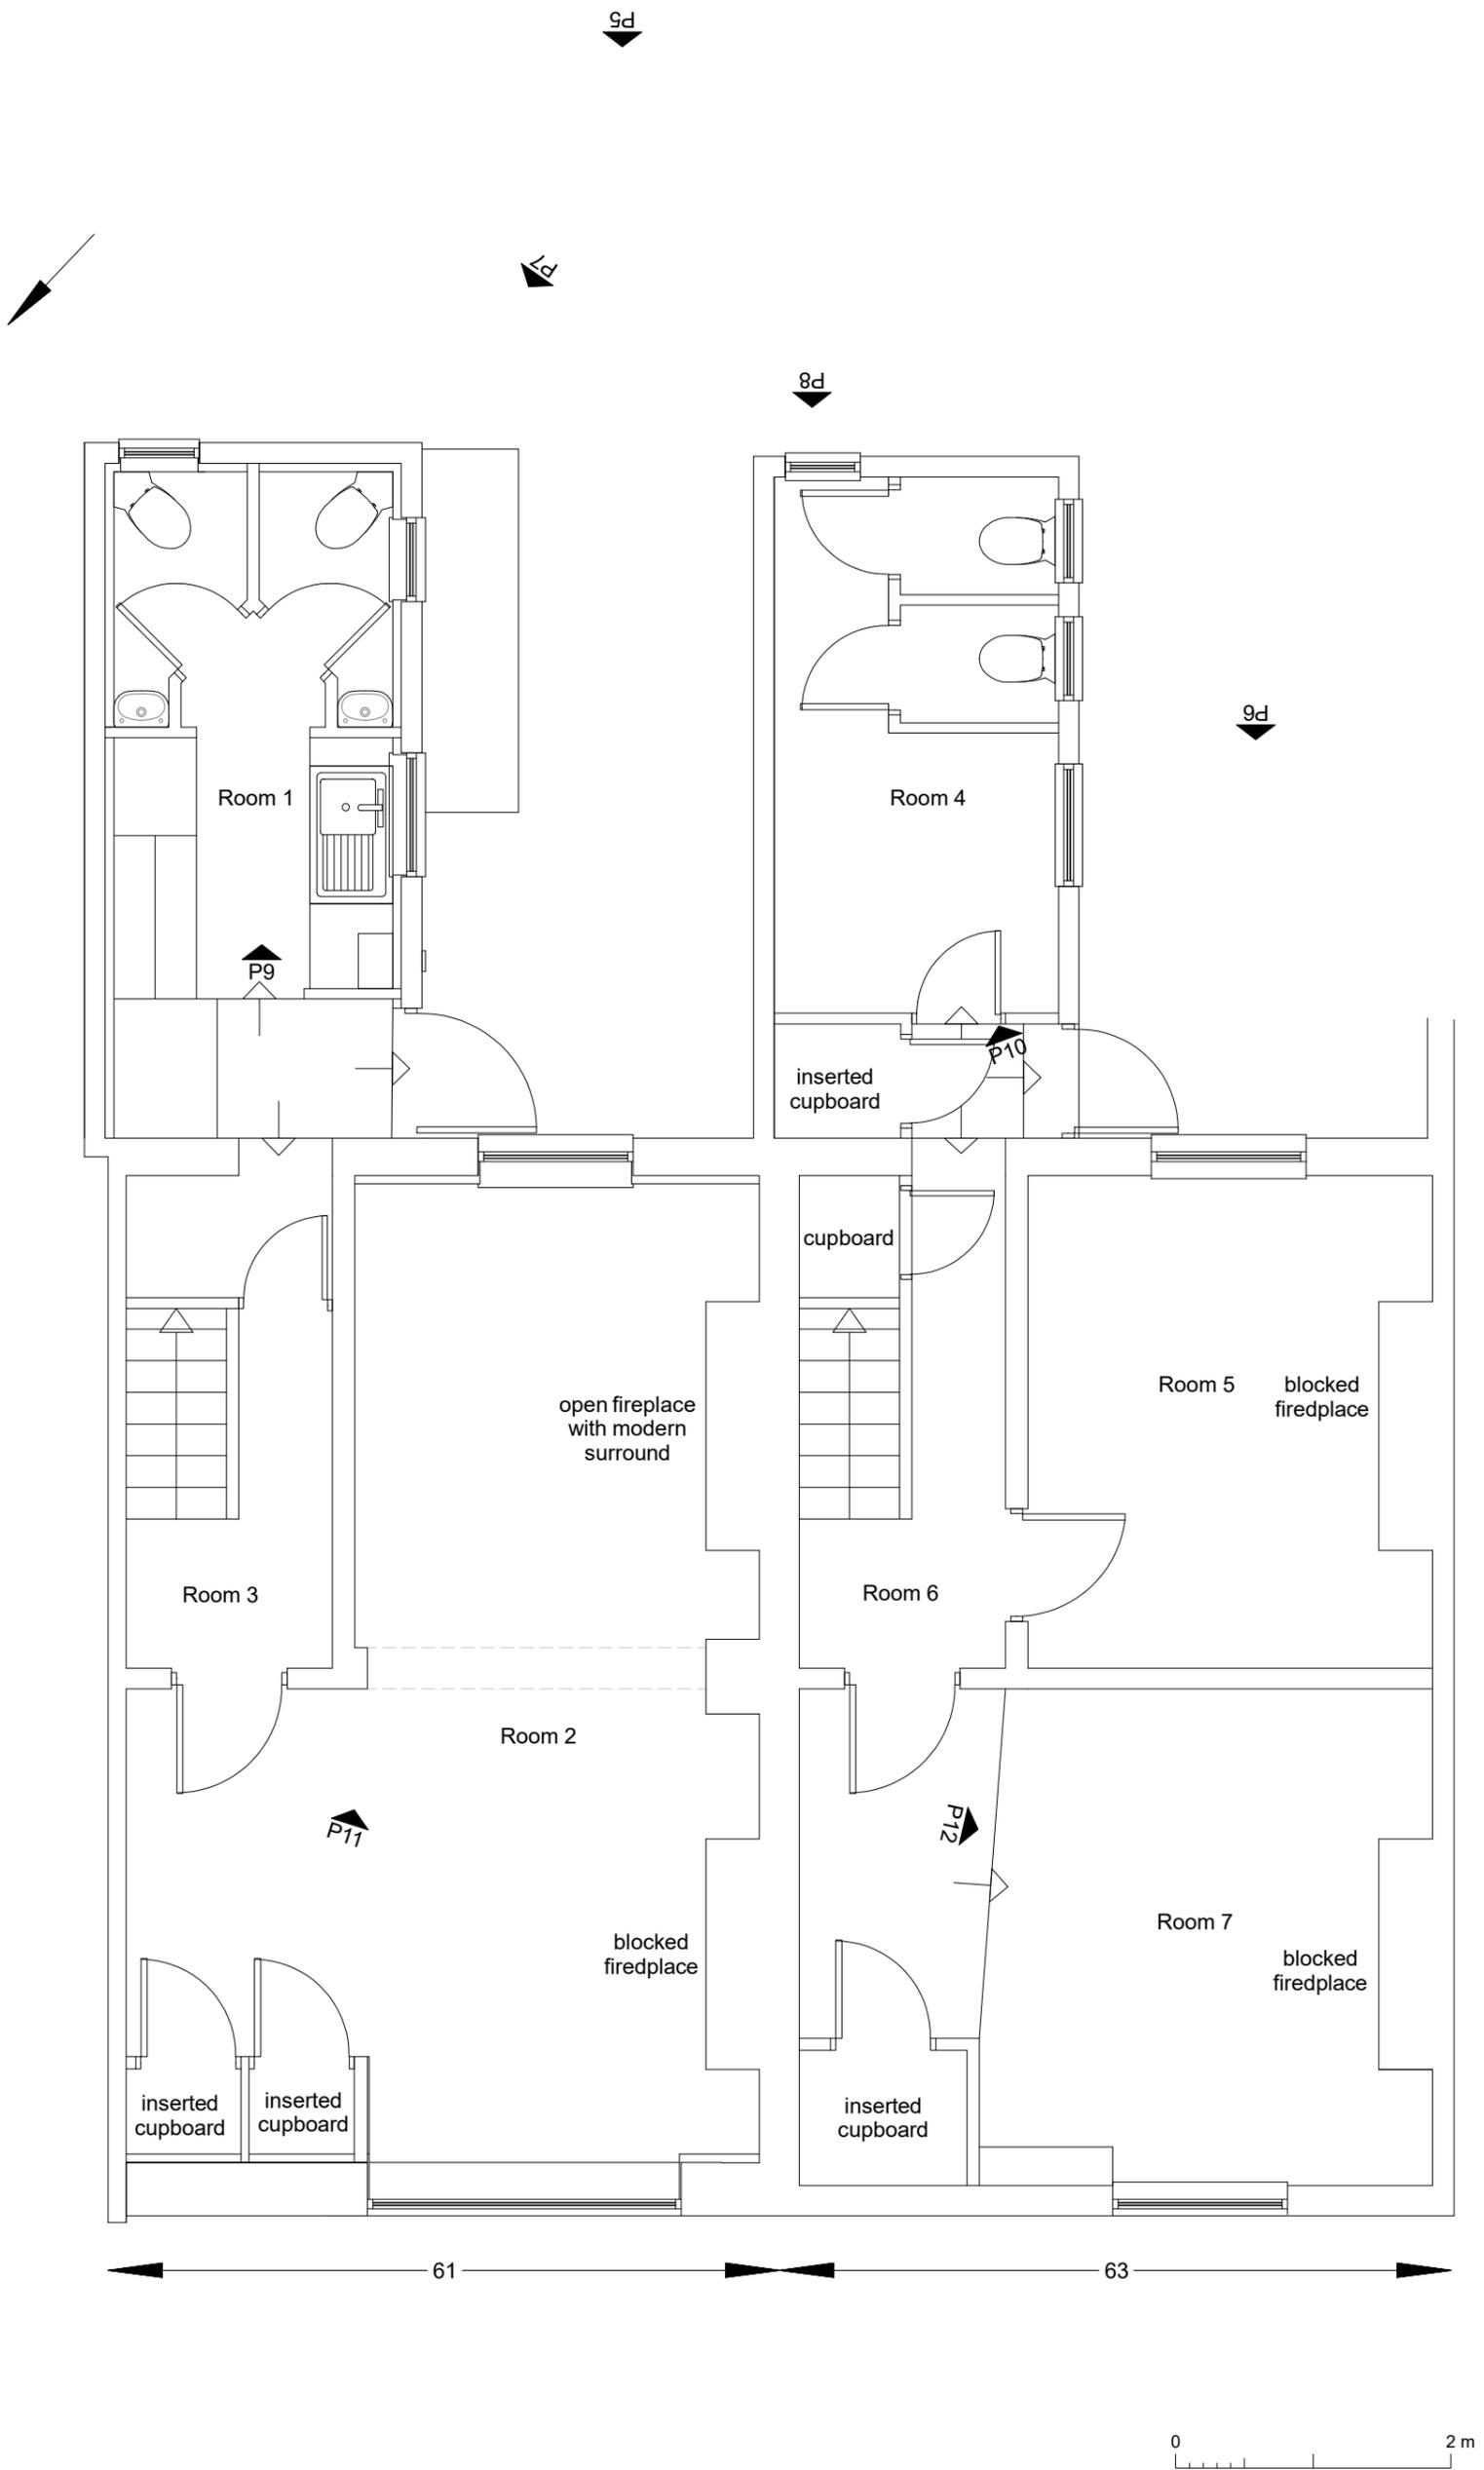
Fig 2 Basement floor plan. Location and direction of photographs reproduced in text shown.

| Fig 2 Basement floor plan. Location and direction of photographs reproduced in report shown. | |

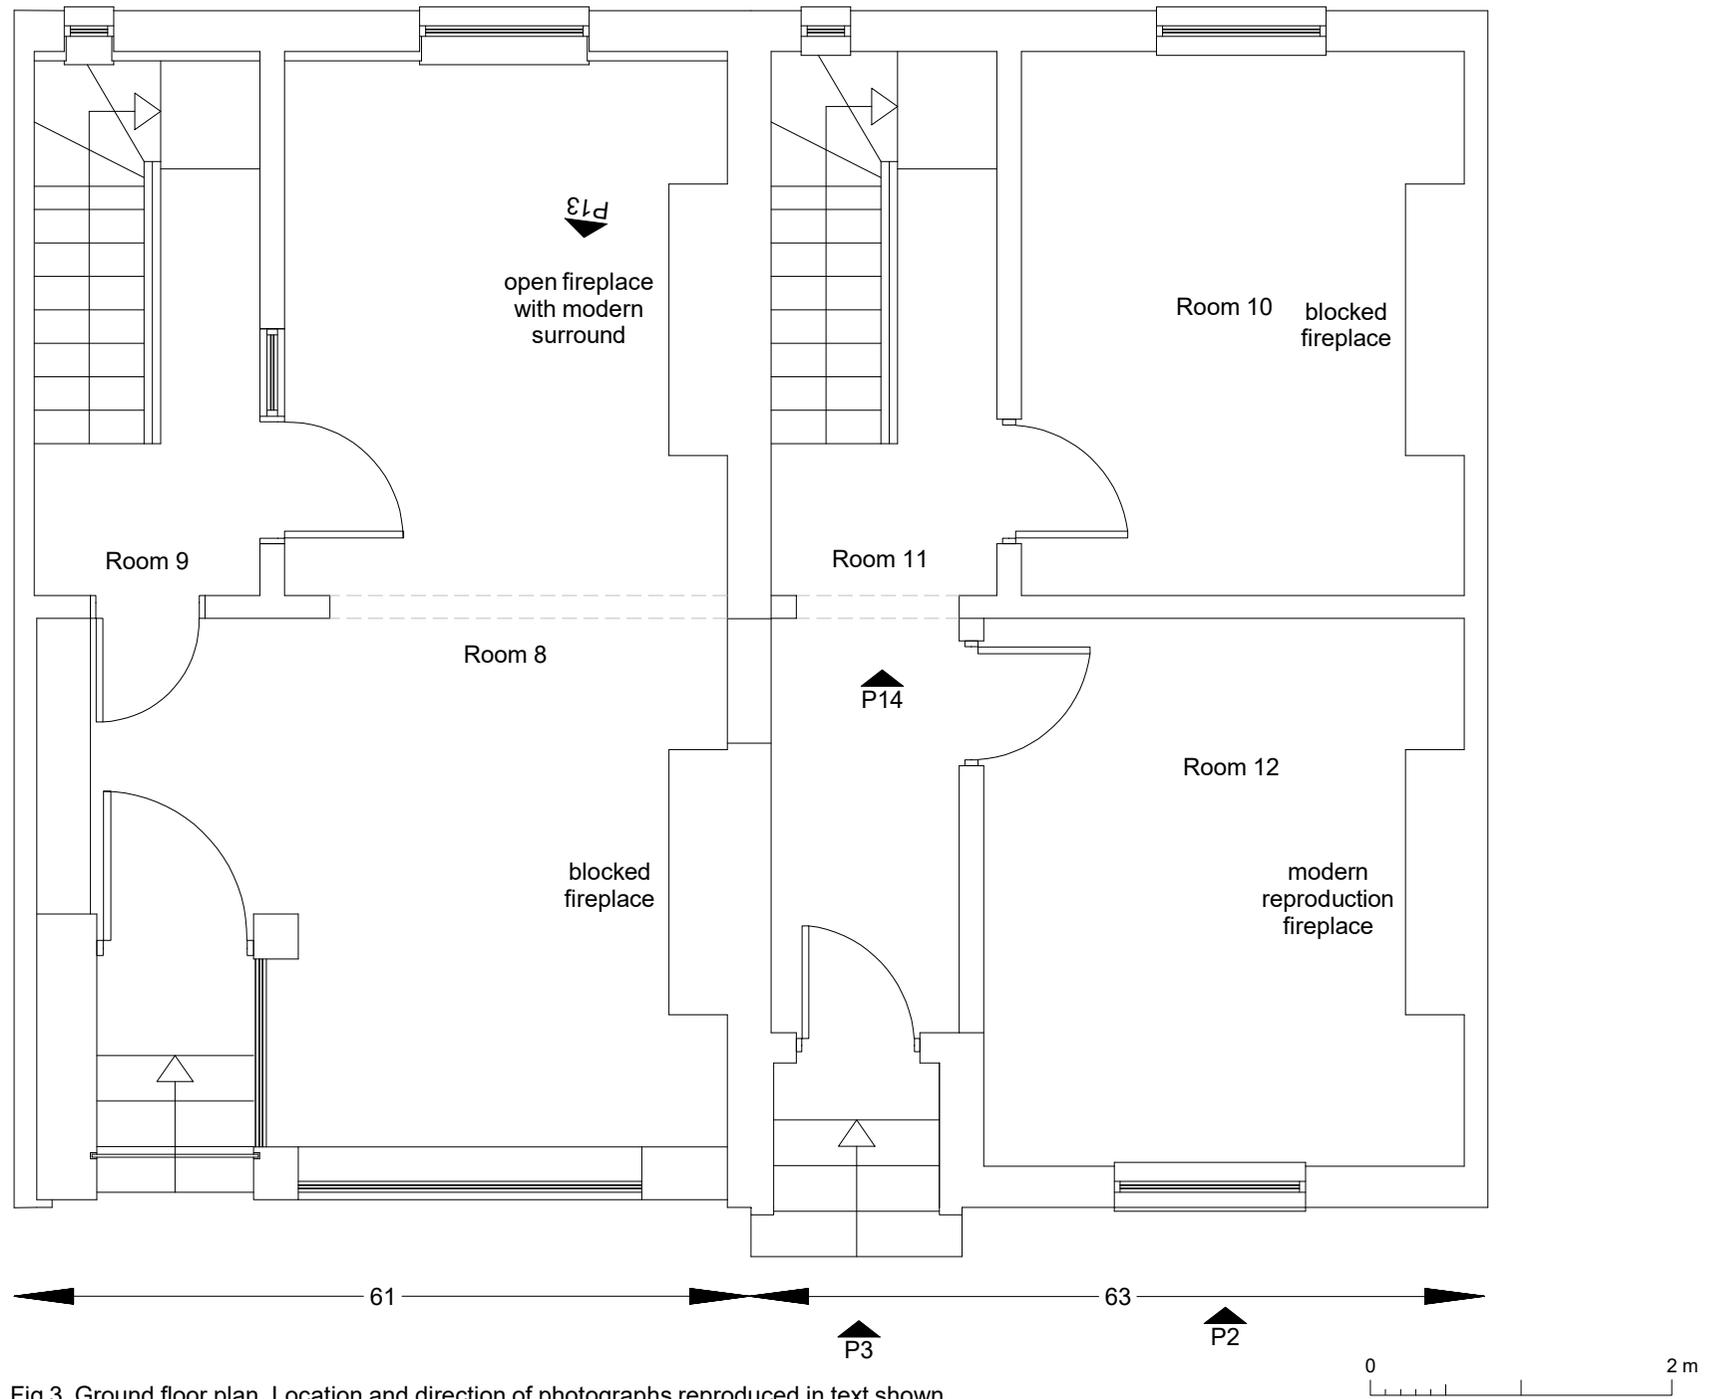
Fig 3 Ground floor plan. Location and direction of photographs reproduced in text shown.

| Fig 3 Ground floor plan. Location and direction of photographs reproduced in report shown. | |
