# Historic building recording of 61-63 New London Road, Chelmsford, Essex, CM2 0ND

**CAT Report 1799**

*A programme of historic building recording was carried out by Colchester Archaeological Trust at 61 and 63 New London Road, Chelmsford CM1 0ND in March 2022.*

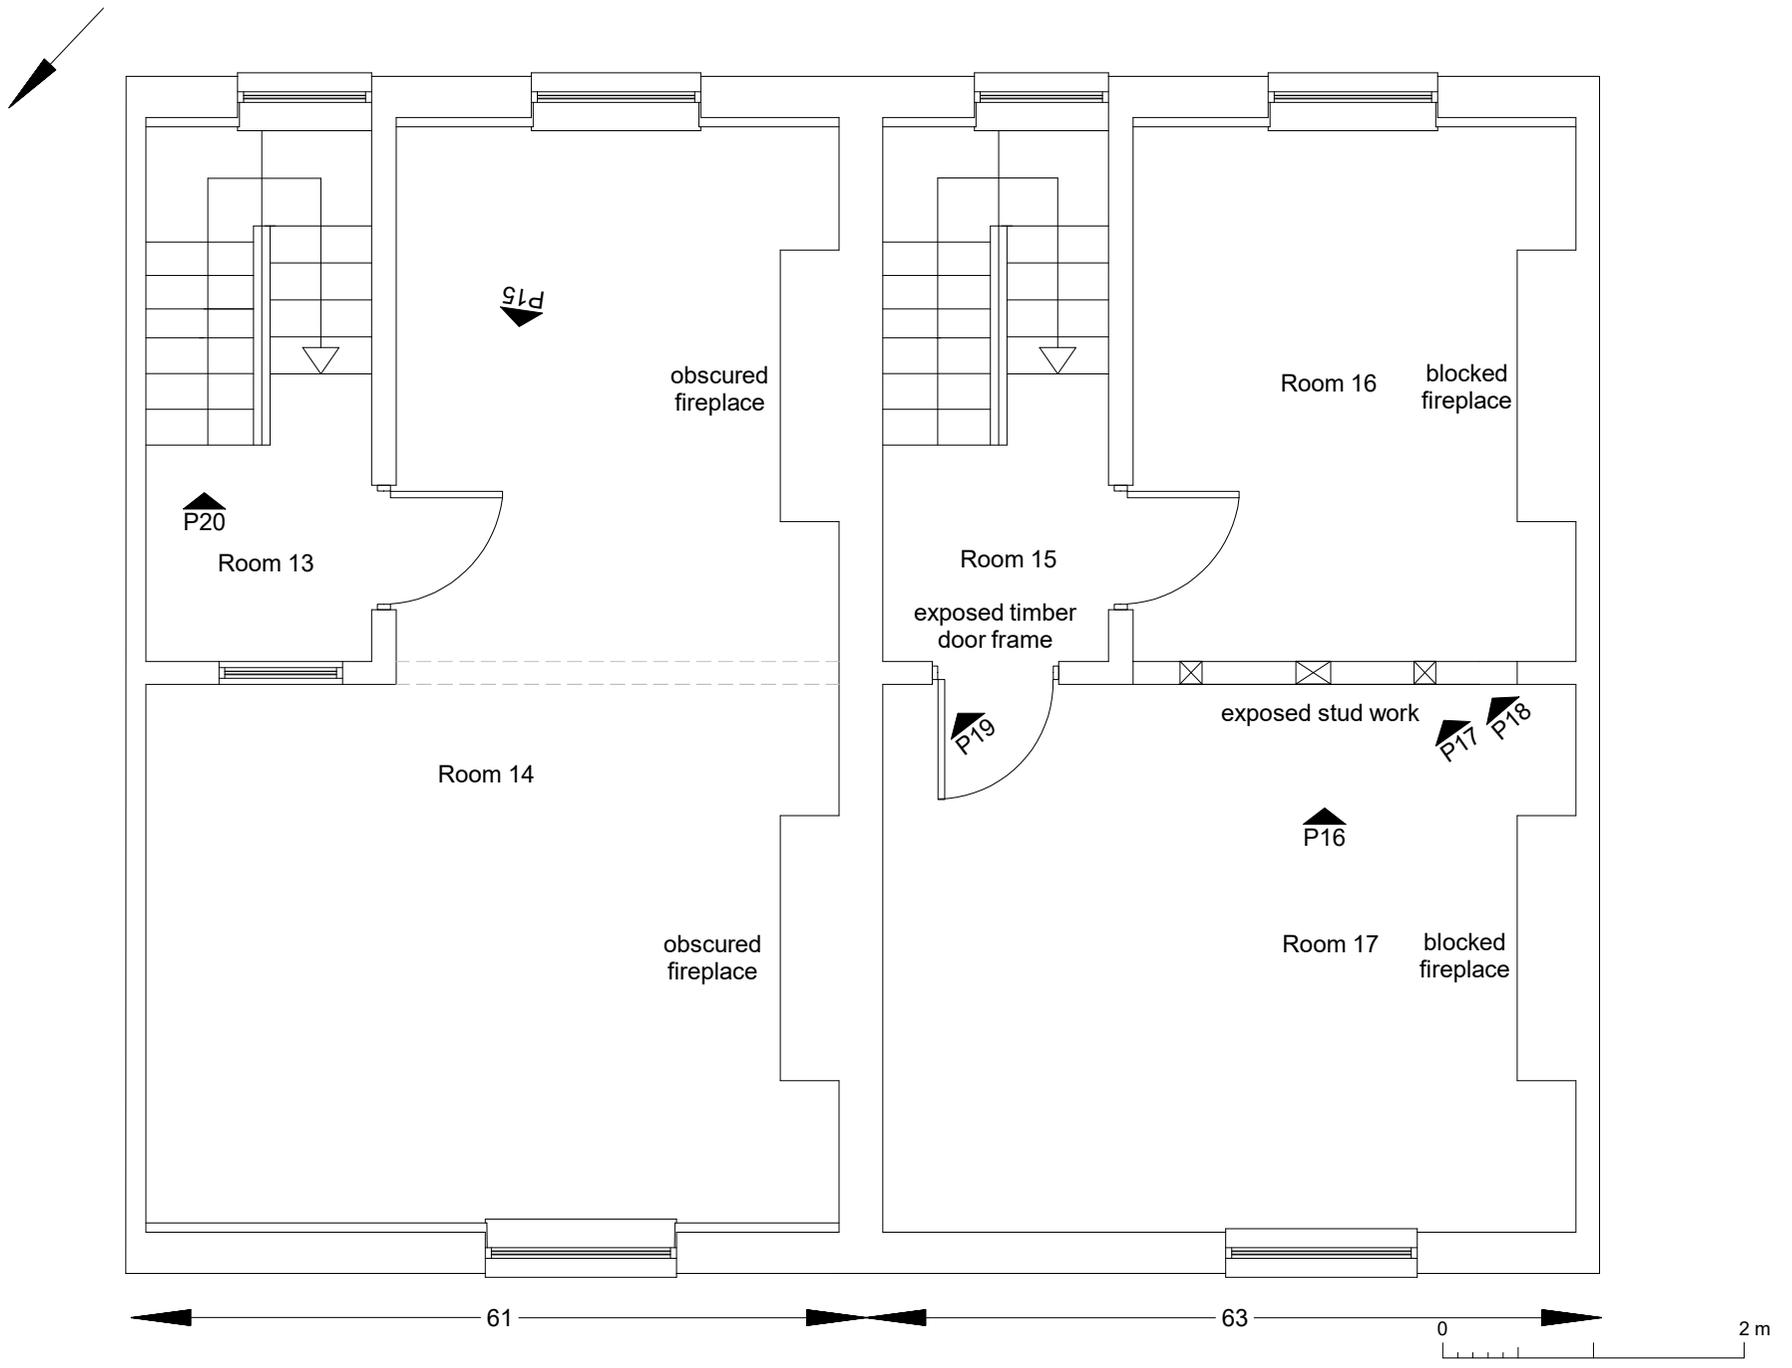
Fig 4 First floor plan. Location and direction of photographs reproduced in text shown.

| Fig 4 First floor plan. Location and direction of photographs reproduced in report shown. | |

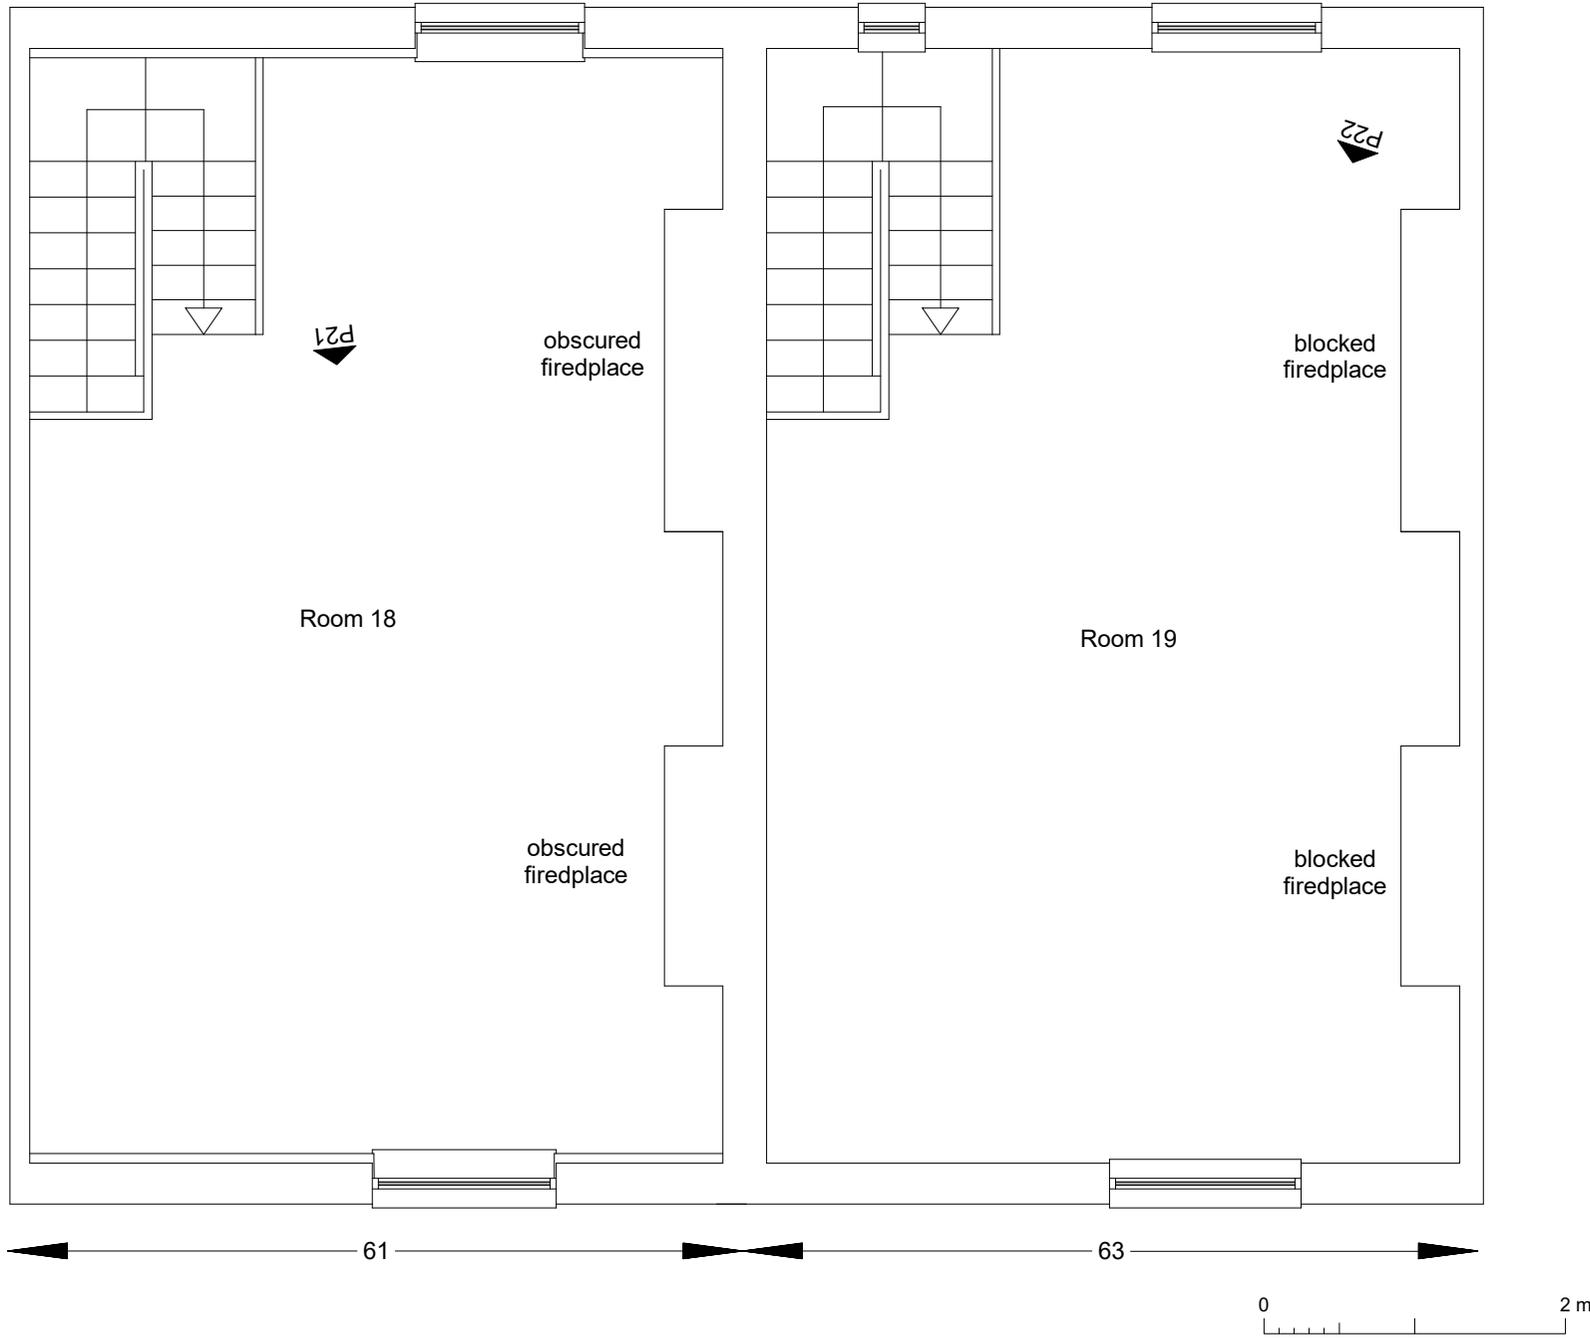
Fig 5 Second floor plan. Location and direction of photographs reproduced in text shown.

| Fig 5 Second floor plan. Location and direction of photographs reproduced in report shown. | |

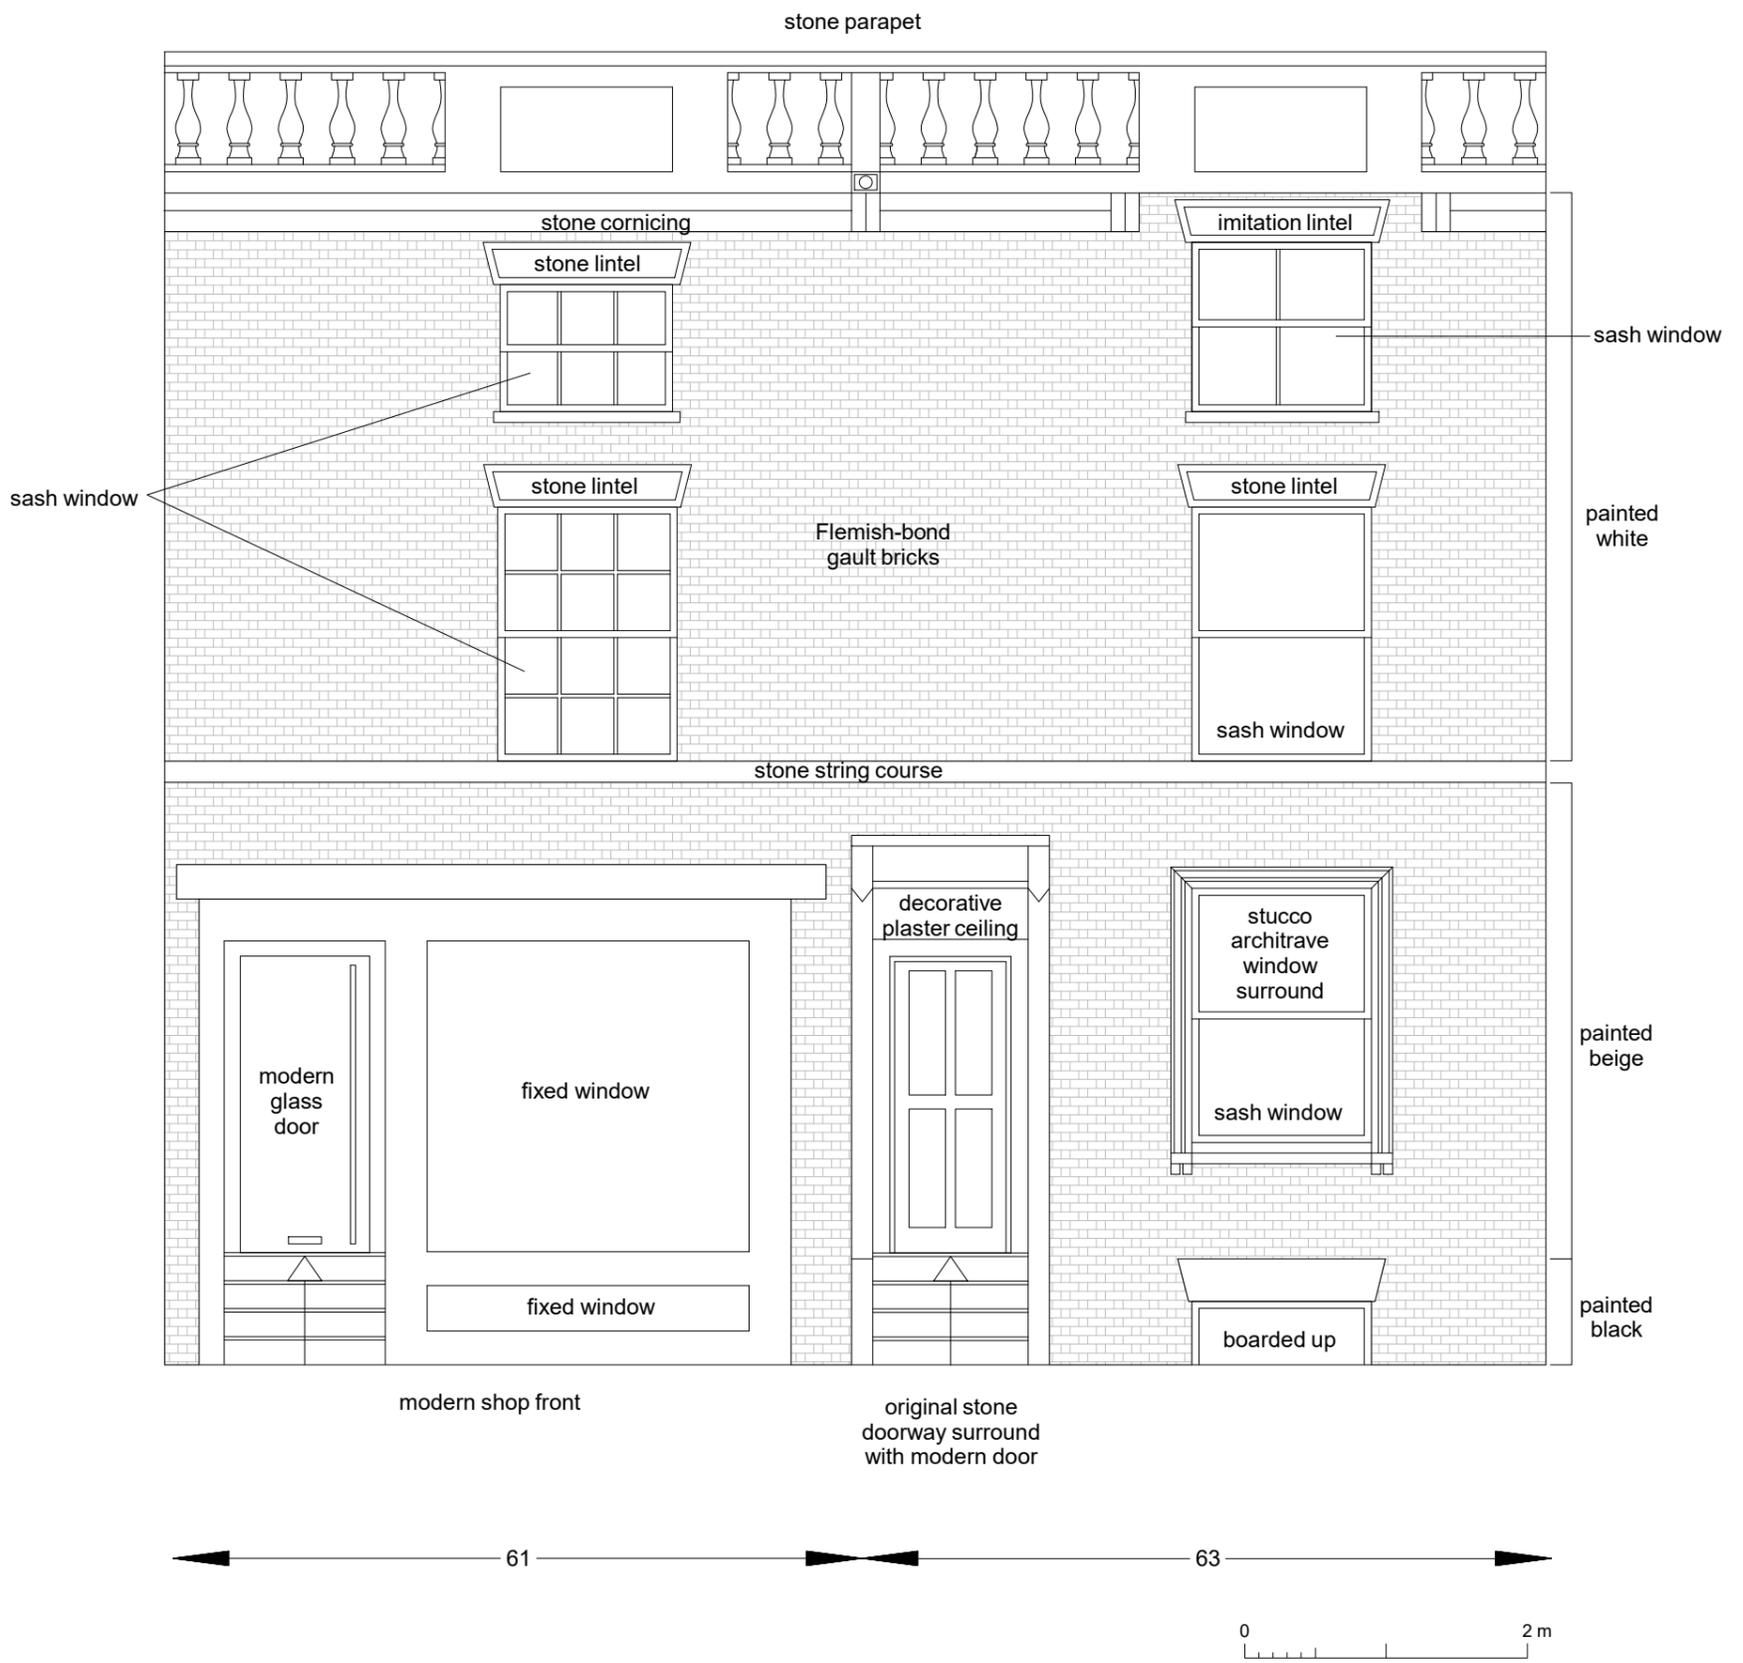
Fig 6 North-west elevation.

| Fig 6 North-west elevation. | |

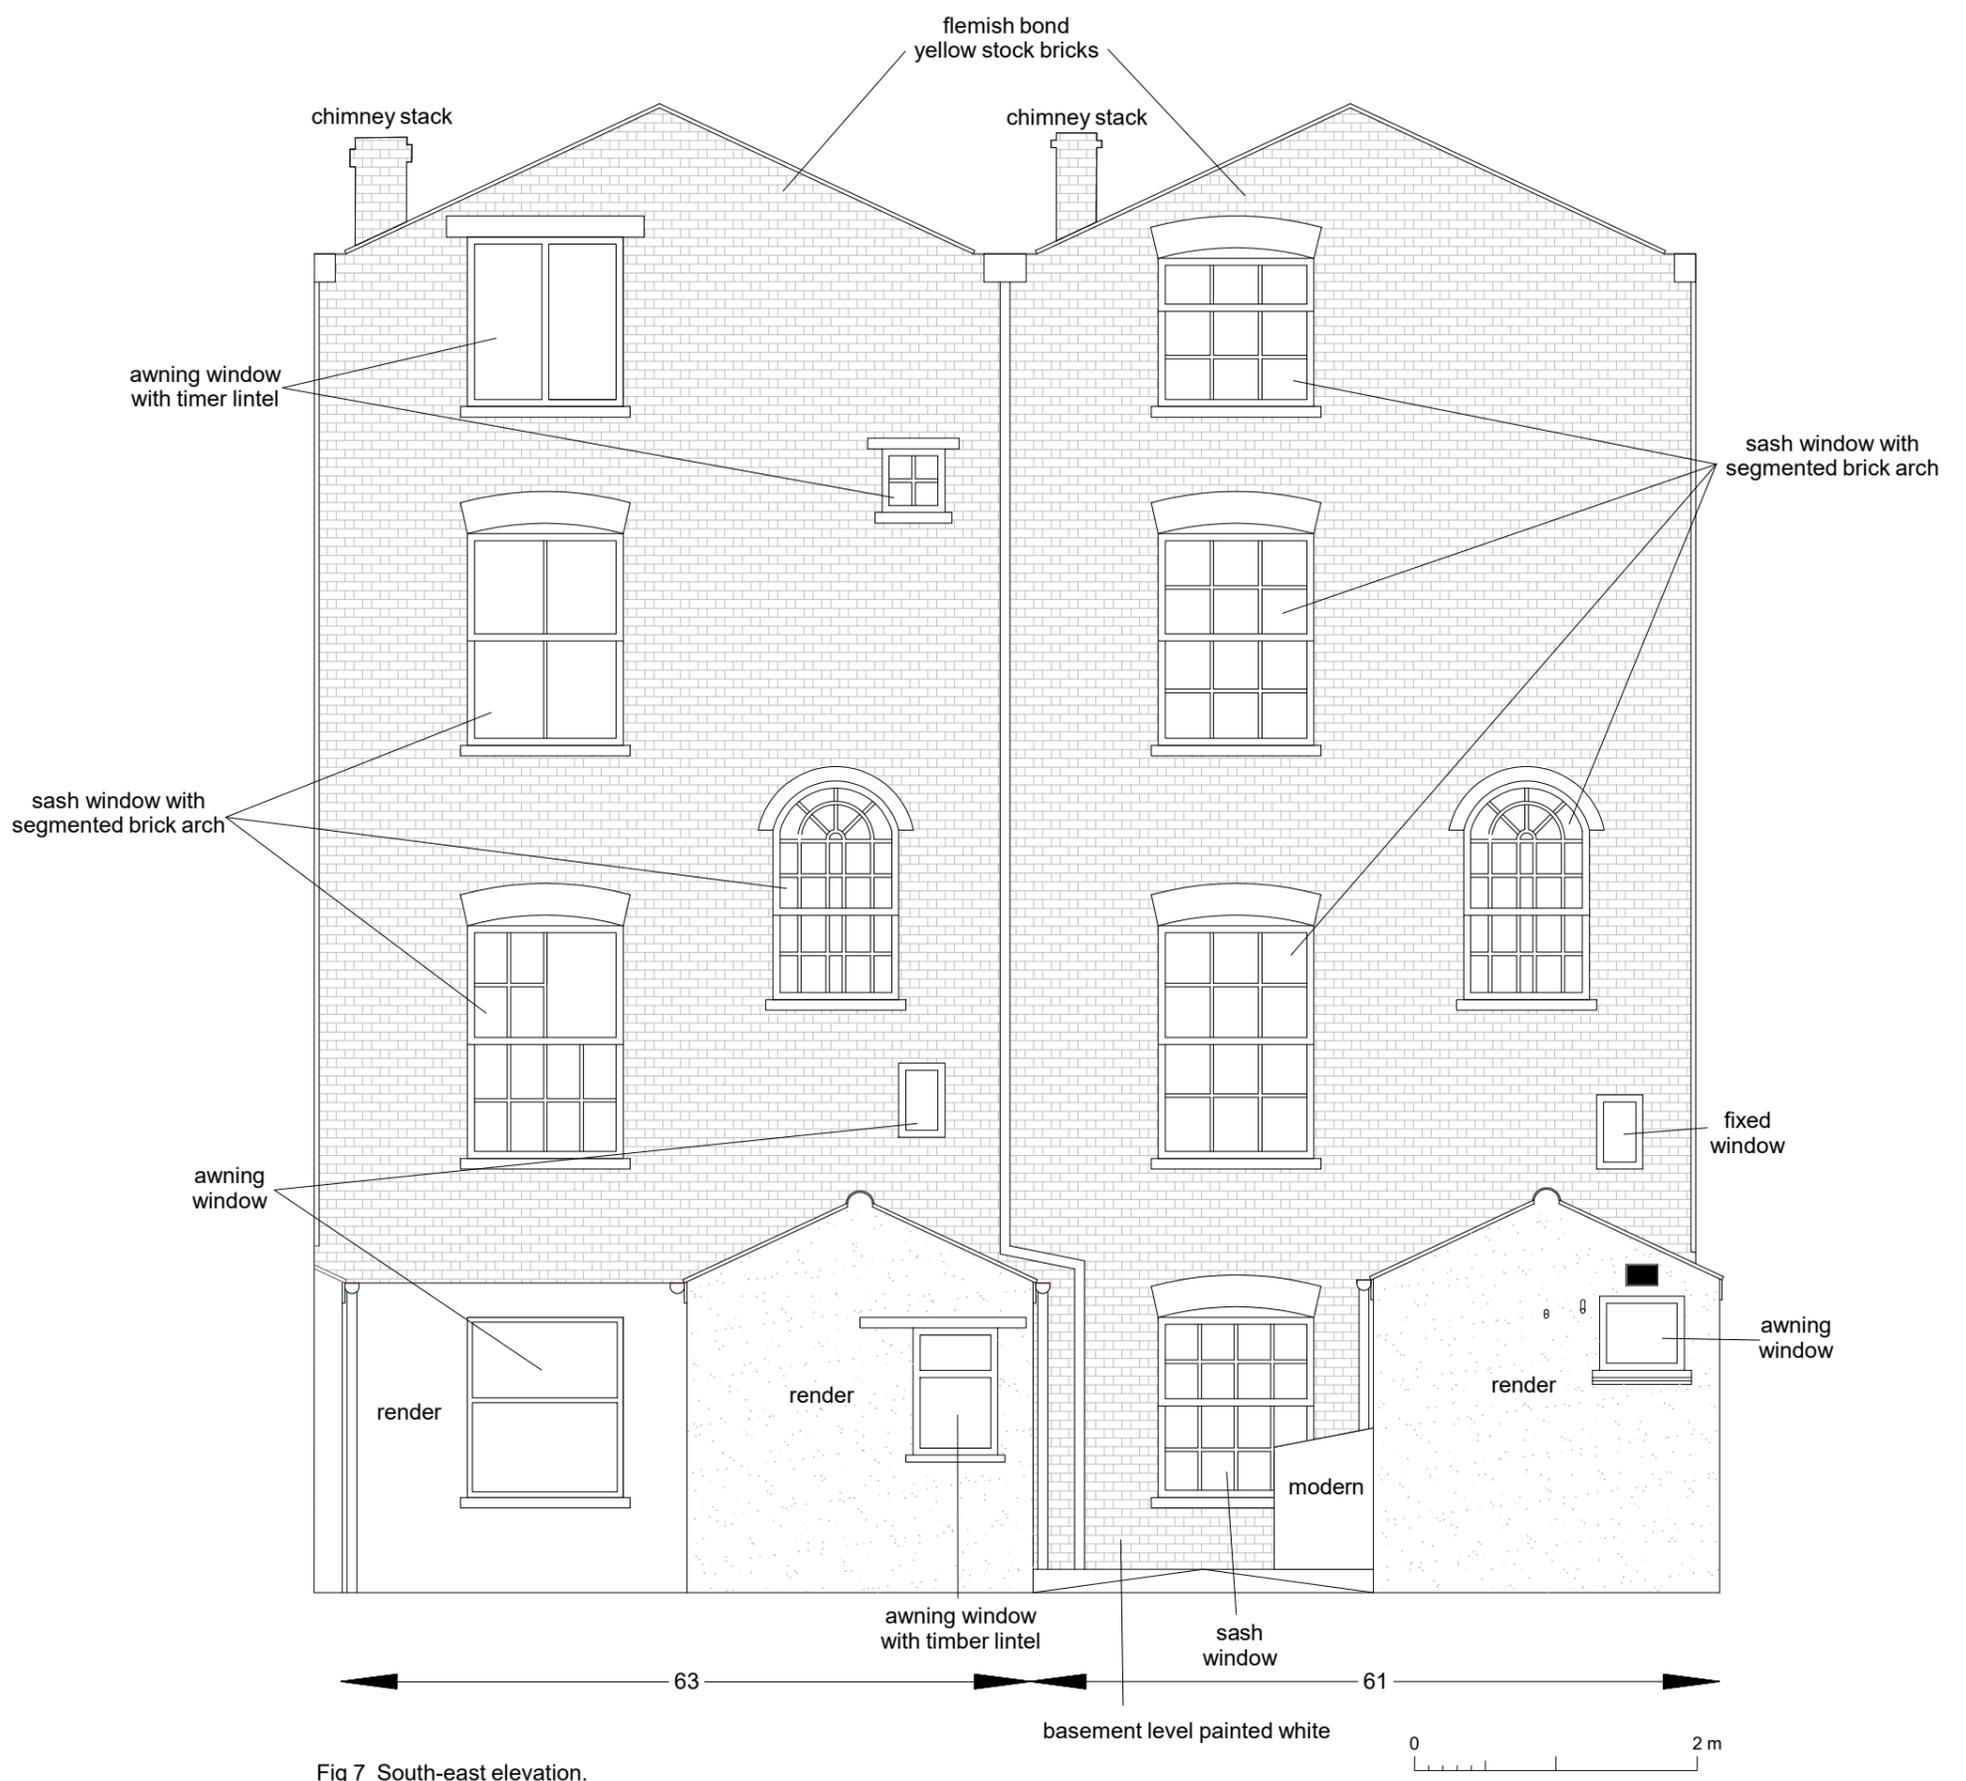
Fig 7 South-east elevation.

| Fig 7 South-east elevation. | |

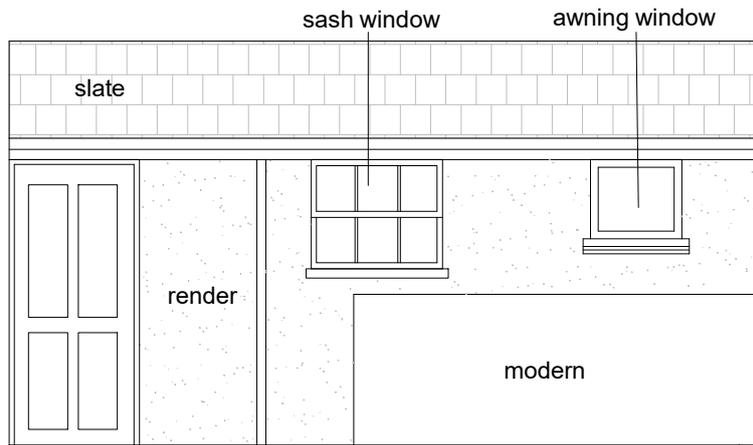
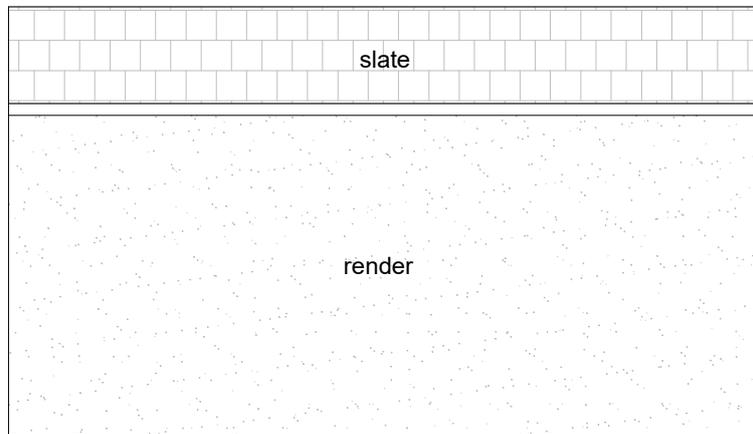
wooden door with  
two fixed windows

Fig 8 North-east and south-west elevations of no. 61.

| Fig 8 North-east and south-west elevations of 61. | |

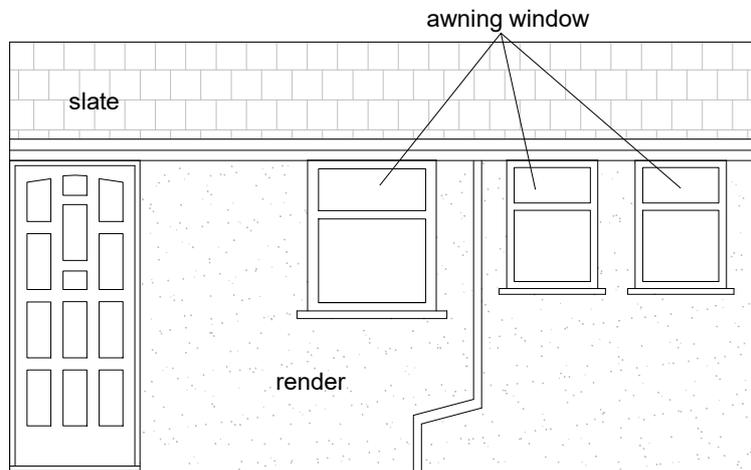
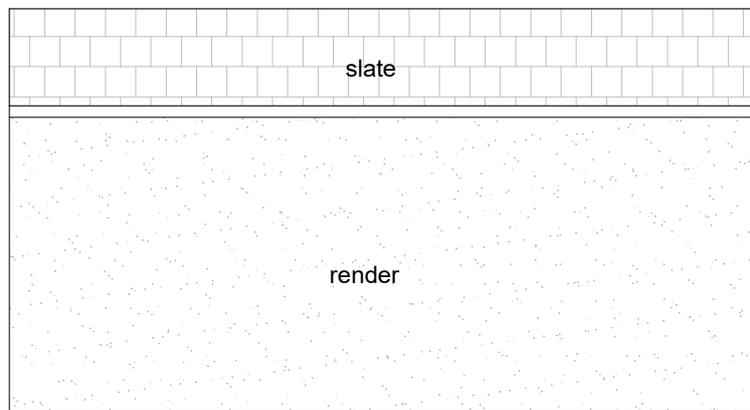
wooden door with  
one fixed windows

Fig 9 North-east and south-west elevations of no. 63.

| Fig 9 North-east and south-west elevations of 63. | |
