**CAT Report 1976  
issued November 2023**

**Historic building recording at Pond Mead,  
High Street, Widdington, Essex, CB11 3SB**

**CAT project ref.: 2023/09a  
ECC code: WDPM23**

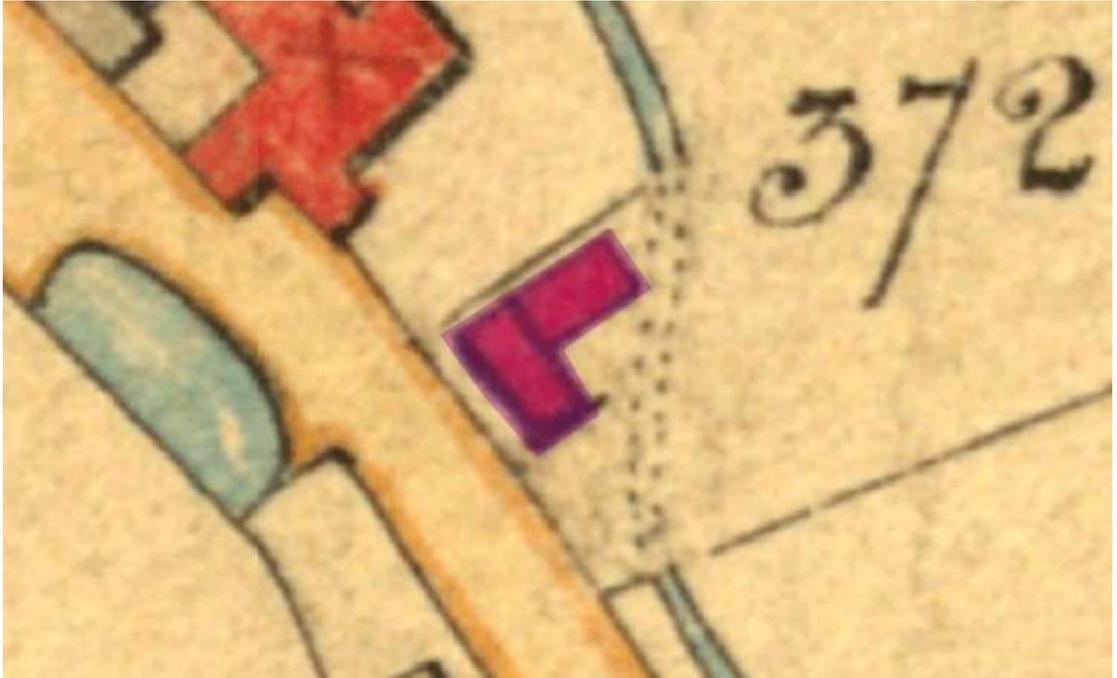
**Map 3** Extract of the tithe map of 1839 showing Pond Mead in purple.

By the 1839 tithe map of Widdington the building has evolved into two adjoining structures arranged in an 'L' shape. The apportionment suggests that the field to the rear of the house was called 'Brick Mead' and that it, and the house, were owned and inhabited by Richard Townsend.

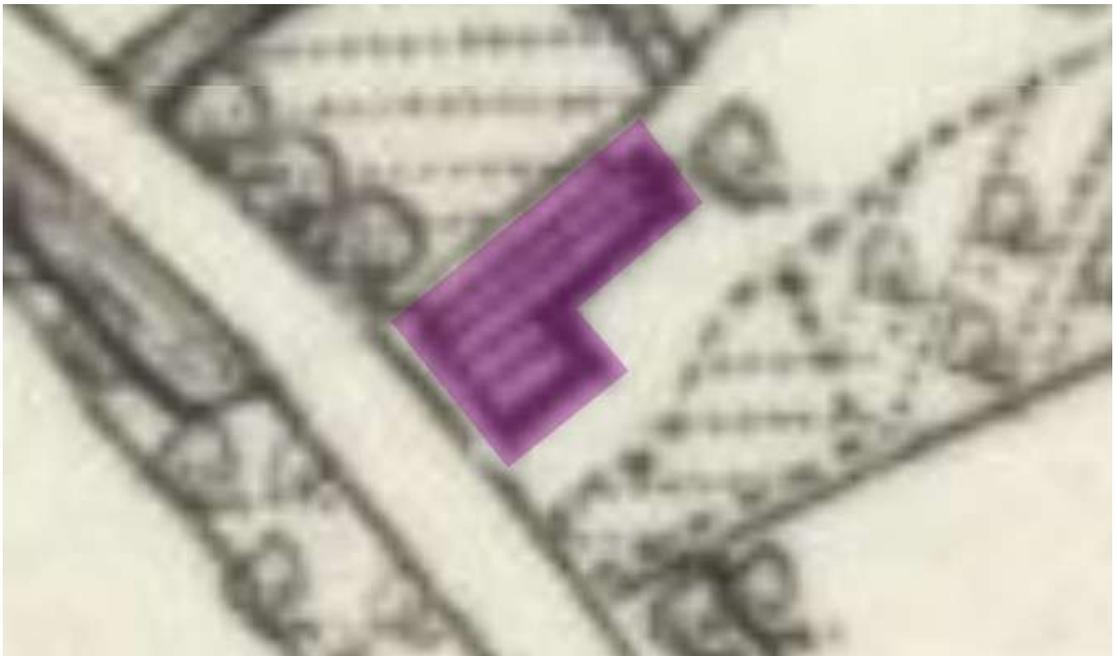
**Map 4** Extract of the 1876 1st edition 6-inch OS map, showing Pond Mead in purple.

The 1876 Ordnance Survey map still shows Pond Mead as an L-shaped building, but no longer divided (although this is likely due to lack of detail in the mapping rather than an amalgamation of the buildings). A small extension has been added to the north-eastern range of the building. The field, previously known as brick mead, appears to have been turned into a garden/orchard at this point.

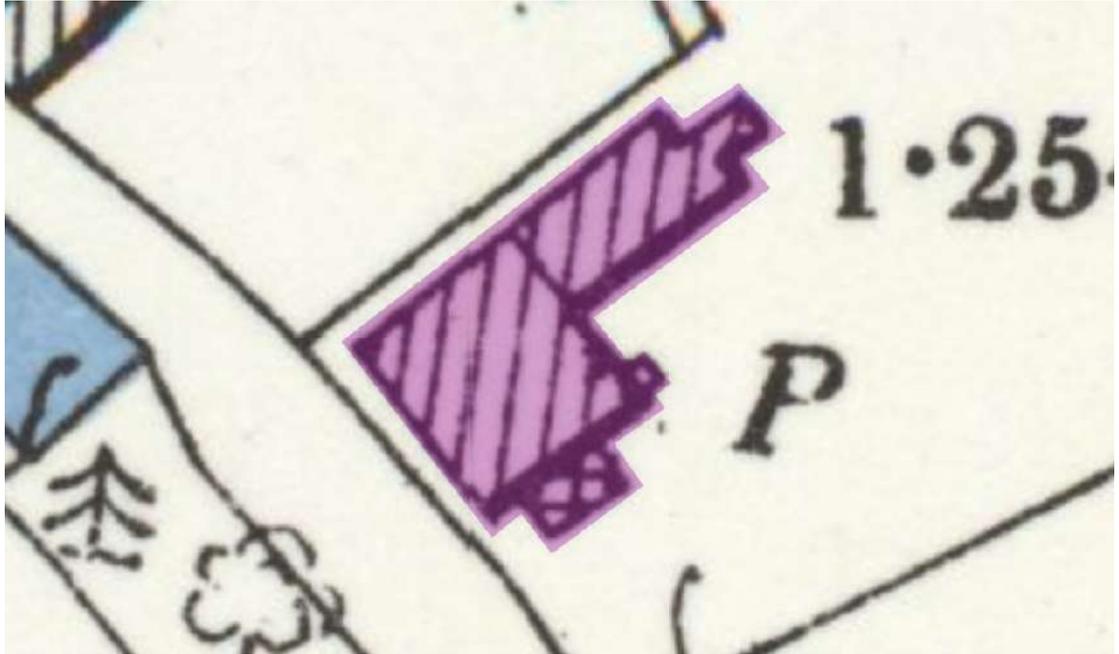
**Map 5** Extract of the 1896 25-inch OS map, showing Pond Mead in purple.

The 1896 Ordnance Survey map shows Pond Mead, once again as two separate buildings. A small extension, indicated by the map to be a conservatory or glasshouse, has been added to the south-east face of the building. Photograph 1, below, shows Pond Mead Cottage in the foreground with Pond Mead visible behind it.

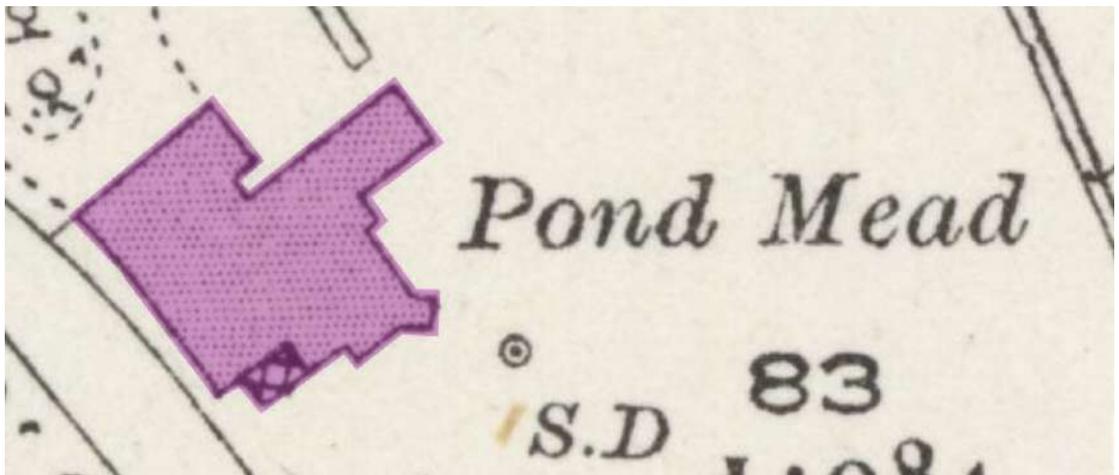
**Map 6** Extract of the 1919 25-inch OS map, showing Pond Mead in purple.

The OS map from 1919 shows that the floor plan of the house has changed substantially from the L-shape of the original building. It has been extended in almost all directions, creating something more akin to the current layout of Pond Mead.

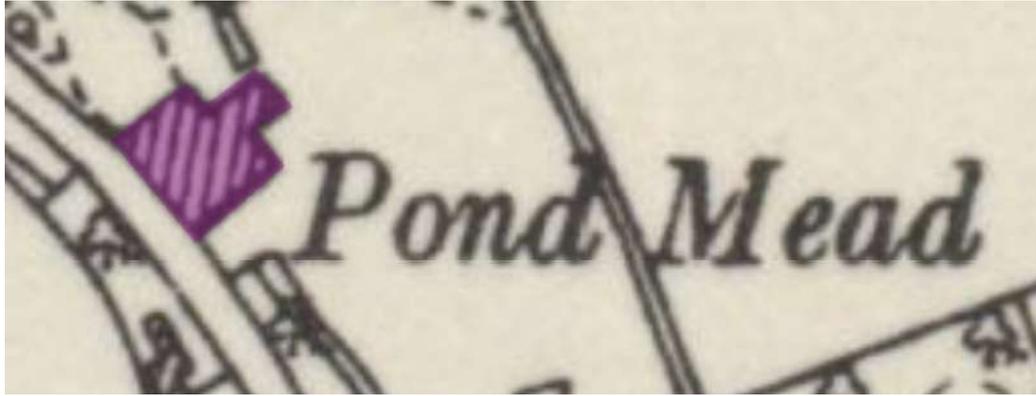
The OS map from 1946 shows Pond Mead in less detail but the size and shape of the building does not appear to have changed since 1919.

**Map 7** Extract of the 1946 6-inch OS map, showing Pond Mead in purple

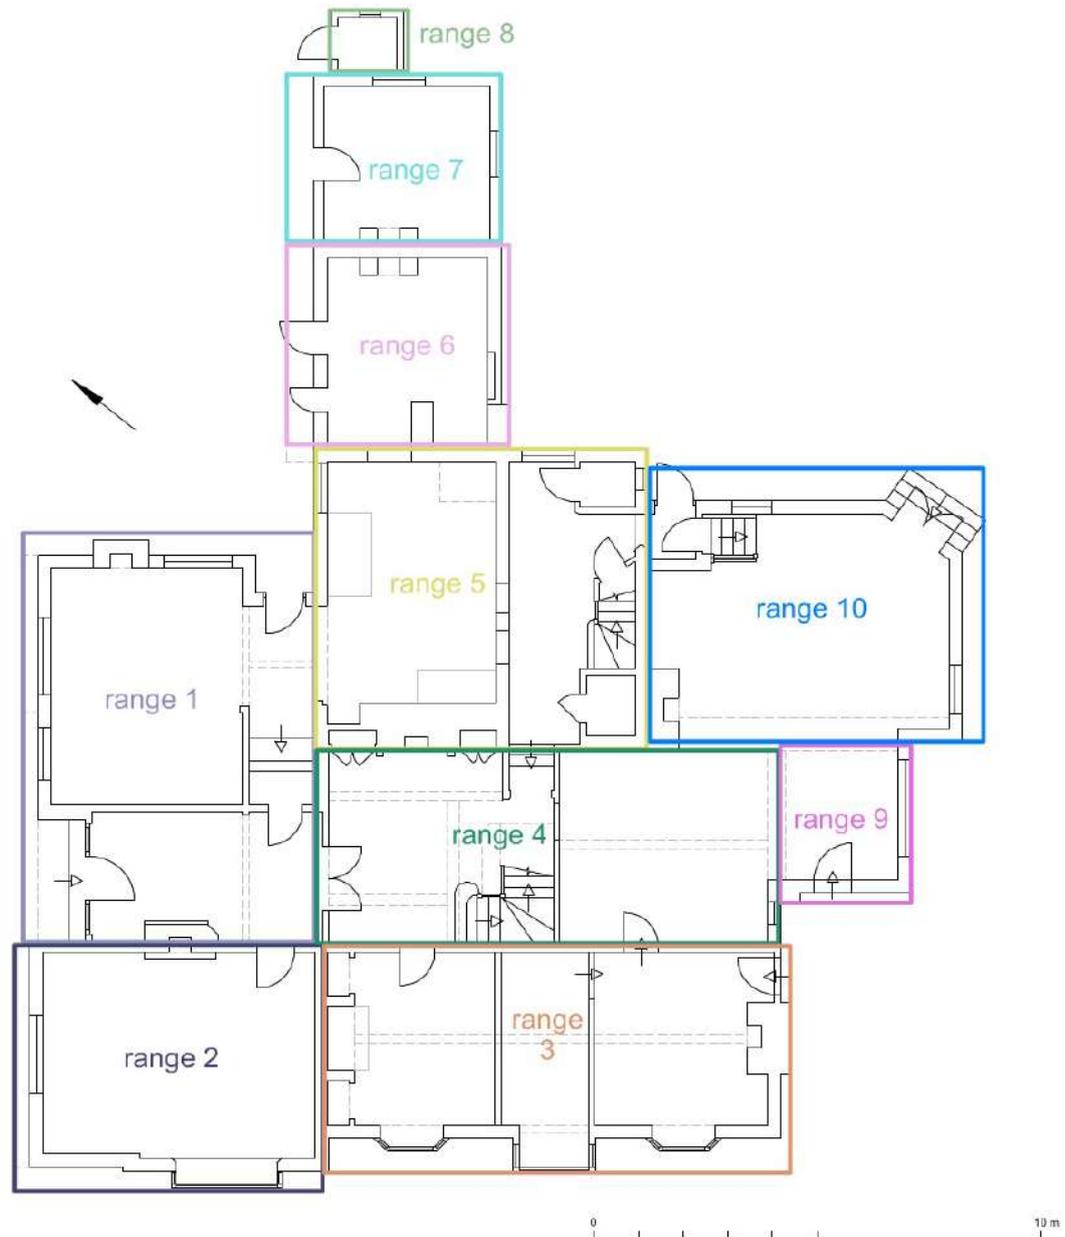
**Fig 1** Range plan (based on roof ridge lines).

Pond Mead is a largely timber-framed structure, aligned north-west/south-east with a range projecting to the north-east. It measures approximately 25.94m by 19.54m and covers an area of roughly 345m<sup>2</sup>. The vast majority of the structure is two-storey except for a few areas where it is single-storey. The building has multiple ridge-lines, which comprise a combination of gabled, hipped and flat roofs. Where the roof is gabled, it has timber barge-boards. Much of the roof is clad in plain-tile, excluding the flat areas where it is covered with roofing felt. Nine chimney stacks, of differing heights, project from various ridge-lines. They are all constructed from red brick with shallow oversailing courses and simple chimney pots.

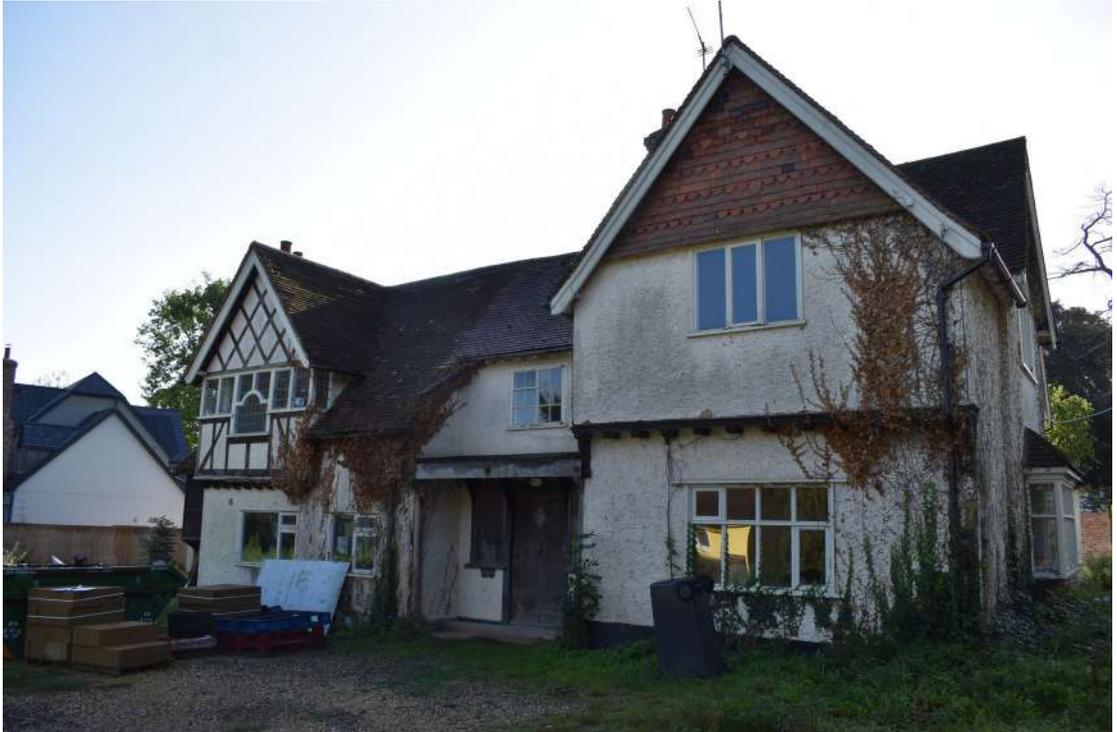
**Photograph 3** North-west elevation. Photograph taken facing east.

Unless otherwise stated, the exterior of Pond Mead is covered pebble-dash render painted off-white.

Range 1 is supported on a brick plinth (brick dimensions: 225 x 110 x 65mm) laid in Stretcher bond, which is visible on the north-west and south-west elevations. Range 2 has a Flemish bond brick plinth (brick dimensions: 210 x 110 x 65mm), visible on the north-west and north-east elevations. The plinth of range 3 comprises brick (brick dimensions: 210 x 105 65mm) laid in English bond. Range 5 has a plinth constructed from unidentified stone topped with a row of Header bond bricks (brick dimensions: 225 x ? x 65mm). Range 7 has a brick plinth (brick dimensions: 220 x 110 x 65mm) laid in Stretcher bond while range 9 has an English bond brick plinth (brick dimensions: 230 x 110 x 60mm). Range 10 has the appearance of an English bond brick plinth (brick dimensions: 225 x 110 x 65mm), but the walls are constructed of brick and clad in pebble-dash render. All plinths are painted black.

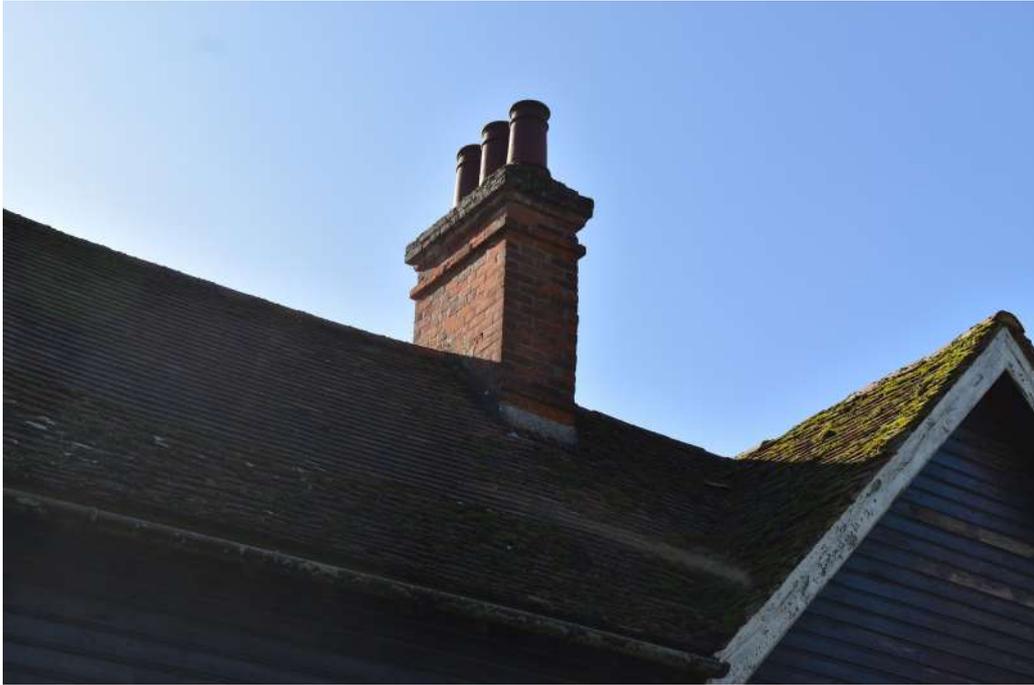
**Photograph 4** Detail of north-eastern chimney. Photograph taken facing south.

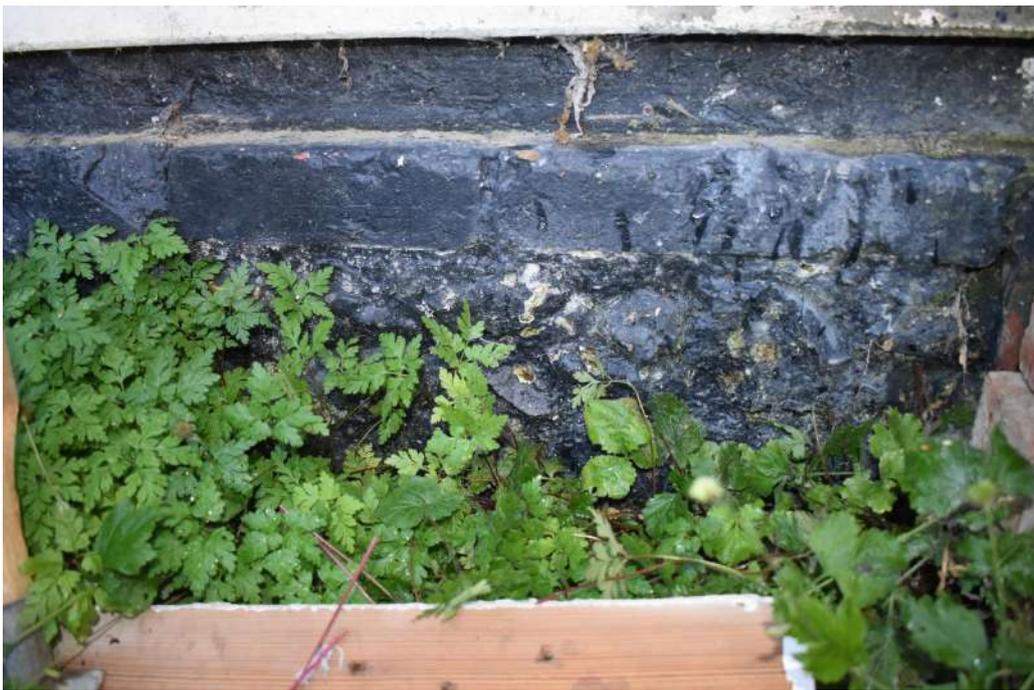
**Photograph 5** Detail of stone plinth on north-west elevation. Photograph taken facing south-east.

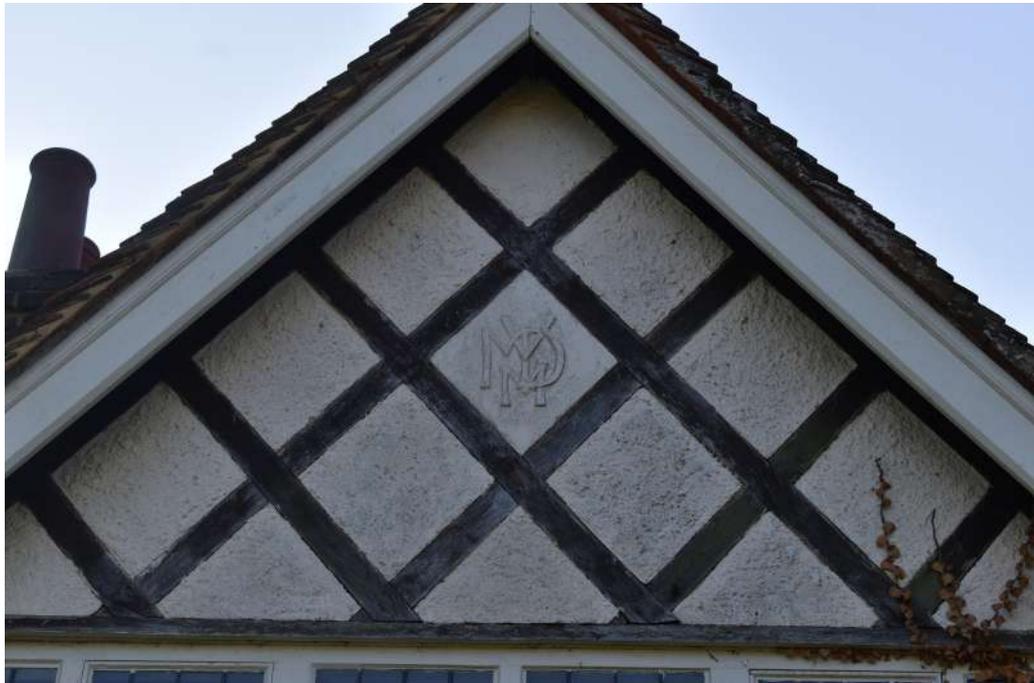
On the north-west elevation, ranges 1 and 2 both have prominent gables. The gable-end of range 1 is clad with decorative terracotta hanging tiles, while range 2 has an exposed timber-frame, comprising machine-cut timbers painted black, with an embossed monogram emblem, which reads 'VMMD'. The electoral register from 1918 (Plate 1) records a woman of the name Violet Mary Moore-Dillon living at Pond Mead. Both gables have a jetty with exposed joists but are slightly different in style. The joists of range 1's jetty have been rounded at the ends and the outer joists both have lightly decorative brackets. The ends of the joists of range 2's jetty are also rounded but with a ridged design and no brackets. Between the two gables is a catslide roof and a flat-roof recessed porch, which has a large timber-door flanked by two single-light fixed windows. The door is secured with iron strap hinges and has a diamond-shaped

**Photograph 6** Detail of monogram emblem and exposed timber-framing on north-west elevation. Photograph taken facing south-east.

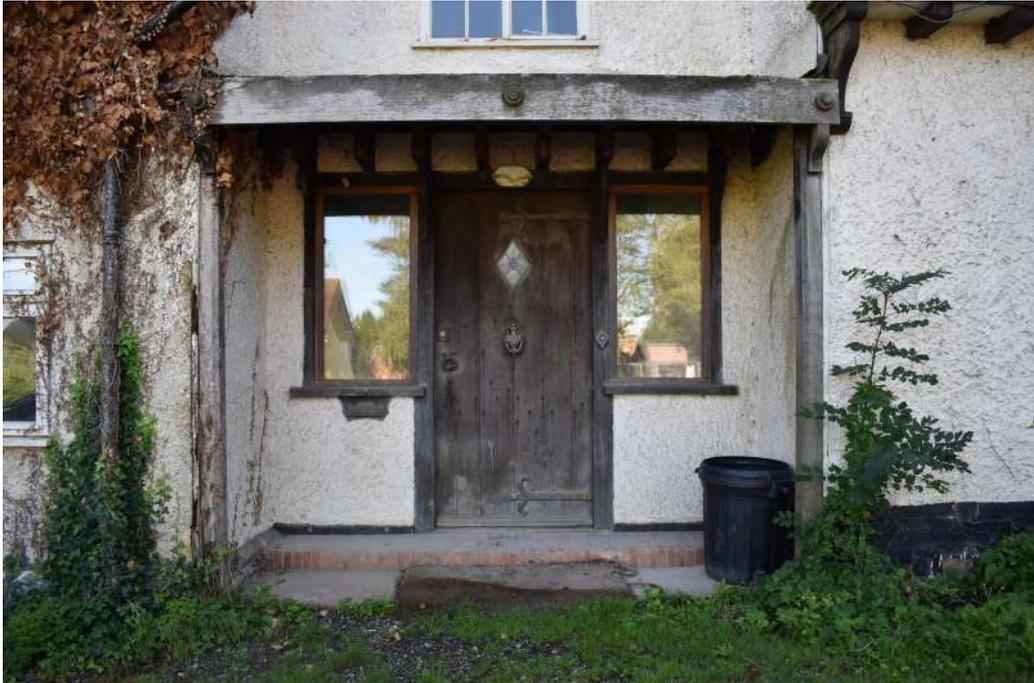
**Photograph 7** Detail of door on north-west elevation. Photograph taken facing south-east.

Plain, vertically planked timber-doors were a favourite choice, usually embellished with by elaborate hinges, knobs, and knockers, particularly when set in a recessed porch. Door furniture was an area where Arts and Crafts designers could exhibit their skill, especially as the plain door allowed the work to stand out. The front door at Pond Mead is a great example of this. The door itself is plain timber, while the hinges, handle and knocker are more decorative. The addition of a modest-sized stained glass window is a further display of hand-craftsmanship.

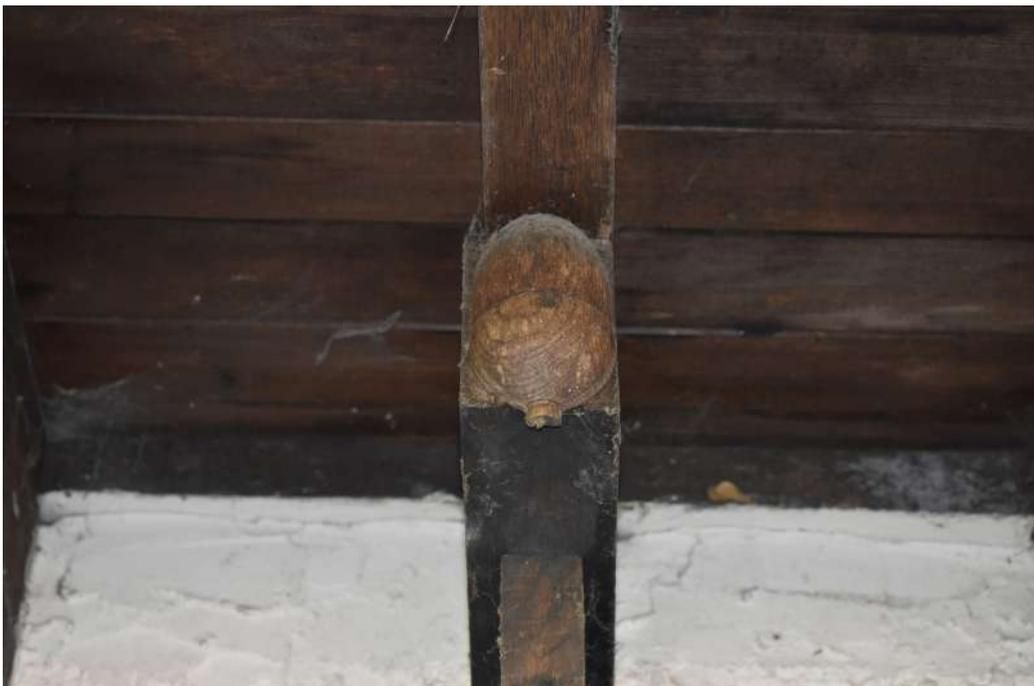
**Photograph 8** Detail of carved acorn in doorway of north-west elevation. Photograph taken facing south-east.

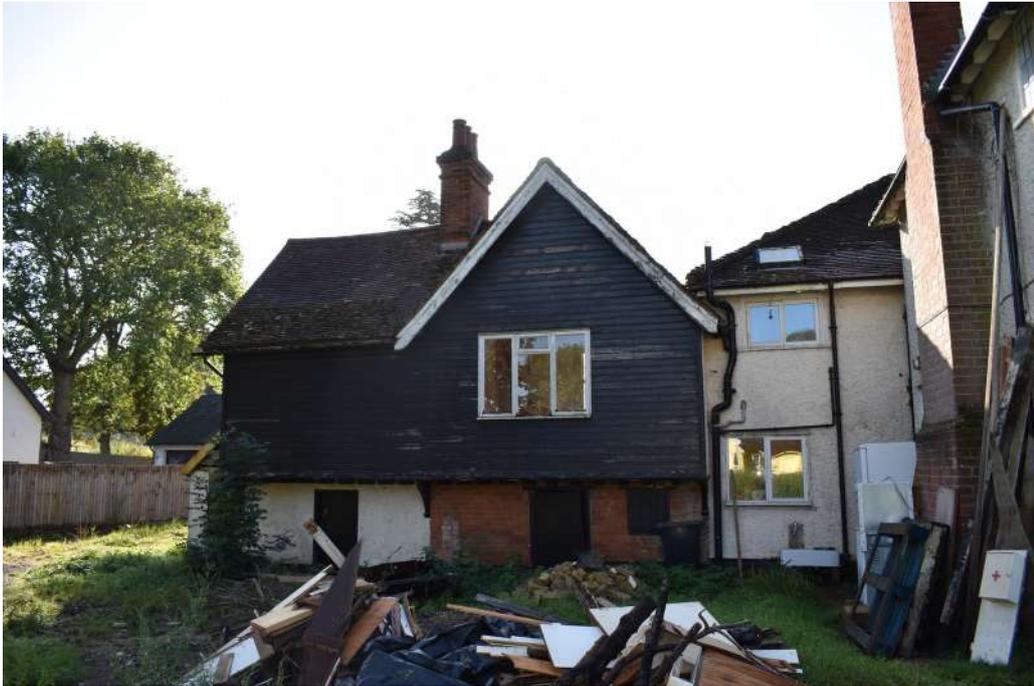
The north-west elevations of ranges 5, 6 and 7 are set back from ranges 1 and 2. Range 5 has two two-light timber-frame casement windows along with a single-light

roof light. On this elevation, ranges 6 and 7 share a jetty, with exposed joists. The joists have rounded ends with a bracket in the middle and at both ends. The ground floor of range 6 is constructed from red brick (brick dimensions: 210 x 110 x 65mm) laid in Flemish bond, the lower quarter of which have been painted black. Range 6 has two vertically-planked timber doors, both secured with iron strap hinges, while range 7 only has a single vertically-planked door. The first floor of both ranges is clad in black weatherboard, with a four-light timber-framed window present on range 6. Range 8 has a single timber door, above which much of the render has come away, revealing the timber-laths beneath.

**Photograph 9** North-west elevation. Photograph taken facing south-east.

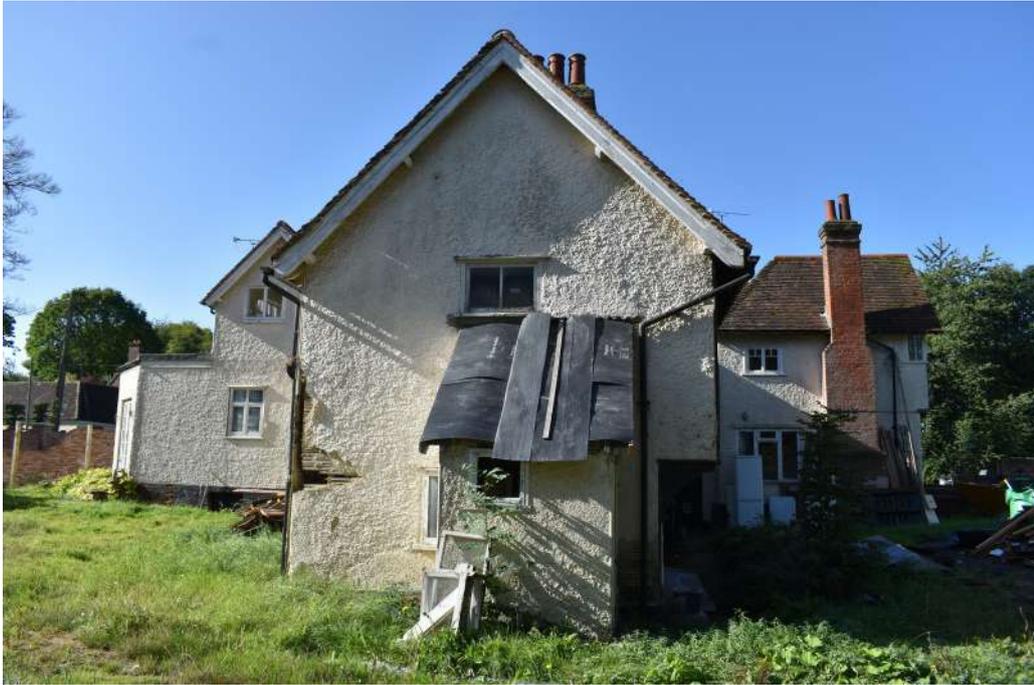
The north-east elevation is busy with fenestration, spread across ranges 5, 6, 7, 9 and 10. All of the windows are timber-framed with a varying number of lights and types of openings. Notable windows include a four-light fanlight on range 10, comprising yellow and blue glass in a chequerboard pattern, and two windows with leaded (with square quarries) upper-lights. A blocked cellar window is present at the bottom of range 10, which has an arched brick lintel. Two timber doors are also present – one on range 1 and the other on range 10. A large chimney is located on range 2, comprising red brick (brick dimensions: 215 x 105 x 65mm) laid in Flemish bond. At the south-eastern end of the elevation, range 10 has a small east-facing elevation with a set of double-patio doors and three brick steps.

**Photograph 10** North-east elevation. Photograph taken facing south-west.

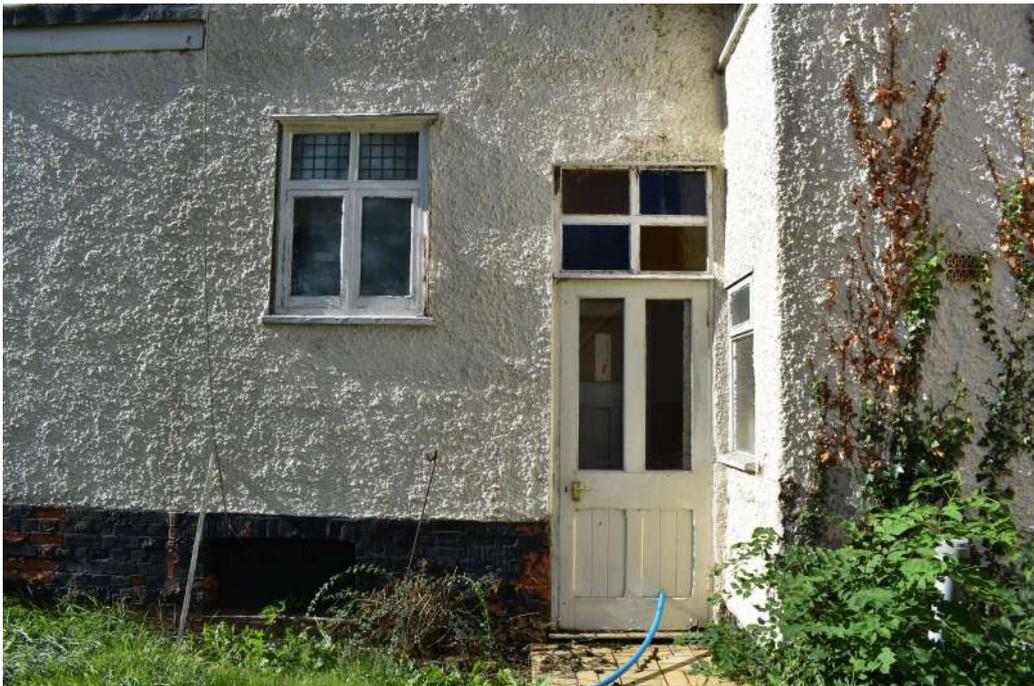
**Photograph 11** Detail of blocked opening, window and door on north-east elevation. Photograph taken facing south-west.

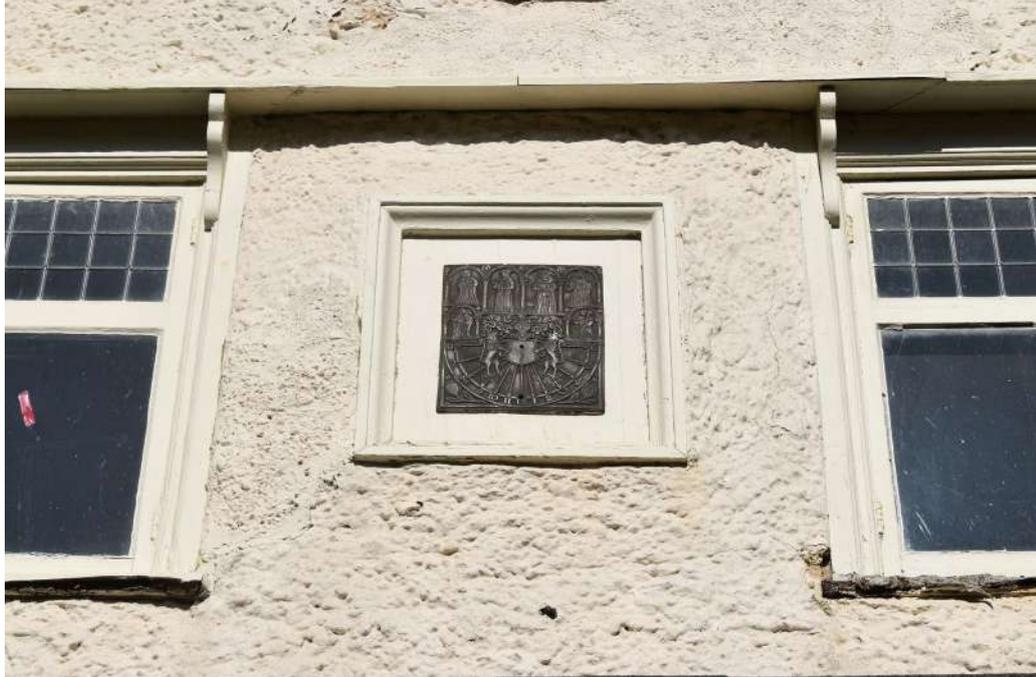
floor and one on the ground floor. The first floor windows are both timber-framed corner windows, with leaded glass in the top rows of lights. The leaded windows comprise square quarries. These corner windows flank a brass sundial which has been set into the wall of range 9, which depicts a friary scene with rearing lions either side of a coat of arms<sup>1</sup>. The gnomon is missing from the sundial. The ground floor window is metal-framed with ten-lights, the top five of which are leaded with diamond-shaped quarries.

**Photograph 12** Detail of sundial on south-east elevation. Photograph taken facing north-west.

<sup>1</sup> Auction listings for sundials of the same design suggest they are a copy of a historic Flemish design and are Victorian in origin.

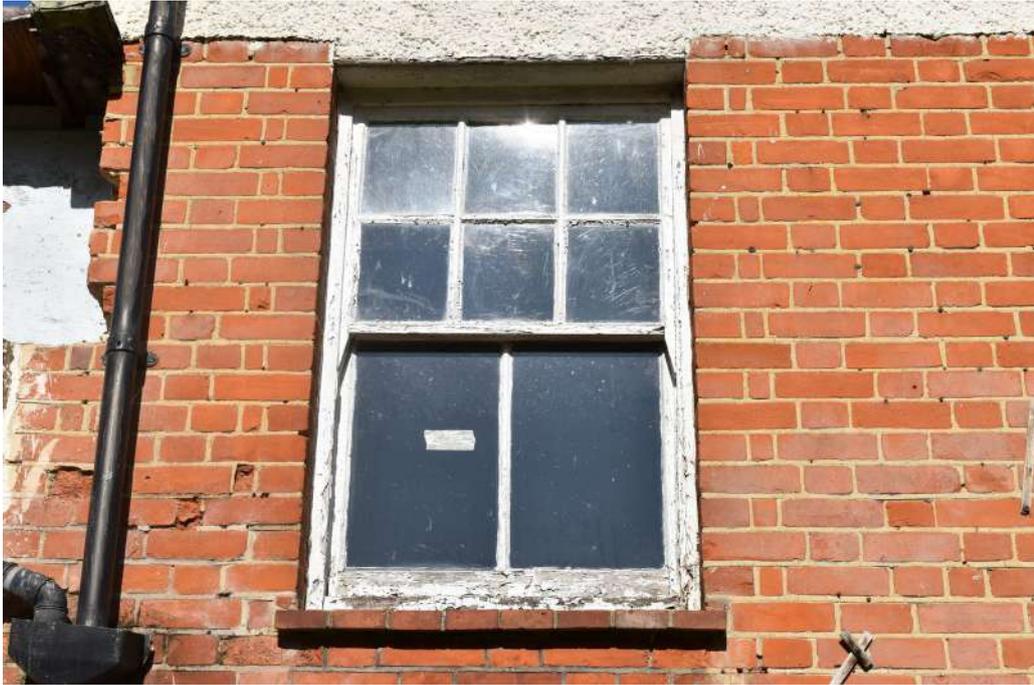
The south-east elevation of range 10 has a gable clad in decorative hanging-tiles, in the same style as those used on the gable of range 1. Two windows are present on range 10, one on the ground floor and one on the first floor. The ground floor window has four lights and a metal frame. The top two lights are leaded with diamond-shaped quarries. The first floor window is timber-framed with eight lights, the top four of which are leaded with square quarries.

**Photograph 13** Detail of window on south-east elevation. Photograph taken facing north-west.

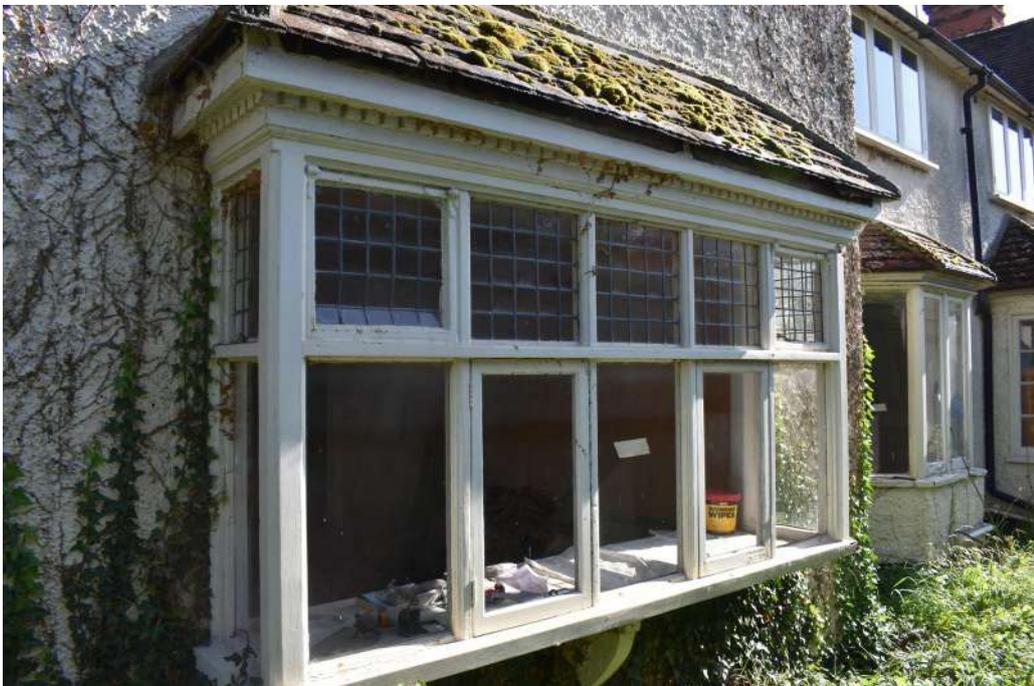
Two gables are present on the south-west elevation, one on range 1 and the other on range 3. Range 1 has a plain gable and a window on the ground and first floors. The ground floor window is a fourteen-light timber-framed oriel window. The top row of lights are leaded with small square-shaped quarries. The roof of the oriel window is clad in plain-tile while the base is support on three carved timber brackets. The window on the first floor is four-light with a timber-frame.

**Photograph 14** Detail of window on south-west elevation. Photograph taken facing north.

A number of the windows used are also typical of this period. Oriel windows were originally fashionable during the 17th century, after which they fell in popularity. They made a resurgence during the Arts and Crafts movement as, similarly to the bay window, they allowed natural light to flood a room, a juxtaposition to stereotypical dark and dingy conditions of Victorian interiors.

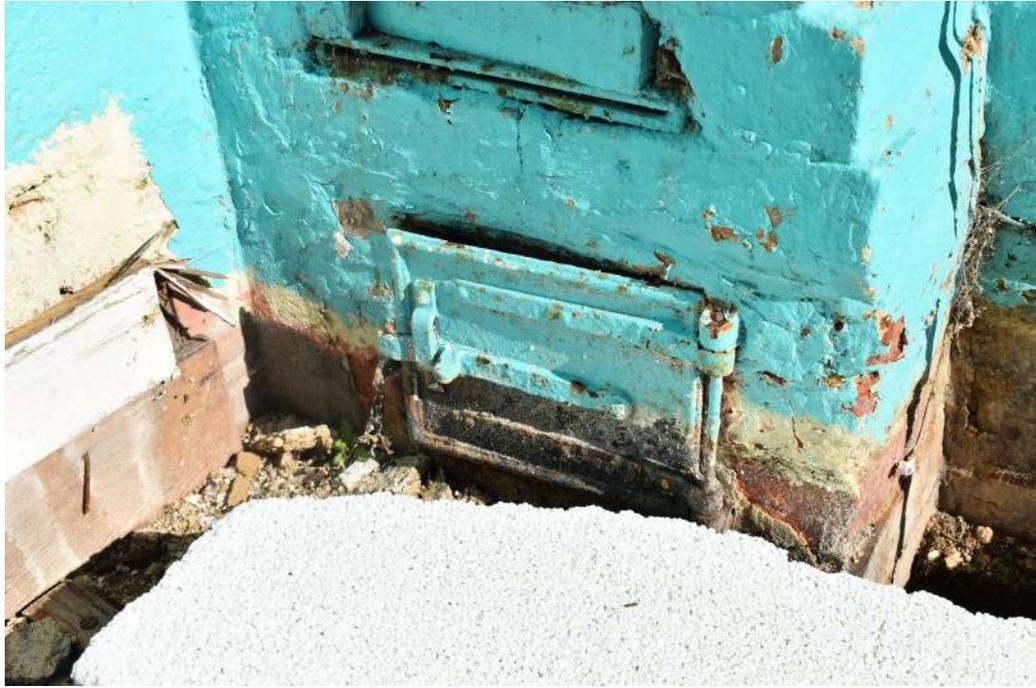
The removal of the conservatory has exposed an interior door on the south-west elevation of range 4. Also exposed on this elevation is an iron clean-out door at the base of the chimney.

**Photograph 15** Detail of clean out door in south-west elevation. Photograph taken facing north.

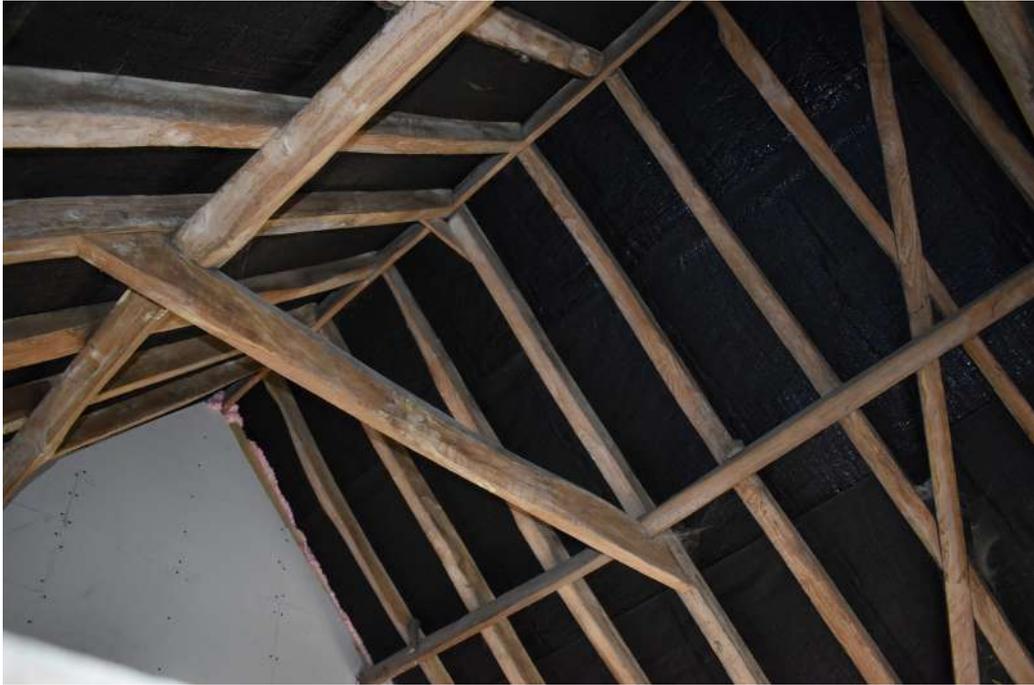
Most of the roof structure was inaccessible at the time of recording but from what could be observed much of the roof appears to be constructed from pairs of rafters, rising from the wall-plates, to meet at a ridge-board at the apex of the roof. A single purlin is present on each roof pitch, clasped by a collar. The roof structure recording in range 3 also has diagonal through-bracing. The timbers used comprise a combination of hand-sawn and machine-cut with no obvious signs of reused.

**Photograph 16** Detail of roof structure above room 22. Photograph taken facing south-east.

The first floor of range 3 comprises of 3 rooms, including room 22. There is a large chimney breast dominating the north-western wall and two replacement windows in the south-western wall. The doorway leading from room 21 has been inserted, as evidenced by an empty mortice in the joist above. The plaster of the ceiling of room 22 has been removed, exposing the roof structure above.

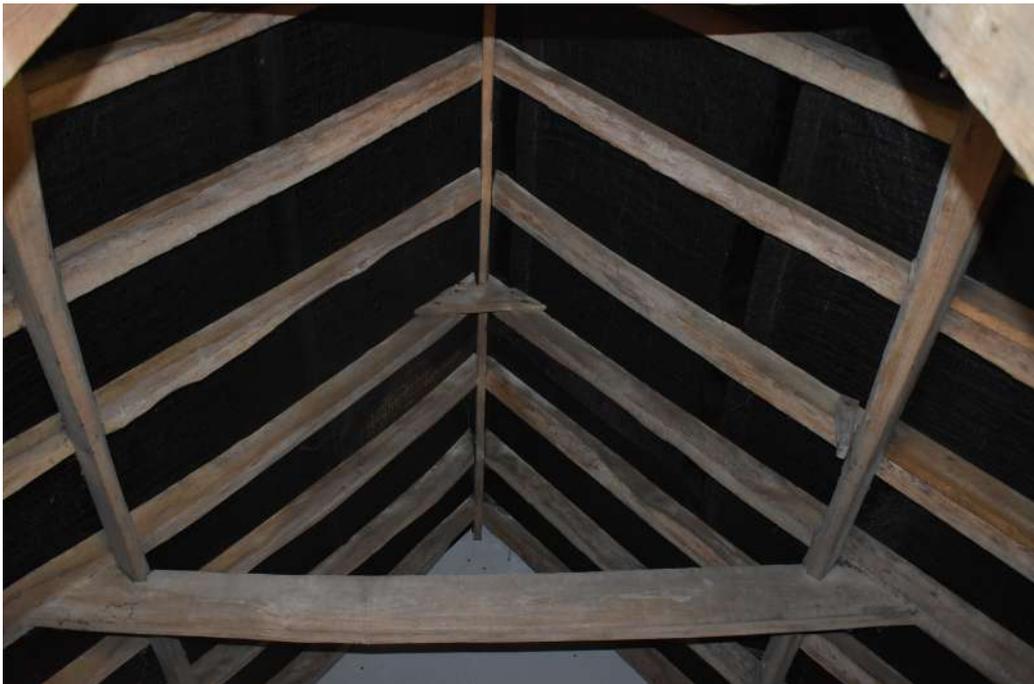
**Photograph 17** Detail of roof structure above room 24. Photograph taken facing north-west.

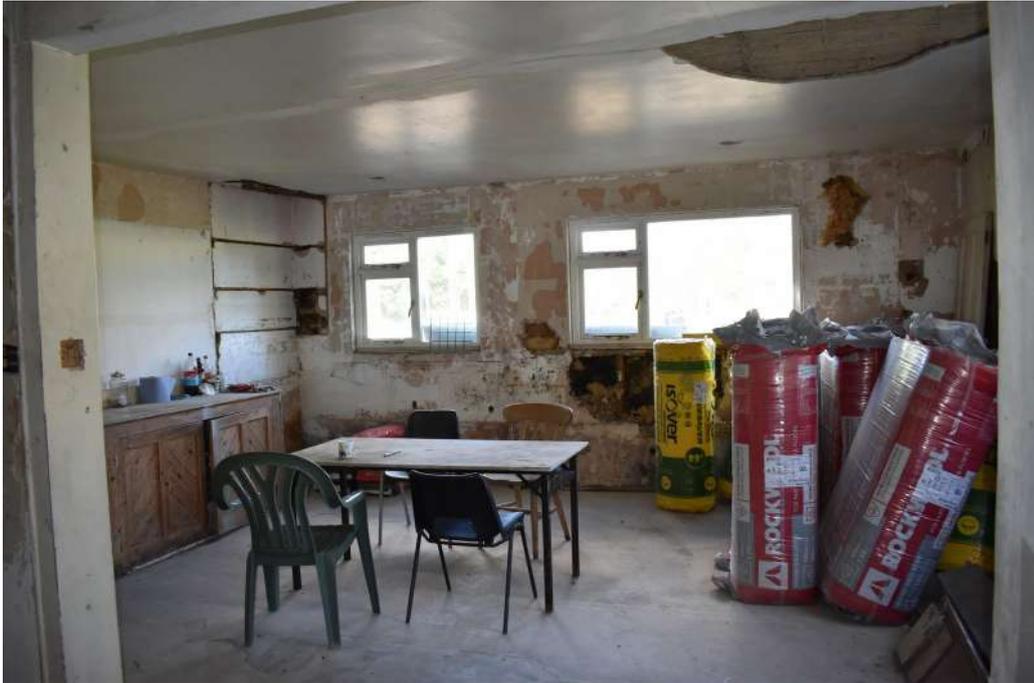
Rooms 1 and 2 occupy the ground floor of range 2. Room 1 has a poured concrete floor. An area of damage to wall has revealed the timber-frame beneath, which comprises machine-cut timbers, and damage to the ceiling has exposed the timber laths beneath. A brick fireplace is present on the north-east wall. It has an arched brick lintel with a rectangular opening. The bricks are a combination of red and yellow in colour. Room 1 has three replacement windows, two in the north-west wall and one in the north-east wall.

**Photograph 18** Interior of room 1. Photograph taken facing north-west.

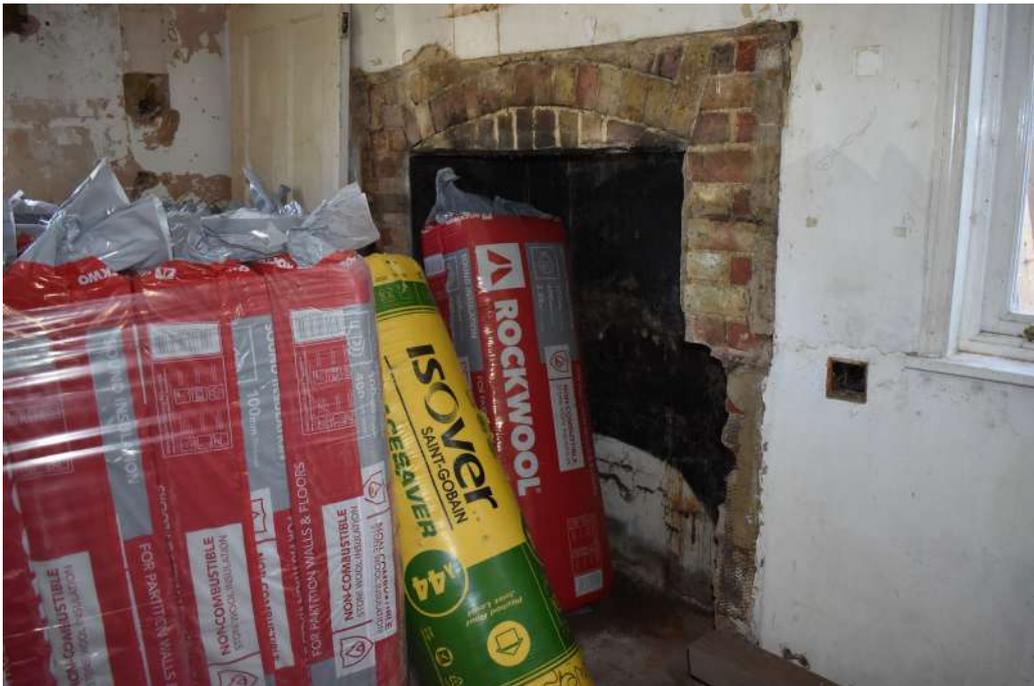
**Photograph 19** Detail of fireplace in room 1. Photograph taken facing north.

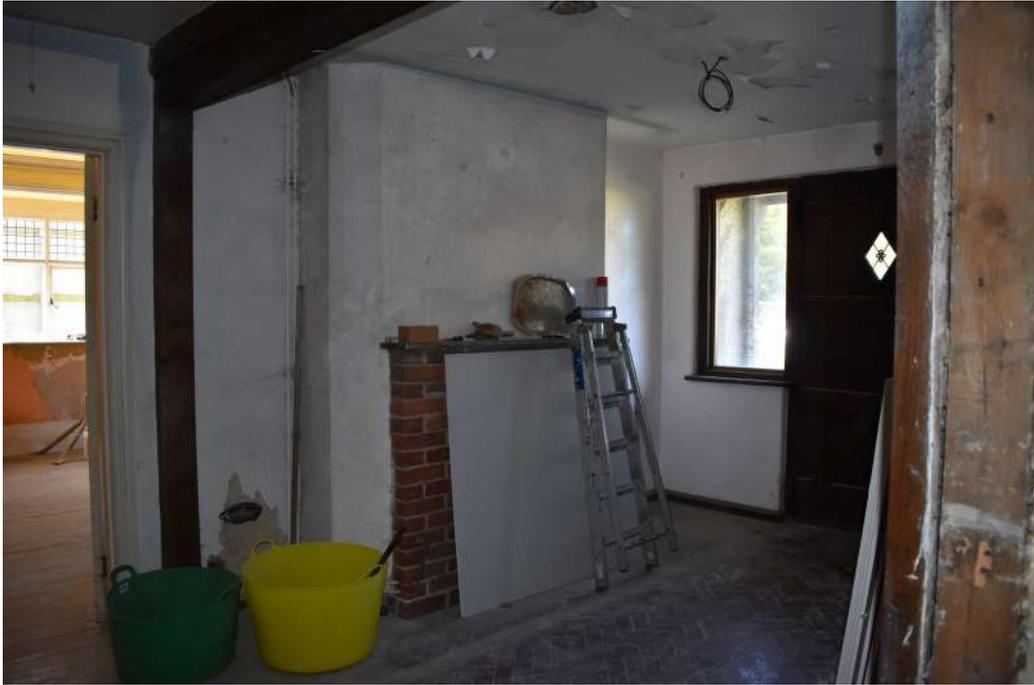
Room 2 is the entrance hall of Pond Mead. The floor is wooden parquet, laid in a herringbone pattern. In the north-east of the room, a flight of three wooden steps lead down into room 1. On the south-western wall is a chimney breast with a brick skin, imitating a brick fireplace, but without an opening, with a wooden mantel. Large areas of damage to the plaster on the south-east wall has uncovered the machine-cut timber-framing and laths beneath. A set of double doors are located in the south-east wall, along with a four-panel door in the south-west wall.

**Photograph 20** Interior of room 2. Photograph taken facing west.

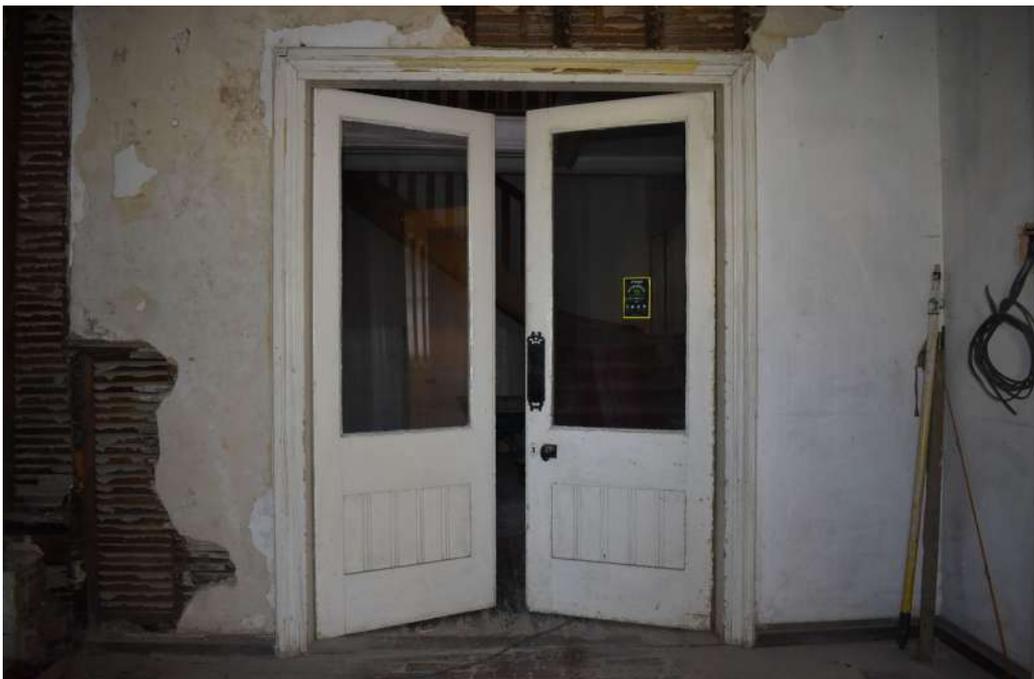
**Photograph 21** Detail of doors in room 2. Photograph taken facing south-east.

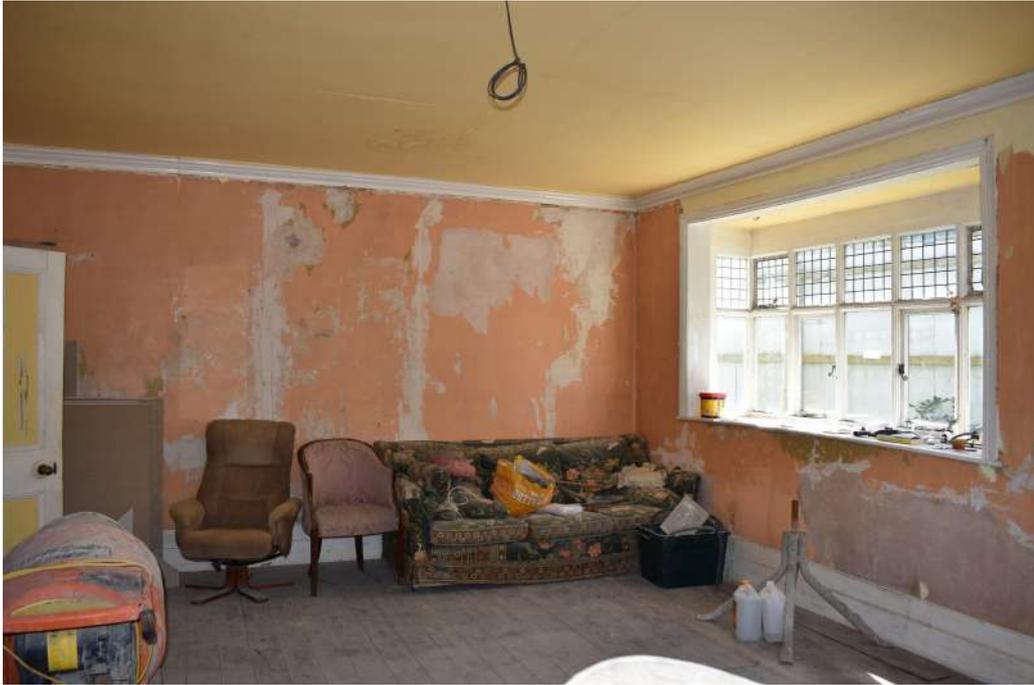
Room 3 dominates the ground floor of range 1 and has the original cornicing and skirting boards. A fireplace is located on the north-east wall. It is brick-built with a timber chimney-piece and tiled hearth. The chimney-piece has a timber overmantle with a mirror between two plain panels and a timber mantle. On both edges of the chimney-piece, the timber has been carved to imitate a stone column. Within the fireplace is a cast-iron fireback and fire-grate. The fire-grate is relative simple in design while the fireback depicts two sitting lions, each resting their paws on a shield, either side of a rose.

**Photograph 22** Interior of room 3. Photograph taken facing south.
