**CAT Report 1976  
issued November 2023**

**Historic building recording at Pond Mead,  
High Street, Widdington, Essex, CB11 3SB**

**CAT project ref.: 2023/09a  
ECC code: WDPM23**

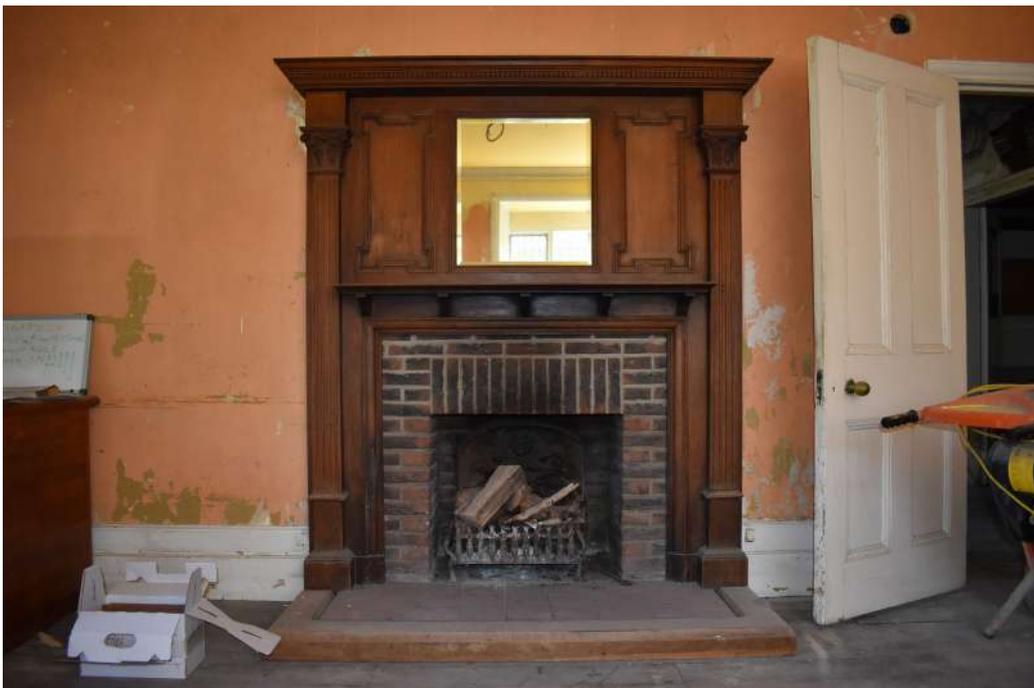
Room 3 dominates the ground floor of range 1 and has the original cornicing and skirting boards. A fireplace is located on the north-east wall. It is brick-built with a timber chimney-piece and tiled hearth. The chimney-piece has a timber overmantle with a mirror between two plain panels and a timber mantle. On both edges of the chimney-piece, the timber has been carved to imitate a stone column. Within the fireplace is a cast-iron fireback and fire-grate. The fire-grate is relative simple in design while the fireback depicts two sitting lions, each resting their paws on a shield, either side of a rose.

**Photograph 23** Detail of fireplace in room 3. Photograph taken facing north-east.

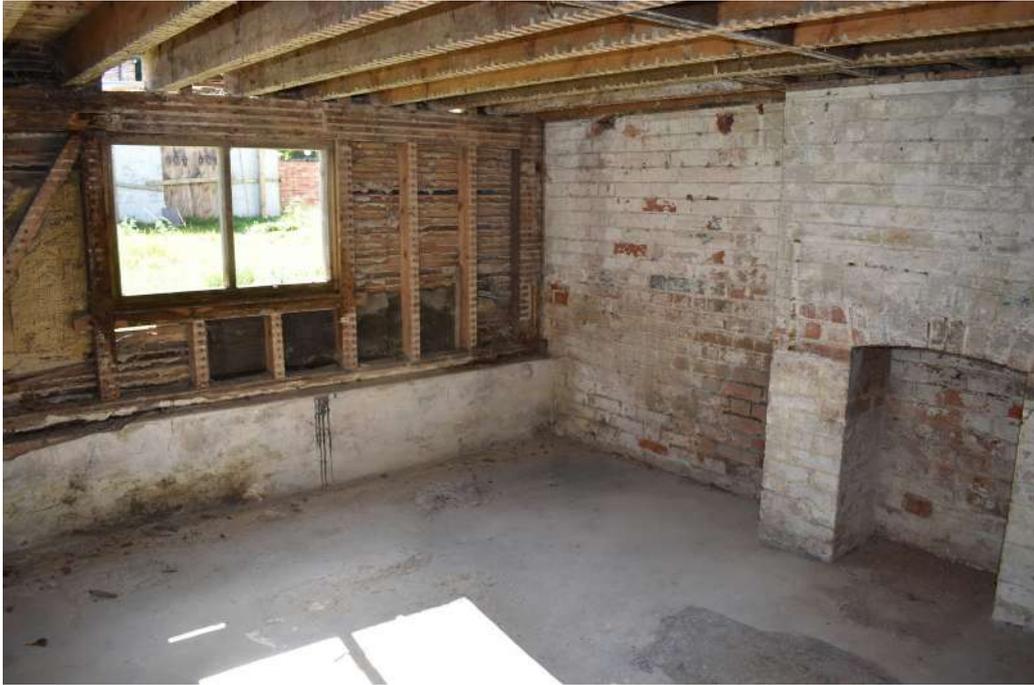
Room 5 is located within range 7. The floor is poured concrete. Three of the walls are timber-framed while the fourth is exposed red brick. The timber-frame comprises machine-cut wood with through-bracing. A brick fireplace, with an arched brick lintel, is located on the south-west wall. Two windows are present in room 5, one in the north-east wall and one in the south-east wall.

**Photograph 24** Interior of room 5. Photograph taken facing south.

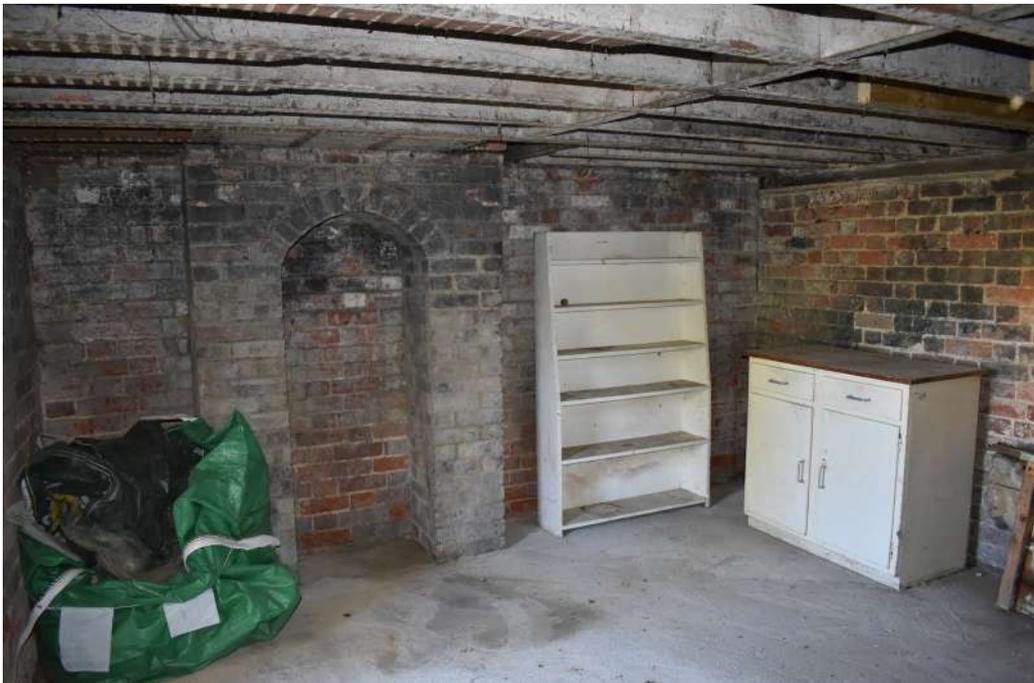
Room 6 is located in ground floor of range 6. All four walls of room 6 are exposed brick while the floor is poured concrete. The south-western brick wall is built on the stone plinth of range 4. A brick arch with two brick piers is located on the north-east wall, creating support for the fireplaces in the rooms above. On the opposite wall, a short length of wall projects into room 6. It comprises a mixture of red and yellow bricks laid in Stretcher bond and was probably inserted to offer support to the floor above. To the north-west of this wall is a blocked doorway. There is an opening, with iron bars, and a door in the north-west wall.

**Photograph 25** Interior of room 6. Photograph taken facing east.

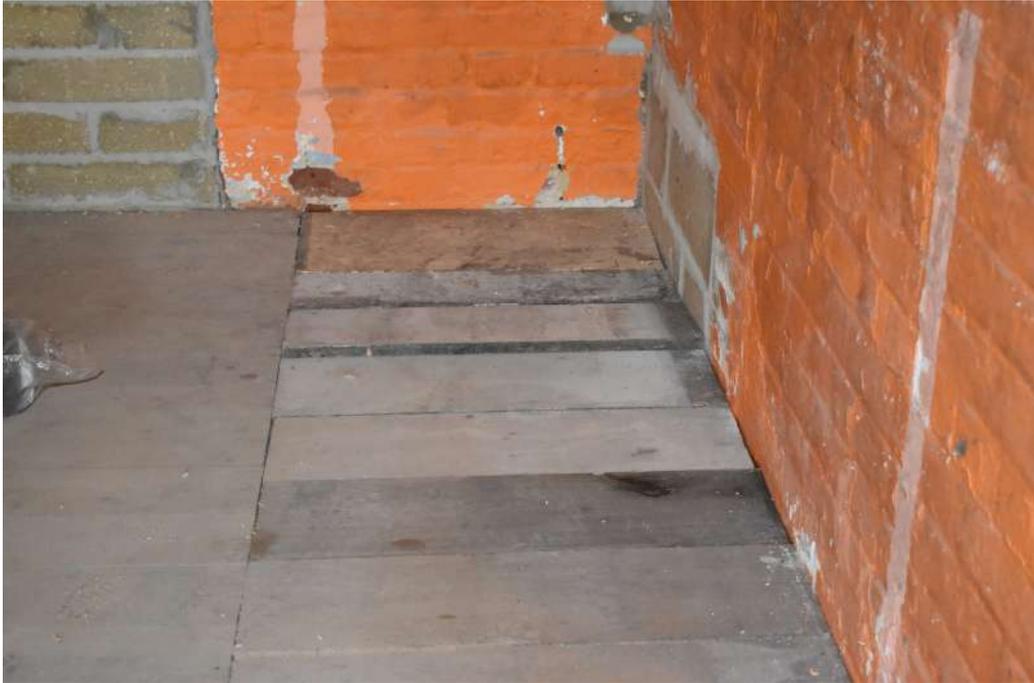
Room 7 is one of two rooms occupying the ground floor of range 5. The floor is mostly exposed timber floorboards, except in a small area adjacent to the north-west wall where it is laid with orange quarry tiles. In the southern corner of the room is a blocked

cellar entrance, evident in the floor and wall. A further blocked doorway and window are present in the south-east wall.

**Photograph 26** Detail of blocked cellar entrance. Photograph taken facing south.

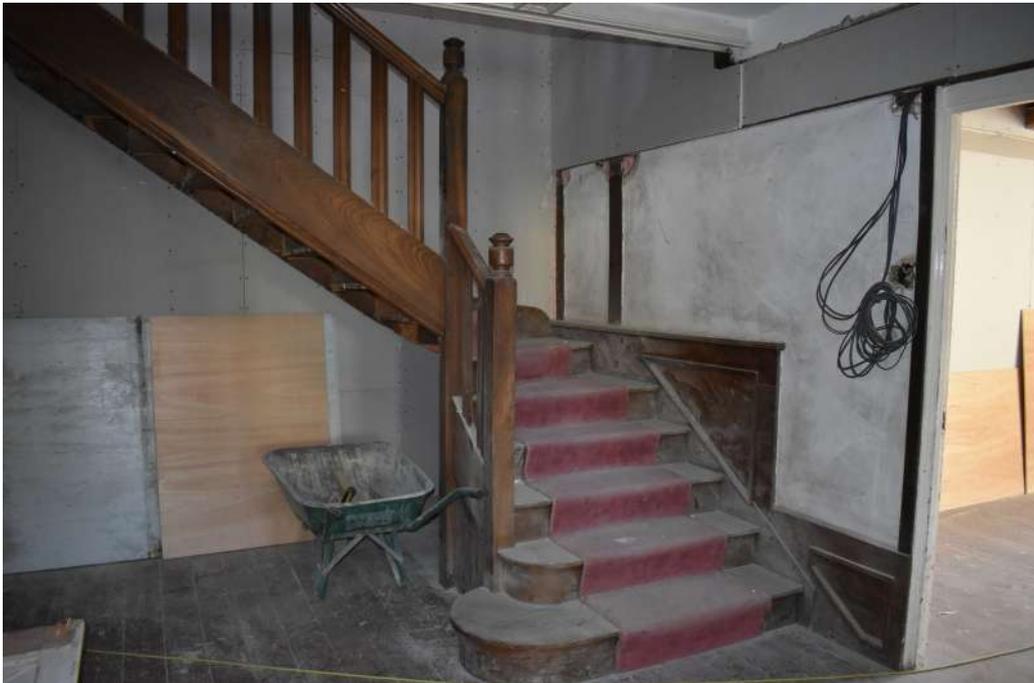
**Photograph 27** Detail of staircase in room 8. Photograph taken facing south.

In the southern corner of room 8 is an original winder timber staircase. The balusters are flat rectangles with a simple carved design, while the newel post is square and

topped with a variant of a ball finial. In the south-western wall are a series of timber-posts, a possible indication this wall was once open. The south-eastern wall of room 8 has been covered with modern plasterboard, which earlier plans indicate has blocked a doorway. There is a set of double doors in the north-west wall and a single door in the south-east wall.

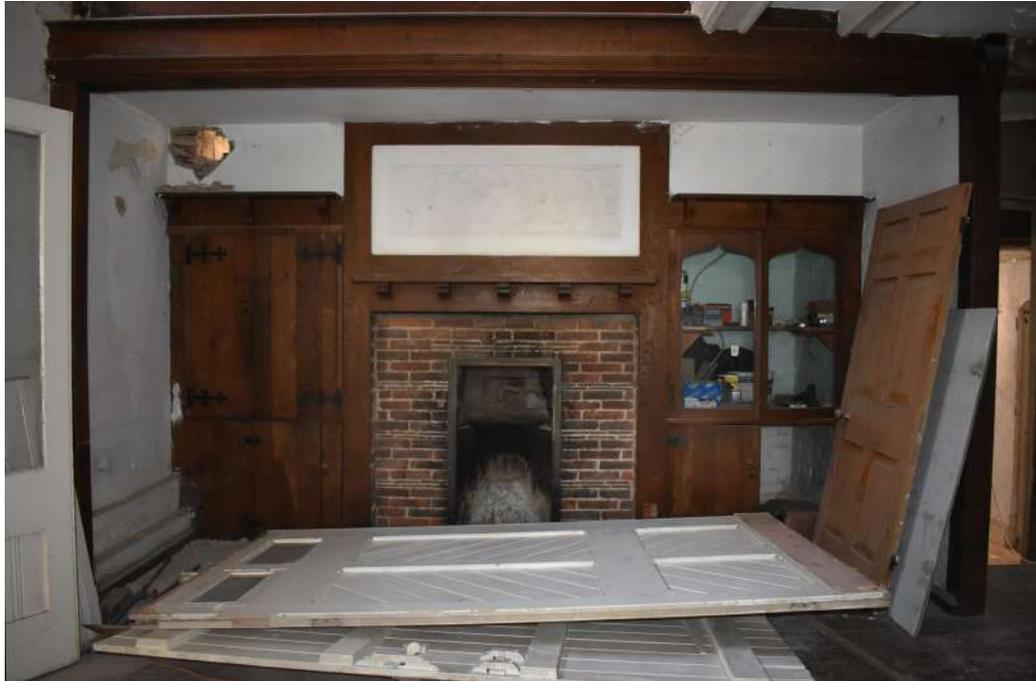
In the centre of the ground floor of Pond Mead resides the hall (room 8). Much of the floor above the hall is open, giving the room a double-height ceiling. The north-east wall is dominated by a brick fireplace, flanked by two in-built cupboards. The fireplace has a timber chimney-piece. The overmantle has been embellished with relief plasterwork in a wave-like pattern. The rest of the chimney-piece is relatively simple in design, with a timber mantle supported on lightly decorative brackets.

**Photograph 28** Detail of fireplace in room 8. Photograph taken facing north-east.

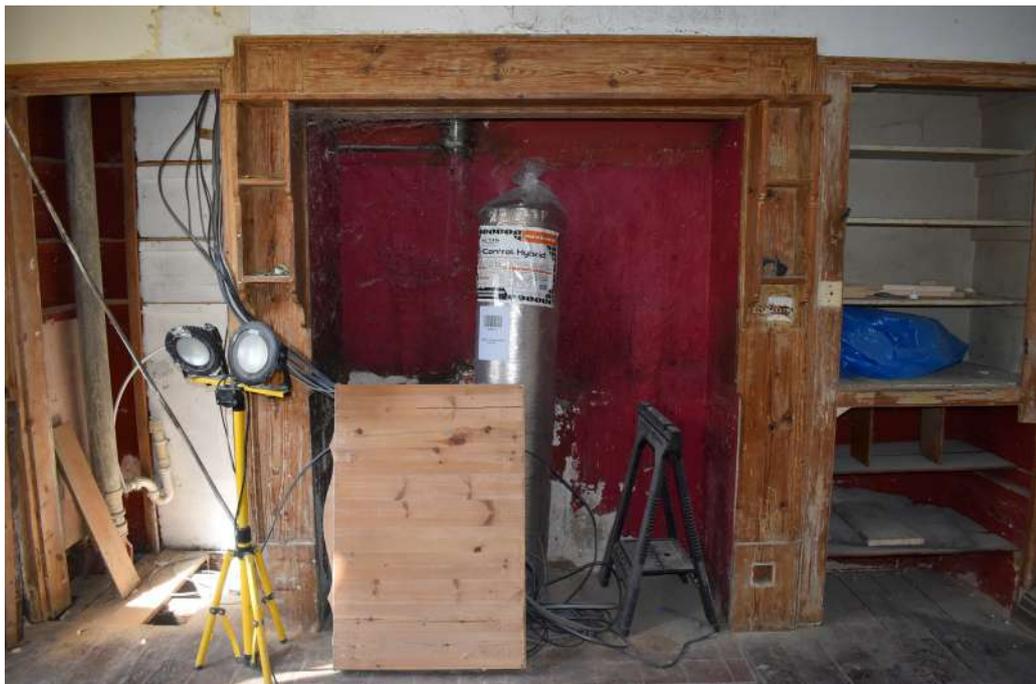
Room 9 is one of three rooms on the ground floor of range 3. The north-west wall is dominated by a large almost full-height fireplace, which, similarly to the fireplace in room 8, is flanked by two in-built cupboards. The size of the fireplace indicates it probably once housed a range cooker. It has a timber surround and a quarry-tile hearth. In the south-western wall is an inserted angled bay window. The south-eastern wall of room 9 is an inserted modern wall, dividing room 9 from room 11.

**Photograph 29** Detail of fireplace in room 9. Photograph taken facing north-west.

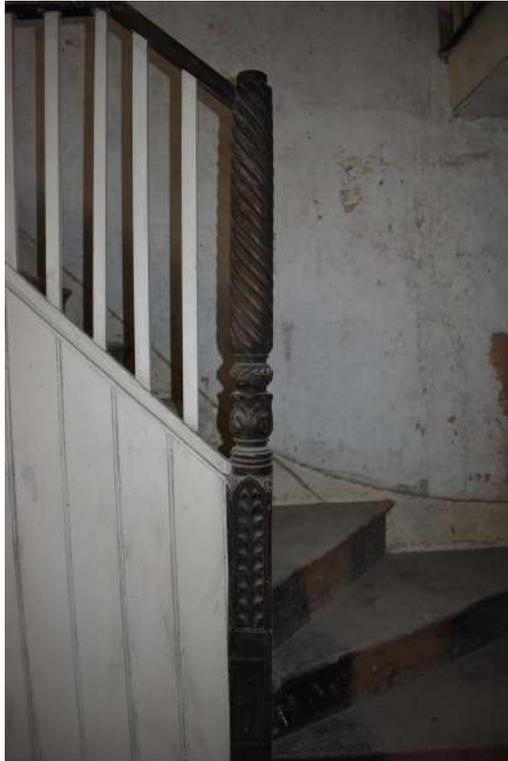
**Photograph 30** Detail of newel post on staircase in room 10. Photograph taken facing south-east.

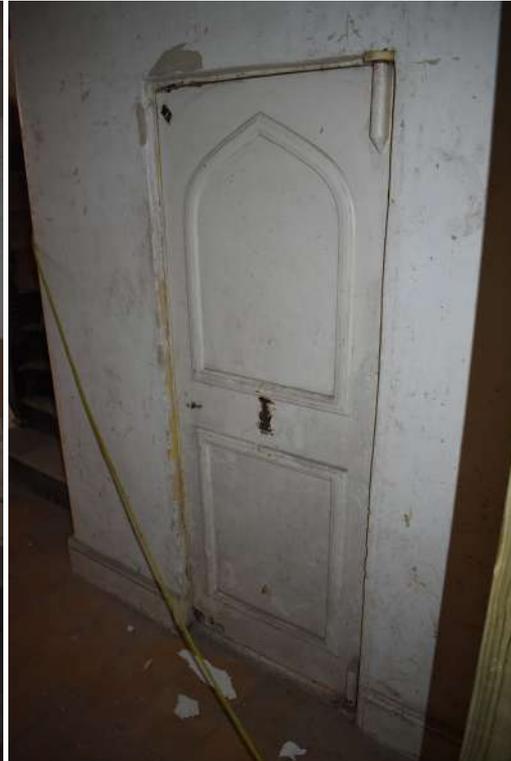
Room 10 is the second room that occupies the ground floor of range 5. The floor is laid with orange quarry tiles. In the southern corner of room 10 is an in-built safe, possibly a silver room but as it was locked the interior could not be recorded to confirm this. It has a heavy metal door with an arched panel design. Adjacent to the safe is original timber staircase, beneath which is a cupboard. The staircase has plain rectangular balusters with an intricately carved newel post. Against the north-eastern wall is a small inserted room. It has a four-panel door and a curved wall. There is a replacement window in the north-east wall.

**Photograph 31** Detail of safe in room 10. Photograph taken facing east.

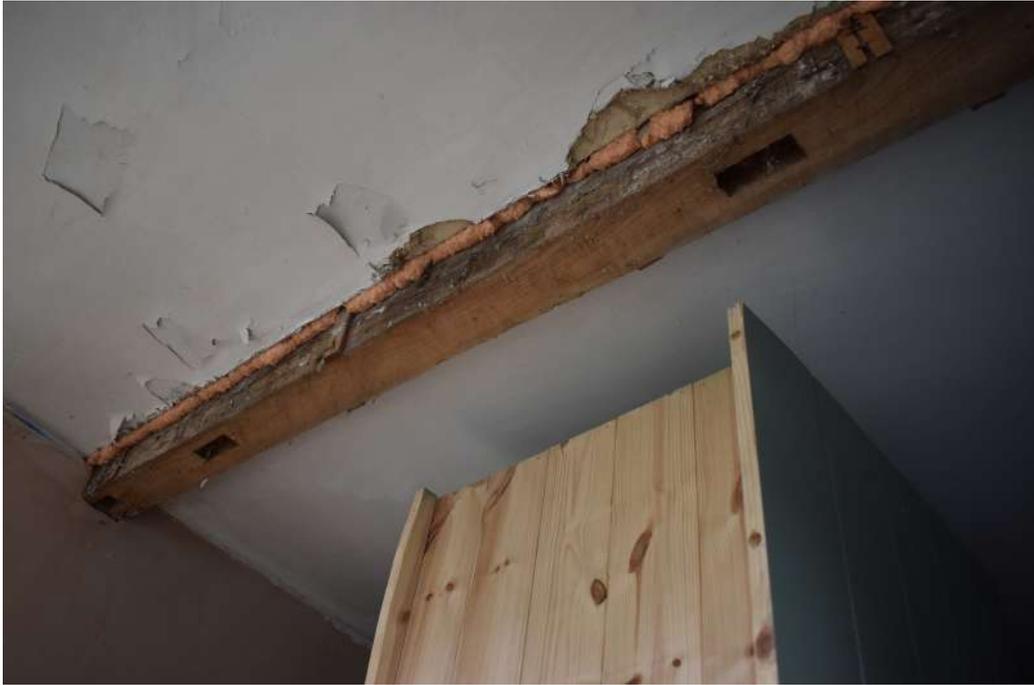
Room 11 is the middle of the three rooms in range 3. The insertion of a bay window in the south-western wall has exposed the wall-plate, complete with empty mortices from the removal of the studs in the timber-frame. The wall-plate comprises a machine-cut timber.

**Photograph 32** Detail of empty mortices in girding-beam above window in room 11. Photograph taken facing south-west.

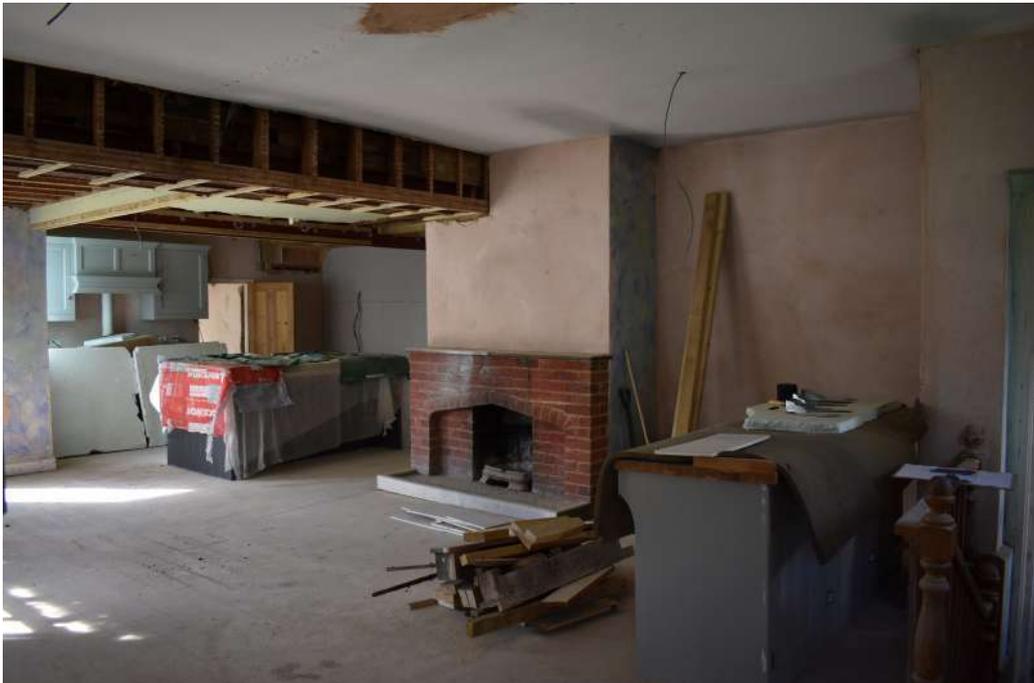
Room 12 occupies the ground floor of ranges 4, 9 and 10. A small flight of original stairs are present in the north-east of the room. They have plain square balusters and carved newel posts topped with acorn finials. A fireplace is located on the north-western wall, with a brick surround with '1830' carved into one of the bricks. The hearth is laid with bricks in a herringbone pattern and a simple grate is present in the opening. Windows are present in the north-eastern and south-eastern walls, three of which have leaded top windows. Double patio doors are present in the eastern wall, while a single-light door and a four-panel door are located in the south-western wall.

**Photograph 33** Interior of room 12. Photograph taken facing west.

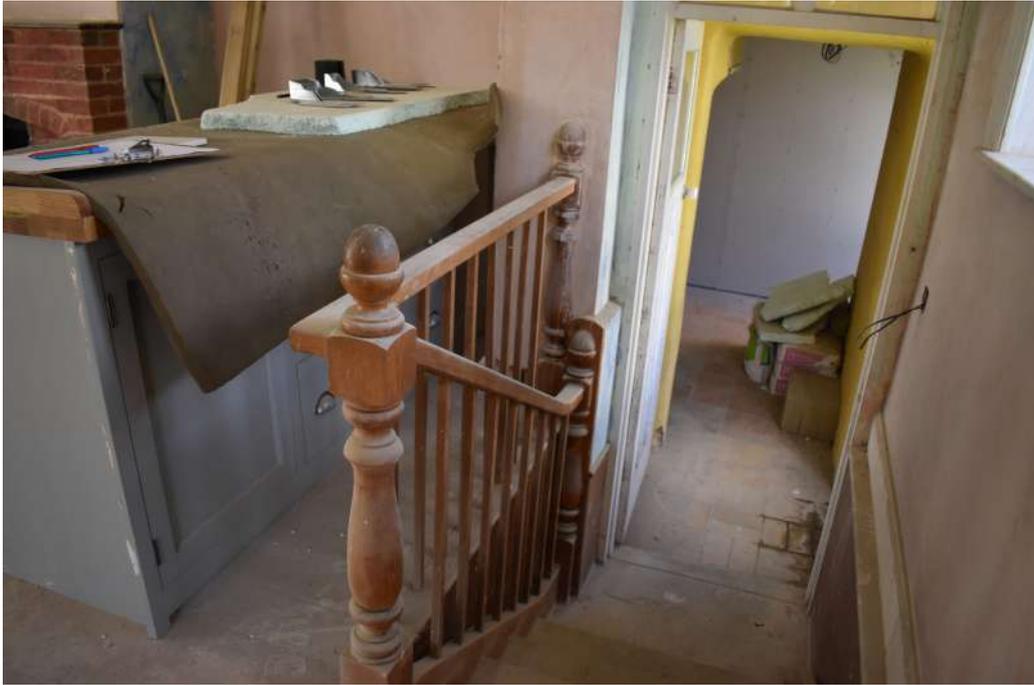
**Photograph 34** Detail of staircase with bannister and newel posts in room 12. Photograph taken facing north-west.

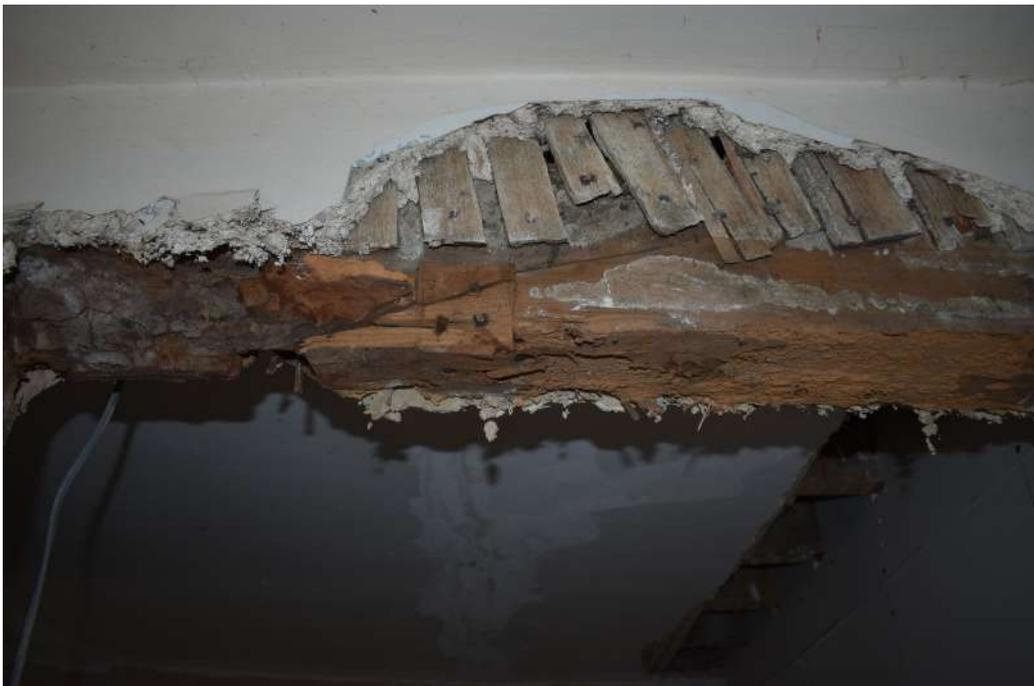
Room 13 is the last room in range 4. Against the south-eastern wall is a fireplace with a timber surround. The surround has six hand-painted tiles on either side of the opening and the phrase '*EAST-WEST-HOME'S-BEST*' carved below the mantel. A proverbial saying with origins in the mid 19th century expressing the idea that wherever you travel to, home is always the best place to be. An inserted bay window is present in south-west wall and a four-panel door in the south-east and north-east walls. The widening of a doorway in the north-western wall has revealed a splayed-scarf joint in a ceiling joist between rooms 11 and 13. The timber appears to be hand-sawn and crudely prepared as it still has bark on its underside.

**Photograph 35** Detail of splayed scarf-joint in girthing-beam in room 13. Photograph taken facing north-west.

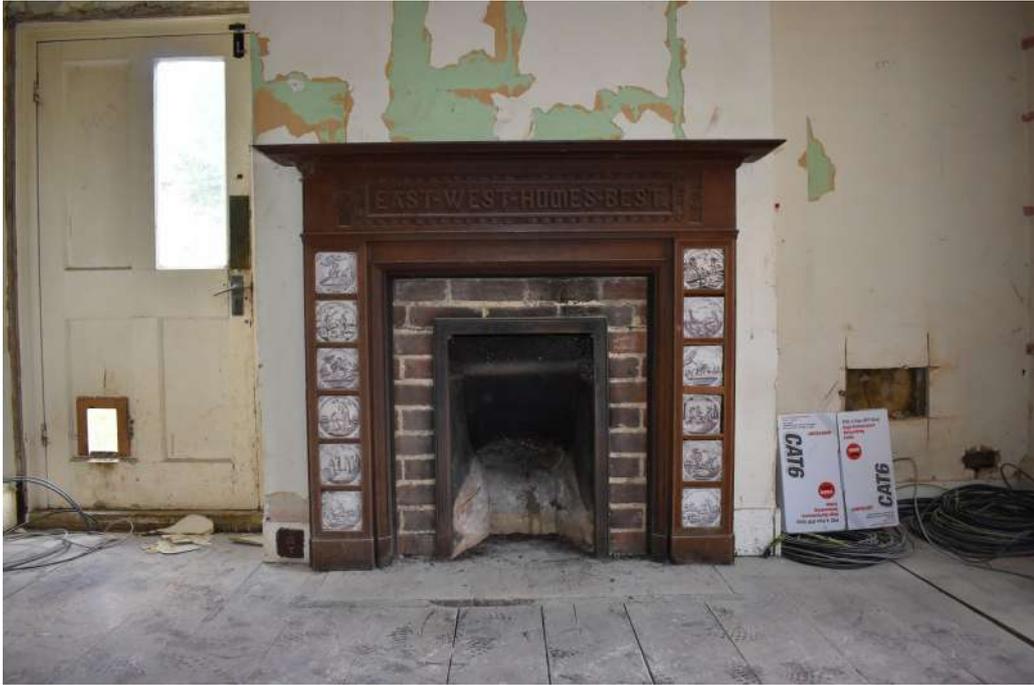
**Photograph 36** Detail of fireplace in room 13. Photograph taken facing south-east.

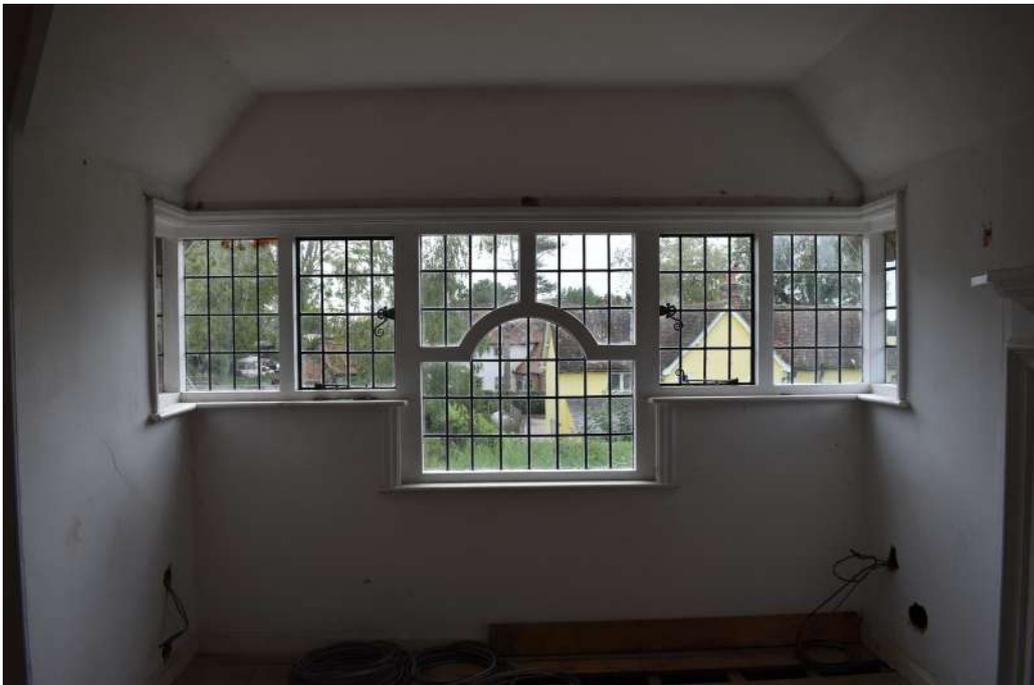
Occupying the first floor of range 2 are rooms 14 and 15. Room 14 has a fireplace in the north-eastern wall, with a timber and square brick surround. A window is present in the north-eastern and north-western walls, the north-western of which is a leaded corner window. There are in-built cupboards on the north-western wall and a four-panel door in the south-eastern wall. Room 15 has a four-panel door in the southern wall, a Crittall window in the north-western wall and recessed shelving unit in the south-eastern wall. A chimney breast is also present in the south-western wall.

**Photograph 37** Detail of window in room 14. Photograph taken facing north-west.

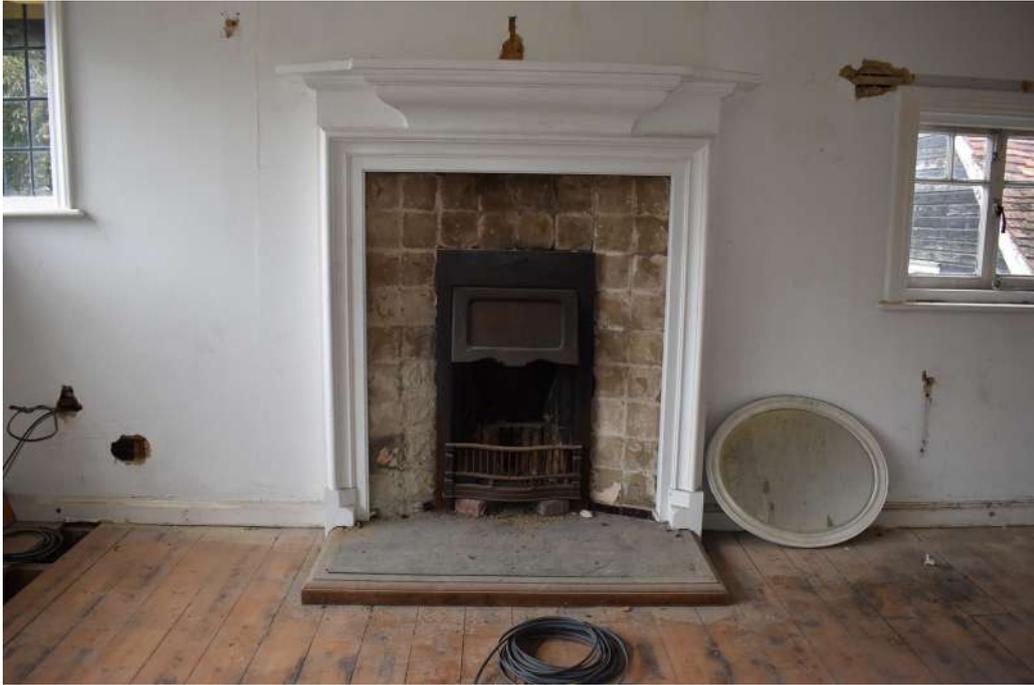
**Photograph 38** Detail of fireplace in room 14. Photograph taken facing north-east.

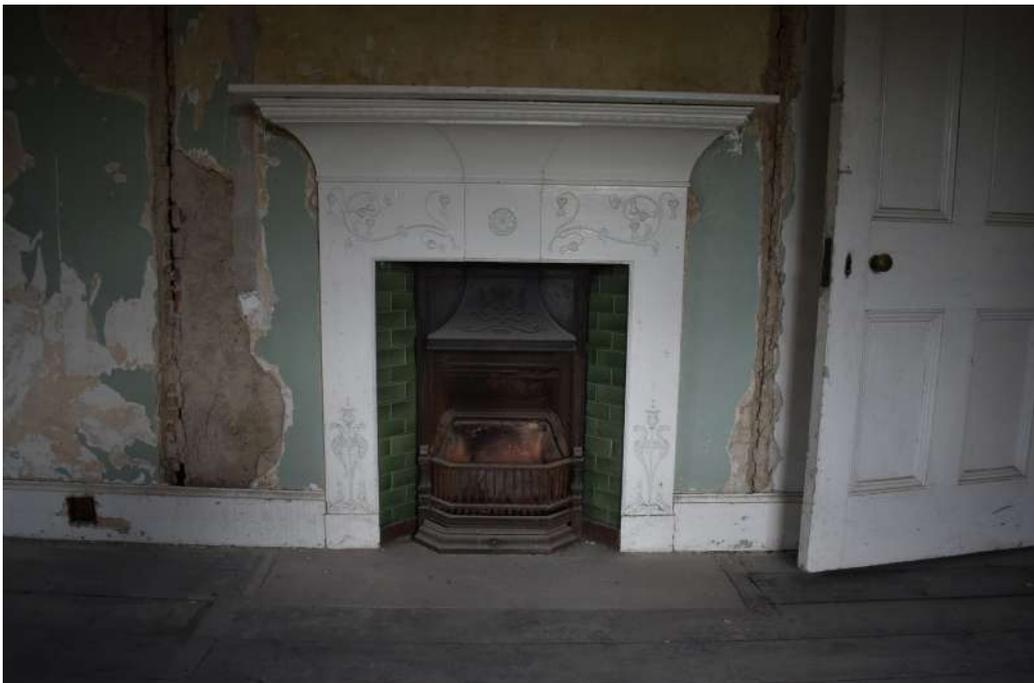
The first floor of range 1 is dominated by room 16. A fireplace is located in the north-eastern wall, which has a cast-iron surround with green tiles and a cast-iron grate. The surround has a simple floral design. Above the fireplace, removal of the wallpaper has revealed two sets of graffiti, one reads '*Papered March 9/1902 A Johns*' and the other '*papered by S. P. Leyerton 27/4/15*'. A full-height timber cupboard is located against the south-western wall. Two doors are present in room 16, a four-panel door in the north-eastern wall and a vertically-planked door in the south-eastern wall. A replacement window is located in the south-west and north-west walls. Several loose roof timbers were located in room 16 at the time of recording, these appeared to be hand-sawn and have a mixture of 'VII' and 'VIII' carpenter's marks.

**Photograph 39** Detail of fireplace in room 16. Photograph taken facing north-east.

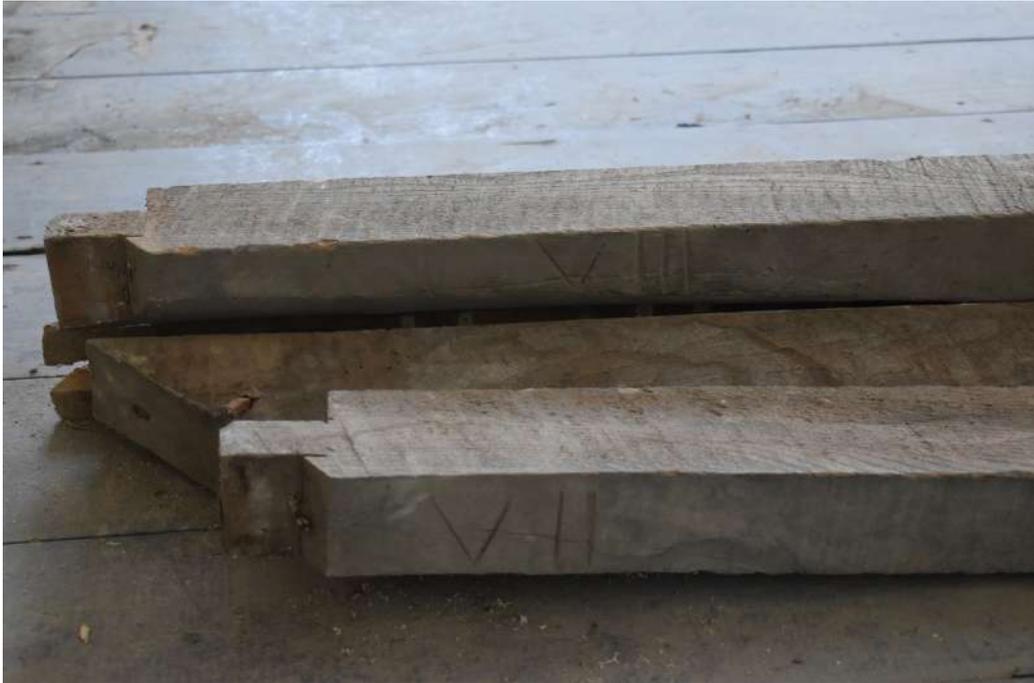
**Photograph 40** Detail of carpenter's marks on loose timbers in room 16.

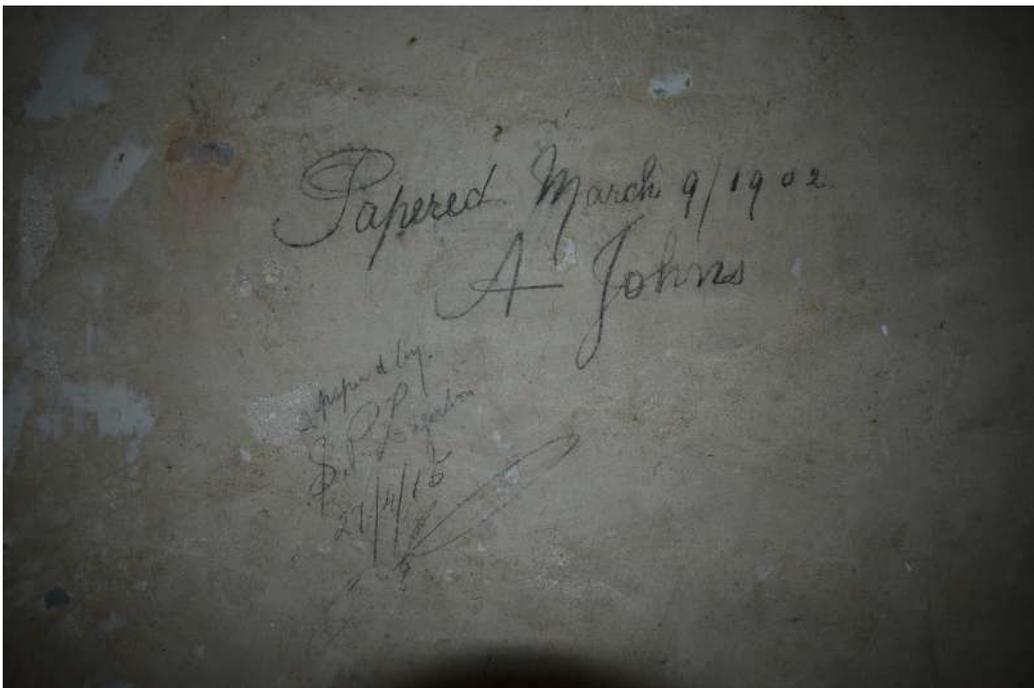
**Photograph 41** Detail of graffiti on wall in room 16. Photograph taken facing north-east.

Historic mapping shows that the building was then extended again between 1896 and 1919, giving the building its current layout. The graffiti recorded in room 16 implies a construction date of 1902 or earlier for range 1. As this range is also the only range that uses Stretcher bond for the plinth, as opposed to English and Flemish-bond used for the other plinths, this was probably the last addition to Pond Mead. The use of Stretcher bond is generally dated to the later 19th century and became the almost invariable choice for brick bonding from then on (Brunskill 1990).

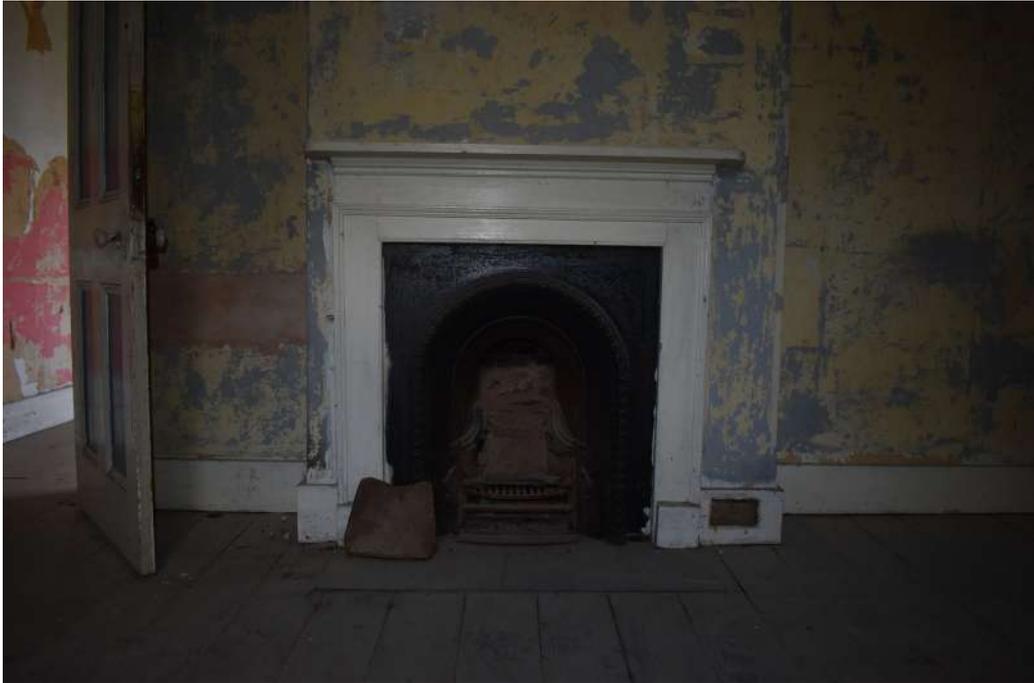
Rooms 17 and 18 reside in the first floor of ranges 6 and 7. Room 17 has a fireplace in the south-western wall, with a cast-iron surround, a replacement window in the north-eastern wall and a blocked window in the south-eastern wall. Room 18 also has a cast-iron fireplace, in the north-eastern wall, which has a simple floral design painted white and blue. Damage to the plaster has exposed the bricks of the south-eastern and south-western walls, including a brick arch above the doorway to rooms 19 and 20. There is a replacement window in the north-western wall and a horned-sash window in the south-eastern wall. A hand-sawn roof timber was located on the floor of room 18 at the time of recording, which had a 'XII' carpenter's mark. A four-panel door is present between rooms 17 and 18.

**Photograph 42** Detail of fireplace in room 17. Photograph taken facing south-west.

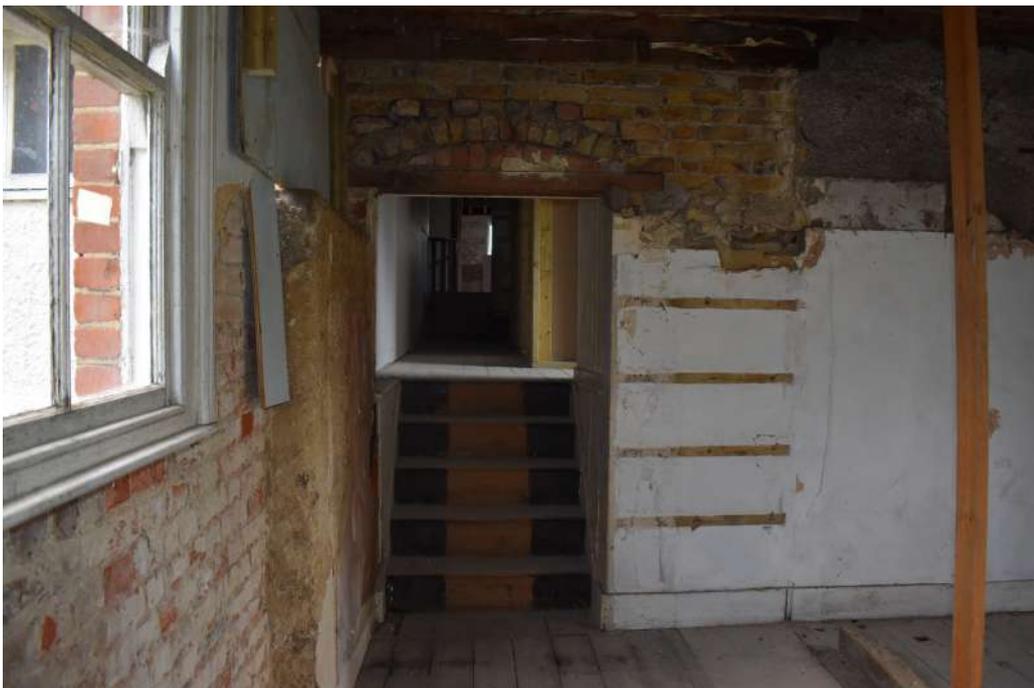
**Photograph 43** Detail of opening in room 18. Photograph taken facing south-west.

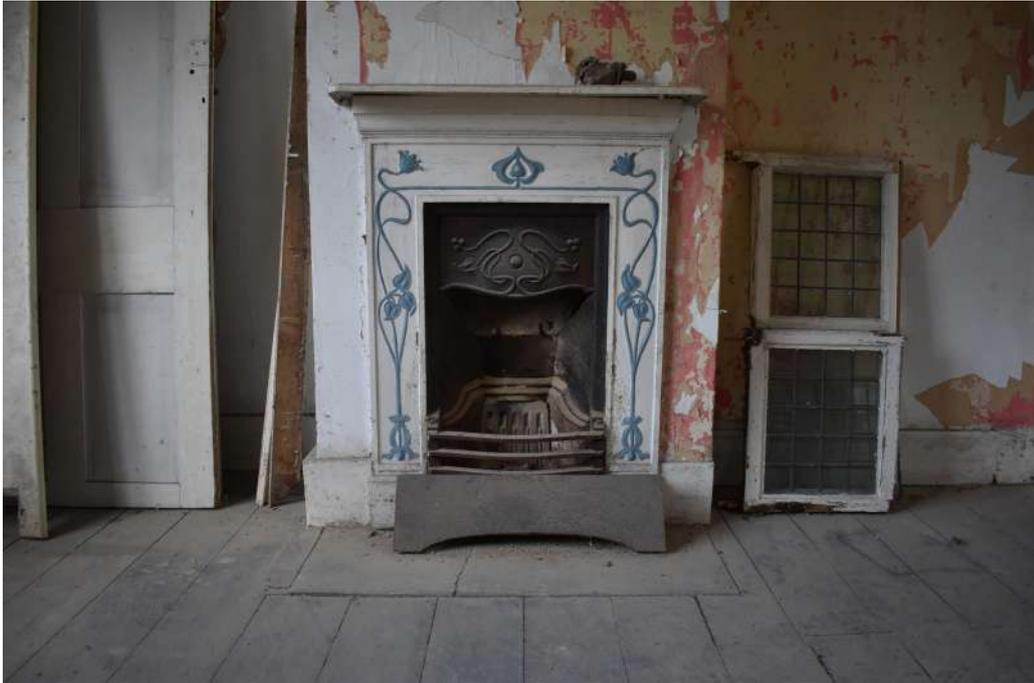
**Photograph 44** Detail of fireplace in room 18. Photograph taken facing north-east.

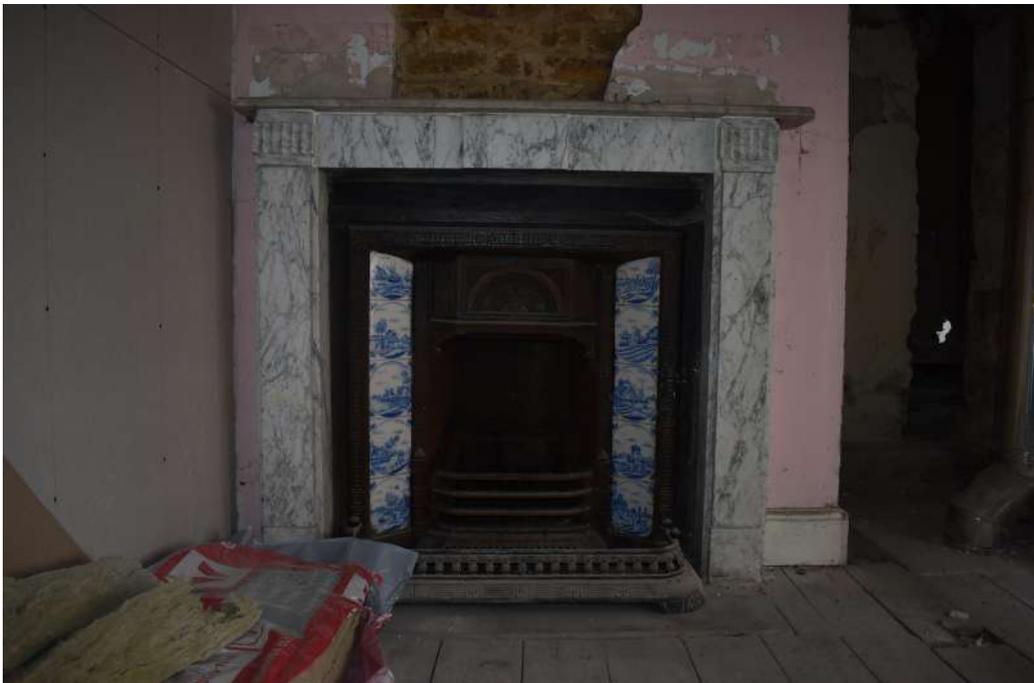
Room 19 is located in range 5, adjacent to room 20. A replacement window is located in the north-west wall as well as a roof light in the ceiling. Room 20 has a fireplace in the south-western wall, with a marble surround, blue and white painted tiles and a cast-iron grate. A window is present in the north-western wall and a dividing wall has been inserted, abutting the fireplace, to create a hallway adjacent to rooms 19 and 20.

**Photograph 45** Detail of fireplace in room 20. Photograph taken facing south-west.

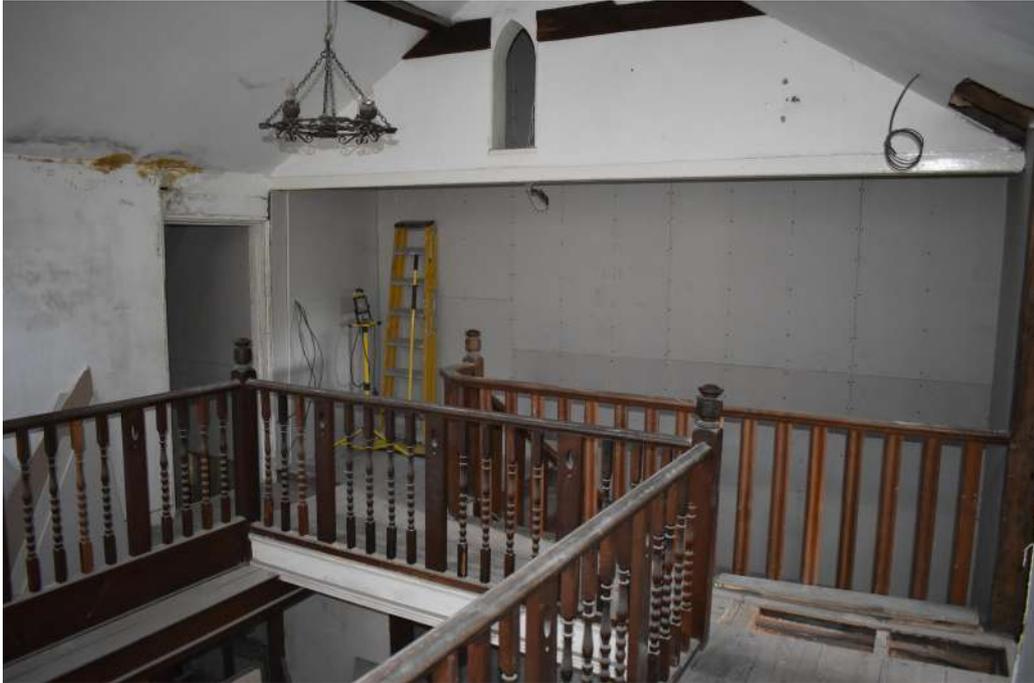
Room 21 is the main landing area on the first floor. Much of the floor is open, creating a balcony looking down into room 8. Surrounding the balcony is a timber balustrade comprising turned balusters, with intermittent rectangular posts, and newel posts in the same design as the staircase. In the north-western wall is a simple stained glass window, composed of colourless glass with glass in shades of yellow in a circular pattern. Above the stairwell, part of the roof truss has been filled in to create a wall.

Within the wall is a small arch-shaped opening and a small timber-door, blocked on one side.

**Photograph 46** Interior of room 21. Photograph taken facing east.

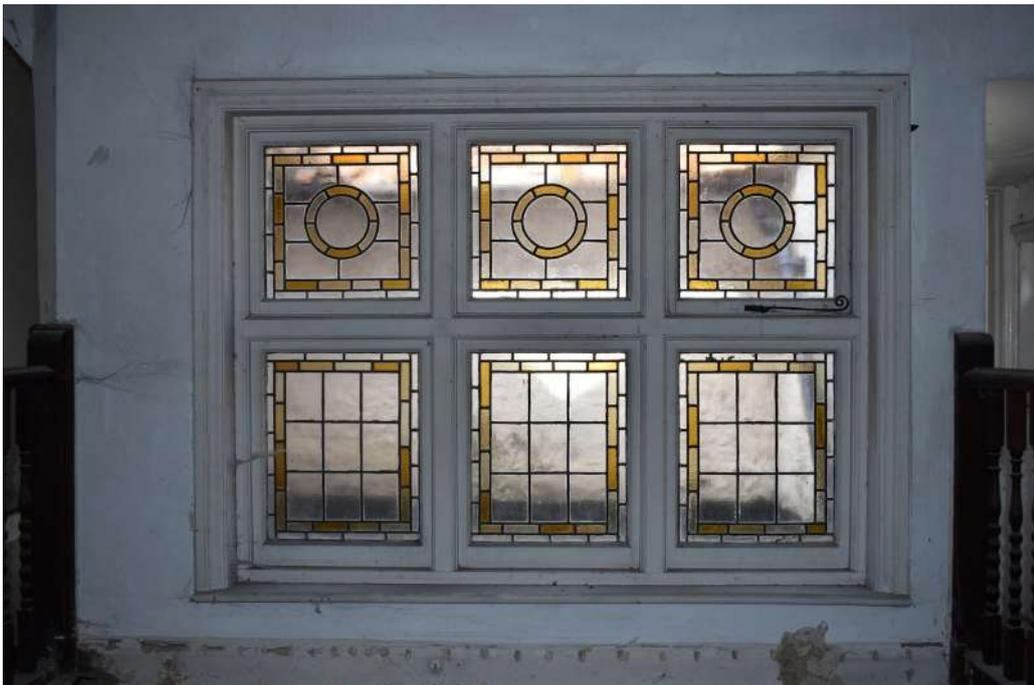
**Photograph 47** Detail of window in room 21. Photograph taken facing north-west.

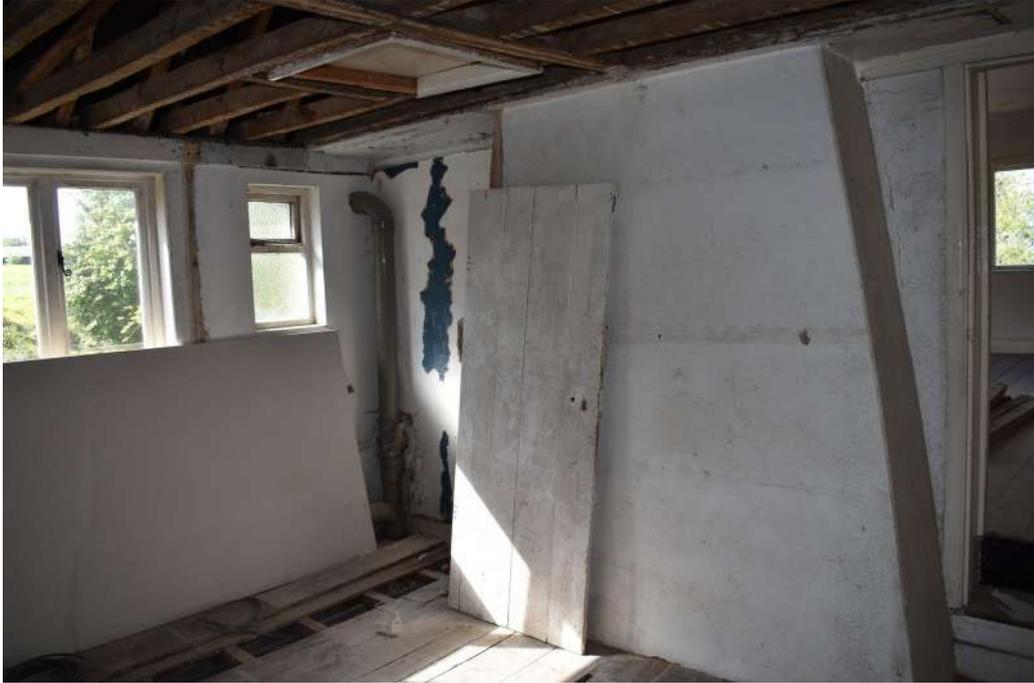
The first floor of range 3 comprises of 3 rooms, including room 22. There is a large chimney breast dominating the north-western wall and two replacement windows in the south-western wall. The doorway leading from room 21 has been inserted, as evidenced by an empty mortice in the joist above. The plaster of the ceiling of room 22 has been removed, exposing the roof structure above.

**Photograph 48** Interior of room 22. Photograph taken facing west.

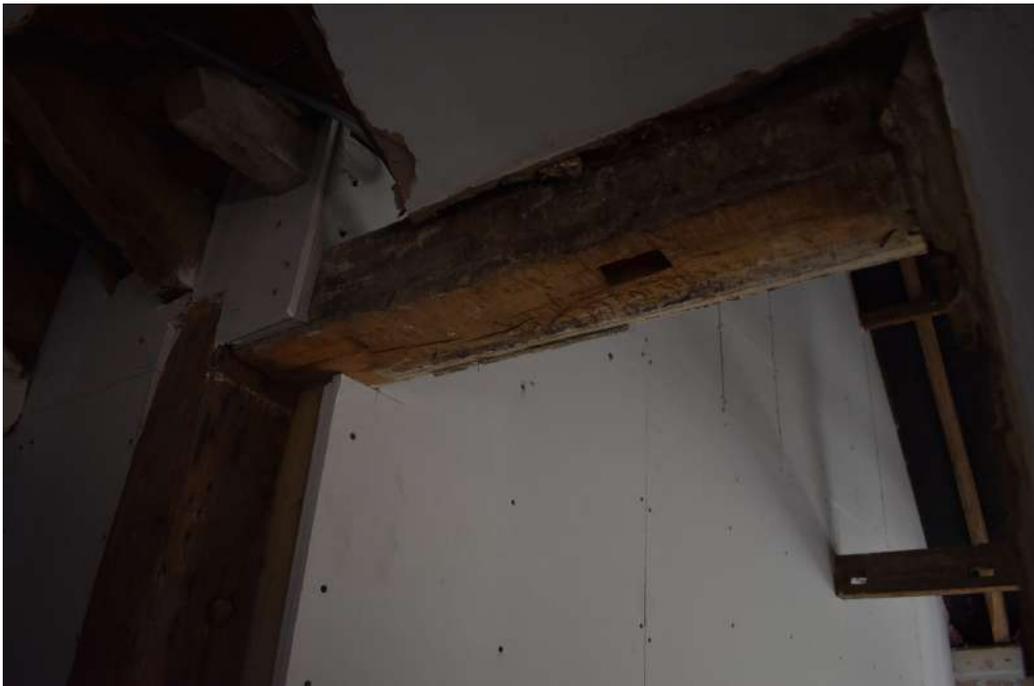
**Photograph 49** Detail of empty mortice in wall-plate in room 21. Photograph taken facing south-west.

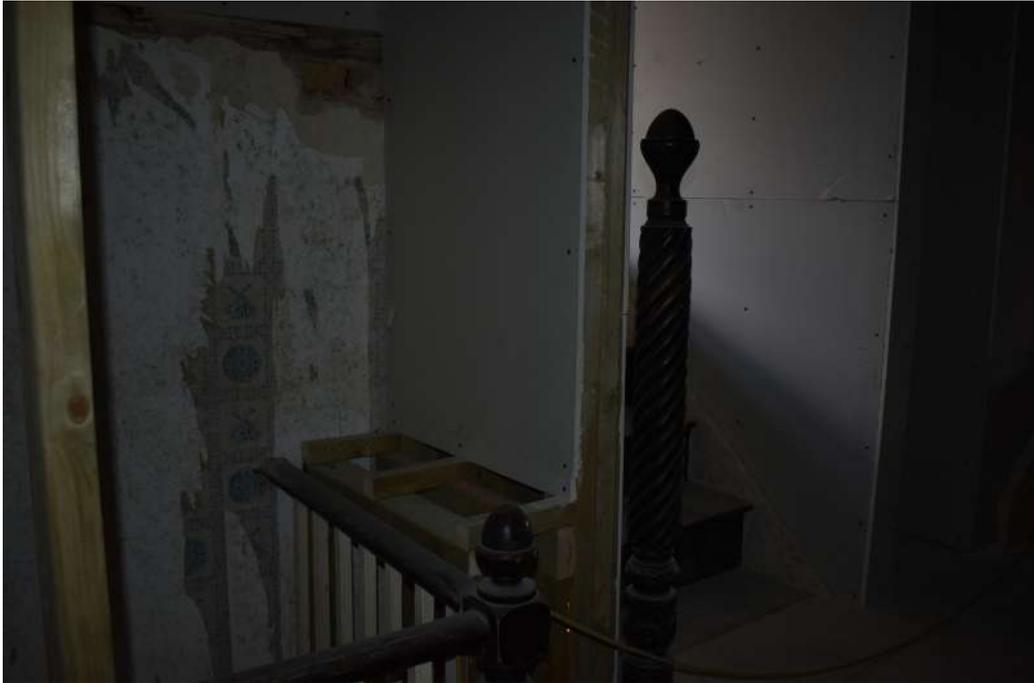
Room 23 is a hallway located in range 5. A timber balustrade is present around the stairs rising from room 10, it has simple rectangular balusters with carved newel posts topped with acorn finials. A small set of stairs, leading to room 25, have a newel post with a carved swirl design with an acorn finial. There is a replacement window in both the north-east and south-east walls. Three sets of modern timber stairs have been inserted into the hallway along with modern dividing walls.

**Photograph 50** Detail of newel posts in room 23. Photograph taken facing south.
