**CAT Report 1976  
issued November 2023**

**Historic building recording at Pond Mead,  
High Street, Widdington, Essex, CB11 3SB**

**CAT project ref.: 2023/09a  
ECC code: WDPM23**

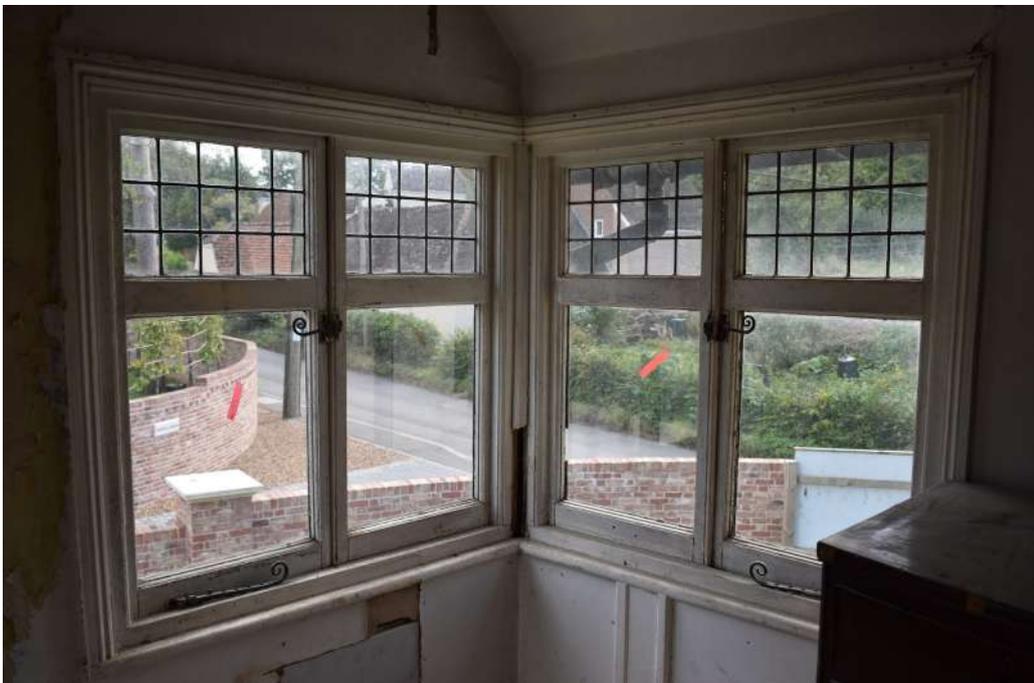
**Photograph 51** Detail of window in room 26. Photograph taken facing south.

Room 26 straddles the first floor of ranges 4 and 9. A fireplace is located on the north-eastern wall, adjacent to a blocked doorway. The fireplace has a timber surround with navy blue tiles. There are two corner windows in room 26, one on the eastern corner of the room and the other on the southern corner, both of which have leaded upper

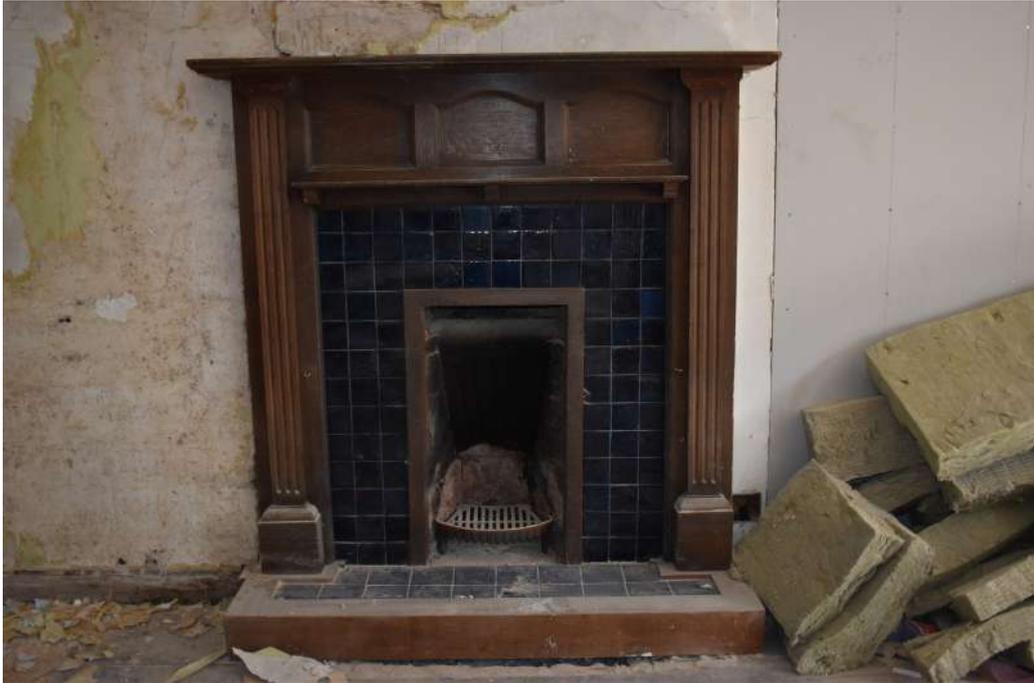
**Photograph 52** Detail of fireplace in room 26. Photograph taken facing north-east.

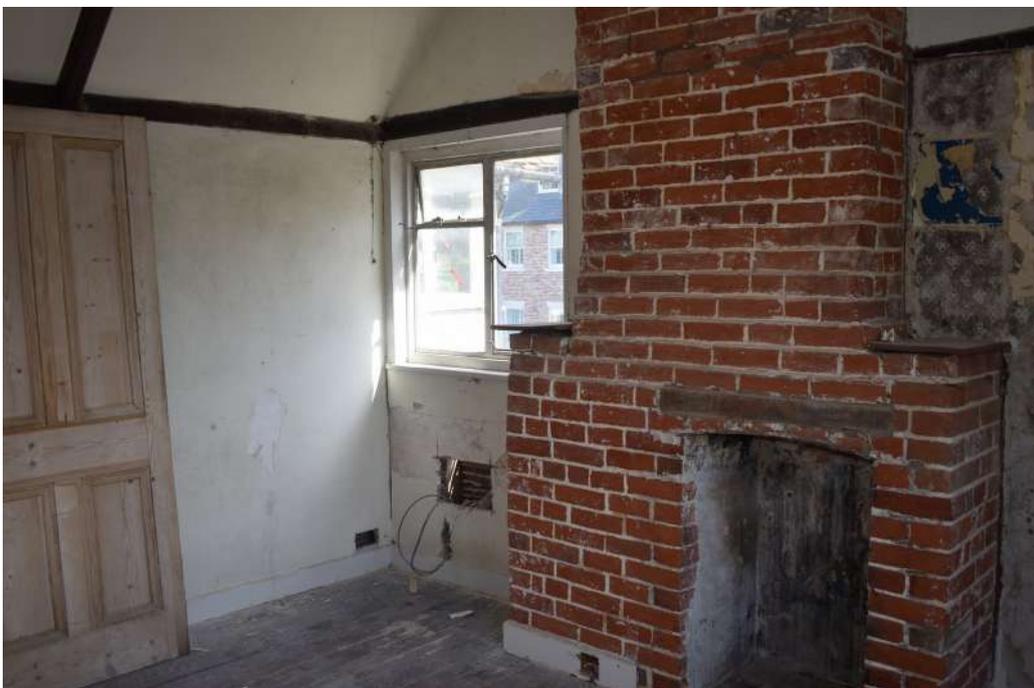
Room 27, the last room in range 3, has a brick-built fireplace on the south-eastern wall, it is simple in design with a tiled hearth and timber lintel. The ceiling of room 27 is high and has exposed rafters and collars, There are three replacement windows, one in the south-east wall and two in the south-west wall.

**Photograph 53** Interior of room 27. Photograph taken facing east.

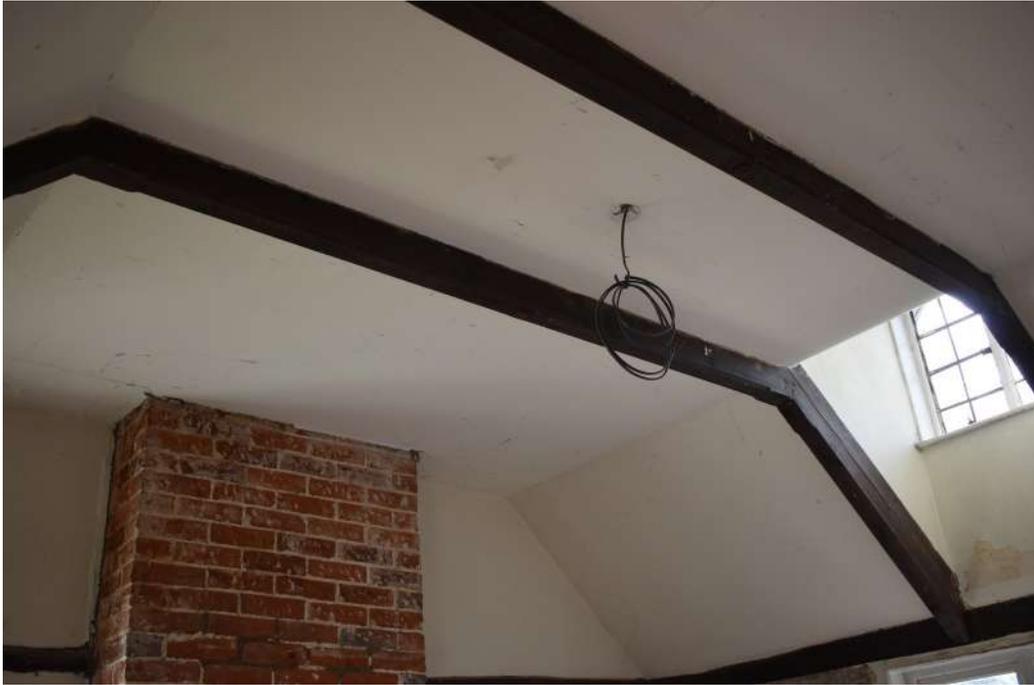
**Photograph 54** Detail of exposed roof structure in room 27. Photograph taken facing south.

Most of the roof structure was inaccessible at the time of recording but from what could be observed much of the roof appears to be constructed from pairs of rafters, rising from the wall-plates, to meet at a ridge-board at the apex of the roof. A single purlin is present on each roof pitch, clasped by a collar. The roof structure recording in range 3 also has diagonal through-bracing. The timbers used comprise a combination of hand-sawn and machine-cut with no obvious signs of reused.

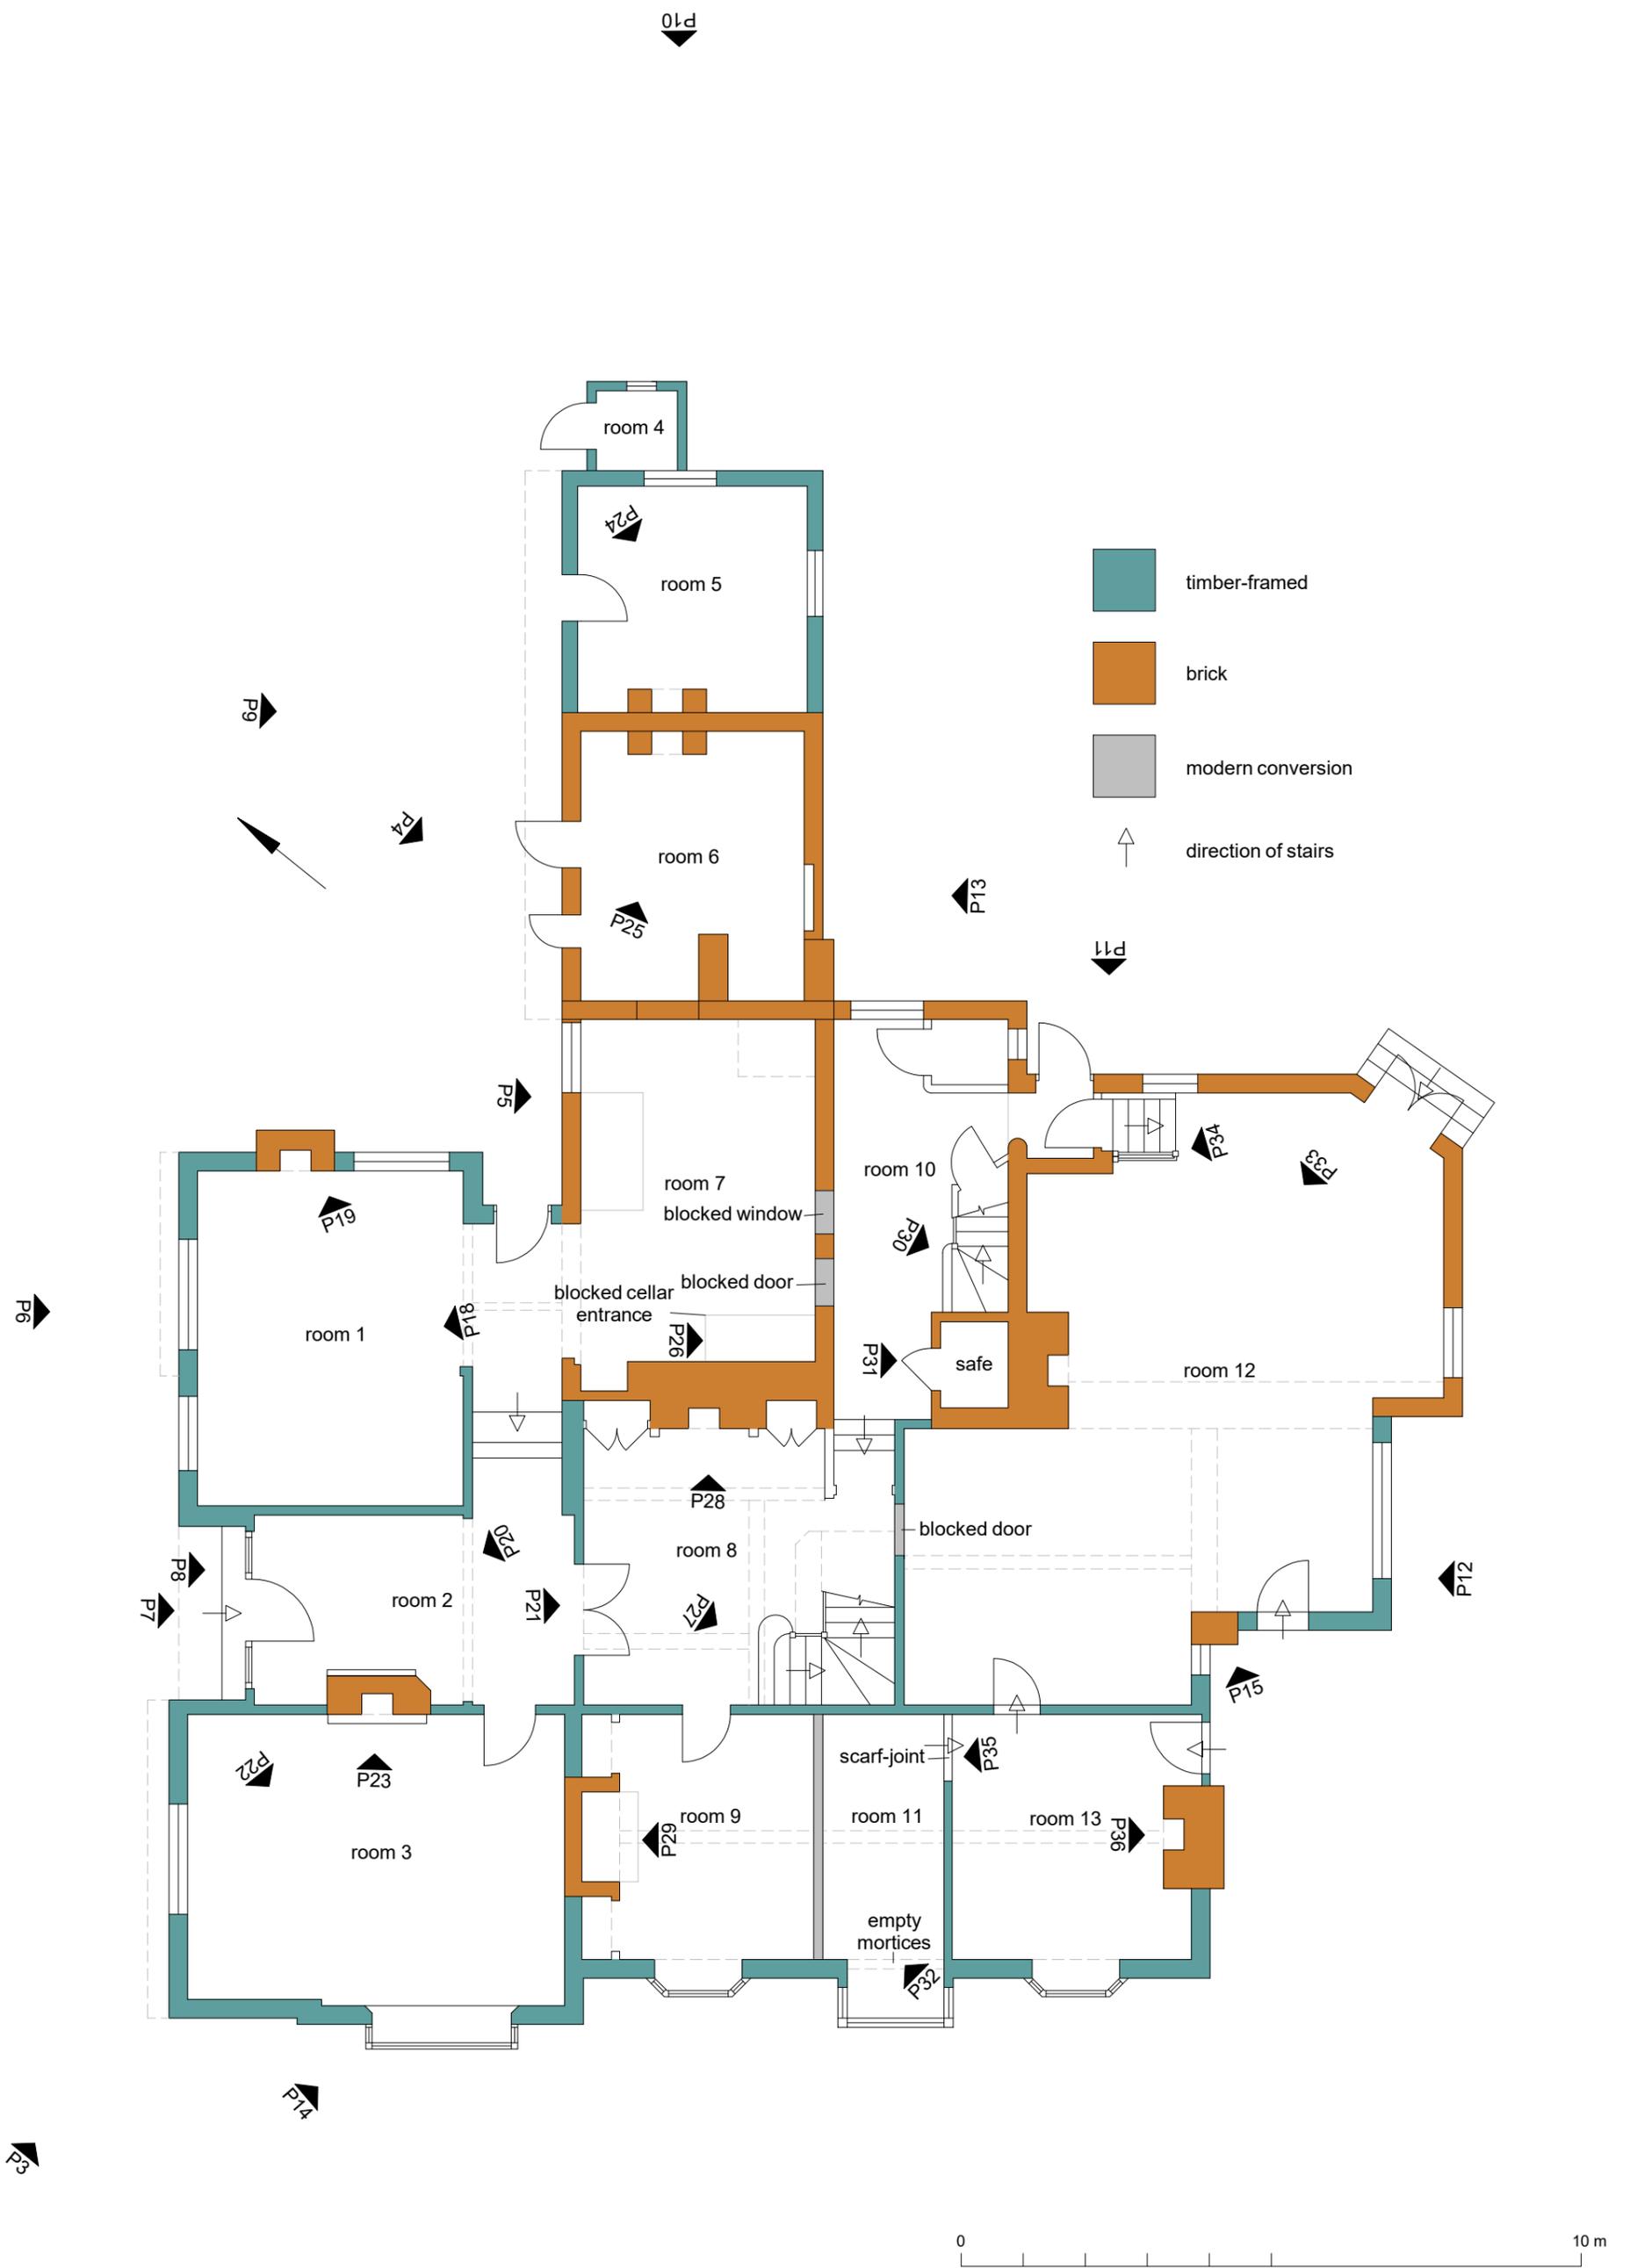
Fig 3 Ground floor plan. Location and direction of photographs reproduced in the text shown.

Almost thirty rooms, over two floors, were recorded at Pond Mead, which have been assigned individual room numbers (see Figs 3&4). Some conversion work had started to take place prior to the building recording, including the insertion of dividing walls.

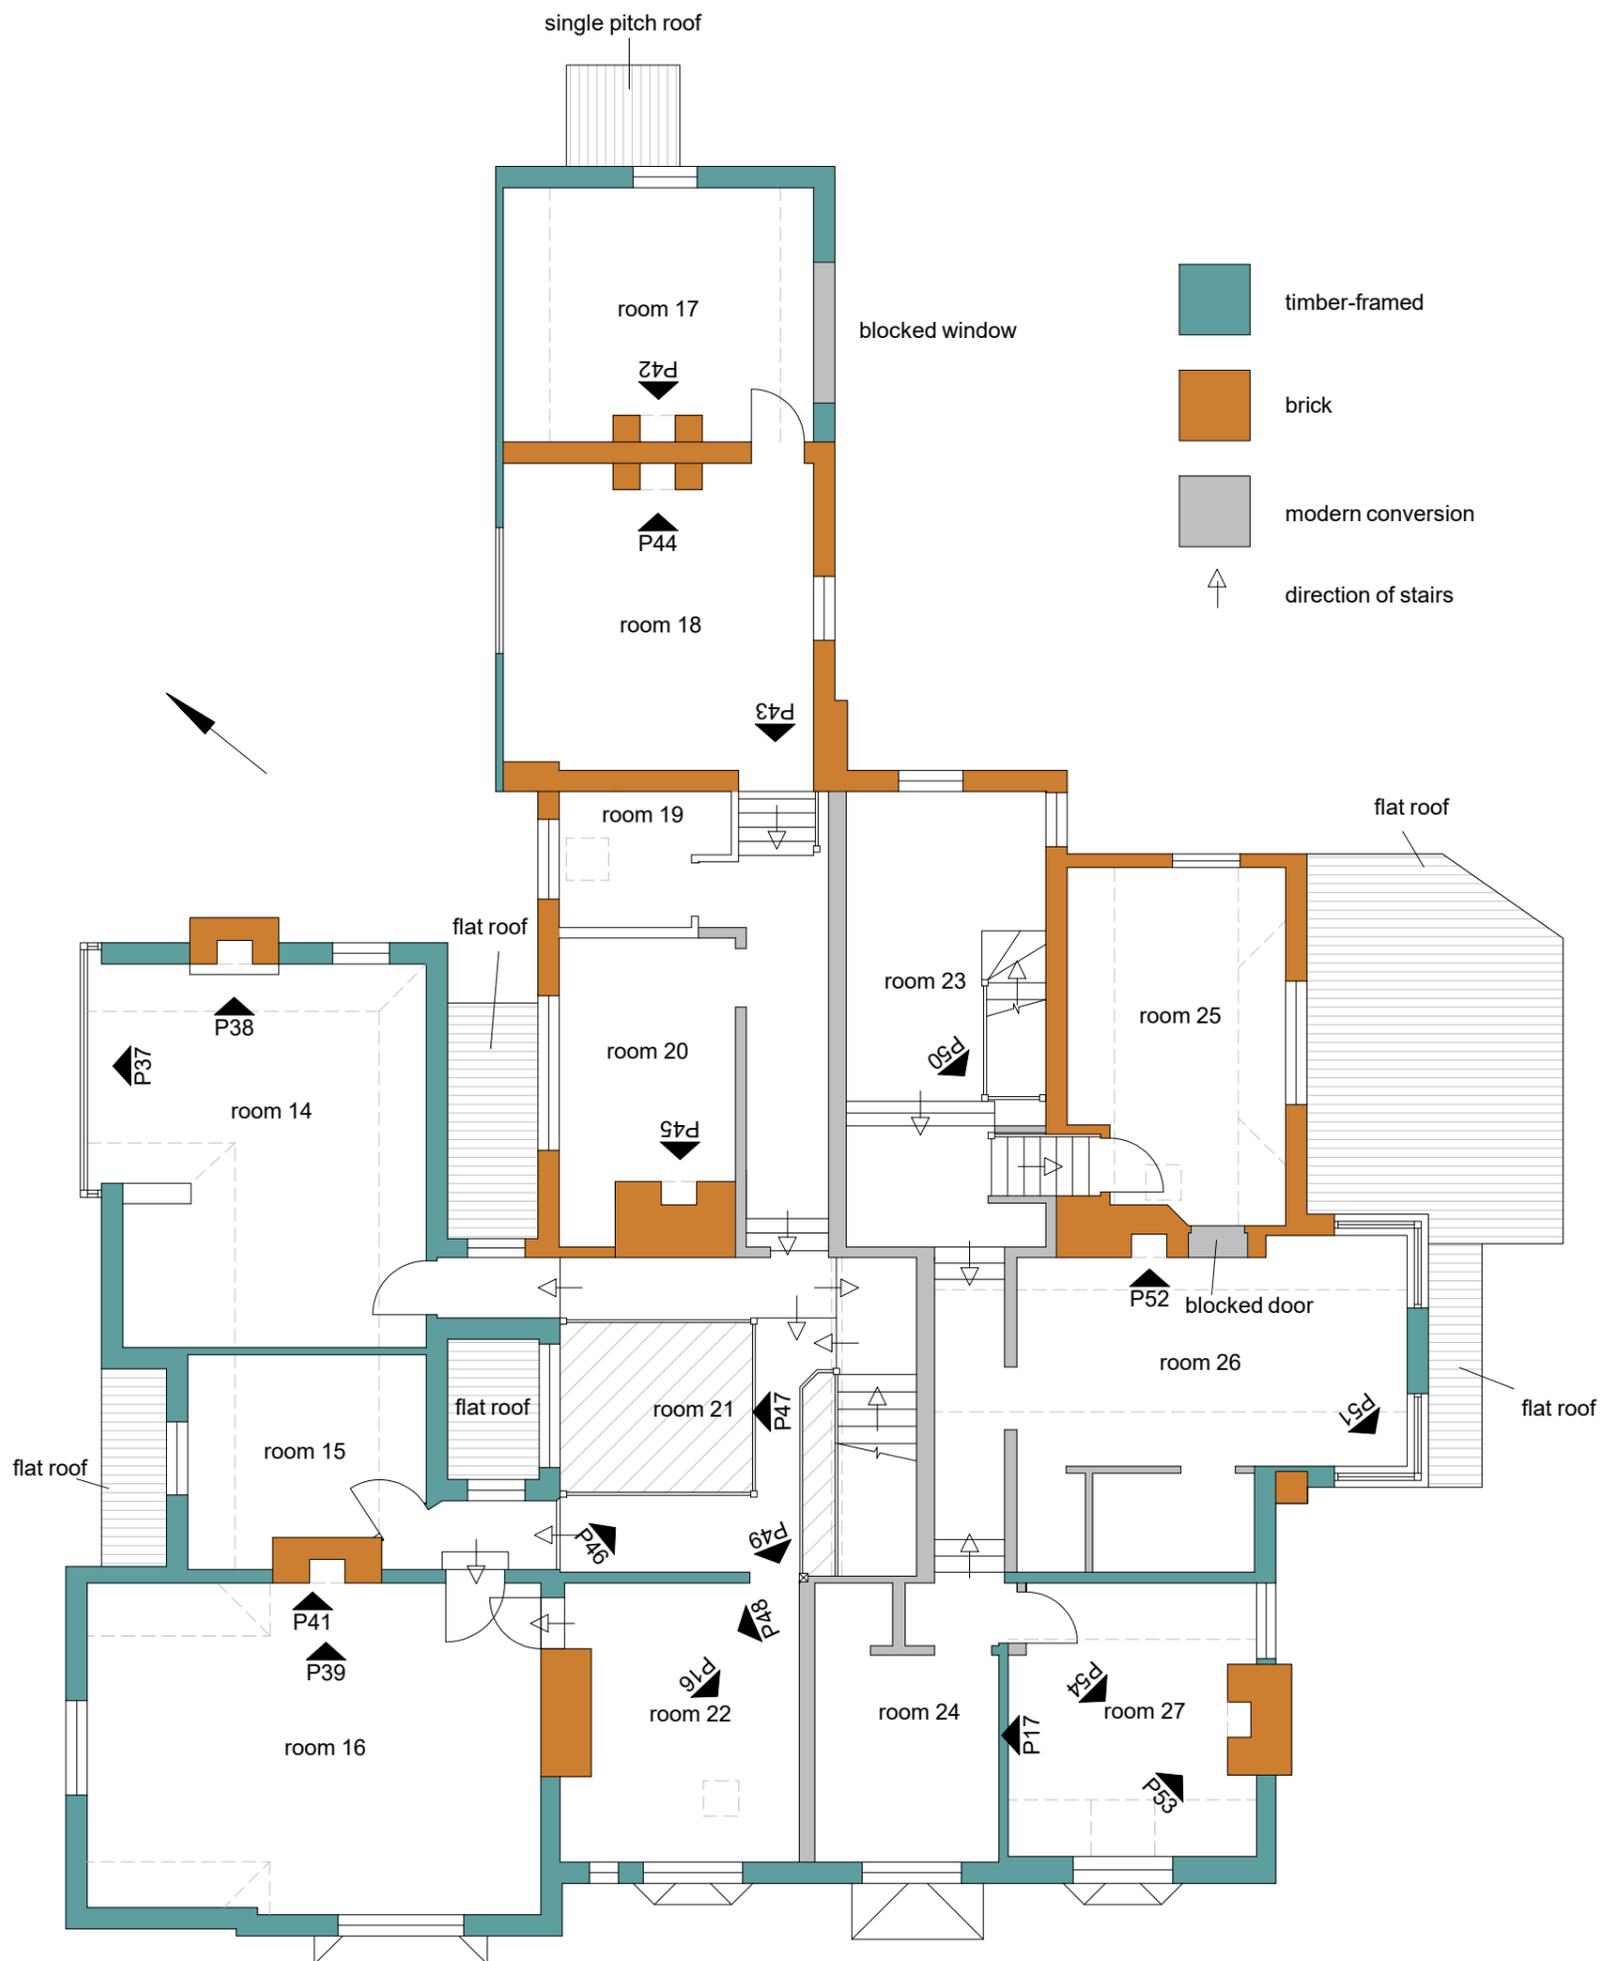
Fig 4 First floor plan. Location and direction of photographs reproduced in the text shown.

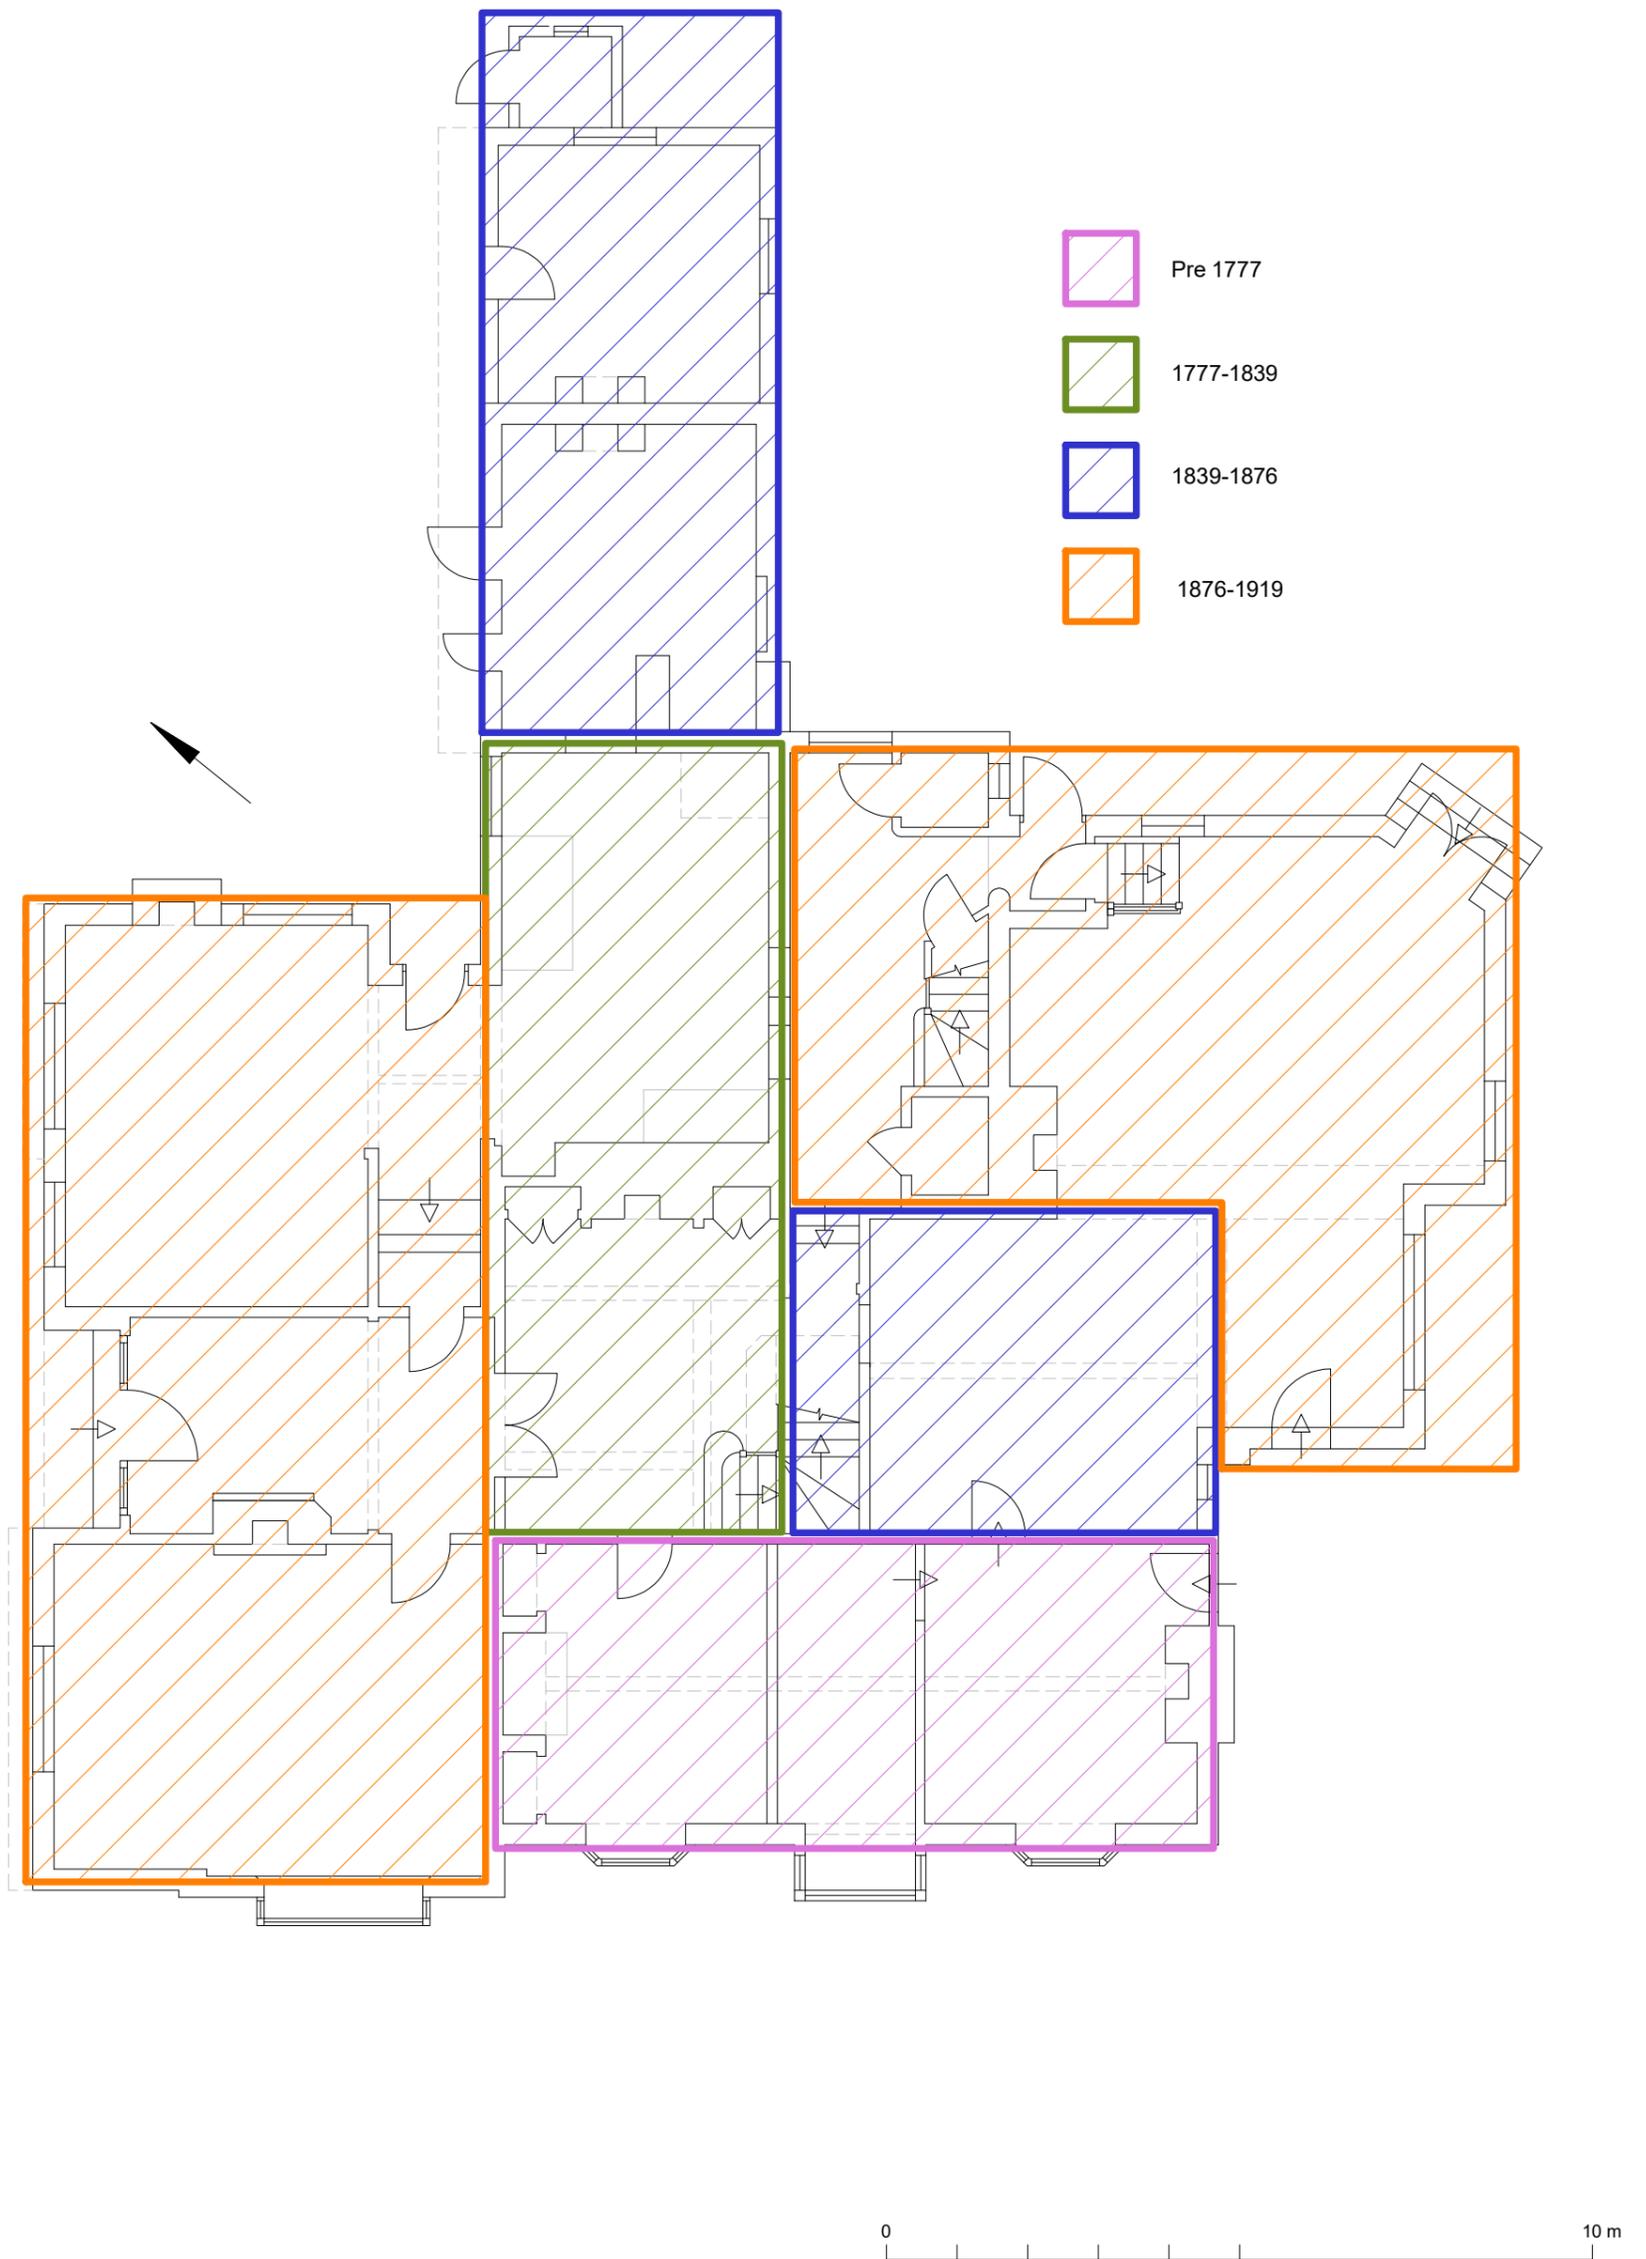
Fig 5 Phased floor plan.

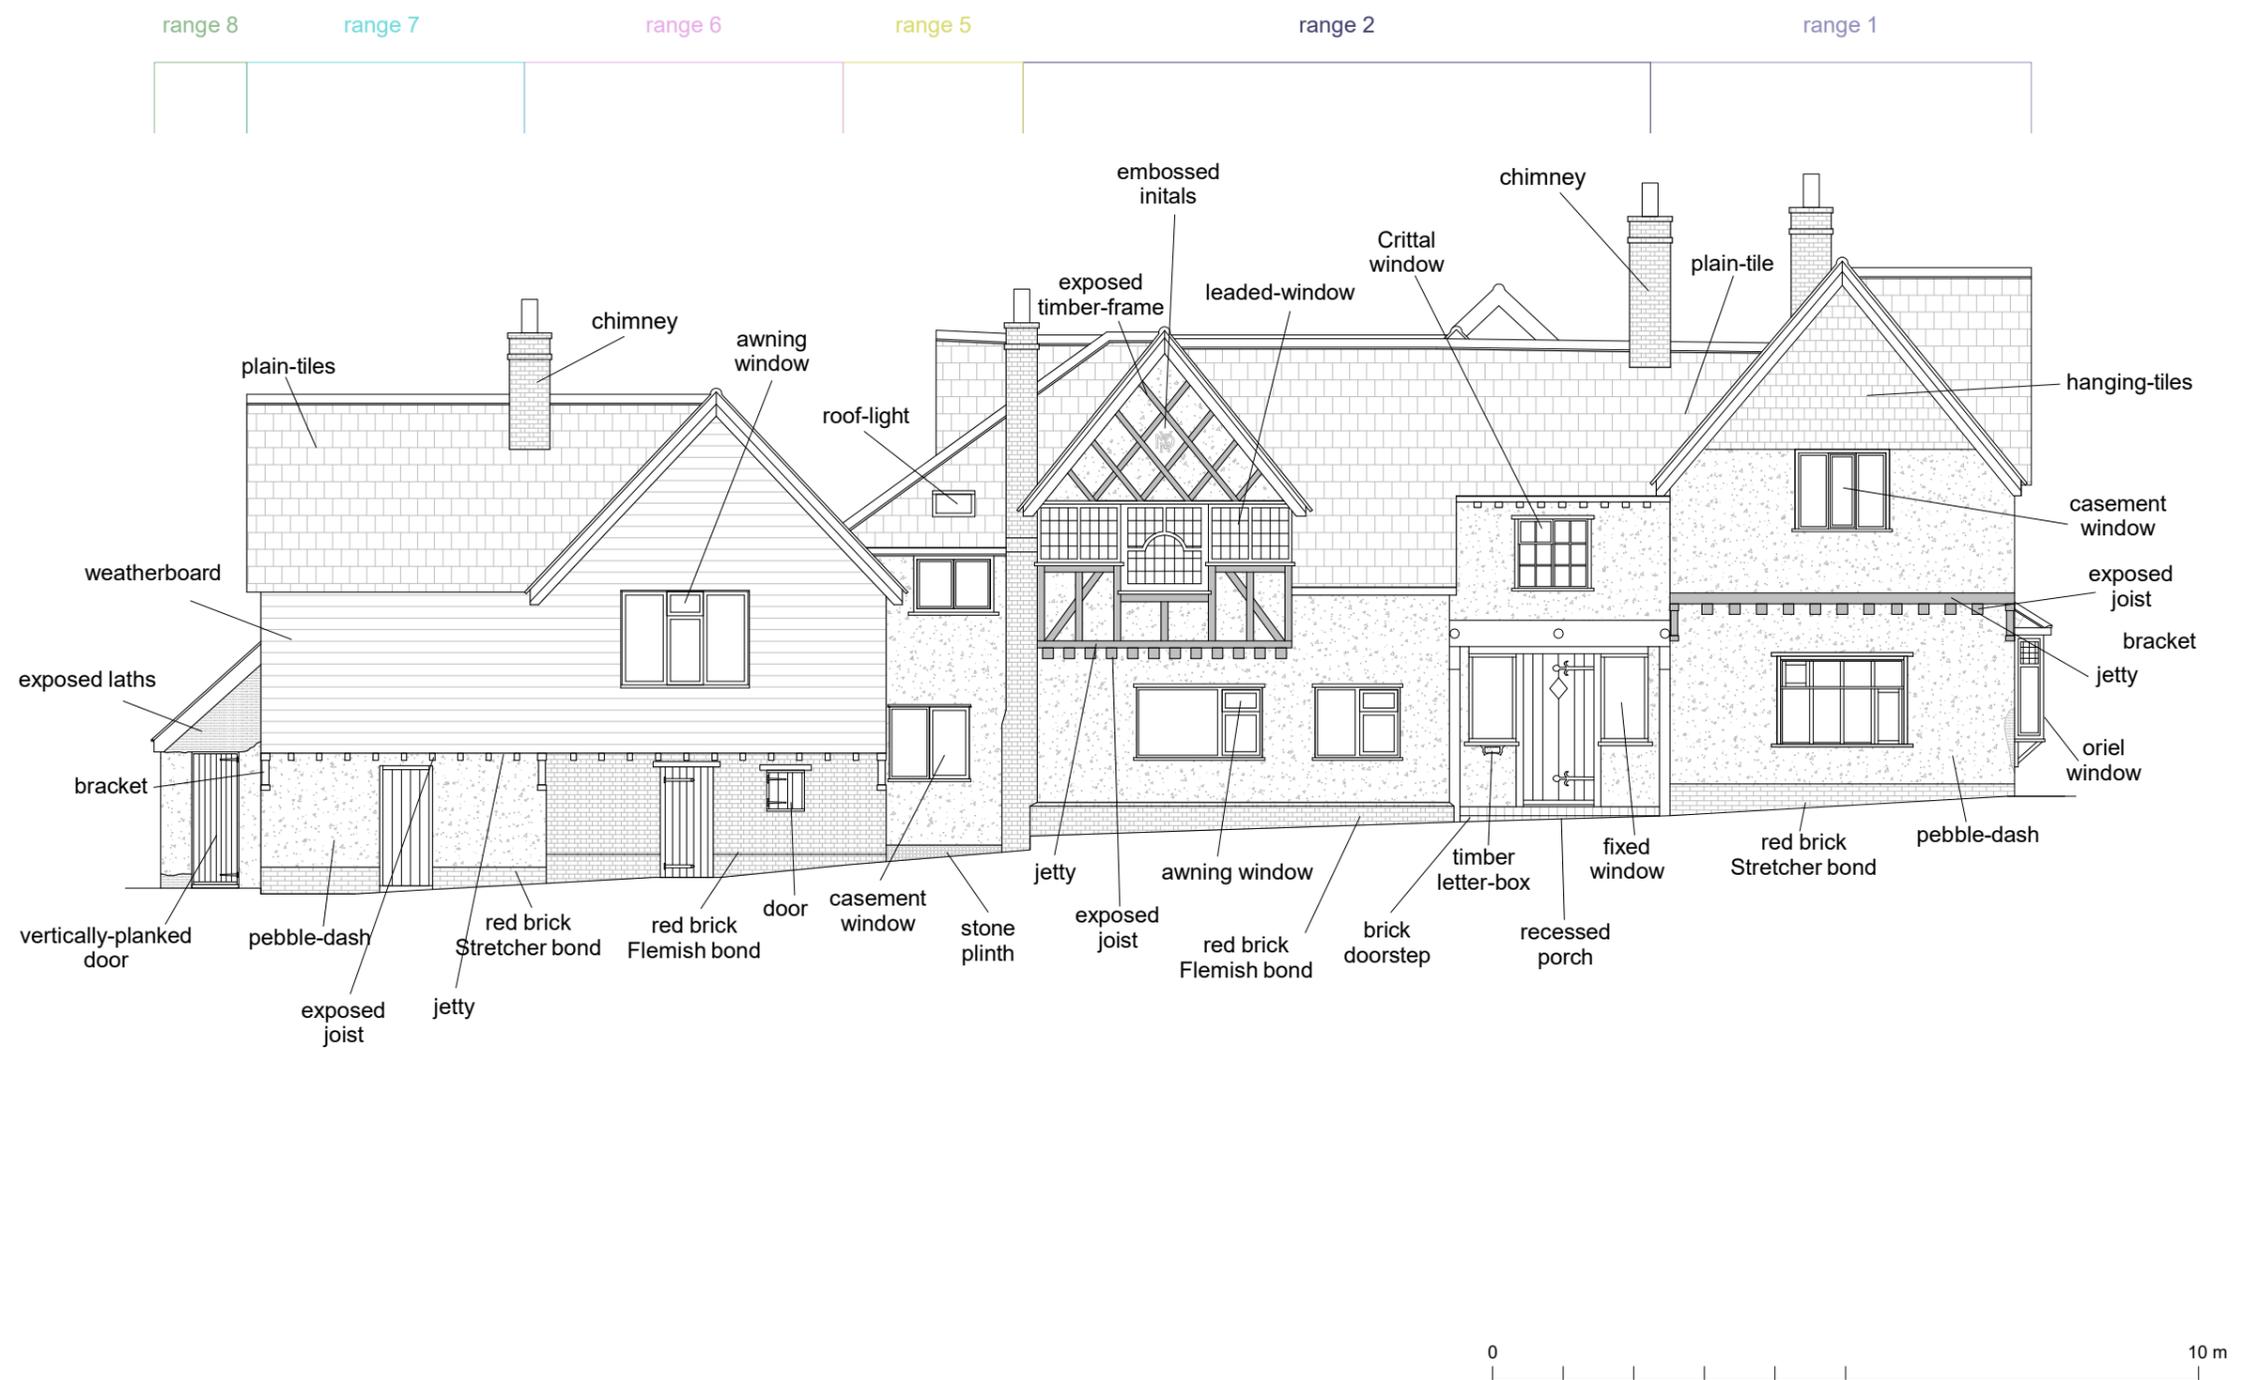
Fig 6 North-western elevation.

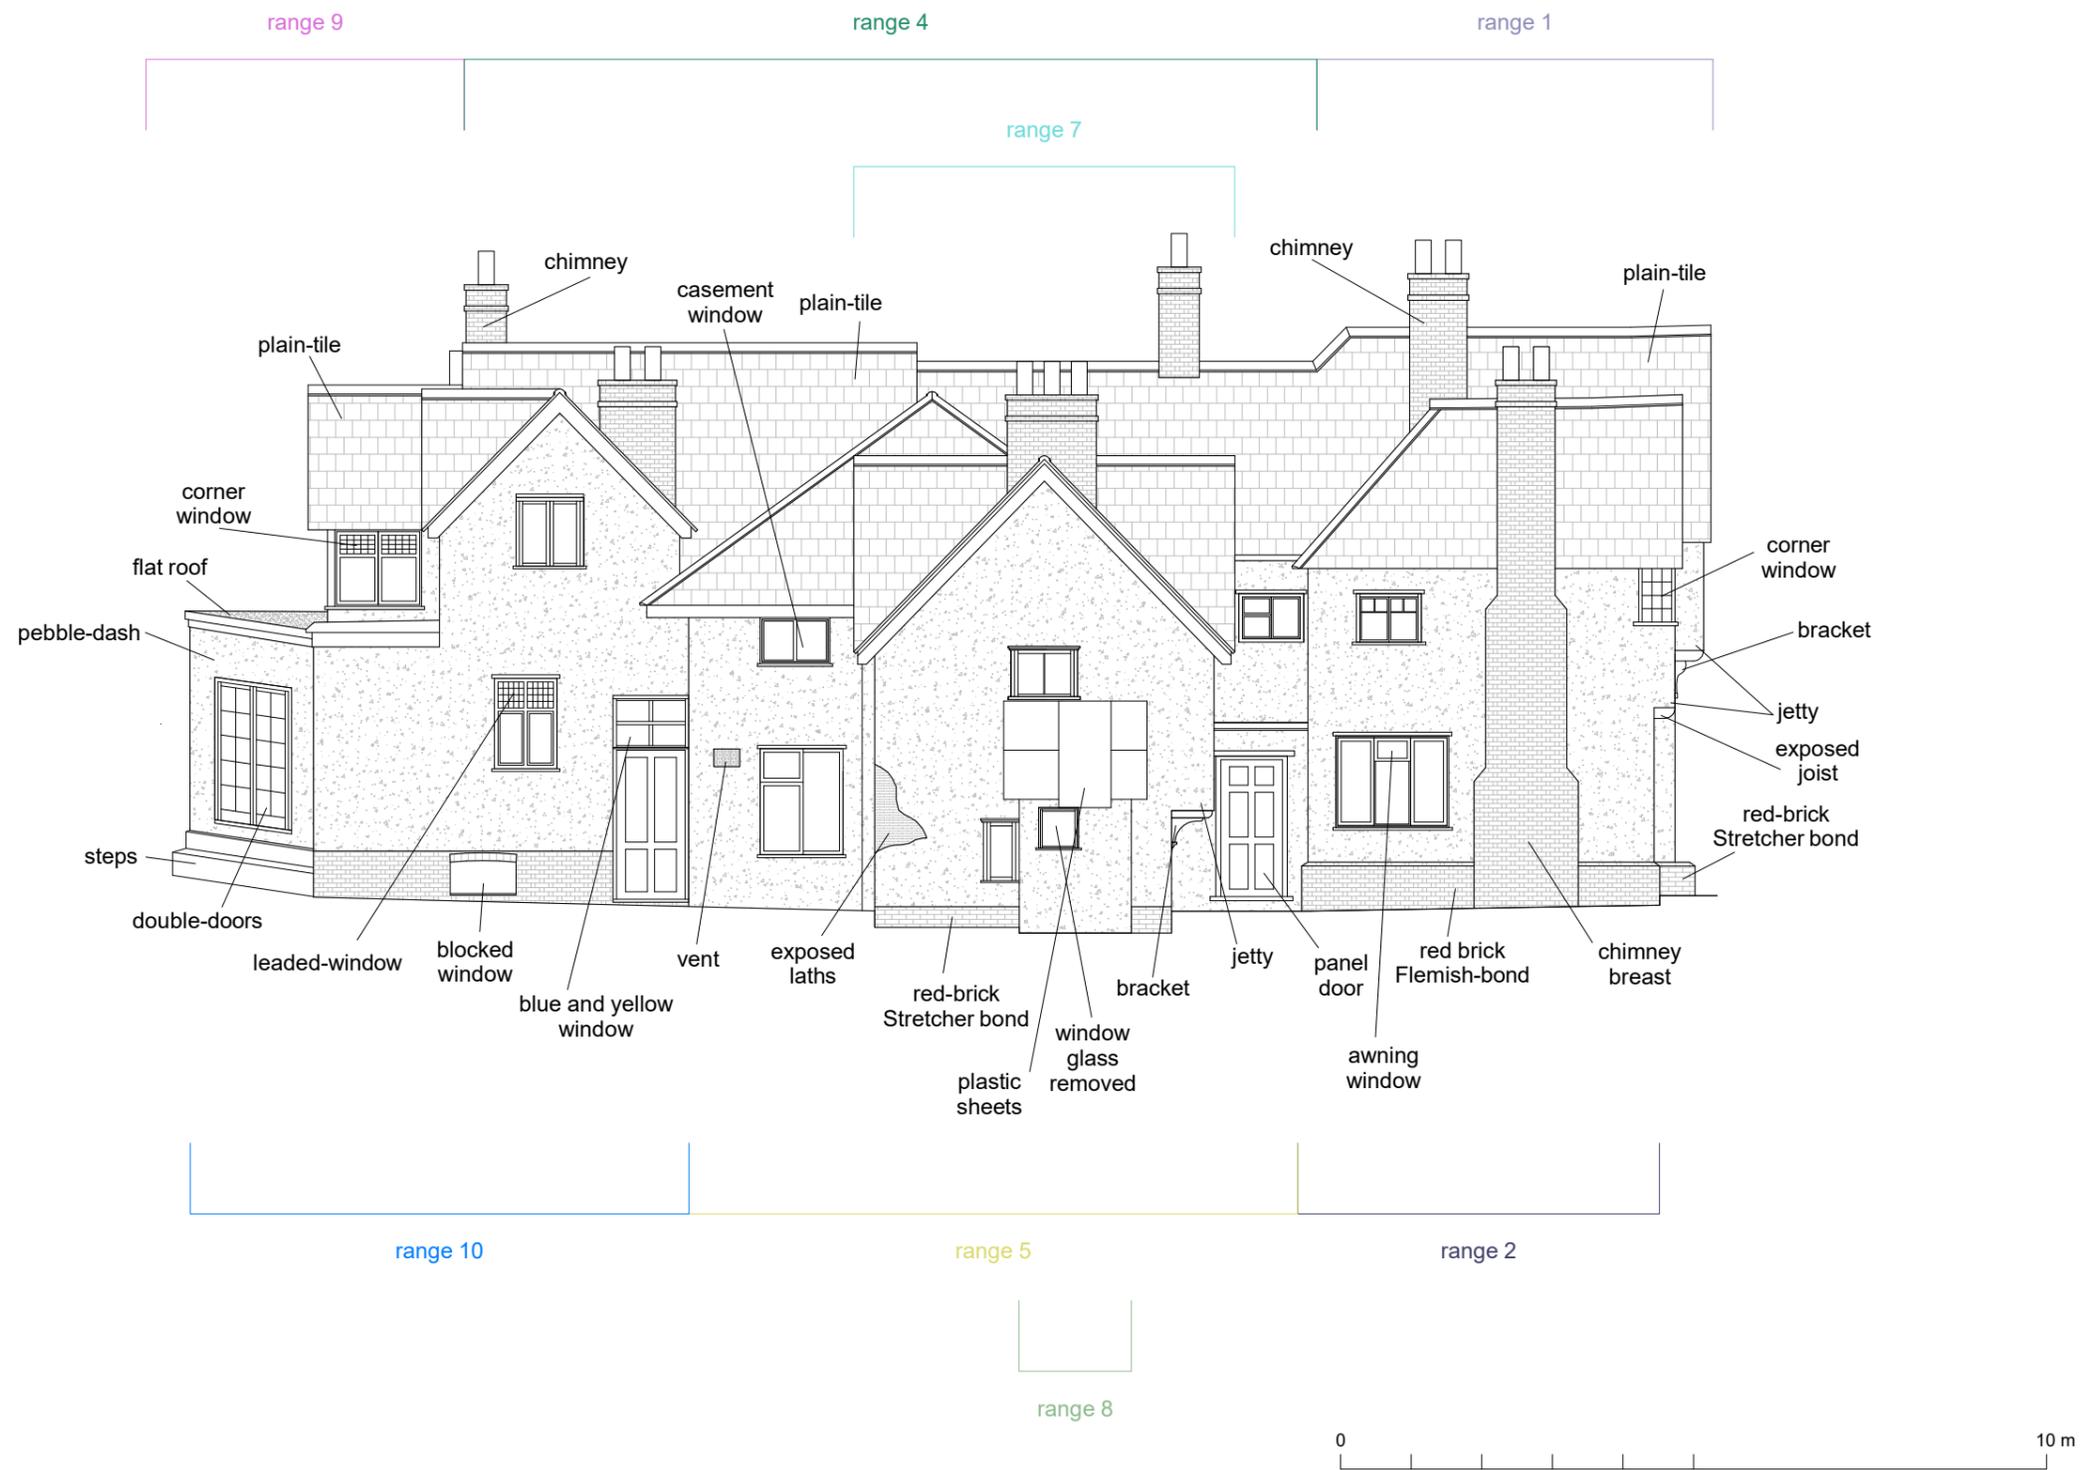
Fig 7 North-eastern elevation.

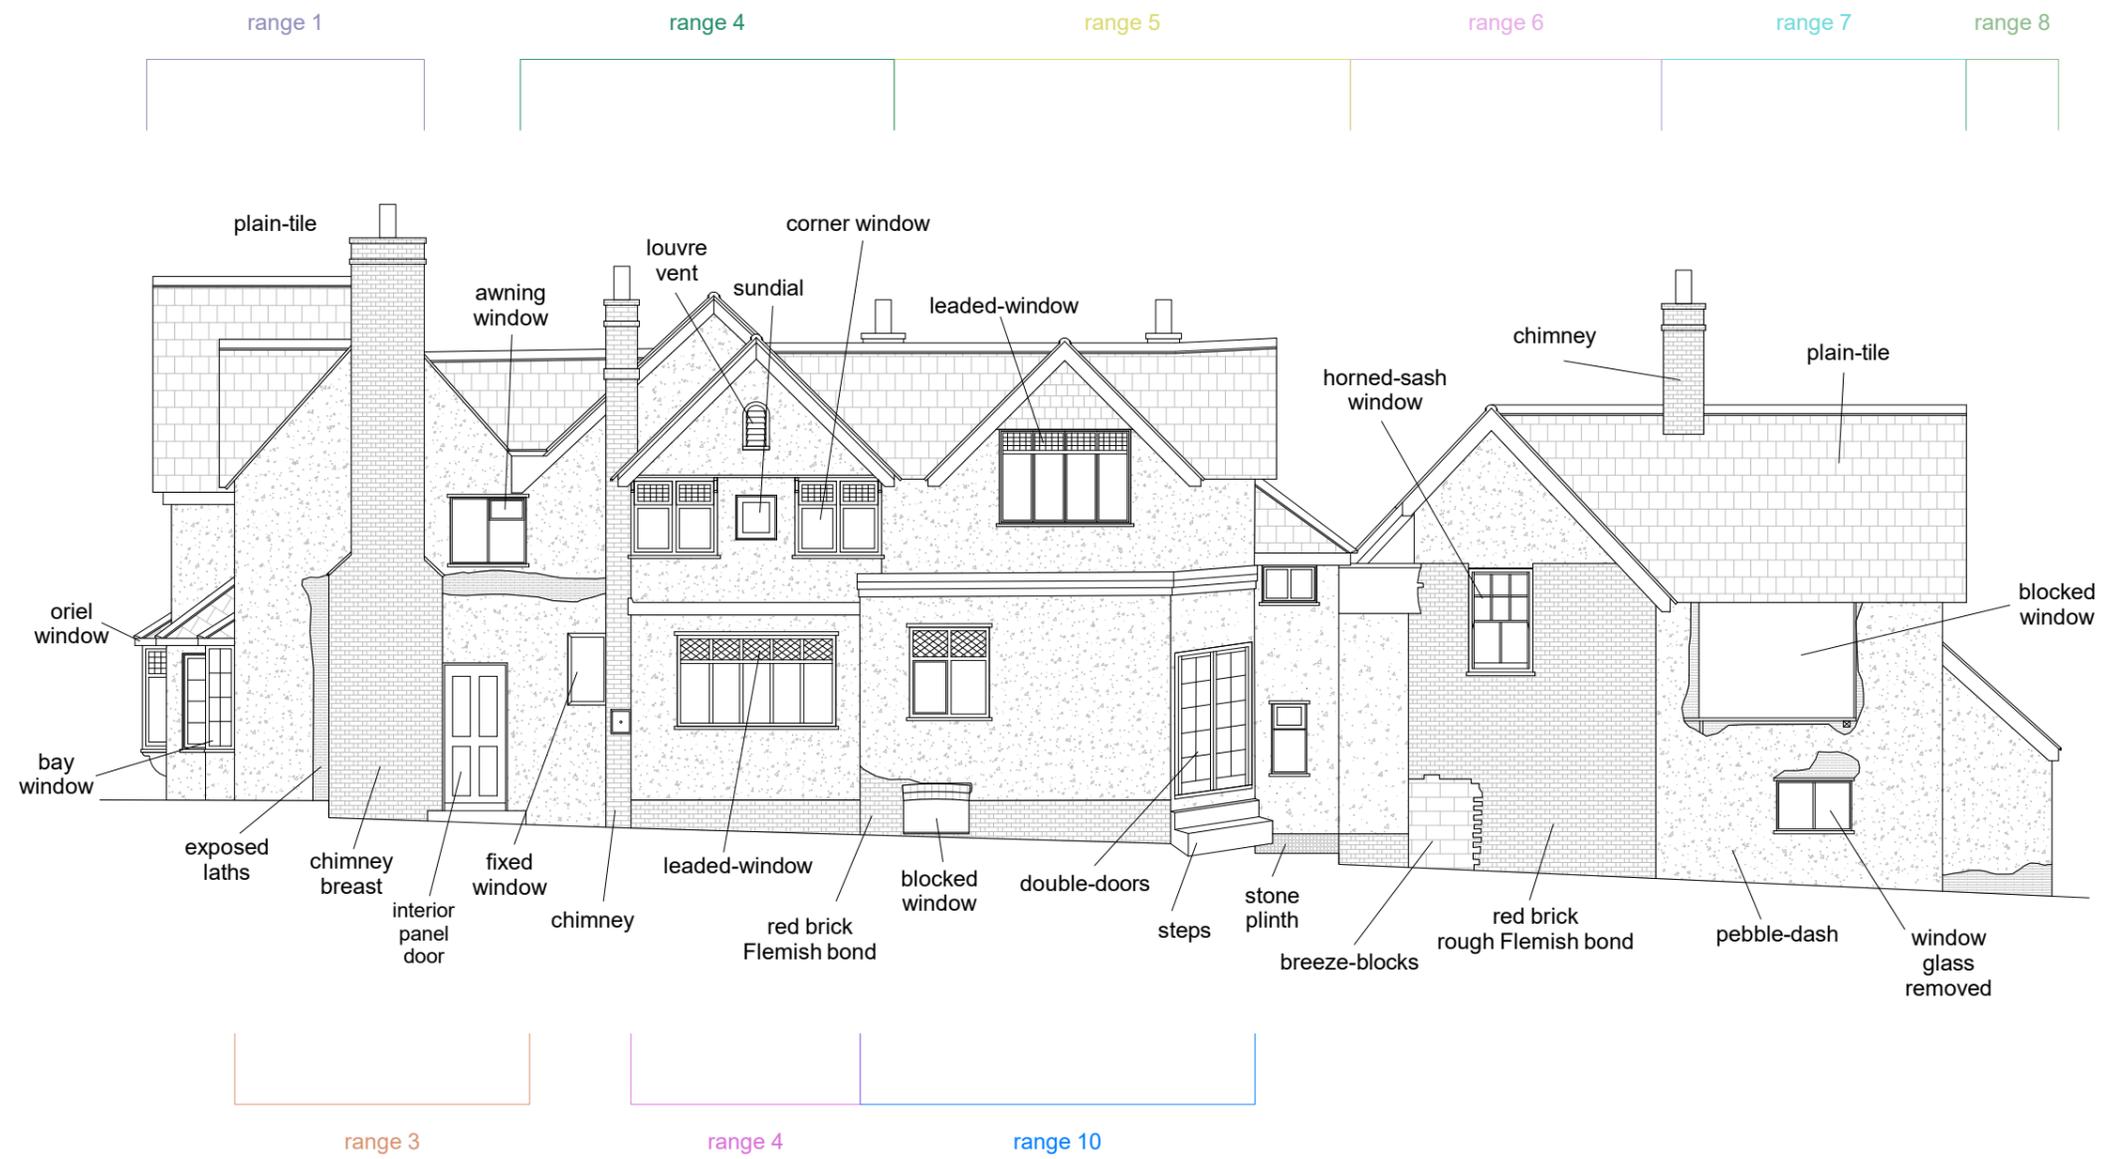
Fig 8 South-eastern elevation.
