**A watching brief at  
The Lindens,  
139 Lexden Road, Colchester  
(Phase 2)**

## **CAT Report 116**

CAT Report 116  
CAT project ref.: 99/10D  
Archive code: 1999-46

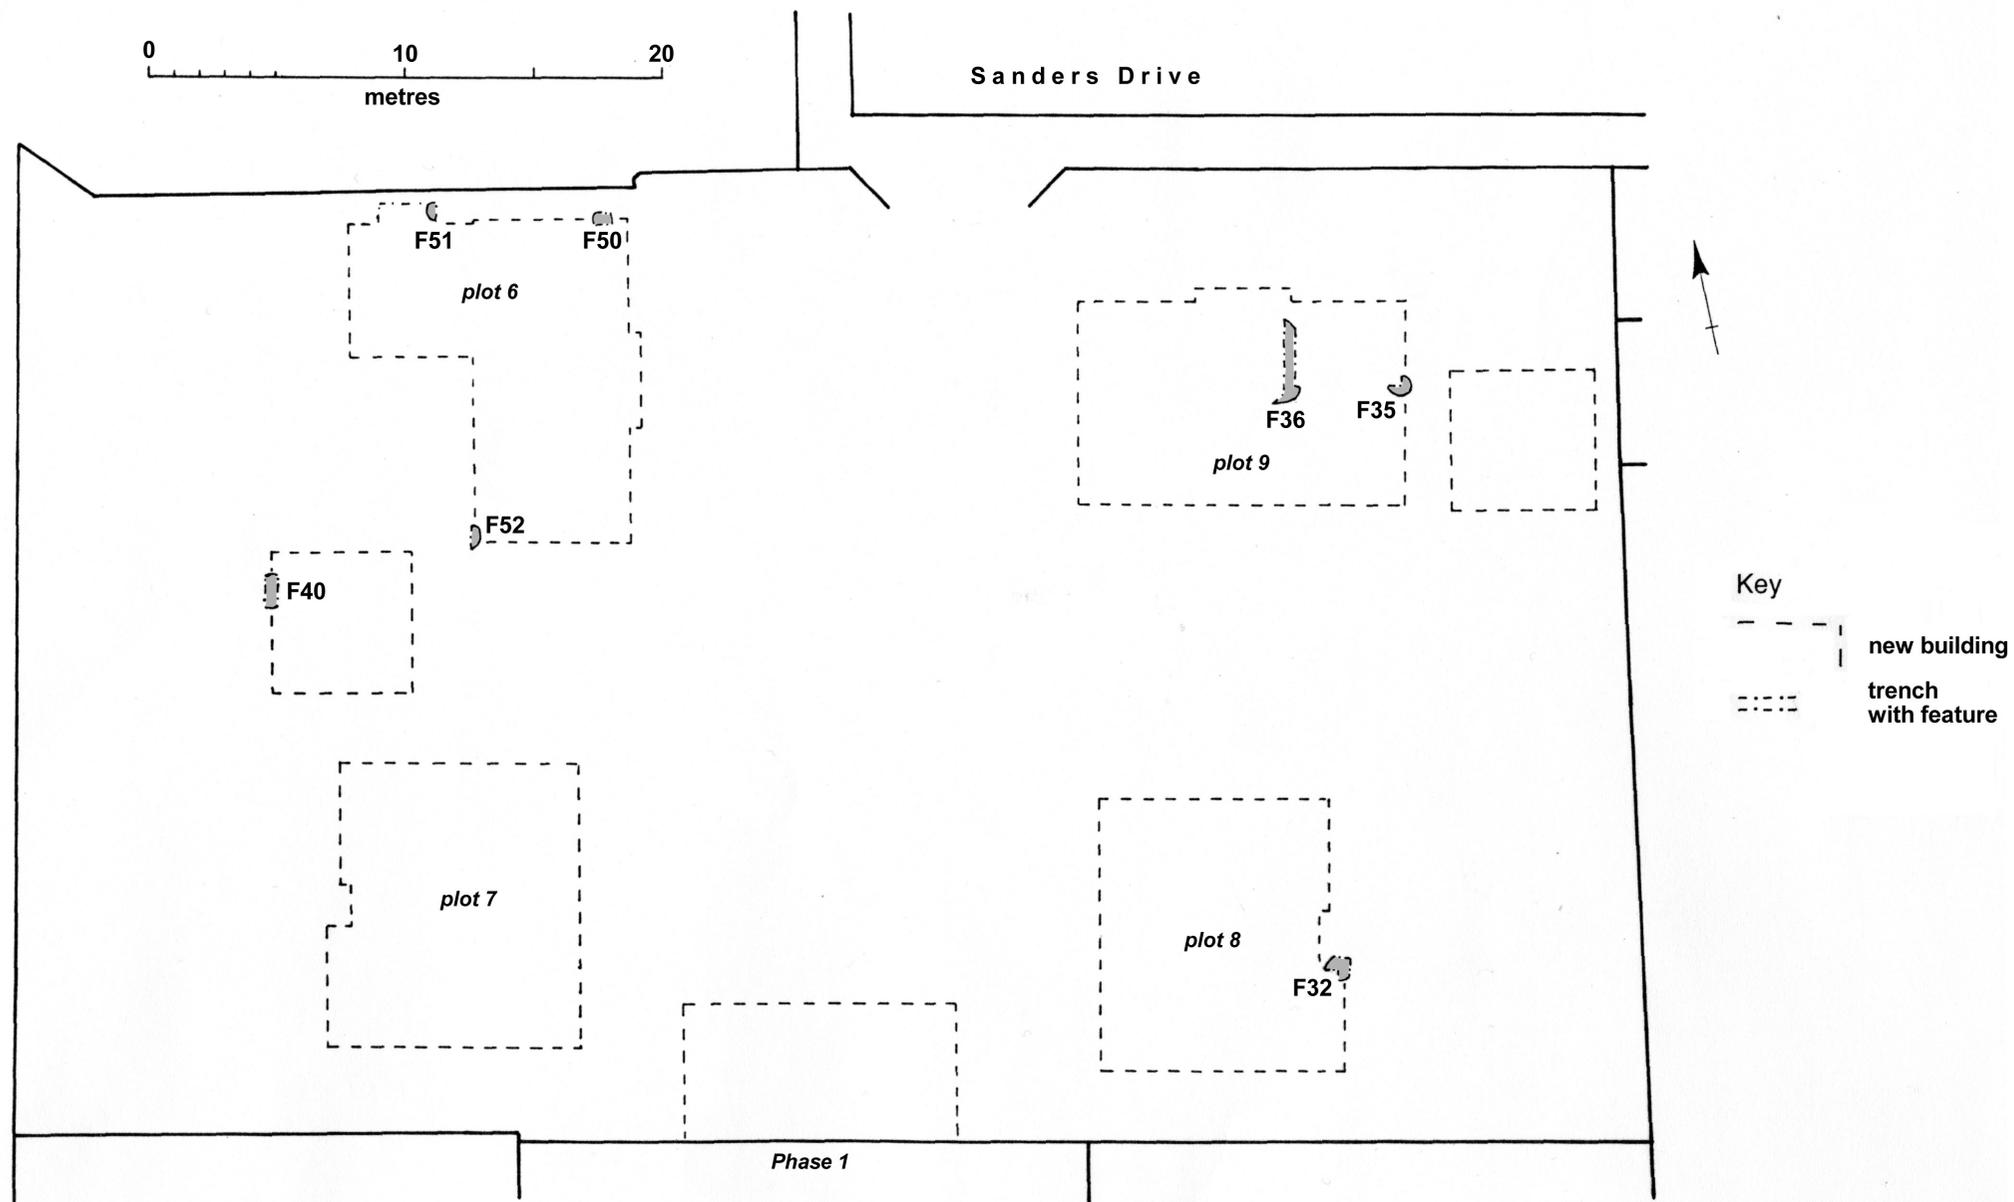
Fig 1 The Lindens, Phase 2: site plan.

Site inspections took place from October 1999 to June 2000. All house foundations were watched, also two garage blocks, boundary walls, drain trenches and a broad cutting along the Sanders Drive frontage. Foundation works for the double garage between plots 7 and 8 were not observed since the ground at that spot was already known to have been disturbed previously by a large basement for the original house called The Lindens. The deep ground disturbance extended east as far as the south-western corner of house plot 8, with shallower but widespread disturbance also affecting the western half of the plot. Significant levels of ground disturbance and modern make-up were found at the northern and eastern fringes of

plot 9. Elsewhere, modern disturbance was minimal and limited to the occasional service trench.

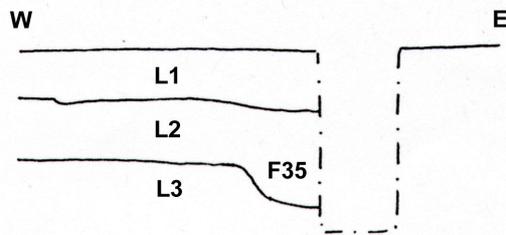
Fig 2 Sections: F32, F35.

Feature no	Description
F32	A pit, 1.1m deep overall. Mid-brown loamy sand fill. Section: Fig 2.
F35	A pit, 1.05m deep overall, with a fill of mid to dark brown sandy loam. Section: Fig 2.
F36	A pit of unknown depth. Mid to dark brown sandy loam fill. Section: Fig 3.
F40	A pit of unknown depth. Mid-brown sandy loam fill, becoming sandier with increasing depth. Section: Fig 3.
F50	A pit, 0.8m deep overall. Greyish-brown sandy loam fill. Section: Fig 4.
F51	A pit, 0.85m deep overall. Mid-brown sandy loam fill. Section: Fig 4.
F52	A flat-bottomed pit, 0.8m deep and 0.9m wide. The fill was mainly a dark greyish brown sandy loam, with darker grey lenses and occasional charcoal flecks in the lowest 15cm. Section: Fig 4.
